**Site and Reach Assessment  
Nason Creek  
at SR207 MP 0.4, 0.65, 0.9**

**Chronic Environmental Deficiency Program  
WSDOT Hydraulics and Environmental Services  
July 2, 2019**

# Site and Reach Assessment, Nason Creek at SR207

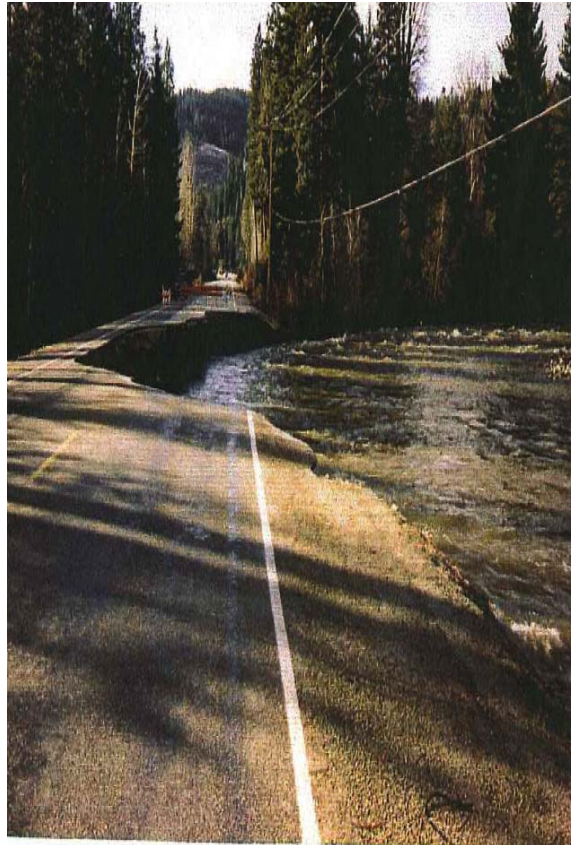
When the new alignment of SR 207 was constructed, Nason Creek was nearly 100 feet away from the highway prism at this location. In November 1995, a flood event on Nason Creek washed out a portion of SR 207 approximately ½ mile from the intersection with SR 2 at Coles Corner (Milepost 0.36 to 0.40; Figure 3). WSDOT repaired the highway in 1995 and installed riprap along the banks of Nason Creek. The emergency highway repair was constructed during high-water conditions and the toe of the slope wasn't constructed below the potential scour depth. Additional riprap was later added to repair additional scouring along the base of the highway riprap protection. This second repair did not fix the toe of slope or the limited width of the highway shoulder (Figure 4). In 2011, WSDOT maintenance crews installed additional riprap to reinforce the toe of slope and slightly expand the width of the bank protection to create a 5-foot wide highway shoulder consistent with highway safety standards. This project also included the installation of four rock barbs to help deflect stream flows away from the highway prism (Figure 5).

**Figure 3. Area 1 erosion from 1995 flood.**

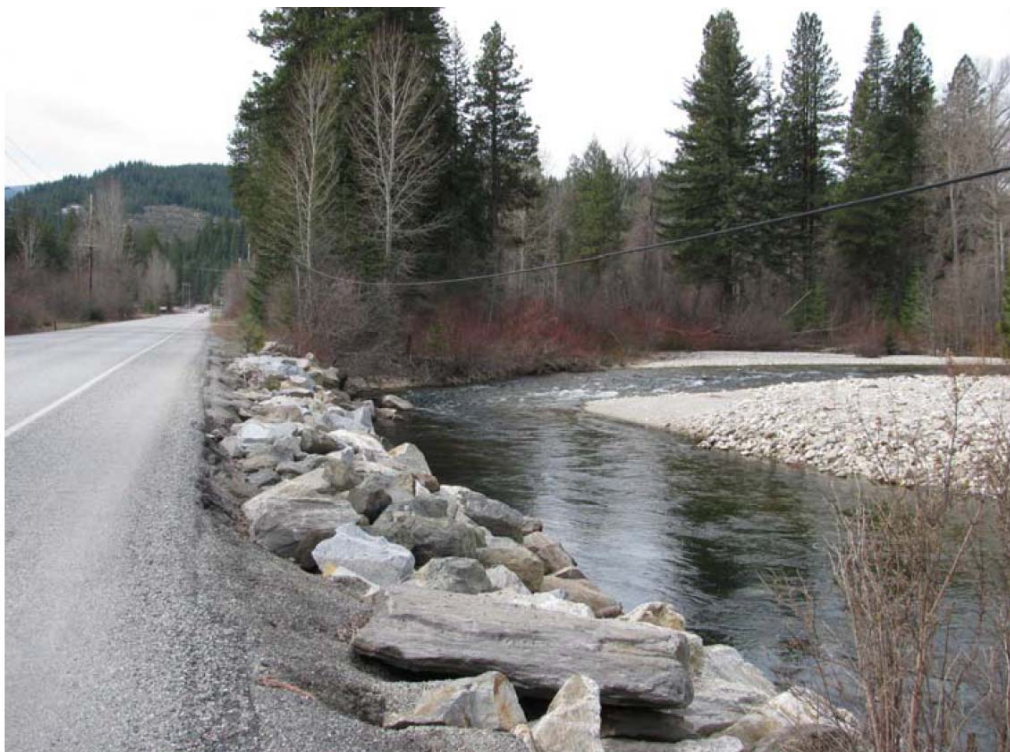
**Figure 4. Riprap installed after 1995 flood, from 2010.**

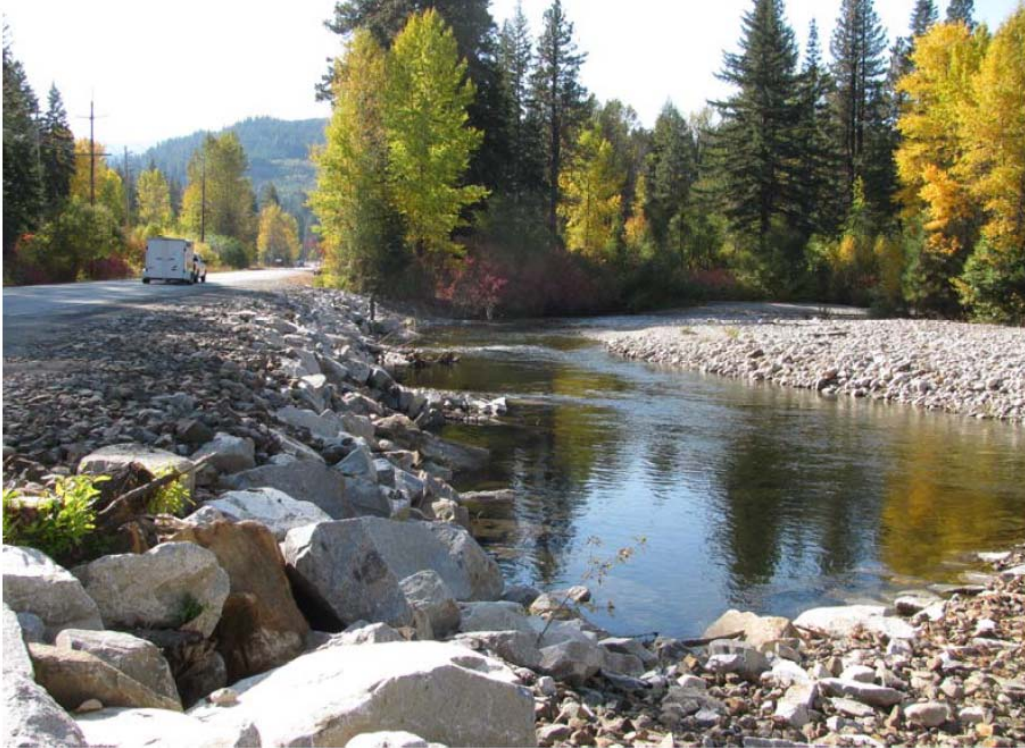
The rock barbs have been effective at diverting flow from the base of the road prism. However, they have been deformed significantly from various flood events and are losing their effectiveness (Figure 6). Some wood has racked on the rock/barb structure at the upstream end, and has held in place for several years.

**Figure 5. Site conditions in Area 1 in 2011, after addition of rock barbs.**

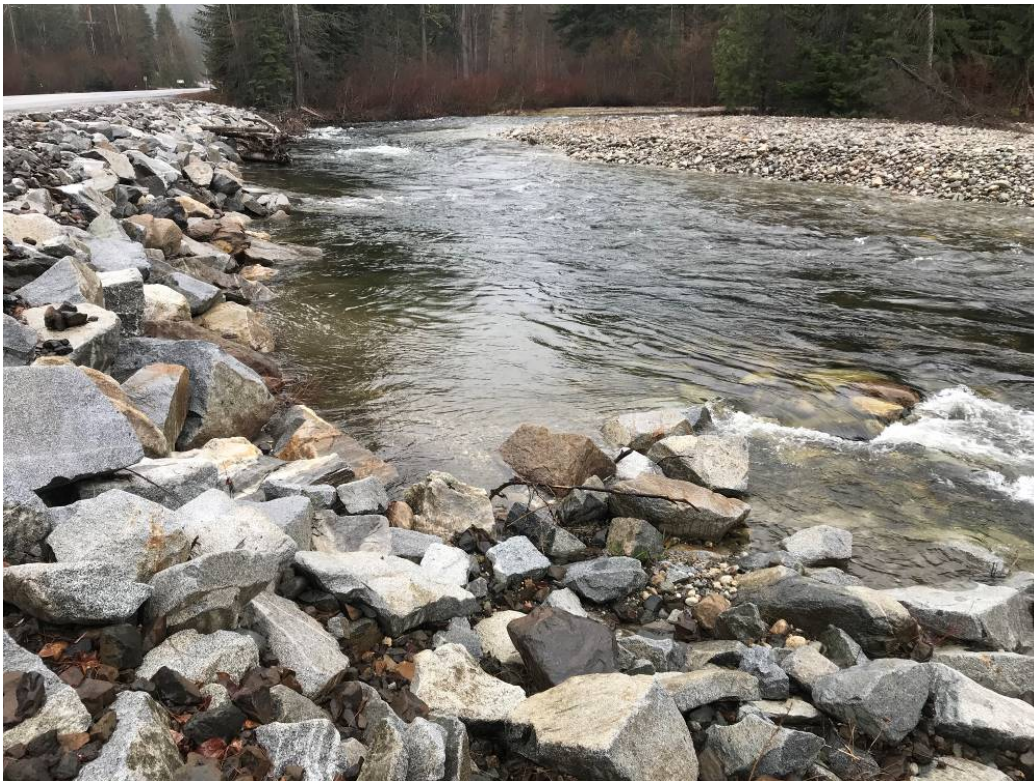
**Figure 6a. Area 1 rock barbs in April 2018.**

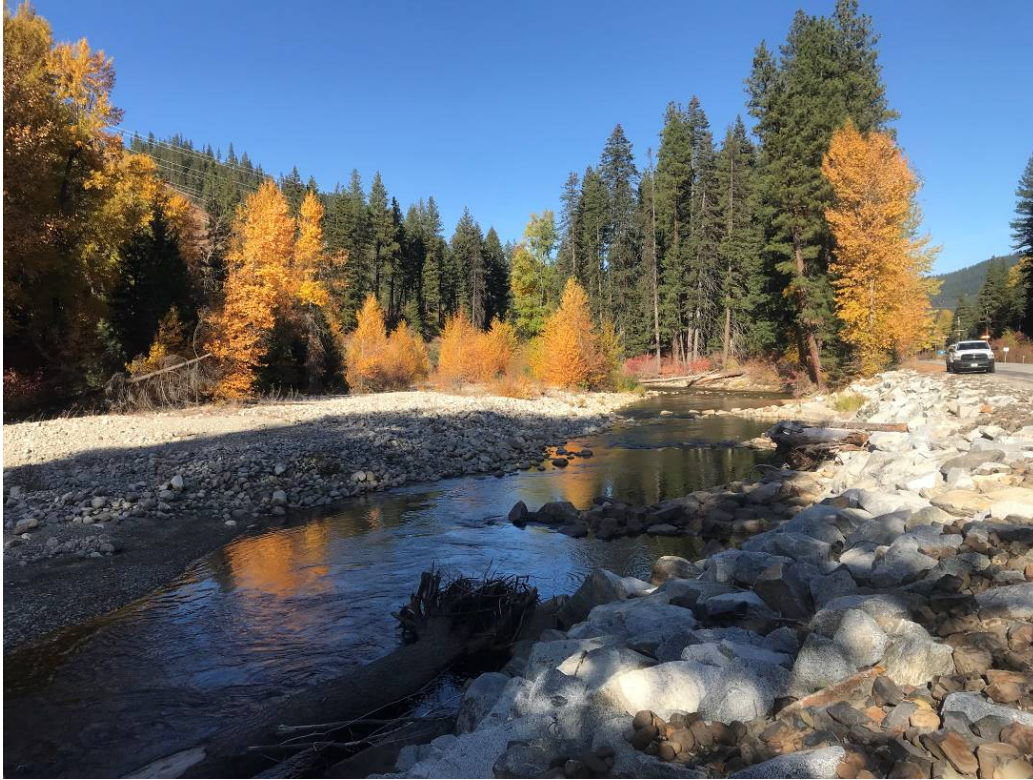
**Figure 6b. Rock barbs in Area 1, low flow, looking downstream (October 2018).**

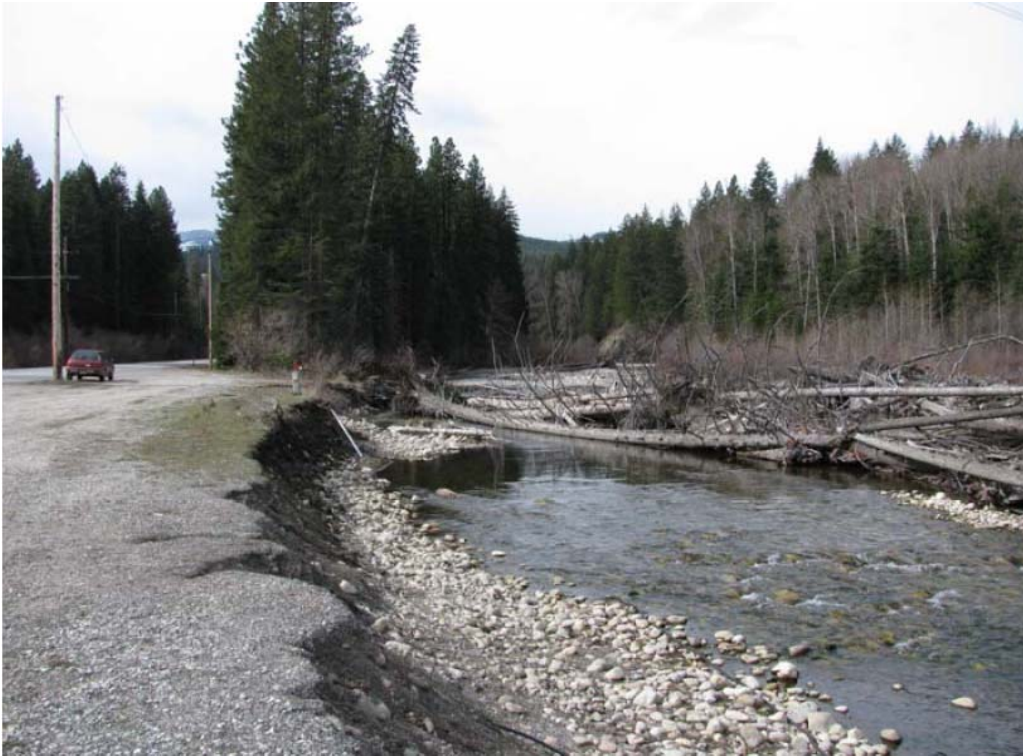
Just downstream of Area 1, between MP 0.6 and 0.7, is another area of concern, which has been the most active recently. This site has been eroding in pulses since 2009. Much of the area lies underneath Bonneville Power Administration (BPA) power lines, where riparian vegetation has been cleared and kept low. A fill pad adjacent to the west side of the highway is a remnant of a log scale facility. This fill has been eroding episodically in part due to the sizeable logjam that has formed just off the creek's right bank. A major flood in 2009 eroded the fill pad rapidly (Figures 7 & 8). Cutting of trees along the bank may have exacerbated this problem. The bank was treated with riprap (2012) to inhibit further erosion of the fill pad. In spring of 2018, erosion occurred behind the rip rap (Figures 9 & 10).

**Figure 7. Area 2 in 2009. Note position of car.**

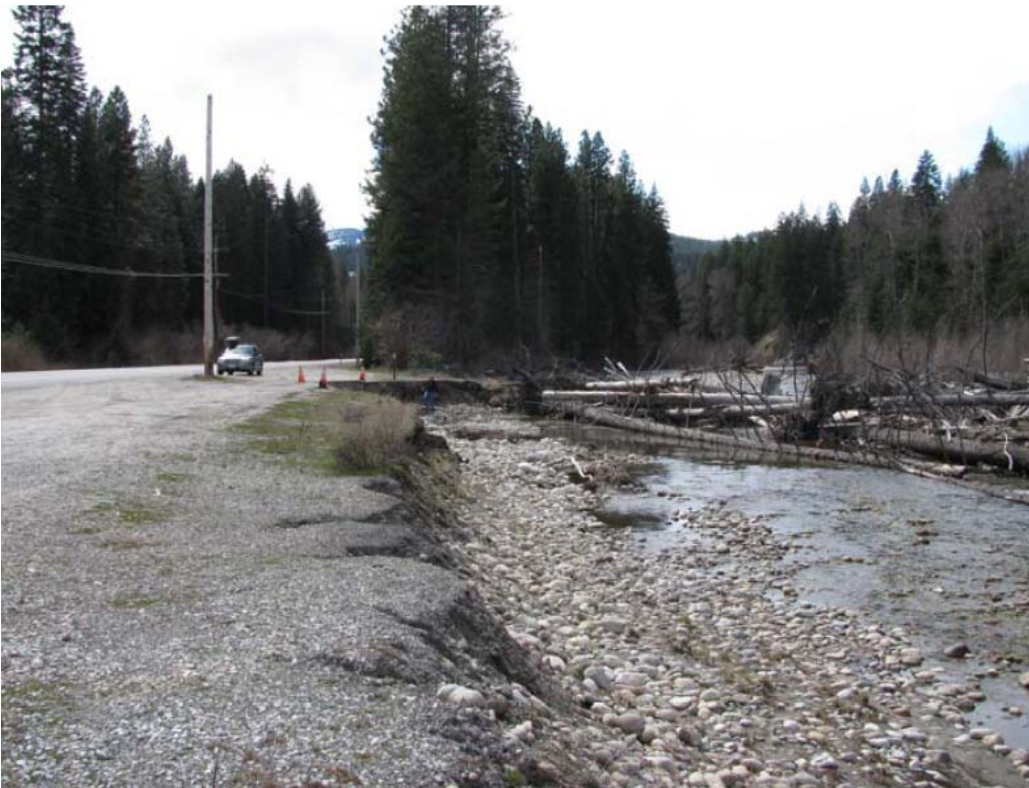
**Figure 8. Area 2 in 2010. Note position of car relative to bank.**

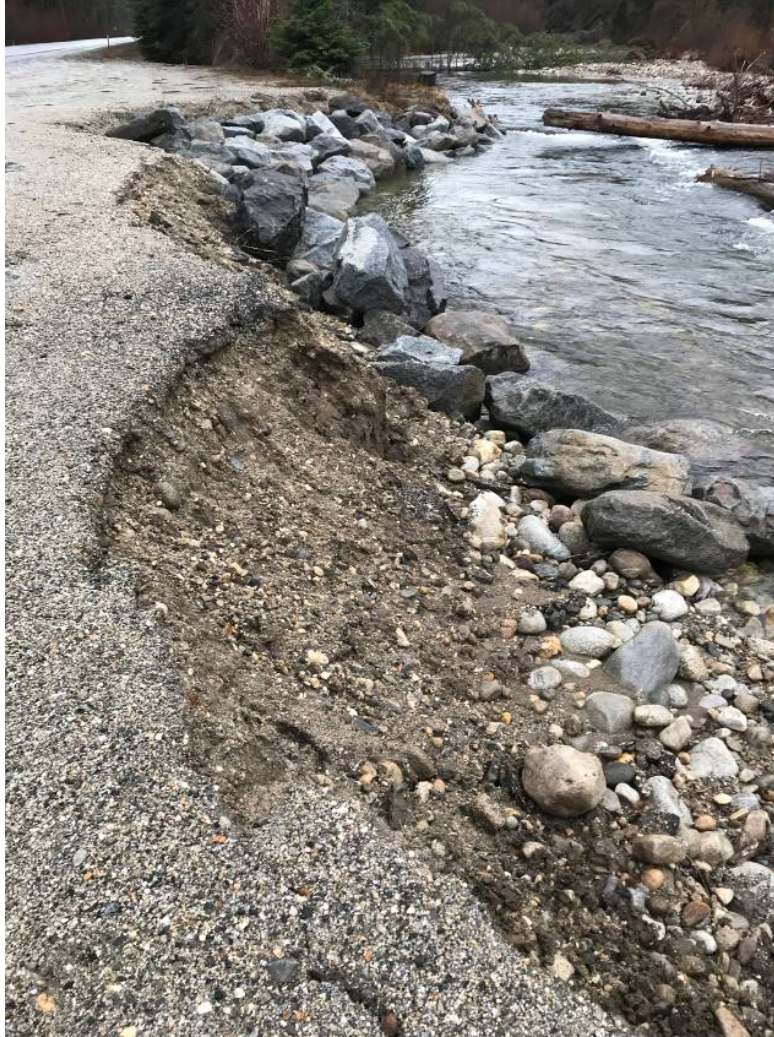
**Figure 9. Area 2 log jam looking upstream, in April of 2018.** Note tree spanning channel upstream.

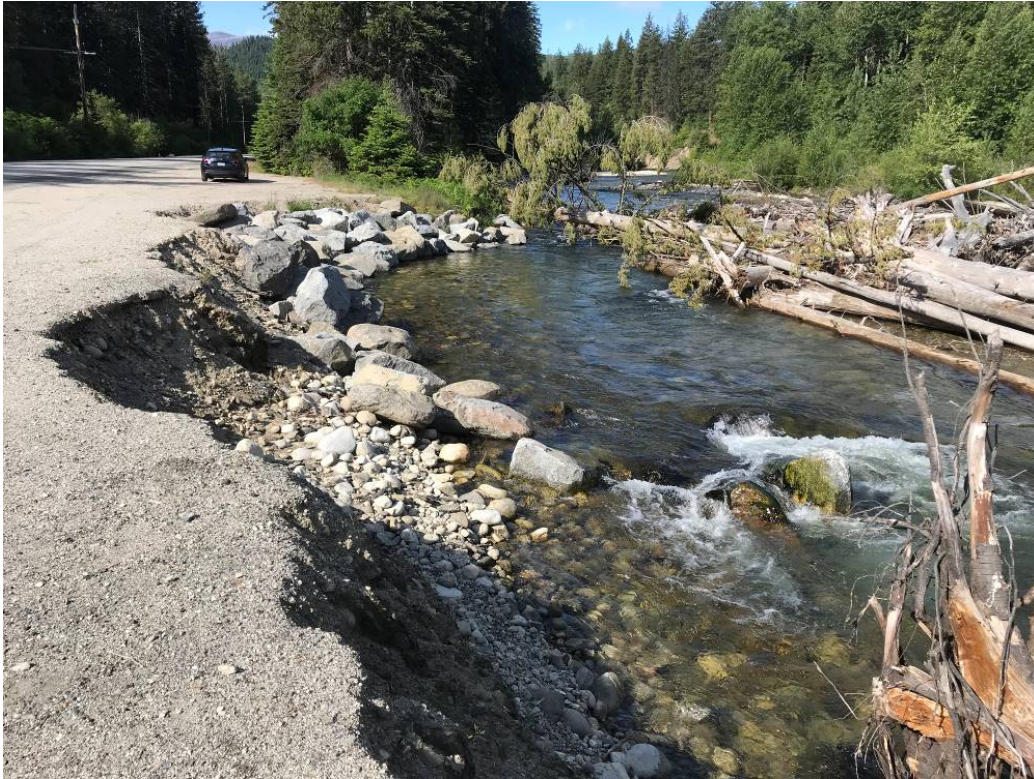
**Figure 10. Area 2 in June of 2018.** Note erosion behind rock revetment, and tree that was upstream in April now at logjam.

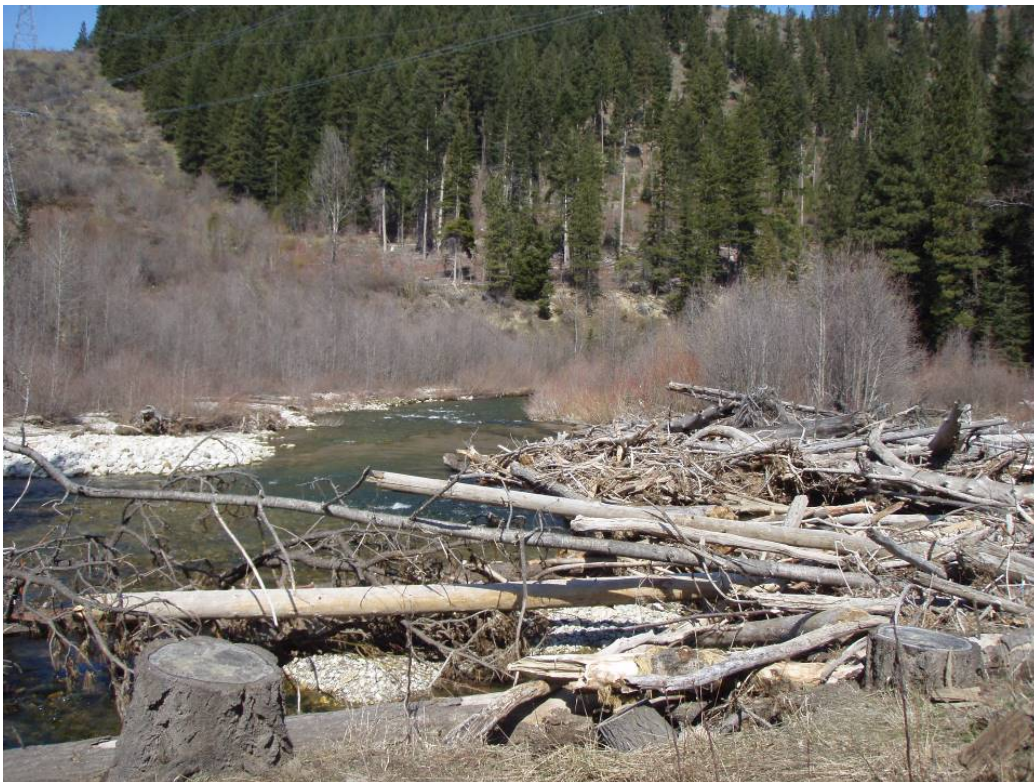
The presence of wood at the logjam is transient, and mobility of wood depends on many factors. In 2011 (Figure 11) and in 2017, a logjam nearly spanned the channel. However, in fall of 2017, the creek broke through. Between April and June of 2018, a large tree that had just fallen in the creek earlier that spring, was transported to the upstream end of the logjam. The flow through the logjam is now highly occluded (Figure 12), and there is a high potential for more debris racking on the structure. However, under right flow conditions, more wood could mobilize and open up the side channel again. The logjam appears to be contributing to bank erosion at times, as water is deflected to the right around the debris, sometimes with significant head loss.

**Figure 11. Area 2 looking west from highway April 2011.**

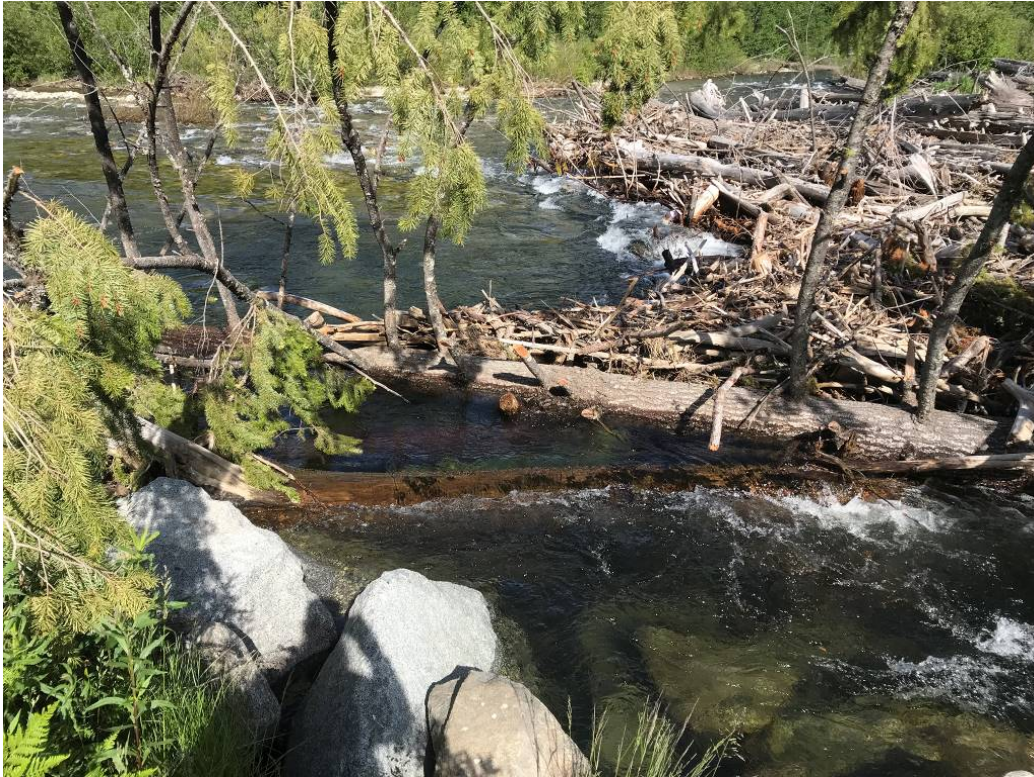
**Figure 12. Area 2 looking west from fill pad, June 2018.**

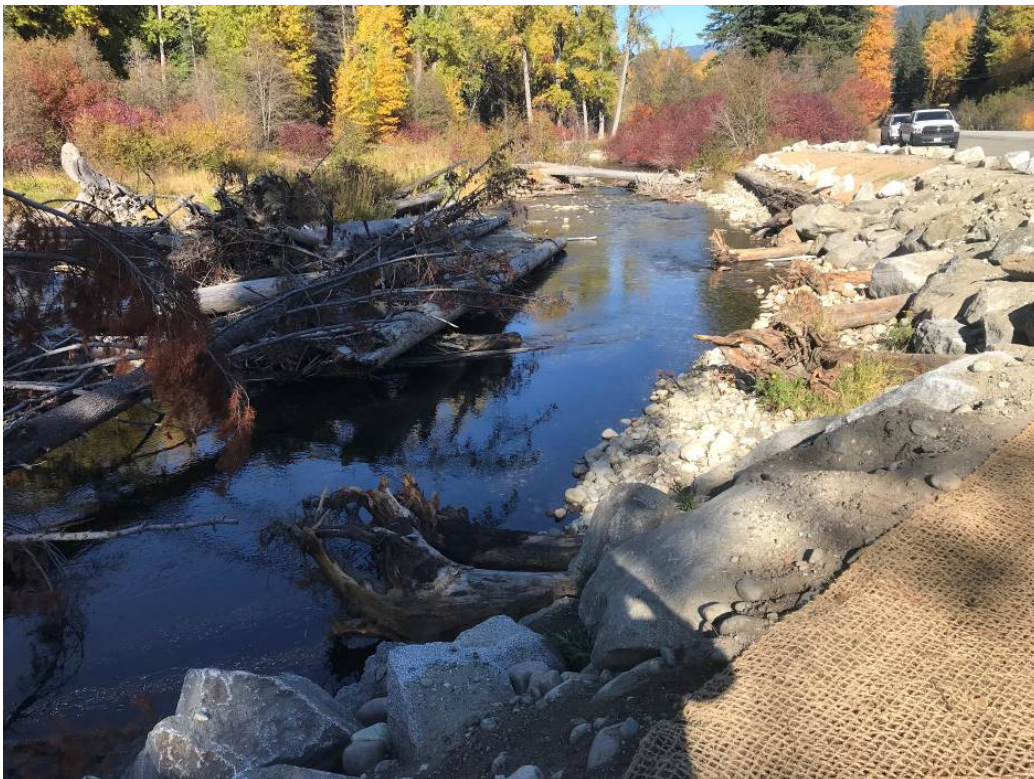
In the summer of 2018, the right bank of the creek along SR207 in this area was stabilized with a combination of rocks, logs with rootwads, and coir-wrapped soil (figure 13). This serves to stabilize the fill pad in this area, but is a temporary solution.

**Figure 13. Bank stabilization measures installed in summer of 2018.**

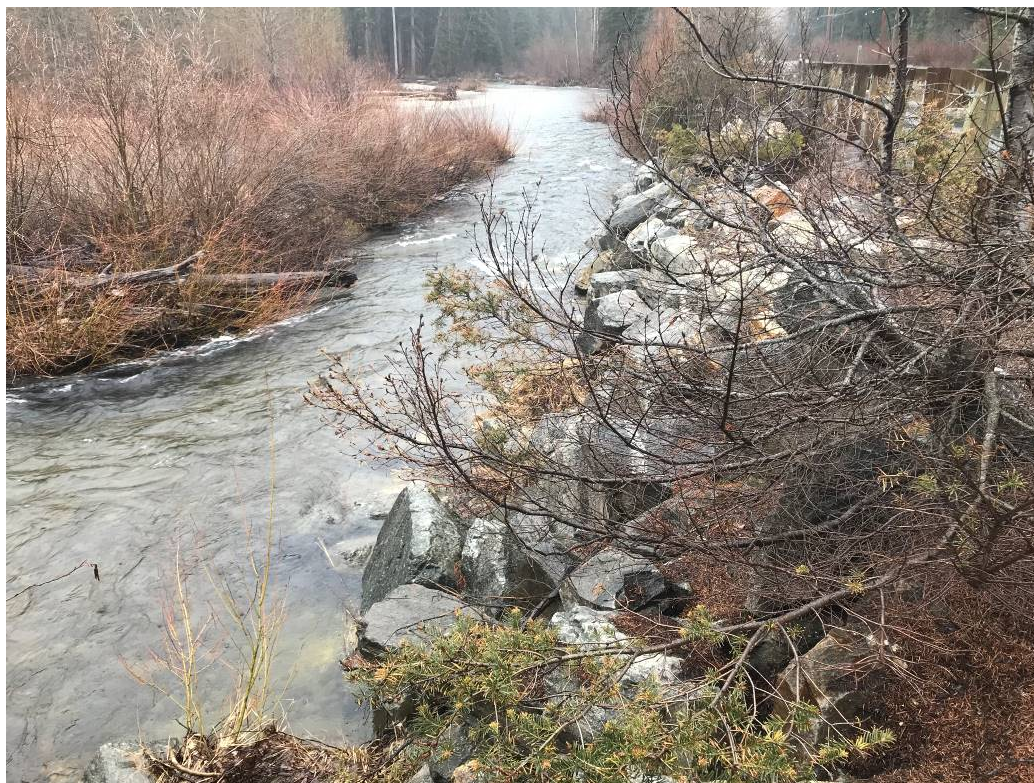
The 1941 re-alignment project cut off the floodplain on the east half of the valley floor and excavated an entirely new, straight channel parallel to the new highway (see Figure 25, page 30). Riprap was added to the upstream bend in order to lead the creek into the straightened section, and a “ditch dike” was built on the upstream end of the straightened section to prevent flanking of the new creek alignment. It is unclear from the plans how this was built or what the dimensions were. Additional rip rap was installed sometime in the last 20 years along the same reach (Figure 13).

**Figure 13. Rock revetment along SR207, April 2018.**

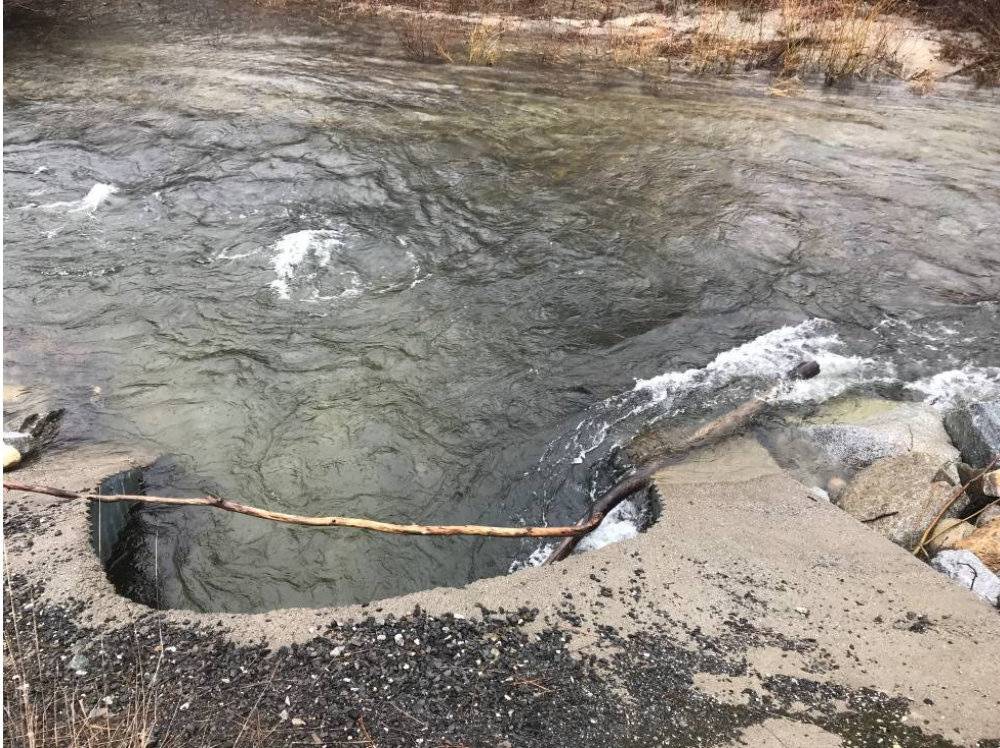
In 2007, Chelan County installed two culverts under SR207 to reconnect some flows to a historic channel on the east portion of the floodplain (Figure 14). The two culverts are both 12 feet in diameter. There appears to have been a substantial amount of sedimentation at the outlet of the upstream culvert since construction (Figure 15).

**Figure 14. Outlet twelve-foot diameter culvert, installed in 2007.**

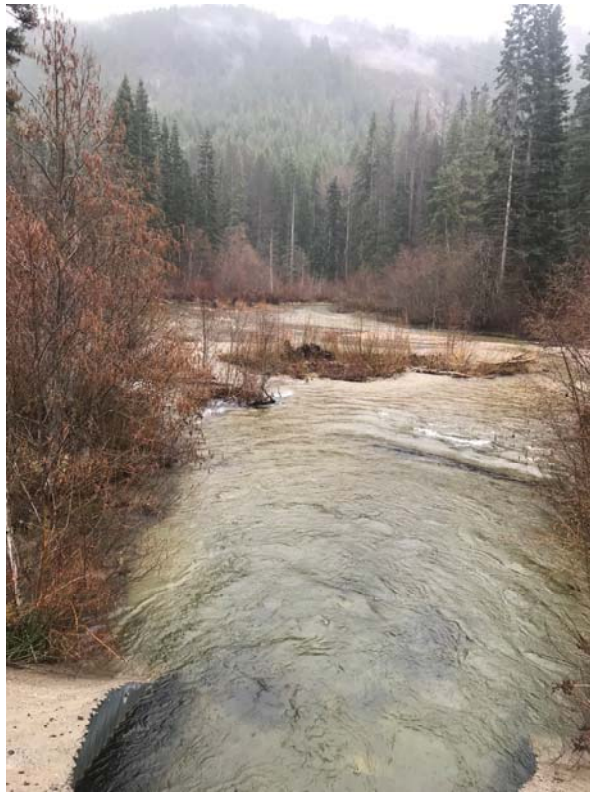
**Figure 15. Sedimentation at outlet of upstream culvert to historic channel (photo from April 2018).**

Though not shown graphically, sedimentation at the outlet of the 2007 side channel culvert was evident in the comparison of LiDAR data. About 5 feet of sedimentation occurred over these 8 years.

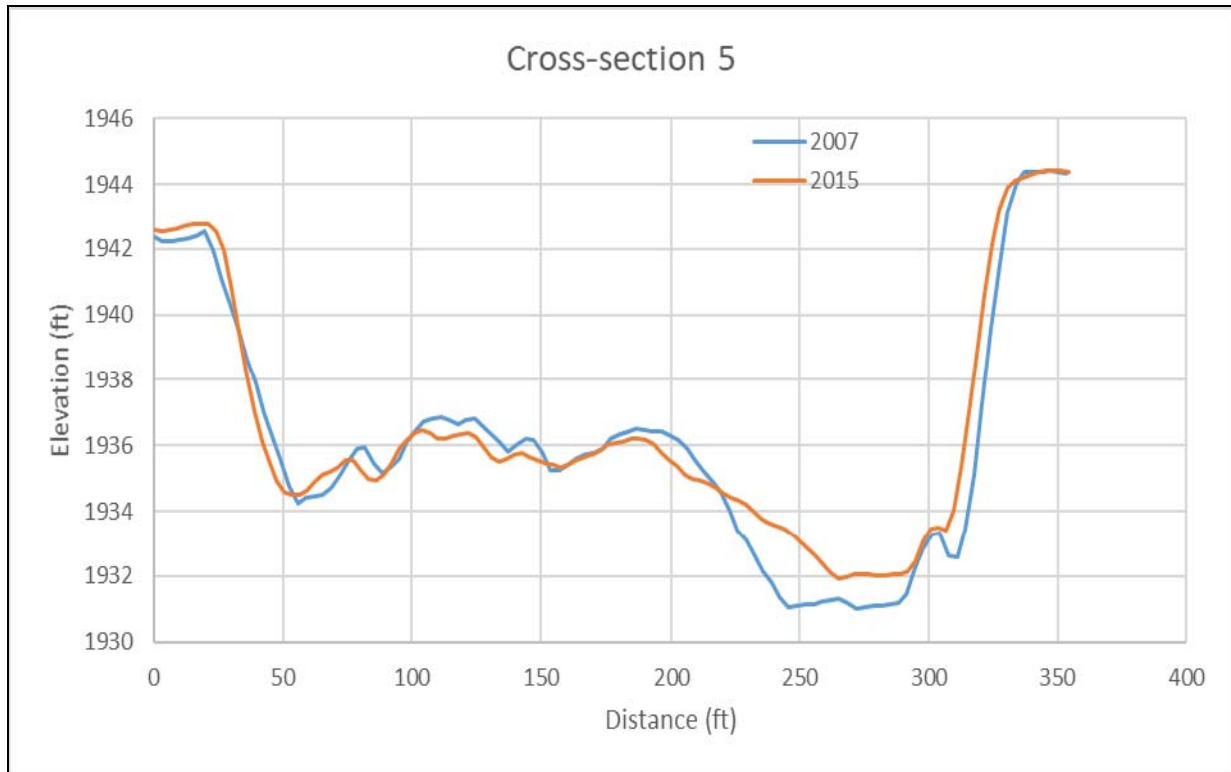
Figure 22. Cross-section 5 elevation data from 2007 and 2015 LiDAR

Cross-section 5 (Figure 22), which is relatively short, is located in the area where the creek is against the highway. Similar to Cross-section 4, aggradation has occurred, though only about a maximum of 2.5 feet. Cross-section 6 (Figure 23) has shown very little change, with only about a foot of aggradation in the main channel.

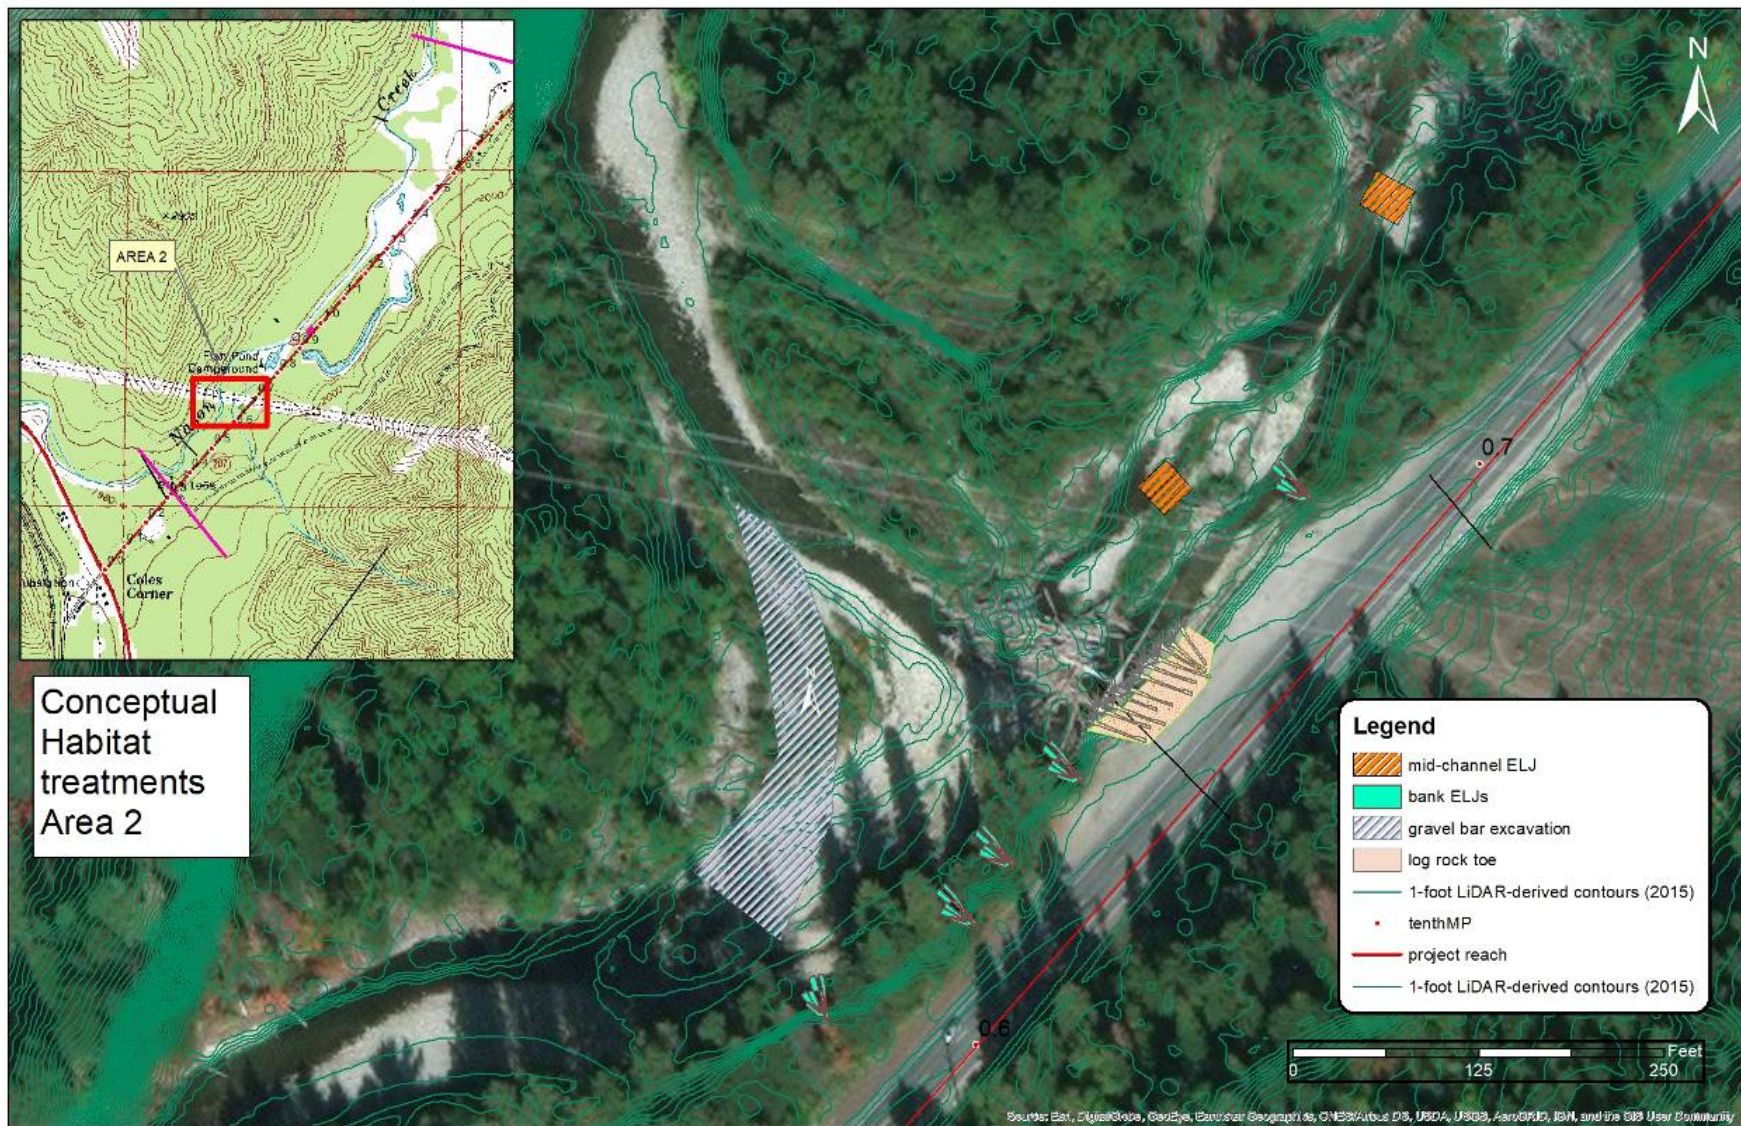
Figure 32. Conceptual treatments for Area 2.

In Area 2, erosion of the right bank is an ongoing threat created in part by the highway location in the middle of the floodplain, but it is exacerbated by the growing log jam at the outside of the meander bend that is working its way down-valley. A point bar on the inside of the meander bend is expanding and forcing flow on the opposite bank where the highway is located. Addressing the causes involve stabilizing the existing bank and stabilizing the log jam so that it does not break up, which may allow more of the mainstem to flow into the side channel along the highway. Additionally, the roadway surface is low enough to be occasionally affected by flooding. Flood frequency could be reduced by expanding other channels in the floodplain cross-section.

- Area 2: Install multi-log, bank-based ELJs that are secured using wood piles and racking logs with rootwads between them. Excavate a high-flow channel into the sediment plug in front of the existing logjam. Install a rock and log toe in the area adjacent to the existing logjam on the right bank. Install two bank-based ELJs downstream of the log and rock toe, and a mid-channel-type ELJ.

**Gravel bar excavation** – This is proposed only in Area 2. The area excavated would be about 300 feet long, and 70 feet wide at the upstream end, tapering to 30 feet wide at the downstream end. Because of the relatively small elevation difference between the pavement and the channel at this location, gravel bar excavation is recommended to increase the capacity of the stream channel and divert flows away from the highway, and reduce flooding of the roadway during high-flow events. As mention in section 3, the existing gravel bar has accumulated and grown in recent years due to the logjam under the BPA power lines. Excavation will take some of the sheer stress of floods off the right bank of Nason Creek.

This alternative would protect the highway while minimizing effects to aquatic habitat in some areas, and enhancing habitat in other areas. Drawings shown in Figure 31, 32, and 33 show the conceptual layout of the various recommended treatments. These would likely need to be constructed over more than one year.
