Beaver Creek

REACH ASSESSMENT

December 2017

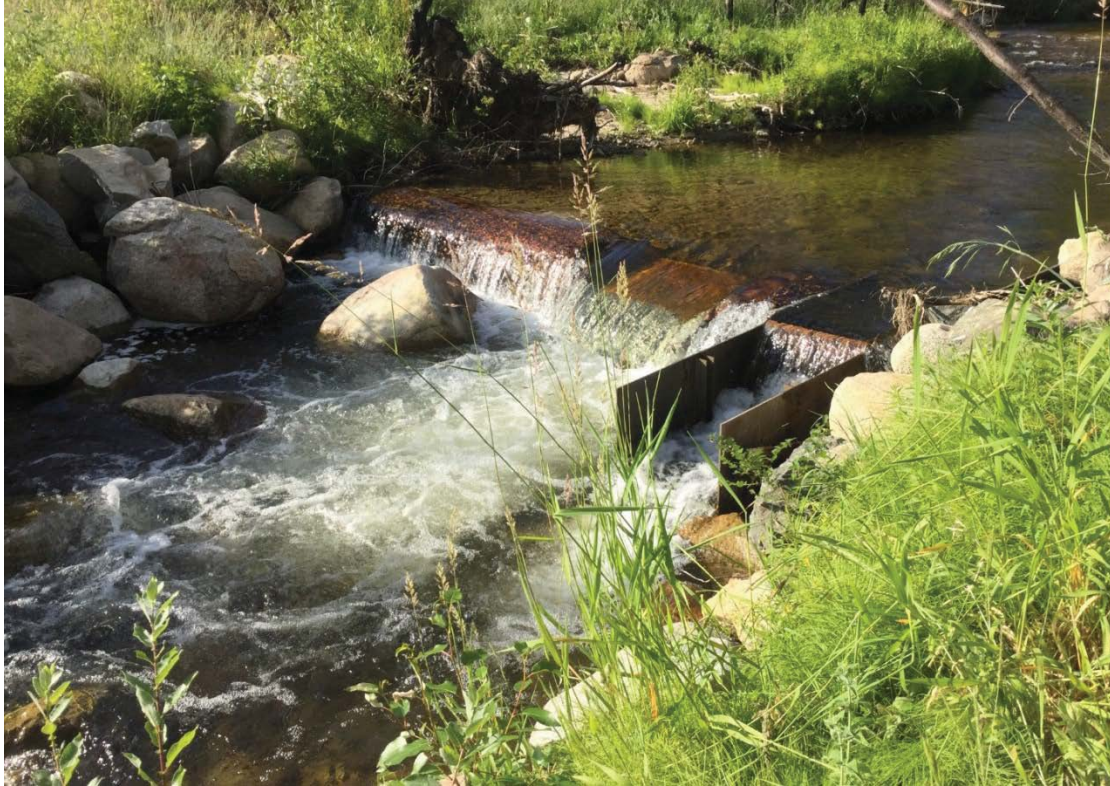
Many diversions presented full or partial passage barriers to adult and juvenile salmonids for many years, although the Methow Subbasin Plan reported that all diversions in Beaver Creek had been screened (NPCC 2005) and many have been altered or replaced to provide passage. The Okanogan Conservation District and USBR partnered with local landowners to replace seven diversions within the Survey Area that were known fish passage barriers on Beaver Creek (USBR 2013a). Although the primary aim of the passage improvements was to reconnect habitat for salmonids, the projects also included related improvements including culvert removal, pump and headgate replacement, additional diversion replacement, piping, and water acquisition actions (USBR 2013a). Ongoing maintenance and monitoring of irrigation diversion structures is needed to ensure continued passage of fish at all life stages. Figure 2-3 shows a recent photograph of the log weir and fish ladder structure at the Batie Diversion near RM 6.3.

Figure 2-3. Photograph of Log Weir and Ladder Structure near RM 6.3 at Batie Diversion

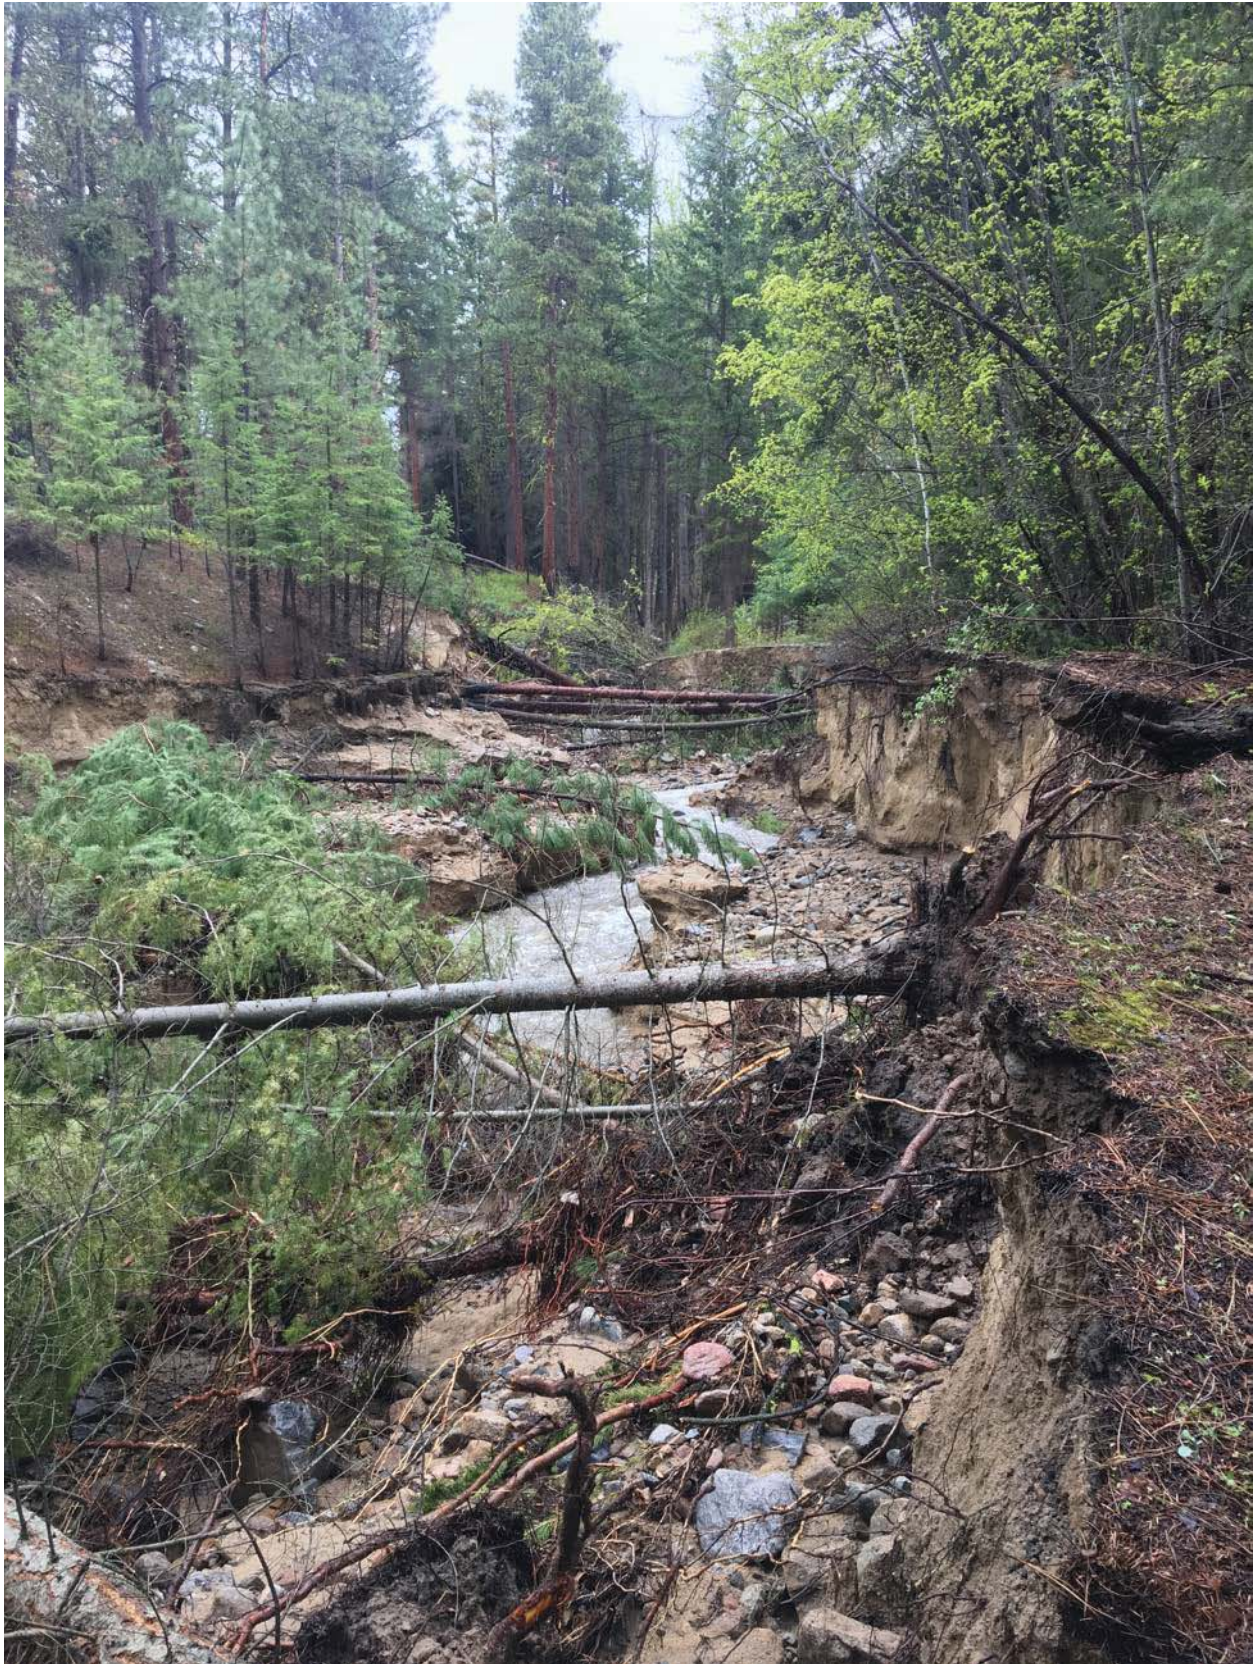
There are also existing culverts that have been identified as known or potential sources of sediment within the Beaver Creek drainage. For example, there are 11 NF-200 Road crossings on Volstead Creek within the lower 1.25 miles that are prone to plugging and have resulted in excessive sediment inputs (Molesworth pers. comm. 2017). Road crossing impacts on Volstead Creek increased following the 2006 Tripod Fire, which burned most of the Volstead Creek drainage and altered runoff and peak flow hydrology. In 2011, the road failed at multiple locations transporting large volumes of sediment into Beaver Creek that severely impacted fish habitat. The road was repaired through the Emergency Relief for Federally Owned Roads (ERFO) process, but the repairs did not address the underlying issues. Volstead Creek road failures and sediment delivery to Beaver Creek are ongoing occurring in 2014 following the Carlton Complex Fire, in 2016, and most recently in 2017 following an intense rainfall event (Wagner 2017). The photograph in Figure 2-5 shows the location of a catastrophic road crossing failure on Volstead Creek that occurred on 2017.

Figure 2-5. Photograph of Road Crossing Failure Location on Volstead Creek (Source: J. Johnson)

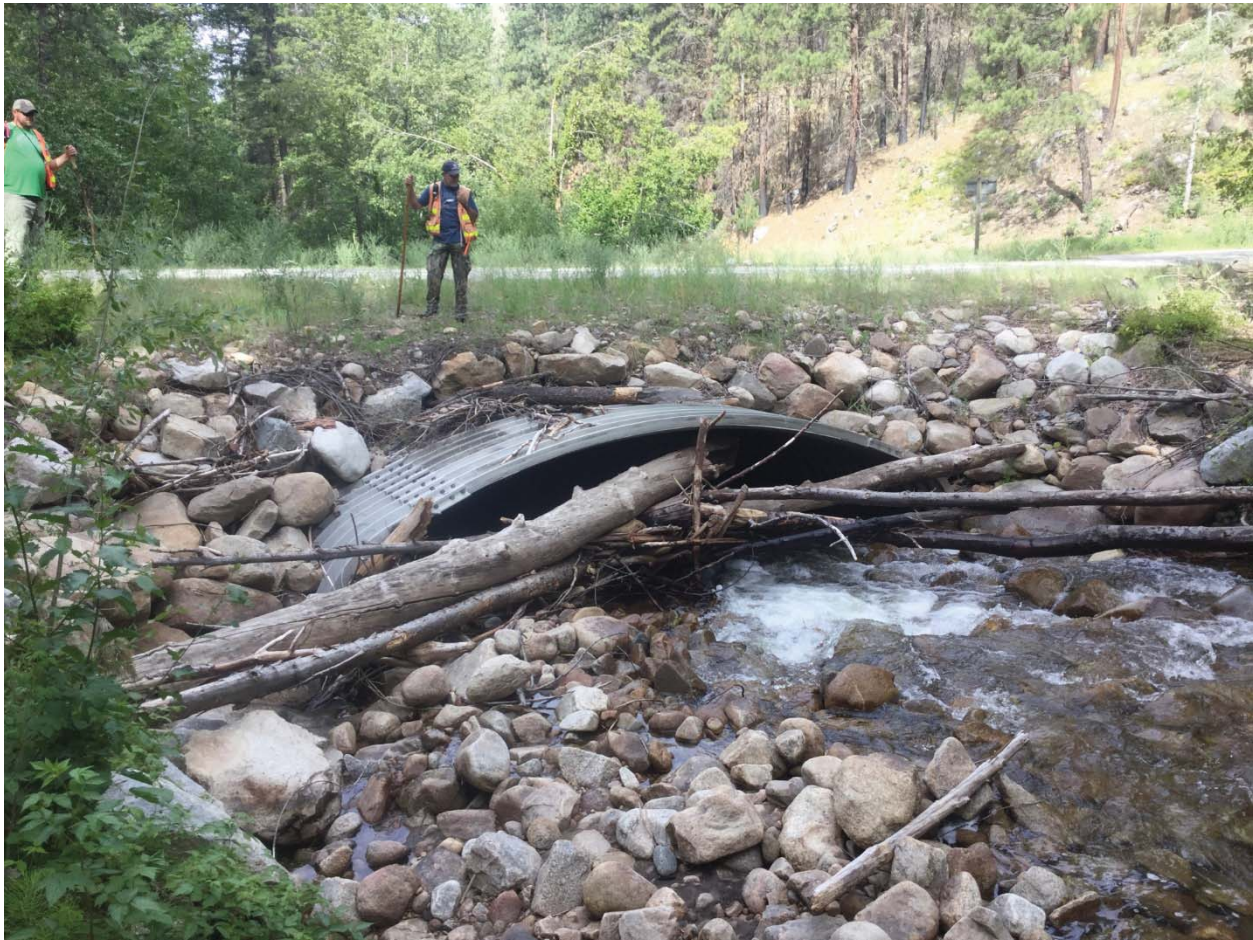
The NF-4225 road culvert crossing of Beaver Creek near RM 9.5 also poses a considerable risk of catastrophic failure due to a high potential for plugging. The photograph in Figure 2-6 shows sediment deposition and wood racking at the inlet of the culvert.

Figure 2-6. Photograph of Wood Racking at Culvert Crossing Inlet on NF-4225 Road near RM 9.5

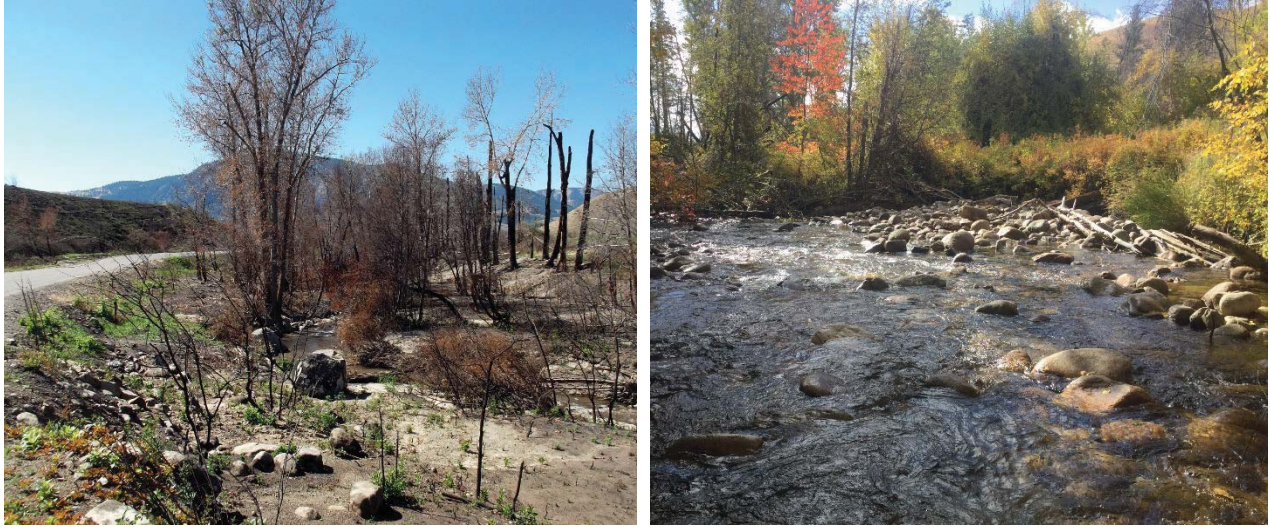
Figure 2-8. Photograph of Burned Riparian Area in Reach 2 Following the 2014 Carlton Complex Fire (Source: BAER 2014) (left), and Regrowth of Riparian Understory in 2017 (right); (photos are representative and were not taken in the exact same location)

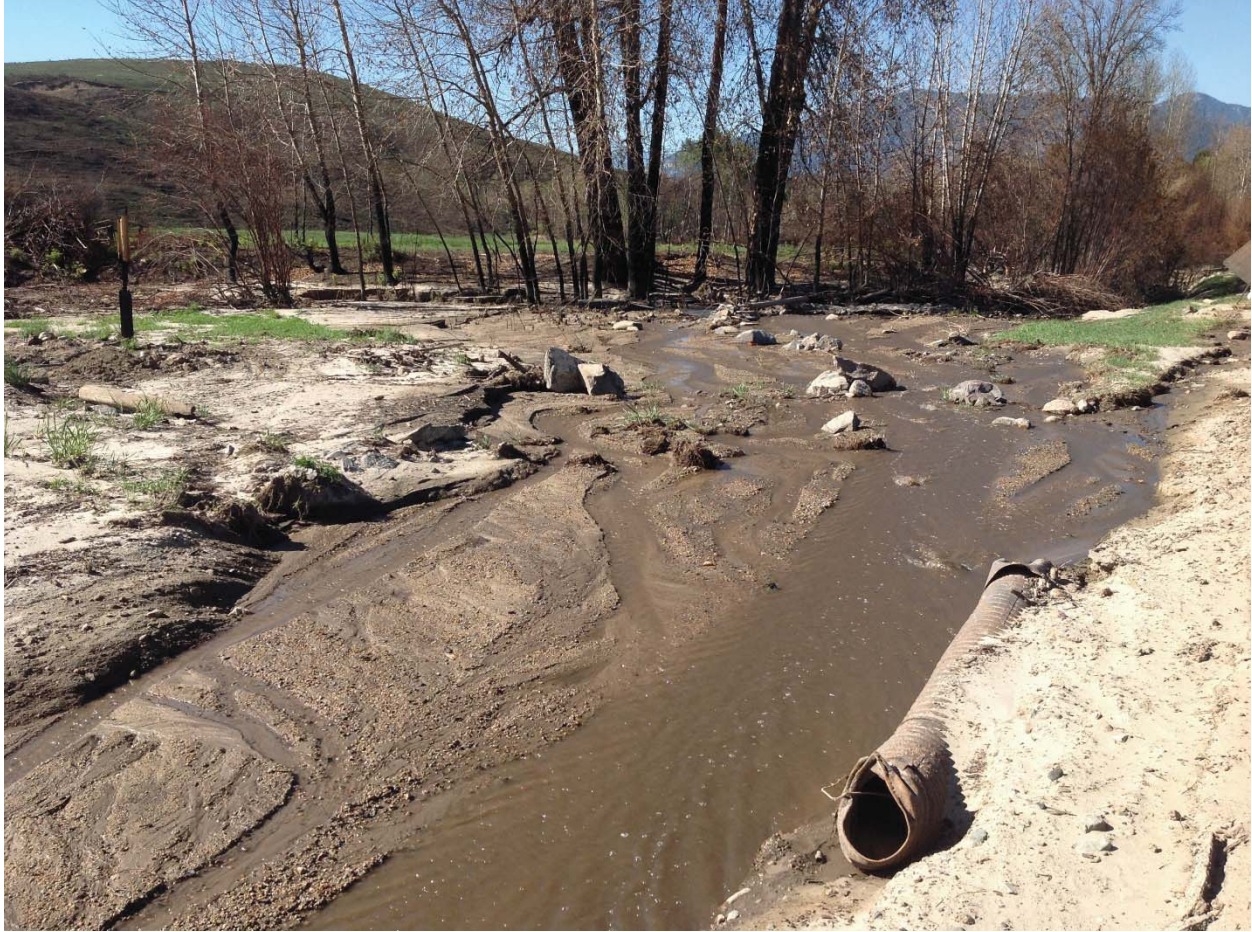
Figure 2-9. Photograph of Road Drainage Failures and Surface Erosion at Storer Creek (Reach 4) Following the Carlton Complex Fire (Source: BAER 2014)

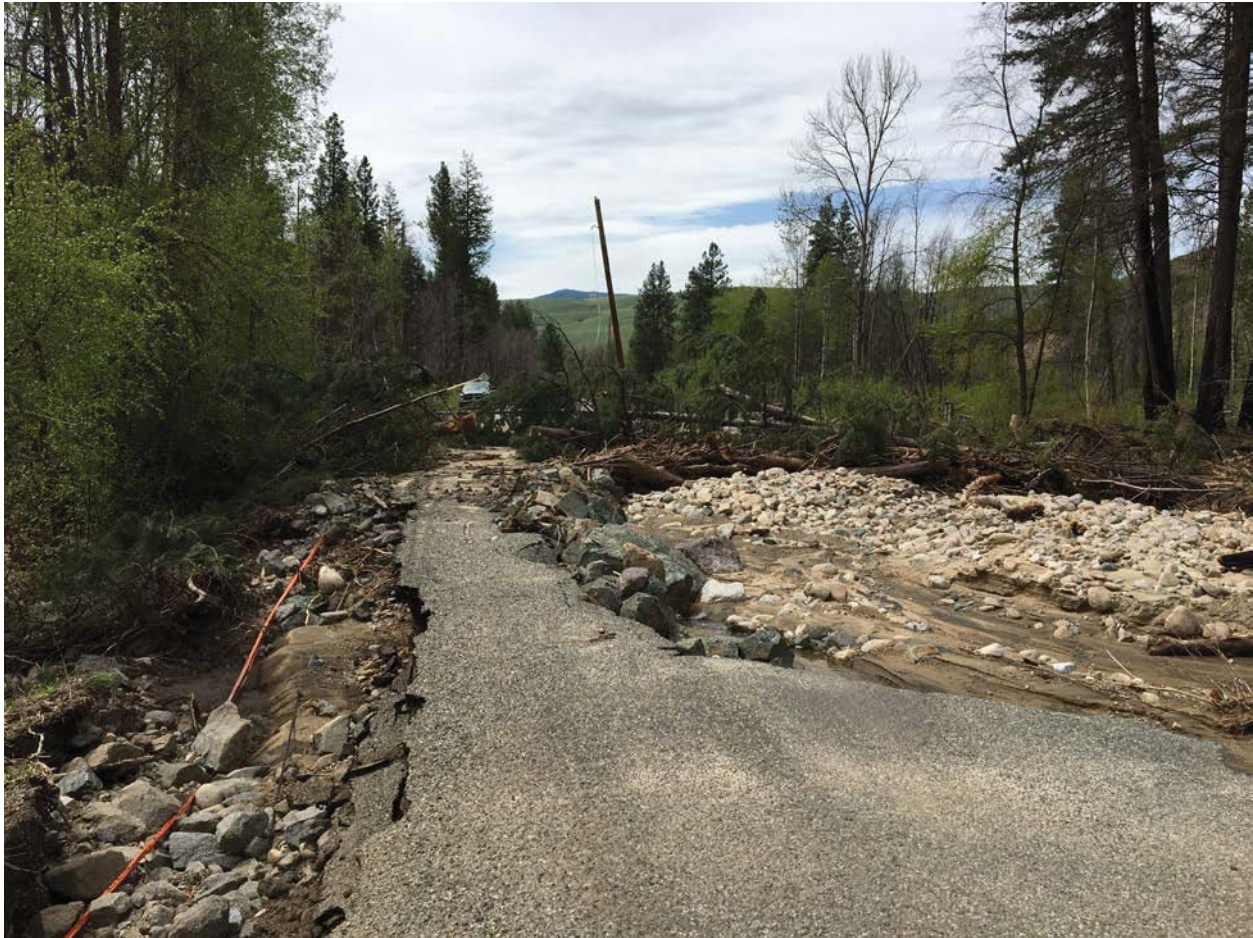
Increased rates of erosion and highly dynamic conditions are continuing to persist in Beaver Creek. The post-fire recovery of watershed processes varies widely by fire and watershed characteristics, but may persist for more than 10 years after the fire (Wondzell and King 2003). Beaver Creek and many tributaries are experiencing increased runoff volatility and flooding caused by thunderstorm-generated rain and rain-on-snow events. Extreme flooding and channel instability in May 2017 caused two major road failures along Beaver Creek. As shown in Figure 2-10, a large asphalt section of Upper Beaver Creek Road washed out upstream of Bally Hill Road near RM 6.5 (Johnson 2017). During the same event, multiple road crossing failures on Volstead Creek resulted in large volumes of sediment input to upper Beaver Creek. The continued instability of Beaver Creek poses a substantial risk to public safety and infrastructure, and continues to considerably alter fish habitat.

Figure 2-10. Photograph of Road Erosion in May 2017 (Source: J. Johnson)

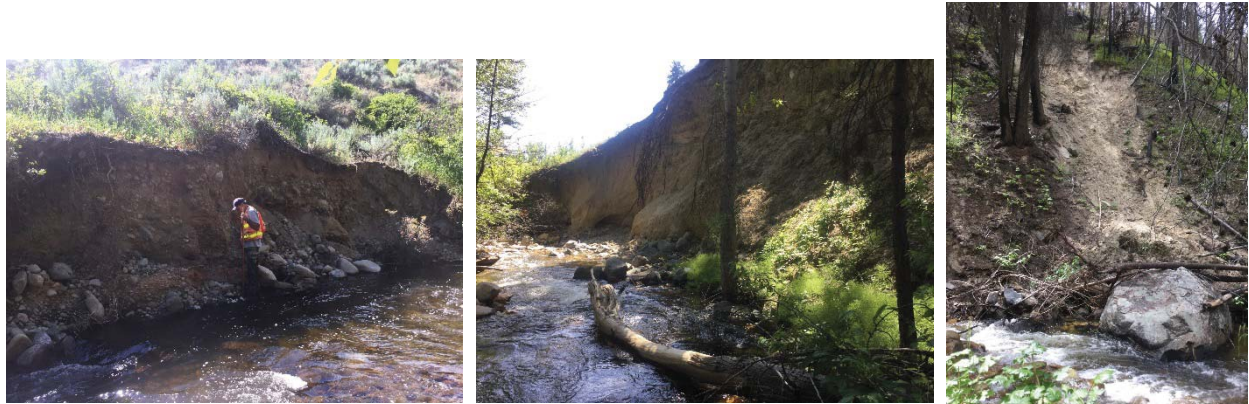
Sediment inputs from several different sources including bank and glacial terrace erosion, post-fire surface rilling, and landslides were all observed throughout the Survey Area during field surveys. Figure 4-5 shows three examples of eroding areas in the Survey Area including an eroding bank, an eroding glacial terrace, and a small stream adjacent landslide.

Figure 4-5. Photographs of Typical Eroding Areas Including Bank Erosion near RM 0.6 in Reach 2 (left), Glacial Terrace Erosion near RM 7.9 in Reach 5 (center), and a Stream-adjacent Landslide near RM 10.1 in Reach 6 (right)

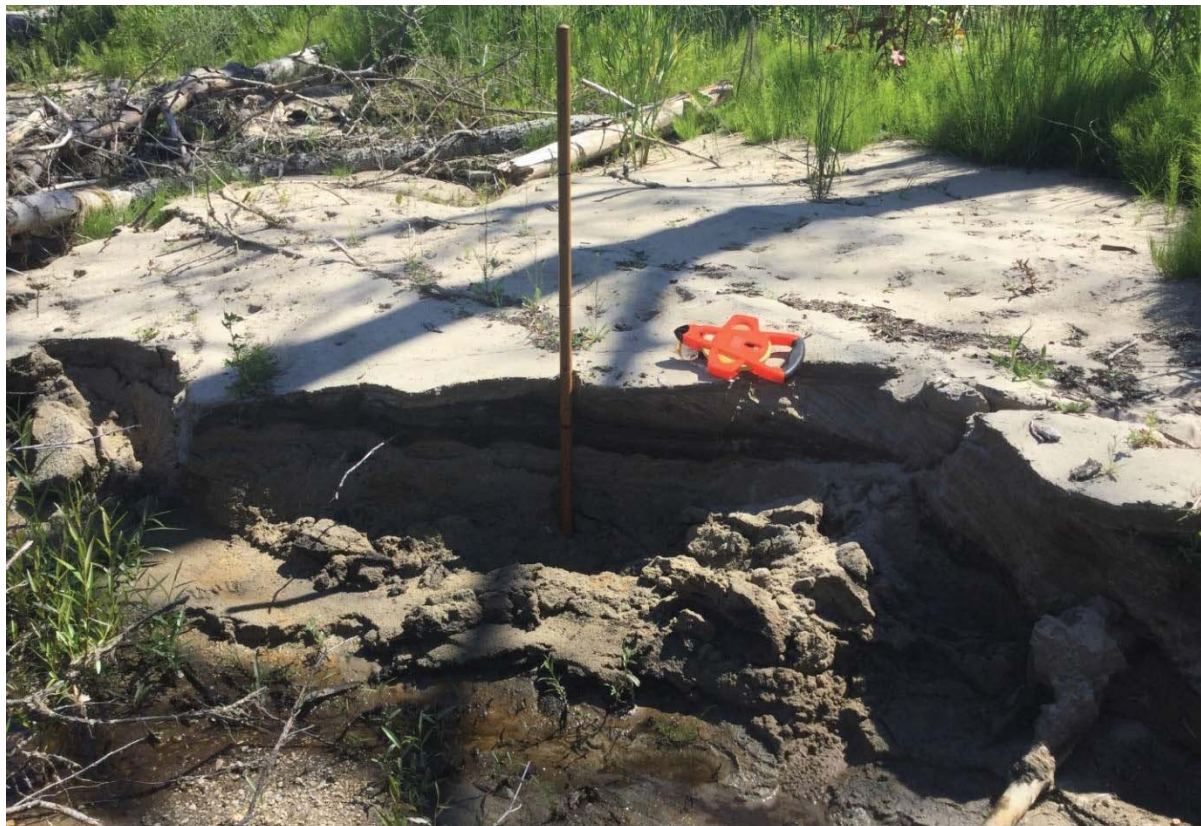
Beaver Creek has naturally high quantities of fine sediments which have been exacerbated by past management activities such as timber harvesting, roads, and cattle grazing. As described in Section 2.4, post-fire rates of erosion and sediment input to Beaver Creek were extremely high following the 2014 Carlton Complex Fire and the debris flows which occurred in response to a large convective thunderstorm shortly after the fire. Post-fire sand deposition in Beaver Creek is important to floodplain development processes. Increased rates of erosion and sediment supply are continuing to persist in Beaver Creek with major road crossing failures and channel instability occurring in 2017. The photograph taken during field surveys in Figure 4-6 shows an example of deep sand deposits in Reach 2. Similar sand deposits on the floodplain were observed intermittently throughout the Survey Area.

Figure 4-6. Photograph of Deep Sand Deposit near RM 1.9 in Reach 2

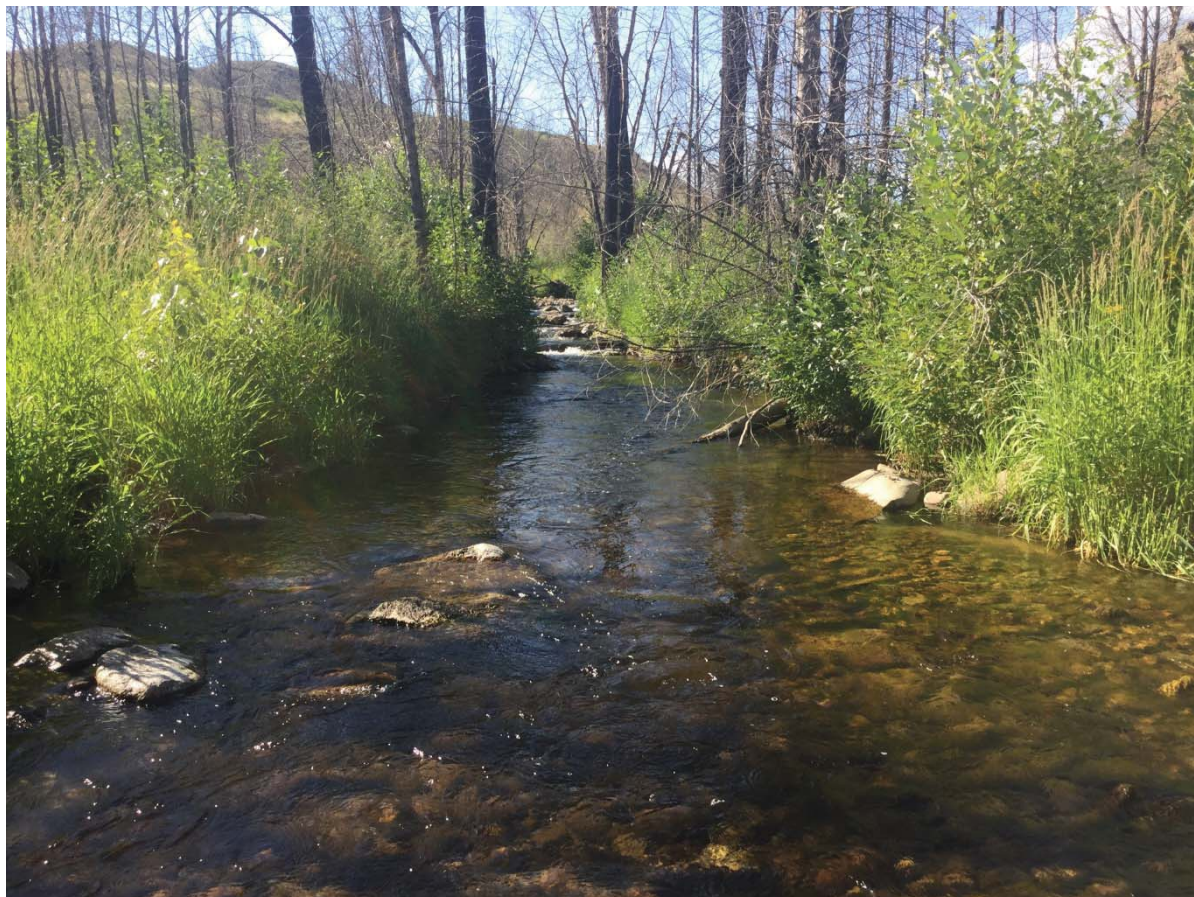
Figure 4-16. Photograph of Burned Riparian Vegetation and Dense Understory Growth near RM 3.5 in Reach 3
