# TECHNICAL MEMORANDUM

**Re:** Upper Burns & Angle Point Reaches of the Entiat River – Year 3 (2024) Monitoring Report

**To:** Yakama Nation Fisheries

**Date:** February 2025

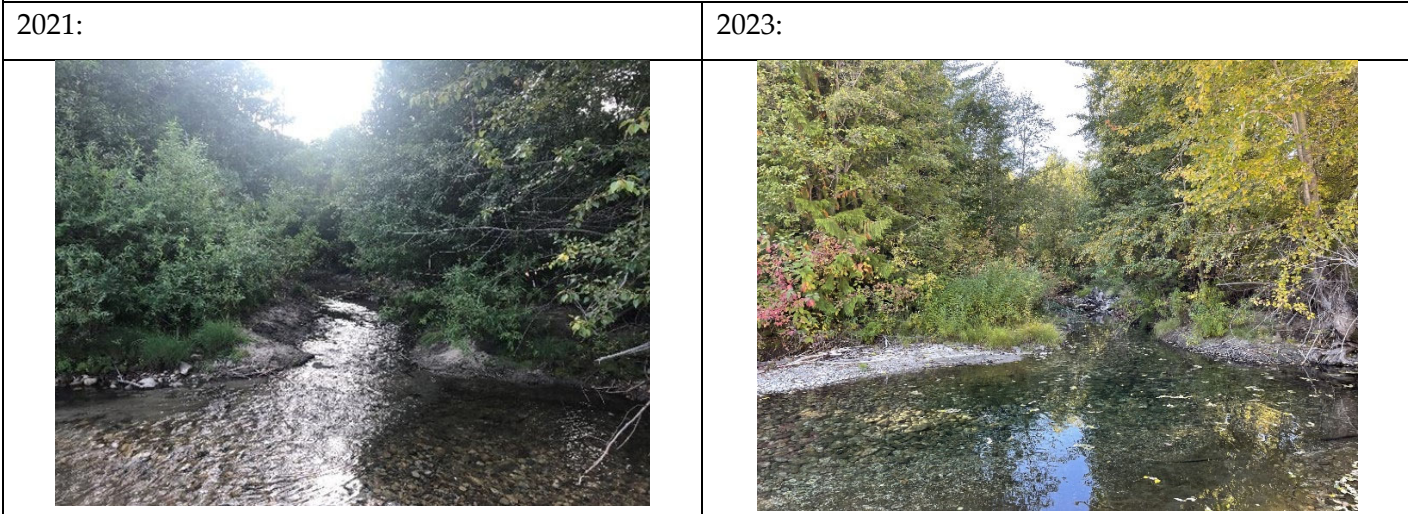
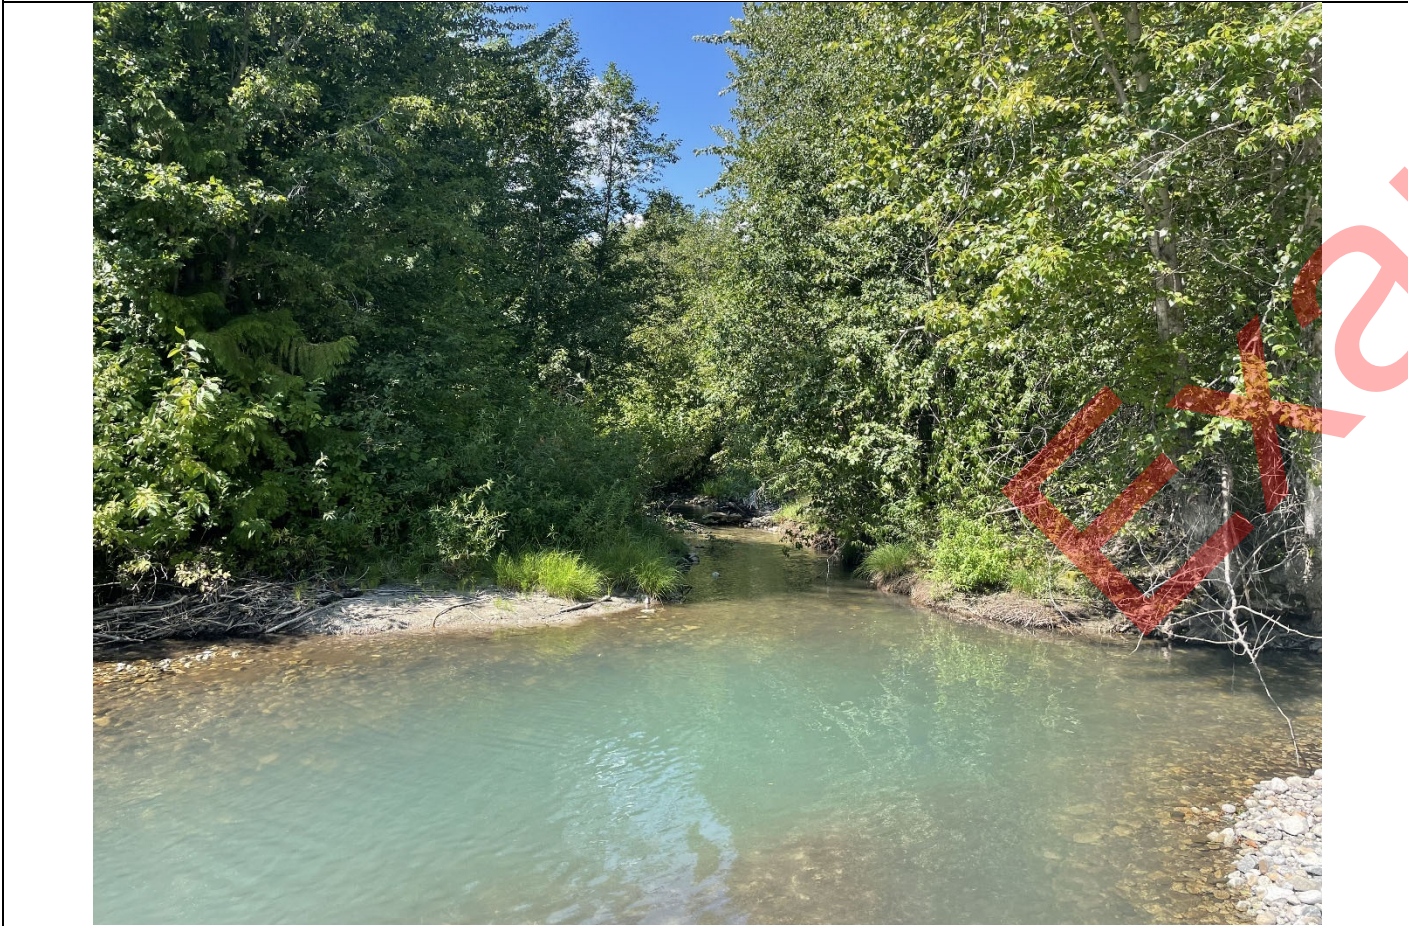
Photo Point 1: Lower Side Channel (LSC) outlet, looking upstream

No significant changes since project implementation. Outlet is well connected to right bank split flow channel of river; however, the split flow channel is still disconnected from the mainstem during low flow.

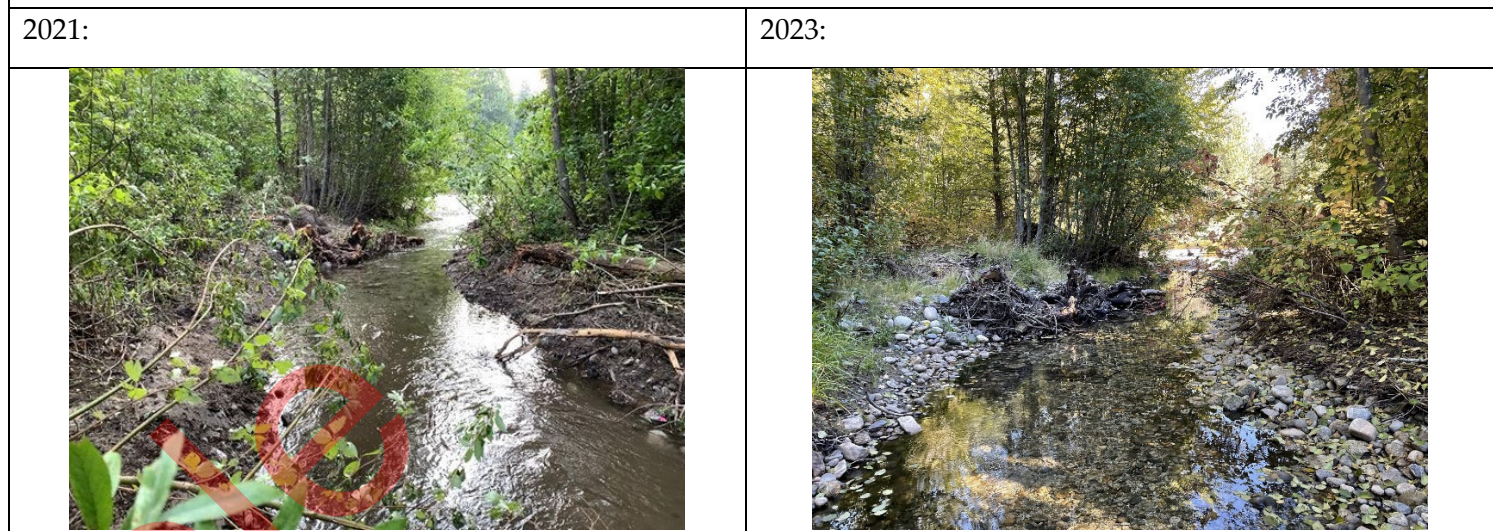
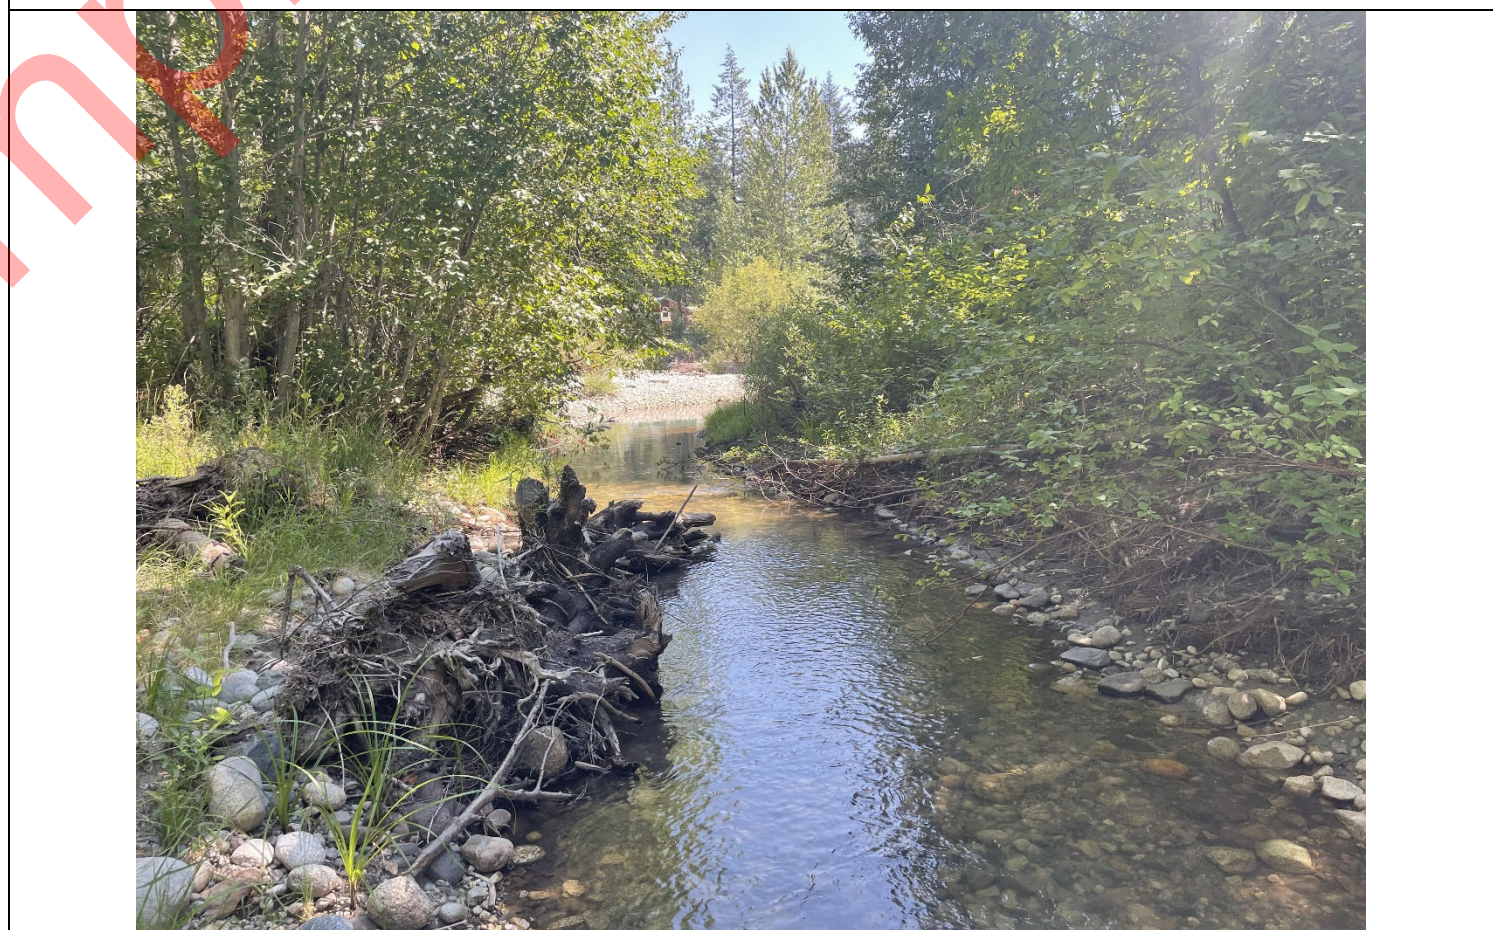
Photo Point 2: LSC outlet, looking downstream

Limited changes in channel geometry since construction in 2021. LWS is intact.

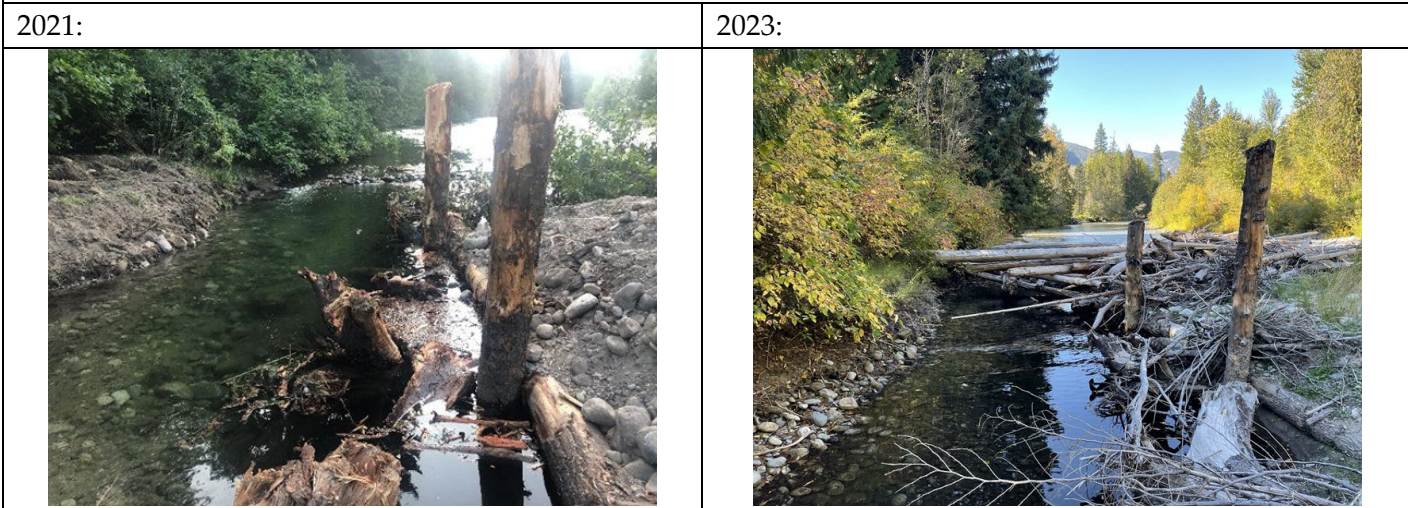
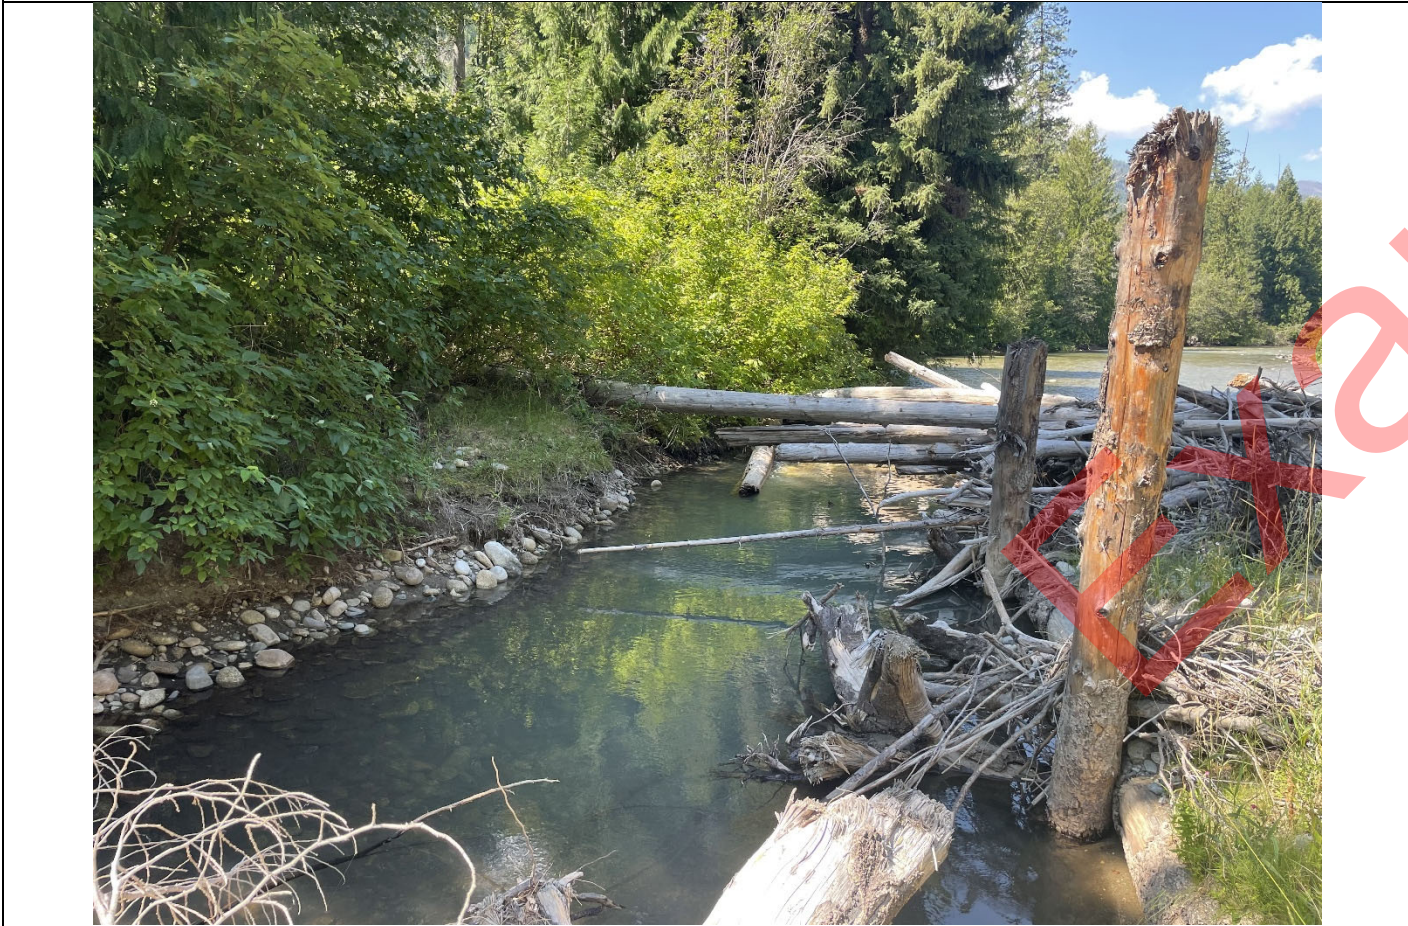
Photo Point 15: LSC inlet looking upstream

Significant large woody debris accumulation at face of inlet structure formed in 2023. The obstruction is still not limiting fish passage as there is a deep pool under the wood and the corner of the LWS, which is intact. See next photo point for additional comments.

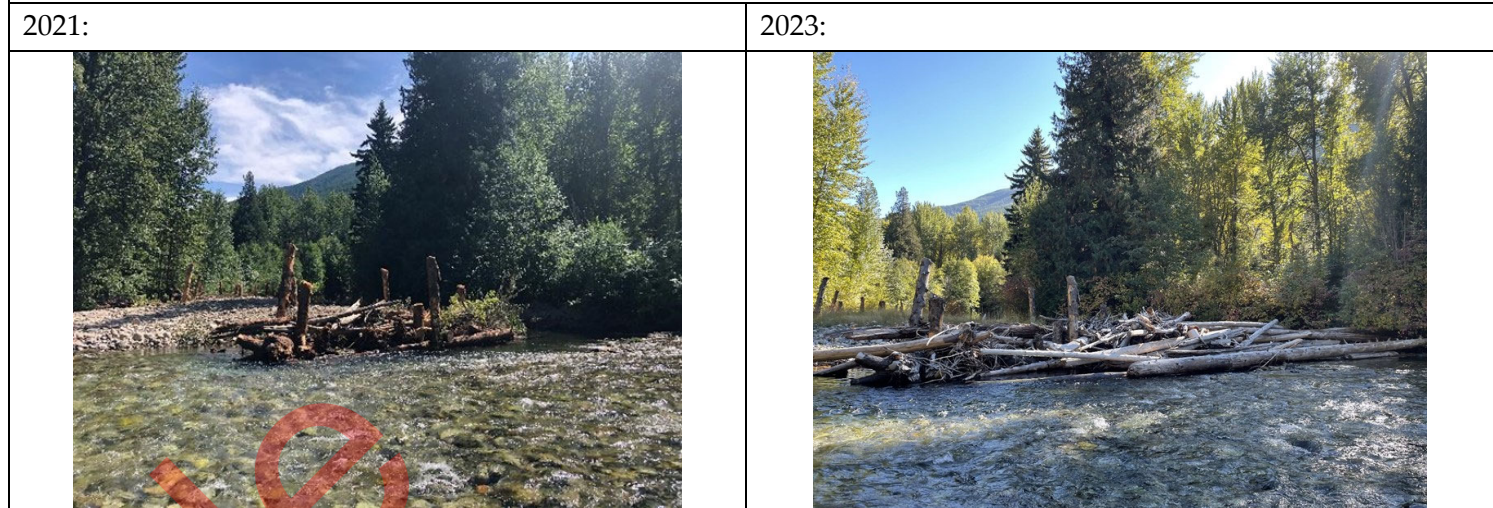
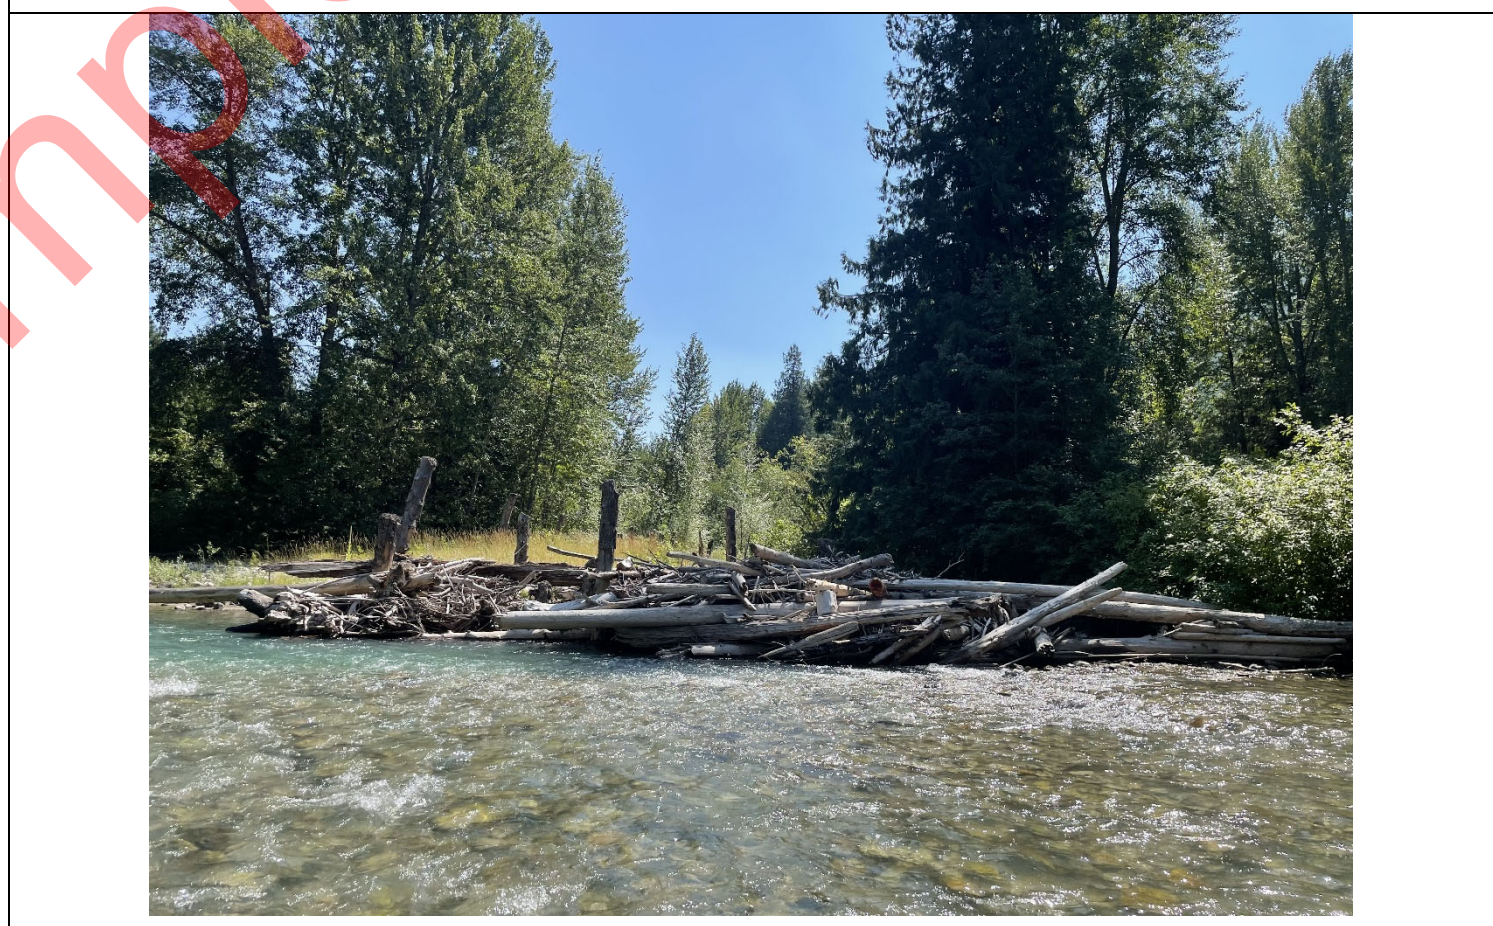
Photo Point 16: LSC Inlet Jam, looking downstream

The project components are stable but, starting in 2022, the Lower Side Channel has accumulated a significant volume of medium to large size wood that has collected on the inlet jam. Some of this material has floated past the inlet and has accumulated within the side channel approximately 250 to 350 feet downstream. A portion of the wood that has collected mid-reach is likely from loose slash material that was placed within constructed floodplain roughness jams, but the majority of the wood was transported during high flow events over the past 3 years. The wood accumulation at the face of inlet jam had little change in size or shape during 2024.

At the moment, this added wood appears to be providing a mostly positive impact on habitat quality since the mucky bed material has eroded and formed deep pools in the mid-reach segment of the Lower Side Channel and the wood is providing great cover habitat. Furthermore, the wood accumulation on the inlet jam is not blocking flow or fish passage, but it does partially shield the channel during higher flows which could limit the future delivery of excess sediment and wood into the channel. Evidence of this shielding effect may already exist since less volume of wood material accumulated within the channel in 2023 compared to 2022, even though 2023 had higher peak flows. This same trend of less wood accumulation within the channel held true in 2024.

The situation should continue to be monitored because the wood accumulation may result in future bed aggradation if it continues to grow larger and the banks do not erode in response. Currently, limited bank erosion has occurred, and one minor sediment plug has formed approximately 130 feet downstream of the inlet. The plug was likely formed due to a local accumulation of wood on a channel spanning salvaged tree that was placed during construction, but this tree floated to a new position in 2023 and the small woody material has dispersed further downstream. The sediment plug was observed in the same area in 2024, but it hadn't appreciably grown. The plug may partially dissipate during a future high flow event if additional sediment delivery is partially cutoff by the racked wood at the inlet jam.

Significant large woody debris accumulation at face of inlet LWS. The wood may actually help keep the side channel open since it will likely limit the amount of sediment and smaller woody debris that can enter the lower side channel. A year after its formation, the jam appears to still have the same size and shape, and no action is recommended. This area should continue to be monitored though.

**Recommendations:** It may be worth considering hand removal of some small woody debris spanning the channel, but it is still not yet clear if this is creating any negative impacts.
