Chewuch River Mile 17-20 2018-19 Post-Construction Monitoring Report

FEBRUARY 2020

This report is the first of three post-construction field-monitoring reports for the Chewuch River Mile 17-20 project. Field work was conducted on October 1, 2019 with the purpose of monitoring the safety, stability, and effectiveness of constructed fish habitat. The project is located on United States Forest Service land between river miles 17 and 20 and was constructed July 2018. The purpose of the project was to increase adult holding and juvenile rearing habitat during low and high flows.

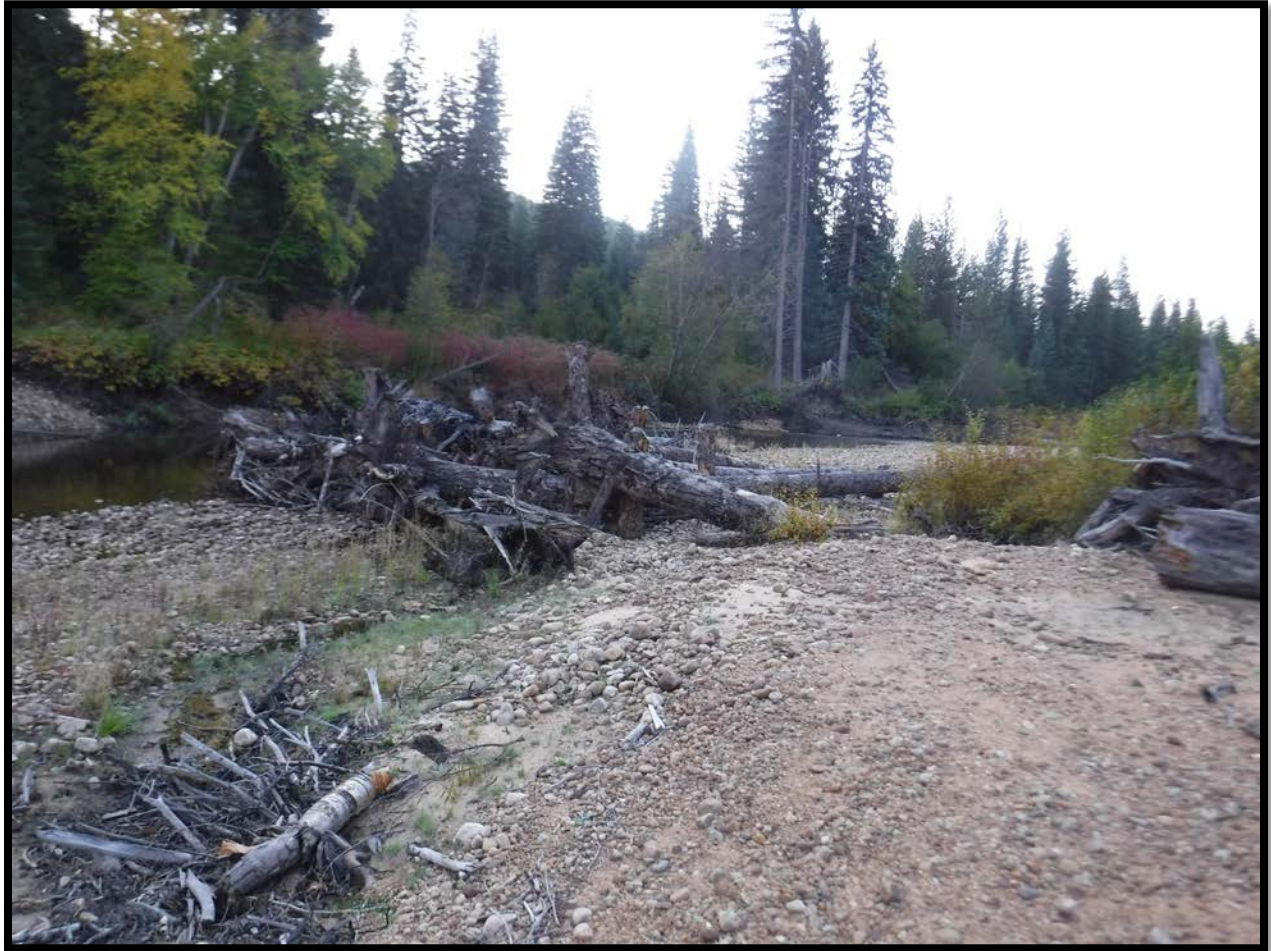
The site is stable. The structure is very similar to post construction conditions. Minor pool scour has occurred along the jam edge. Revegetation recovery along the access path to the site is very good.

Figure 2. Site A. Photo looking east at the jam from existing right bank gravel bar.

Recommendations: None. Continue to monitor the site as needed.

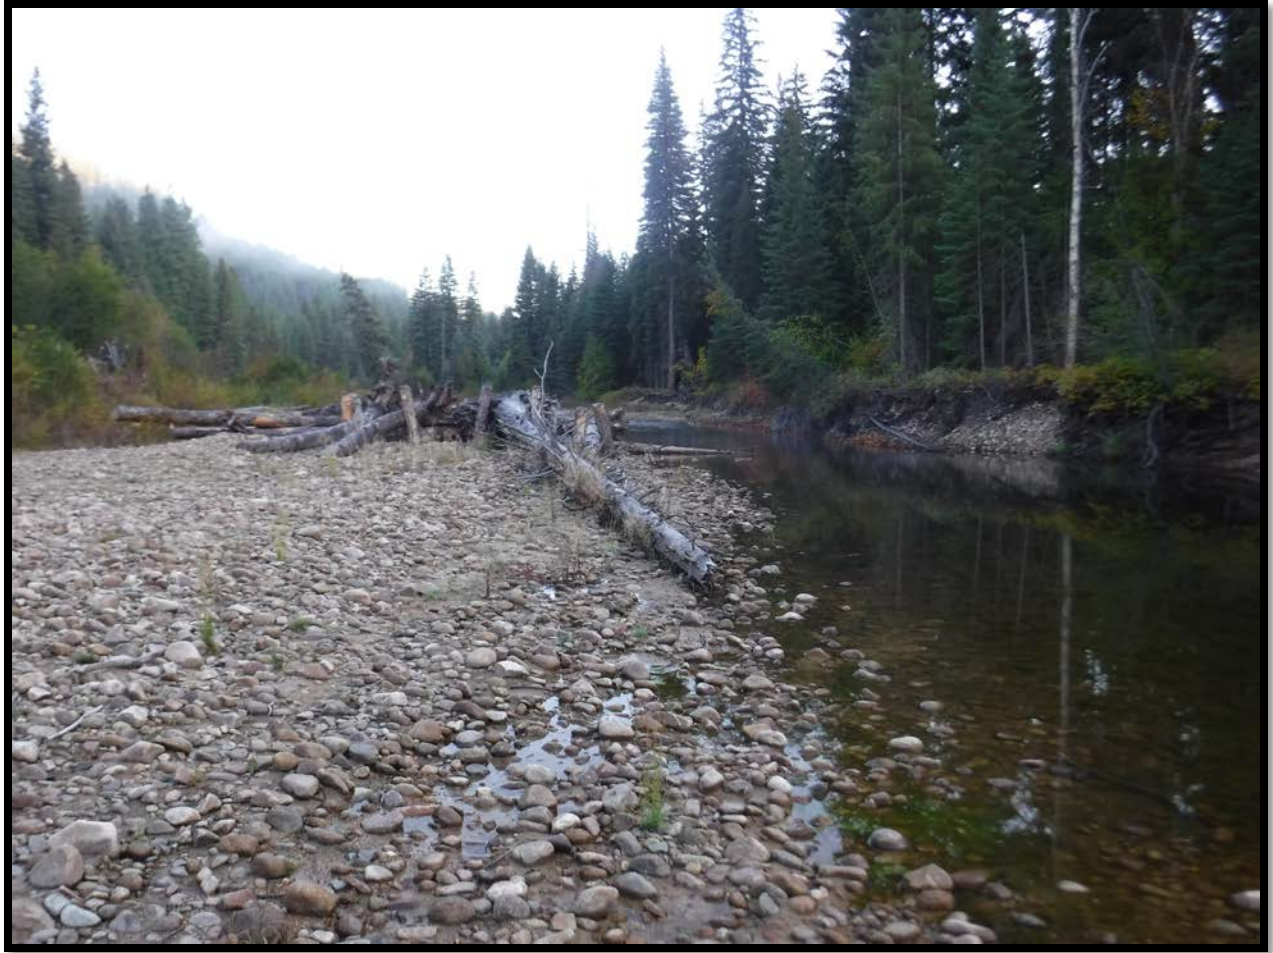
Figure 3. Site A. Looking upstream.

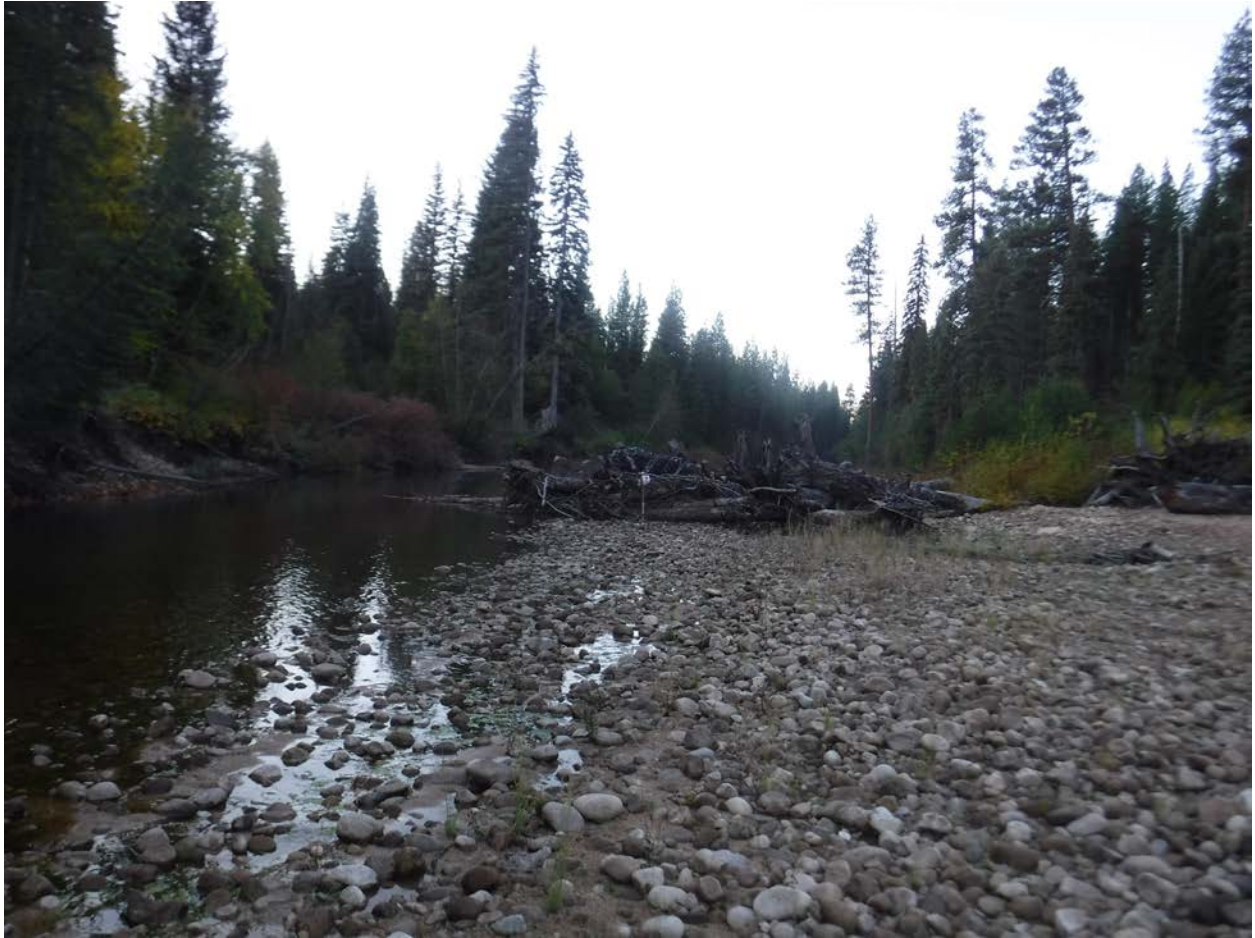
Figure 4. Site A. Looking downstream.

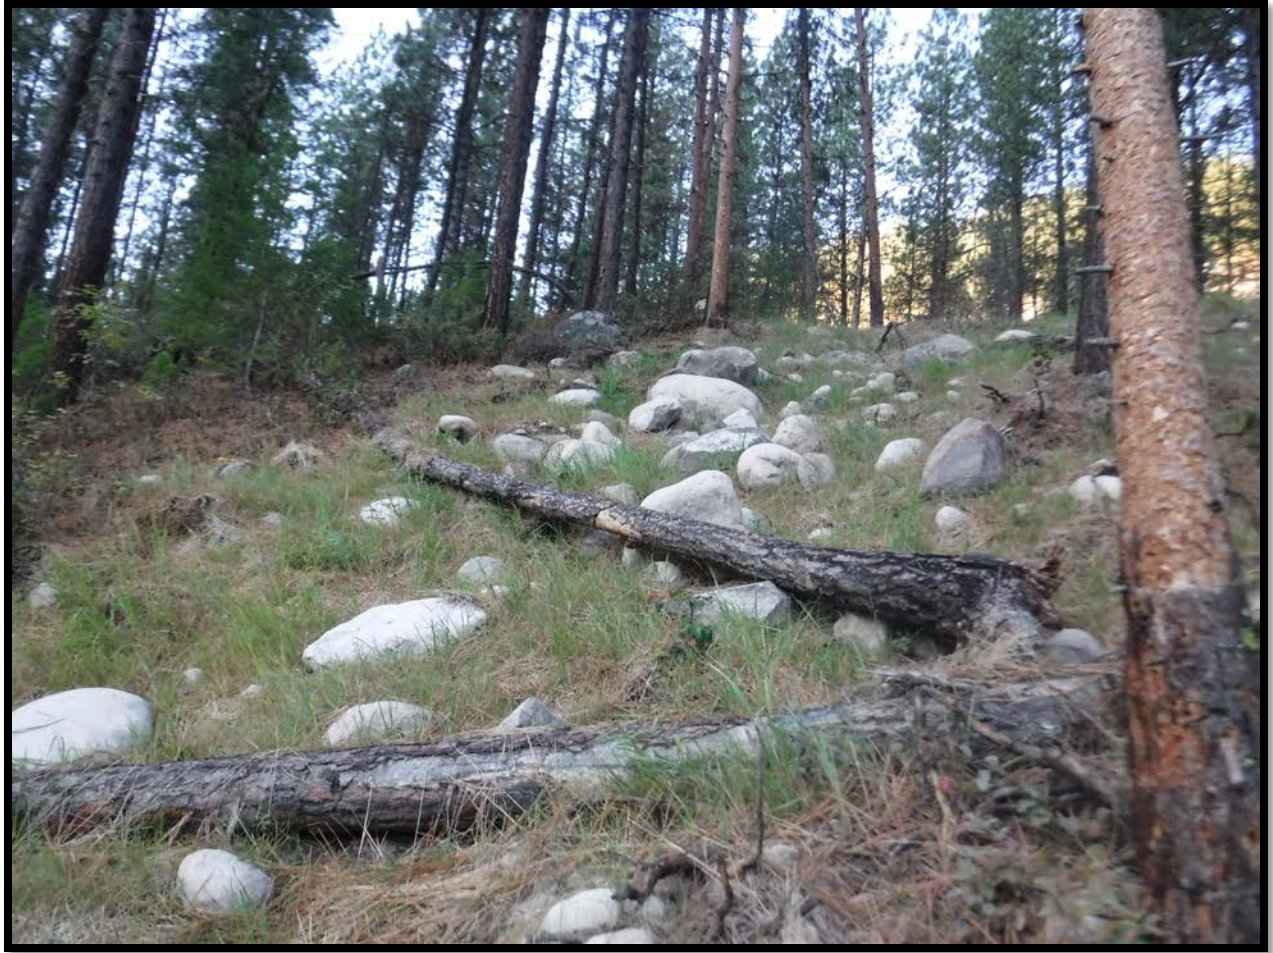
Figure 5. Site A. Access path revegetation.

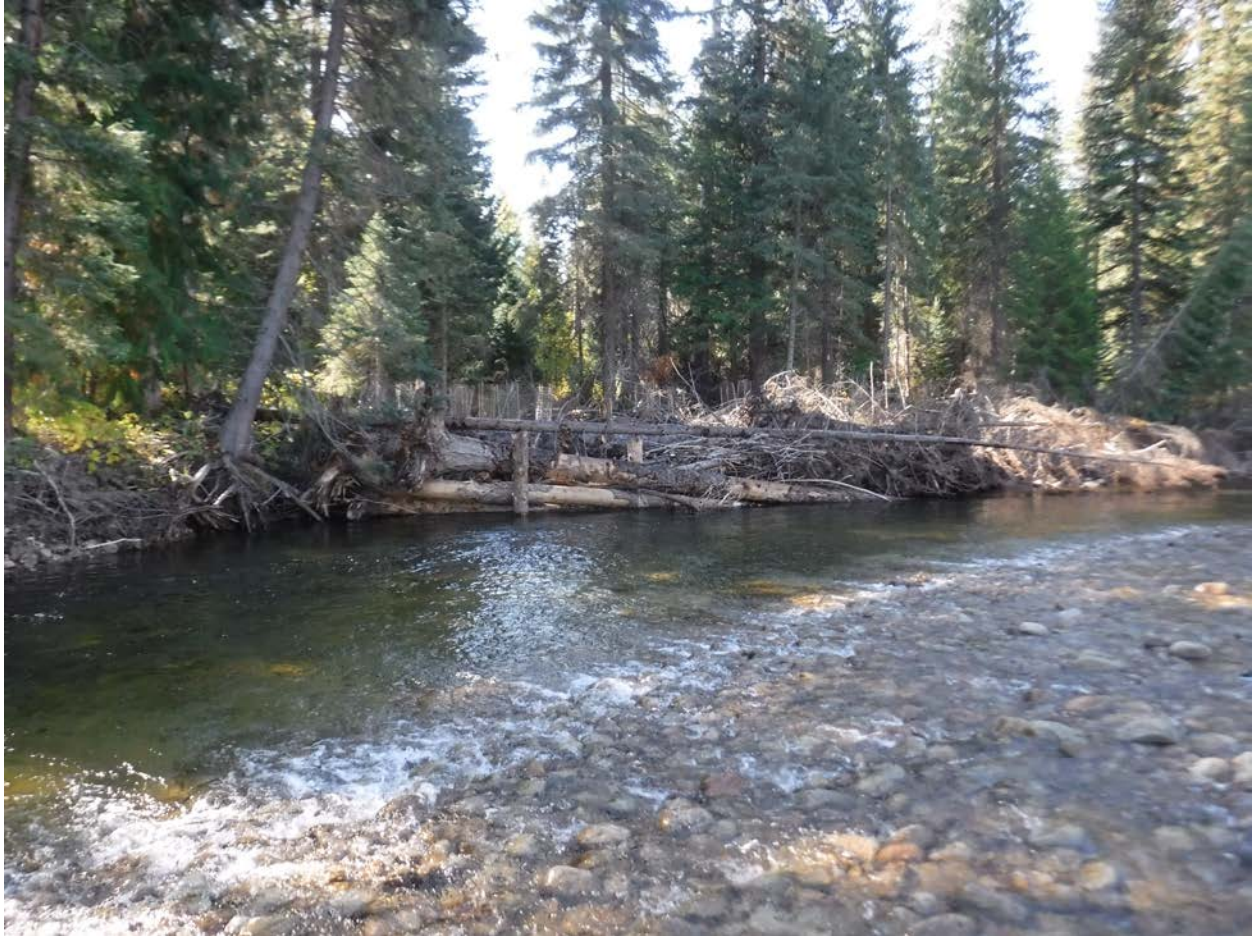
Site L is stable and similar to post construction conditions. Pool depth is 3-4 feet. Very good cover area and pool volume exists within the structure. Revegetation along access path is very good.

Figure 6. Site L. Looking downstream.

Recommendations: None. Continue to monitor the site as needed.

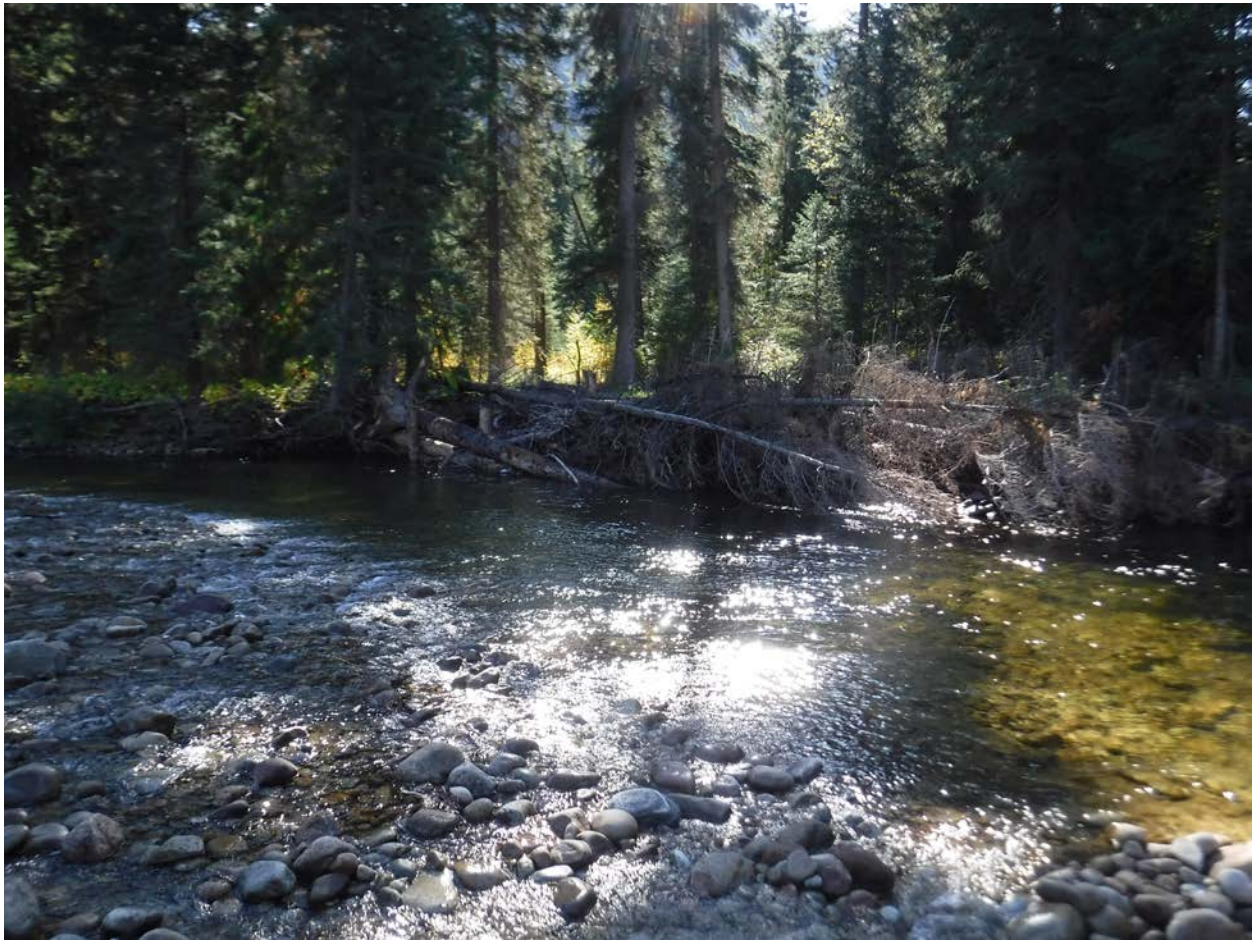
Figure 7. Site L. Looking at the jam face.

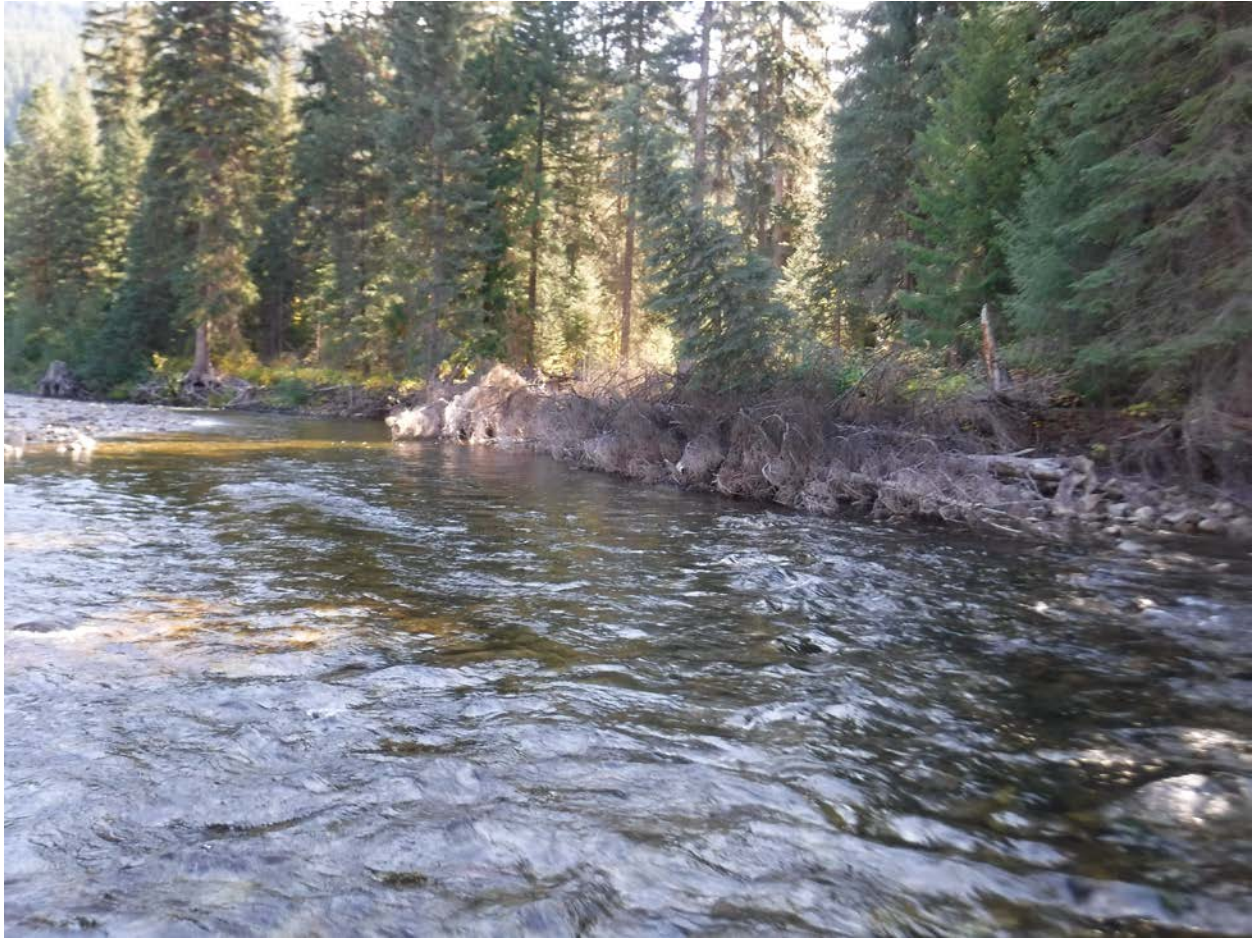
Figure 8. Site L. Looking upstream.

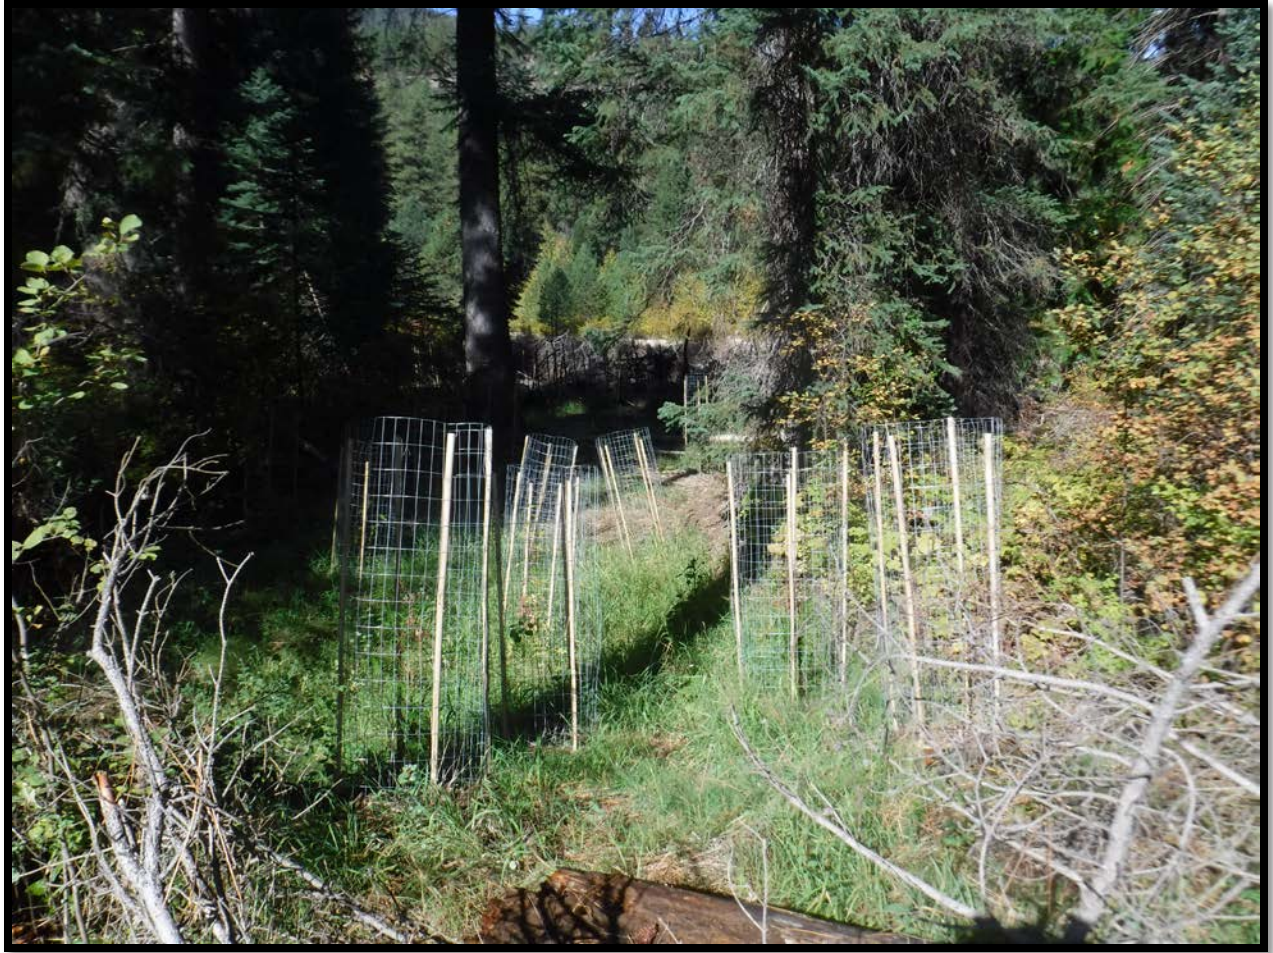
Figure 9. Site L. Access path revegetation.

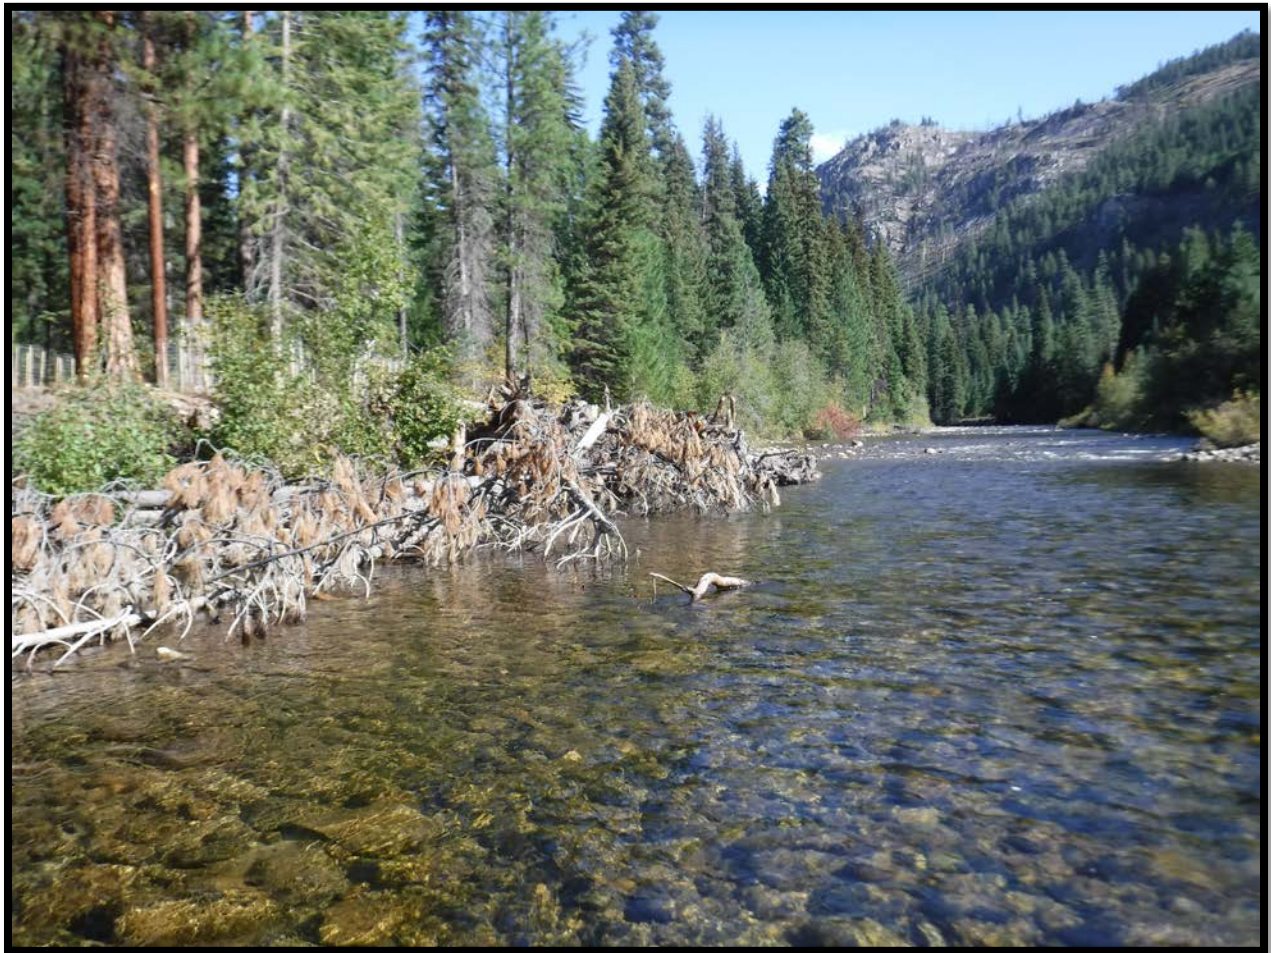
Site M is stable and similar to post construction conditions. Internal pool depth beneath the jam has been maintained. A small sand bar has formed at the downstream end of the jam along the right bank. Pool depth is between 3-4 feet. Revegetation is in good condition.

Figure 10. Site M. Looking upstream.

Recommendations: None. Continue to monitor the site as needed.

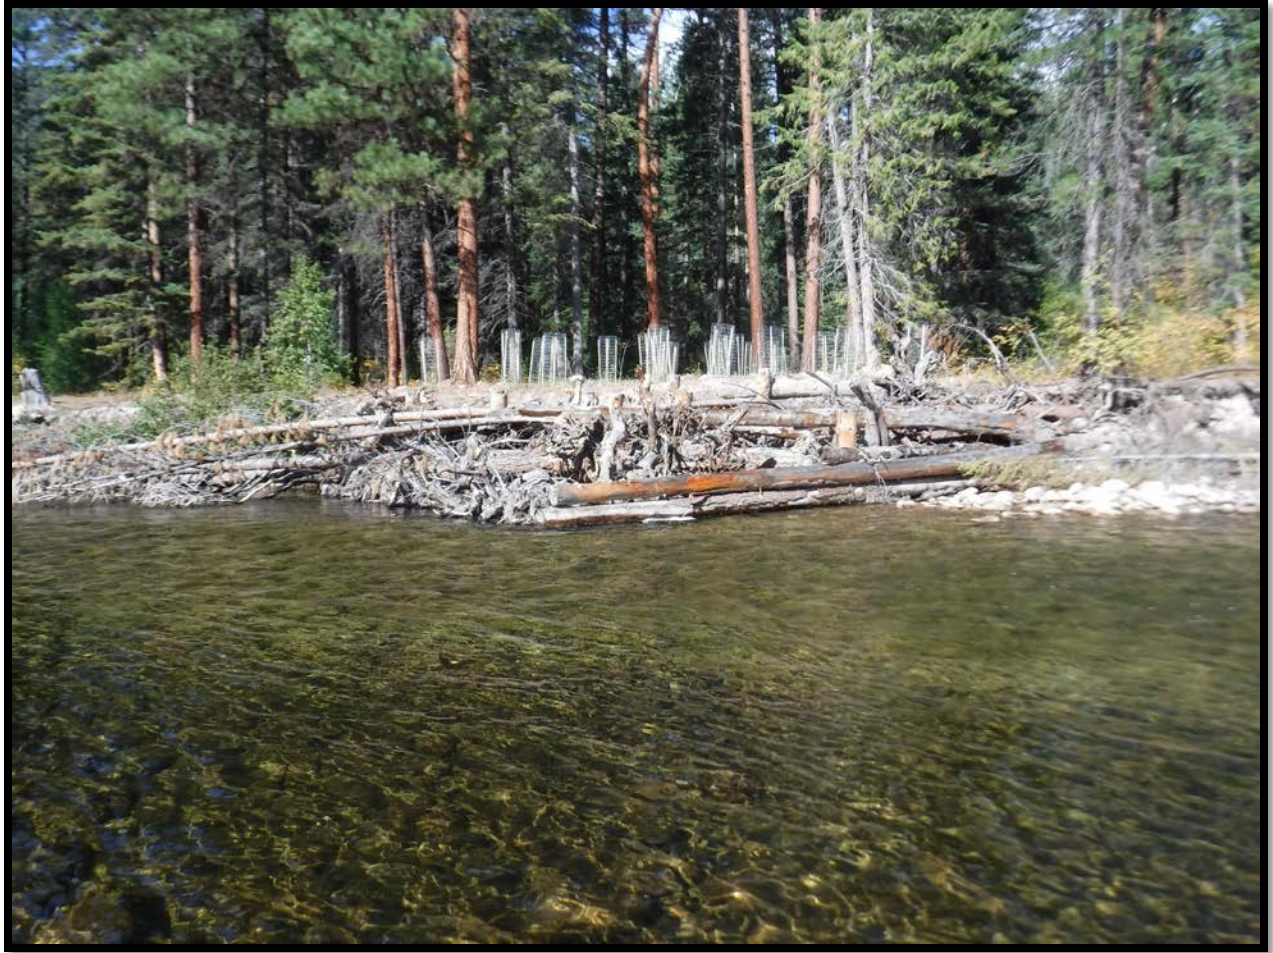
Figure 11. Site M. Face view.

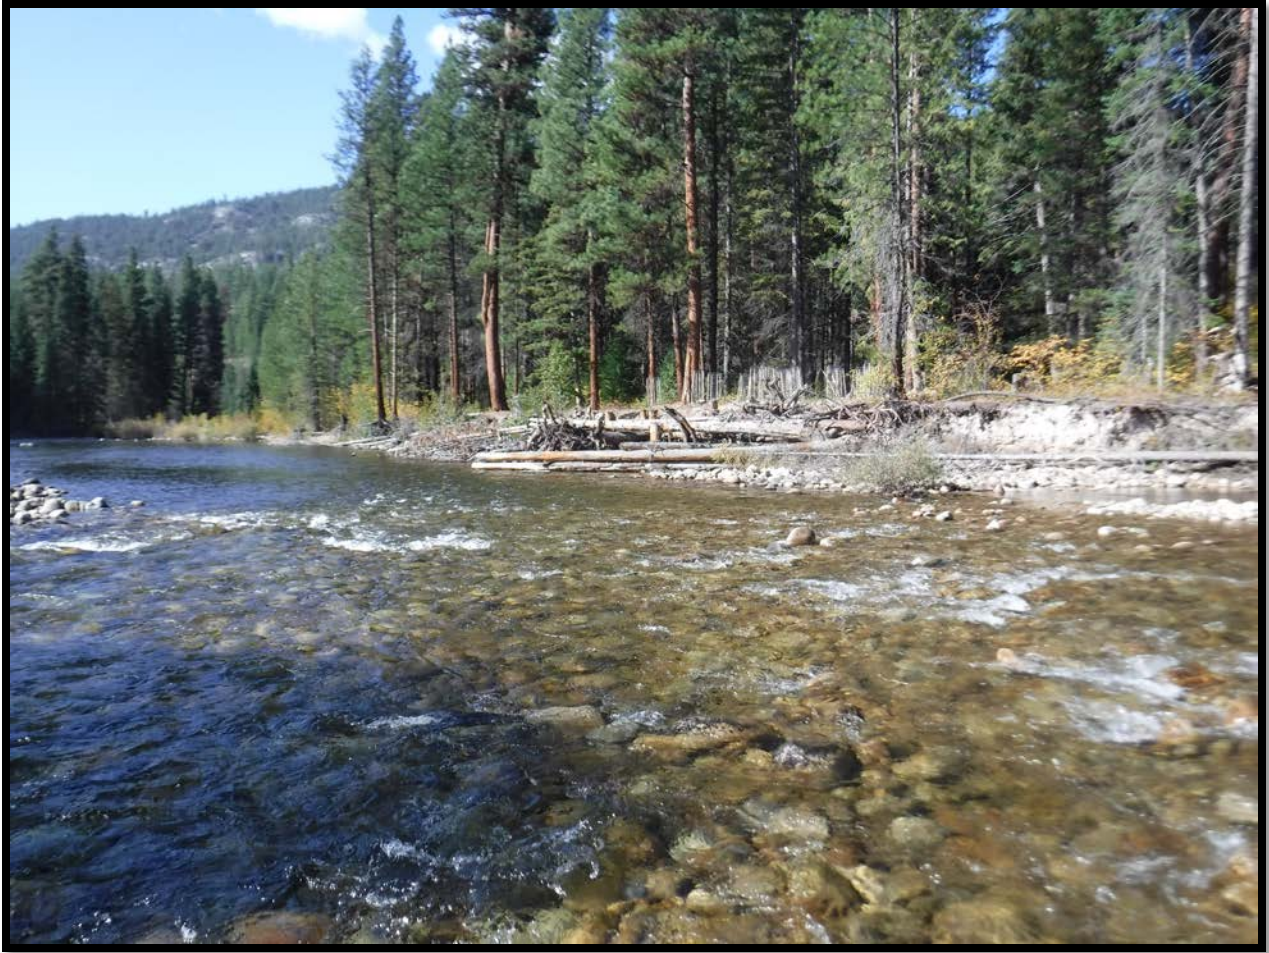
Figure 12. Site M. Looking downstream.

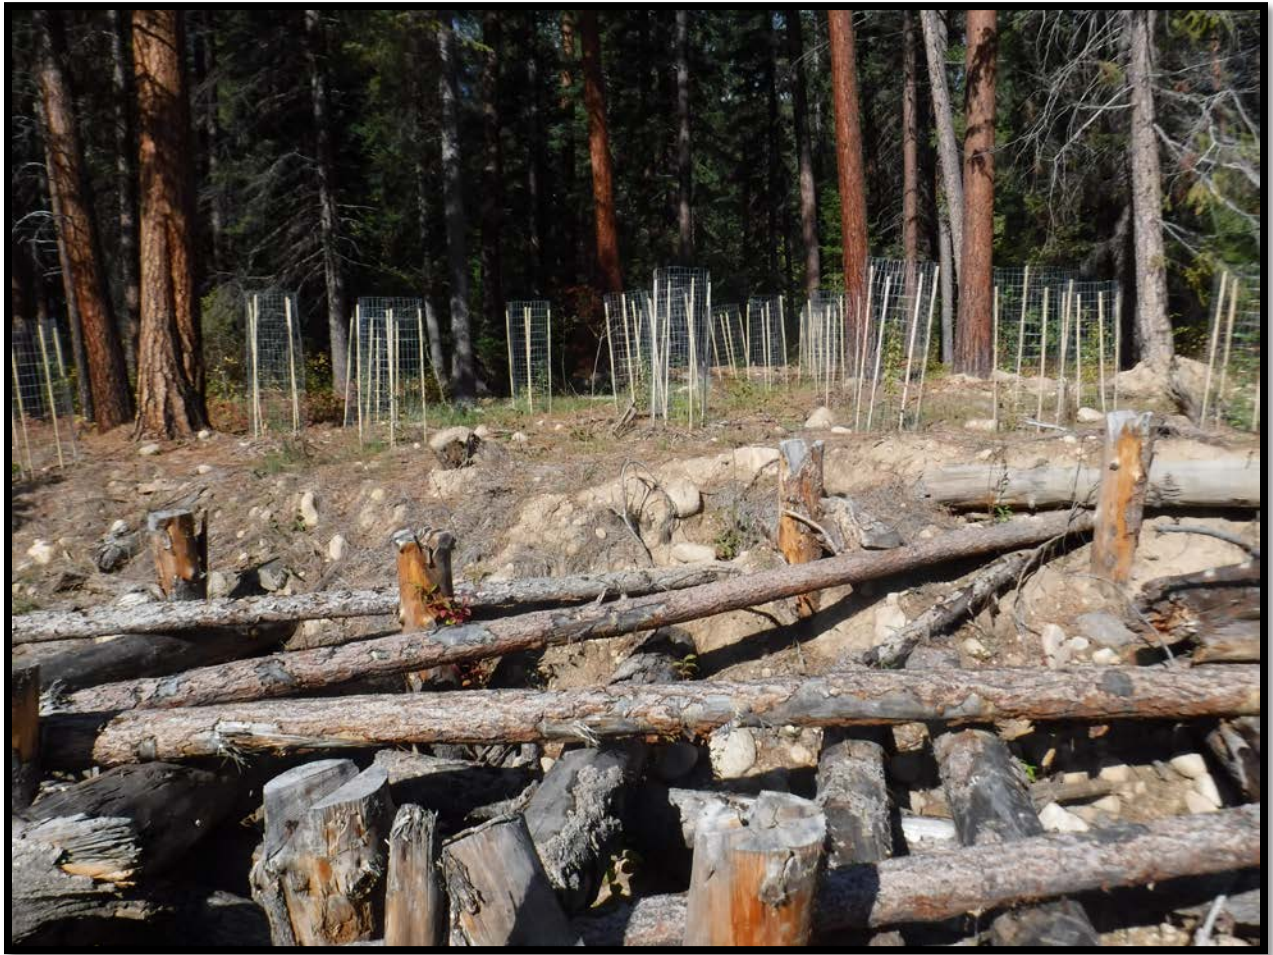
Figure 13. Site M. Back of the jam and revegetation within excavated area.

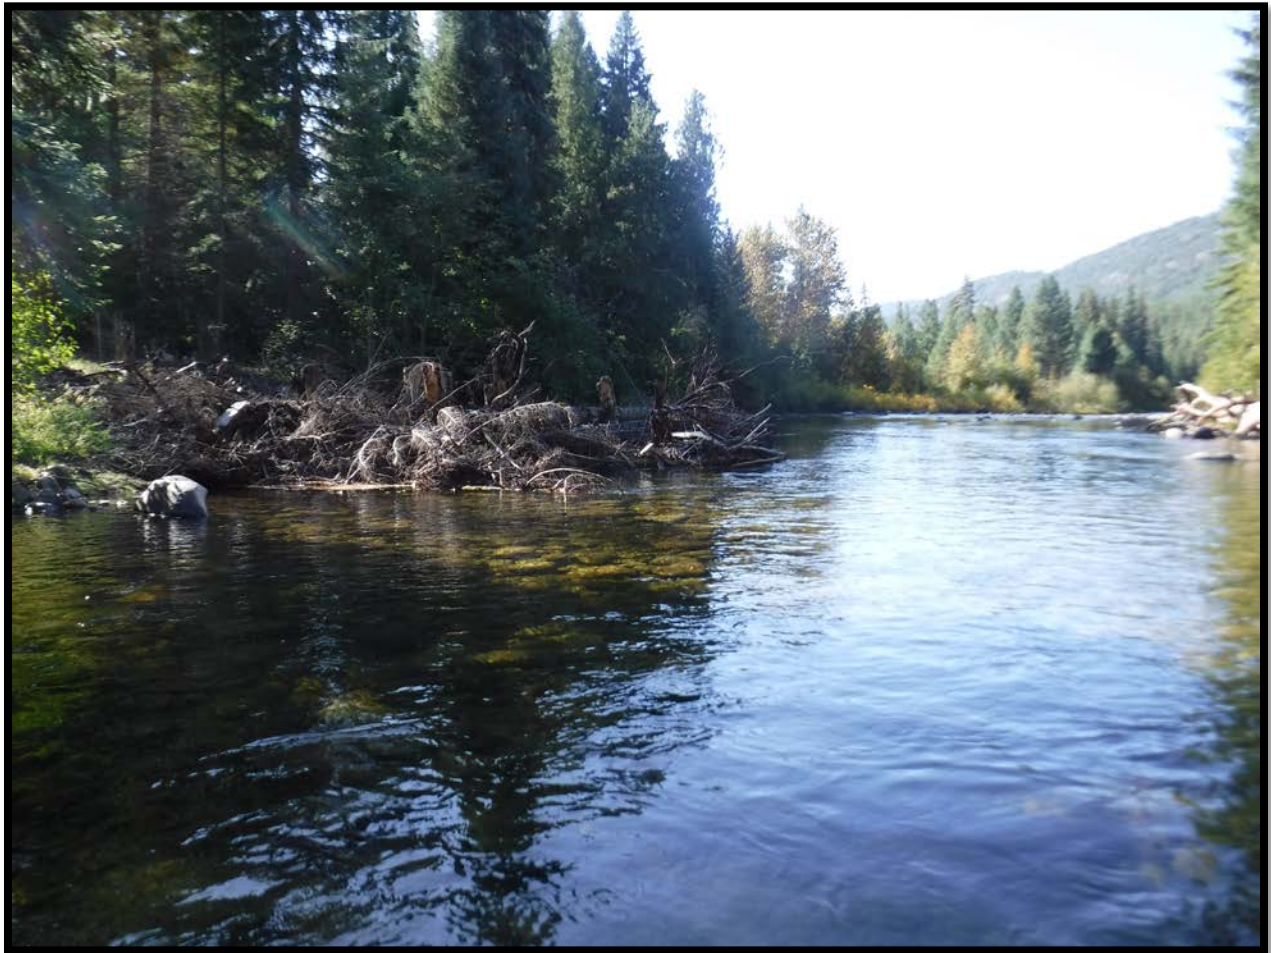
Site N is stable. The structure is similar to post construction conditions. There has been good pool maintenance with additional scour along the outside edge of the jam. Internal pool volume is 3-4 feet. Downstream of the structure, pea gravel has accumulated within the cobble bed substrate. Revegetation throughout the access path to the site is very good.

Figure 14. Site N. Looking downstream.

Recommendations: None. Continue to monitor the site as needed.

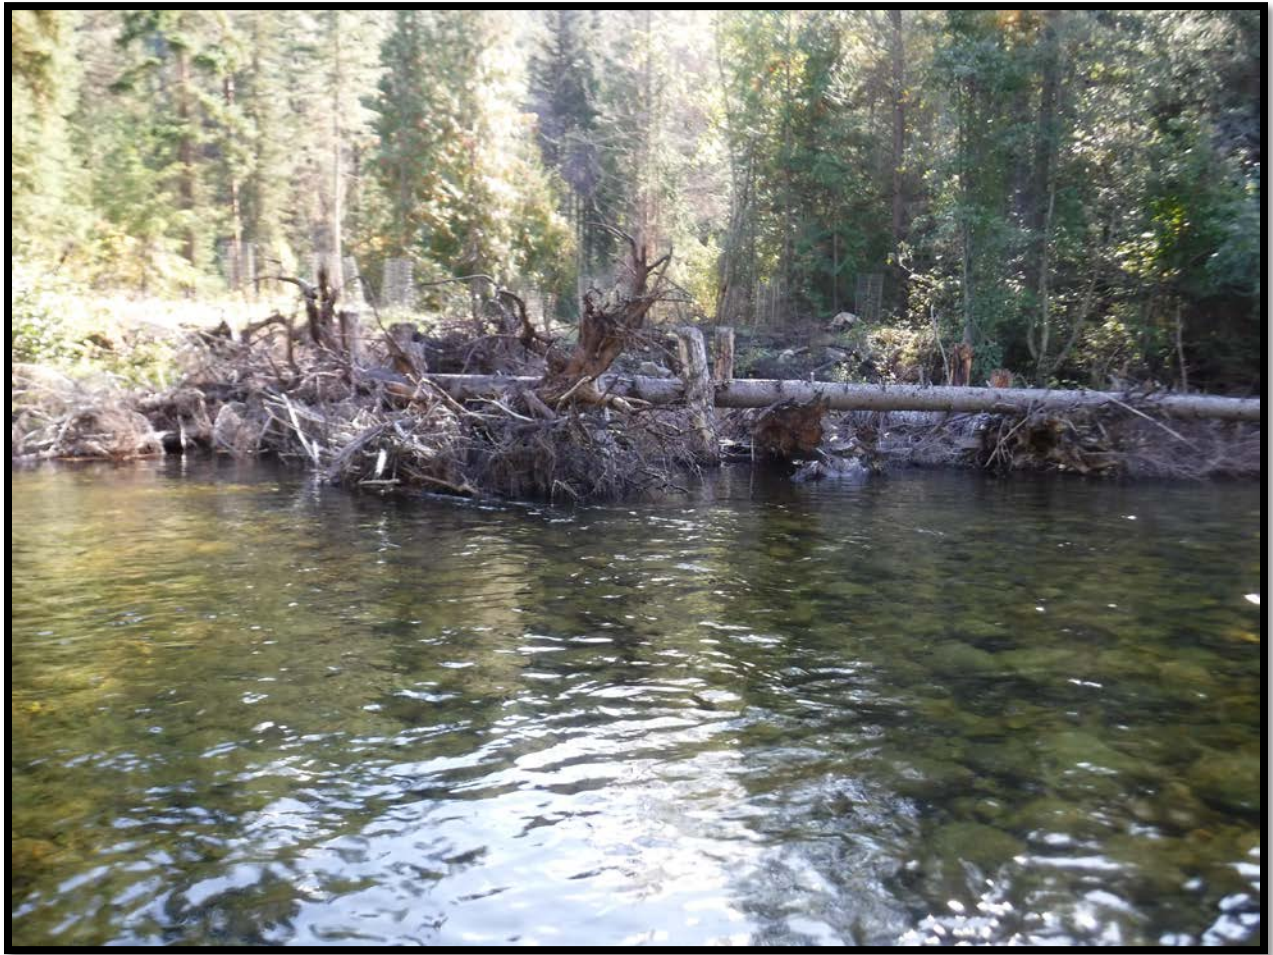
Figure 15. Site N. Face view.

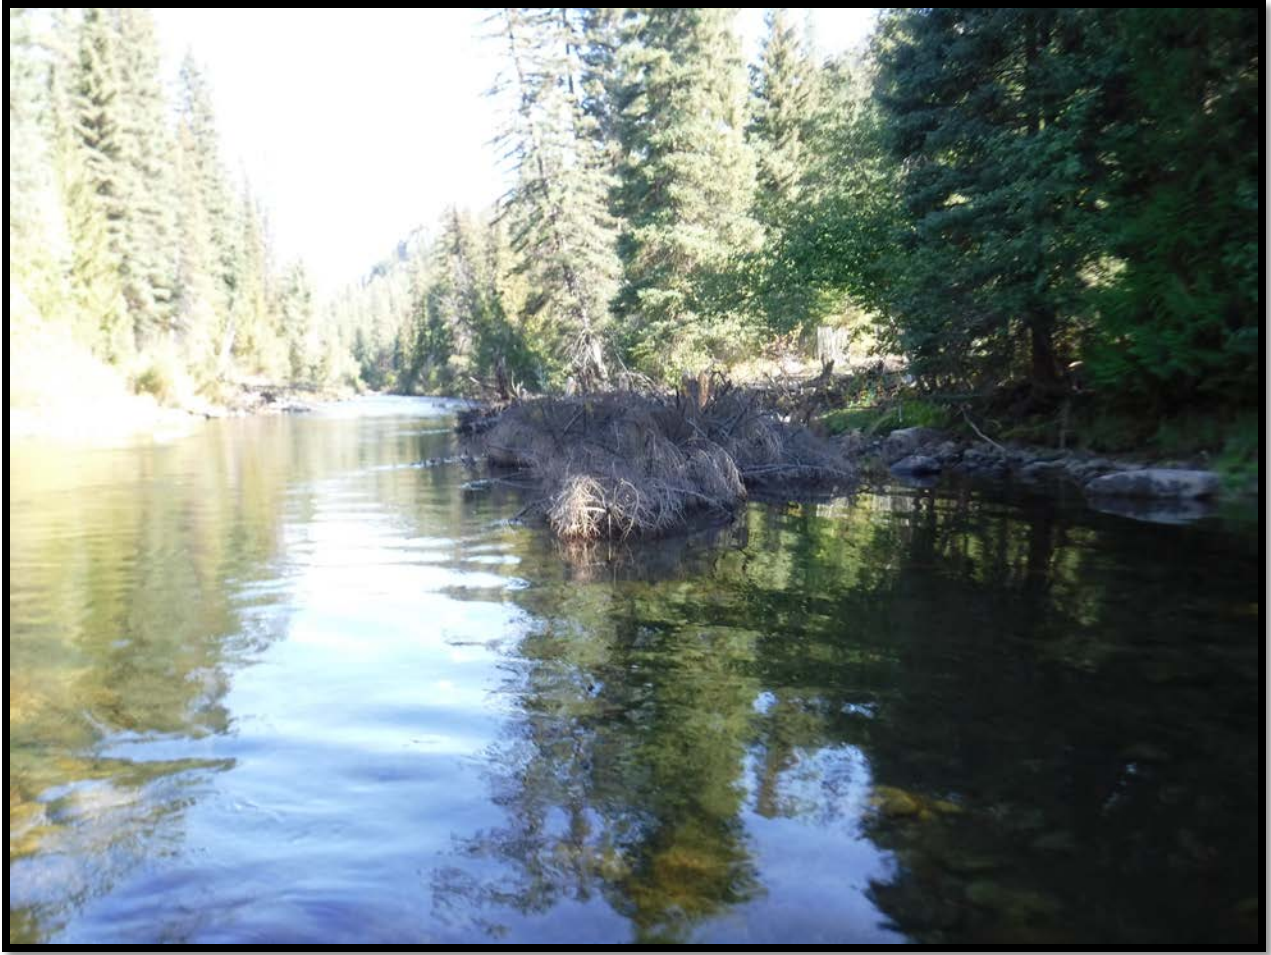
Figure 16. Site N. Looking upstream.

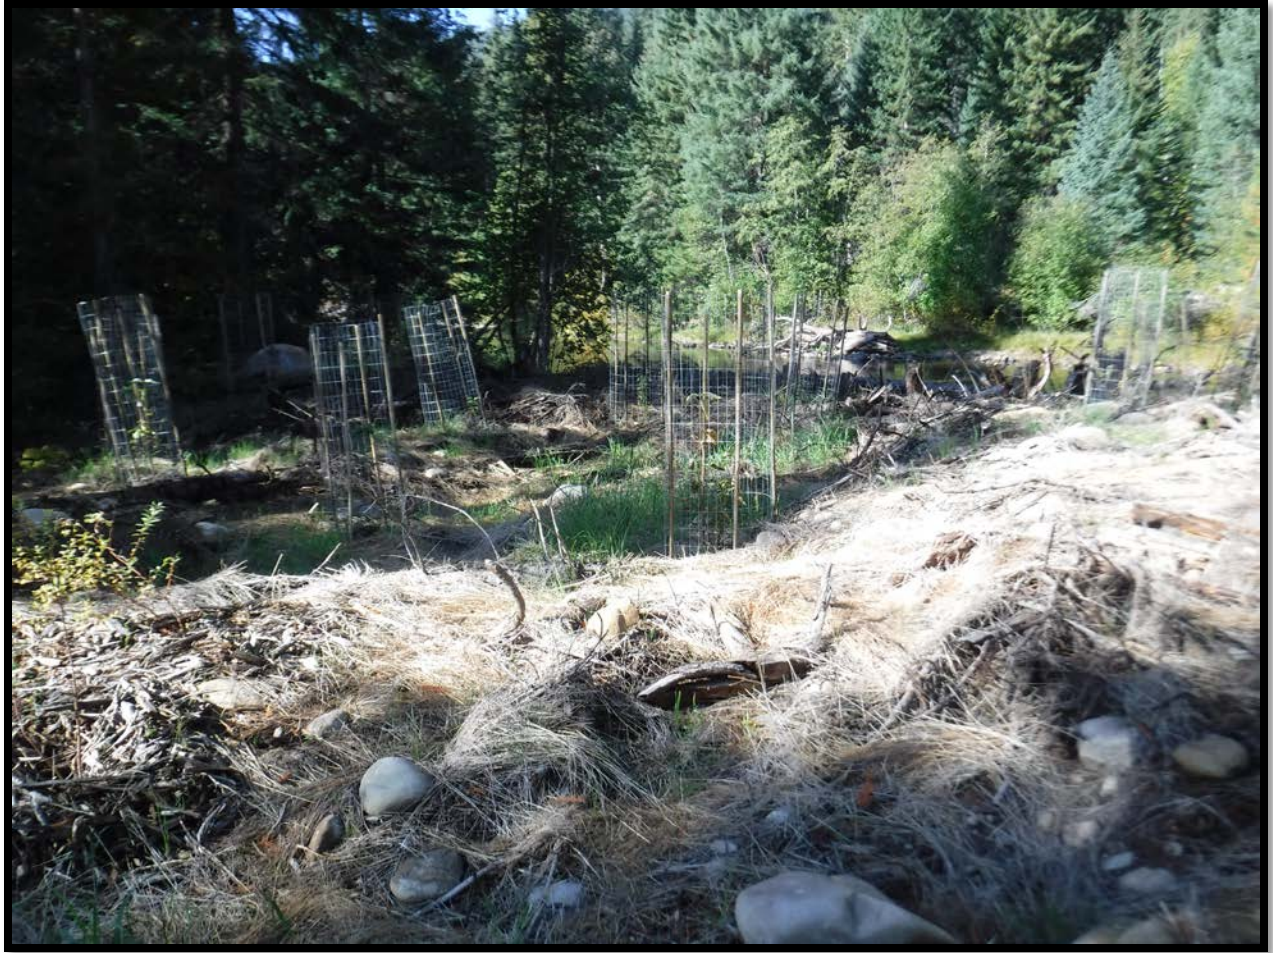
Figure 17. Site N. Revegetation along access path to the site.

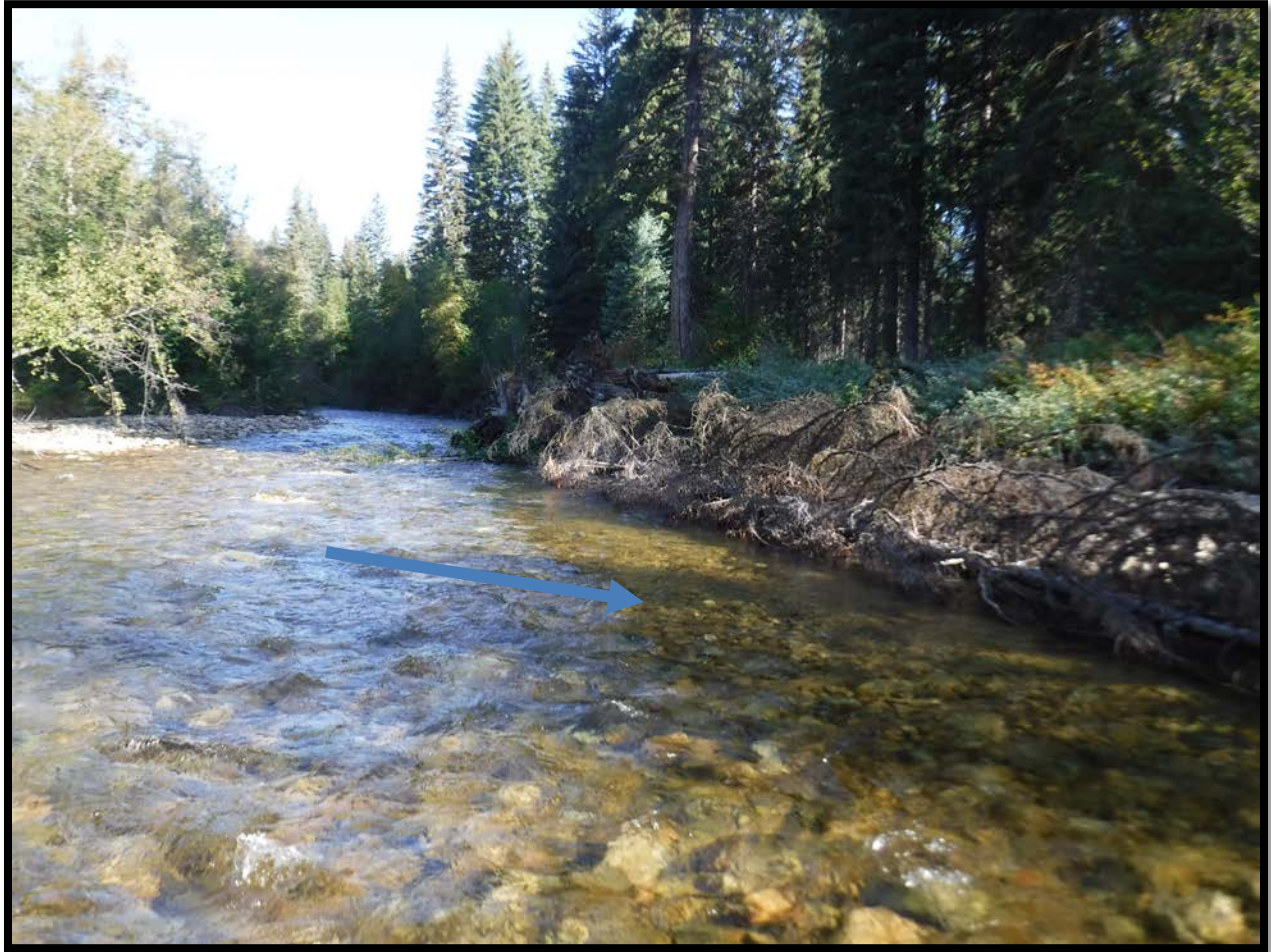
Site O is stable. Pool depth is 2-feet along the jam face. A 10 X 20-foot gravel patch has deposited downstream of the jam and one recent salmon redd was observed within it.

Figure 18. Site O. Looking upstream. Blue arrow indicates salmon red in gravel deposited behind the new structure.

Recommendations: None. Continue to monitor the site as needed.

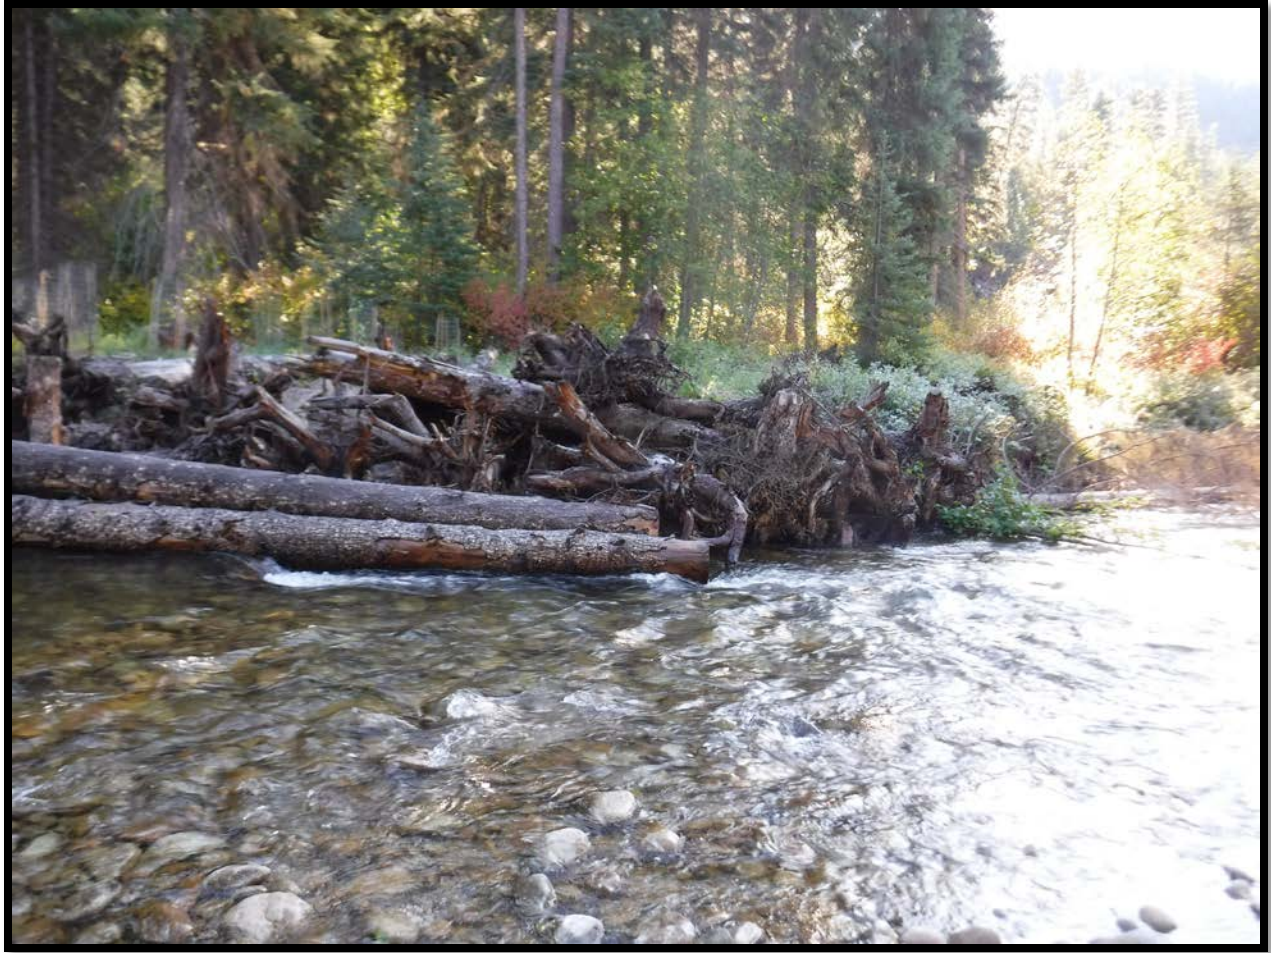
Figure 19. Site O. Face view.
