Chewuch River Mile 17-20 2018-19 Post-Construction Monitoring Report

FEBRUARY 2020

This report is the first of three post-construction field-monitoring reports for the Chewuch River Mile 17-20 project. Field work was conducted on October 1, 2019 with the purpose of monitoring the safety, stability, and effectiveness of constructed fish habitat. The project is located on United States Forest Service land between river miles 17 and 20 and was constructed July 2018. The purpose of the project was to increase adult holding and juvenile rearing habitat during low and high flows.

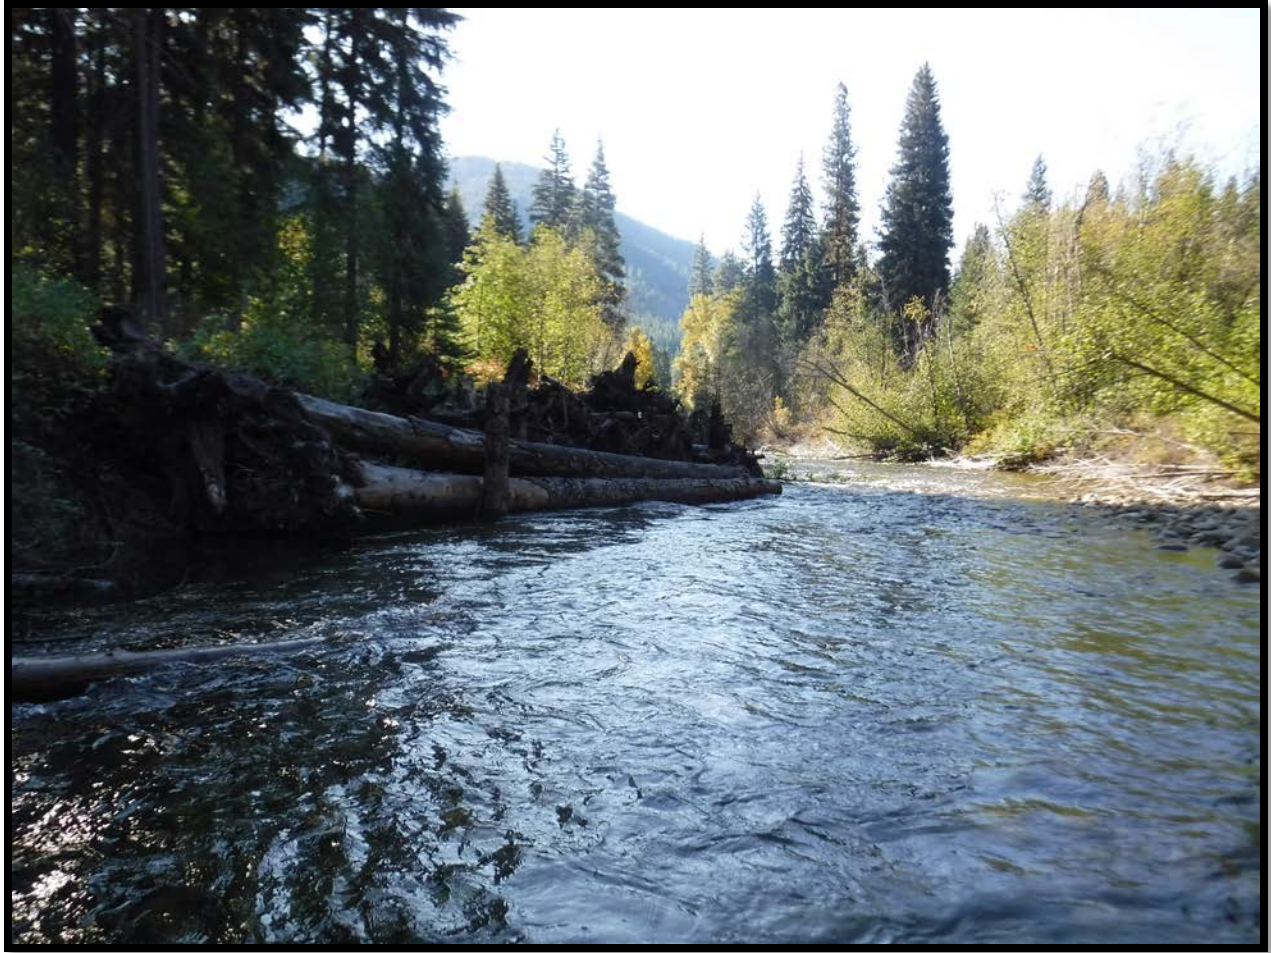
Figure 20. Site O. Looking downstream.

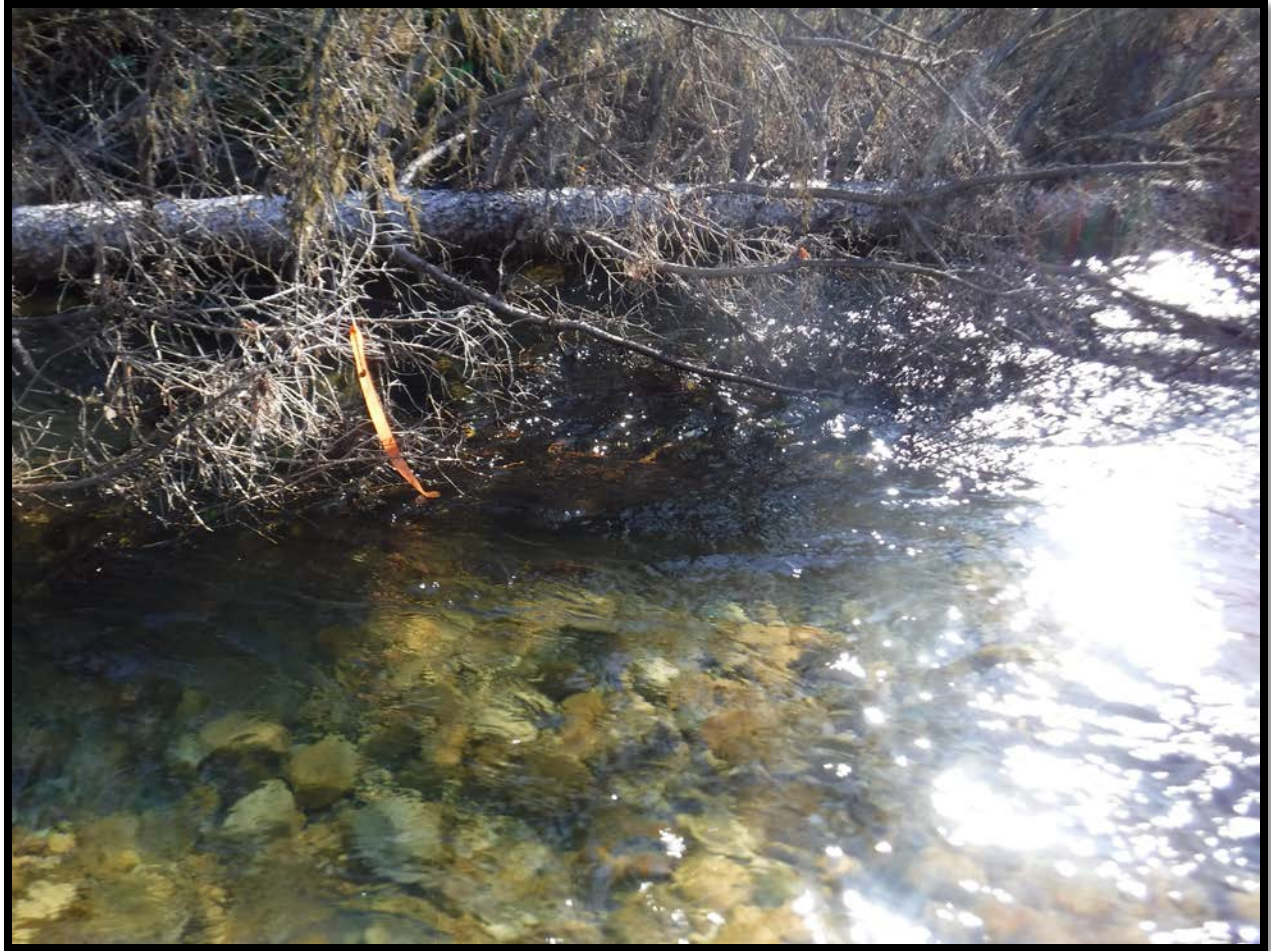
Figure 21. Site O. Redd located in new gravel at the downstream end of the structure.

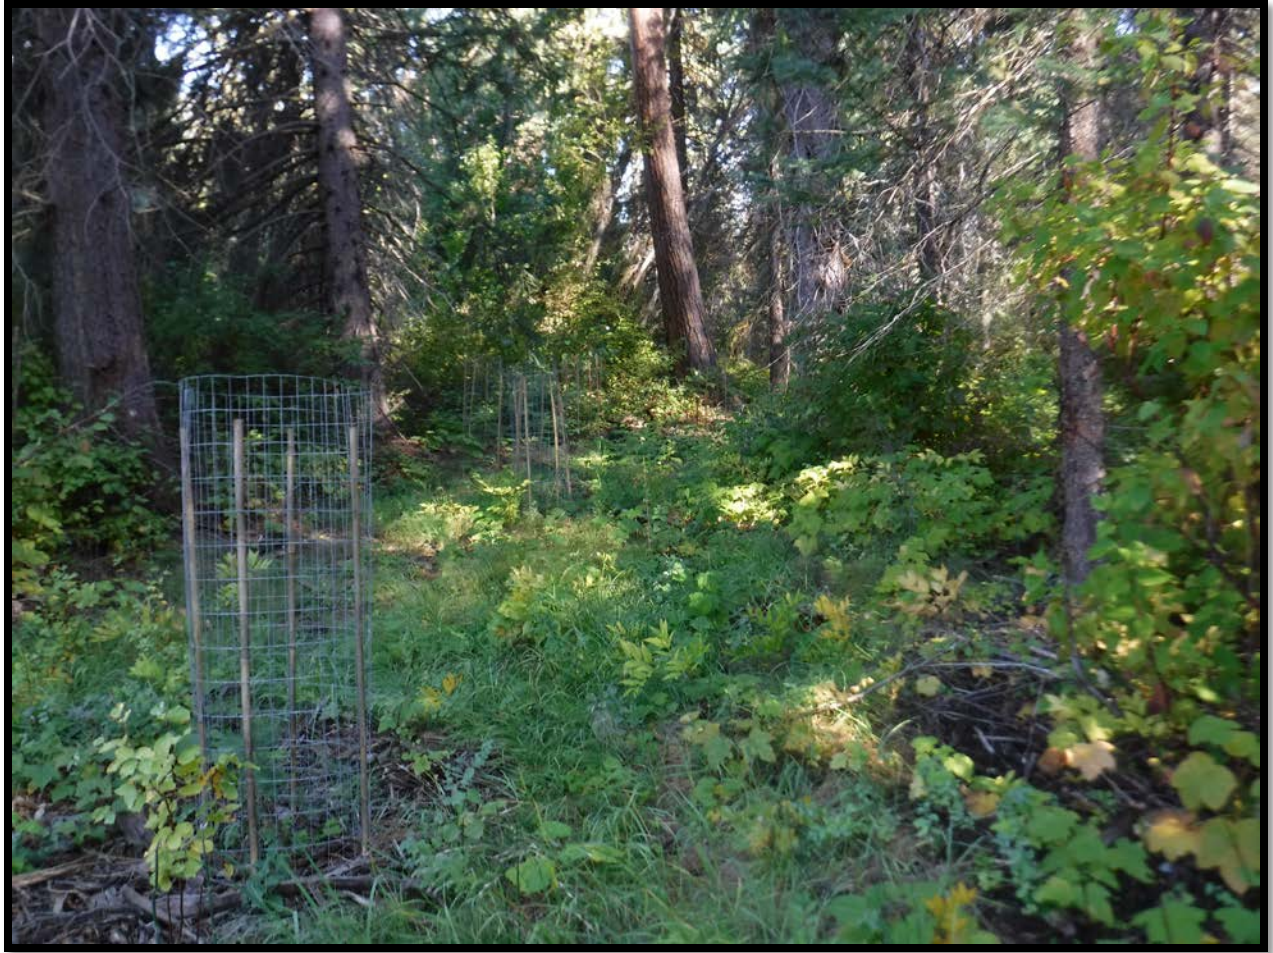
Figure 22. Site O. Revegetation conditions along access path to the site.

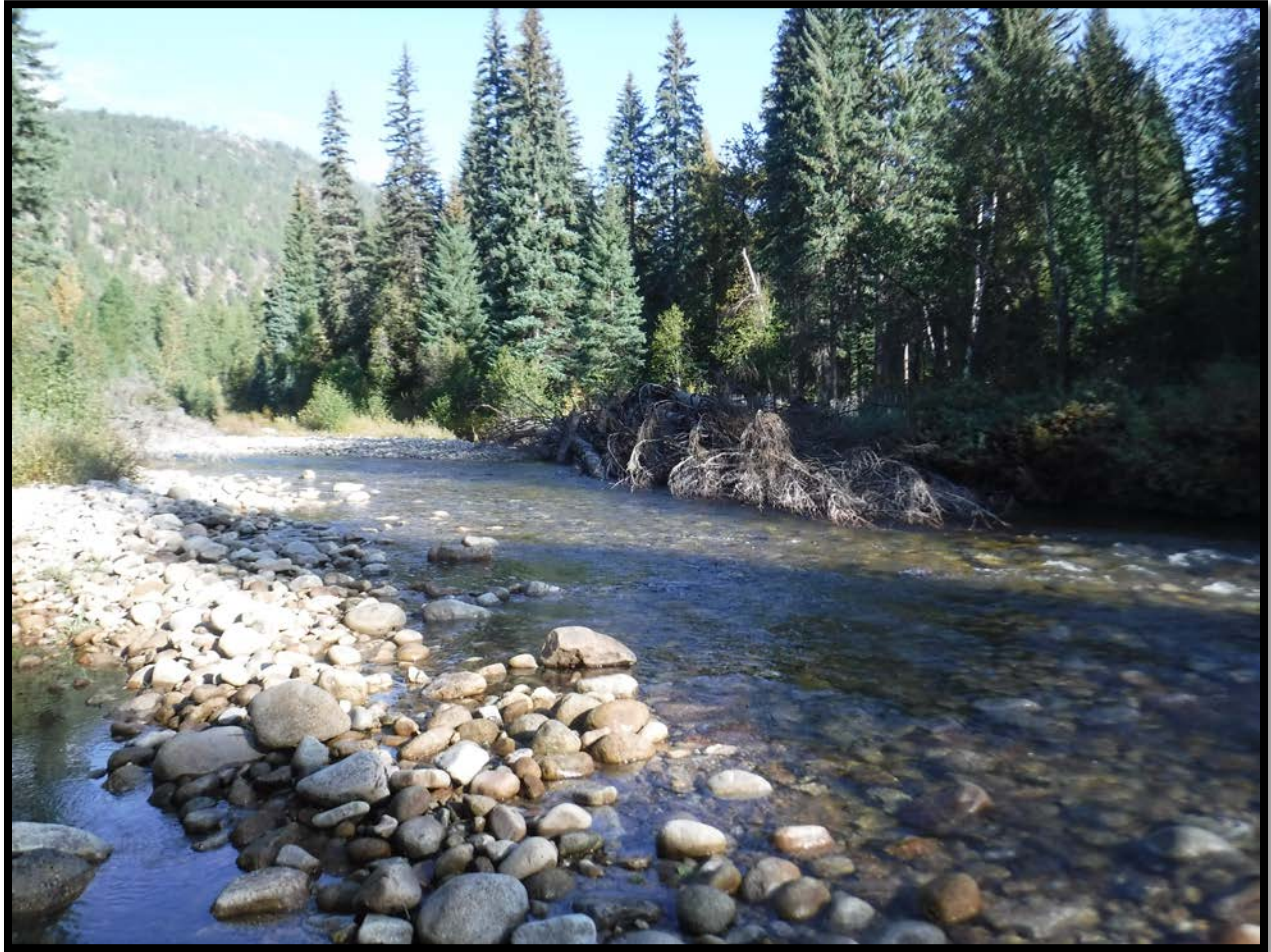
Site P is stable and similar to post construction conditions. The pool at the jam face is 2-3 feet deep. Revegetation throughout access to the site is in good condition.

Figure 23. Site P. Looking upstream.

Recommendations: None. Continue to monitor the site as needed.

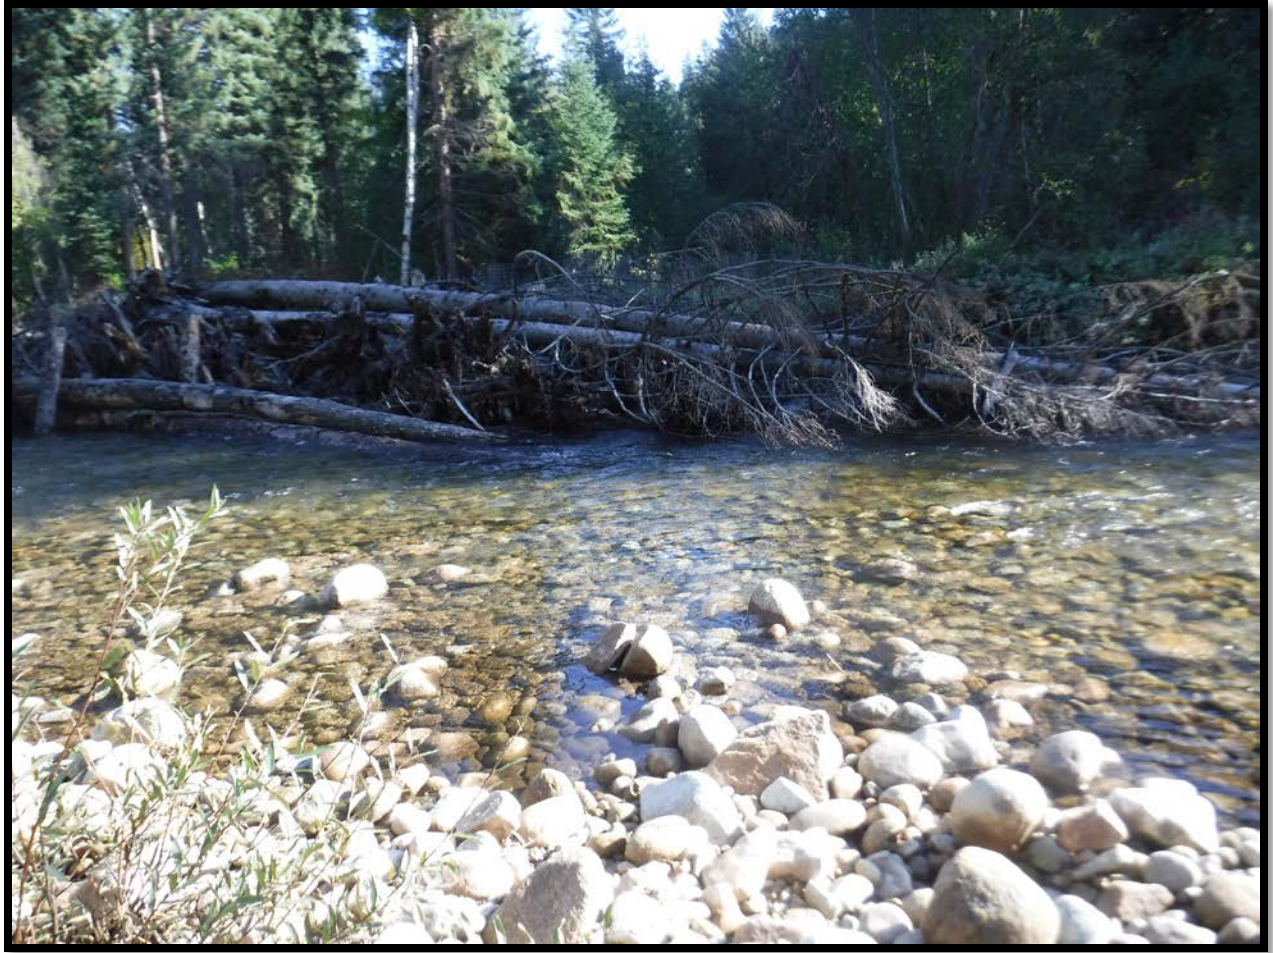
Figure 24. Site P. Face view.

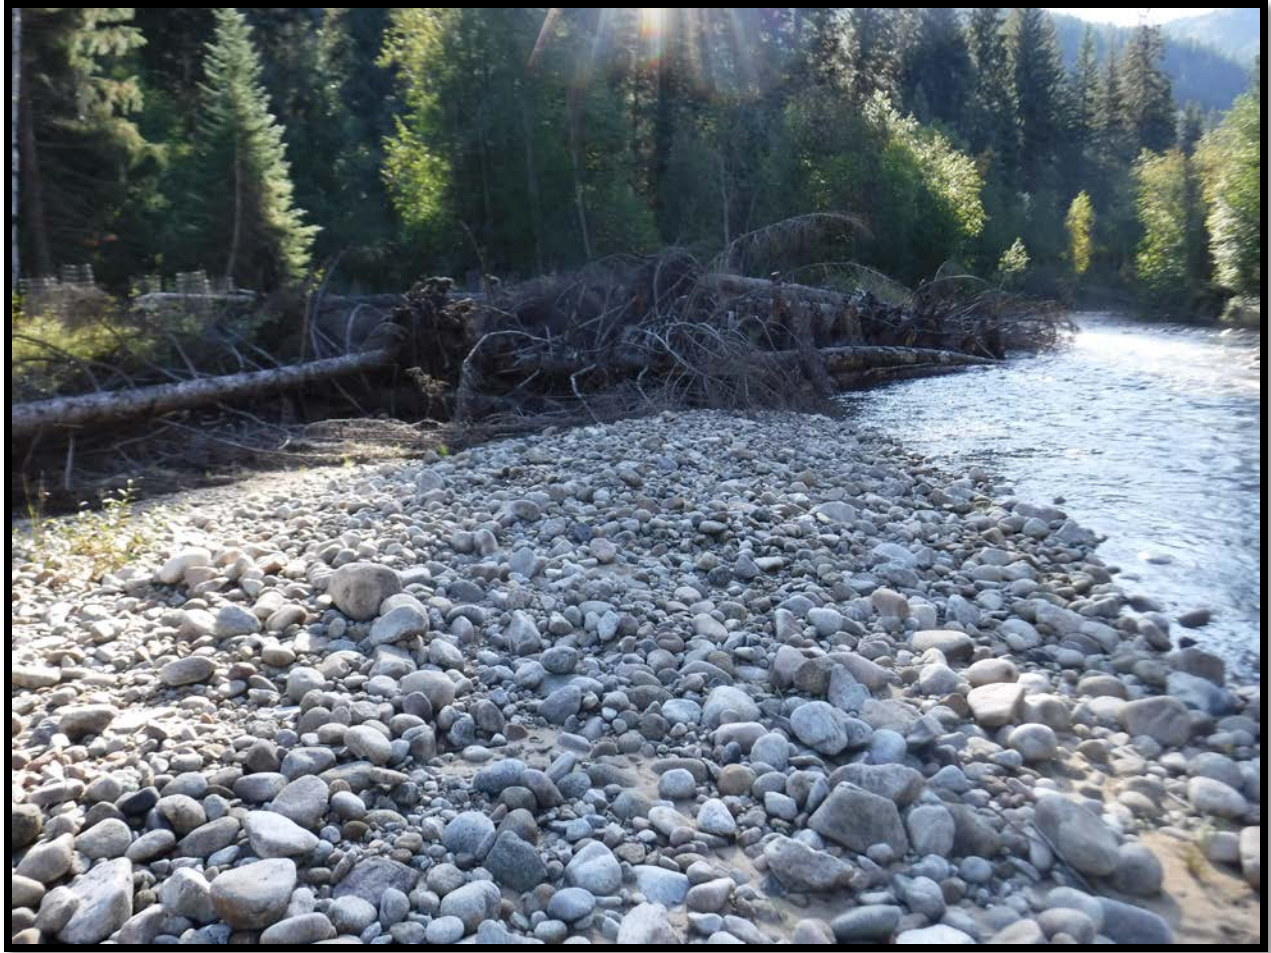
Figure 25. Site P. Looking downstream.

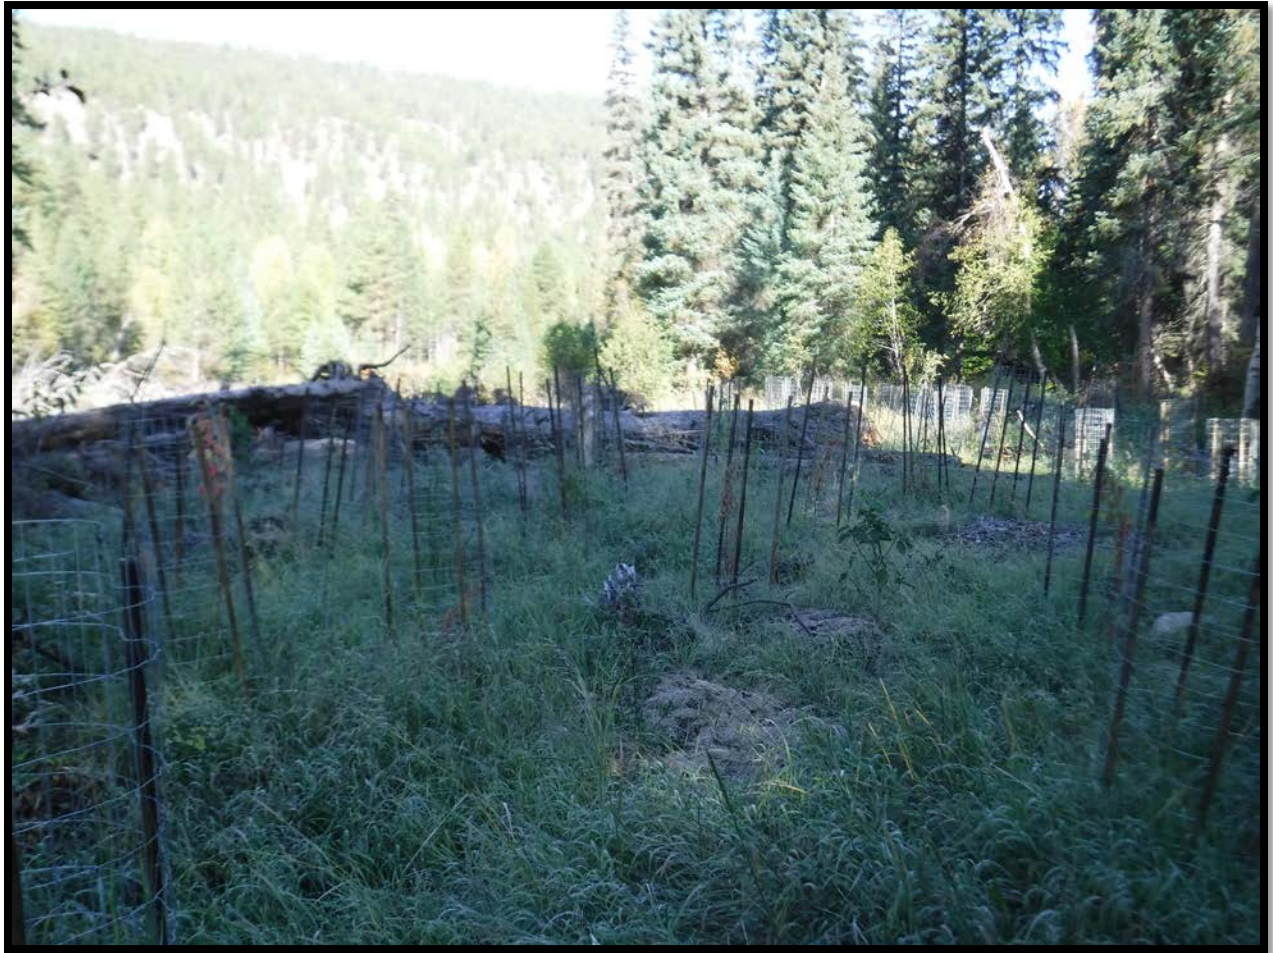
Figure 26. Site P. Revegetation within excavated area and access path.

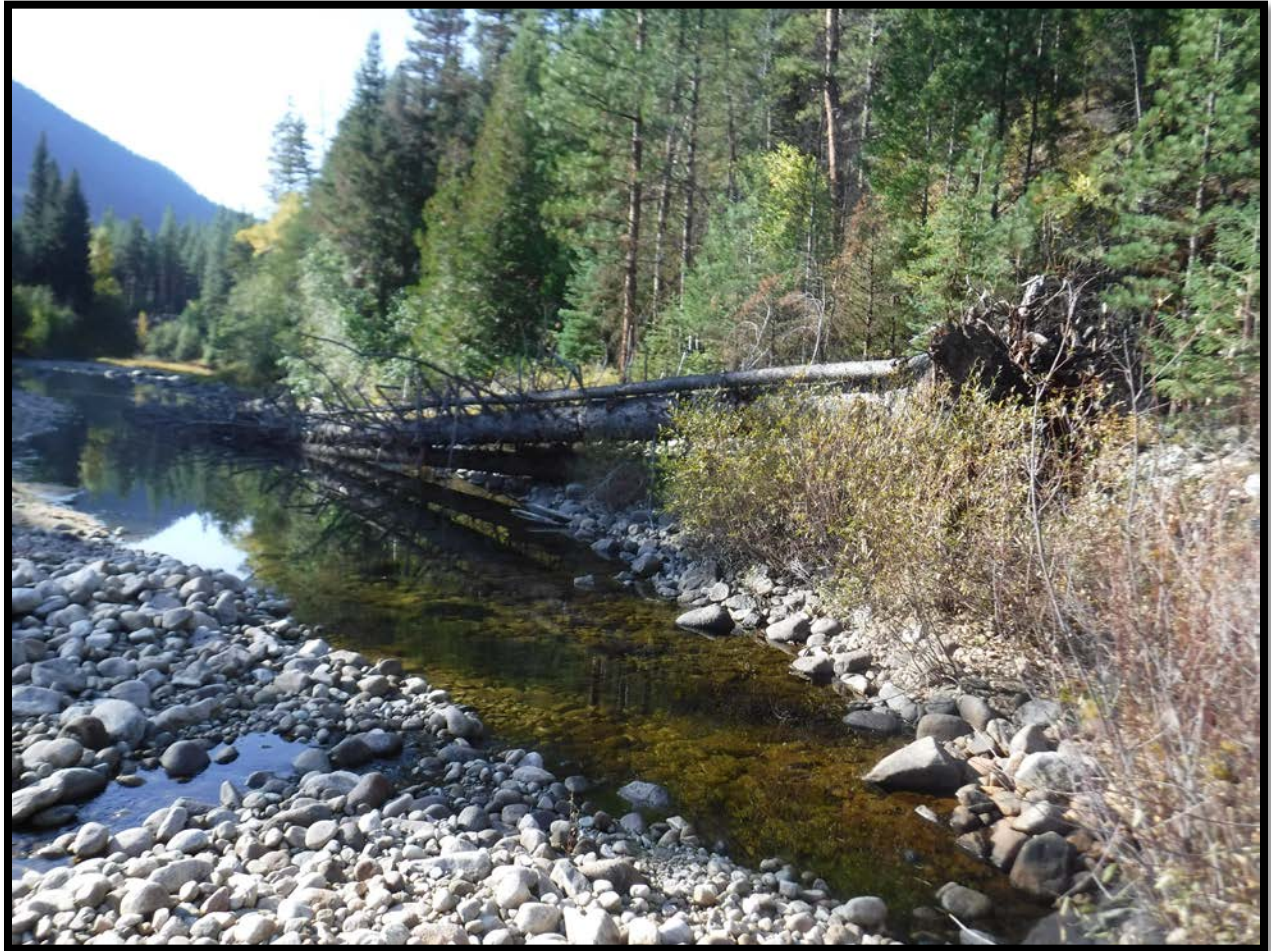
Site Q is stable. The wood has not moved and provides similar cover habitat as it did last year.

Figure 27. Site Q Looking downstream.

Recommendations: None. Continue to monitor the site as needed.

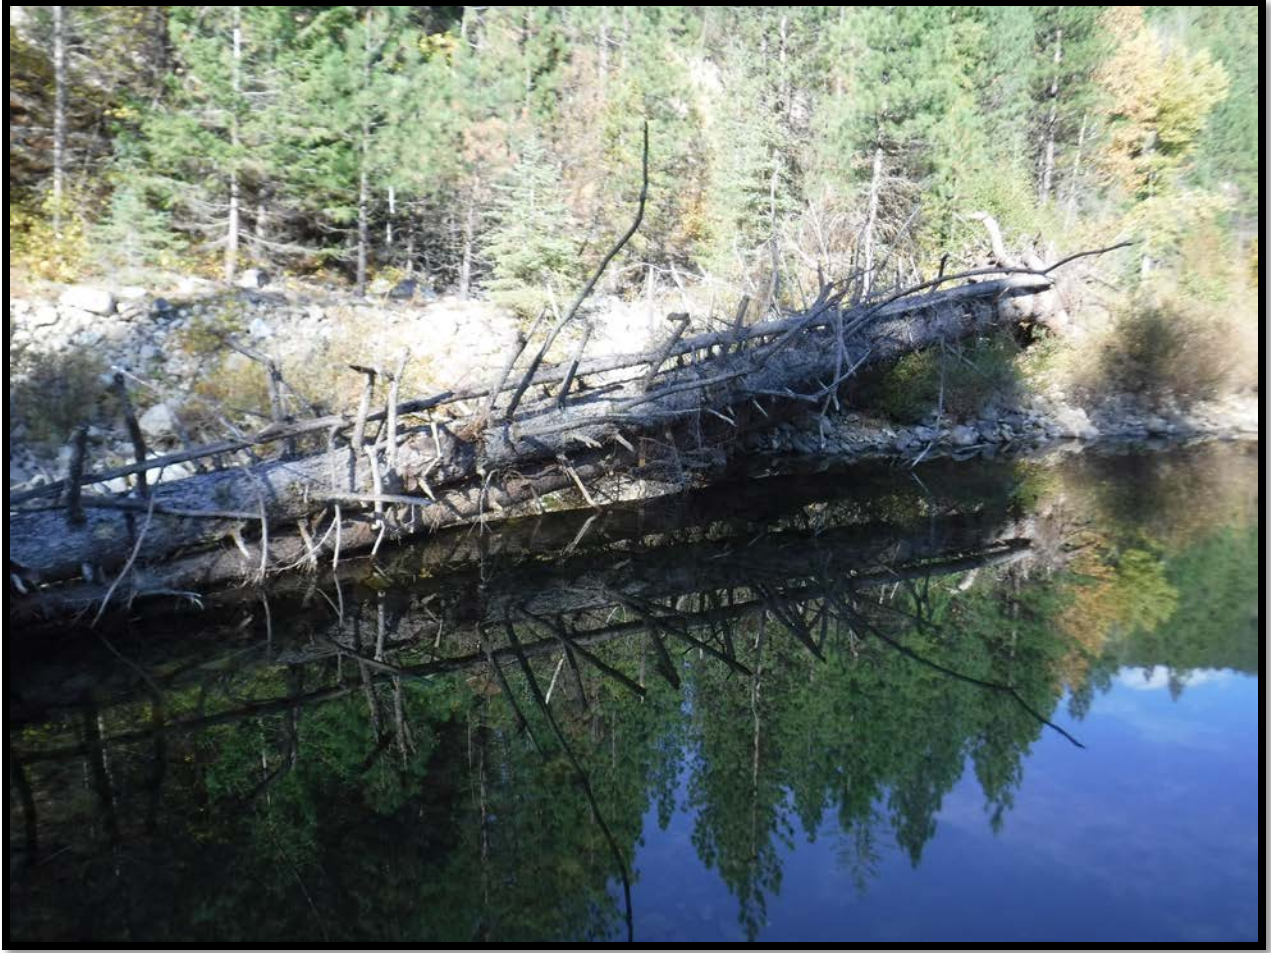
Figure 28. Site Q. Face view.

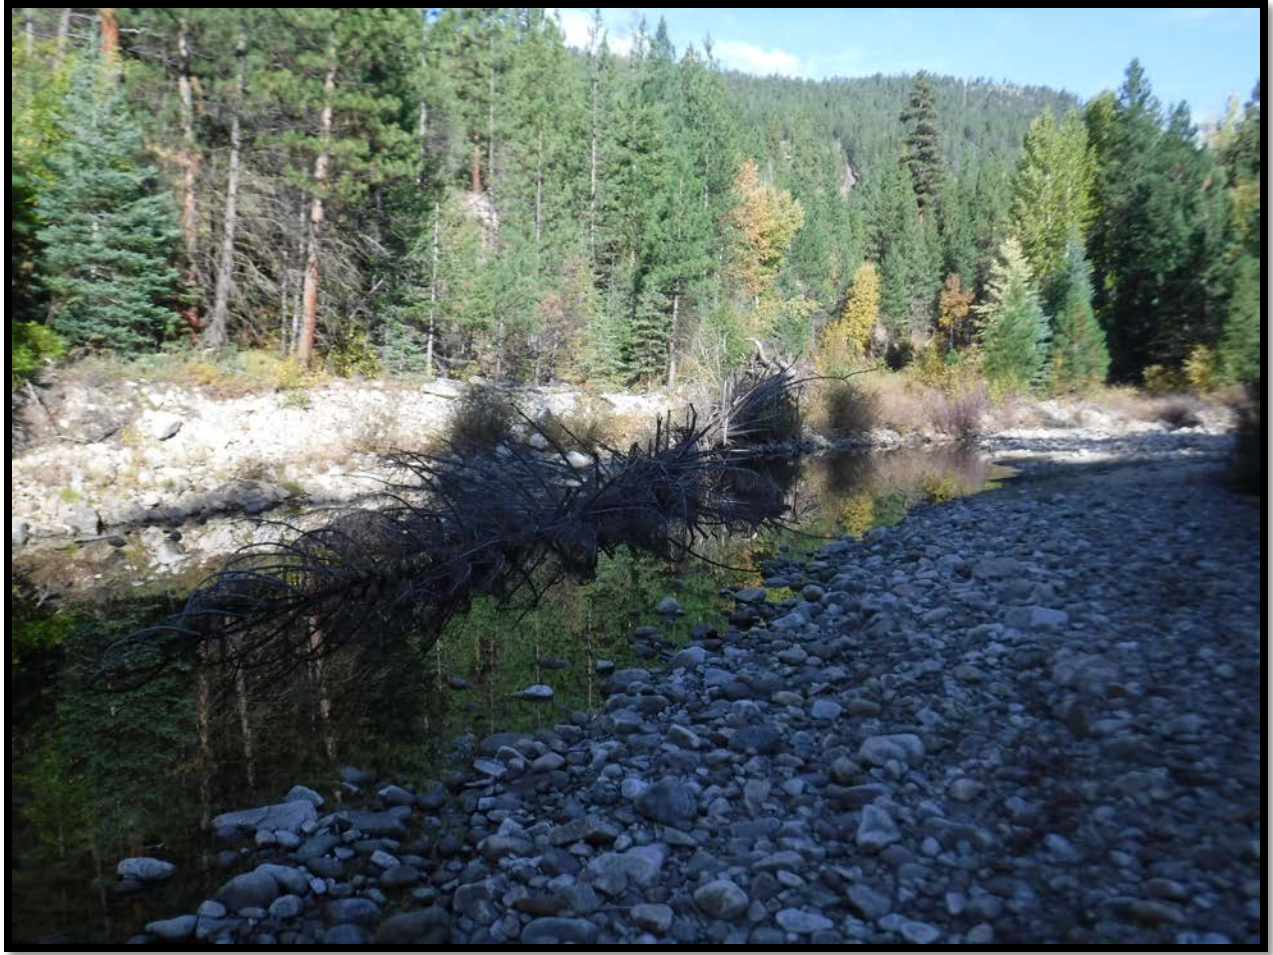
Figure 29. Site Q. Looking upstream.

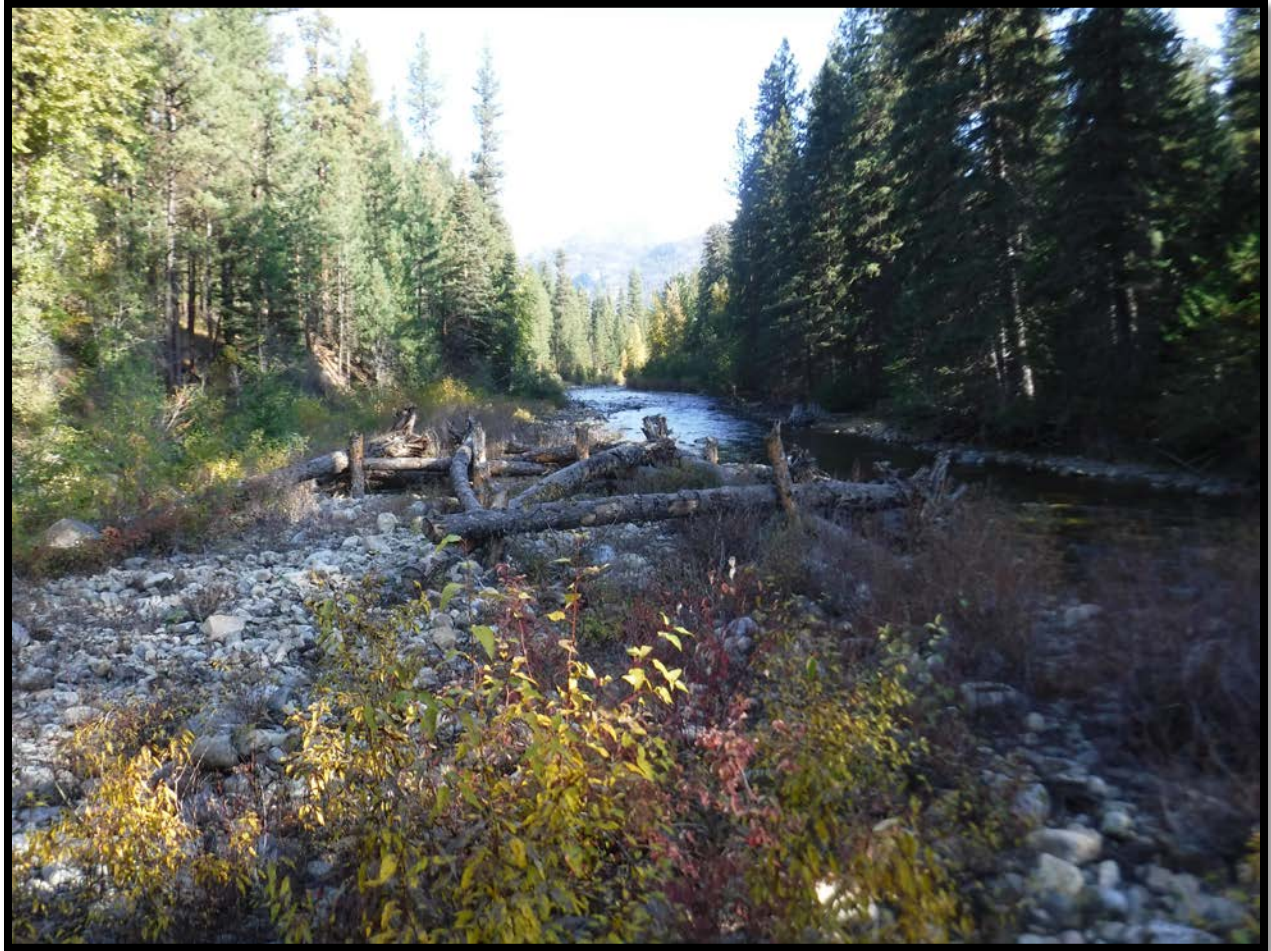
Site S is stable. Site S is unchanged from original construction. No native LW accumulation has occurred at the jam face. The wood structure is functioning as designed. The access path to the site is recovering.

Figure 30. Site S. Looking upstream.

Recommendations: None. Continue to monitor the site as needed.

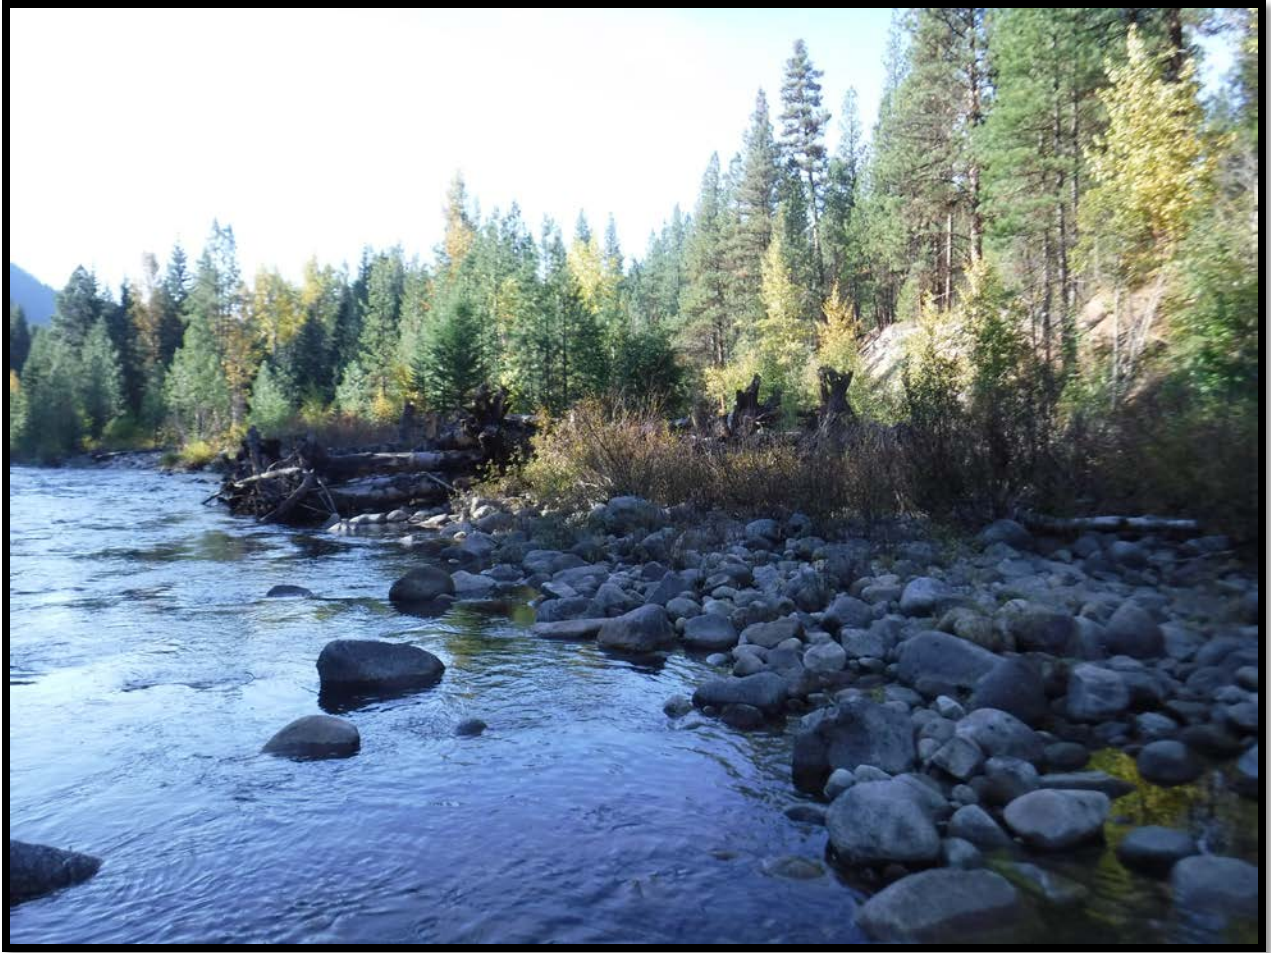
Figure 31. Site S. Looking downstream.

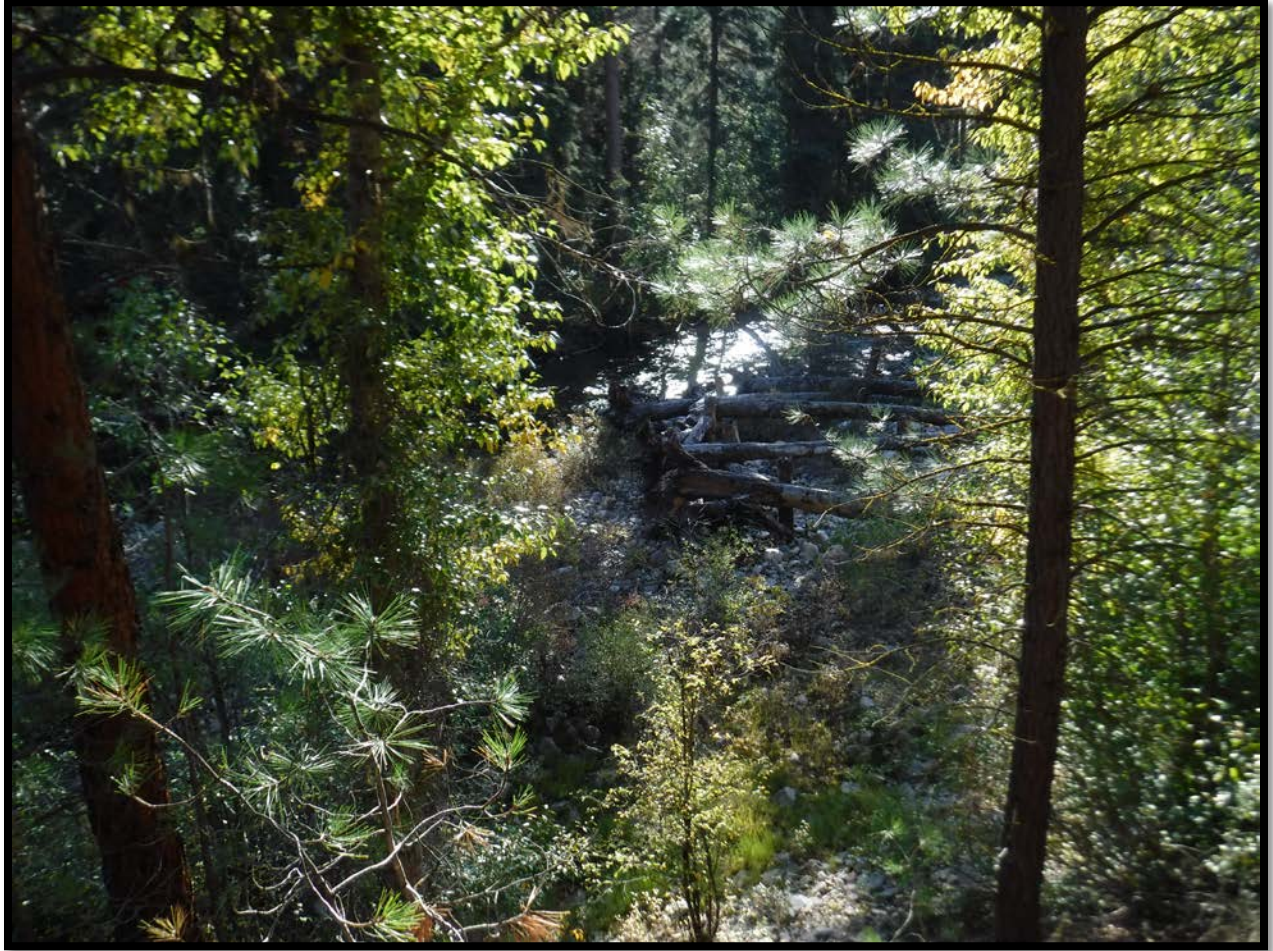
Figure 32. Site S. Looking from the west chewuch road.

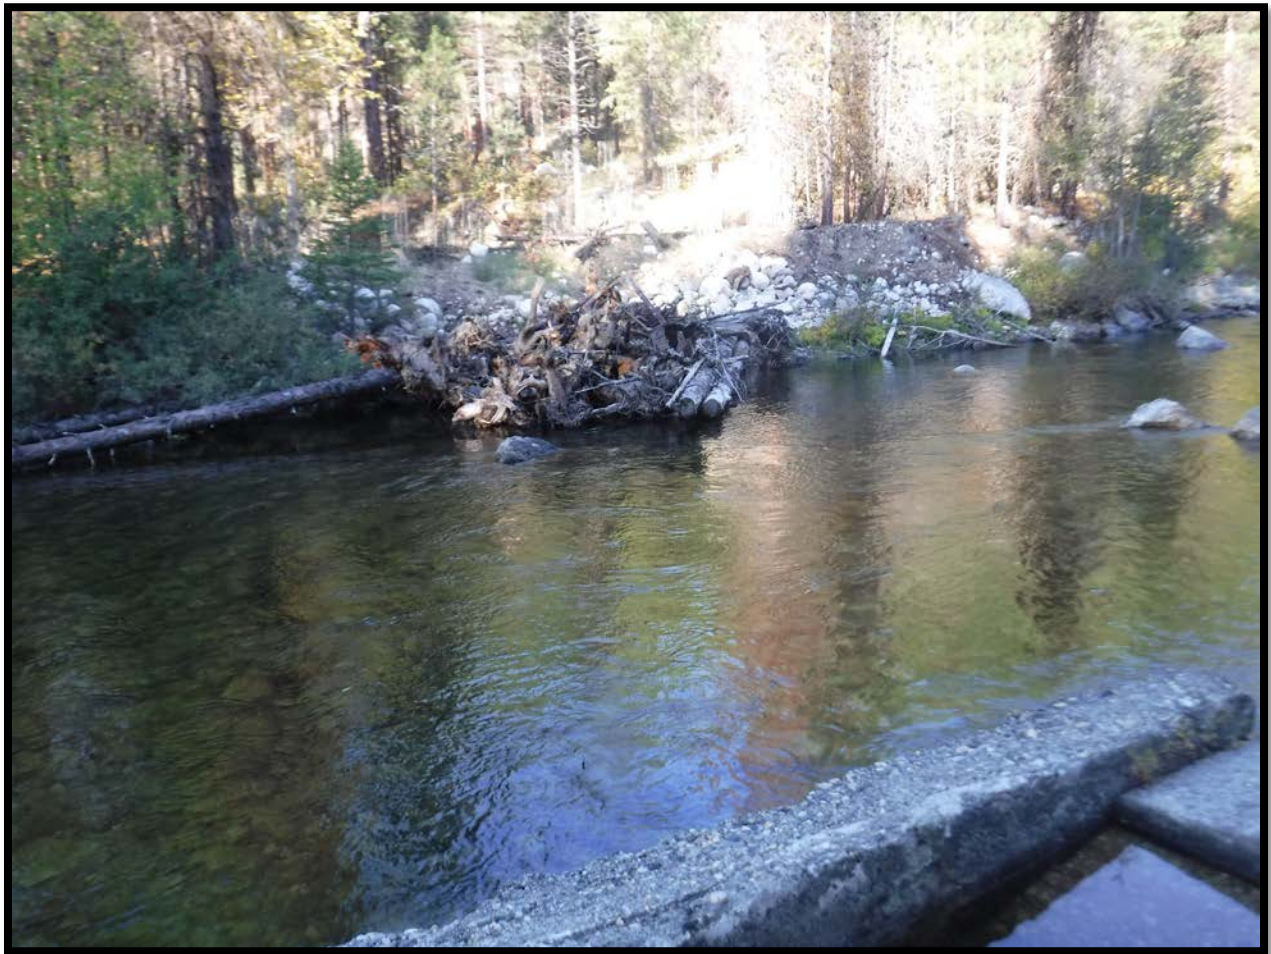
Site T is stable. The site is similar to post construction conditions. A small volume of native slash has accumulated at the jam face. Pool depth is approximately 3 feet deep. Revegetation is in good condition given the dry site conditions.

Figure 33. Site T. Face view from the old bridge footing.

Recommendations: None. Continue to monitor the site as needed.

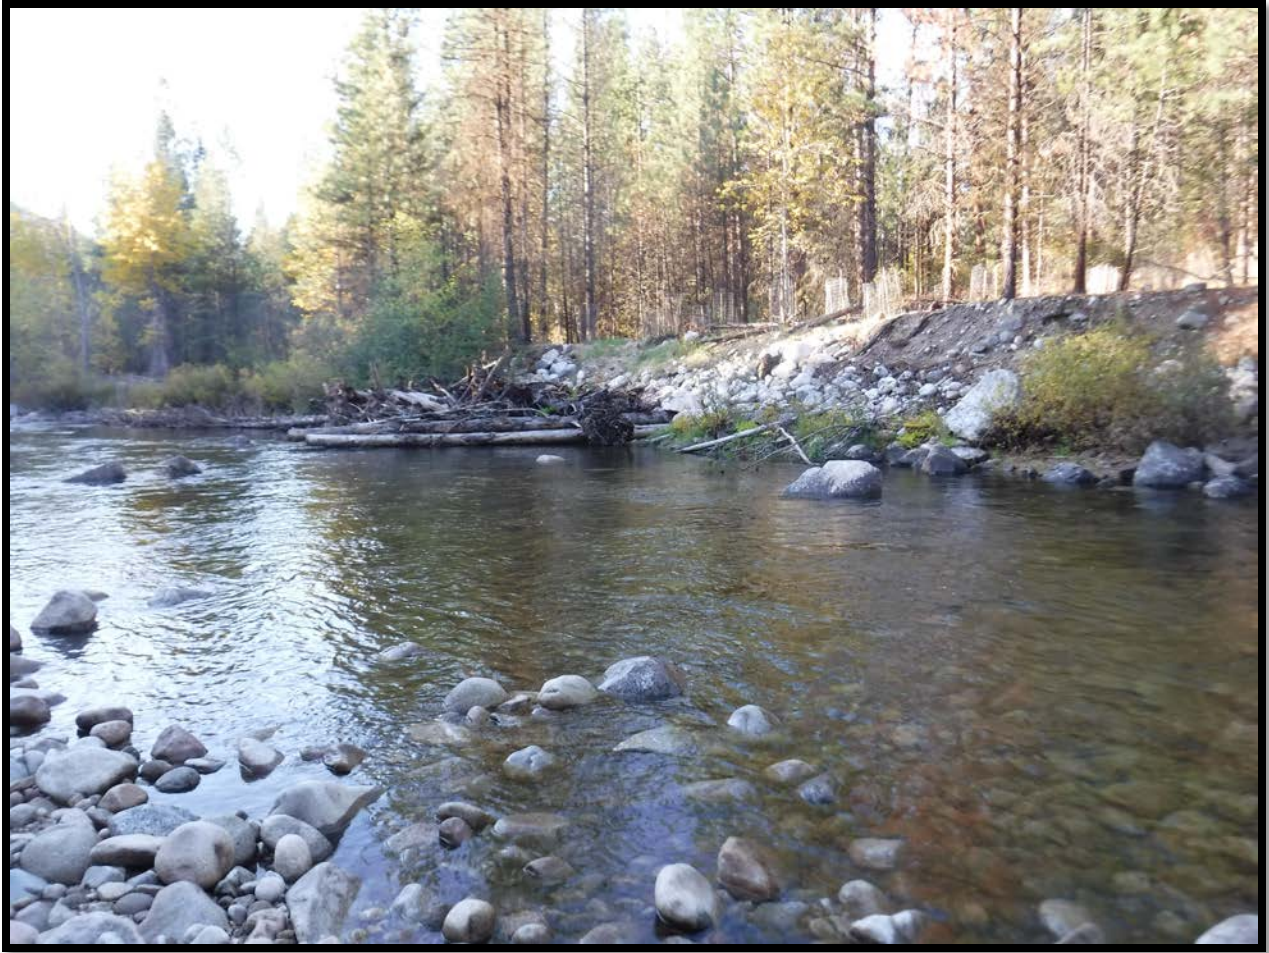
Figure 34. Site T. Looking downstream.

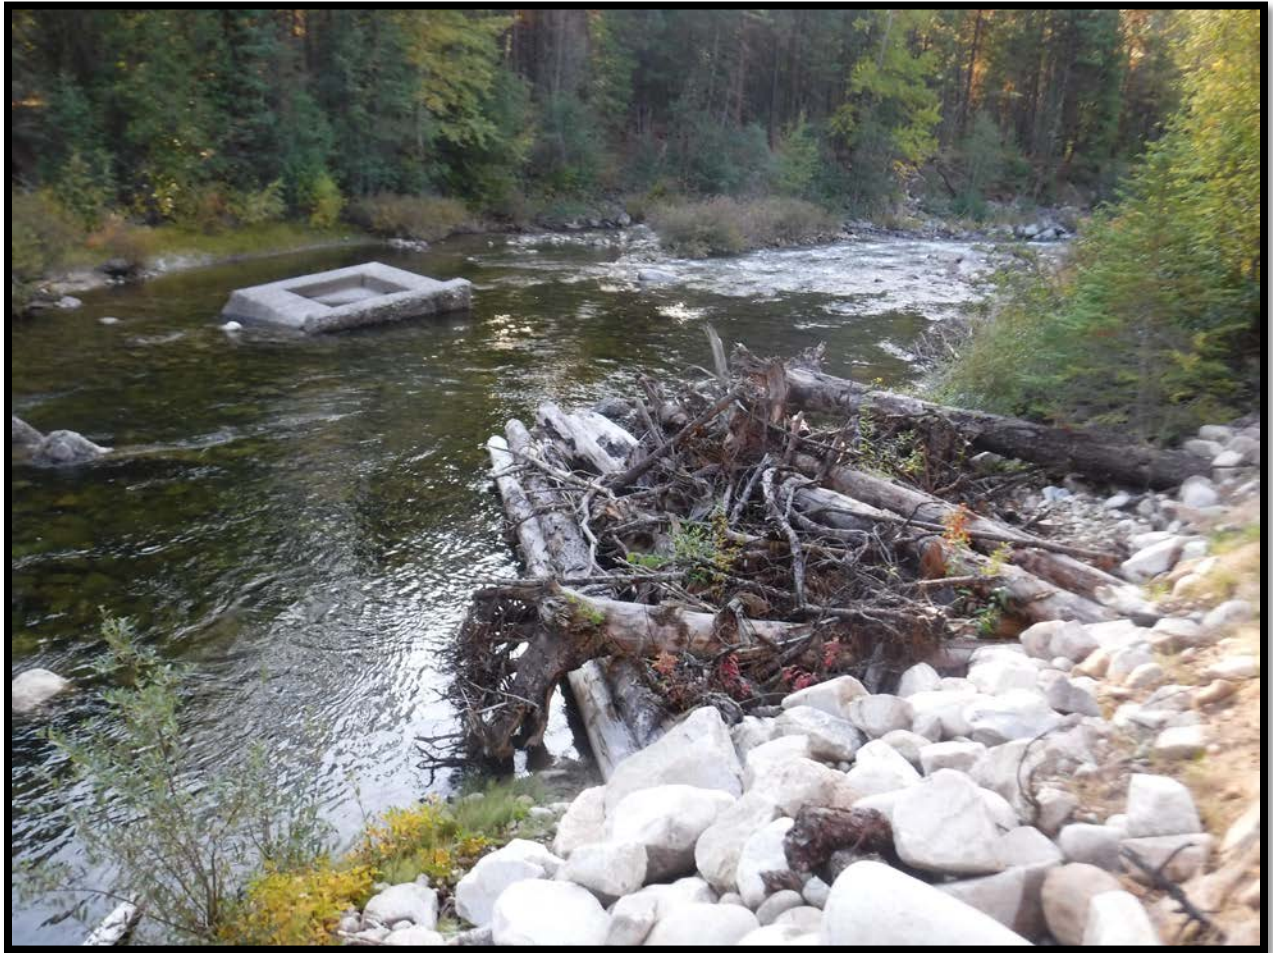
Figure 35. Site T. View from right bank looking downstream.

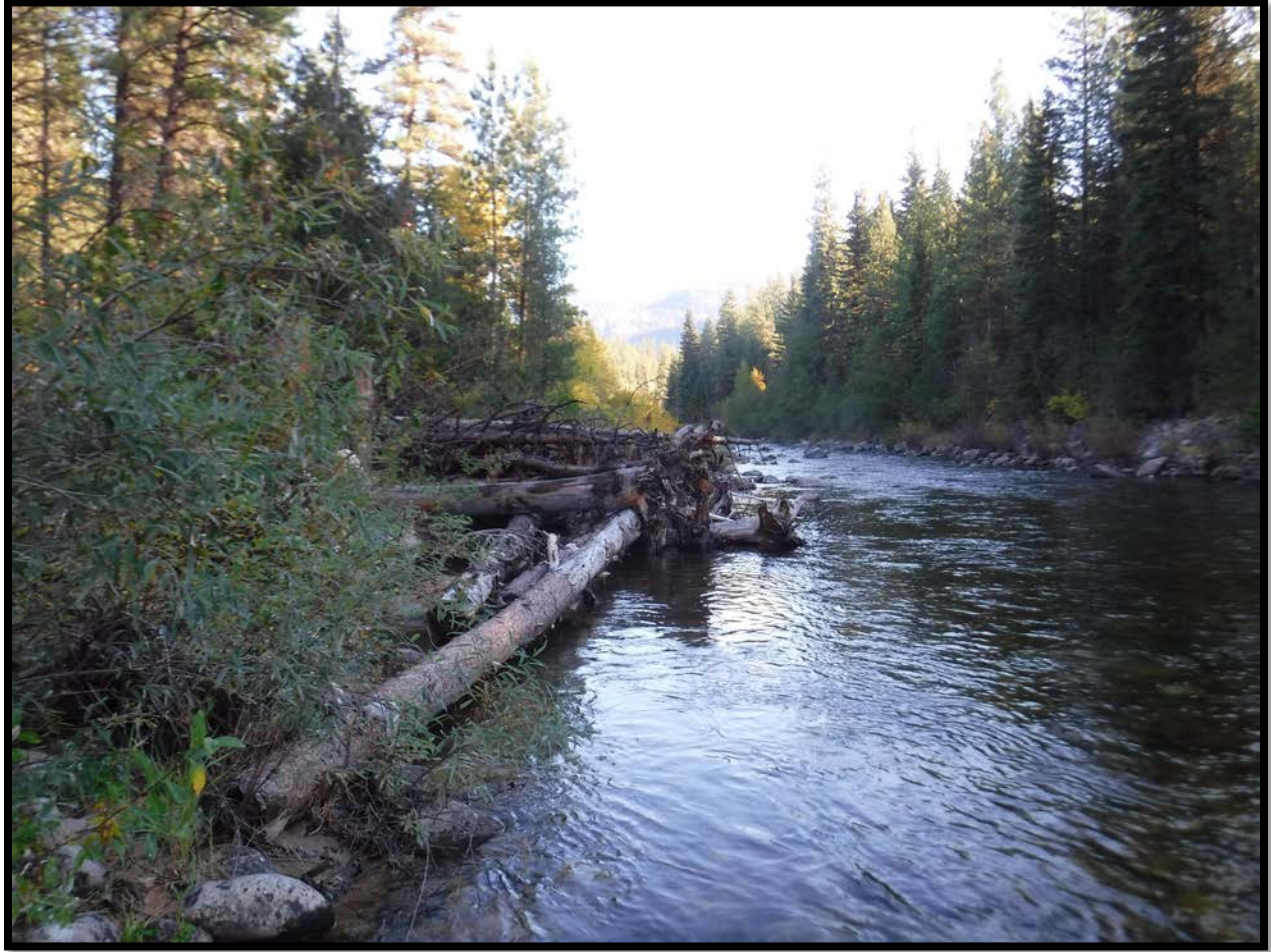
Site U is stable. Pool depths under the jam are greater than 4-feet. Revegetation is very good. Cedar tree plantings are showing stress (dry site). The rest of the revegetation has a near 100% survival.

Figure 36. Site U. Looking upstream.

Recommendations: None. Continue to monitor the site as needed.

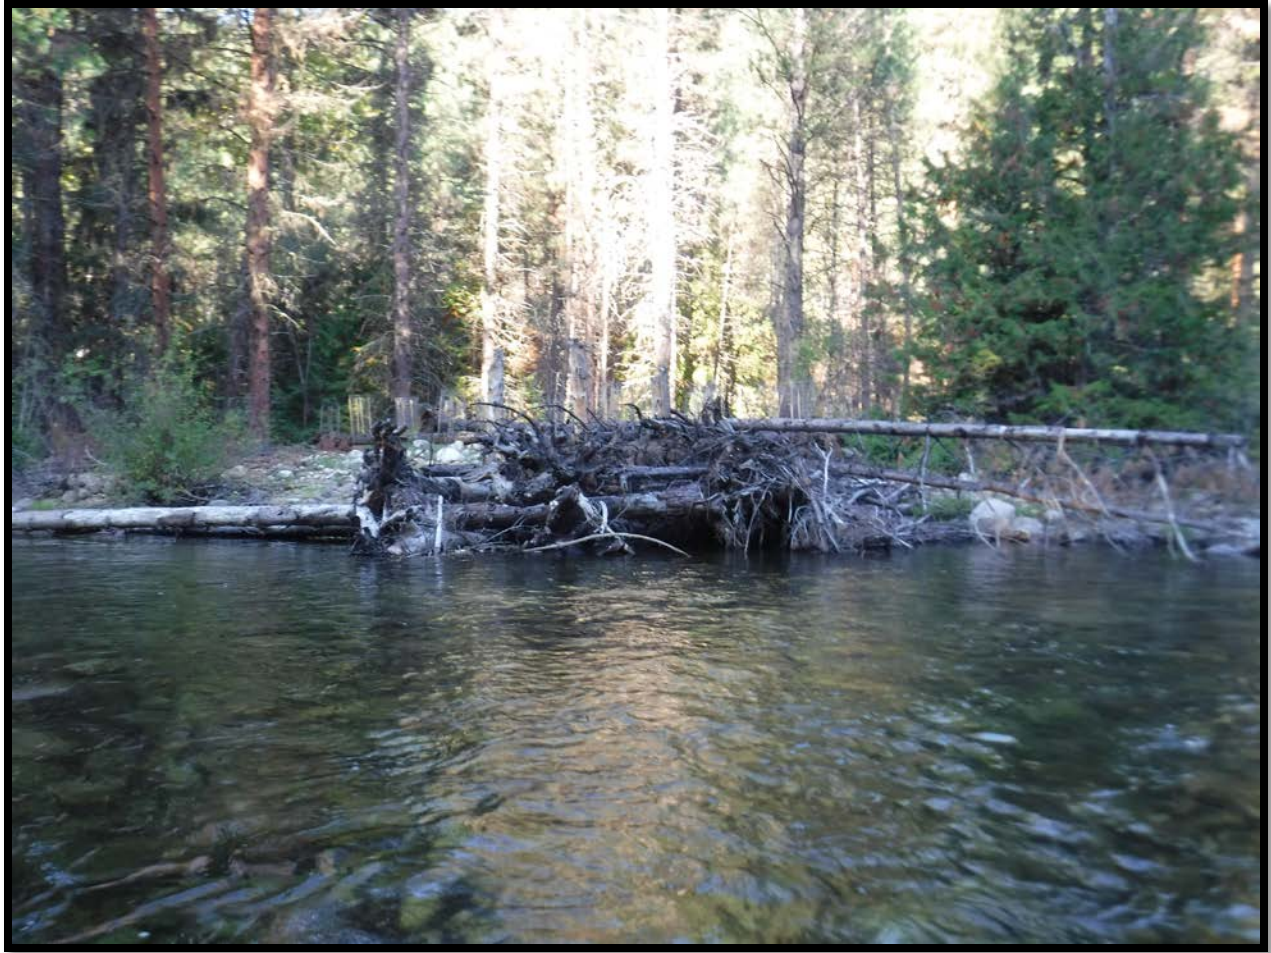
Figure 37. Site U. Face view.
