Chewuch River Mile 17-20 2018-19 Post-Construction Monitoring Report

FEBRUARY 2020

This report is the first of three post-construction field-monitoring reports for the Chewuch River Mile 17-20 project. Field work was conducted on October 1, 2019 with the purpose of monitoring the safety, stability, and effectiveness of constructed fish habitat. The project is located on United States Forest Service land between river miles 17 and 20 and was constructed July 2018. The purpose of the project was to increase adult holding and juvenile rearing habitat during low and high flows.

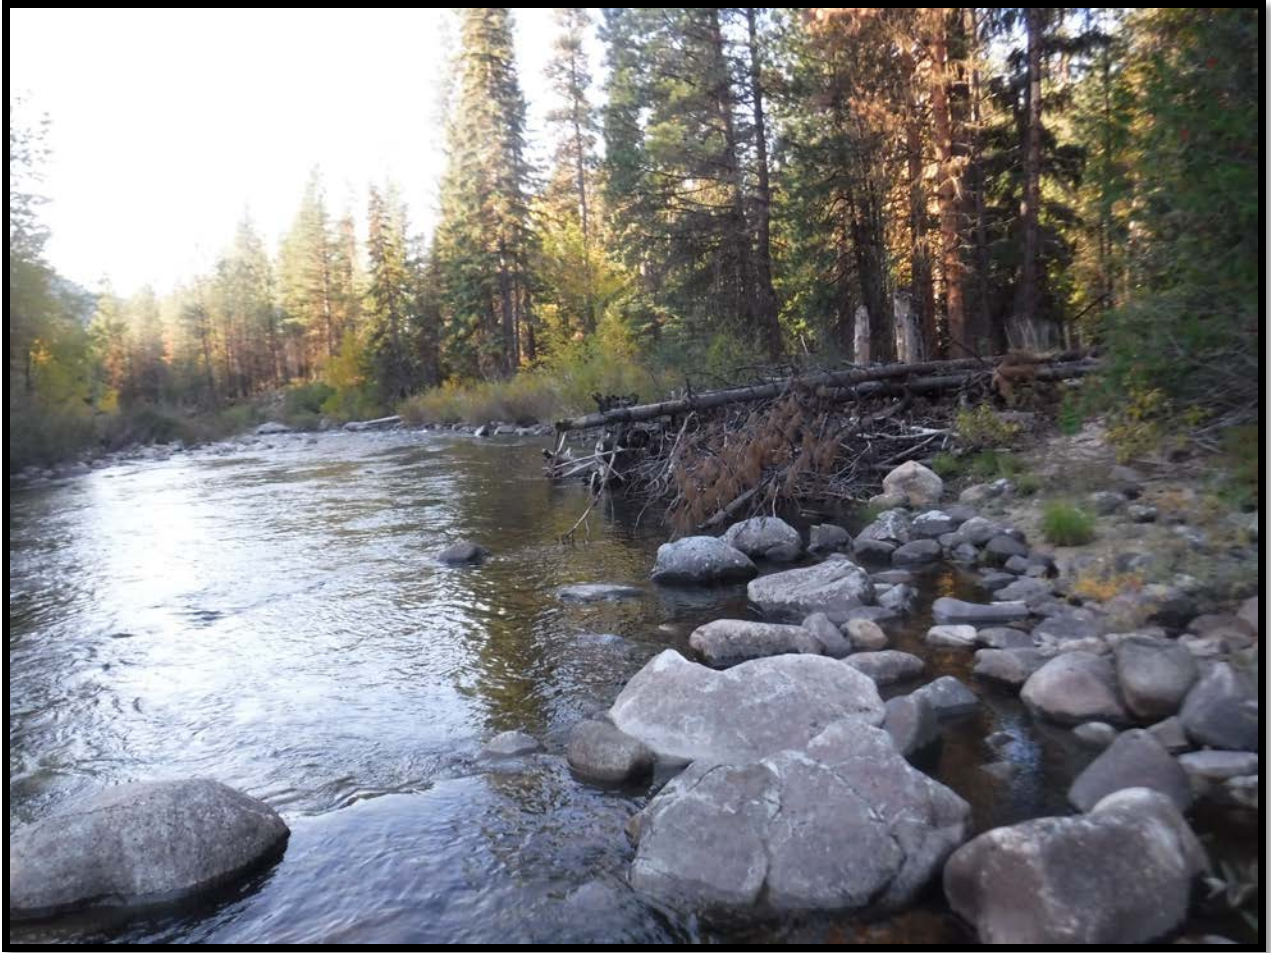
Figure 38. Site U. Looking downstream.

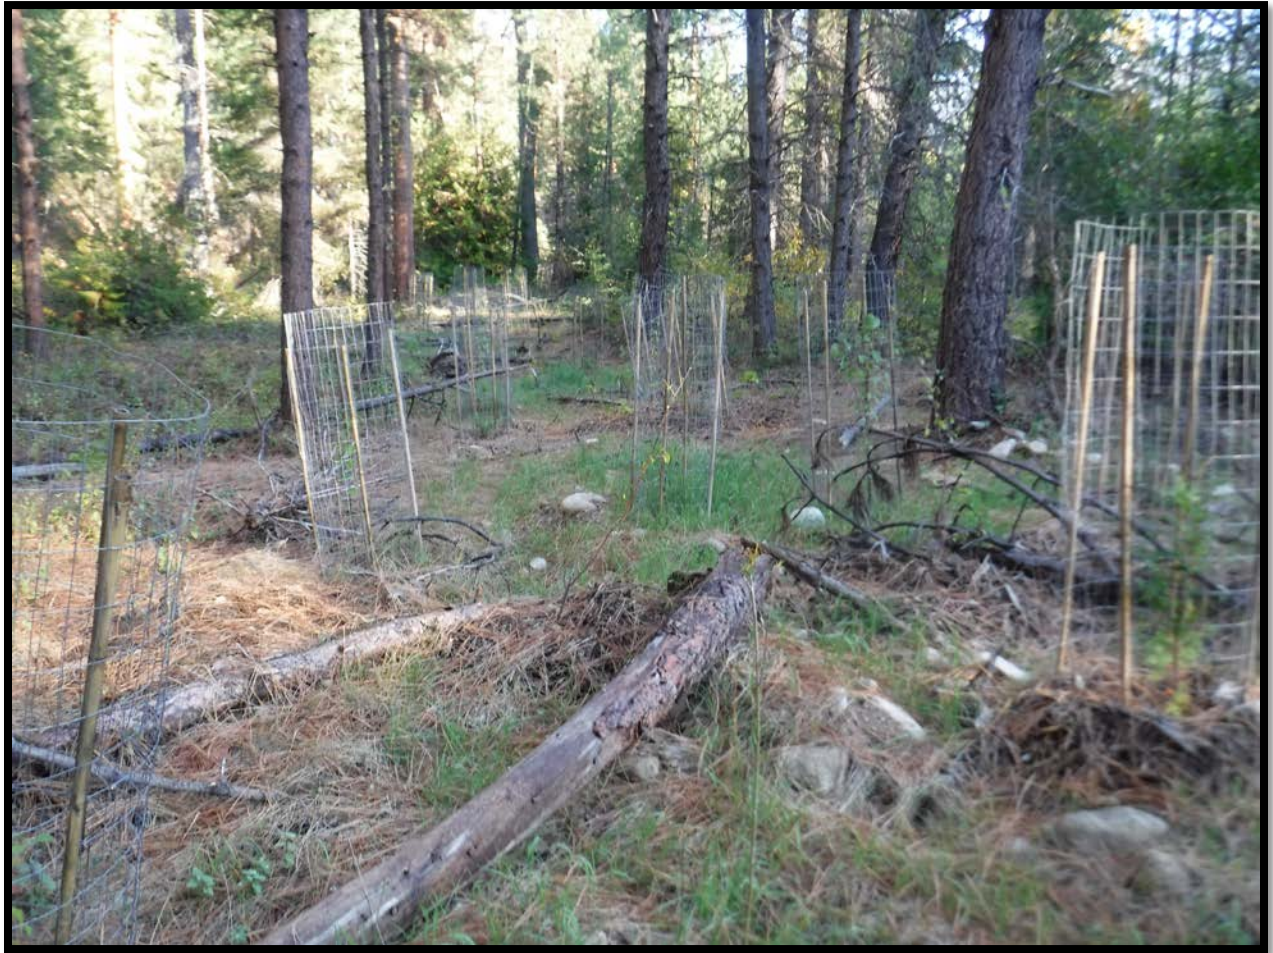
Figure 39. Site U. Revegetation along access path to the site.

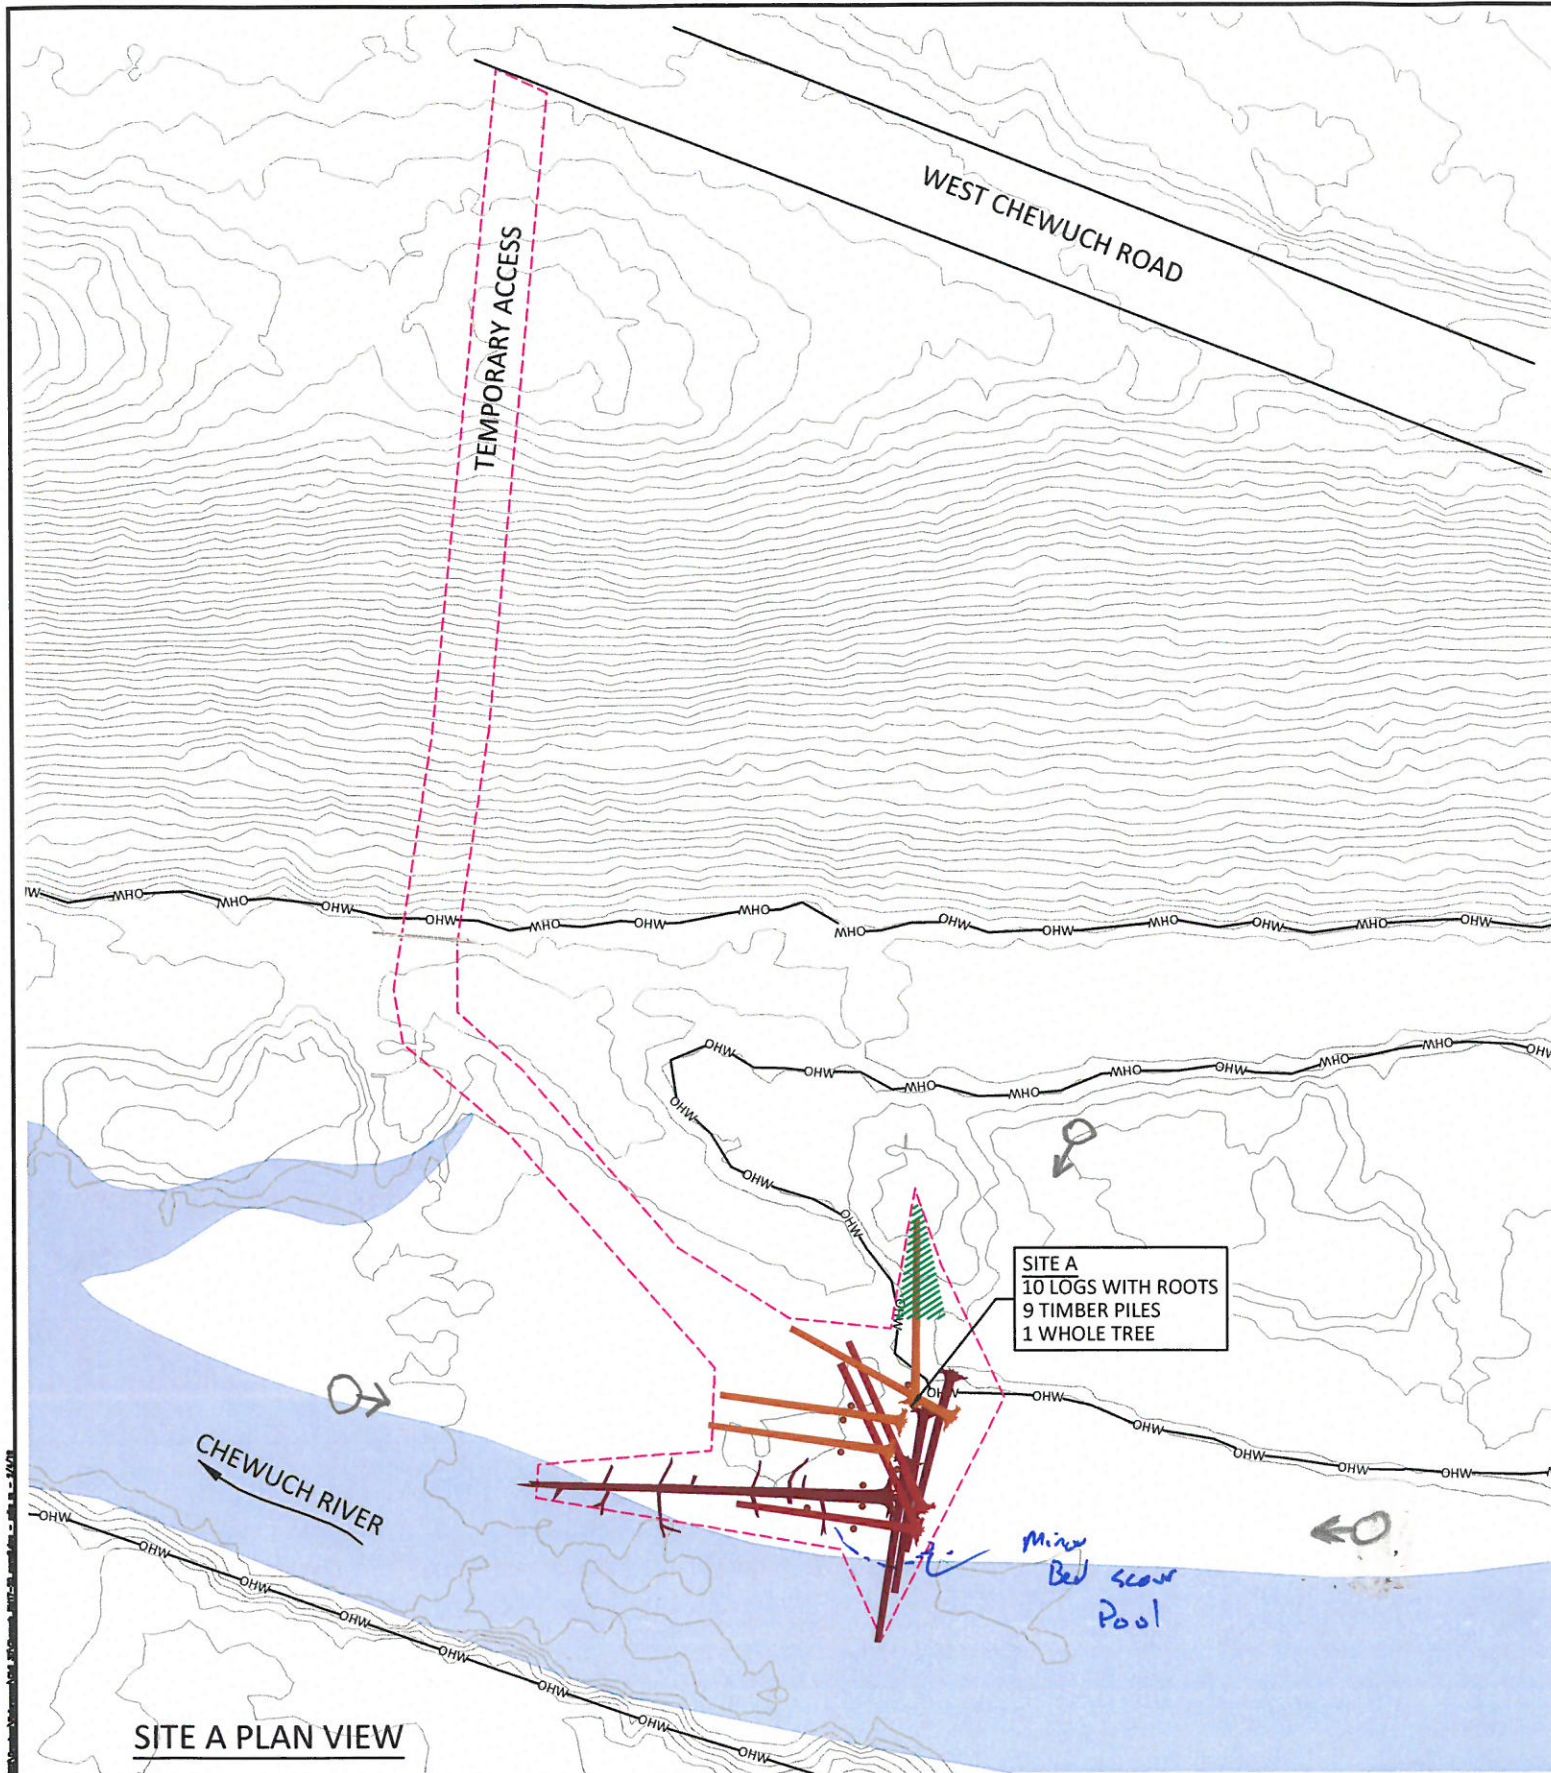
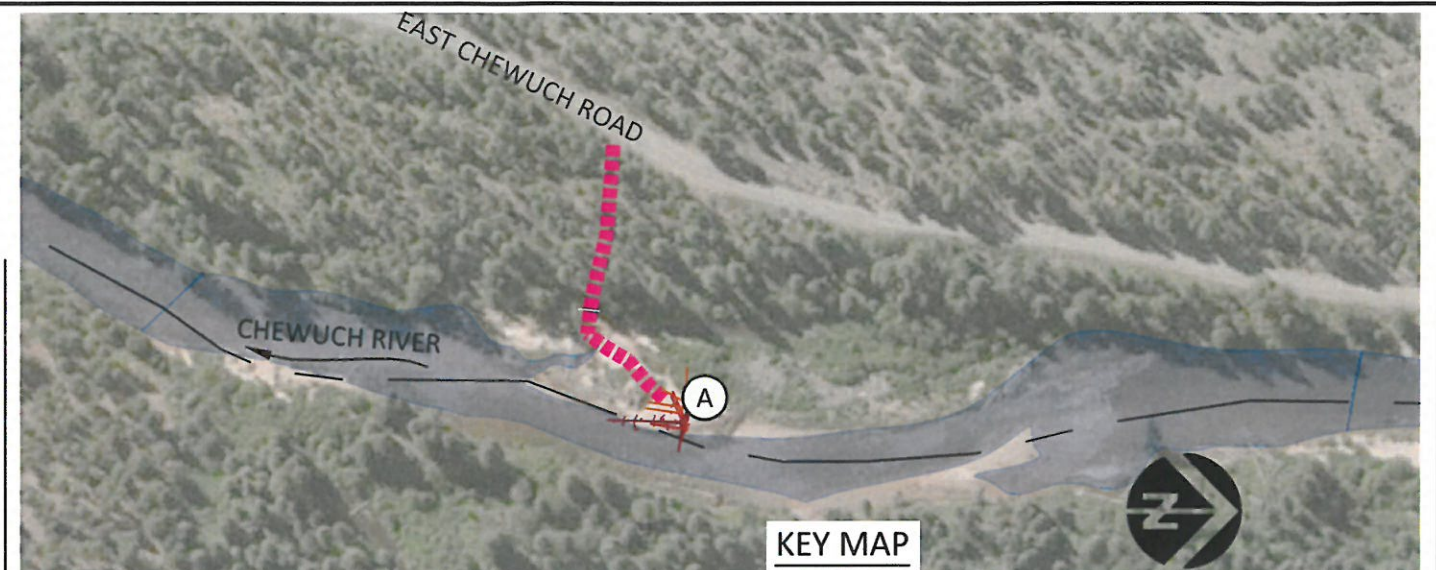
SITE A

- site is stable
- Revegetation Recovery Excellent ~100%
- Very similar to construction - no additional Native Cnr likely due to upstream apron.
- minor bed scour on join edge.

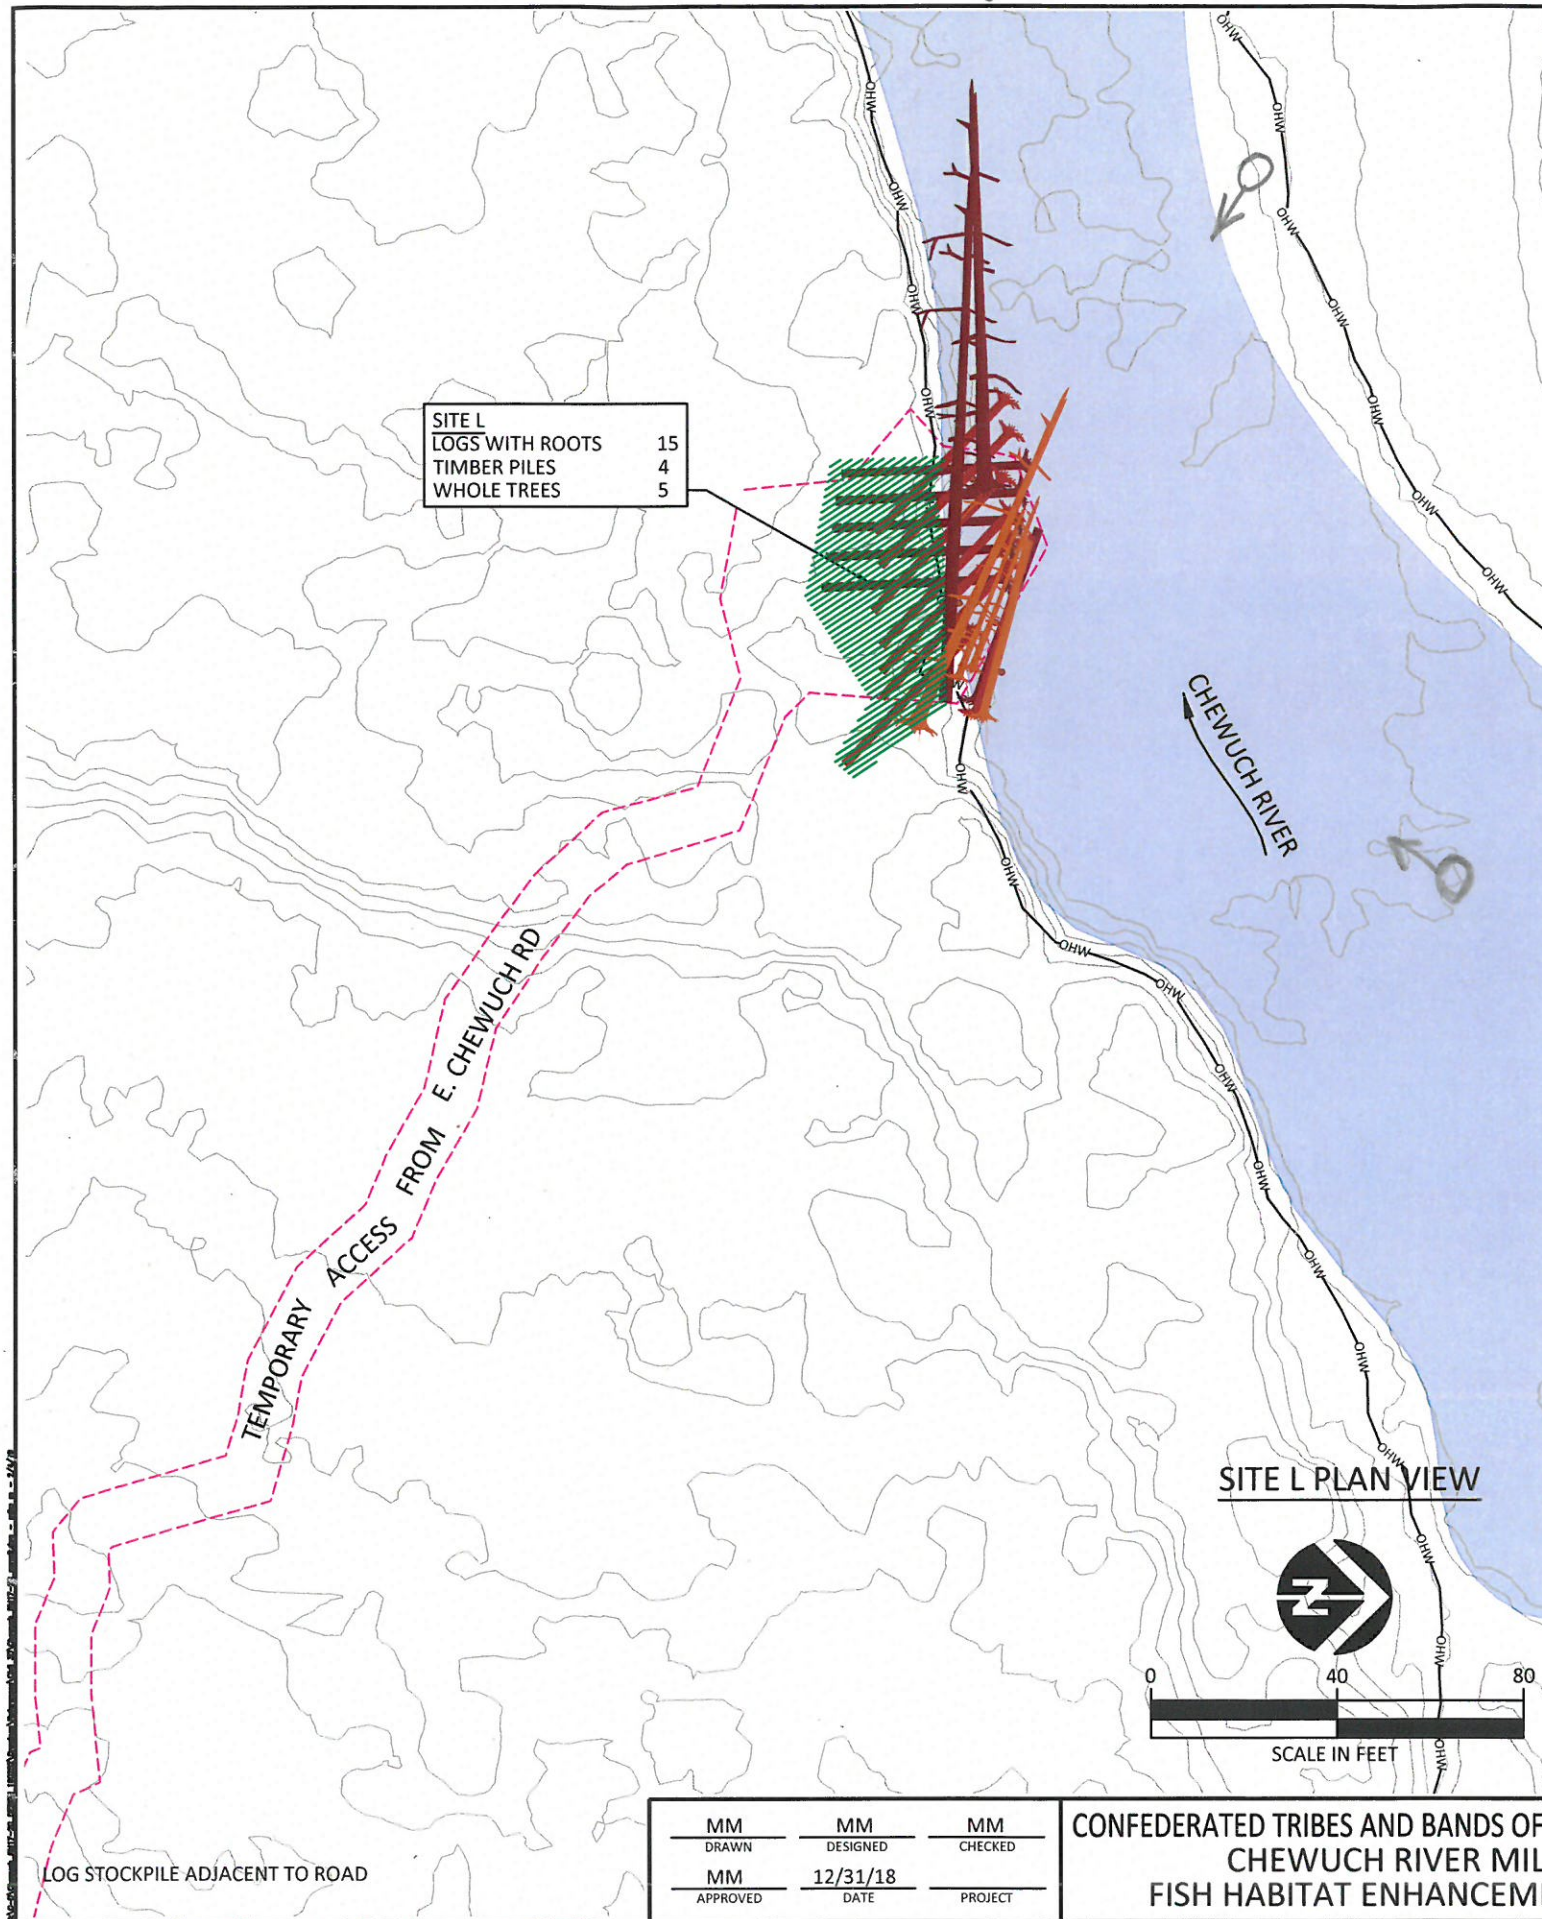
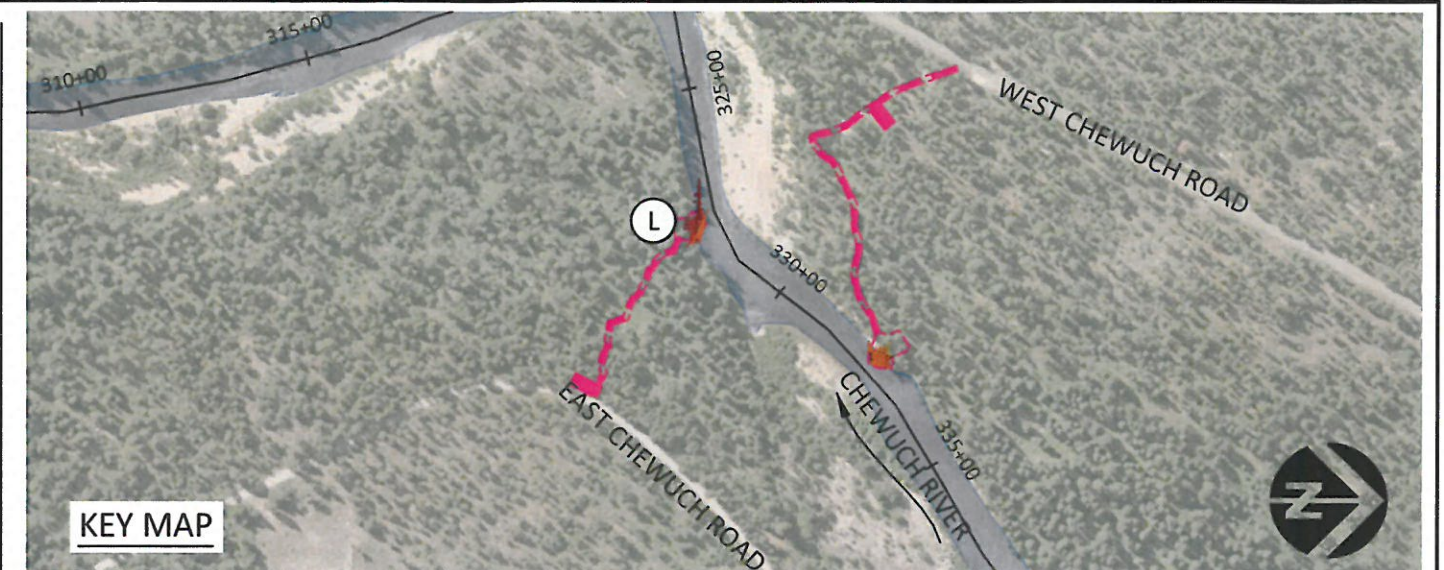
SITE L

- Site is stable
- Very similar to post constructed condition
- Pool depth 3-4' - ~~10~~
- Very good vegetation conditions
- it - Great cover area/volume.

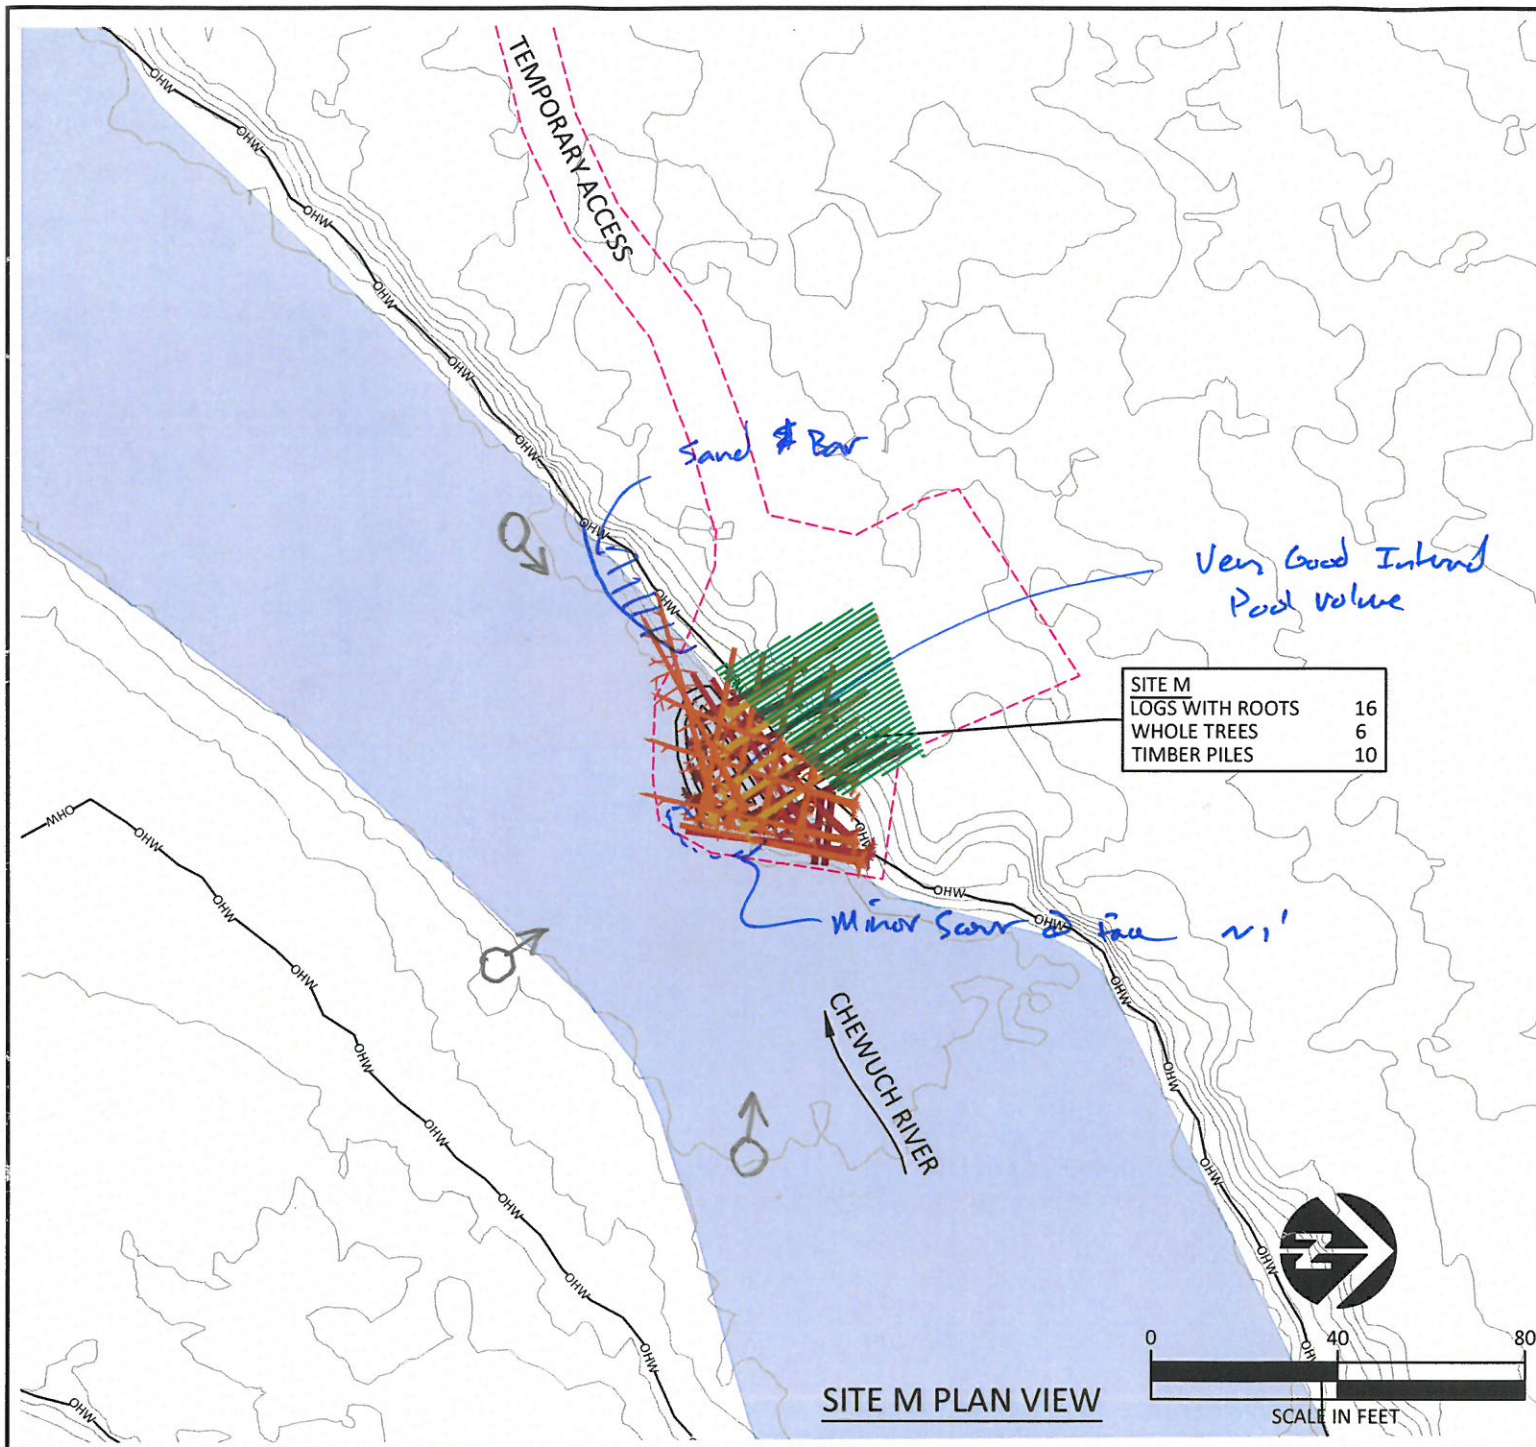
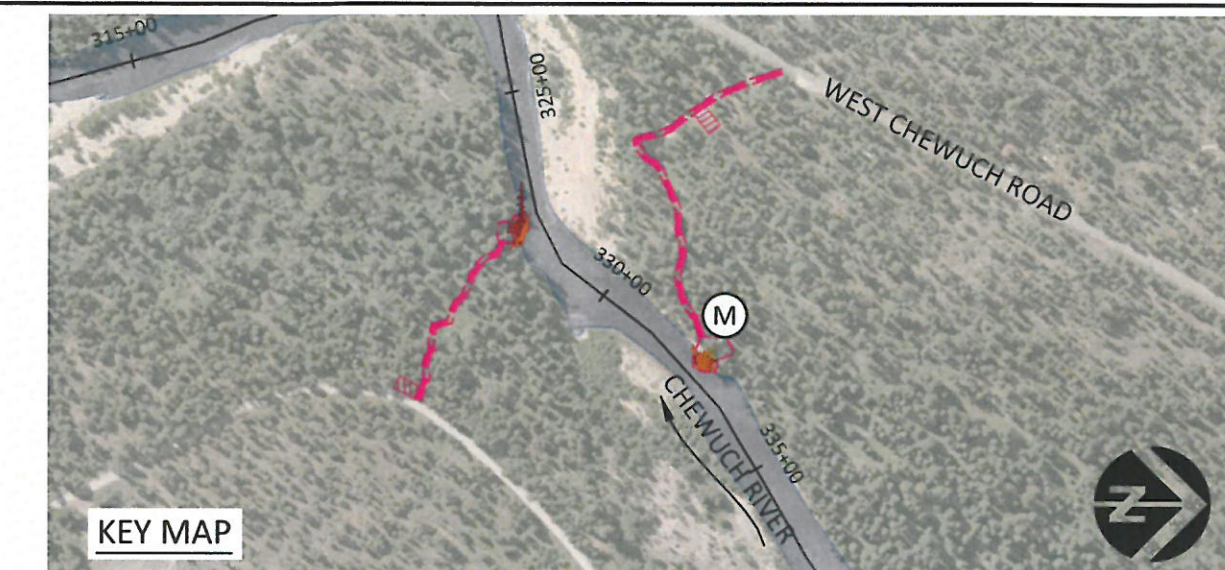
SITE M

- Site is stable
- very similar to post construct conditions
- Inland pool depth has been maintained
a small sand bar has formed at the D/S end
along the right bank.
- Regeneration is very good (80-90%)

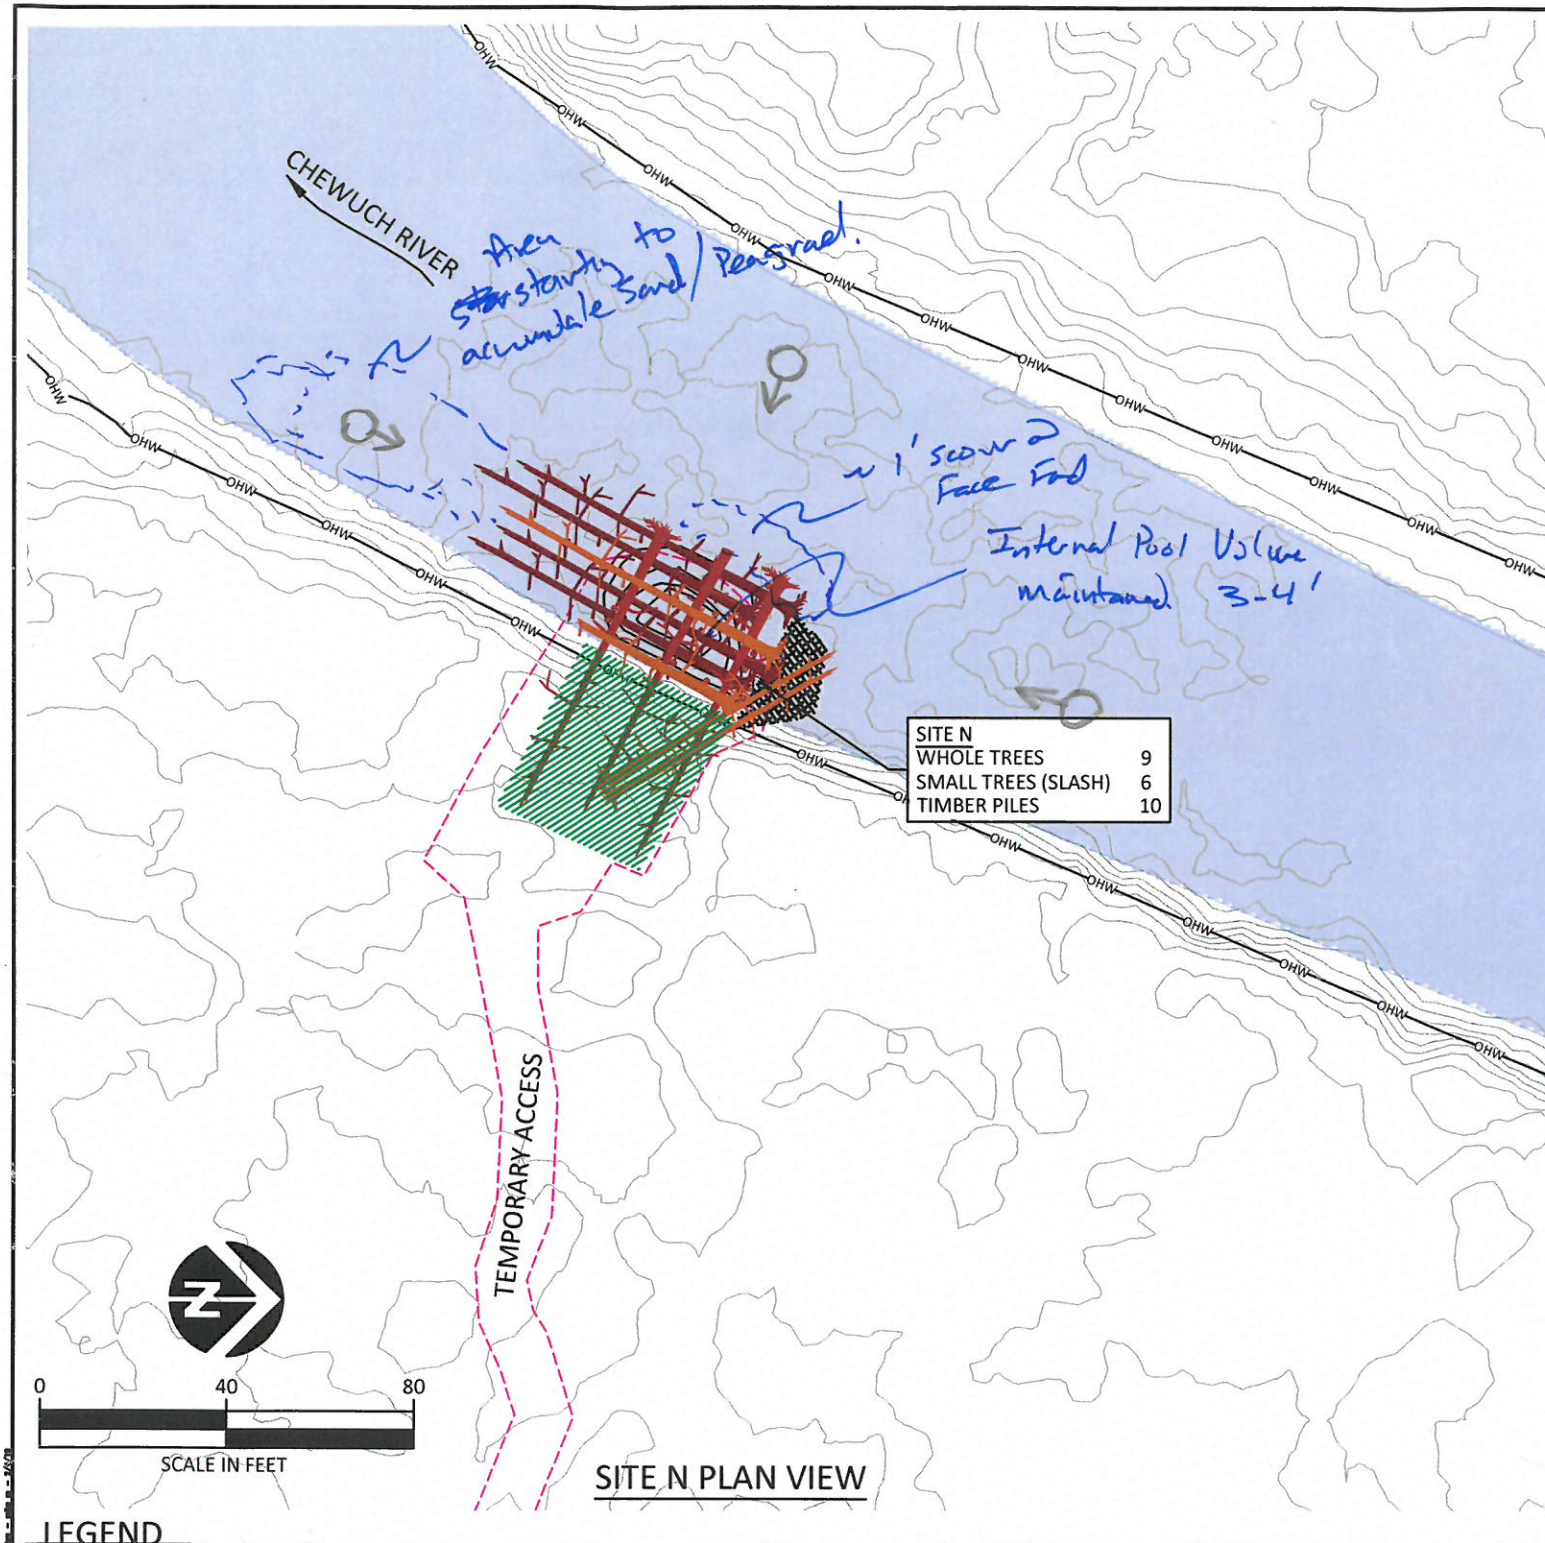
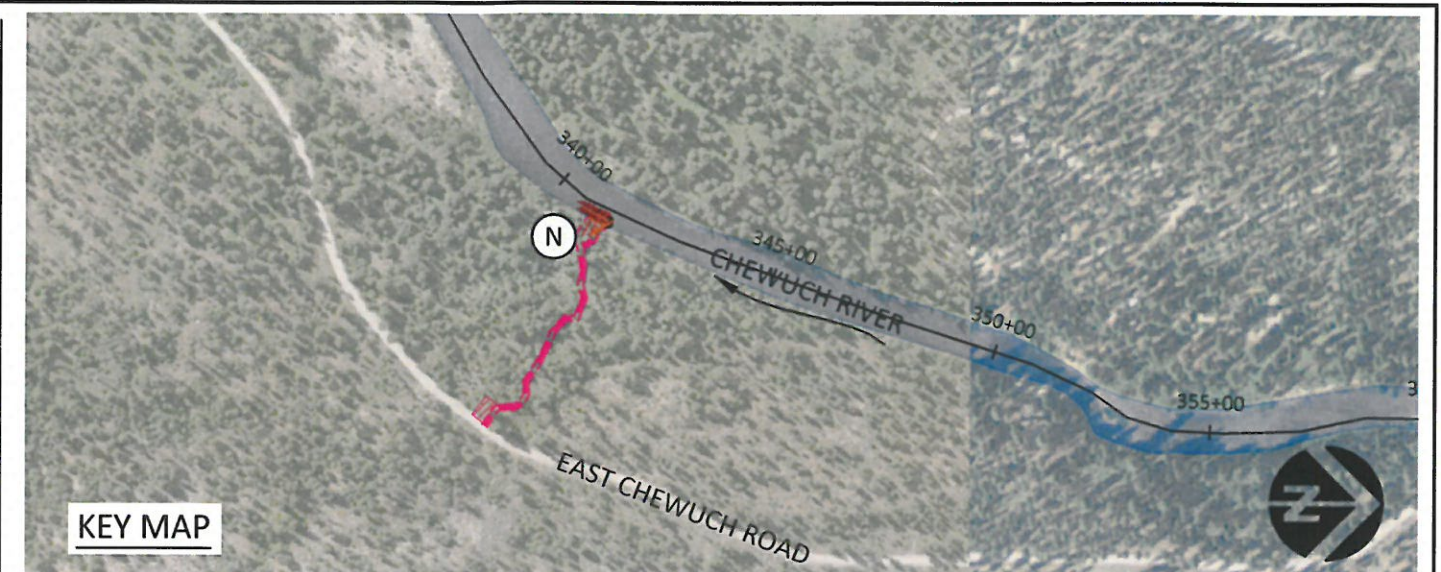
SITE N

- Site is stable
- Very similar to post constructed condition
- No Notice wood accumulation at face
- Minor scour along outside edge and good pool volume maintenance.
- Regeneration is good throughout. (80-90%)

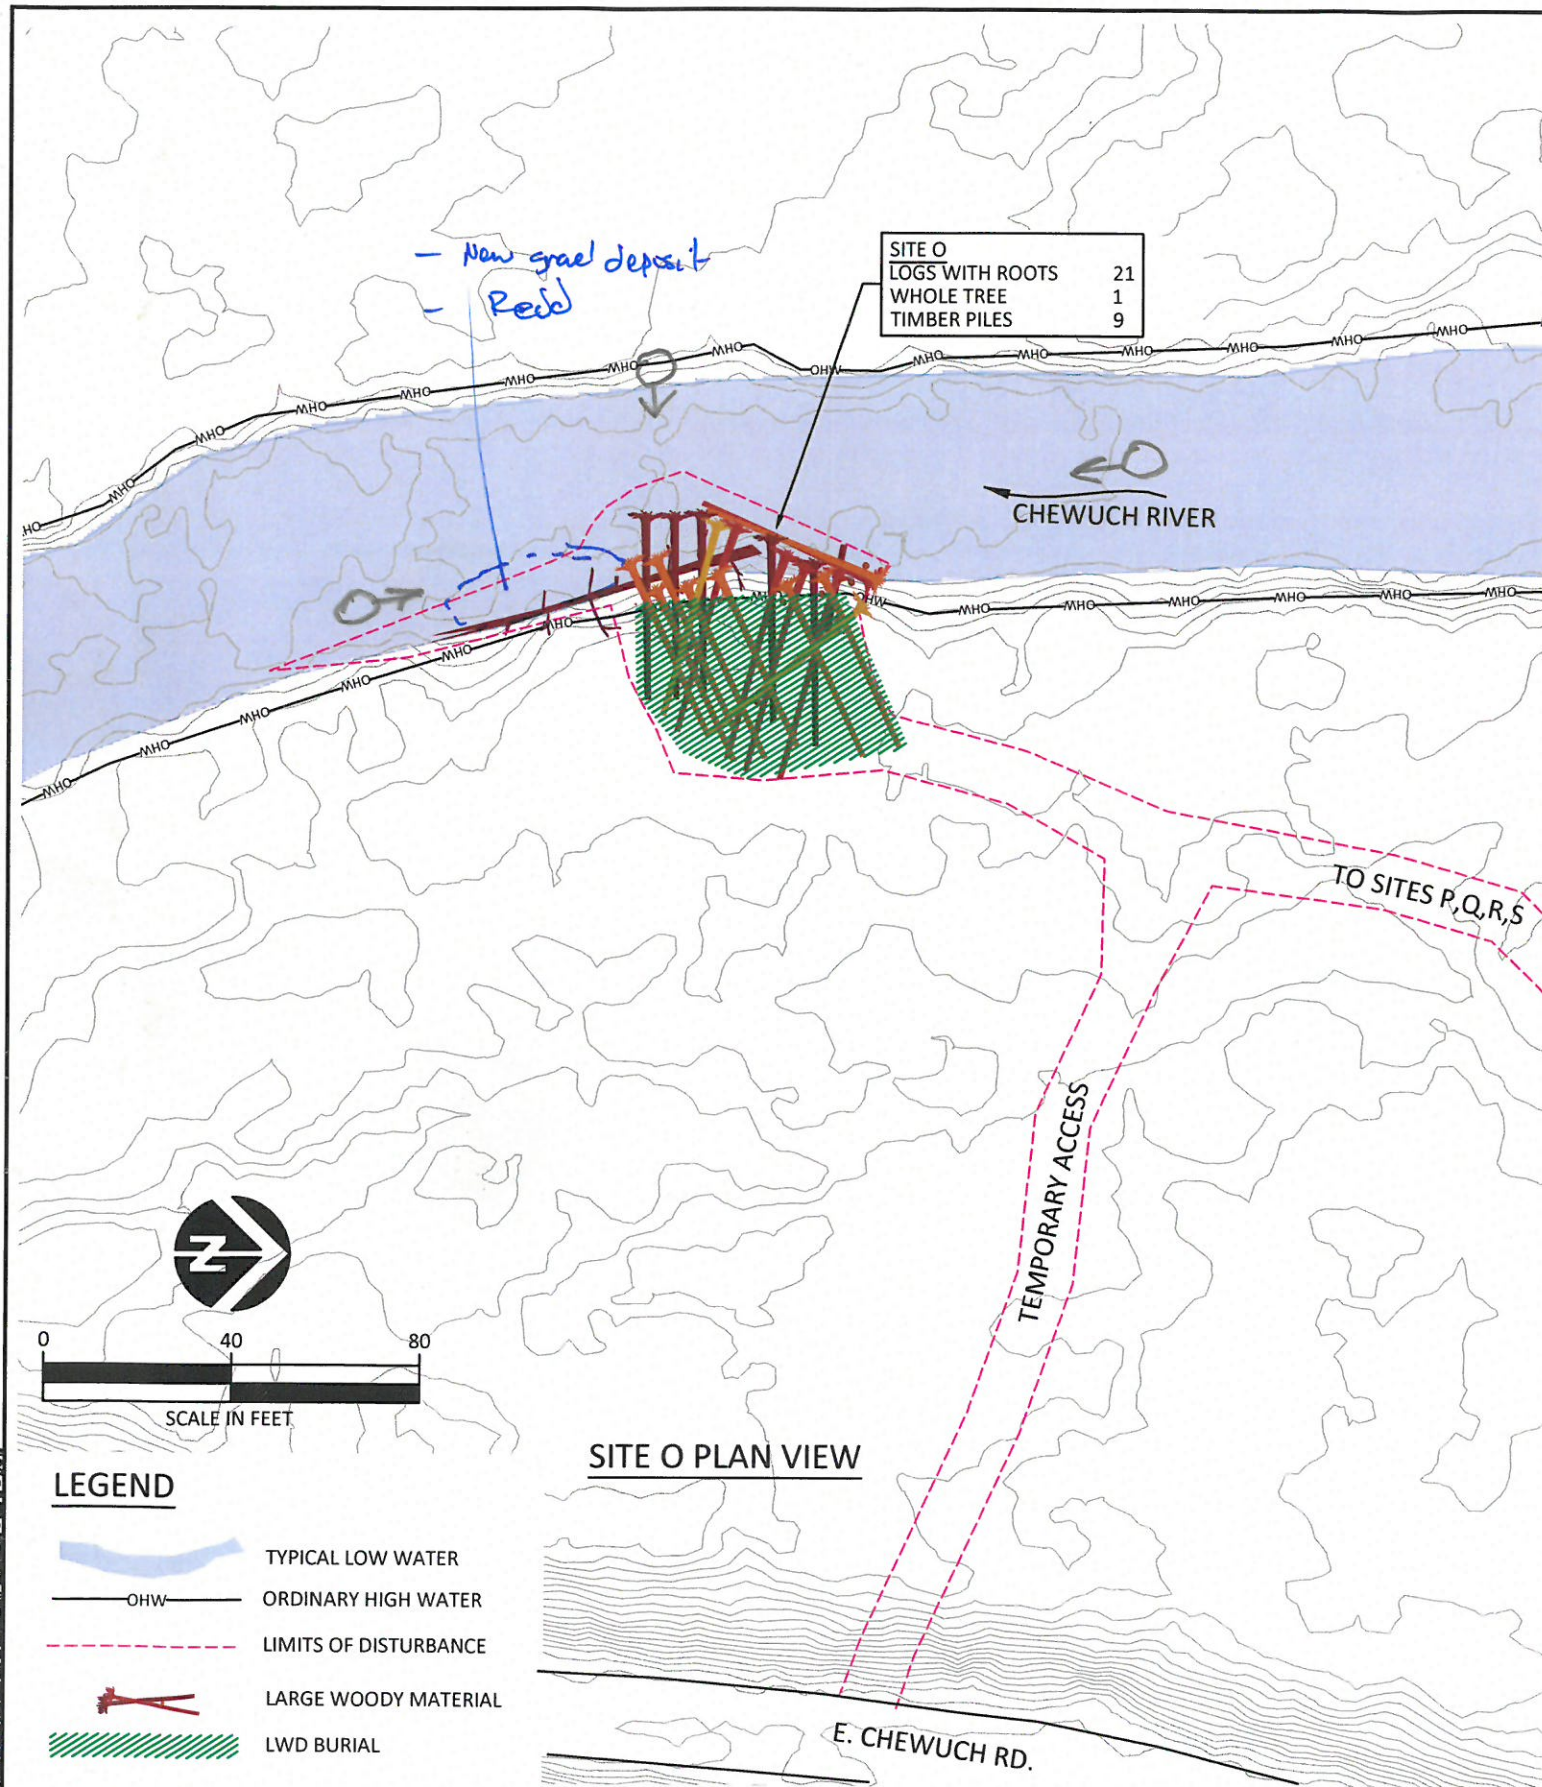
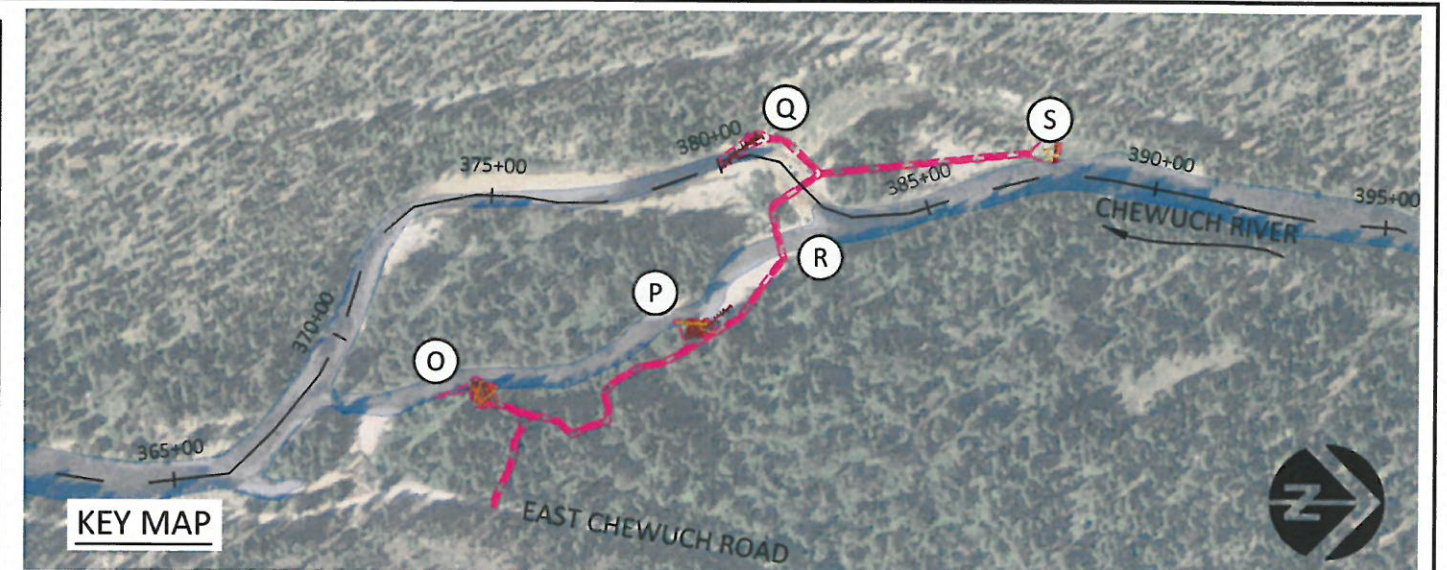
SITE O

- Site is stable
- Very good revegetation ~ 100%
- conditions are similar to post construction.
- Pool Depth ~ 2' @ face
- A E 10X20' patch of spawning gravel deposited DS of main jam w/ recent Redd.

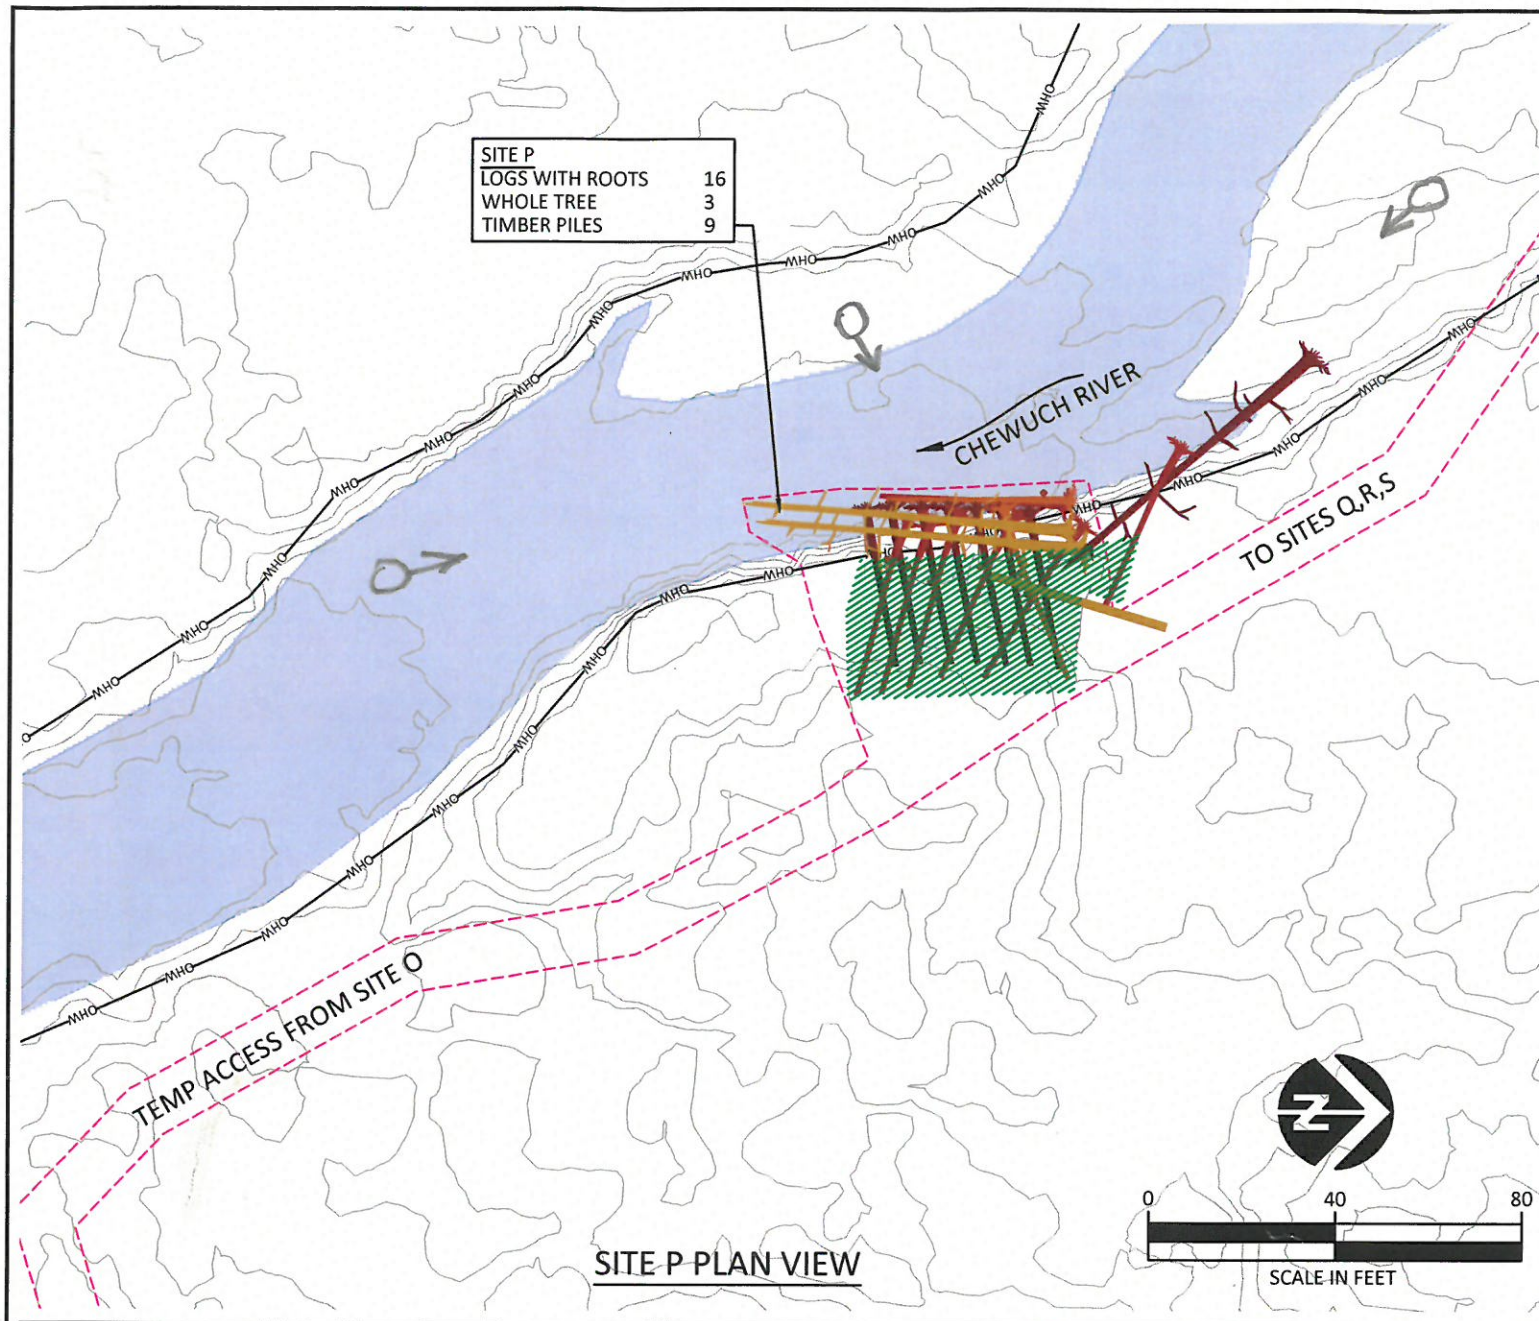
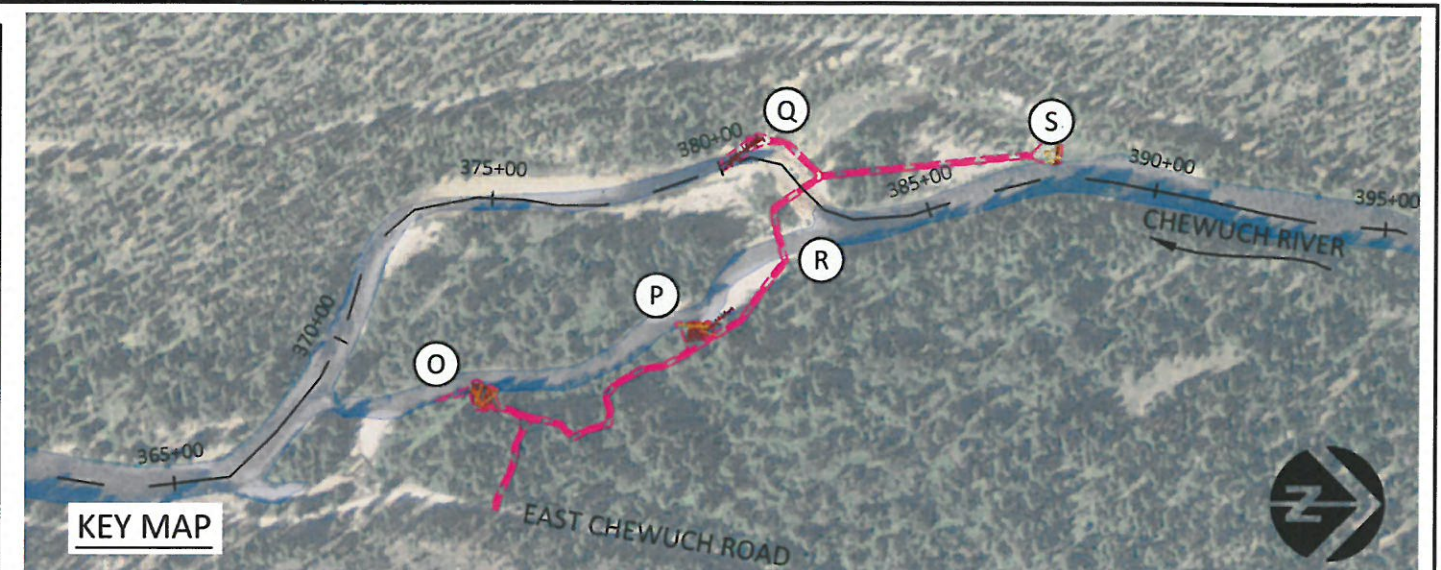
SITE P

- Site is stable
- Similar to Post Const. condition.
- Revegetation thru-stake is ~ 100%
- Pool depth 2-3'
