Chewuch River Mile 17-20 2018-19 Post-Construction Monitoring Report

FEBRUARY 2020

This report is the first of three post-construction field-monitoring reports for the Chewuch River Mile 17-20 project. Field work was conducted on October 1, 2019 with the purpose of monitoring the safety, stability, and effectiveness of constructed fish habitat. The project is located on United States Forest Service land between river miles 17 and 20 and was constructed July 2018. The purpose of the project was to increase adult holding and juvenile rearing habitat during low and high flows.

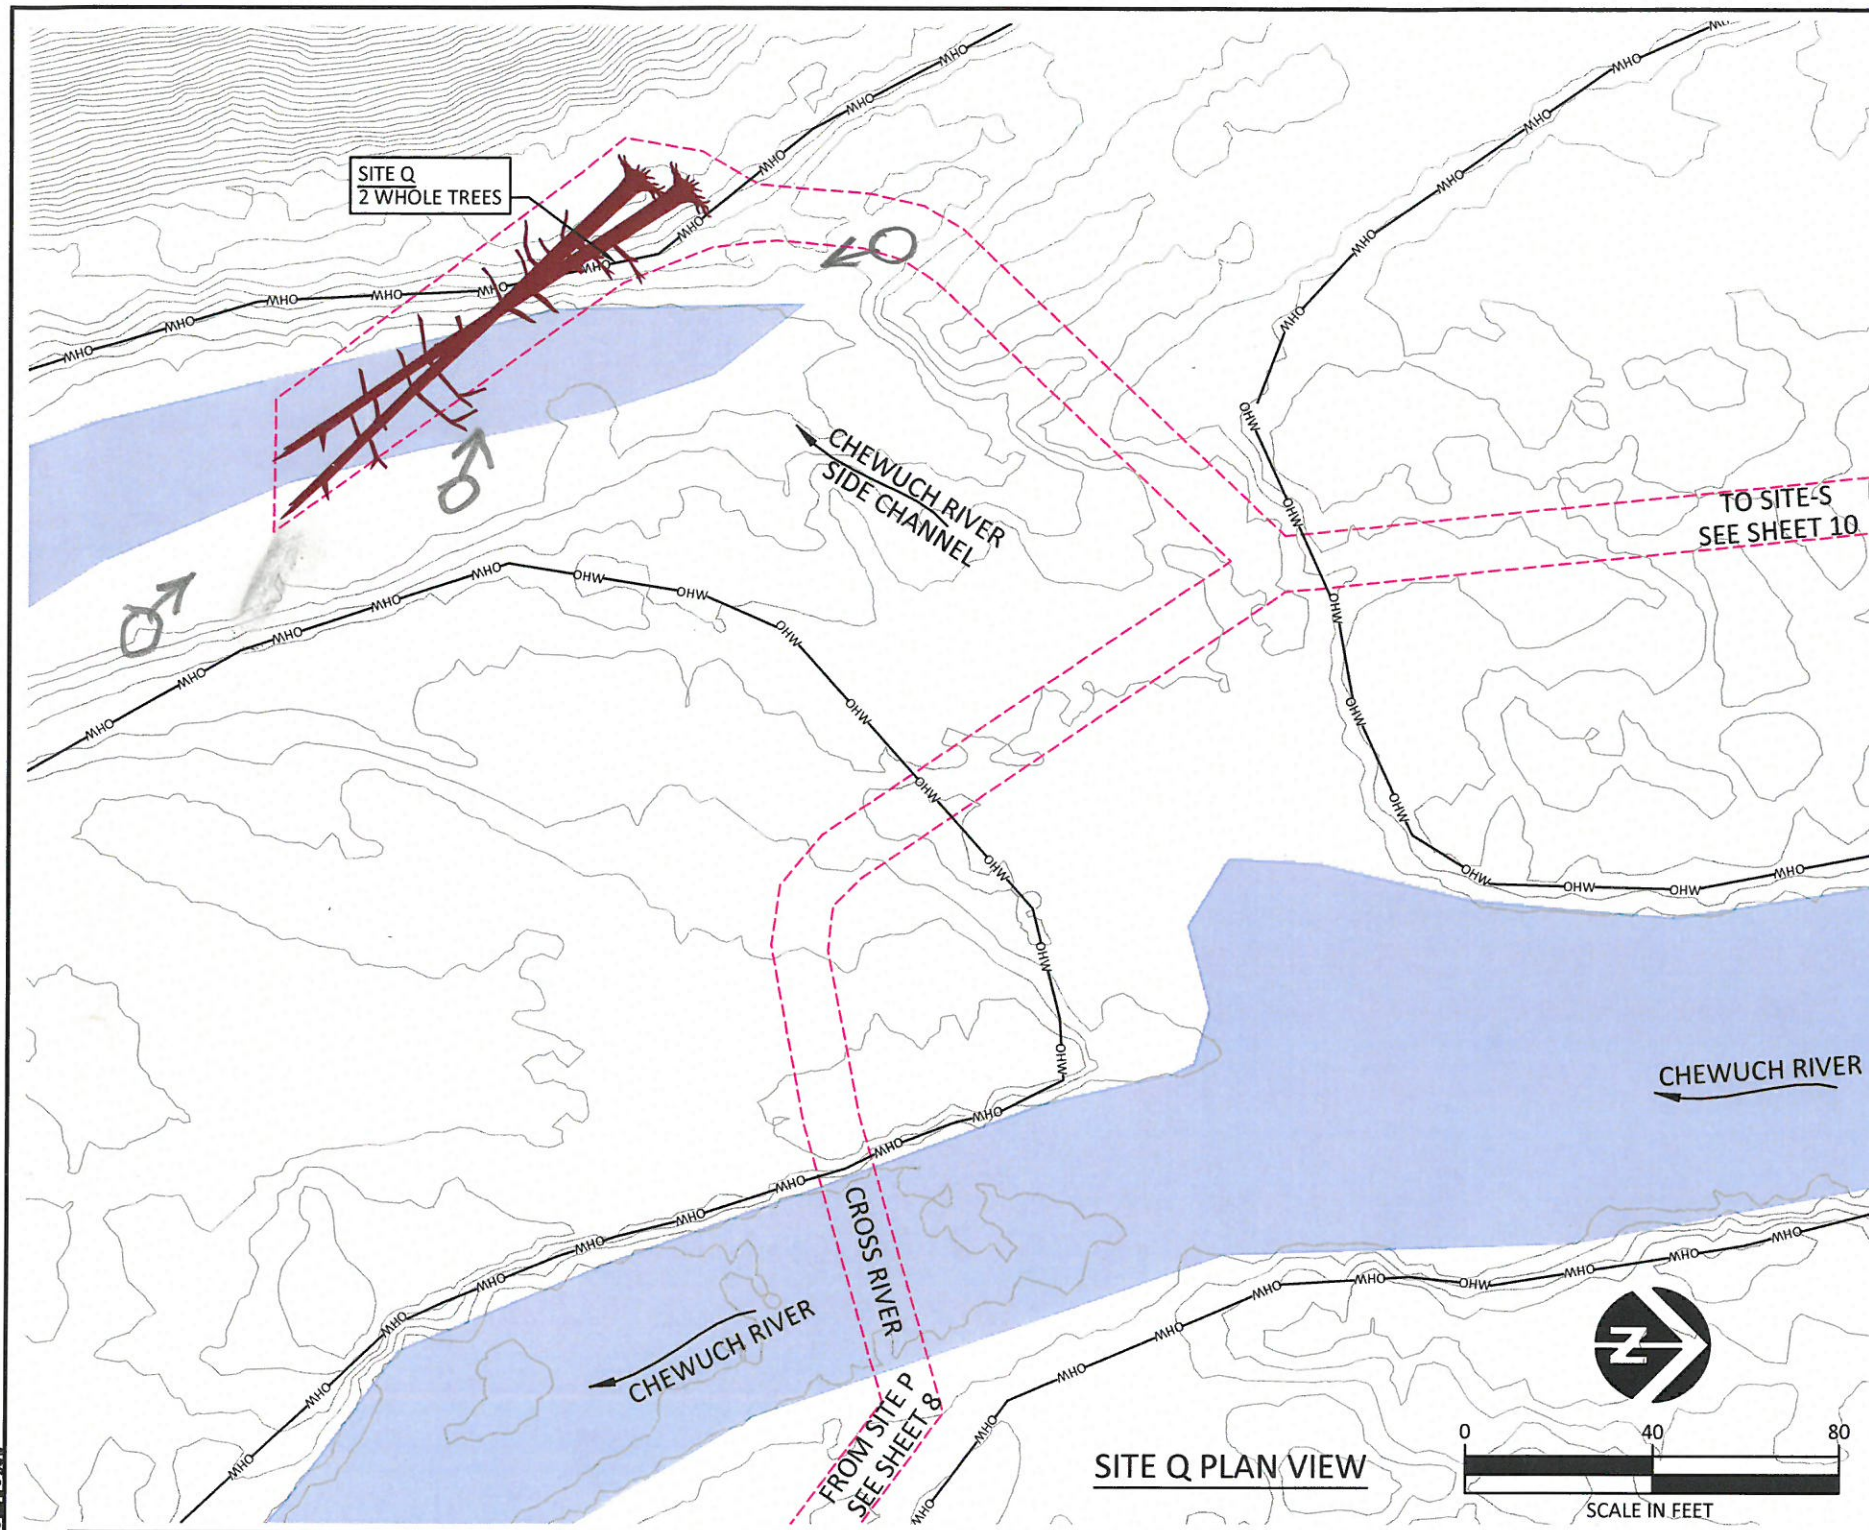
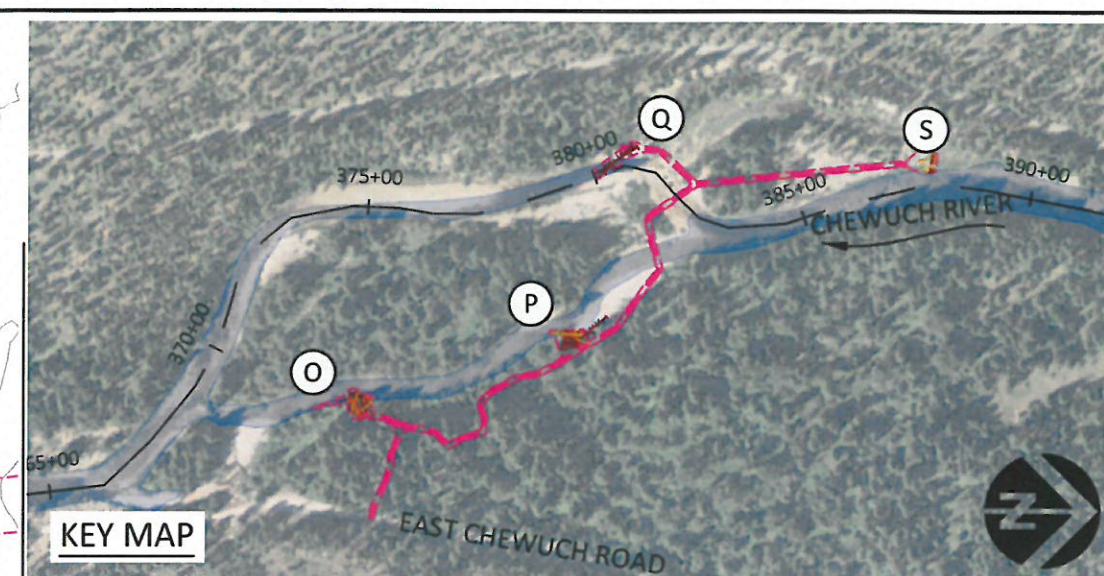
SITE Q

- Placed wood has not moved
- Provides similar cover habitat as it did last year.
- na - Remains stable.

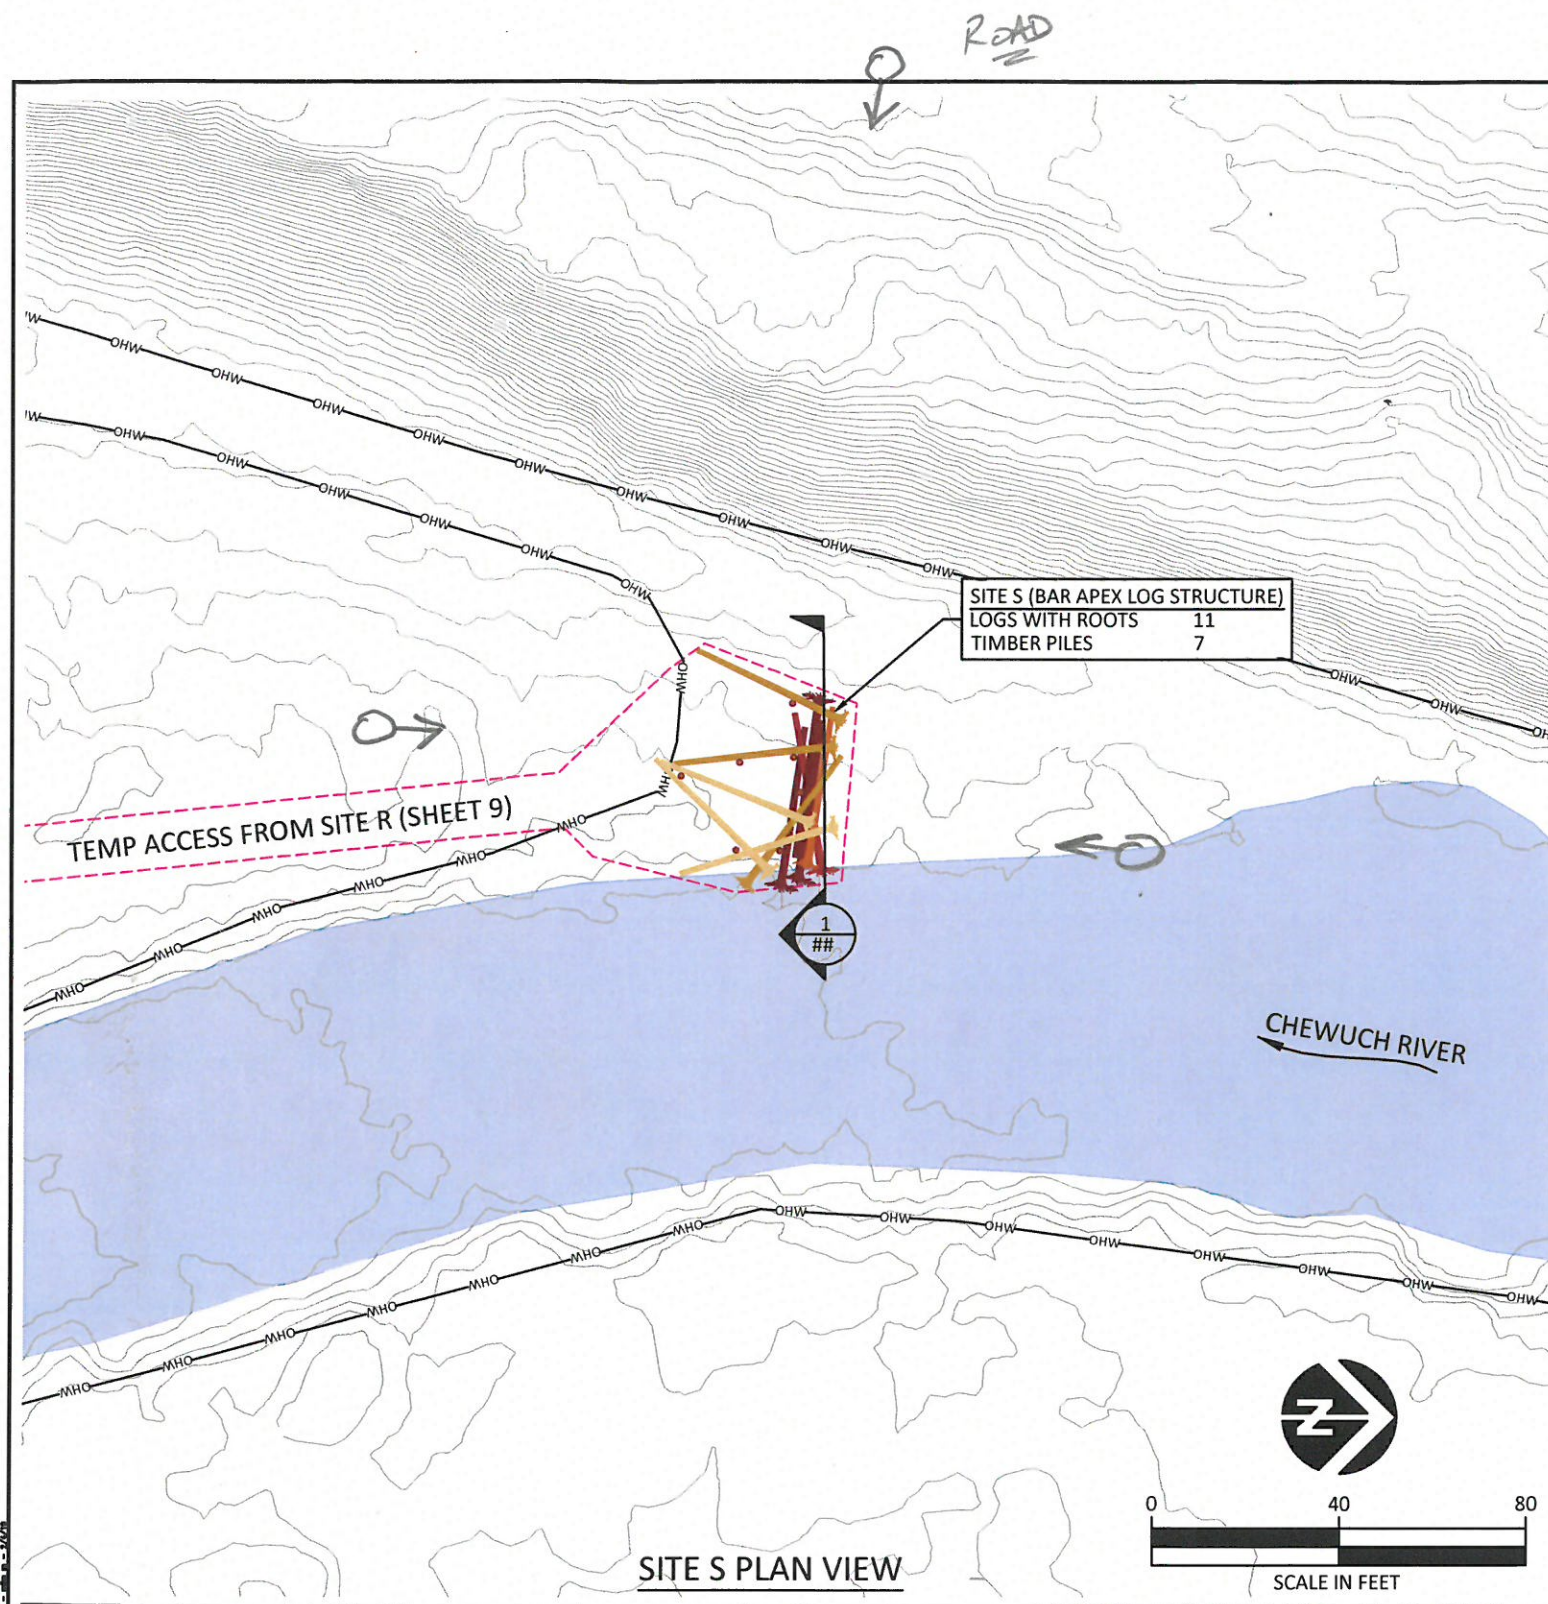
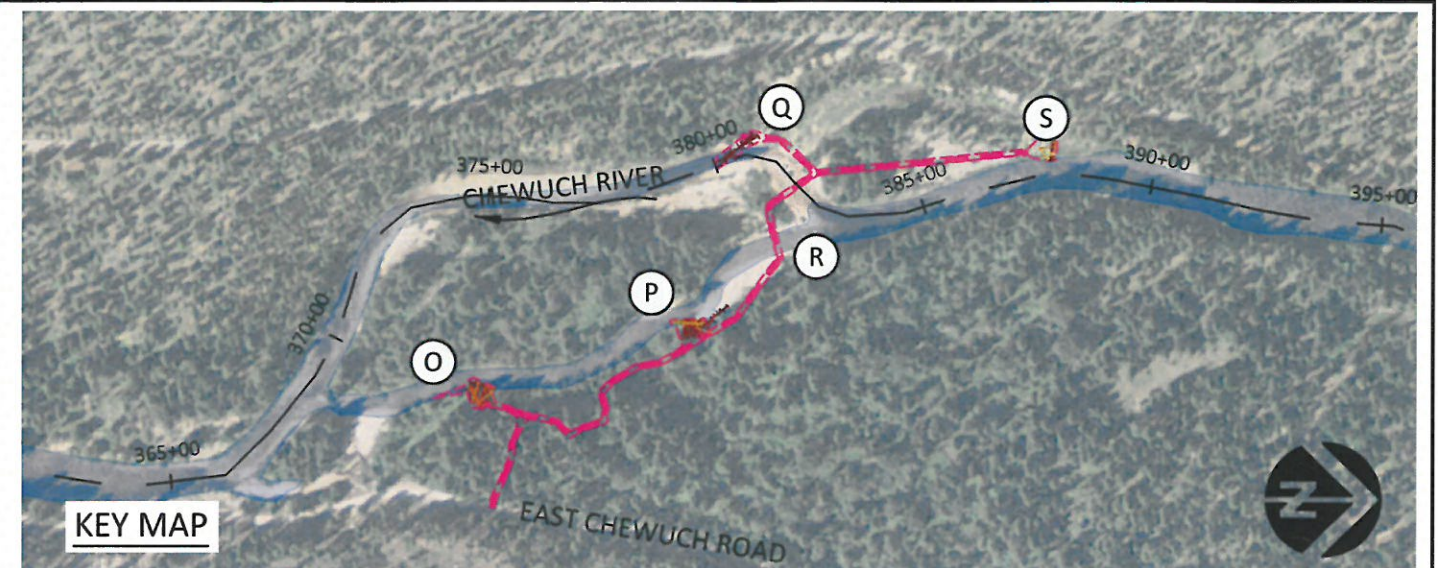
SITE S

- Site is stable
- Unchanged from original construction
- No Native ~~W~~ accumulation
- Revegetation along access is good.
- Functions as Designed.

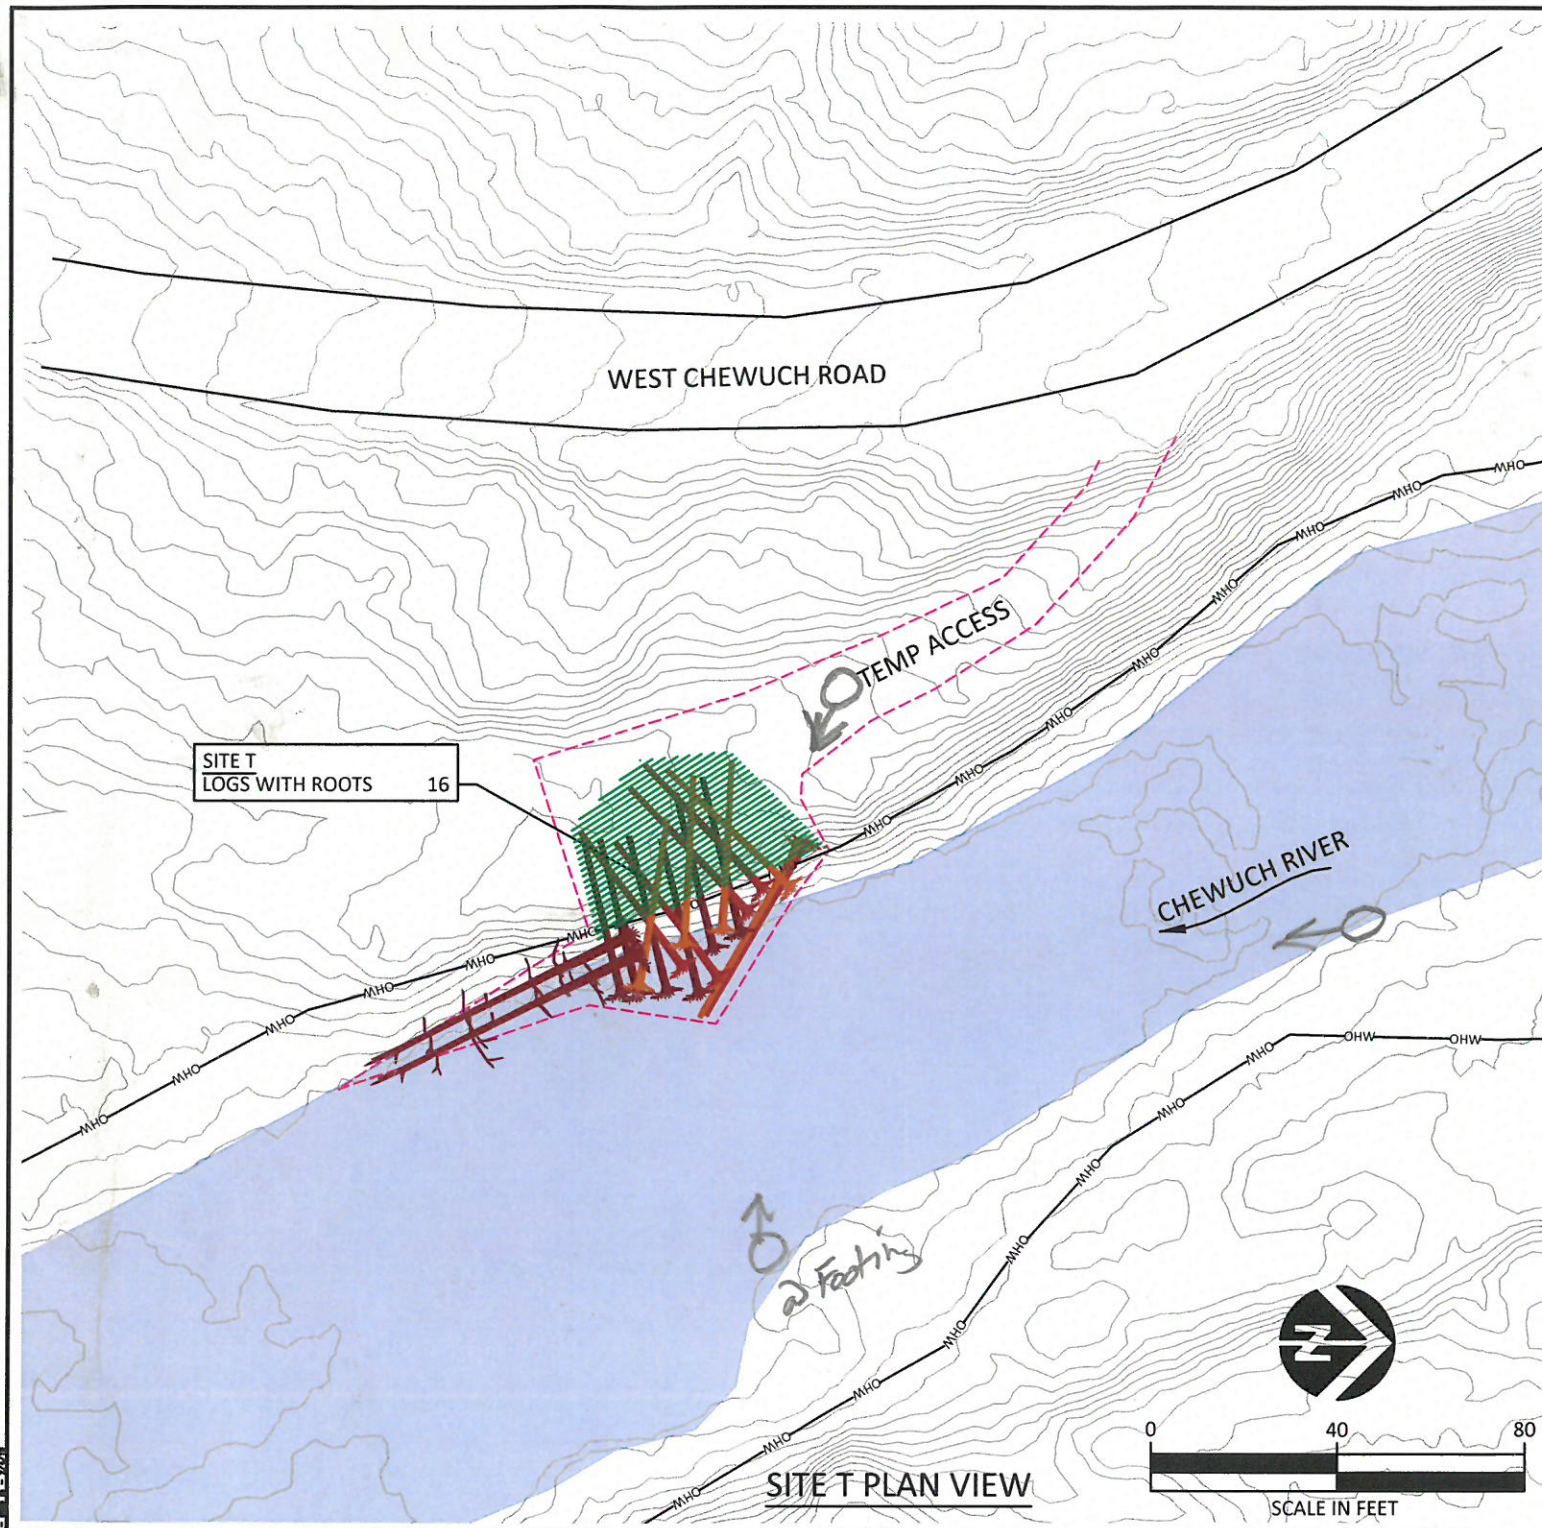
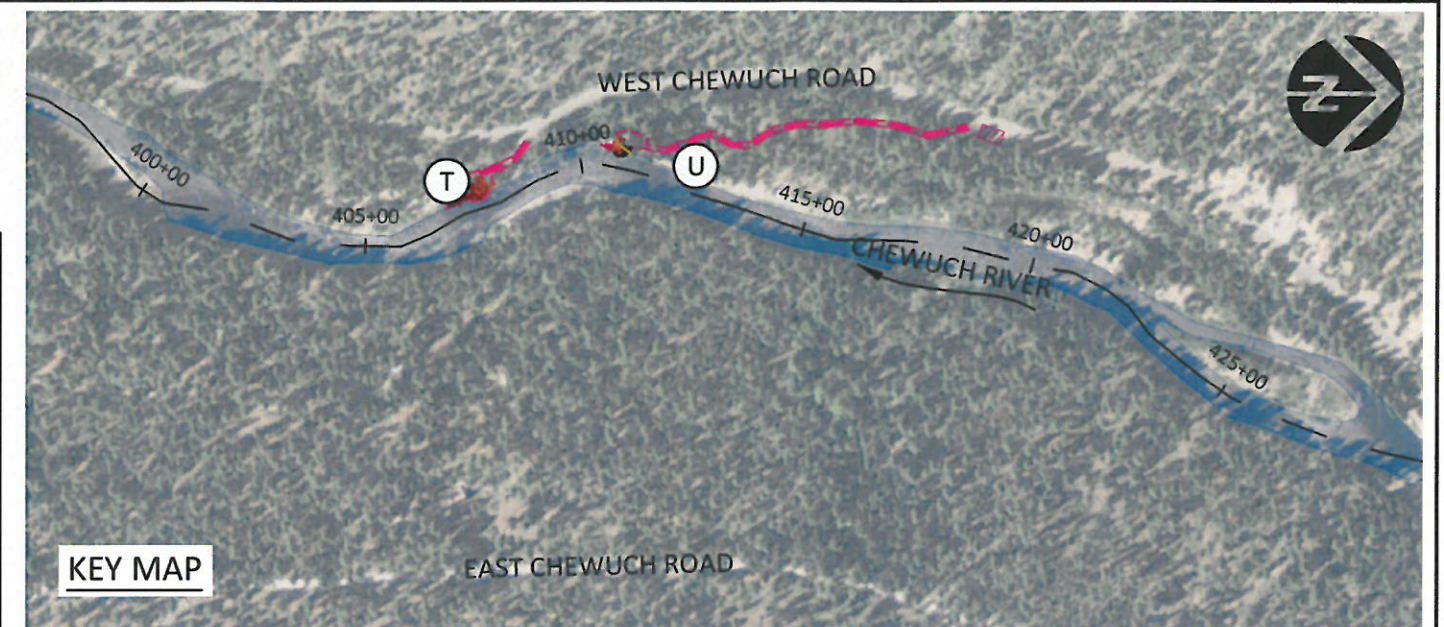
SITE T

- Site is stable.
- ~~Min~~ minor notch slash 2 Jan face.
- 3' pool depth
- ↳ New logs revegetation.
- very similar to post construct conditions.

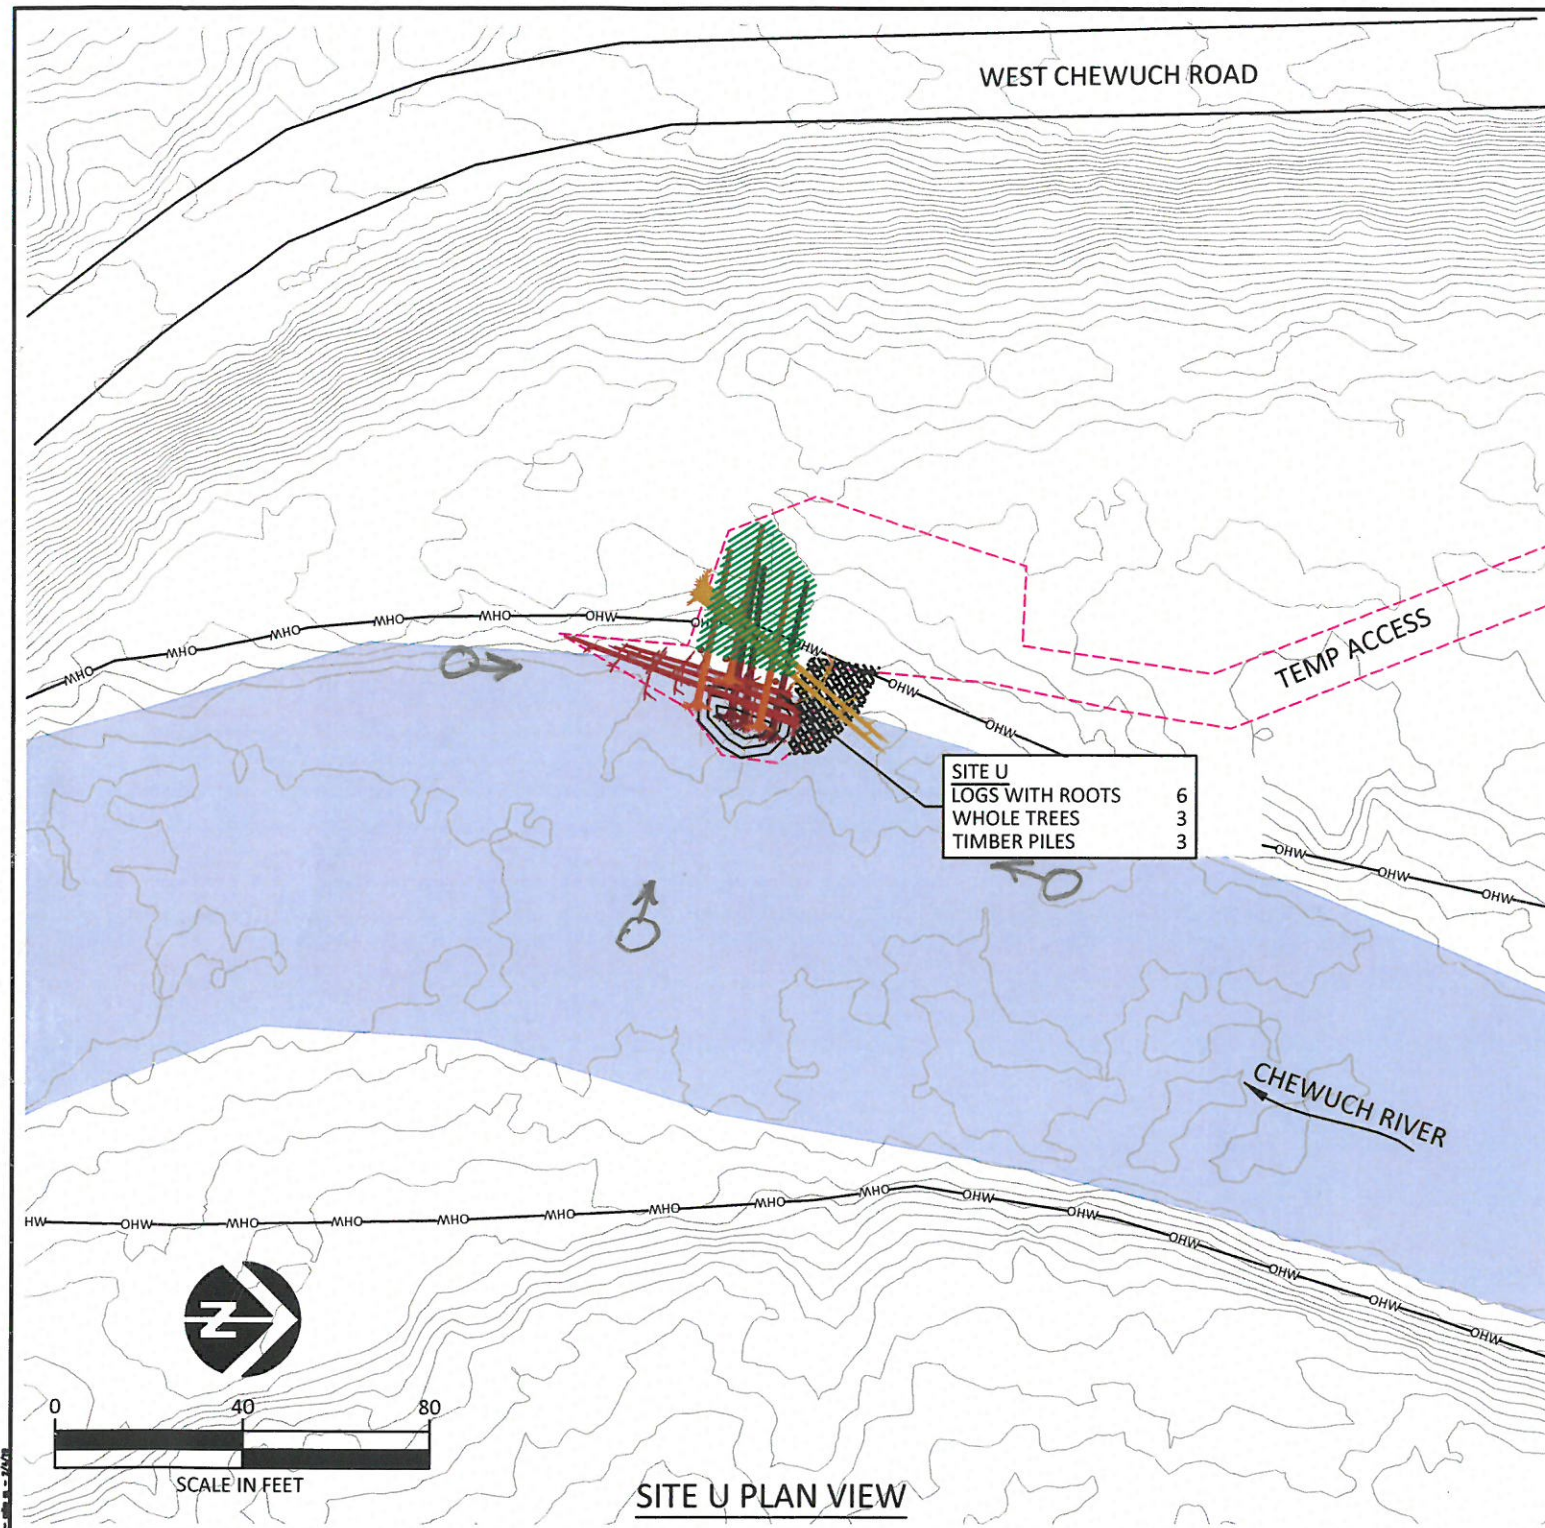
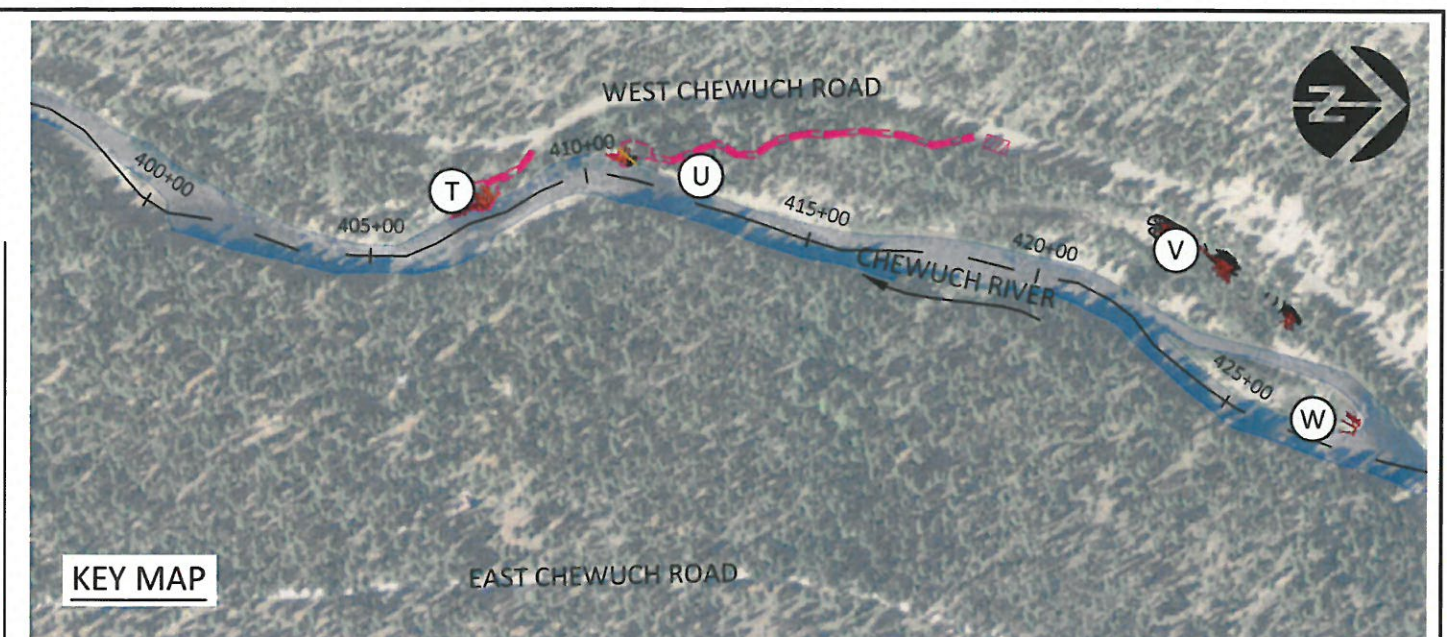
Site is stable.
 No additional Native wood accumulation @ jam face.
 Pool depths are good +4' under the jam.
 Revegetation is very good throughout access.
 Cedar tree plantings show stress. The Rest near 100%
