UPPER WENATCHEE RIVER STREAM CORRIDOR ASSESSMENT AND HABITAT RESTORATION STRATEGY

YAKAMA NATION FISHERIES | PO BOX 15, FORT ROAD | TOPPENISH, WA 98948

INTER-FLUVE, INC.
1020 WASCO STREET, SUITE I | HOOD RIVER, OR 97031
541.386.9003 | www.interfluve.com

August 2012

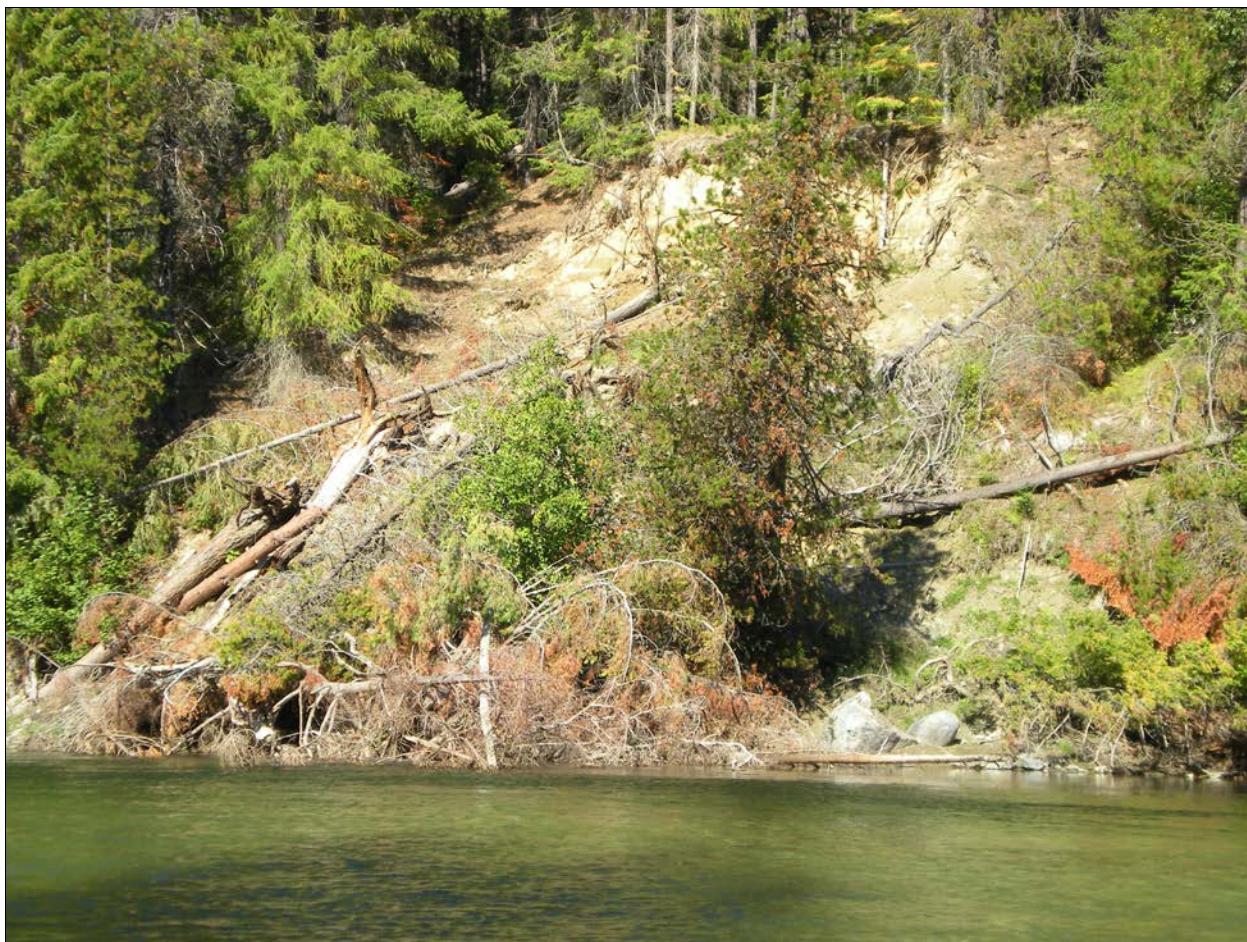
Figure 8. Example of contemporary 'colluvial jam' on Upper Wenatchee River. Historically, these types of jams would have been composed of much larger riparian trees (photo October 2011).

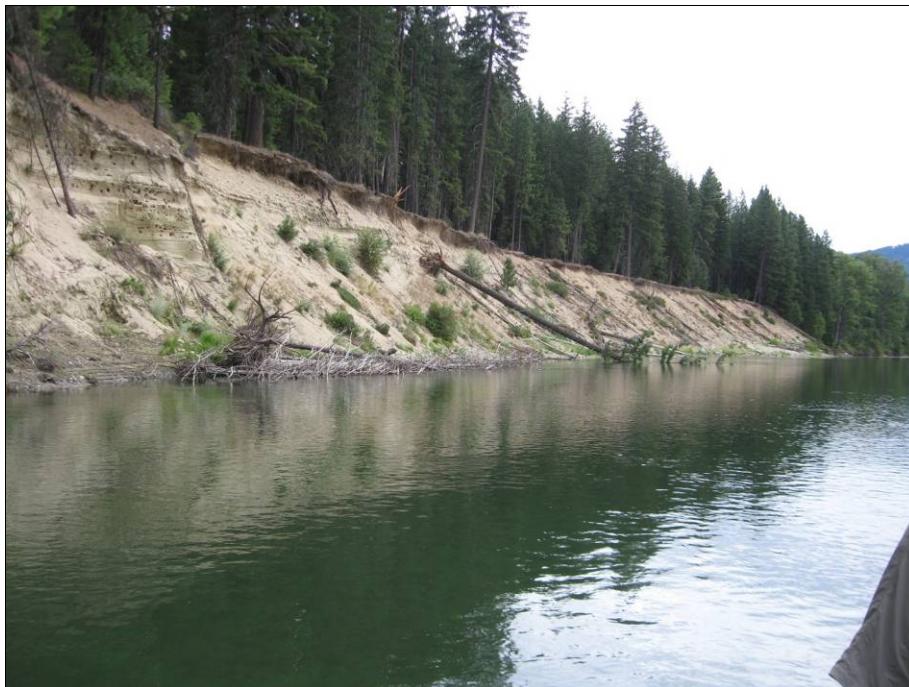
Figure 26. View of unconsolidated fine grain sediment in terrace slopes along the channel in the study area.

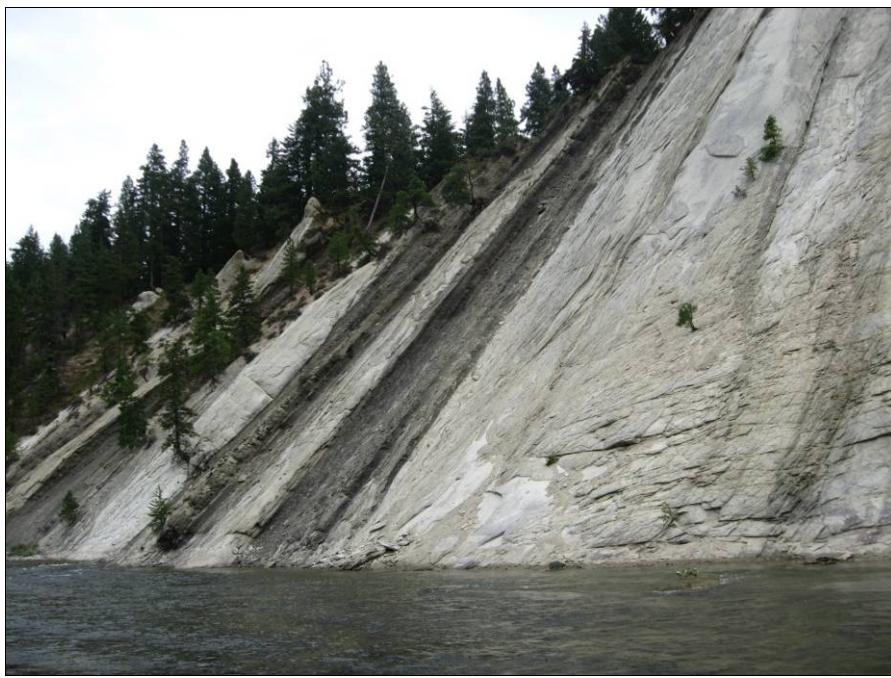
Figure 27. Bedrock outcrop along the channel in the study area (Chumstick Formation). Note that tilting of stratigraphy has resulted in steep dip-slopes toward the channel that can result in planar failures along weak bedding planes.

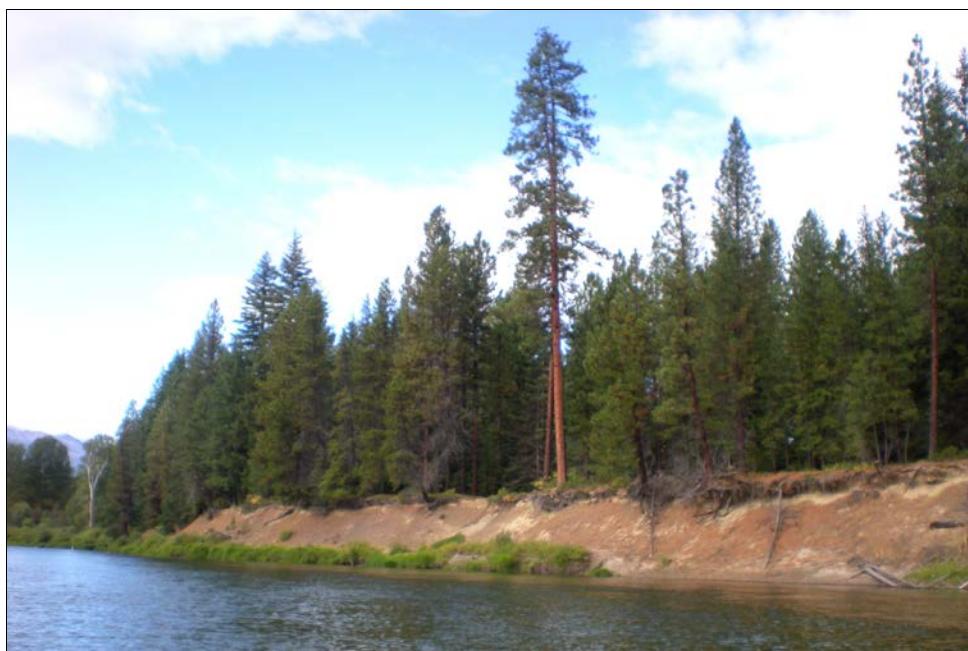
Figure 29. Existing riparian area in Reach 9 (taken October 2011). Large ponderosa pine at center represents an older tree that escaped the last harvest and gives some indication of what historical LWD sources may have looked like.

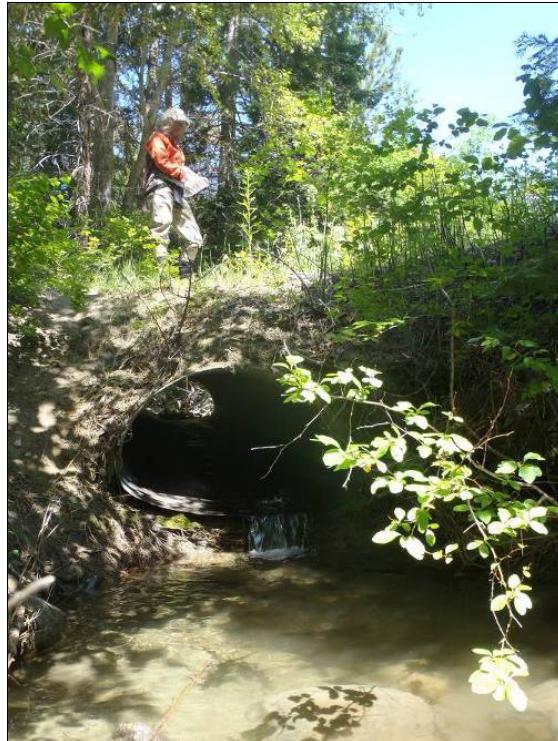
Figure 45. Perched culvert in Deadhorse Creek (RM 38.6). Surface water connection was present on day of survey (July 26, 2011).

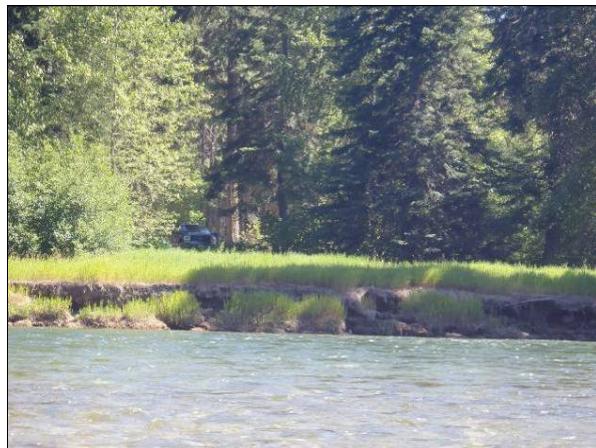
Figure 76. Left bank slumping due to lack of riparian vegetation.
