**PRELIMINARY GEOMORPHIC ASSESSMENT OF THE 32 ROAD
WASH-OUT, KICKITAT RIVER
YAKAMA RESERVATION, WASHINGTON**

Will Conley

Hydrologist/Geomorphologist
Yakama Nation Fisheries Program
Klickitat Field Office
Wahkiacus, WA

July 1, 2016

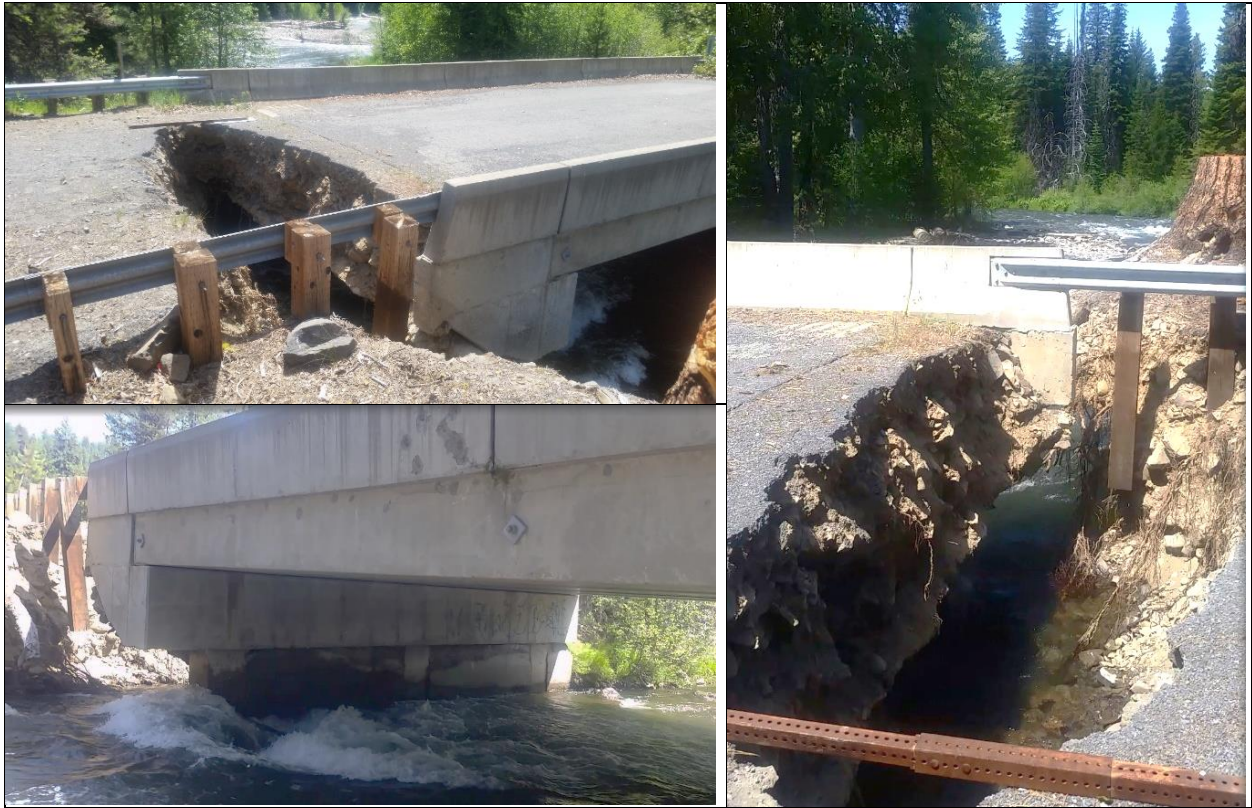
The wash-out occurred at the east end of the east bridge which crosses the primary river channel and is oriented more-or-less normal to the channel alignment. The river has undercut the left-bank immediately upstream of the flanked east abutment, and partly eroded fill material of the approach

(Figure 2). The road was impassable to vehicular traffic and traffic barricades were in-place at the time of the site visit.

Figure 2. Close-up photos of east abutment washout (all photos taken 6/7/16).

The east bridge has a deck length of ~65' and traveled way width of 30'. The deck slopes downward from east to west at 1–2%. The span is composed of eight concrete panels, each 4' wide that are cross-bolted (visible in bottom-left photo in Figure 2).

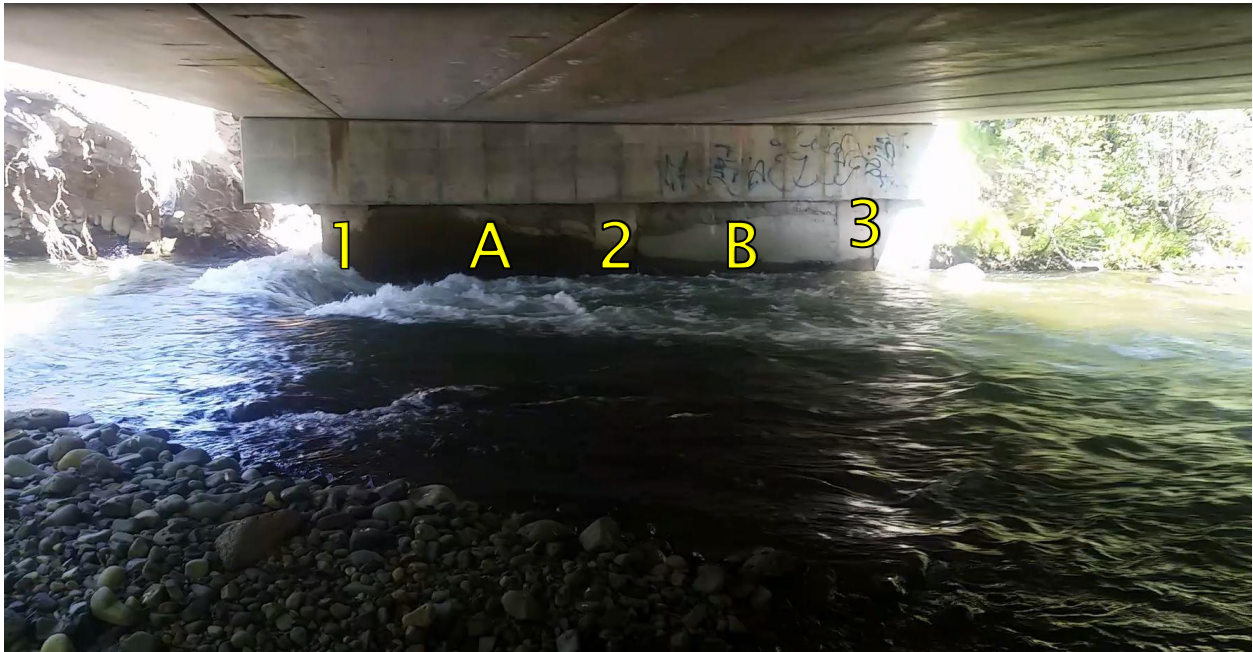
Riprap formerly on the river face of the east abutment was mostly absent (Figure 3). Riprap on the face of the west abutment was largely in-place, but the slope steepens in the downstream direction, has a sheared appearance, and the toe deflects toward the abutment by several feet (Figure 4) resulting in a slope steeper than angle of repose. Riprap size, based on median particle axis, was estimated with a $D_{100} \approx 1.5'$ and $D_{84} \approx 1.1'$. Alluvial gravels and sands have been deposited at the toe along the upstream half (by length) of the west abutment's riprap.

Figure 3. Face of east abutment.

The abutment appears to be composed of three pilings with concrete panels between for grade separation (numbered and lettered, respectively in Figure 3). No warping, cracking, or other visual indicators of differential settling were observed that might suggest structural compromise. However, there is definitely flow from behind the abutment back to the river between the pilings and underneath one or both of the grade separation panels. Panel 'A' (Figure 3) also appears to have differentially shifted vertically.

Downstream extension of the bar into the bridge section (foreground of Figure 3) has resulted in vertical clearance between top of the cobble/gravel bar and upstream face of the bottom bridge chord measured as 5.5 feet on June 7, 2016 (Figure 6). The wetted channel was unwadeable at the time of visit, but maximum depth of bridge section was estimated to be at least 4–5 feet.

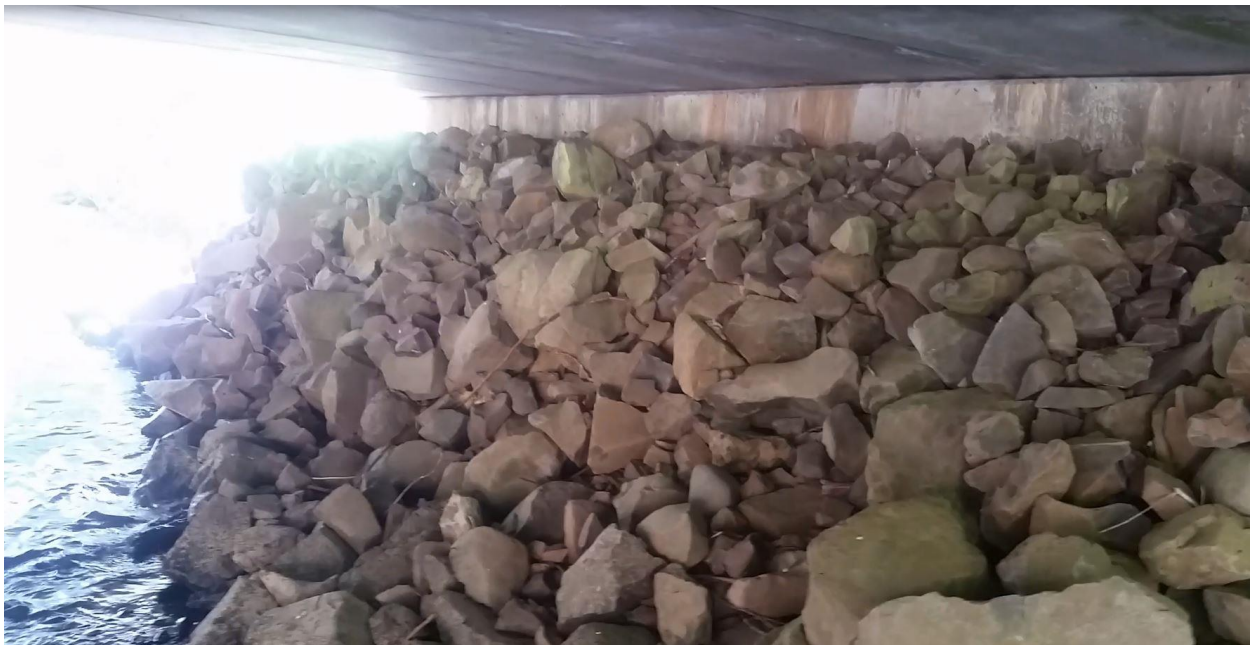
Figure 4. Face of west abutment.

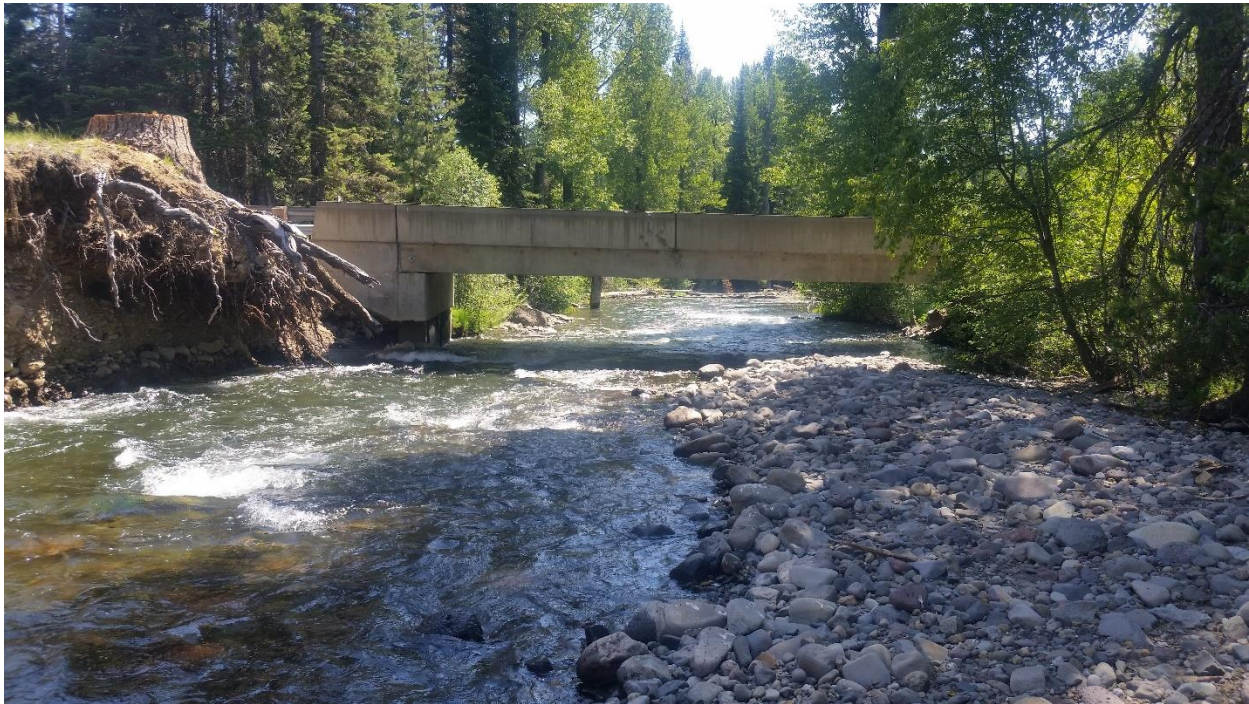
The asymmetrical distribution of erosion and deposition across the bridge section is due to approaching flow vectors resulting from upstream bar accretion (Figure 5). The bar accretion focuses sheer on the left/east half of the active channel and creates a hydraulic shadow along the right-bank.

Figure 5. Downstream view of bar accretion (river-right) associated with asymmetrical flow distribution at bridge section.

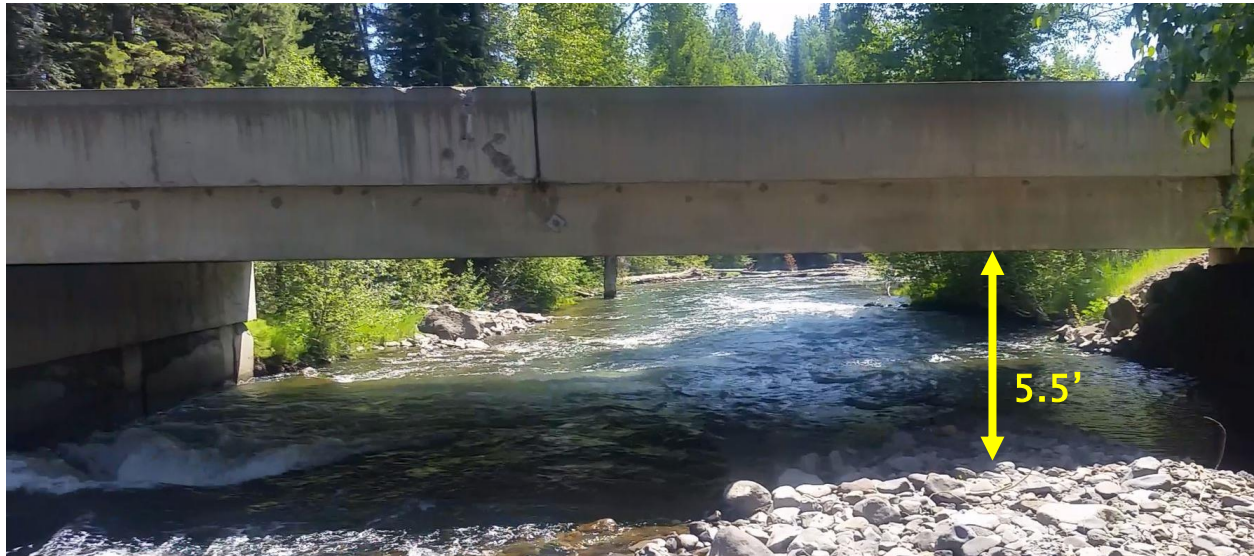
Figure 6. Close-up of bridge section looking downstream at distal end of bar accretion under bridge.

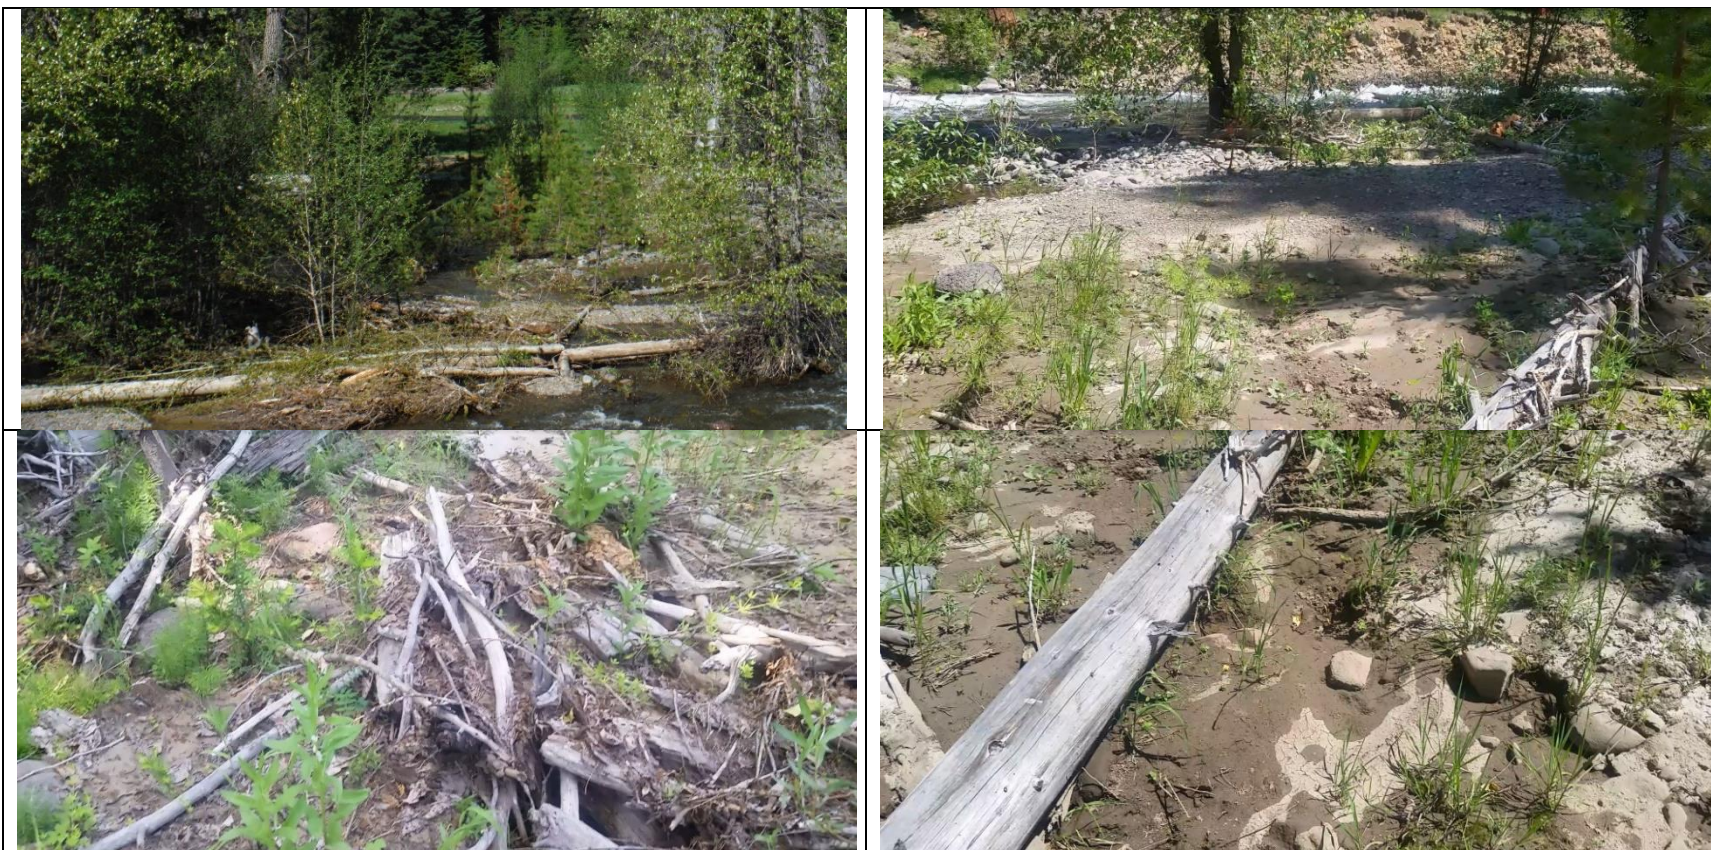
Opposite the eroding bank and adjacent to the previously mentioned bar accretion is a very active floodplain surface (Figure 1, point "3"), significant portions of which show signs of frequent inundation including 1.2-year recurrence and less flows (Figure 7). Signs include extensive fresh woody debris and uncolonized fine sediment deposits. Some fine sediment deposits were still saturated at the time of visit (daily flow at gage = 518 cfs) suggesting inundation within the last day or two and at fairly low magnitudes.

Figure 7. Recent overbank flow (5/9/2016, ~1.2-yr RI) and subsequent indicators (6/7/2016) on right-bank floodplain upstream of east bridge.

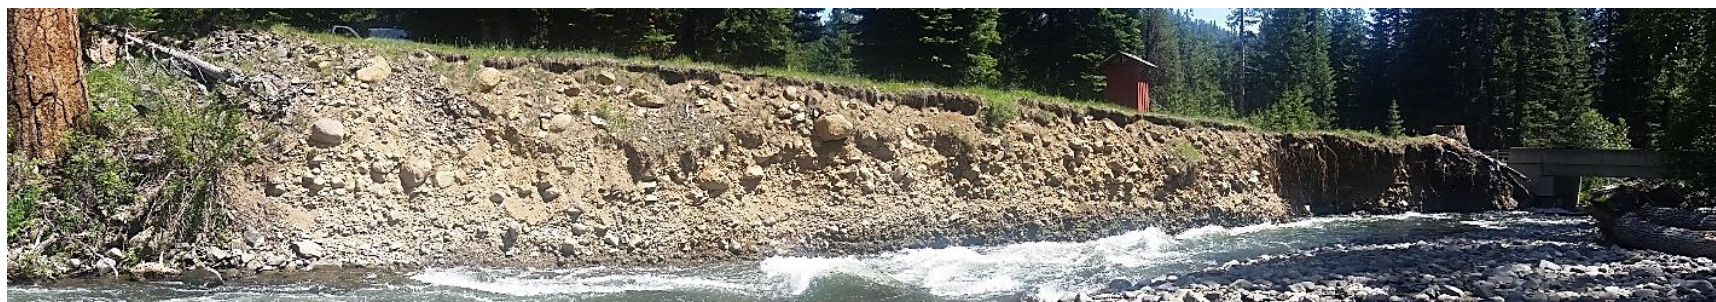
This margin is a steep, eroded face that marks the left/east boundary of the active valley bottom and floodplain (Figure 8). The bank is composed of multiple units with at least four major ones, including:

- Upper (top 4–5' of profile) – poorly sorted, weakly clast-supported (possibly matrix-supported), rounded to sub-angular large gravels to medium boulders, silty matrix
- Upper Middle – thin, variable unit of clast-supported, sub-rounded gravels to large-cobbles with a few boulders

Figure 8. Actively eroding face of left bank approximately 200 l.f. upstream of bridge.

- Lower Middle – variable, sub-angular gravels with some cobbles, possibly matrix-supported
- Toe (lower 2' visible above waterline) – clast-supported sub-rounded gravels up to medium-cobble with cohesive matrix; likely multiple units

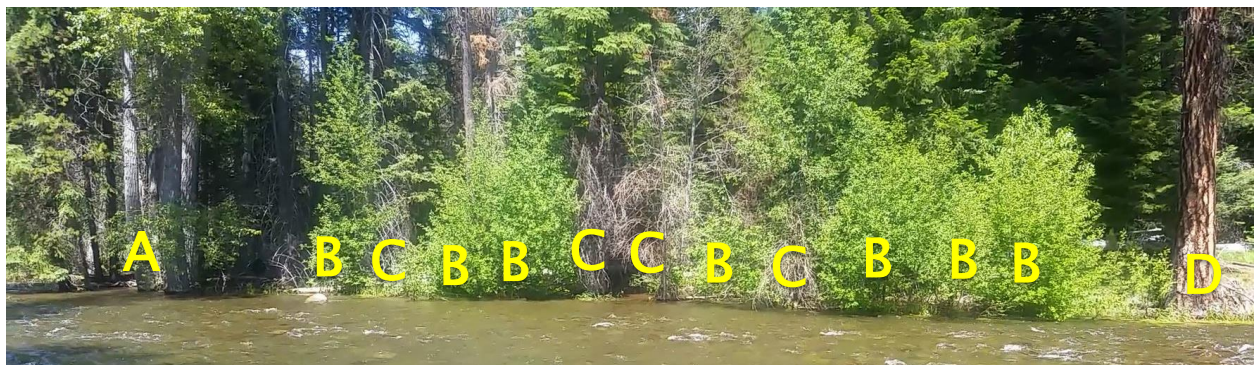
An active side channel bifurcates from the right bank of the main channel approximately 500 l.f. upstream of the bridge. During the site visit, surface flow was observed entering the side-channel and flowing toward the west bridge/channel. This area has signs of mainstem bed aggradation in the area with vegetation providing the most recognizable indicators (Figure 10).

Figure 10. Signs of aggradation in vicinity of side-channel inlet approximately 500' upstream of bridge.

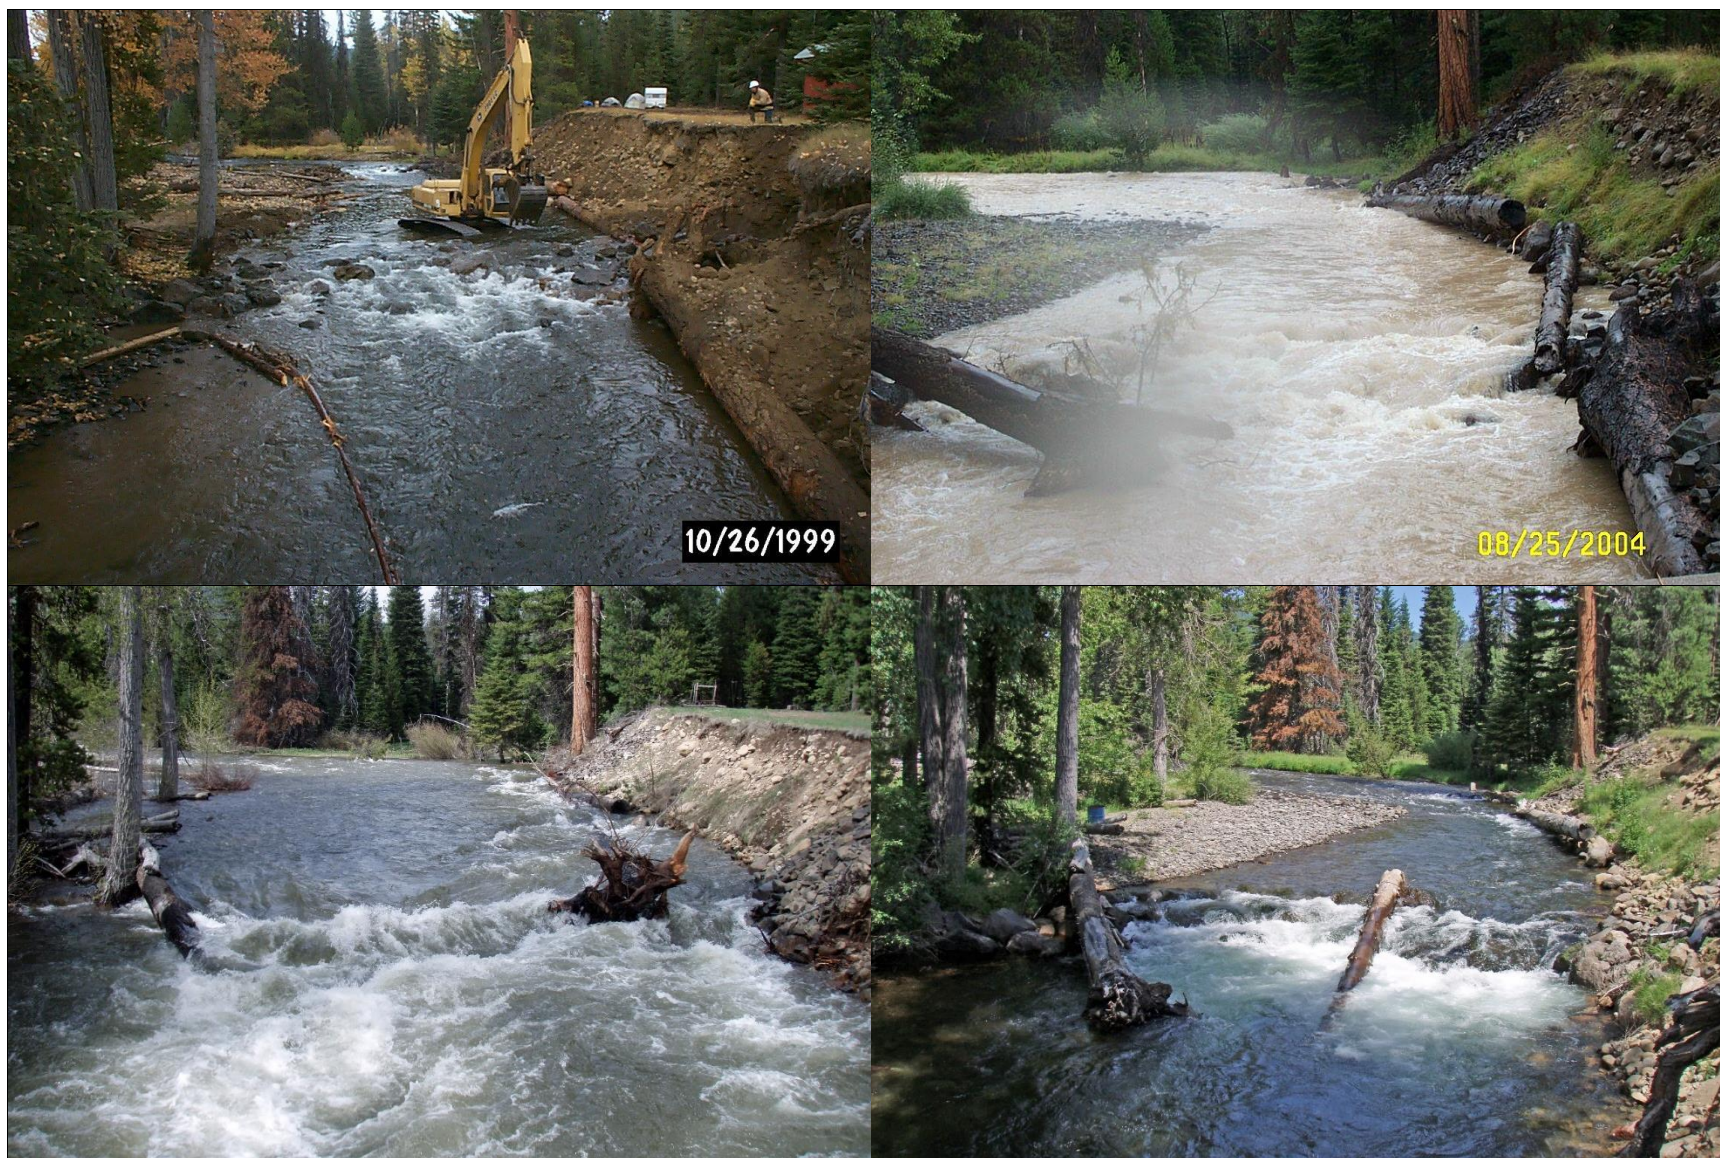
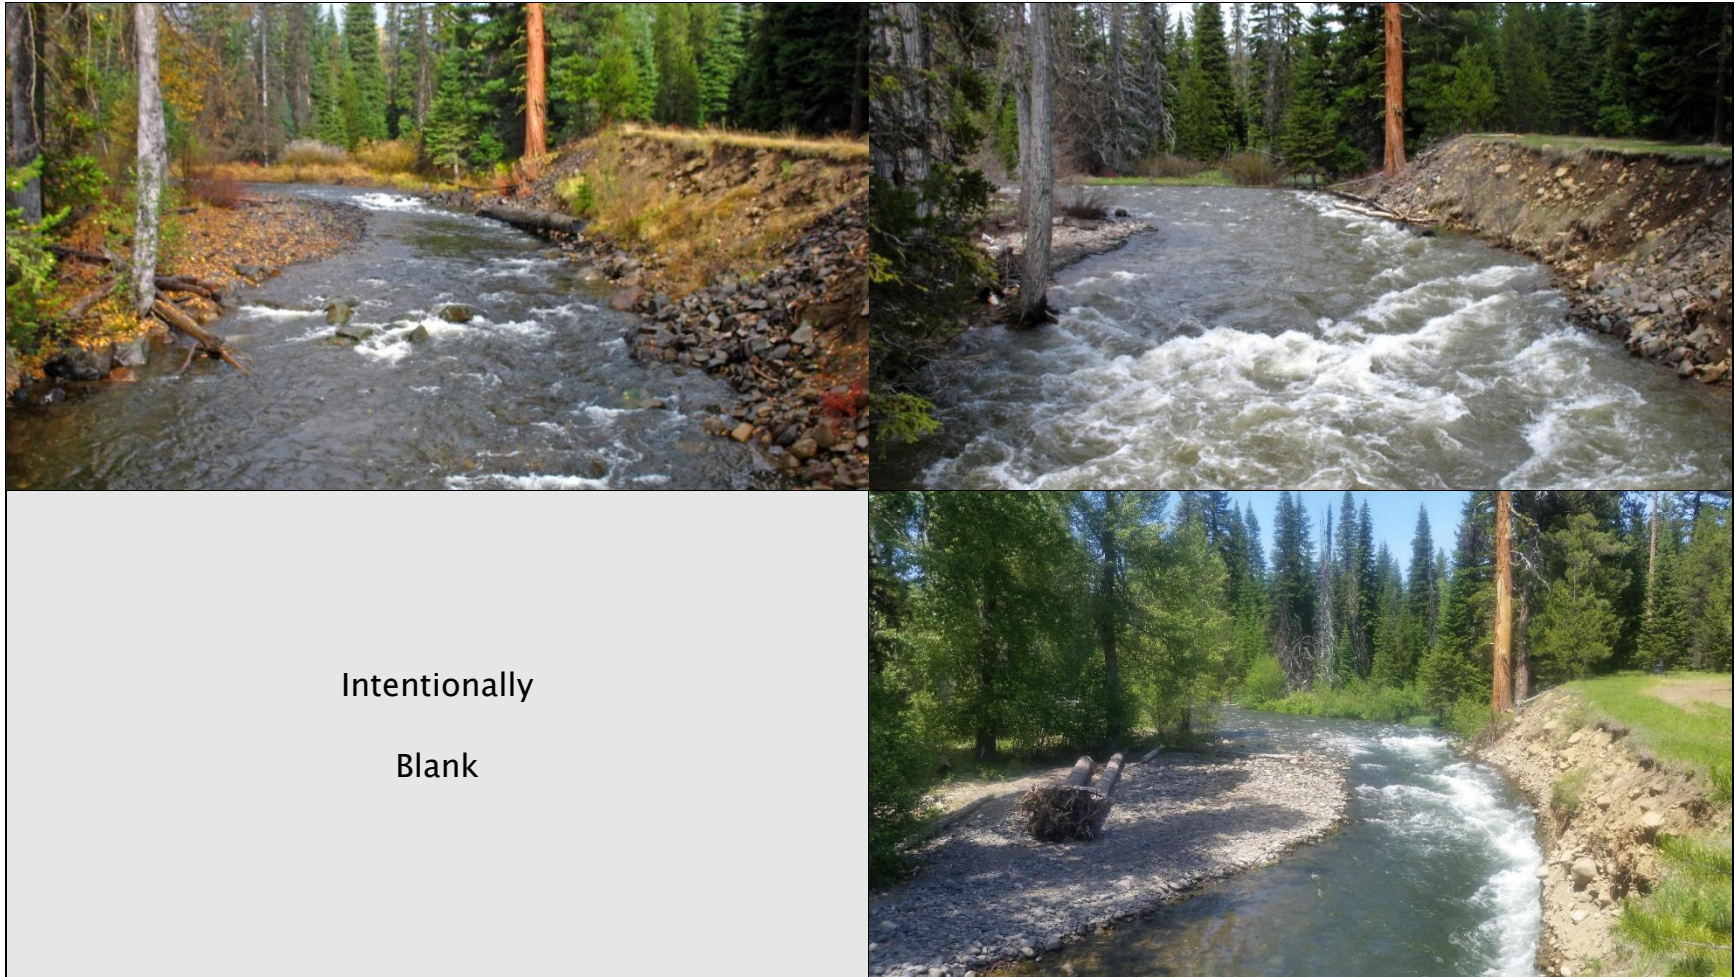
The greatest number of ground-based images were taken from the bridge looking upstream (Figure 13 and Figure 14). The earliest photos are from October 1999 and show construction of a boulder drop-structure. At that time, there also appears to be reshaping of the left bank and installation of several toe logs. The treatment was more-or-less intact and functional through at least August 2004. By May 2007, most of the toe logs were gone. The rock structure remained intact through at least July 2007 with some hydraulic effect persisting until May 2011. By October 2010, the bed upstream had aggraded upstream to the crest of the rock structure.

There are three main observations of interest between the May 2011 and June 2016 photos: reactivation of left-bank erosion, breaching of the left side of the rock structure, and significant bar accretion (lateral and vertical) along the right channel margin. It's worth noting some ebb and flow of bed/bar cutting and accretion along the right channel margin for the 2007–2011 photos.

Figure 13. Looking upstream at east (main) channel of Klickitat River from 32 Road Bridge, clockwise from top-left: 10/26/99, 8/25/04 (top) and 7/6/07, 5/21/08.

Figure 14. Looking upstream at east (main) channel of Klickitat River from 32 Road Bridge, clockwise from top-left: 10/25/10, 5/16/11, and 6/7/16.

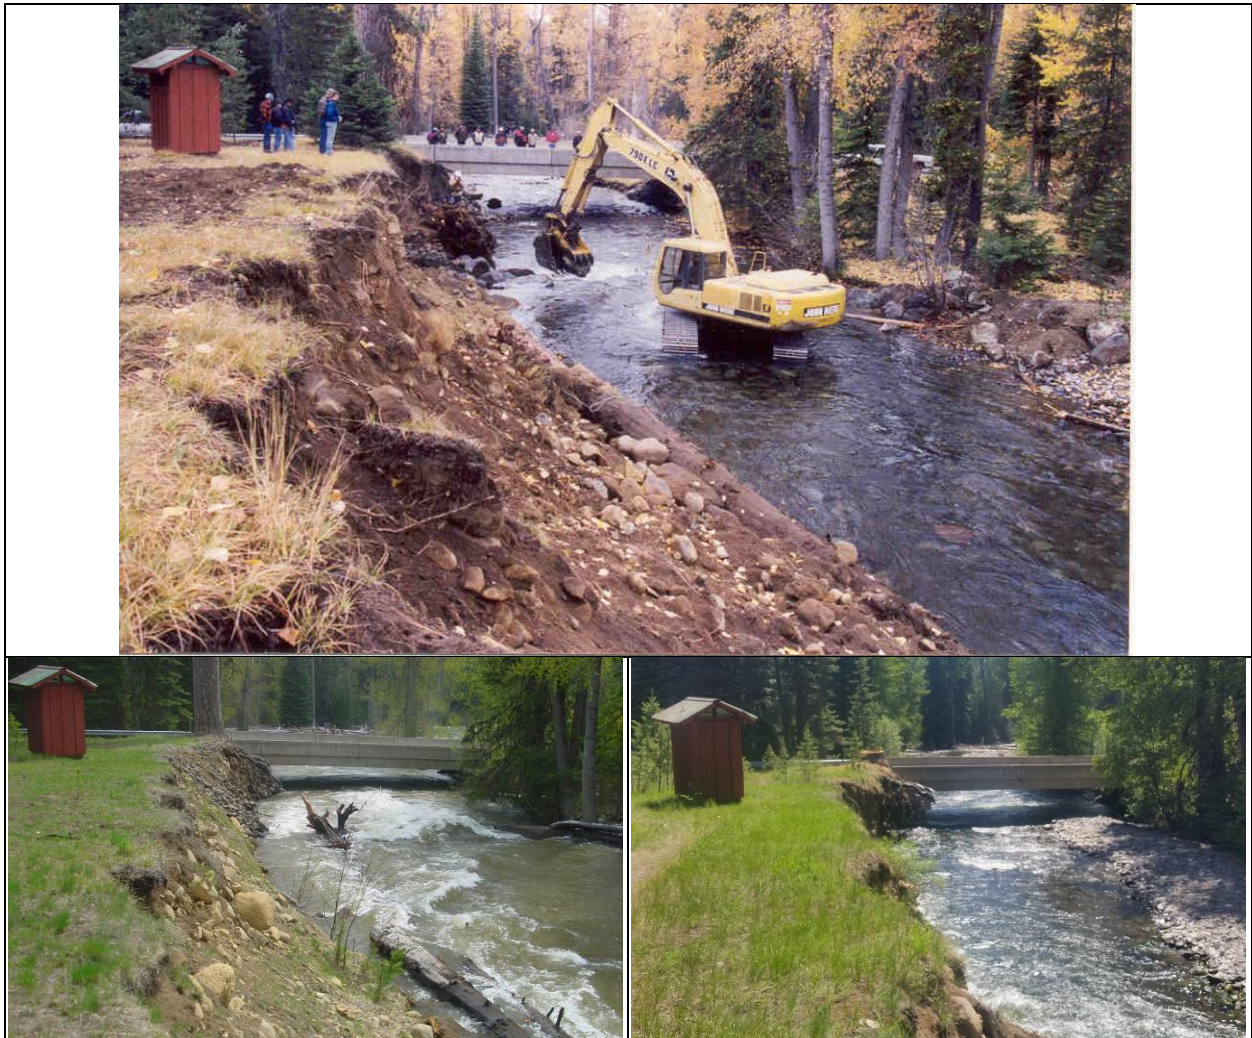
Downstream photos of the bridge (Figure 15) are less frequent, but show lateral accretion and downstream extension of the right-bank bar. They also suggest a transition from a plane-bed in 1996 to a skewed cross-sectional shape with thalweg alignment left-of-centerline (also see Figure 5). It seems likely that hydraulic capacity at the bridge has decreased. Also note the bank face has steepened considerably in the 2016 photo.

Figure 15. Looking downstream at bridge across east (main) channel of Klickitat River; counter-clockwise from top: 10/26/99, 5/20/08 (left) and 6/7/16 (right).

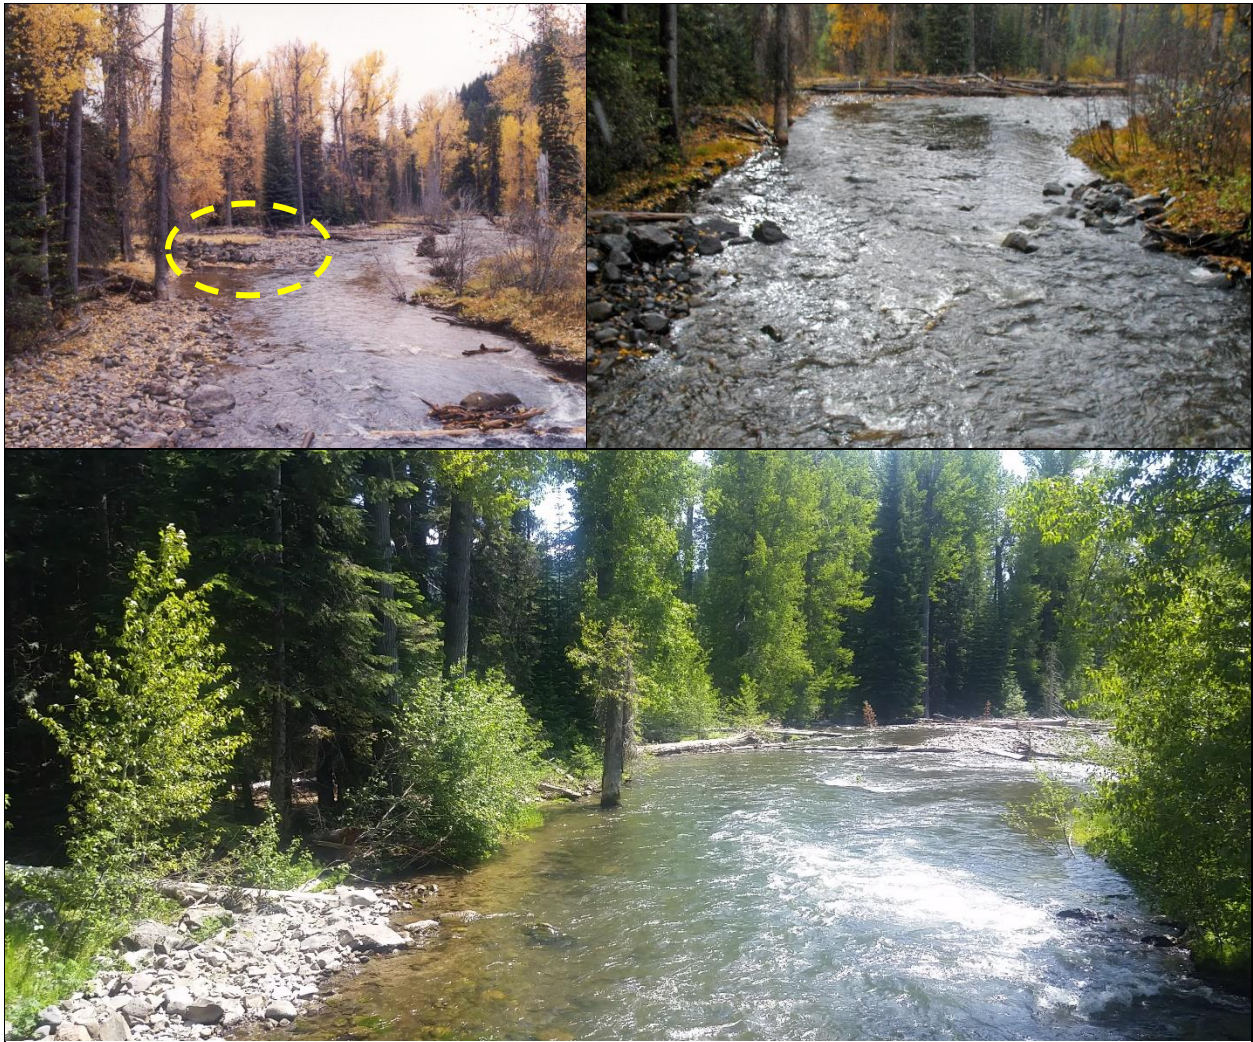
Reduced capacity due to depositional effects on local channel form at the bridge are likely compounded by increased backwatering associated with aggradation of the tailwater control (Figure 16). It appears angular boulders were placed at the inlet of a left-bank side channel during the 1999 in-channel treatment (Figure 16, circled upper-left; Figure 1, point “8”). This element

seems an unlikely cause for the aggradation, though. Decreased confinement just downstream of the bridge makes flow–expansion a more likely local cause and may be working in concert with a change in local slope where there is some range of discharges where competency (i.e. maximum particle size that can be transported) diminishes compared to upstream. In other words, there is some range of flows where steeper channel slope upstream of the bridge and confinement through the bridge section move larger particles that hydraulic conditions downstream of the bridge cannot.

Figure 16. Looking downstream from bridge; clockwise from top-left: 10/26/99, 10/25/10, and 6/7/16.

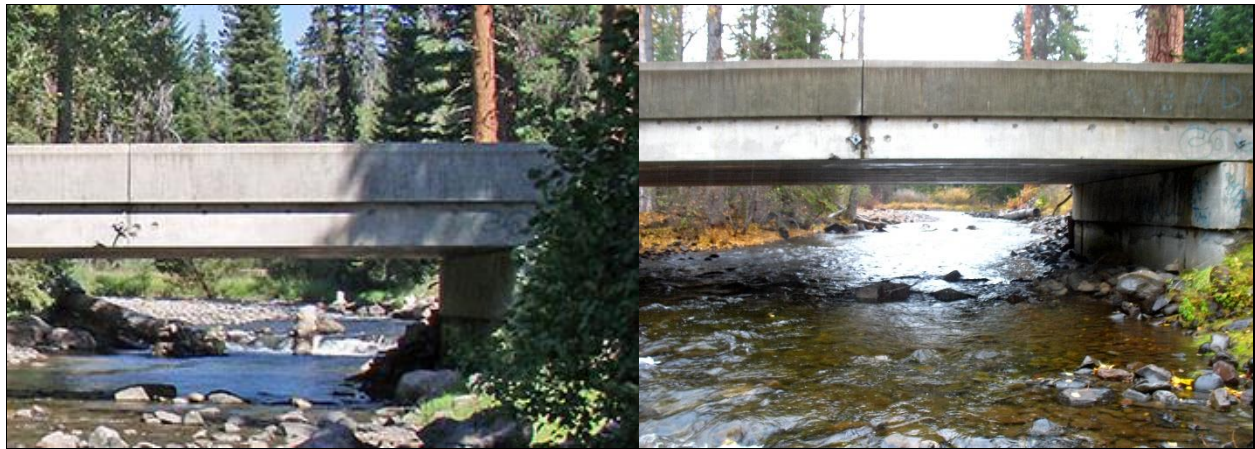
Loss of capacity due to bed changes and backwatering within the bridge section are partly offset by the loss of armor on the face of the east abutment (Figure 17). The photo from 2007 shows lower sectional area (and height on face of concrete) occupied by armor than even the west abutment in 2016 (Figure 4).

By 2010, more armor appears to have been removed, though some aggradation is apparent and may have buried/embedded residual armor along the toe.

Figure 17. Looking upstream at east abutment 8/16/07 (left) and 10/25/10 (right).

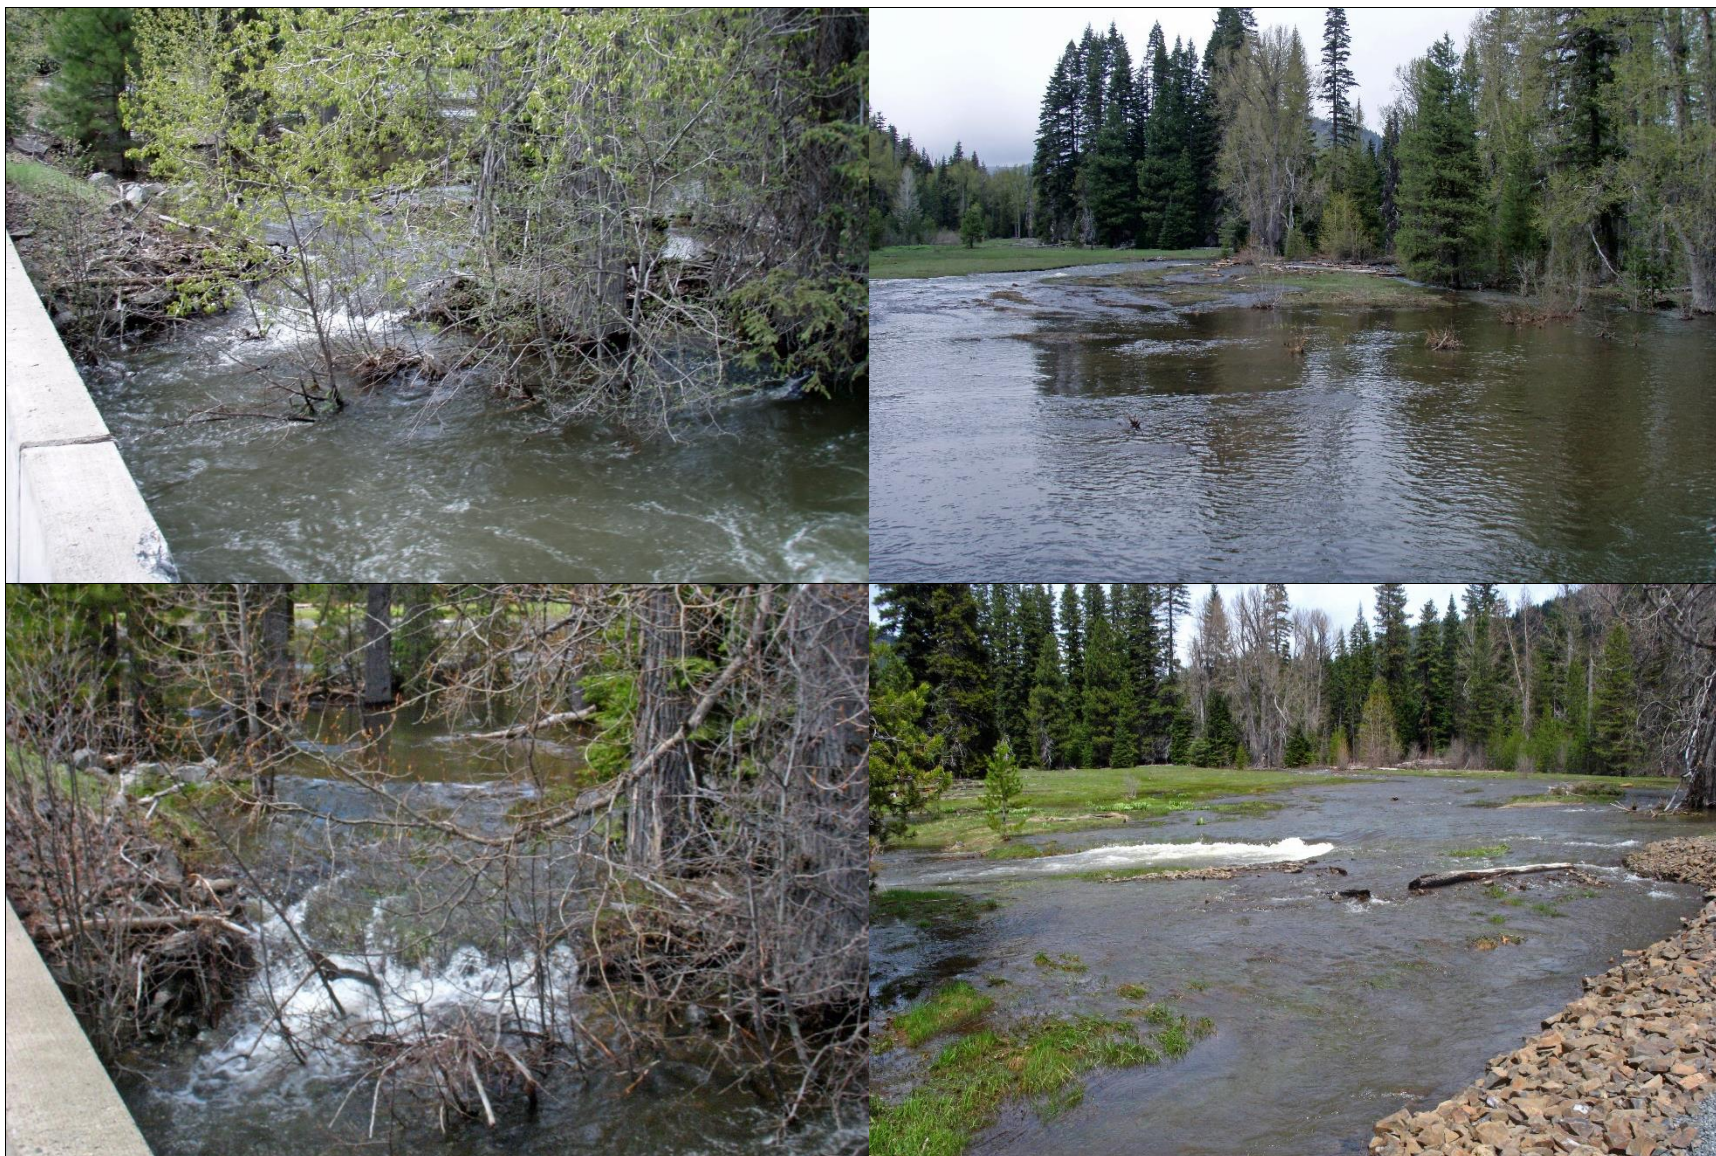
Accretion of the upstream right-bank bar and general channel aggradation between the rock structure and right-bank side channel are the proximal causes for routine overbank flows, including discharges lower than what would typically be expected (<1.3 or 1.4 RI) for this area. Some overbank flow re-enters the east channel immediately upstream of the bridge and the remainder crosses the floodplain and routed to the west channel (Figure 18). Some smaller portion is transmitted via two different culvert cross-drains through the road embankment.

Figure 18. Overbank flow on 5/21/08 (top photos) and 5/16/11 (bottom photos) approximately 1.9- and 2.2-year recurrence events

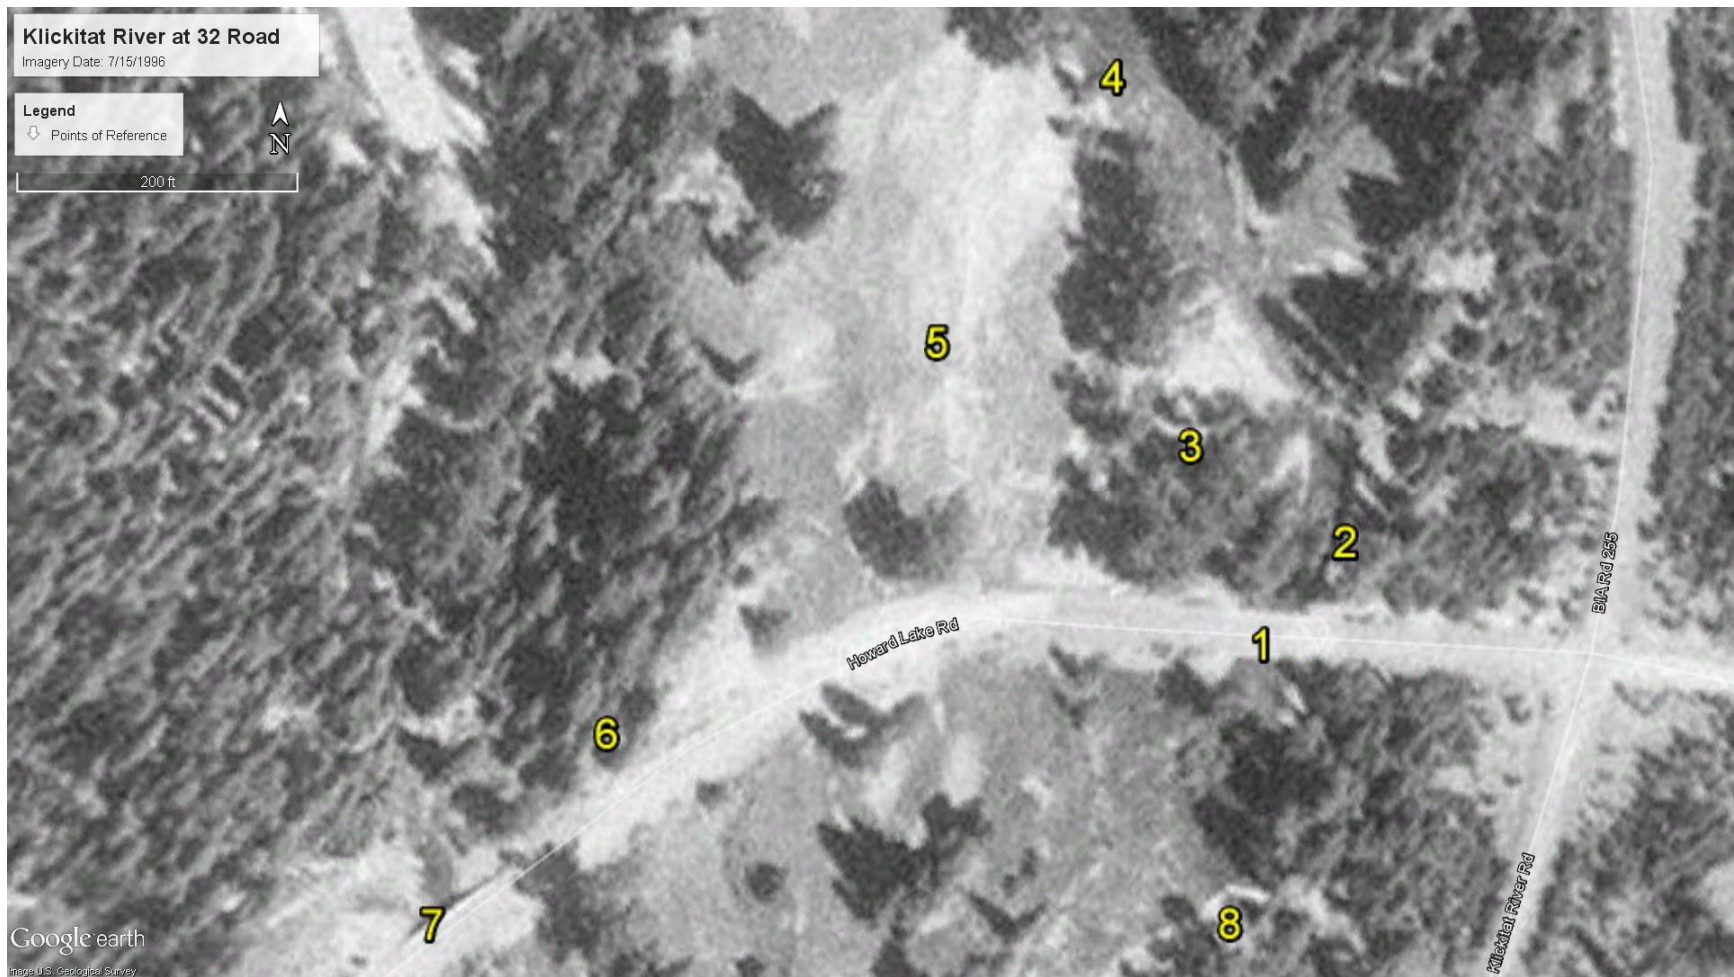
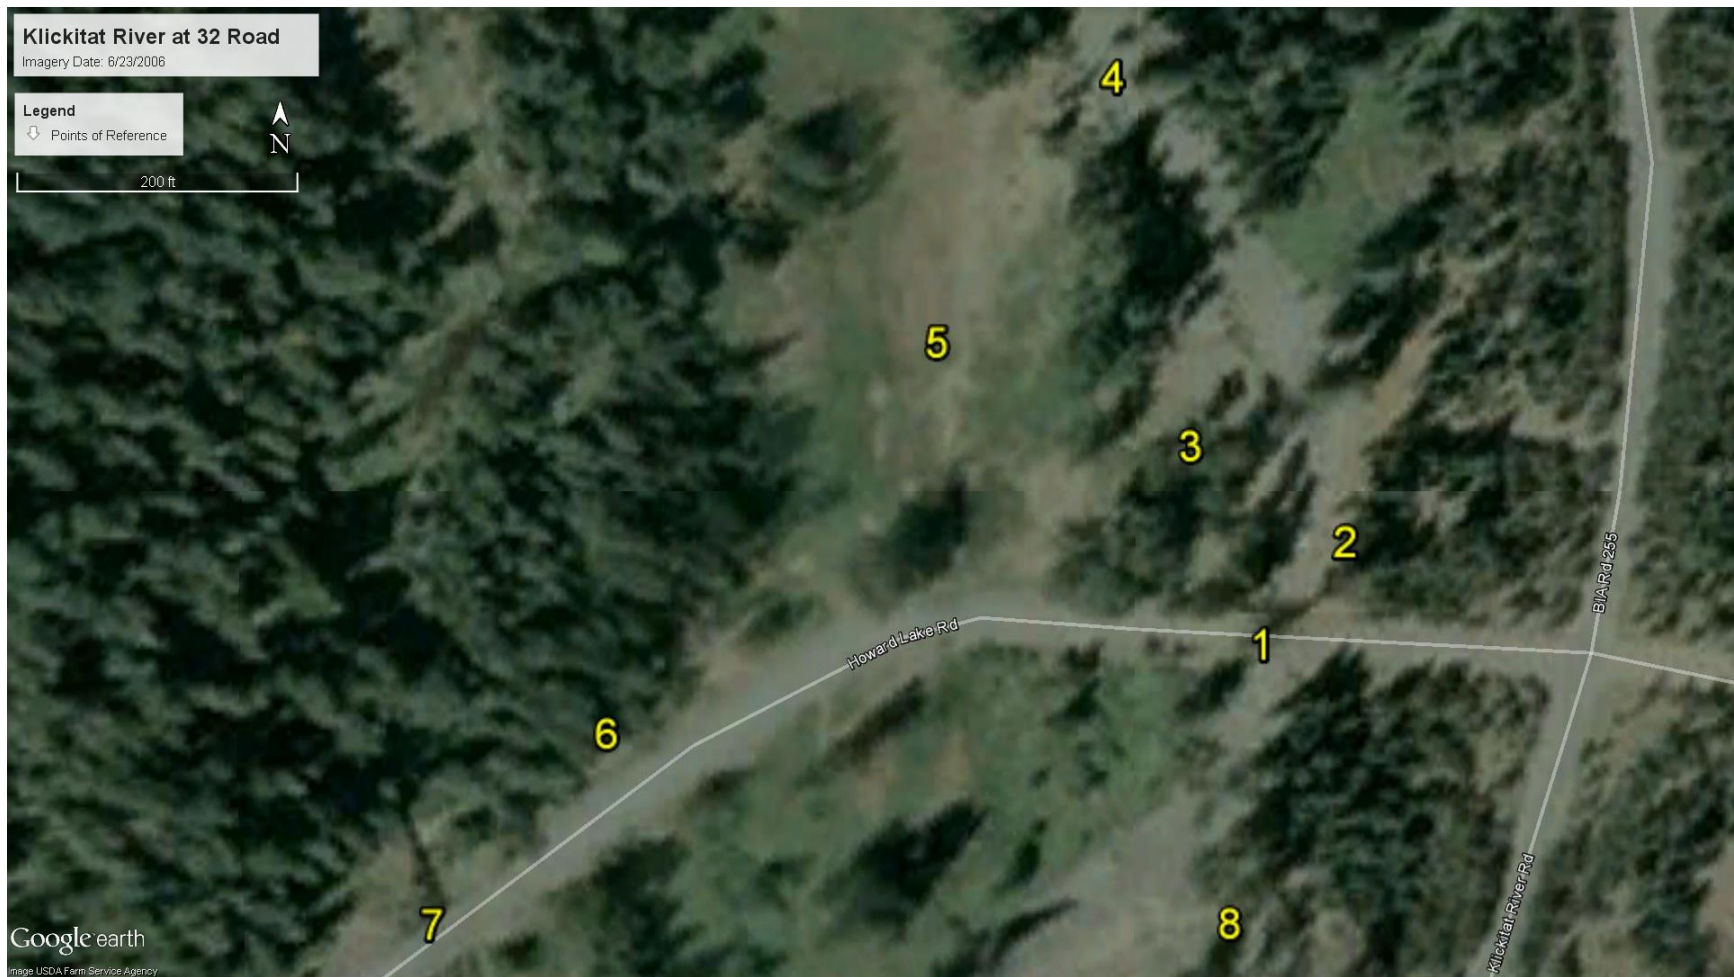
The previously noted side channel (Figure 1, along points 4–7) does not appear to be present in either the 1996 or 2006 imagery (Figure 19 and Figure 20, respectively). By 2009, a channel is clearly evident crossing the floodplain (Figure 21, vicinity of point “5”) and erosion along the road embankment face (point “7”) appears to have occurred. The 2011 photo (Figure 22) was taken during base-flow conditions (late-September) and suggests the floodplain channel has developed into a perennial channel. The channel appears better defined in the 2013 and 2015 imagery (Figure 23 and Figure 24, respectively), suggesting continued channel evolution. Lateral bar development is visible in the 2015 photo.

Figure 19. Aerial photo of active valley in vicinity of 32 Road on 7/15/1996; flow direction is top to bottom.

Figure 20. Aerial photo of active valley in vicinity of 32 Road on 6/23/2006; flow direction is top to bottom.
