**PRELIMINARY GEOMORPHIC ASSESSMENT OF THE 32 ROAD
WASH-OUT, KICKITAT RIVER
YAKAMA RESERVATION, WASHINGTON**

Will Conley

Hydrologist/Geomorphologist
Yakama Nation Fisheries Program
Klickitat Field Office
Wahkiacus, WA

July 1, 2016

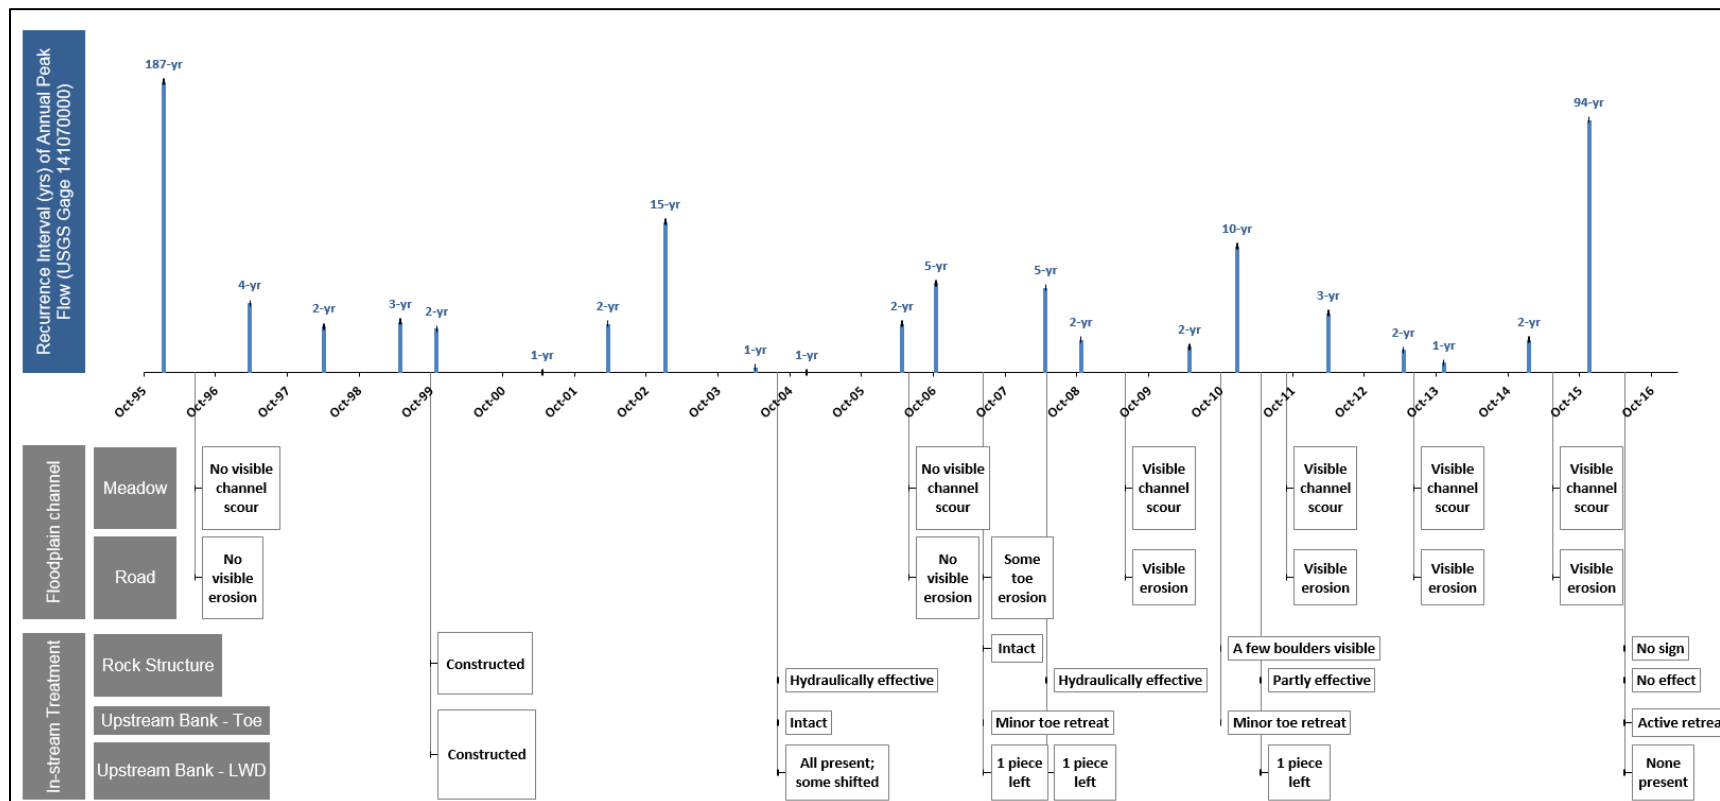
Peak discharges from the gage record and observations from the photographic record were compiled into a common chronology and presented in Figure 25. The main window where a threshold seems to have been crossed is between November 2007 and May 2010. This period of time is where the initial development of the floodplain channel occurs, left-bank erosion resumes, and the drop structure deteriorates. However, bed aggradation was likely occurring prior to that. The October 1999 in-channel treatment effectively persisted for 8–10 years and functioned during three 1-year, four 2-year, two five-year, and one 15-year events. There does not appear to have been a single, acute flow event causing its demise as there was nothing larger than a 5-year recurrence event in the preceding eight years. A shift in flow distribution and forcing caused by aggradation and bar accretion are the most likely causes. As the

Figure 25. Post-1996 flood peak-flow recurrence annotated with observations from photographic record in the vicinity of the 32 Road crossing.

magnitude and cumulative duration of overbank flow across the floodplain toward the west channel increased, a side-channel has developed in the last ten years (points 4, 5, 6, and 7 in air photo series).
