## APPENDIX B LIBBY CREEK PROJECT OPPORTUNITIES

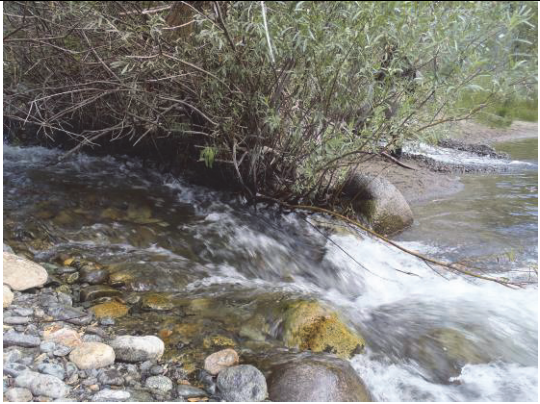
Reach	Sub-Unit	Project Number	Strategy Category	Project Name	Description	Photo
1	IZ-16	Project RM 0.0	Instream Habitat Enhancement	Confluence Maintenance	A Low flow passage problem currently exists at the confluence of Libby Creek and the Methow River. There is currently a short, steep riffle to connect the base flow elevation of Libby Creek to the base flow water surface elevation of the Methow River. This may present a passage problem for juveniles at low flow. This location should be monitored, and if necessary, grade control should be installed to ensure fish passage at all flows.

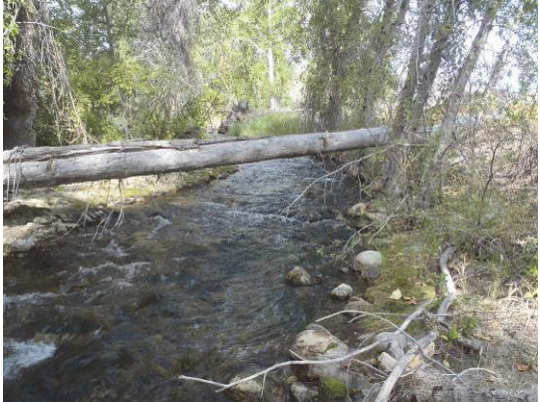
1	IZ-15	Project RM 0.04	Instream Habitat Enhancement	LW Enhancement	This project would include a lateral log-jam along the right bank of the channel. The goal of the wood placement would be to provide adult holding and juvenile rearing habitat. Large wood would promote lateral channel dynamics, recruit spawning gravels, initiate pool scour, and provide cover for habitat. This location benefits from having few infrastructure constraints; this project would also promote overland flow on one of the few connected OZs

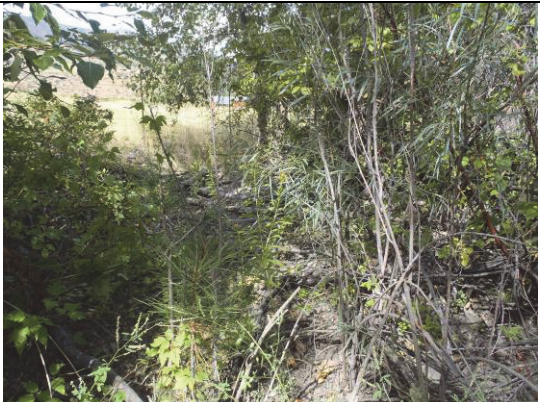
1	DOZ-06	Project RM 0.06 (Left Bank)	Riparian Restoration	Expand Riparian Buffer (left bank).	A very narrow band of riparian forest extends along the left bank. This project would plant high density native riparian forest vegetation within a 150 foot buffer in order to restore riparian functions including stream shade, bank stabilization, and futures sources of LWM.

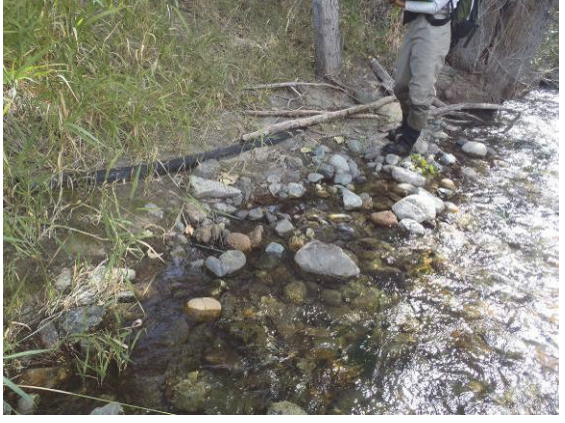
Reach	Sub-Unit	Project Number	Strategy Category	Project Name	Description	Photo
1	IZ-13	Project RM 0. 1	Instream Habitat Enhancement	Monitor Instream Flow & Withdrawal Rates	This project includes monitoring instream flows to ensure flow is meeting the requirements for fish passage and habitat. If necessary, investigate opportunities for reducing withdrawals during low flow periods to increase instream flows.

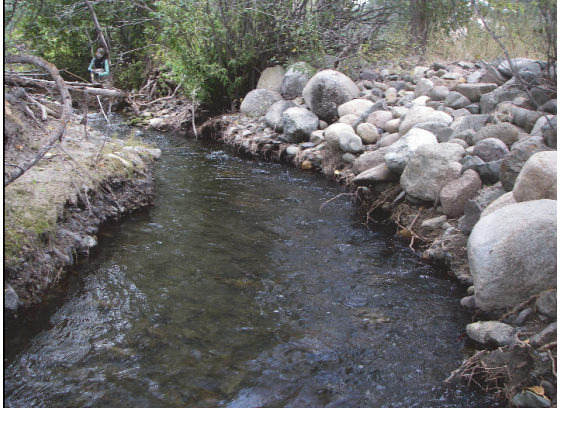
1	IZ-10	Project RM 0.12 (Left Bank).	Reconnect Stream Channel Processes	Remove Riprap	This project involves the removal of approximately 75 feet of riprap along the left bank. Riprap removal would restore lateral channel dynamics and would reduce the rate of incision within Libby Creek. A small jam could be placed along the right bank to promote habitat diversity and inundation along the left floodplain.

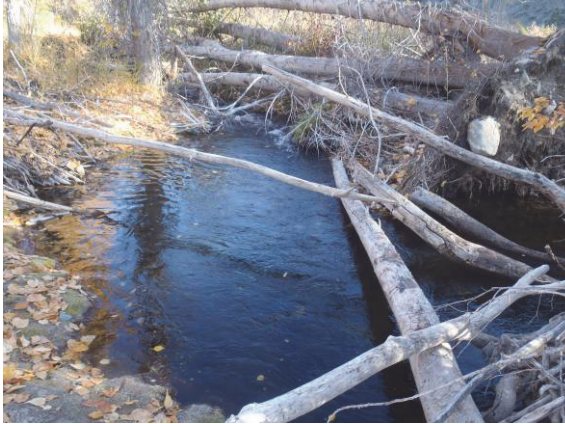
1	IZ-03	Project RM 0.15	Instream Habitat Enhancement	LW Enhancement	This project involves placement of large wood to promote channel process and to provide cover for habitat that is extremely limited in this reach. The project would include a lateral bank jam and cover wood along the right bank into existing pool/glide habitat.

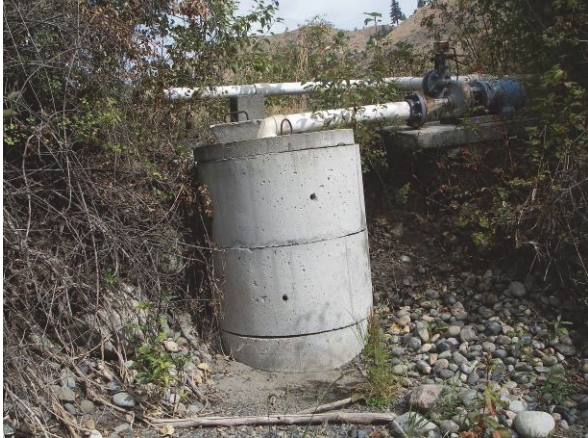
Reach	Sub-Unit	Project Number	Strategy Category	Project Name	Description	Photo
1	IZ-09	Project RM 0.21-L	Instream Habitat Enhancement	Monitor Instream Flow & Withdrawal Rates	This project includes monitoring instream flows to ensure flow is meeting the requirements for fish passage and habitat. If necessary, investigate opportunities for reducing withdrawals during low flow periods to increase instream flows.

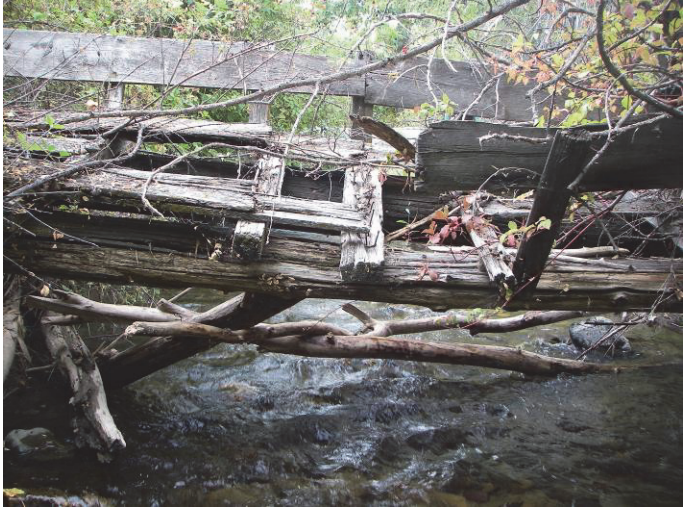
1	IZ-09	Project RM 0.21-C	Reconnect Stream Channel Processes	Remove Channel Spanning Wood Bridge and Replace with Channel-spanning Log Jam.	The existing channel-spanning wood bridge could be removed and replaced with LW material. A channel-spanning jam could be tied into the banks where the existing bridge abutments are located. This would promote vertical stability of the Libby Creek channel.

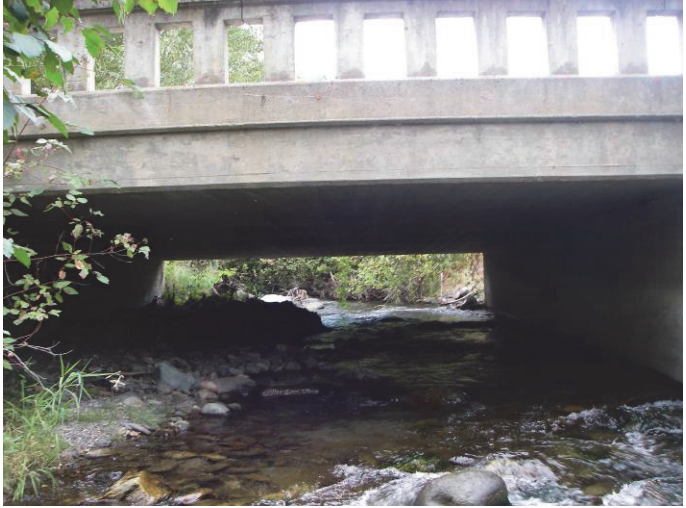
1	IZ-08	Project RM 0.29	Reconnect Stream Channel Processes	Replace Highway 153 Bridge	The existing Highway 153 bridge is undersized – it is currently only equivalent to 1.25 channel widths at low flow. The bridge is acting as a hydraulic constriction and limiting lateral migration of the channel. Additionally, it is causing scour downstream of the bridge. The bridge should be replaced with a wider and higher structure to allow for the lateral and vertical expansion of Libby Creek.

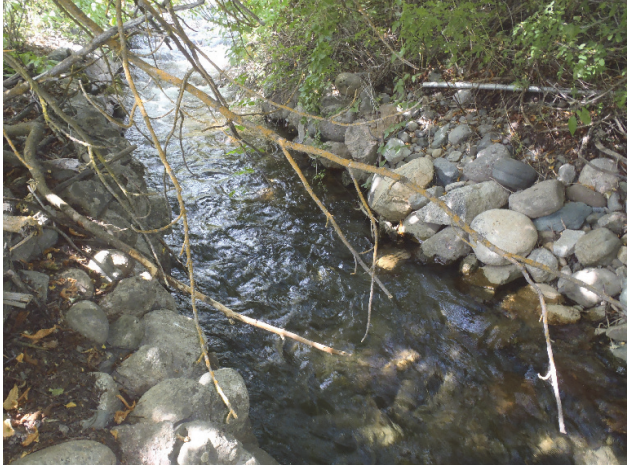
Reach	Sub-Unit	Project Number	Strategy Category	Project Name	Description	Photo
1	IZ-07	Project RM 0.3	Reconnect Stream Channel Processes	Riprap Removal & Grade Control	Libby Creek has been channelized and riprap has been placed along both the left and right banks. Riprap begins 40 feet upstream of the Highway 153 Bridge and extends along both banks for 116 feet. This project would include the removal or modification of the riprap to enhance channel margin habitat and to restore lateral channel dynamics. If necessary, wood jams and grade control could be placed to protect property.

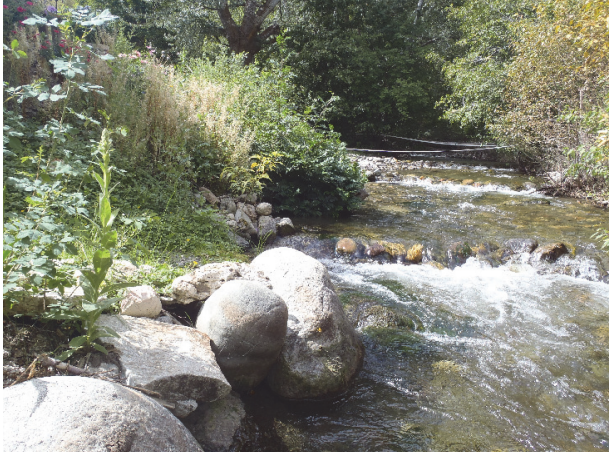
1	IZ-06	Project RM 0.33	Reconnect Stream Channel Processes	Transverse Bar Construction	Instream alterations have been made to create a step-pool sequence. These alterations extend 100 feet upstream of the riprap at RM 0.3. The steps could be removed and replaced with constructed transverse riffles/bars to improve habitat conditions for spawning, rearing, and insect production. This would introduce more lateral movement within the stream and would promote scour pool development. Large wood could be added for habitat enhancement within the pools. It would be necessary to work closely with the landowners to ensure maintenance of aesthetics and adjacent uses.

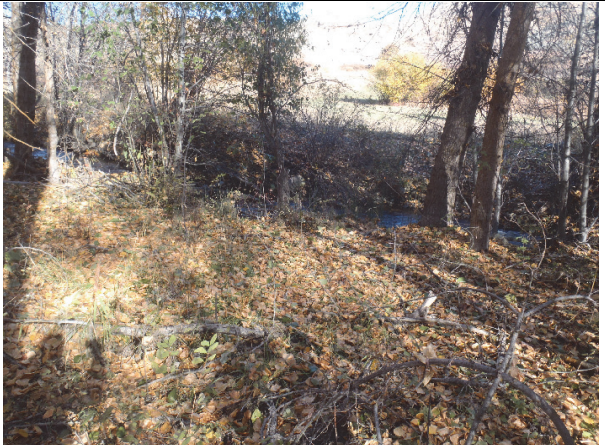
1	OZ-03	Project RM 0.38	Reconnect Floodplain Processes	Floodplain Reconnection	The incision of Libby Creek has resulted in extremely limited connected floodplain throughout the survey reach. This location presents adequate space to lower floodplain surfaces on either side and install alternating large wood jams. This would promote increased hydraulic and hydrologic connectivity with floodplain surfaces on either side, as well as provide habitat diversity throughout the reach.

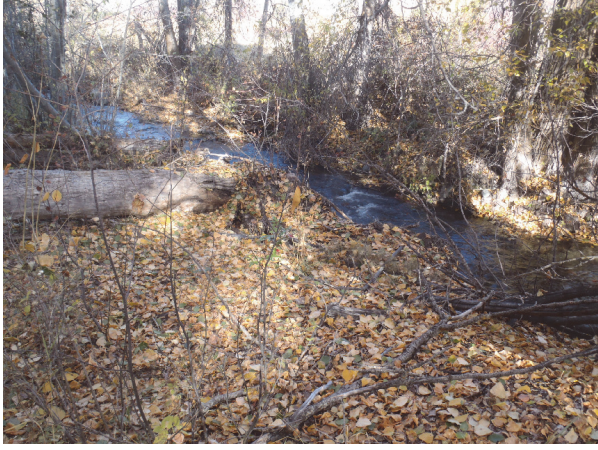
Reach	Sub-Unit	Project Number	Strategy Category	Project Name	Description	Photo
1	DOZ-03 and DOZ-01	Project RM 0.41	Reconnect Floodplain Processes	Floodplain Reconnection	The left and right bank throughout this area provide space to lower floodplain elevations to create an active floodplain. Floodplains would be treated with large wood to increase complexity and provide roughness throughout the reach. Large wood would promote gravel recruitment and pool scour over time.

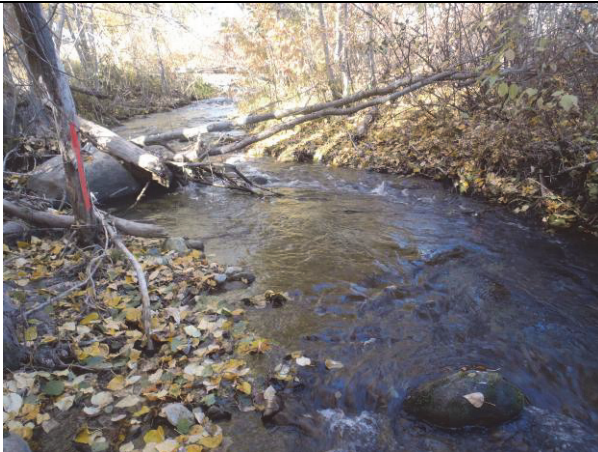
1	DOZ-03 and DOZ-01	Project RM 0.42	Reconnect Stream Channel Processes	LW Enhancement	This project would be paired with RM 0.41 if possible. This project would include creating alternating channel margin log jams to reintroduce lateral migration into Libby Creek and slow its rate of incision.

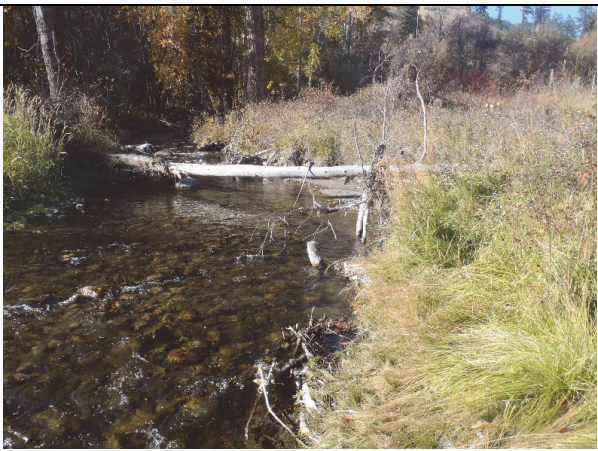
1	IZ-03	Project RM 0.5	Instream Habitat Enhancement	LW Enhancement	This project would involve the placement of two large log jams (one along the right bank at the downstream end, and one along the right bank at the upstream end) that extend out into the channel. This would promote lateral channel dynamics, pool scour, gravel recruitment, and cover enhancement. These actions would be paired with dense plantings of riparian vegetation along both banks.

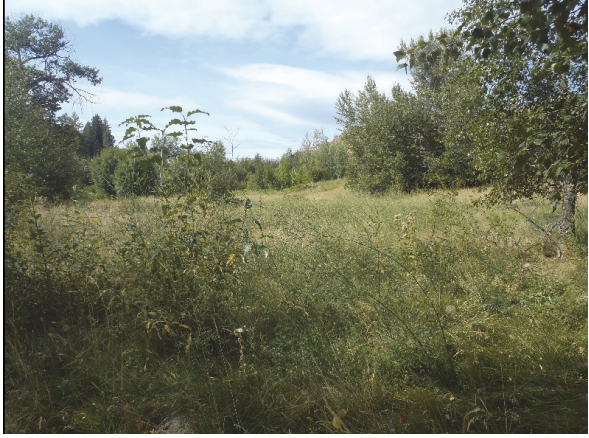
Reach	Sub-Unit	Project Number	Strategy Category	Project Name	Description	Photo
2	DOZ-09	Project RM 0.62	Riparian Restoration	Riparian Restoration (right bank)	Approximately 150 feet of the right bank is unvegetated along this reach. Native replanting would improve shade, natural stability, and provide future sources of large wood.

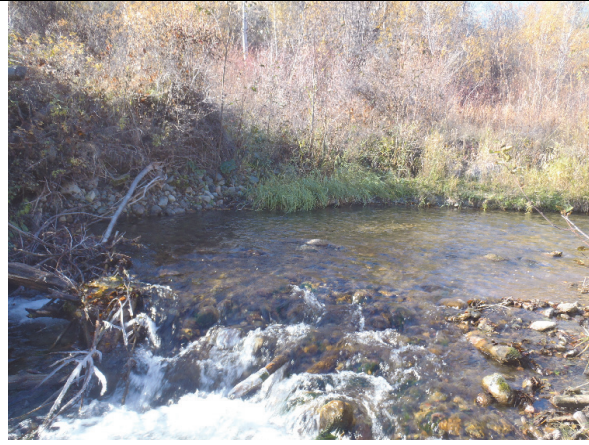
2	IZ 17	Project RM 0.7	Instream Habitat Enhancement and Riparian Restoration	LW Enhancement, Riparian Restoration, and Diversion Monitoring	Large wood could be keyed into the right bank to provide overhanging cover, recruit gravels, and promote pool scour. This would be paired with riparian restoration along the right bank to provide shade, natural stability, and future sources of large wood material.

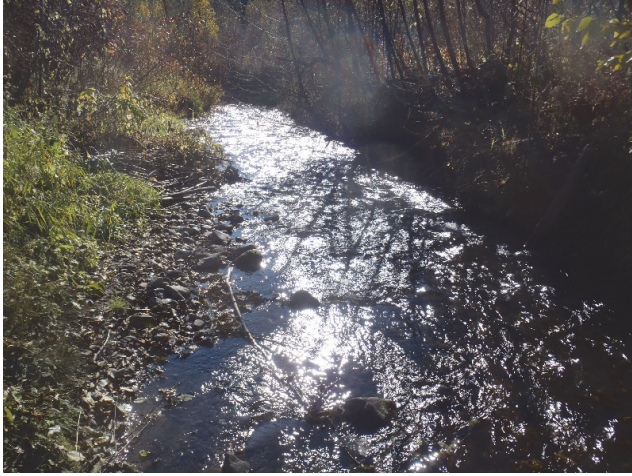
2	IZ-16	Project RM 0.71	Reconnect Stream Channel Processes	LW Enhancement	Alternating jams would be placed along the left and right banks throughout this long riffle. This would promote lateral migration of the channel as well as initiate gravel recruitment and pool scour. This would provide habitat complexity in this long, uniform riffle.

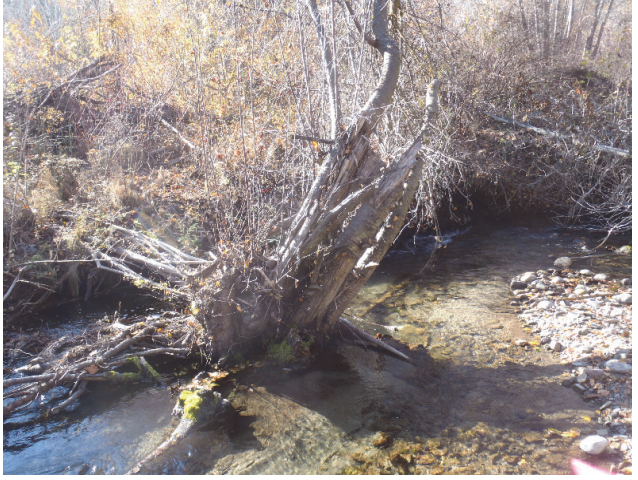
Reach	Sub-Unit	Project Number	Strategy Category	Project Name	Description	Photo
2	IZ-15	Project RM 0.75	Instream Habitat Enhancement	LW Enhancement	A small jam could be built into the right bank along this reach. The goal of the jam would be to add complexity and cover.

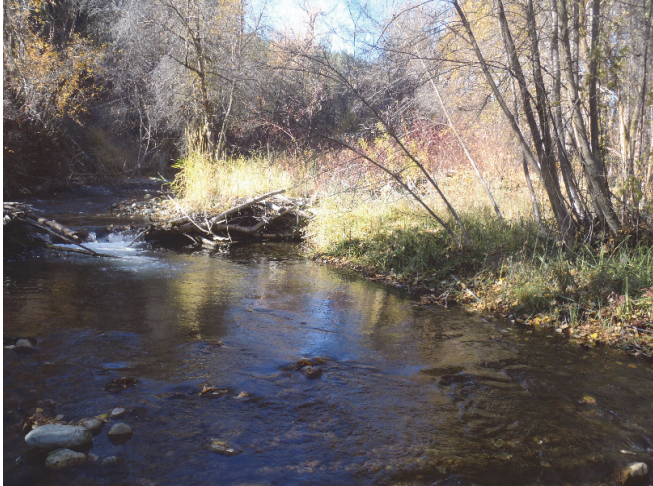
2	IZ-12 and OZ 07	Project RM 0.9	Instream Habitat Enhancement and Reconnect Stream Channel Processes	LW Enhancement and Fill Removal	The location of a connected outer zone (OZ-07) along the left bank makes this an excellent location for a channel- and valley-spanning jam. A large jam complex here would promote floodplain connectivity and habitat complexity. Fill along the floodplain would need to be removed and portions of the floodplain may also need to be regraded. An additional log jam could also be installed along the left bank approximately 100 feet downstream.

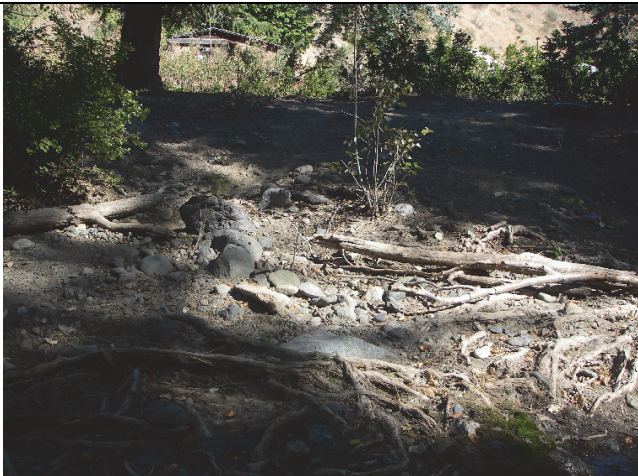
2	DOZ -04	Project RM 1.07	Riparian Restoration	Riparian Restoration	The right bank is sparsely vegetated from RM 1.07 to RM 1.14. The shoreline has been altered, regraded, and cleared for residential development along the banks. This project would replant banks with native riparian seedlings and regrade where necessary.

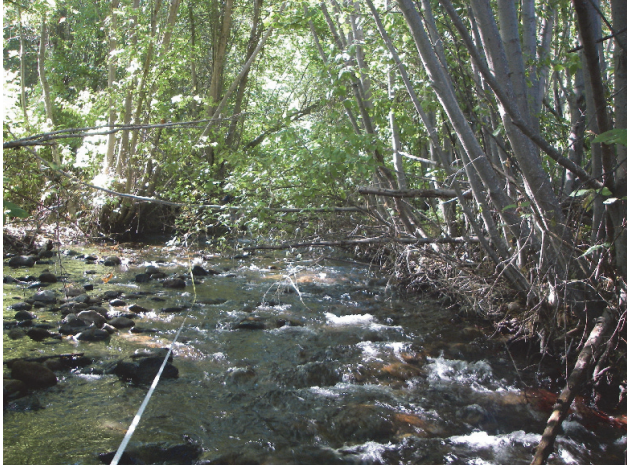
Reach	Sub-Unit	Project Number	Strategy Category	Project Name	Description	Photo
2	IZ-06 and OZ-06	Project RM 1.18	Reconnect Stream Channel Processes	LW Enhancement	The left and right banks throughout this reach are relatively well connected floodplains. Large, alternating, left and right bank jams could be placed to promote lateral channel migration, gravel recruitment, and pool habitat formation.
