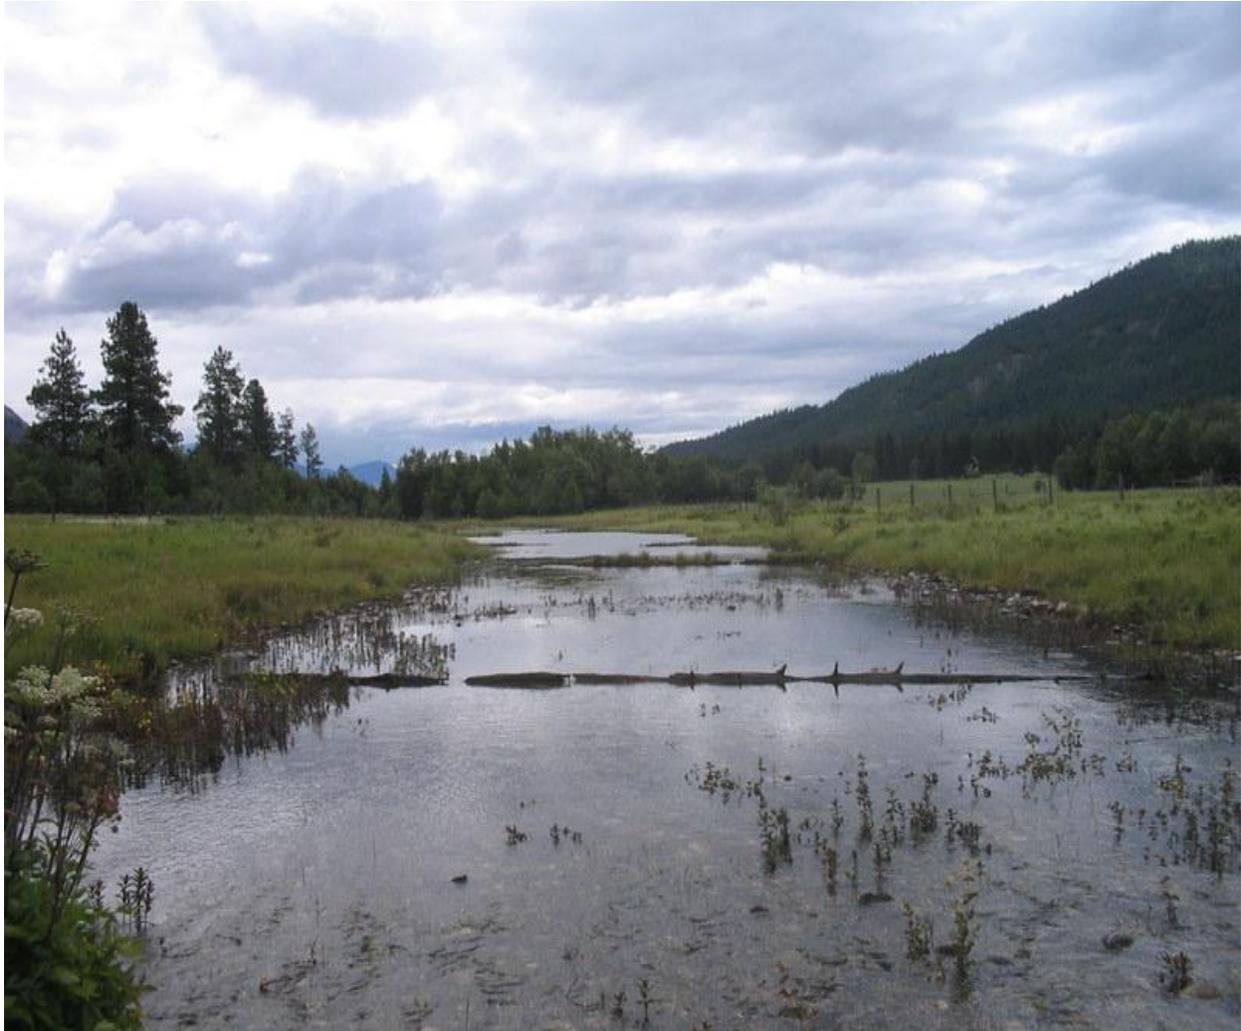
**Photo 1: Looking downstream (June 2005), after decades of uncontrolled livestock use. Trampled banks created a over-widened channel with little to no sinuosity or channel complexity. At this point there was no documented use of native salmonids within the spring creek.**

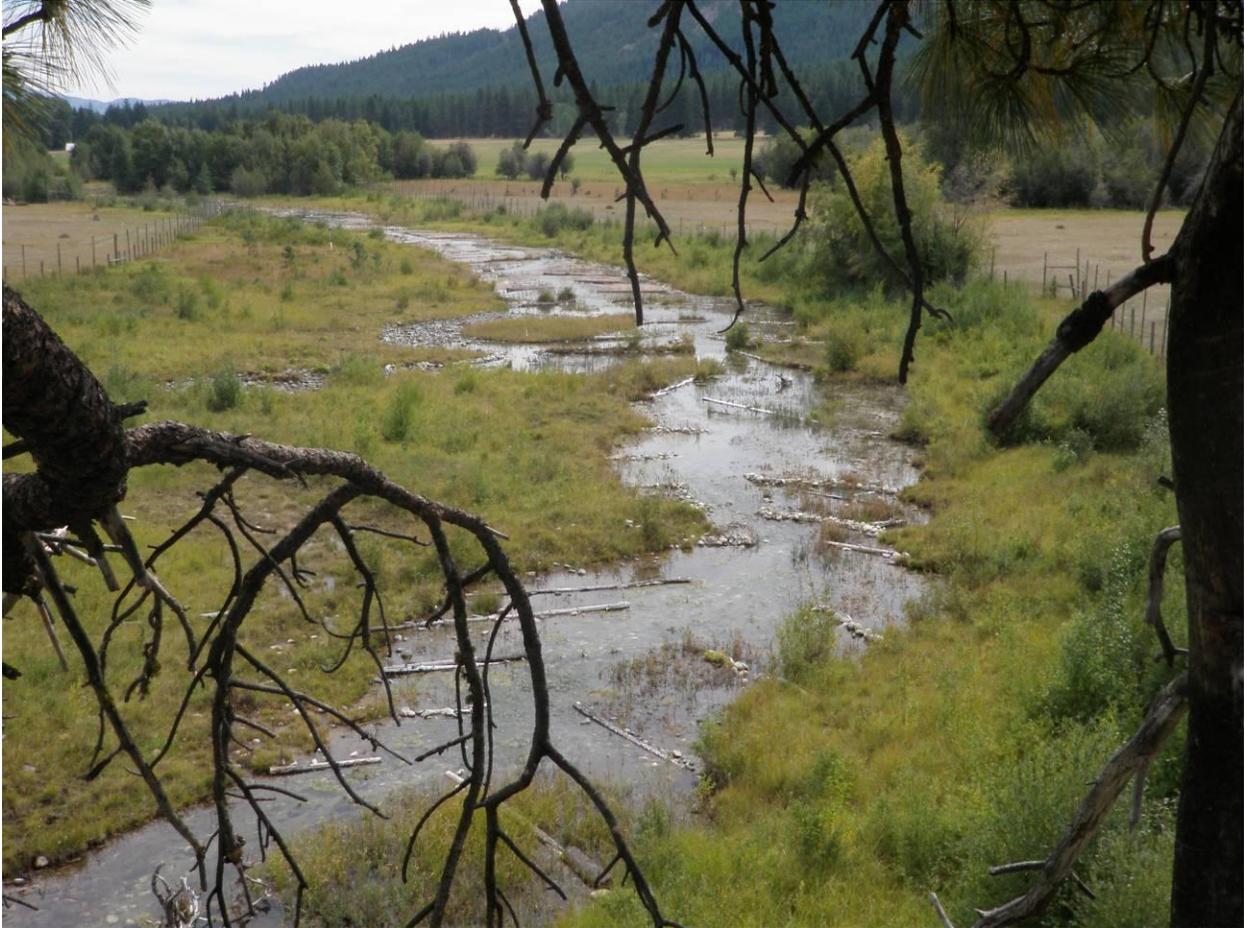
**Photo 2: Looking downstream (July 2009) at the first phase of construction. Limited by HPA permit restrictions, all restoration activities were completed by hand. Though primitive looking, the increased channel complexity (added wood, riffle and pool habitat) brought impressive fish results. Years of double digit redd counts (for both spring chinook and summer steelhead) as well as overwinter rearing of their offspring.**

**With years of well documented fish response, permitting agencies relaxed their restrictions on "heavy handed" restoration techniques and allowed a more aggressive channel reconstruction design. These restoration techniques would fix some of the hydraulic problems not fixable under previous permit restrictions.**

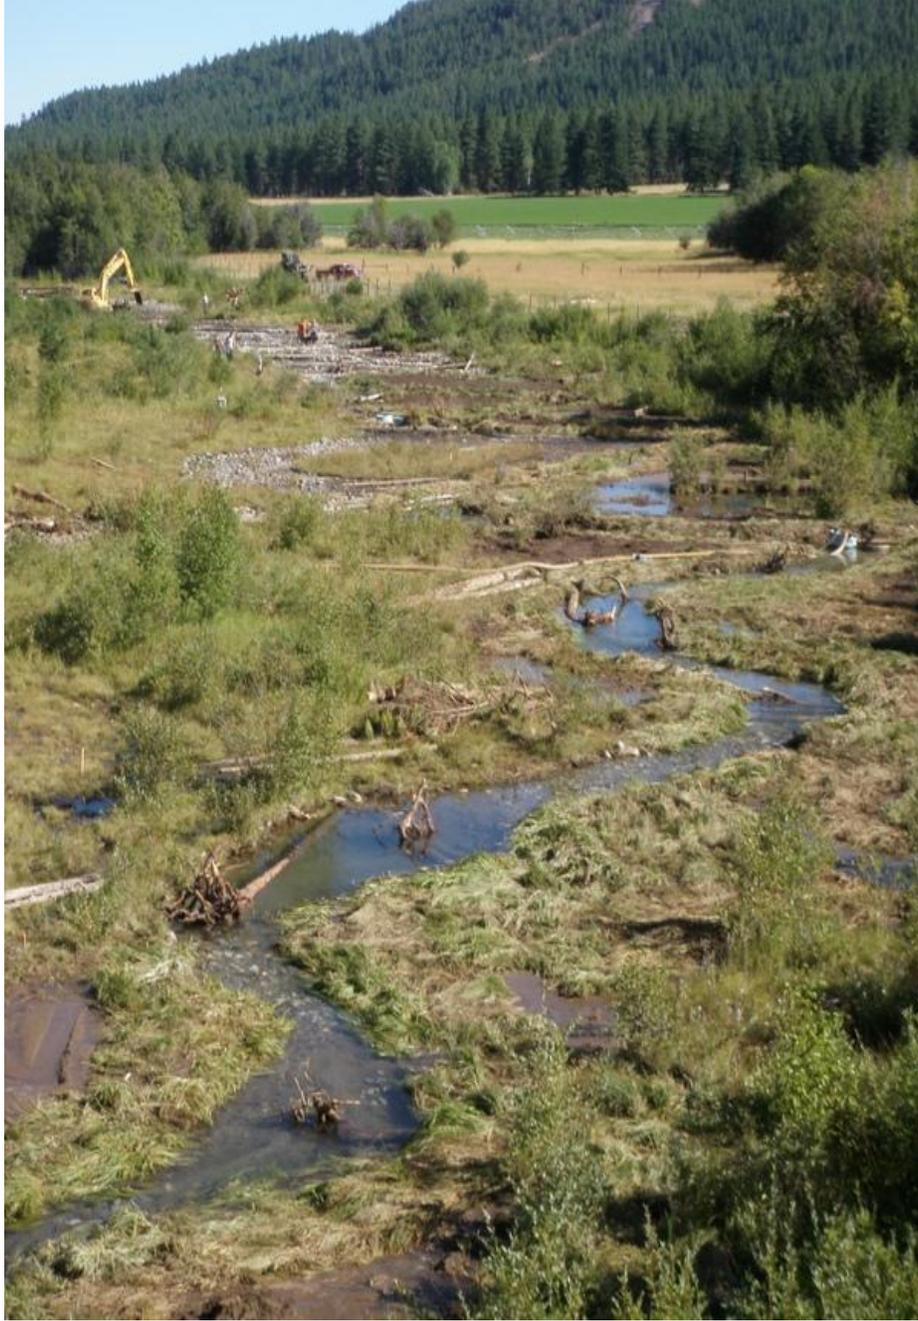
**Photo 3: (August 2011) Looking downstream at different phases of construction.**

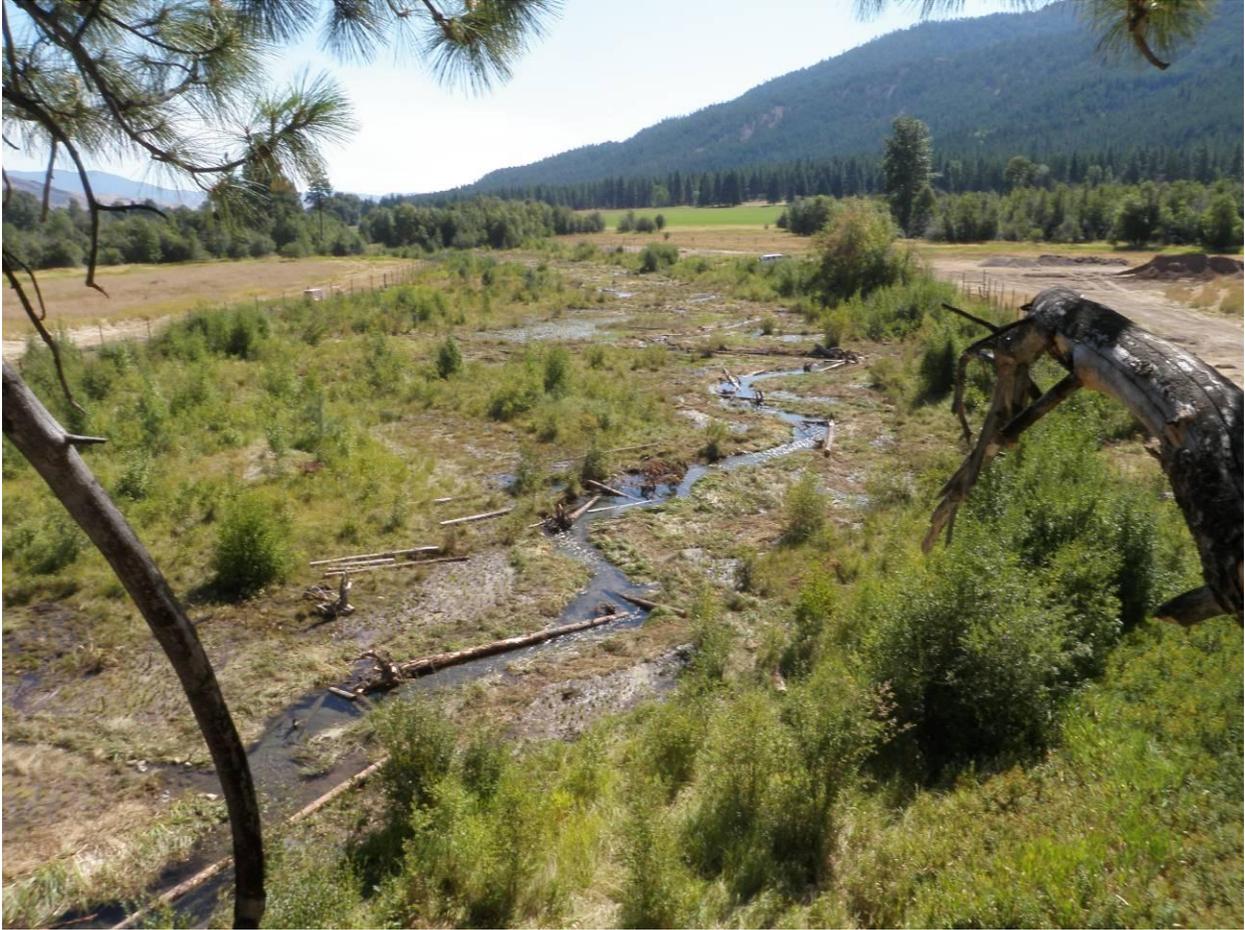
**Photo 4: (September 2011) Looking downstream following construction,. Note constructed pools and riffles within previous channel prism. Also note placement of native wetland sod, large woody debris, and containerized plants.**

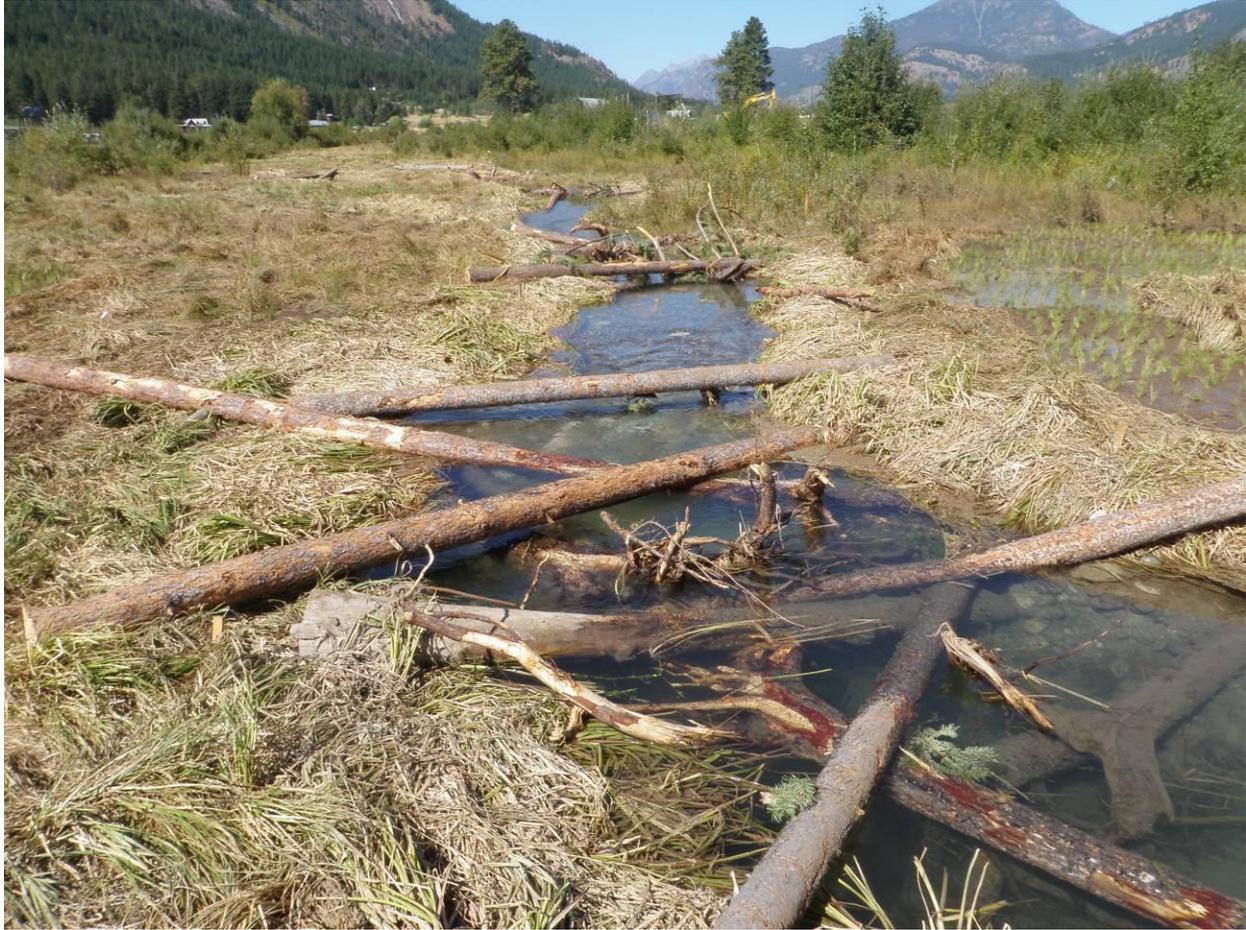
**Photo 14: Restored pool habitat following construction. Note abundance of wood placed below water surface. Chinook salmon were seen using this pool within 24 hours following construction.**

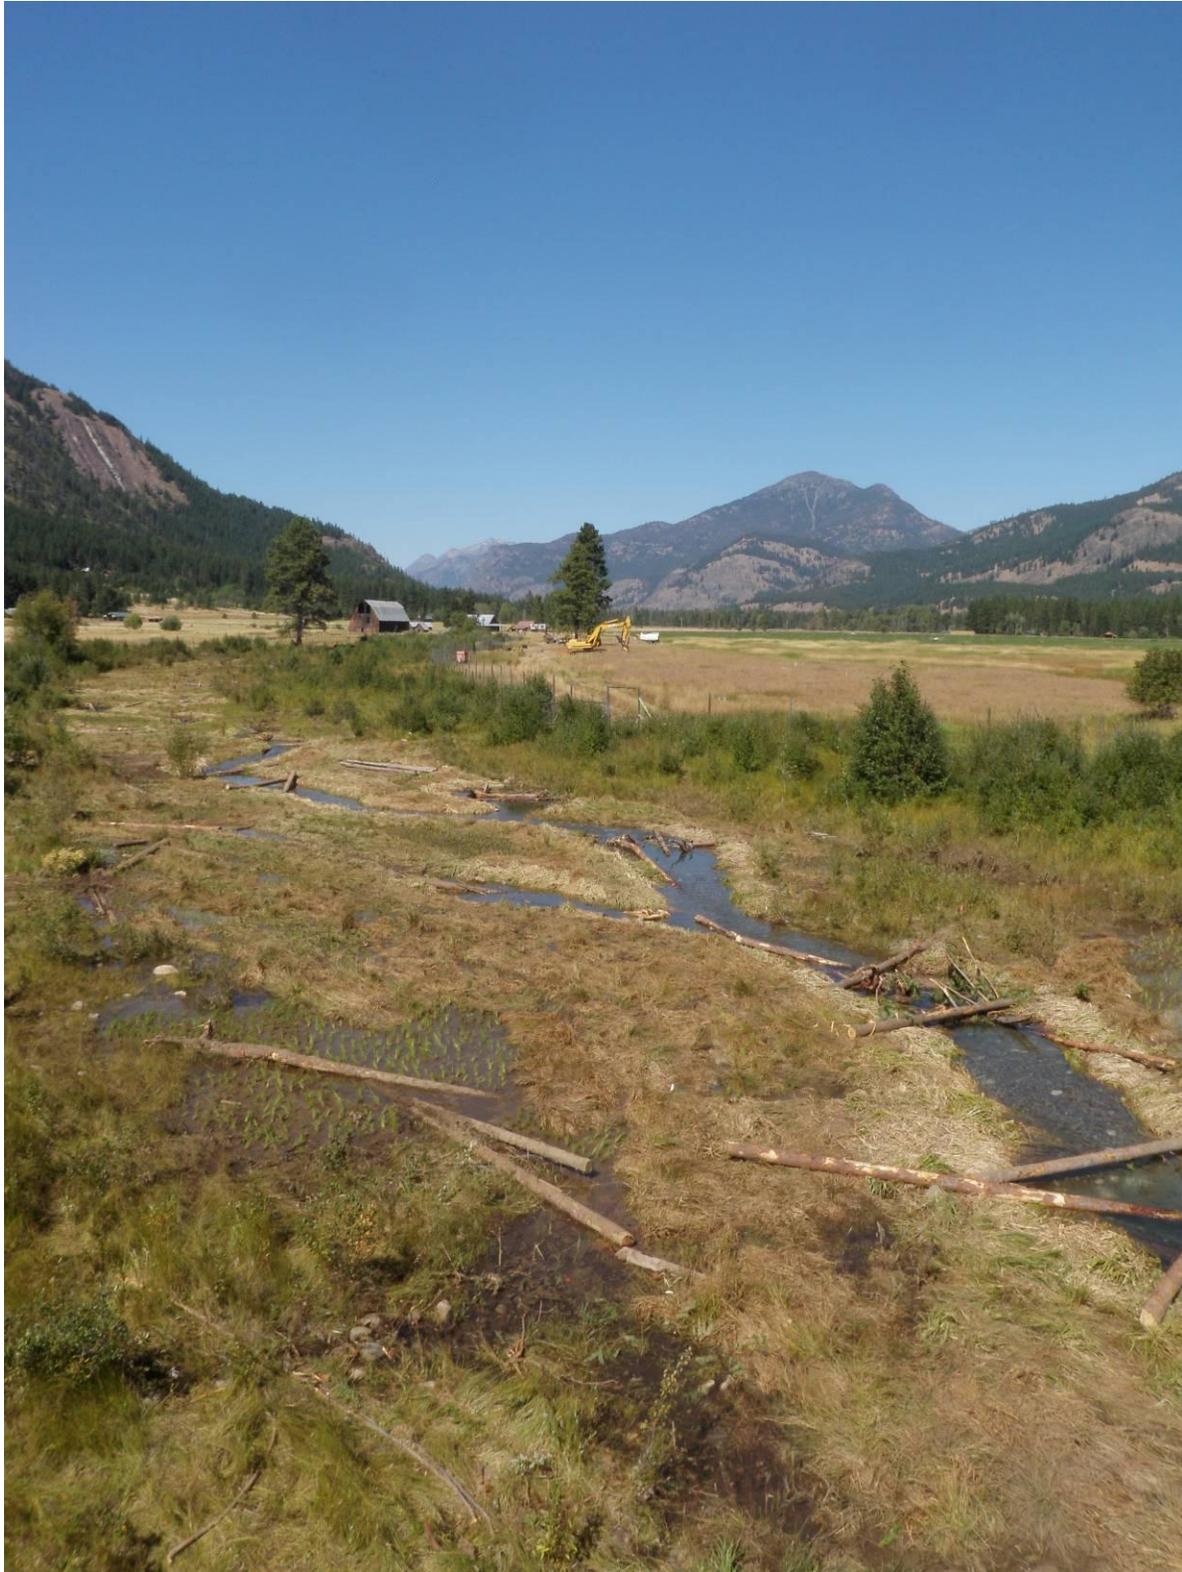
**Photo 15: Looking at middle reach of reconstructed channel. Note all new wetland sod, plugs, and narrow pool- riffle channel with backwater habitats.**
