Lower Peshastin Creek

Tributary and Reach Assessment

Wenatchee Subbasin, Chelan County, WA

June 2010

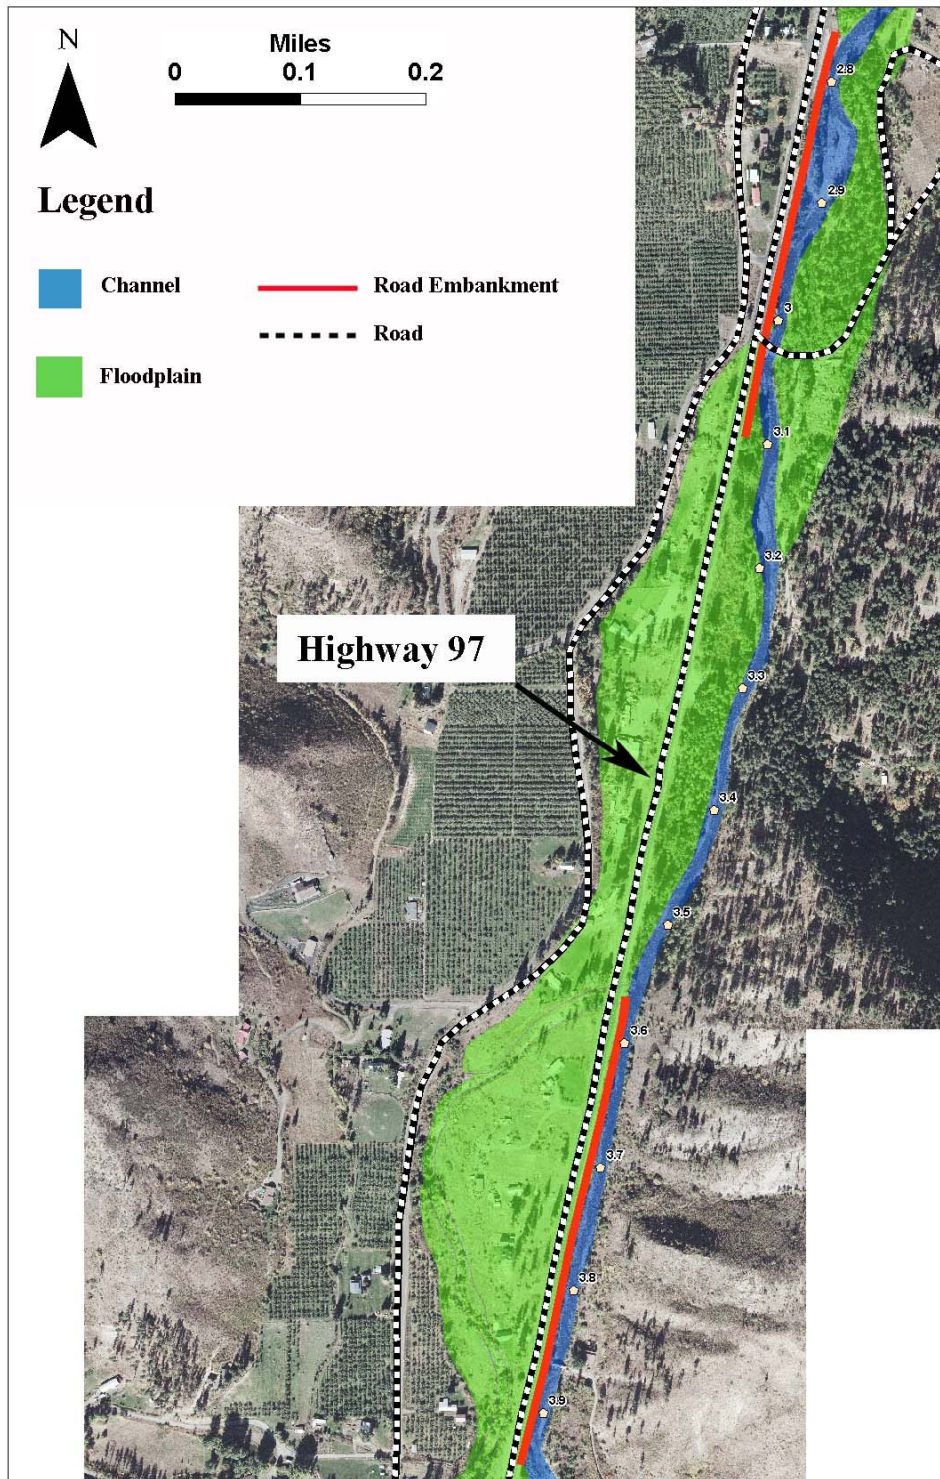
the study area. Between river miles 1.4 and 5.0, the roadway is directly adjacent to the channel for over 30% of the total channel length, and much of this segment has been hardened with rip-rap (Figure 2). Similar conditions exist where the roadway directly abuts the channel between RM 8.4 and 9.2.

Figure 2. Aerial photo depicting channelization and floodplain disconnection due to Highway 97 between RM 2 and 3.

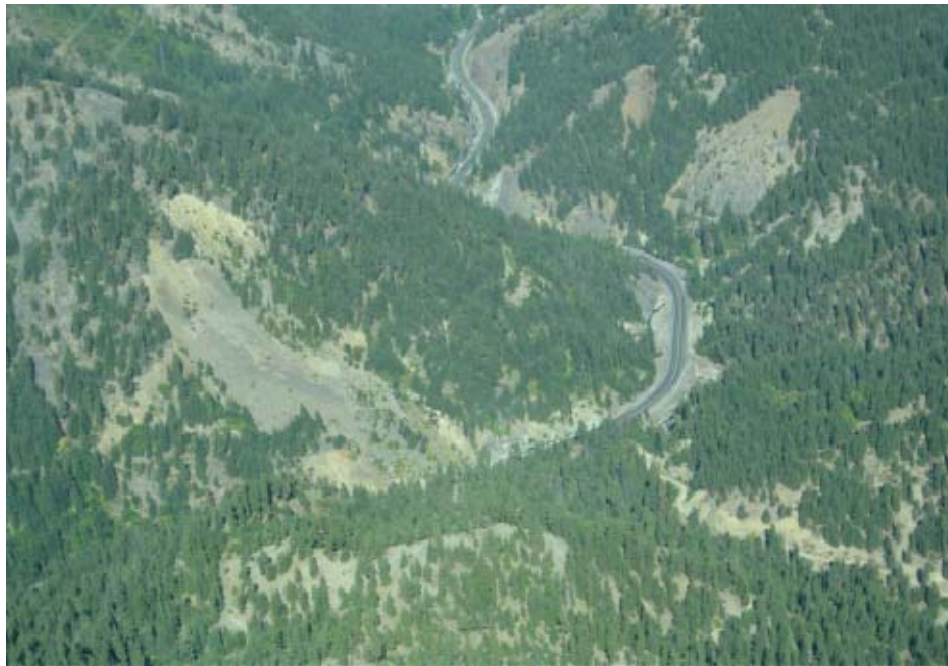
Sediment sources are provided by bed and bank material, tributary inputs, and hillslope inputs. Hillslope and tributary inputs are derived chiefly from sedimentary rocks within the Swauk or Chumstick Formations. The Chumstick Formation is the dominant formation, and has the potential for large mass wasting events caused by down slope trending bed plane failures within shale units (USFS 1999). The Chumstick Formation would be expected to provide fine-grain sediment out of sandstone and shale units, and some gravels out of conglomerates (Piety 2009). Much of the Ingalls Creek basin is granodiorite or quartz diorite, which provide larger and more durable channel substrate. At the stream valley scale within and upstream of the study area, sediment sources include bedrock (sedimentary), tributary deposits, and glacial deposits, providing a wide-range of material to the channel. Two significant sediment sources are the Larsen Creek drainage (junction near river mile 4.0) which saw a large fire and subsequent flooding in 1994, and the Ruby Creek slide (near river mile 10.4) which provided substantial fine sediment to the channel during the 1996 flood (Andonegui 2001) (Figure 7).

Figure 7. Low elevation aerial photo looking toward the northwest approximately 2.2 river miles upstream of the study area. The obvious slope instability on the left side of the photo is the Ruby Creek Slide.

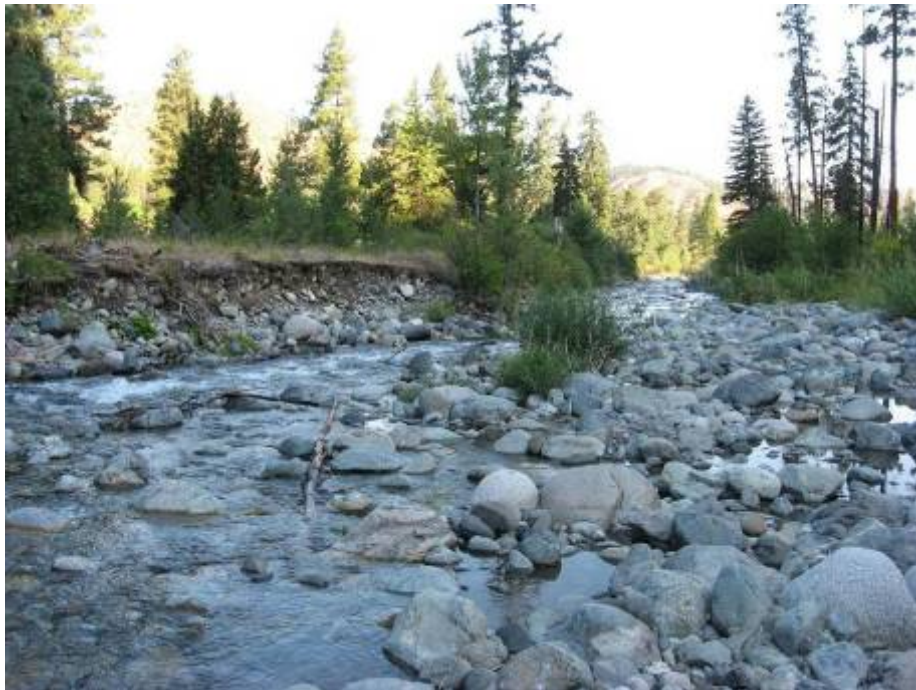
Figure 8. Illustration of typical coarse bed and bank material along the study reach. River mile 4.5.

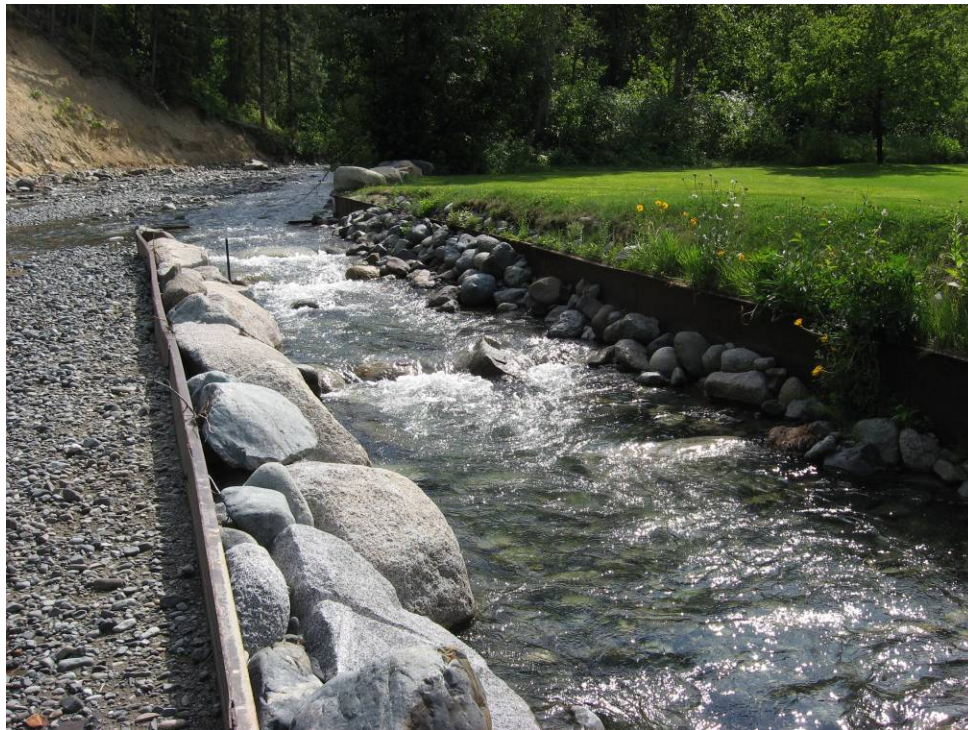
Figure 46. Fish passage channel at diversion dam at river mile 2.5. (August 2009)

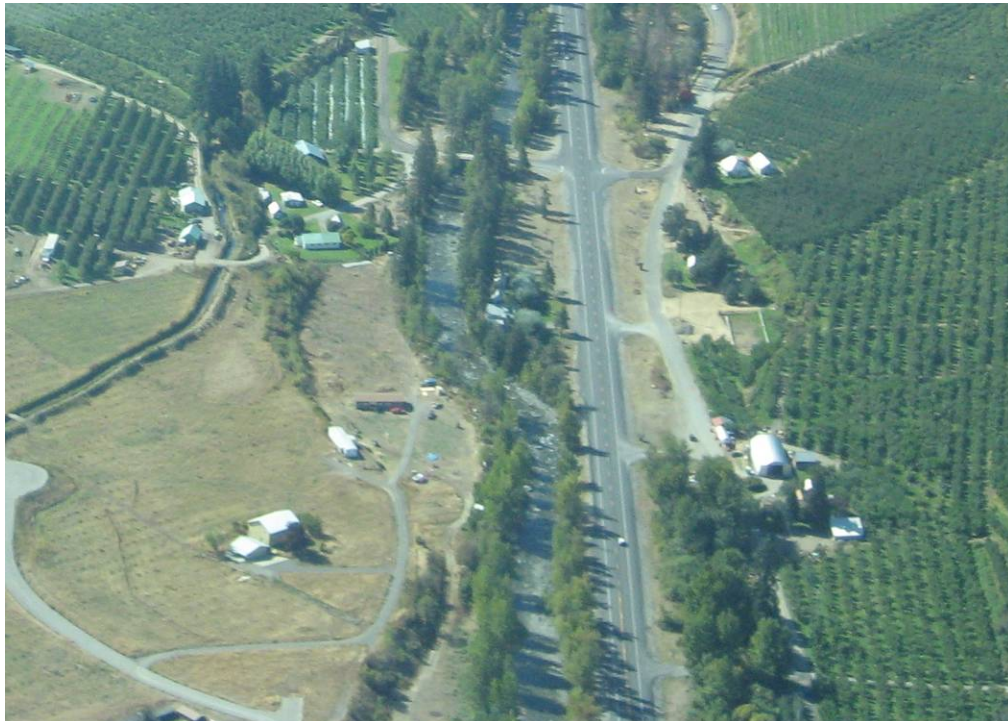
Figure 49. Narrow riparian corridor influenced by the Highway 97, agriculture, and residential development near river mile 1.7. (August 2009)

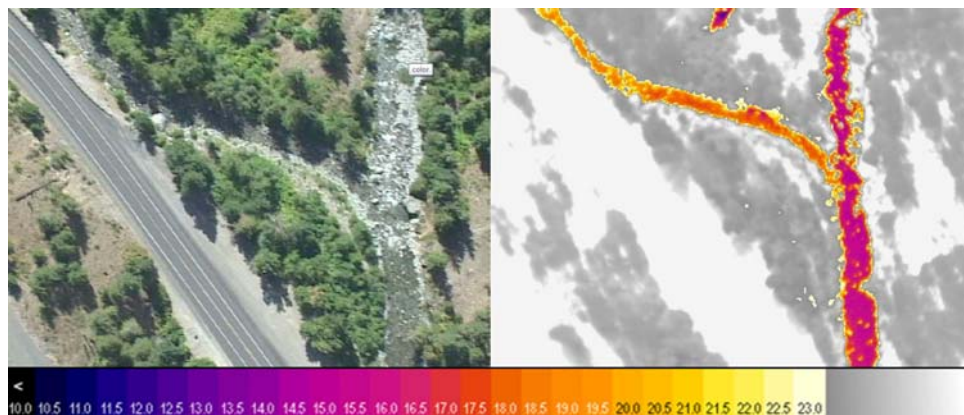
Figure 53. Thermal (TIR) image of Peshastin Creek at the Ingalls Creek confluence. The temperature scale at the bottom is in degrees Celsius. Streamflow is from top to bottom of images. Ingalls Creek enters at the top right and upper Peshastin is at left. Ingalls Creek is an important contributor of cool water to Peshastin Creek, and its impact carries downstream for a few miles.

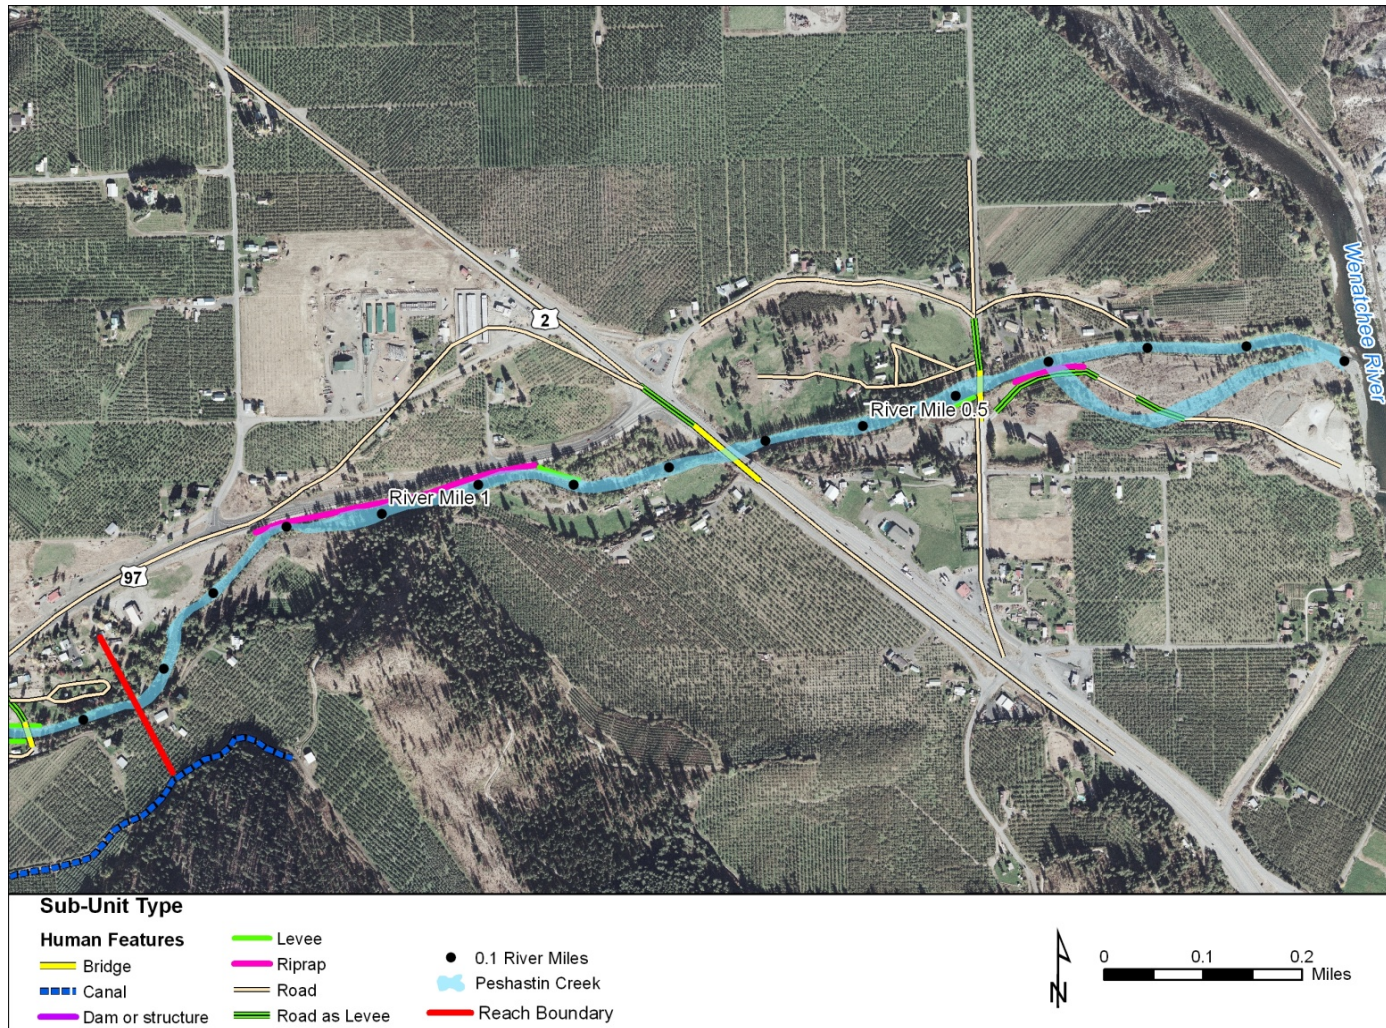
Figure 58. Aerial photo showing human features in Reach 1. Flow is from left to right. Processes are hindered by roadway encroachment, bank hardening, bridge crossings, and floodplain development. The road lines reflect the current alignment of Highway 97, though the photo represents the area before reconfiguration of the highway interchange.

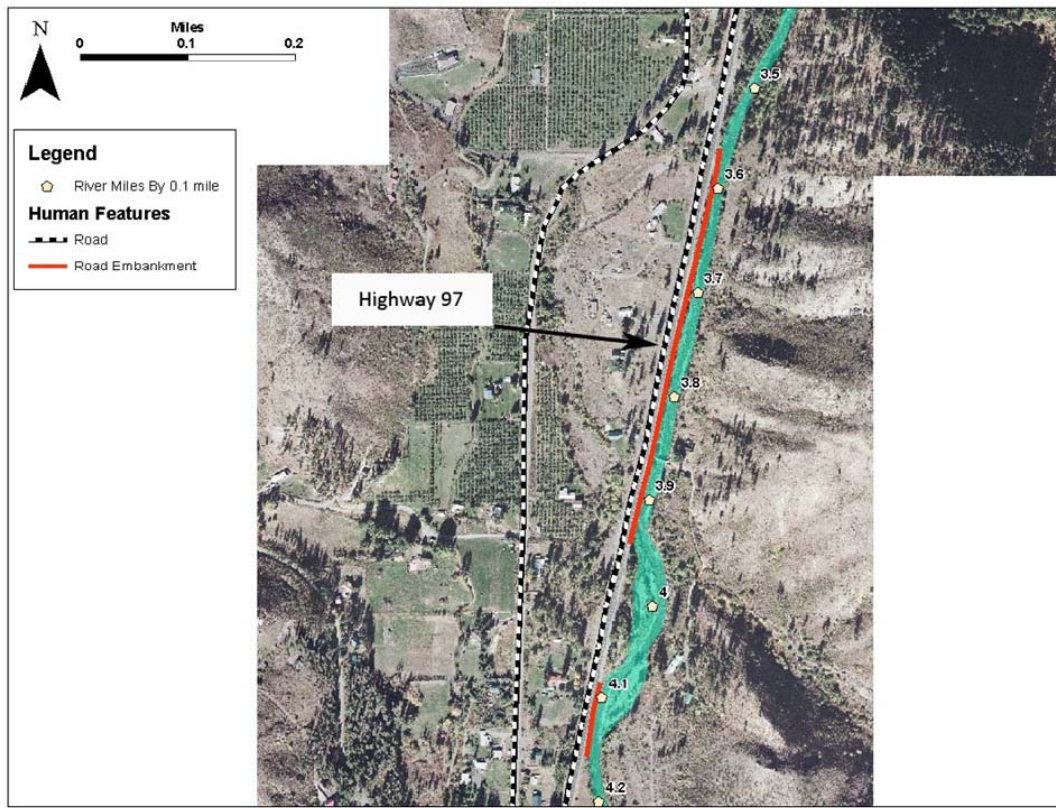
Figure 62. Aerial photo depicting the impact of Highway 97 on channel and floodplain processes for a 0.8 mile portion of Reach 2. Flow is from south to north.

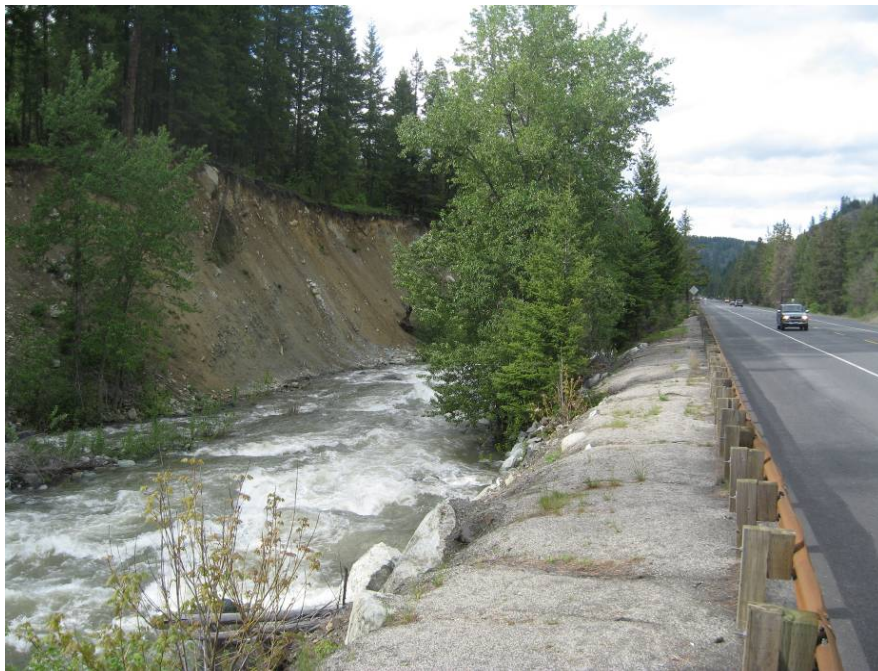
Figure 86. View downstream just downstream of the Ingalls Cr confluence. Hwy 97 directly abuts the channel and contributes to erosion of the high glacial terrace on the opposite bank (May 2010 Photo).
