# Reversing Channel Incision and Enhancing Steelhead Habitat in Tepee Cr

Will Conley, Hydrologist  
Yakama Nation Fisheries Program

Salmon Habitat Project Conference  
Shelton, WA April 15, 2009

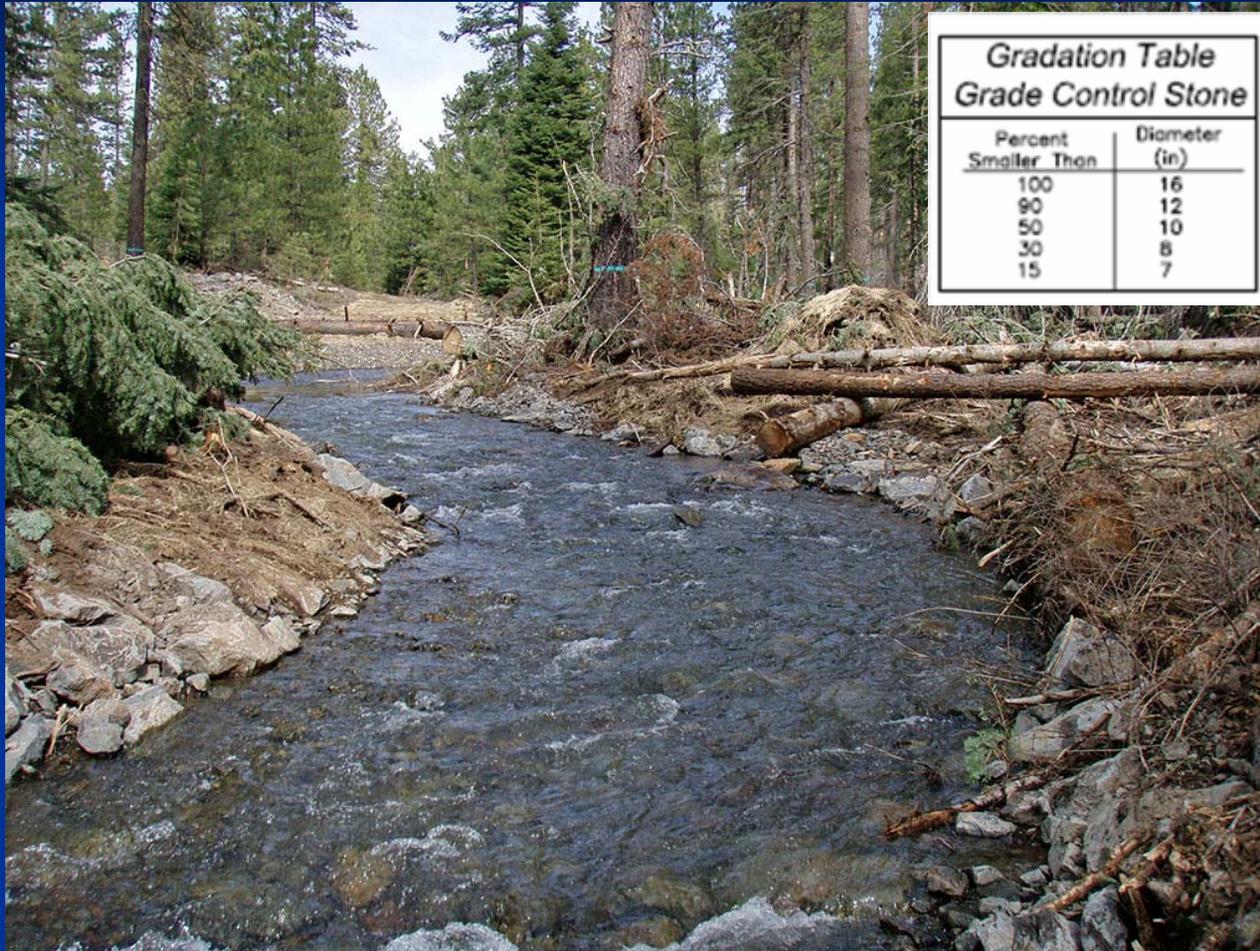
# Downstream Grade Control

140' roughened channel subreach (0.03 ft/ft) to transition to untreated downstream reach

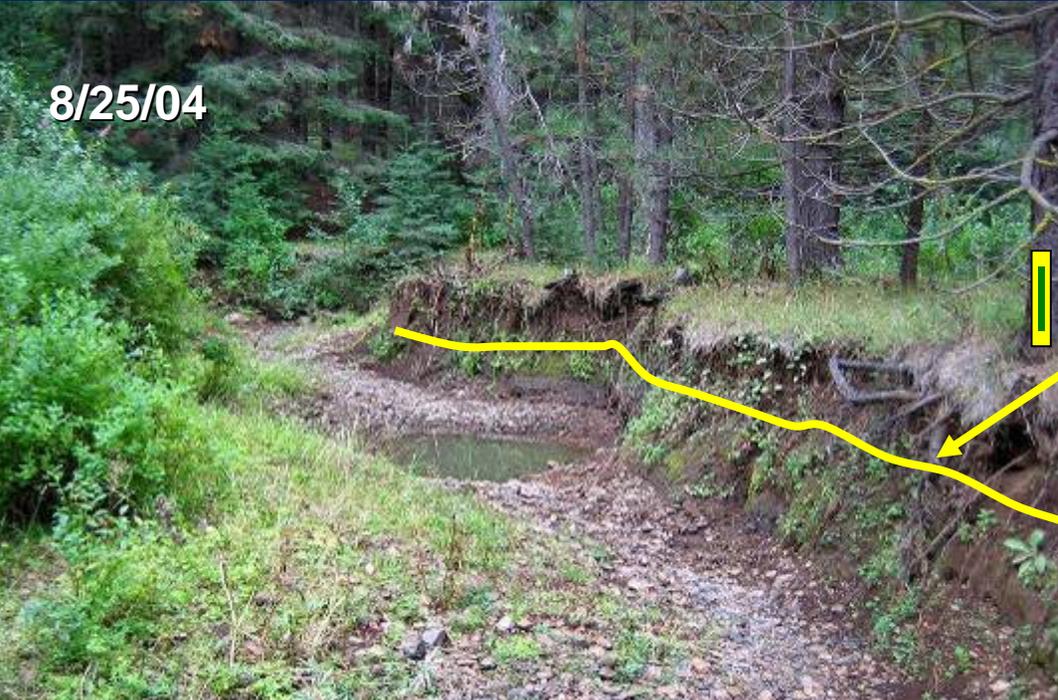
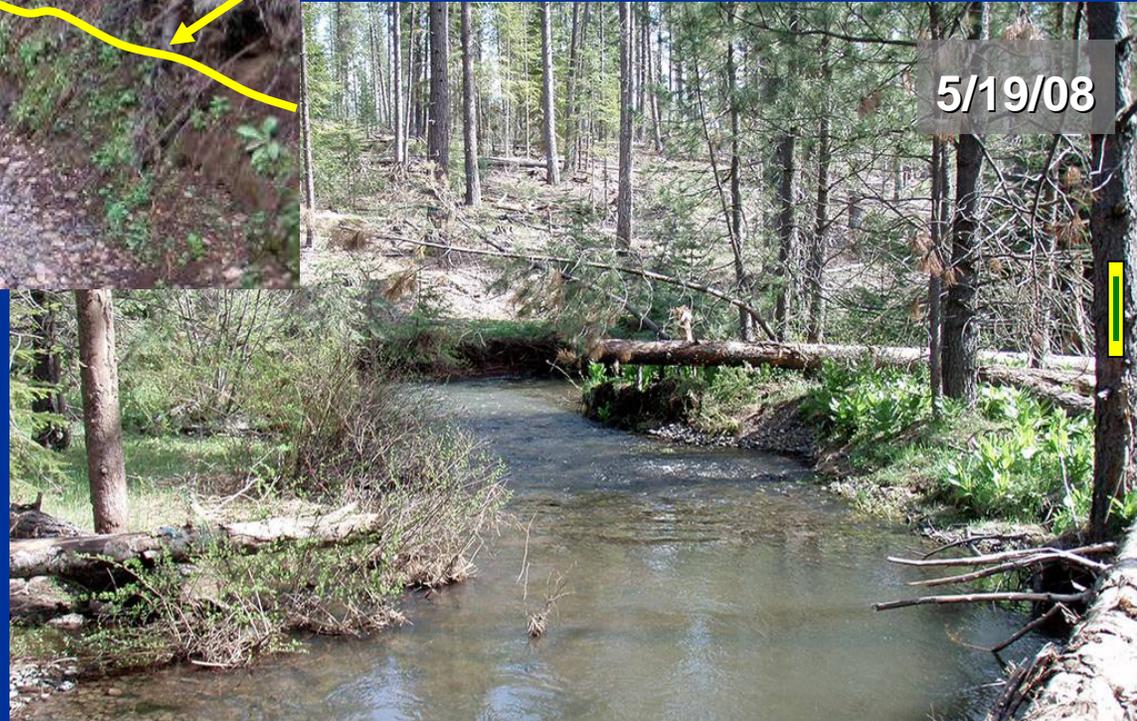
STA 6+35

Elevation of constructed  
bank toe / channel invert

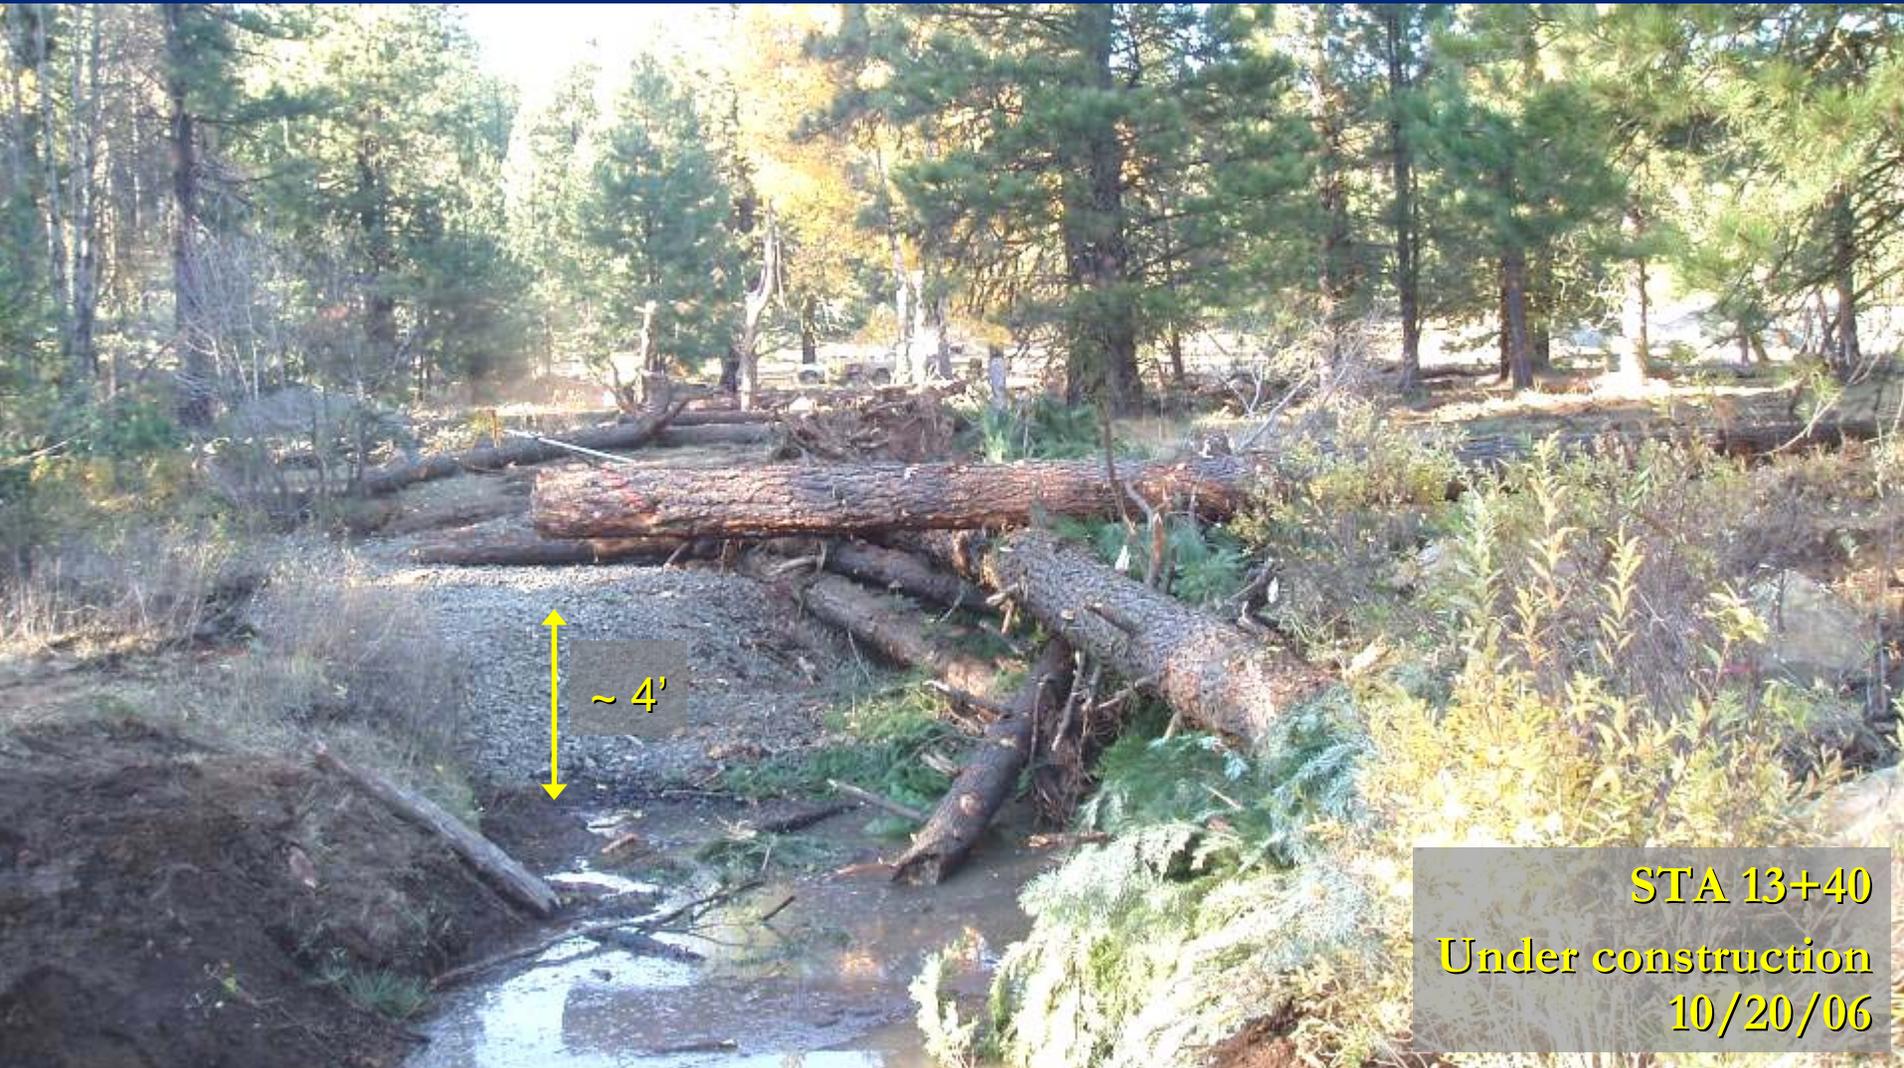
STA 13+40  
Under construction  
10/20/06

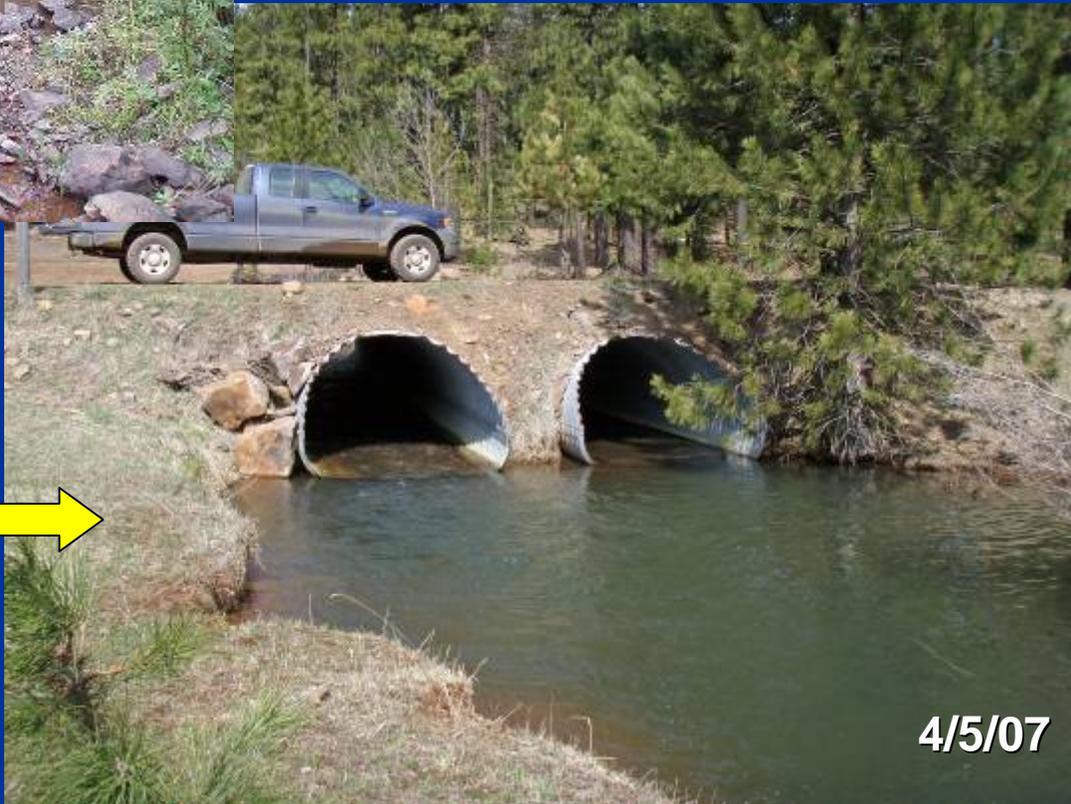
## STA 20+90

(IXL Road Crossing – upstream end of project reach)

Culvert outlets backwatered to improve fish passage

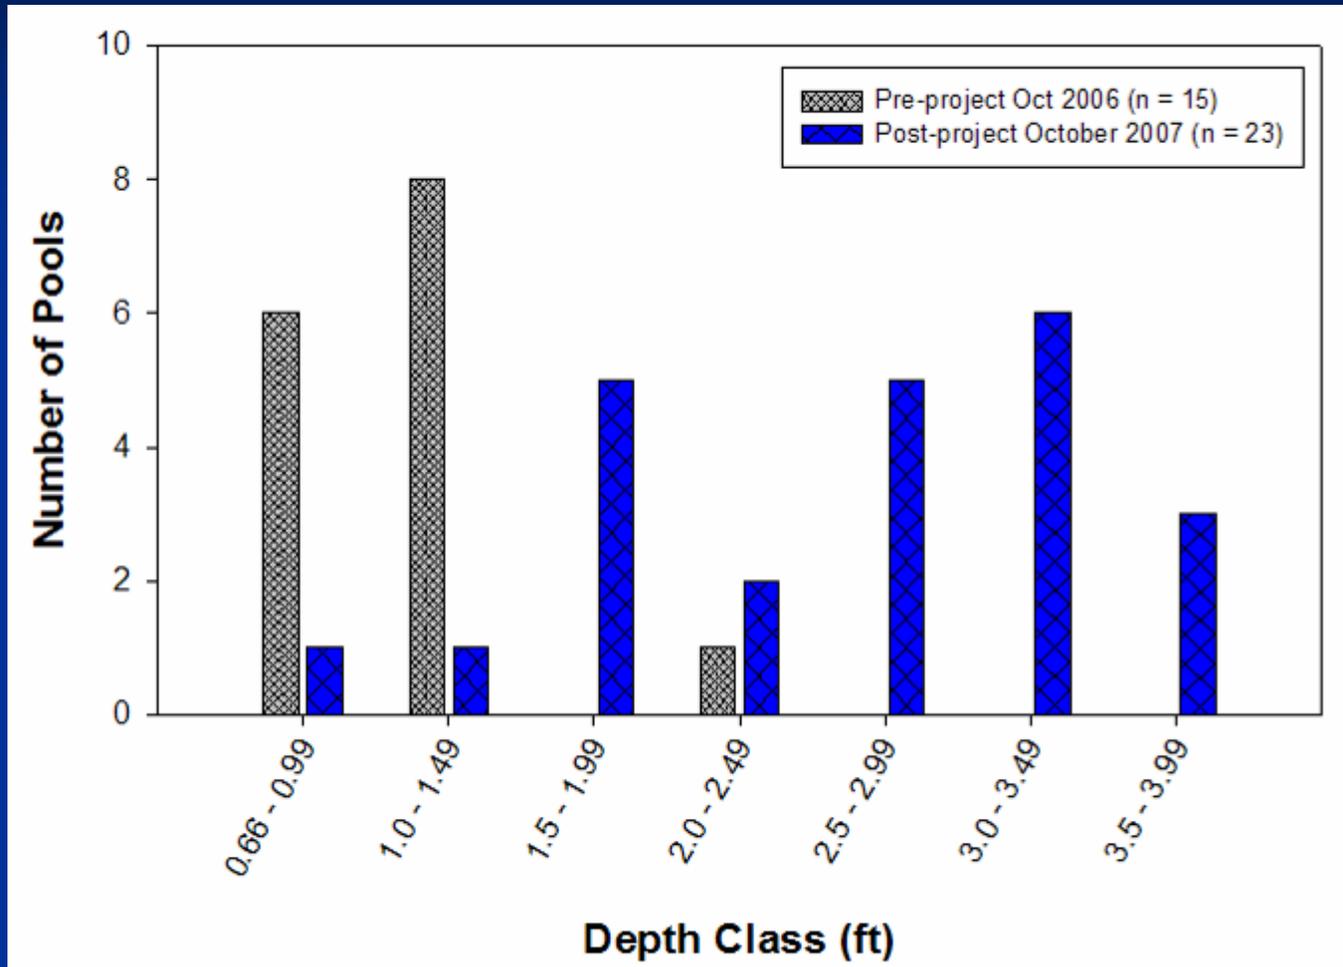
Note: because some pools were under-filled during construction, the median value for residual depths under equilibrium conditions is anticipated to be 2.0' - 2.49'

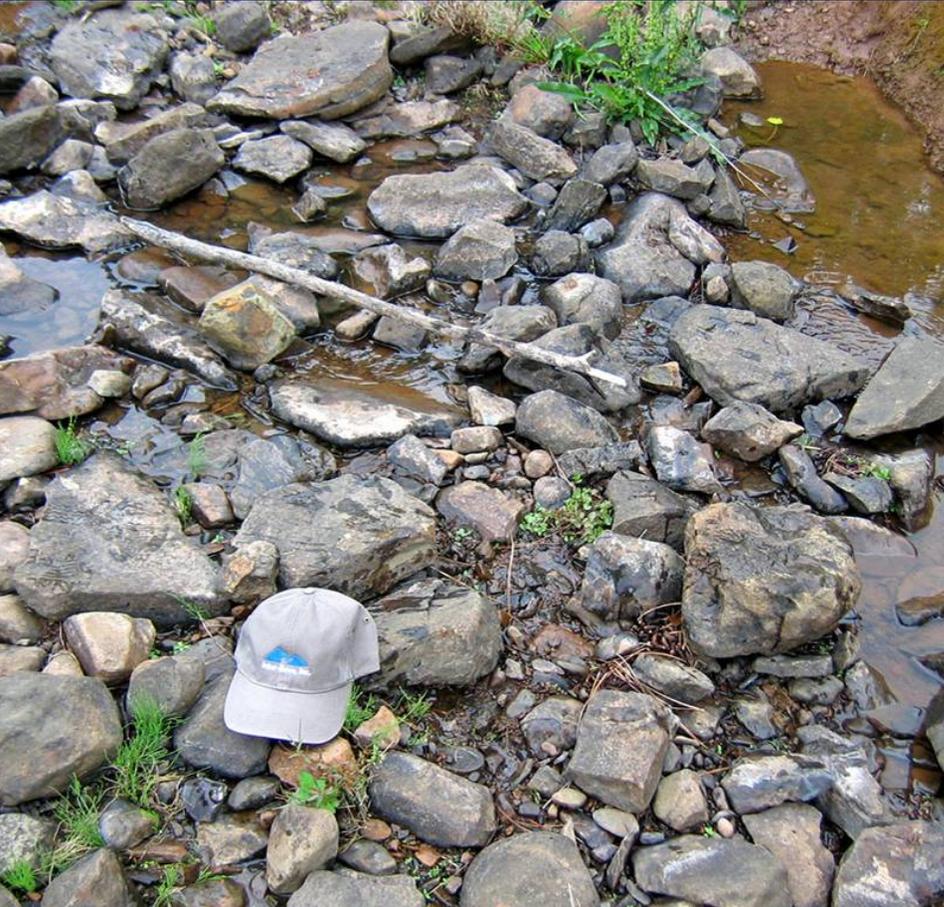
colluvial armor; clasts  $>40\text{mm}$   
mostly sub-angular

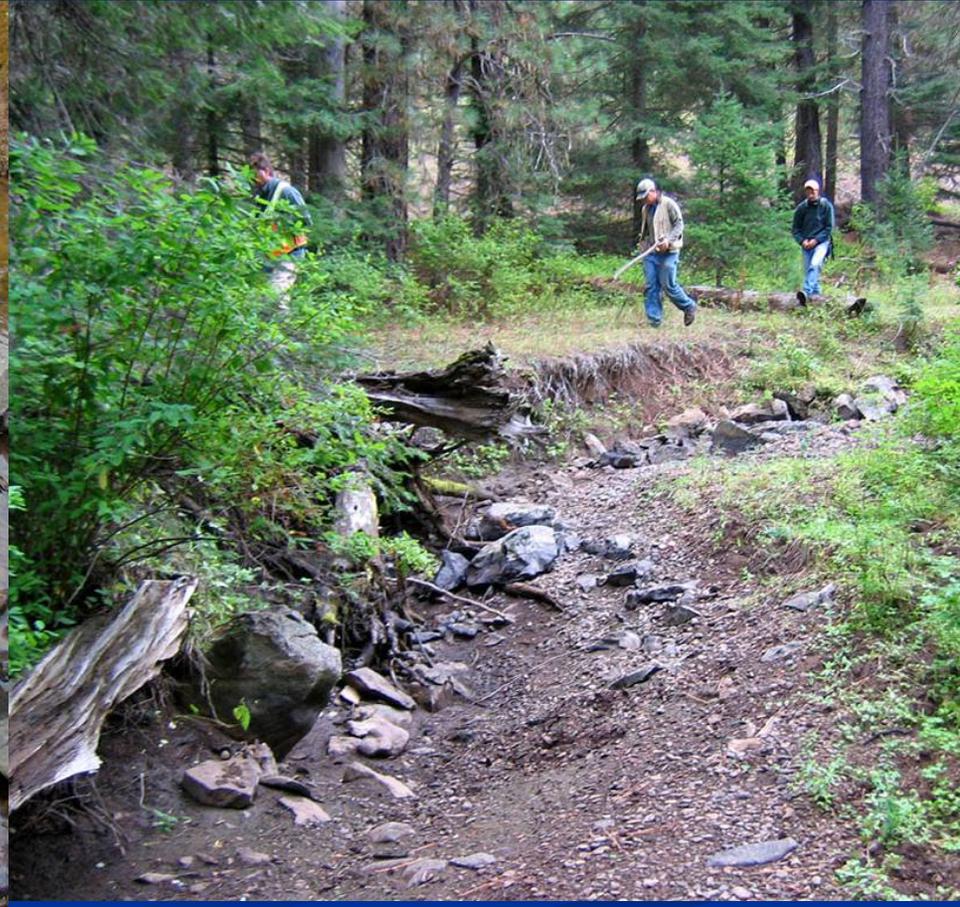
bi-modal distribution;  
very high fines content

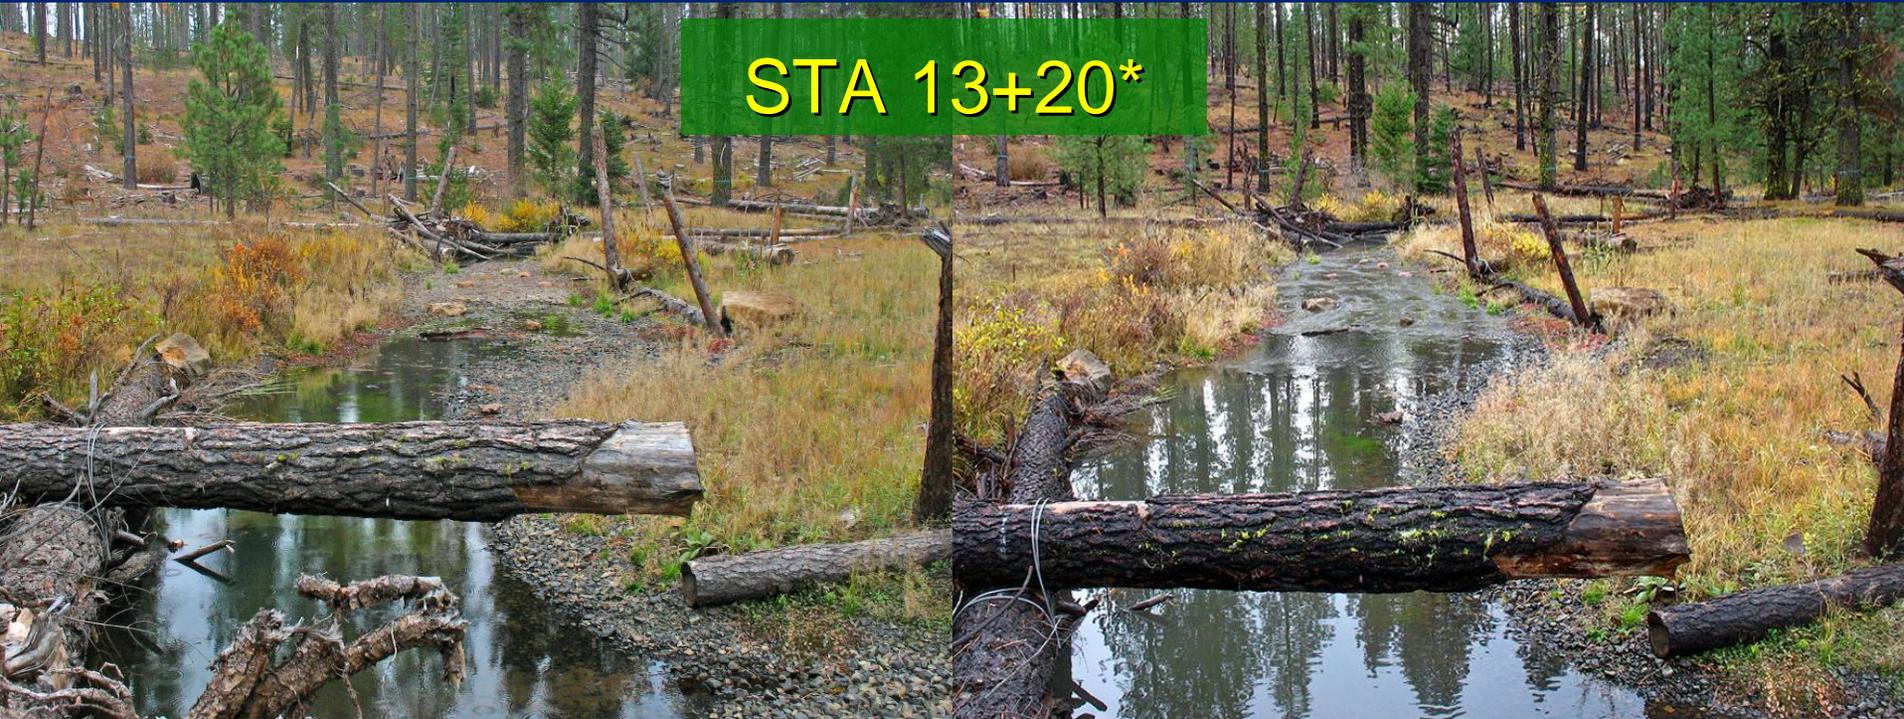
STA 13+20\*

Threshold for wetting

Surface flow at control

~ 0.56 cfs\*\*

Top-to-bottom surface flow

~ 1.90 cfs\*\*

\* STA 13+20 is one of four controls that has a “plug” of native soil in the subgrade

\*\* adult passage and spawning throughout project is comparable to untreated reaches  
(median spawning flow = 12.6 cfs)

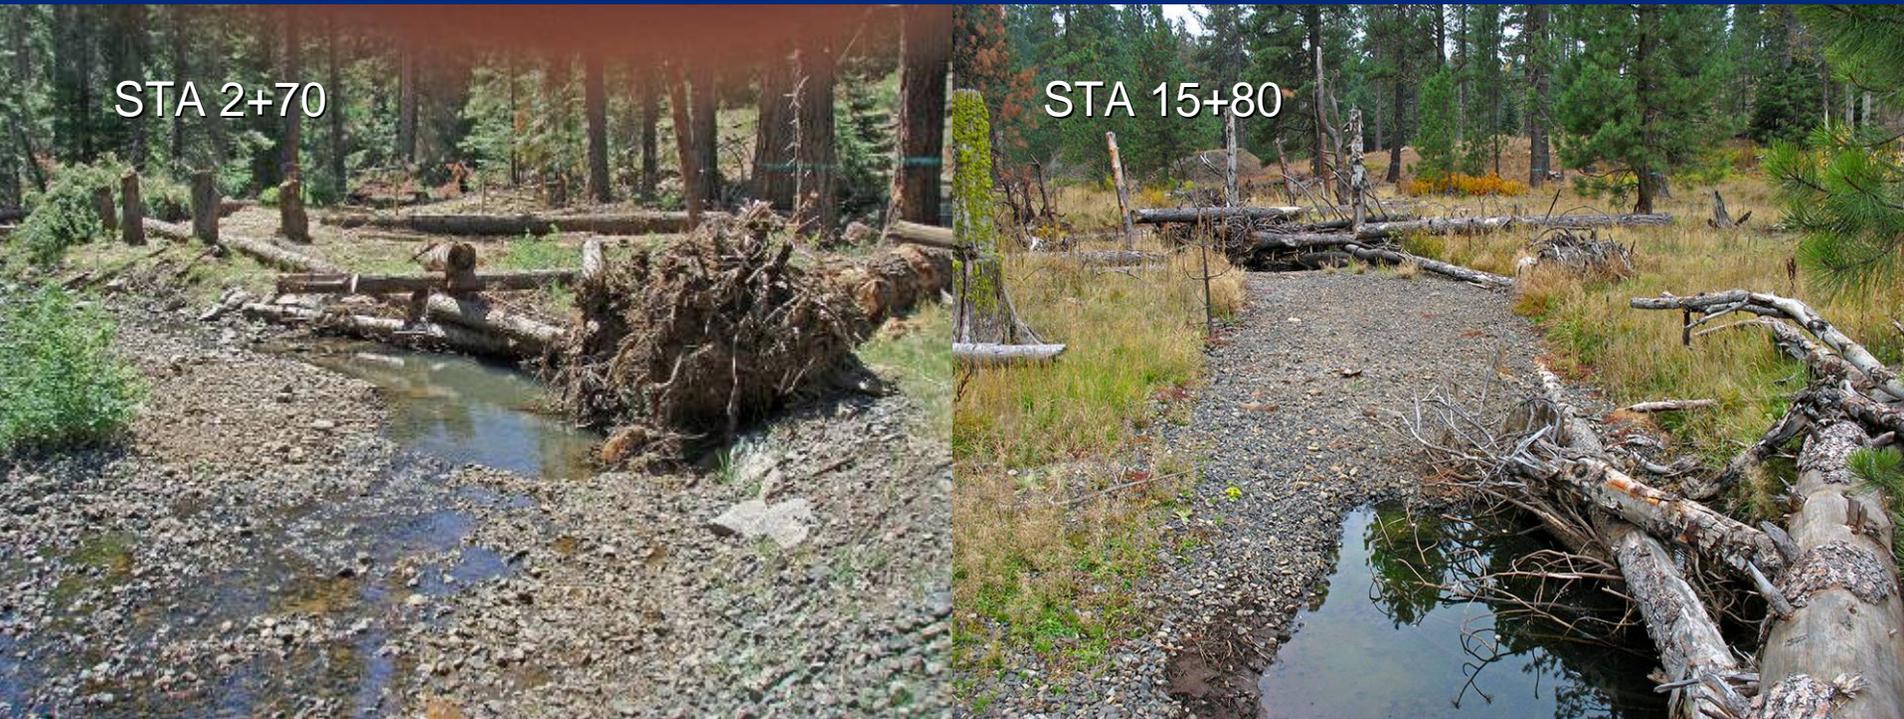
$Q < 0.5$  cfs

- No subgrade “plug” in either control
- Both stations have comparable cross-sectional fill areas
- STA 2+70 constructed under wetter ambient conditions than 15+80 (i.e. more intrusion of native fines into fill during construction)

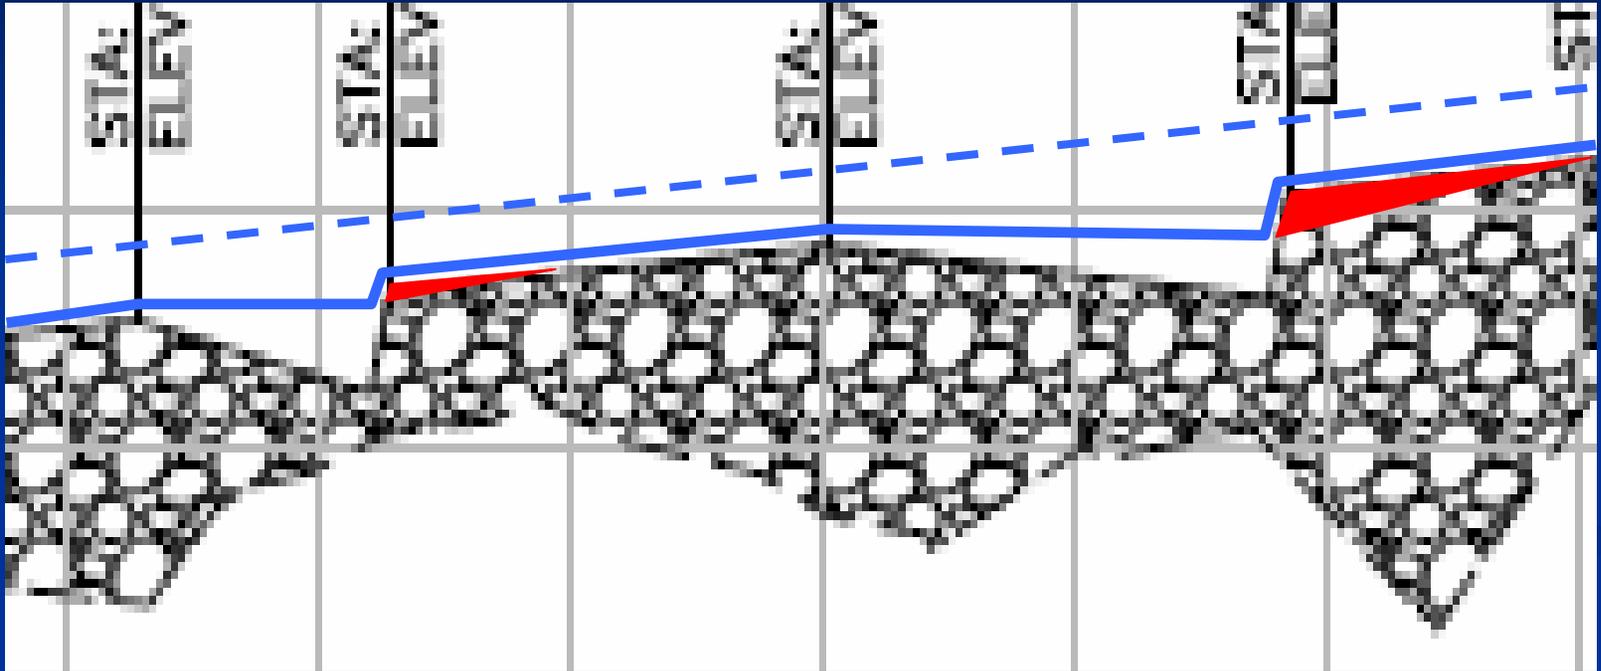
- Medium to high flows: OK because energy line and bed slope are more or less parallel
- Low flows: energy line is stepped which (in the absence of further treatment) causes headcutting of riffle toes

- Extend riffle downstream into pool  
and / or
- Transition slope into head of pool  
and / or
- Harden / armor riffle toe
  - coarsen bed material
  - add a log drop (only done in one place)

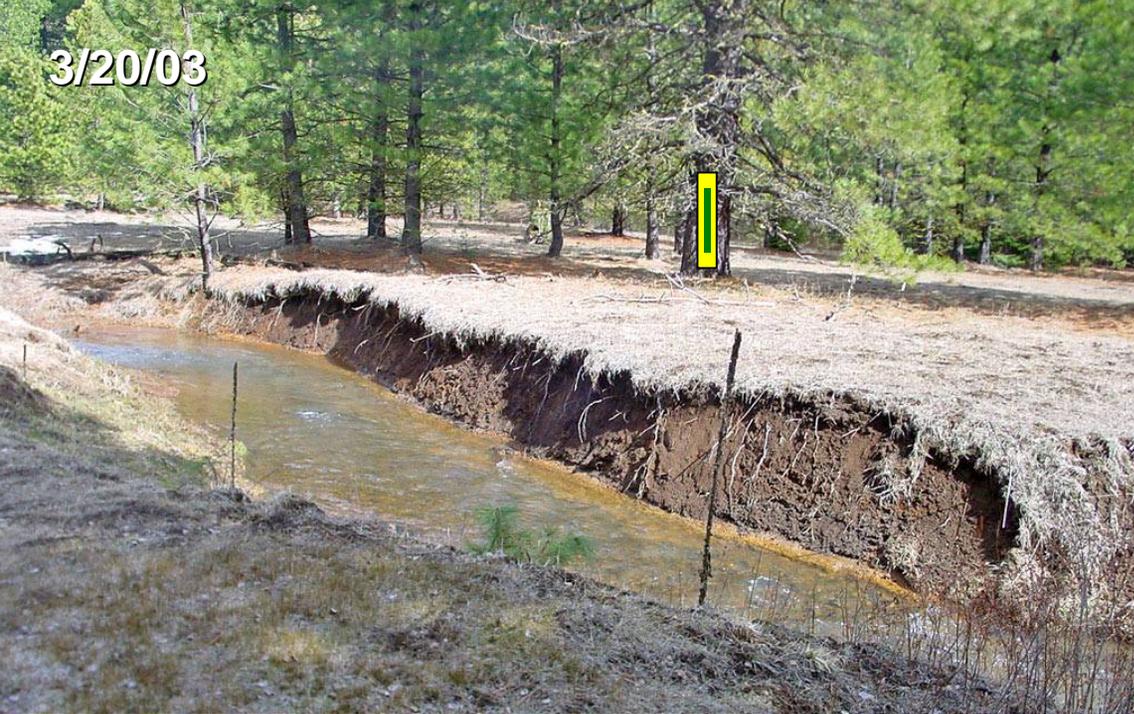
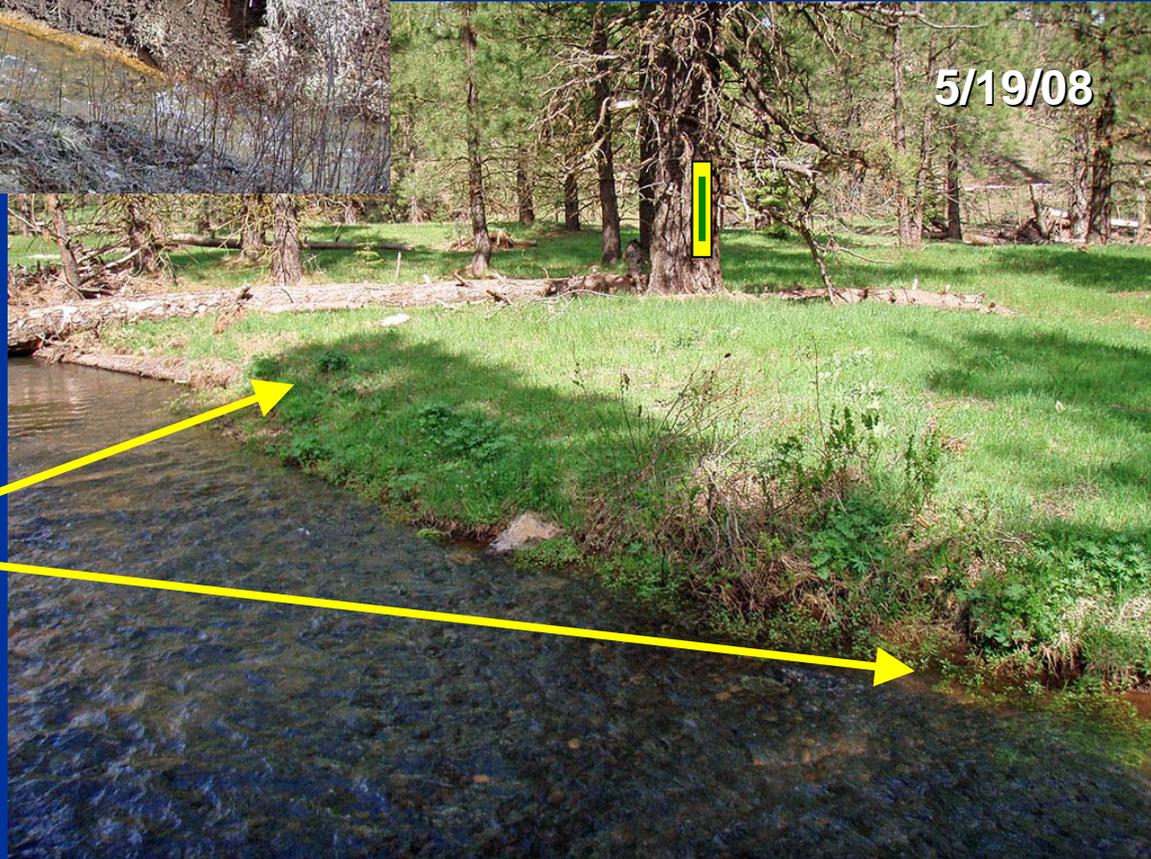
STA 14+80

Salvaged sod and shrubs used along bank

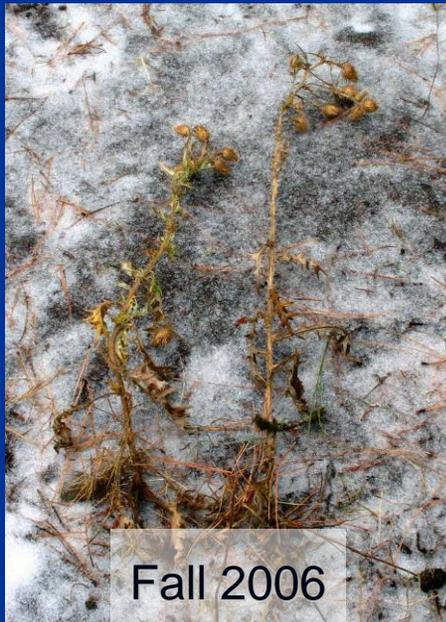
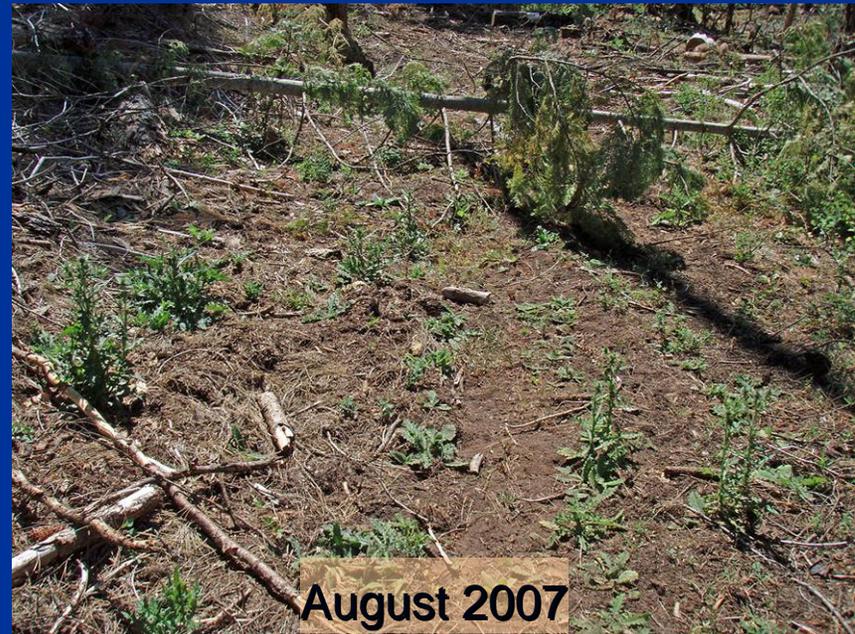
- Two bull thistle (*Cirsium vulgare*) individuals observed pre-project
- Thousands of bull thistle rosettes and scores of stalks in first growing season

- Intensive manual pulling in first season (August 2007)
- Virtually no subsequent control required
