# LOWER LIBBY CREEK REACH ASSESSMENT

Prepared for **YAKAMA NATION FISHERIES** | PO BOX 15, FORT ROAD | TOPPENISH, WA 98948

Prepared by  
**INTER-FLUVE, INC.**  
1020 WASCO STREET, SUITE I | HOOD RIVER, OR 97031  
541.386.9003 | [www.interfluve.com](http://www.interfluve.com)

July 2012

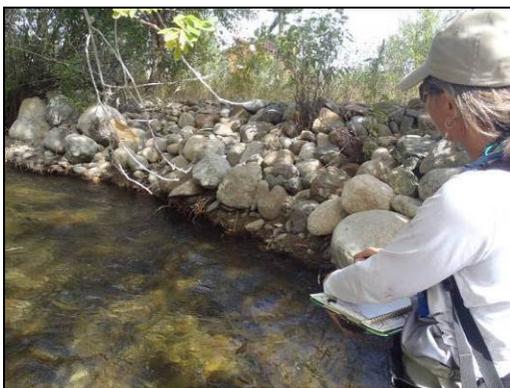
There are multiple instream alterations present throughout Reach 1. Two of the most significant alterations within Reach 1 are a 42-ft long riprap wall that has been installed along the river left bank at RM 0.11 (Figure 6) and the Highway 153 bridge (Figure 7).

**Figure 6. Riprap wall near RM 0.11. The top elevation is approximately 5.5 ft above OWH.**

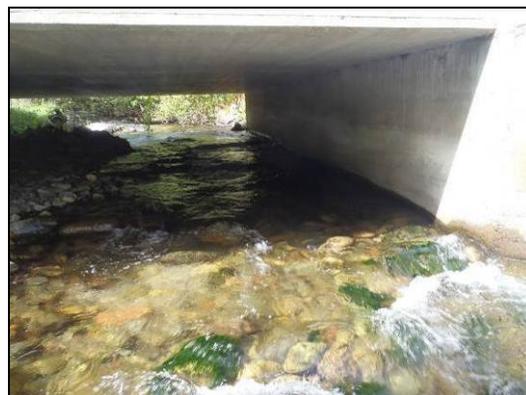
**Figure 7. Highway 153 bridge facing upstream.**

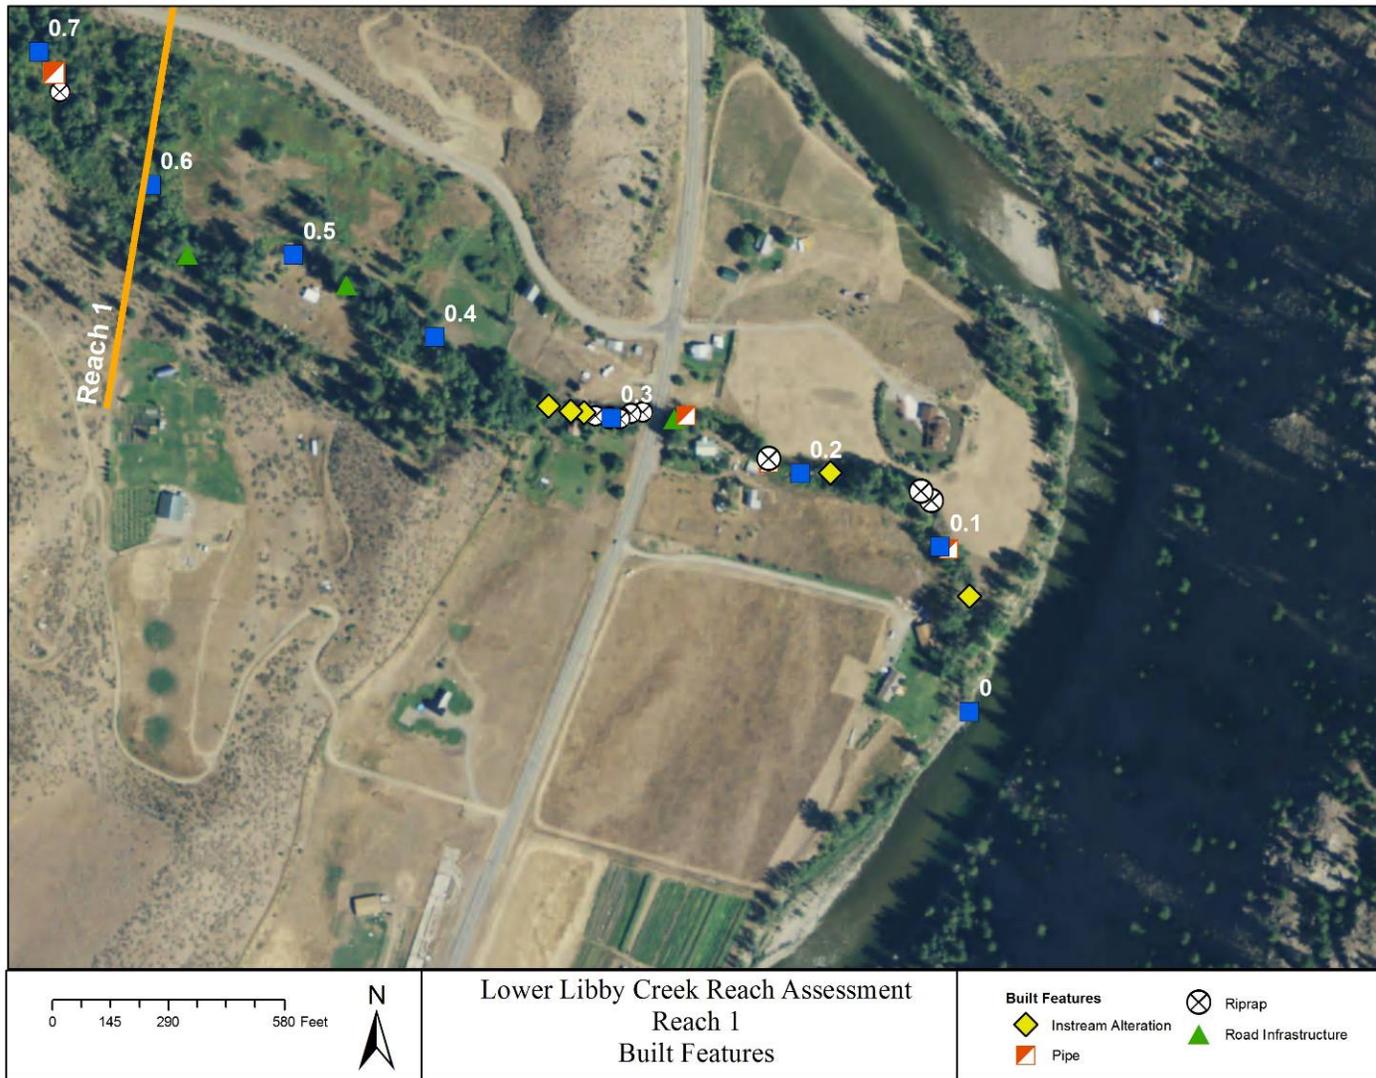
Figure 8. Human alterations in Reach 1.

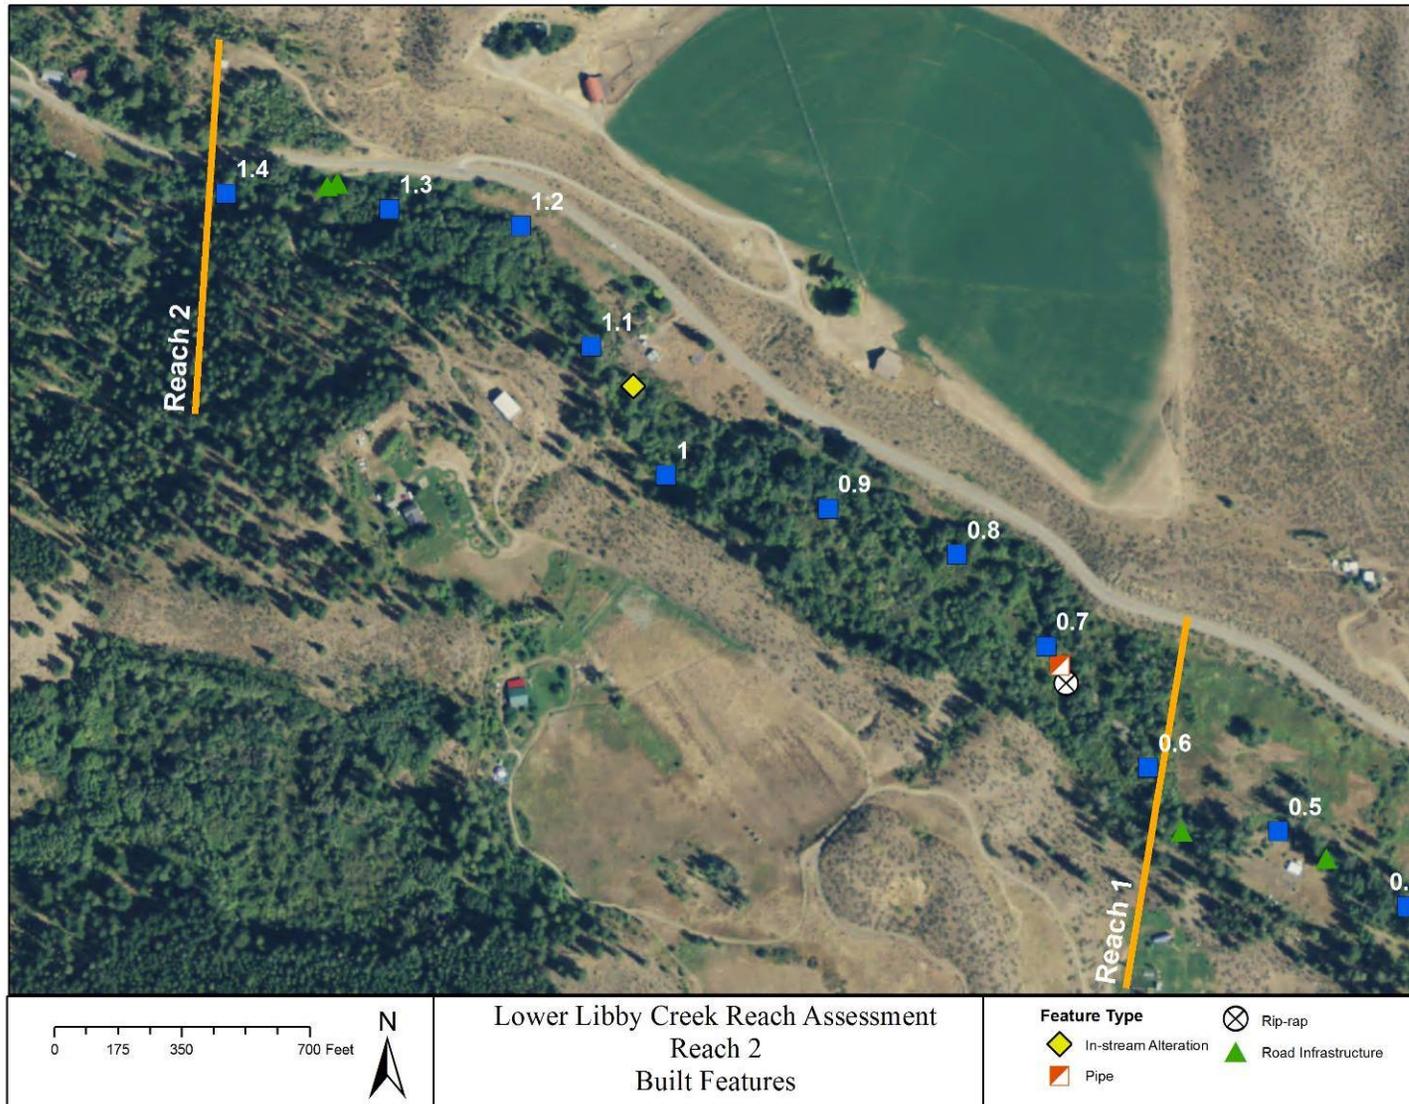
At the downstream end of the reach, Libby Creek has been channelized and confined through riprap bank protection. This has accelerated incision throughout this portion of the channel. Humans have further modified the channel bed by constructing step-pools and digging out of areas of the channel bed. At the upstream end of the reach, riprap and bridge abutments confine the channel and there is evidence of channel incision. A private road continues from Libby Creek Road, over the bridge, and then along the right bank. The road fill confines the channel by limiting lateral migration.

Figure 14. Aerial photo showing human features in Reach 2.
