Lower Mad River Reach Assessment & Restoration Strategy Report

SUBMITTED TO
Yakama Nation Fisheries - Wenatchee

DECEMBER 2018

PREPARED BY
Inter-Fluve
501 Portway Ave, Suite 101
Hood River, OR 97031
(541) 386-9003

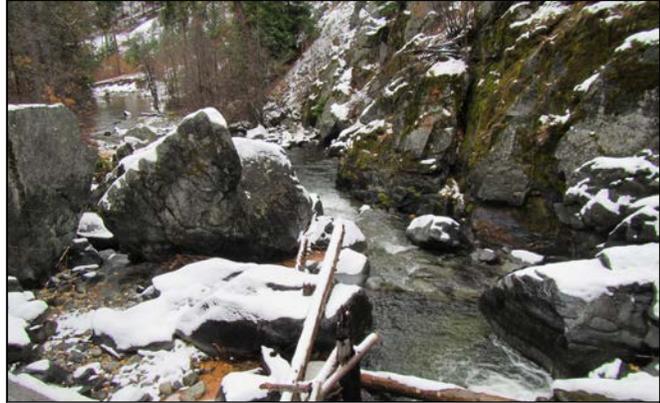
Immediately upstream of the assessment area (upstream of RM 4.3), channel gradient steepens and confinement increases. Here, bed load material smaller than gravels are readily flushed downstream or stored temporarily in small pools or pocket eddies found near large boulders or large wood jams. Bedload is a mix of cobble-boulder alluvium and colluvium contributed from the hillslopes and bedrock contacts (Figure 20).

Figure 20. Confined section immediately upstream of assessment area (RM 4.31). Photo: 11/10/2017

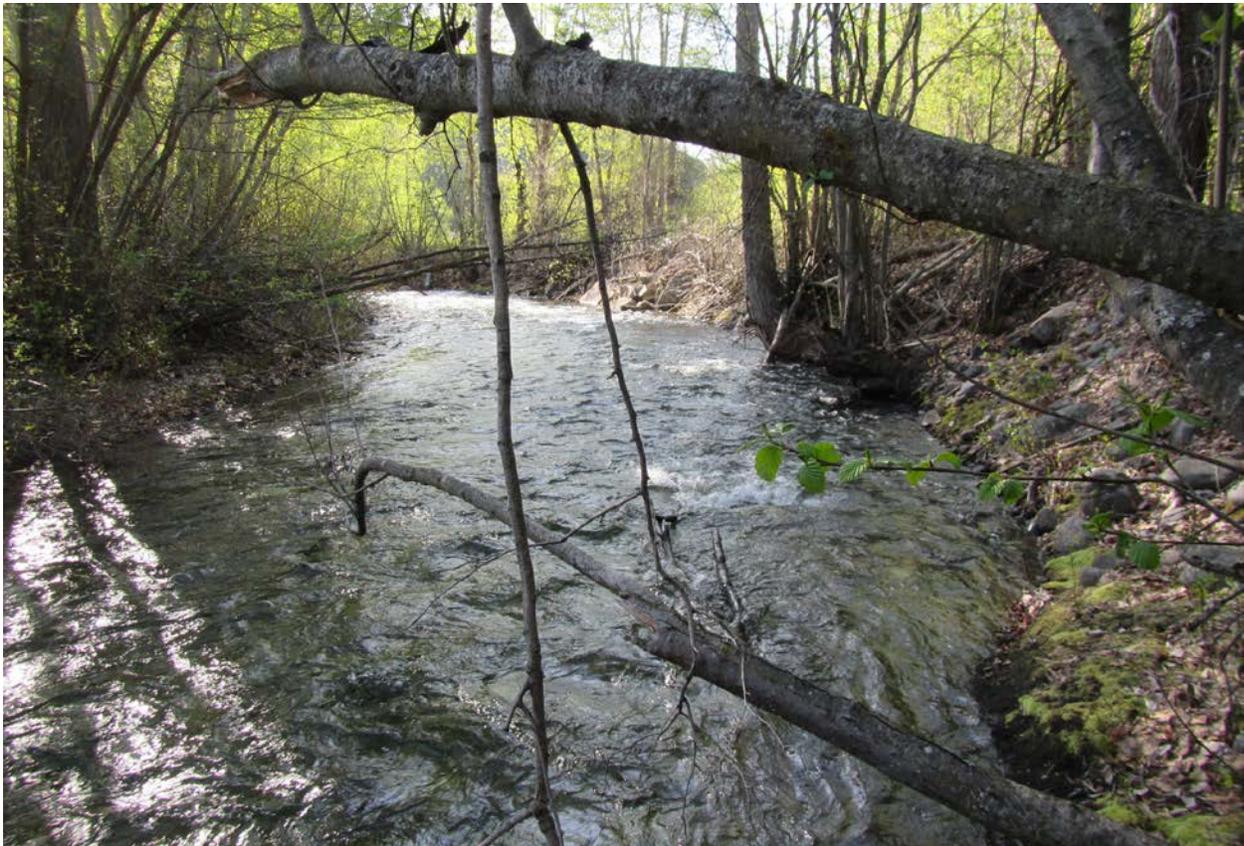
Figure 25. Looking downstream at RM 0.15. River right: outside meander, partially vegetated stabilized cobble-boulder bank topped with a levee; River left: vegetated floodplain pocket with small gravel-cobble point bar (partially inundated during spring flows). (Photo: 4/25/2017).

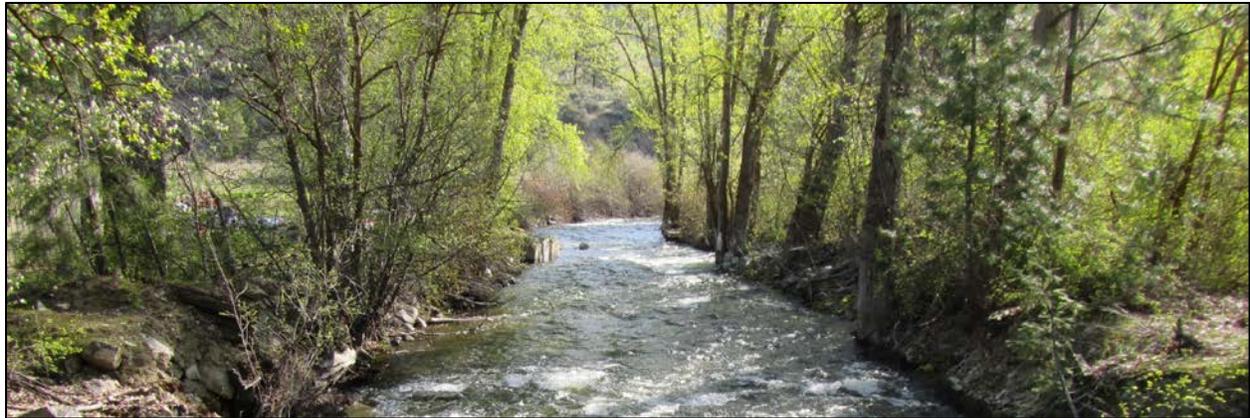
Figure 27. Riparian vegetation strip at RM 0.3. (Photo: 4/25/2018)

The lack of mature or large trees (21-32-inch dbh), narrowness of the vegetated riparian zone, and lack of lateral channel process limits local source and recruitment potential of large woody materials (LWM) into the channel. A total of only 11 pieces of wood and no log jams were observed in the channel during the survey (10/24/2017). All 11 pieces were in the small size class (9 to 12-inch dbh). No quality large woody material (>12-inch dbh and at least 35-feet long) were observed in the channel (Figure 28). Due to the small size and scarcity of large wood material (LWM), it plays only a minor temporary role in aquatic habitat and geomorphic complexity in Reach 1. The lack of LWM in Reach 1 is the result of past riparian vegetation removal, lack of mature trees in the riparian corridor, lack of channel migration capacity, and probably continued periodic “cleaning” of wood from the channel. Clearing large wood from the channel has been a common practice in places where infrastructure such as bridges or culverts exist.

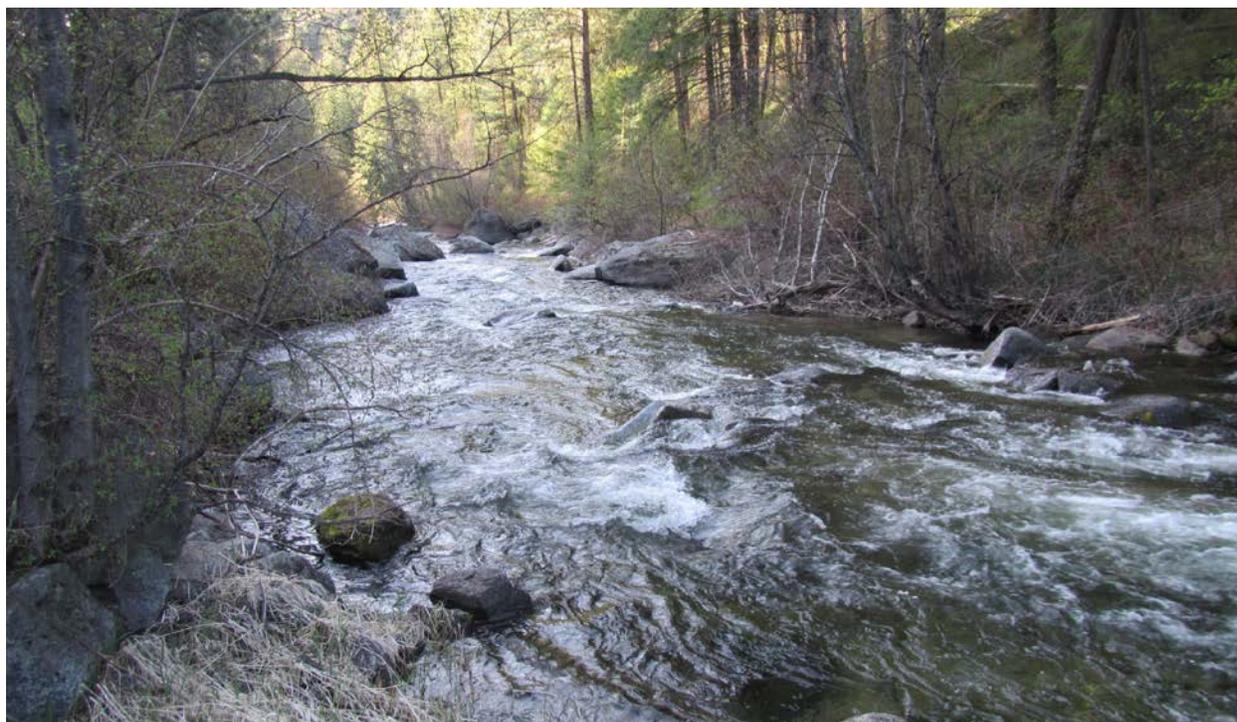
Figure 33. Reach 2 at RM 1.48, a hillslope and road confined section - looking downstream. (Photo: 4/25/2018)

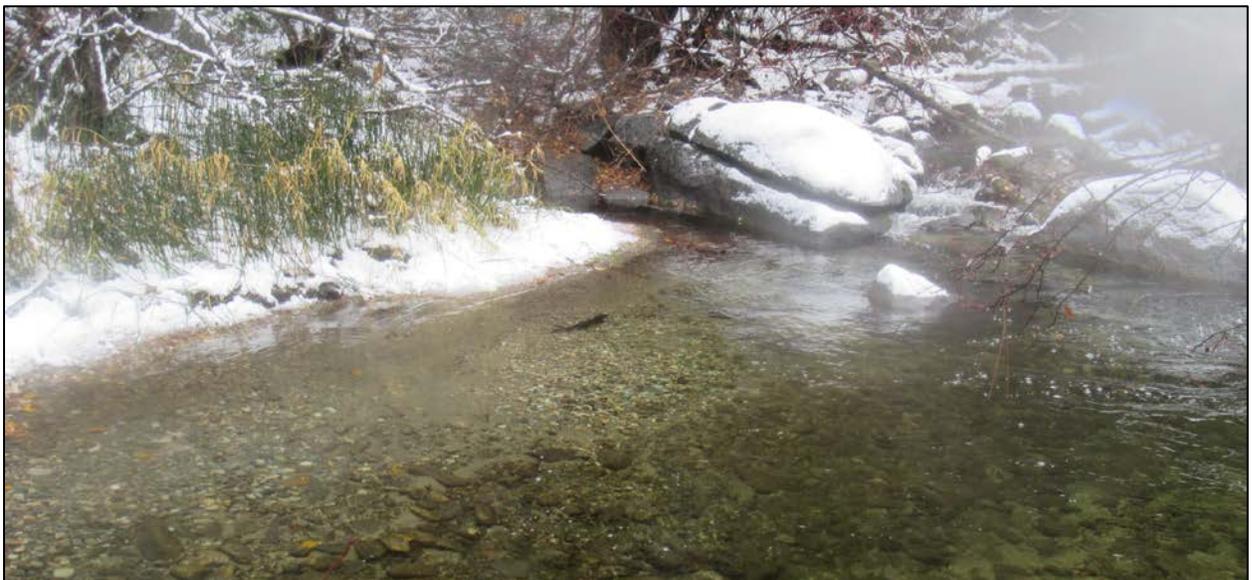
Channel complexity in Reach 2 is impaired. The 2017 Habitat Assessment (see Appendix A) measured 79% of the channel as extended riffles while only 8% is pool habitat and the remaining 13% is glides. The glides and several of the riffles are plane-bed. The pools occur where large boulders create a grade control that produces scour on the downstream side. The bed of the channel is dominated by coarse alluvium (cobble and small boulders). A few small gravel accumulations were observed in eddies or pools behind boulders or upstream of large wood (Figure 35).

Figure 35. Spawning gravel accumulation behind boulders (with spawning salmoid) at RM 1.45. (Photo: 11/9/2017)

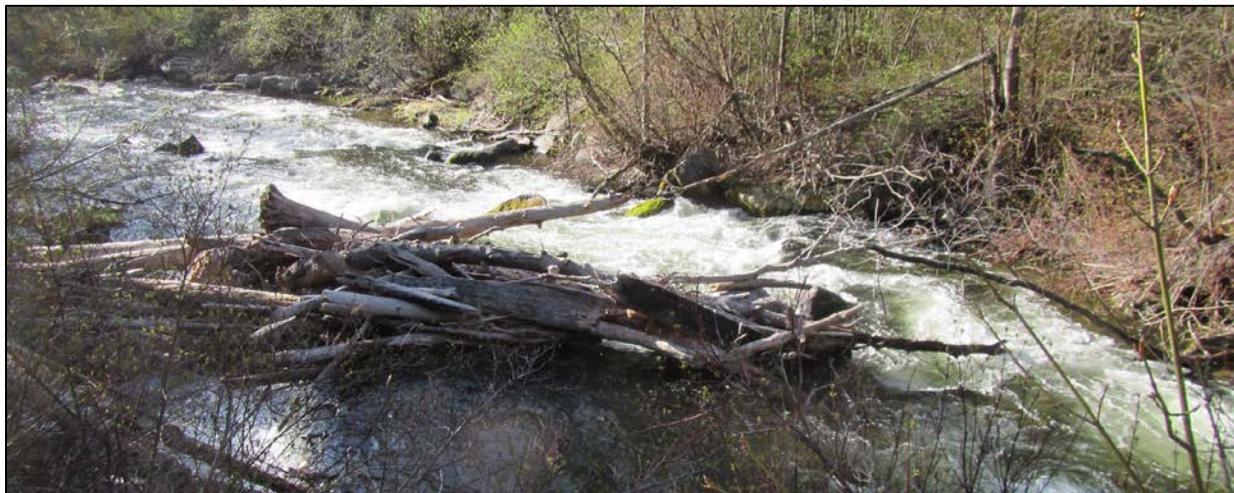
The log jam observed in Reach 2 contained only one large piece of wood and 9 small pieces (Figure 38). This is an example of the lack of quality in-stream Large Woody Material (LWM) and riparian recruitment potential in the reach. As a result, LWM currently plays only a minor role in localized aquatic habitat and geomorphic complexity. Where it does exist, channel complexity is improved. The lack of LWM and jams in Reach 2 today is likely the result of past riparian vegetation removal for the construction of the Mad River Road and periodic “cleaning” of wood from the channel. Cleaning LWM from the channel has been a common practice where infrastructure such as roads and bridges exist.

Figure 38. Large wood jam at RM 1.19 in Reach 2. (Photo: 4/25/2018)

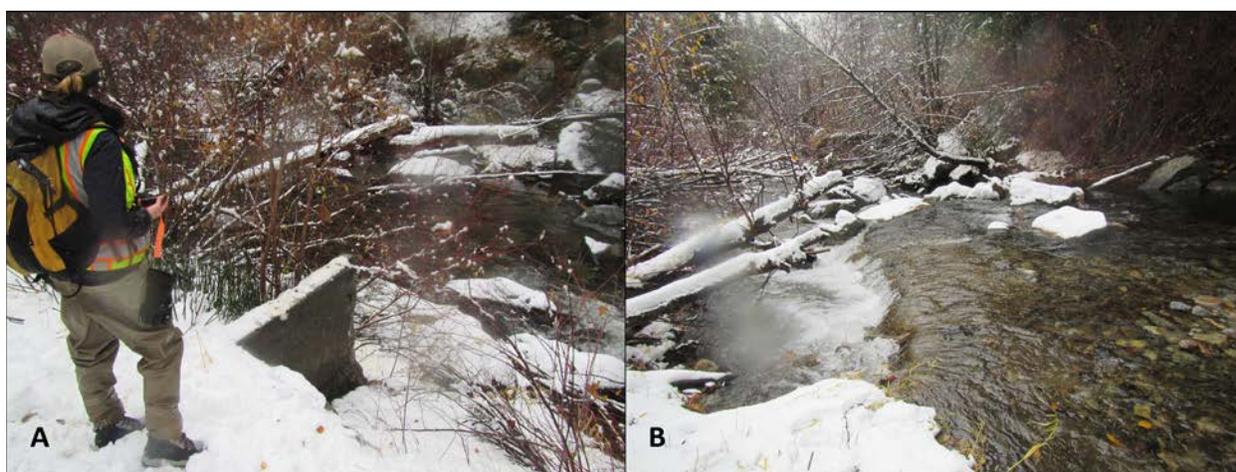
Figure 41. A) cement wall on bank at RM 1.42; B) cement slab on channel bed at RM 1.33. (Photos: 11/9/2017)

Recommended actions for Reach 2 are focused on increasing channel complexity and improving available aquatic habitat. These actions include riparian restoration, enhancing channel complexity, removing unnecessary materials, creating side/off-channel habitat, and improving available aquatic habitat in the mainstem. All recommended actions downstream of RM 1.25 are on private and everything upstream of that in Reach 2 is on public lands managed by the US Forest Service. Sustainability of the action treatment and protection of the Mad River Road was considered in selecting recommendations for this reach. Primary actions are installing small, medium and large-sized log jams, some with placed large boulders, in appropriate locations that take advantage of existing features or instigate geomorphic function to increase channel complexity and habitat quality. Constructing side channels through existing functioning floodplains has the potential to notably increase available high-quality habitat in the reach.

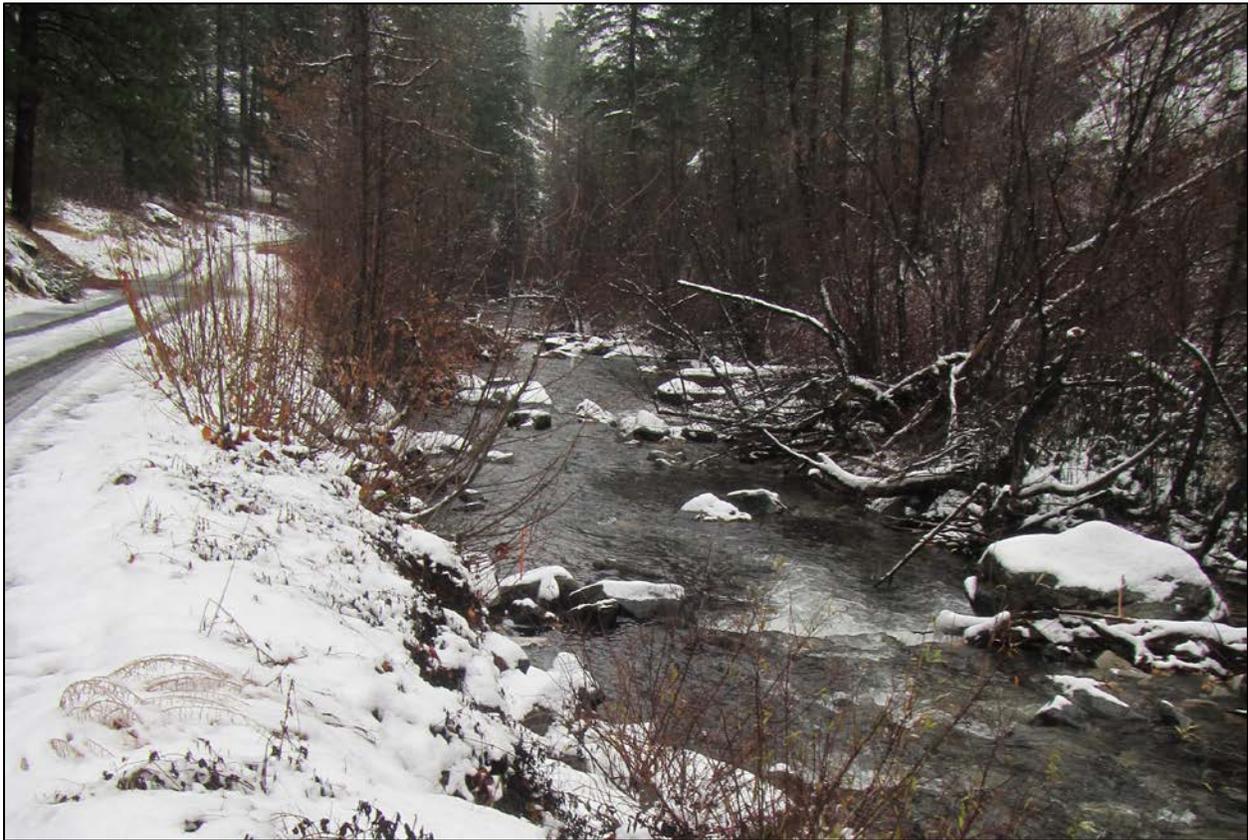
Figure 43. Mad River confined by hillslope and road at RM 2.45. (Photo: 11/9/2017)

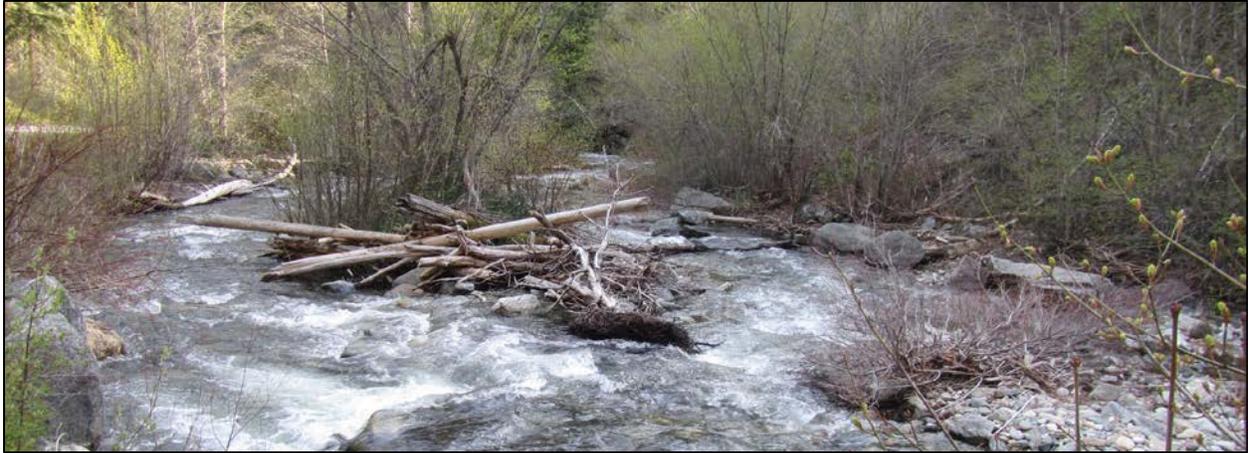
Split-flow conditions (side channels) occur near RM 2.85 and RM 2.95. In these locations, woody material accumulations and/or boulders support mid-channel bar development and island maintenance. Geomorphic complexity of the channel is higher where split-flow conditions occur (Figure 44).

Figure 44. Mad River at RM 2.95: Split-flow at wood accumulation. (Photo: 4/24/2018)

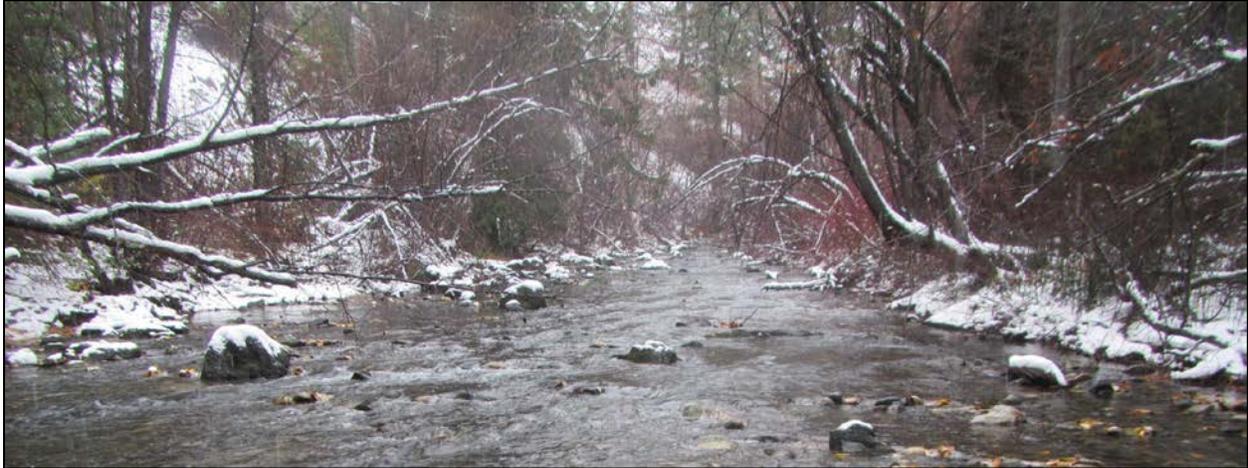
Figure 46. Extended riffle (~800 feet long), photo looking upstream at RM 2.75. (Photo: 11/9/2017)

Channel complexity in Reach 3 is impaired. The 2017 Habitat Assessment (see Appendix A) measured 82% of the channel as extended riffles while only 1% is pool habitat, 17% is glides, and 1% is side channels. The glides and some of the riffles are generally plane-bed. The pools occur where boulders create a grade control or scour. The bed of the channel is dominated by coarse alluvium (cobble and small boulders). Only small pockets of coarse sand and gravel were observed in eddies and pools behind boulders and/or wood accumulations.

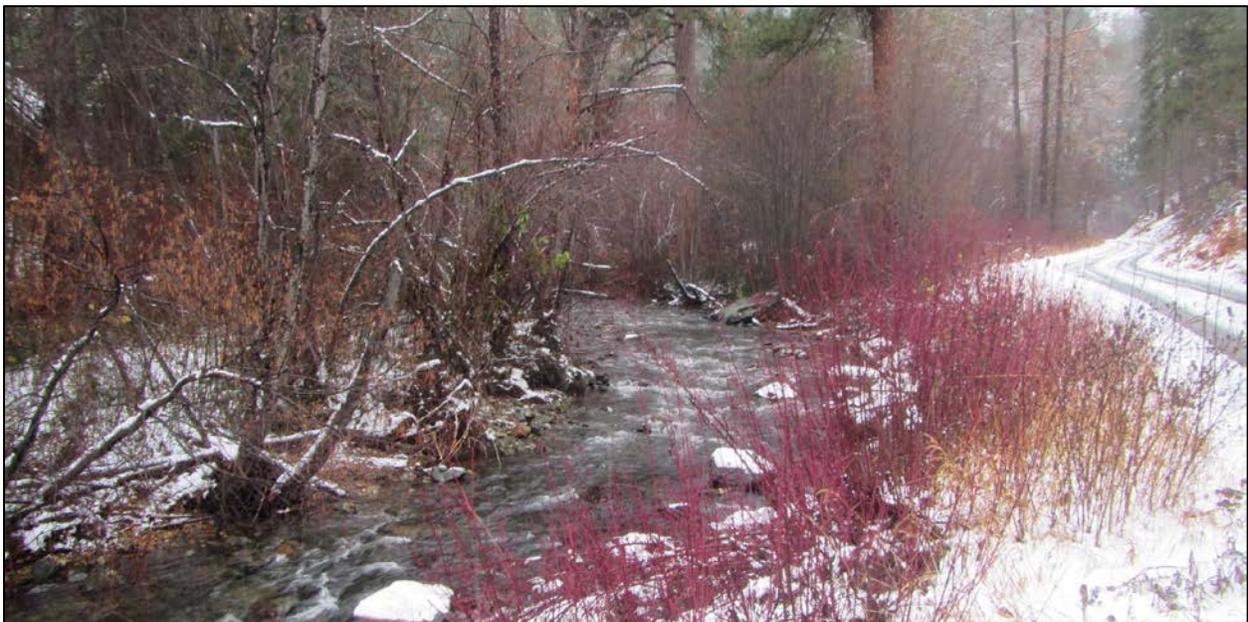
Figure 51. Mad River Road occupying valley floor and the associated impaired riprapped channel bank. (Photo: 11/9/2017)

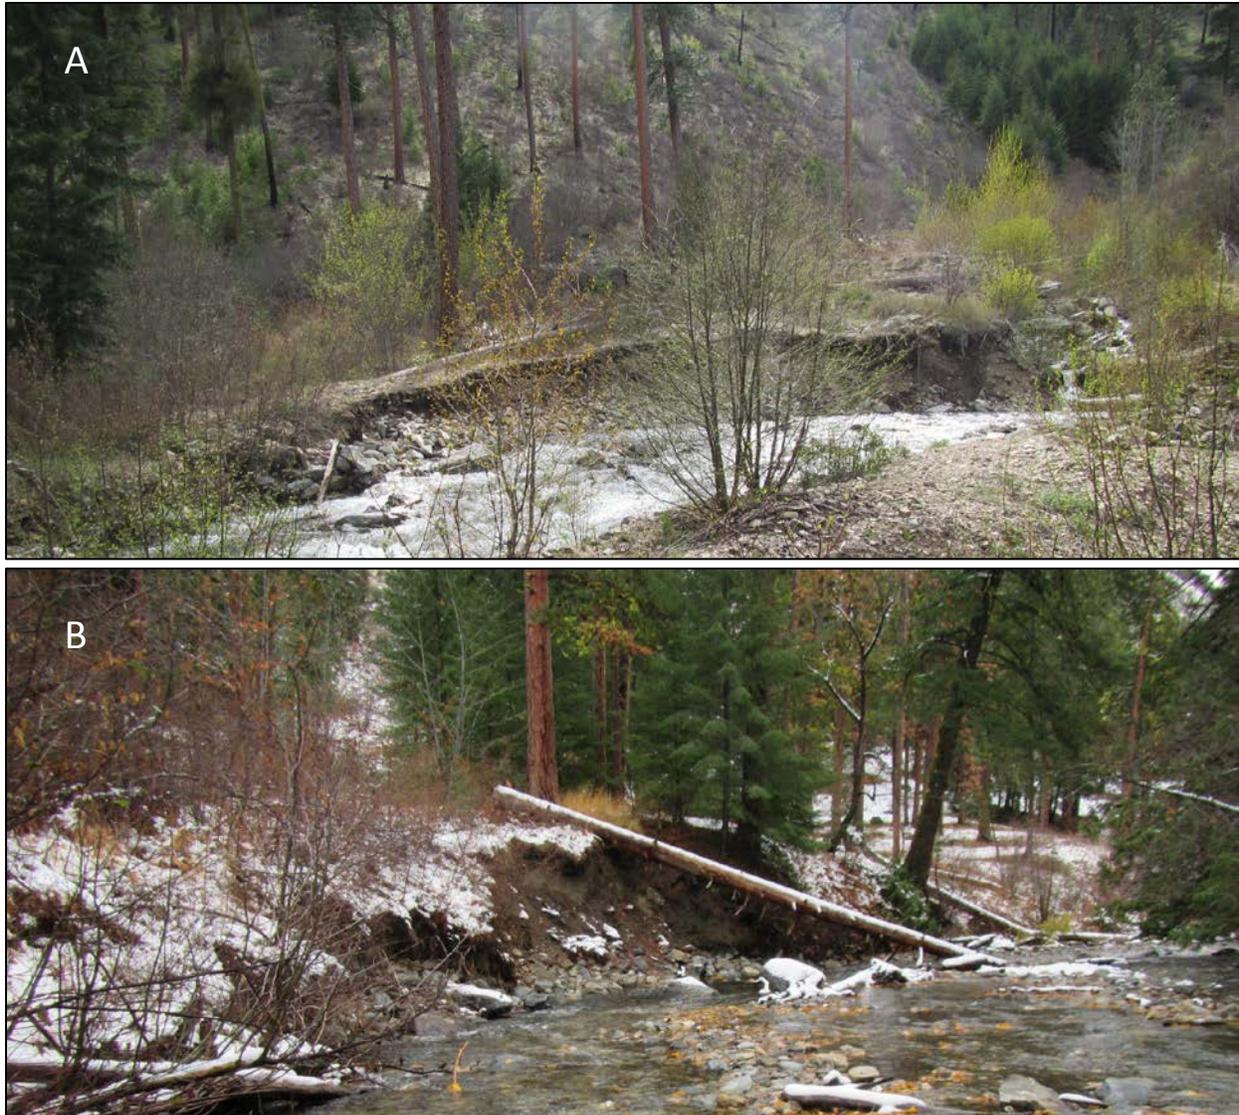
Figure 55. Sediment sources: A) debris fan on river right at RM 4.27, B) terrace & fan bank on river left at RM 4.07. (Photos: 11/10/2017)

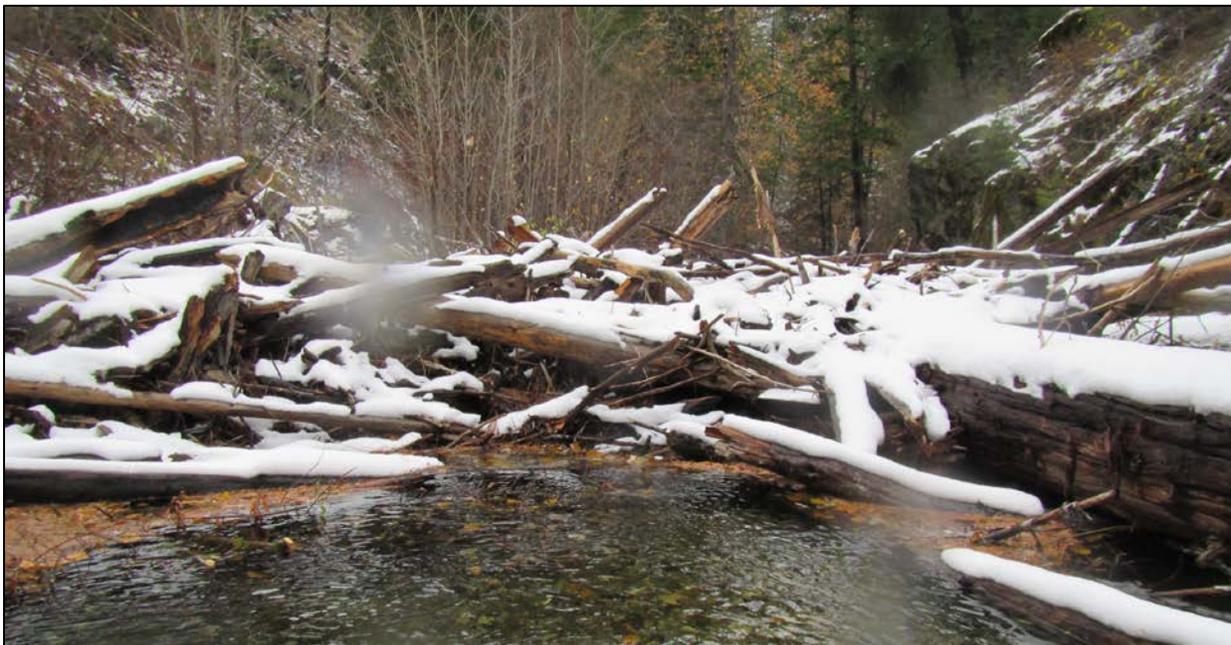
Figure 57. Channel-spanning LWM jam at RM 3.18. (Photo: 11/9/2017)

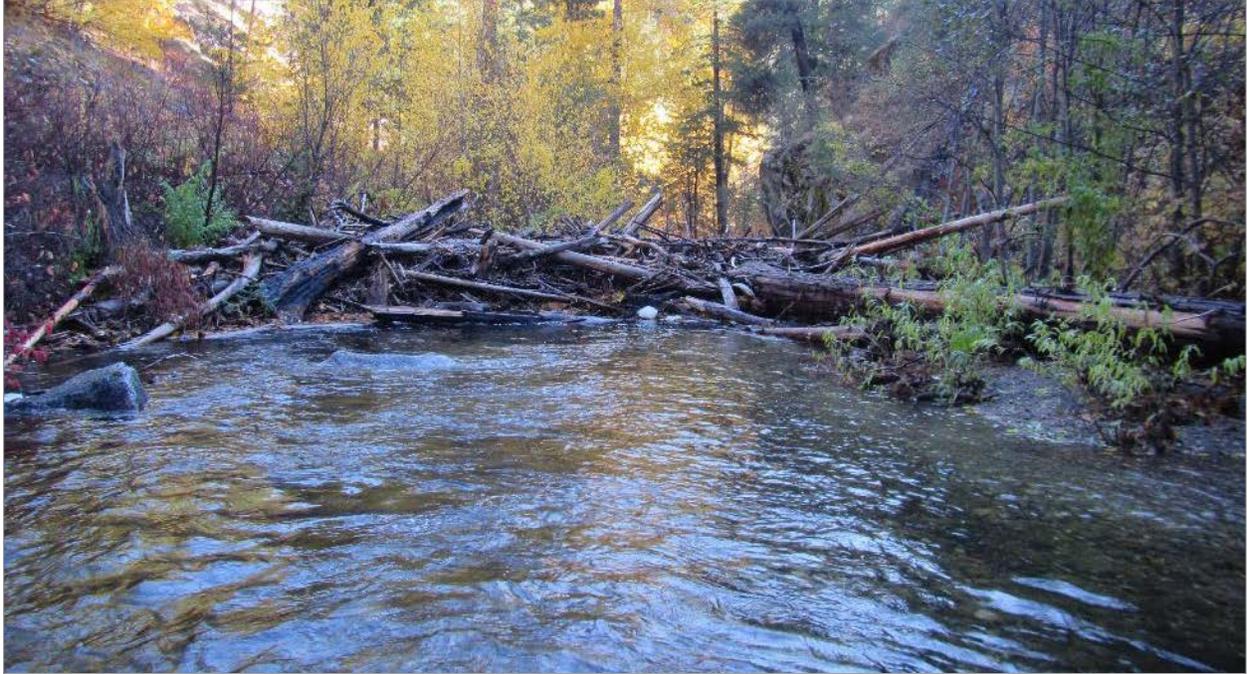
Figure 10. Looking downstream at a channel-spanning log jam that may act as a migratory impediment for certain species or life stages at some flows. (Photo: 10/26/2017)

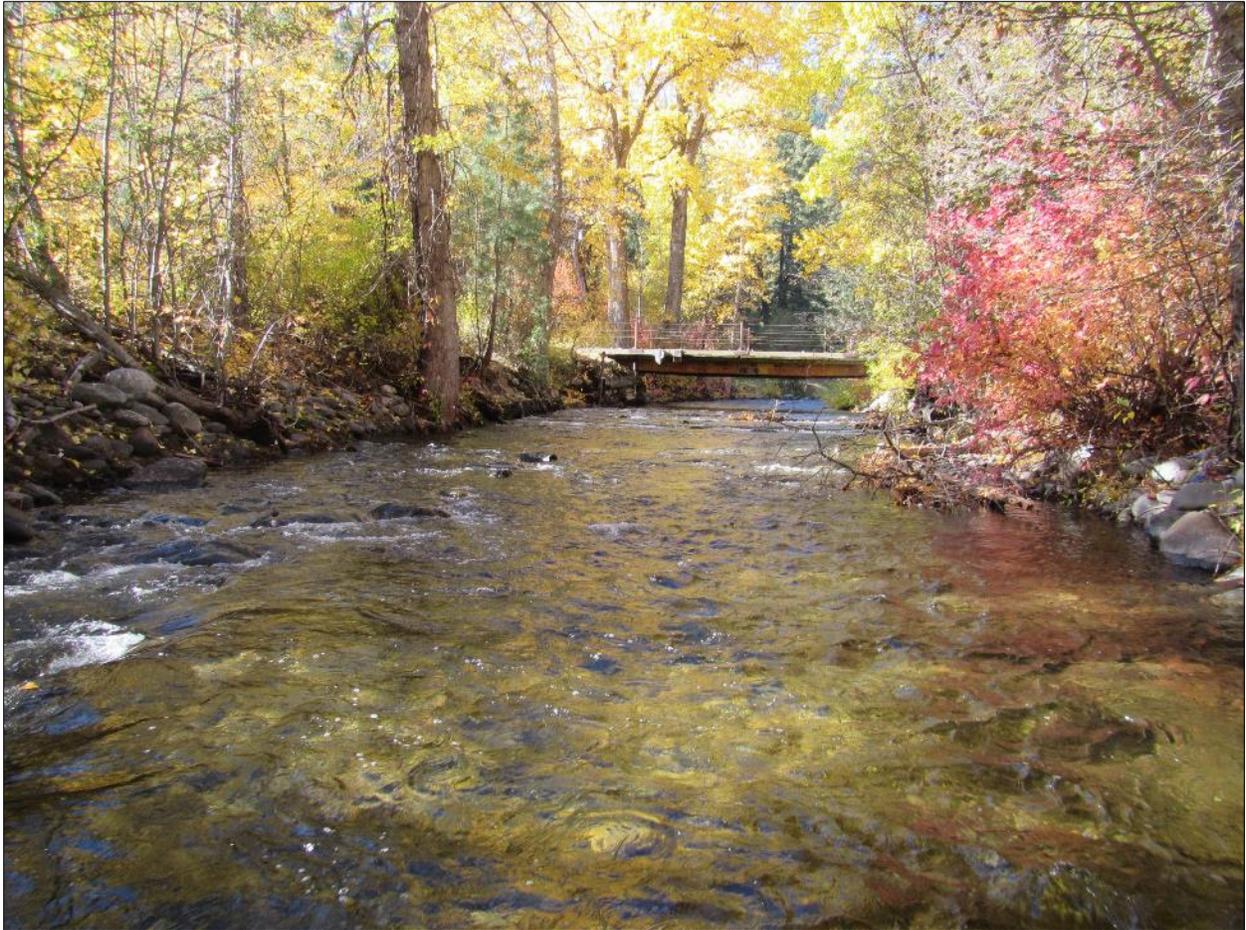
Figure 15. Representative view of Reach 1. Human disturbance within the channel and riparian area are most frequent in this reach. (Photo: 10/24/2017)
