## APPENDIX B PESHASTIN CREEK PROJECT OPPORTUNITIES

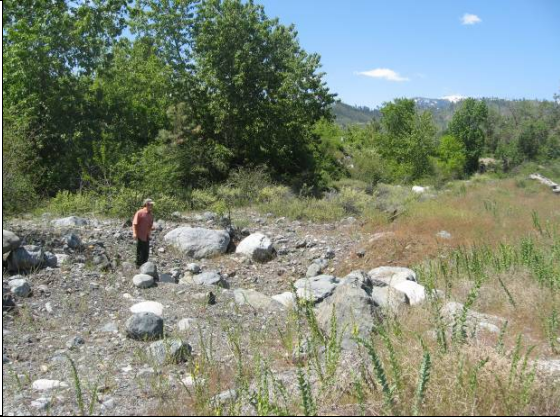
<p>Historical channel in right-bank floodplain near mouth (May 2010).</p>

Reach	Sub-Unit	Project Number	Strategy Category	Project Name	Description	Photo
1	Inner Zone 2 (IZ-2)	Project RM 0.2R&L	Riparian Restoration	Expand riparian buffer (right and left banks).	A very narrow band of riparian forest extends along the right and left banks between river mile 0.1 and 0.45 (approx. 1,800 ft). Plant native riparian forest vegetation within a 100 foot buffer in order to restore riparian functions including stream shade, bank stabilization, and LWD recruitment.	
1	Disconnected Inner Zone 3 (DIZ-3)	Project RM 0.3R (Alt. 1)	Reconnect Stream Channel Processes	Full side-channel reconnection.	This option would entail reconfiguring the WDOT access road to completely reconnect the historic channel to the active inner zone. In this option, split-flow could be created enhancing channel complexity. The access road would need to be moved south onto the terrace surface at the edge of the outer zone.

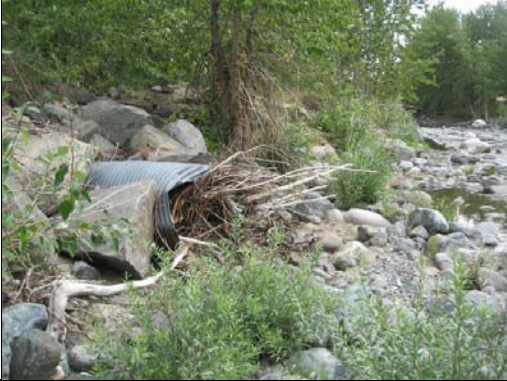
<p>Push-up levee and culvert on river-left bank near river mile 0.85. (August 2009).</p>
1	Inner Zone 1 (IZ-1)	Project RM 0.9L	Reconnect Stream Channel Processes	Rip-rap removal/replacement.	Rip-rap begins on the river left bank at RM 0.85 and extends upstream approximately 400 feet. The rip-rap is associated with the old Highway 97 alignment prior to the reconstruction of the interchange of Highways 2 and 97. Rip-rap limits geomorphic connectivity (e.g. channel migration), riparian function, and habitat complexity. The rip-rap could be removed and replaced with LWD to reconnect long-term channel migration processes, enhance instream habitat cover/complexity, and provide bank stability until a restored riparian forest can provide long-term natural stability (riparian revegetation work is currently underway). This project could be associated with removal of the small push-up levee and culvert removal just downstream (see Project RM 0.8L in DIZ-1).

Reach	Sub-Unit	Project Number	Strategy Category	Project Name	Description	Photo
1	Disconnected Inner Zone 1 (DIZ-1)	Project RM 0.8L	Reconnect Stream Channel Processes	Side-channel reconnection	This site is on river left upstream of the Highway 2 Bridge. There is an existing culvert through a push-up levee at the upstream end that allows high flows to enter the river left flood overflow channel. The levee and culvert could be removed to provide flows into the side channel during high flows to provide flood refuge for juvenile fish. Excavation may be necessary to allow inundation at the desired flow level. An active low-flow side-channel could also be considered at this site. In addition, there are good opportunities for log jam placements in the main river adjacent to this area.

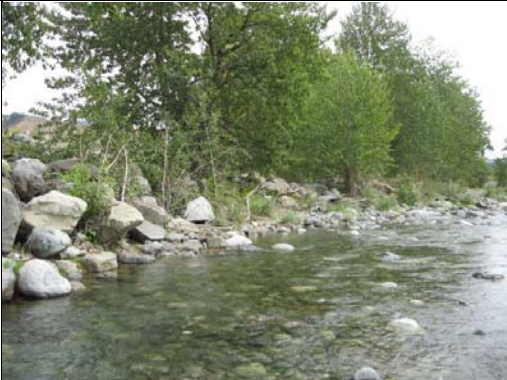
<p>Looking downstream to the east at the river left bank near river mile 0.85 that has been heavily rip-rapped (August 2009).</p>

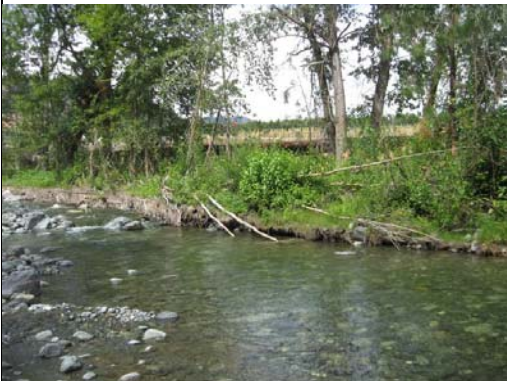
<p>Looking upstream to the northwest at the left river bank near river mile 1.0 (August 2009).</p>

1	Inner Zone 1 (IZ-1)	Project RM 1.0C	Instream Habitat Enhancement	LWD enhancement.	Pool habitat is extremely limited in this reach, and opportunities to increase pool quality should be considered. The project would include a lateral log jam constructed on the river-left bank. Sandstone bed rock in the channel could limit pool depth at this site. However it may be possible to easily excavate the sandstone.  If possible, pool depth could be enhanced through excavation and maintained by log jam hydraulics.

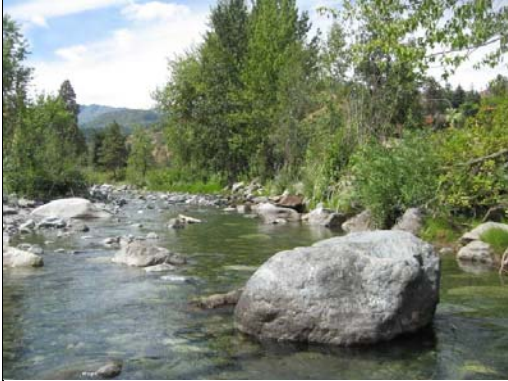
<p>Upstream view near river mile 1.1. Rip-rap associated with old Highway 97 alignment is located on the river left bank (right side of photo) (August 2009).</p>

Reach	Sub-Unit	Project Number	Strategy Category	Project Name	Description	Photo
1	Inner Zone 1 (IZ-1)	Project RM 1.1L	Reconnect Stream Channel Processes	Rip-rap removal/replacement.	Rip-rap begins on the river left bank at RM 1.05 and extends upstream approximately 500 feet. The rip-rap is associated with the old Highway 97 alignment prior to the reconstruction of the interchange of Highways 2 and 97. Rip-rap limits geomorphic connectivity (e.g. channel migration), riparian function, and habitat complexity. The rip-rap could be removed and replaced with LWD to reconnect long-term channel migration processes, enhance instream habitat cover/complexity, and provide bank stability until a restored riparian forest can provide long-term natural stability (riparian revegetation work is currently underway).

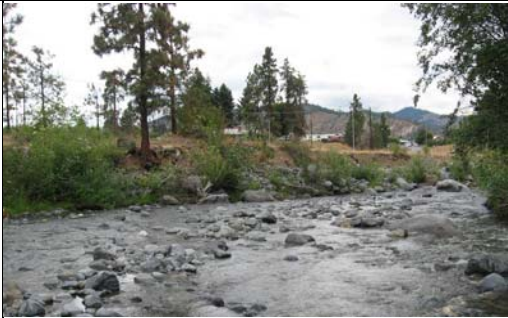
<p>Cleared riparian zone on river left bank near river mile 1.2. (August 2009).</p>
2	Inner Zone 5 (IZ-5)	Project RM 1.65C	Instream Habitat Enhancement	LWD enhancement	This wood placement project includes a river right bank log-jam. The goal of the jam is to add complexity to the otherwise plane bed morphology of the reach, thereby increasing ecological value.

1	Outer Zone 1 (OZ-1)	Project RM 1.1R	Riparian Restoration	Expand riparian buffer (right bank).	A very narrow band of riparian forest extends along the right bank between river mile 1.05 and 1.2 (approx. 900 ft). Plant native riparian forest vegetation within a 100 foot buffer in order to restore riparian functions including stream shade, bank stabilization, and LWD recruitment.	
1	Outer Zone 2 (OZ-2)	Project RM 1.2L	Riparian Restoration	Native plant revegetation (left bank).	There is little to no riparian forest along the left bank between river mile 1.1 and 1.25 (approx. 700 ft). Plant native riparian forest vegetation within a 100 foot buffer in order to restore riparian functions including stream shade, bank stabilization, and LWD recruitment.

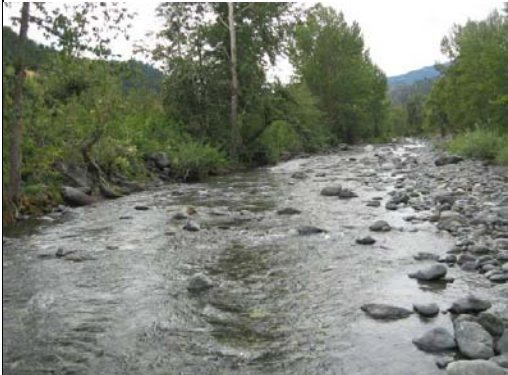
<p>View looking upstream toward the south at a potential log jam location near river mile 1.7 associated with Project RM 1.65C. (August 2009).</p>

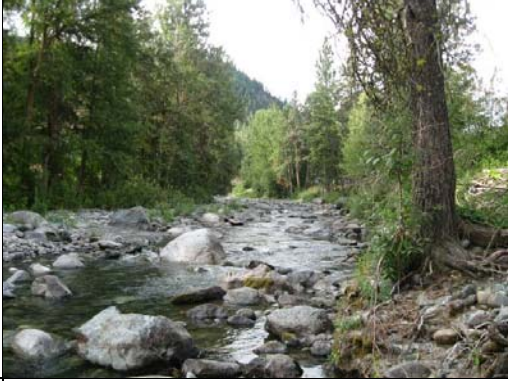
<p>View looking upstream toward the south near river mile 2.2 at a potential log jam location associated with Project RM 2.25C. (August 2009).</p>
2	Disconnected Outer Zone 8 (DOZ-8)	Project RM 2.4R	Off-Channel Habitat Enhancement	Side-channel enhancement	The fish bypass channel at the Peshastin Canal runs along the river-right bank. There is a connection with a floodplain pond that may provide potential stranding risk during certain periods. There may also be off-channel habitat restoration opportunity in this area (this information was provided by Mike Kane, Chelan County Dept of Natural Resources). This site warrants further investigation with respect to stranding risk and restoration potential.

Reach	Sub-Unit	Project Number	Strategy Category	Project Name	Description	Photo
2	Inner Zone 4 (IZ-4)	Project RM 2.25C	Instream Habitat Enhancement	LWD enhancement.	This project includes two potential locations for lateral log-jams between river miles 2.2 and 2.3. These structures would enhance pool habitat and provide instream cover and complexity.

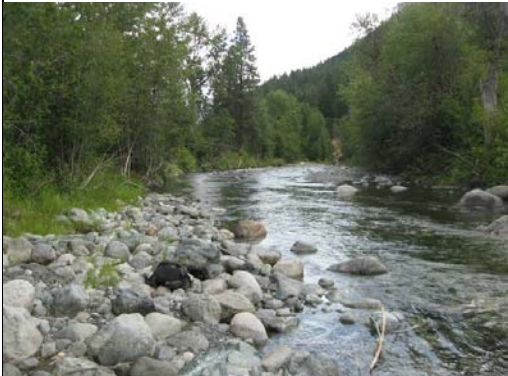
<p>View looking downstream toward the north near river mile 2.75 at a potential upstream inlet to the Project RM 2.7L side-channel. (August 2009).</p>

2	Disconnected Outer Zone 7 (DOZ-7)	Project RM 2.7L	Off-Channel Habitat Enhancement	Side-channel enhancement.	This site provides a good opportunity to create off-channel and side-channel habitats by excavating new flood-prone area and side-channels. It might be possible to supplement side-channel work with constructed ground water galleries. The landowner was very receptive to enhancement work on his land.

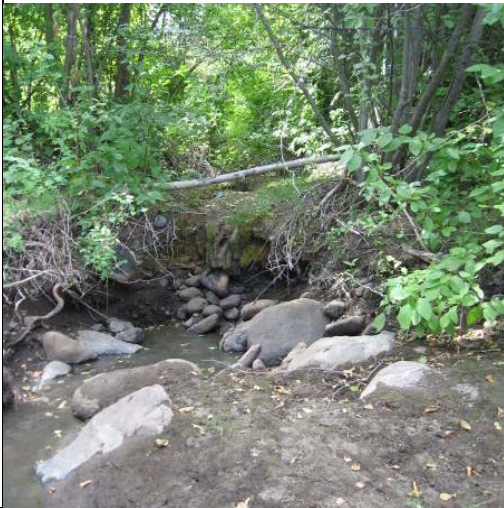
<p>The outflow of the secondary channel on river-left associated with project RM 2.9R. During low flow there is no surface discharge here. (August 2009).</p>

Reach	Sub-Unit	Project Number	Strategy Category	Project Name	Description	Photo
2	Inner Zone 4 (IZ-4)	Project RM 2.9L	Protect and Maintain	Reduction of avulsion risk.	At this site, the existing channel has locally aggraded creating a possibility that the channel will avulse into a side channel adjacent to Highway 97. No rip-rap exists in this area. If the channel avulsed during a flood it is possible the Highway 97 road prism would rapidly erode. Log jams constructed in the lower segments of the valley adjacent to the road would increase local roughness and reduce this avulsion risk. Wood placed on the adjacent gravel bar would further reduce avulsion risk and force floodwater to the right side of the valley where riparian areas and habitats are more intact.

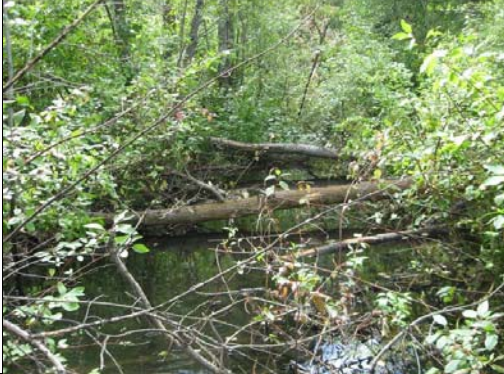
<p>Groundwater pond in a side-channel on river-right near river mile 2.9. (August 2009).</p>
2	Disconnected Outer Zone 5 (DOZ-5)	Project RM 3.0R	Protect and Maintain	Riparian and floodplain protection	The riparian and floodplain area in the downstream portion of the unit (RM 2.8 to 3.0) is undeveloped and retains mature riparian vegetation and floodplain function, especially compared to the upstream portion of the unit where floodplain filling and development have disconnected riparian and floodplain processes.

2	Disconnected Outer Zone 5 (DOZ-5)	Project RM 2.9R	Off-Channel Habitat Enhancement	Side-channel enhancement/reconnection.	This project is on the right (east) side of the valley where a high flow side channel runs through an intact valley bottom riparian wetland. The high flow side channel could be re-graded to function as a low flow side channel. There is evidence of beaver activity in the riparian area and the goal of the project would be to enhance the connection of this side-channel to create off-channel habitat and high-flow refuge. Log-jams would be necessary to ensure stability of the main channel and side channel inlet location.

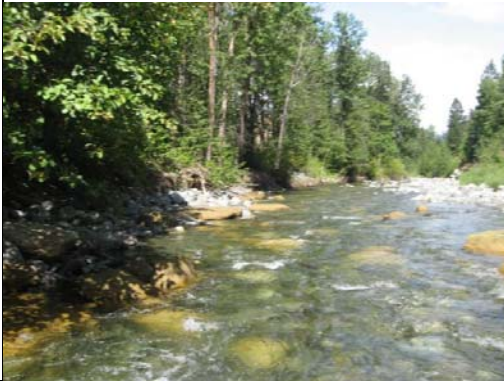
<p>View looking downstream at a potential log jam location near river mile 3.35. (August 2009).</p>
2	Inner Zone 4 (IZ-4)	Project RM 3.45L	Instream Habitat Enhancement	LWD enhancement.	This project includes a lateral log-jam along the left bank of the channel. The goal of the wood placement is to provide adult holding and juvenile rearing habitat. This location benefits from having few infrastructure constraints, good existing riparian habitat in the adjacent floodplain, and site access.

Reach	Sub-Unit	Project Number	Strategy Category	Project Name	Description	Photo
2	Inner Zone 4 (IZ-4)	Project RM 3.35L	Instream Habitat Enhancement	LWD enhancement	This project includes a lateral log-jam along the left bank of the channel. The goal of the wood placement is to provide adult holding and juvenile rearing habitat. This location benefits from having few infrastructure constraints, good existing riparian habitat in the adjacent floodplain, and site access.

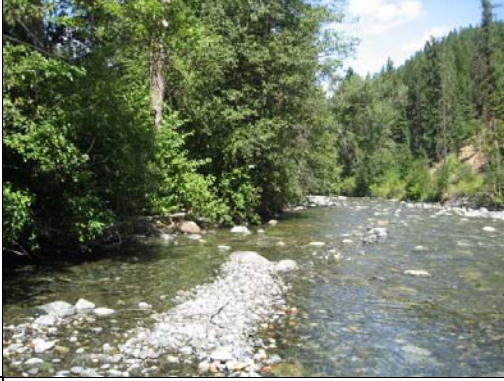
<p>View in the downstream direction toward the northeast at a potential log jam location near river mile 3.45. (August 2009).</p>

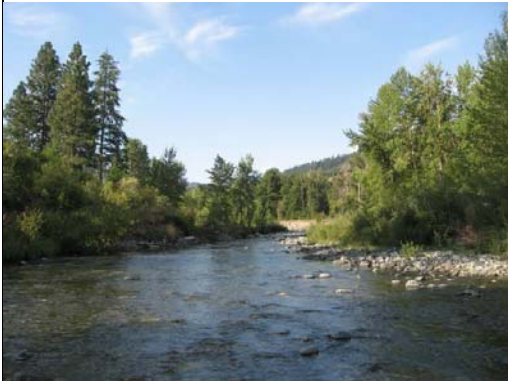
<p>View looking upstream at a potential log jam location on the river-right bank (left side of photo) near river mile 3.95 associated with Project 4.0R. (August 2009).</p>
2	Outer Zone 4 (OZ-4)	Project RM 4.0L	Off-Channel Habitat Enhancement	Side-channel enhancement	This site consists of an existing hyporheic-fed side-channel between RM 3.95 and 4.05 along the river-left side. This project would enhance the cover habitat in the existing side channel. Additional investigation is needed to determine the potential for enhancing flow through excavation and the use of groundwater galleries.

Reach	Sub-Unit	Project Number	Strategy Category	Project Name	Description	Photo
2	Inner Zone 2 (IZ-2)	Project RM 4.0R	Instream Habitat Enhancement	LWD enhancement.	This project is a log jam downstream of Larsen Creek on the right bank. The log jam is a good site to provide habitat and reduce existing bank erosion.

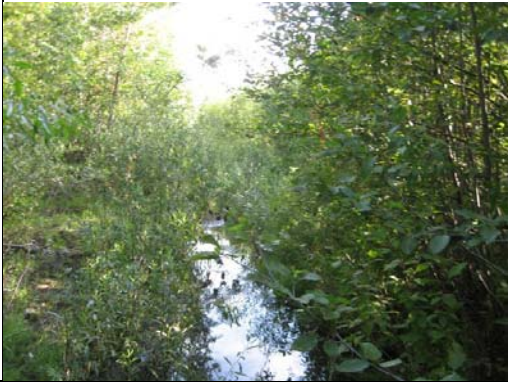
<p>View looking south at the groundwater-fed channel on river left near river mile 4.0. (August 2009).</p>

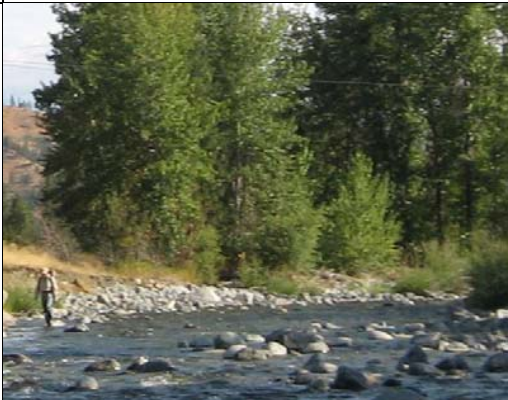
<p>View looking downstream near river mile 4.1 at the potential log jam location associated with Project RM4.1L. (August 2009).</p>

2	Inner Zone 2 (IZ-2)	Project RM 4.05L	Reconnect Stream Channel Processes	Levee removal/set-back.	This project involves setting back the levee at this location in order to maintain protection of Highway 97 and nearby residential development, but allow for more natural channel dynamics during high flow events.	
2	Inner Zone 2 (IZ-2)	Project RM 4.1L	Instream Habitat Enhancement	LWD enhancement	This site is located at the inlet to the side channel associated with Project RM 4.0L. The work here would construct a log jam at the inlet to prevent an avulsion down the existing side channel in order to maintain existing Peshastin Creek channel length. The log jam would extend out into the Creek and extend approximately 300 feet upstream along the eroding bank adjacent to Highway 97. The log jam would be partially buried, extending from the eroding bank outward into the channel to provide pool formation and habitat complexity.

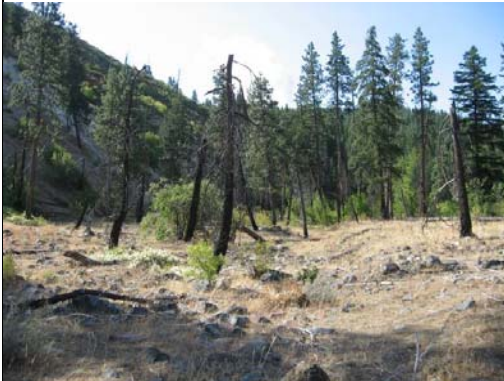
<p>View looking south in the upstream direction at OZ4 near river mile 4.25. This surface is the proposed site for a side-channel project associated with Project 13. (August 2009).</p>

Reach	Sub-Unit	Project Number	Strategy Category	Project Name	Description	Photo
2	Outer Zone 4 (OZ-4)	Project RM 4.2R		Floodplain protection and riparian restoration	This undeveloped floodplain surface is important for protection due to the extremely limited acreage of undeveloped floodplain in this reach. This sub-unit appears from the LiDAR to be relatively free of floodplain fill and has the potential to provide important floodplain and channel migration zone function. There is no substantial development. Protect and allow no further degradation of geomorphic, hydrologic, and vegetative function. Riparian restoration could be conducted to re-establish a native large conifer community. Evaluate existing land-use protections and, if necessary, look for opportunities to purchase conservation easements on the property. The following project (Project RM 4.3R) would also be located in this same area.

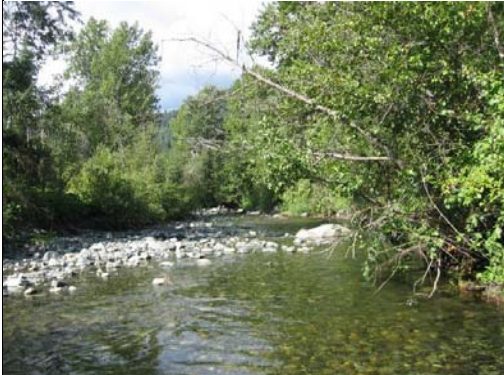
<p>View looking downstream toward the northeast at a potential log-jam location near RM 4.65. (August 2009).</p>

2	Inner Zone 1 (IZ-1)	Project RM 4.6C	Instream Habitat Enhancement	LWD habitat enhancement	This site is on a bend in the Creek near RM 4.65. A log jam here would provide habitat complexity and cover.

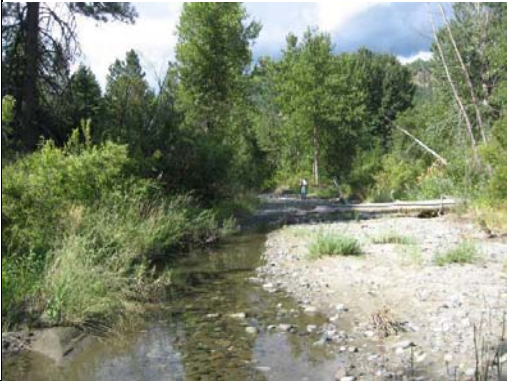
<p>Potential side-channel enhancement area near RM 4.6. (August 2009).</p>
2	Inner Zone 1 (IZ-1)	Project RM 4.8C	Instream Habitat Enhancement	LWD habitat enhancement	This site extends approximately 200 feet centered on RM 4.8. A log jam here would provide habitat and could be used to restore natural stability to the rapidly eroding left bank. This effort should be combined with riparian restoration.

Reach	Sub-Unit	Project Number	Strategy Category	Project Name	Description	Photo
2	Inner Zone 1 (IZ-1)	Project RM 4.6R	Off-Channel Habitat Enhancement	Side-channel habitat enhancement.	There is an existing side- channel (primarily a high-flow channel) within the right side of the valley bottom from approximately RM 4.55 to RM 4.7. This project would enhance the existing side-channel habitat by deepening the lower one third of the channel to increase hyporheic flows. LWD placement within the side-channel would enhance habitat complexity and cover.

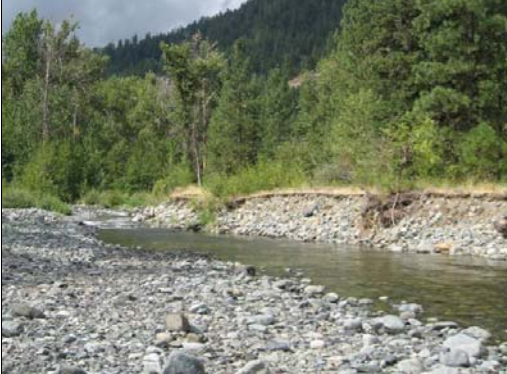
<p>View looking upstream near RM 4.8. Potential log jam placements on river-left bank (right side of photo) to enhance pool complexity and restore natural bank erosion rates. (August 2009).</p>

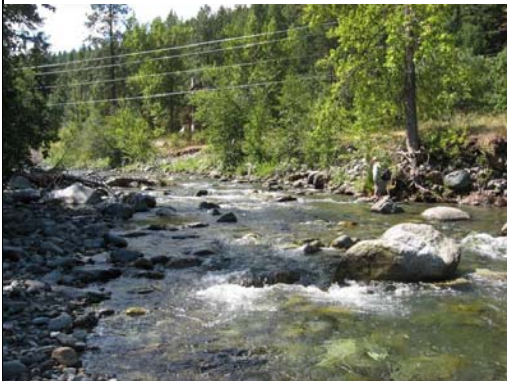
<p>View looking upstream near river mile 5.2. There are opportunities for riparian restoration along the river-left bank (right side of photo). (August 2009).</p>
3	Inner Zone 2 (IZ-2)	Project RM 5.25C	Reconnect Stream Channel Processes	Bridge abutment removal and LWD enhancement	There is an old road, associated fill, and concrete bridge abutments near river mile 5.25. Although there is no longer a bridge in this location, the concrete abutments continue to constrict the channel and affect channel processes. This project would remove the bridge abutments and the associated fill. Lateral log jams could be constructed to provide stability of the disturbed area and to enhance pool formation and instream habitat complexity.

3	Disconnected Outer Zone 2 (DOZ-2)	Project RM 5.2L	Riparian Restoration	Riparian restoration (left bank).	Approximately 1,000 feet of stream in this area, which extends from river mile 5.05 to 5.25, has limited riparian function due to a narrow and intermittent forested riparian buffer. This project would restore a native riparian forest within 100 feet of the stream along this section in order to restore riparian functions including stream shade, bank stabilization, and LWD recruitment.

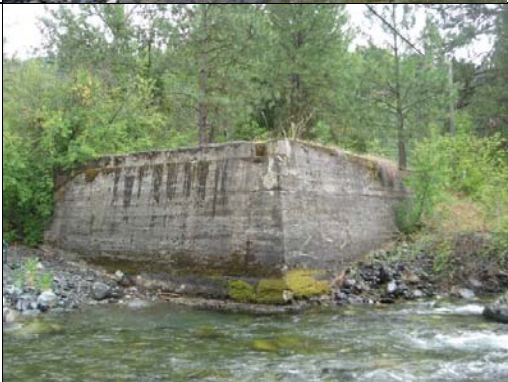
<p>Old bridge abutment at river mile 5.25. (August 2009).</p>

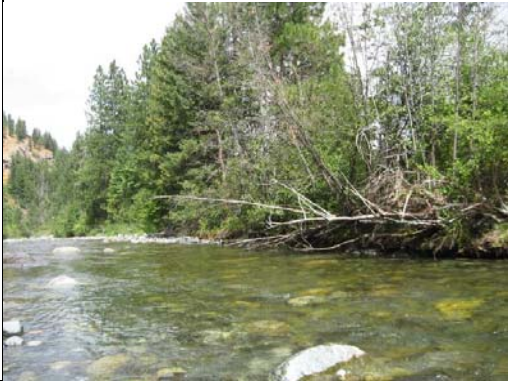
<p>View looking downstream toward the northeast at a potential log-jam location near river mile 5.41. (August 2009).</p>

Reach	Sub-Unit	Project Number	Strategy Category	Project Name	Description	Photo
3	Outer Zone 2 (OZ-2)	Project RM 5.4L	Protect and Maintain	Riparian and floodplain habitat protection.	This undeveloped floodplain surface is important for protection due to the limited acreage of undeveloped floodplain in this reach. Protect and allow no further degradation of geomorphic, hydrologic, and vegetative function. Evaluate existing protections and, if necessary, look for opportunities to purchase conservation easements on the property.	
3	Inner Zone 2 (IZ-2)	Project RM 5.4C	Instream Habitat Enhancement	LWD enhancement.	This project is located along the river-right bank and provides an opportunity to place a lateral log-jam in order to increase habitat quality and diversity in the reach. Constraints at this location include houses in the floodplain on river right, and a nearby power line crossing. The log jam site is near RM 5.4.

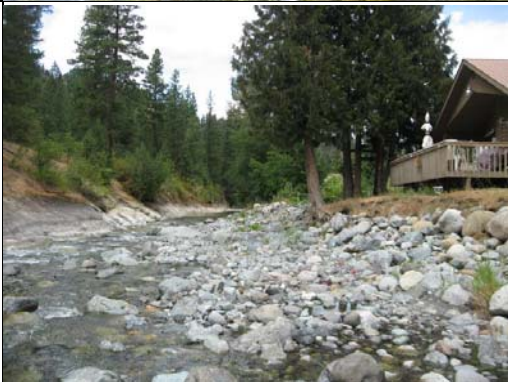
<p>Residential development impacts on riparian function near river mile 5.65, left bank. (August 2009).</p>
3	Outer Zone 1 (OZ-1)	Project RM 5.8L	Protect and Maintain	Riparian and floodplain habitat protection	This undeveloped floodplain surface is important for protection due to the limited acreage of undeveloped floodplain in this reach. Protect and allow no further degradation of geomorphic, hydrologic, and vegetative function. Evaluate existing protections and, if necessary, look for opportunities to purchase conservation easements on the property.

3	Disconnected Outer Zone 1 (DOZ-1)	Project RM 5.6R	Riparian Restoration	Riparian restoration (right bank).	Maintained lawns and residential areas impair riparian function along over 700 feet of stream in this area, which extends from river mile 5.55 to 5.7. This project would restore a native riparian forest within 100 feet of the stream where feasible along this section in order to restore riparian functions including stream shade, bank stabilization, and LWD recruitment.

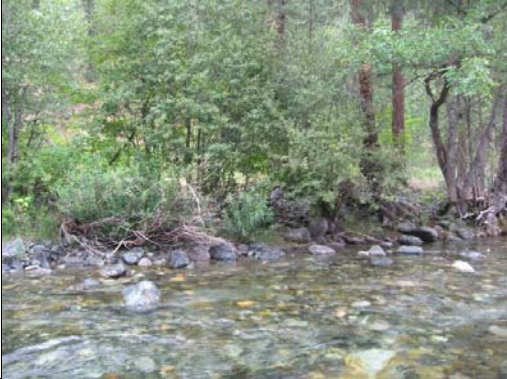
<p>View looking upstream toward the southwest at a potential log jam location along river-left near river mile 6.65. (August 2009).</p>

Reach	Sub-Unit	Project Number	Strategy Category	Project Name	Description	Photo
4	Disconnected Inner Zone 1 (DIZ-1)	Project RM 6.2R	Reconnect Stream Channel Processes	Levee removal	This project would remove the levee near river mile 6.2 in order to reconnect this portion of the active high-flow channel. Removal of the total length of levee (over 300 ft) would also restore hydrologic connectivity to DOZ-1). Local flooding concerns/risks would need to be addressed as part of this project.	
4	Inner Zone 2 (IZ-2)	Project RM 6.55C	Instream Habitat Enhancement	LWD habitat enhancement	There is good opportunity for a log jam to enhance the quality of pool habitat and habitat diversity. A private bridge just downstream will require any wood in this reach to be immobile. The site is a natural wood transport site and may not be high priority for LWD enhancement.	
4	Inner Zone 2 (IZ-2)	Project RM 6.65C	Instream Habitat Enhancement	LWD habitat enhancement	There is good opportunity for a log jam on river-left at the downstream end of a long boulder riffle with the goal of enhancing pool habitat and increasing roughness on the immediately adjacent floodplain. There may be other potential log-jam locations in the vicinity where grade breaks create glides that could be enhanced. The site is a natural wood transport site and may not be high priority for LWD enhancement.

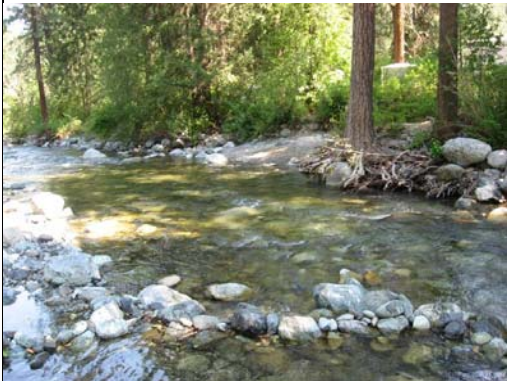
<p>View looking downstream at access area associated with RV Park on river-right bank. There is only a narrow forested riparian buffer along this segment. (August 2009).</p>
5a	Inner Zone 1 (IZ-1)	Project RM 8.15R	Reconnect Stream Channel Processes	Rip-rap removal and LWD habitat enhancement	There is an approximately 100 ft long grouted rip-rap wall on the river-left bank near river mile 8.15 that protects private property from erosion. Investigate opportunities to remove the rip-rap and replace with LWD jams that would provide bank stability as well as aquatic habitat cover, complexity, and pool formation. Re-plant the riparian area in order to provide long-term stability and riparian functions.

Reach	Sub-Unit	Project Number	Strategy Category	Project Name	Description	Photo
5a	Disconnected Outer Zone 2 (DOZ-2)	Project RM 8.0R	Riparian Restoration	Expand riparian buffer (right bank).	Vegetation clearing associated with the RV Park and recreational access leaves only a narrow riparian buffer along approximately 600 feet of channel. This project would restore a native riparian forest within 100 feet of the stream where feasible along this section in order to restore riparian functions including stream shade, bank stabilization, and LWD recruitment.

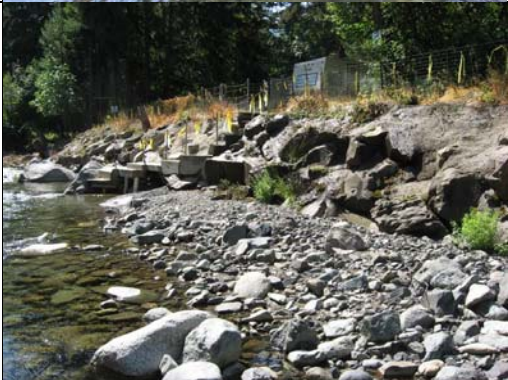
<p>View looking upstream near river mile 8.15 at a grouted rip-rap bank and concrete access stairway along private property. (August 2009).</p>

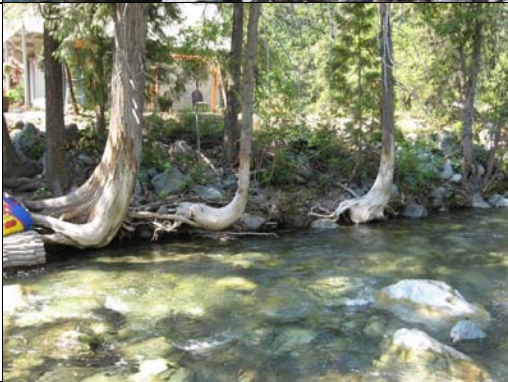
<p>Narrow riparian buffer associated with residential development near river mile 8.3. This condition is typical along much of Reach 5. (August 2009).</p>
5b/6	Disconnected Outer Zone 3 (DOZ-3)	Project RM 8.65R	Riparian Restoration	Riparian revegetation	This project responds to similar impacts and shares similar goals with Project RM 8.9R. This area has been disconnected by Highway 97, and subsequently cleared. Revegetation would ideally occur in tandem with larger-scale stream channel and floodplain reconnections in this reach

5a	Inner Zone 1 (IZ-1)	Project RM 8.3L	Riparian Restoration	Expand riparian buffer (left bank).	Numerous residences along the left bank have only a narrow strip of forested riparian vegetation. This condition extends intermittently between river miles 7.7 and river mile 8.35. Look for opportunities to restore a native riparian forest within 100 feet of the stream where feasible along this section in order to restore riparian functions including stream shade, bank stabilization, and LWD recruitment.

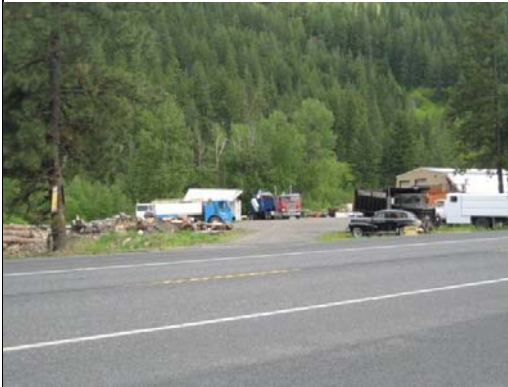
<p>View to the southeast at industrial development of the former floodplain east of Highway 97. ( May 2010).</p>

Reach	Sub-Unit	Project Number	Strategy Category	Project Name	Description	Photo
5b/6	Disconnected Outer Zone 4 (DOZ-4)	Project RM 8.7L	Reconnect Floodplain Processes	Levee removal, reconnect off-channel habitat.	This project involves removing 835 ft of spoils piles along the channel margin between RM 8.61 and 8.78. The spoils are composed of poorly sorted material ranging from boulders to sand. The area inside of the spoils is disconnected from Peshastin Creek. Removal of the spoils would allow for natural tributary interactions at the mouth of Hansel Creek and would connect Peshastin Creek with habitat in Hansel Creek and the floodplain of Hansel Creek at its mouth. A scaled back option here would be to increase the connectivity at the upstream and downstream ends of the sub-unit to allow moderate flows from Peshastin Creek to connect with this floodplain area.	
5b/6	Disconnected Inner Zone 1 (DIZ-1)	Project RM 8.8R	Reconnect Stream Channel Processes	Bridge highway, reconnect main channel, reconnect side-channel habitat, reconnect off-channel habitat.	This project involves reconnecting the historical channel of Peshastin Creek downstream of the Ingalls Creek confluence. There are multiple options, with a range of potential benefits. Full reconnection of the channel (i.e. moving the main channel into its historical alignment) would require rerouting or bridging Highway 97. Bridges would be needed at the upstream and downstream ends of the sub-unit for full process reconnection. Culverts may allow for partial habitat and hydrologic reconnection. Several side-channel and overflow channels can be seen in LiDAR data. Re-connection of these features to the former/restored main channel could also be included in restoration alternative scenarios. Due to the current highway alignment and industrial uses of the site, this effort would require extensive coordination with landowners and other stakeholders.

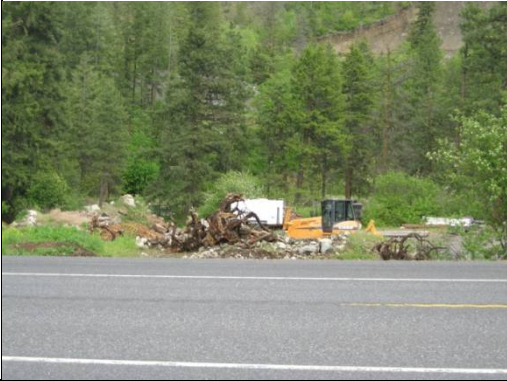
<p>View to the east across Highway 97 at the cleared surface of the historical floodplain of Peshastin Creek. ( May 2010).</p>
5b/6	Disconnected Inner Zone 2 (DIZ-2)	Project RM 8.9L	Reconnect Stream Channel Processes	Levee removal, reconnect side-channel habitat.	This project involves removing 630 ft of levee between RM 8.85 and 8.99. The material forming the levee includes alluvium that was dredged or pushed up from the channel or floodplain nearby, as well as large, angular material that was imported to the site. By removing this levee, habitat and process reconnection could be established for DIZ-2, as well as DOZ-2 downstream. Once the levee has been removed, options for enhancing side-channel or off-channel habitat could be assessed.

Reach	Sub-Unit	Project Number	Strategy Category	Project Name	Description	Photo
5b/6	Disconnected Outer Zone 1 (DOZ-1)	Project RM 8.9R	Riparian Restoration	Riparian restoration.	This surface has been cleared over large areas. Revegetation efforts in this sub-unit could be scale to achieve a variety of habitat goals. As a minimum effort, riparian vegetation could be planted around the margins of wetlands and wet depressions in the former channel. As a larger scale effort, riparian and upland vegetation, including sage and pine would be planted over larger areas of the sub-unit. This option might include purchase of some developed land. If reconnection of the historical channel was carried forward, this revegetation would be a component of the project.

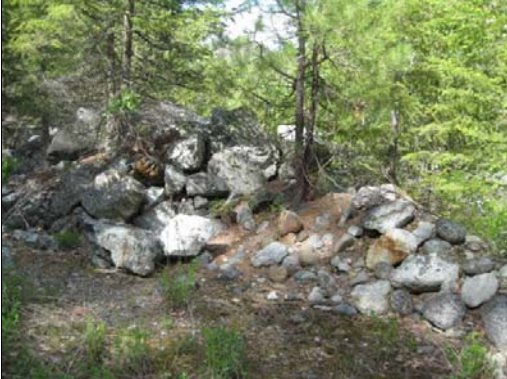
<p>View to the north in the downstream direction at a portion of the levee near RM 8.9 where newer riprap has been placed on top of older alluvial material. (May 2010).</p>
