Appendix A

Wenatchee River Stream Habitat Assessment River Mile 35.5 to 54.2

Survey: August 2011

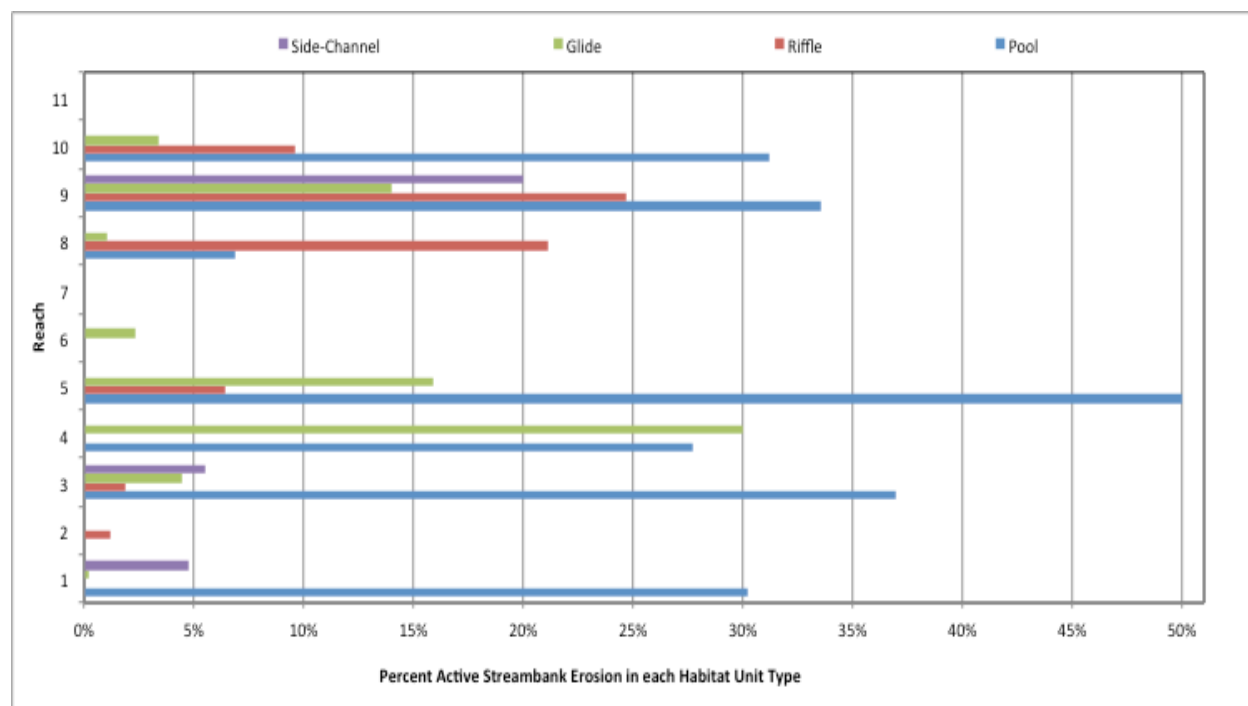
In total, 12% of the streambanks along the upper 18.7 miles of the Wenatchee River were actively eroding. The greatest amount of bank erosion was observed in reaches 9 and 10, where an average of 23% and 18% (respectively) of the streambanks displayed active erosion. The other nine reaches contained between 0% to 16% bank erosion overall. Bank erosion was observed in all habitat unit types (Figure 10), but was most common along pool habitat. Twenty-eight percent (28%) of all pool habitat in the study area exhibited bank erosion. Much of the erosion is natural process and is related to the natural incision of the channel into terrace deposits of glacial origin. In some cases, the incision and related bank erosion has been exacerbated by human alterations including past riparian clearing, past splash damming/log drives, and bank armoring. Streambank erosion has been halted at some locations by riprap, spur dikes, concrete retaining walls, and other bank hardening features.

Figure 10. Percent active streambank erosion in each habitat unit type.

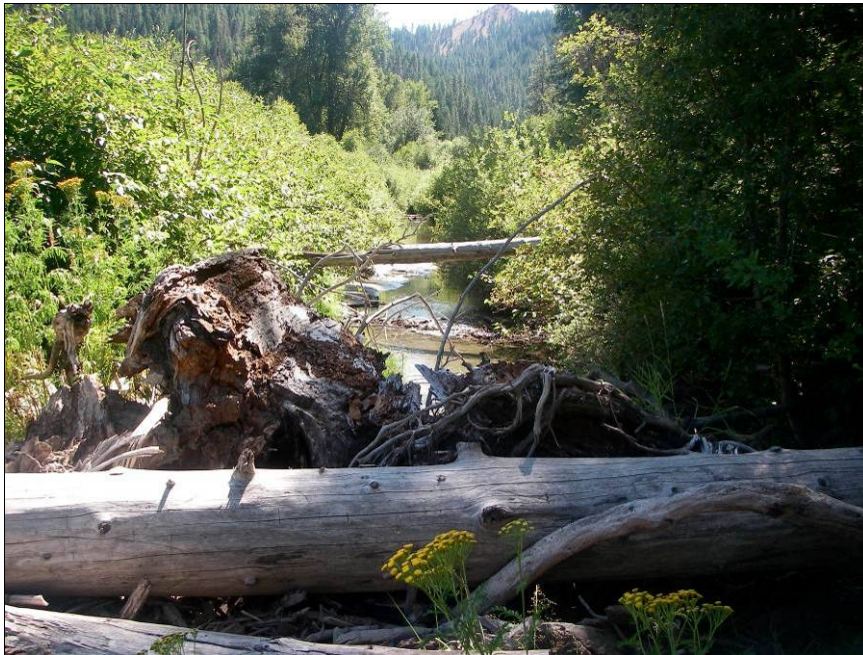
Figure 17. A backwater marsh (RM 35.95 to RM 36.30) has filled in a historical splash dam channel along the right bank floodplain surface in Reach 1 (August 2011).

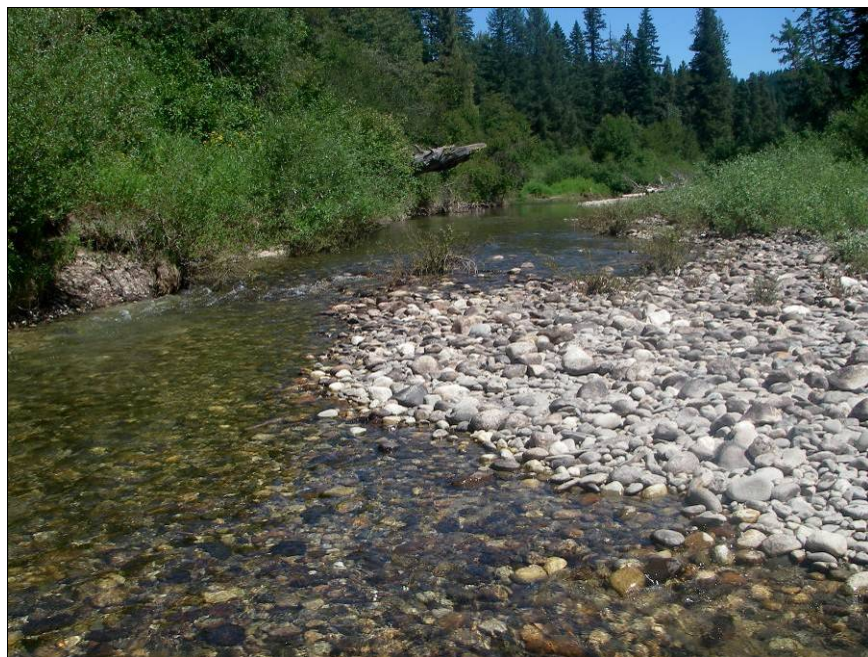
Figure 21. View looking upstream at a meander bend side-channel (RM 36.35 to RM 36.80) with sparsely vegetated cobble bars and LWD.

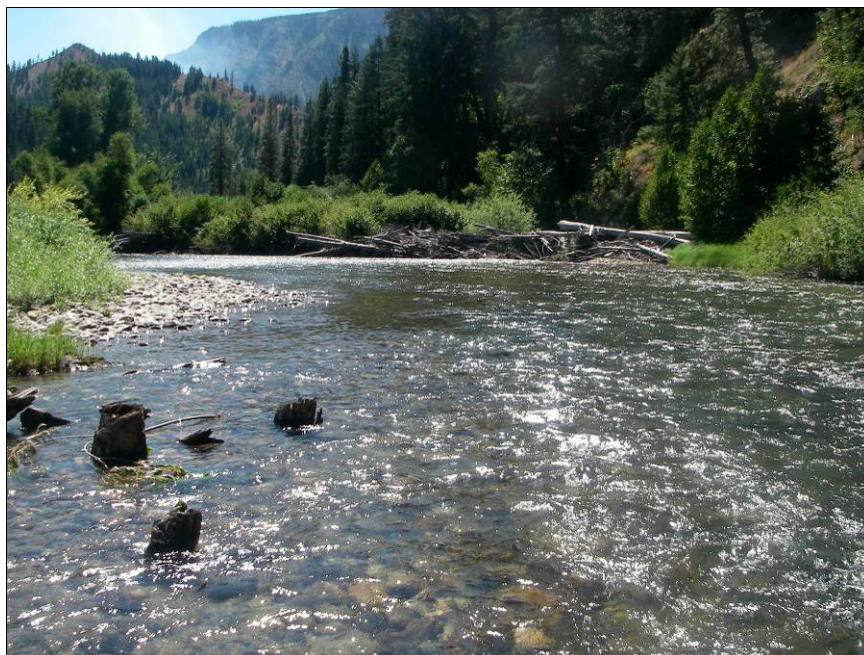
Figure 25. Wood pilings that are presumed to be remnants from historical log drives are found throughout Reach 1.

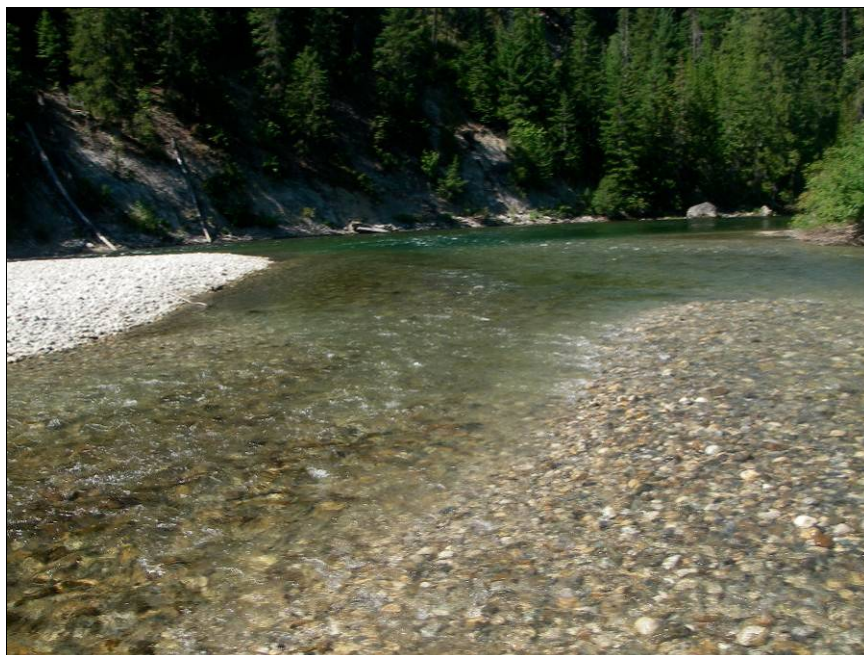
Figure 26. Spawning gravel and rearing habitat near RM 36.9 where the channel becomes confined at the downstream end of a side-channel complex (August 2011).

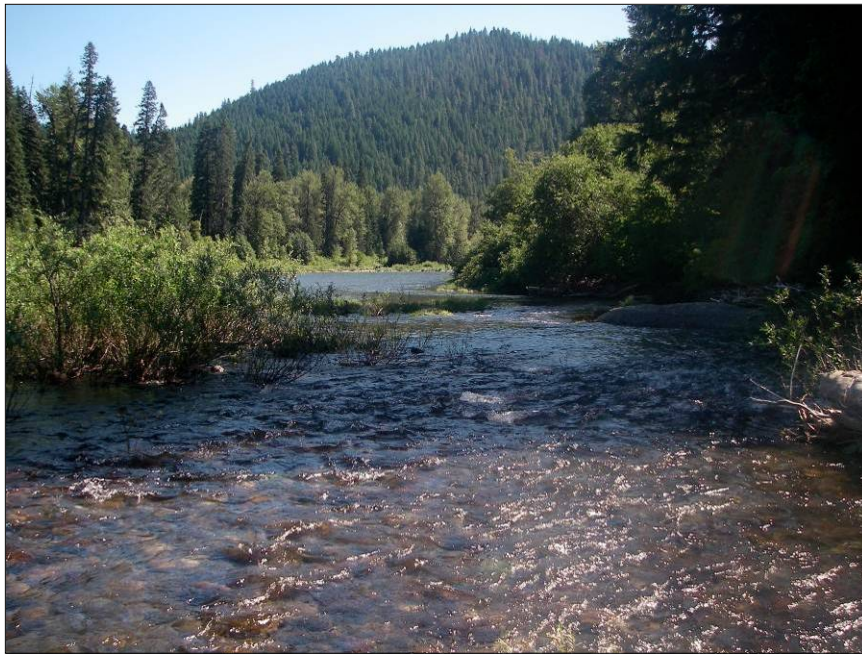
Figure 32. View looking downstream at a river-right side-channel near RM 37.7 that has a frequently inundated sandbar with willow and grasses (August 2011).

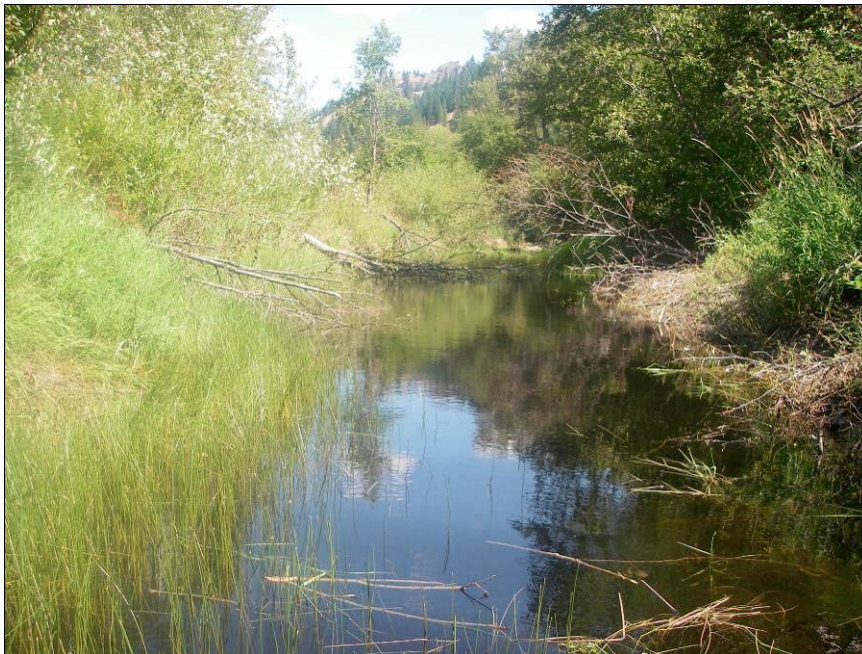
Figure 44. Representative disconnected (at average flows) side-channel found throughout the upper portion of Reach 3. Many of these side-channels flow around sparsely vegetated, yet highly stable cobble bars. High water or hyporheic flow maintains surface water in these side-channels (August 2011).

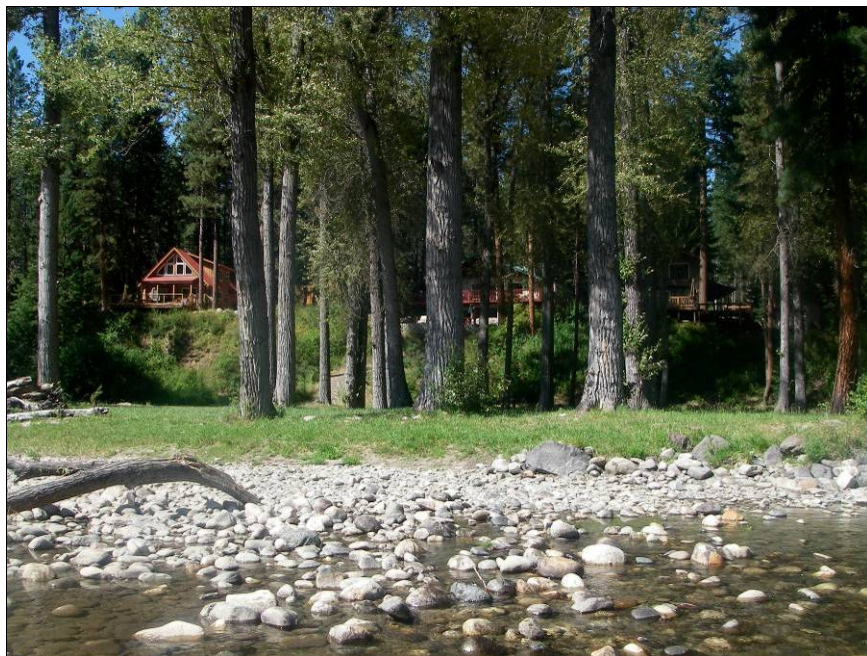
Figure 45. A low elevation floodplain surface along river-right affected by clearing and residential impacts (RM 40.1).

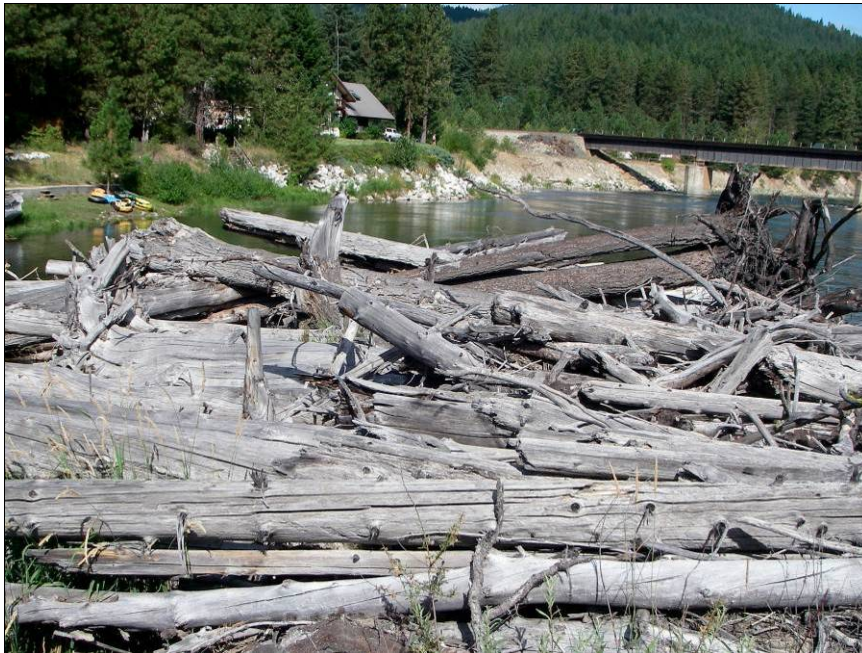
Figure 46. The largest LWD jam observed throughout the Upper Wenatchee study area was located in Reach 3, just downstream of the Burlington Northern Railroad Bridge at RM 41.8 (August 2011).

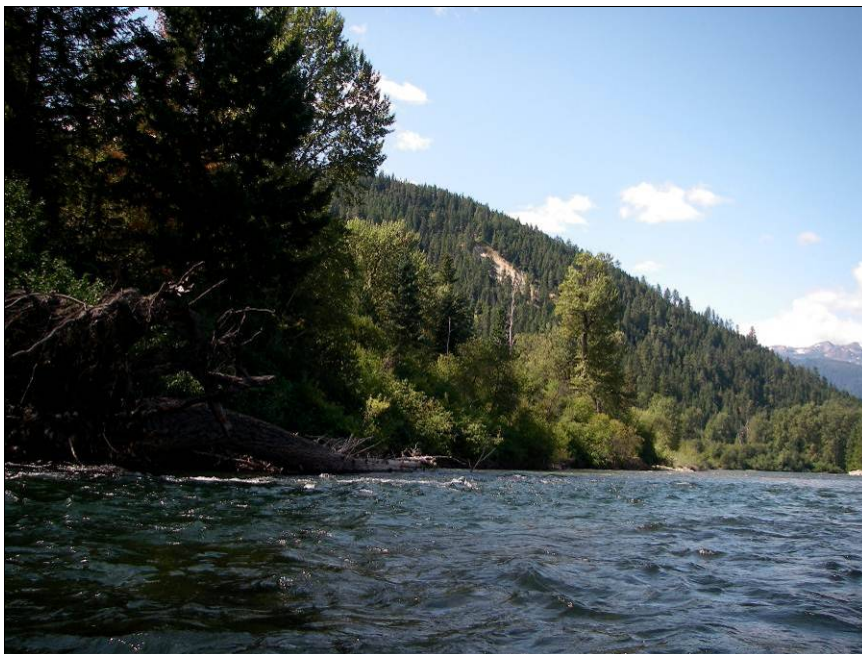
Figure 47. LWD with attached root wad provides habitat complexity and refuge in Reach 3 (August 2011).

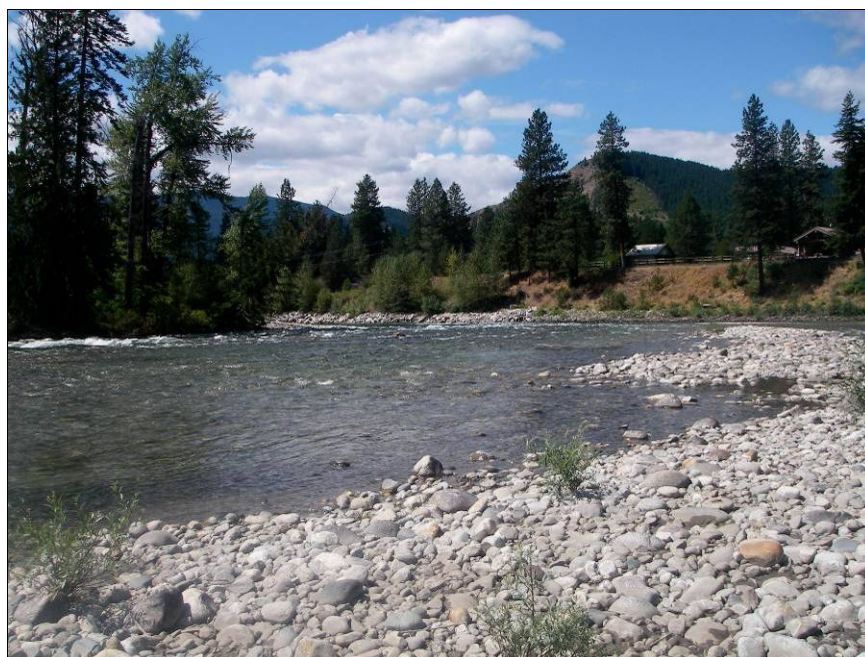
Figure 53. Large substrate was encountered throughout many mainstem Reach 3 riffles and bars (August 2011).

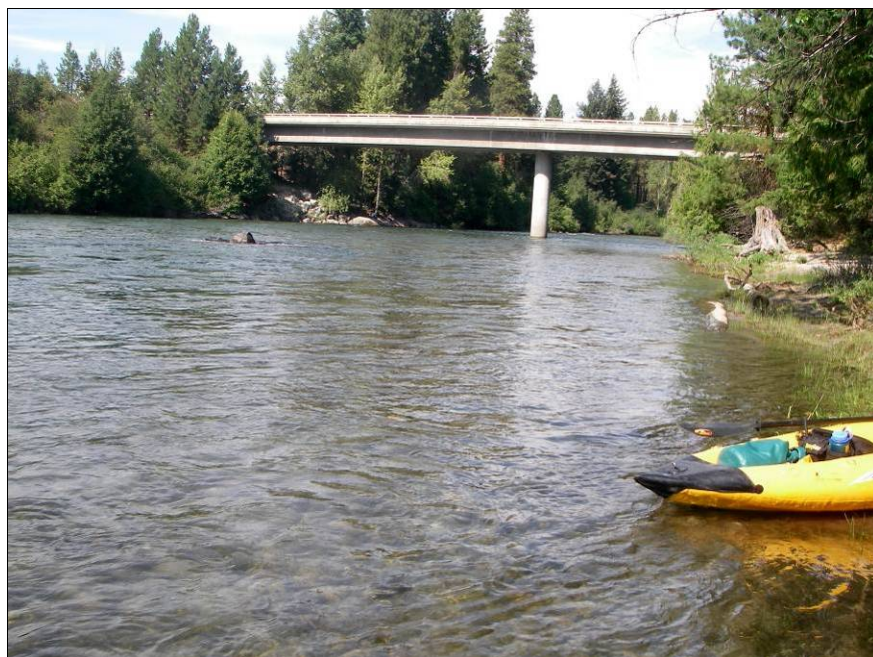
Figure 73. Beaver Valley Rd Bridge bisects the upper portion of Reach 5, where the channel is artificially confined by riprap armoring (August 2011).

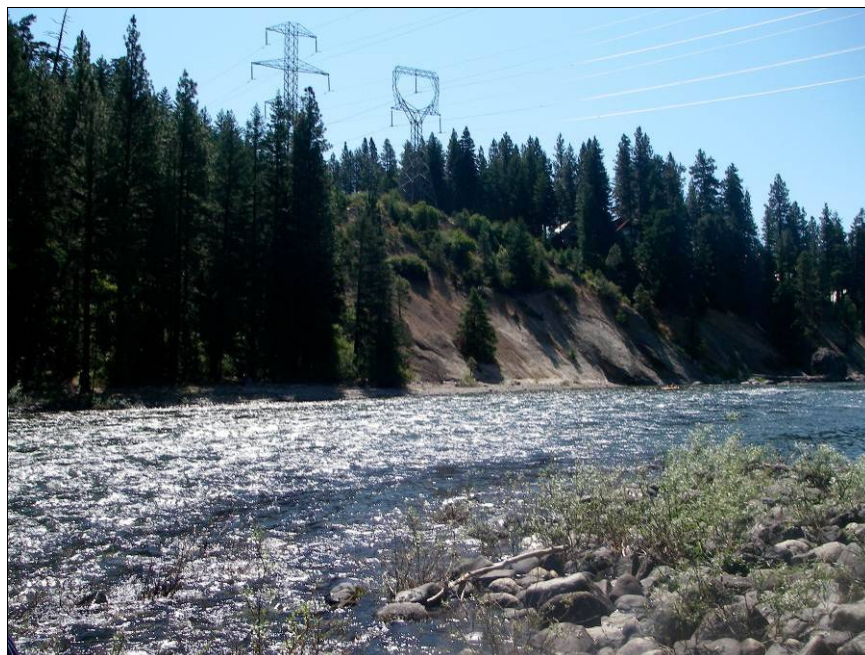
Figure 74. Transmission line clearing affects the riparian buffer and erosion near RM 44.45 (August 2011).

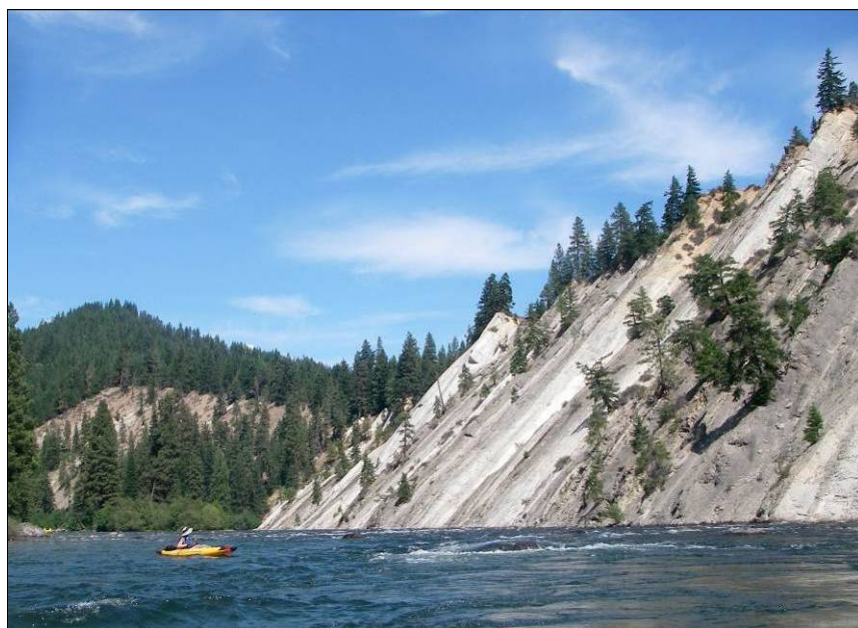
Figure 76. The Chumstick formation confines much of Reach 6 along river-left. This steep exposed sedimentary rock formation extends from RM 46.7 to RM 46.9 (August 2011).

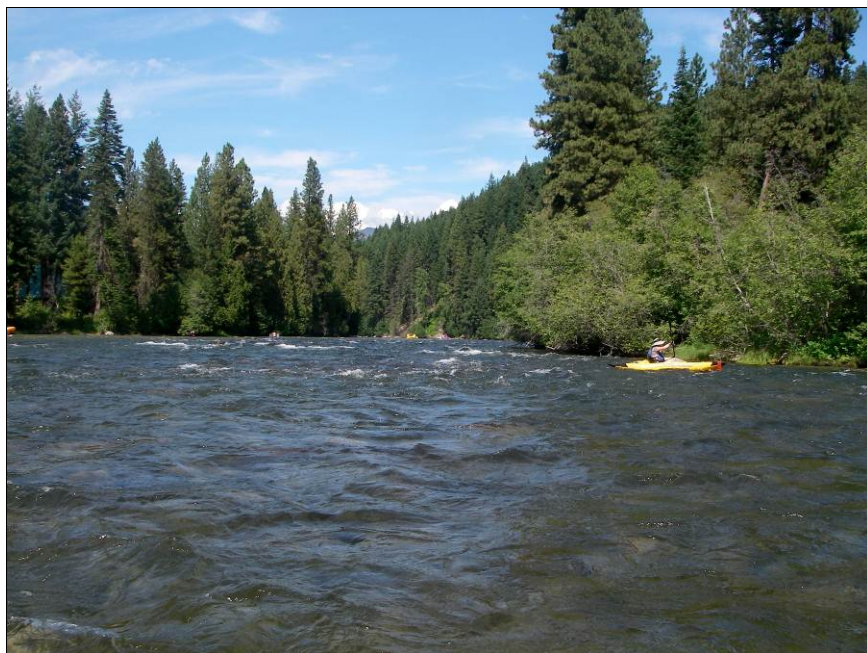
Figure 81. A side-channel (RM 46.9) flows along river-right opposite the steep sedimentary rock formation of Reach 6 (August 2011).

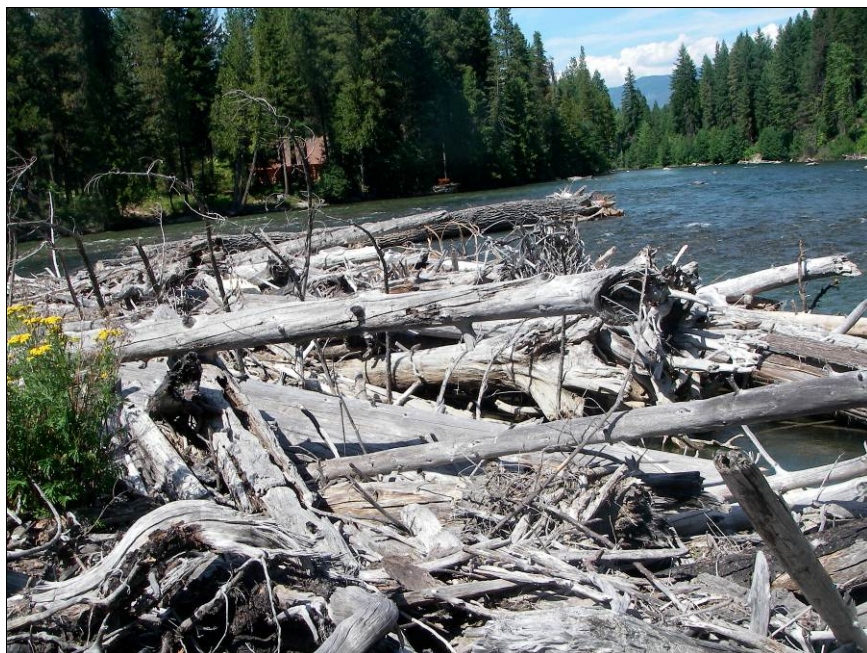
Figure 82. LWD jams have formed along the upstream margins of both mid-channel islands in Reach 6 (August 2011).

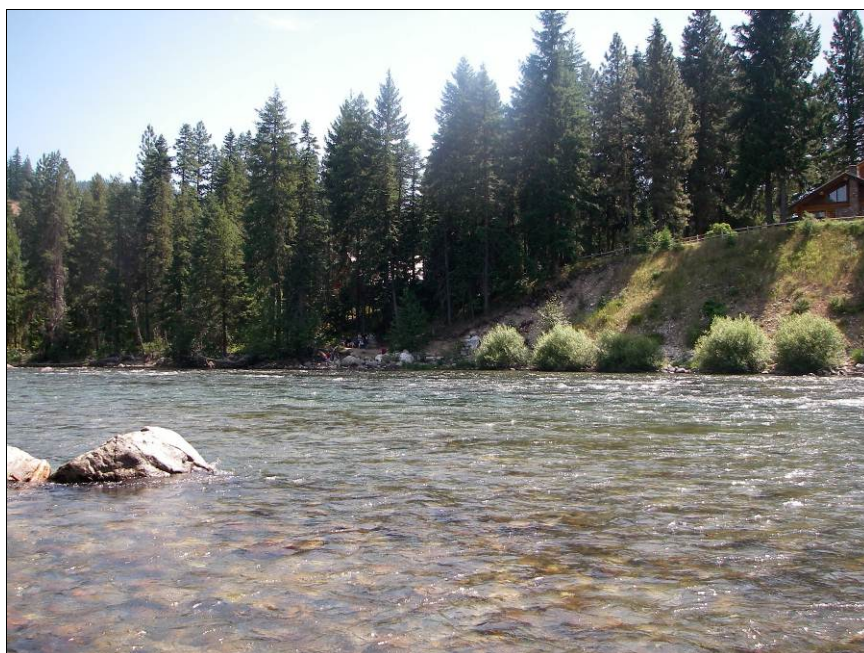
Figure 84. Vegetation clearing and river access impacts riparian buffers at residential properties in Reach 6 (August 2011).

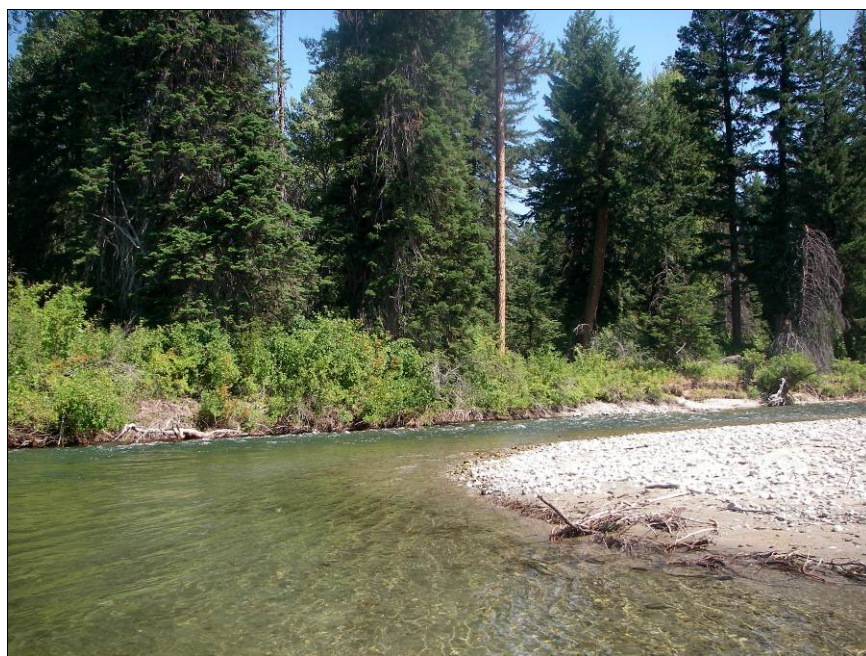
Figure 86. Sand and gravel alluvial deposits form a bar along the upper portion of Reach 7 on river-left just downstream of the Chiwawa River confluence (August 2011).

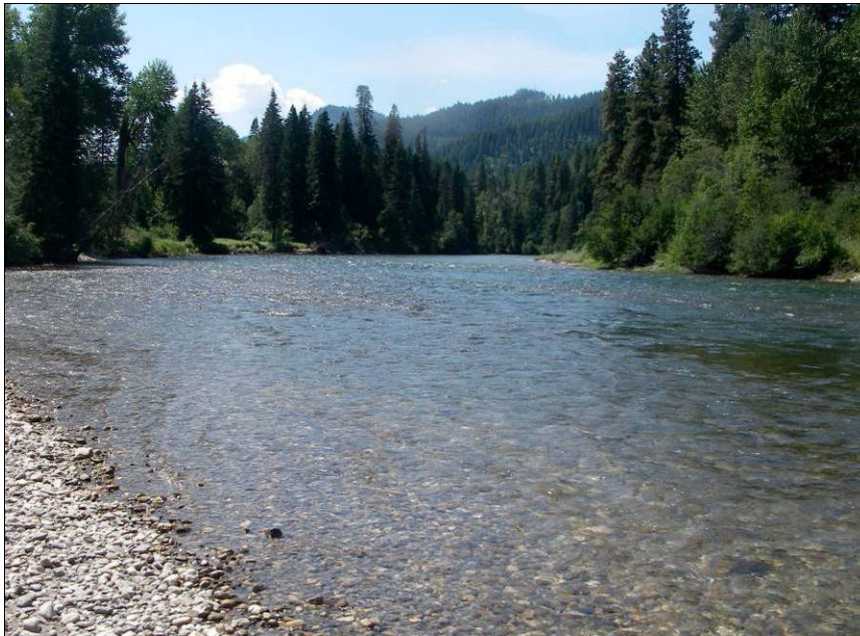
Figure 90. Alluvial gravel deposits from the Chiwawa River create areas of localized spawning habitat in Reach 7 (August 2011).

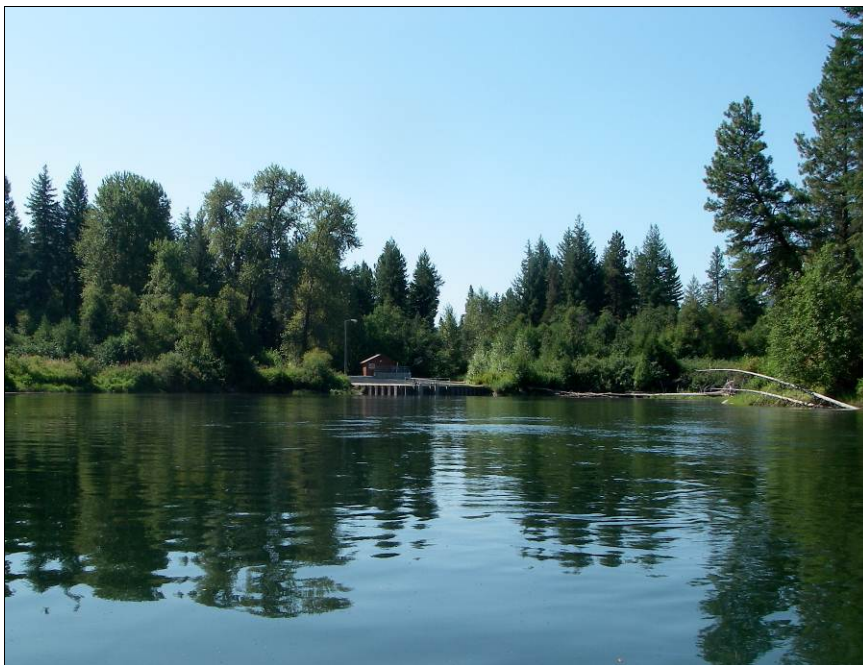
Figure 93. Small concrete retaining wall at meander bend just upstream from the WDFW hatchery facility (August 2011).

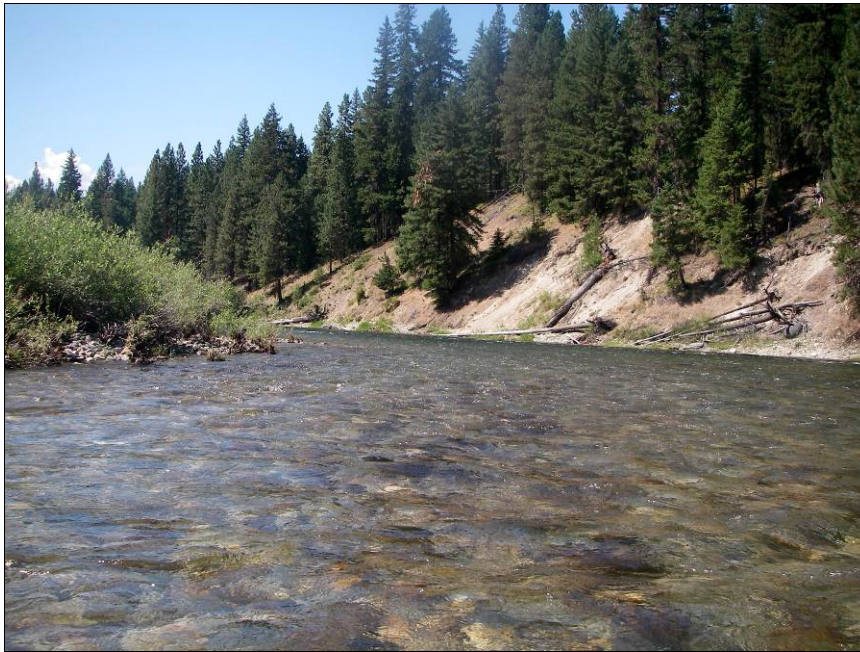
Figure 96. View downstream at a sparsely vegetated cobble bar and right bank terrace in the lower portion of Reach 8 near RM 48.8 (August 20011).

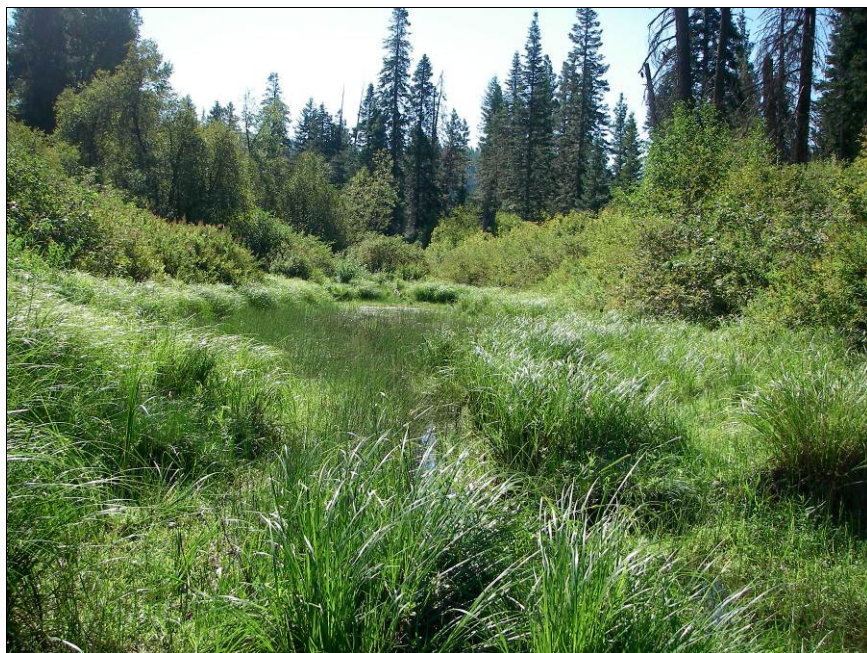
Figure 97. Off-channel marsh along the river-left bank at RM 49.1 (August 2011).

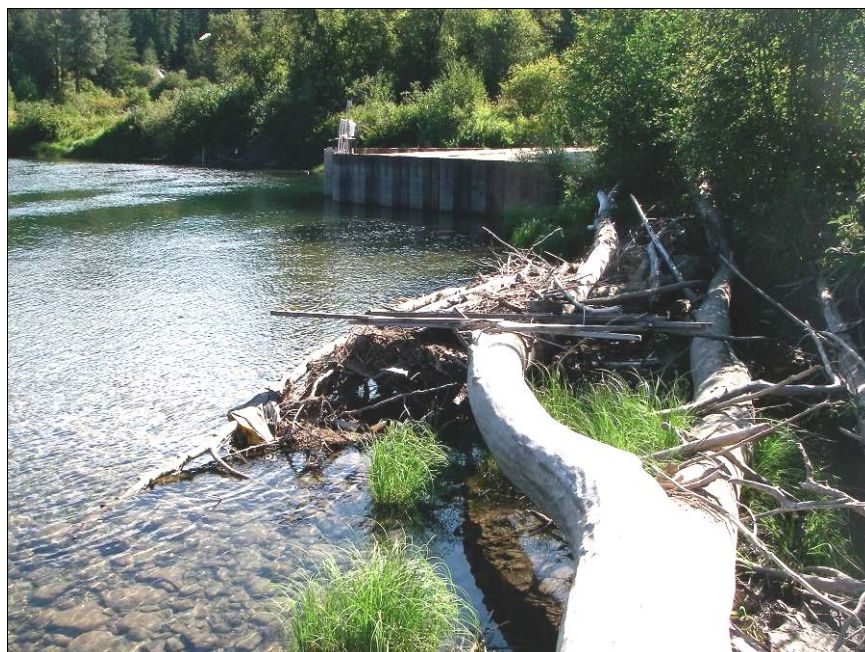
Figure 100. Concrete intake structure at the WDFW hatchery facility (August 2011).

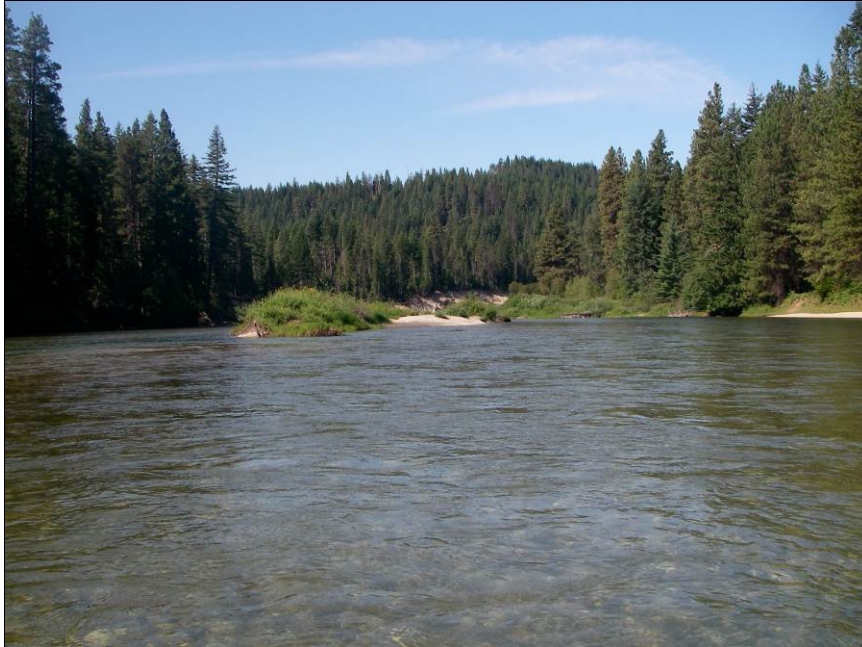
Figure 106. Reach 9 side-channel habitat provides adequately sized spawning gravels (August 2011).

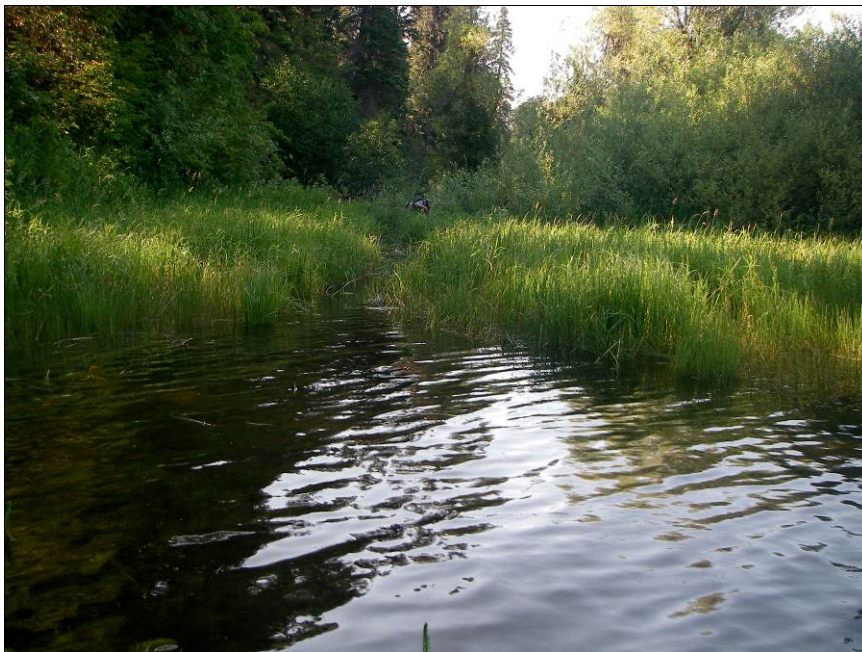
Figure 107. Beaver activity was observed along a river-right backwater near RM 50.9 (August 2011).

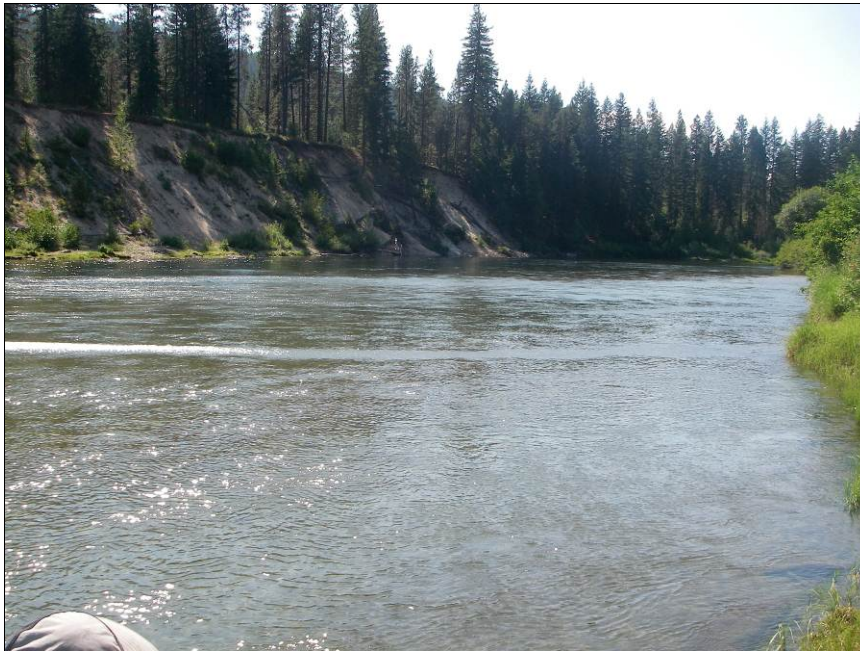
Figure 112. Bank instability was observed along many of the steep terrace banks throughout Reach 9 (August 2011).

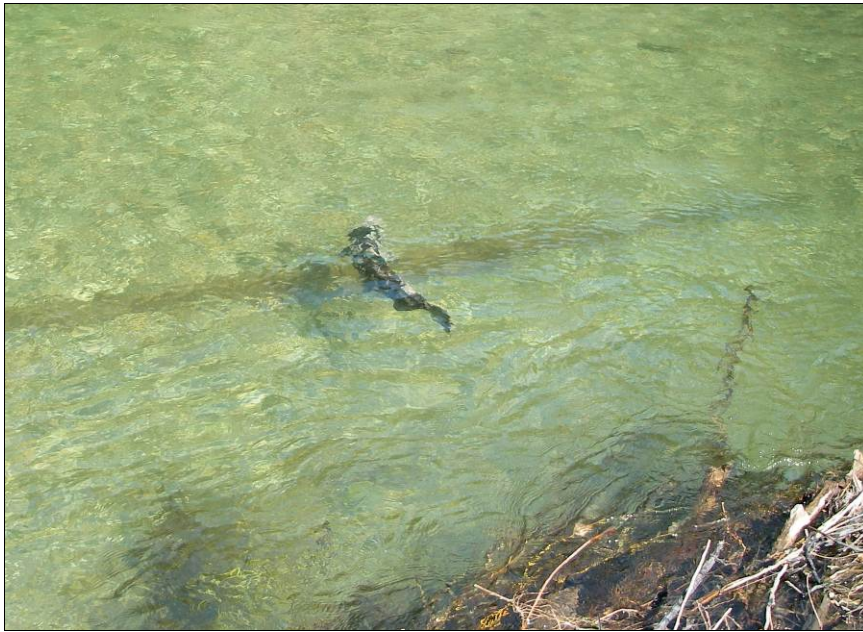
Figure 113. Submerged woody material provides refugia for Chinook in Reach 9 (August 2011).

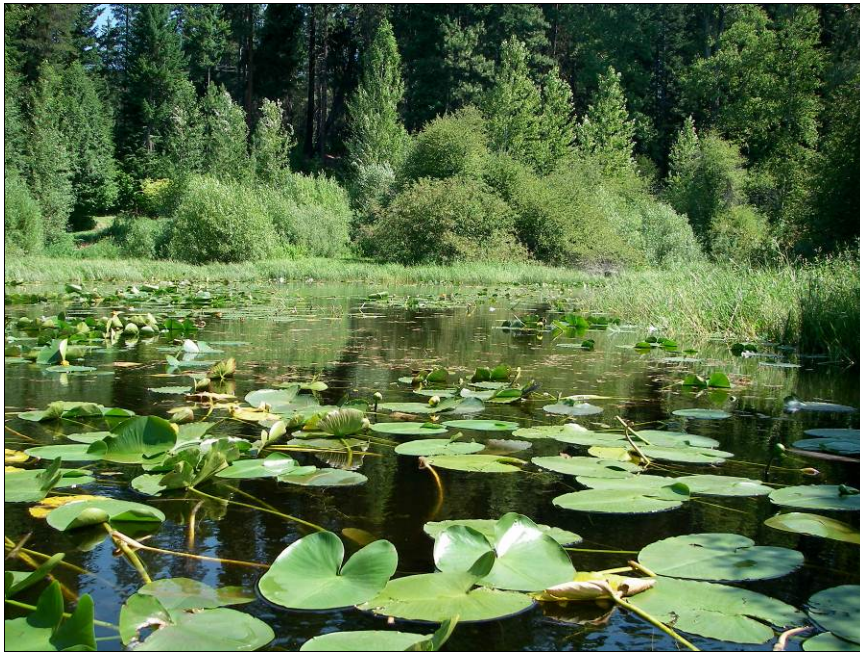
Figure 122. One of two extensive open water marshlands on river-left, Reach 10 (August 2011).

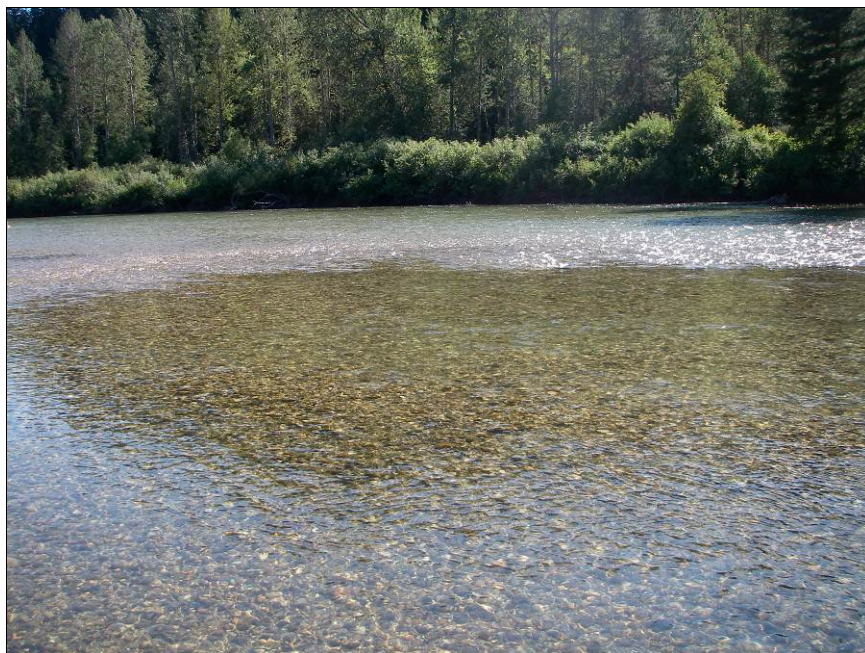
Figure 129. Gravel was the dominant substrate found in spawning riffles throughout Reach 10 (August 2011).
