APPENDIX D

Reach-Based Ecosystem Indicators (REI)

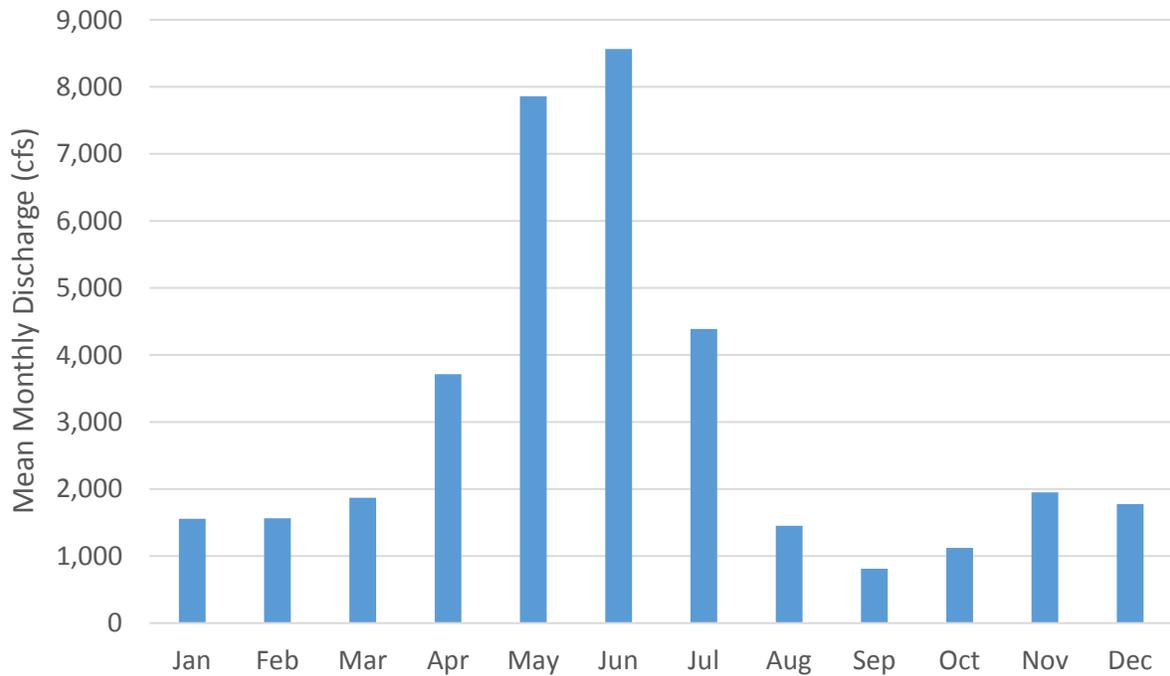
Figure 1. Mean Monthly Discharge at Peshastin for period 1929 to 2014 (USGS Gage 12459000)

In the Wenatchee River watershed, precipitation falls mostly as snow; the snowmelt in spring and early summer is the primary source of surface water (MWG et al. 2003). Spring snowmelt dominates the seasonal flow pattern in the watershed, with peak runoff from April through July, with the highest rates in May and June (Figure 1).

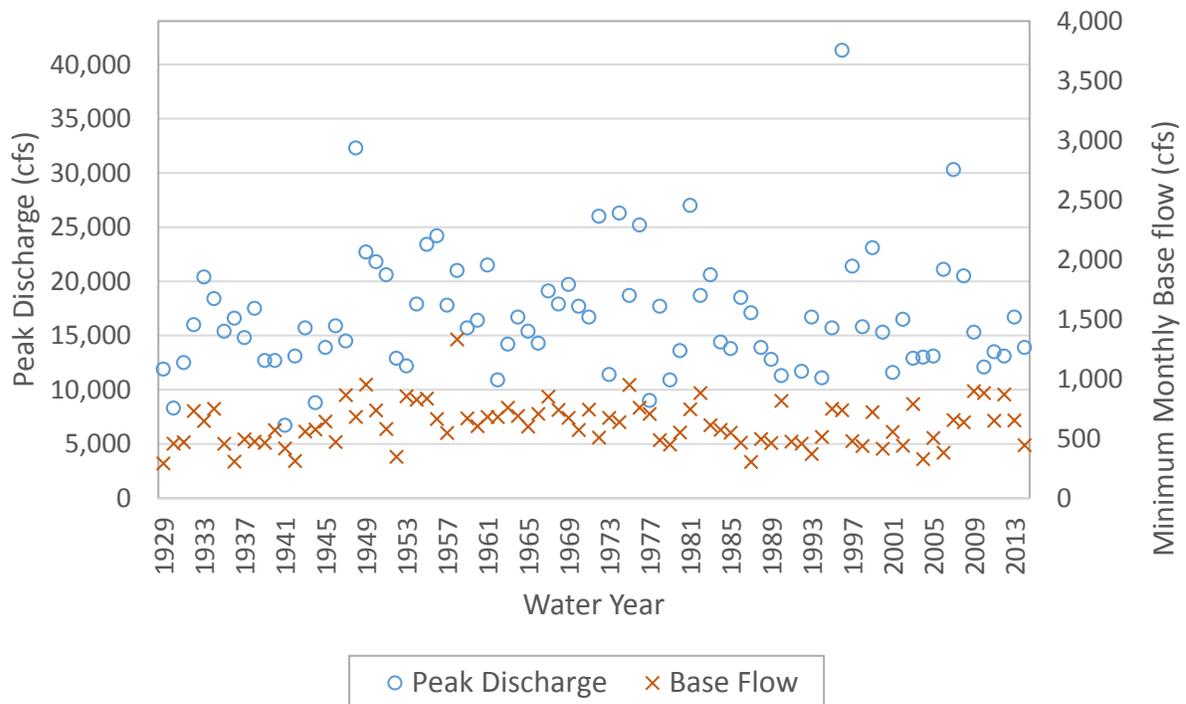
Figure 2. Peak and Base Flows of the Wenatchee River at Peshastin from 1929 to 2013 (USGS Gage 12459000).

Top flood events have not noticeably increased in frequency or magnitude since 1929 (Table 1), with the largest 20 events spread out over the 1940s through 2000s. Figure 2 shows base flows and peak flows calculated for the Wenatchee River at Peshastin gage (USGS 12459000) since 1929. While human alterations to the watershed may have contributed to a change in peak flows, determining this causal relationship would require more complex analysis than is possible for this assessment (Hall et al. 2014).

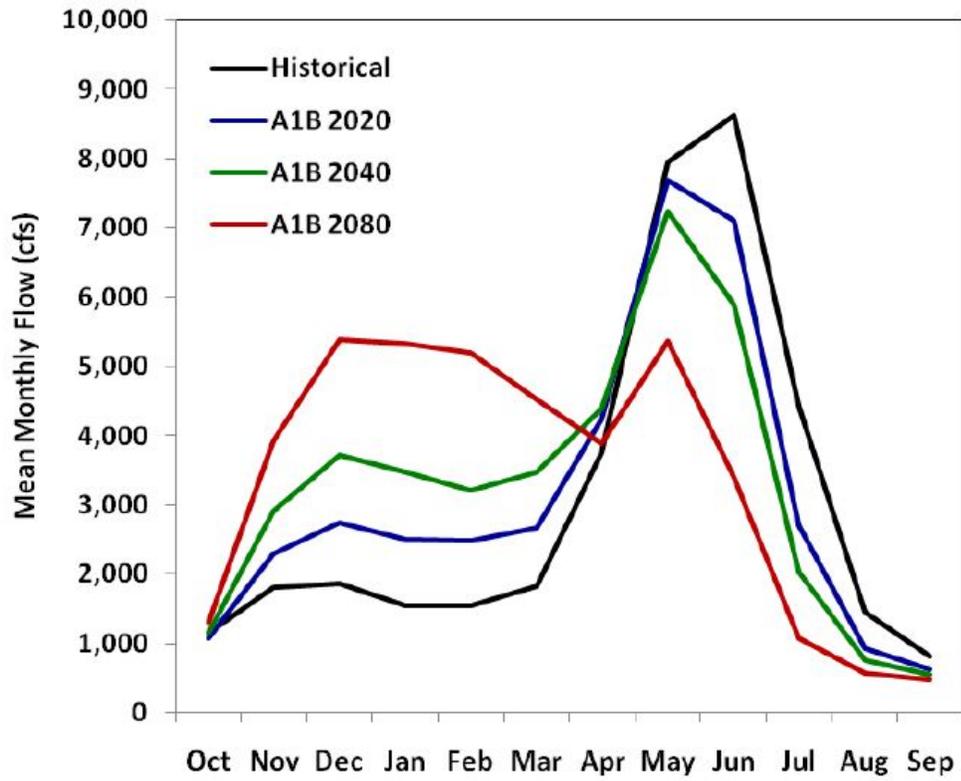
Figure 3. Projected Impacts of Climate Change on Mean Monthly Flows of Wenatchee River at Peshastin (Elsner 2011)

Climate change projections indicate that rainfall may increase 1 to 2 percent by 2040, and 4 percent by 2080 (e.g., Mote and Salanthe 2009). Climate change models (synthesized by CIG 2009) also predict an increase in winter stream flows, earlier and lower peak runoff, and lower

summer baseflows (Figure 3). These analyses suggest that human-induced climate change is likely to alter the magnitude, timing, duration, and frequency of streamflows.

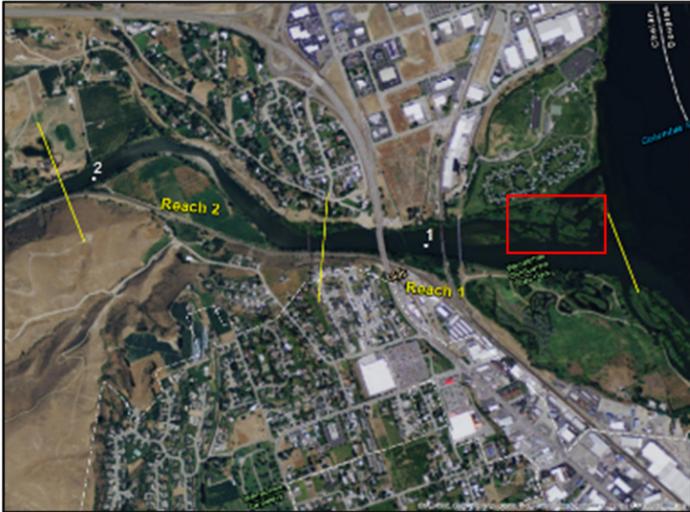
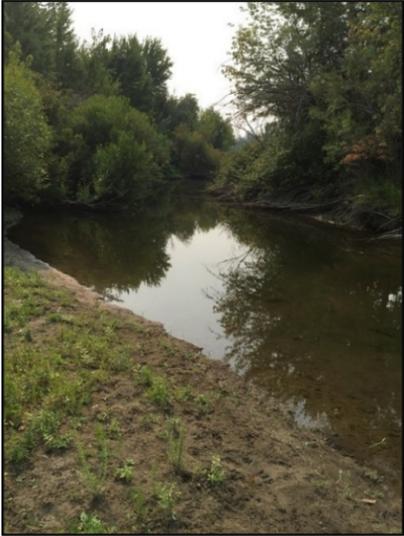
Project Area 1 RM 0.3 to 0.8 Left Bank	Install Habitat Structures	<ul style="list-style-type: none"> Remove non-native plants Riparian planting Install LWD structures (whole trees, jams, etc.) 	Existing distributary channels lack complex instream habitat and cover. Installing LWD habitat structures would create habitat complexity and cover in distributary channels. Heavy equipment access to distributary channels may be limited requiring additional design considerations.	3

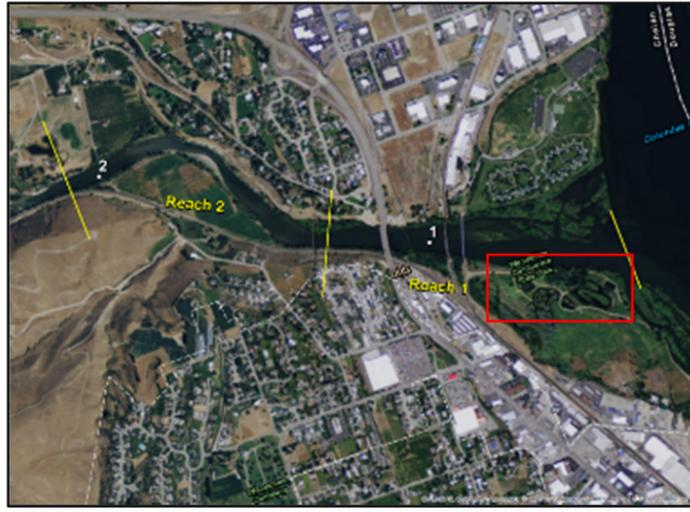
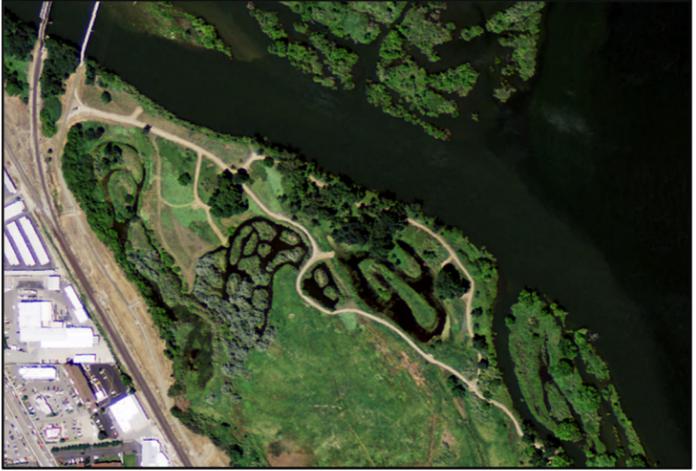
Project Area 2 RM 0.3 to 0.9 Right Bank	Floodplain Habitat Reconnection	<ul style="list-style-type: none"> Remove non-native plants Riparian planting Remove or setback levee Bank stabilization with LWD and bioengineering Install LWD structures (whole trees, jams, etc.) Remove or relocate floodplain infrastructure Perennial side channel creation/enhancement Secondary channel (non-perennial) creation/enhancement Wetland creation/enhancement Alcove creation/enhancement 	Historical distributary channels are disconnected from mainstem river. Past restoration efforts have focused on wildlife habitat. Reconnecting historical distributary channels, wetlands, and floodplain habitat would increase rearing habitat availability. Bank stabilization with LWD and bioengineering would provide added instream habitat and cover. Riparian vegetation restoration in cleared areas would provide shade and long-term recruitment potential. This project would require modification of existing trails and infrastructure.	1

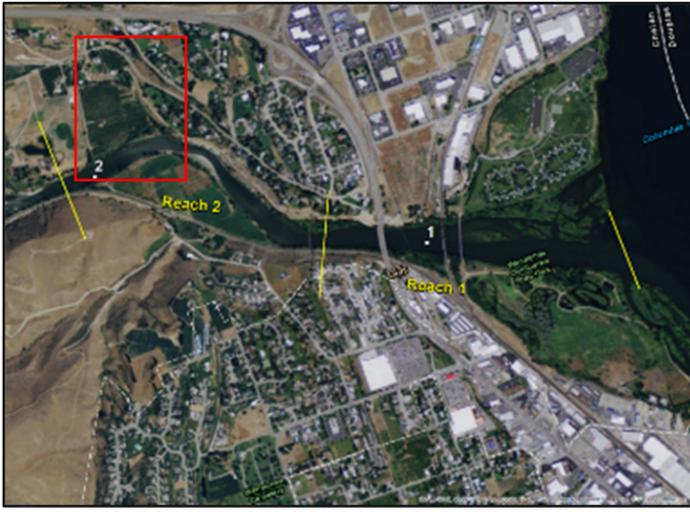
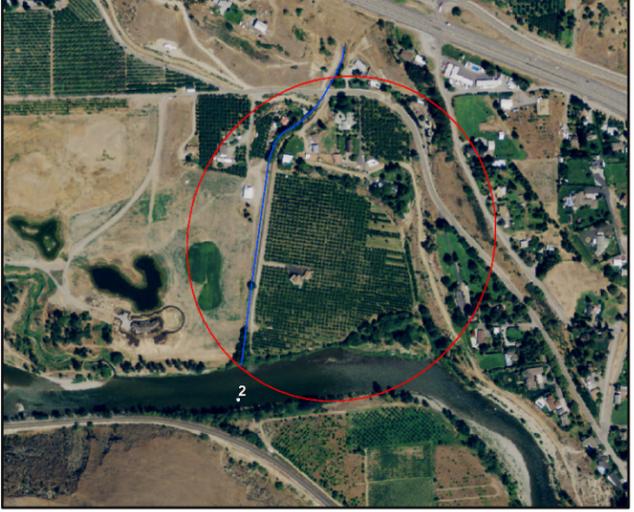
Project Area 3 RM 1.8 to 2.0 Left Bank	Floodplain Habitat Reconnection	<ul style="list-style-type: none"> Remove non-native plants Riparian planting Riparian fencing Install LWD structures (whole trees, jams, etc.) Perennial side channel creation/enhancement Wetland creation/enhancement Alcove creation/enhancement 	Existing irrigation ditch (Highline Ditch return) currently functions as a cold water return source. There is also a small existing alcove providing limited habitat. Realigning and enhancing this irrigation return ditch with pools and LWD structures as well as expanding and enhancing the existing alcove would increase rearing habitat availability. Riparian vegetation restoration in cleared areas would provide shade and long-term recruitment potential.	1

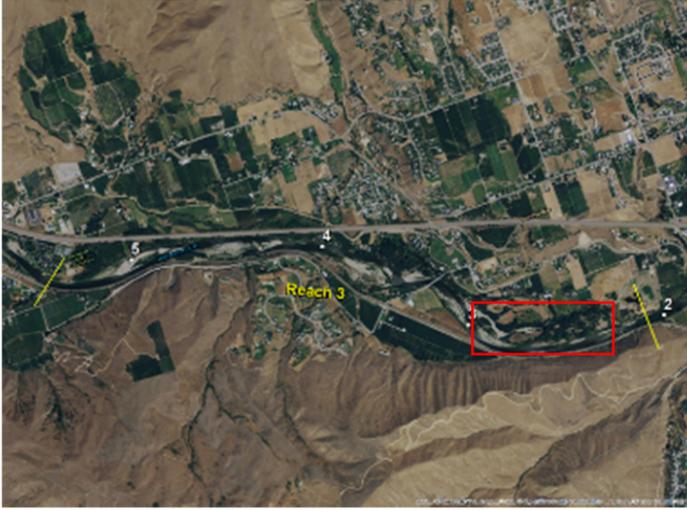
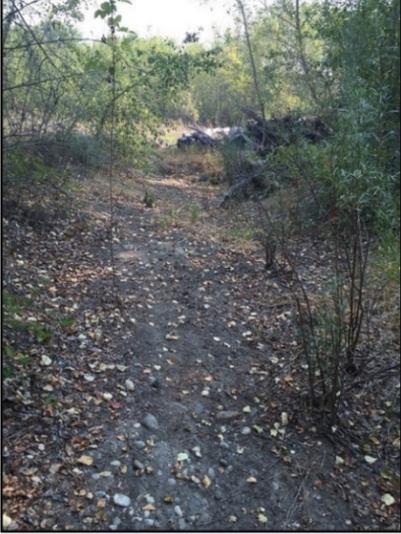
Project Area 4 RM 2.2 to 3.0 Left Bank	Floodplain Habitat Reconnection	<ul style="list-style-type: none"> Remove non-native plants Riparian planting Install LWD structures (whole trees, jams, etc.) Perennial side channel creation/enhancement Secondary channel (non-perennial) creation/enhancement Wetland creation/enhancement Alcove creation/enhancement Groundwater fed off-channel creation/enhancement 	<p>There is a network of existing side channels that are disconnected at lower flows. The project area is relatively large with considerable potential.</p> <p>Reconnecting side channels and installing LWD structures would increase available rearing habitat.</p> <p>Riparian vegetation restoration would provide shade and long-term recruitment potential.</p> <p>This project would require excavating the inlet and LWD structures to control inlet flows.</p>	1

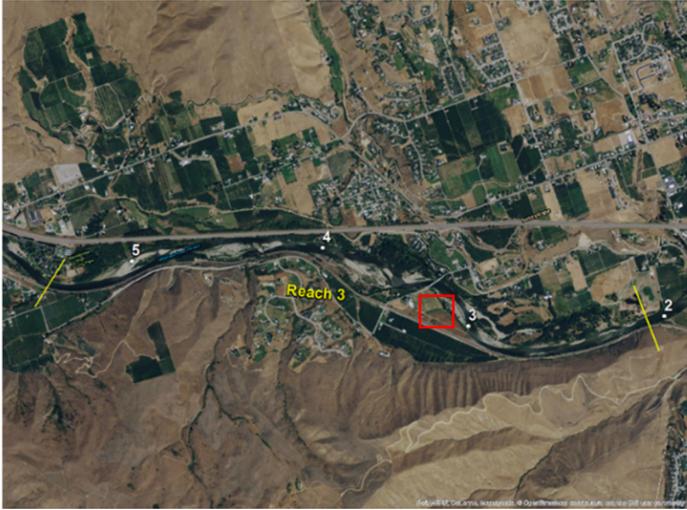
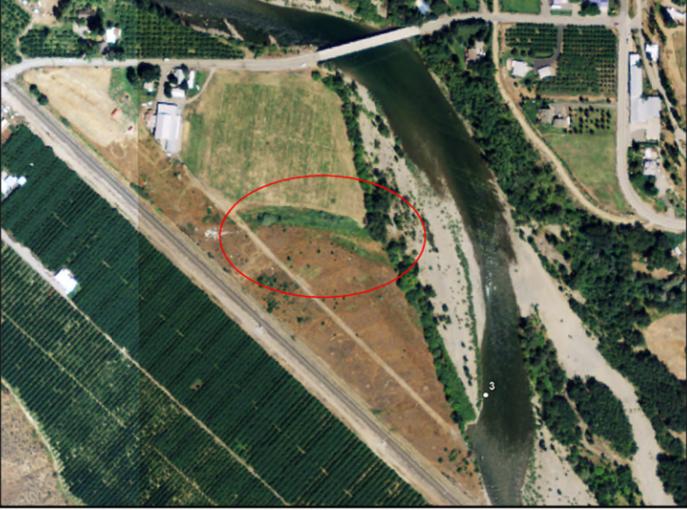
Project Area 5 RM 3.1 to 3.2 Right Bank	Floodplain Habitat Reconnection	<ul style="list-style-type: none"> Remove non-native plants Riparian planting Install LWD structures (whole trees, jams, etc.) Wetland creation/enhancement Alcove creation/enhancement Groundwater fed off-channel creation/enhancement 	<p>The low floodplain topography in this project area is currently inundated at the 2-yr flood event.</p> <p>Reconnecting this floodplain habitat and constructing or enhancing alcoves, wetlands, and off-channel areas would require minimal excavation and would increase available rearing habitat.</p> <p>This project would require excavation and/or LWD structure upstream to encourage perennial flows.</p> <p>Riparian vegetation restoration in cleared areas would provide shade and long-term recruitment potential.</p>	2

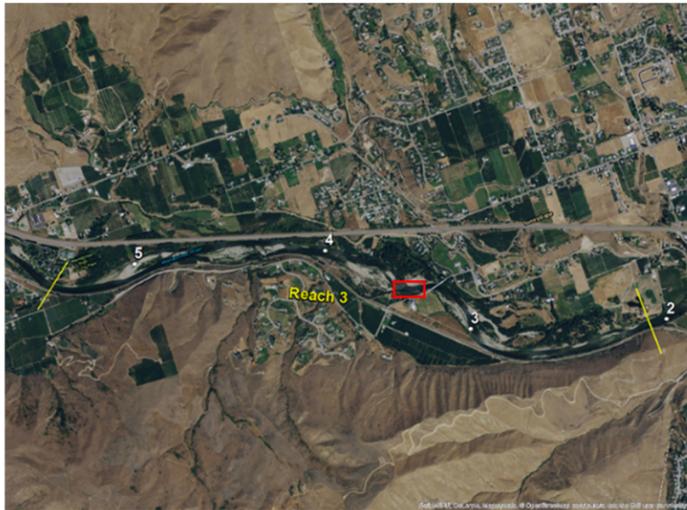
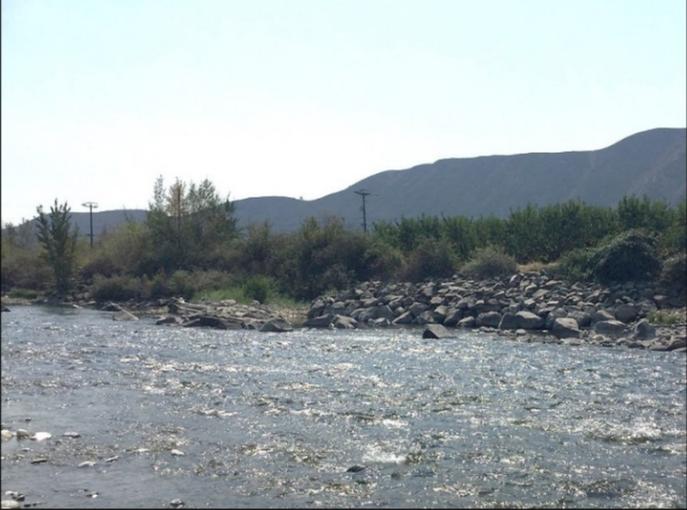
Project Area 6 RM 3.3 to 3.4 Right Bank	Enhance Existing Bank Protection	<ul style="list-style-type: none"> Bank stabilization with LWD and bioengineering 	<p>The existing boulder groins in this project area provide bank stability, but only minimal habitat benefit.</p> <p>Incorporating LWD into the bank protection would create local habitat complexity and cover. LWD structures would also provide opportunity to create local scour pools.</p> <p>The design of bank stabilization structures in this project area would need to consider recreational boater safety.</p>	3

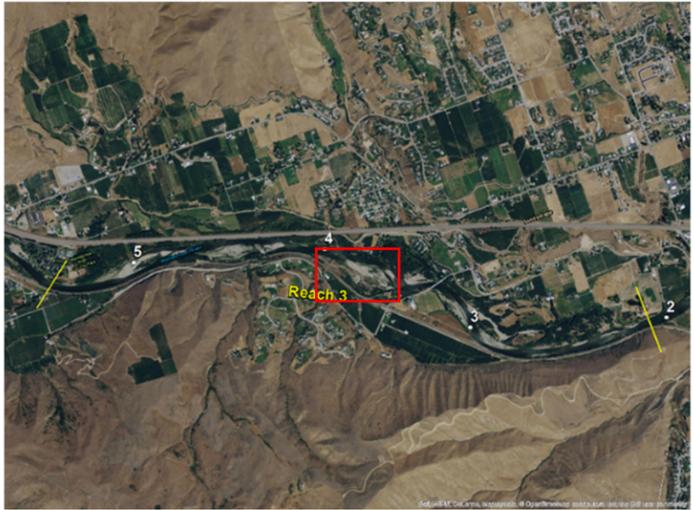
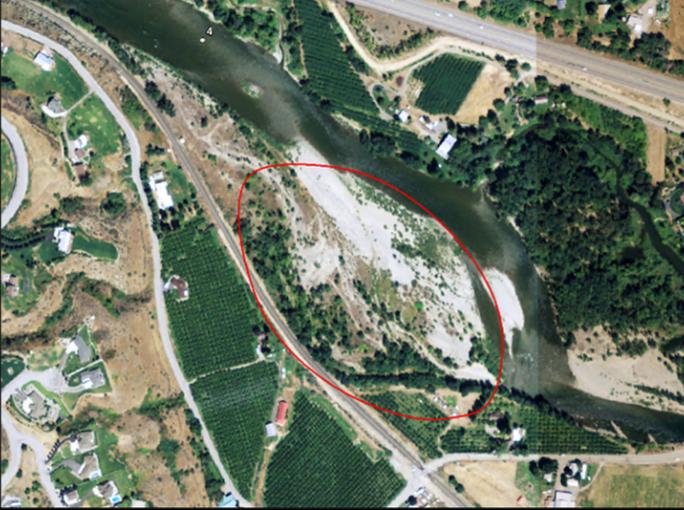
Project Area 7 RM 3.6 to 4.0 Right Bank	Floodplain Habitat Reconnection	<ul style="list-style-type: none"> Remove non-native plants Riparian planting Install LWD structures (whole trees, jams, etc.) Perennial side channel creation/enhancement Secondary channel (non-perennial) creation/enhancement Alcove creation/enhancement 	<p>The downstream section of existing side channel has good habitat complexity and cover, while upstream section is lacking. There is currently no defined inlet to the side channel. Reconnecting side channels and enhancing alcove habitat with LWD for habitat complexity and cover would increase available rearing habitat.</p> <p>Riparian vegetation restoration in disturbed areas would provide shade and long-term recruitment potential. This project will require a relatively large excavation to initiate side channel and/or LWD structure to control inlet flows.</p>	1

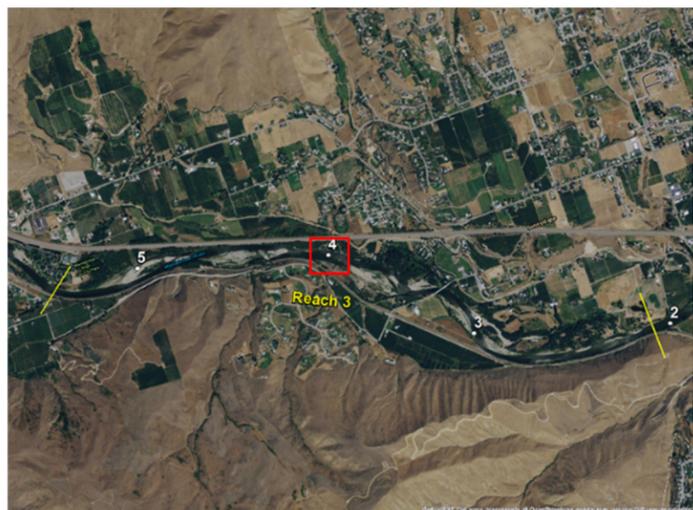
Project Area 8 (CMZ 6) RM 3.9 to 4.1 Left Bank	Floodplain Habitat Reconnection (Modify Existing Restoration Site)	<ul style="list-style-type: none"> Install LWD structures (whole trees, jams, etc.) Perennial side channel creation/enhancement 	<p>This existing side channel restoration project (CMZ 6) has good habitat complexity and cover, but does not receive perennial flow. Sediment accumulation at the inlet has reduced connectivity.</p> <p>Installing LWD structures and modifying the side channel inlet would improve function by providing perennial flow and an increase in available rearing habitat.</p>	2

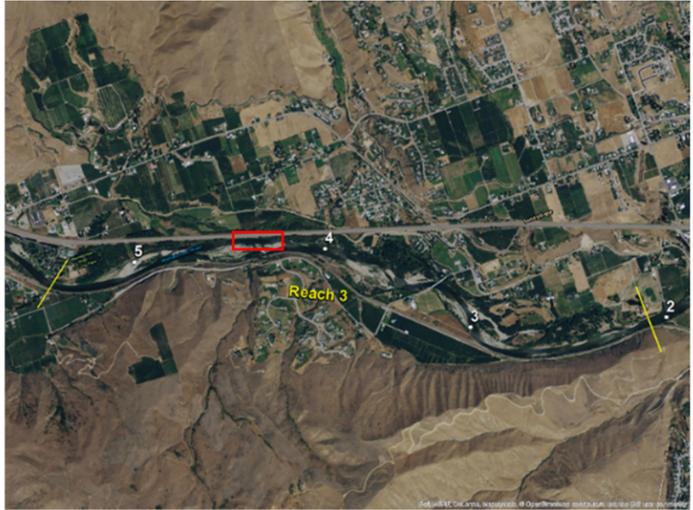
Project Area 9 RM 4.3 to 4.6 Left Bank	Enhance Existing Bank Protection	<ul style="list-style-type: none"> Bank stabilization with LWD and bioengineering 	<p>The existing boulder groins in this project area provide bank stability, but only minimal habitat benefit. Incorporating LWD into the bank protection would create local habitat complexity and cover. LWD structures would also provide opportunity to create local scour pools.</p> <p>The design of bank stabilization structures in this project area would need to consider recreational boater safety.</p>	3

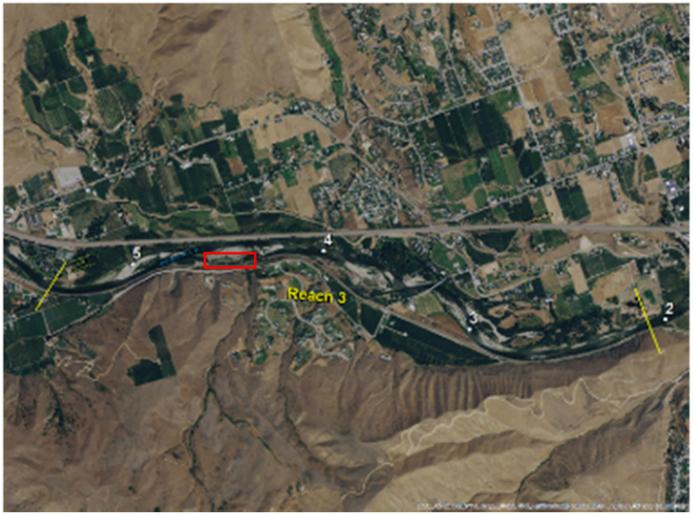
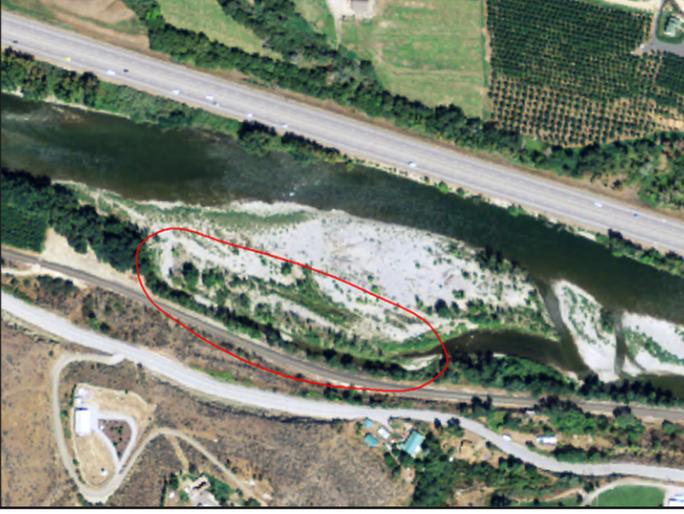
Project Area 10 RM 4.4 to 4.7 Right Bank	Floodplain Habitat Reconnection	<ul style="list-style-type: none"> Remove non-native plants Riparian planting Install LWD structures (whole trees, jams, etc.) Perennial side channel creation/enhancement Secondary channel (non-perennial) creation/enhancement Alcove creation/enhancement 	<p>The existing alcove in this project area has good complexity but cover is limited.</p> <p>Expanding and enhancing the existing alcove would increase available rearing habitat.</p> <p>Reconnecting side channels and installing LWD structures would also increase available rearing habitat</p> <p>Riparian vegetation restoration in disturbed areas would provide shade and long-term recruitment potential.</p>	2

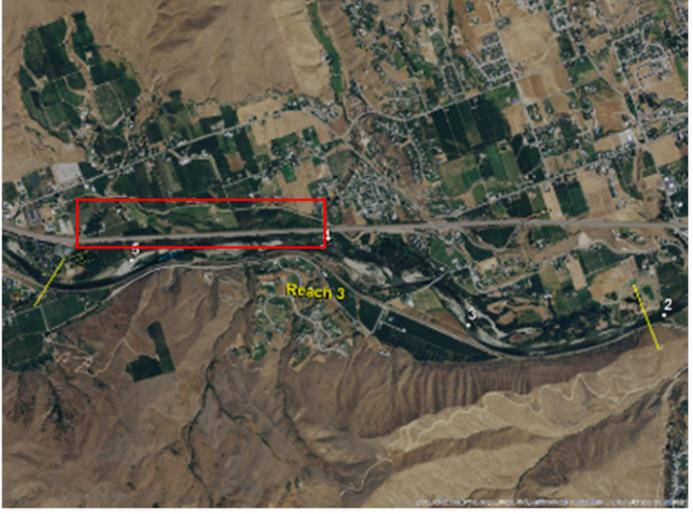
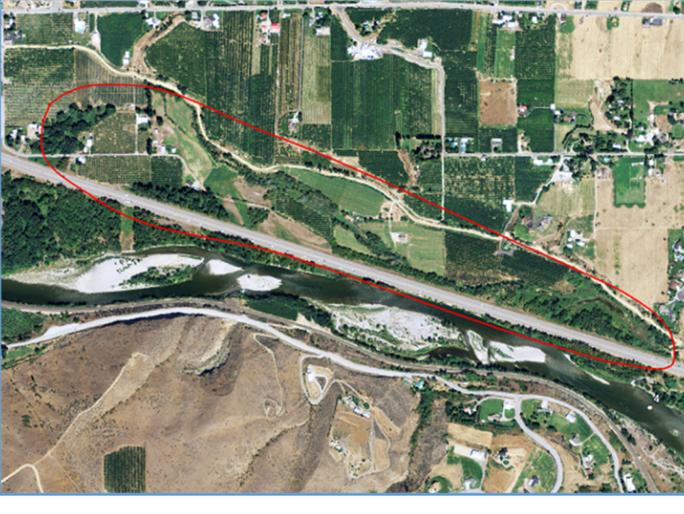
Project Area 11 RM 4.0 to 5.2 Left Bank	Floodplain Habitat Reconnection	<ul style="list-style-type: none"> Remove non-native plants Riparian planting Install LWD structures (whole trees, jams, etc.) Perennial side channel creation/enhancement Secondary channel (non-perennial) creation/enhancement Wetland creation/enhancement Alcove creation/enhancement Groundwater fed off-channel creation/enhancement Road relocation or modification Remove or relocate floodplain infrastructure Reconnect historical meander bend 	<p>A large portion of the historical floodplain in this project area is disconnected by U.S. Highway 2. The project area is relatively large with considerable potential. Reconnection of this section of floodplain would greatly increase rearing habitat availability.</p> <p>This project would evaluate several alternatives for floodplain restoration and reconnection including groundwater-fed, off-channel habitat.</p> <p>Installing new bridges or realigning the highway would need to be considered as a part of this project.</p>	1

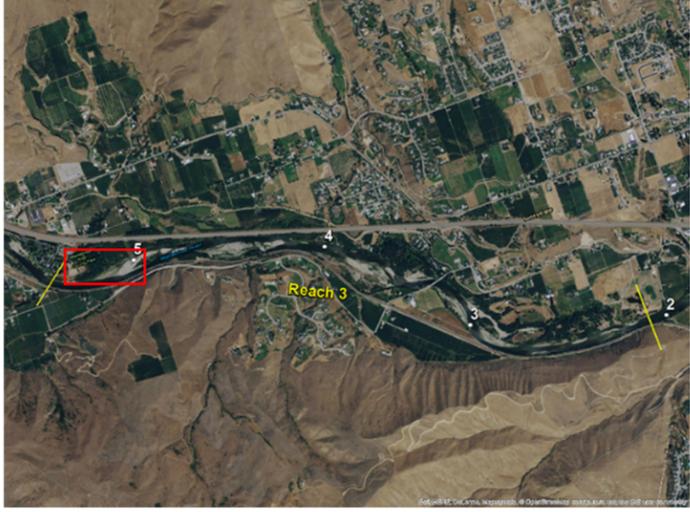
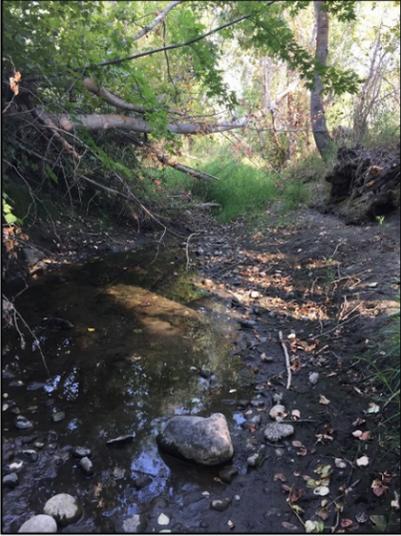
Project Area 12 RM 4.9 to 5.4 Left Bank	Floodplain Habitat Reconnection	<ul style="list-style-type: none"> Remove non-native plants Riparian planting Install LWD structures (whole trees, jams, etc.) Perennial side channel creation/enhancement Alcove creation/enhancement Groundwater fed off-channel creation/enhancement 	<p>The existing side channel in this project area has good habitat complexity and cover, but is disconnected at lower flows.</p> <p>Reconnecting side channels and creating/enhancing alcove habitat with LWD for habitat complexity and cover would increase available rearing habitat.</p> <p>Riparian vegetation restoration would provide shade and long-term recruitment potential.</p>	2

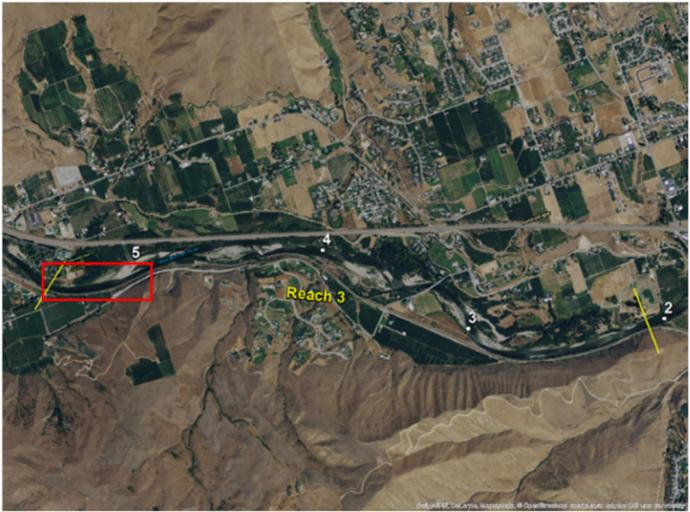
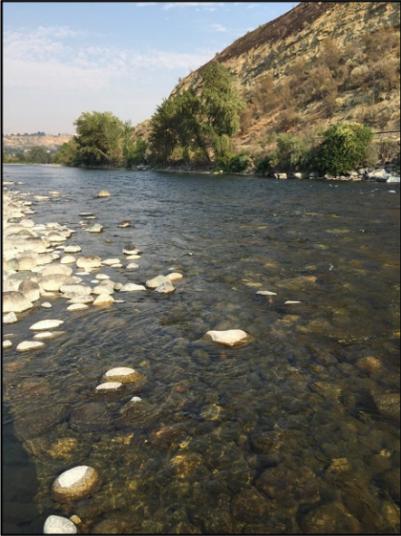
Project Area 13 RM 4.9 to 5.5 Right Bank	Enhance Existing Bank Protection	<ul style="list-style-type: none"> Bank stabilization with LWD and bioengineering 	<p>The existing boulder groins in this project area provide bank stability, but only minimal habitat benefit.</p> <p>Incorporating LWD into the bank protection would create local habitat complexity and cover. LWD structures would also provide opportunity to create local scour pools.</p> <p>The design of bank stabilization structures in this project area would need to consider recreational boater safety.</p>	3

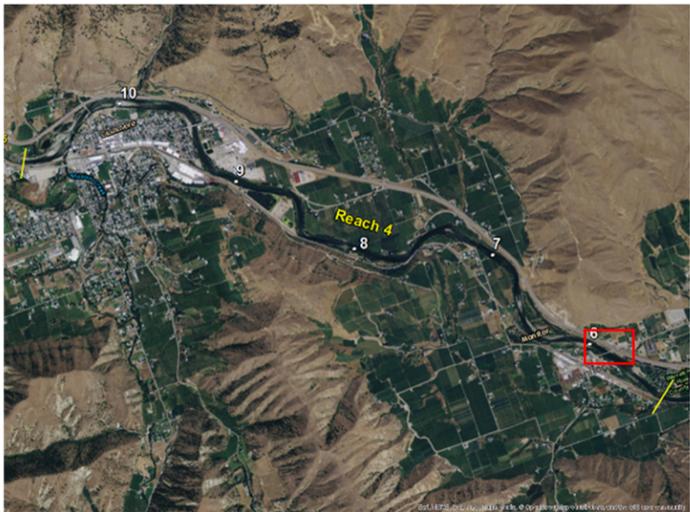
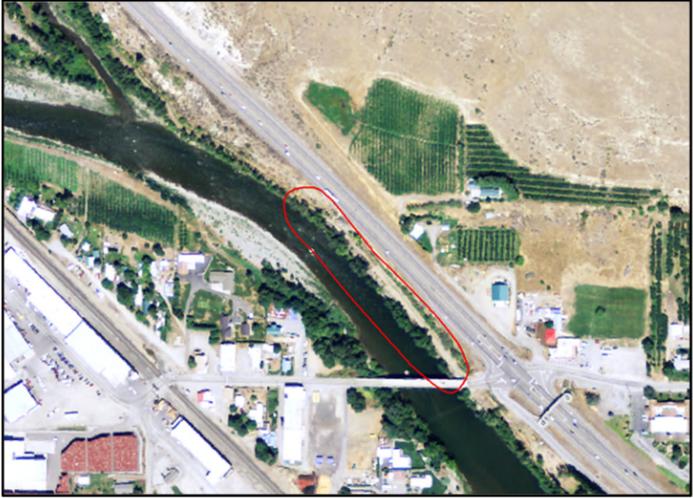
Project Area 14 RM 5.7 to 6.0 Left Bank	Enhance Existing Bank Protection	<ul style="list-style-type: none"> Bank stabilization with LWD and bioengineering 	<p>The existing boulder groins in this project area provide bank stability, but only minimal habitat benefit.</p> <p>Incorporating LWD into the bank protection would create local habitat complexity and cover. LWD structures would also provide opportunity to create local scour pools.</p>	3

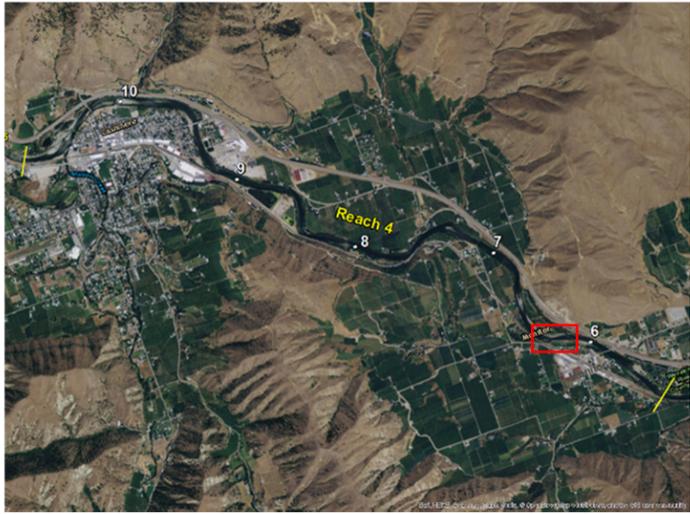
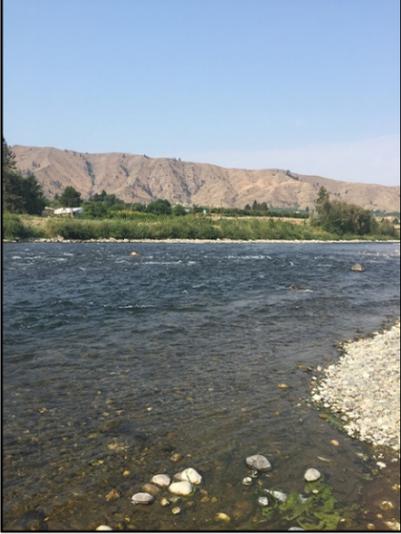
Project Area 15 RM 6.2 to 6.4 Mid-channel	Install Habitat Structures	<ul style="list-style-type: none"> • Install boulder structures 	This section of river is lacking instream habitat complexity. Addition of mid-channel boulder clusters would create local scour pools and increase the instream habitat complexity in areas where hydraulic characteristics are suitable.	3

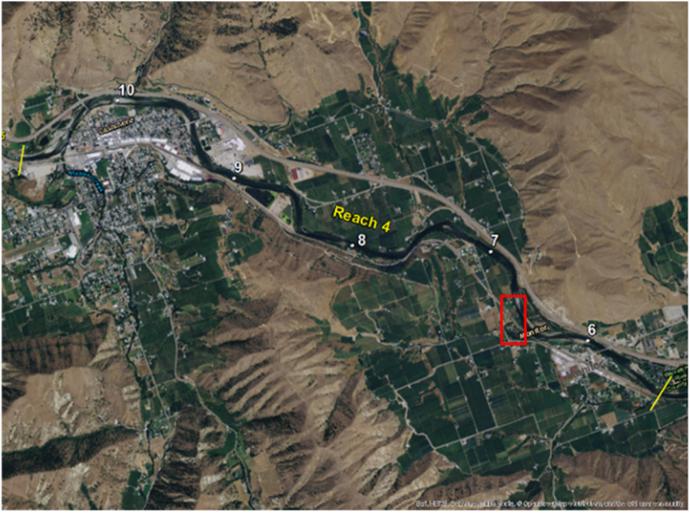
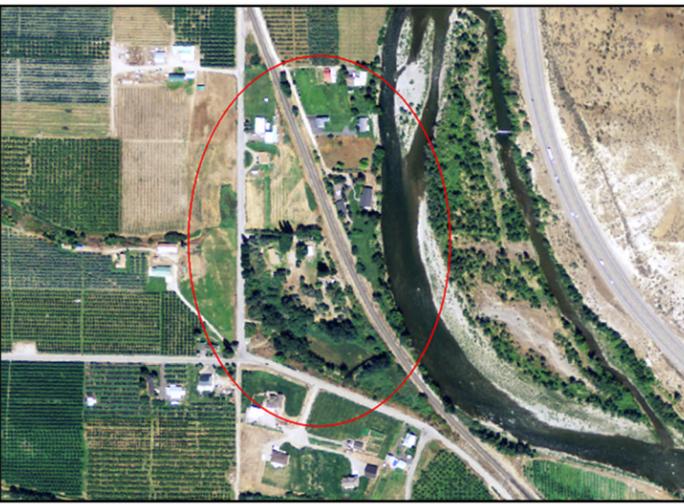
Project Area 16 RM 6.4 to 6.5 Right Bank	Floodplain Habitat Reconnection	<ul style="list-style-type: none"> • Remove non-native plants • Riparian planting • Install LWD structures (whole trees, jams, etc.) • Alcove creation/enhancement • Groundwater-fed off-channel creation/enhancement • Railroad modification 	The floodplain and off-channel habitat in this project area is currently disconnected by the BNSF Railway. Reconnecting floodplain habitat and constructing or enhancing alcoves, wetlands, and off-channel areas would increase available rearing habitat. Riparian vegetation restoration in cleared areas would provide shade and long-term recruitment potential. BNSF Railway water crossing structures would need to be considered as a part of this project.	1

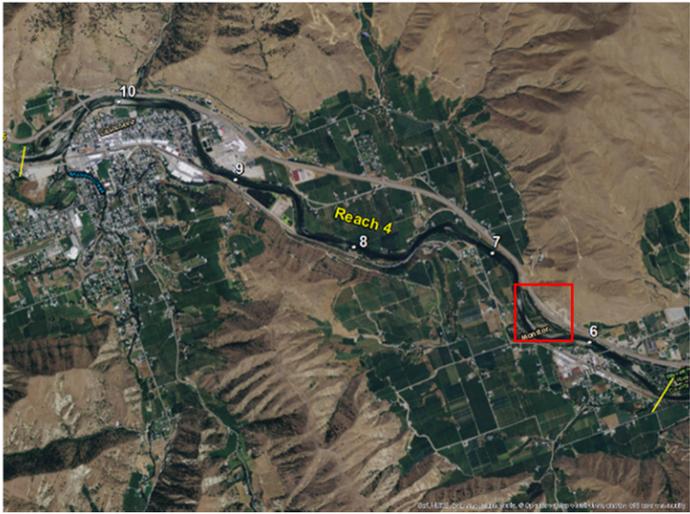
Project Area 17 (Pioneer Side Channel) RM 6.2 to 6.6 Left Bank	Install Habitat Structures (Modify Existing Restoration Site)	<ul style="list-style-type: none"> • Remove non-native plants • Riparian planting • Install LWD structures (whole trees, jams, etc.) • Perennial side channel creation/enhancement • Wetland creation/enhancement • Alcove creation/enhancement 	This existing side channel restoration project (Pioneer Side Channel) lacks habitat complexity and cover. Incorporating LWD structures would increase habitat complexity and cover. Other alternatives to consider for this project include channel reconstruction (e.g., with pools associated with LWD structures) and construction of wetland and alcove habitat which would increase available rearing habitat.	1

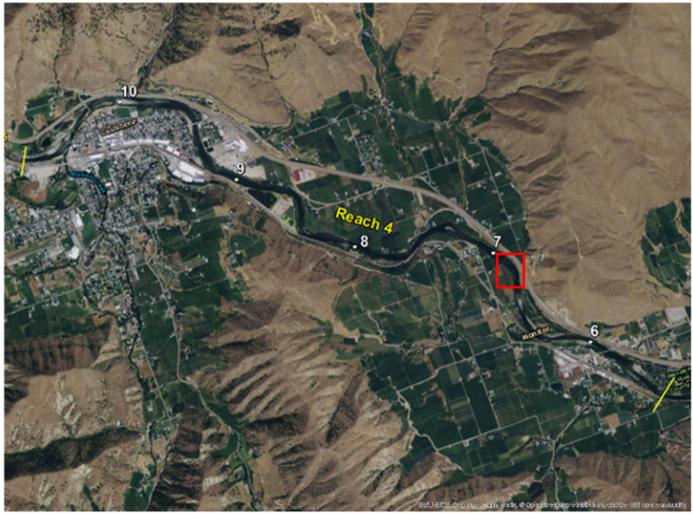
Project Area 18 RM 6.8 to 7.0 Mid-channel	Install Habitat Structures	<ul style="list-style-type: none"> Install boulder structures 	This section of river is lacking instream habitat complexity. Addition of mid-channel boulder clusters would create local scour pools and increase the instream habitat complexity in areas where hydraulics characteristics are suitable.	3

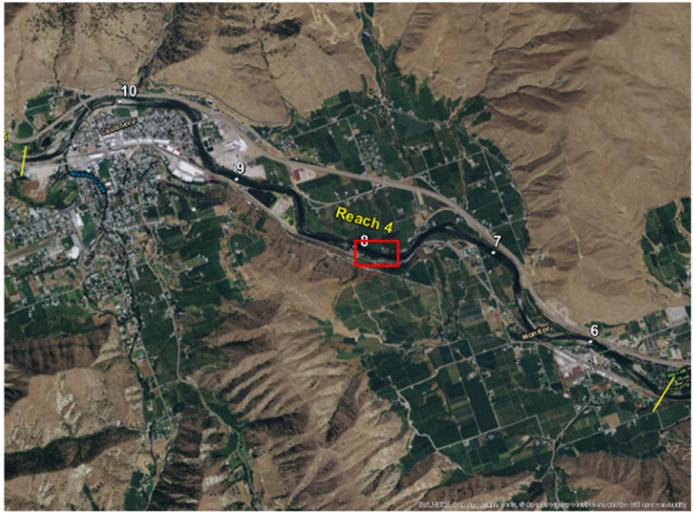
Project Area 19 RM 7.8 to 8.0 Mid-channel	Install Habitat Structures	<ul style="list-style-type: none"> Install boulder structures 	This section of river is lacking instream habitat complexity. Addition of mid-channel boulder clusters would create local scour pools and increase the instream habitat complexity in areas where hydraulics characteristics are suitable.	3

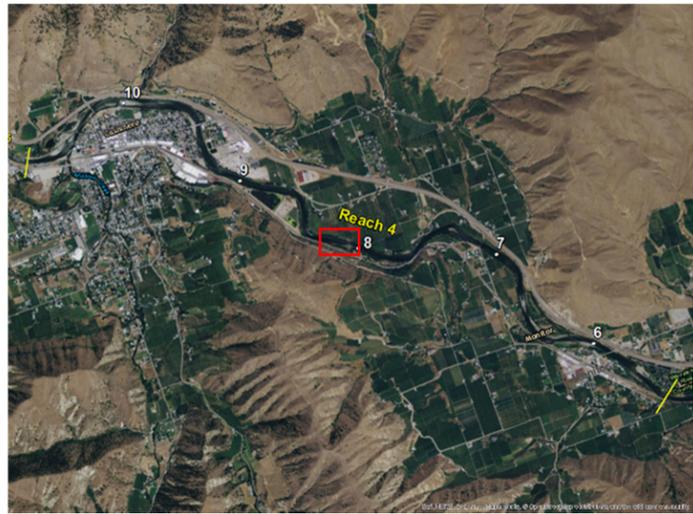
Project Area 20 RM 8.0 to 8.2 Right Bank	Floodplain Habitat Reconnection	<ul style="list-style-type: none"> Remove non-native plants Riparian planting Install LWD structures (whole trees, jams, etc.) Remove or relocate Floodplain Infrastructure Perennial side channel creation/enhancement Secondary channel (non-perennial) creation/enhancement 	There is a historical side channel in this project area that has been altered by man-made construction. There are residential structures in low lying topography near the existing sided channel. Reconnecting side channels and installing LWD structures would also increase available rearing habitat. Reconnection would require some excavation at the inlet and fill removal. An LWD structure at the inlet would control inlet flows and create habitat complexity and cover. Riparian vegetation restoration in disturbed areas would provide shade and long-term recruitment potential.	2

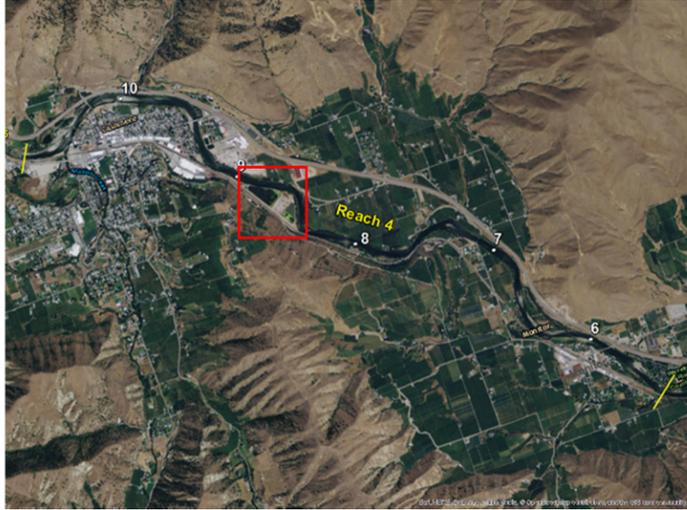
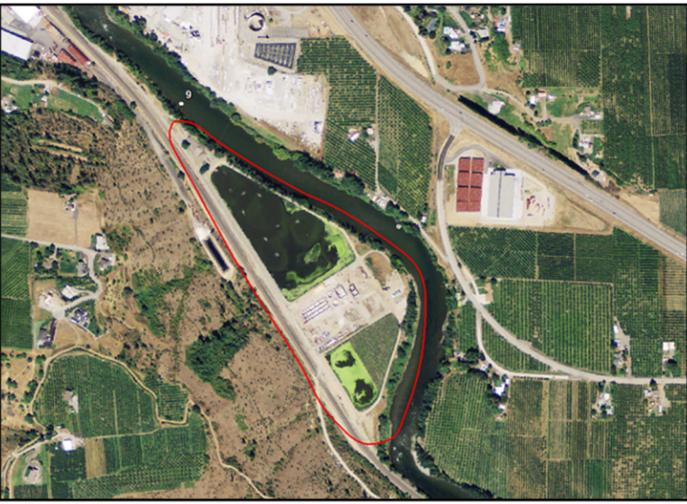
Project Area 21 RM 8.4 to 9.0 Right Bank	Floodplain Habitat Reconnection	<ul style="list-style-type: none"> Remove non-native plants Riparian planting Relocate sewage treatment facility Perennial side channel creation/enhancement Secondary channel (non-perennial) creation/enhancement Wetland creation/enhancement Alcove creation/enhancement 	<p>The City of Cashmere wastewater treatment facility is located within the historical floodplain in this project area.</p> <p>Relocating the facilities and restoring the floodplain in this area would provide much-needed habitat complexity in a section of river that lacks both rearing habitat and cover. The floodplain restoration would require large amounts of excavation with soil and site remediation in addition to traditional restoration techniques to for floodplain and riparian restoration.</p>	1

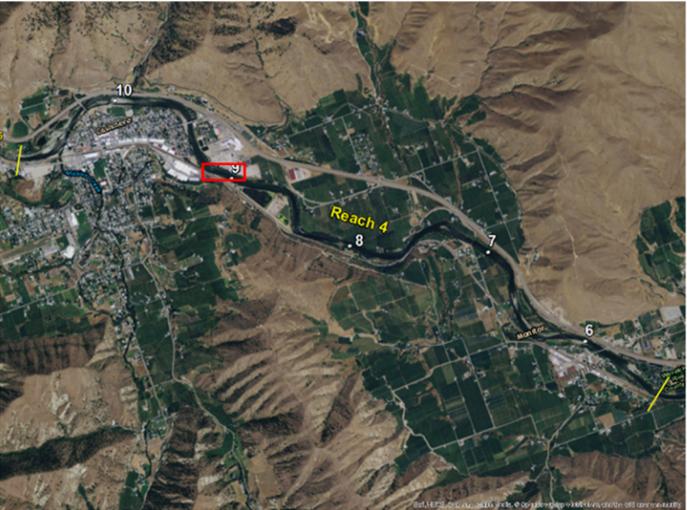
Project Area 22 RM 9.0 to 9.2 Mid-channel	Install Habitat Structures	<ul style="list-style-type: none"> Install boulder structures 	<p>This section of river is lacking instream habitat complexity. Addition of mid-channel boulder clusters would create local scour pools and increase the instream habitat complexity in areas where hydraulic characteristics are suitable.</p>	3

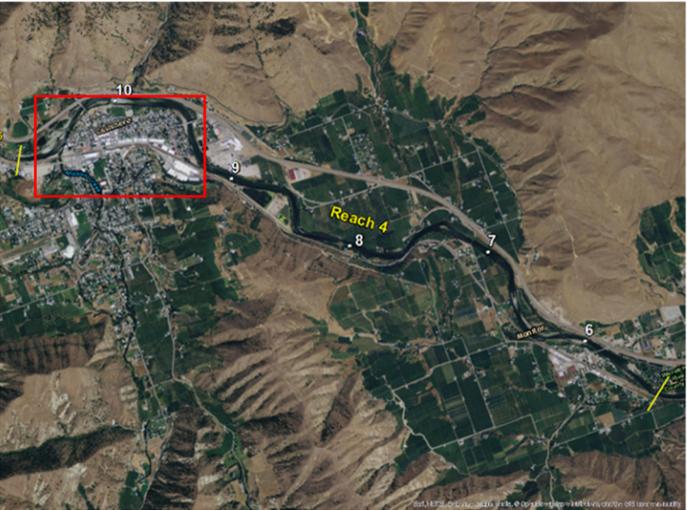
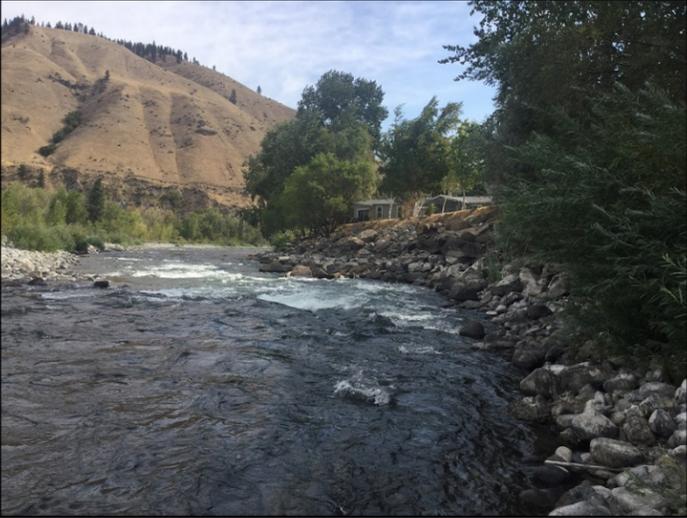
Project Area 23 RM 9.2 to 10.6 Right Bank	Floodplain Habitat Reconnection	<ul style="list-style-type: none"> Remove non-native plants Riparian planting Install LWD structures (whole trees, jams, etc.) Remove or setback existing levees Remove or relocate Floodplain Infrastructure Perennial side channel creation/enhancement Secondary channel (non-perennial) creation/enhancement Alcove creation/enhancement Reconnect historical meander bend 	<p>There is an existing levee system providing flood protection for the City of Cashmere in this project area. Modification of the existing levee would allow for floodplain restoration and reestablish the historical meander pattern, which would provide much-needed habitat complexity in a section of river that lacks both rearing habitat and cover. This project opportunity has many potential constraints and would require the relocation of many residences and businesses.</p>	1

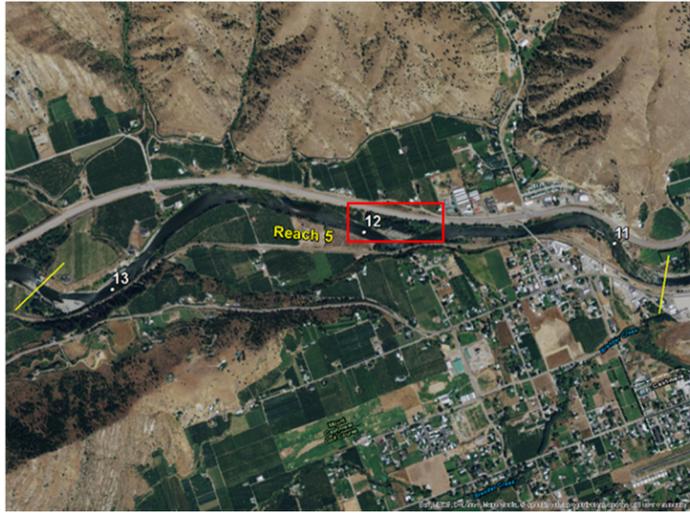
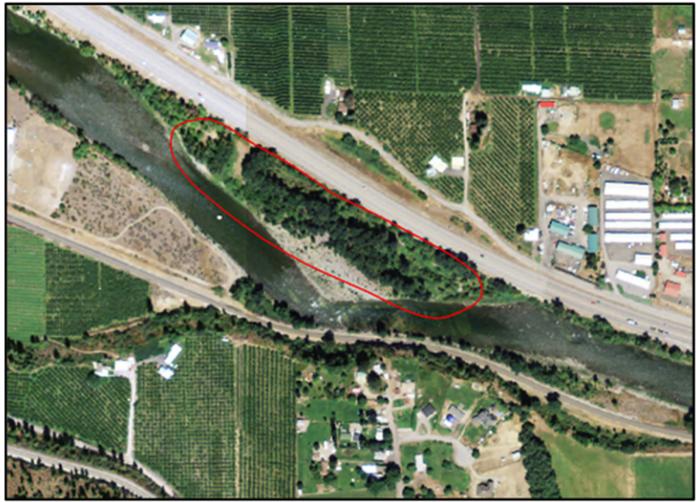
Project Area 24 RM 11.7 to 12.1 Left Bank	Floodplain Habitat Reconnection	<ul style="list-style-type: none"> • Install LWD structures (whole trees, jams, etc.) • Perennial side channel creation/enhancement • Secondary channel (non-perennial) creation/enhancement • Groundwater fed off-channel creation/enhancement 	<p>The existing side channel in this project area has good habitat and cover but is disconnected at lower flows. There are relatively large quantities of existing LWD in the side channel.</p> <p>Reconnecting side channels and installing LWD structures would increase available rearing habitat. There may also be potential for incorporating groundwater flows in this project area.</p> <p>Reconnection would require some excavation at the inlet. This project may require modification of large log jam at inlet of side channel.</p>	1

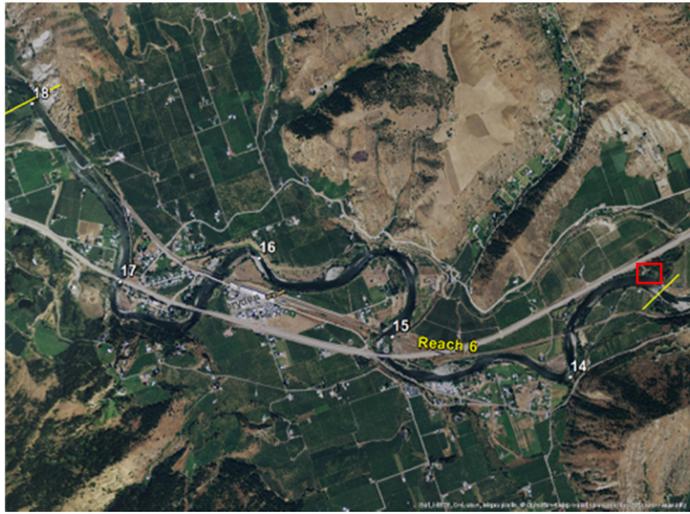
Project Area 25 (CMZ 11) RM 13.3 to 13.4 Left Bank	Floodplain Habitat Reconnection (Modify Existing Restoration Site)	<ul style="list-style-type: none"> • Install LWD structures (whole trees, jams, etc.) • Perennial side channel creation/enhancement • Secondary channel (non-perennial) creation/enhancement • Alcove creation/enhancement 	<p>This existing side channel restoration project (CMZ 11) lacks habitat complexity and cover and does not receive perennially flow.</p> <p>Excavating the channel inlet and incorporating LWD structures would increase habitat complexity and cover and provide perennial flows. Other alternates to consider for this project include channel reconstruction (e.g. with pools associated with LWD structures) and construction alcove habitat which would increase available rearing habitat.</p>	2

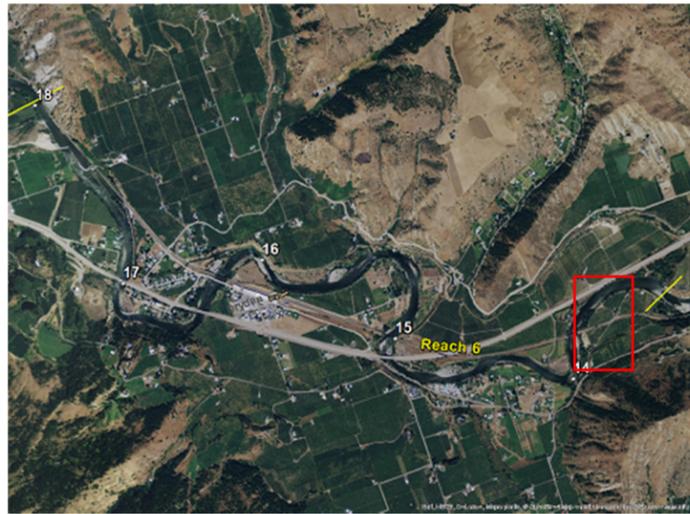
Project Area 26 RM 13.5 to 13.9 Right Bank	Floodplain Habitat Reconnection	<ul style="list-style-type: none"> • Remove non-native plants • Riparian planting • Install LWD structures (whole trees, jams, etc.) • Railroad modification • Remove or relocate Floodplain Infrastructure • Perennial side channel creation/enhancement • Secondary channel (non-perennial) creation/enhancement • Alcove creation/enhancement 	<p>The floodplain in this project area is dissected by the BNSF Railway and the river is constrained by the bridge crossing.</p> <p>Modification of the BNSF Railway would allow for floodplain restoration including perennial and secondary side channels and alcoves which would provide much needed rearing habitat in this section of river.</p> <p>Complete floodplain reconnection in this project area would require construction of BNSF Railway bridges and a relatively large amount of excavation.</p>	1
