APPENDIX D

Reach-Based Ecosystem Indicators (REI)

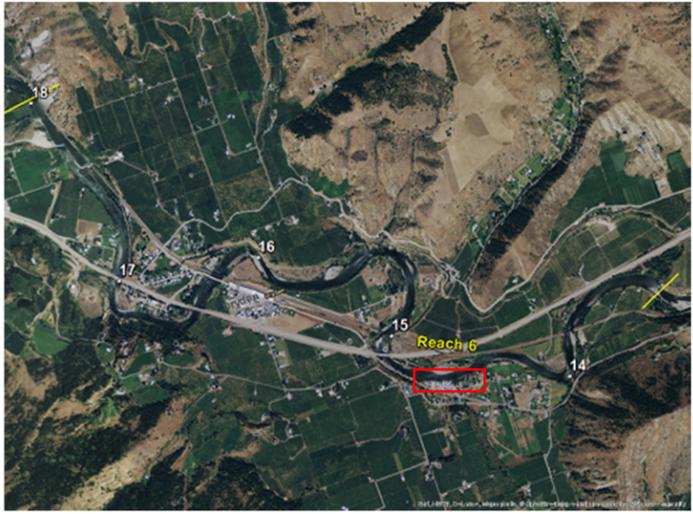
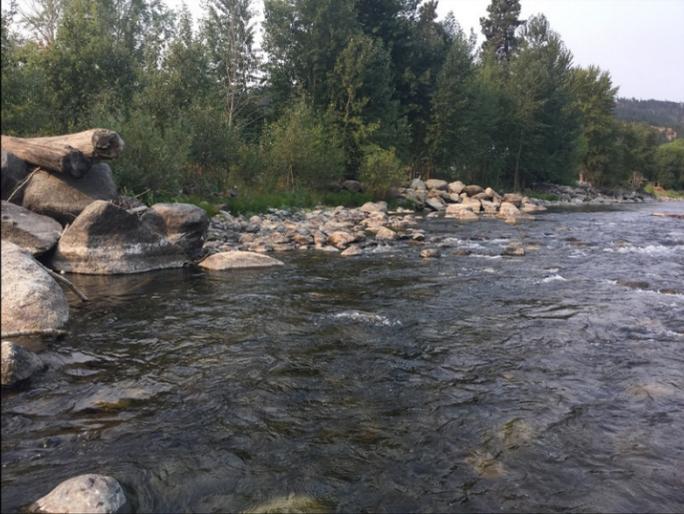
Project Area 27 RM 14.4 to 14.7 Right Bank	Enhance Existing Bank Protection	<ul style="list-style-type: none"> Bank stabilization with LWD and bioengineering 	<p>Existing groins provide some bank protection, but minimal habitat benefit to river. Additions of large wood would create local habitat complexity and cover. ELJ and large wood additions provide opportunity to create local scour pools.</p> <p>The design of bank stabilization structures in this project area would need to consider recreational boater safety.</p>	3

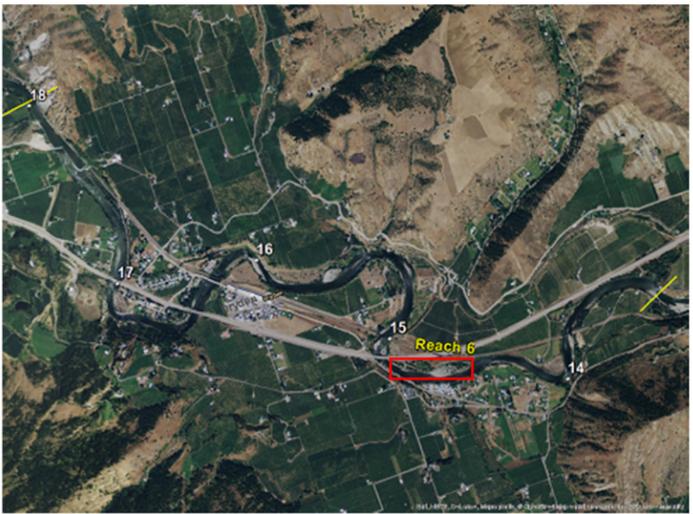
Project Area 28 (CMZ 12 and 13) RM 14.4 to 14.8 Left Bank	Floodplain Habitat Reconnection (Modify Existing Restoration Site)	<ul style="list-style-type: none"> Install LWD structures (whole trees, jams, etc.) Perennial side channel creation/enhancement Alcove creation/enhancement 	<p>This existing side channel restoration project (CMZ 12 and 13) has good habitat complexity and cover but is disconnected at lower flows and is accumulating fine sediments.</p> <p>Excavating the channel inlet and incorporating LWD structures would provide perennial sediment flushing flows and increase habitat complexity and cover. Construction of alcove habitat would also increase available rearing habitat.</p>	2

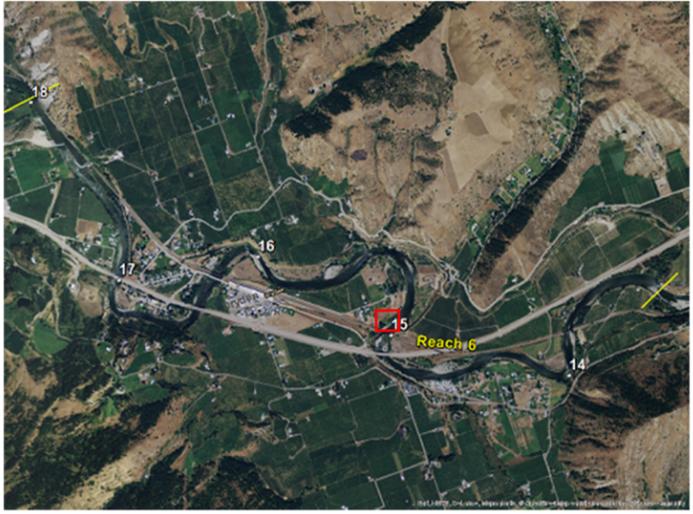
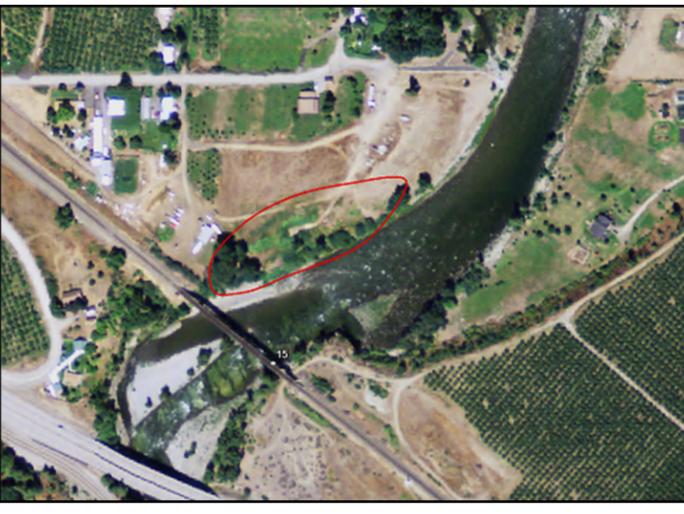
Project Area 29 RM 15.0 to 15.1 Right Bank	Floodplain Habitat Reconnection	<ul style="list-style-type: none"> Remove non-native plants Riparian planting Install LWD structures (whole trees, jams, etc.) Alcove creation/enhancement Groundwater fed off-channel creation/enhancement 	<p>There is an existing cold water spring in this project area.</p> <p>Constructing a perennial alcove at this existing groundwater spring would provide high-quality rearing habitat. The installation of LWD structures to protect inlet and to create habitat complexity and cover in the alcove.</p> <p>Riparian vegetation restoration in cleared areas would provide shade and long-term recruitment potential.</p>	2

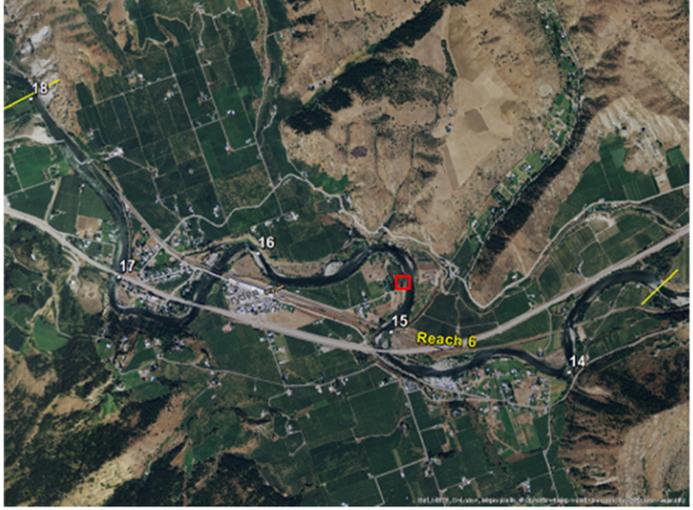
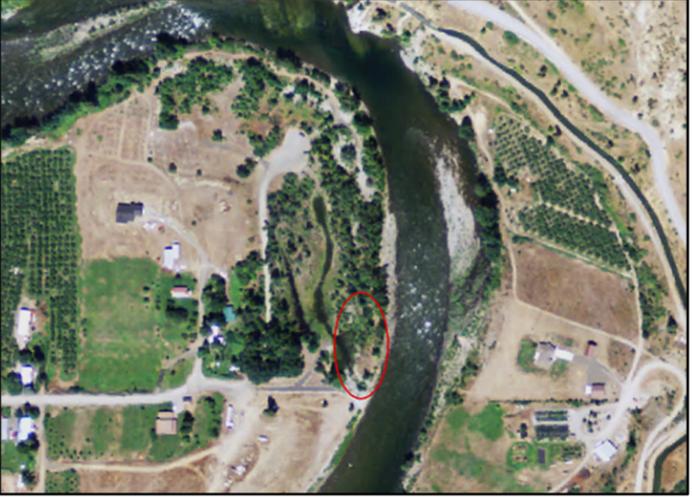
Project Area 30 (Dryden Fish Enhancement Project) RM 15.2 Right Bank	Floodplain Habitat Reconnection (Modify Existing Restoration Site)	<ul style="list-style-type: none"> Bank stabilization with LWD and bioengineering Install LWD structures (whole trees, jams, etc.) Levee modification Improve fish passage 	<p>This existing alcove and wetland restoration project (Dryden Fish Enhancement Project) that has high quality rearing habitat, but fish access is restricted due to a beaver dam at the narrow outlet of the alcove cut into the existing levee.</p> <p>Expanding the size of the outlet channel and constructing multiple outlet channels would improve fish passage and provide greater access to this restoration site.</p>	2

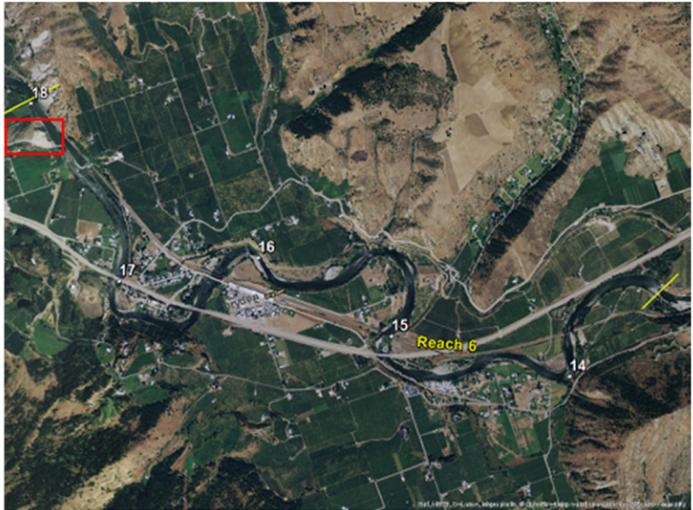
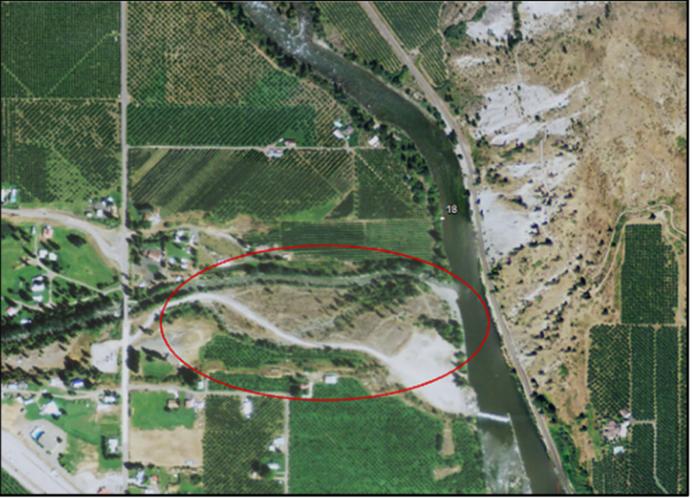
Project Area 31 RM 17.8 to 17.9 Right Bank	Tributary Restoration	<ul style="list-style-type: none"> Remove non-native plants Riparian planting Install LWD structures (whole trees, jams, etc.) Road relocation or modification Remove or relocate Floodplain Infrastructure Tributary channel relocation and enhancement Perennial side channel creation/enhancement Alcove creation/enhancement 	<p>Peshastin Creek is currently straightened and simplified near the Wenatchee River confluence. Relocating Peshastin Creek into its historical channel and adding a perennial side channel and alcove would create habitat complexity and cover. Large wood structures would increase habitat complexity and cover in restored channels.</p> <p>Riparian vegetation restoration in cleared areas would provide shade and long-term recruitment potential. Peshastin Creek channel realignment would require modifications to the existing access road.</p>	1

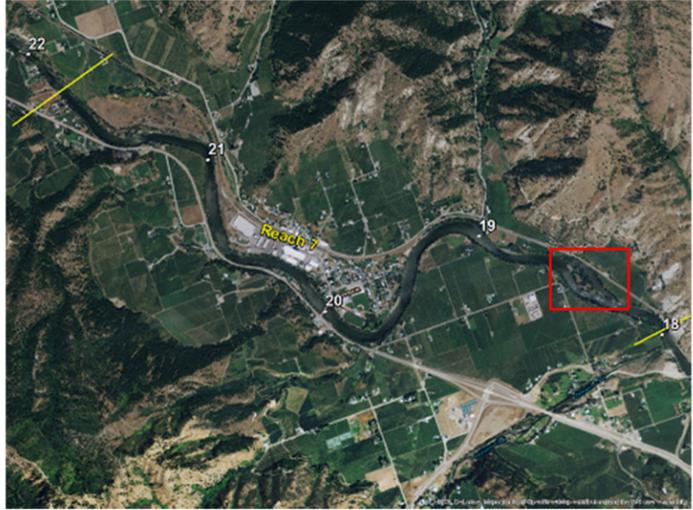
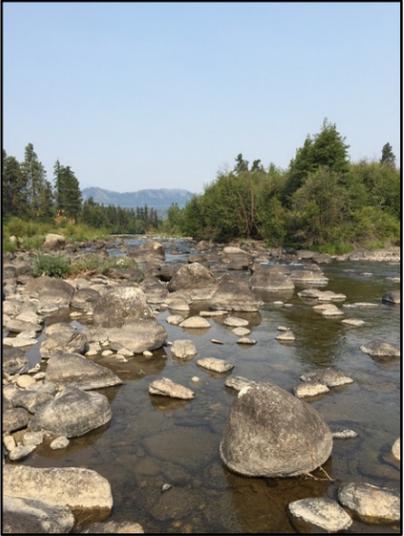
Project Area 32 RM 18.3 to 18.6 Left Bank	Install Habitat Structures	<ul style="list-style-type: none"> Perennial side channel creation/enhancement Install LWD structures (whole trees, jams, etc.) 	<p>The existing side channel in this project area receives perennial flow, but lacks complex habitat and cover. Installing LWD structures would increase habitat complexity and cover.</p> <p>This project would require an extensive stability analysis for LWD structures as this side channel receives large volumes of water during high flow events. The design of LWD structures would also need to consider recreational boater safety.</p>	2

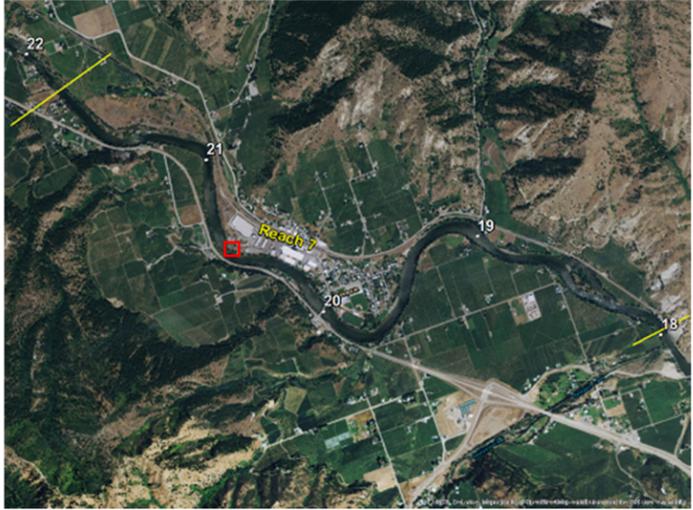
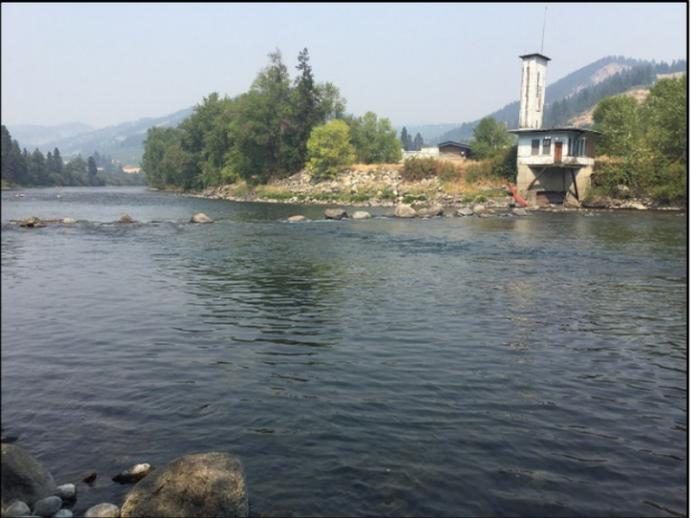
Project Area 33 RM 20.5 Left Bank	Remove Instream Structures	<ul style="list-style-type: none"> Remove or relocate Floodplain Infrastructure 	There is existing infrastructure within the river channel in this project area. The removal of this structure would increase flood capacity and eliminate the risk of structure failure and debris entering the river.	3

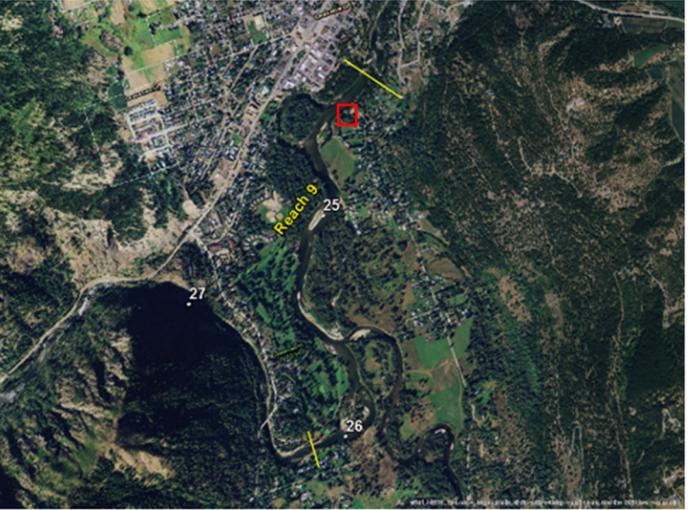
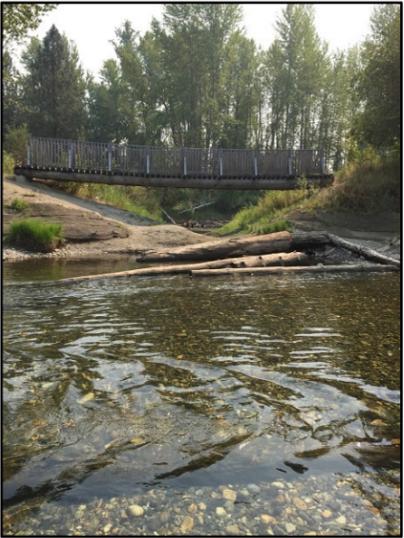
Project Area 34 (CMZ 19A – Boat Launch) 24.4 to 24.6 Right Bank	Floodplain Habitat Reconnection (Modify Existing Restoration Site)	<ul style="list-style-type: none"> Install LWD structures (whole trees, jams, etc.) Perennial side channel creation/enhancement Alcove creation/enhancement 	This existing alcove restoration project (CMZ 19A – Boat Launch) lacks cover. The alcove is disconnected at lower flows and is accumulating fine sediments. Excavating an inlet channel may be required to create sediment flushing flows at the outlet and maintain perennial access. Installing LWD structures in the perennial side channel and alcove would increase habitat complexity and cover.	2

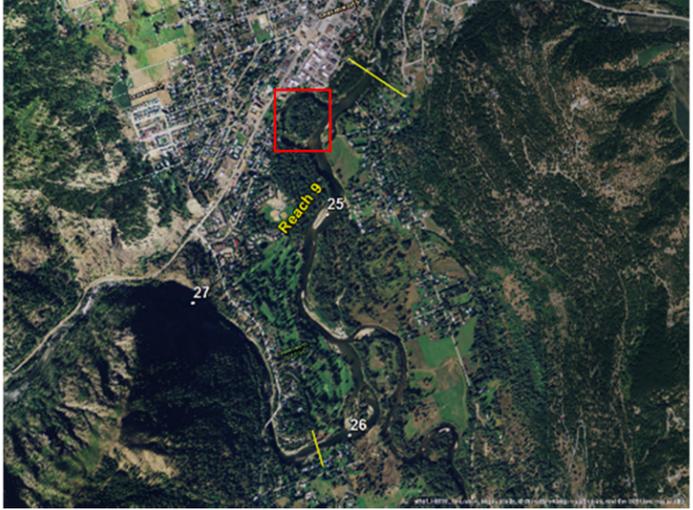
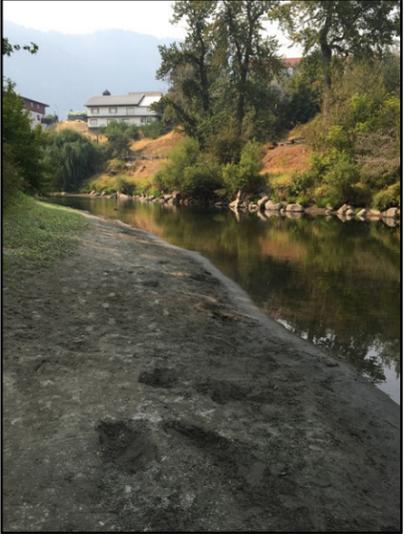
Project Area 35 (Blackbird Island) RM 24.6 to 24.7 Left Bank	Install Habitat Structures	<ul style="list-style-type: none"> Install LWD structures (whole trees, jams, etc.) Perennial side channel creation/enhancement 	The existing side channel in this project area (Blackbird Island) lacks complex instream habitat. There is evidence of large wood under streambed creating grade controls. There are also signs of scour around existing bridge abutments. Installing LWD structures would promote the formation of scour pools and provide instream habitat and cover. Restoration designs in this project area would identify alternatives to protect existing bridge abutments and would also need to consider recreational boater safety.	2

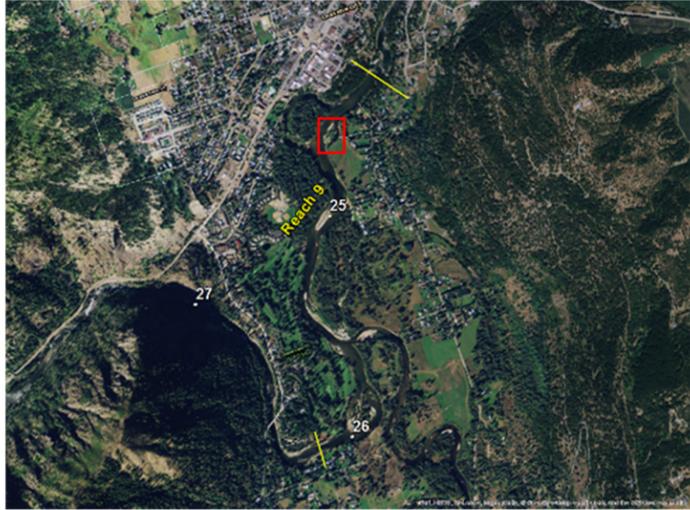
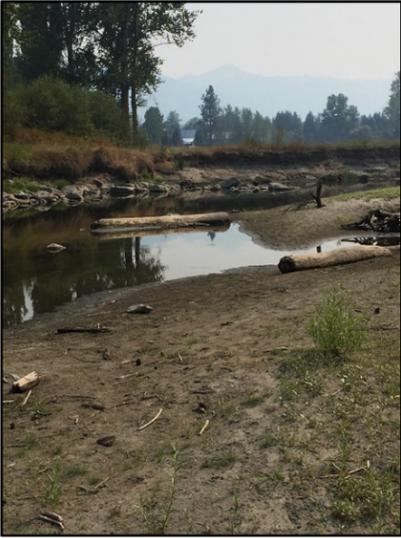
Project Area 36 (CMZ 19) RM 24.6 to 24.7 Right Bank	Install Habitat Structures	<ul style="list-style-type: none"> • Install LWD structures (whole trees, jams, etc.) • Perennial side channel creation/enhancement 	<p>The existing side channel in this project area receives perennial flow, but lacks complex habitat and cover. Installing LWD structures would promote the formation of scour pools and increase habitat complexity and cover.</p> <p>LWD structure designs in this project area would need to consider recreational boater safety.</p>	1

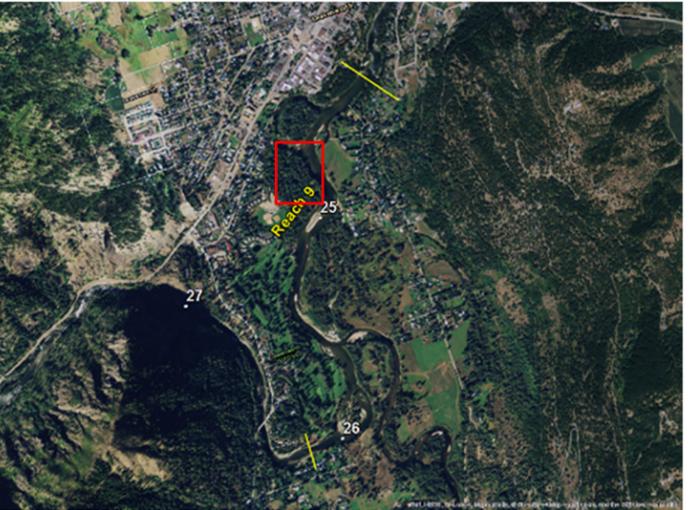
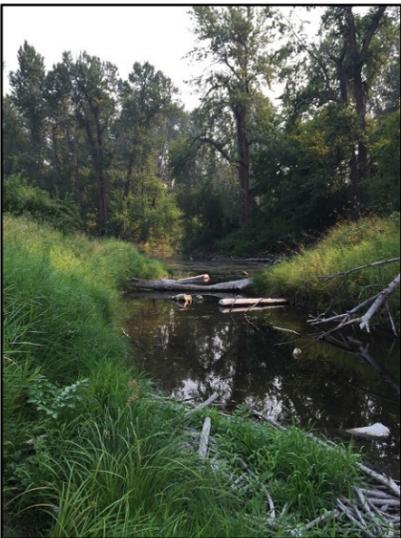
Project Area 37 (ICTU Blackbird Island) RM 24.7 to 24.9 Left Bank	Floodplain Habitat Reconnection (Modify Existing Restoration Site)	<ul style="list-style-type: none"> • Install LWD structures (whole trees, jams, etc.) • Perennial side channel creation/enhancement • Improve fish passage 	<p>This existing restoration site (ICTU Blackbird Island) has high quality rearing habitat, but fish access is restricted by a beaver dam at the narrow channel outlet.</p> <p>Expanding the size of the outlet channel and constructing multiple outlet channels would improve fish passage and provide greater access to this restoration site.</p> <p>There are also potential alternatives to excavate an upstream inlet to provide a combination of perennial side channel and alcove habitat in this project area.</p>	2

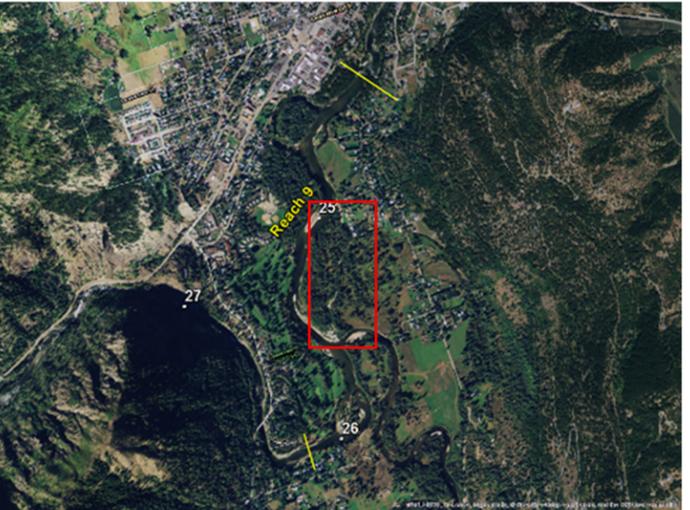
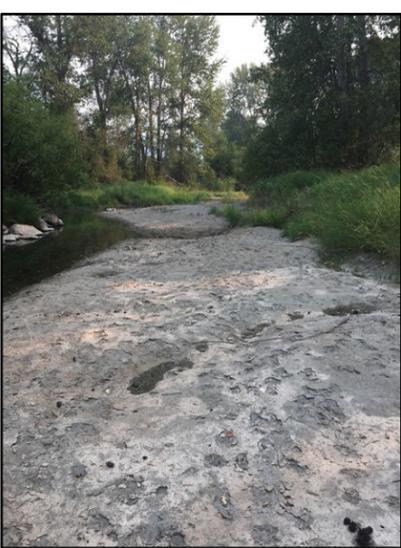
Project Area 38 (CMZ 20) RM 24.9 to 25.6 Right Bank	Floodplain Habitat Reconnection (Modify Existing Restoration Site)	<ul style="list-style-type: none"> • Remove non-native plants • Riparian planting • Install LWD structures (whole trees, jams, etc.) • Perennial side channel creation/enhancement • Groundwater-fed off-channel creation/enhancement 	<p>This existing restoration project (CMZ 20) has good complexity, but is mostly disconnected at lower flows and is accumulating large volumes of fine sediment.</p> <p>Excavating this side channel would provide perennial sediment flushing flows. Installing LWD structures would promote the formation of scour pools and increase habitat complexity and cover. Riparian vegetation restoration in disturbed areas would provide shade and long-term recruitment potential.</p> <p>LWD structure designs in this project area would need to consider recreational boater safety.</p>	1
