Appendix A

Stream Habitat Assessment

Middle Twisp River (RM 7.8 – 18.12)

Survey: October 2013

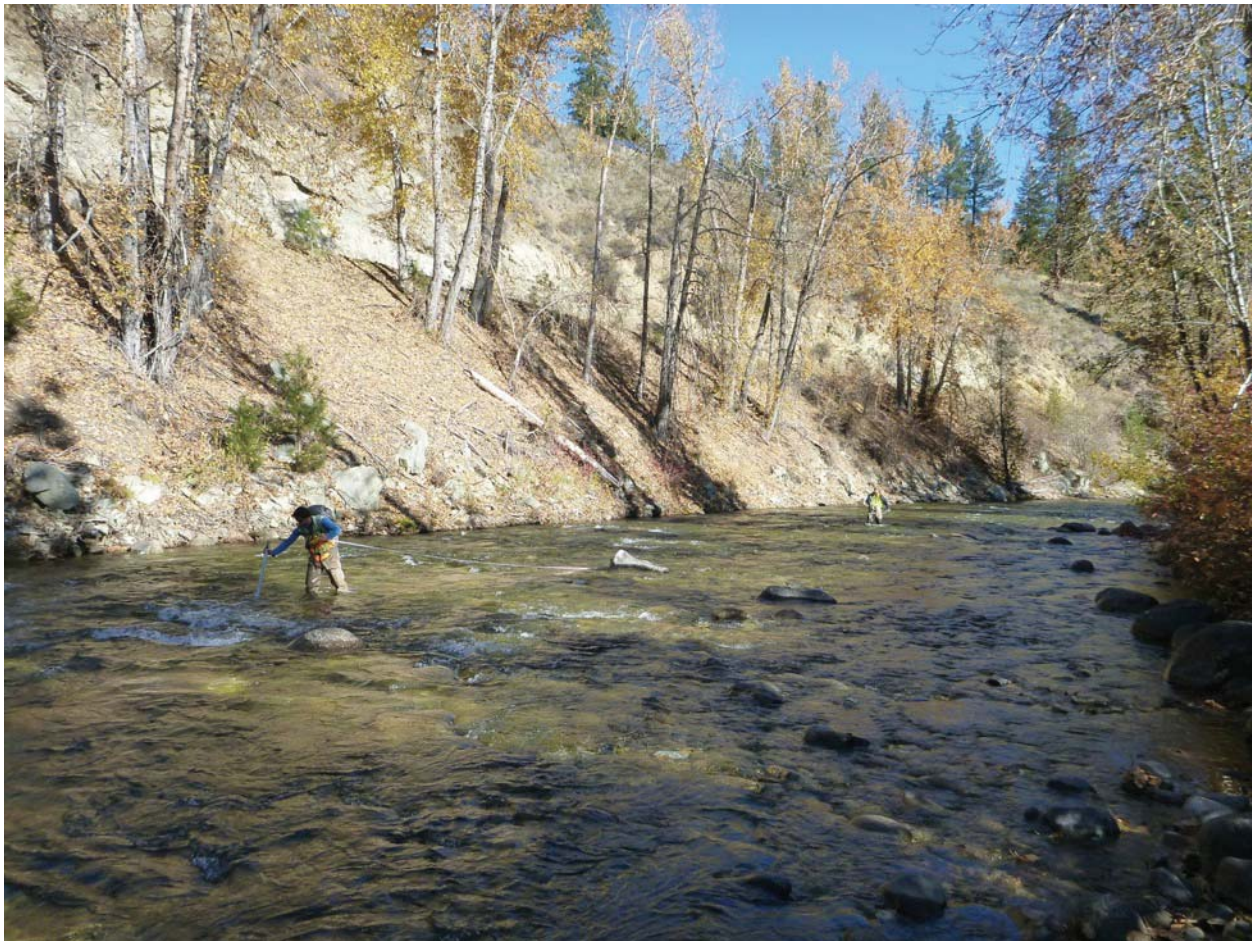
Figure 12. Representative view of a Reach 1 riffle. Riffles composed 74% of the reach.

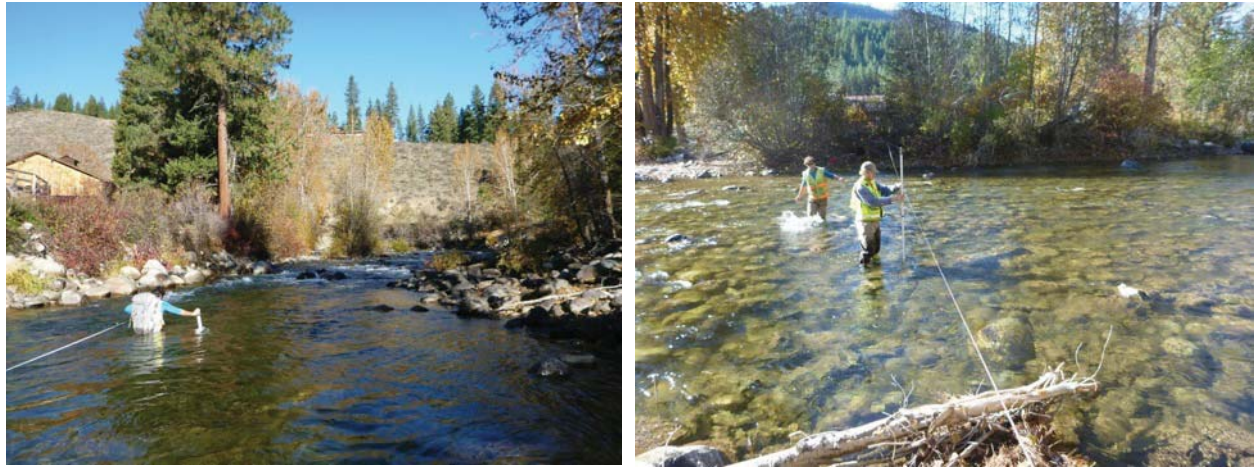
Figure 16. One of five pools in Reach 1 at RM 7.95 (left). Measuring bankful width (right).

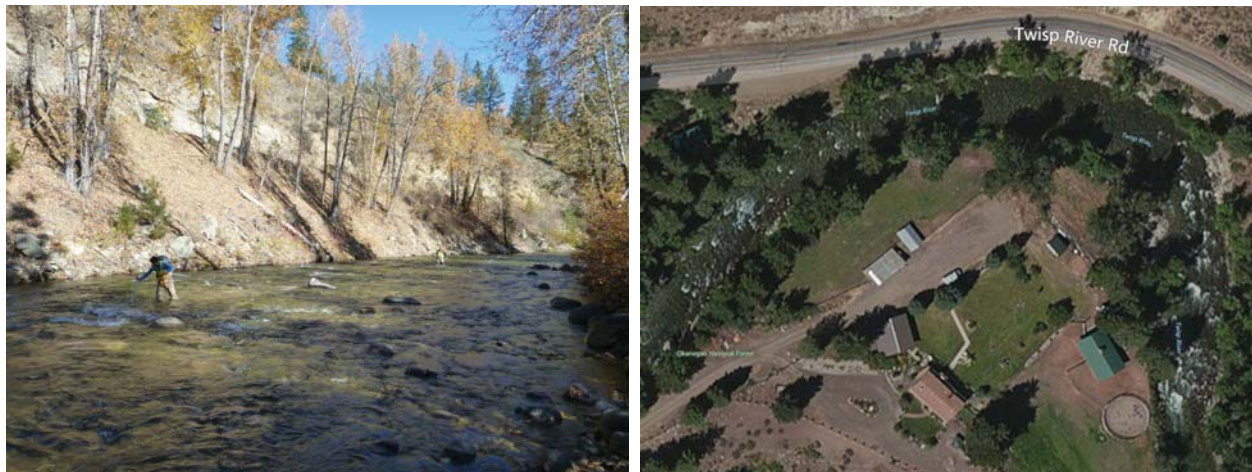
Reach 1 had a variable riparian corridor with significant cleared areas for roads and residential yards. The majority of the riparian clearing was prevalent on the south side of the river for the first half of the reach, and on the north side of the river for the second half of the reach. The four nth units measured in Reach 1 classified 25% of the riparian area within 100 feet of the measurement as small trees measuring 9 – 20.9 in. diameter; the remaining 75% measured was classified as grassland/forbes. Understory species composition was variable with a majority of species identified as Hawthorne, dogwood, and willow. The overstory was largely composed of cottonwood, Douglas fir, and ponderosa pine.

Figure 20. Reach 1 is bordered on the north by the Twisp River Rd and on the south by several residences. The reach is relatively fast moving with little wood retention. Both images taken at RM 8.1.

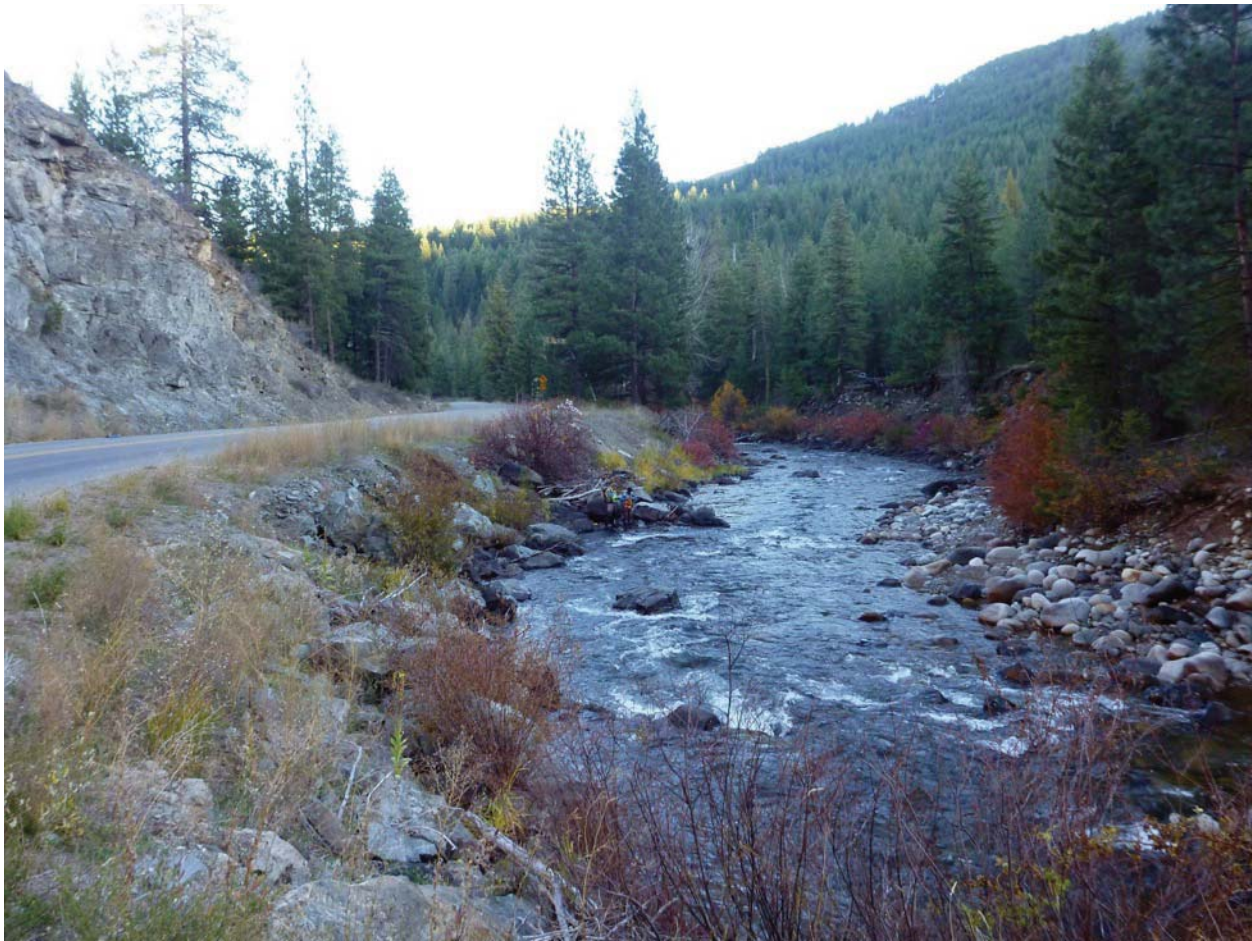
Figure 22. Downstream view of a riffle in Reach 2 with high percentages of boulders.

Reach 2 was the shortest reach in the study area. It is a high gradient reach, largely constrained by road on the north (left side of photo in Figure 22) and residential housing with push-up levees and rip-rap on the south side of the river. Fast water units (glides and riffles) comprised 99% of the reach area habitat (Figure 24). Only one pool was identified in the Reach, accounting for 1% of the reach area. No side channels were present in this reach.

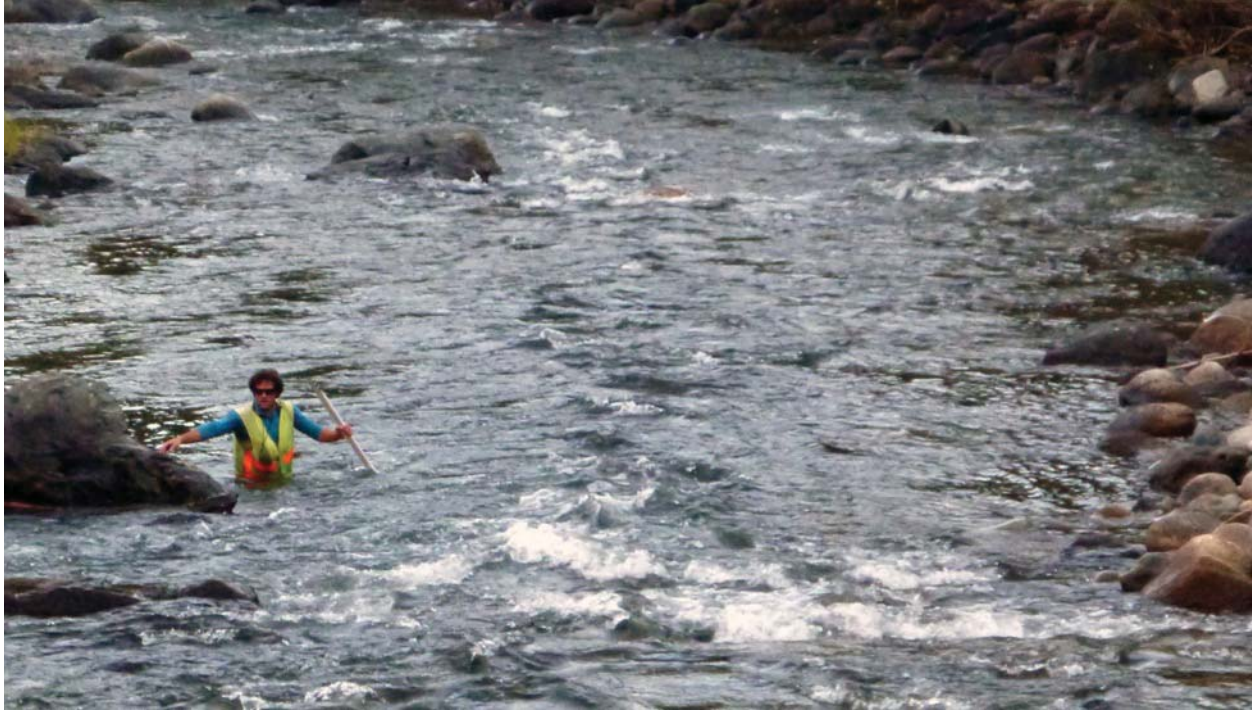
One pool was identified in Reach 2, equating to a pool frequency of 1.54 pools per mile (compared to a study area average of 7 pools/mile). While the pool did have a residual depth of 2.7, it was not exemplary of good salmon habitat (Figure 26) due to fast current, large substrate, and no wood or significant cover. Reach 2 had a frequency of 36.8 channel widths/pool (verses the average of 15.4 channel width/pool observed within the study area).

Figure 26. A relatively high-gradient reach, only one pool was identified in Reach 2. While the residual depth qualified this unit as a pool, due to fast current, large substrate, and no wood or cover, this pool is not representative of good habitat.

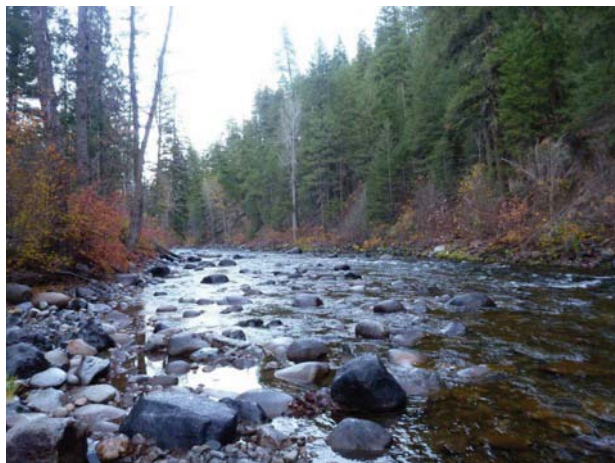
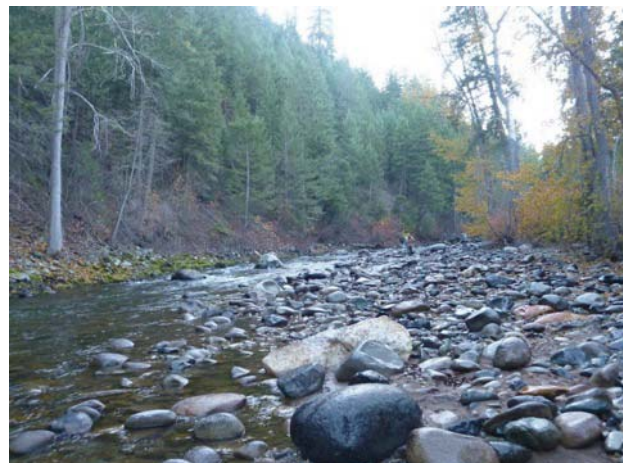
Figure 30. Upstream and downstream photos at RM 9.33 show large cobbles and boulders.

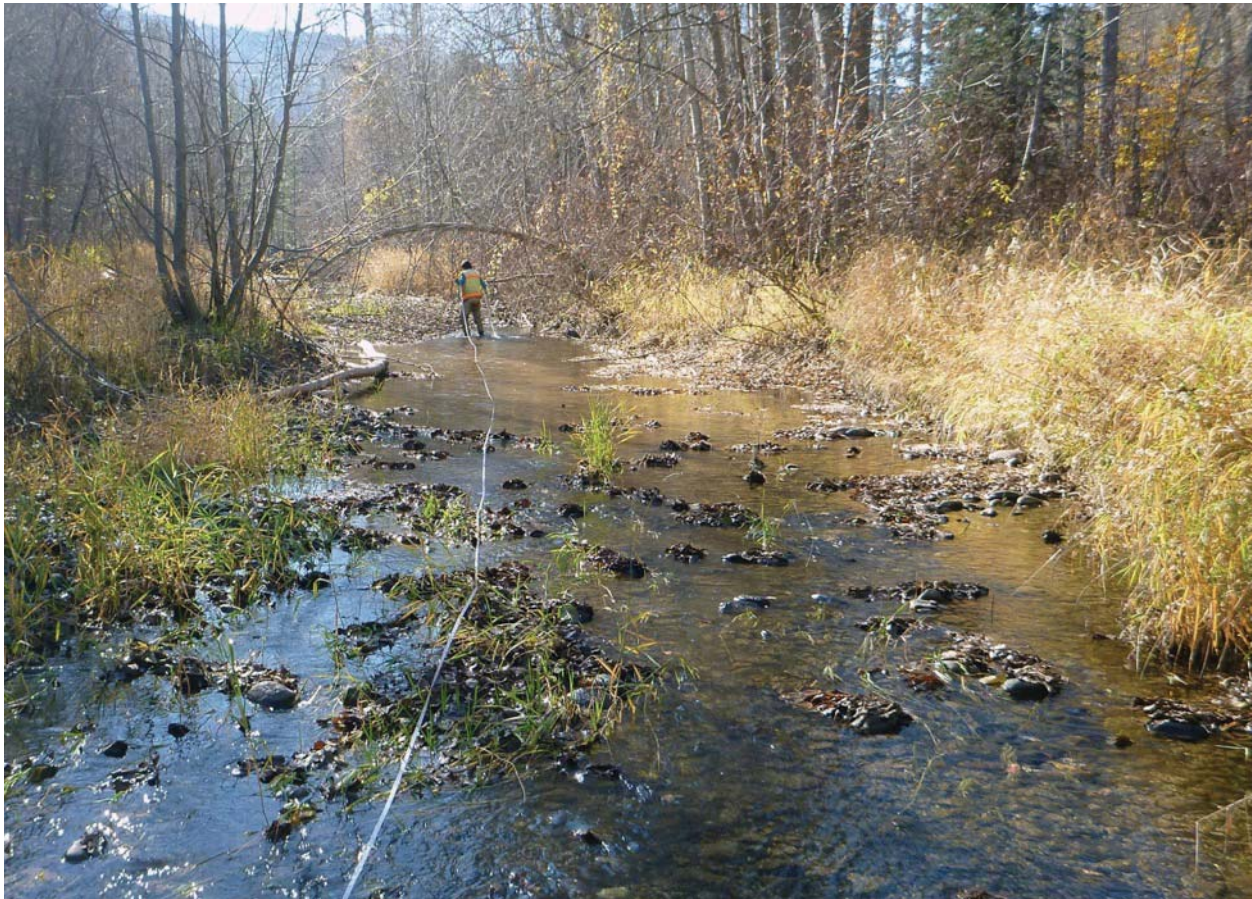
Figure 37. Reach 3 had 765 feet of side channel. Above is an image a 505-ft-long side channel that enters the Twisp River at RM 10.35

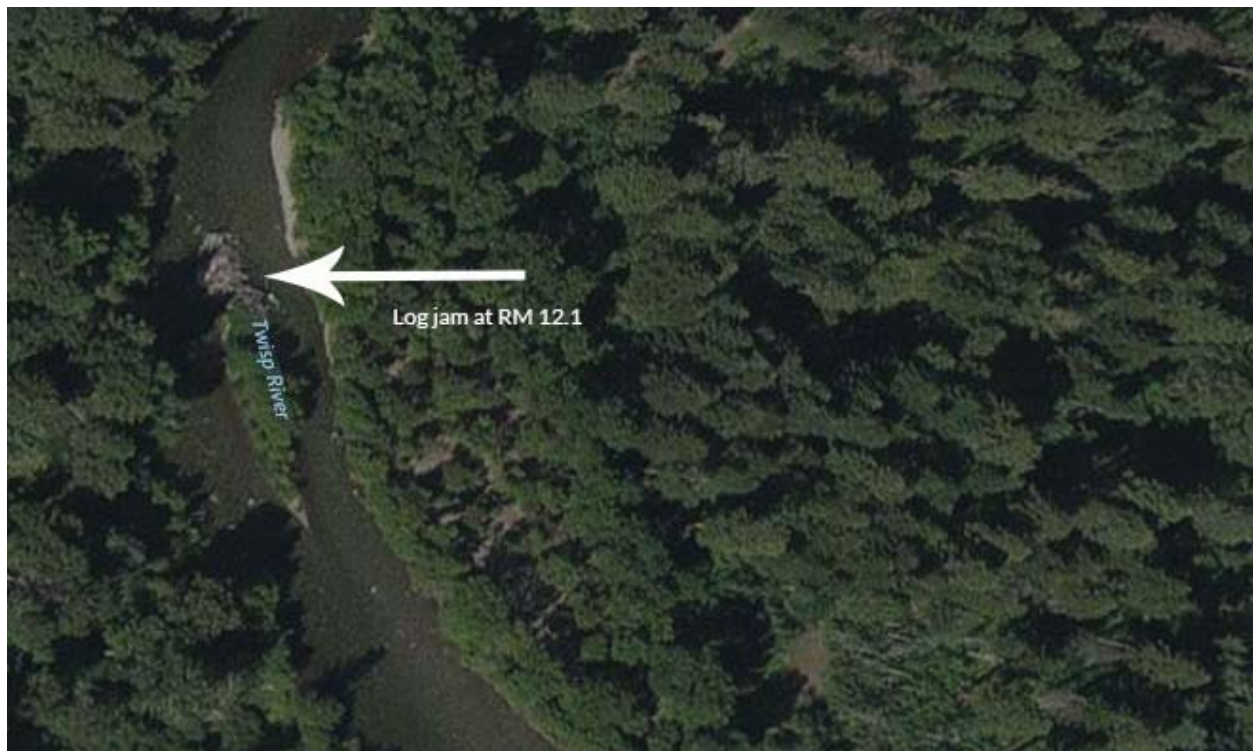
Large wood in Reach 3 averaged 54 pieces/mile (compared to the study area average of 96 pieces/mile). Small wood was the most prevalent, composing 66% of the total wood count and 35 pieces per mile (Table 13). Reach 3 had two log jams present, both apex log jams. Together, the two jams composed 37% of the wood found in the Reach. Approximately 12% of the wood was in pools.

Figure 38. Two log jams were present in Reach 3. This apex log jam at RM 12.1 had 10 medium and 25 small pieces of wood.

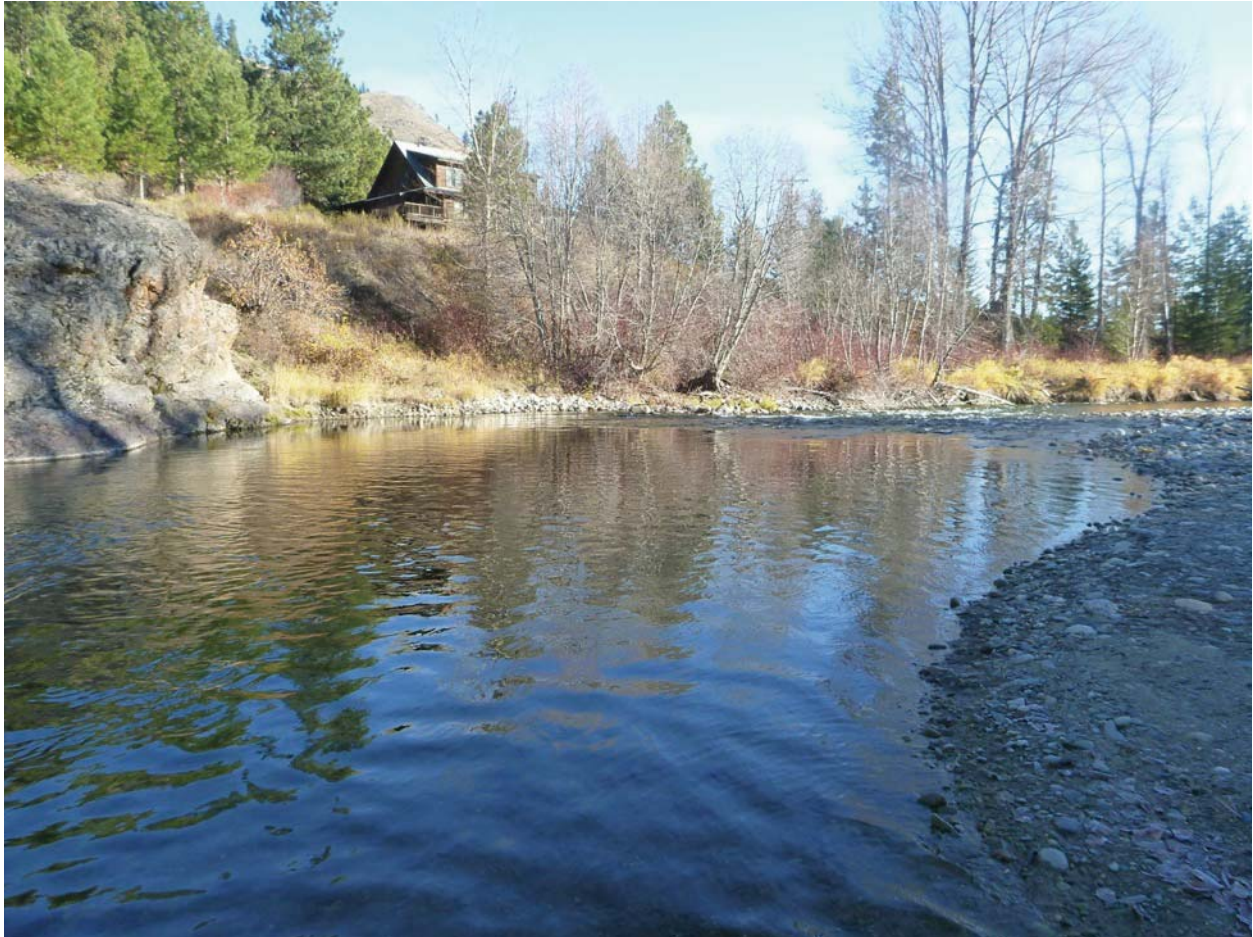
Figure 43. Looking upstream at a 9-foot-deep pool at RM 12.55 in Reach 4.

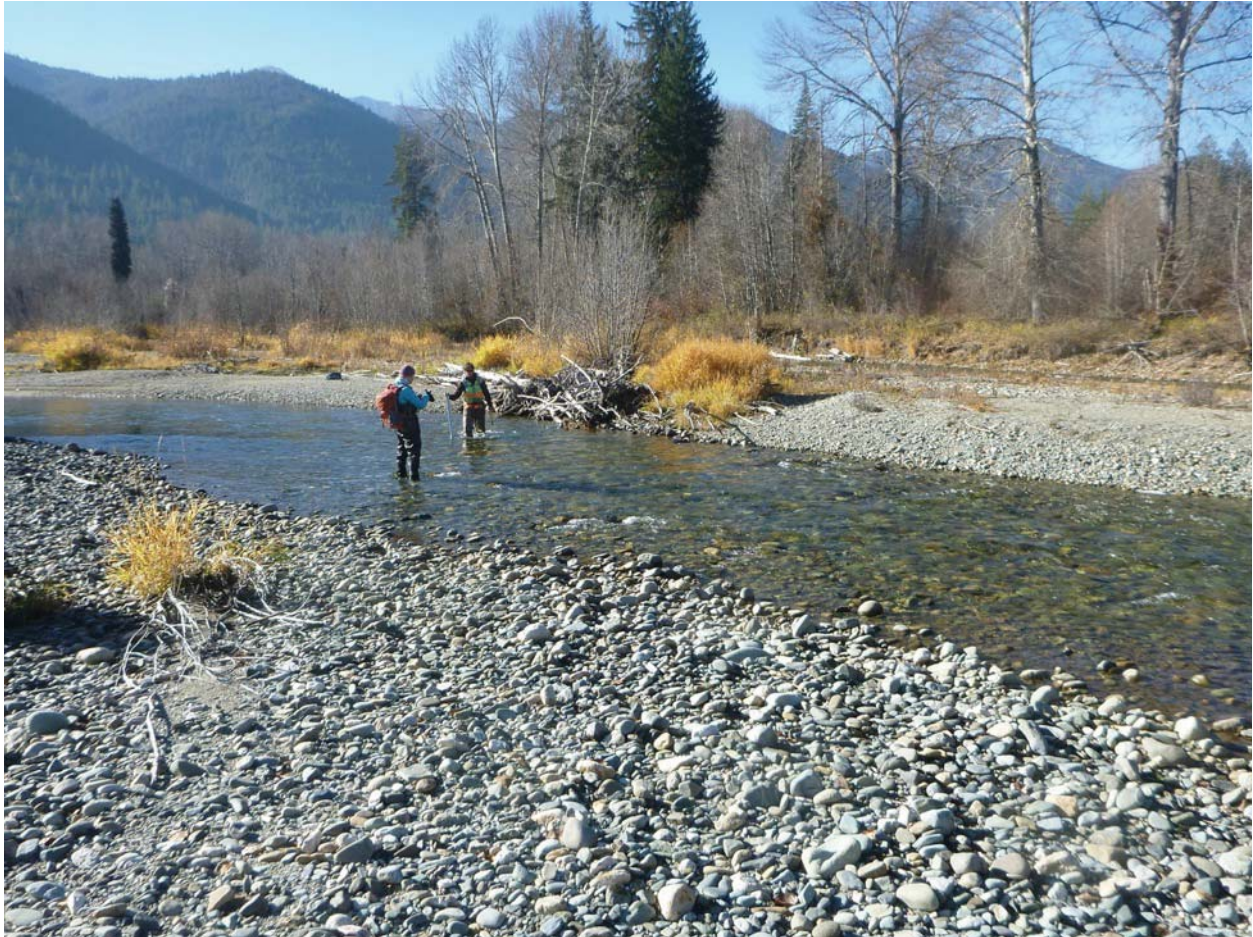
Figure 53. Reach 5 is a lower gradient, highly braided reach with vastly improved habitat characteristics compared to lower reaches in this study area.

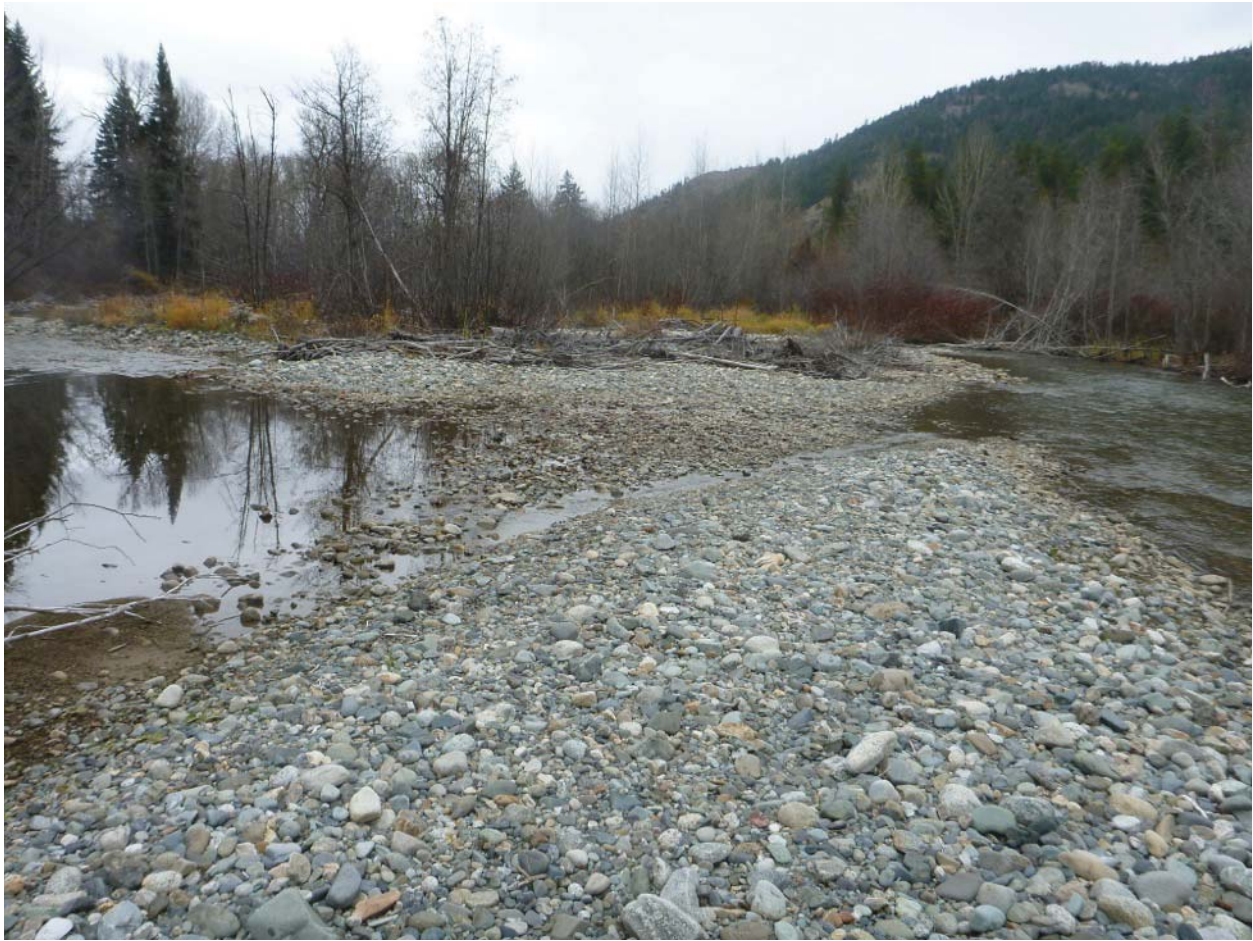
Figure 56. Bankfull widths varied from 48 – 200 feet in Reach 5. The above photo is taken near RM 15.4 where the bankfull width was recorded at 200 feet.

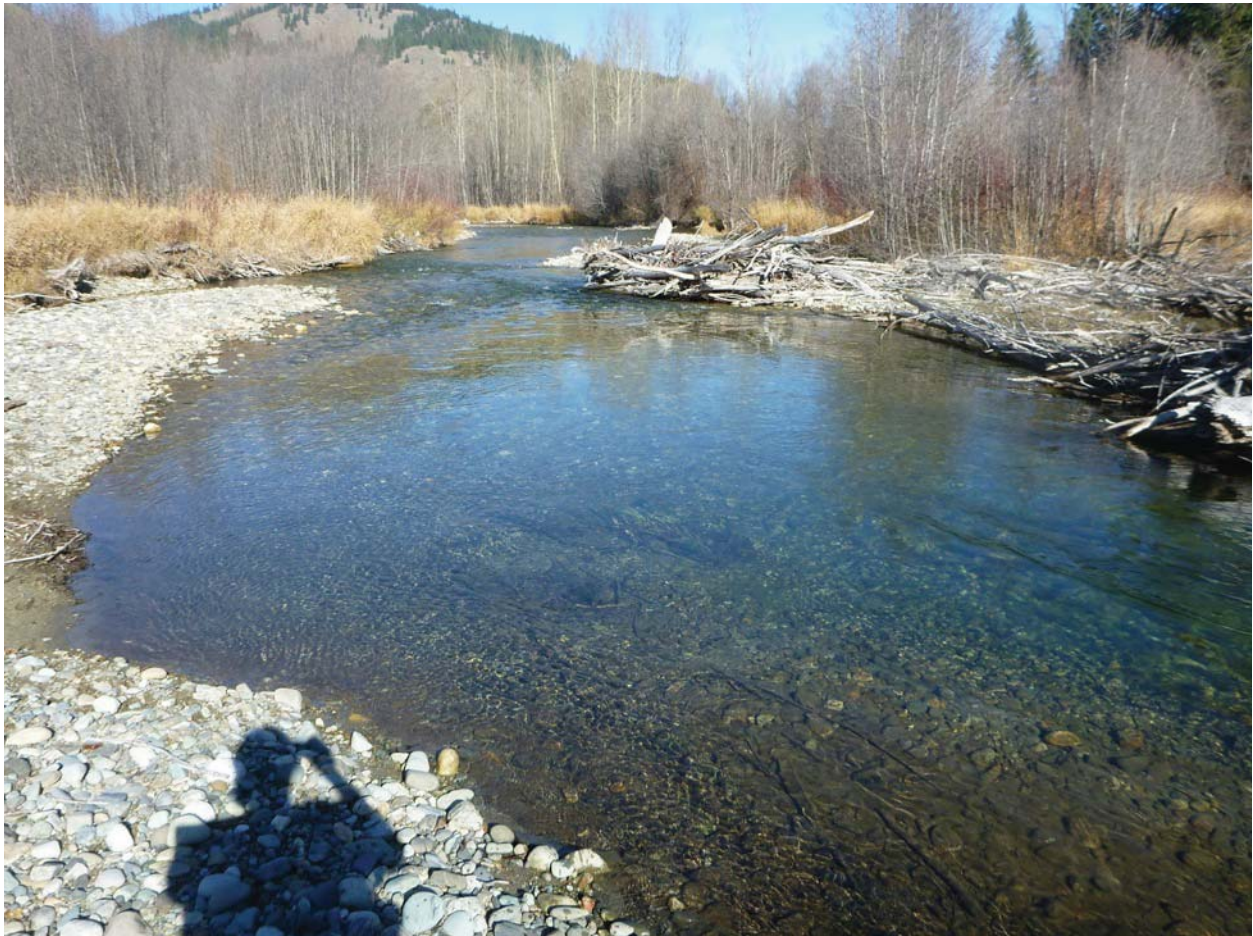
There is significant high-quality pool habitat throughout Reach 5, including 20 pools with 1-3 feet of residual depth and 14 pools of 3-6 feet residual depth. Pool frequency is 13.12 pools/mile (compared to the study area average of 7 pools/mile) (Figure 57) and 4.2 channel widths/pool – the lowest frequency in the study area. Unlike downstream reaches, many of the pools are formed in a back-to-back sequence, with short (non-qualifying) riffles or glides between them. Dozens of salmon redds were observed in marked and unmarked areas throughout the reach.

Figure 58. Looking downstream at a six-foot deep pool at RM 14.35. Note side channel entering on river right.

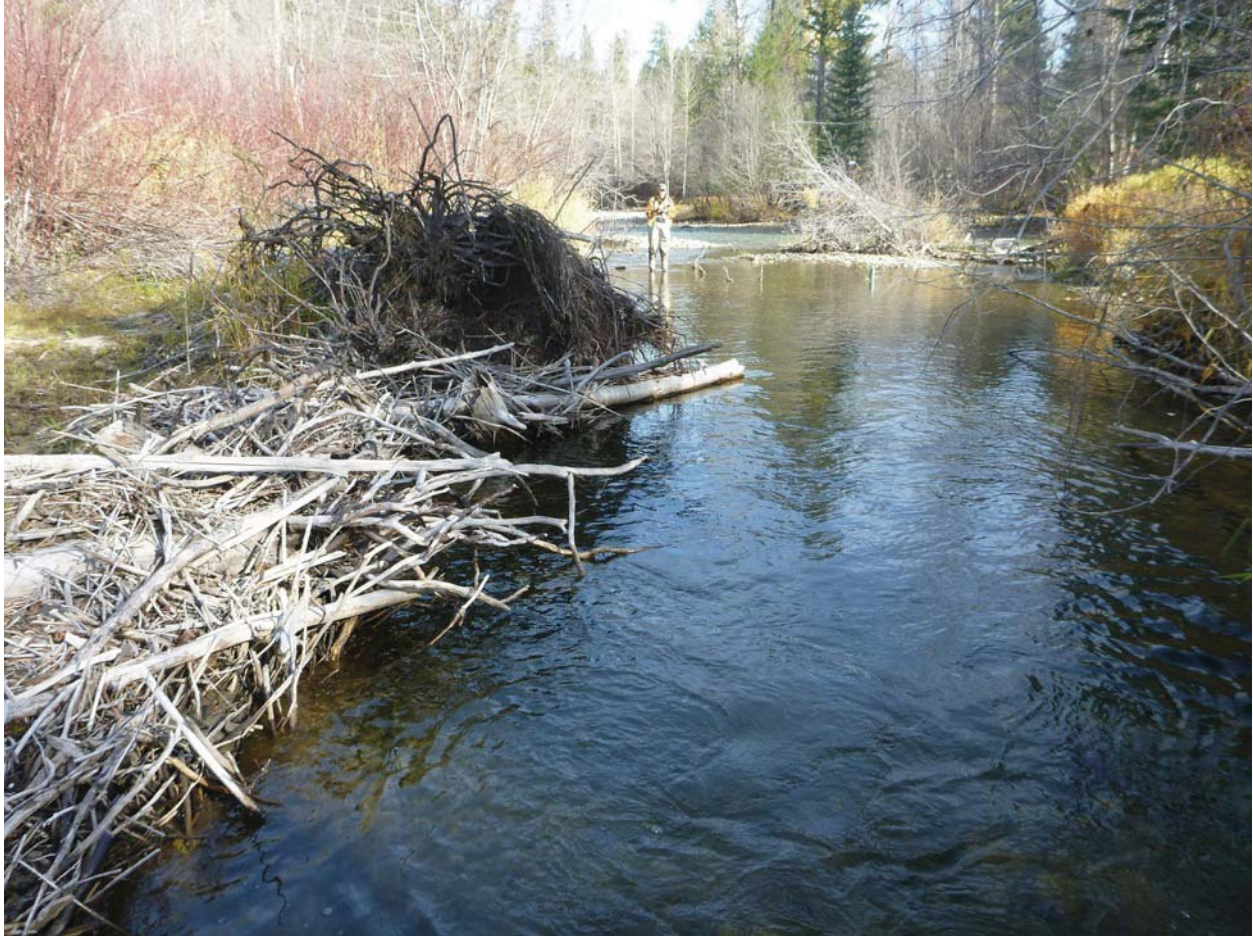
Figure 60. Downstream end of 4956-foot side channel that exits at RM 13.65. While there was significant wood throughout the channel (see left of photo), most of the wood was not long enough to quantify as small wood. As a result, only 34 pieces of wood quantified as LWD.

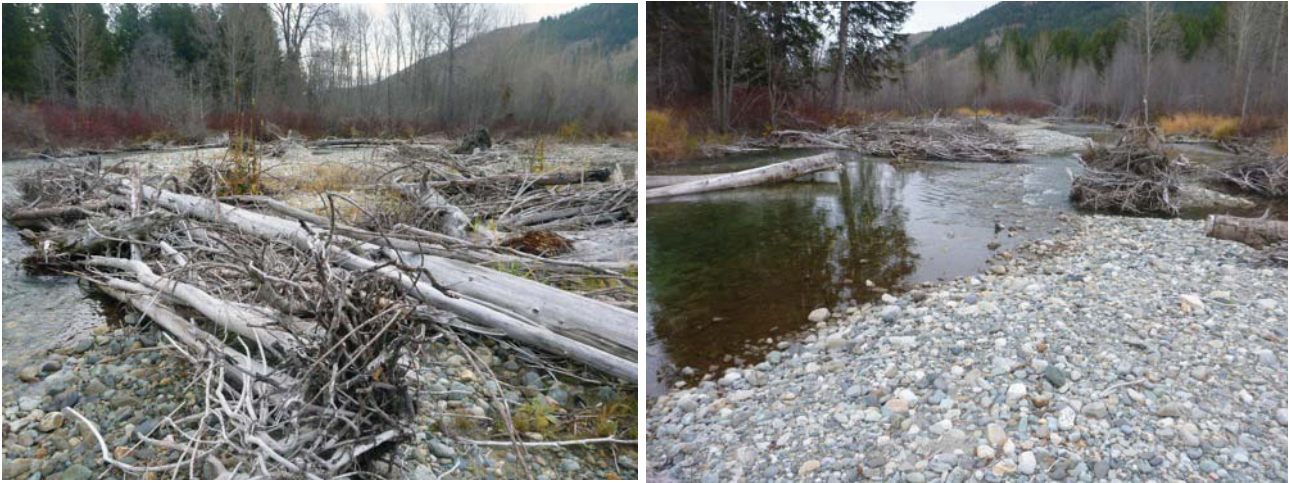
While the reach had excellent habitat overall, a significant amount of wood was observed in the river near RM 15.4, including a log jam in SO 181, that appeared to have been cut instream just upriver.

Figure 61. Significant portions of wood were observed in SO 181 that appeared to have been cut instream just upstream of where this photo was captured.

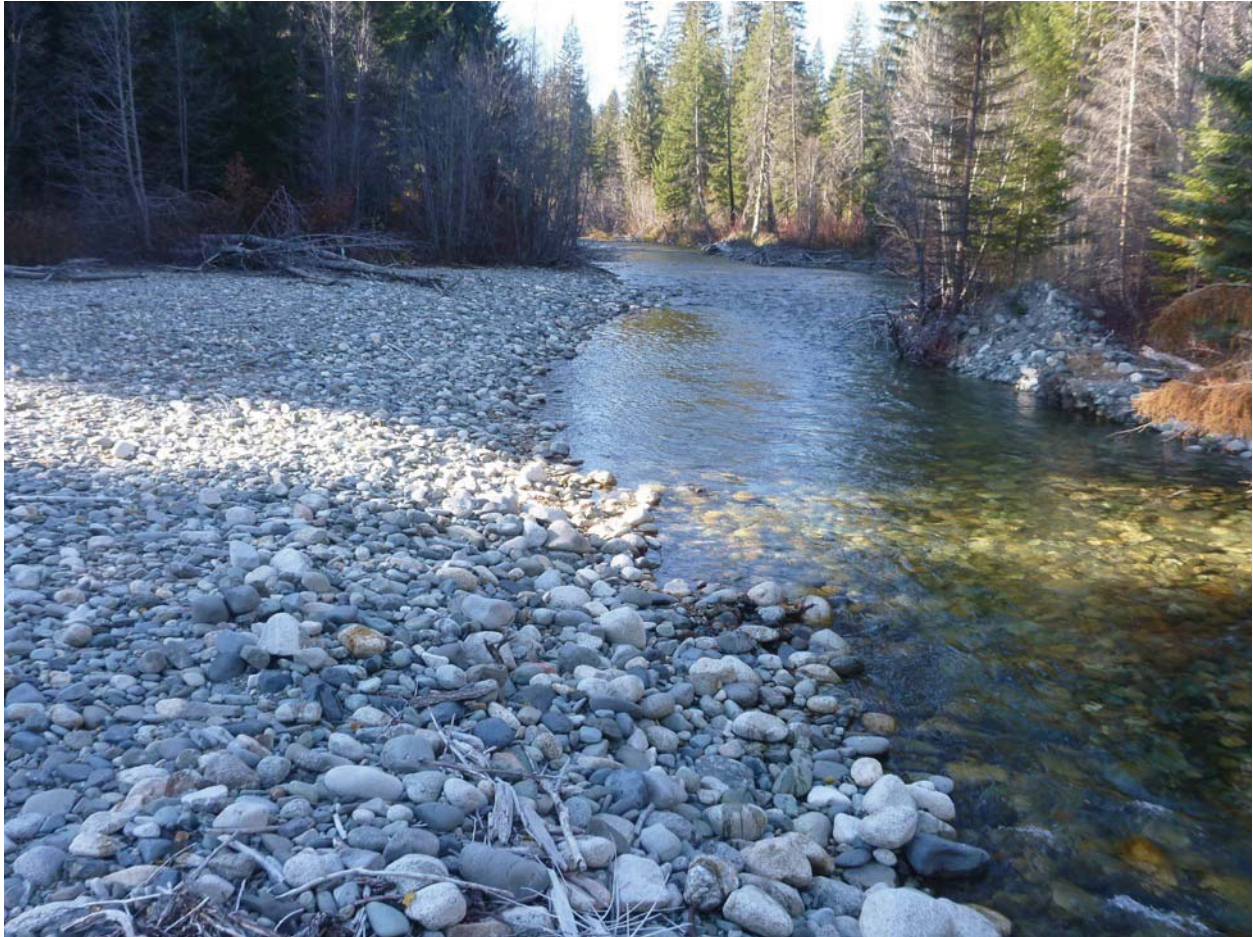
Figure 66. Reach 6 had 15 pools translating into 7.7 pools per mile. While pools were prevalent, they were relatively short in length, many only slightly longer than the channel width. Note the pool/glide/pool sequence at RM 16.9.
