Entiat River 3D Reach Assessment and Conceptual Project Development

March 2, 2010

APPENDIX A: SITE MAPS AND TYPICAL DRAWINGS

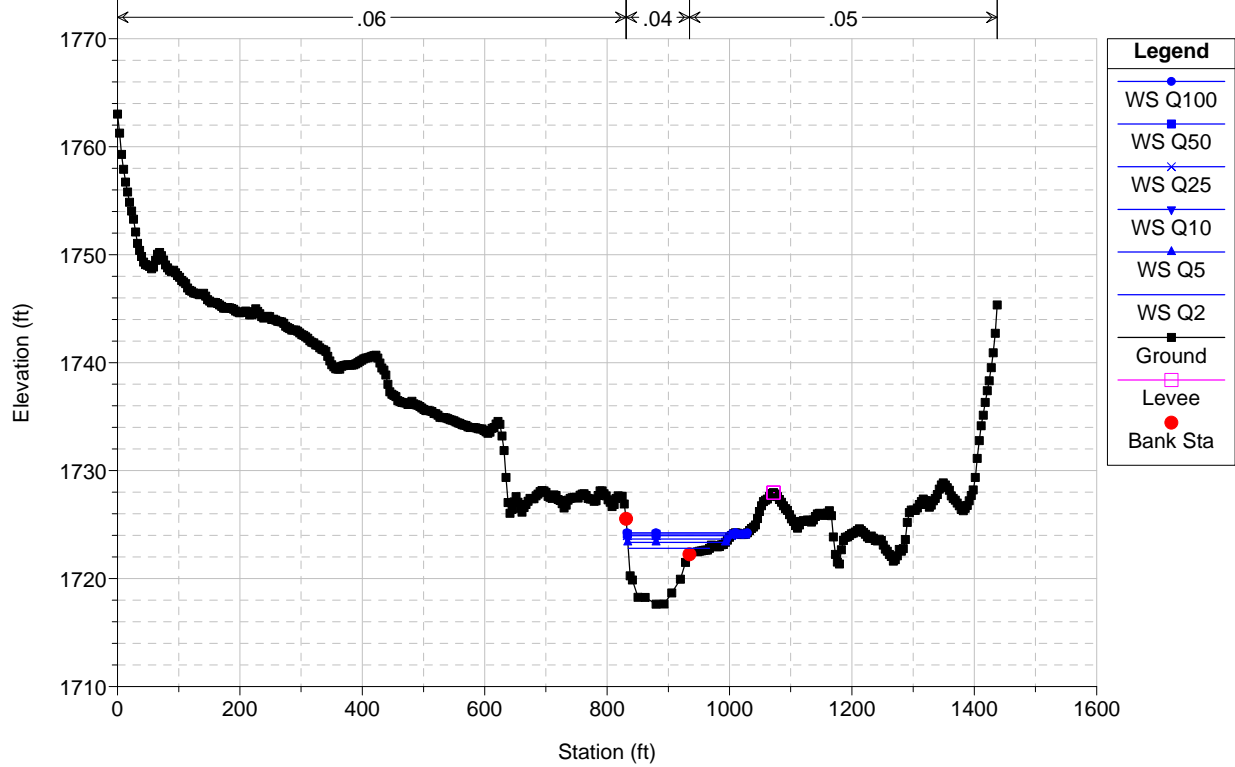
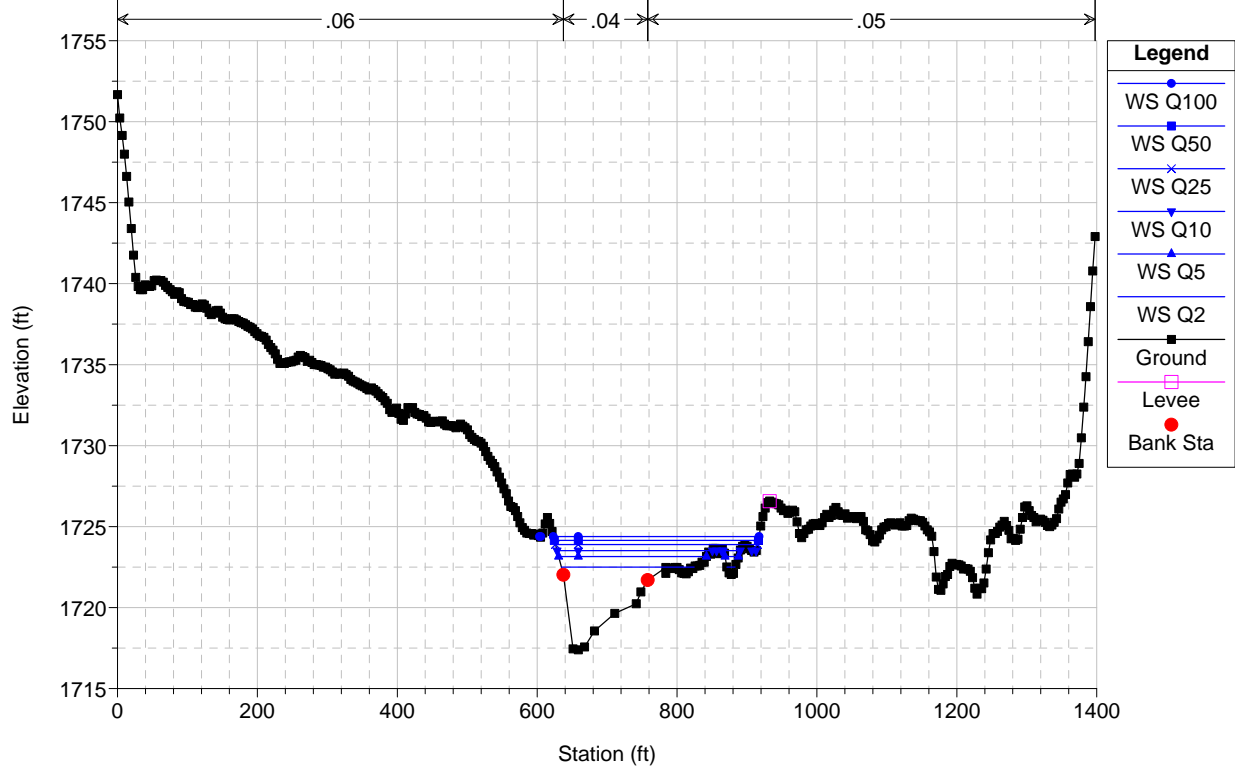
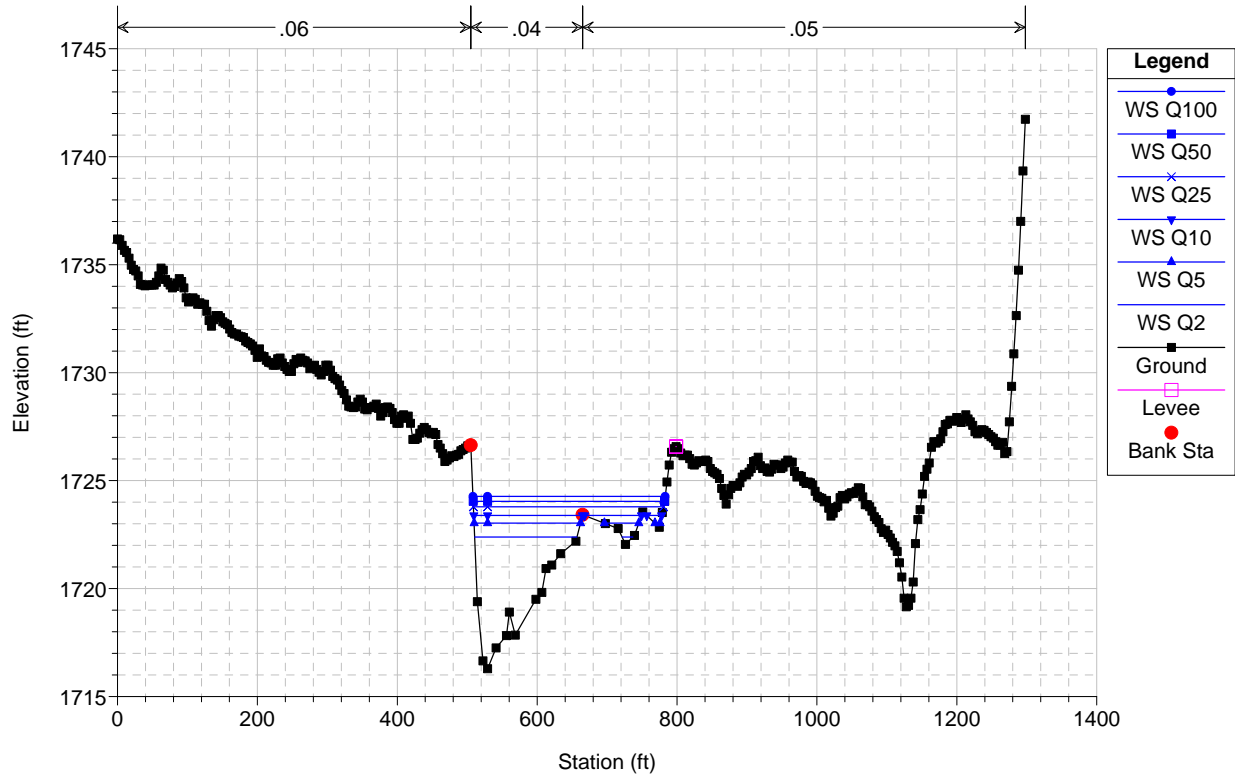
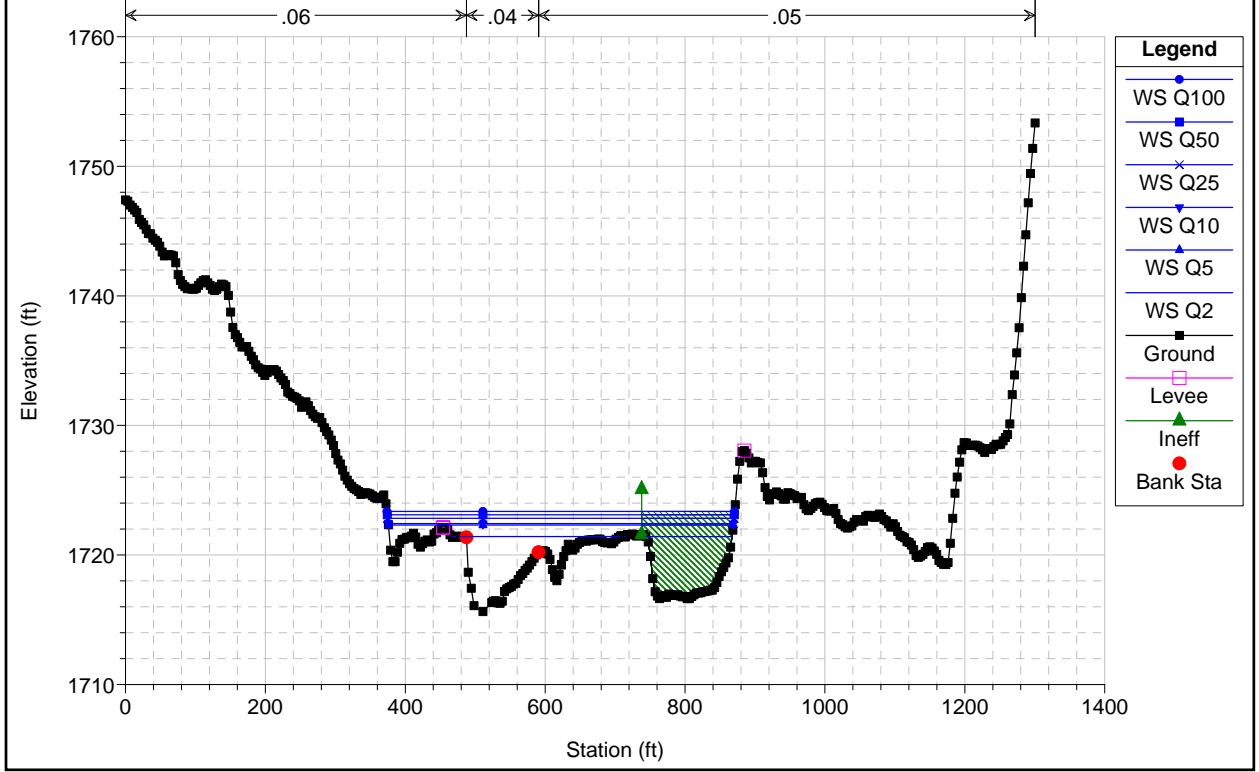
Entiat_3D_1_ft_feb1 Plan: 3D_1_feb1final 2/5/2010
 River = Entiat Reach = 3D_1 RS = 299.1595

Entiat_3D_1_ft_feb1 Plan: 3D_1_feb1final 2/5/2010
 River = Entiat Reach = 3D_1 RS = 247.6486

River = Entiat Reach = 3D_1 RS = 209.3842

River = Entiat Reach = 3D_1 RS = 172.6036

River = Entiat Reach = 3D_1 RS = 102.4473

River = Entiat Reach = 3D_1 RS = 63.53466

Bank heights ranged between 6 and 10 feet. Variation in bank height can be caused by channel incision, local channel slope, meander bend amplitude, local roughness, older flood terraces and valley width. For example, the higher bank elevation surveyed in the upstream hydraulic model near RM 25 is the downstream terminus of the McCrea Creek alluvial fan. Hydraulic output data is in Appendix B.
