GEOTECHNICAL ENGINEERING REPORT

Toppenish Creek 3-Way Diversion Levee Removal and Habitat Restoration

Prepared for: Inter-Fluve, Inc.

Project No. 160325 • May 25, 2018 Final

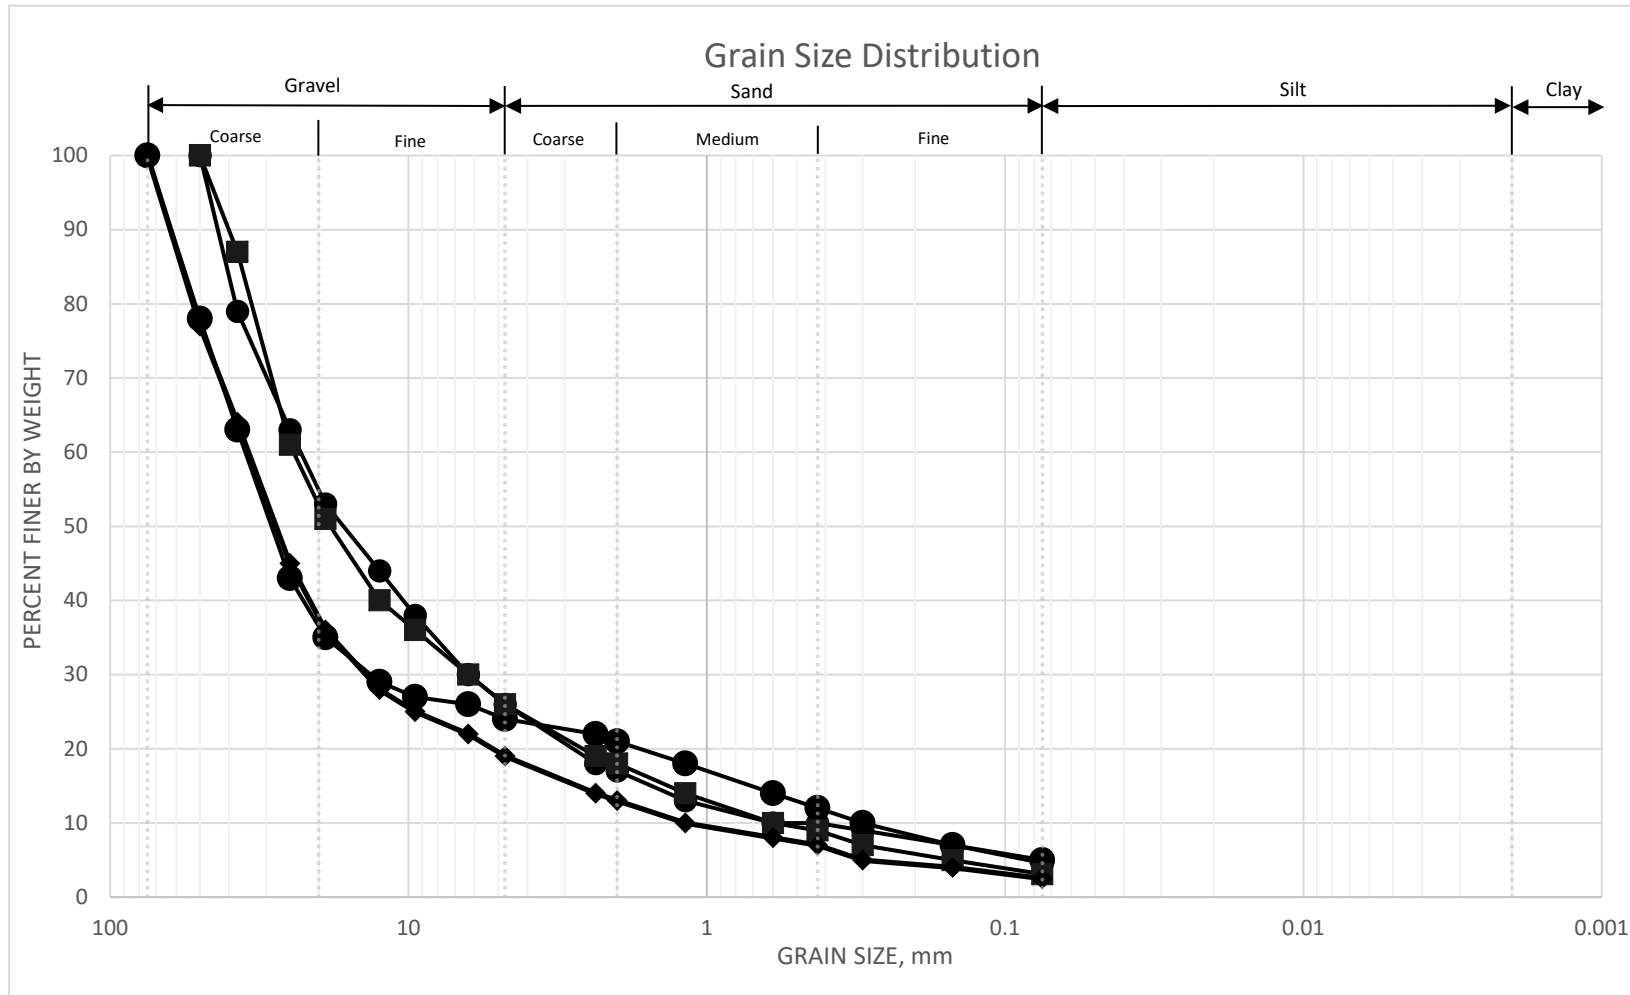
Symbol	Exploration, Sample, Depth	Moisture Content (%)	Silt/Clay Content (%)	Sand Content (%)	Gravel Content (%)	Coefficient of Uniformity, Cu	Coefficient of Curvature, Cc	USCS Soil Type
●	TP-1, S-2, 5ft	N/A	5.0	19.0	76.0	120.0	16.9	GP-GM
■	TP-1, S-4, 10ft	N/A	4.6	21.2	74.0	52.9	4.2	GP
▲	TP-4, S-1, 3ft	N/A	3.1	22.9	74.0	34.2	3.3	GP
◆	TP-5, S-4, 10.5ft	N/A	2.5	16.5	81.0	29.7	5.4	GP
