Columbia Basin Fish Recovery

January 2011

Hancock Springs Restoration Project

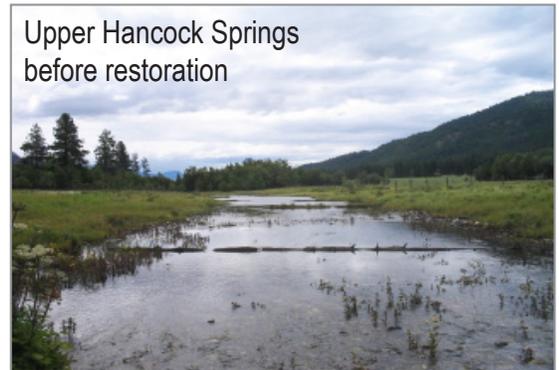
Upper Hancock Springs before restoration

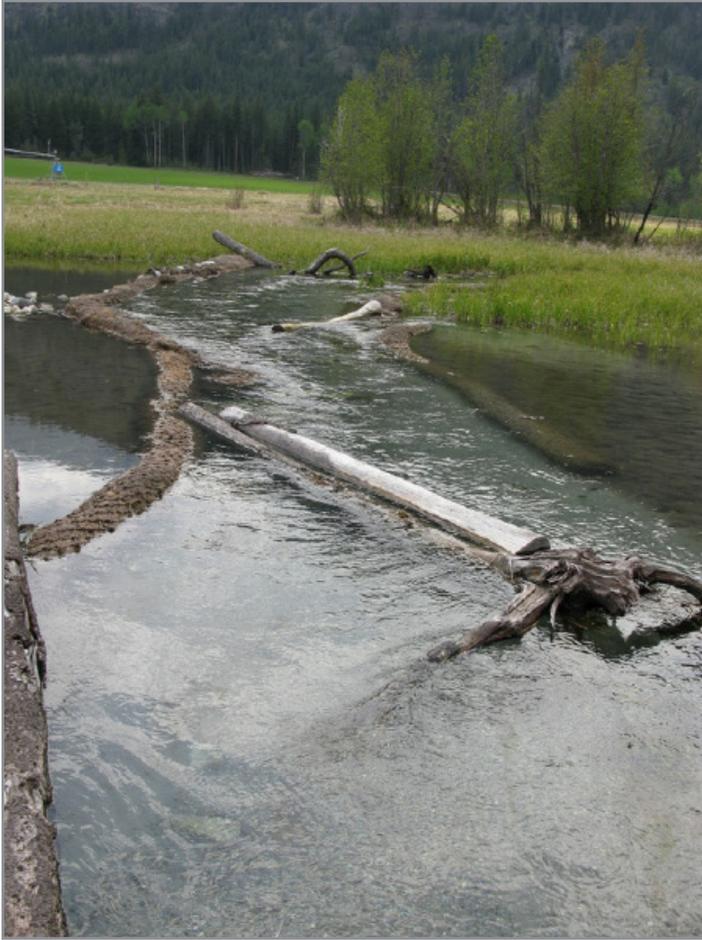
Restoration process

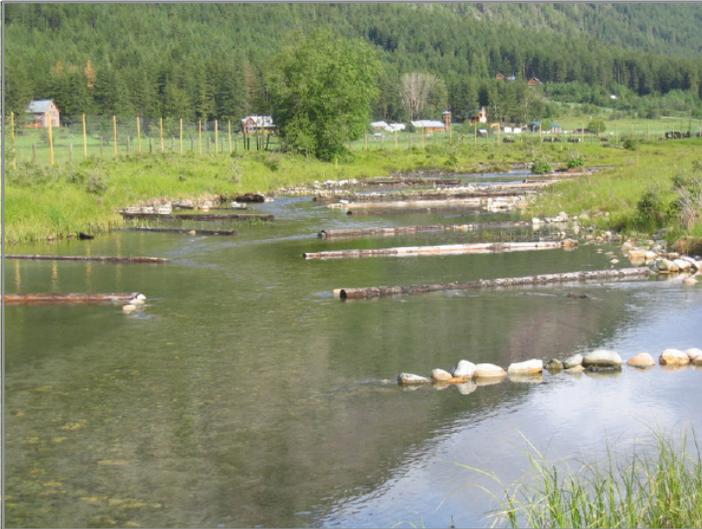
Defining the channel

Channel narrowing

greater harm to migrating fish than potential project benefits, channel restoration was completed by hand. The project was designed to improve existing conditions by employing low impact methods, such as placing structures and pools manually. Project improvements include channel narrowing, placement of large woody debris, pool and riffle construction and riparian restoration

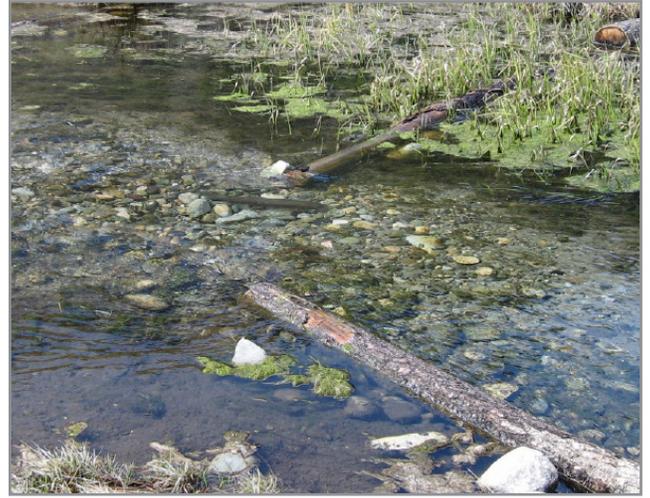
After restoration

Steelhead spawning in constructed V-structure

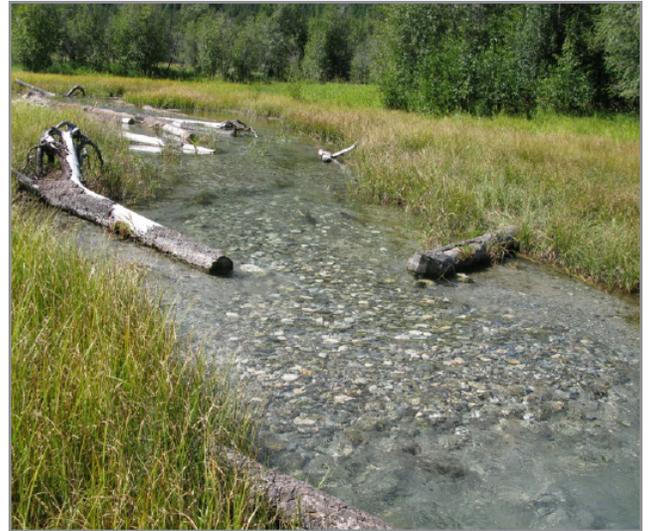
Chinook spawning in constructed riffle

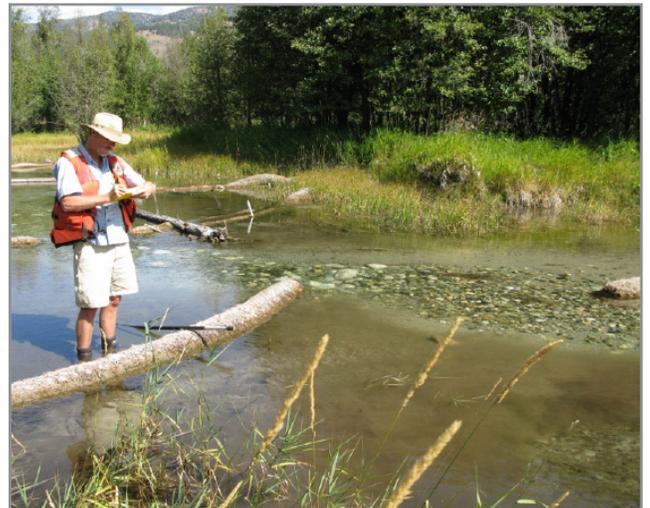
Counting redds

A monitoring plan traces the biological effects of the project over time. Beginning in 2007, the restoration effort showed clear ecological results. For the first recorded time, 50 steelhead spawned throughout the restored areas and the spawning distribution continues to expand throughout the watershed today. There is now record of nearly 100 steelhead redds, or nesting sites, in the restored areas of Hancock Springs. In addition, 60 spawning Chinook were sighted in the creek this September. Building over 20 redds, the spawning salmon used some of the same riffles as steelhead, but their redd construction was more aggressive and distributed over a larger range.
