# Upper Methow River – Fawn Creek & Weeman Habitat Restoration Concept Design Report

SUBMITTED TO  
Yakama Nation Fisheries

## Concept Design Report

PREPARED BY  
Inter-Fluve, Inc.  
501 Portway Ave, Suite 101  
Hood River, OR 97031  
(541) 386-9003

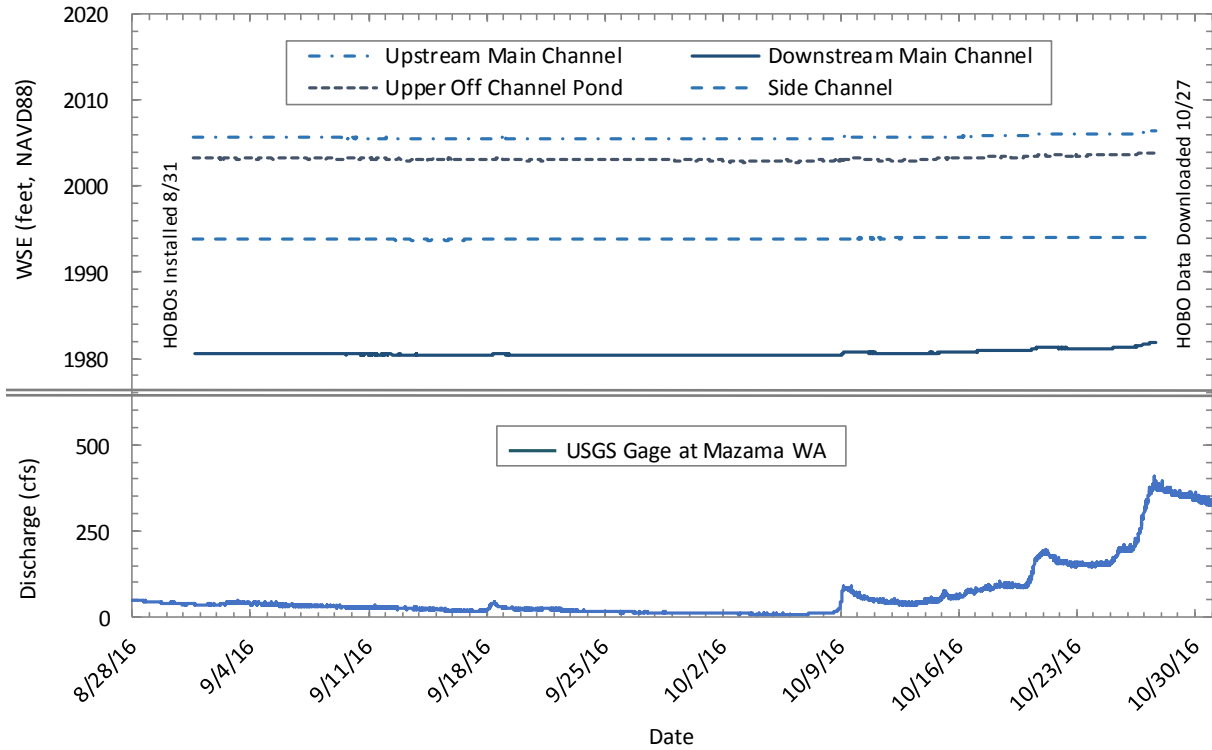
Figure 5. HOBOb water surface elevation data and river gage discharge in cubic feet per second (cfs)

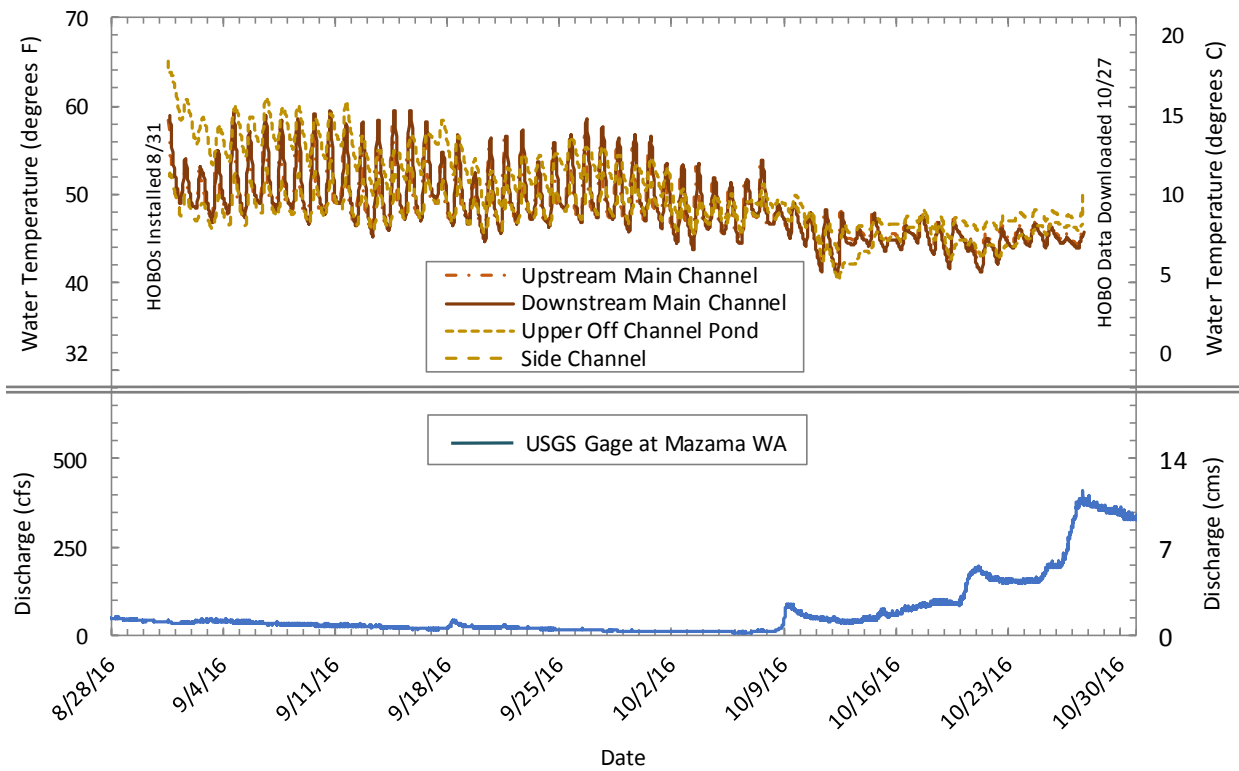
Figure 6. HOBOb temperature data and river gage discharge in cubic feet per second (cfs) and cubic meters per second (cms).

The temperature data for the period of record show typical diurnal fluctuations and a seasonal cooling trend from the later summer into the fall. Along with the cooling trend the magnitude of diurnal fluctuations decreases, especially from early October on. The seasonal cooling trend is related to both lower air temperatures and also increases in river discharge caused by fall rain events in the watershed. In general, all 4 locations track together and have relatively similar daily high and

low temperatures. One notable exception is the higher temperatures in the Upper Off Channel Pond in early September. Given the surface water isolation of the pond in the late summer and high daytime air temperatures, these higher water temperatures are not unexpected. The Side Channel water temperature tracks with the main channel temperatures through September indicating a good groundwater connection with the main channel. In October, the side channel temperature is greater than the main channel and lags behind the main channel – a reflection of the side channel temperature being buffered by the thermal capacity of the ground between the main and side channels.

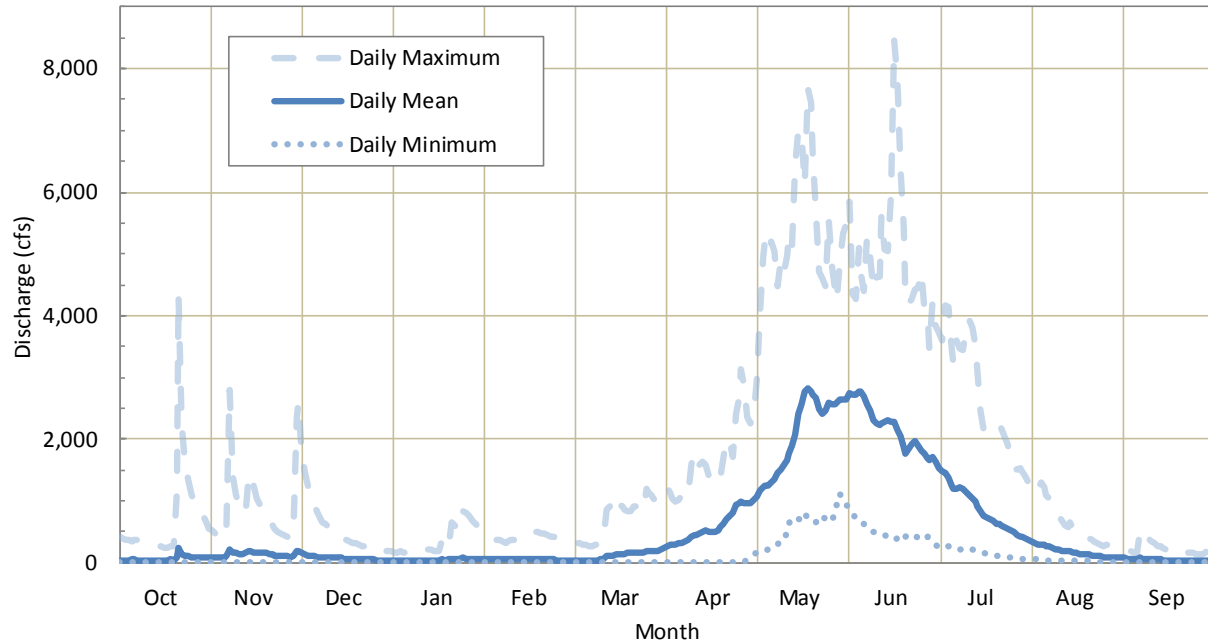
**Figure 20. Average, maximum, and minimum values of average daily flows for the period between 1991 to 2015 (USGS gage #12447383 – Methow River above Goat Creek near Mazama, WA).**

Methow River hydrology is driven by precipitation in the form of snow and the subsequent spring snowmelt. Peak discharge usually occurs from May to July and the river returns to baseflow by September (Figure 20). Mean annual flow is 525 cubic feet per second based on annual average flows from 1993-2013 (USGS 2014). Portions of the upper Methow have gone dry during drought years, with all flow contained within the unconsolidated alluvial bed (Inter-Fluve 2015). Note that this is not the typical condition for the Methow River within the project areas.

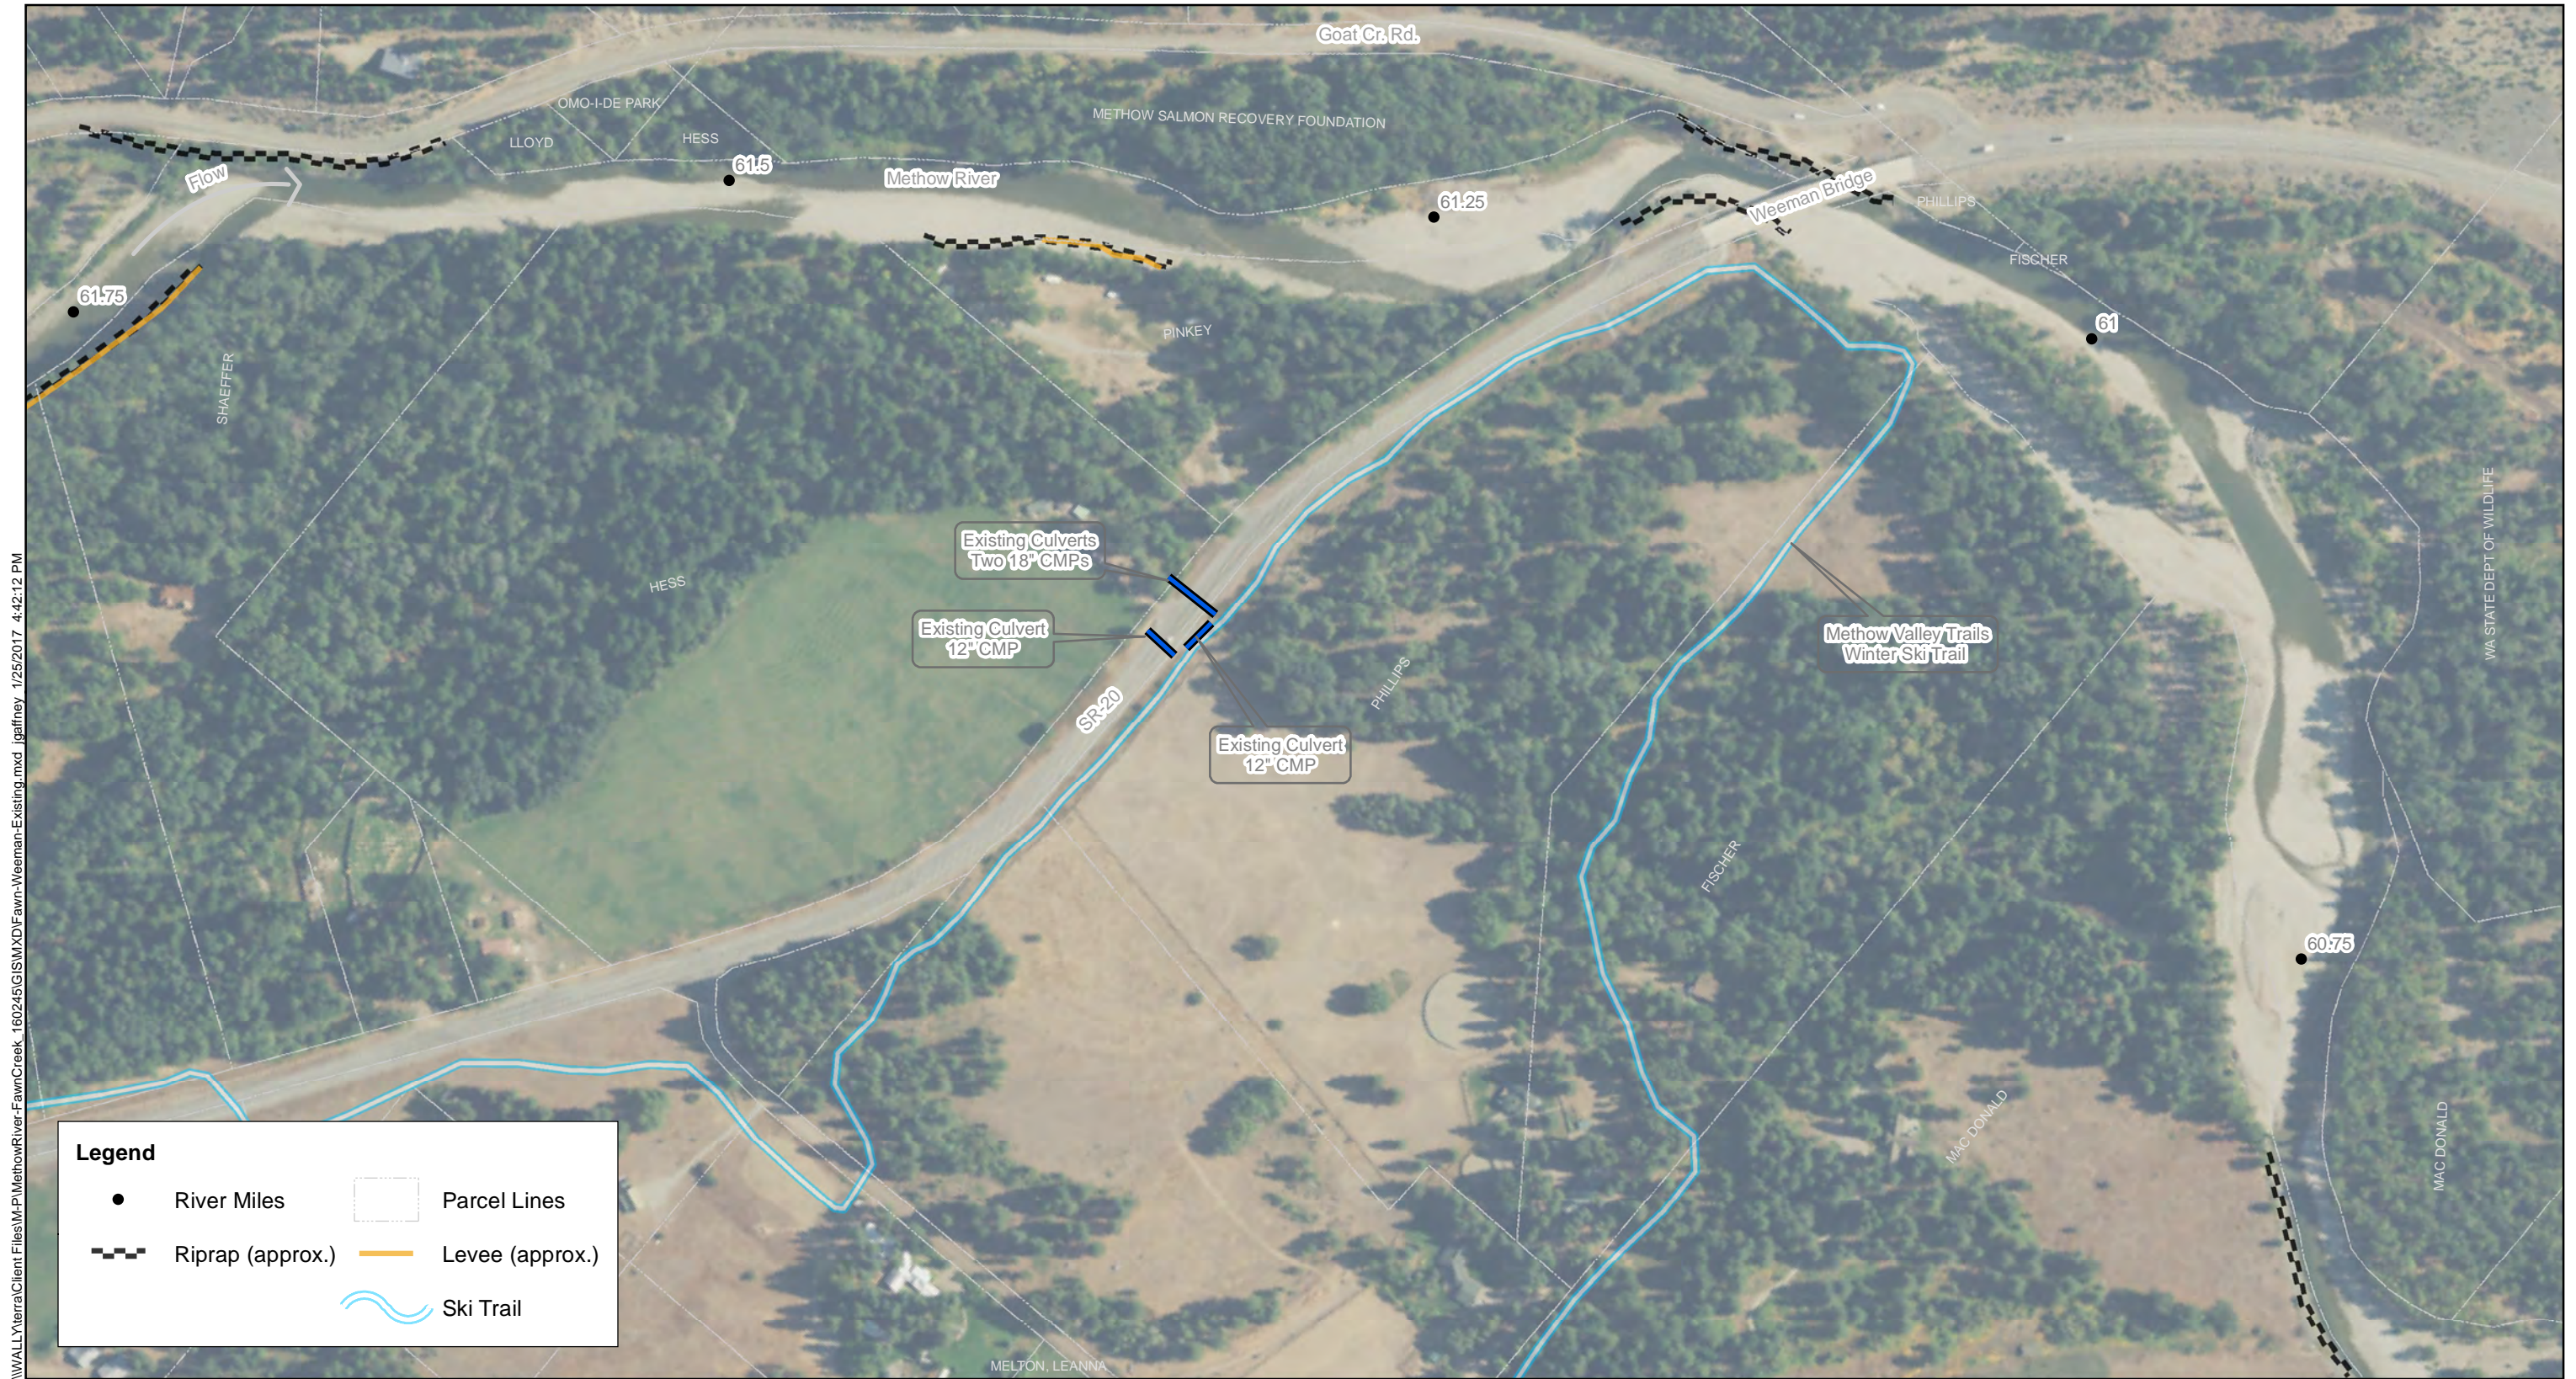
**Conceptual Project Layout - Figure F5**  
Alt. 4 - Main Channel Large Wood

Fawn Creek Project Area  
Methow River, WA  
Yakama Nation Fisheries

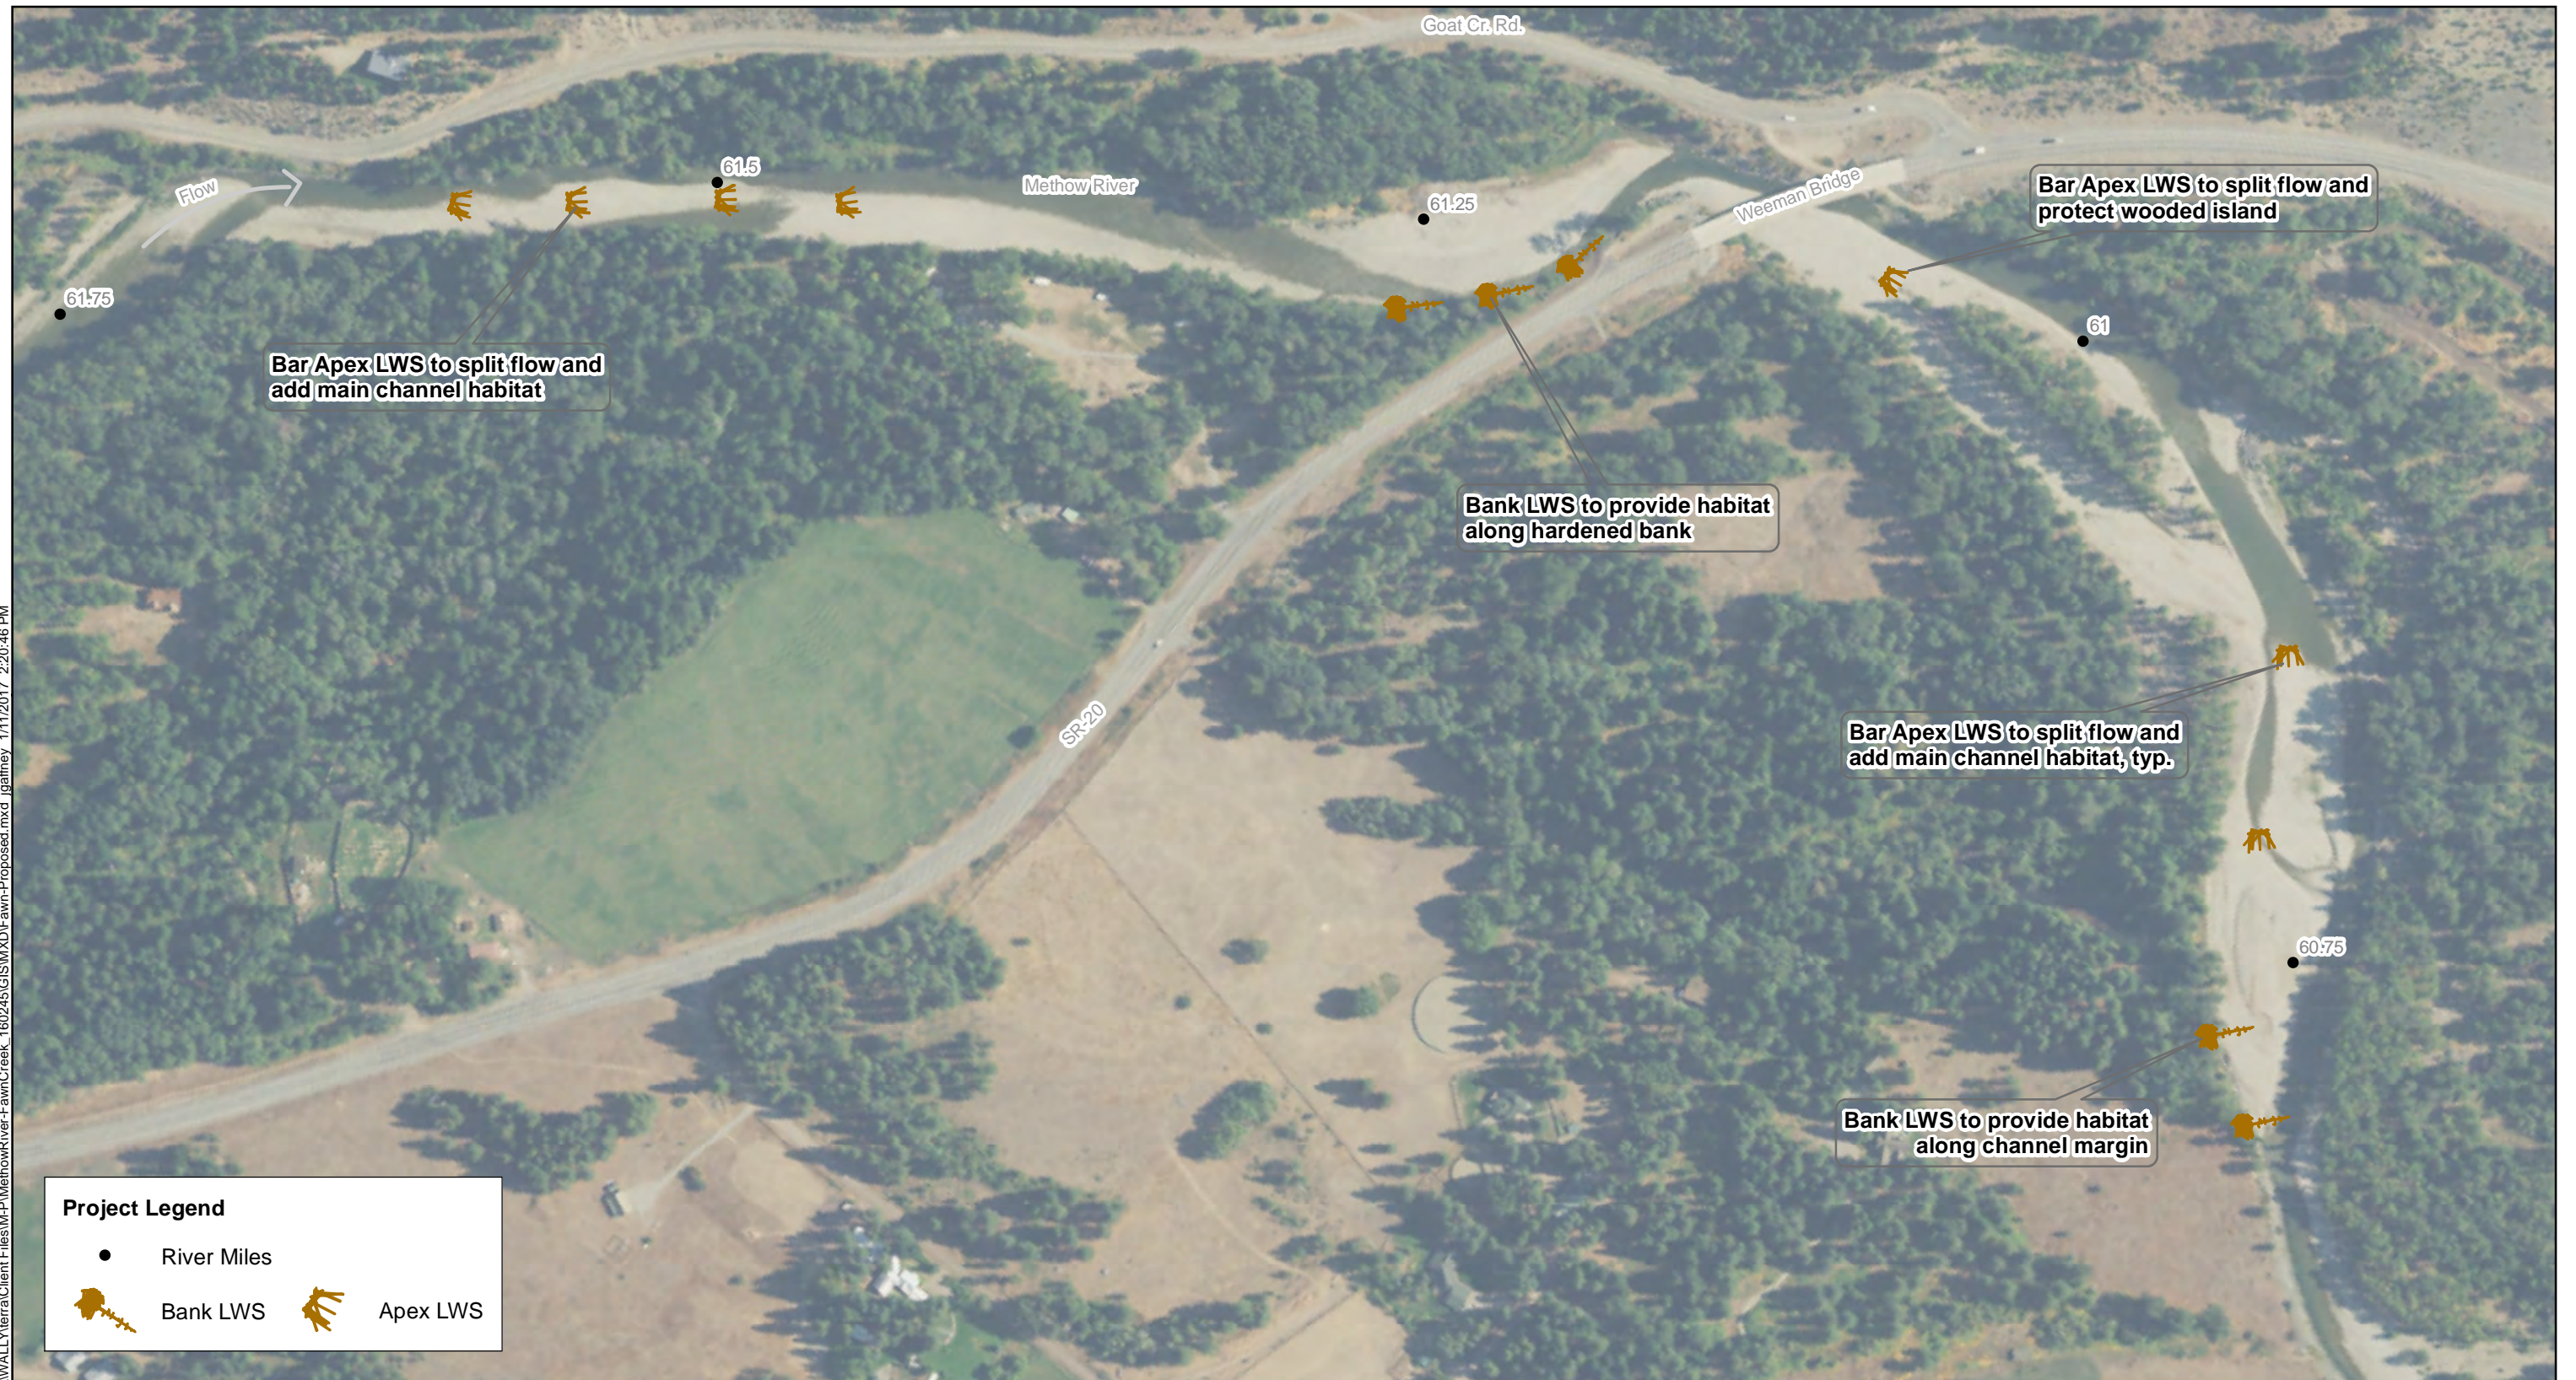
**Conceptual Project Layout - Figure W3**  
 Main Channel Large Wood
