UPPER TWISP RIVER RESTORATION DESIGN
PROJECT AREAS 2, 3, AND 4
CONCEPT LEVEL DESIGN

August 2018

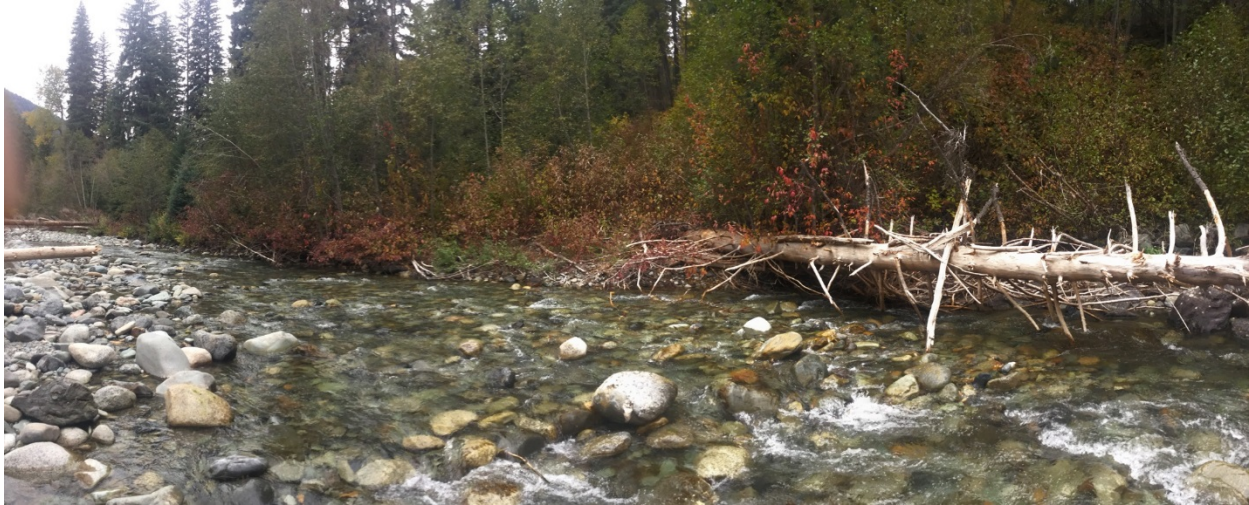
Figure 2-1. Riparian Vegetation Typical of the Upper Twisp River Project Area

Existing riparian vegetation was documented during the 2017 field surveys conducted for the Project. Overstory consists primarily of mature black cottonwoods (*Populus balsamifera* ssp. *trichocarpa*) and large conifers including Engelmann spruce (*Picea engelmannii*), Douglas fir (*Pseudotsuga menziesii*), and to a lesser degree ponderosa pine (*Pinus ponderosa*), interspersed with alders (*Alnus* sp.) along the bank margins. Toward the downstream end of the Project Western red cedar (*Thuja plicata*) were also noted in greater frequency. Understory coverage consists of young alders, willows (*Salix* spp.), vine maple (*Acer circinatum*), red-osier dogwood (*Cornus sericea*), and snowberry (*Symphoricarpos* sp.) on the drier terraces. The ground cover is patchy weeds and duff (decaying leaves and conifer needles). The recolonizing vegetation in unconstrained segments along the river bars consists of young cottonwoods and willows. Overall vegetation and canopy density is high, with minor gaps spread across the Project Area. The single largest gap is a terraced meadow on river left, approximately in the middle of the Project Area (near RM 20.7). Figure 2-1 illustrates the riparian vegetation community typical within the Project.

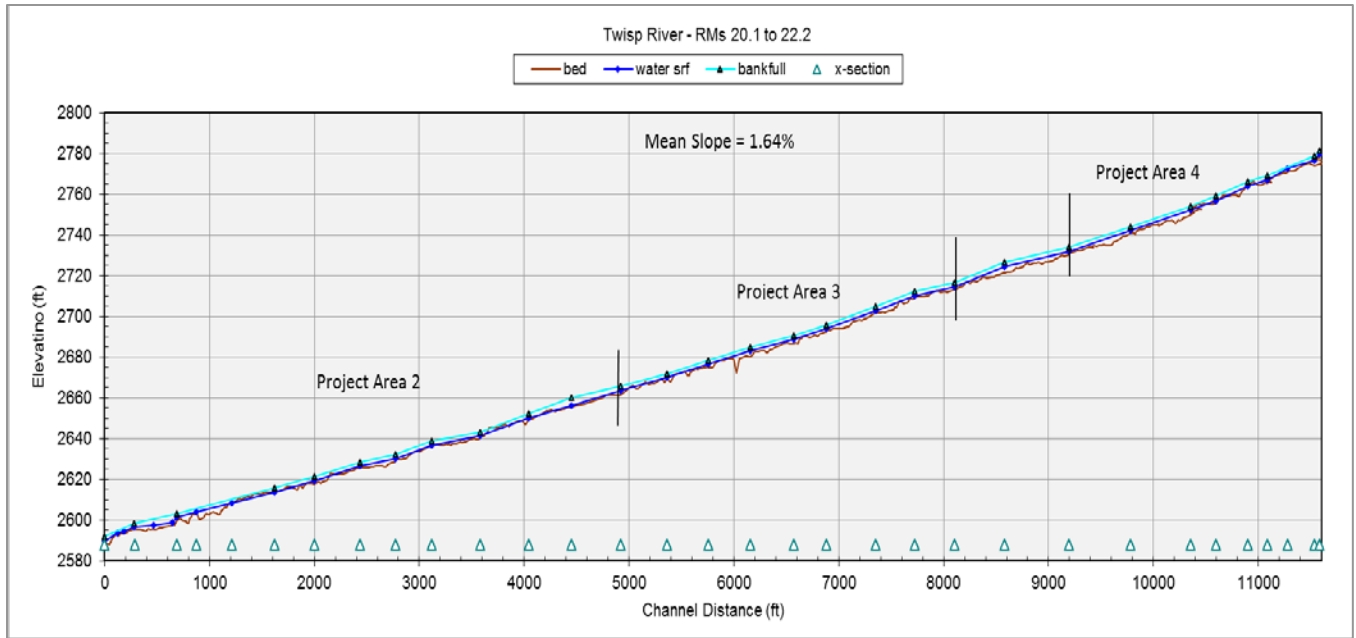
Figure 3-1. Longitudinal Profile of the Twisp River, Project Areas 2, 3, and 4

The topographic survey included a longitudinal profile of the thalweg, with data collected at approximately 20-foot intervals, and capturing all major breaks in slope necessary for hydraulic analyses. The profile covered 11,581 feet of river (Figure 3-1). The slope at the upper end in Project Area 4 averaged 1.99 percent, 1.63 percent in Project Area 3, and 1.46 percent at the downstream end in Project Area 2.

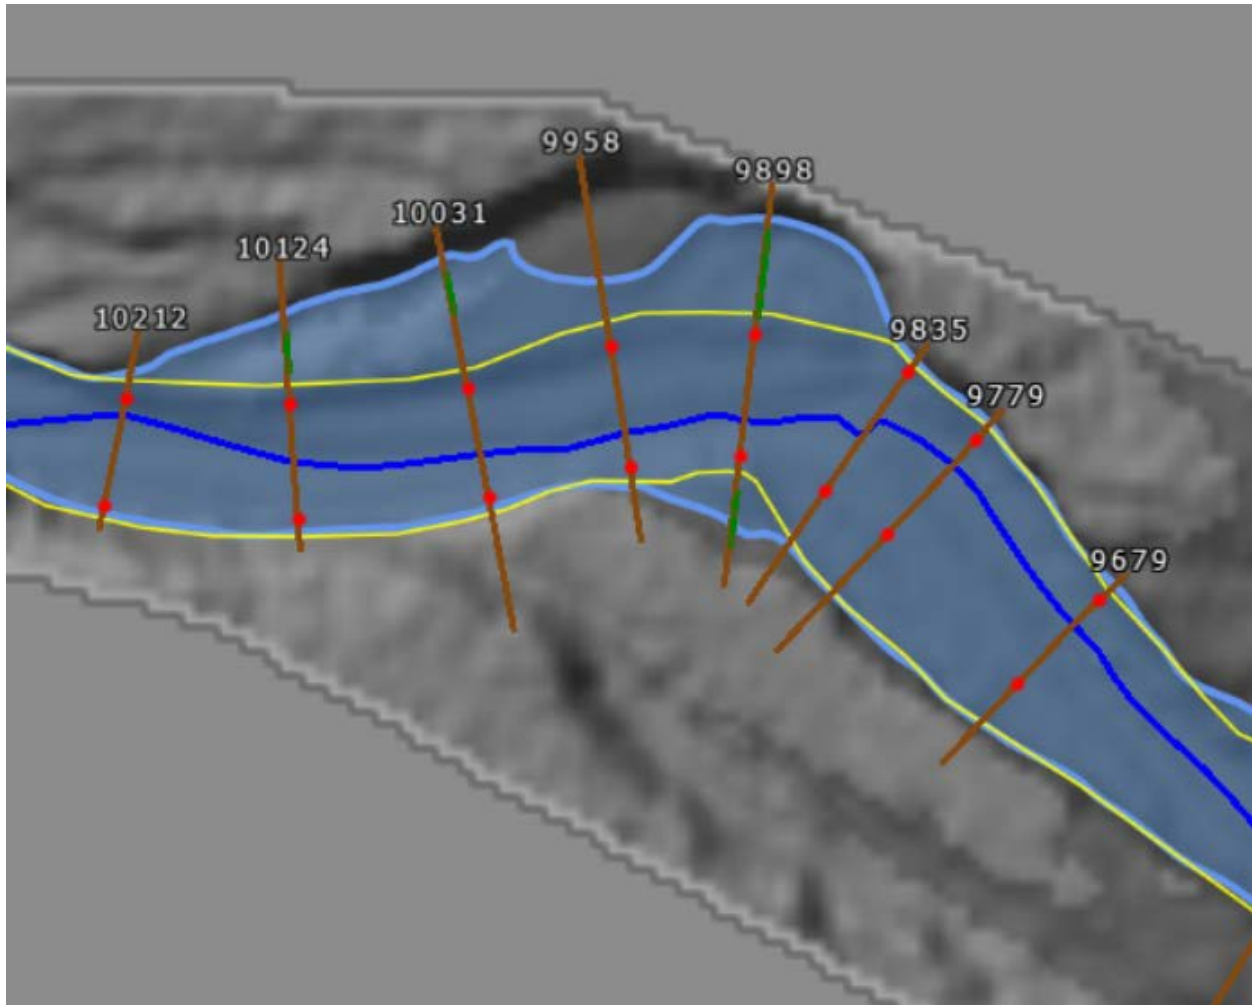
Figure 3-3. Hydraulic Model Typical Meander Section

match the values listed in Table 3-4. Model geometry includes the entire reach length alignment and multiple cross sections, flow paths, bank stations, and roughness coefficients to best represent the hydraulic behavior of the existing system. The Geolocation feature within Civil 3D was used to overlay an aerial map on the project extents. Based on the landcover presented in the aerial, a Manning's roughness value of 0.05 was selected for the channel and a value of 0.1 was used for the heavily vegetated overbanks. Boundary conditions were set for each terminus of the model, inflow at the upstream end representing the recurrence interval flow rate, and normal depth at the downstream end representing the energy slope measured at the end of the model. Initial modifications to the channel alignment were necessary based on field survey data collected for thalweg locations. Figure 3-3 below illustrates a meander section of the hydraulic model and shows the typical cross sections, flow paths, and bank stations that were used throughout the reach.

After entering the geometry and hydraulic parameter information, steady flow analysis was computed for the time of survey flow value to review geometry input parameters and model calibration. Edge of water survey points were reviewed against inundation extents for 44 cfs (flow at time of survey). Results suggested that a slightly higher Manning's roughness value was necessary for model calibration, and the process was repeated for a channel Manning's value of 0.055. Results of the second iteration indicated an accurate match between inundation extents and surveyed edge of water points. Additional revisions to cross sections, bank stations, and flow paths were made for calibration against estimated bankfull flow and bankfull surveyed points using
