Restoring Floodplain Connectivity Along the Klickitat Haul Road: Technical Approach and Results

**Will Conley, Hydrologist / Watershed Restoration Specialist
YN Fisheries Program, Klickitat Field Office
PO Box 215, Klickitat, WA 98628**

2011 Klickitat / White Salmon Science Conference

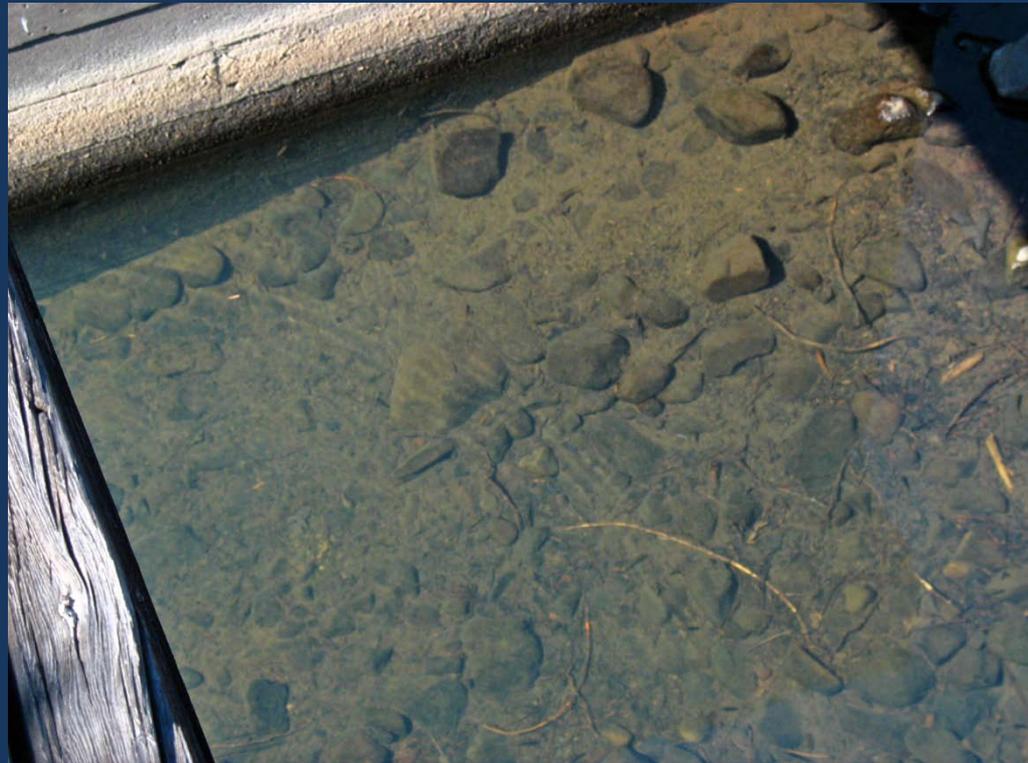
Dead Canyon RR Embankment

- Abandoned when converted to truck road (~1950s)
- Cross-valley embankment constricted flow
- Seasonal pool associated with abutment scour caused routine *O. mykiss* mortality

- 570 l.f. of cross-valley embankment removed
 - graded into adjacent borrow ditches, or
 - end-hauled and graded into approaches
- Trestle and abutments removed
- Channel graded to match stream profile (and eliminate false-attraction of pool)
- Pullback of 2800' l.f. of embankment (south approach)

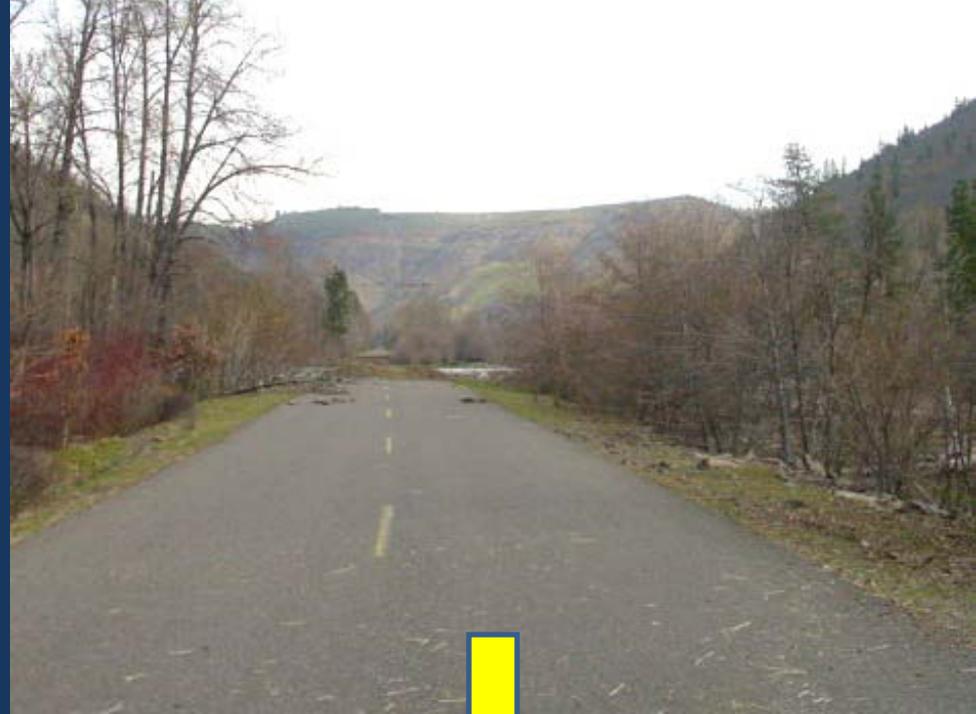
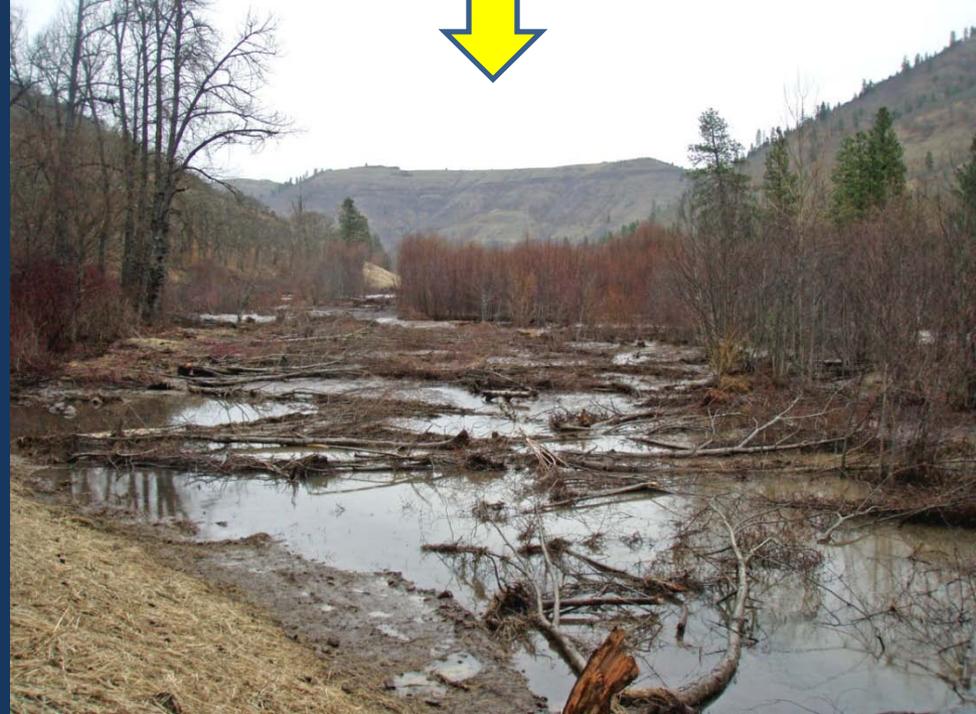
Segment 7.13

Constructed floodplain
inundated at ~2-year
recurrence flow (Jan 2011)

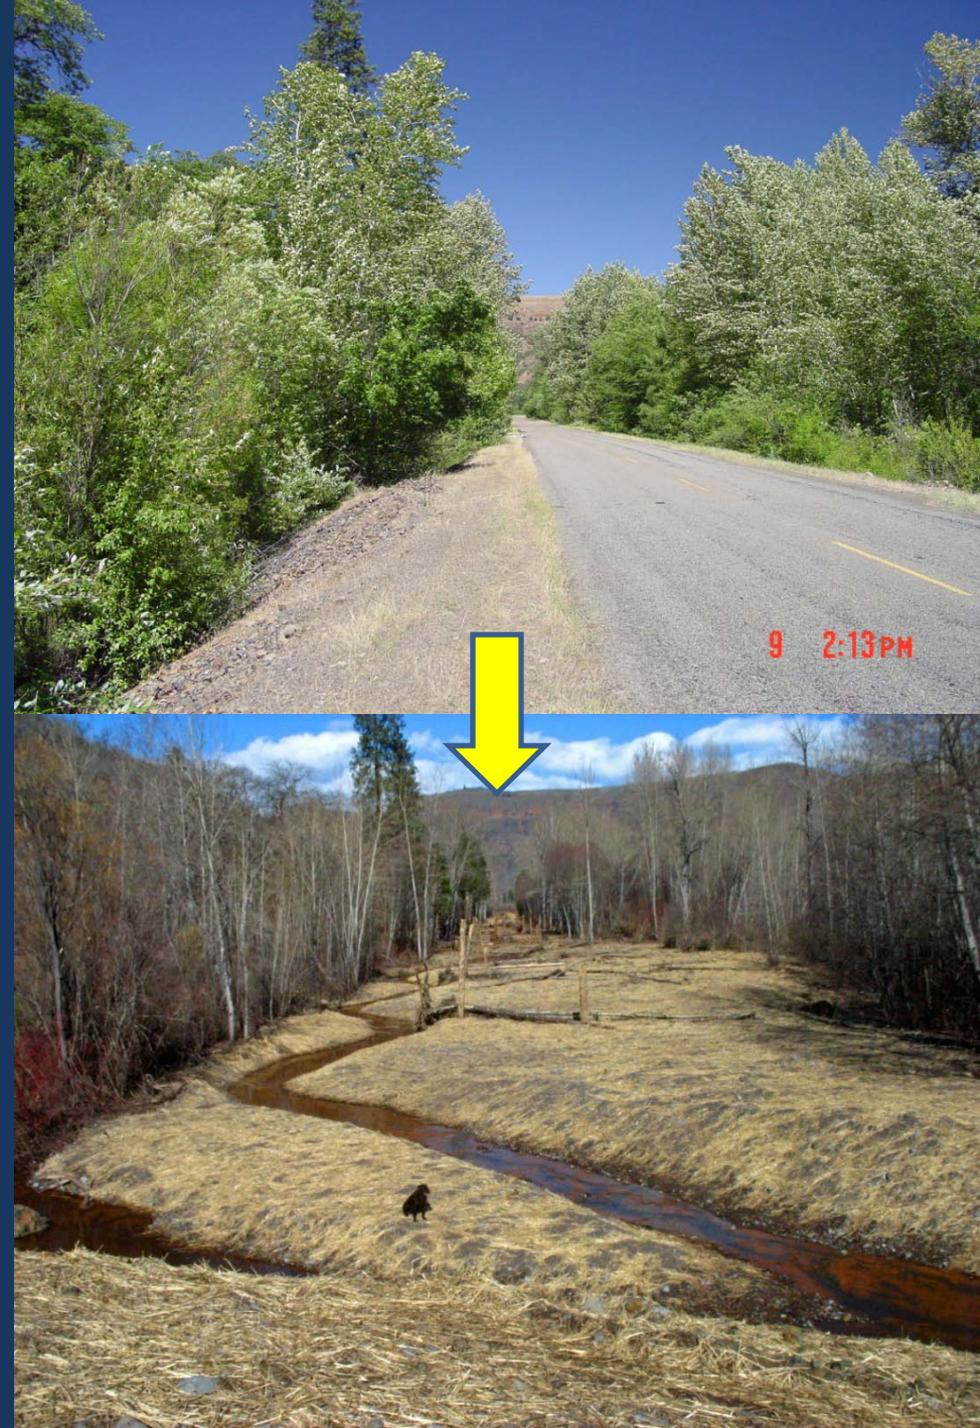
Segment 7.51

floodplain channel
constructed for spatial
diversity, flood conveyance,
and future capture (i.e. not
built as 1° fish habitat)

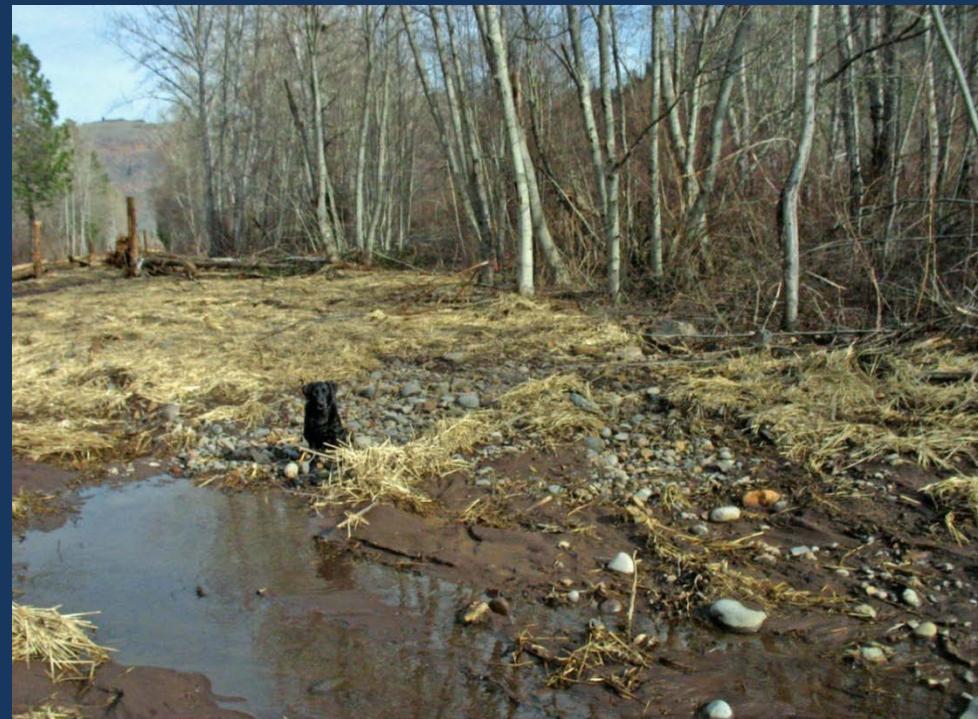
Segment 7.56

Overbank flow from
~3.5 year recurrence
event inundated
constructed
floodplain (Jan 2011)

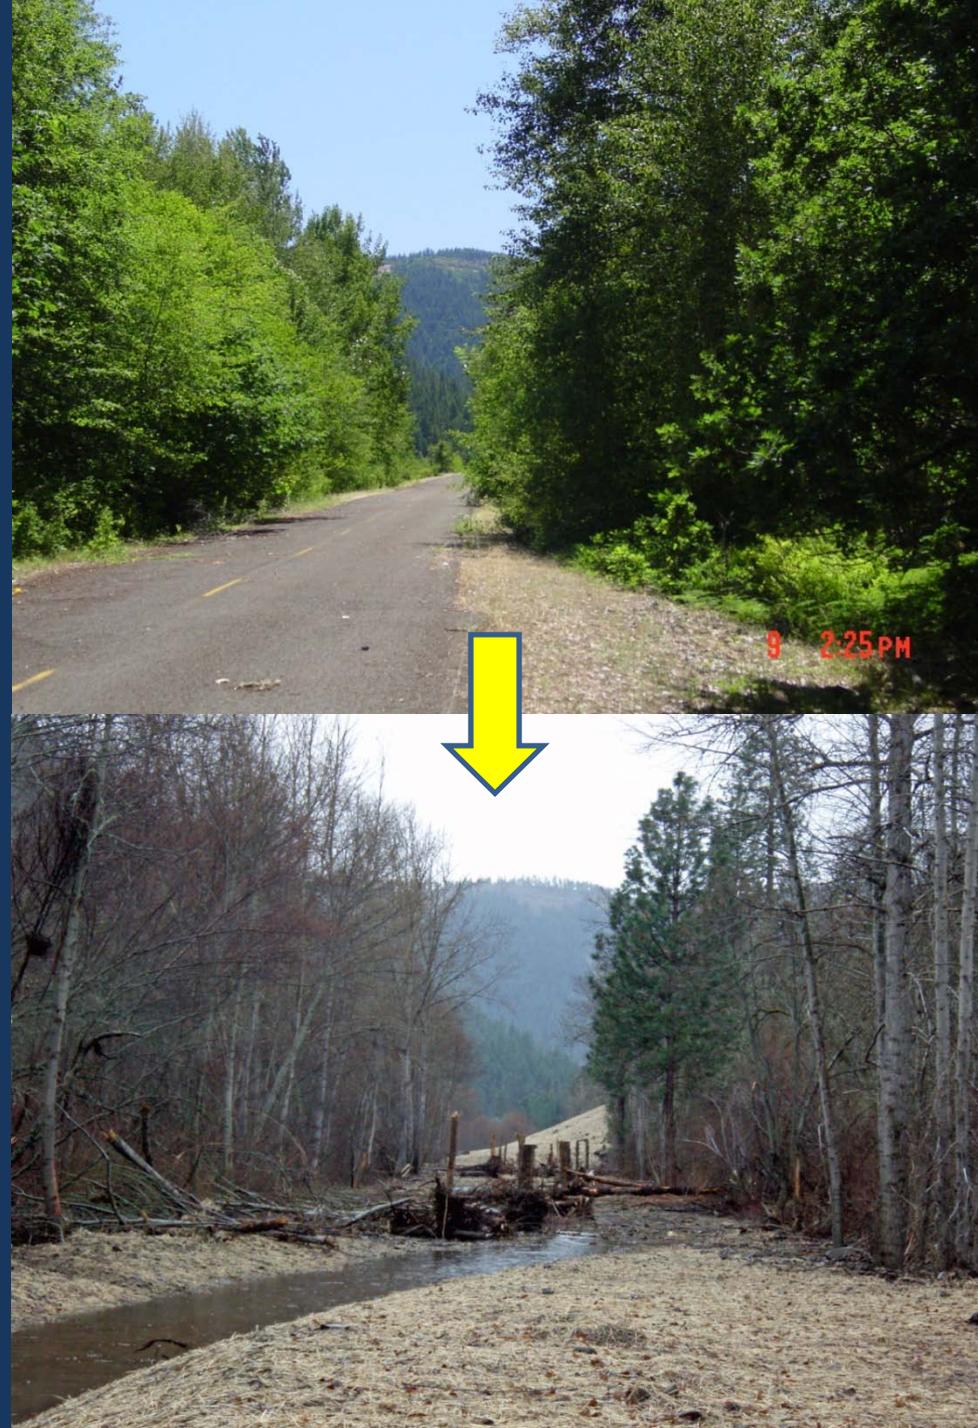
Segment 7.62

floodplain channel
constructed for spatial
diversity, flood conveyance,
and future capture (i.e. not
built as 1° fish habitat)

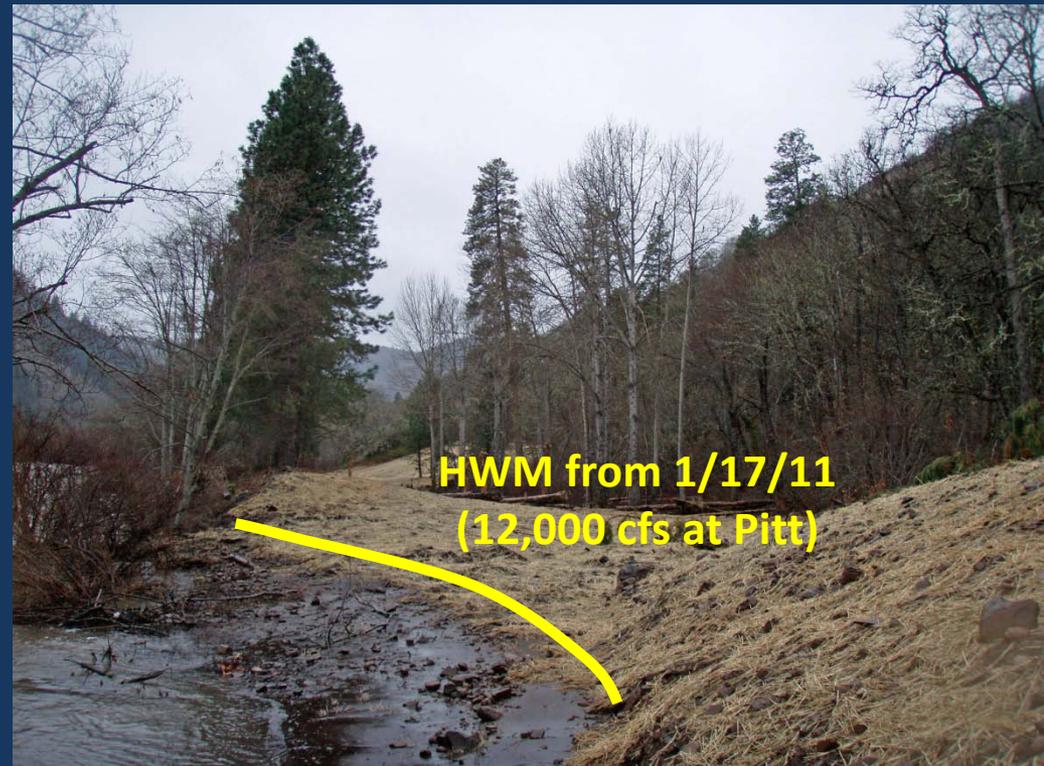
Segment 7.83

High water mark from
~3.5-year recurrence
flow (Jan 2011)
approximately 0.5'
from topping breach
constructed to flow at a
3 to 5 year flood
