Riparian Enhancement Plan

24-1719 Rest, pond 5 reach active channel planting

Tom Elliott, Yakama Nation, 6/23/2024

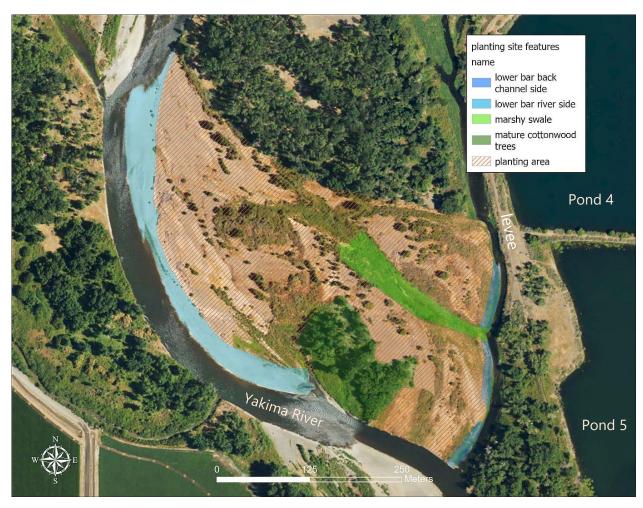
Figure 4. Features of planting site. The lower bar surfaces are inundated by the average winter flow (4,000 cfs) and do not support perennial vegetation. The grove of mature cottonwood trees does not need additional planting, and the marshy swale is too wet for terrestrial plants. The red hashed area is at appropriate elevations and of suitable substrate for riparian plantings. Aerial image is from July 2023.

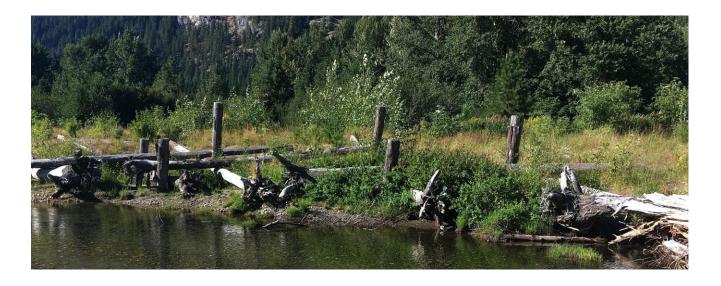
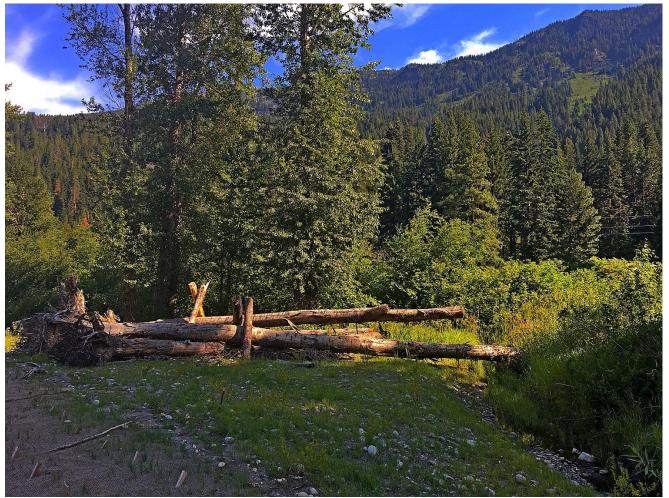
Figure 6. Examples of protective hydraulic structures similar to what is expected at the Pond 5 site. They consist of large logs pinned in place by piles driven in at an angle, to prevent floating. The piles can be driven by hand held pneumatic hammers or by drivers mounted on heavy equipment.

Plant protection structures: Log structures to protect plantings from scour and damage from debris moving with the current will be designed in year one of the project, and installed in the summer of year 2, prior to weed control and planting. Structures will be designed to be simple and cost effective, and will consist of large logs pinned in place by piles driven in at angles. The location and placement of structures will be determined using hydraulic models and field evidence to determine high energy flow locations. Planting locations, distributed in clusters, will be determined by hydraulic modelling of the shape and size of the "hydraulic shadow" created by the protection structures.
