# *Yakima RM 89.5- Floodplain Restoration*

## *Technical Memo: Site Assessment*

**SUBMITTED TO**  
Yakama Nation  
Wildlife Resources Management Program

Inter-Fluve  
501 Portway Ave., Suite 101  
Hood River, OR 97031

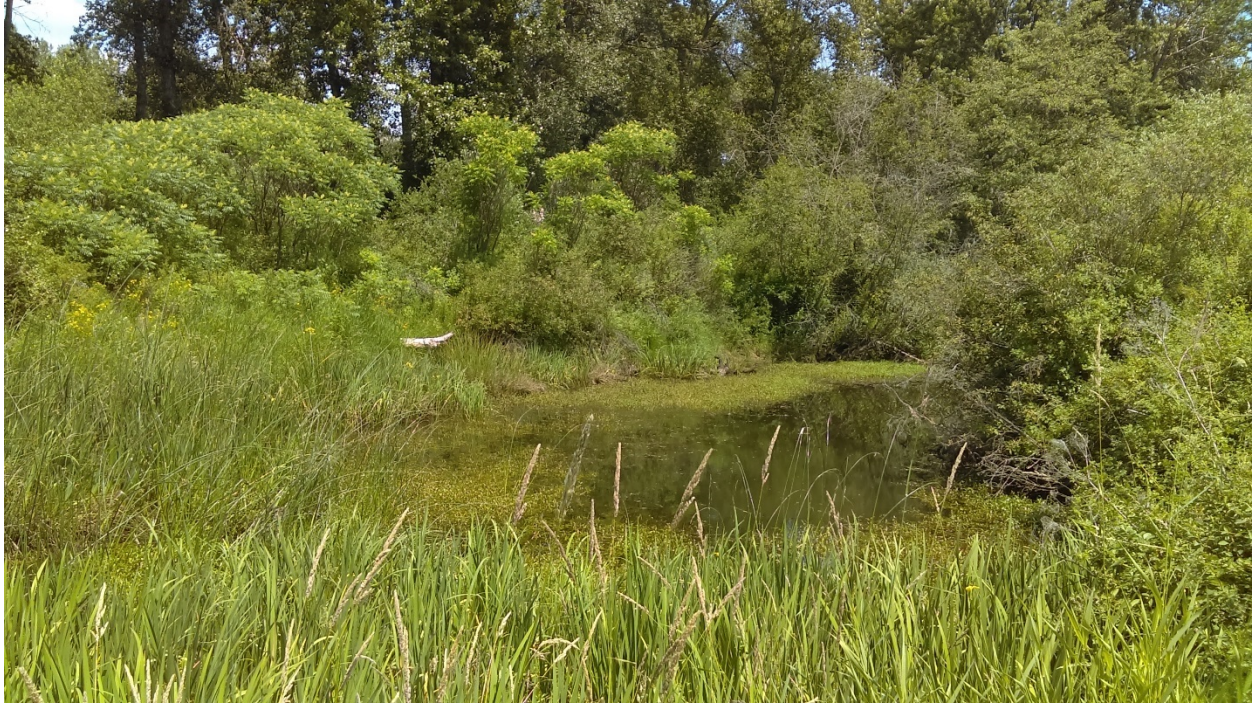
**Figure 3. Disconnected groundwater-fed oxbow downstream of levee with vegetated banks. (Photo: Inter-Fluve, June 2017)**

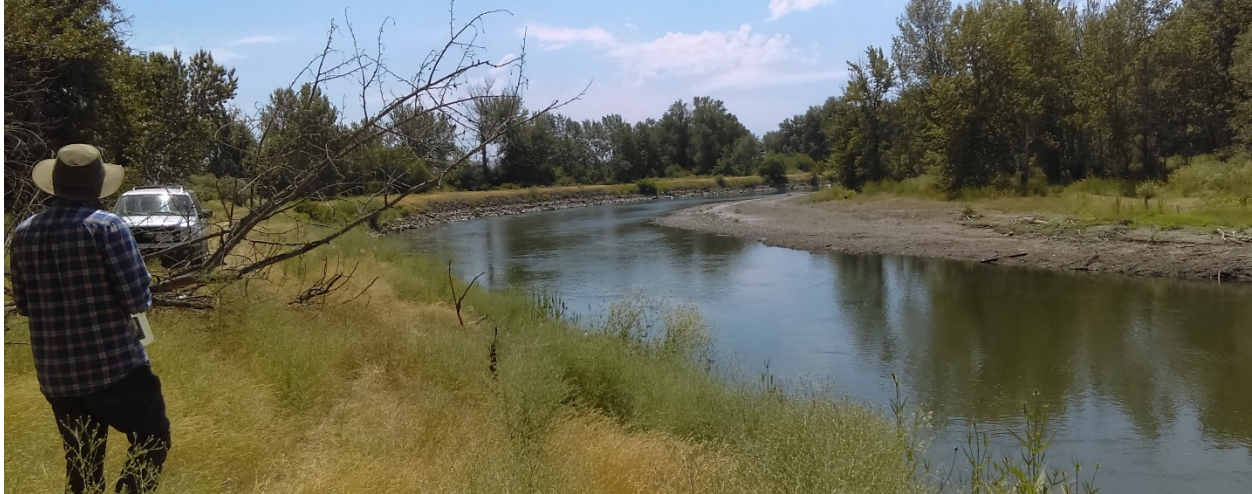
**Figure 5. Mainstem Yakima River at RM 89.5 – looking upstream. The vehicle is parked on the road atop the large boulder riprap levee. (Photo: Inter-Fluve, June 2017)**

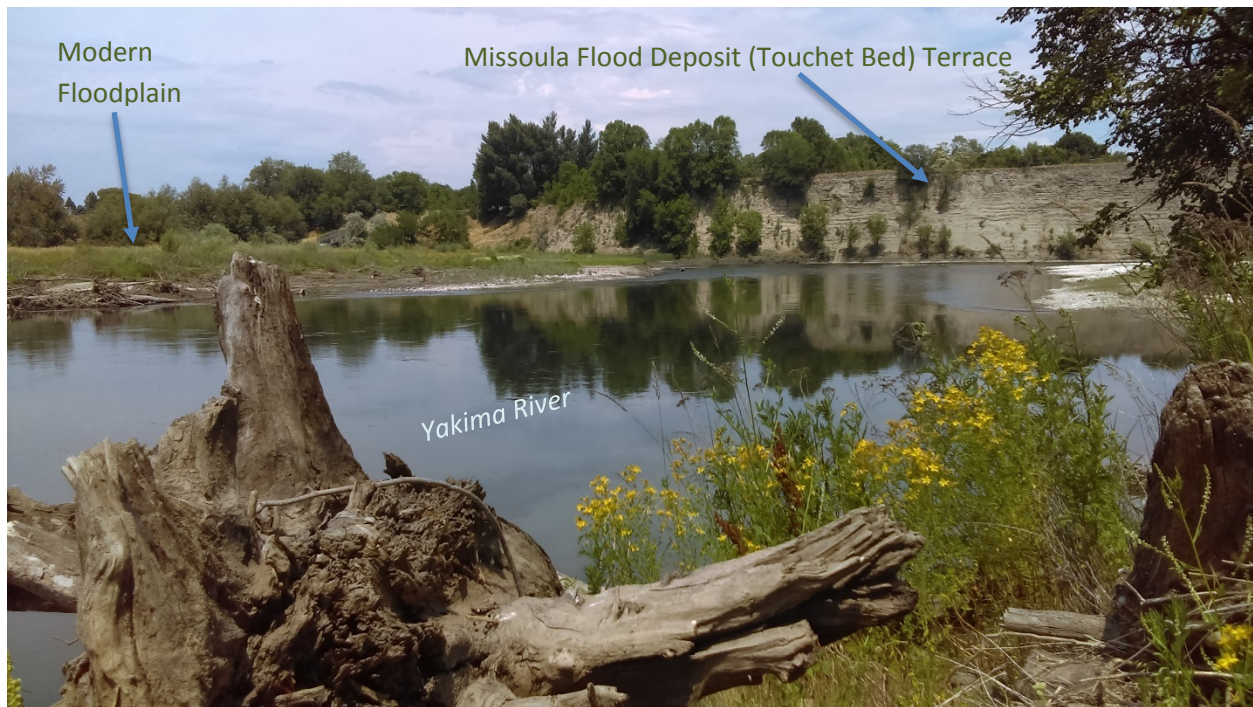
**Figure 6. Yakima River at RM 89.5 – on river right looking downstream. (Photo: Inter-Fluve June 2017)**

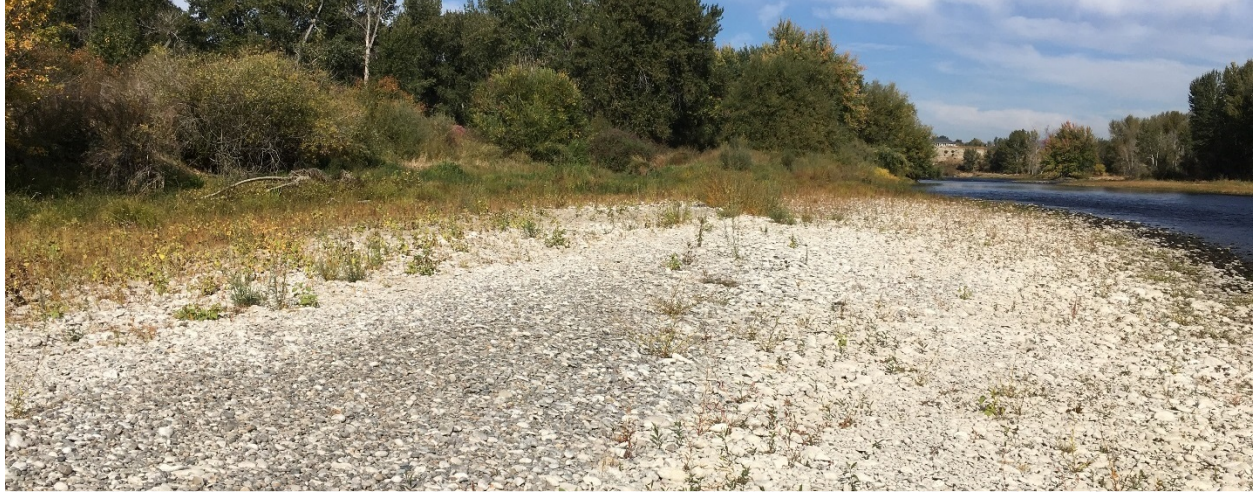
**Figure 18. Active gravel-cobble bar and low, well-vegetated floodplain along the mainstem Yakima River. (Photo: Inter-Fluve Oct 2017)**

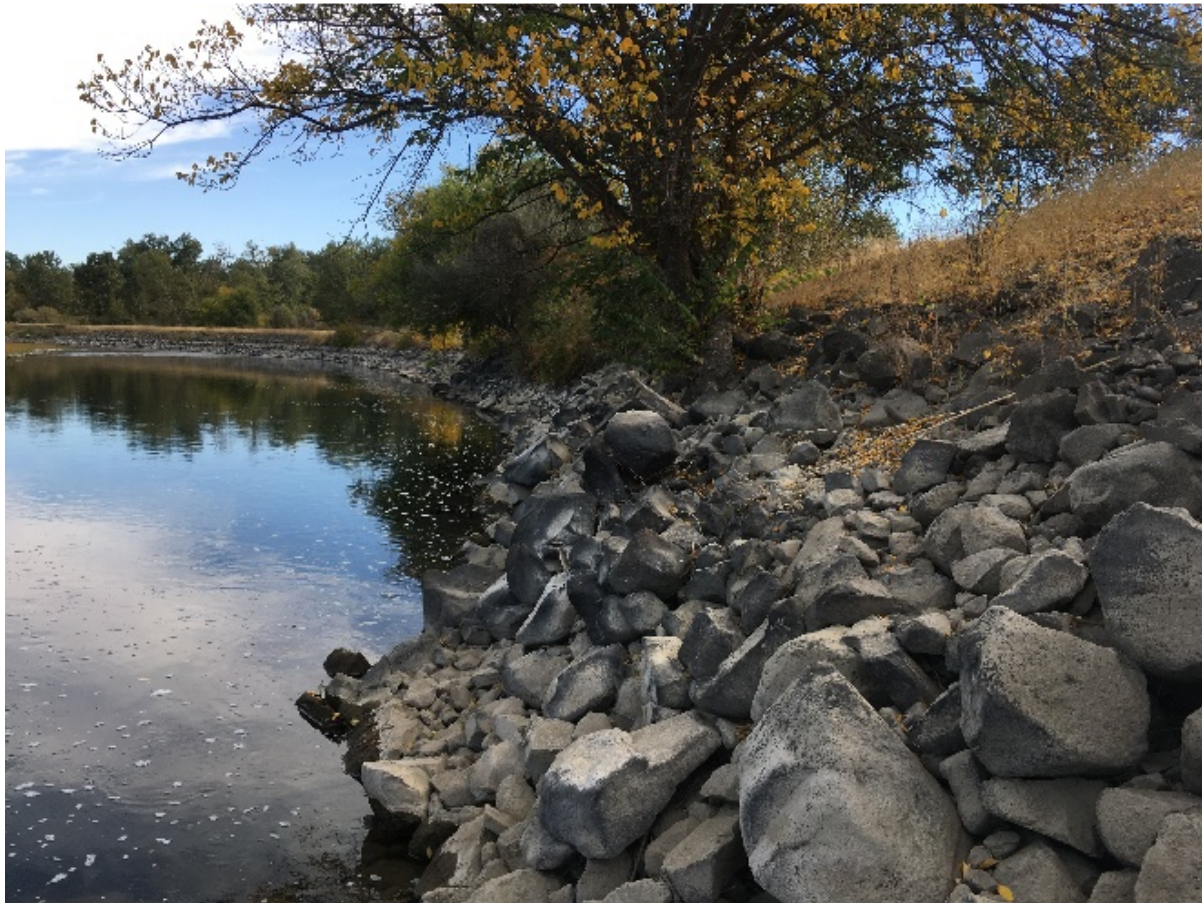
**Figure 20. Mainstem levee at RM 89.5. (Photo: Inter-Fluve, Oct 2017)**

Lateral channel processes with active bar arrangements are expected to continue in the mainstem channel except at and immediately upstream of the constructed levee. Upstream and at the levee, the channel will continue to be locked in place (Figure 20). This will maintain a stable point bar position on river left and scour in the bed of the channel along the levee. Flow hydraulics here will continue to result in bedload deposition downstream at the next meander bend. Channel complexity will remain low along the levee if the structure remains in place without habitat enhancement treatments.

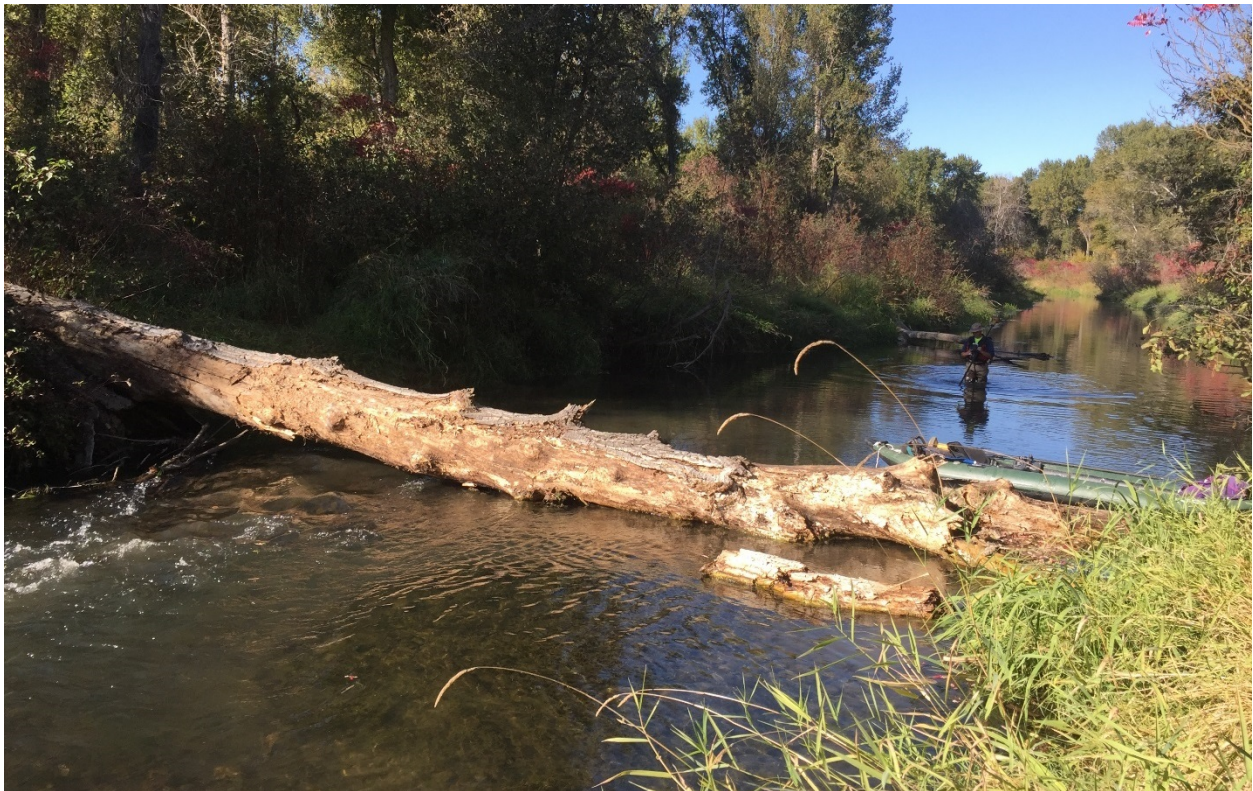
**Figure 21. Existing side channel at mid-section with well-vegetated banks and tree-fall. (Photo: Inter-Fluve Oct 2017)**

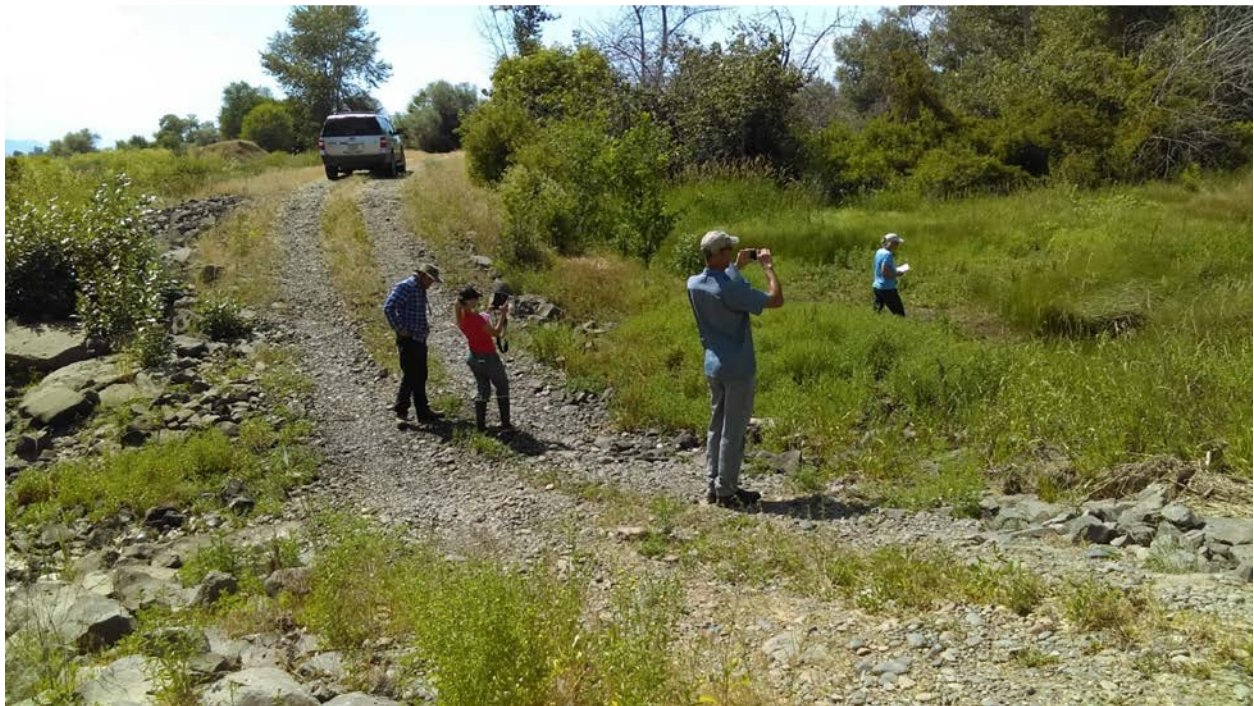
**Figure 22. Levee extension breach across the floodplain to reactive floodplain connectivity during high-flow or flood events. (Photo: Inter-Fluve June 2017)**

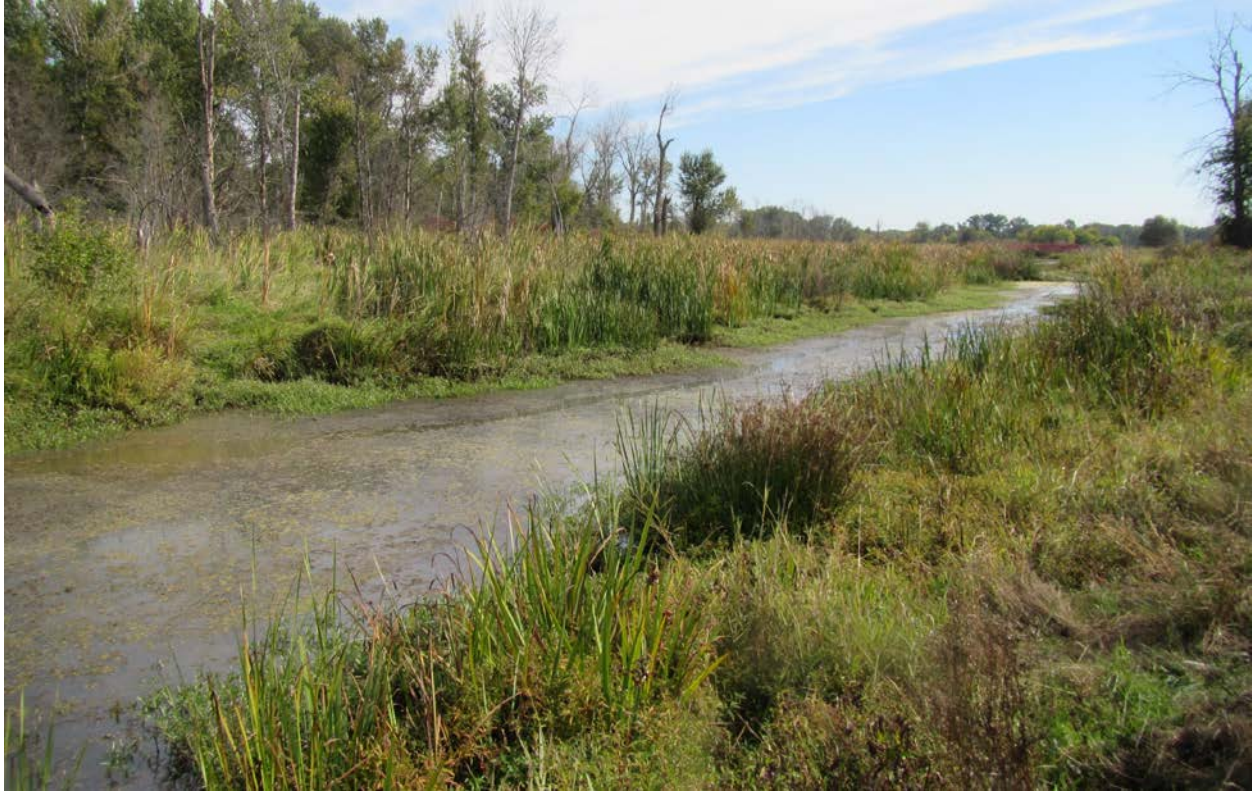
**Figure 23. Off-channel wetland feature (oxbow) wetted by groundwater with a beaver dam pond. (Photo: Inter-Fluve Oct 2017)**

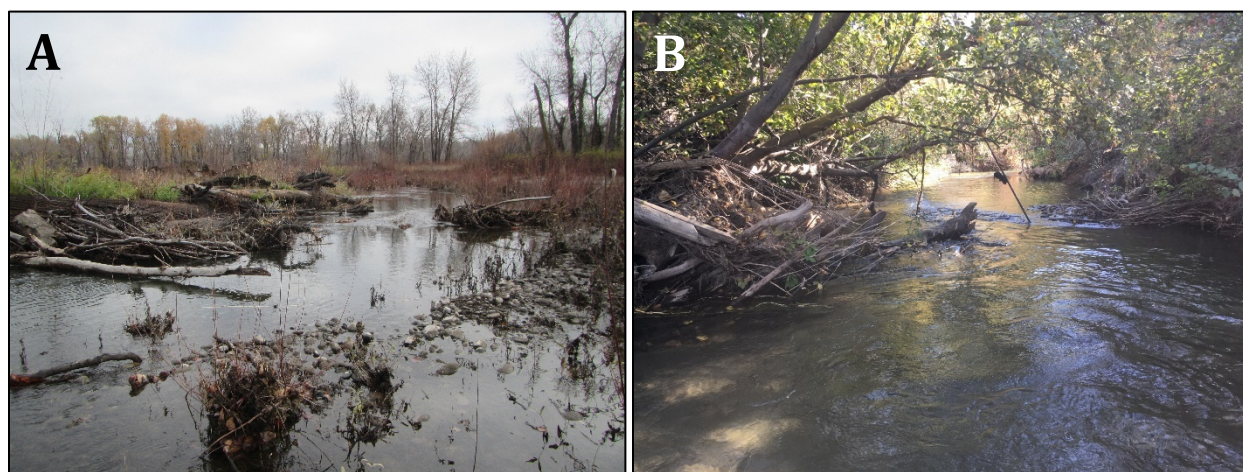
The existing aquatic habitat conditions in the RM 89.9 project area are generally tolerable for steelhead and marginal for Pacific lamprey. Habitat improvements such as reactivation of side channels to the mainstem and reconnection of off-channel habitat to the main and existing side channel have the potential to notably improve aquatic habitat conditions within the project area. Channel unit (riffle, pool, glide) sequencing, active lateral migration processes, and the presence of large wood occur in the mainstem in the project area – except along the riprap levee in the mid-section. These characteristics support desired habitat complexity. The existing side channel in the upstream portion of the project area is annually wetted and also contains large wood, overhanging vegetation and channel unit complexity. Both the existing side-channel and margin areas of the mainstem channel offer some low velocity habitat for rearing juvenile salmonids. Juvenile salmonids were observed in the mainstem backwater at the upstream end of the existing side channel in November 2017 (Figure 26A). Low-velocity alcoves and other connected off-channel features where fines accumulate offer good habitat conditions for lamprey (Crandall & Wittenbach, 2015).

**Figure 26. A) Existing high quality mainstem back-water habitat at upstream end of project area where juvenile salmonids were observed Nov 2017, and B) good slow-velocity habitat in existing side channel Oct 2017. Photos: Inter-Fluve**

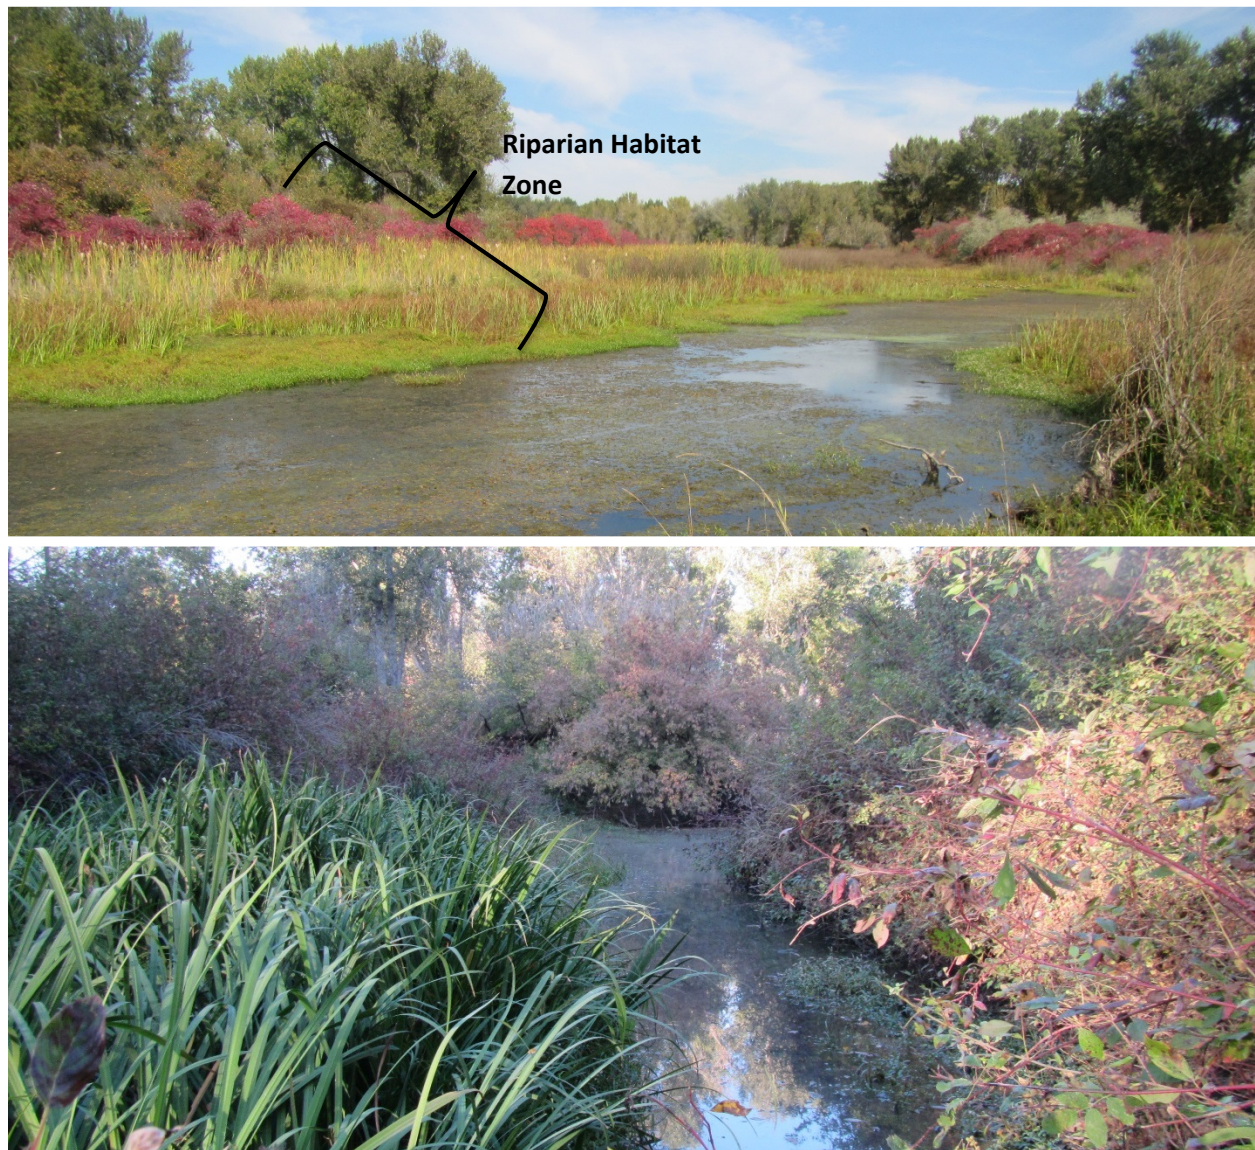
There are riparian habitats along the mainstem, side channel, and off-channel features throughout the project area. This habitat type sequences from emergent vegetation along the margins of the wet features (i.e. sedges and rushes) to terrestrial bands of hydrophilic plants up the banks where soil moisture allows. Where human disturbance and clearing has not occurred, the project area has relatively intact, diverse, high quality riparian habitat that hosts a variety of species (e.g. amphibians, beaver, water fowl, and other birds).

**Figure 28. Riparian habitat along off-channel wetland oxbow ponds. (Photo: Inter-Fluve October 2017)**

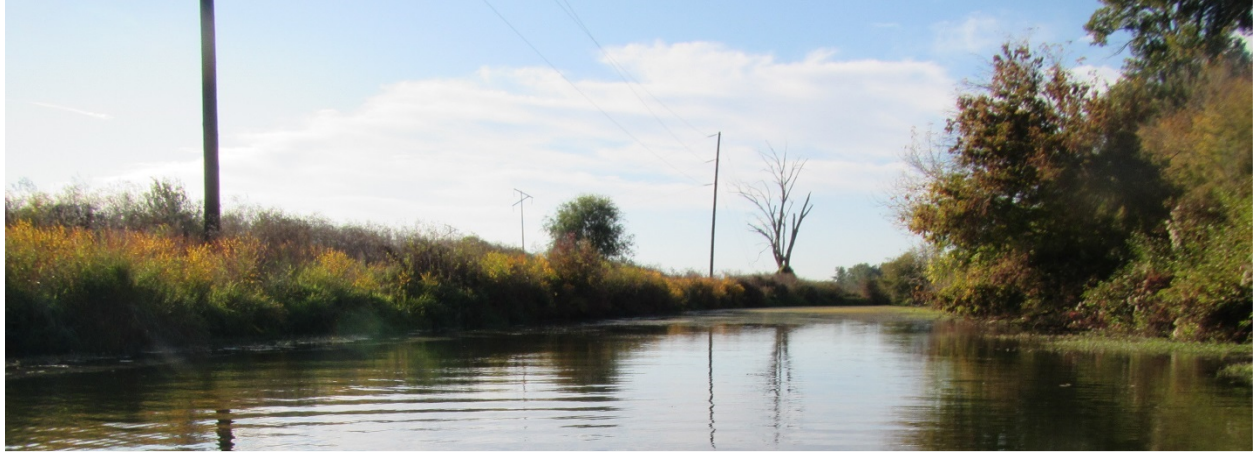
**Figure 29. Steep bank with cleared vegetation on the left; naturally vegetated riparian habitat on the right in a disconnected oxbow pond in the downstream portion of the project area. (Photo: Inter-Fluve Oct 2017)**

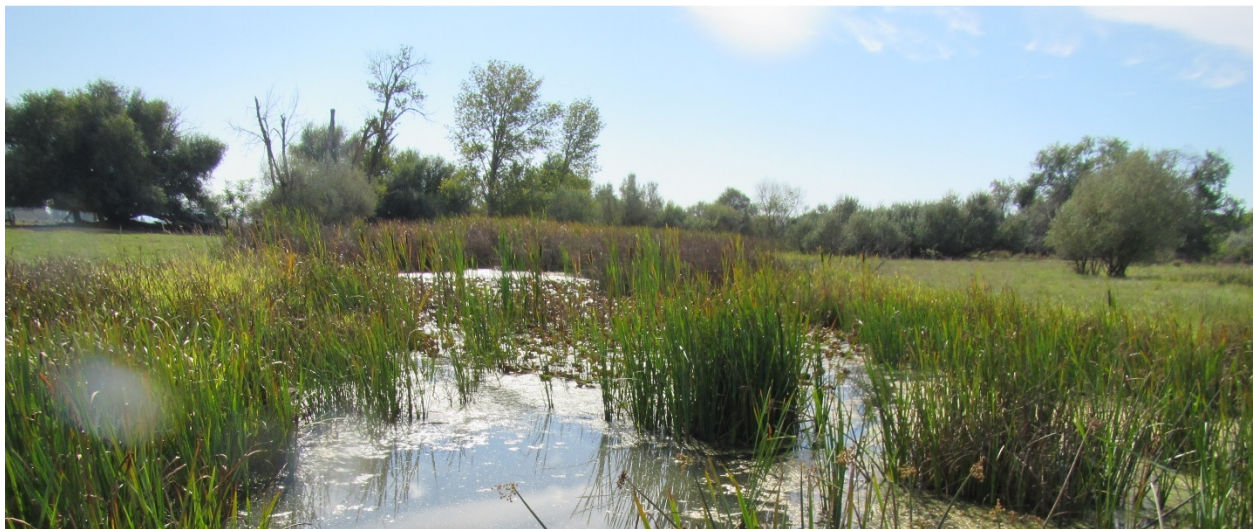
**Figure 30. Simplified riparian vegetation along oxbow in northwestern portion of the project area. (Photo: Inter-Fluve Oct 2017)**

Where vegetation clearing and agriculture occur next to the bank of surface water features, riparian habitat is simplified and consists primarily of emergent vegetation such as sedges and rushes (Figure 30). Riparian vegetation clearing occurs along the off-channel wetland features located along the west side of the project area.

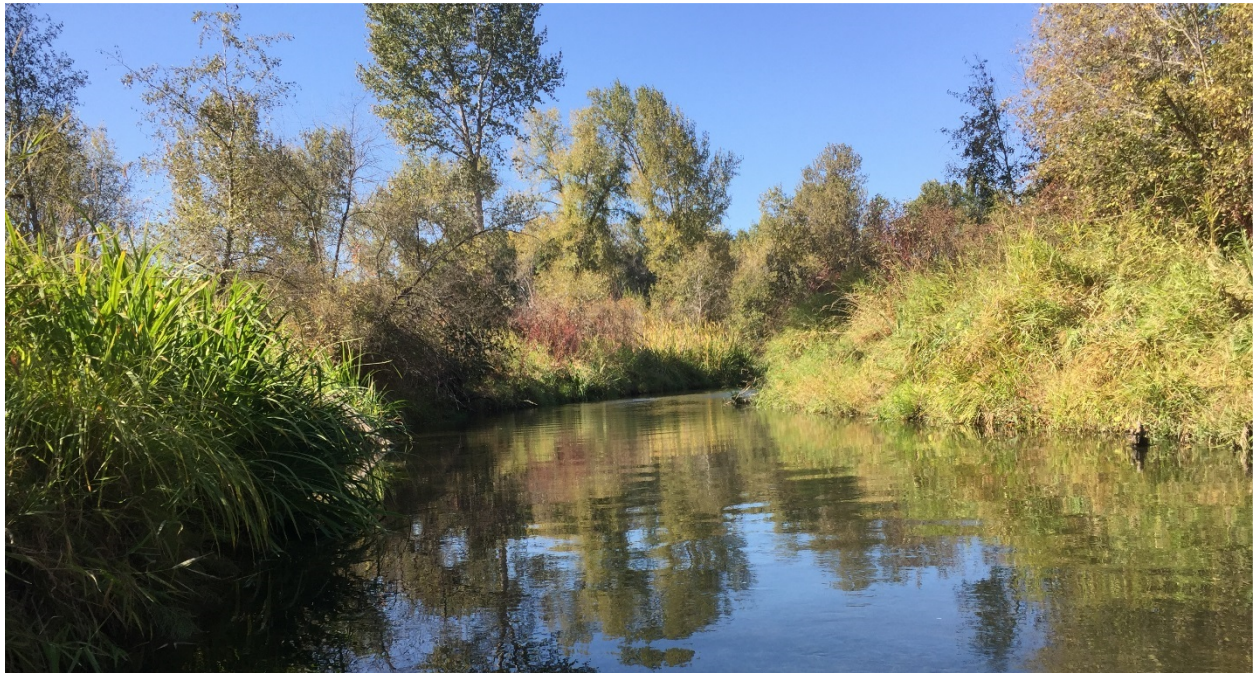
Along the mainstem and existing side channel, riparian habitat occupies the relatively stable banks and emergent riparian vegetation is limited to calm backwater areas where low-flow velocity allows it to establish. Riparian bank vegetation is generally well established along the existing side channel. Riparian vegetation along the mainstem Yakima is more patchy but present where flow hydraulics allow. Active lateral processes result in natural revegetation processes along new or active banks.

Invasive grasses (i.e. Reed Canary) are encroaching on the mainstem and side-channel banks, which reduces riparian habitat diversity.

**Figure 31. Existing side channel with varied riparian habitat compositions. (Photo: Inter-Fluve Oct 2017)**

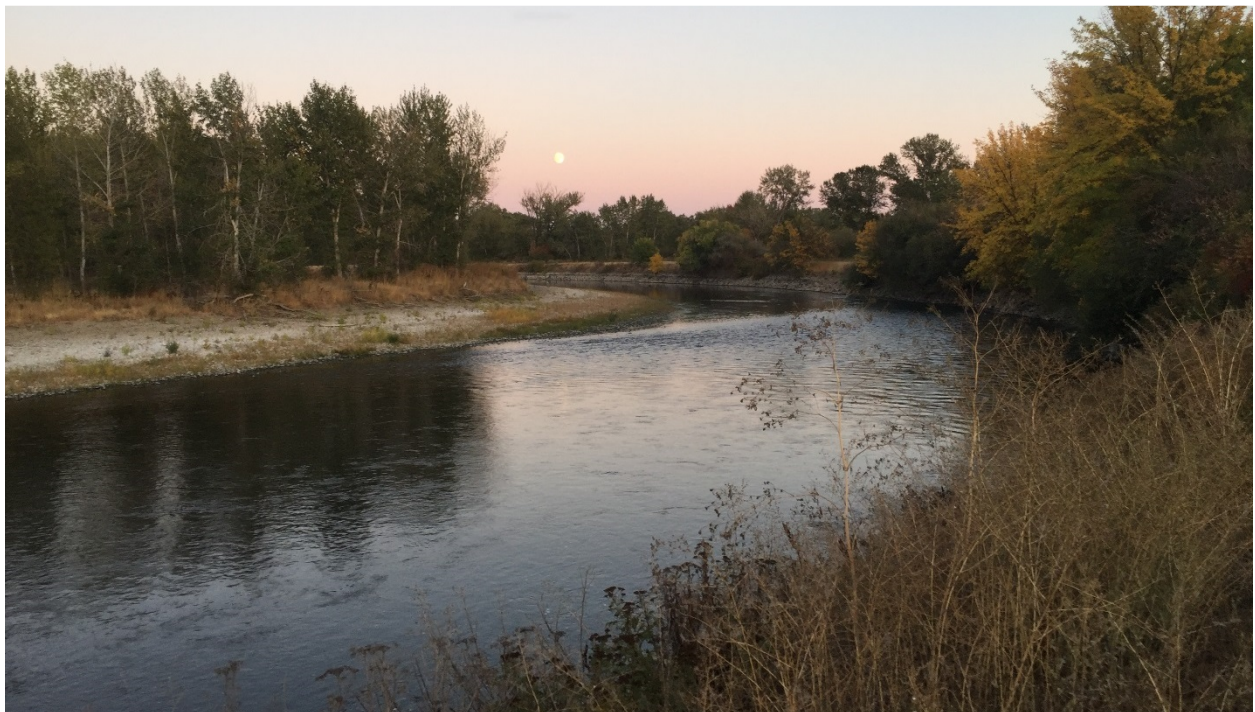
**Figure 32. Yakima River near RM 90 with varied riparian habitat composition. (Photo: Inter-Fluve Oct 2017)**

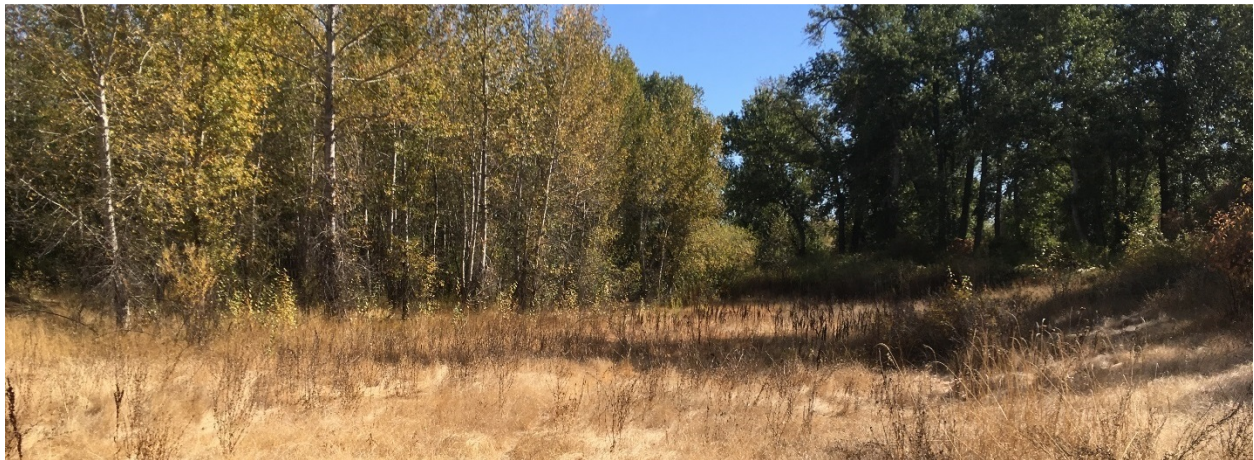
The transitional habitat occupies the remaining portions of the floodplain not considered aquatic or riparian. Transitional habitat offers a mix of vegetation types depending on frequency of surface inundation, access to groundwater, soil moisture holding capacity, and vegetation clearing. The diversity of the transitional areas offer habitat to a wide variety of avian and terrestrial species such as birds of prey, rabbits, reptiles, coyotes, deer, song birds, and bear. The habitat condition and diversity are least healthy along the western border of the project area where there is vegetation clearing and agricultural uses. Forest density is highest in topographic depressions such as abandoned channels. An understory of shrubs (i.e. rose, snowberry, dogwood, hawthorne), sometimes impassably thick, occur on slightly lower and more frequently wetted floodplain surfaces where the more well-drained floodplain surfaces or areas of clearing host an understory of grasses and forbs. Slightly higher floodplain surfaces (less frequently inundated with accumulated fines on the surface) and areas of clearing are not forested but instead are dominated with grasses, forbs, and weeds. Establishment of non-native plants such as Himalayan blackberry and a variety of weeds was observed and are expected to continue to be an issue in disturbed or roaded areas.

**Figure 33. Transitional floodplain habitat with open areas of grass and forbs. (Photo: Inter-Fluve Oct 2017)**

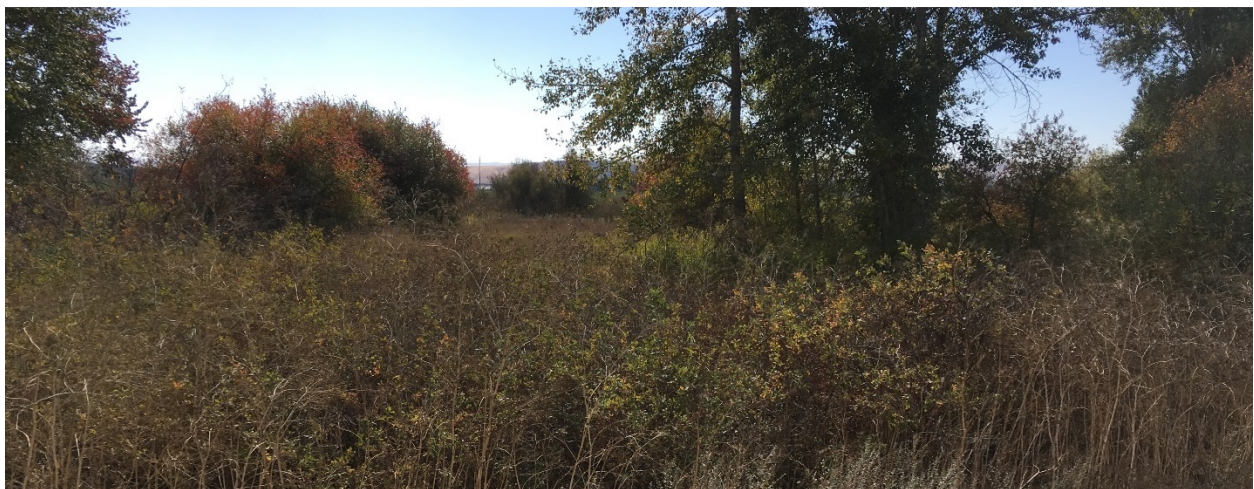
**Figure 34. Transitional floodplain habitat with thick understory of brush (Photo: Inter-Fluve Oct 2017).**
