**REQUEST FOR PROPOSALS**  
**Engineering Design Services:**  
**HOWARD LAKE ROAD/UPPER KLIKITAT RIVER**  
**FLOODPLAIN ENHANCEMENT**  
**Geomorphic Assessment and Conceptual Design**  
**for Floodplain and Side-Channel Reconnection**  
**Yakama Reservation**

**YAKAMA NATION FISHERIES PROGRAM**

# REQUEST for PROPOSALS for ANALYSIS & DESIGN SERVICES

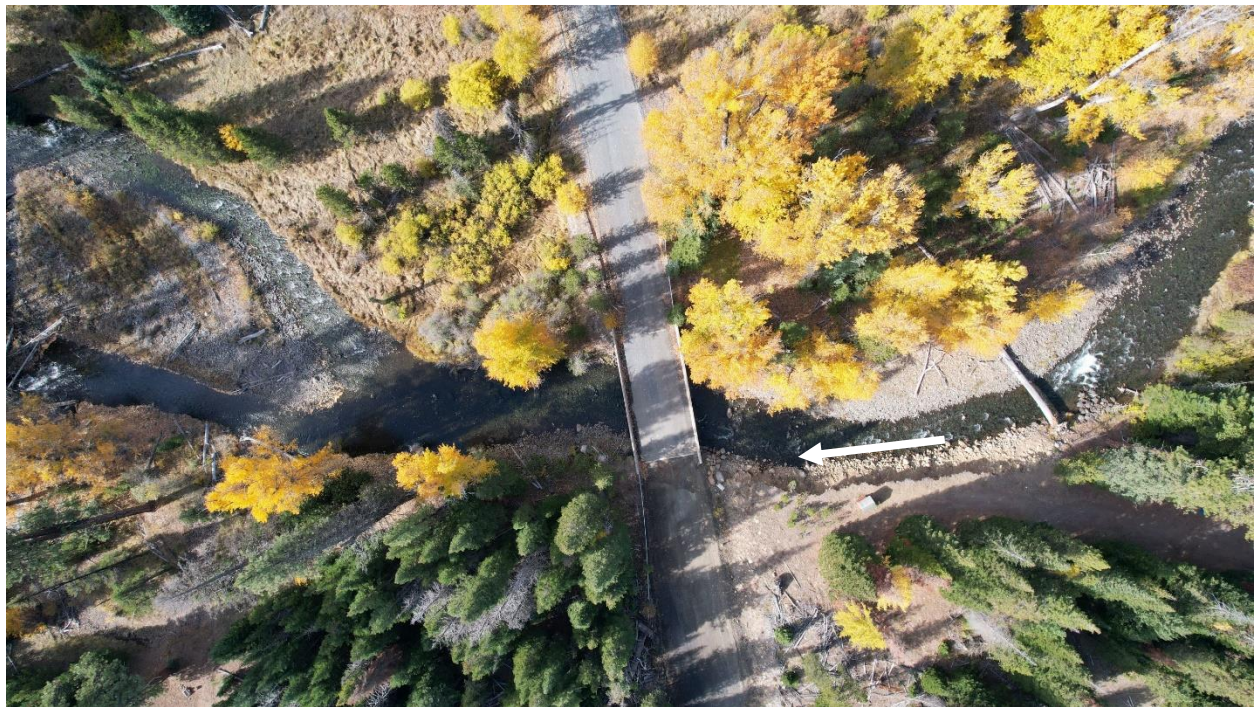
**Figure 1.** Drone Imagery from October 2021. Flow pattern is right to left.

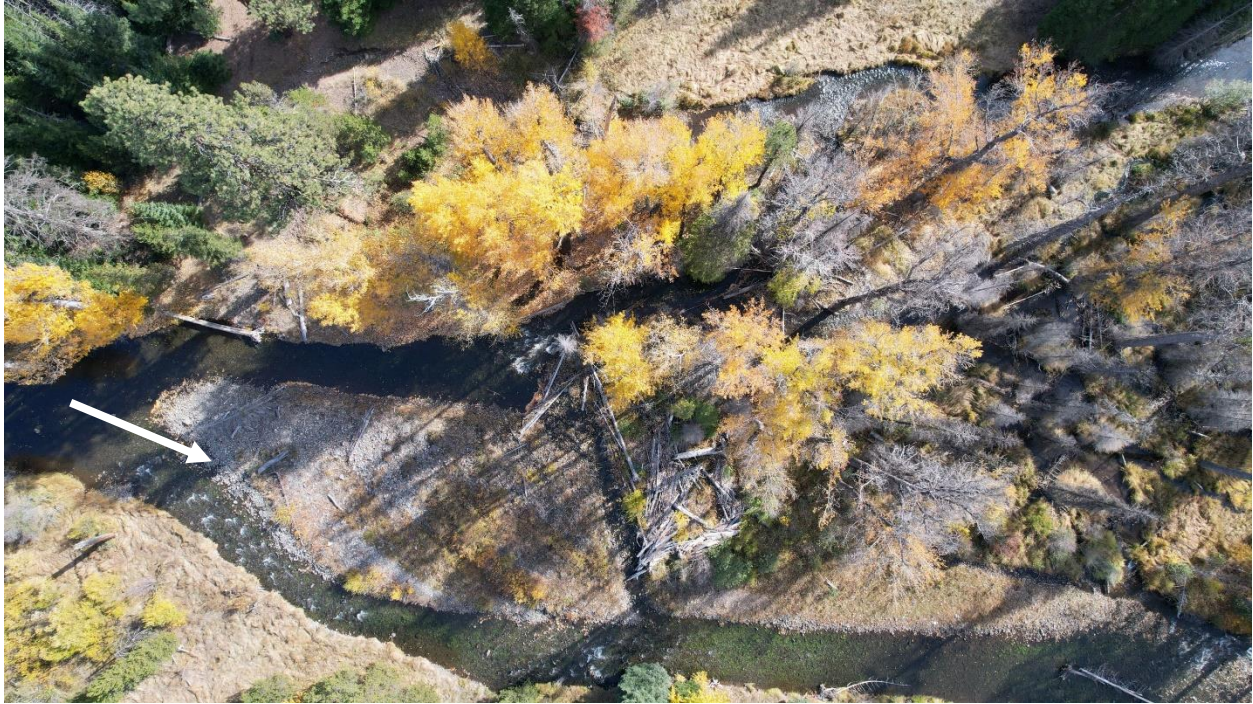
**Figure 2.** Drone Imagery from October 2021. Channel evolution 250 ft. downstream of east channel 32 road crossing, flow is from left to right.

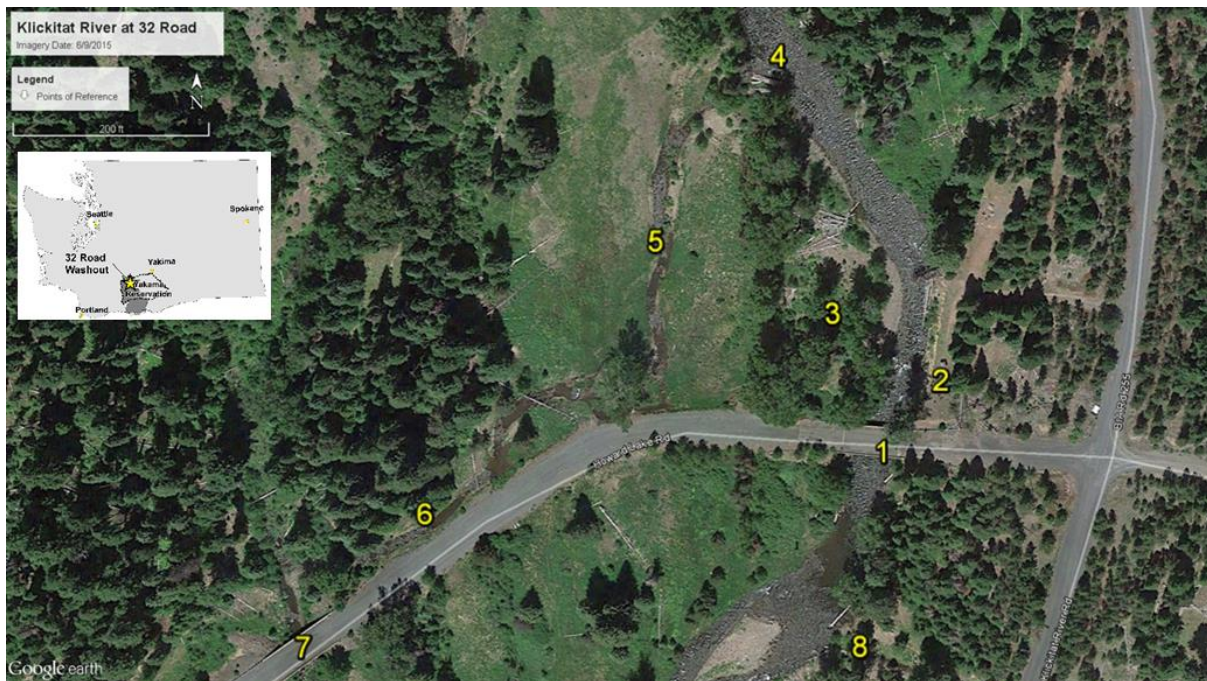
**Figure 3:** Point 1. East bridge 2. Eroding bank 3. Alluvial deposits 4. Side Channel inlet 5. Side Channel 6. West bridge 7. 32 Rd.

### **Left-Bank Upstream of Bridge (Figure 3, point “2” vicinity)**

### **Vicinity of Side-Channel Inlet (Figure 3, vicinity of point “4”)**

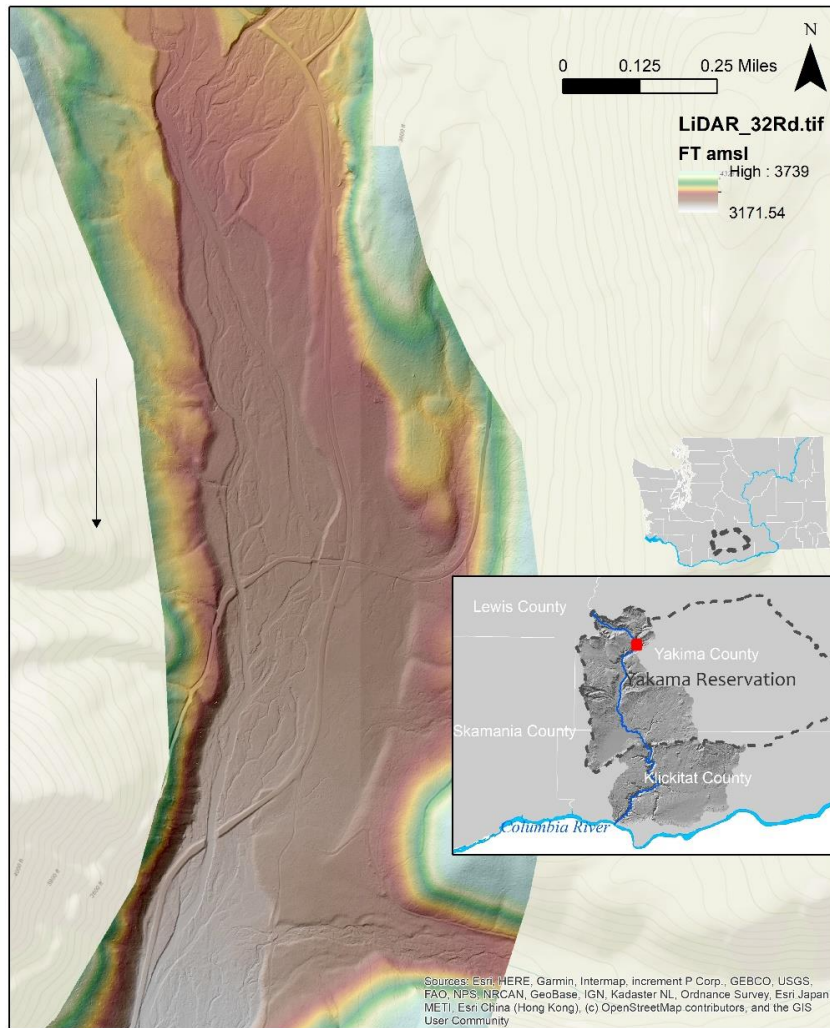
**Figure 4.** Area map showing elevation (left) **Figure 5.** Area map showing road locations – 32 Rd/255 Rd is the focal area (right)

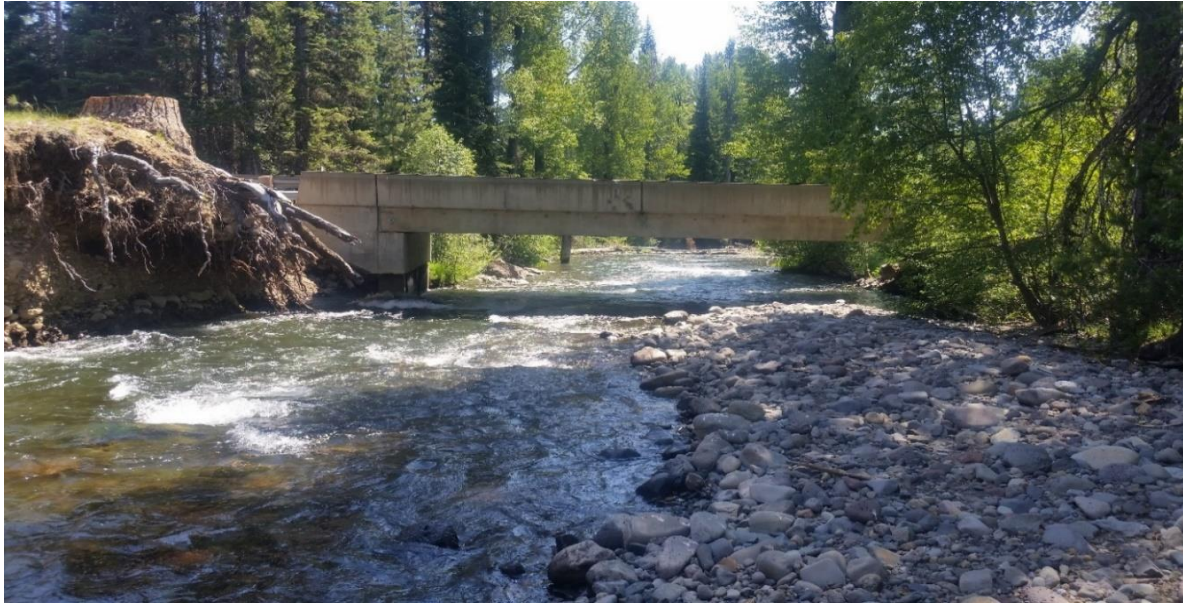
**Figure 5.** Downstream view of bar accretion (river right) associated with flow distribution at the bridge.

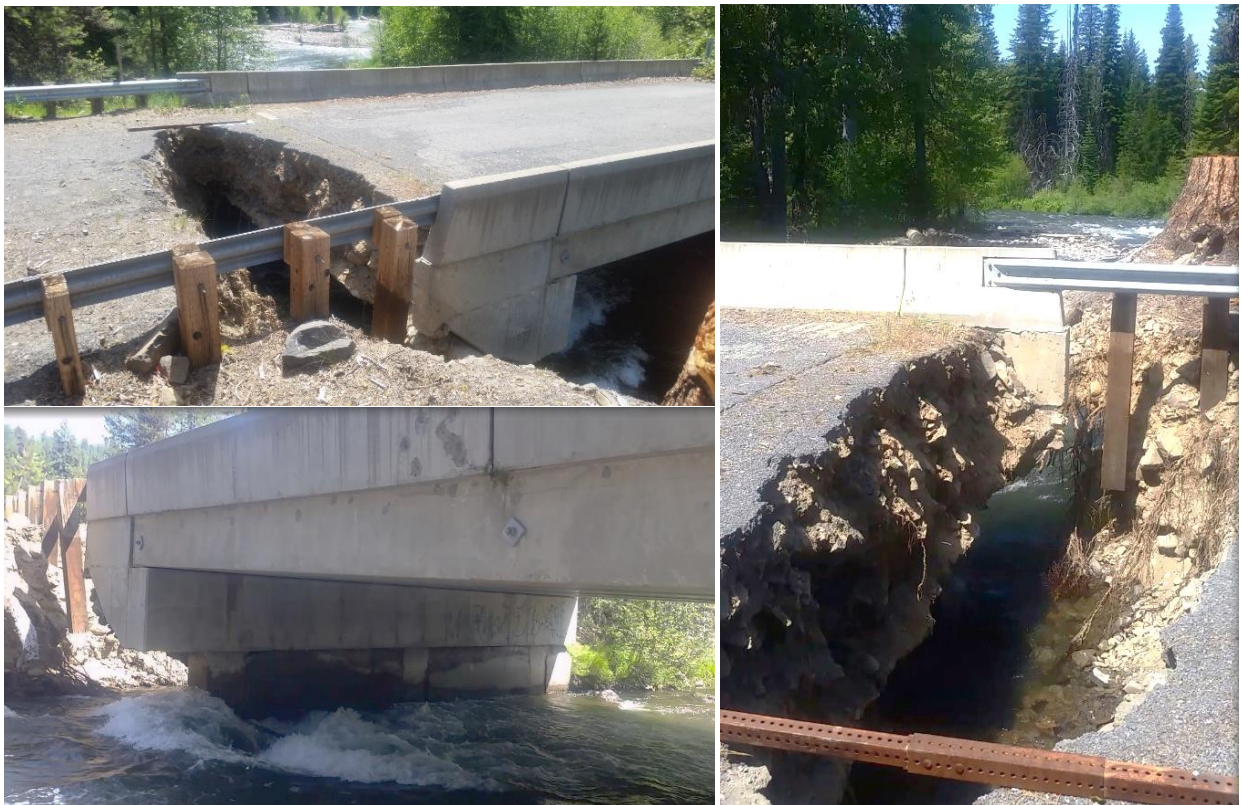
**Figure 6.** Close up photos of east abutment washout (taken 6/17/2016).

The east bridge has a deck length of ~65’ and traveled way width of 30’. The deck slopes downward from east to west at 1-2%. The span is composed of eight concrete panels, each 4’ wide that are cross-bolted. A wash-out over the winter of 2015-2016 occurred at the east end of the east bridge which crosses the primary river channel and is oriented more-or-less normal to the channel alignment. The river has undercut the left-bank immediately upstream of the flanked east abutment, and partly eroded fill material of the approach. Riprap formerly on the river face of the east abutment was washed away. Riprap on the face of the west abutment was largely in-place, but the slope steepens in the downstream direction, has a sheared appearance, and the toe deflects toward the abutment by several feet (resulting in a slope steeper than angle of repose. This washout has been temporarily halted through the addition

of riprap sized material and pre-fabricated concrete blocks. Lateral bank erosion continues at this location.

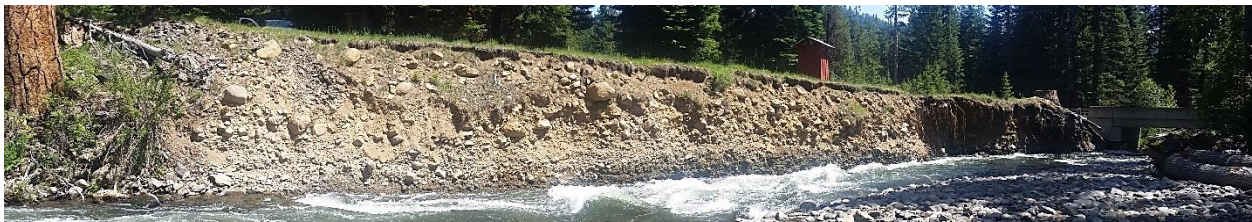
**Figure 7.** Actively eroding face of left bank approximately 200 l.f. upstream of bridge.

Aside from the bridge itself, the most visible feature in the vicinity of the bridge is the left channel margin upstream of the bridge.

This margin is a steep, eroded face that marks the left/east boundary of the active valley bottom and floodplain. The bank is composed of multiple units with at least four major ones, including:

- Upper (top 4-5' of profile) – poorly sorted, weakly clast-supported (possibly matrix-supported), rounded to sub-angular large gravels to medium boulders, silty matrix
- Upper Middle – thin, variable unit of clast-supported, sub-rounded gravels to large-cobbles with a few boulders
- Lower Middle – variable, sub-angular gravels with some cobbles, possibly matrix-supported
- Toe (lower 2' visible above waterline) – clast-supported sub-rounded gravels up to medium-cobble with cohesive matrix; likely multiple units
