Lower Peshastin Creek

Tributary and Reach Assessment

Wenatchee Subbasin, Chelan County, WA

June 2010

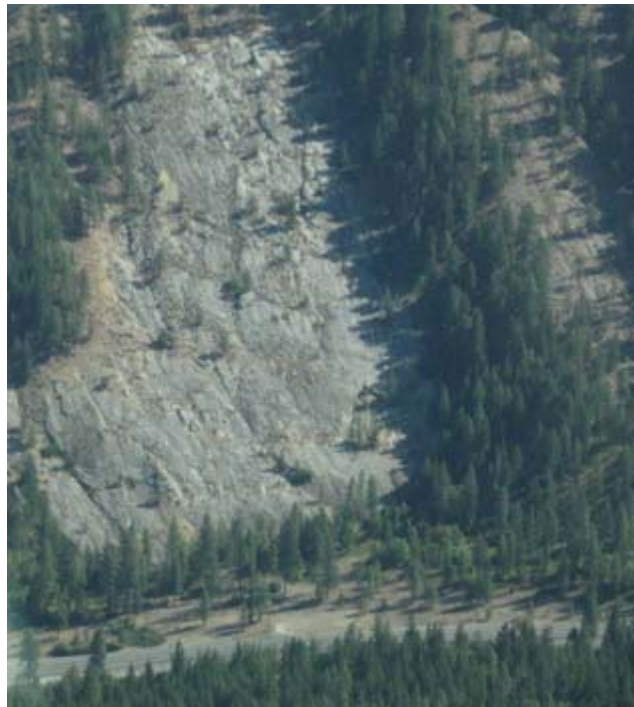
Figure 3. Low elevation aerial photograph of a large Chumstick Formation outcrop on a northwest facing slope of a hogback ridge near river mile 5.9. Sandstone outcrops such as this can contribute fine sediment to the channel over time.

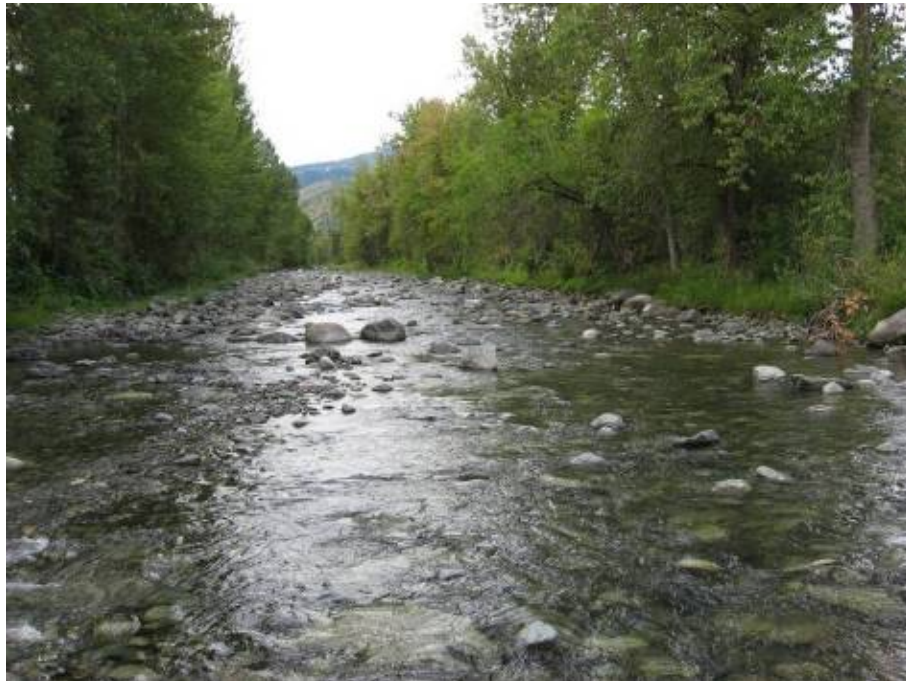
Anthropogenic channel straightening, riparian clearing, and floodplain disconnection have affected natural channel equilibrium processes. Stream segments once characterized by greater sinuosity and pool-riffle sequences have given way to straightened plane-bed segments with uniform bed topography (Figure 10) (USFS 1999). Higher gradient segments with natural confinement have been less impacted by roadway construction. These segments are influenced by large boulders and bedrock outcrops and exhibit step-pool morphology (Figure 11).

Figure 10. Upstream view near river mile 1.6. Long, plane-bed sections such as this are typical in the lower 8.4 miles of Peshastin Creek.

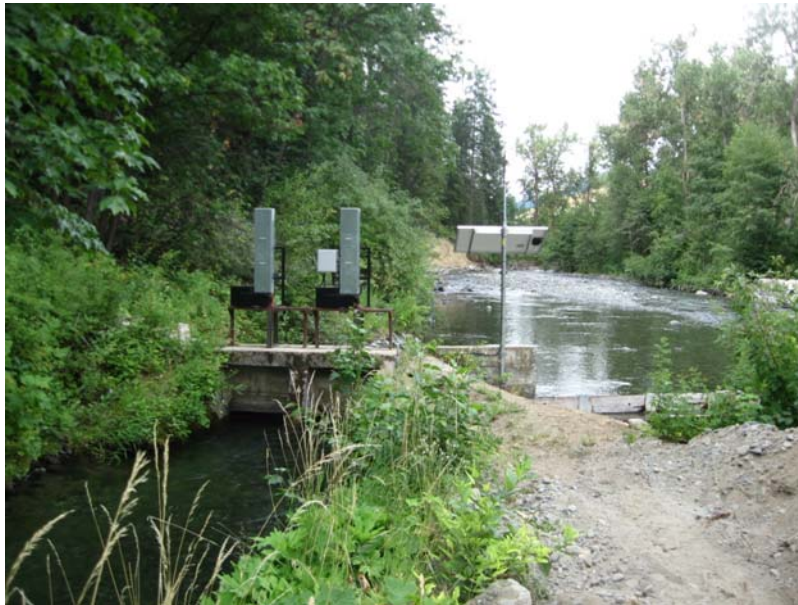
Irrigation demands for local agriculture drive the need for flow alteration to Peshastin Creek (Anchor Environmental and EES Consulting 2007). There are two primary irrigation diversions on the mainstem of Peshastin Creek within the study area (Figure 20). Located near river mile 2.5, the primary agricultural diversion in the basin supplies the Peshastin Canal operated by the Peshastin Irrigation District (Figure 21). The Peshastin Canal has a maximum capacity of 40 cfs, which far surpasses the maximum capacity of any other diversion in the basin. The next largest diversion is located at river mile 4.9 and supplies the Tandy Ditch at a maximum rate 4.6 cfs (Figure 22). The Tandy Ditch is also operated by the Peshastin Irrigation District. A few small diversions are located on Mill Creek and other unnamed tributaries to Peshastin Creek (Andonegui 2001).

Figure 21. View looking upstream toward the southwest at the Peshastin Canal diversion near river mile 2.5.

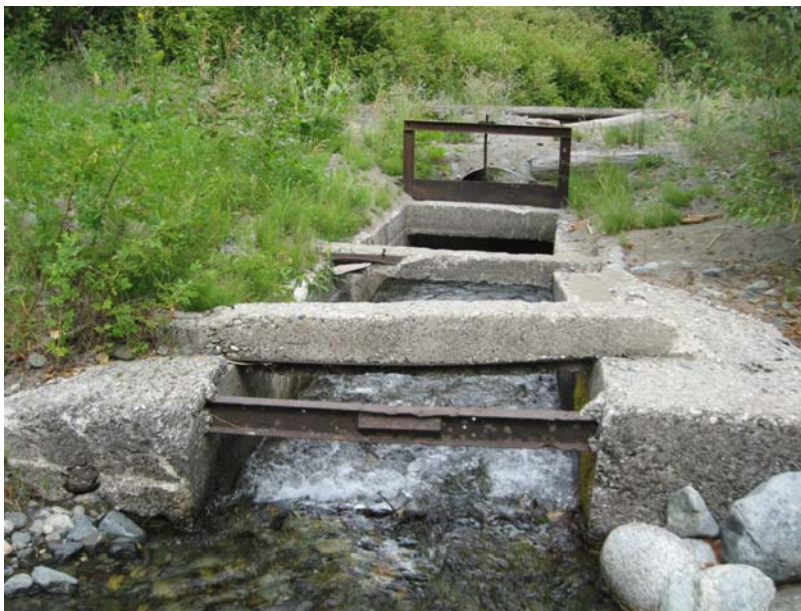
Figure 22. View looking to the north at the Tandy Ditch diversion near river mile 4.9.

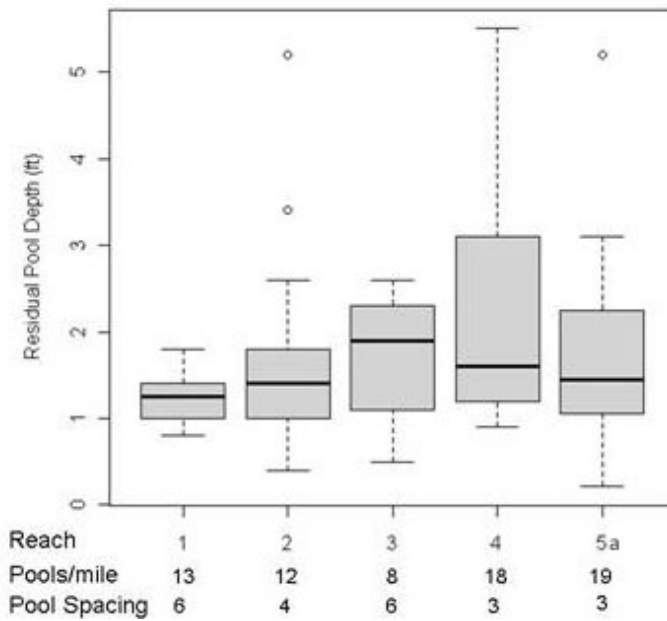
Pool frequency ranges from 8 to 19 pools/mile per reach, with a mean pool spacing of 320 ft, or a pool approximately every 4 bankfull widths. Reaches 4 and 5a have the greatest number of pools/mile (17.9 and 19.3, respectively) and the shortest pool spacing (188 ft and 195 ft, respectively). These reaches also have the greatest number of deep pools (residual depth exceeds 3 ft in several pools). The majority of the pools throughout the study site are relatively shallow, with residual depths of 1-2 ft in one-half to two-thirds of the pools. According to the REI metrics (Section 2.9), pool frequency and quality are considered “at risk” for reaches 2, 4, and 5a due to an adequate number of pools/mi but inadequate habitat cover. Pool frequency and quality in Reaches 1 and 3 is considered “unacceptable” due to a lack of pools >1 m deep with good fish cover.

Figure 40. Boxplot of residual pool depth in feet for each reach.

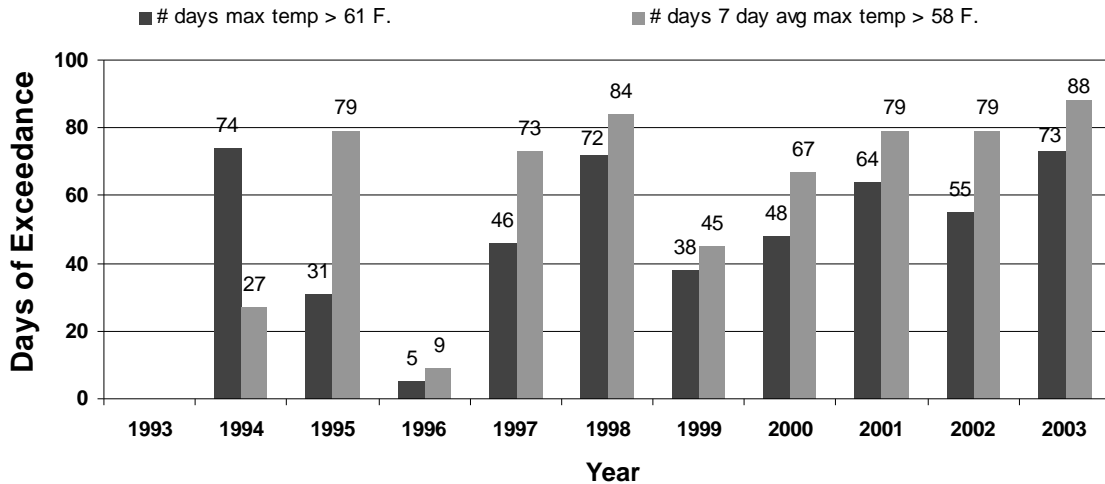
2008). Upstream of the confluence of Negro Creek, Peshastin Creek stream temperature is extremely poor, often exceeding 70°F during the summer (Figure 50). Negro Creek provides a cold water input that improves stream temperature in Peshastin Creek, which fluctuates from the mid to low 60’s between Negro Creek and Ingalls Creek (Figure 51). These temperatures still exceed USFS and Washington State water quality standards for temperature. Ingalls Creek provides another cold water input that moderates stream temperature downstream of the confluence, although high temperatures continue to occur in lower Peshastin Creek (Figure 52).

Figure 50. Temperature record for Peshastin Creek above Negro Creek from 1994-2003. Data is from USFS (2008).

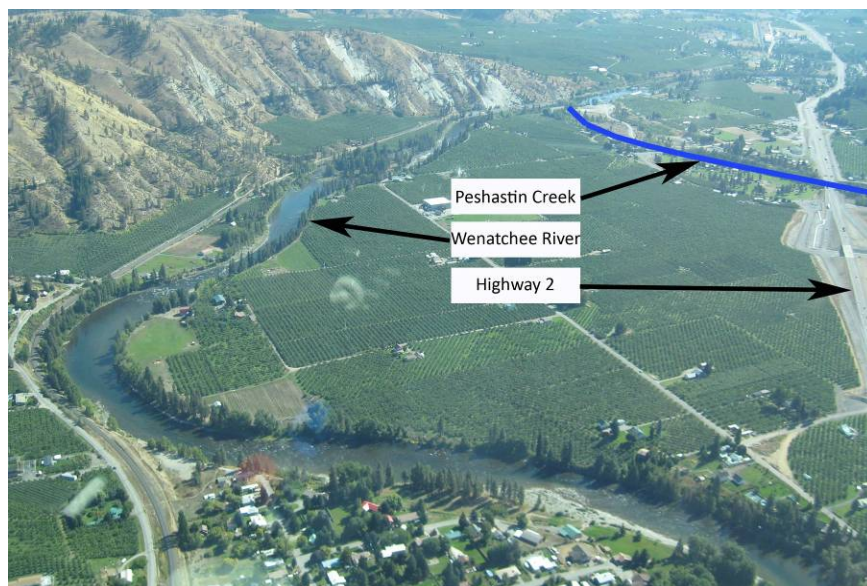
Reach 1 lies within the broad alluvial floodplain valley of the mainstem Wenatchee River. Valley width for Peshastin Creek is unconstrained and a wide alluvial fan has developed over time (Figure 56). The fan deposit is estimated to be about 425 acres, and up to a depth of 100 ft. (MWG 2006). The deposition of this large fan is associated with Pleistocene hydrologic and geomorphic regimes. The modern channel has incised into this material and has established a relatively narrow migration zone and active floodplain restricted to the southern portion of the fan.

Figure 56. Low elevation oblique aerial photo looking downstream to the southeast of the Wenatchee River valley. The blue line in the upper right corner of the photo shows Peshastin Creek's position on the southern portion of the alluvial fan that comprises the entire area between the Wenatchee River and Peshastin Creek. Photo taken September 24, 2009.

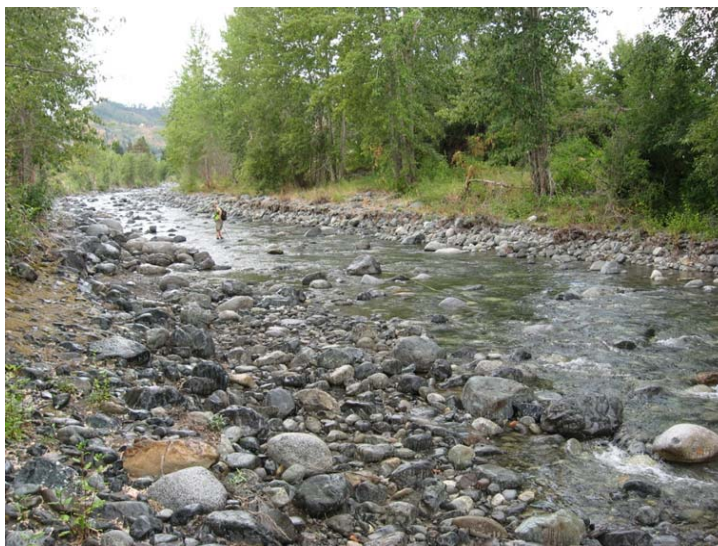
The channel is dominated by plane-bed morphology (Figure 57). Riffles are the dominant habitat unit type, comprising about 86% of the reach (See Section 2.7). Long riffles are separated by short pool sections that do not exceed 2 ft in residual depth. Streambanks through this reach are composed mainly of unconsolidated glacial outwash ranging in size from boulders to sand. This material is easily erodible and provides a sediment source for the channel in this reach. Bed and bank erosion is limited in some areas by bank armoring and hydromodifications. Channel erosion may be further limited due to the presence of large material of glacial origin. Median grain size in the reach is in the small to medium cobble size class (See Section 2.7).

Figure 57. Typical plane-bed riffle morphology, upstream view near river mile 0.1. Photo taken August 13, 2009.

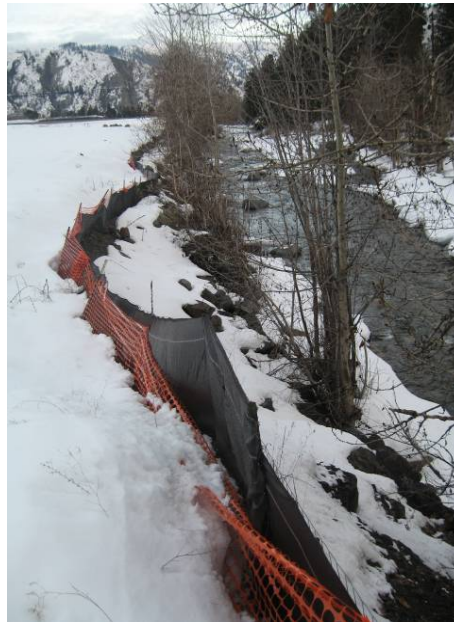
Figure 59. View looking downstream toward the northeast along the former Highway 97 road embankment. Rip-rap was left in place along this channel margin, and enhanced in some locations (January 2010).

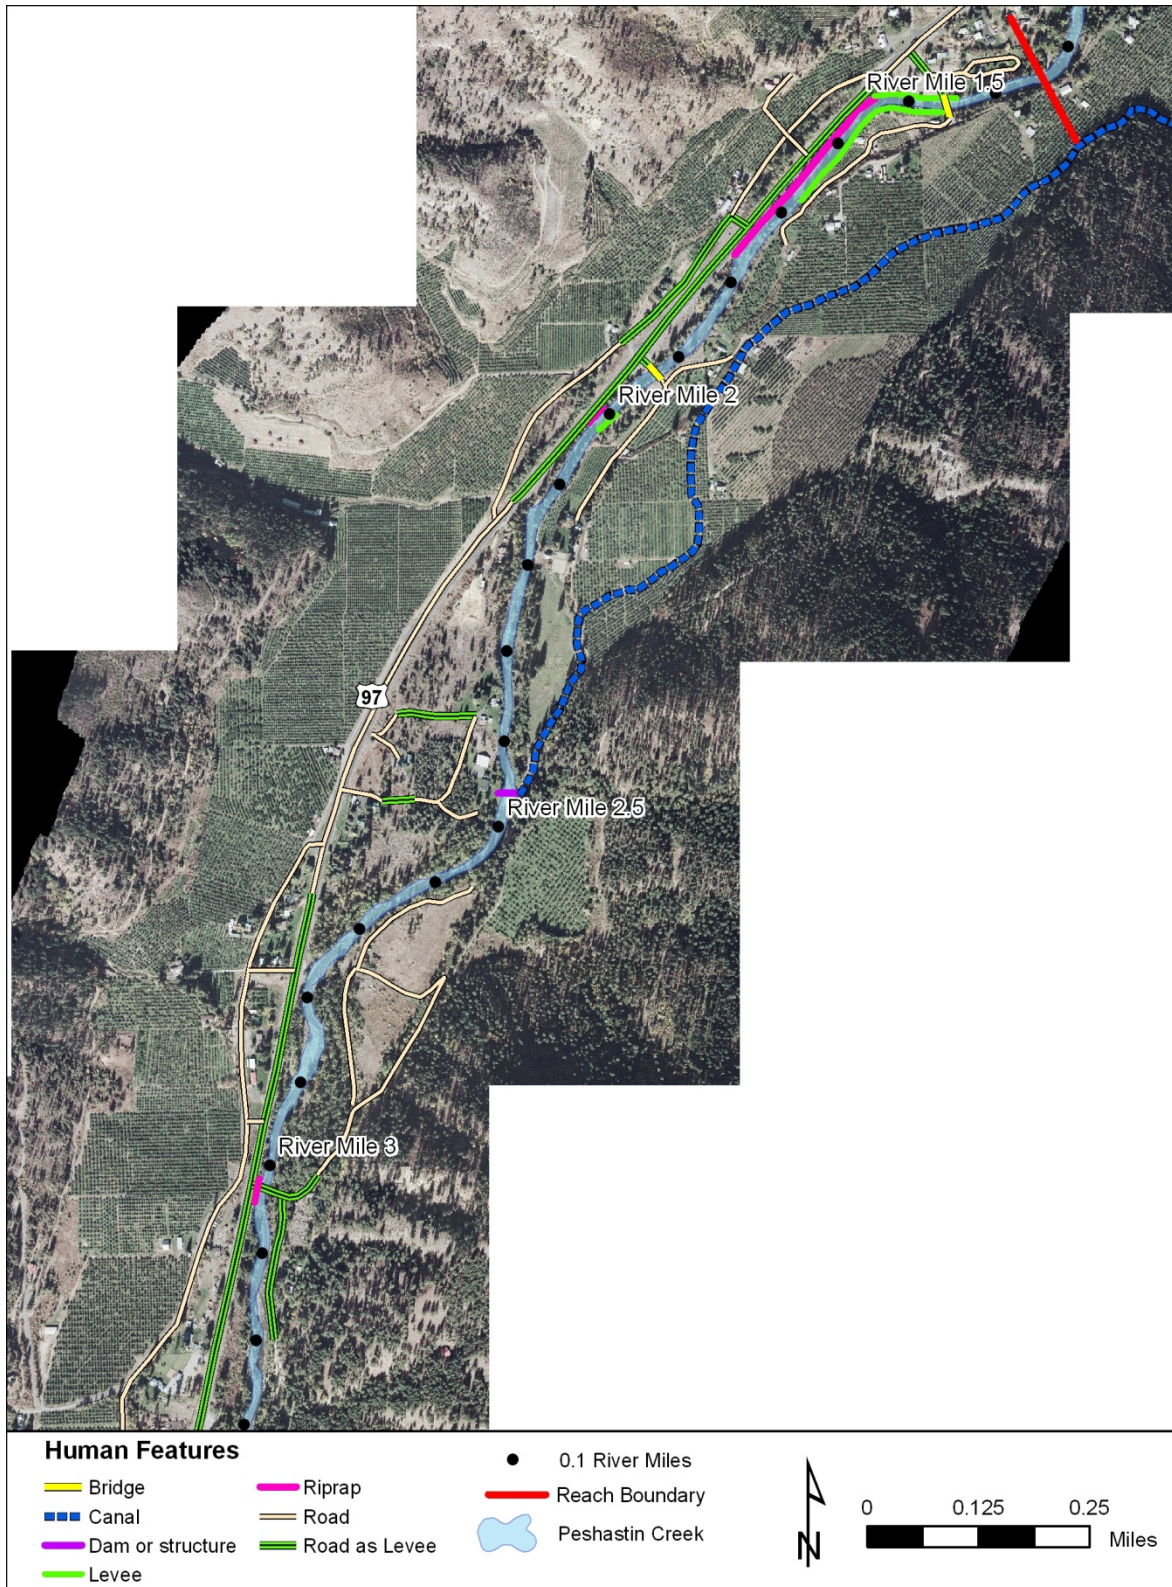
Figure 63. Human features in Reach 2 (downstream portion). Flow is from south to north.

Highway 97 is the dominant barrier to process and habitat connection in this reach. The total length of roadway parallel to the channel in this reach is 3.34 miles. There is over 6,600 feet of road embankment that impinges directly on the north side of the channel (Figure 62). The road, and associated bank hardening, creates a severe limitation to what would otherwise be a laterally extensive floodplain across the valley. Channel straightening associated with the roadway has the potential to steepen the channel, increase sediment transport capacity, and cause incision. Aside from road infrastructure, there are 1,283 feet of other levees in the reach. About 91% of the total area of outer zone sub-units is disconnected from hydrologic and geomorphic processes by the roadway. There are 5 bridge crossings in this reach, located at river miles 5.0, 3.85, 3.05, 1.95, and 1.45. Each of these crossings divides the floodplain and creates a longitudinal barrier to process and habitat connection. The entire valley bottom, including all outer zone sub-units and adjacent terrace surfaces, have been cleared and developed for agriculture and residential uses. Maps of human features are included in Figure 63 and Figure 64.

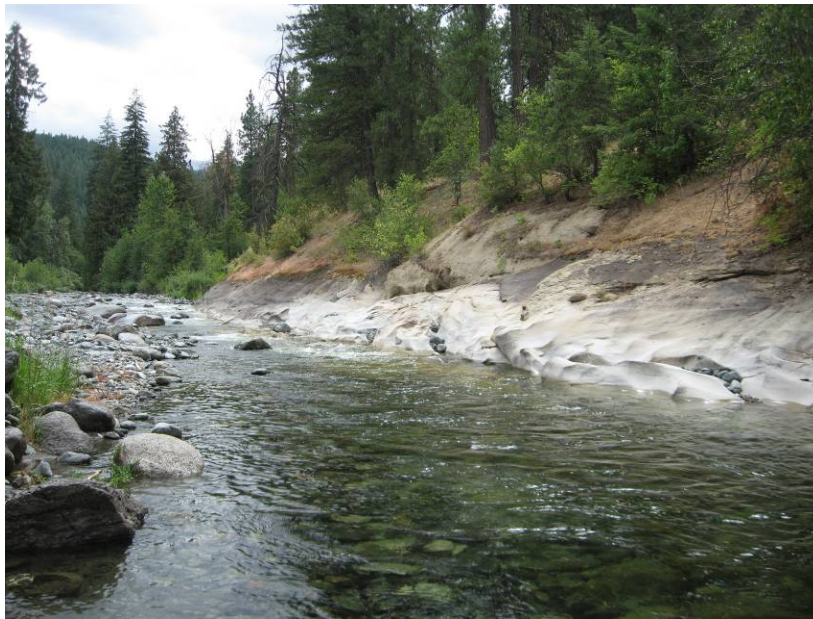
Figure 69. View looking toward the southeast in the upstream direction near river mile 5.5. At this location, bedrock controls play a role in pool formation. Photo taken in August 2009.

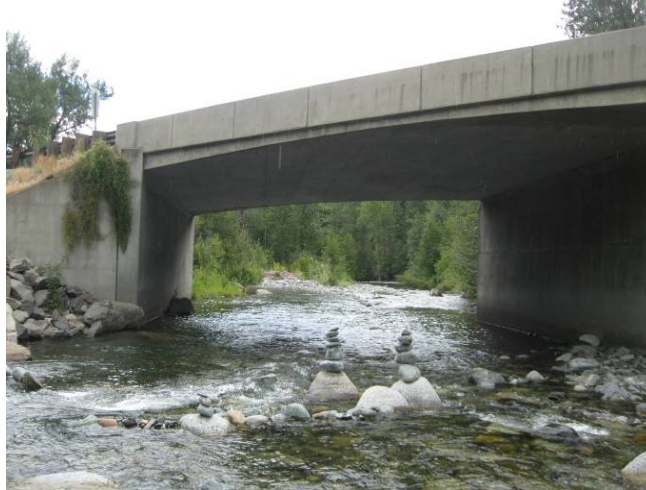
Figure 70. View toward the northeast in the downstream direction near river mile 5.0. The bridge at this location limits local channel dynamics, and floodplain connection downstream. Photo taken in August, 2009.

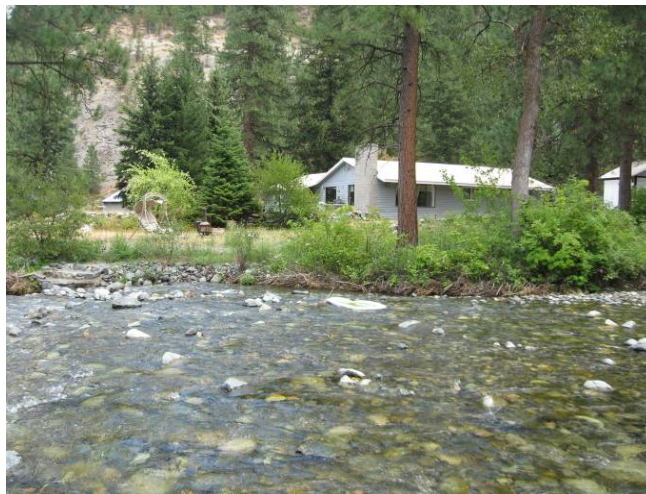
The greatest impact is between river miles 5.2 and 5.7 (Figure 71). In this area, much of the riparian area and floodplain has been cleared. LiDAR data also suggests considerable filling and grading of the floodplain in this area. A map of human features is included in Figure 72.

Figure 71. View to the northeast in the downstream direction at the river right floodplain near river mile 5.6. This floodplain area has been cleared and residentially developed. Photo taken in August 2009.

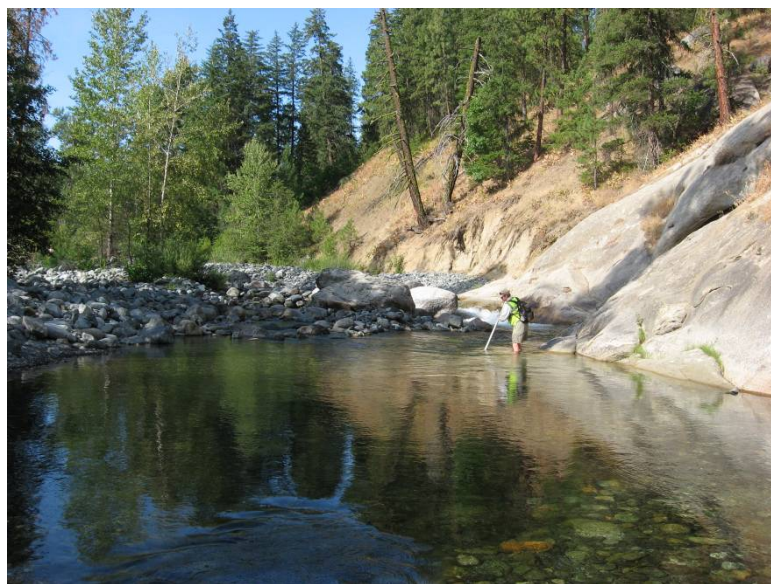
Figure 76. Bedrock pool near river mile 6.2. Photo taken in August 2009.

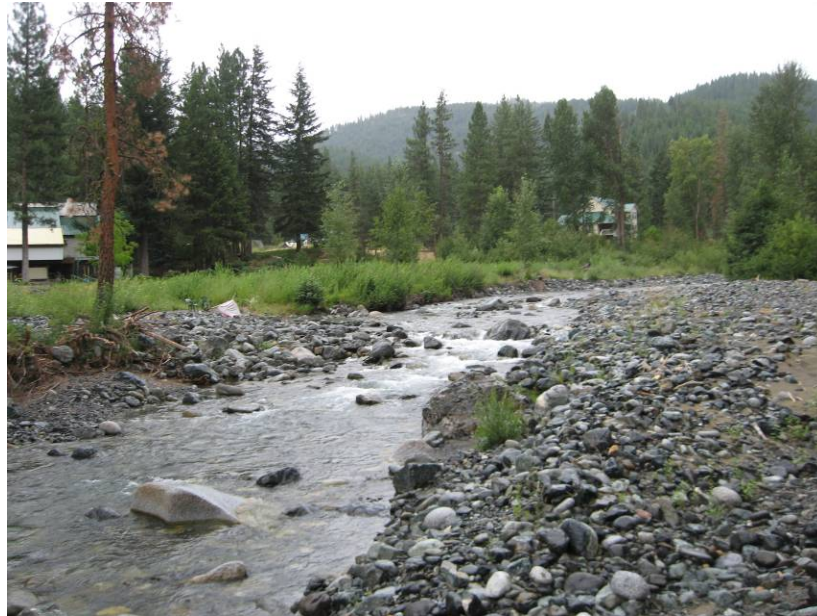
There is scattered residential development primarily along the river-right bank throughout the reach (Figure 77). However, relative to downstream reaches, there is a low degree of human alteration in Reach 4 with about 26% floodplain disconnection. A bridge crossing at river mile 6.45 limits local channel dynamics (Figure 78). Highway 97 cuts off an old glacial channel (possibly an historical, post-glacial mainstem channel location) between river miles 6.5 and 7.3;

Figure 77. View looking toward the southwest in the upstream direction near river mile 6.25. Residential development along the right side of the valley has impacted the riparian area. Photo taken in August 2009.

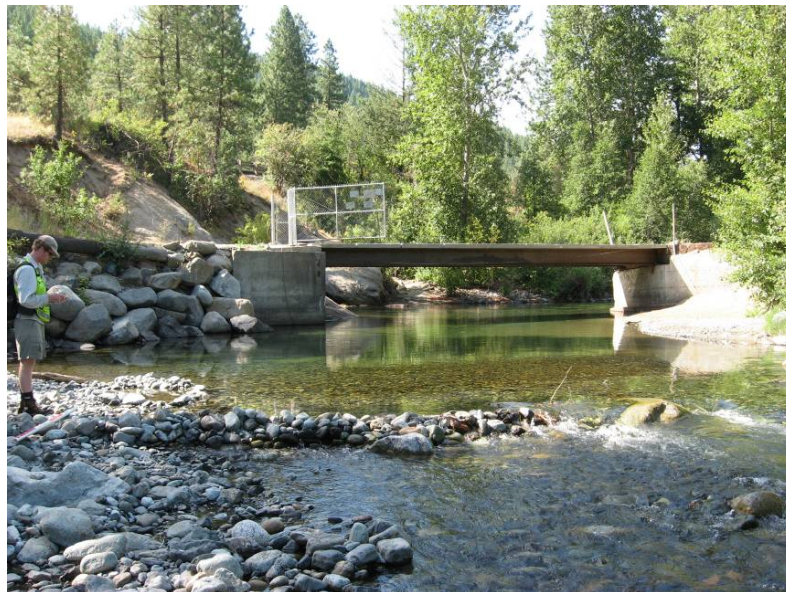
Figure 78. View looking toward the southwest in the upstream direction near river mile 6.45. This narrow private bridge creates hydraulic and geomorphic constraints on the channel and floodplain. Photo taken in August 2009.

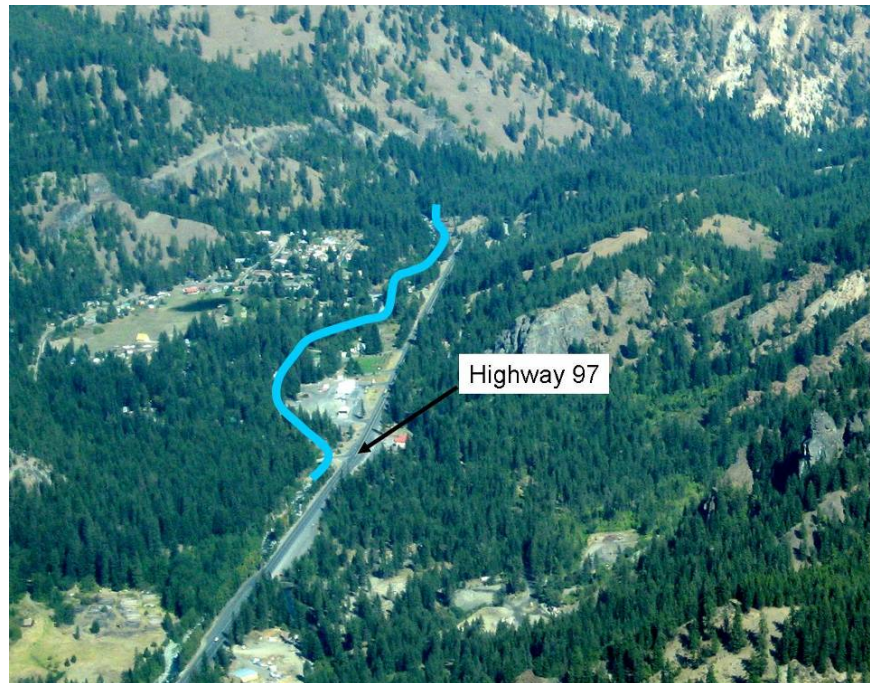
Figure 82. View looking downstream at Reach 5a. The channel of Peshastin Creek is highlighted in blue. Ingalls Creek enters just upstream of the bottom left corner of the photo. Photo taken in September 2009.
