**Site and Reach Assessment  
Nason Creek  
at SR207 MP 0.4, 0.65, 0.9**

**Chronic Environmental Deficiency Program  
WSDOT Hydraulics and Environmental Services  
July 2, 2019**

# Site and Reach Assessment, Nason Creek at SR207

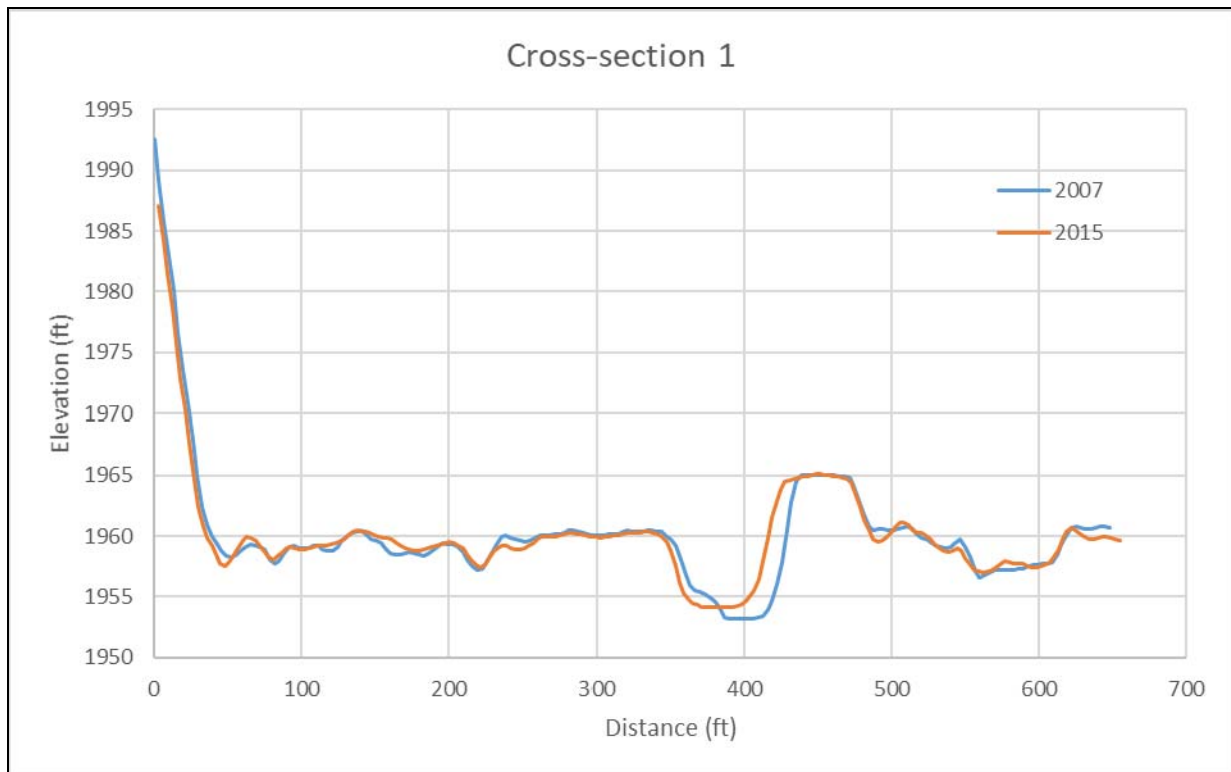
Figure 18. Cross-section 1 elevation data from 2007 and 2015 LiDAR.

Figures 18 through 23 show elevation data for 2007 and 2015 at cross-sections 1 through 6. Cross-section 1 (Figure 18), shows the rip rap revetment that was reconstructed and expanded in 2011. The active channel appears to have been forced westward by several feet.

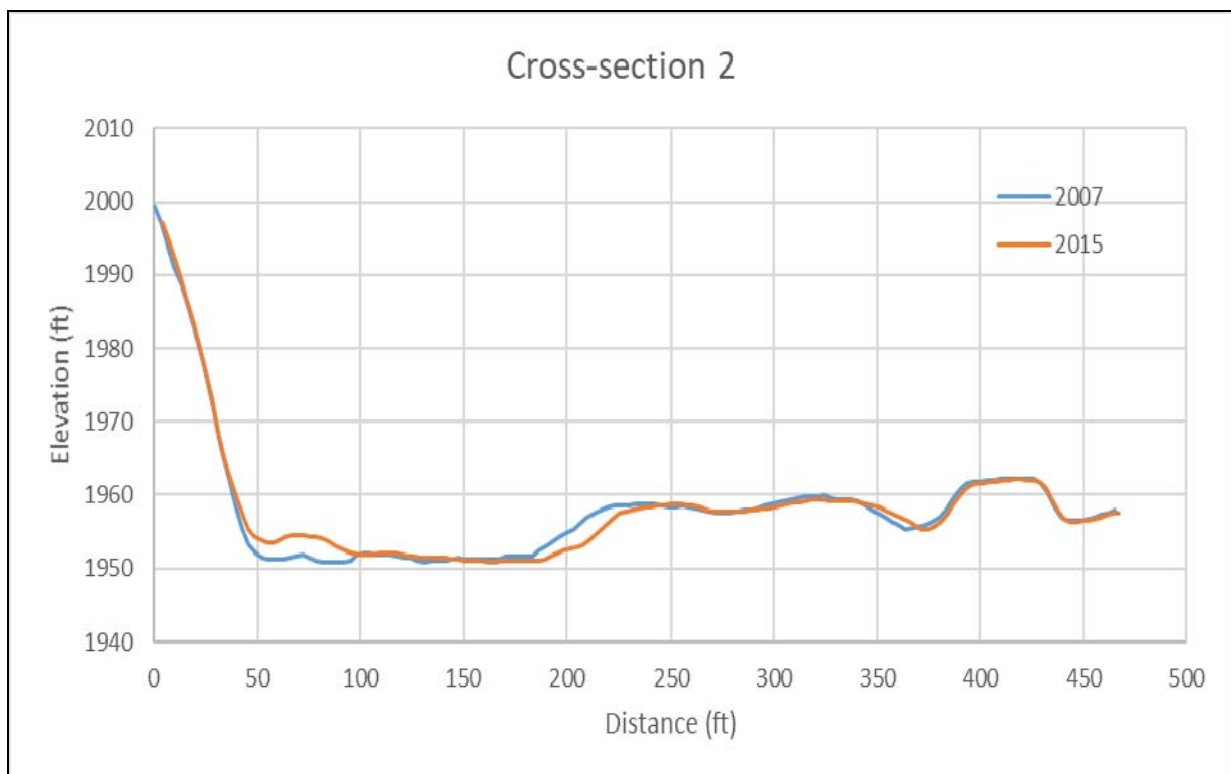
Figure 19. Cross-section 2 elevation data from 2007 and 2015 LiDAR

At cross-section 2 (Figure 19), about 10 feet of right bank erosion occurred between 2007 and 2015. In addition, a gravel bar about 4 feet high formed on the left side of the channel. At cross-section 3 (Figure 20), about 10 feet of right bank erosion is also seen. There is also some erosion of the far left of the floodplain, which is difficult to explain, but may be an error in post-processing of the data. Cross-section 4 (Figure 21), which is in the side channel area downstream of the log jam, shows a highly variable pattern of erosion and deposition. One of the two major channels in 2007 was completely filled in by 2015; there was also some erosion on natural floodplain to the left of the side channels.

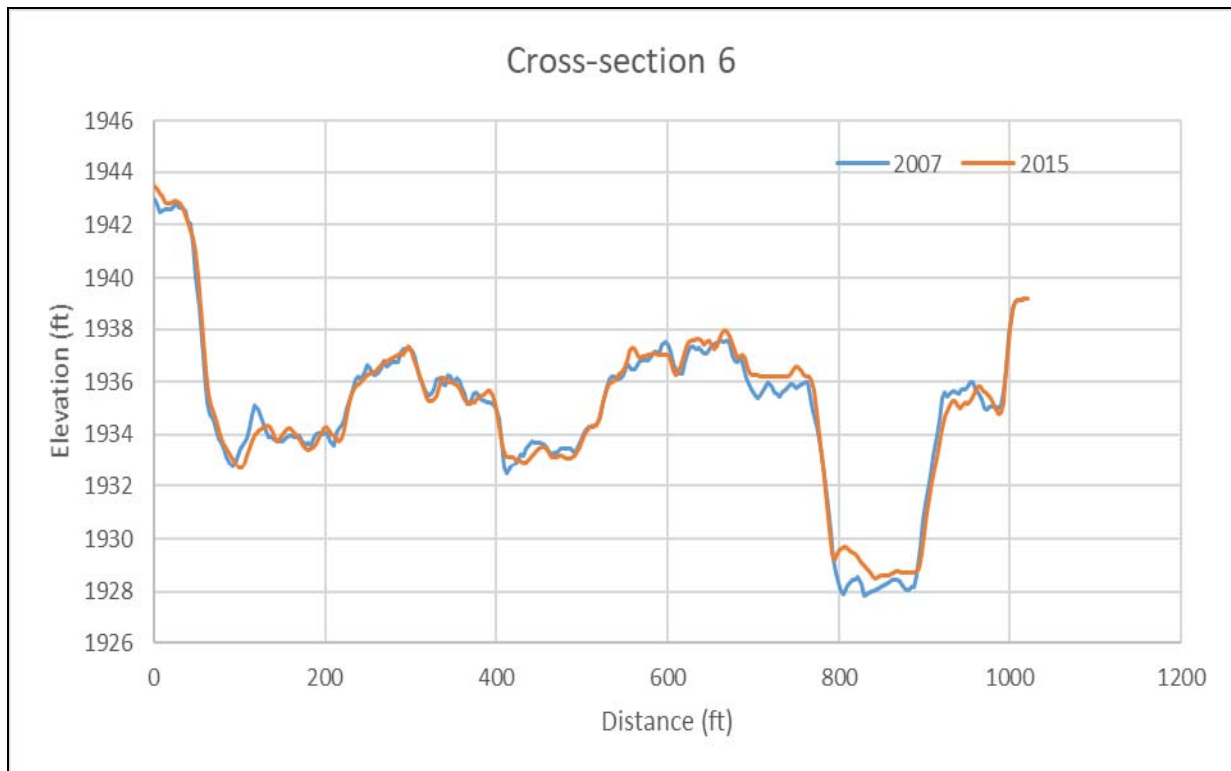
Figure 23. Cross-section 6 elevation data from 2007 and 2015 LiDAR.

Cross-section 5 (Figure 22), which is relatively short, is located in the area where the creek is against the highway. Similar to Cross-section 4, aggradation has occurred, though only about a maximum of 2.5 feet. Cross-section 6 (Figure 23) has shown very little change, with only about a foot of aggradation in the main channel.

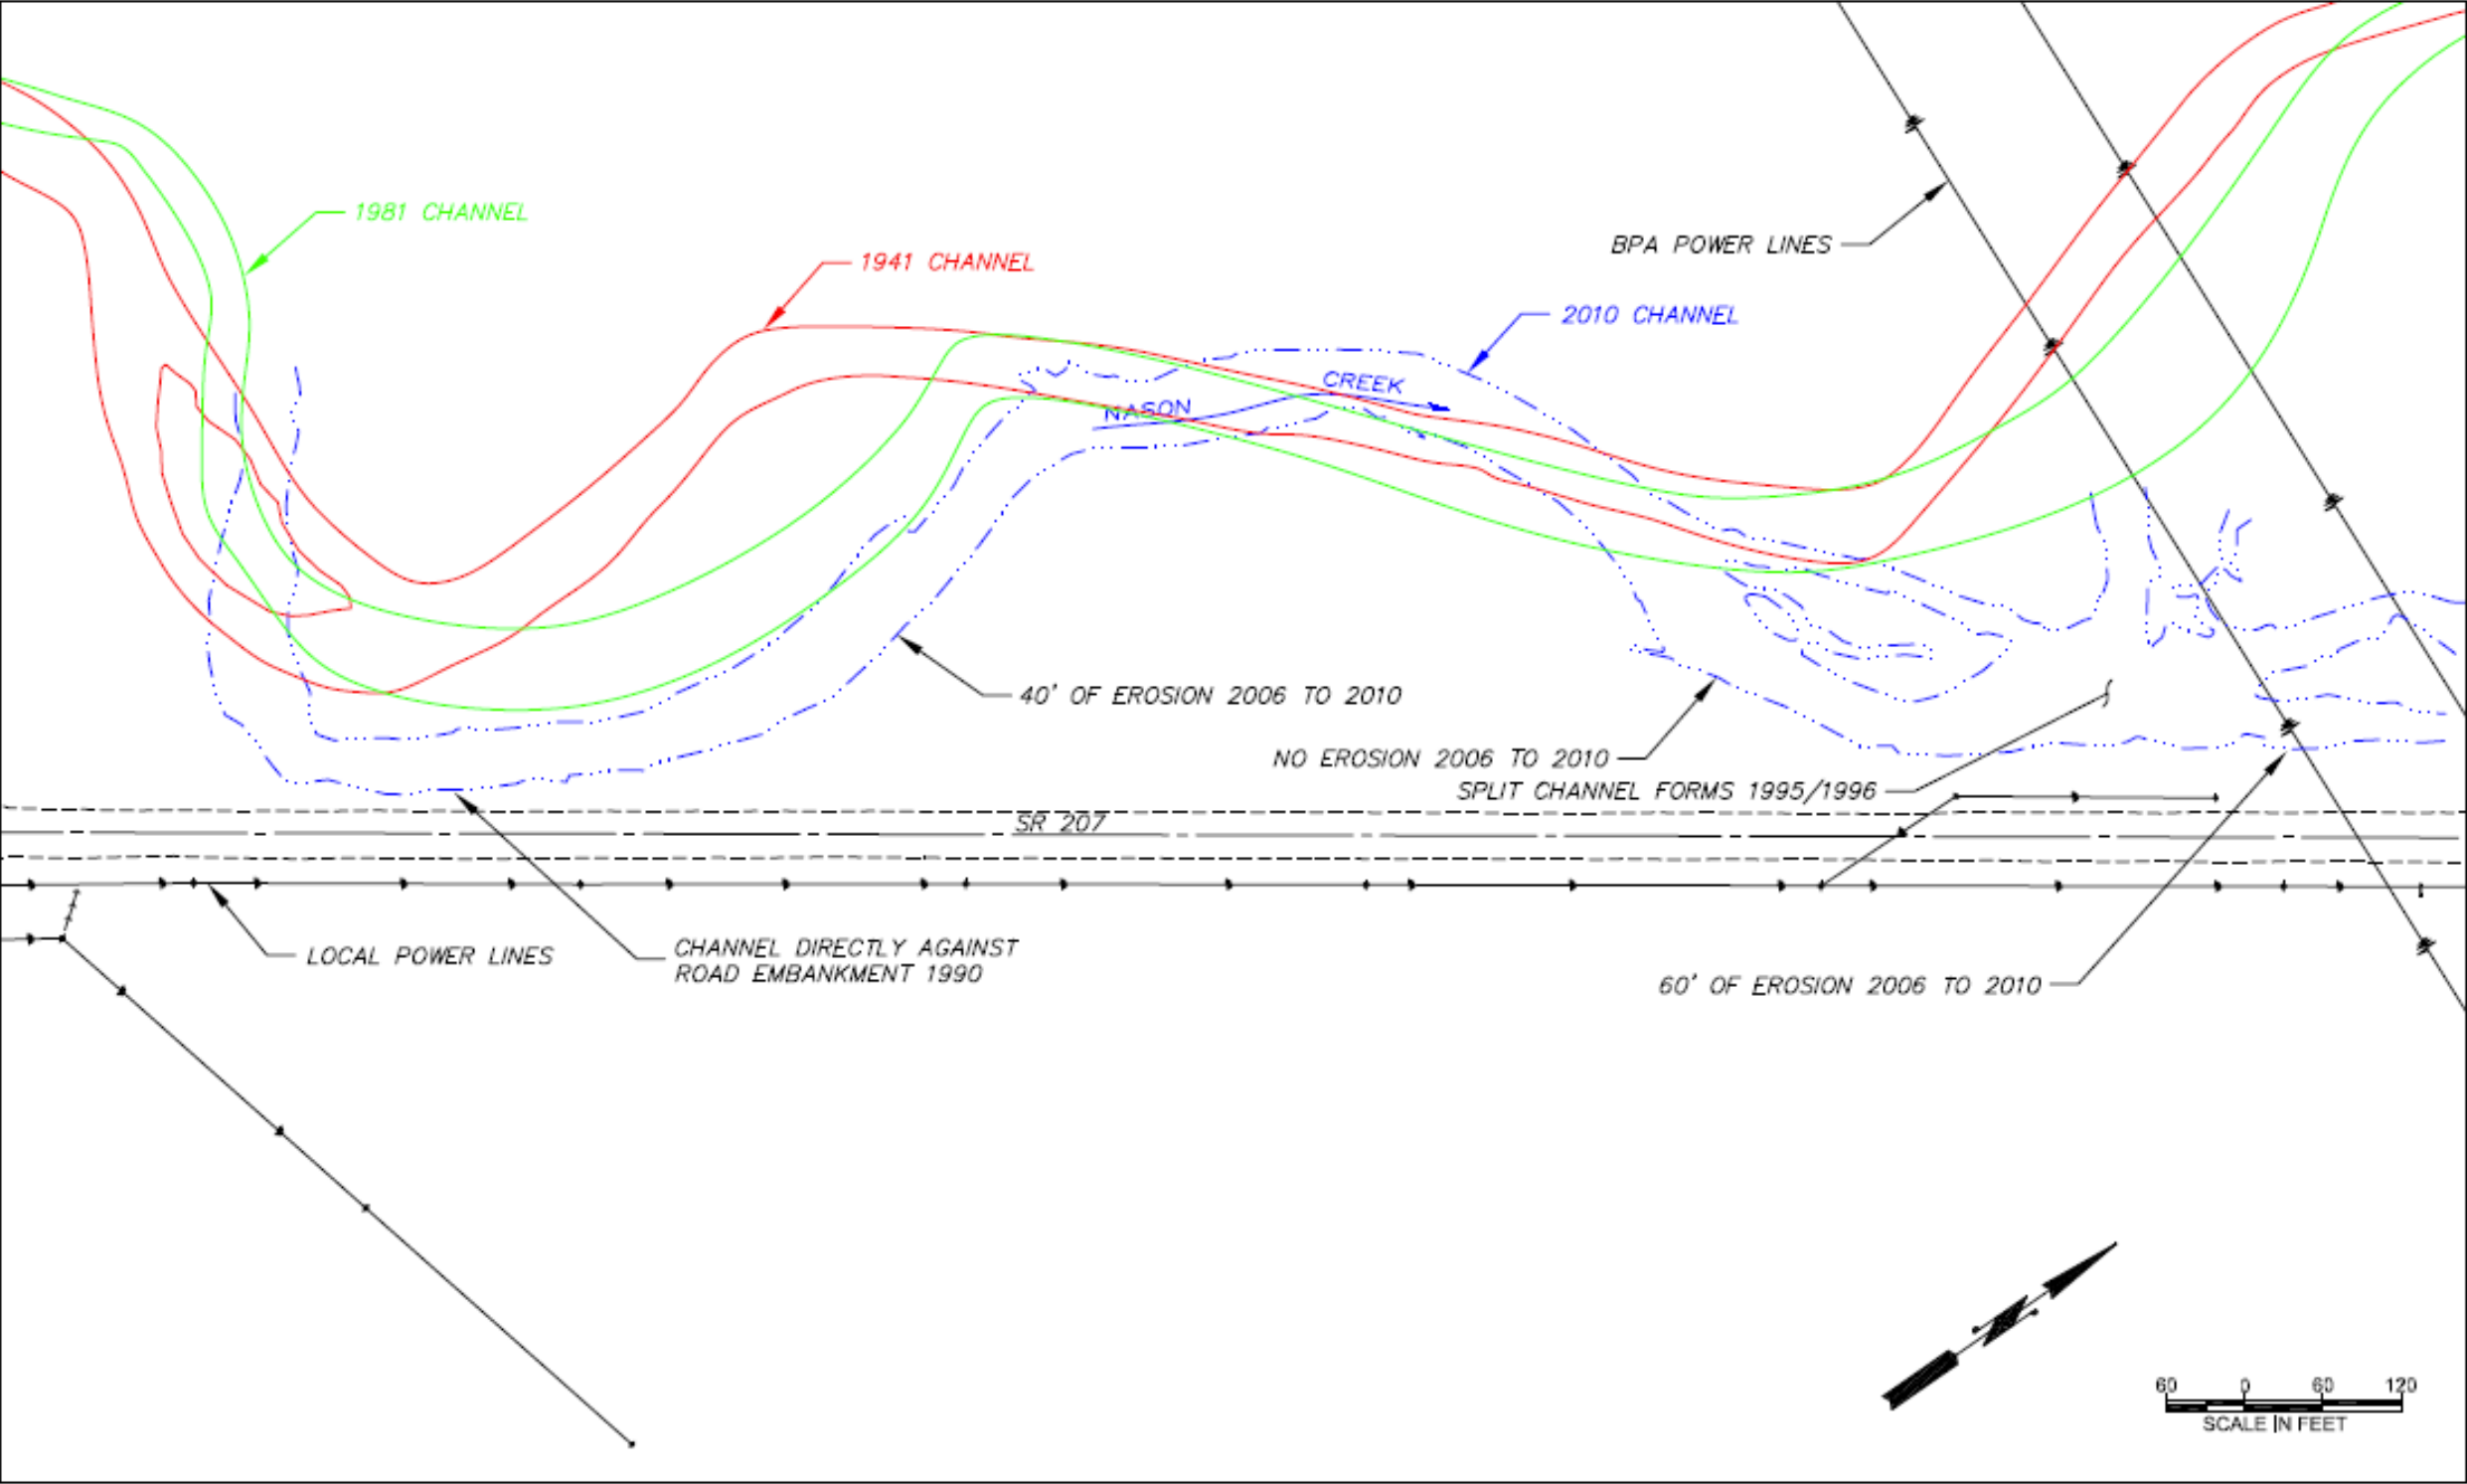
Figure 24. Channel migration, 1940-2010 (Bureau of Reclamation, 2011).

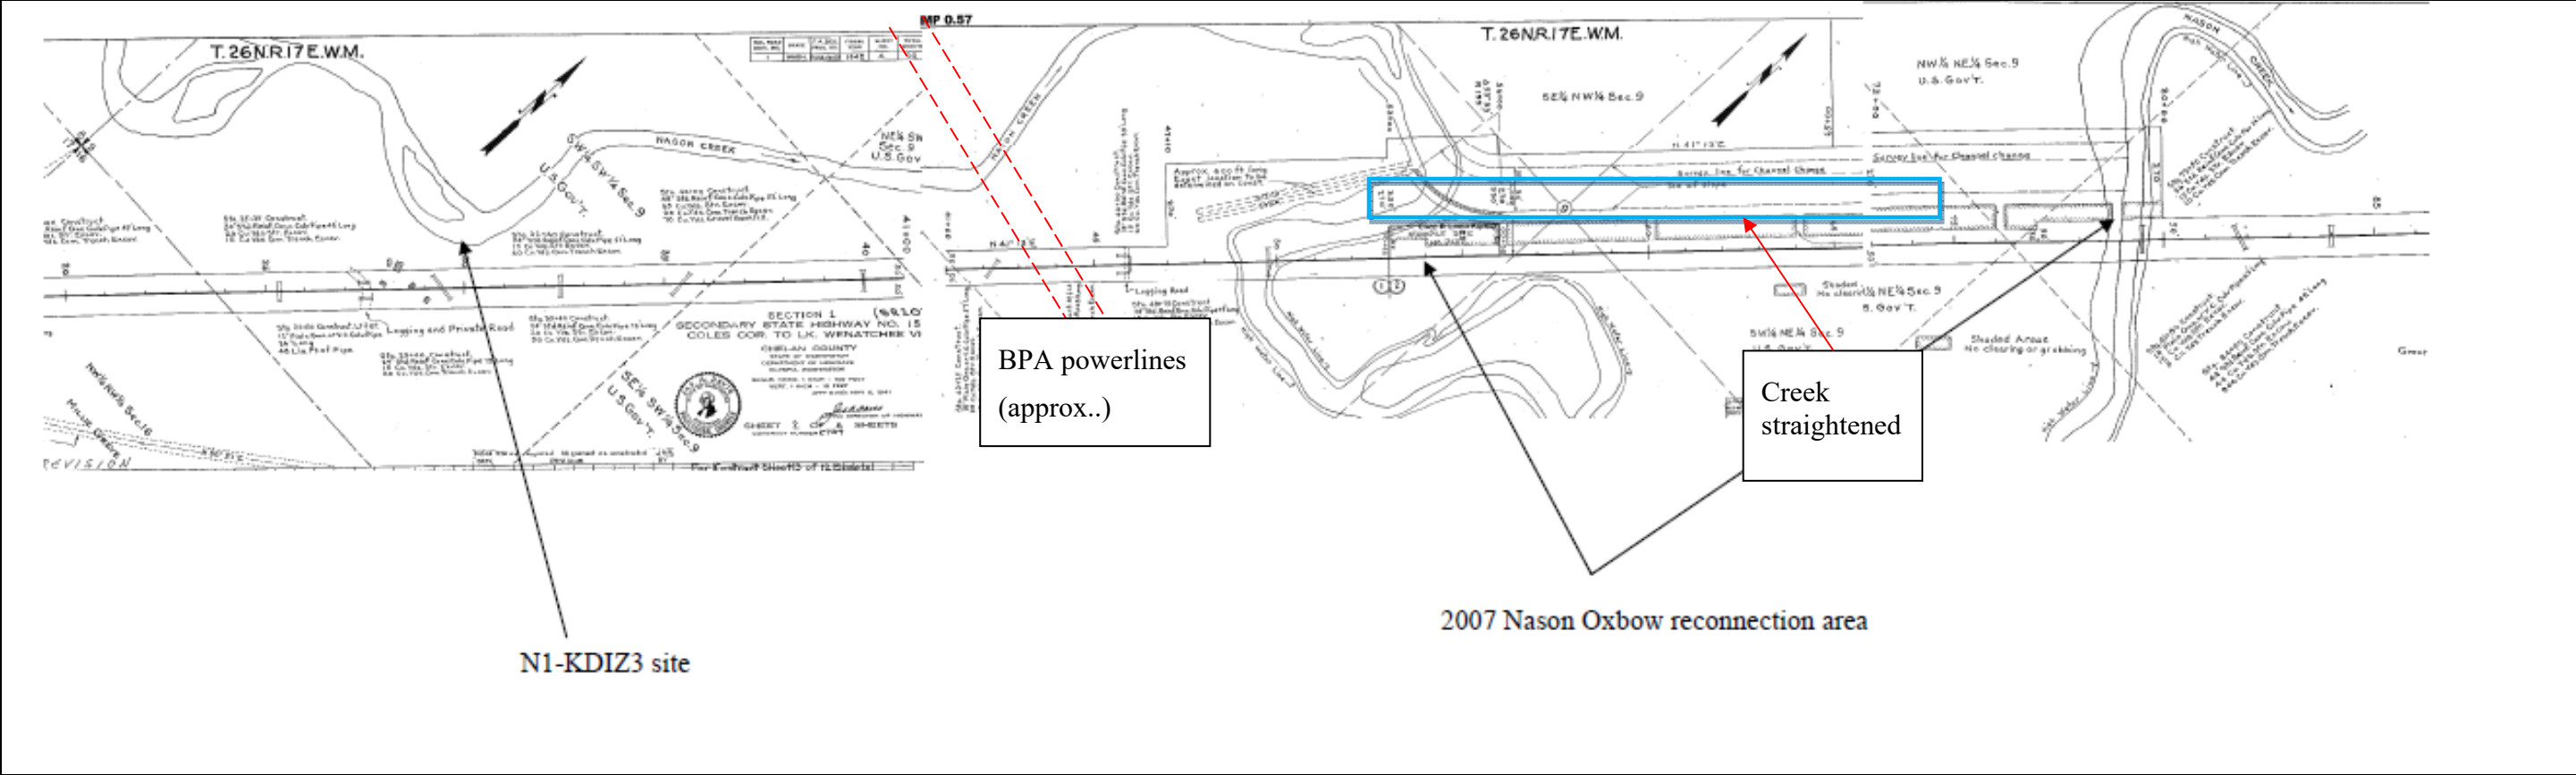
The 1941 re-alignment project cut off the floodplain on the east half of the valley floor and excavated an entirely new, straight channel parallel to the new highway (see Figure 25, page 30). Riprap was added to the upstream bend in order to lead the creek into the straightened section, and a “ditch dike” was built on the upstream end of the straightened section to prevent flanking of the new creek alignment. It is unclear from the plans how this was built or what the dimensions were. Additional rip rap was installed sometime in the last 20 years along the same reach (Figure 13).

Figure 25. 1941 re-alignment plans in the project reach.

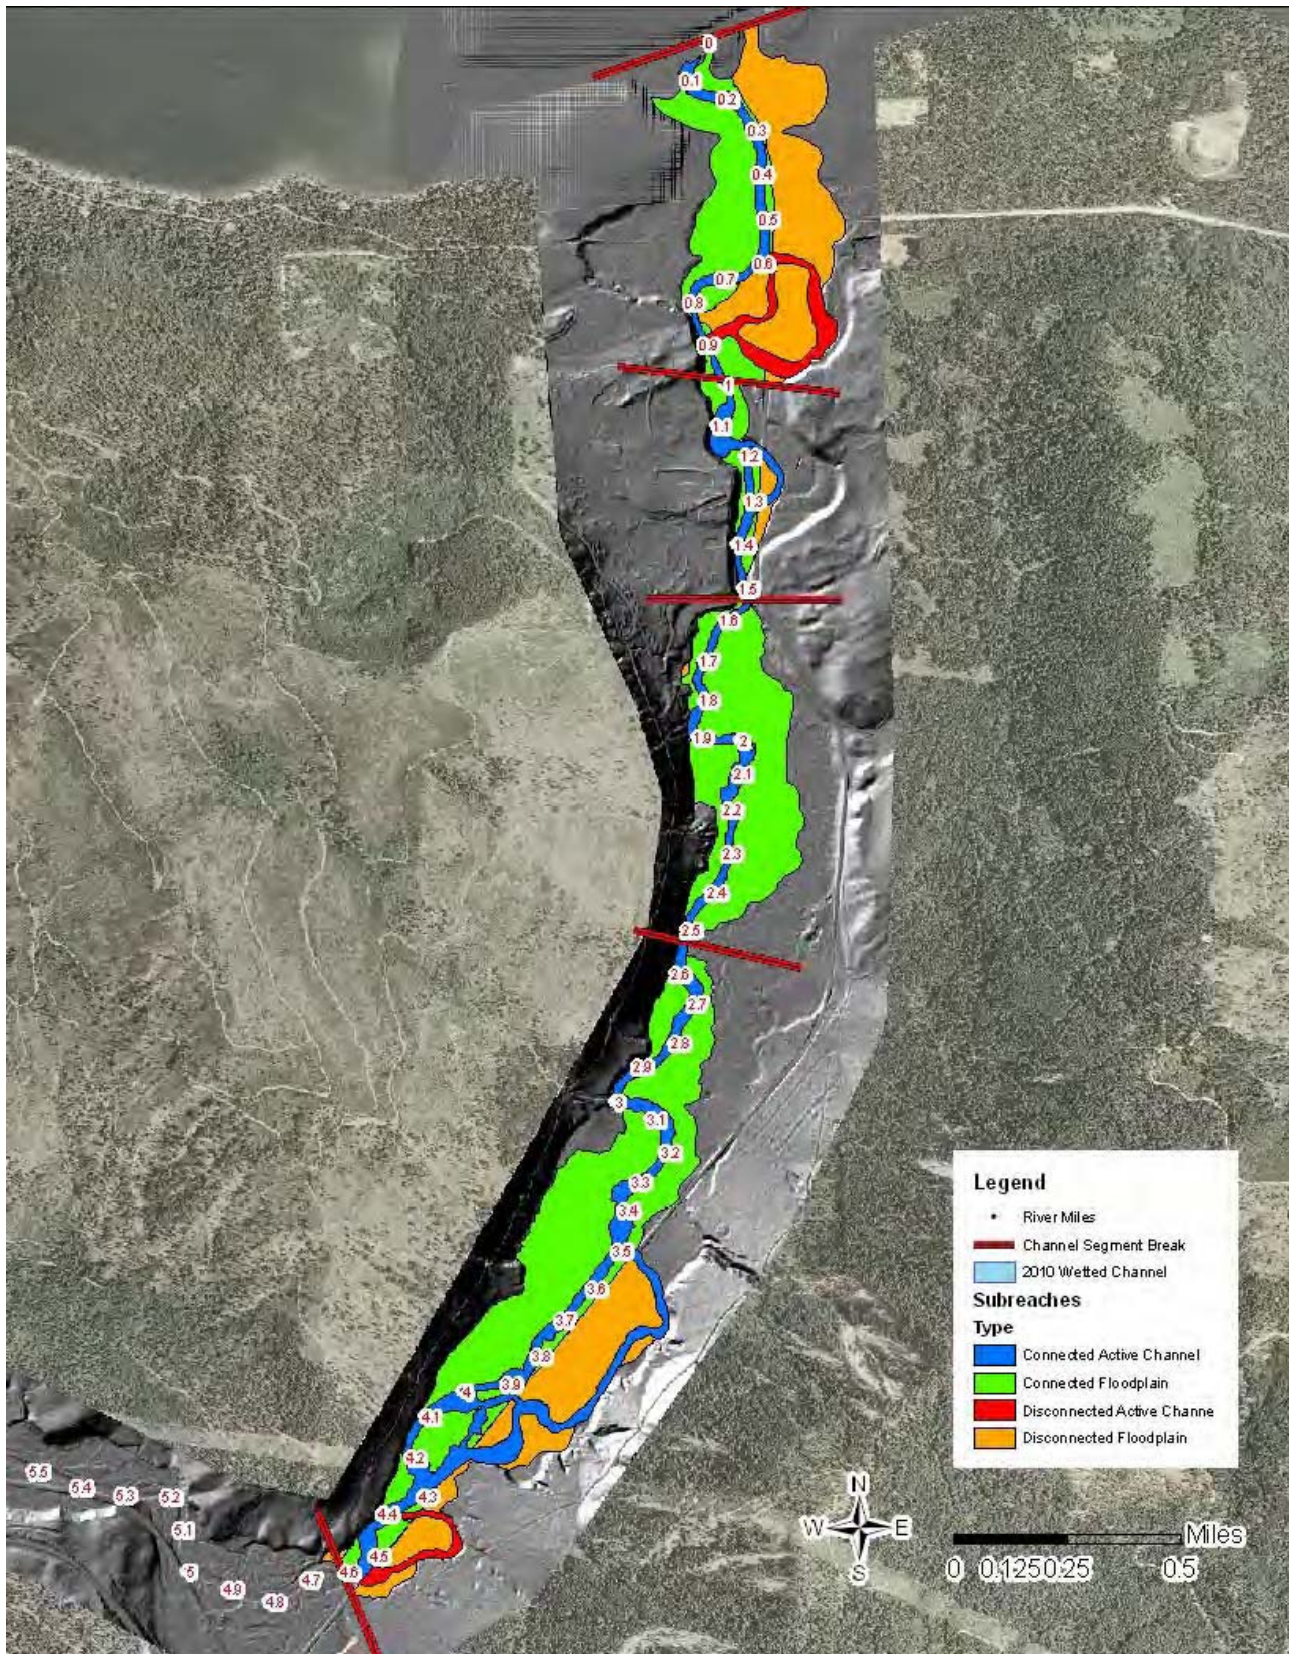
The natural floodplain in the project reach varies between 400 and 1700 feet wide. However, the SR207 road prism has cut off about 25% of the natural floodplain in much of the project reach. As mentioned above, the re-location of the highway to the floodplain in 1941 radically altered the stream-floodplain connection. Figure 25 shows the 1941 plans and where the channel was cut off. The hydrologic connection has been at least partially restored by the reconnection project sponsored by Chelan County, in 2008. The County, in cooperation with WSDOT installed two 12-foot diameter culverts under SR207 at MP 0.9 and 1.33 to reconnect a historic stream oxbow. This oxbow was formerly the mainstem of Nason Creek that was disconnected in the 1940s during the SR 207 realignment construction (Figure 25).

Figure 26. Mapped floodplain/channel connectivity (Bureau of Reclamation, 2011)
