Beaver Creek

REACH ASSESSMENT

December 2017

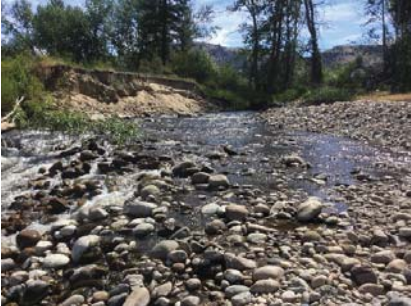
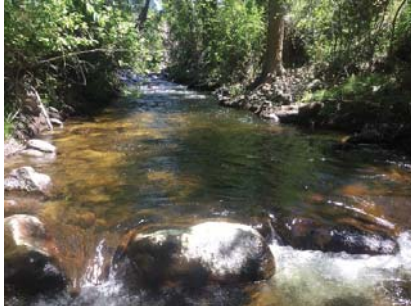
Table 4-3. Reach 1 Physical Characteristics, Location Map, and Photos

Reach 1: This is a relatively short reach from the confluence with the Methow River to RM 0.4; key features include the alluvial fan and the Methow Valley Highway (SR 153) crossing near RM 0.3. The Lower Beaver Creek Road parallels the creek to the east upstream of the Methow Valley Highway (SR 153). The channel in this reach is 2 percent gradient, deeply incised, and lacks instream habitat complexity and cover. Most of the channel banks downstream of the Methow Valley Highway (SR 153) crossing show signs of active erosion. There are multiple side channels across the fan in this reach but they are hydrologically disconnected at most flows due to channel incision. The planform of Reach 1 is relatively straight with limited sediment storage in sparse bars. This reach was not burned in the 2014 Carlton Complex Fire.

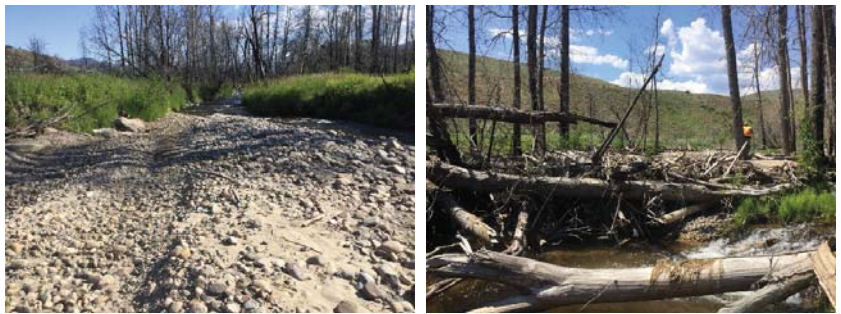
Table 4-5. Reach 3 Physical Characteristics, Location Map, and Photos

Valley Setting	U-shaped, terraced, moderately confined	
Channel Morphology	Pool-riffle	
Migration Type	Irregular lateral	
Rosgen Type	C3	
Gradient	1.9%	
Sinuosity	1.26	
Bankfull Width (feet)	28.9	
Width-to-Depth Ratio	11	
Floodprone Width (feet)	64	
Entrenchment Ratio	2.21	
Substrate (dominant (%), subdominant (%))	Cobble (58%), gravel (33%) ^{1/}	
Bank Condition	Armored (0.2%), eroding (1.8%)	
Floodplain Disconnected	53.3%	
LWD (pieces/mile)	3.5	
Jams (jams/mile)	6.0	
Pools (pools/mile)	8.9	
Unit Stream Power (watts/meter)	232	
Habitat Units	Pool (15%), glide (3%), riffle (76%), rapid (6%), cascade (0%)	
REI Score	16

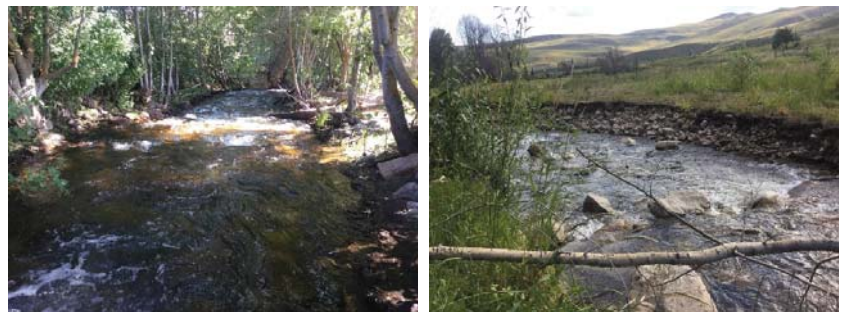
Table 4-6. Reach 4 Physical Characteristics, Location Map, and Photos

Valley Setting	U-shaped, terraced, moderately confined	
Channel Morphology	Pool-riffle	
Migration Type	Irregular lateral	
Rosgen Type	C3	
Gradient	2.5%	
Sinuosity	1.16	
Bankfull Width (feet)	25.0	
Width-to-Depth Ratio	9	
Floodprone Width (feet)	77	
Entrenchment Ratio	3.08	
Substrate (dominant (%), subdominant (%))	Cobble (53%), gravel (25%) ^{1/}	
Bank Condition	Armored (5.7%), eroding (14.8%)	
Floodplain Disconnected	53.3%	
LWD (pieces/mile)	3.2	
Jams (jams/mile)	2.4	
Pools (pools/mile)	11.0	
Unit Stream Power (watts/meter)	248	
Habitat	Pool (12%), glide (2%), riffle (69%), rapid (18%), cascade (0%)	
REI Score	14

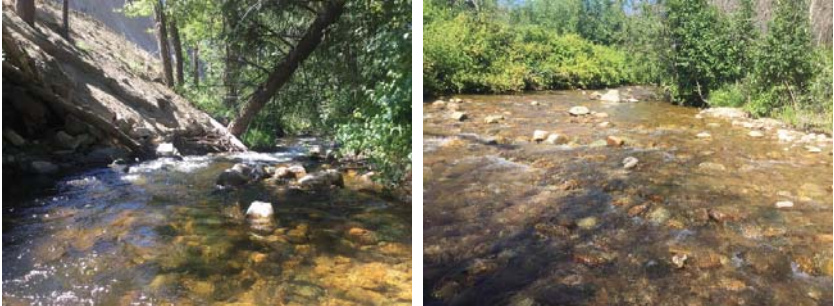
Table 4-7. Reach 5 Physical Characteristics, Location Map, and Photos

Bank Condition	Armored (1.3%), eroding (2.9%)			
Floodplain Disconnected	60.9%			
LWD (pieces/mile)	6.8			
Jams (jams/mile)	5.0			
Pools (pools/mile)	5.3			
Unit Stream Power (watts/meter)	322			
Habitat Units	Pool (5%), glide (2%), riffle (27%), rapid (65%), cascade (0%)			
REI Score	22

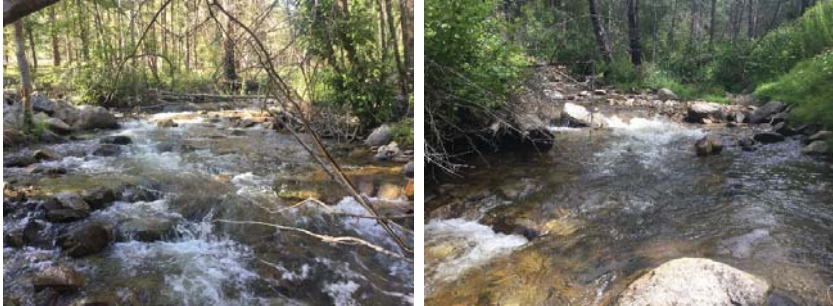
Table 4-8. Reach 6 Physical Characteristics, Location Map, and Photos

Bank Condition	Armored (0.0%), eroding (1.4%)				
Floodplain Disconnected	50.2%				
LWD (pieces/mile)	12.7				
Jams (jams/mile)	1.8				
Pools (pools/mile)	20.8				
Unit Stream Power (watts/meter)	389				
Habitat Units	Pool (11%), glide (1%), riffle (11%), rapid (75%), cascade (2%)				
REI Score	27

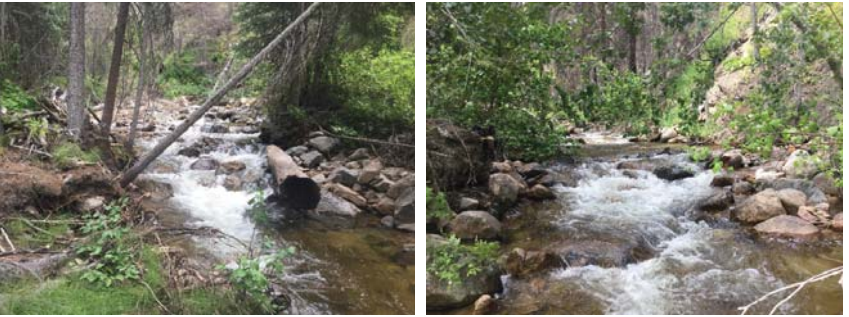
Table 4-9. Reach 7 Physical Characteristics, Location Map, and Photos

Bank Condition	Armored (0.0%), eroding (1.3%)			
Floodplain Disconnected	46.8%			
LWD (pieces/mile)	26.4			
Jams (jams/mile)	5.3			
Pools (pools/mile)	30.6			
Unit Stream Power (watts/meter)	366			
Habitat Units	Pool (15%), glide (0%), riffle (3%), rapid (74%), cascade (8%)			
REI Score	30

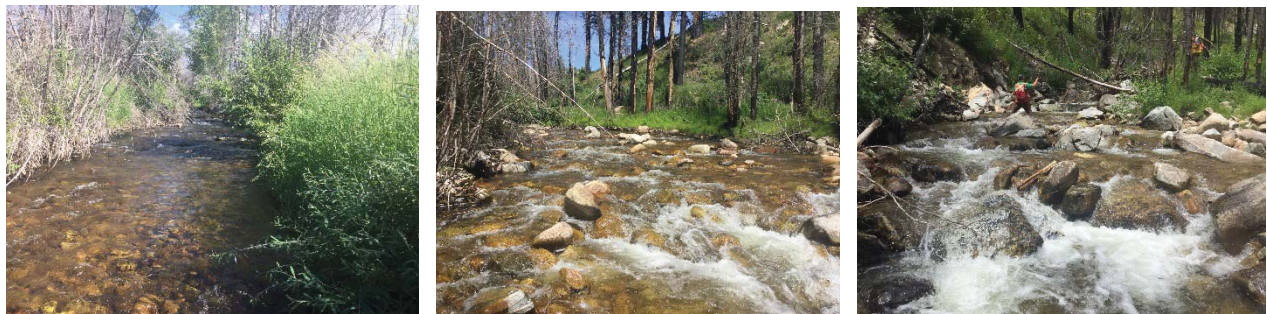
Figure 4-12 shows the distribution of habitat units by reach in Beaver Creek. Fast water riffle habitat units dominate the lower reaches of Beaver Creek (Reaches 1 through 4) ranging from 69 to 76 percent of the total, while rapid habitat units dominate the upper reaches (Reaches 5 through 7) ranging from 65 to 75 percent of the total. Reach 7 had the highest proportion of cascade habitat units at 8 percent of the total. The photographs in Figure 4-13 show typical riffle, rapid, and cascade habitat units in the Survey Area.

Figure 4-13. Photographs of Typical Fast Water Habitat Units Including a Riffle near RM 4.4 in Reach 3 (left), a Rapid near RM 7.8 in Reach 5 (center), and a Cascade in RM 10.6 in Reach 7 (right).
