# LOWER LIBBY CREEK REACH ASSESSMENT

Prepared for **YAKAMA NATION FISHERIES** | PO BOX 15, FORT ROAD | TOPPENISH, WA 98948

Prepared by  
**INTER-FLUVE, INC.**  
1020 WASCO STREET, SUITE I | HOOD RIVER, OR 97031  
541.386.9003 | [www.interfluve.com](http://www.interfluve.com)

July 2012

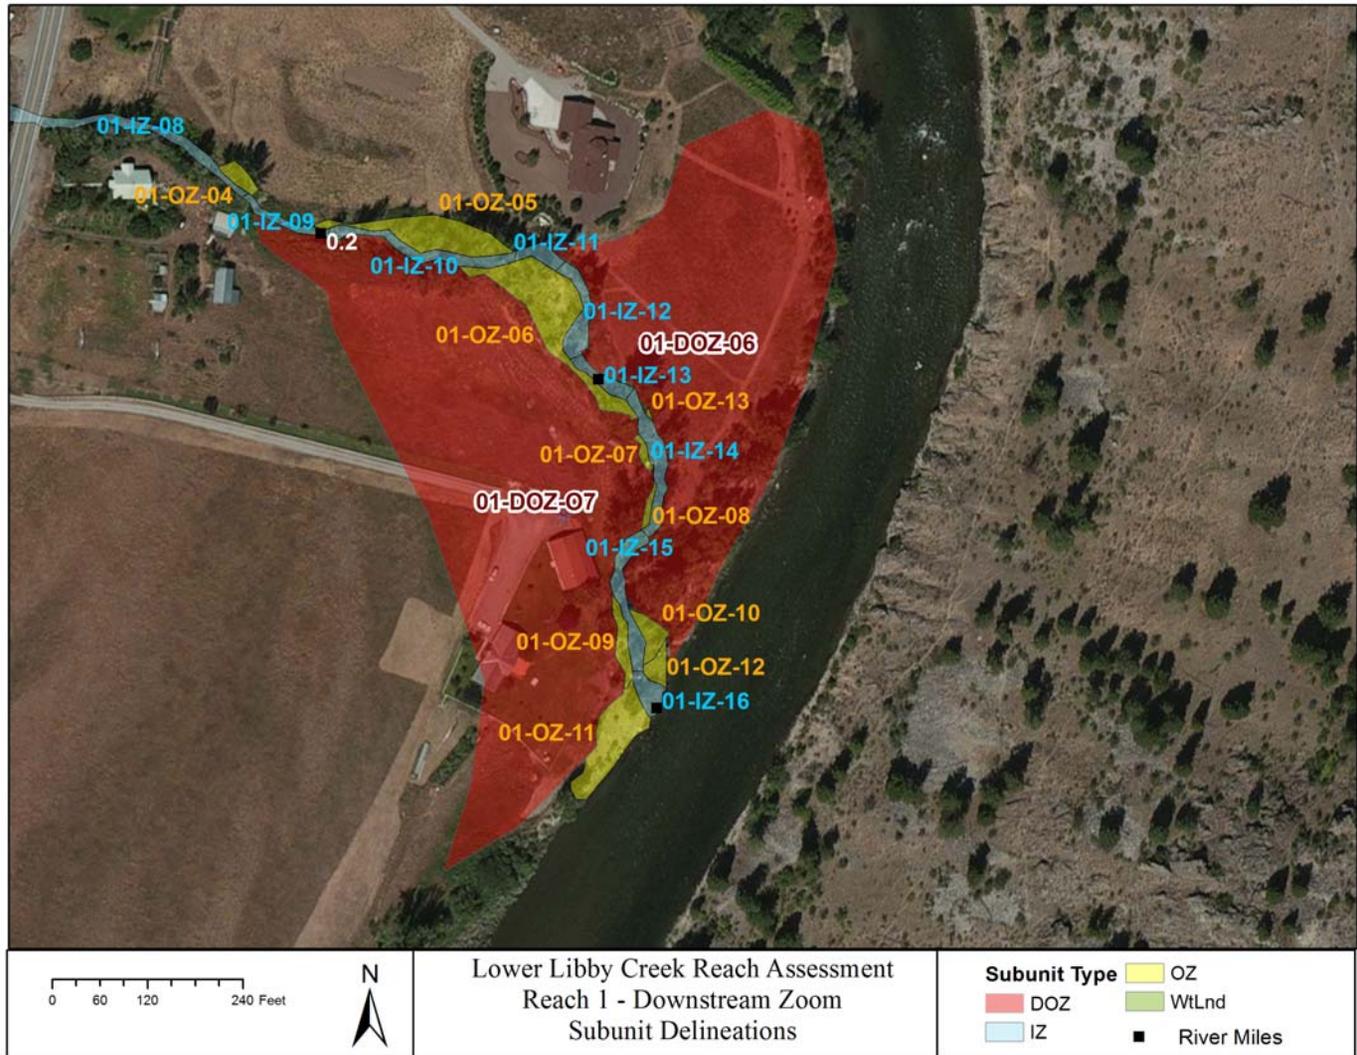
Thirty six subunits were identified in Reach 1, including seven disconnected outer zones, sixteen inner zones, and thirteen outer zones (Table 5, Figure 9, and Figure 10). The majority (95.8%) of the river's historical floodplain surfaces have become disconnected through a combination of natural and human-accelerated incision of Libby Creek and riprap channelization. Connected outer zones are small, discrete floodplain pockets (less than 0.2 acres) that provide space for overland flow.

Figure 9. Subunit delineations in the downstream portion of Reach 1. Flow is from northwest to southeast.

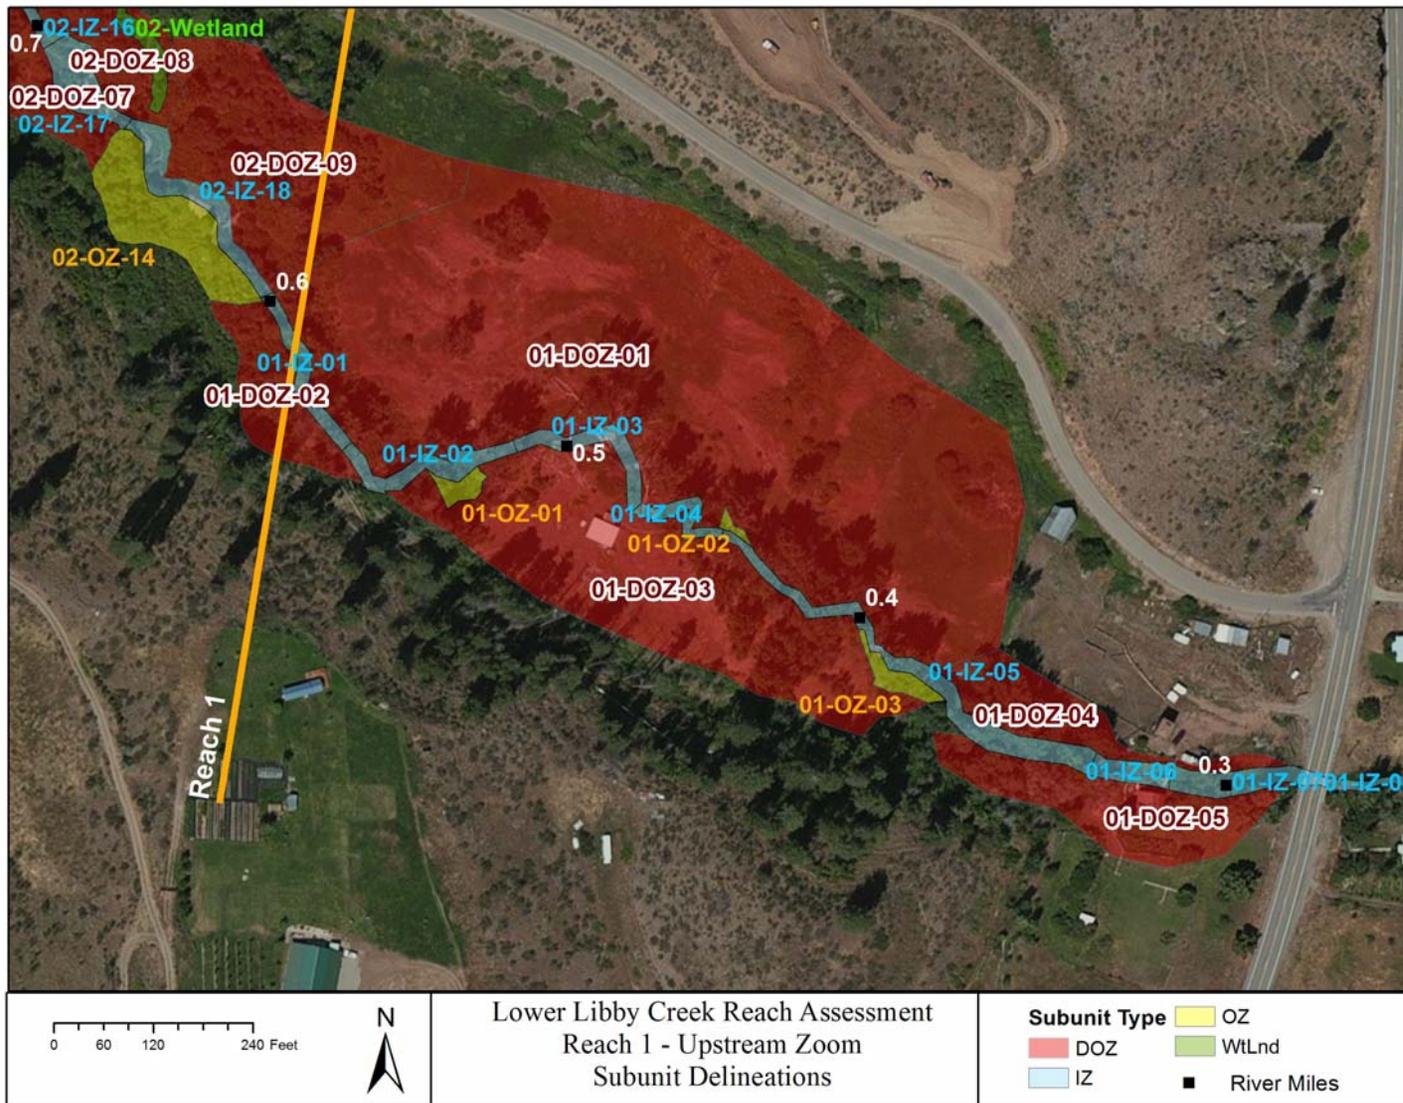
Figure 10. Subunit delineations in the upstream portion of Reach 1. Flow is from northwest to southeast.

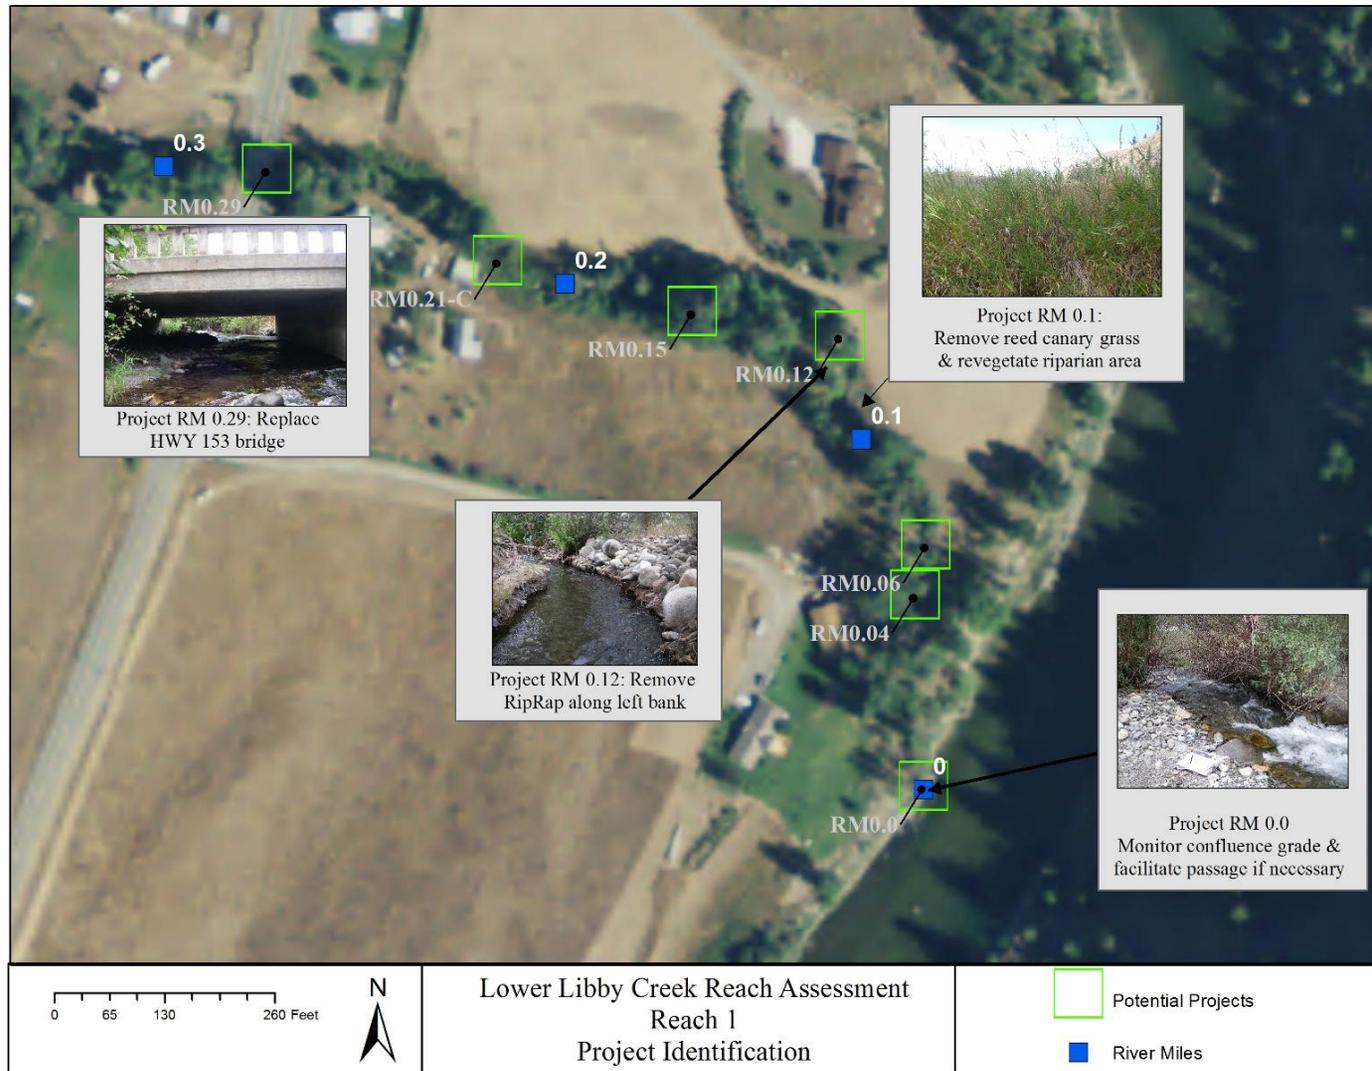
**Figure 11. Potential project locations in the downstream portion of Reach 1. Project photographs are provided for selected sites to illustrate the types of project opportunities that are available throughout the reach. Additional project detail is included in Appendix B.**

The restoration strategy for each subunit is presented in Table 5. Thirteen specific project opportunities that are included in Table 5 have been identified in this reach and are mapped in Figure 11 and Figure 12. Additional project detail is provided in Appendix B.

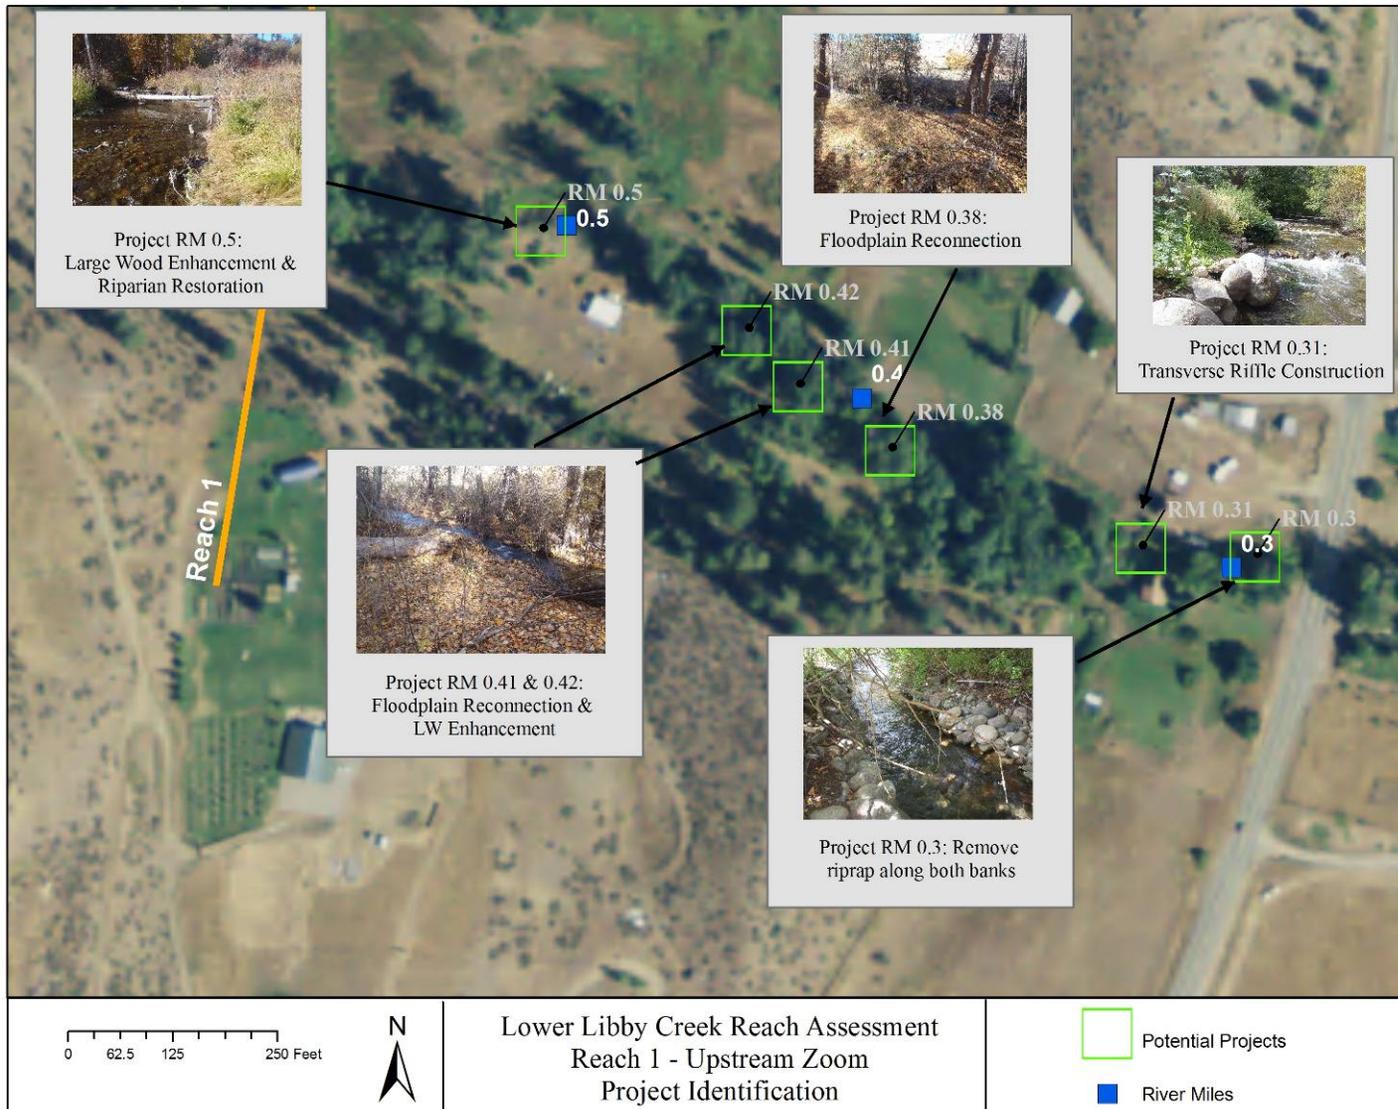
Figure 12. Potential project locations in the upstream portion of Reach 1. Additional project detail is included in Appendix B.

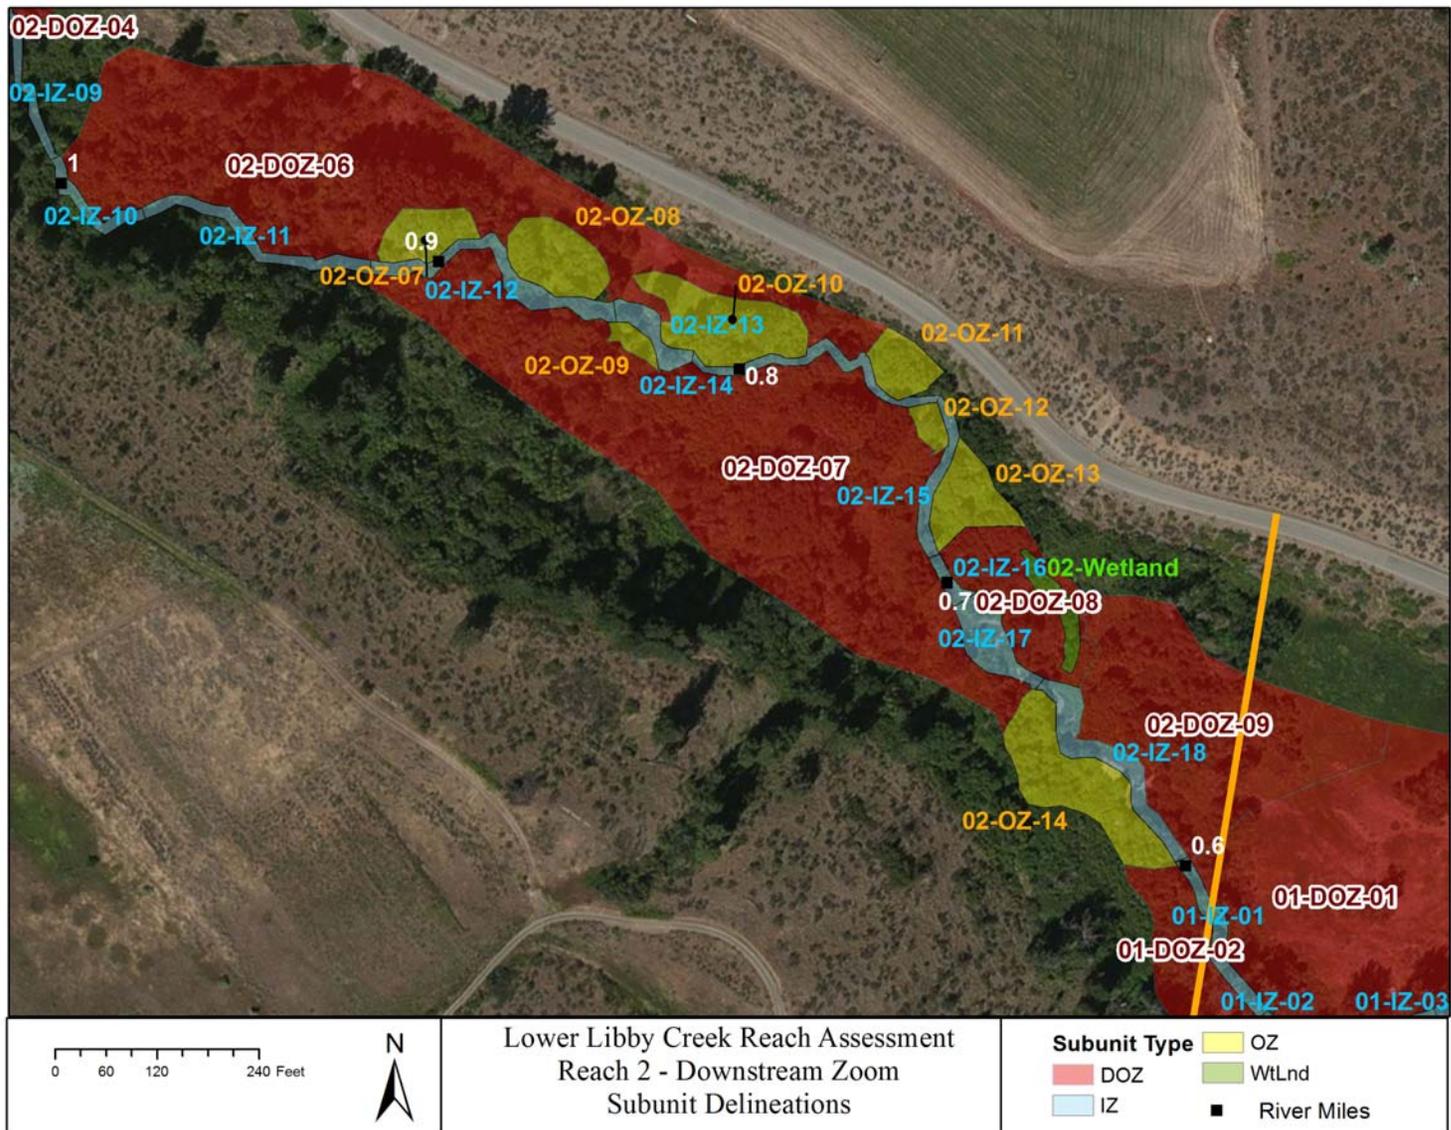
Forty-two subunits were identified in Reach 2, including nine disconnected outer zones, eighteen inner zones, and fourteen outer zones (Table 6, Figure 15, Figure 16). The majority of the historical floodplain is disconnected (80%), with only small, discrete active floodplain areas remaining. This current condition provides substantial opportunity for restoration and enhancement. The lack of active floodplain and off-channel habitat should be mitigated wherever possible.

Figure 15. Subunit delineations in the downstream portion of Reach 2. Flow is from northwest to southeast.

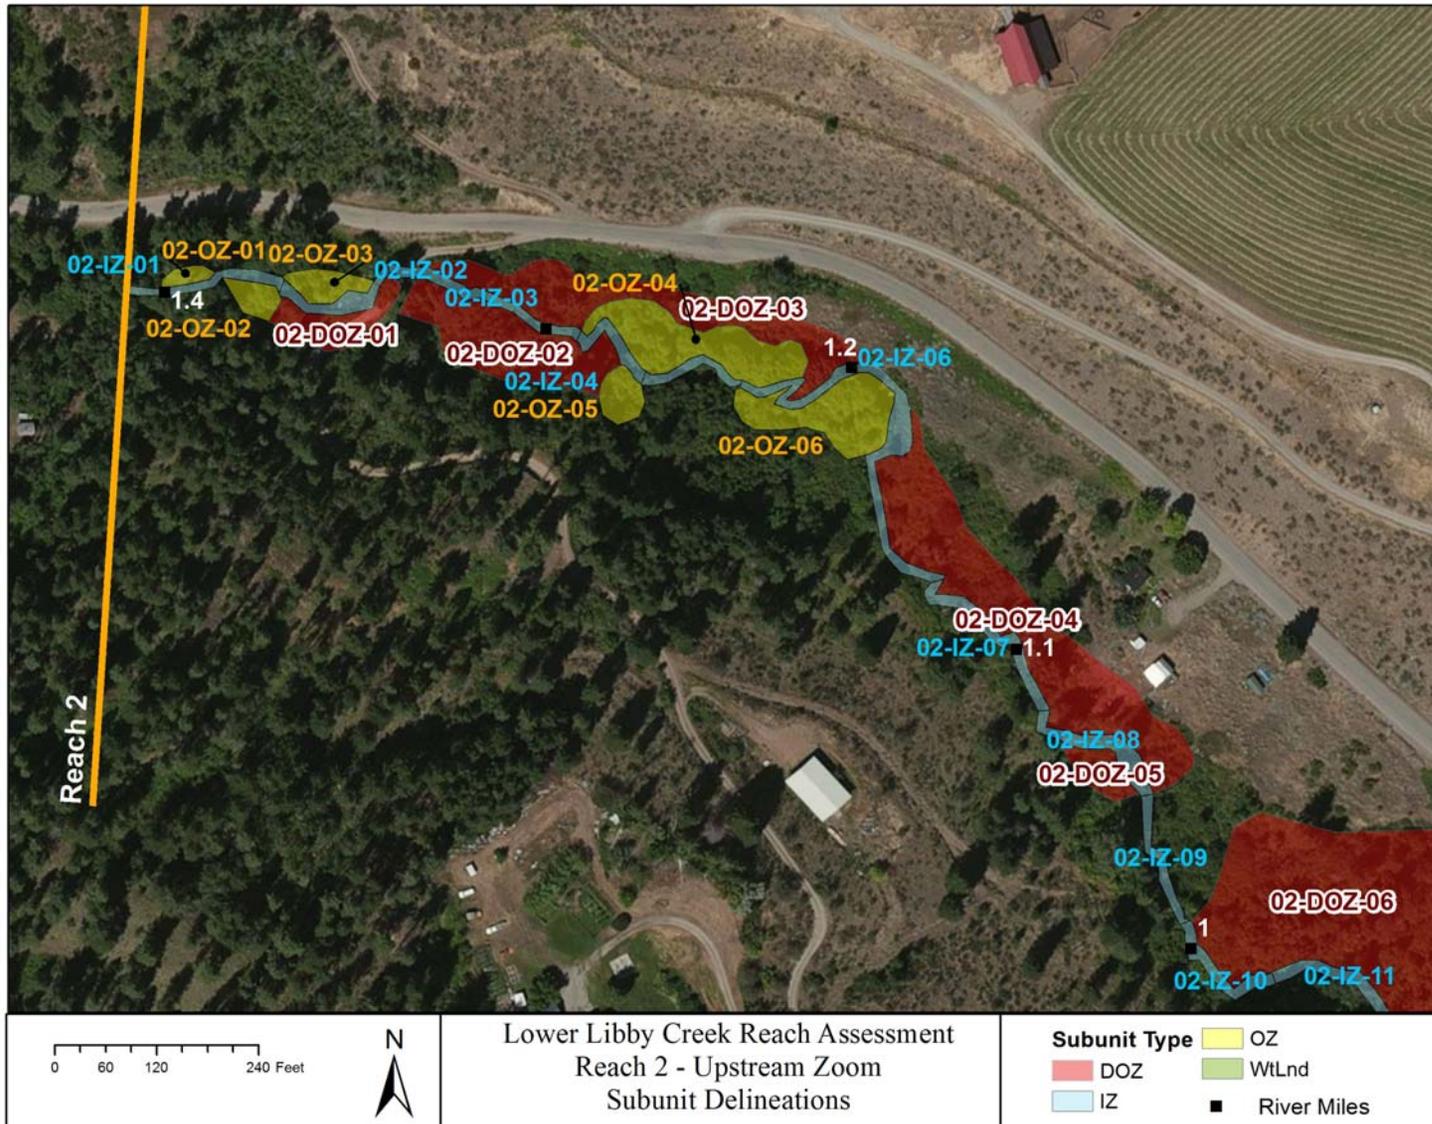
Figure 16. Subunit delineations in the upstream portion of Reach 2. Flow is from northwest to southeast.

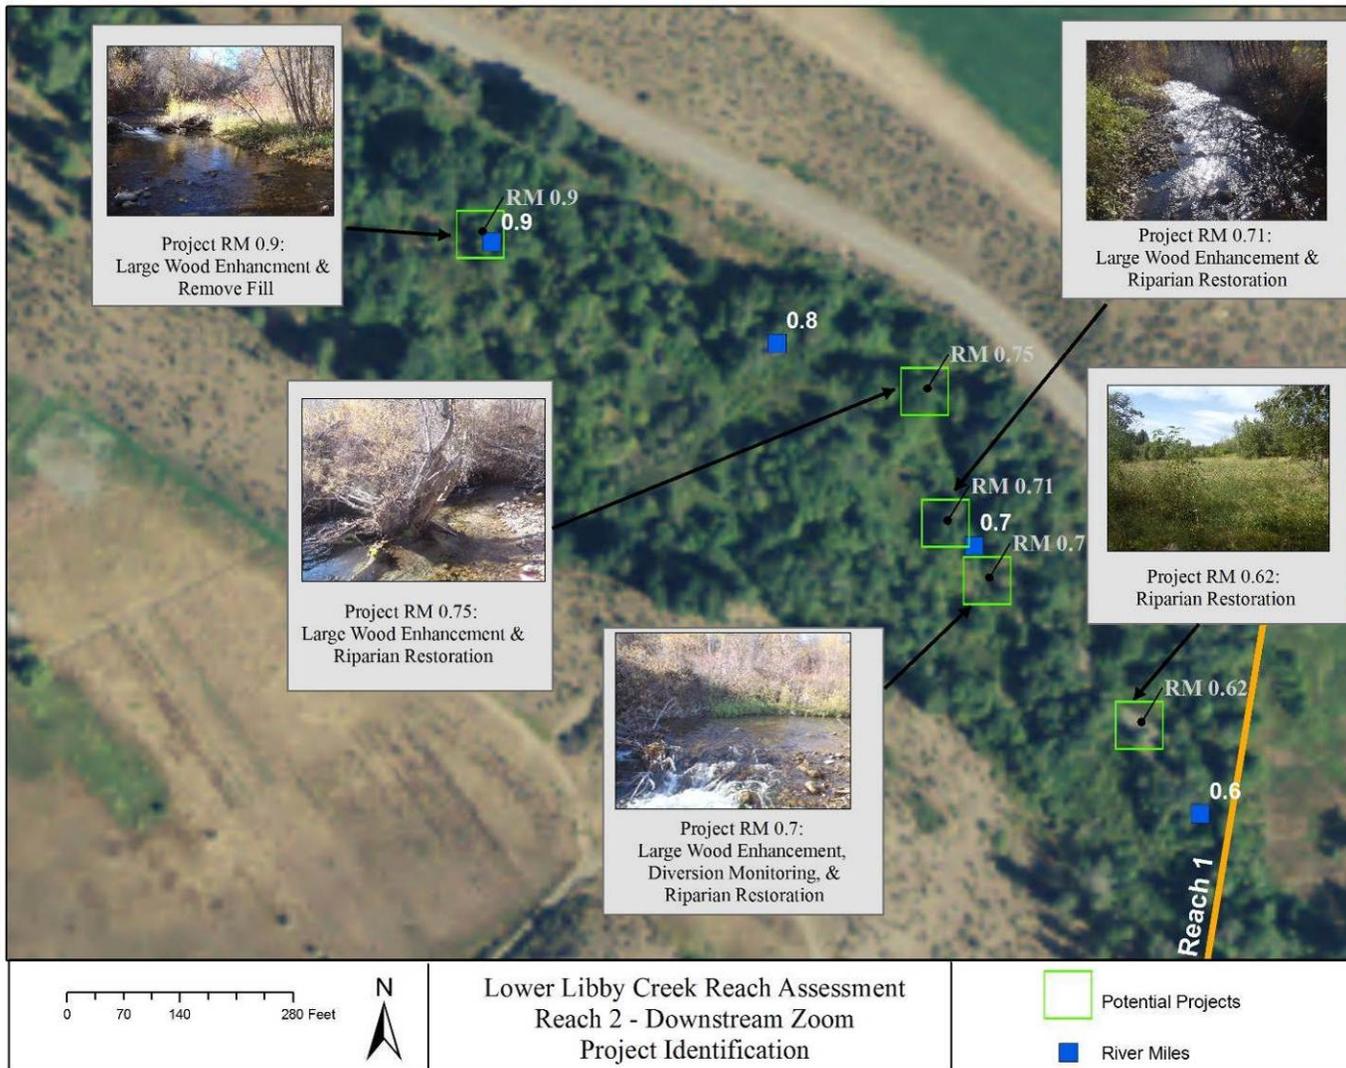
Figure 17. Potential project locations in the downstream portion of Reach 2. Project photographs are provided for selected sites to illustrate the types of project opportunities that are available throughout the reach. Additional project detail is included in Appendix B.

The restoration strategy for each subunit is presented in Table 6. Eight specific project opportunities have been identified in this reach and these are included in the table and are mapped in Figure 17 and Figure 18. Additional project detail is provided in Appendix B.

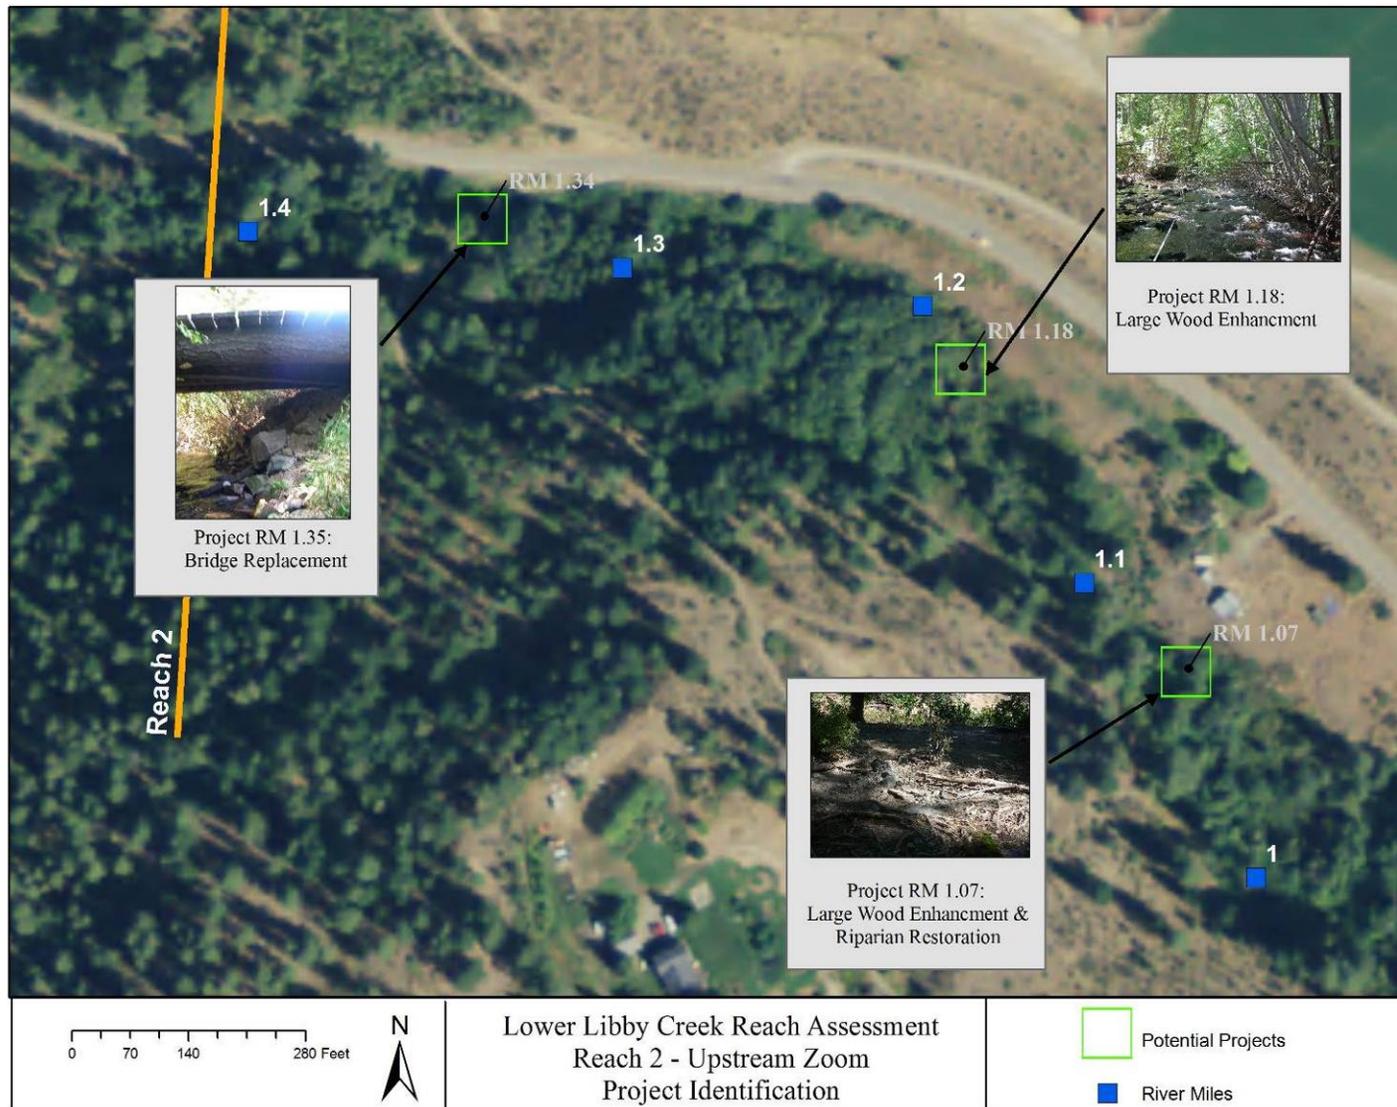
Figure 18. Potential project locations in the upstream portion of Reach 2. Flow is from northwest to southeast. Additional project detail is included in Appendix B.
