Lower Mad River Reach Assessment & Restoration Strategy Report

SUBMITTED TO
Yakama Nation Fisheries - Wenatchee

DECEMBER 2018

PREPARED BY
Inter-Fluve
501 Portway Ave, Suite 101
Hood River, OR 97031
(541) 386-9003

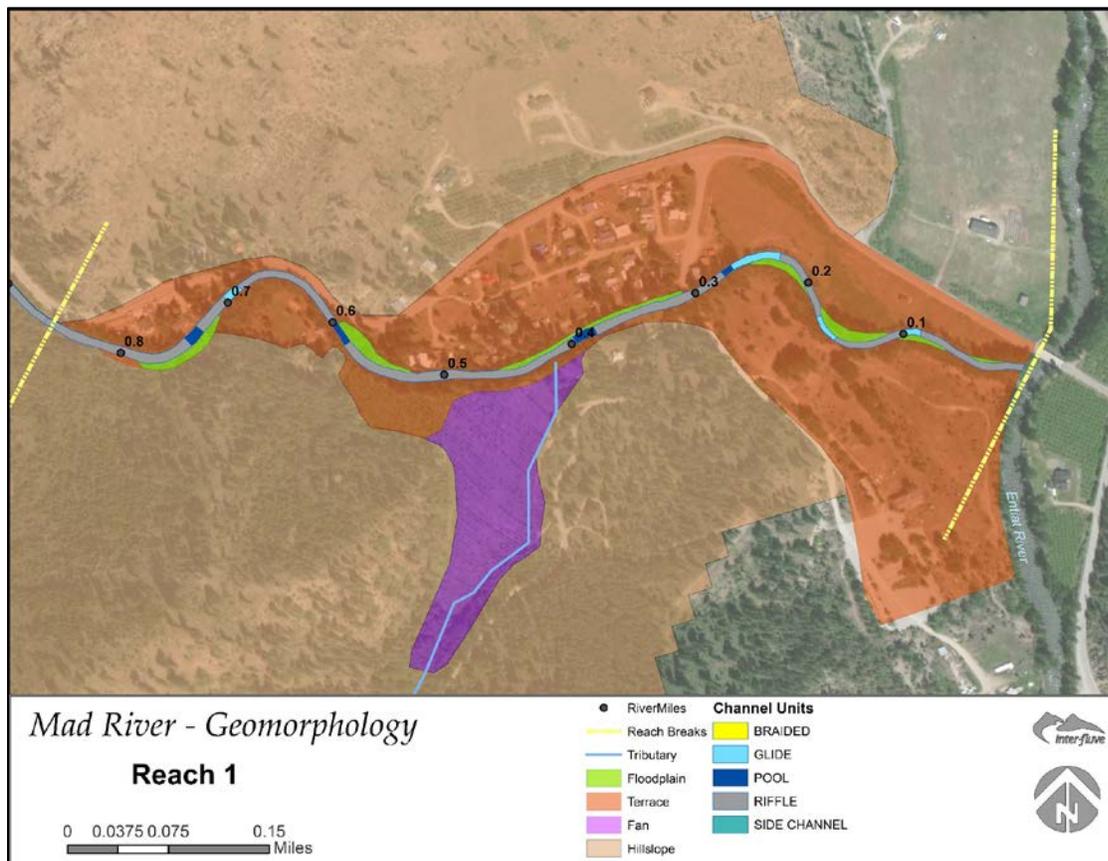
Figure 24. Reach 1: Geomorphic surfaces and channel units. Basemap: ESRI World Imagery

The Mad River in Reach 1 has a moderate gradient (1.54%) with a planform that alternates between straight and sinuous (Figure 24). The channel is entrenched below its historical floodplain throughout the reach. The levees along the channel from RM 0-0.55 appear to be constructed of material excavated from the bed of the channel, exaggerating entrenchment in this portion of the reach. Banks are composed of coarse alluvium (gravel to boulder) that is mixed and topped with sands and fines. Valley soils are gravelly sandy loam (USDA and NRCS 2017). Inset floodplain surfaces range from 1 to approximately 4-5 feet above the elevation of the channel bed. Terrace surface banks are generally steeper than the floodplain banks and range from 5-12 feet above the elevation of the channel bed. Active lateral channel processes are minimal and historical aerial photos from 1957 confirm that the channel has been in basically the same position for over 60 years. A lack of lateral processes equates to minimal local sediment sources for bar or spawning habitat development. The lack of lateral channel processes through the wide river valley is due to channel entrenchment, leveeing, bridge confinement, and bank hardening with cement slabs, wood, and riprap. Where established, tree roots and riparian vegetation contribute additional stability to the banks (Figure 25).

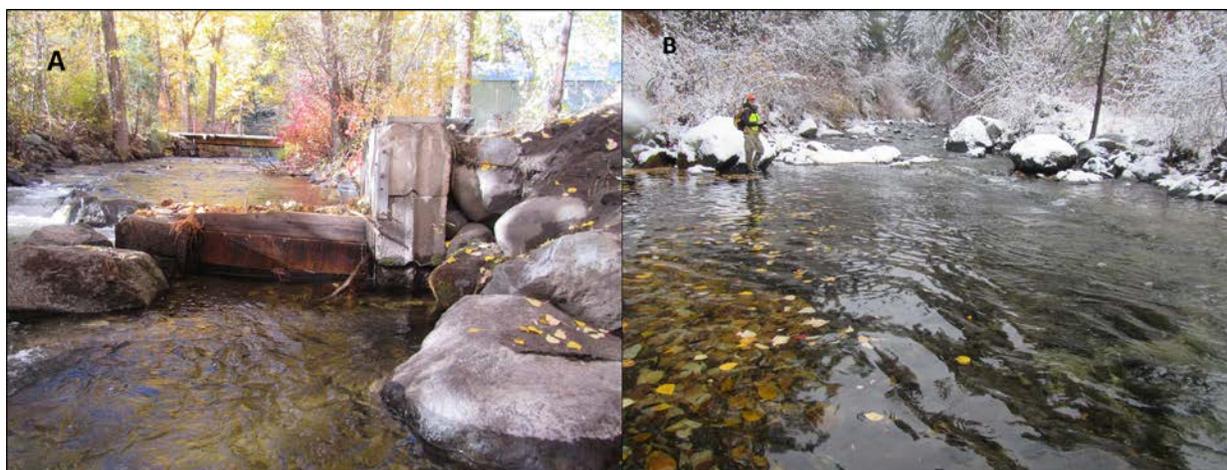
Channel complexity in Reach 1 is impaired. The 2017 Habitat Assessment (see Appendix A) measured 84% of the channel as extended riffles, while only 7% is pool habitat, and the remaining 9% is glides. The glides and several of the riffles are plane-bed. The four pools occur where large boulders and/or built features such as a collapsed bridge footing or an irrigation out-take weir create a stable grade control that produces scour on the downstream side. The bed of the channel is dominated by coarse alluvium (cobble and small boulders). Narrow gravel-cobble bars form at the inside bends of the subtle meanders at RM 0.15 and 0.22, as well as at the mouth of the channel. Otherwise, the only other gravel accumulations observed occur at the grade control and eddies associated with the four small pools – confirming that gravels are mobilized through Reach 1 but that retention is limited and local generation of sediment is likely minimal. Based on bed and bank material, hyporheic flow is expected to occur between the channel bed, bars, and floodplain surfaces.

Figure 26. Two of the four pools in Reach 1: A) Small pool downstream of Irrigation out-take weir and related boulder spur at RM. 0.27 (10/24/2017); B) Pool downstream of hillslope contributed boulders at RM 0.39 (11/9/2017).

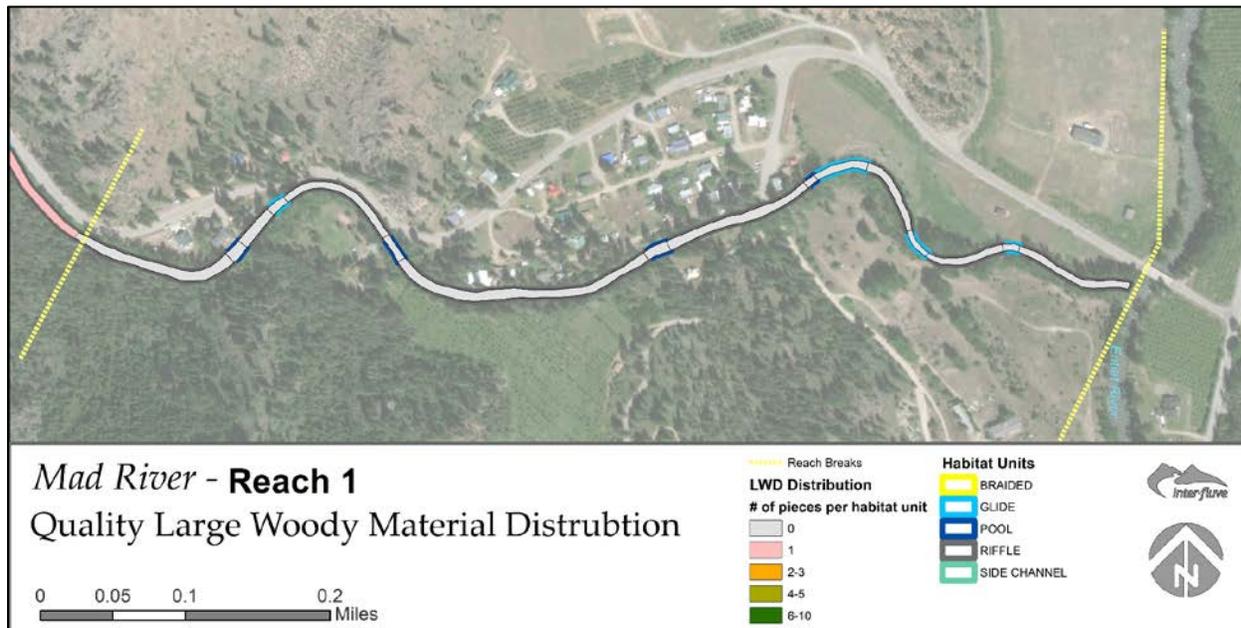
The lack of mature or large trees (21-32-inch dbh), narrowness of the vegetated riparian zone, and lack of lateral channel process limits local source and recruitment potential of large woody materials (LWM) into the channel. A total of only 11 pieces of wood and no log jams were observed in the channel during the survey (10/24/2017). All 11 pieces were in the small size class (9 to 12-inch dbh). No quality large woody material (>12-inch dbh and at least 35-feet long) were observed in the channel (Figure 28). Due to the small size and scarcity of large wood material (LWM), it plays only a minor temporary role in aquatic habitat and geomorphic complexity in Reach 1. The lack of LWM in Reach 1 is the result of past riparian vegetation removal, lack of mature trees in the riparian corridor, lack of channel migration capacity, and probably continued periodic “cleaning” of wood from the channel. Clearing large wood from the channel has been a common practice in places where infrastructure such as bridges or culverts exist.

Figure 28. Reach 1 – Quality Large Woody Material (>12-inch dbh and at least 35 feet long) distribution by number of pieces per mapped habitat unit per the 2017 survey.

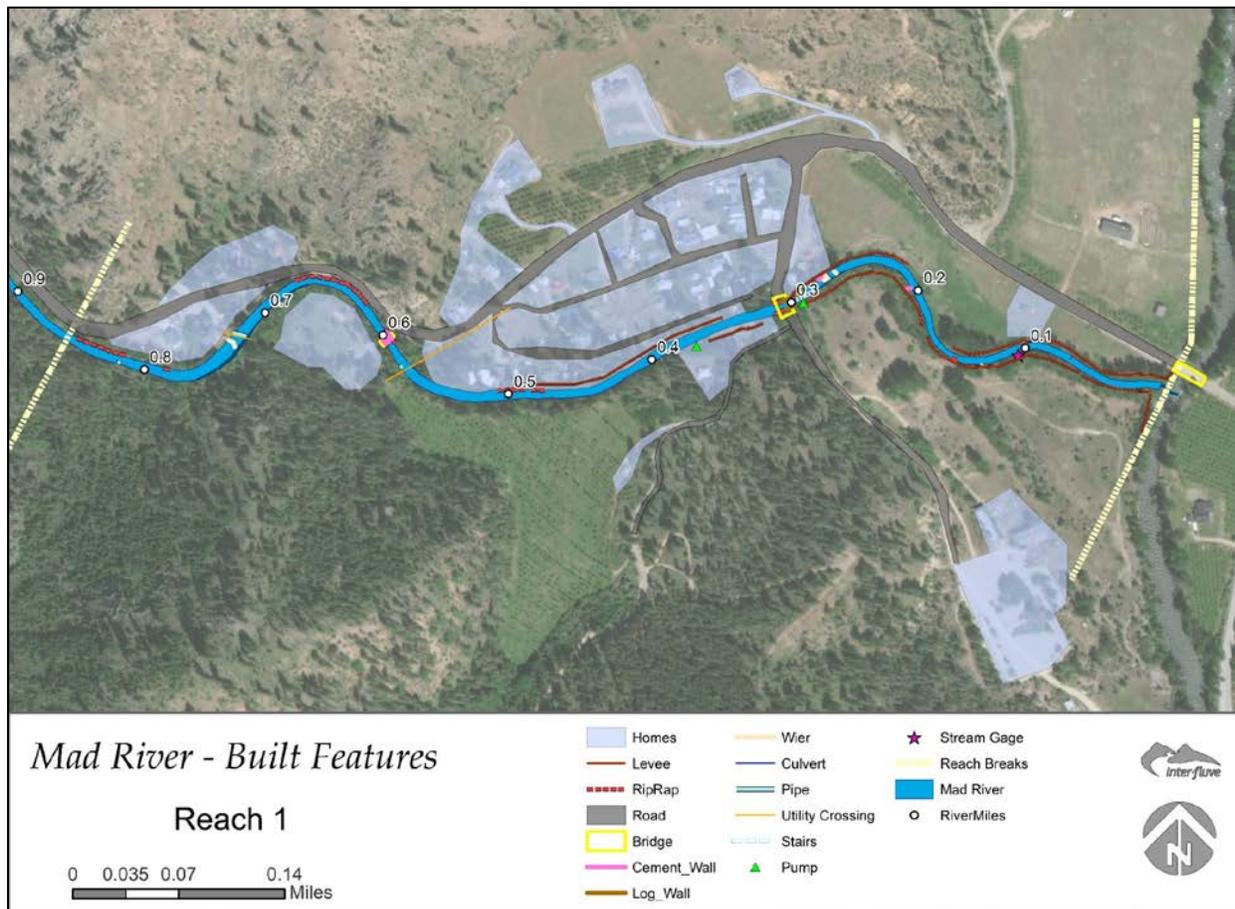
Figure 29. Reach 1: anthropogenic built features. Basemap: ESRI World Imagery.

Reach 1 contains the most anthropogenic built-feature impediments compared to the other reaches in the assessment area. In addition to clearing and altering the valley floor and riparian vegetation, anthropogenic features in Reach 1 include buildings, roads, bridges, levees, bank protection, weirs, irrigation, and utility crossings (Figure 29). Levees of up to 3.5 feet high, and constructed of material that looks to be excavated from the channel, line both sides of the river bank from RM 0.0-0.3. Additional similarly-constructed levees exist on river right from RM 0.34-0.36 and on river left from RM 0.35-0.49. Two railroad-car bridges have footings of cement, wood, and/or rock that protect the bank and confine the channel near RM 0.3 and RM 0.6 (Figure 30). At the bridge near RM 0.6, an old cement footing collapsed into the channel and remains in place under the bridge, armoring over half of the channel bed.

Recommended actions for Reach 1 are focused on increasing channel complexity and floodplain connectivity to improve available habitat and channel function. These actions include riparian

restoration, removal of unnecessary anthropogenic materials, enhancing channel complexity, and improving available aquatic habitat. There is a lot of potential for actions to notably improve habitat quantity and quality in the downstream portion of Reach 1 (RM 0.0-0.3) that would benefit aquatic species that utilize the Mad and/or Entiat Rivers. These recommendations consider private land ownership and density of development on both sides of the channel through Reach 1. Several of the recommended actions in Reach 1 will likely require landowner engagement and approval. Although bordered by private land, the lower section of the reach has minimal developed and no occupied structures. In this area, recommended actions include levee, riprap, and weir removal, as well as excavation to create a wider inset floodplain, installation of large log jams, and native riparian vegetation restoration. The weir and associated irrigation out-take structure at RM 0.29 should be evaluated and improved or removed for fish passage. Additional recommended actions in the upstream section of reach 1 include the removal a short weir and cement slab from the channel and adding a large wood jam in an existing pool to increase and maintain habitat quality. Improving the two existing bridge crossings by removing associated bank armoring and then widening the span between footings is recommended to reduce channel confinement and further entrenchment at these crossings. The additional bank armoring and surface water out-take infrastructure at RM

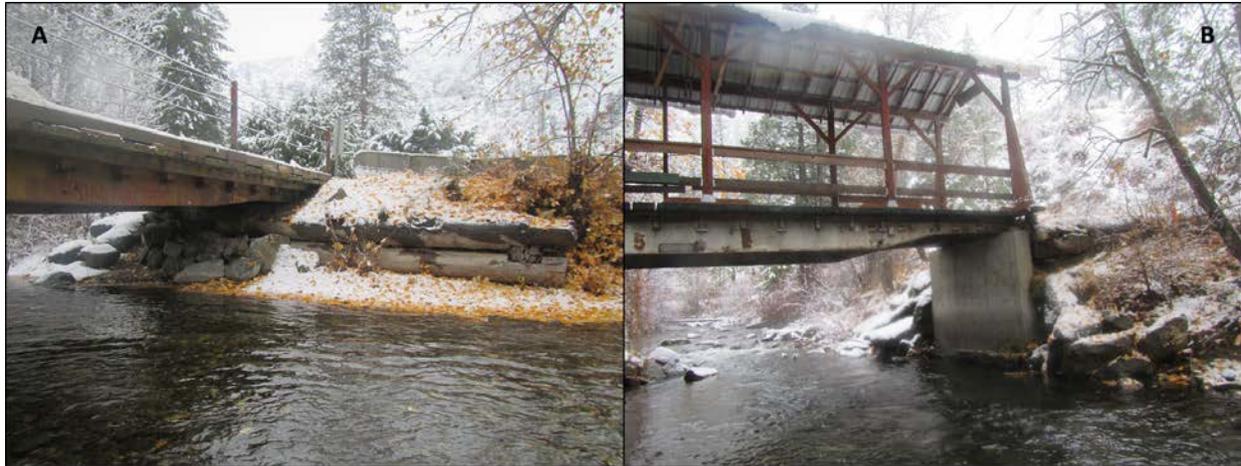
Figure 30. Railroad-car bridge crossings: A) near RM 0.3 with log, cement, and riprap footings and bank protection. Logs are old footings from historical bridge crossing, and B) near RM 0.6 with cement footings and large boulder riprap. (Photos: 11/9/2017).

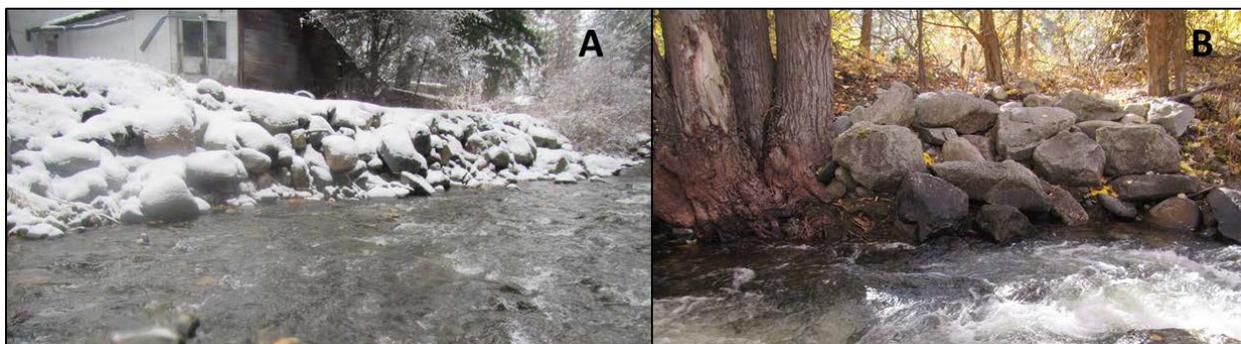
Bank armoring and protection treatments occur throughout Reach 1. Large boulder riprap has been placed along the banks at RM 0.28 in correlation with a cement-walled irrigation out-take and weir. Riprap is also present at RM 0.48-0.51 on river left in front of homes built on relative low surfaces, at RM 0.63-0.67 and RM 0.82-0.85 on river left to protect the Mad River Road and homes (Figure 31), and at RM 0.15. On river left at RM 0.78, pieces of steal and cabling are buried into and protecting the bank. Cement blocks on river right at RM 0.2 also add bank protection to an already anthropogenically-confined reach.

Figure 31. Riprapped banks: A) river left at RM 0.51 (11/9/2017), and B) river left at RM 0.28 (10/24/2017).

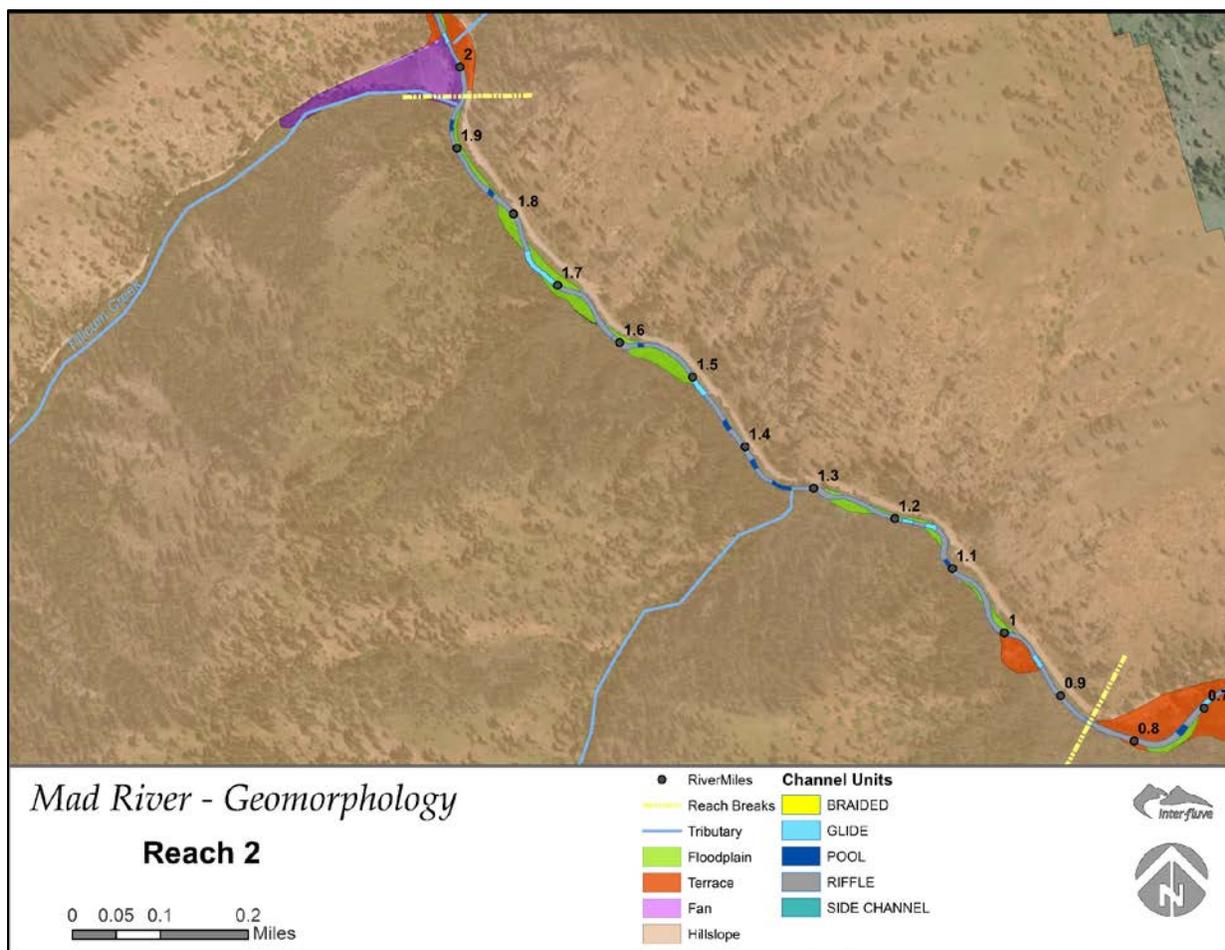
Figure 32. Reach 2: Geomorphic surfaces and channel units. Basemap: ESRI World Imagery

The Mad River in Reach 2 has a moderate gradient (1.79%) with a generally straight planform (Figure 32). Planform is straightest where the channel is confined between hillslope and the Mad River Road (RM 0.86-0.95, 1.04-1.2, 1.3-1.49, and 1.82-1.93). In these sections, hillslope contributions of boulders add some complexity (scour pools and back eddies) to channel geomorphology. Channel substrate is composed of cobble and boulders with sparse gravels. Gravels were observed in back water eddies and pool-tailouts – indicating mobilization of spawning-sized material through Reach 2, but limited retention. Based on bed and bank material, hyporheic flow is expected to occur between the channel bed, bars, and floodplain surfaces.

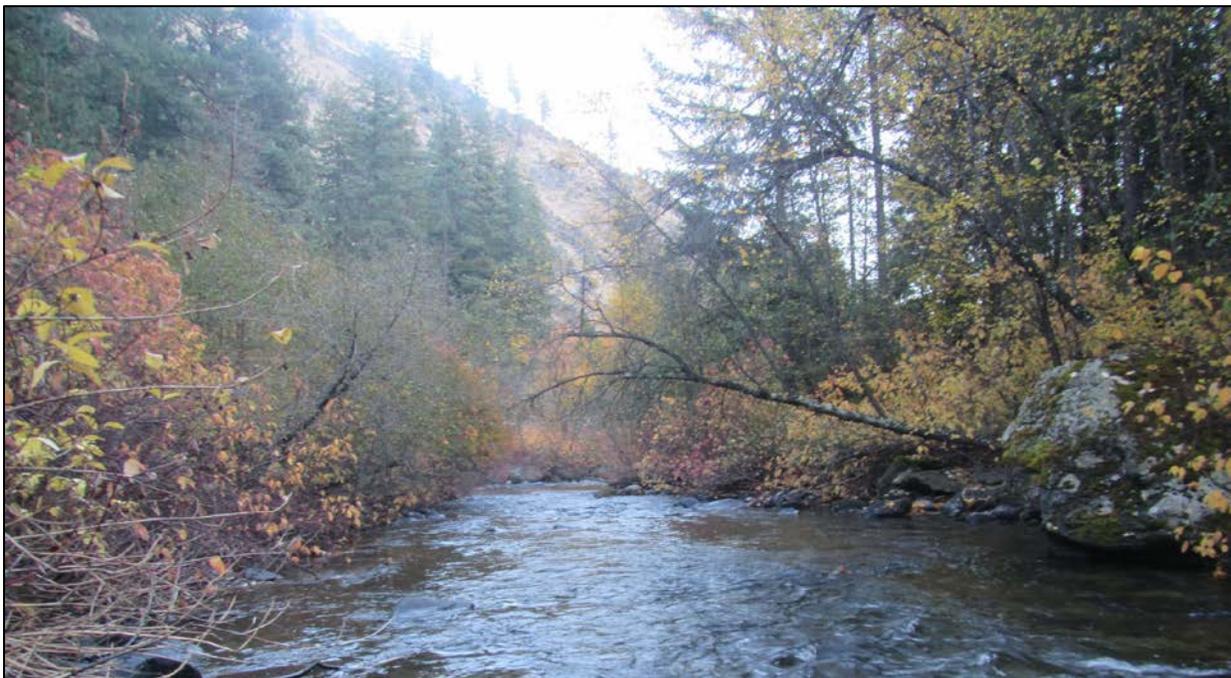
Riparian vegetation in Reach 2 is well established except where the channel is bordered by the Mad River Road. The riparian vegetation is primarily an overstory of fir trees, Ponderosa pine, and a few cottonwoods with a thick understory of alder and dogwood (Figure 36). The adjoining hillslope vegetation is dominated with conifers (fir and pine). Floodplain surfaces are densely vegetated with alder and dogwood with a sparse overstory of conifer or cottonwood. Only 33% of the overstory trees are considered large (21 to 32-inch dbh). However, the understory and small trees are thick enough that the existing vegetation provides a shade canopy for the channel during summer months, except in the less vegetated areas adjacent to the Mad River Road. It is probable that most of the riparian vegetation on river left in Reach 2 was removed in the past during the construction of the Mad River Road.

Figure 36. Riparian vegetation example in Reach 2, at RM 1.6. (Photo: 11/24/2017)

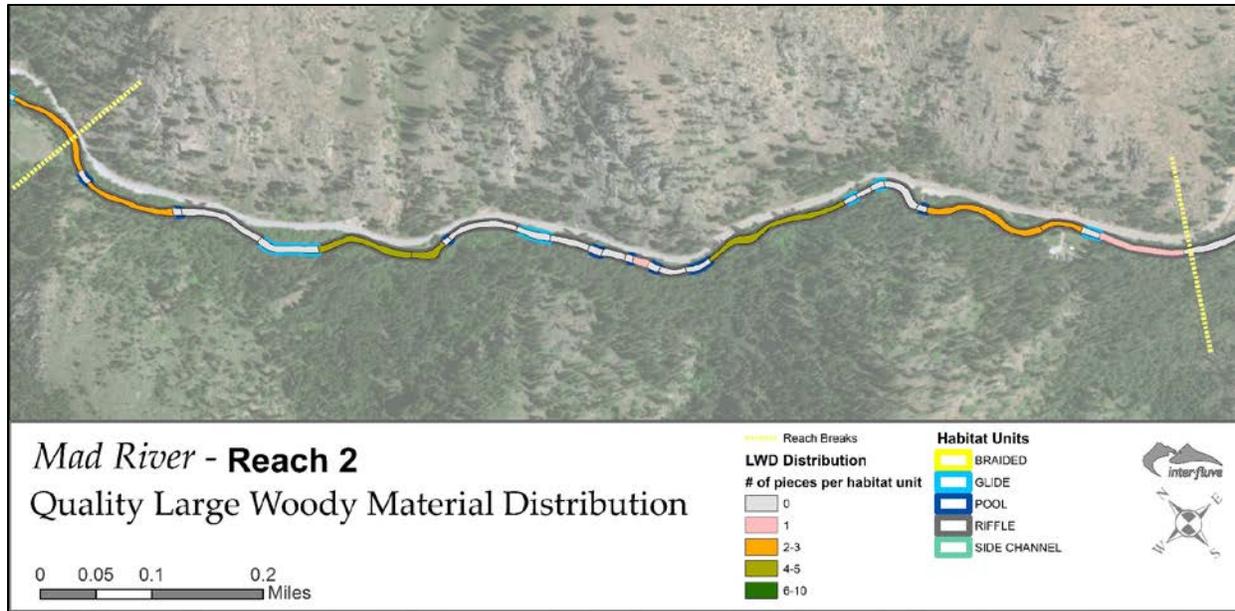
A total of 49 pieces of woody material and only one log jam was observed in the channel during the survey (10/24/2017). Of the 49 pieces, only three classified as large size class (≥ 20 -inches dbh and >35-foot long), 19 were classified as medium size class (12 to 20-inch dbh and at least 35-foot long), and the rest were all small size classified (9 to 12-inch dbh). See Figure 37 for distribution of quality large woody material (>12-in dbh and at least 35-foot long) per mapped habitat unit throughout the reach.

Figure 37. Reach 2: Quality Large Woody Material (>12-inch dbh and at least 35 feet long) distribution by number of pieces per mapped habitat unit per the 2017 survey.

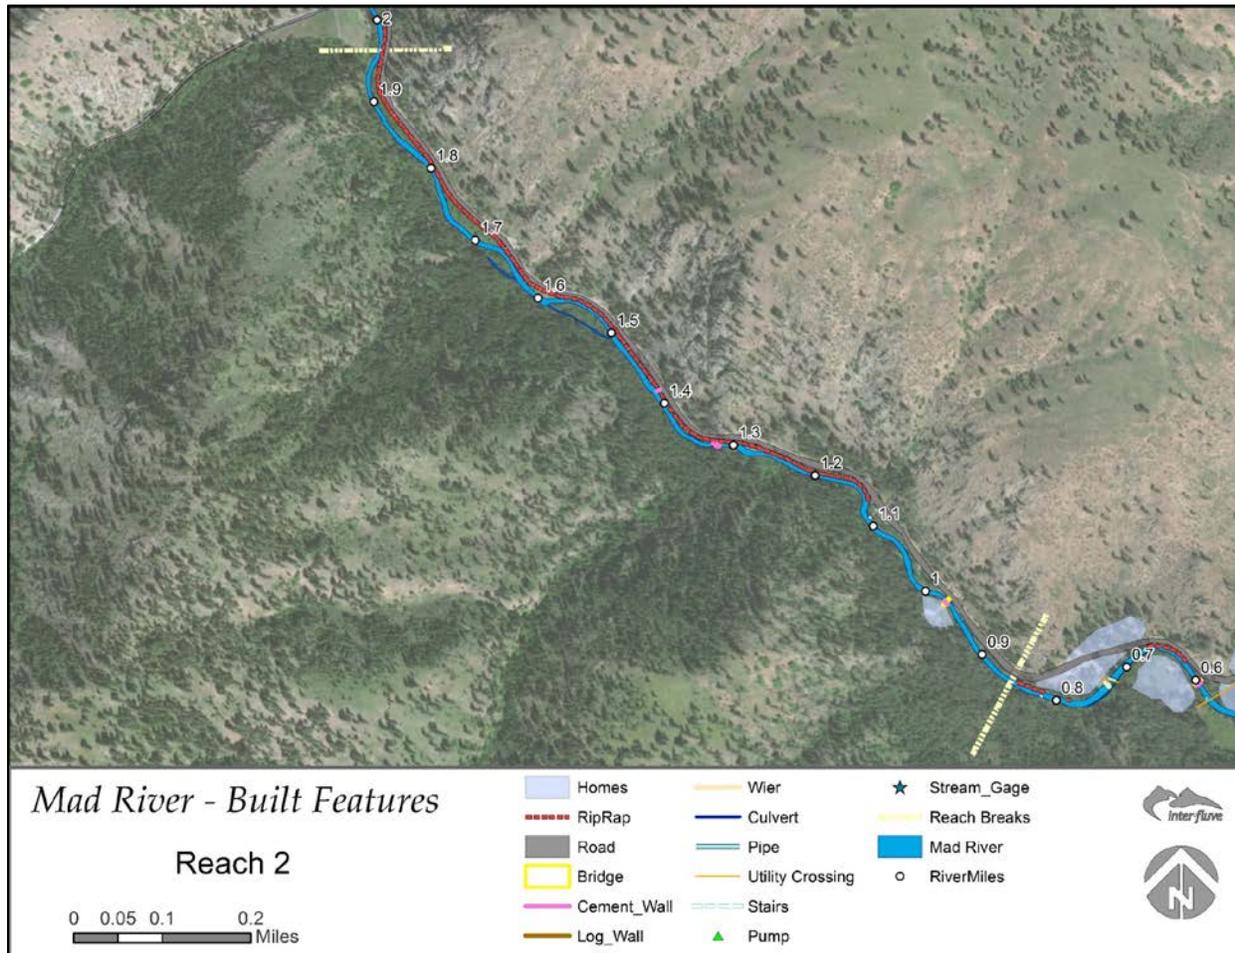
Figure 39. Reach 2: Anthropogenic built features. Basemap: ESRI World Imagery

Anthropogenic features in Reach 2 include the Mad River Road, bank riprap, a bridge crossing, an existing homesite, related vegetation clearing, and cement wall bank and bed armoring. The Mad River Road occupies approximately half of the available valley floor from RM 0.86-1.65 and from RM 1.65-1.93 it occupies approximately a third of it (Figure 40A). From RM 1.13-1.93, the road bank is armored with large-boulder riprap. The bridge crossing at RM 0.98 includes cement, steel beam, log, and large boulder riprap footings and bank protection (Figure 40B). A homesite located on a low terrace on river right at the bridge crossing (RM 0.98) includes riparian vegetation clearing. A remnant cement wall extends from the road perpendicular to flow on the river left bank at RM 1.42 but it does not contact the channel at normal or low flows (Figure 41A). Another cement slab was observed on the channel bed with steel pipe embedded into it at RM 1.33. The slab is creating a grade control with a step pool on the downstream side and accumulated gravels and cobbles on the upstream side (Figure 41B).

Recommended actions for Reach 2 are focused on increasing channel complexity and improving available aquatic habitat. These actions include riparian restoration, enhancing channel complexity, removing unnecessary materials, creating side/off-channel habitat, and improving available aquatic habitat in the mainstem. All recommended actions downstream of RM 1.25 are on private and everything upstream of that in Reach 2 is on public lands managed by the US Forest Service. Sustainability of the action treatment and protection of the Mad River Road was considered in selecting recommendations for this reach. Primary actions are installing small, medium and large-sized log jams, some with placed large boulders, in appropriate locations that take advantage of existing features or instigate geomorphic function to increase channel complexity and habitat quality. Constructing side channels through existing functioning floodplains has the potential to notably increase available high-quality habitat in the reach.

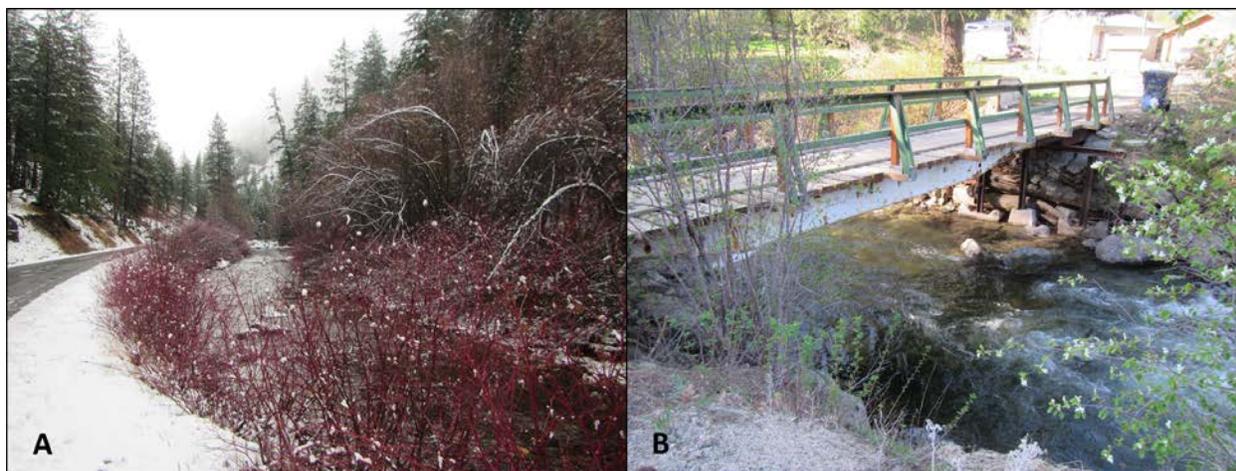
Figure 40. A) Mad River Road along Reach 2 occupying ½ of valley floor at RM 1.55 (Photo: 11/9/2017); B) bridge crossing at RM 0.98. (Photos: 4/25/2018)

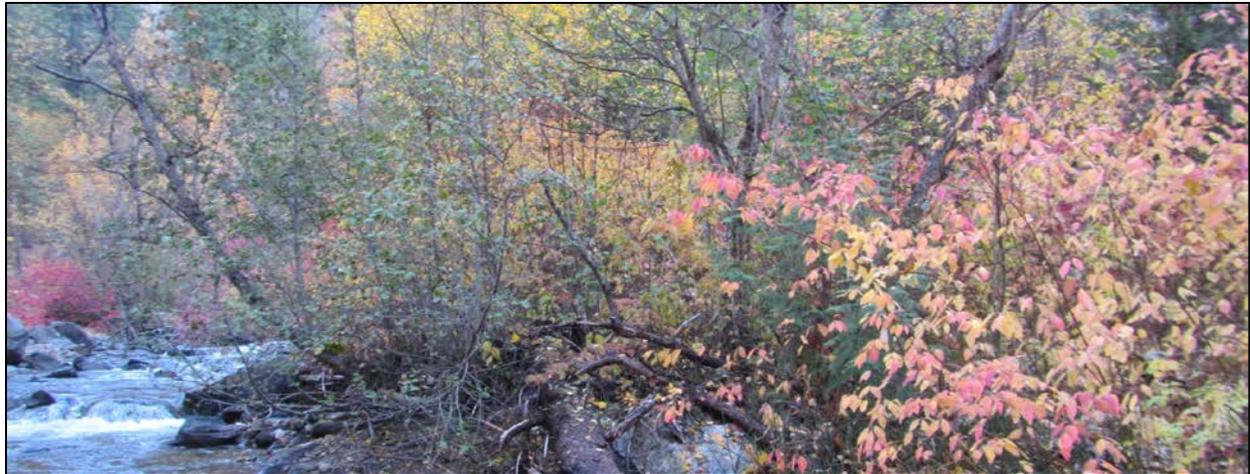
Figure 47. Riparian understory vegetation on floodplain at RM 2.84. (Photo: 11/25/2017)

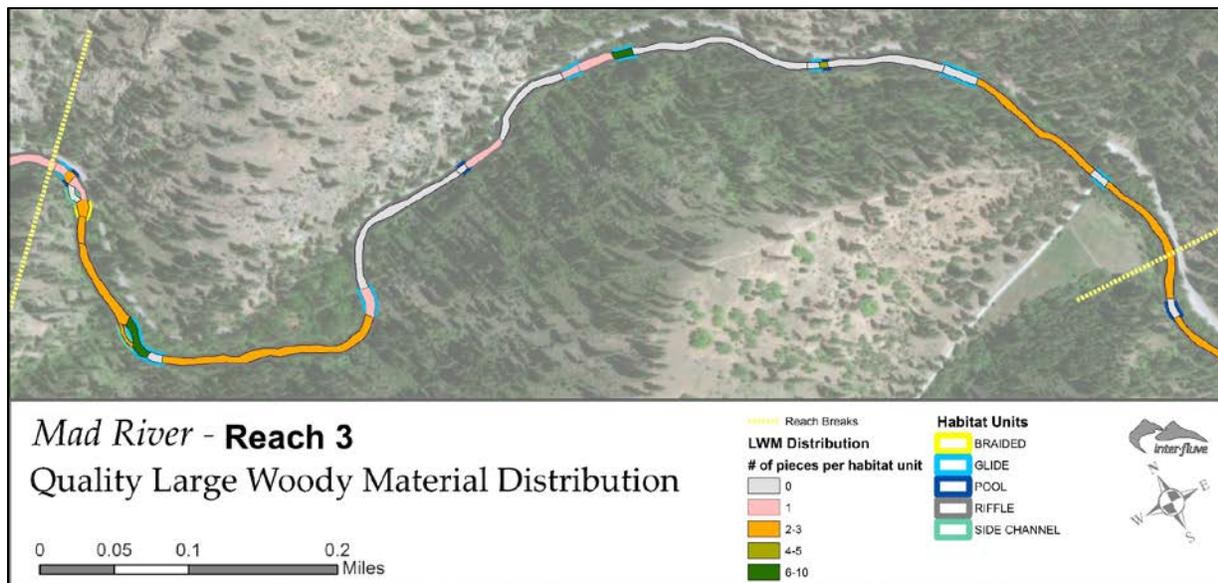
A total of 89 pieces of wood were observed in the channel during the survey (10/25/2017). Of the 89 pieces, fourteen pieces classified as large size class (≥ 20 -inches dbh and >35 feet long), 30 were classified as medium (12 to 20-inch dbh and at least 35 feet long), and 45 were all small size classified (9 to 12-inch dbh). No wood accumulations that constitute a log jam were observed. See Figure 48 for distribution of quality large woody material (>12 -in dbh and at least 35 feet long) per mapped habitat unit throughout the reach. Where LWM exists, it plays an important role in aquatic habitat and geomorphic channel complexity. The lack of LWM is due to past riparian vegetation removal, lack of mature forests within the riparian corridor, increased confinement of lateral process by the Mad River Road, and potentially periodic “cleaning” of wood from the channel. Cleaning of LW from the channel is a common practice where infrastructure such as roads and bridges exist.

Figure 48. Reach 3: Quality Large Woody Material (>12 -inch dbh and at least 35 feet long) distribution by number of pieces per mapped habitat unit per the 2017 survey.

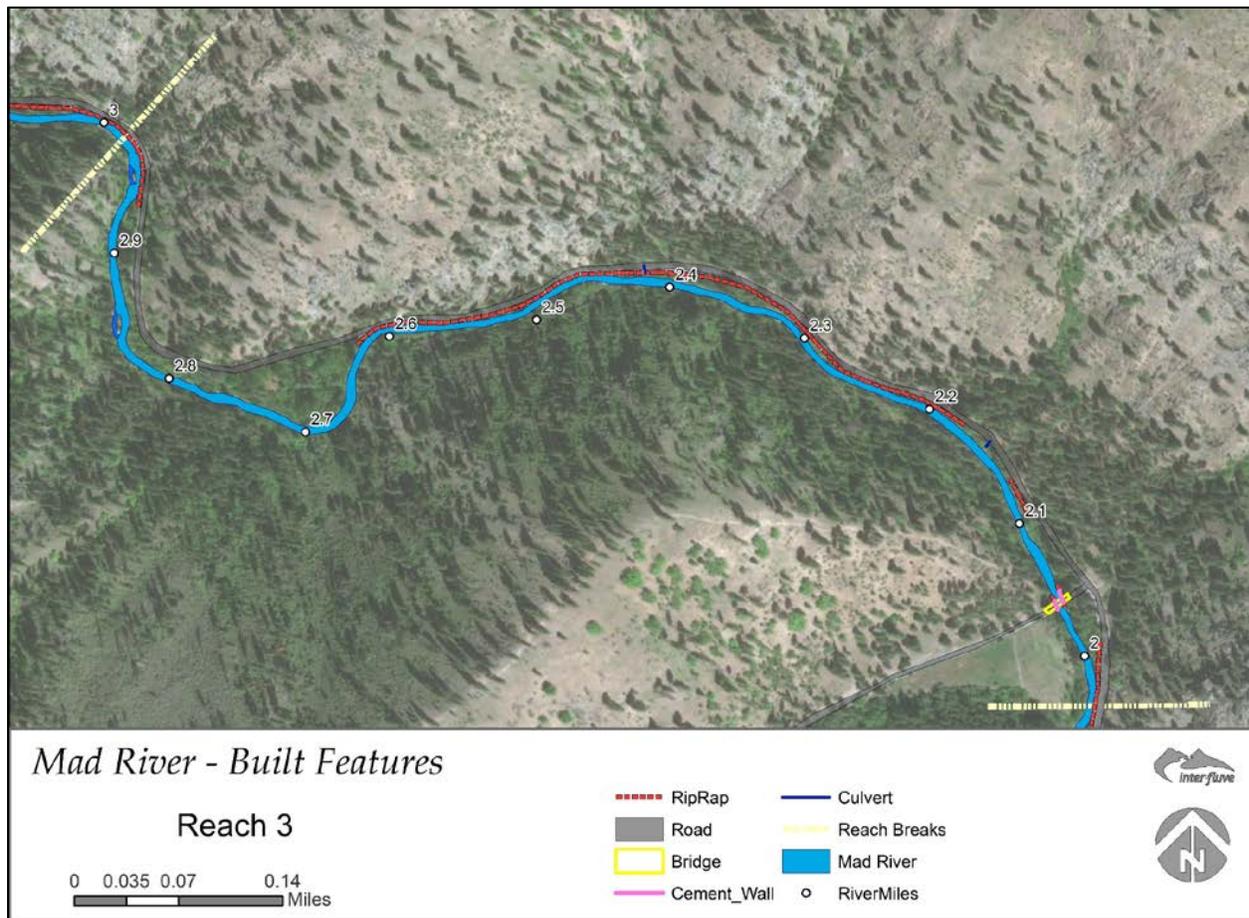
Figure 49. Reach 3: Anthropogenic built features. Basemap: ESRI World Imagery

Anthropogenic features in Reach 3 include the Mad River Road, bank riprap, a bridge crossing, an abandoned homesite, and related vegetation clearing. The Mad River Road occupies up to half of the available valley floor in the most confined sections of Reach 3. From RM 2.1-2.13, RM 2.17-2.63, and RM 2.93-3.14 the road bank is armored with large-boulder riprap which restricts the bank from contributing sediment or supporting riparian vegetation. Culverts under the Mad River Road at RM 2.15 and 2.42 control surface water contribution points from the hillslopes into the Mad River. The Tillicum Road bridge crossing at RM 2.04 includes cement footings and large-boulder riprap bank protection that locally confine the channel and control its pathway. This, in conjunction with a dam that was located immediately upstream of the bridge until the 1970's, has resulted in channel entrenchment and simplification in this area. A public day-use area on river right, immediately upstream of the bridge, is the site of an historical homestead. The home has been removed but the area remains mostly cleared of vegetation. A public parking and day-use area on river left immediately downstream of the bridge is also cleared of surface vegetation.

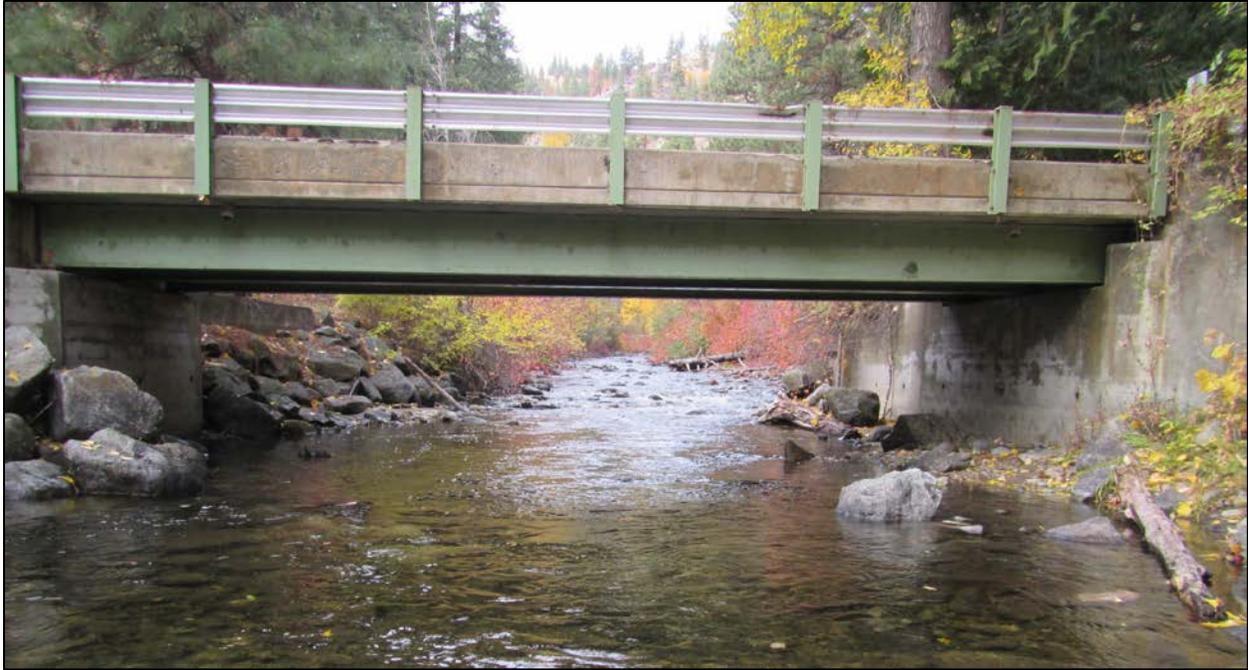
Figure 50. Tillicum Road bridge crossing at RM 2.04, looking upstream. (Photo: 10/25/2017)

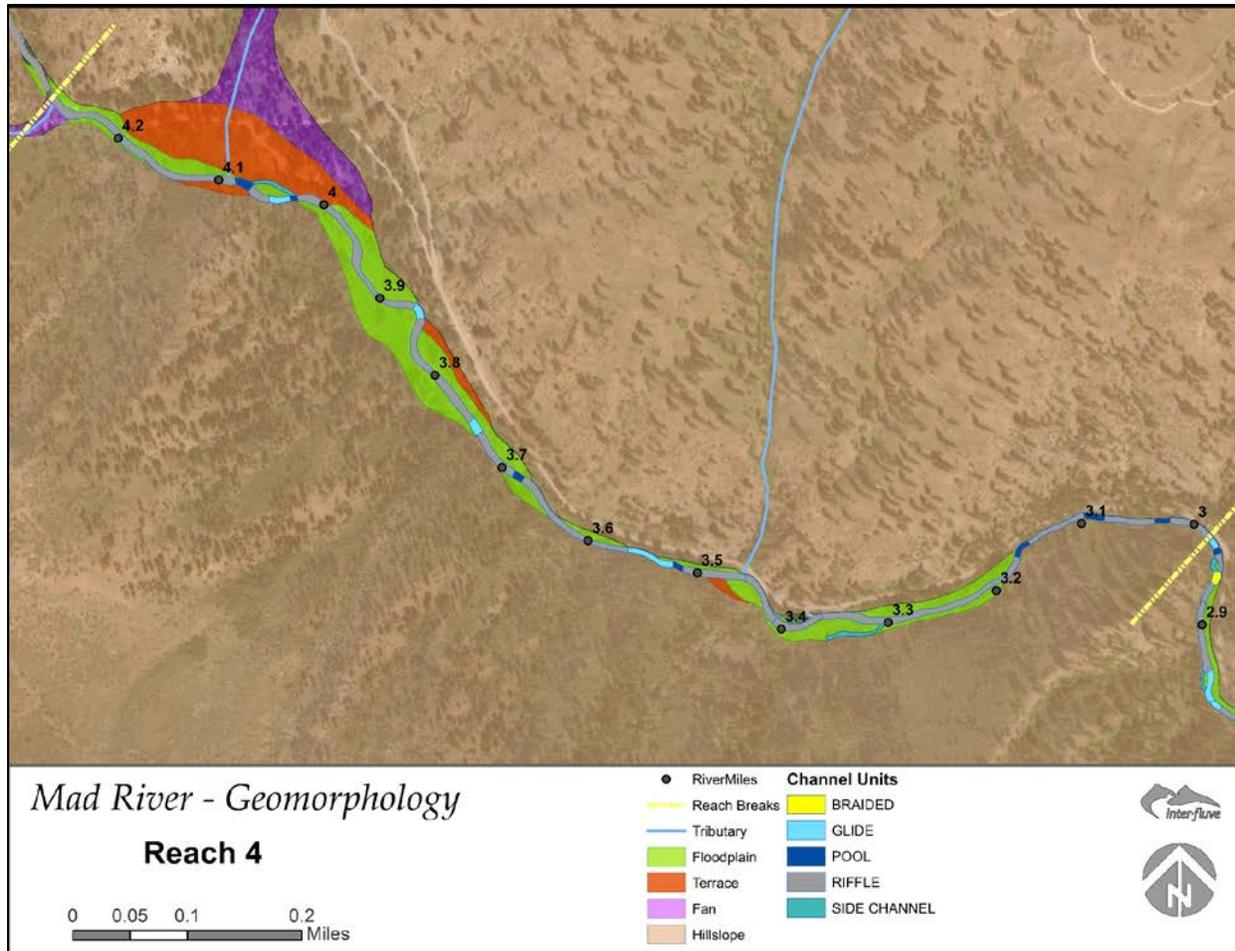
Figure 52. Reach 4: Geomorphic surfaces and channel units. Basemap: ESRI World Imagery

The Mad River in Reach 4 has a moderate gradient (1.65%) with a subtle sinuous planform (Figure 52). The channel is partially confined upstream of RM 3.17 and completely confined at the downstream end between the Mad River Road and hillslopes (RM 2.98 and 3.17). Channel habitat complexity in Reach 4 is impaired. The 2017 Habitat Assessment (see Appendix A) measured 87% of the channel as extended riffles while only 7% is pool habitat, 5% is glides, and just 1% is side channels. The glides and some of the riffles are generally plane-bed. The pools occur where boulders and/or large wood accumulations create a grade control or scour (see Figure 53). Based on ocular survey, channel substrate in Reach 4 is composed of gravels, cobbles, and small boulders. Plentiful gravels were observed in the upstream portion of the reach. Throughout, gravels and coarse sands were observed in depositional areas such as bars and upstream of large wood log jams. Local hillslope contributions of boulders add localized complexity (steps, scour pools, and wood retention) to channel geomorphology. Split-flow conditions occur near RM 4.05 and a hillslope and/or groundwater-generated side channel join the mainstem Mad River on river right at RM 3.3.

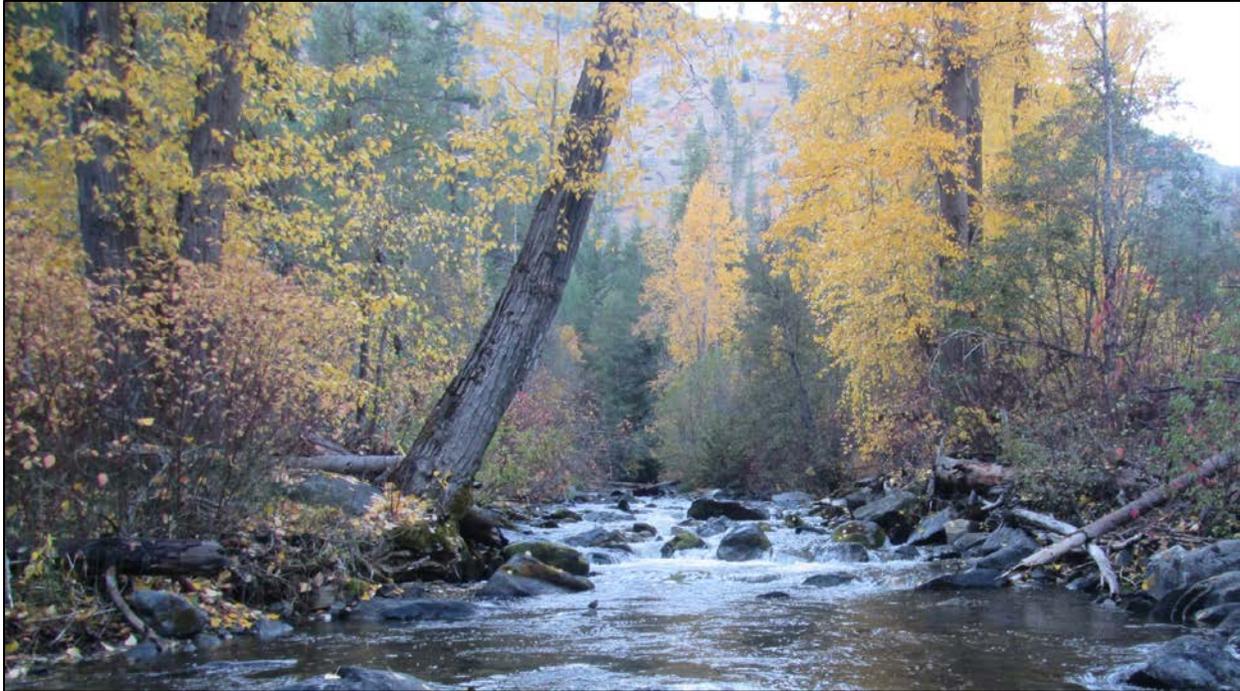
Figure 53. Boulder colluvium creating cascade step into small pool at RM 4.08. (Photo: 10/26/2017)

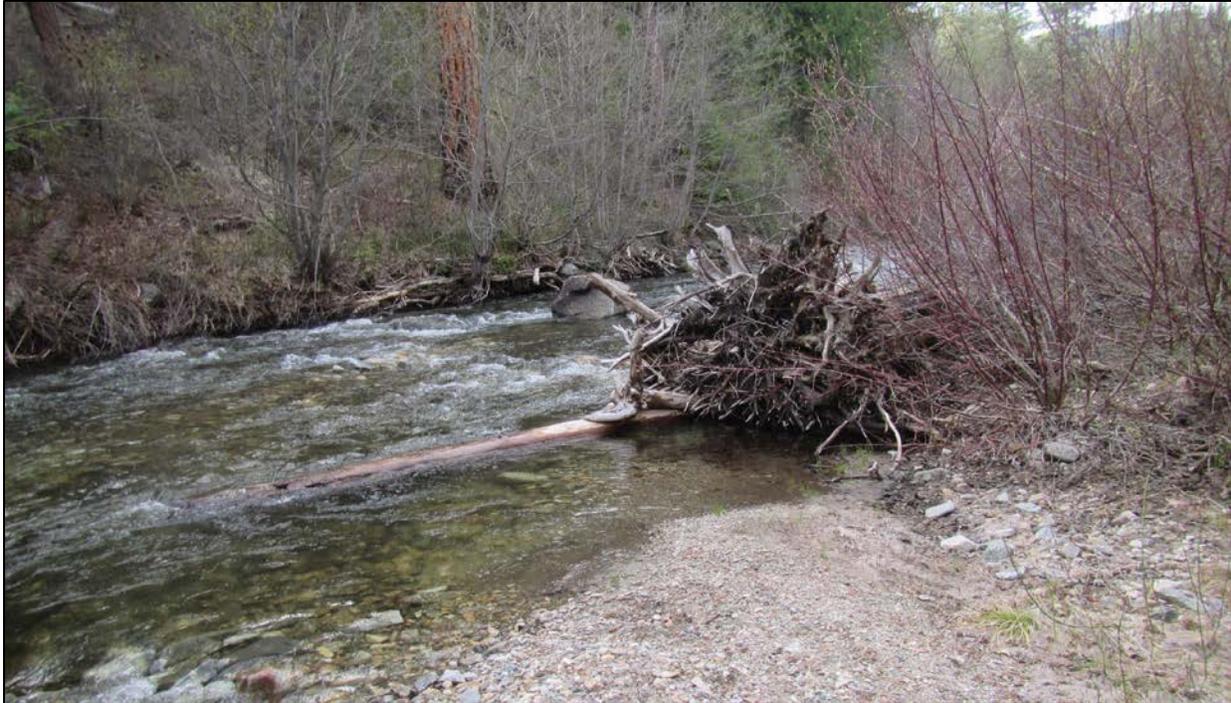
The hillslopes in Reach 4 are relatively sparsely vegetated. The hillslopes on river right contain bedrock exposures and/or large boulder colluvium toes that periodically contact the channel. Bedrock contacts (25-100 feet long) occur along the right bank of the channel at RM 3.0, 3.09, 3.4 and 4.3. Boulder colluvium occurs along the river right side of the channel along the toe of most other confining hillslope contacts. Hillslope-channel contacts on river right alternate with extended pockets of floodplain. Based on exposed banks, the floodplains are composed of a cobble-boulder base topped with gravels that fine-upward to coarse sands. Based on bed and bank material, hyporheic flow is expected to occur throughout the channel bed, bars, and floodplain surfaces. Soils in Reach 4 are described as gravely fine sandy loam (USDA and NRCS 2017). Floodplain surfaces range from 1 to approximately 4 feet above the bed of the channel. The floodplain surfaces are well-vegetated with a mix of riparian shrubs and trees.

Figure 54. At RM 3.86: Hillslope contact on river right, boulder colluvium, large wood piece with gravel bar accumulation in front of active floodplain on river left. (Photo: 4/24/2018)

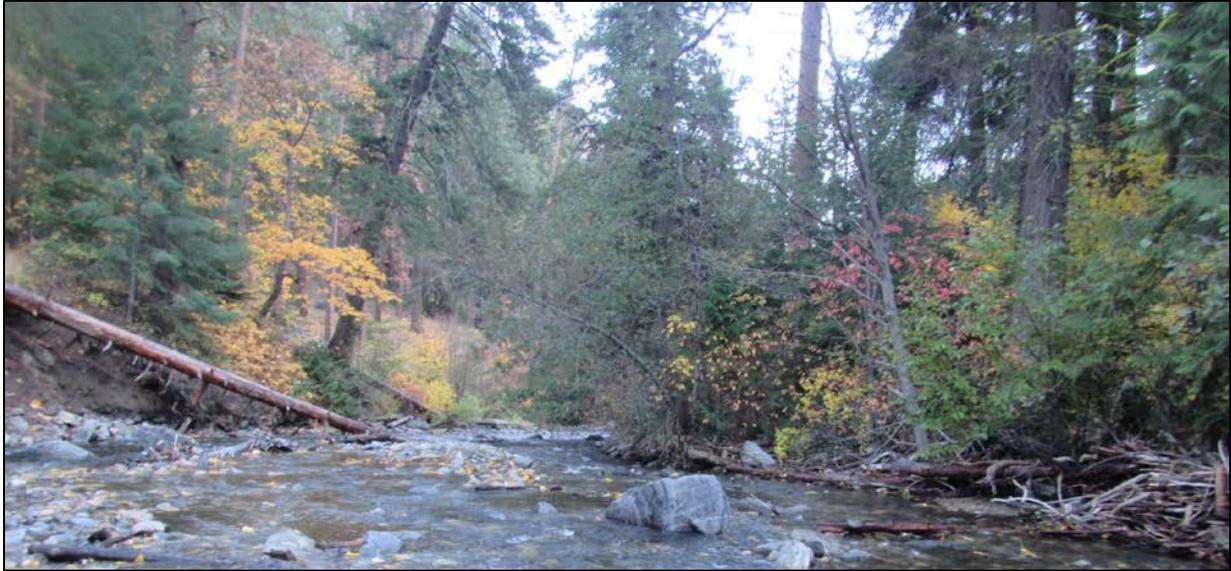
Figure 56. Example of riparian forests in Reach 4 – at ~RM 4.0 looking downstream. (Photo: 10/26/2017)

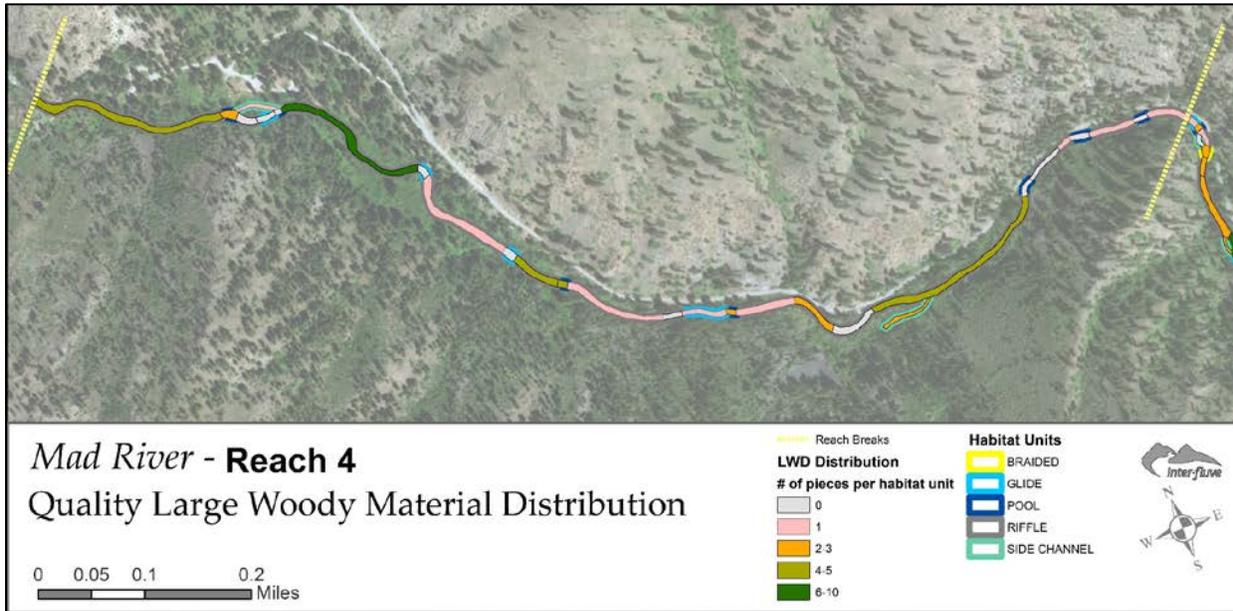
A total of 137 pieces of wood were observed in the channel during the habitat survey (10/26/2017). Of those pieces, 31 classified as large size class (>20-inches dbh and >35 feet long), 43 as medium (12 to 20-inch dbh and at least 35 feet long), and 63 as small (9 to 12-inch dbh). Three large wood jams were counted and additional small wood accumulations were observed along the channel margins. A channel spanning large wood jam at RM 3.18 created a grade control pool and upstream gravel accumulations (Figure 57). See Figure 58 for distribution of quality large woody material (>12-in dbh and at least 35 feet long) per mapped habitat unit throughout the reach. Note that LWM distribution

is correlated to less confined sections with vegetated floodplains. The availability of mature forests combined with lateral bank processes increases large wood recruitment potential in Reach 4 compared to downstream reaches.

Figure 58. Reach 4 - Quality Large Woody Material (>12-inch dbh and at least 35 feet long) distribution by number of pieces per mapped habitat unit per the 2017 survey.
