Lower Mad River Reach Assessment & Restoration Strategy Report

SUBMITTED TO
Yakama Nation Fisheries - Wenatchee

DECEMBER 2018

PREPARED BY
Inter-Fluve
501 Portway Ave, Suite 101
Hood River, OR 97031
(541) 386-9003

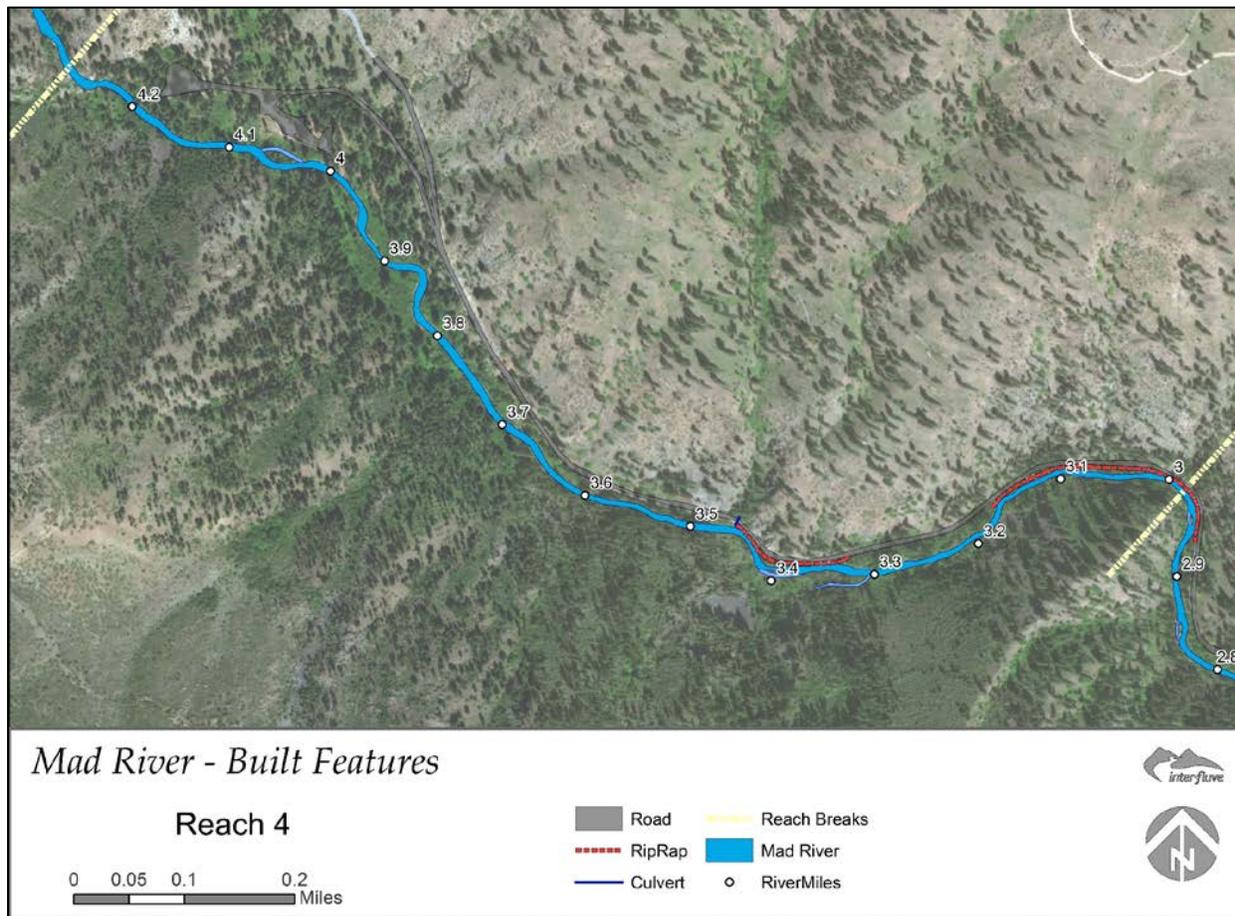
Figure 59. Reach 4: anthropogenic built features. Basemap: ESRI World Imagery

Anthropogenic features in Reach 4 include the Mad River Road, bank riprap, a culvert, Pine Flats Campground, and related vegetation management. The Mad River Road occupies up to half of the available valley floor from RM 2.98-3.16, exaggerating channel confinement. Between RM 3.34-3.46 the Mad River Road and its related bank rip rap border the channel in this less-confined section before it leaves the floor of the valley and continues upslope. A culvert passes hillslope surface water contributions under the Mad River Road at RM 3.16. Pine Flats Campground occupies the terrace and part of the floodplain on river left between RM 4.0 to 4.2. The campground includes cleared dirt and gravel roads, campsites, trails parking areas and a vaulted outhouse. It is unknown if water quality issues exist(ed) related to the campground and outhouse, which was converted from a pit house to vaulted in 2013, but the porosity of the floodplain material suggests that periodic testing may be warranted.

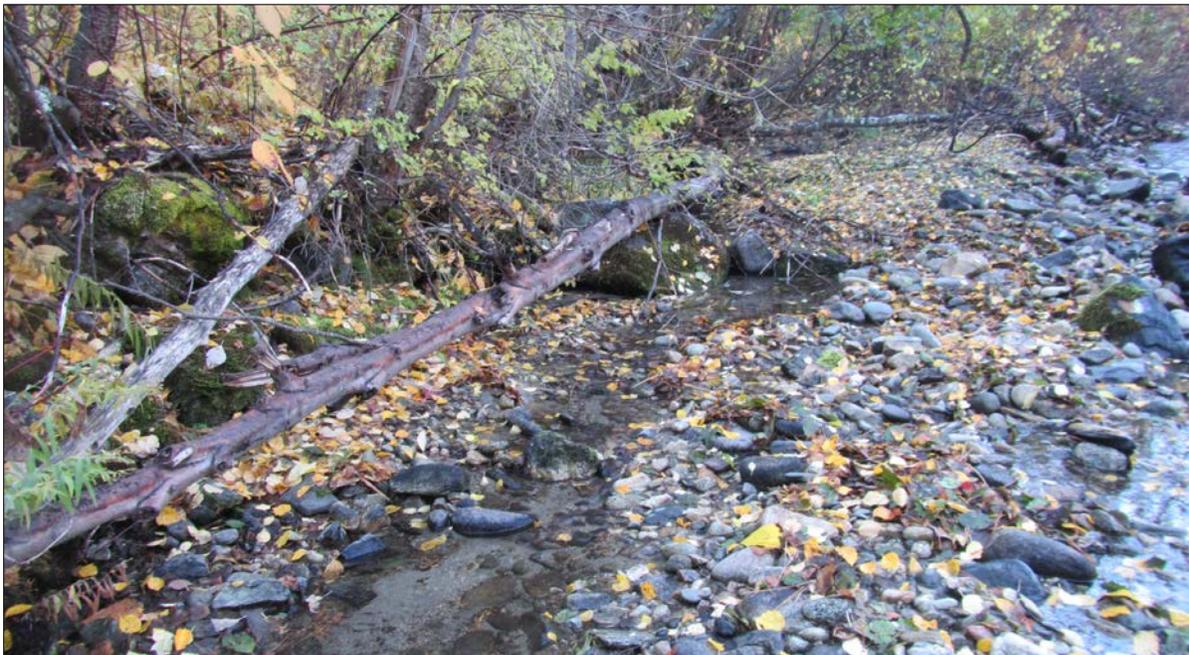
Figure 3. 300-foot long side channel in Reach 4 with low flows during the time of survey. (Photo: 10/26/2017)

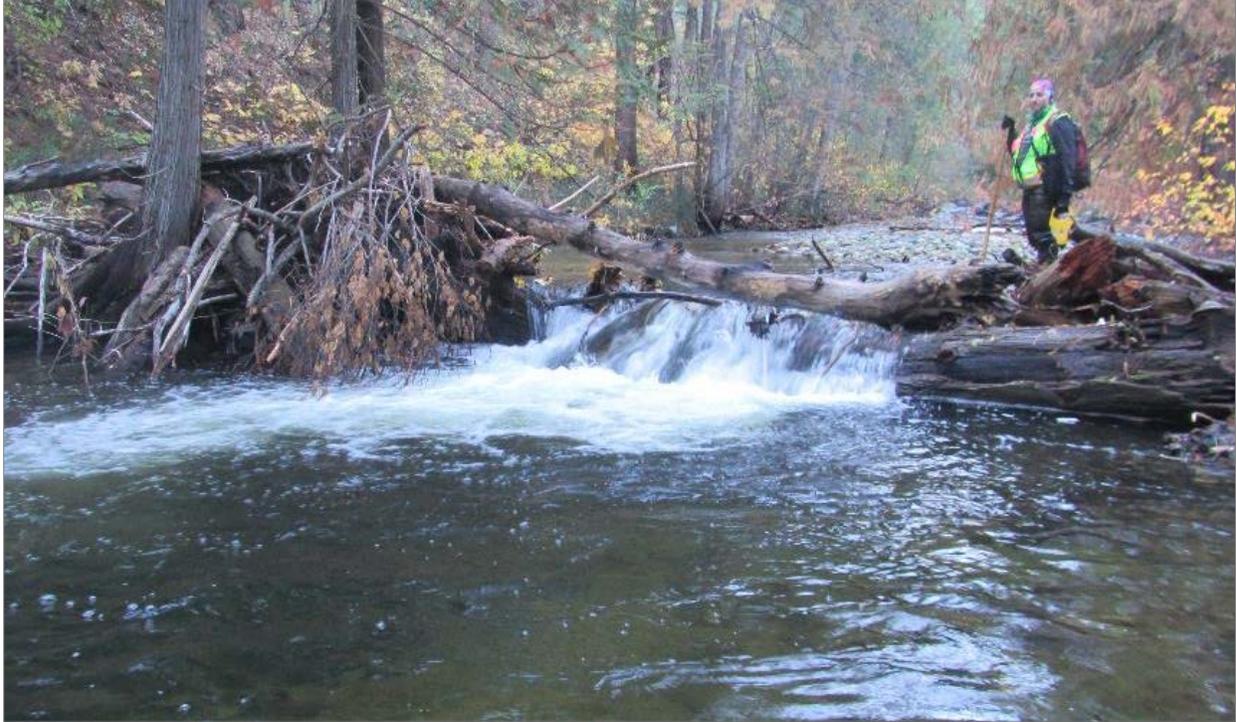
Figure 5. Large in-channel woody material in Reach 4; (Photo: 10/26/2017)

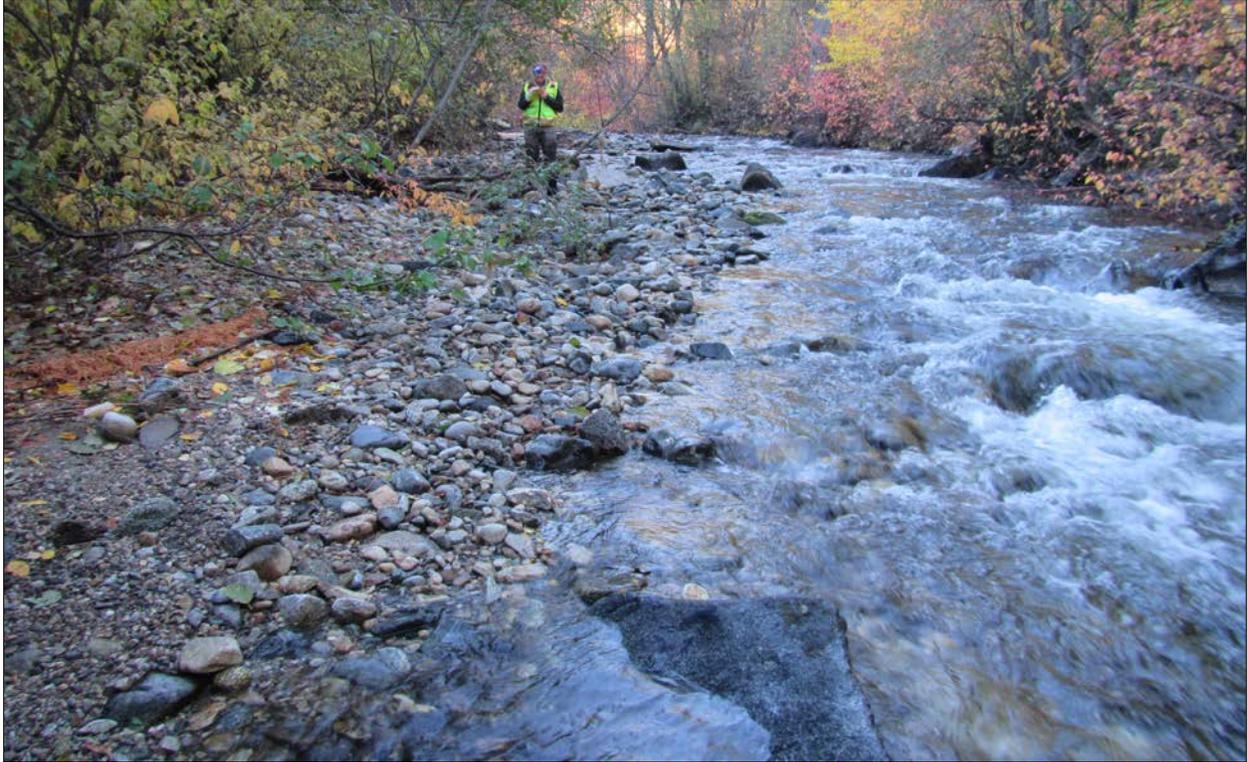
Figure 8. Gravel Count 4.1 (in Reach 4) location on an exposed bar. (Photo: 10/26/2017)

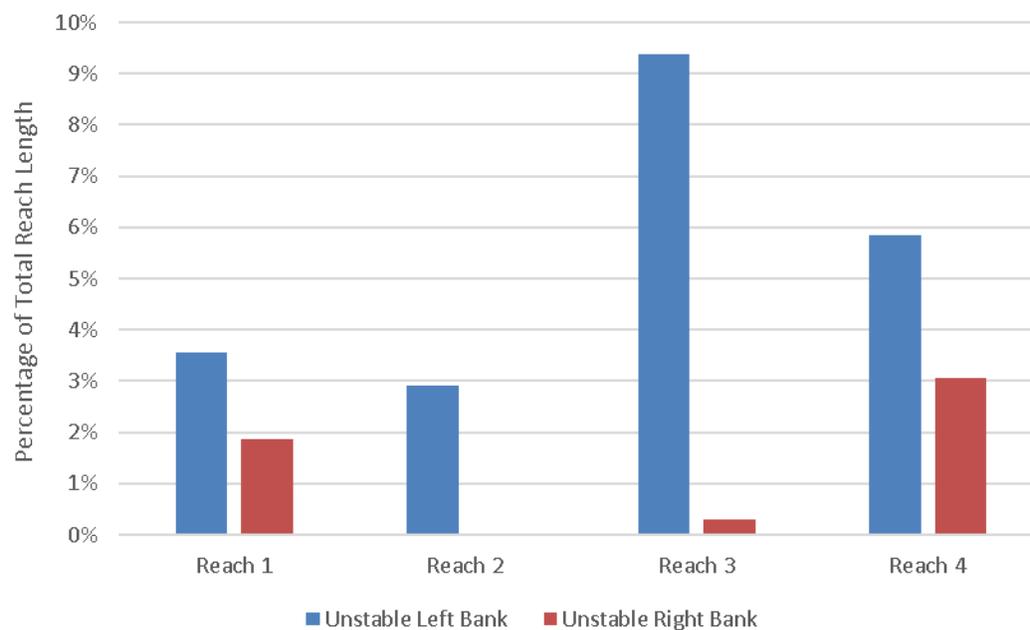
The habitat team estimated the extent of bank erosion (instability) on both the left and right banks at each channel unit. The length of the unstable (eroding) left and right banks was then divided by the total length (left and right bank) of each reach to determine the percentage of each reach that had eroding banks. Overall, bank instability is low, averaging only 3.5% throughout the study area (Figure 9). The highest percentage of erosion was in Reach 3 on the river left bank (9.4%), while Reach 2 had no unstable banks on river right. Although large portions of it are protected with Mad River Rad riprap, river left generally had a higher proportion of unstable banks throughout the project area.

Figure 9. Total percentage of right and left-bank erosion for each reach. Percentages are based on left and right bank ocular estimates measured at each habitat unit throughout the project area.

Unstable banks indicate lateral and sometimes vertical processes and serve as sediment sources to the channel. Bank erosion is currently expressed as “low” throughout the project area. Confining hillslopes on river right in Reaches 2, 3, and 4 often have colluvium at their toe that protects from bank erosion. Riprap along the Mad River Road also protects large portions of the bank on river left in these same reaches. It is assumed that where bank erosion was present historically in Reaches 1, 2, and 3, riprap, cement slabs, pieces of metal, and logs were used to minimize it. The discontinuous pockets of floodplain provide areas for bank erosion to occur. Terrace banks and debris fan also provide good bank sediment sources in Reach 4.
