UPPER WENATCHEE RIVER STREAM CORRIDOR ASSESSMENT AND HABITAT RESTORATION STRATEGY

YAKAMA NATION FISHERIES | PO BOX 15, FORT ROAD | TOPPENISH, WA 98948

INTER-FLUVE, INC.
1020 WASCO STREET, SUITE I | HOOD RIVER, OR 97031
541.386.9003 | www.interfluve.com

August 2012

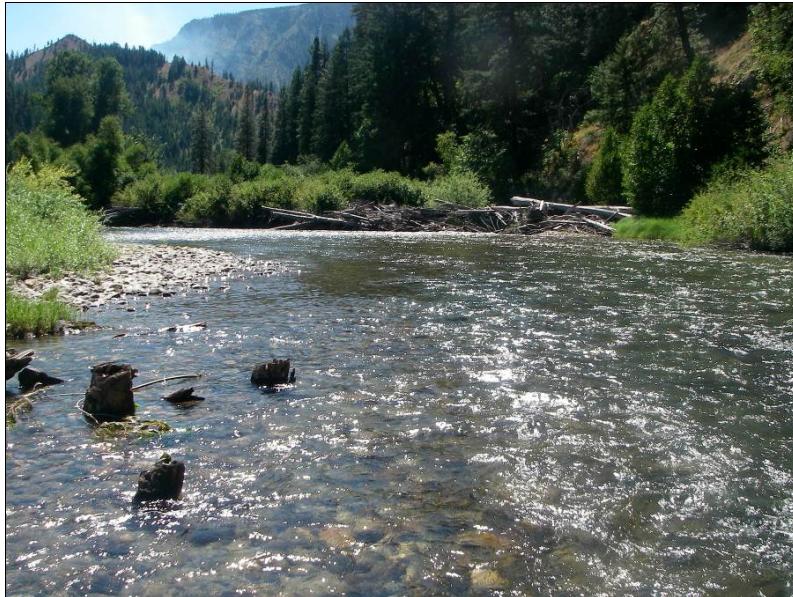
Modern human alterations to this reach are limited, but there is evidence of historical timber harvest and log transport, including a mid-seral stage riparian forest, remnant log pilings (Figure 32), and sunken cut logs (presumably log drive remnants). Potential impacts from these activities are discussed in Section 3.4, but without historical data it is difficult to estimate the specific extent of human alteration. Despite past impacts, it is believed that this reach has been on a trajectory of recovery over at least the past 50 years, which has resulted in the modern habitat complexity observed today.

Figure 32. Remnant pilings assumed to be from historical logging practices (splash damming).

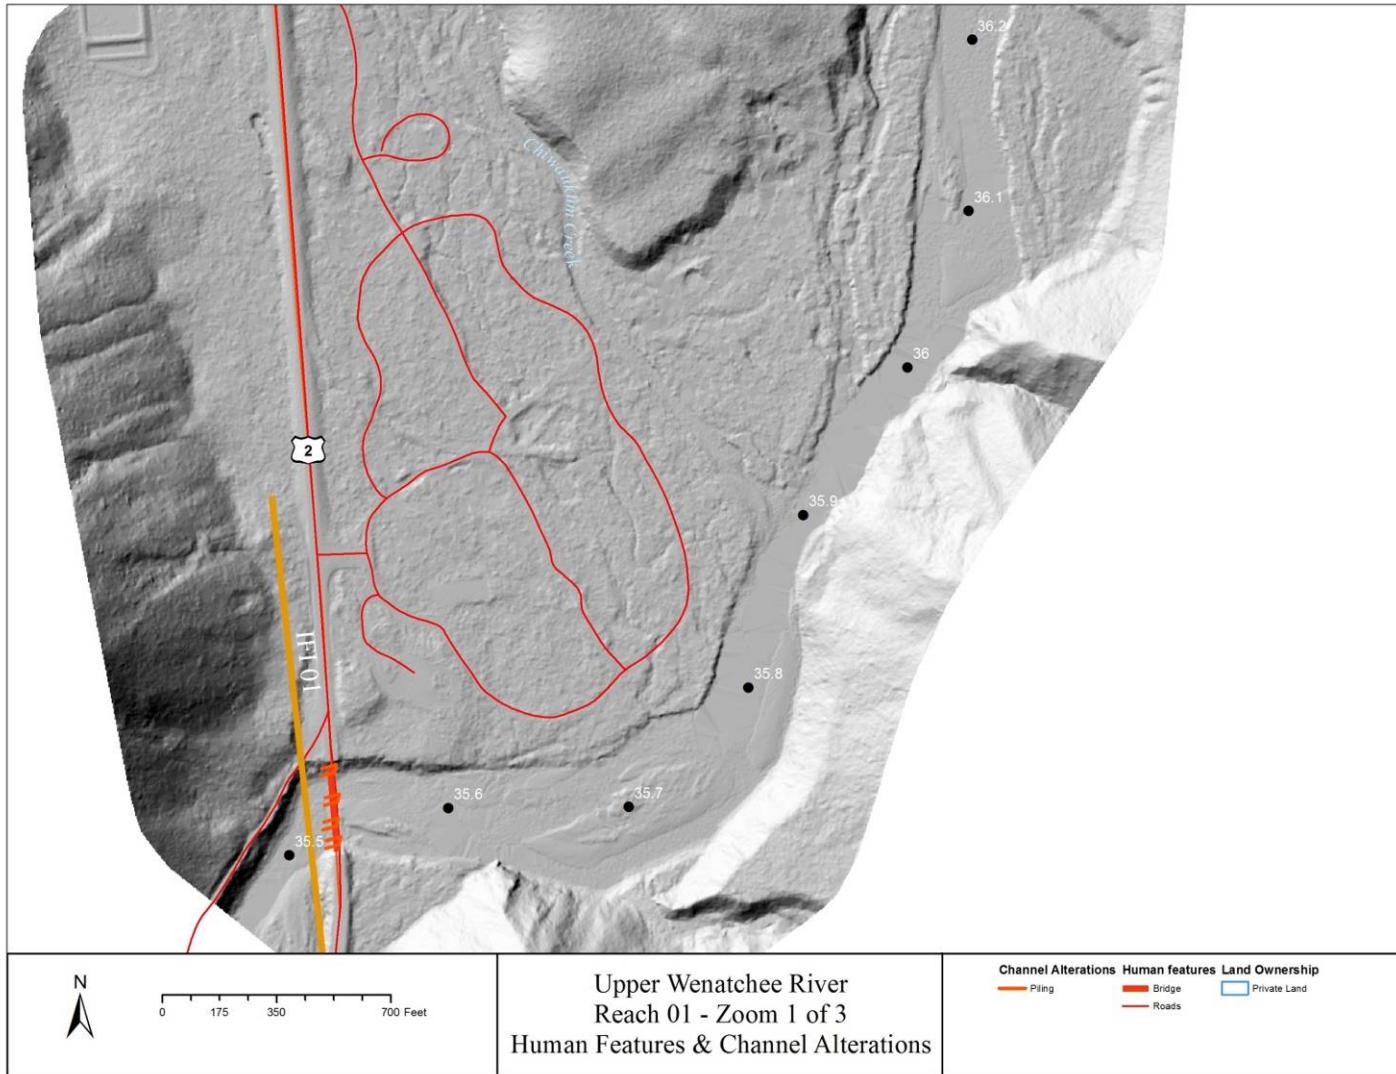
Figure 33. Human alterations in the downstream portion of Reach 1. Flow is from north to south.

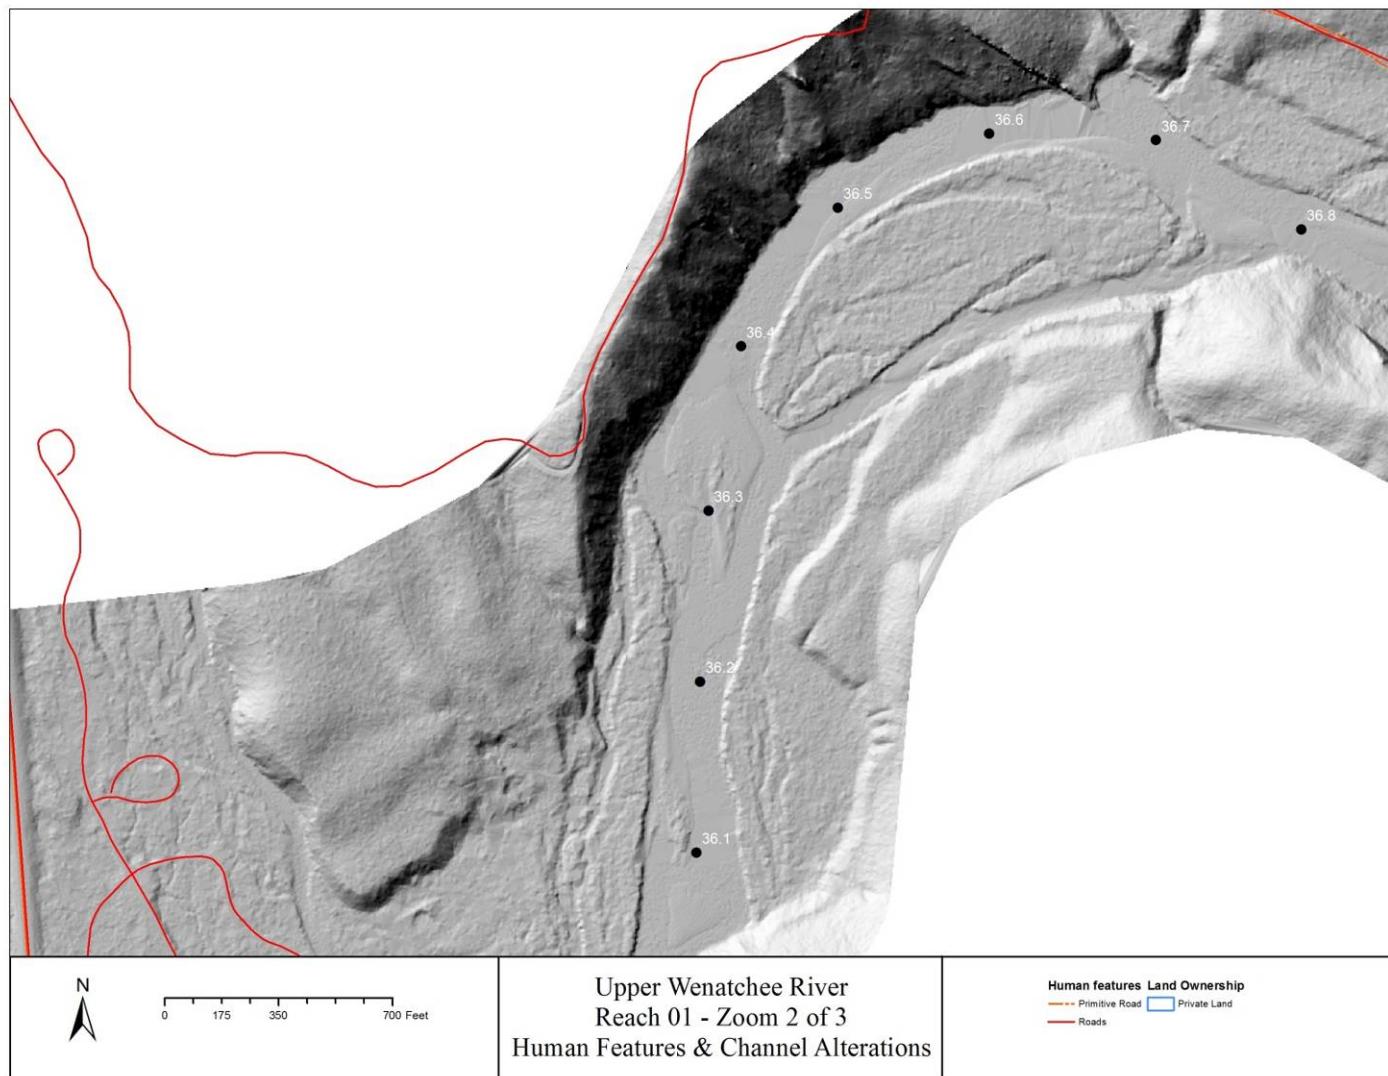
Figure 34. Human alterations in Reach 1. Flow is from north to south.

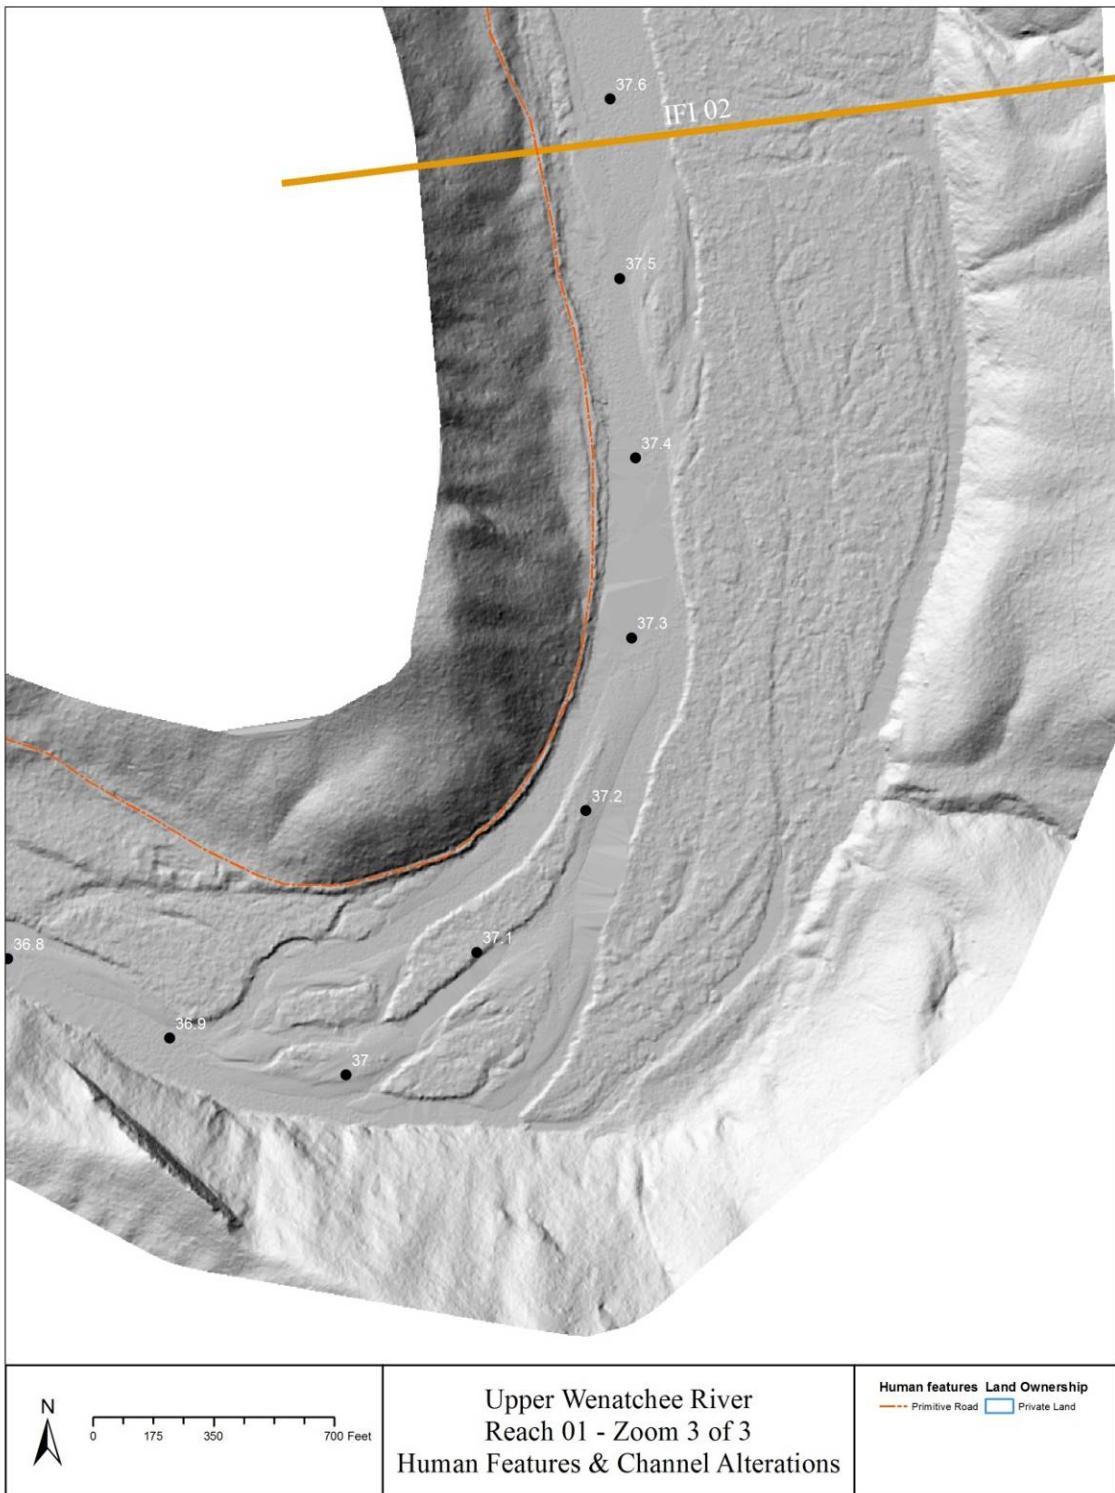
Figure 35. Human alterations in the upstream portion Reach 1. Flow is from north to south.

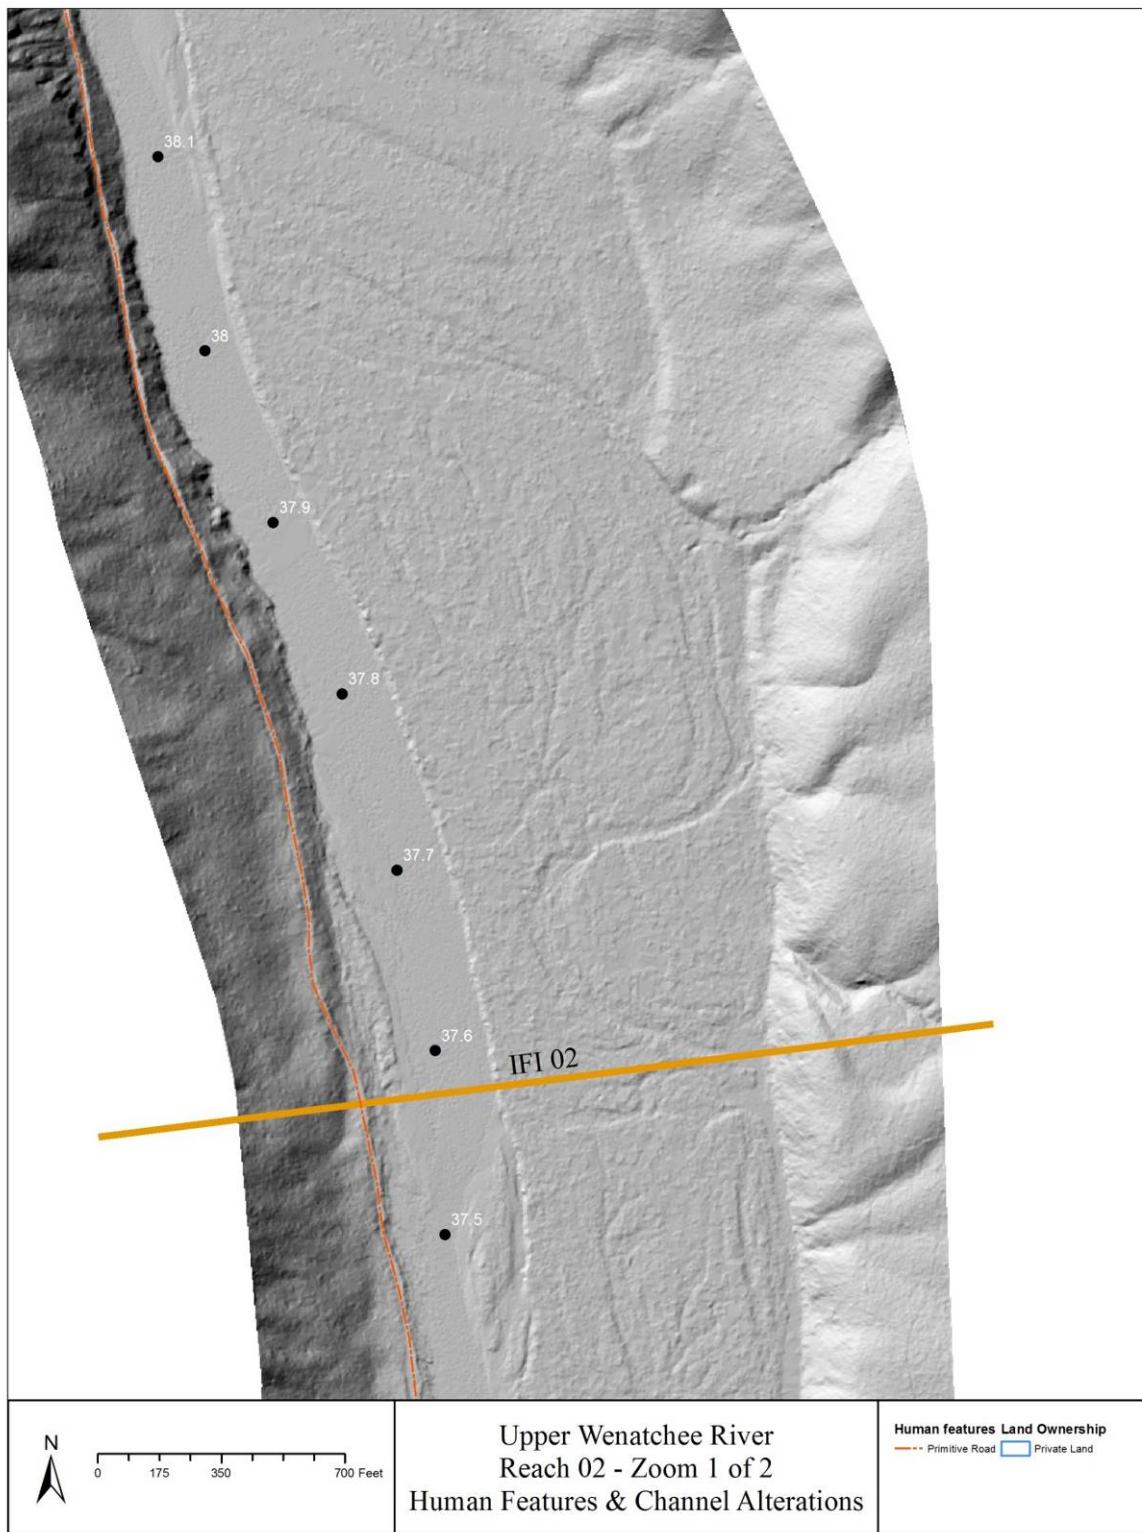
Existing human alterations include a primitive road that abuts the channel on river-right from RM 38.5 to RM 38.6. There is some fill associated with the road but impacts to the channel are minimal as it does not appear to affect channel migration rates or impact floodplain inundation.

Figure 38. Human alterations in the downstream portion of Reach 2. Flow is from north to south.

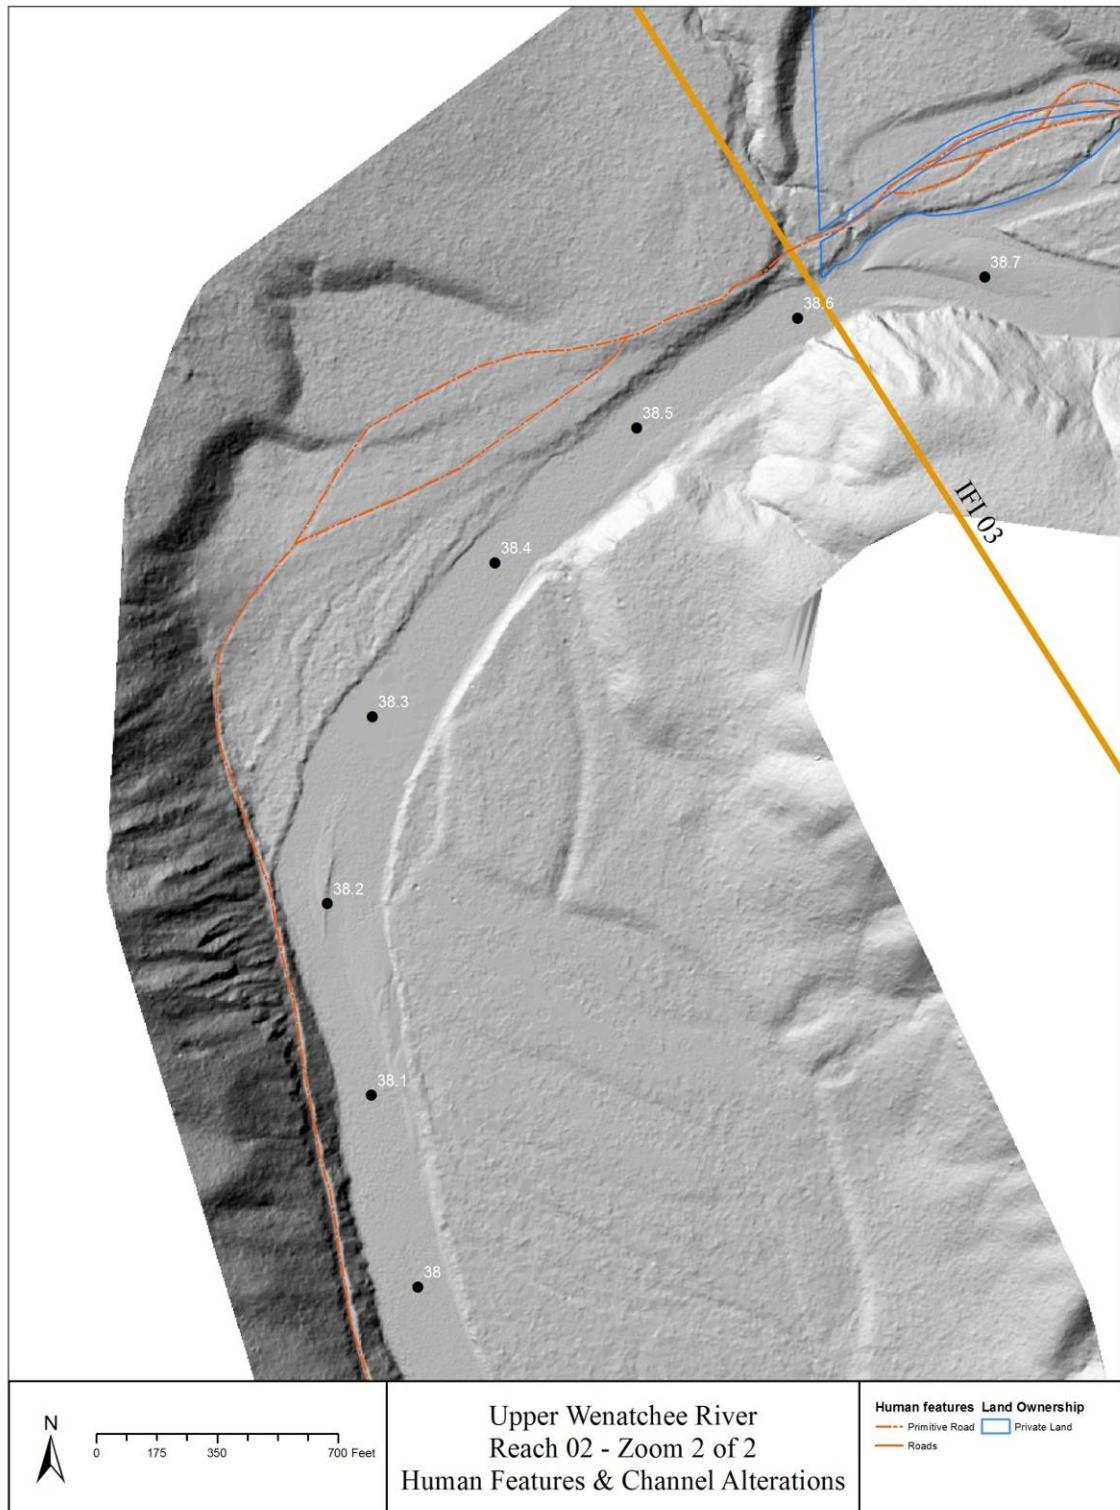
Figure 39. Human alterations in the upstream portion of Reach 2. Flow is from north to south.

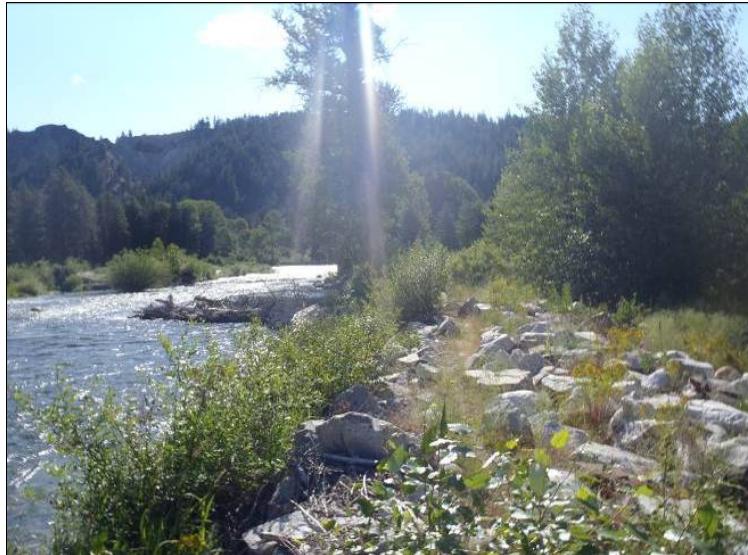
Bank hardening (e.g. riprap, concrete walls) and boulder spurs associated with the development of homesites are present in Reach 3 along the right bank (RM 39.55 to RM 41.81). Extensive riprap (Figure 44) and cement wall construction are located at RM 40.9 to RM 41.8. This bank hardening has disconnected a significant portion of floodplain and restricts channel migration. Site assessment and LiDAR elevation data indicate that this area would be active if bank hardening and walls did not prevent (or limit) floodplain inundation. Despite extensive bank alteration, field observations indicate that flooding continues to be a challenge to homeowners.

Figure 44. Riprap on river-right (RM 42.8).

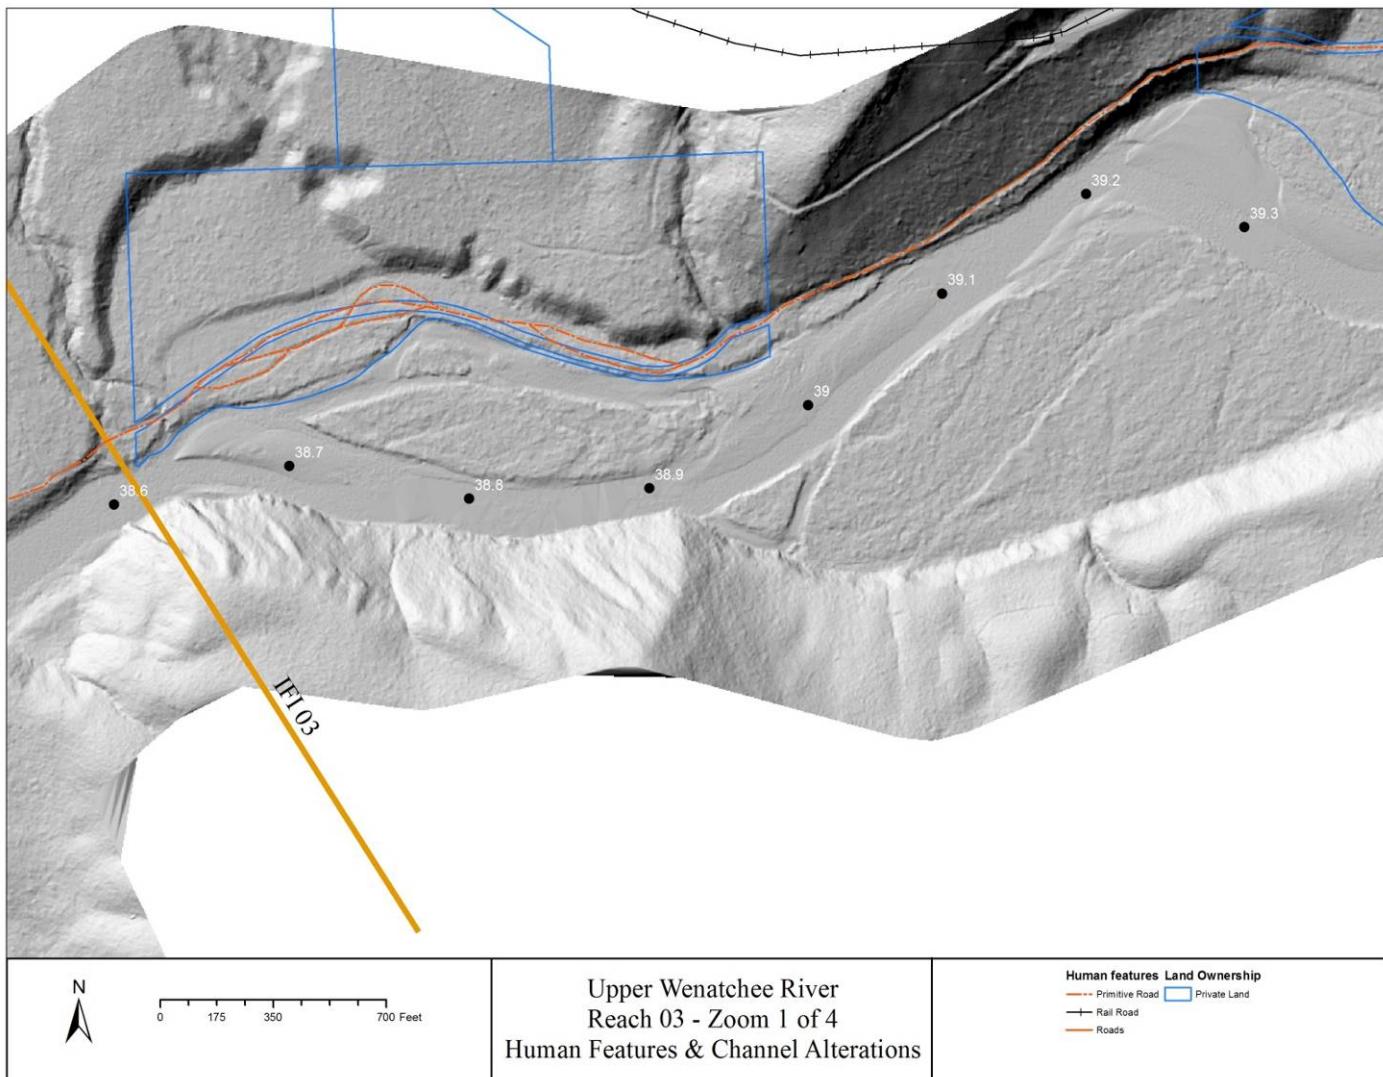
Figure 46. Human alterations in the downstream portion of Reach 3. Flow is from east to west.

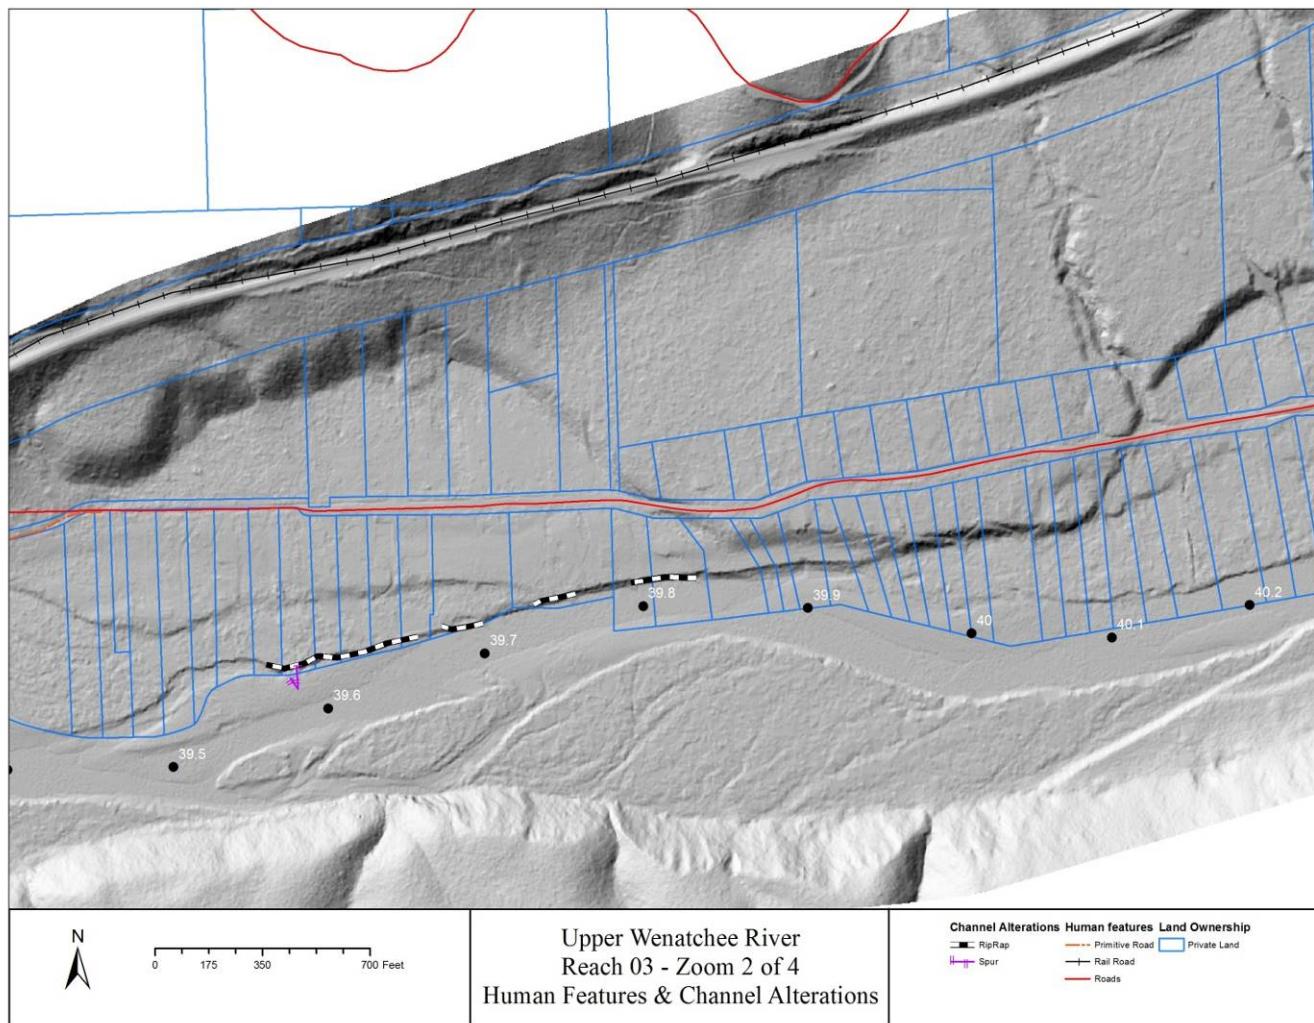
Figure 47. Human alterations in Reach 3. Flow is from east to west.

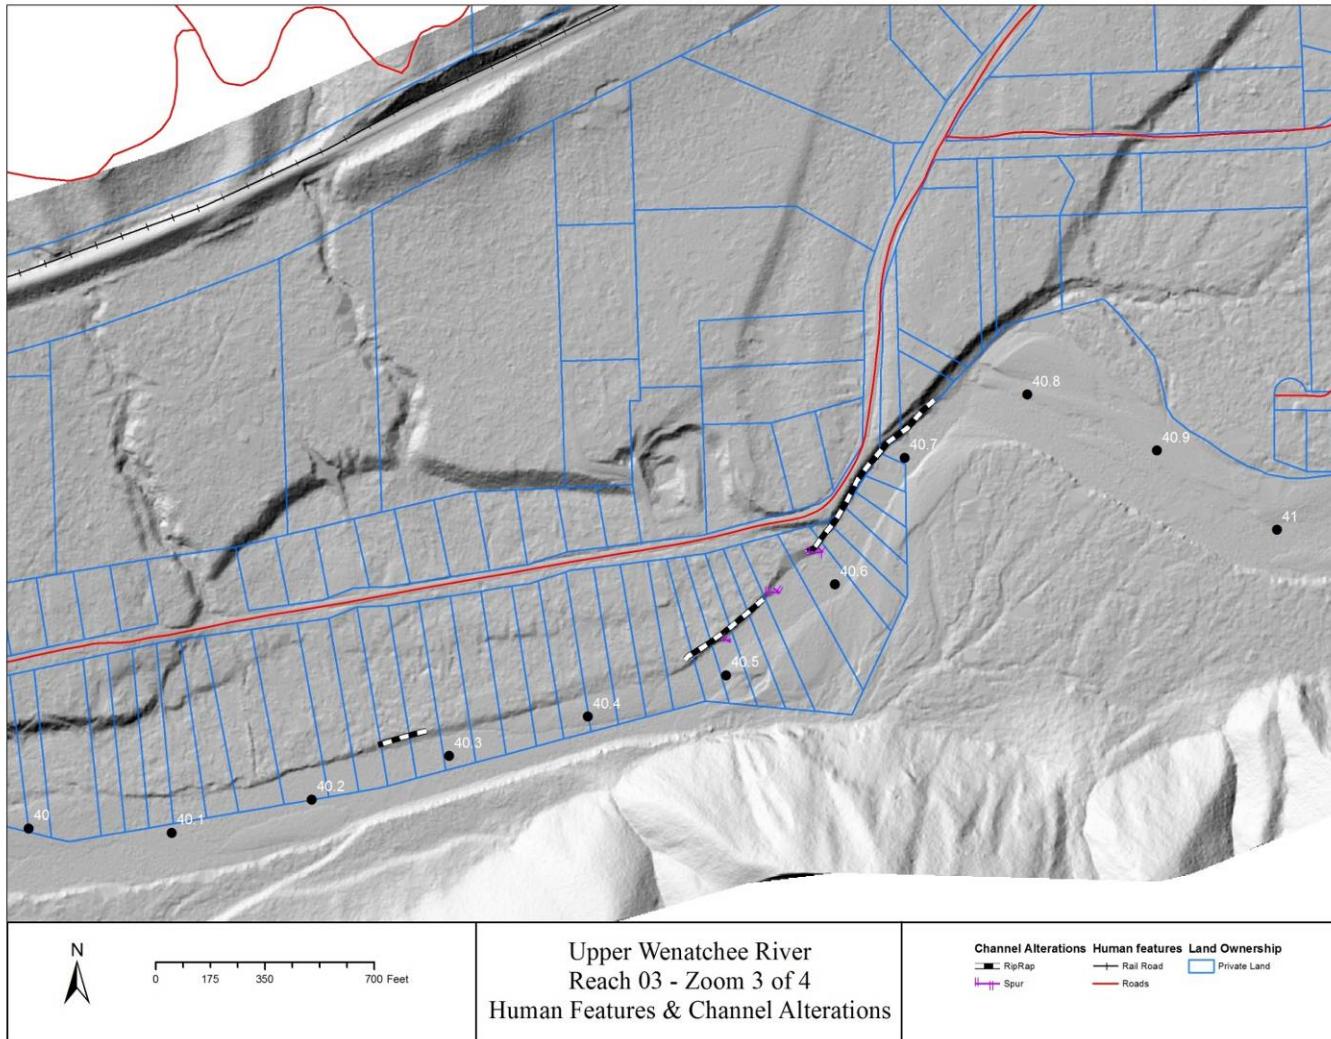
Figure 48. Human alterations Reach 3. Flow is from east to west.

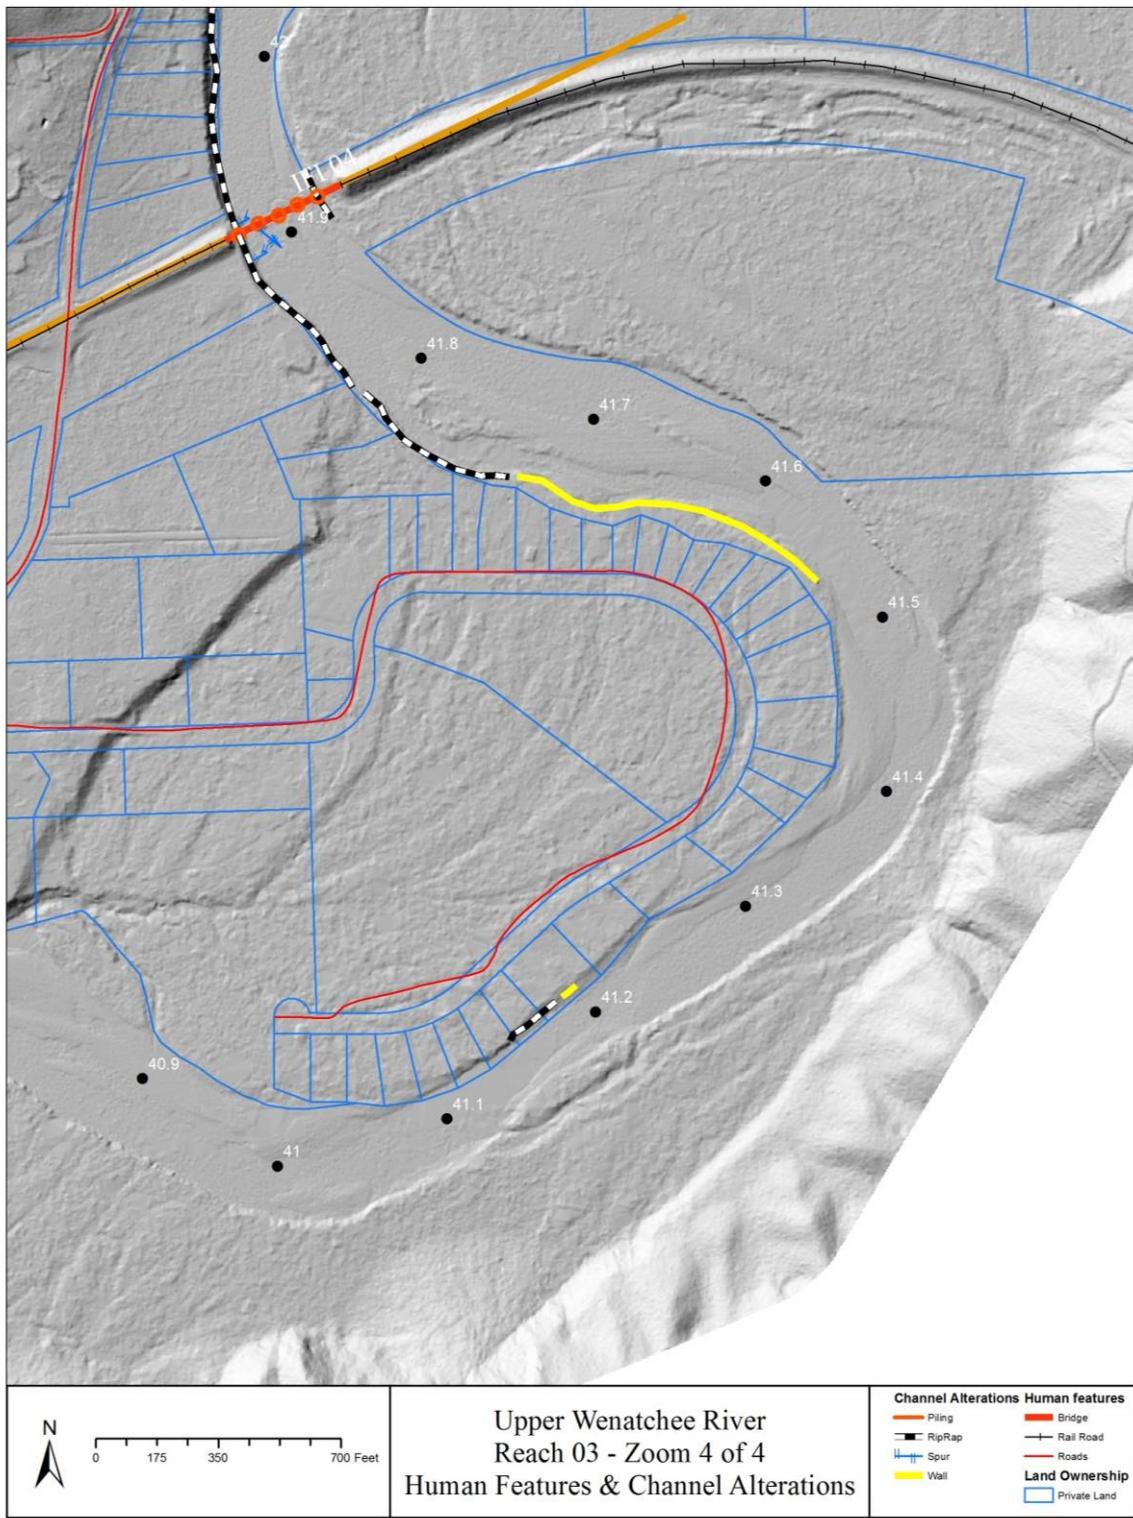
Figure 49. Human alterations in the upstream portion of Reach 3. Flow is from north to south.

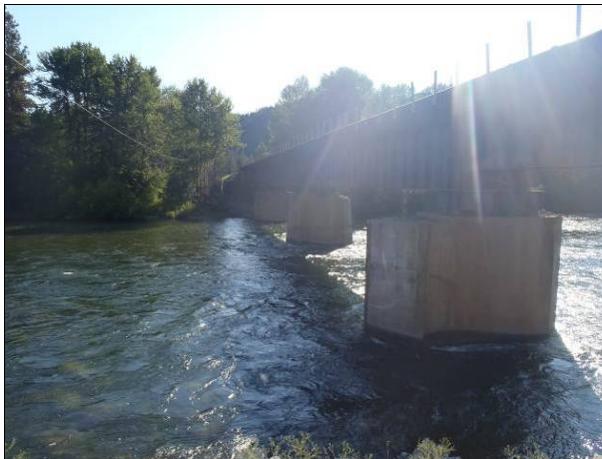
Anthropogenic landscape alterations are prevalent throughout Reach 4. At the downstream-most boundary of the reach the Burlington Northern Railroad laterally confines the channel. Both the left and right bank bridge abutments currently act as hydraulic constrictions during over-bank flows (Figure 52). Riprap has also been installed up and downstream of the railroad bridge further immobilizing the channel and impairing the growth of riparian vegetation (Figure 53).

Figure 52. Burlington Northern Railroad Bridge Pilings

Inundation mapping conducted as part of the hydraulics analysis shows that considerable floodplain constriction is created by the Burlington Northern Railroad Bridge crossing at the downstream end of Reach 4, which has likely caused base lowering that has progressed upstream. This is supported by inundation extents within the meander bends in Reach 4 that show limited inundation only at the largest flood events (e.g. 50 to 100-yr events) despite scroll scars evident from LiDAR that indicate these surfaces were laid down in relatively recent history and would therefore be expected to have greater floodplain connectivity.

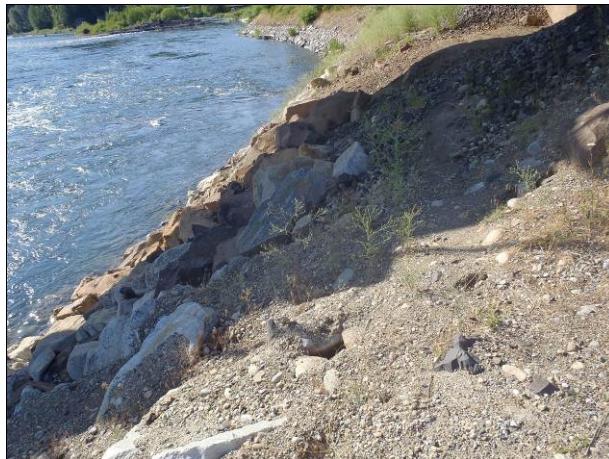
Figure 53. Right bank armoring

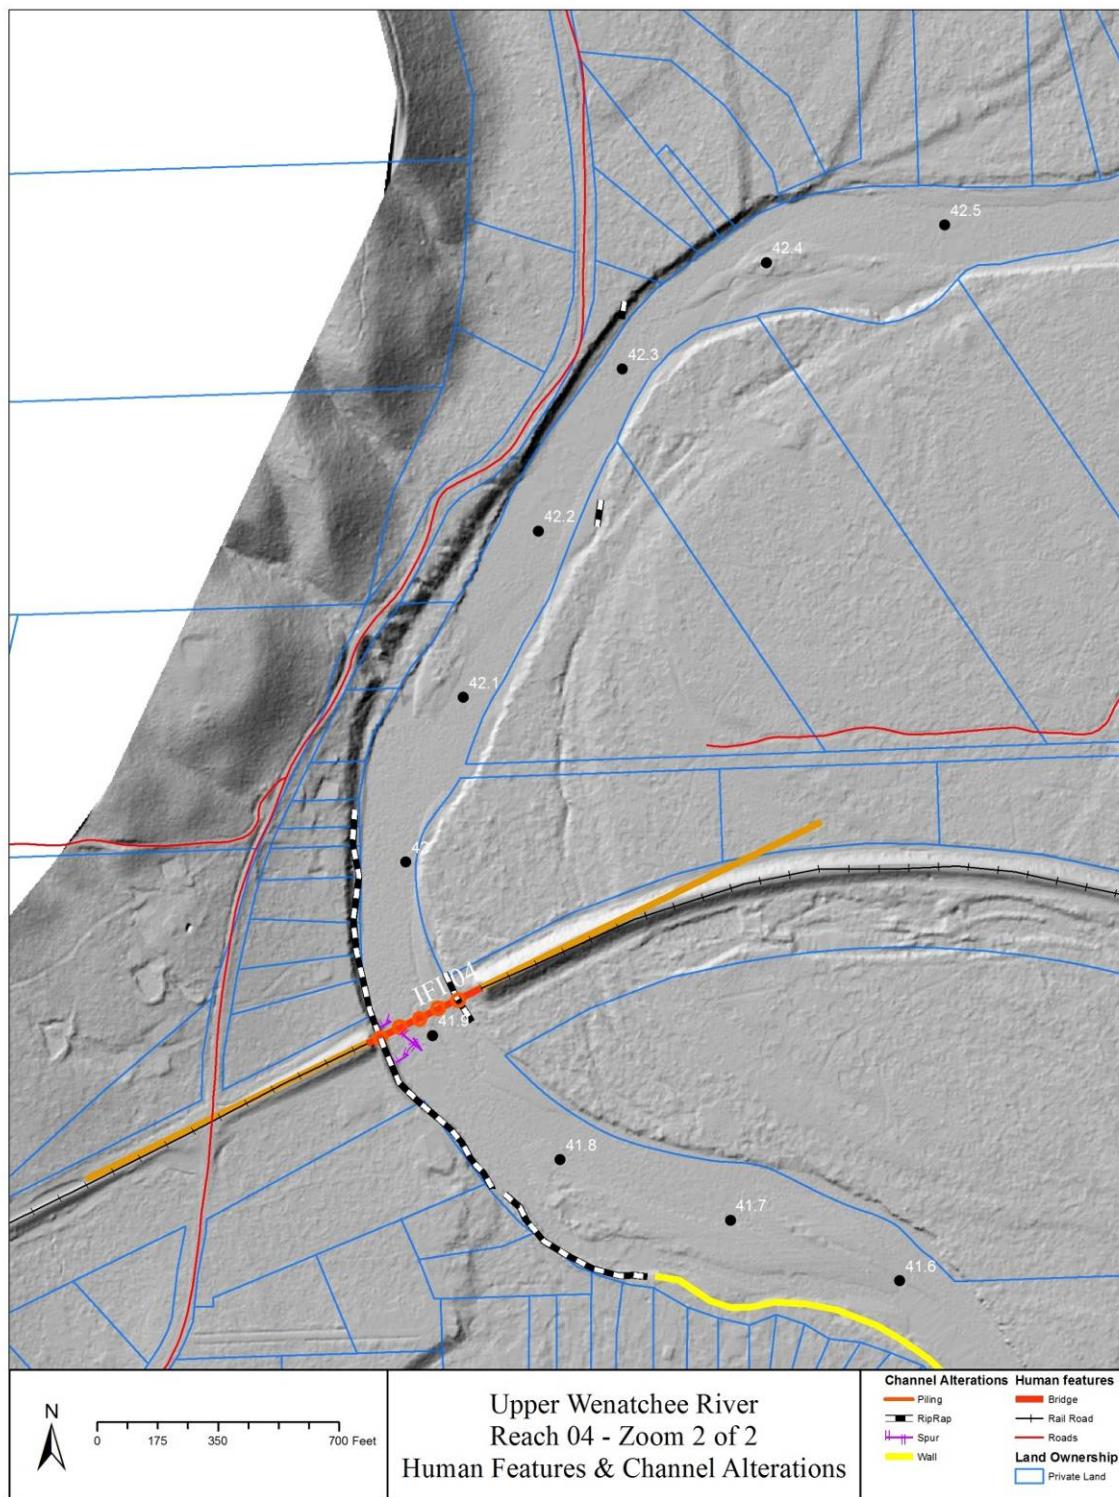
Figure 54. Human alterations in the downstream portion of Reach 4. Flow is from north to south.

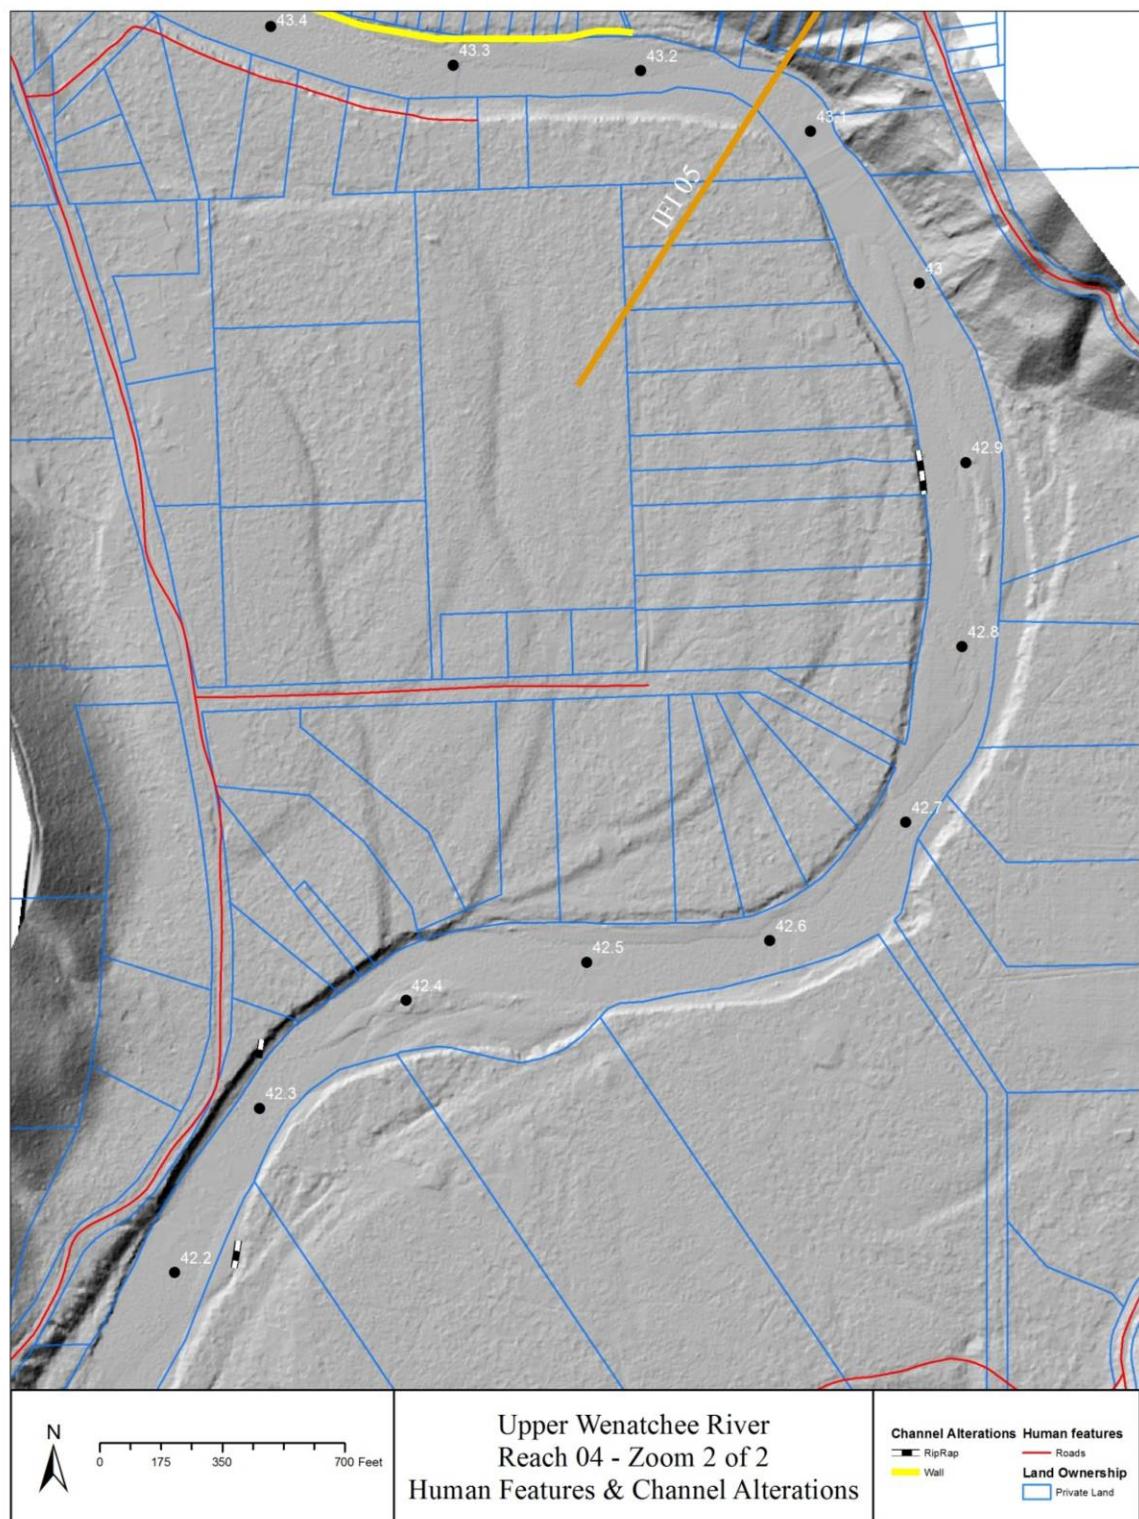
Figure 55. Human alterations in the upstream portion of Reach 4. Flow is from north to south.

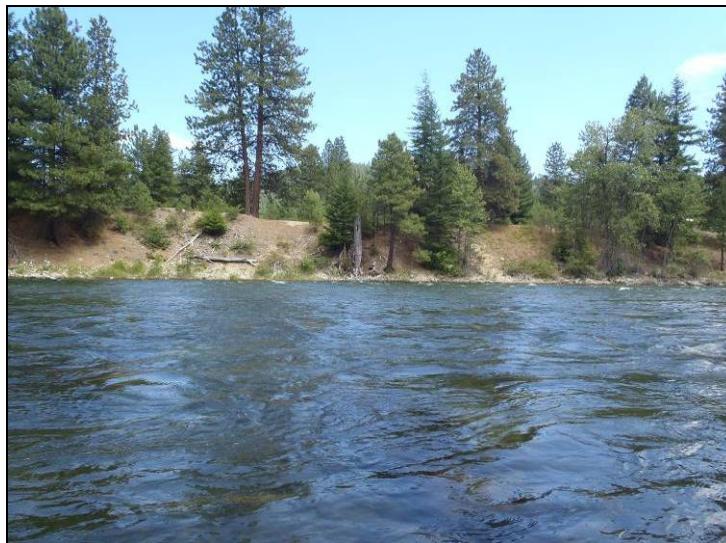
The channel and its modern floodplain are naturally confined within terraces of glacial outwash (Figure 58) and exposures of the Chumstick Formation. The glacial outwash terraces are a result of glacial meltwater mobilizing, transporting, and depositing materials in the Wenatchee valley during and after the last glacial period. Since deposition, the channel has incised into and reworked the glacial outwash deposits (NPCC 2004, Tabor et al. 1987). The channel is further confined by development and bank hardening of the marginal floodplain surfaces. Confinement limits lateral migration and exaggerates changes in flood stage relative to discharge. As a result the river is a transport dominant reach with minimal available off-channel habitat or large wood retention. The gradient of Reach 5 is 0.25%.

Figure 58. Terraced banks (alluvium terrace deposits). Terrace surface was approximately 8' above water surface elevation (August 2011).

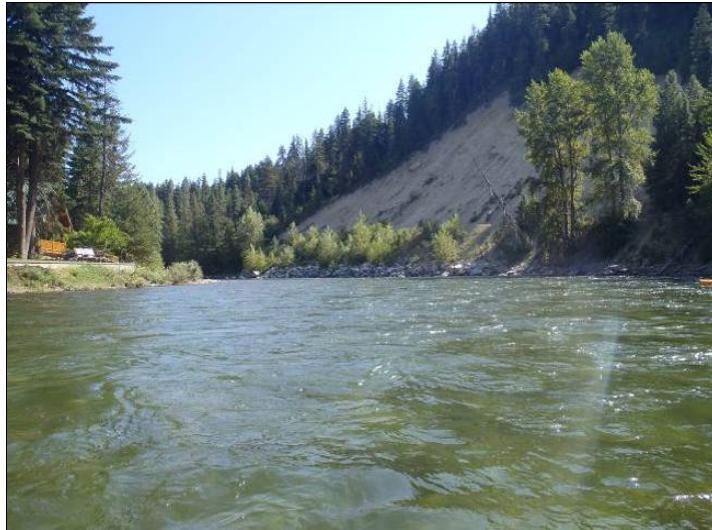
Figure 66. Homesites along the right bank across from the exposed Chumstick Formation (photo taken at RM 47.1, facing upstream).

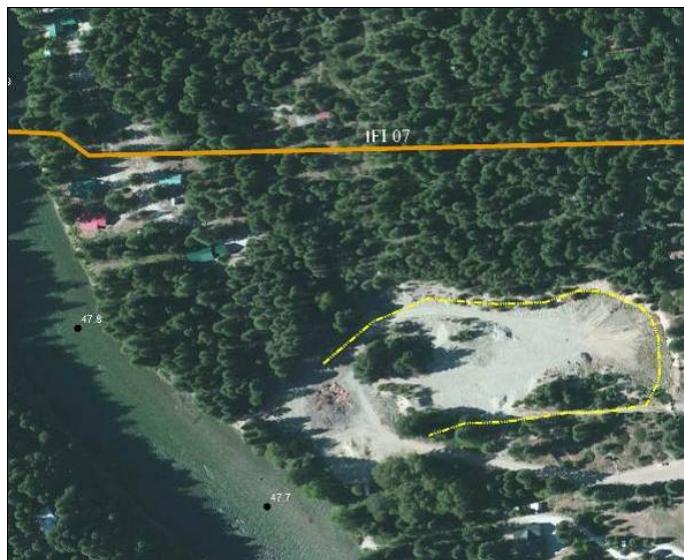
On the river-left floodplain surface at RM 47.7 there is a 3.52 acre gravel excavation pit (Figure 67). Adjacent to the pit a push-up levee has been constructed along river-left to protect the excavation pit. The levee extends up and downstream of the pit in front of residential homes and alters the frequency and extent of floodplain inundation.

Figure 67. Gravel excavation pit (highlighted in yellow) along left bank in upstream portion of Reach 6.

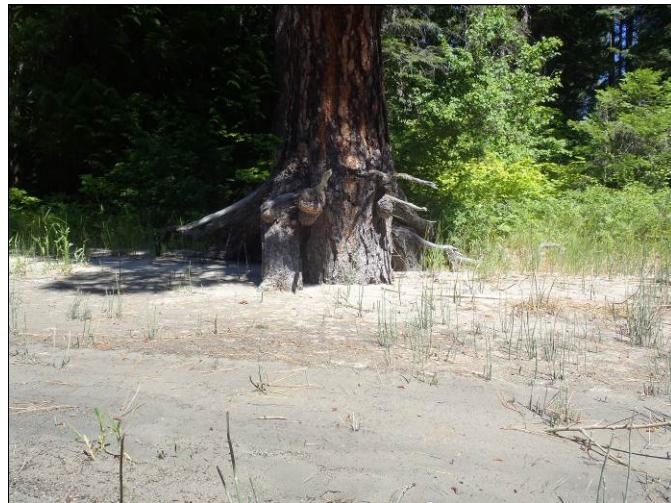
The channel and its modern floodplain are partially confined by terraces of glacial outwash deposits. The channel abuts the high terrace bank on river-right from RM 47.9 to RM 48.14. The modern floodplain surfaces are low with sloping banks and alternate between human-altered and functioning. Hydraulic modeling of floodplain inundation reveals that most of the modern floodplain surfaces in Reach 7 are not inundated with flow events equivalent to or less than the two year flood (Section 3.5.2). This suggests that incision is occurring in this reach even with the additional sediment inputs from the Chiwawa River and its alluvial fan. The relatively short length of the reach and terrace confinement result in a sinuosity of 1.06. The gradient of Reach 7 is 0.25%. Slope is greatest in the downstream portion of the reach where the channel is confined by the terrace. Here transport capacity of wood and sediment also increases, as evidenced by modern scour at the base of riparian vegetation throughout the reach (Figure 74).

Figure 74. Scour at base of mature ponderosa pine in riparian area.

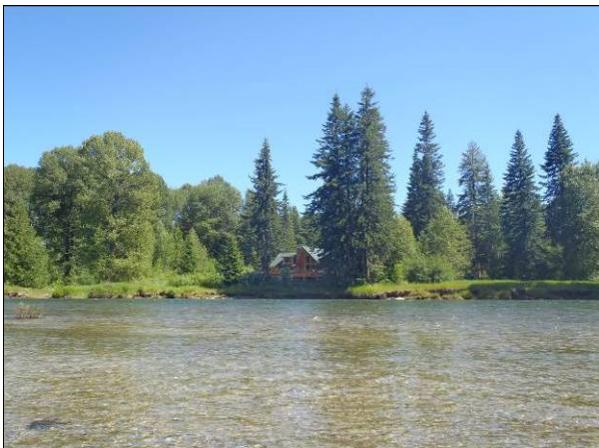
Human alterations affecting the channel are primarily restricted to the left bank. These alterations include home development and riparian vegetation removal and/or alteration. Where homesite development has occurred much of the floodplain has been altered by fill or grading. The riparian canopy has been completely cleared at many homesites, and at other sites, understory shrubs and saplings have been cleared and only select large trees remain. Where canopies have been completely cleared, lateral channel scour is undercutting banks and they are slumping into the channel (Figure 75 and Figure 76).

Figure 75. Clearing of riparian vegetation resulting in bank slumping.

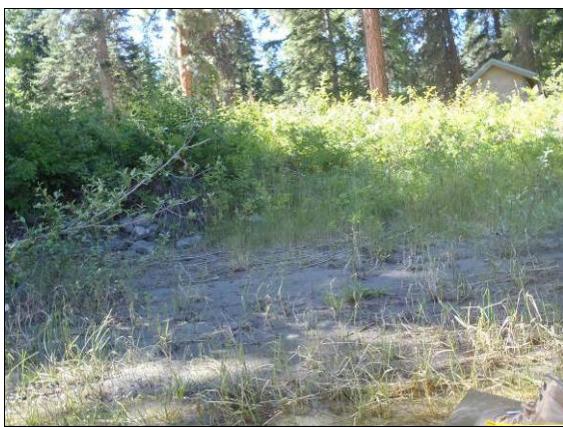
The modern floodplain and its banks alternate between human altered and functioning (Figure 77 and Figure 78). In the lower portion of the reach fewer impacts to riparian vegetation have occurred in conjunction with homesite development. However, the relative seral stage of these canopies is young compared to intact riparian canopies. Only small-scale riprap was observed at two sites and presents minimal influence on the channel or floodplain inundation.

Figure 77. Homesite where small willows and dogwood has been allowed to establish.
