UPPER WENATCHEE RIVER STREAM CORRIDOR ASSESSMENT AND HABITAT RESTORATION STRATEGY

YAKAMA NATION FISHERIES | PO BOX 15, FORT ROAD | TOPPENISH, WA 98948

INTER-FLUVE, INC.
1020 WASCO STREET, SUITE I | HOOD RIVER, OR 97031
541.386.9003 | www.interfluve.com

August 2012

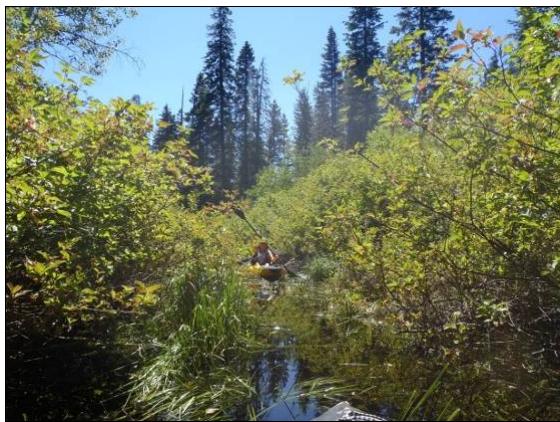
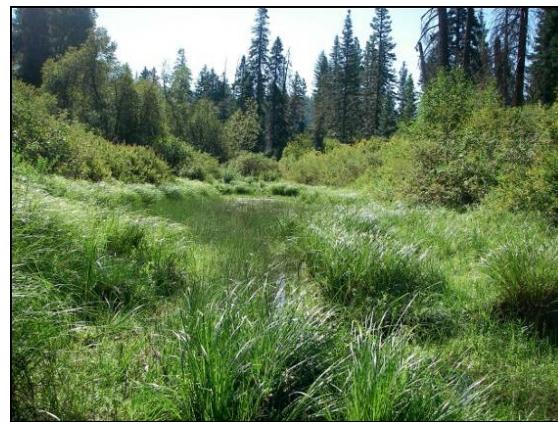
In the upstream portion of the reach incision (translating into Reach 9) is resulting in minor floodplain disconnection. Multiple elevations of abandoned floodplain surfaces exist along the left bank indicating a long-term process of incision. A disconnected floodplain wetland on river-left at RM 49.3 is evidence of more modern incision. The upstream-most modern floodplain surface on river-right has sandy soils but inundation is historical or only very infrequent. Hydraulic modeling of floodplain inundation (Section 3.5.2) confirms these findings. Low elevation floodplain surfaces with sloping banks are present further downstream where modern incision processes are minimal. These lower surfaces house narrow backwater habitats that connect to the main channel at the downstream end. These backwaters exchange both surface and hyporheic flow with the mainstem Wenatchee (Figure 81).

Figure 81. Off-channel habitat at RM 49.2 (river-left) looking downstream (left photo), and looking upstream (right photo).

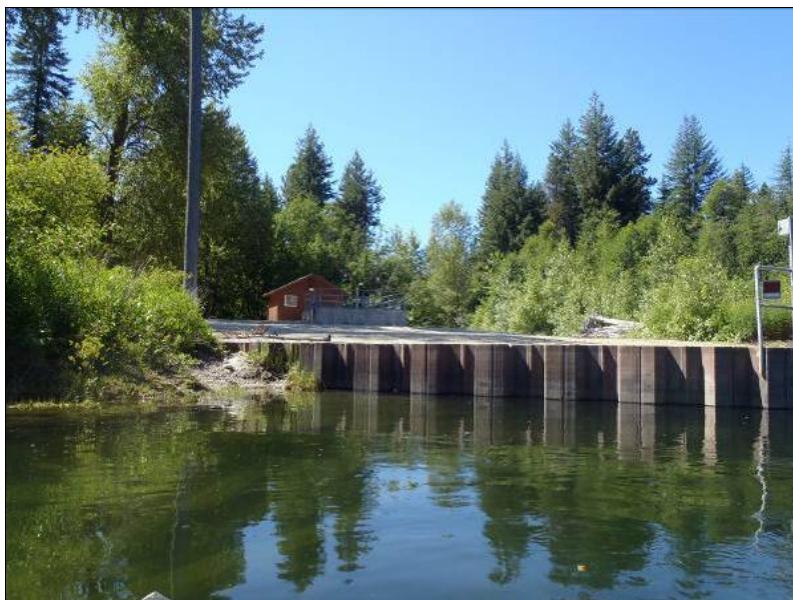
Bank hardening at RM 49.3 further impairs floodplain inundation and lateral migration. A cement and steel retaining wall protrudes slightly into the channel protecting the bank from all channel processes (Figure 82). The wall is part of the Washington Department of Fish and Wildlife's Chiwawa Ponds fish hatchery facility. This facility also includes fill and small buildings. Just upstream from the fish hatchery facility the floodplain surface has been graded and much of the native vegetation has been removed (now dominated with mowed grass) to facilitate community recreational activities. This area contains a disconnected wetland complex. According to the hydraulic modeling, the fish pond facility and its structures directly limit inundation on this low surface. The nearby disconnected wetland complex does get inundation with flows equivalent or less than a two year flood event.

Figure 82. WDFW Chiwawa Ponds Fish Hatchery intake structure.

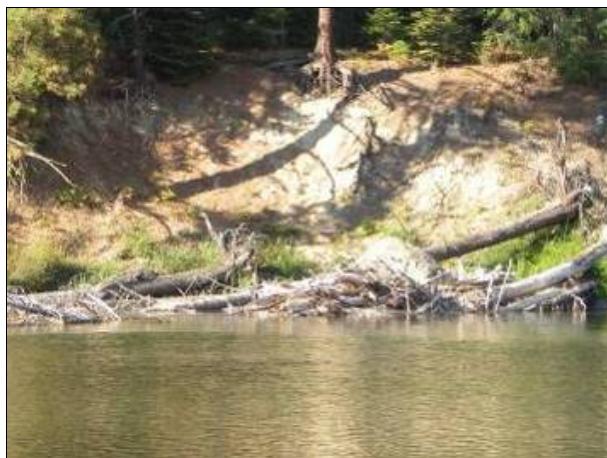
The channel and its modern floodplain are partially confined by terraces of glacial drift and outwash. The steep terrace banks supply sediment to the system at cut-bank exposures. Minor periodic large-wood inputs are supplied by the forested terrace surfaces that create wood accumulations at the base of the terrace slope (Figure 86). Alternating terrace banks have naturally limited the channel's lateral migration throughout the reach.

Figure 86. Example of a channel margin large wood accumulation from steep terrace banks.
