**PRELIMINARY GEOMORPHIC ASSESSMENT OF THE 32 ROAD
WASH-OUT, KICKITAT RIVER
YAKAMA RESERVATION, WASHINGTON**

Will Conley

Hydrologist/Geomorphologist
Yakama Nation Fisheries Program
Klickitat Field Office
Wahkiacus, WA

July 1, 2016

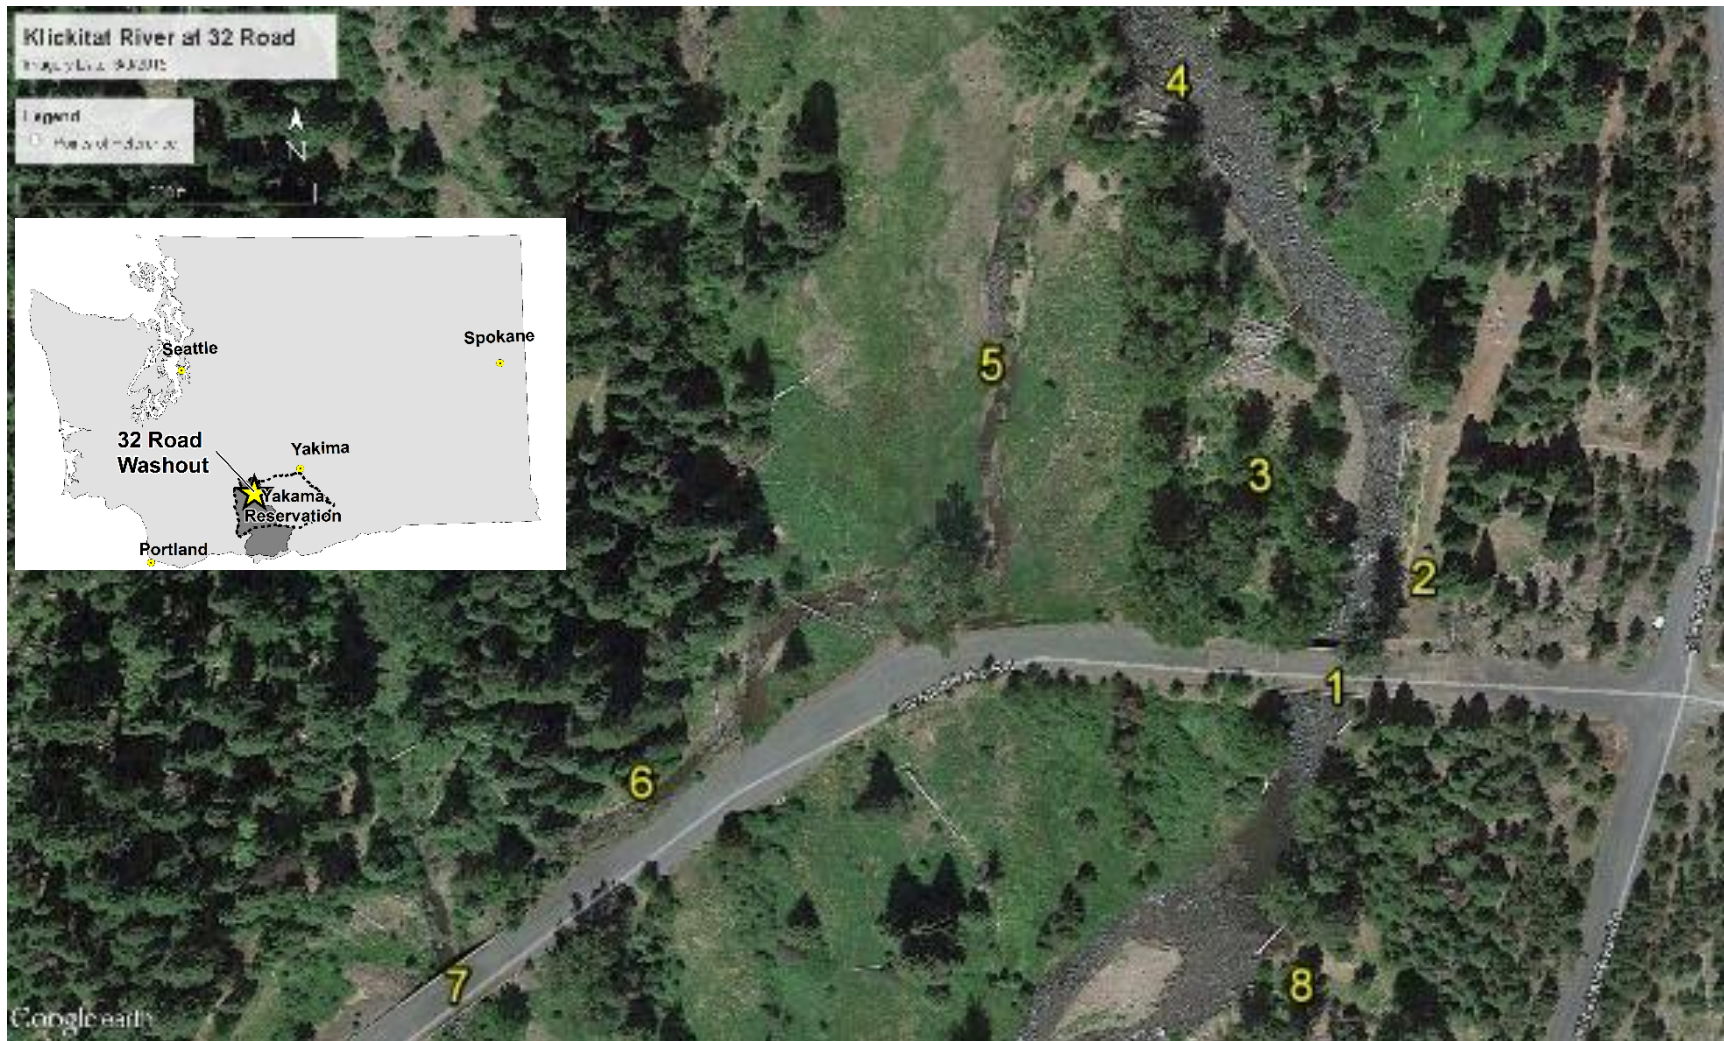
Figure 1. Location and site map with reference points for Klickitat River at 32 Road (streamflow is from top to bottom).

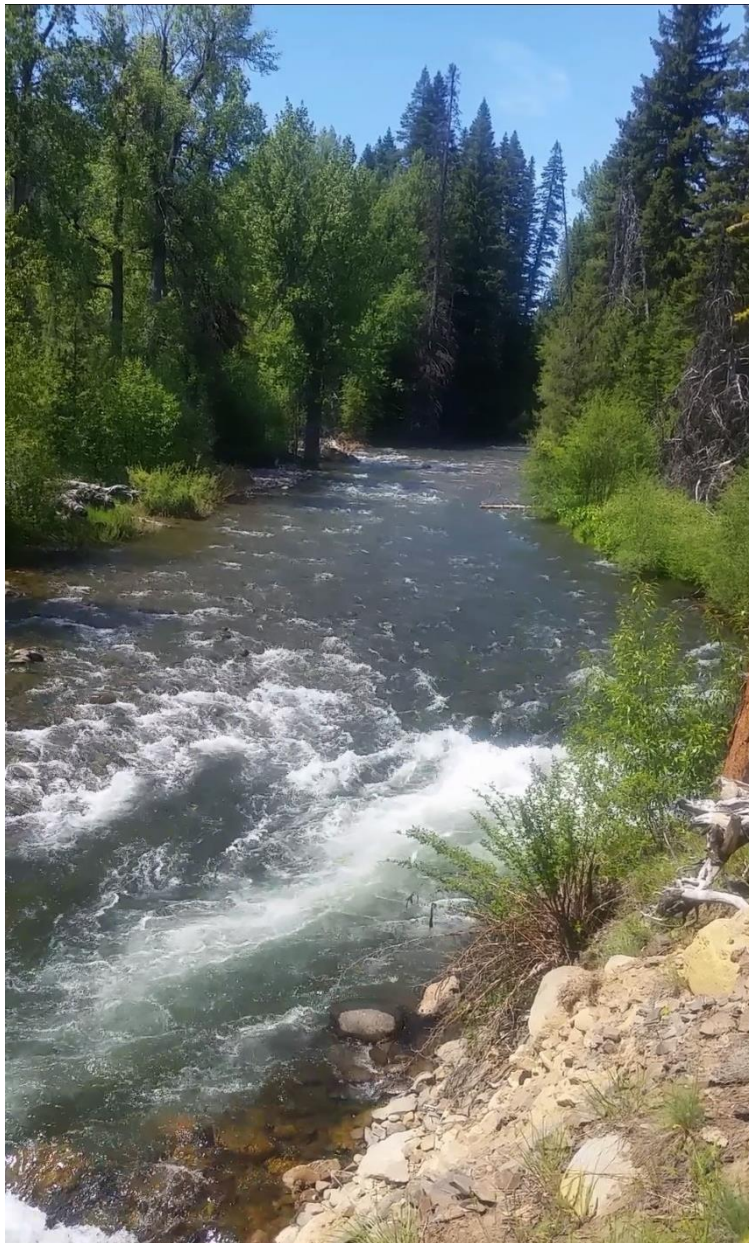
Figure 9. Looking upstream at main (east) channel of Klickitat River from upstream end of eroding bank.

The contact along the active channel extends approximately 200 feet upstream from the bridge. The cohesion of the “toe” unit provides the main resistance along the bank as it is unvegetated and there is a seam of deeper water along the boundary. The seam extends slightly upstream of the contact (Figure 9). However, at the upstream end, it may be due a combination of resistance associated with boulders, vegetation, and flow contraction.

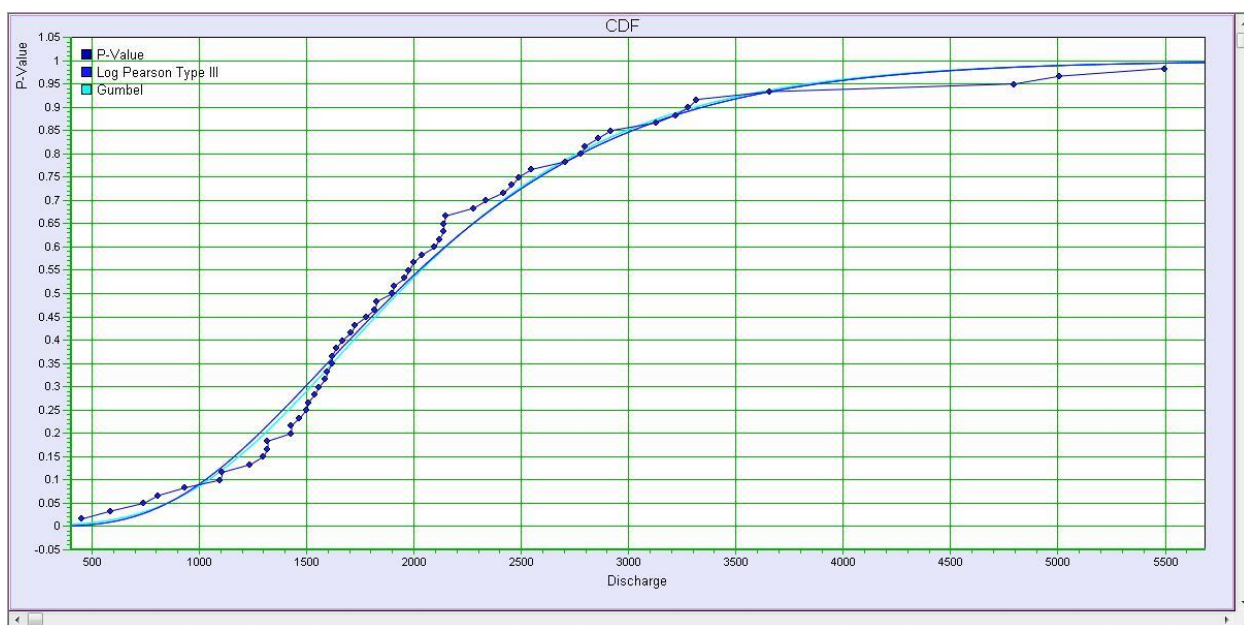
A magnitude–frequency analysis was performed on an annual maxima series of 59 records in Aquarius Workstation v3.7.134. Data from the Log–Pearson Type III (LPIII) and Gumbel distributions provided a best fit of the data (Figure 11). Tabular values for standard recurrence intervals are presented in Table 1. Other distributions evaluated were Normal, log–normal, Pearson Type III, gamma, log–gamma, GEV, and Weibull. Only values related to the LPIII distribution are used subsequently because of fit to data and widespread use.

Figure 11. Magnitude–frequency analysis for annual maximum discharge (cfs) for USGS gage 14107000.

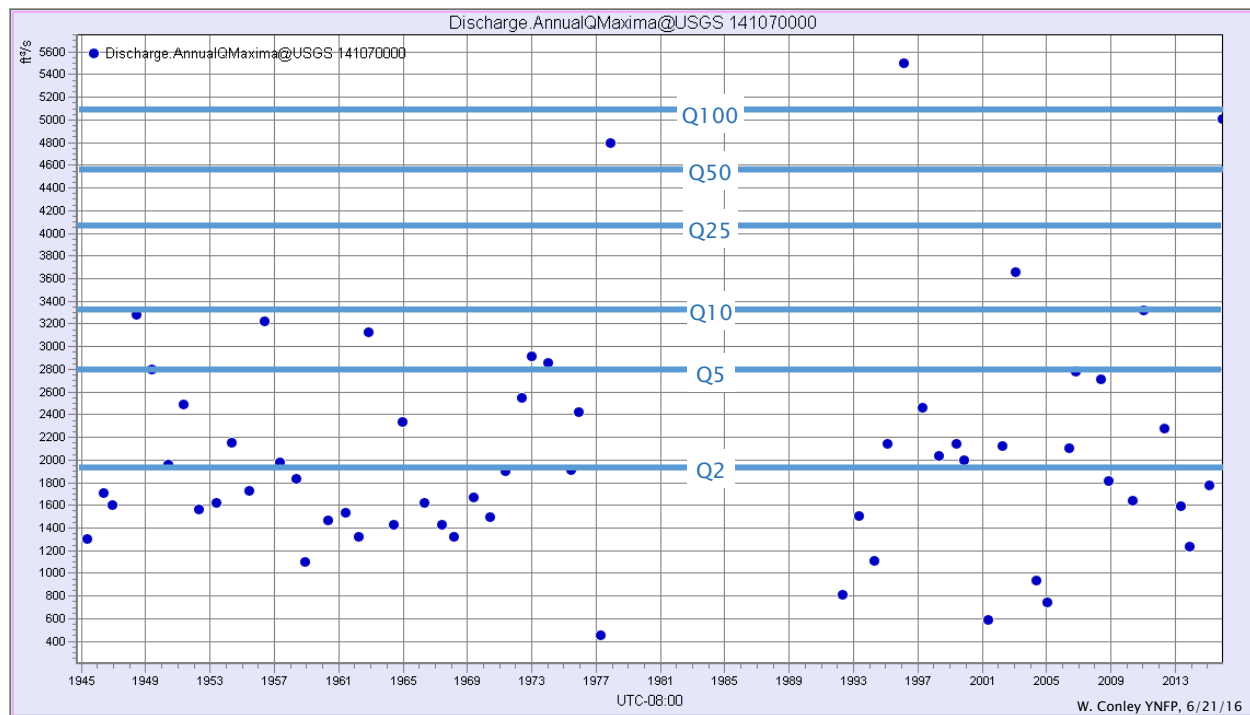
The fitted LPIII curve was used to compute discharge values for standard recurrence intervals (Table 1). The magnitude–frequency values were then superimposed onto a scatterplot of recent and historic peak flow events for interpretive context (Figure 12). This affords the opportunity to discuss flow frequency at the ungaged site independent of discharge.

Figure 12. Scatterplot of annual maxima for USGS gage 14107000 from WY 1945 through 2016; annotated, blue horizontal lines indicate computed recurrence intervals.

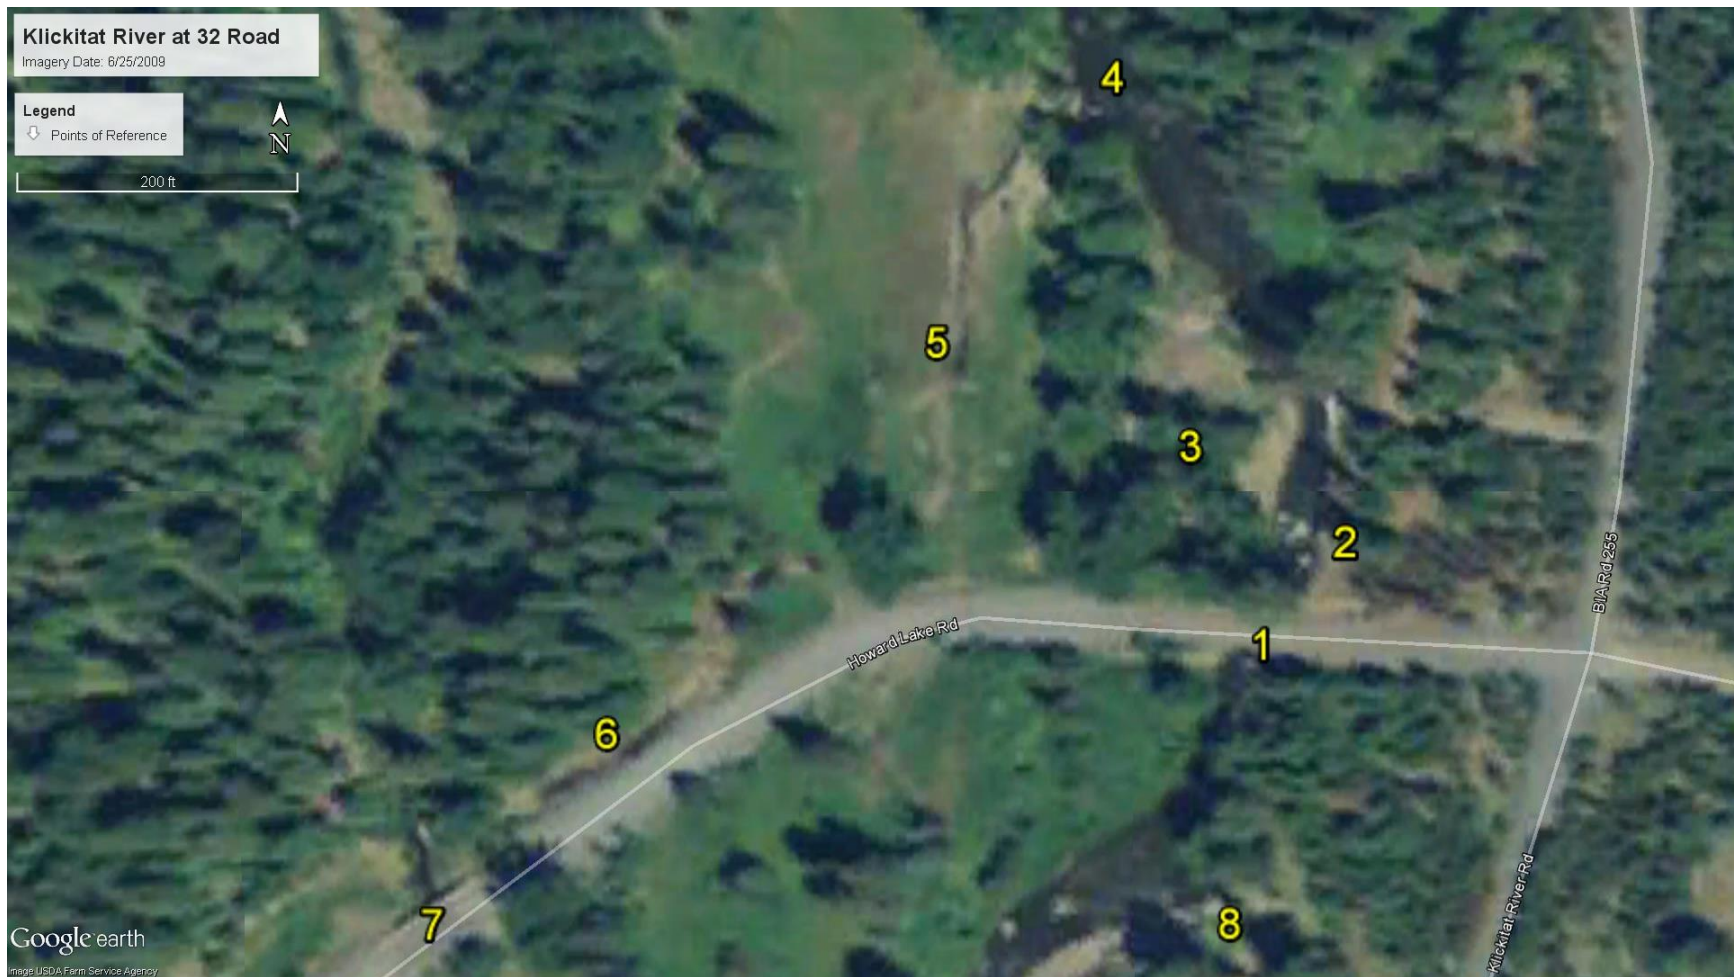
The previously noted side channel (Figure 1, along points 4–7) does not appear to be present in either the 1996 or 2006 imagery (Figure 19 and Figure 20, respectively). By 2009, a channel is clearly evident crossing the floodplain (Figure 21, vicinity of point “5”) and erosion along the road embankment face (point “7”) appears to have occurred. The 2011 photo (Figure 22) was taken during base-flow conditions (late-September) and suggests the floodplain channel has developed into a perennial channel. The channel appears better defined in the 2013 and 2015 imagery (Figure 23 and Figure 24, respectively), suggesting continued channel evolution. Lateral bar development is visible in the 2015 photo.

Figure 21. Aerial photo of active valley in vicinity of 32 Road on 6/25/2009; flow direction is top to bottom.

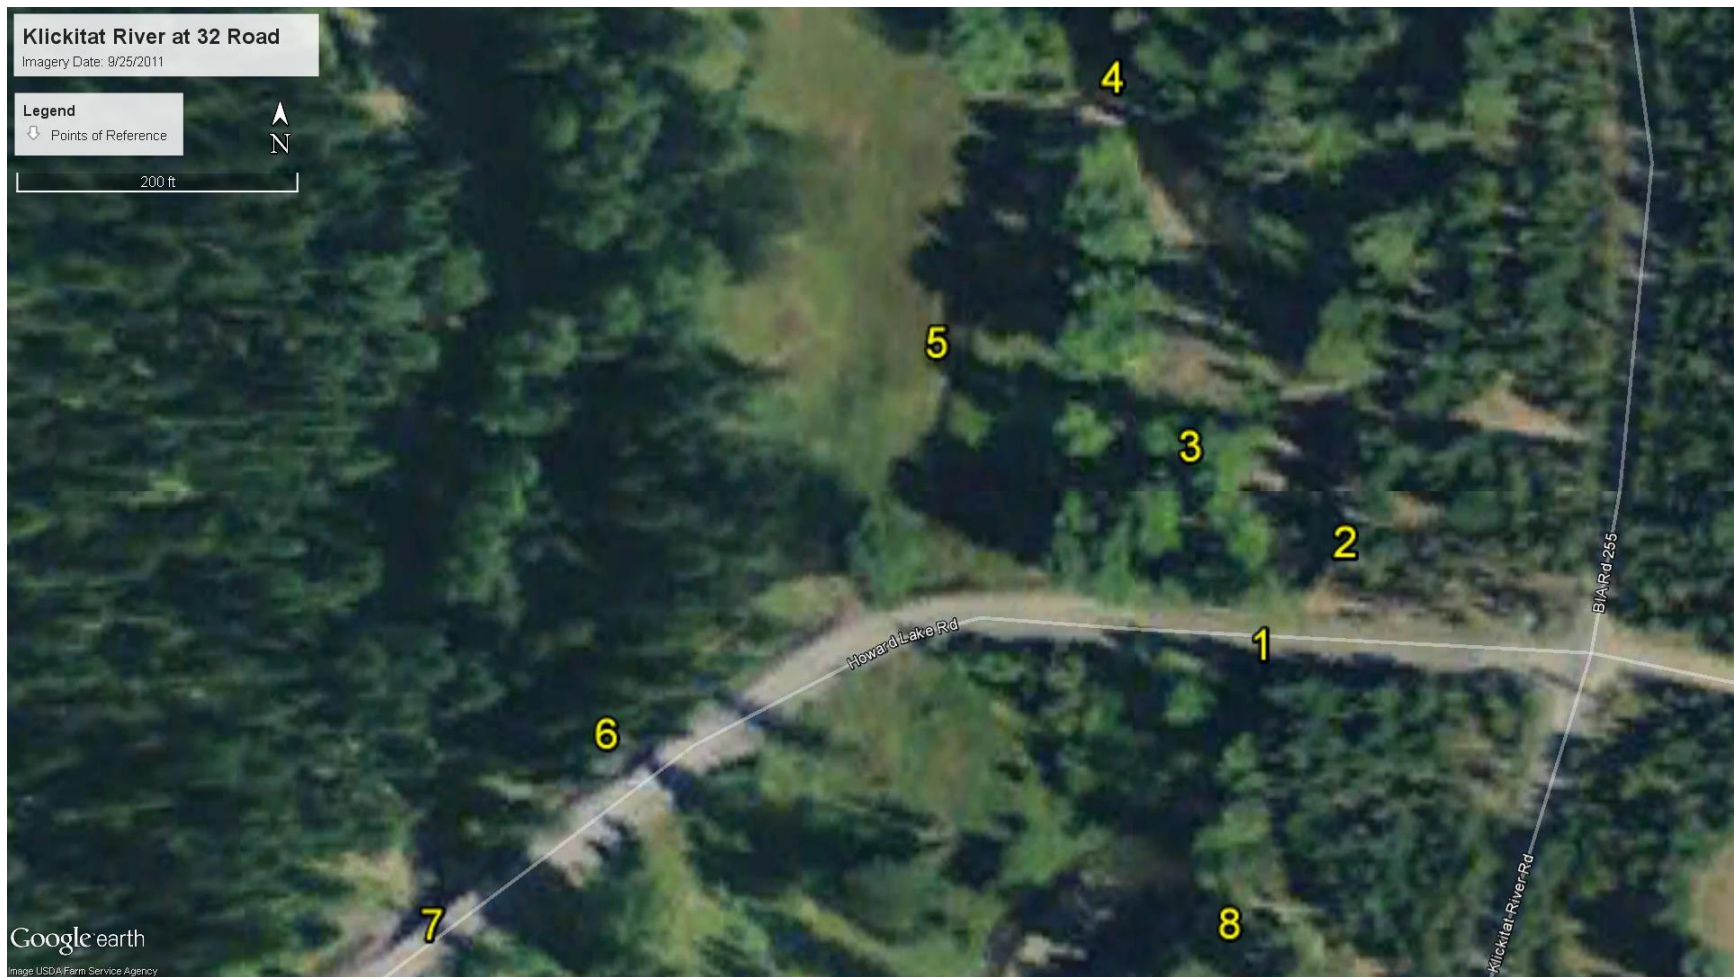
Figure 22. Aerial photo of active valley in vicinity of 32 Road on 9/25/2011; flow direction is top to bottom.

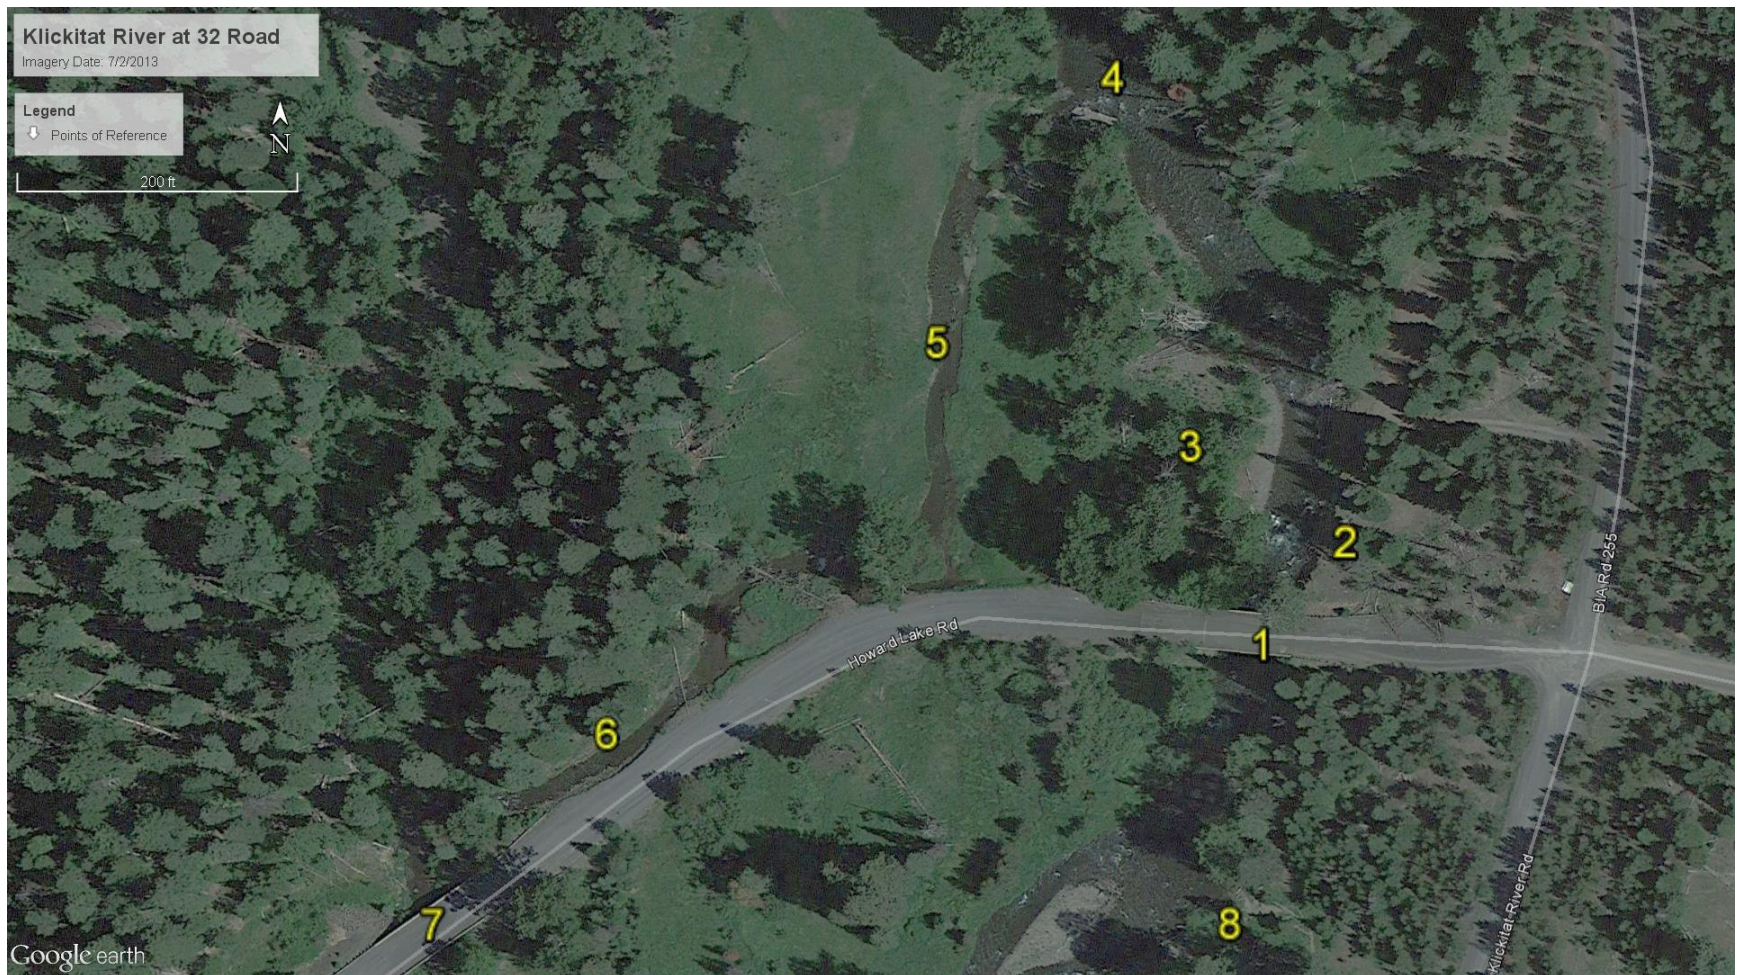
Figure 23. Aerial photo of active valley in vicinity of 32 Road on 7/2/2013; flow direction is top to bottom.

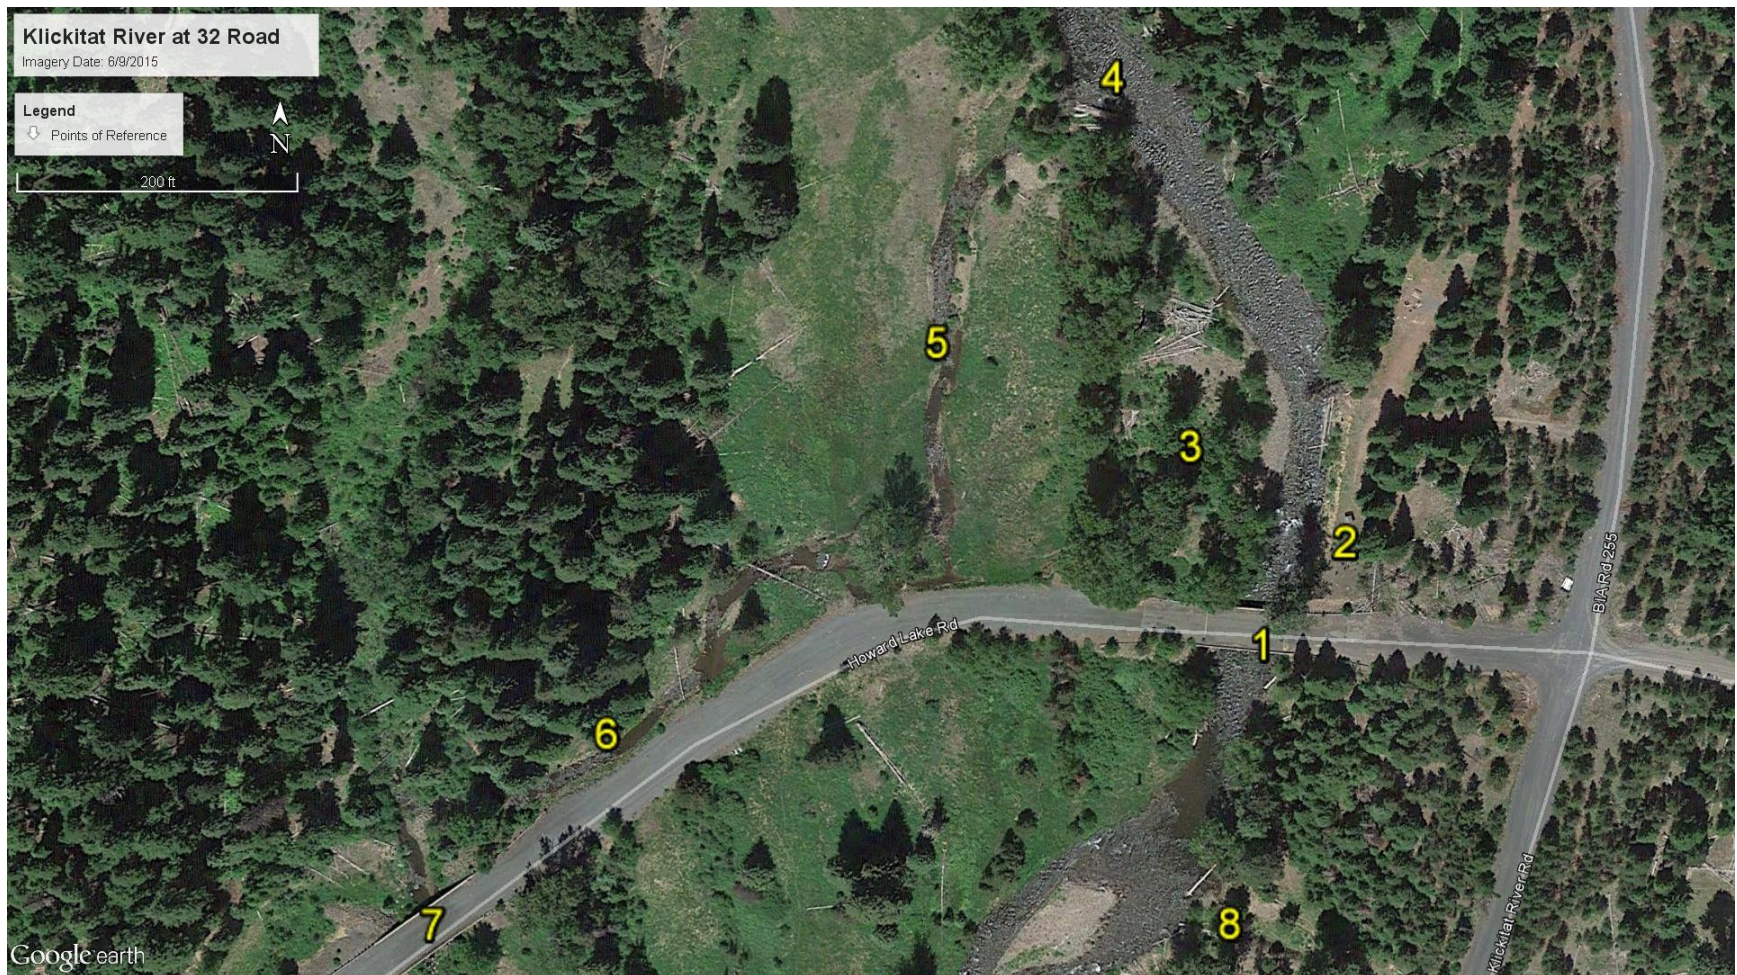
Figure 24. Aerial photo of active valley in vicinity of 32 Road on 6/9/2015; flow direction is top to bottom.

Sediment deposition upstream of the bridge is aggrading the bed and accreting and extending the bar. This increases lateral hydraulic forcing contributing to erosion of the left bank and effectively changes flow approach vectors to the bridge. Overbank flow frequency also seems to be increasing (and flow magnitude for occurrence decreasing). This 'loss' of flow to the channel diminishes sediment transport capacity and positively reinforces recent/current depositional processes. Based on conditions observed at the site visit, these processes can be expected to continue into the foreseeable future.

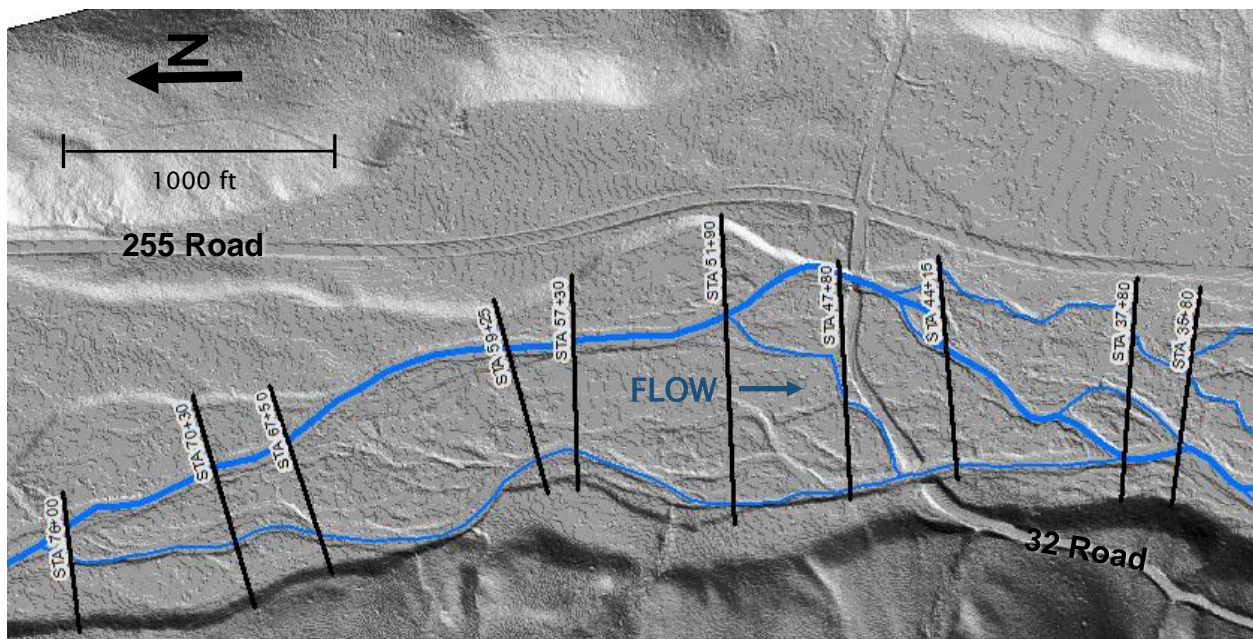
The Klickitat River splits into two major channels (“east/main” and “west”) approximately 3,000 feet upstream of the 32 Road. Both channels exhibit wandering forms. Review of high resolution topography collected in 2011 indicate overbank flow is typically from the east/main channel across the floodplain toward the west channel (Figure 26). Within approximately 2,100 feet upstream of the road crossing, the west channel generally occupies lower positions for most valley cross-sections (Figure 27) which is consistent with flow patterns.

Figure 26. High resolution topography of Klickitat River valley in vicinity of 32 Road derived from LiDAR collected in 2011; stationing in feet along valley centerline from Piscoe Creek confluence; Diamond Fork confluence is at left edge of image; line stationing indicates cross-sections presented in Figure 27.

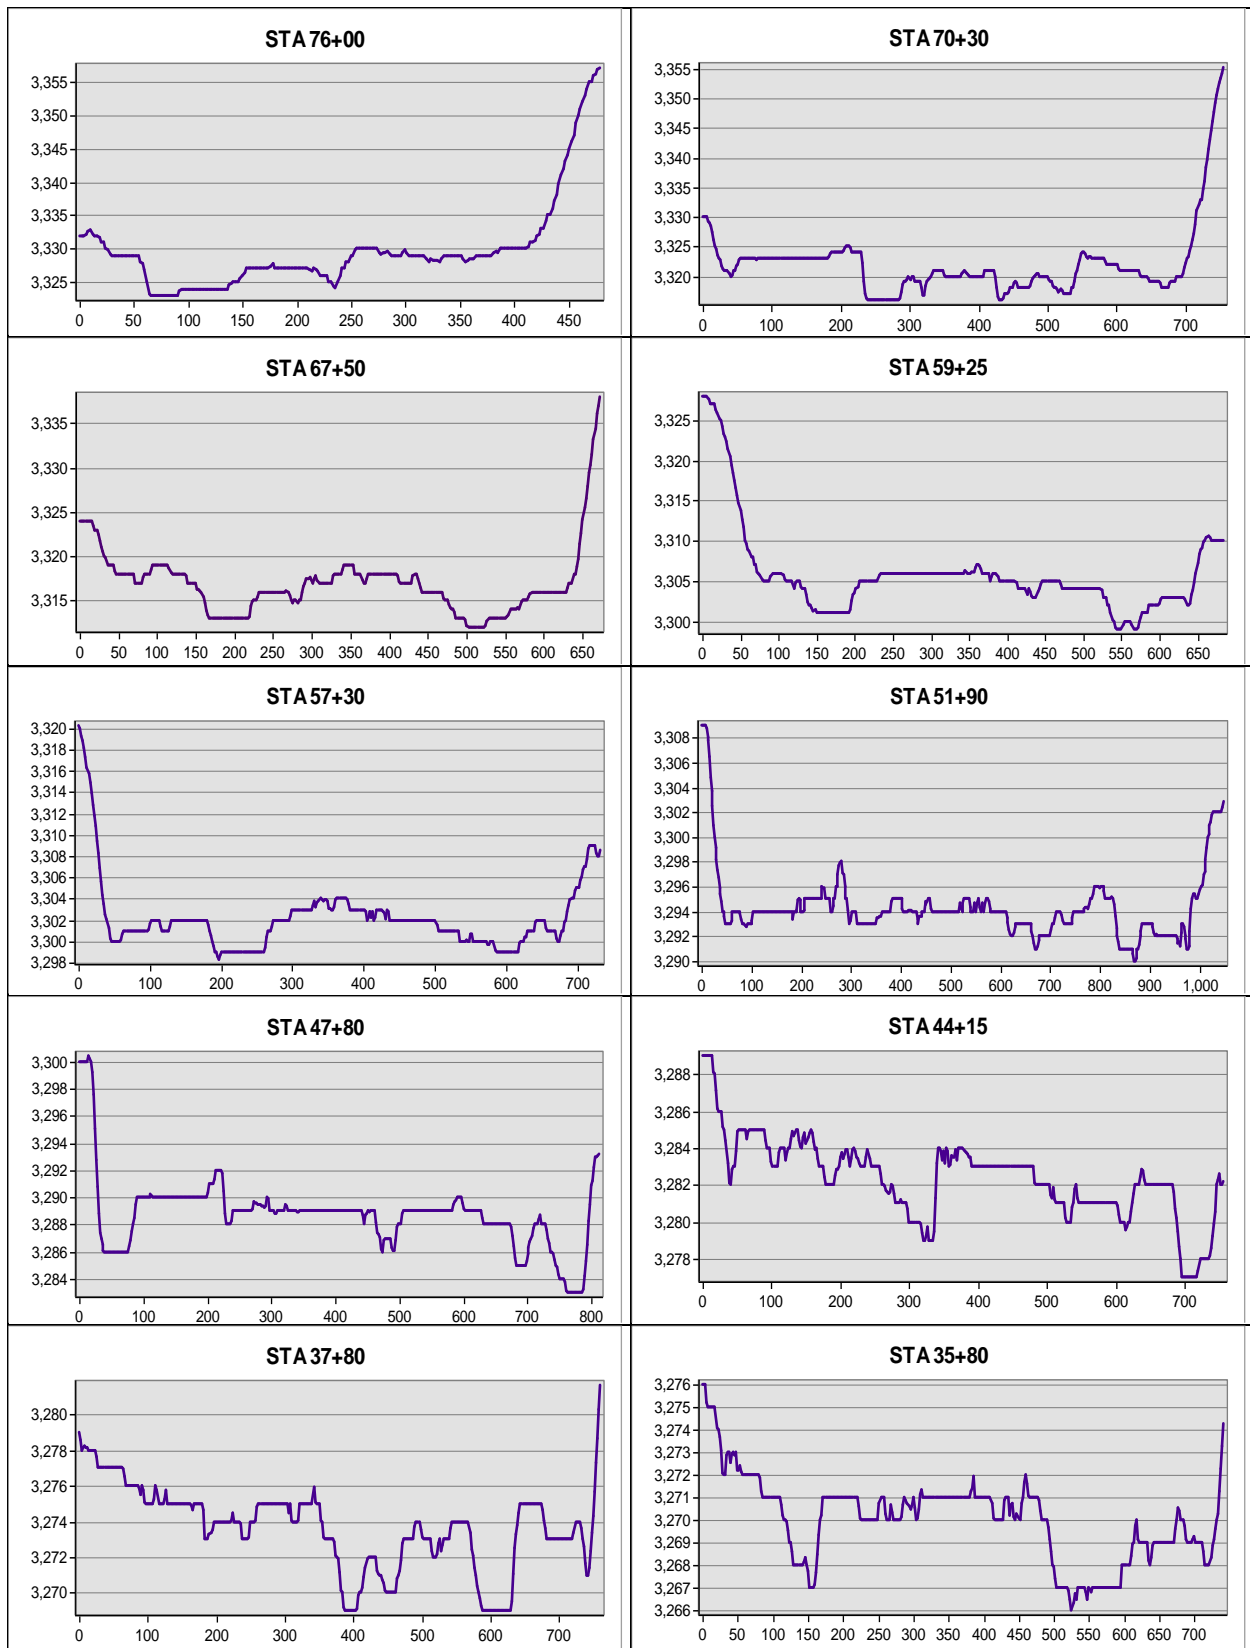
Figure 27. Cross-sections of active valley from bare-earth LiDAR (all views looking down-valley); stationing same as Figure 26.

The combination of the relative vertical position of the west channel invert 4–5 feet lower than the east channel at the road crossing, ongoing aggradation of the east channel, and floodplain channel development, preconditions exist for channel avulsion. If avulsion were to occur, substantial damage or even complete removal of the embankment to the east of the west bridge can be expected. Even in the absence of avulsion, increased pressure on the up-valley embankment face can be expected into the future.
