Beaver Creek Reach 5

15 PERCENT CONCEPT
DESIGN REPORT AND
ALTERNATIVES DRAWINGS

BEAVER CREEK REACH 5

15 PERCENT CONCEPT DESIGN REPORT

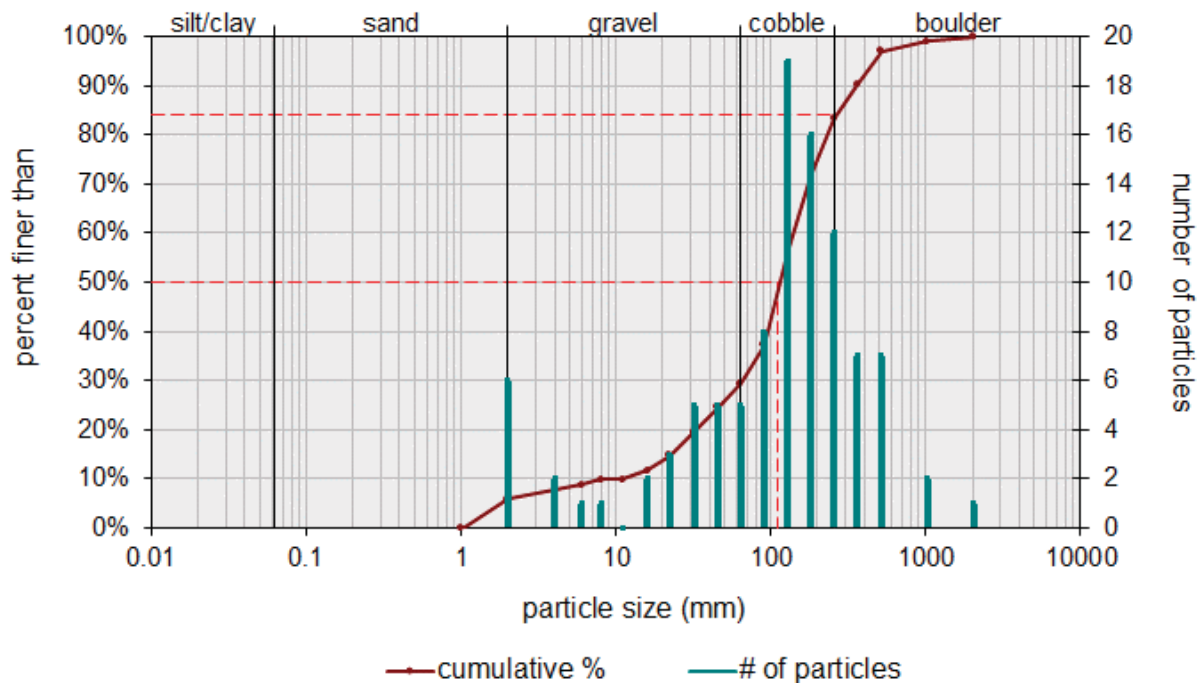
Figure 2-1. Pebble Count Grain Size Distribution in Reach 5

Beaver Creek and its tributaries have naturally high quantities of fine sediments that have been exacerbated by past management activities such as timber harvesting, roads, and cattle grazing. Post-fire rates of erosion and sediment input to Beaver Creek were extremely high following the 2014 Carlton Complex Fire and the debris flows which occurred in response to a large convective thunderstorm shortly after the fire. Within Reach 5, Piper Creek has been highly unstable and contributing large quantities of sediment to Beaver Creek since the fire. Pebble counts and ocular substrate estimates were used to characterize the existing bed sediment size distributions in Reach 5. Table 2-2 and Figure 2-1 show the bed sediment size distribution as measured at a pebble count sample site near RM 7.6.

Sediment Size		Sediment Classes	
Distribution Statistic	Sediment Size (mm)	Sediment Size Class	Percent of Total
D ₁₆	20	Sand/Silt/Clay	9%
D ₃₅	56	Gravel	33%
D ₅₀	78	Cobble	58%
D ₈₄	150	Boulder	1%
D ₉₅	190	Bedrock	0%

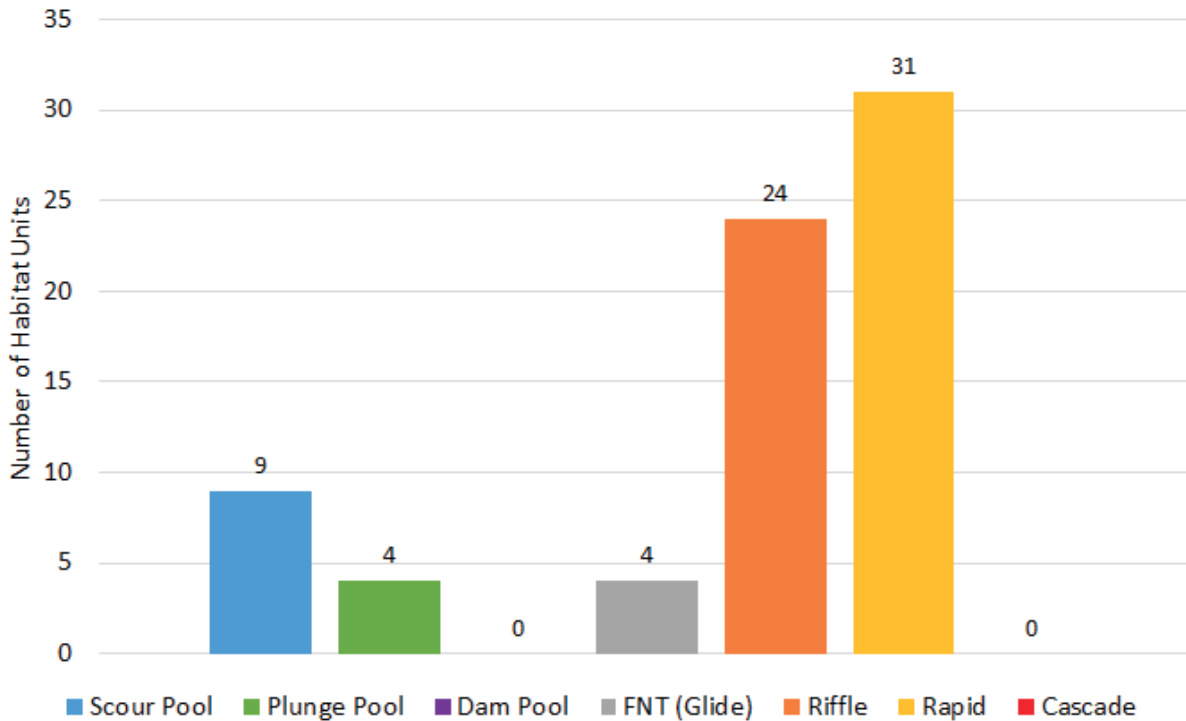
Figure 2-2. Distribution of Habitat Units in Reach 5

Habitat units were inventoried during field surveys following the USFS (2016) Level II protocols. The slow water mainstem habitat units identified during surveys included scour pools, plunge pools, and dam pools. The fast water habitat units included glides (fast non-turbulent), riffles, rapids, and cascades. Side channels were also mapped and identified as slow water or fast water. Figure 2-2 shows the distribution of habitat units in Reach 5. This reach is dominated by rapid habitat units and has the lowest frequency of pools in the Beaver Creek Reach Assessment (Tetra Tech 2017). The presence of side-channel habitat units was limited in Reach 5. Relict channel scars are more prevalent in the upstream extent of the Project area, some of which appear to be disconnected by roads in the floodplain near RM 8.9.

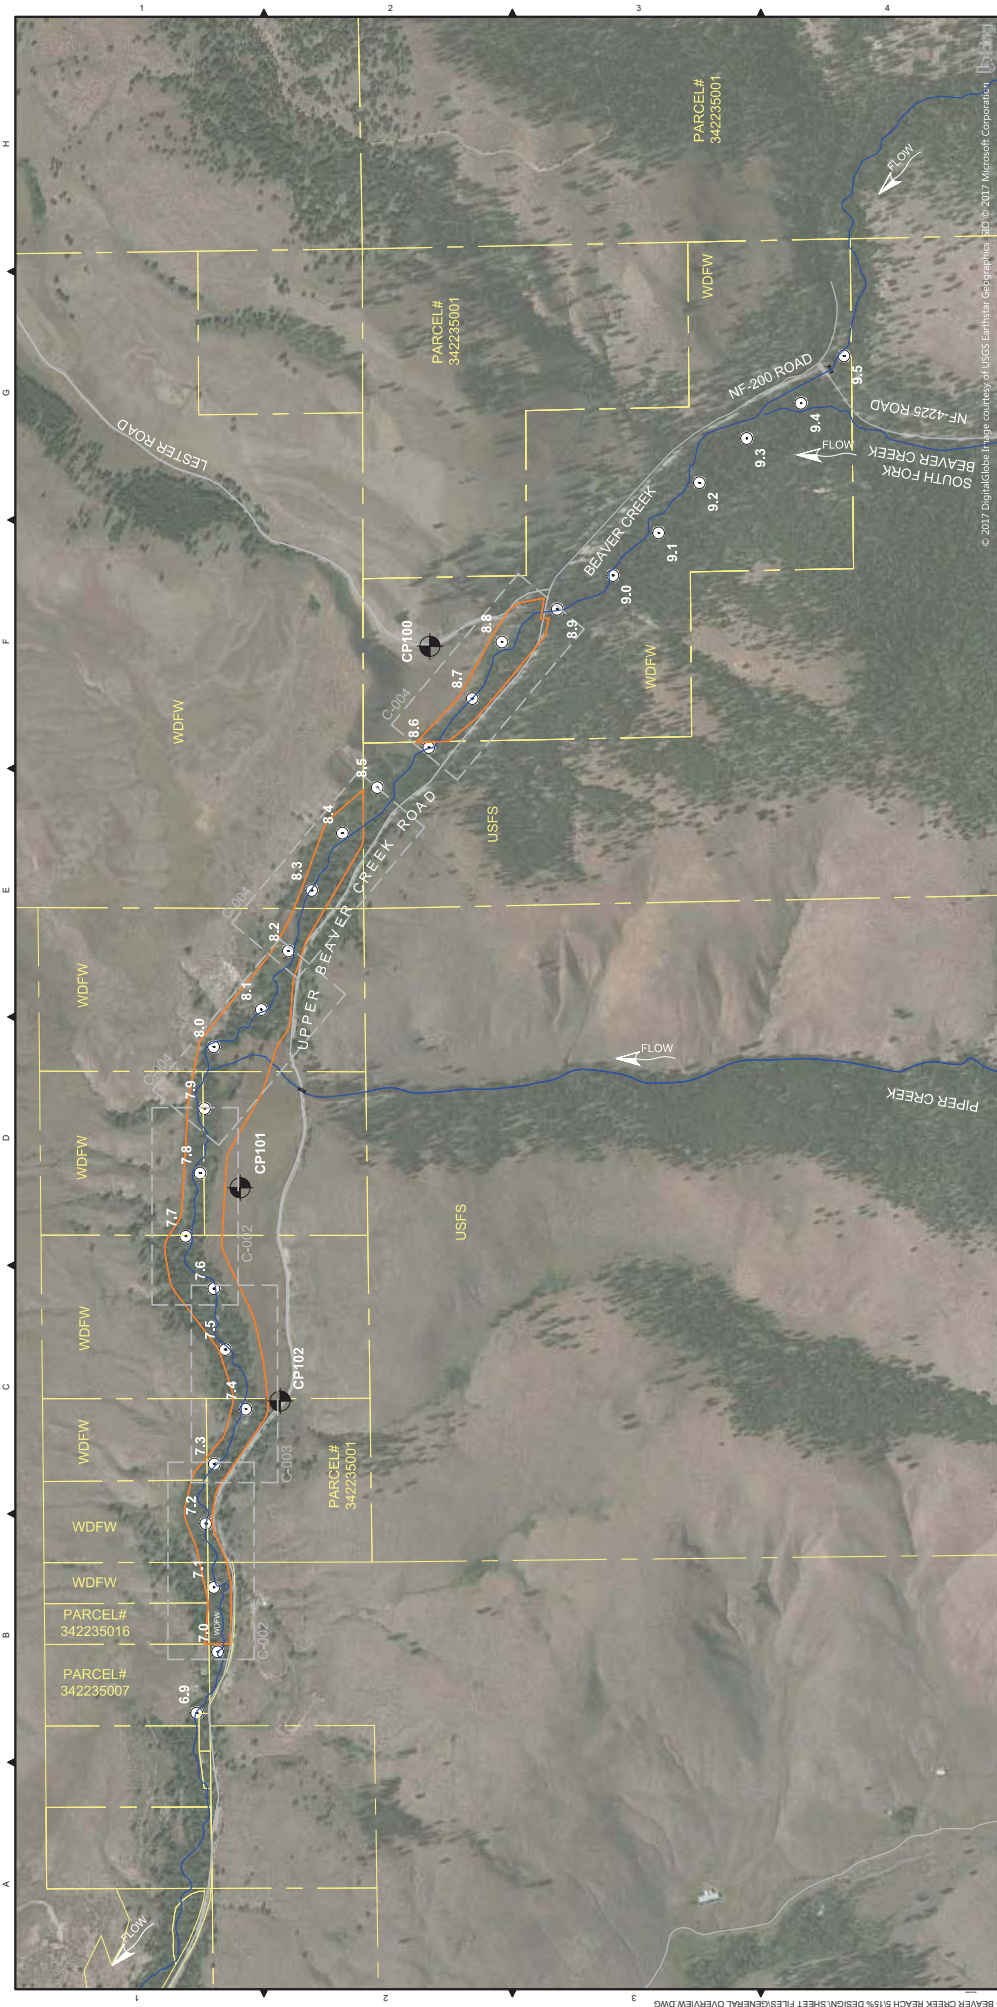
TETRA TECH www.tetratech.com 1845 N. Washington Bozeman, Washington 98011 Phone: 425-452-7600 Fax: 425-452-7652	NOT FOR CONSTRUCTION	PLOTTED AS ANSIS B (11 X 17) PLAN SHEET FULL SIZE ANSIS D (22 X 34)	DRW	ENG	APP	DWG NO.		
	YAKAMA NATION FISHERIES - BEAVER CREEK REACH 5 DESIGN	REVISION DESCRIPTION	USA	USA	USA	C-001		
		REV.	DATE				CREATED:	
		A	4/12/17				4/11/2017	
		15 PERCENT CONCEPT DESIGN				SHEET:	9 of 12	
		GENERAL OVERVIEW

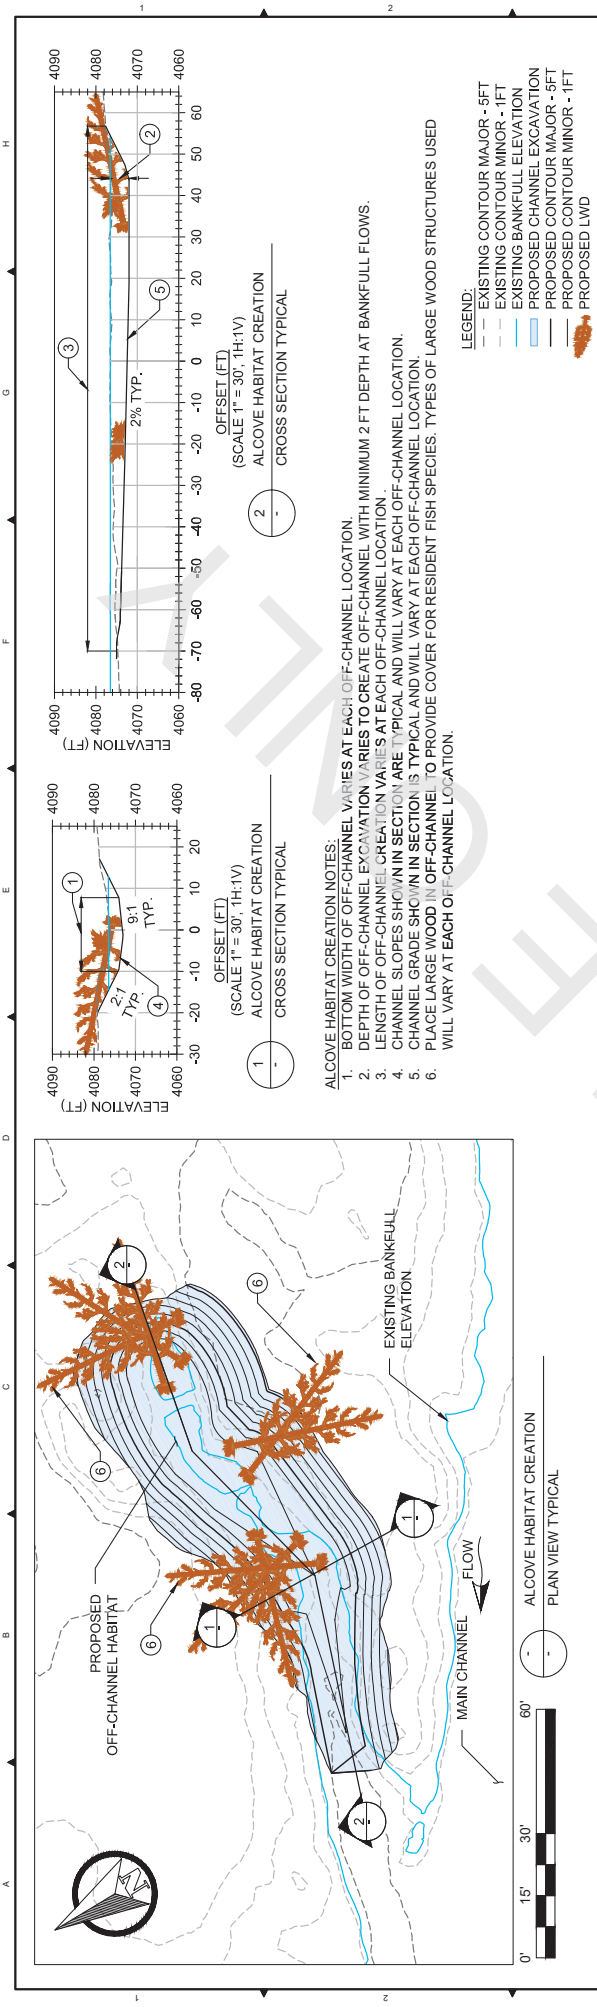
TETRA TECH www.tetrattech.com 1845 N. 19th Street Boise, Idaho 83704 Phone: 425-452-7600 Fax: 425-452-7652		DWG. NO. C-009 YAKAMA NATION FISHERIES - BEAVER CREEK REACH 5 DESIGN ALCOVE HABITAT CREATION EXAMPLE	
		DRW ENG APP USA USA USA	15 PERCENT CONCEPT DESIGN A 4/12/17
