# Appendix C

## **Project Opportunities and Prioritization**

Upper Methow River Reach Assessment

*December 2015*

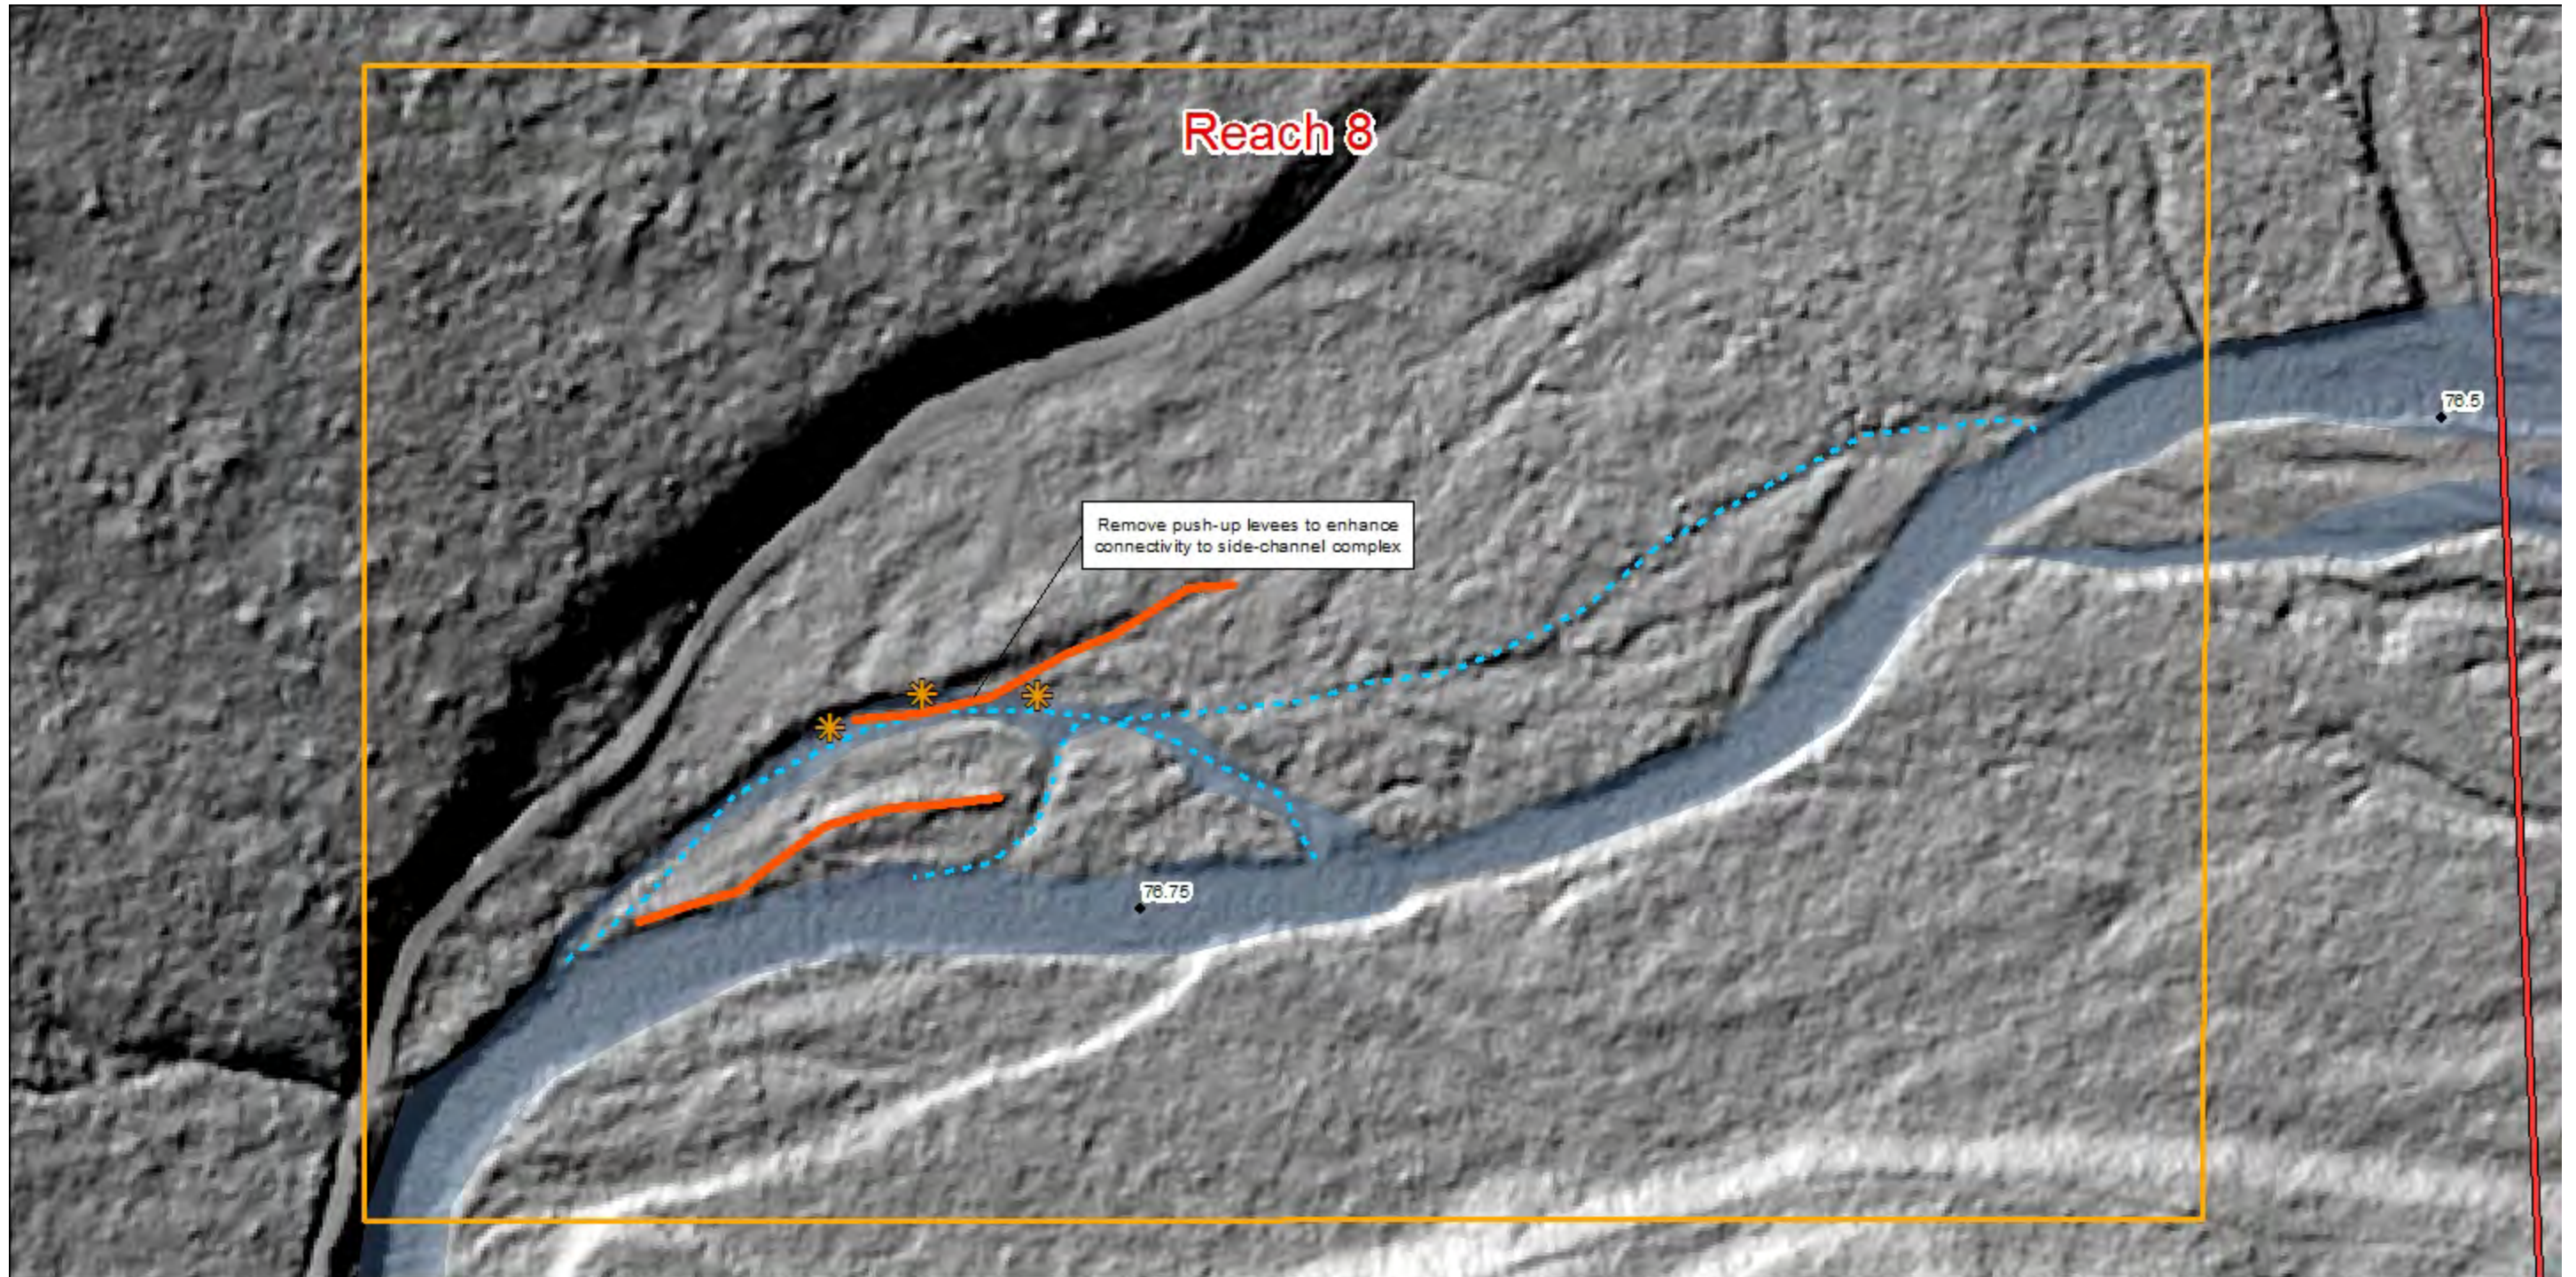
Upper Methow Reach Assessment  
 Project Opportunities  
**Ballard Project**

2006 LiDAR

These drawings should be viewed only as very preliminary concepts intended to describe the type of potential restoration work that could be performed. Additional site investigations and analysis will be necessary to determine specific treatment types and locations.

Reach	Project RM	Project Name	Project Description	Considerations
9		No Projects Identified		Well-functioning reach with high instream and off-channel complexity. Recent disturbance contributing abundant large wood.
8		Ballard Project	<p><b>Narrative</b> This project would remove push up levees and bank armoring (much of it naturally sourced) and activate river-left side-channels and floodplain adjacent to the US Forest Service campground. This is a fairly small project, and there are potential impacts to the campground (e.g. erosion potential) that would need to be further evaluated.</p> <p><b>Project Elements</b></p> <ul style="list-style-type: none"> <li>• RM 76.7 – 76.85 river-left: Remove push-up levees and bank armoring at campground</li> <li>• RM 76.6 – 76.85 river-left: Enhance side-channel connectivity and habitat at Ballard Campground. Add log jam in mainstem to enhance flow in side-channel. Add wood to side-channel complex. Riparian revegetation in campground area.</li> </ul>	<p>Erosion risk at campground would need to be evaluated and addressed (if necessary) as part of this project.</p> <p>Wood placements need to account for potential river recreational uses.</p>

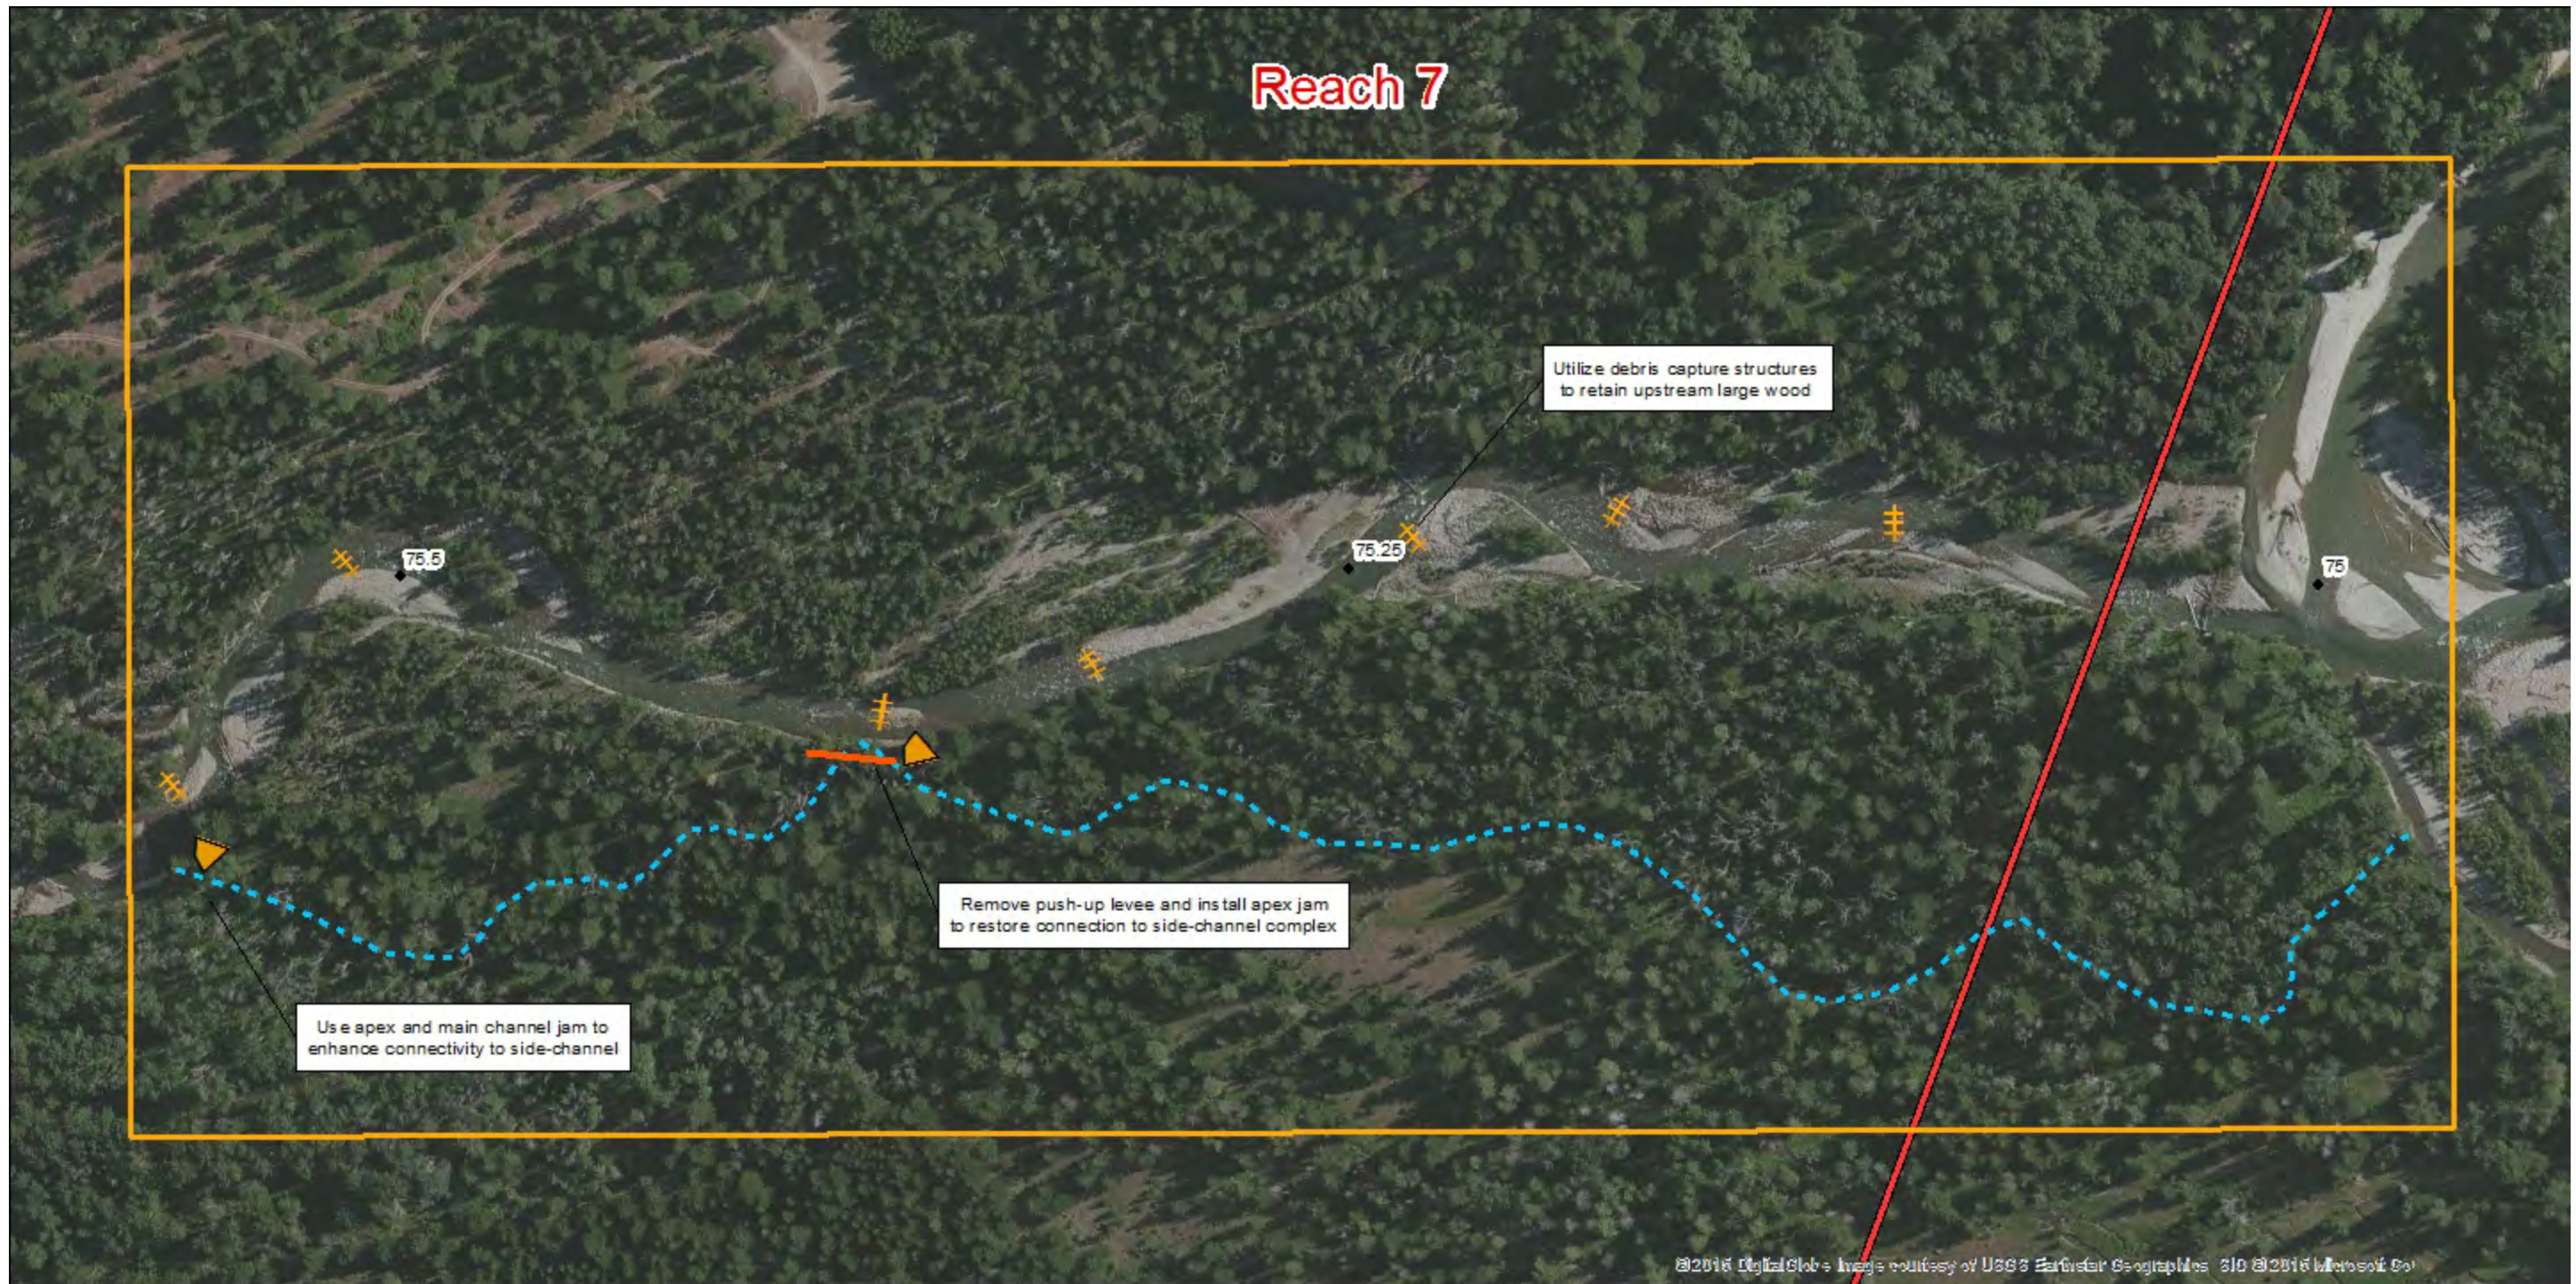
**Upper Methow Reach Assessment**  
*Project Opportunities*  
**Two Rivers Project**

These drawings should be viewed only as very preliminary concepts intended to describe the type of potential restoration work that could be performed. Additional site investigations and analysis will be necessary to determine specific treatment types and locations

Recent Bing Aerial Image

Reach	Project RM	Project Name	Project Description	Considerations
7		Two Rivers Project	<p><b>Narrative</b> The Two Rivers Project includes the reconnection of side-channels in the river-right floodplain via removal of a push-up levee, construction of apex log jams, and potentially select excavation within the side-channel alignment. The push-up levee is approximately 130 feet long and three feet tall and could be graded back into the floodplain. The primary side-channel to be reconnected is 2,400 feet long and joins back to the Methow River just downstream of the Lost River confluence in Reach 6. There is another side-channel upstream that could potentially connect into the main side-channel. This upstream side-channel is approximately 1,000 feet long. The connectivity of this side-channel would also be enhanced by removal of the levee, which is at the downstream end. Construction of an apex log jam and select excavation at the entrance would further enhance connectivity.</p> <p><b>Project Elements</b></p> <ul style="list-style-type: none"> <li>• RM 75.6 river-right: add apex jam and mainstem LW capture jam to initiate river-right side-channel</li> <li>• RM 75.4 river-right: remove push-up levee to reconnect 2,400-ft long river-right side-channel</li> <li>• Entire project area: Main channel jams including LW capture jams to capture LW and form stable, vegetated, mid-channel islands and split flow. Place jams strategically to encourage erosion into banks with mature forests and to discourage erosion into banks with young forest.</li> </ul>	<p>Very little infrastructure at risk.</p> <p>Wood placements need to account for potential river recreational uses.</p>

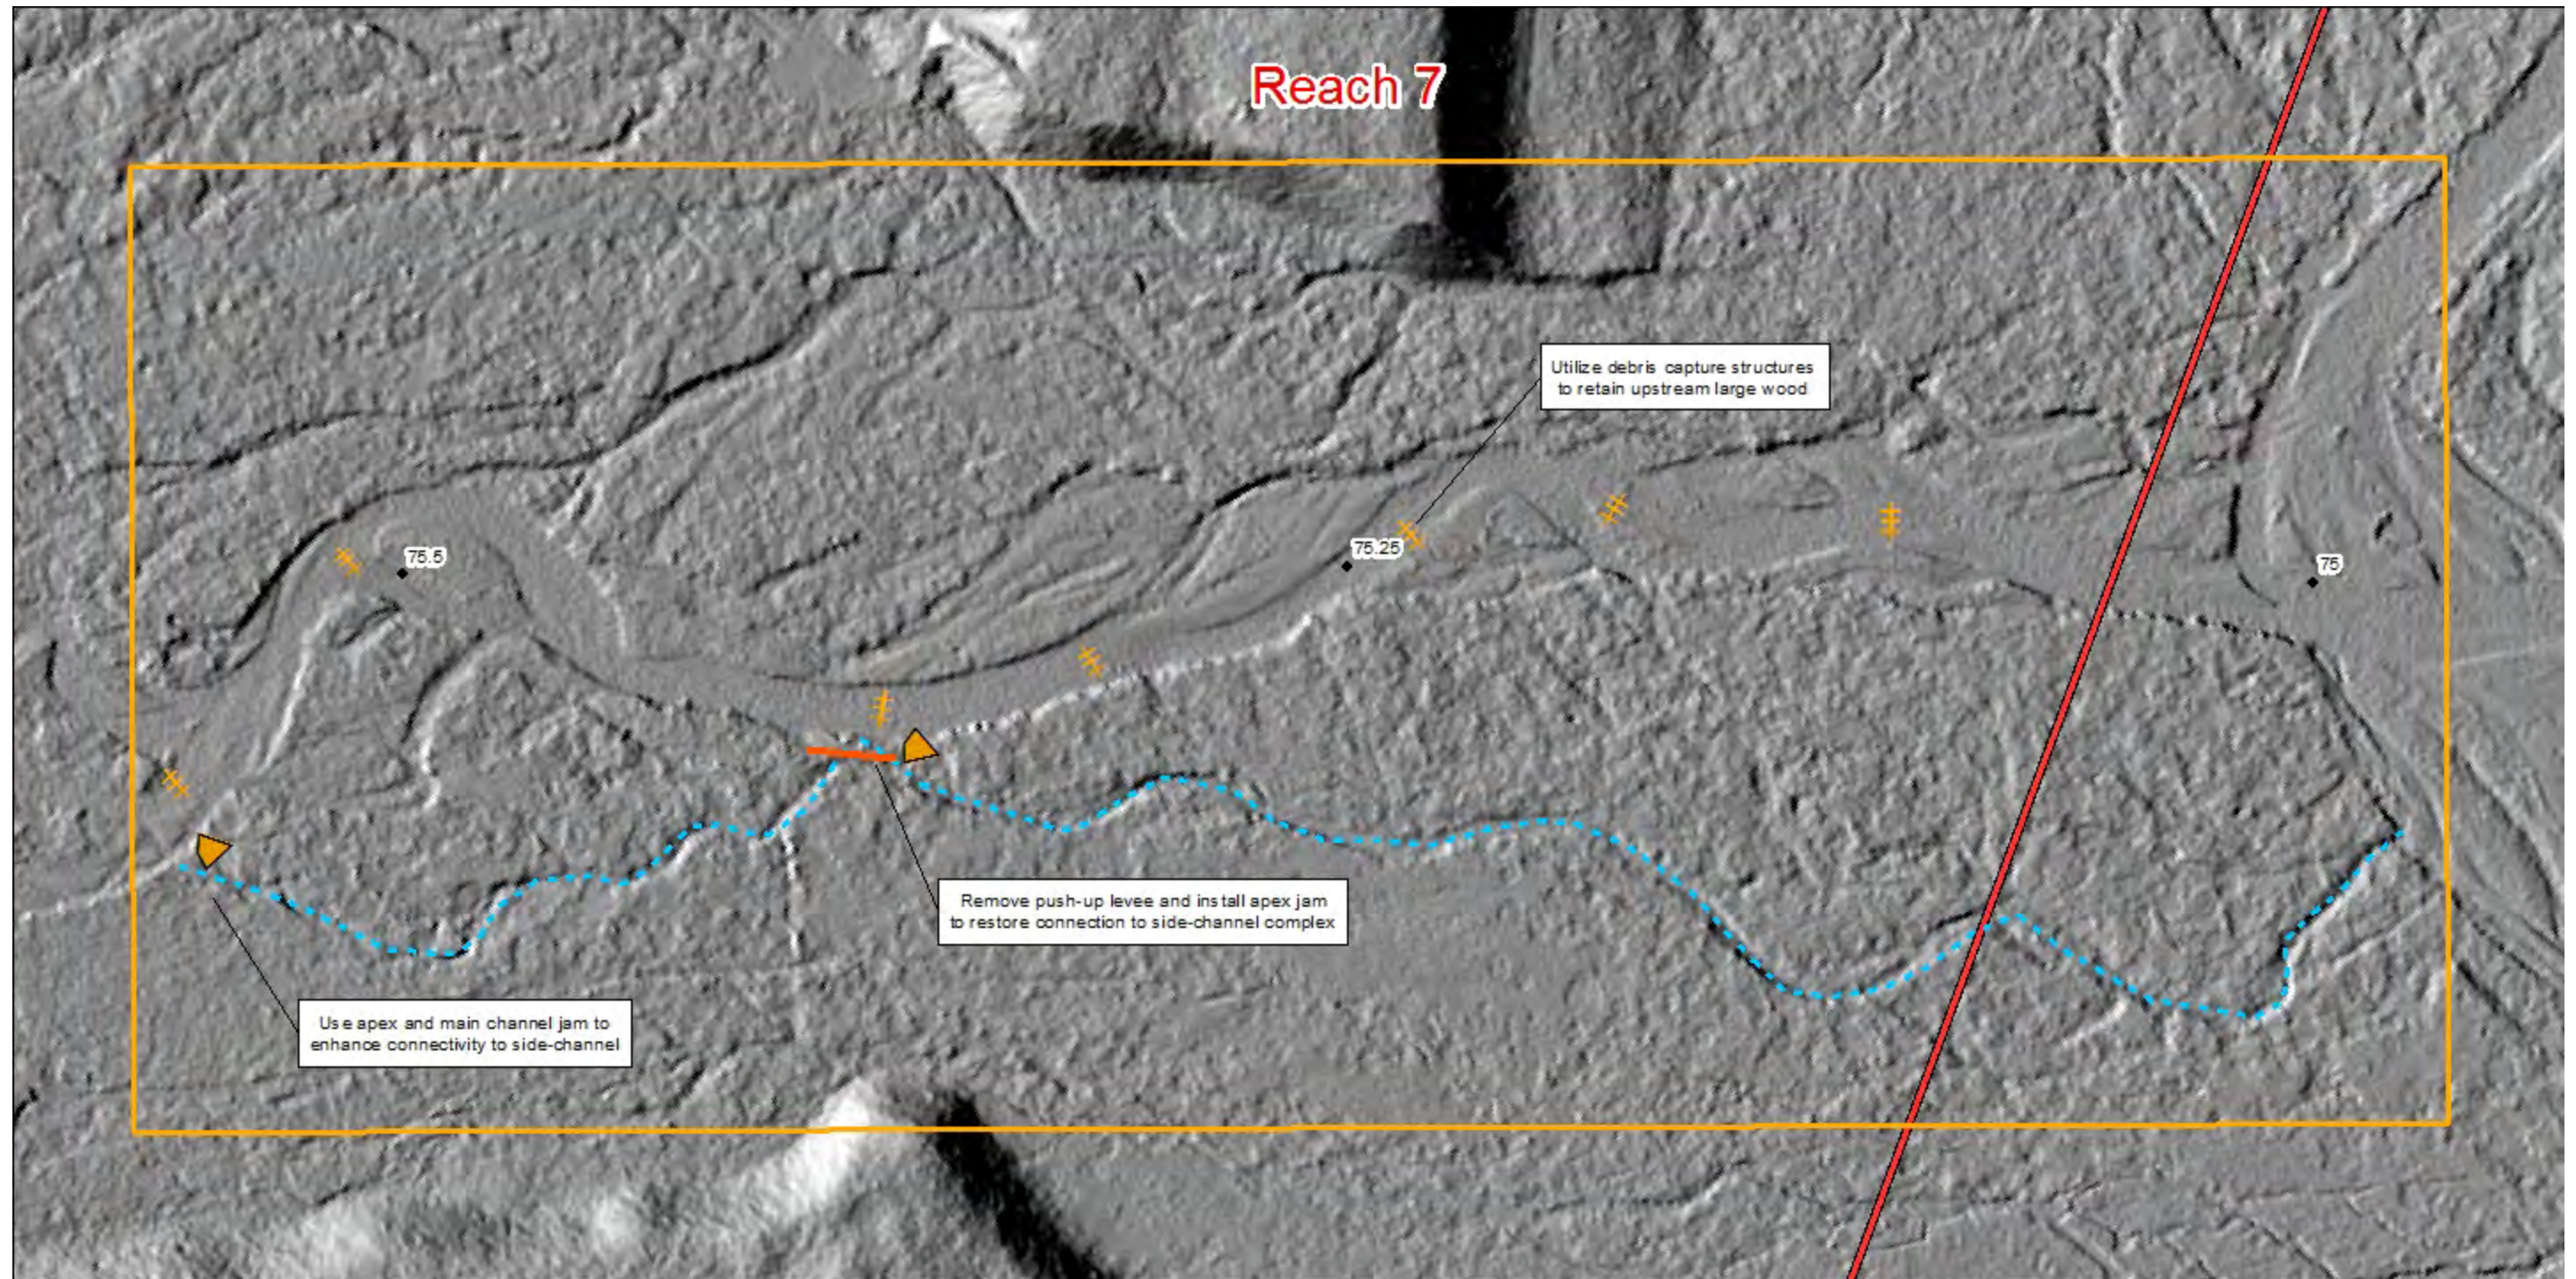
**Upper Methow Reach Assessment**  
*Project Opportunities*  
**Two Rivers Project**

2006 LiDAR

These drawings should be viewed only as very preliminary concepts intended to describe the type of potential restoration work that could be performed. Additional site investigations and analysis will be necessary to determine specific treatment types and locations.

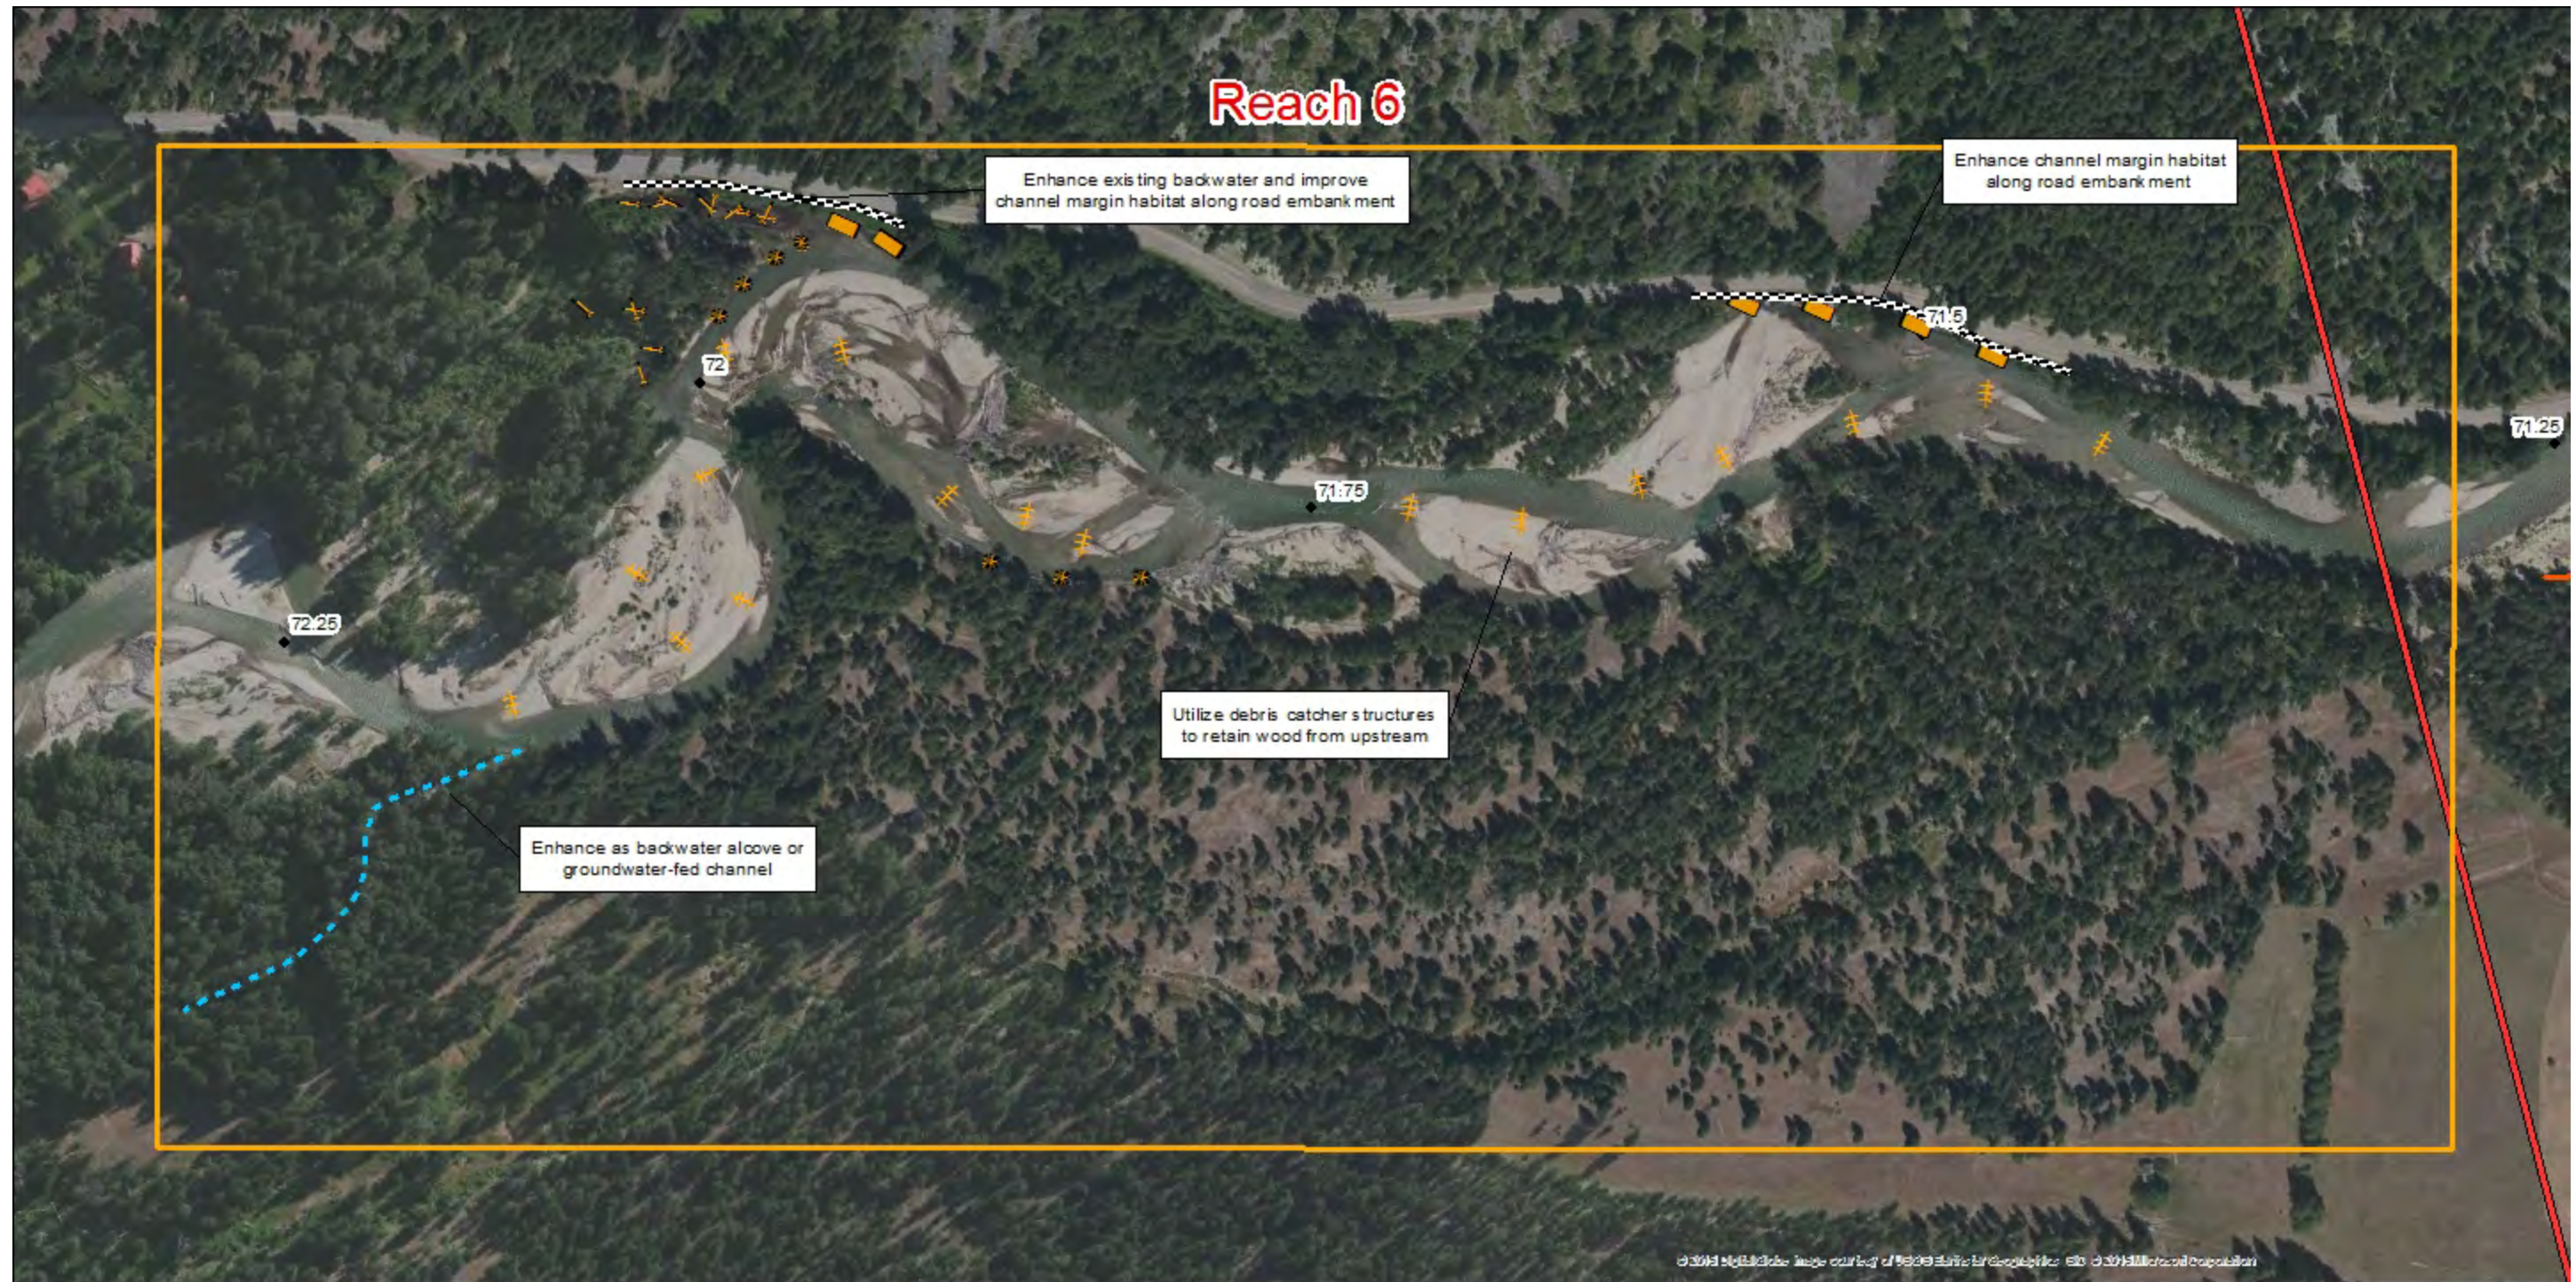
**Upper Methow Reach Assessment**  
*Project Opportunities*  
**Gate Creek Project**

These drawings should be viewed only as very preliminary concepts intended to describe the type of potential restoration work that could be performed. Additional site investigations and analysis will be necessary to determine specific treatment types and locations.

Recent Bing Aerial Imagery

3	Gate Creek	6	71.30	72.30	1.00	5	6	1	Moderate to high existing. Moderate to high potential given lack of significant infrastructure	2	Moderate spawning use. Assumed rearing but seasonally dry conditions may affect usability	2	Mostly enhancement	5	2	Moderately dense mainstem log jams. Engineered jams on margins. Some access challenges	2.5	Moderate - High	Private lands on river-right but little infrastructure. USFS and road on river-left.
	Ballard	8	76.50	76.90	0.40	6	6.5	0.5	Moderate to high existing. High potential given lack of significant infrastructure	1.5	Mainly riffle habitat. Only one redd on record	3	Levee removals	5	1	No main channel work. Levee spoils likely spoiled on site	5.0	Moderate	Campground protection needs to be considered
	Two Rivers	7	74.90	75.60	0.70	6	6.5	0.5	Moderate to high existing. High potential given lack of significant infrastructure	1.5	Limited spawning use. Unknown rearing use. Rarely dewaterers	2.5	Combination of Recovery (levee removal) and Enhancement (log jams)	4.5	2	Mod dense main channel jams. Small levee can be spoiled on site. Mod access requirements	2.3	High	USFS land. No infrastructure at risk

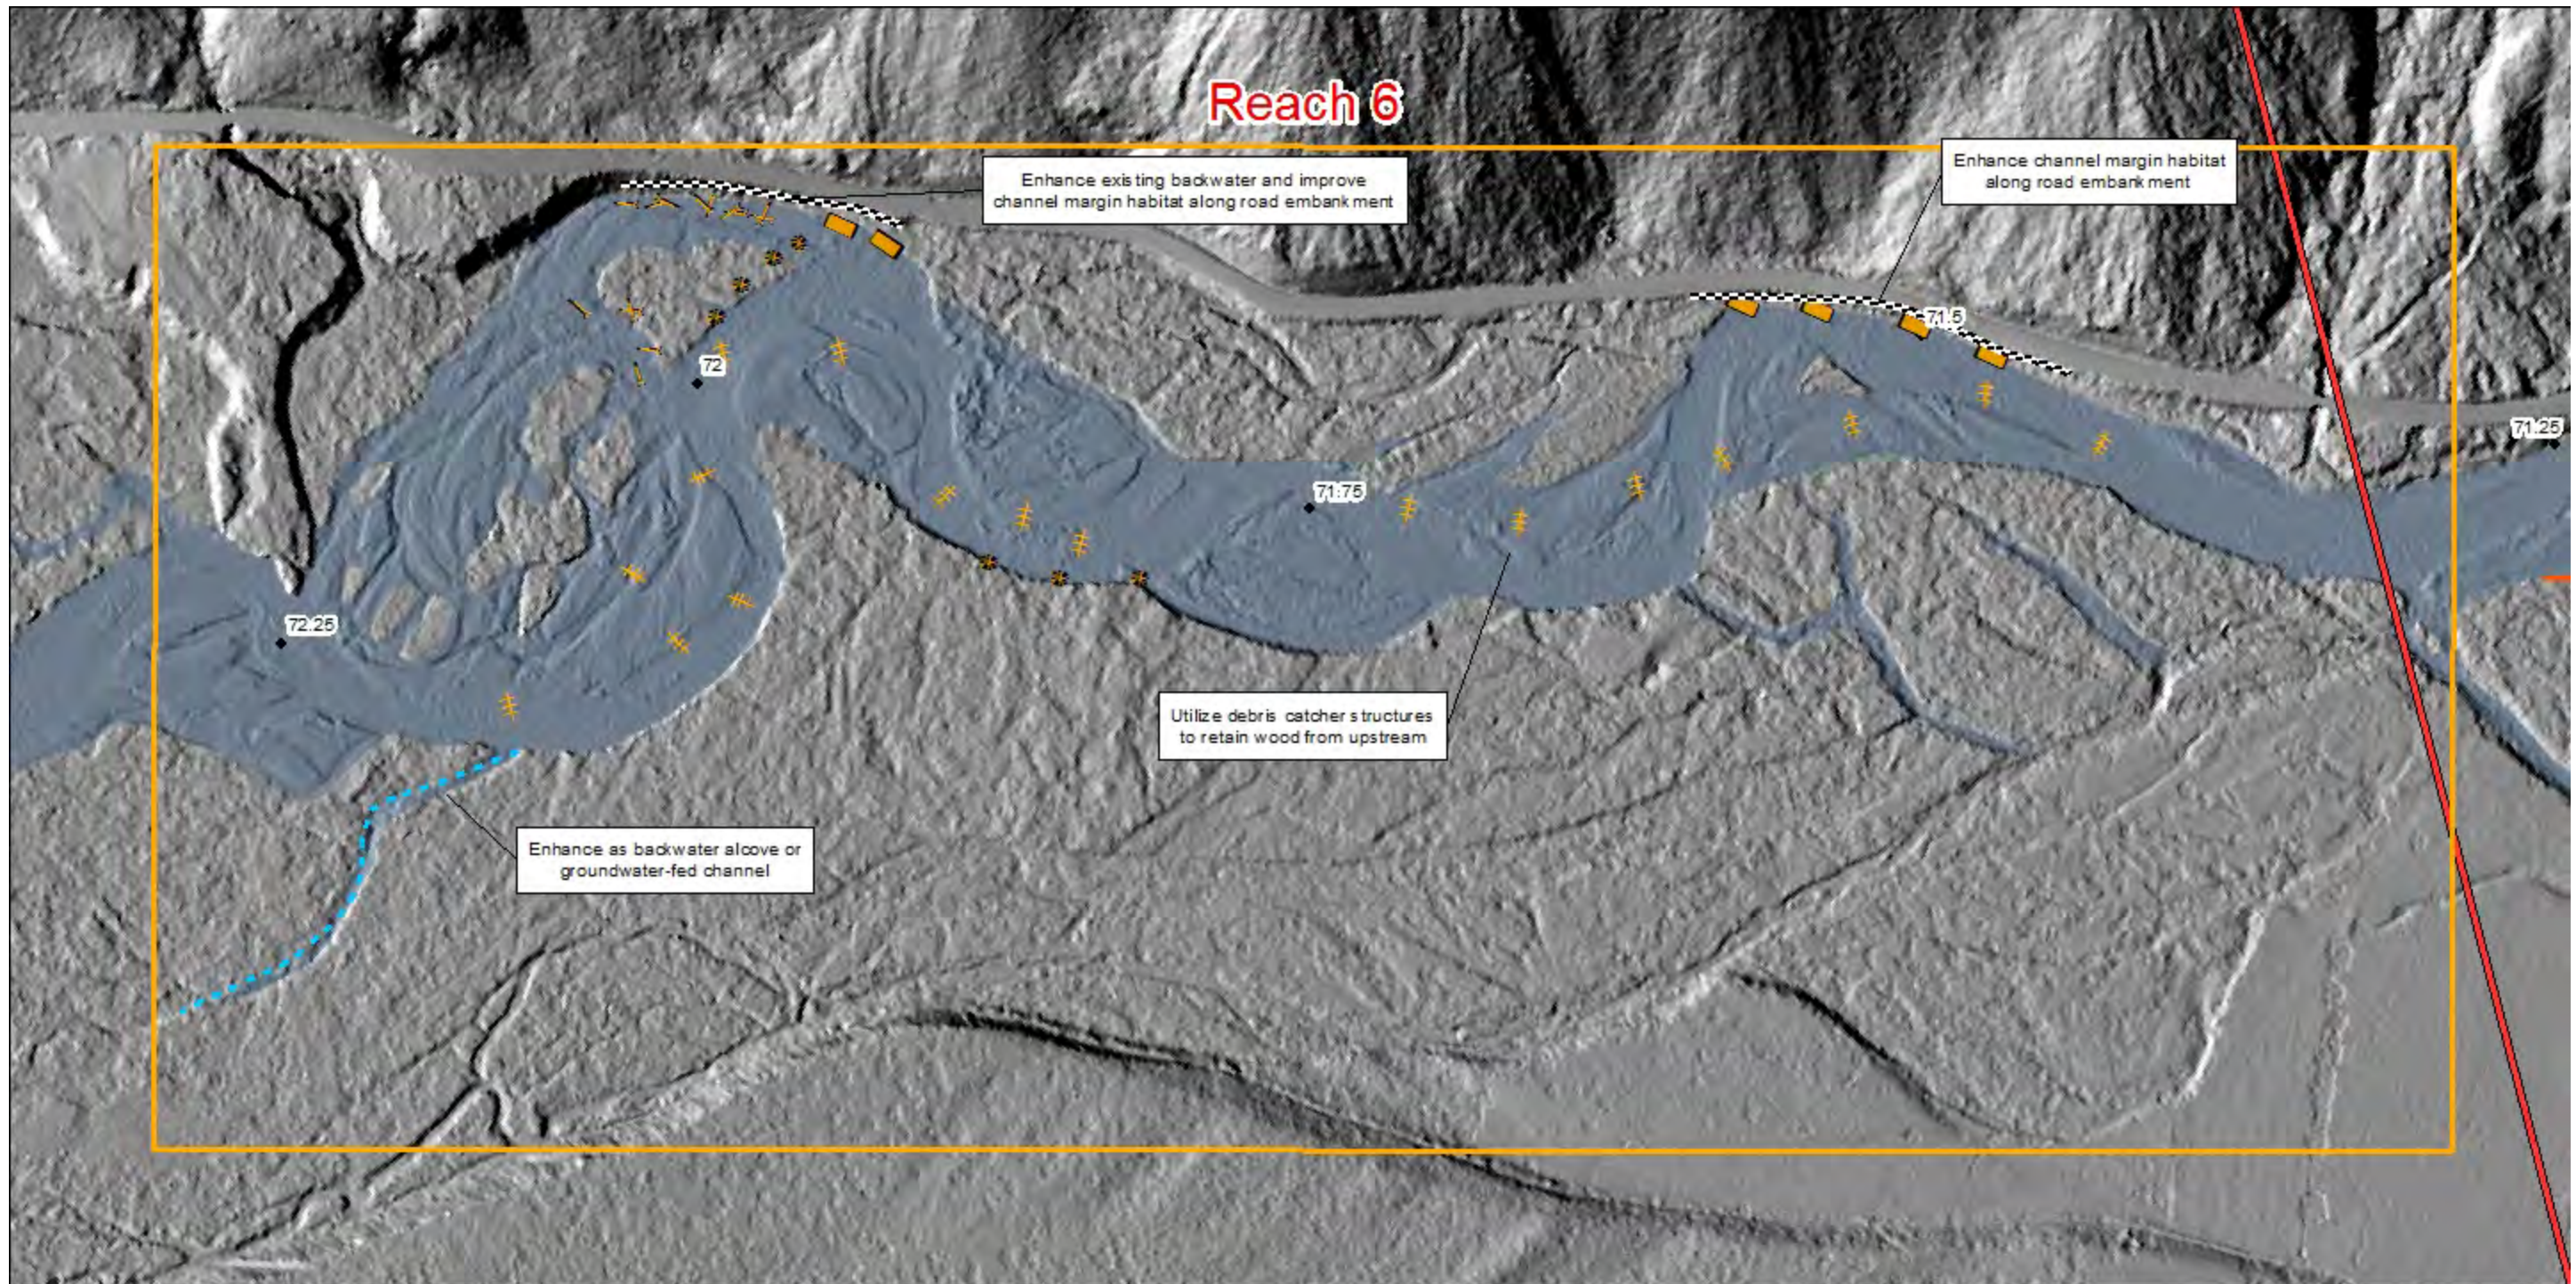
**Upper Methow Reach Assessment**  
*Project Opportunities*  
**Gate Creek Project**

2006 LiDAR

These drawings should be viewed only as very preliminary concepts intended to describe the type of potential restoration work that could be performed. Additional site investigations and analysis will be necessary to determine specific treatment types and locations.

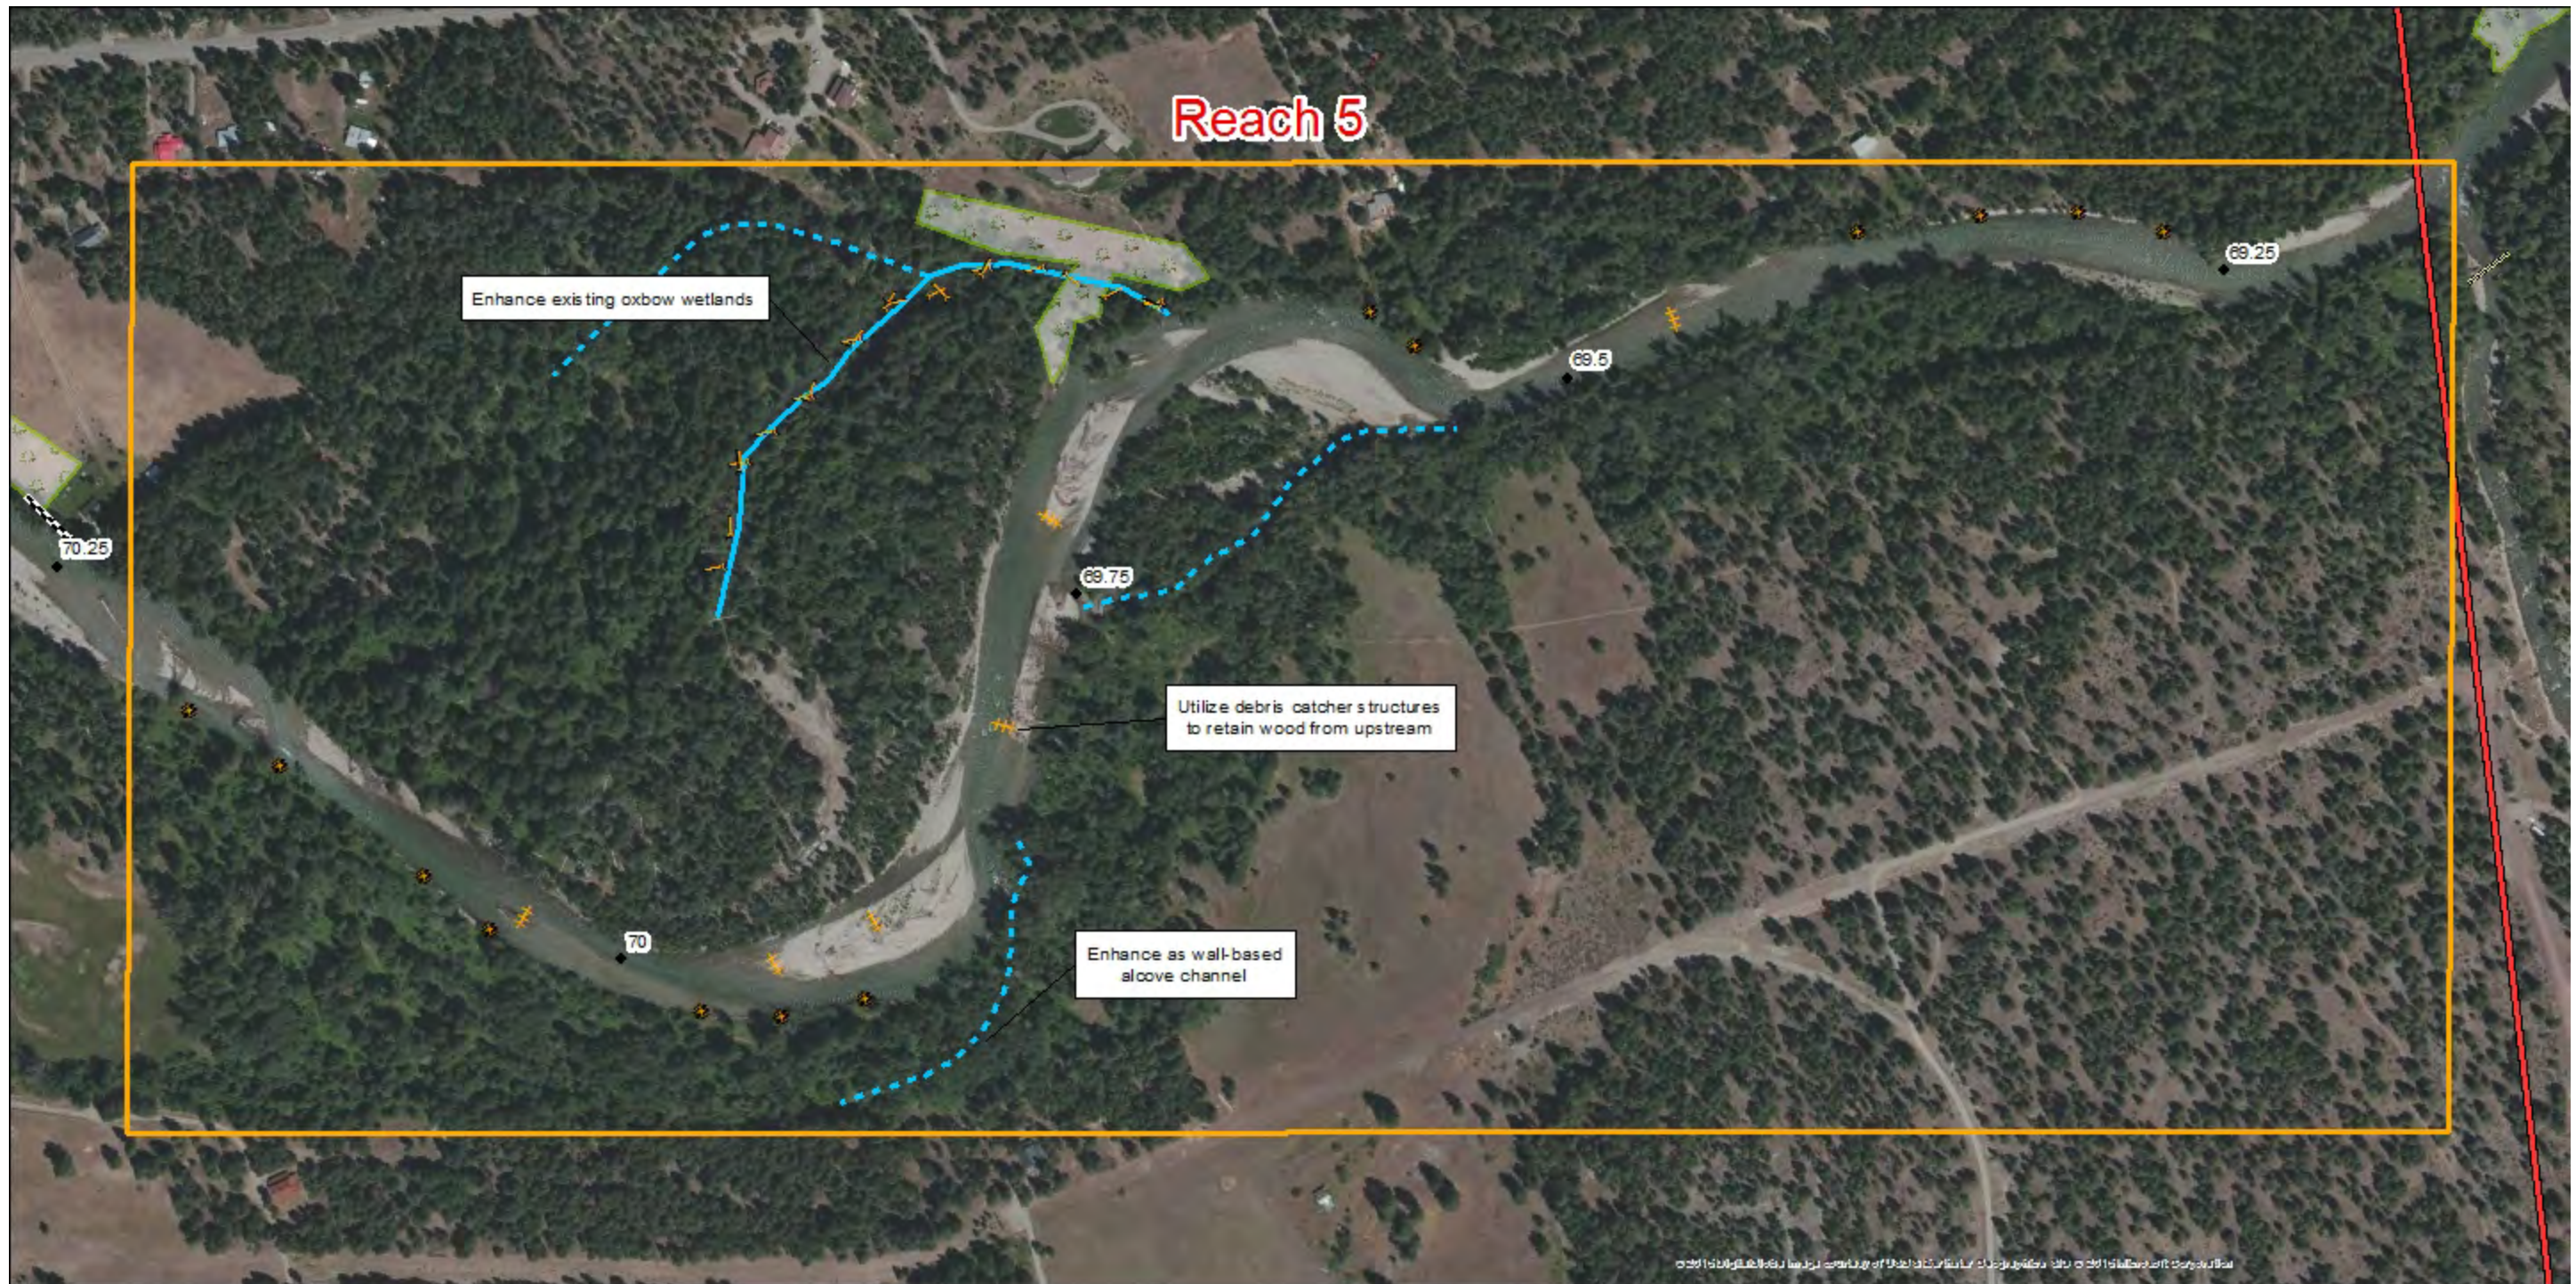
**Upper Methow Reach Assessment**  
*Project Opportunities*  
**A-Wall Project**

These drawings should be viewed only as very preliminary concepts intended to describe the type of potential restoration work that could be performed. Additional site investigations and analysis will be necessary to determine specific treatment types and locations.

Recent Bing Aerial Imagery
