# Appendix C

## **Project Opportunities and Prioritization**

Upper Methow River Reach Assessment

*December 2015*

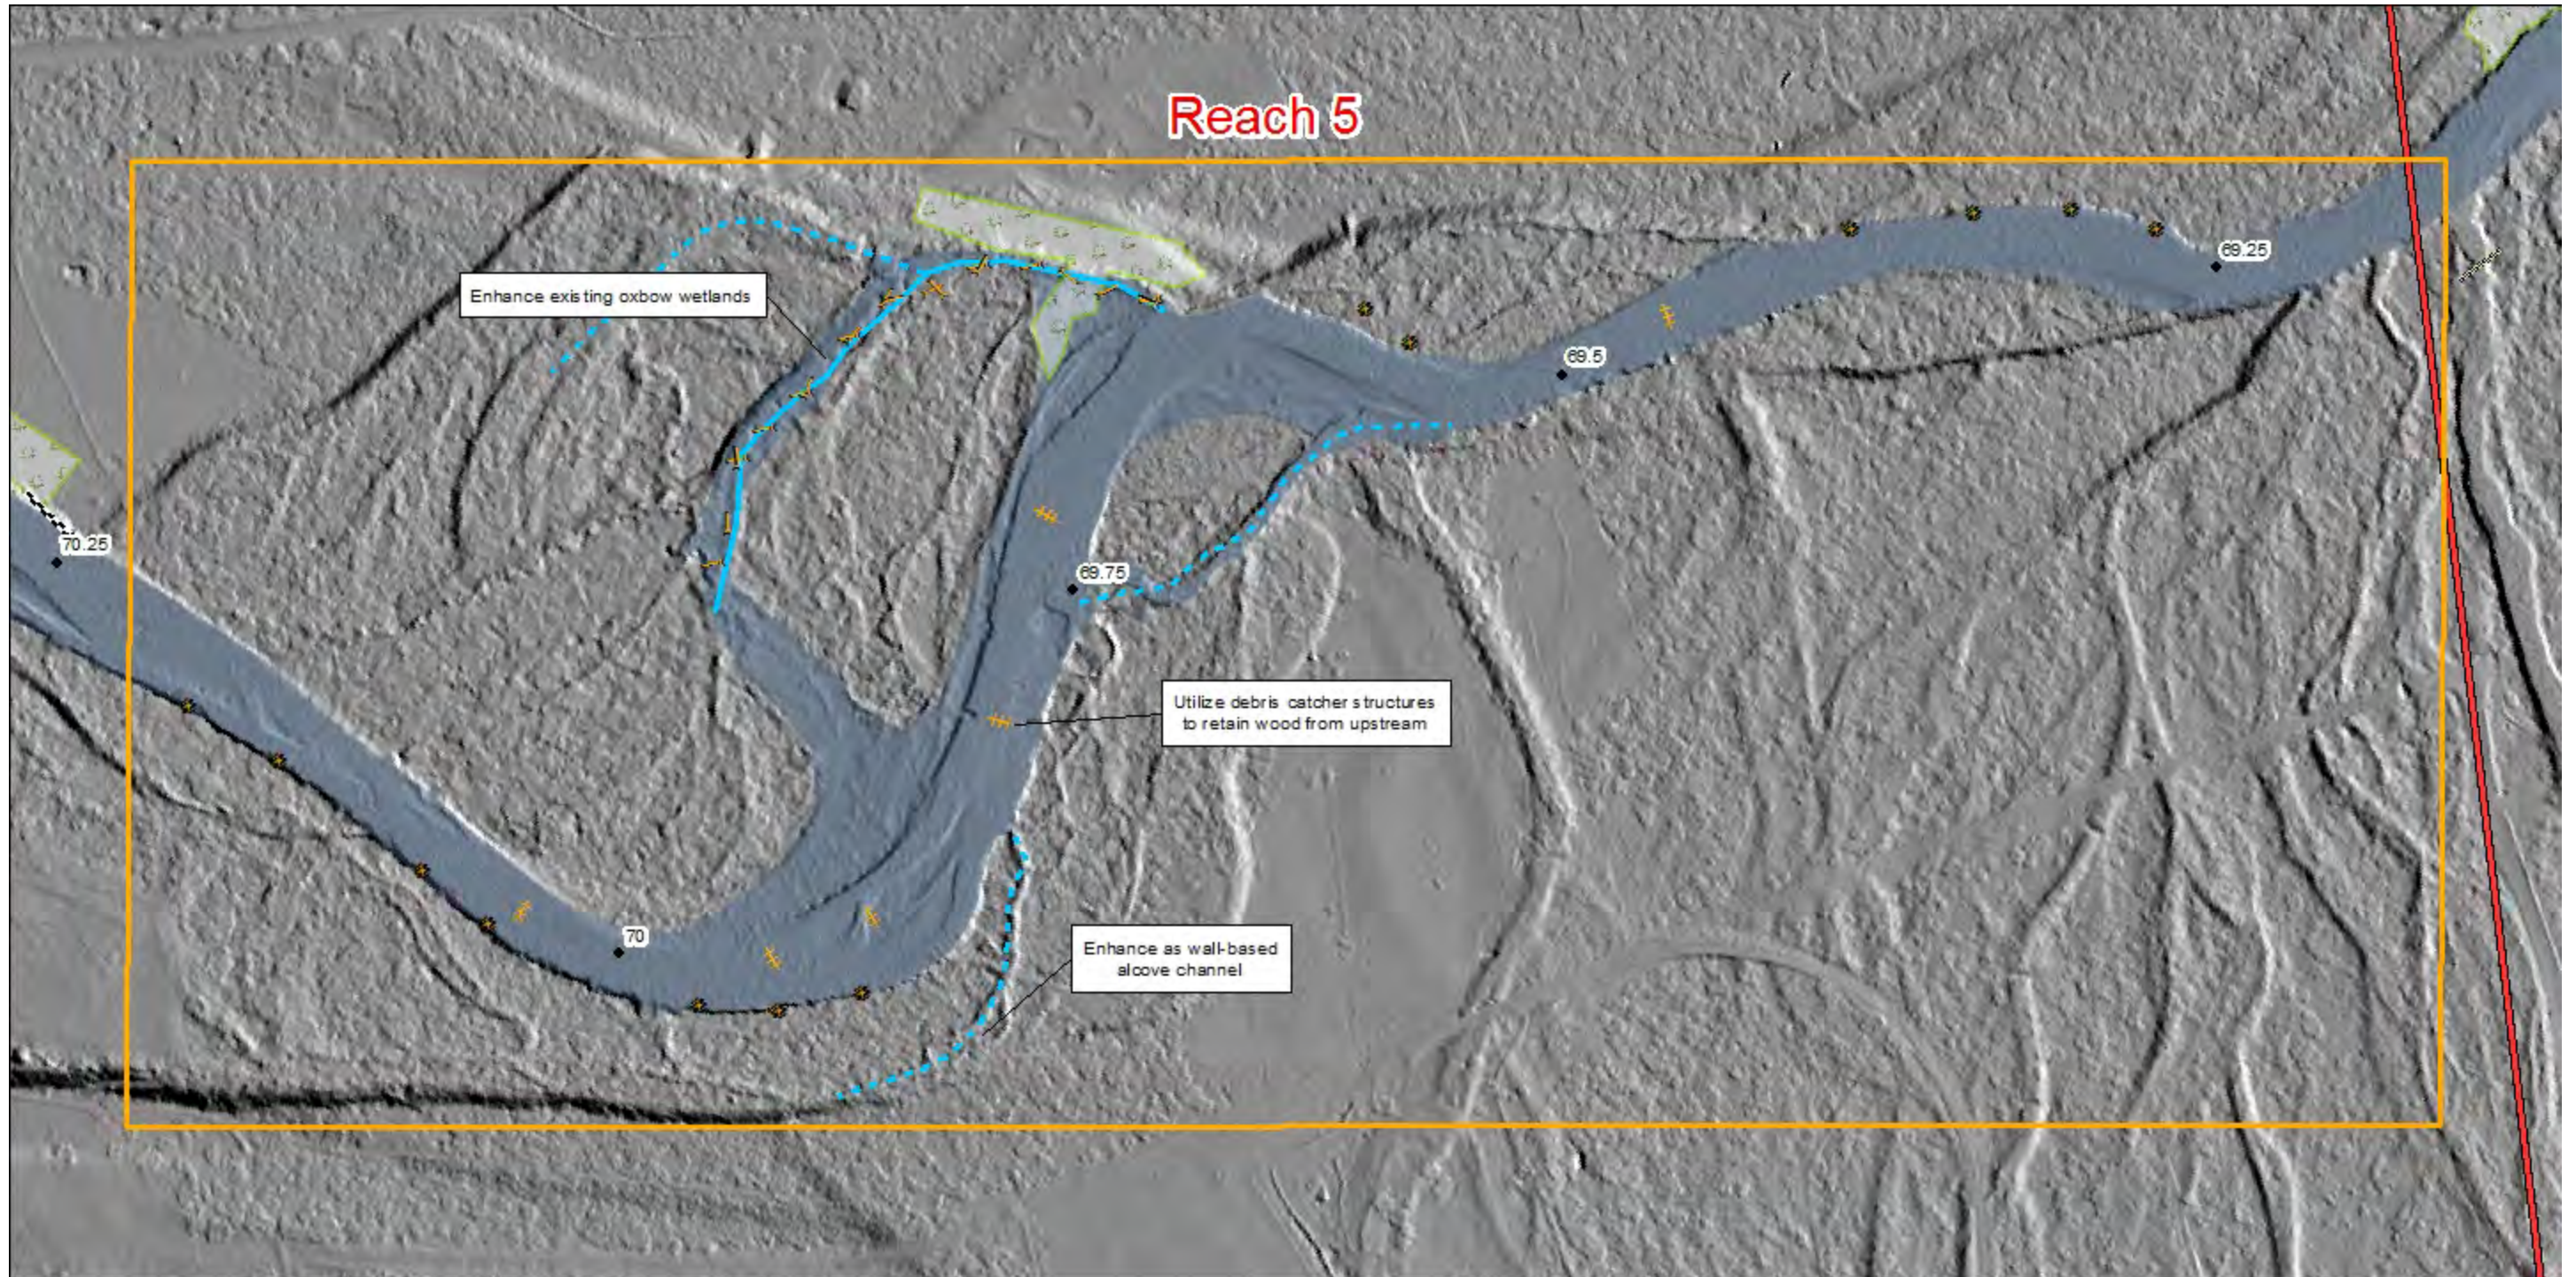
**Upper Methow Reach Assessment**  
*Project Opportunities*  
**A-Wall Project**

2006 LiDAR

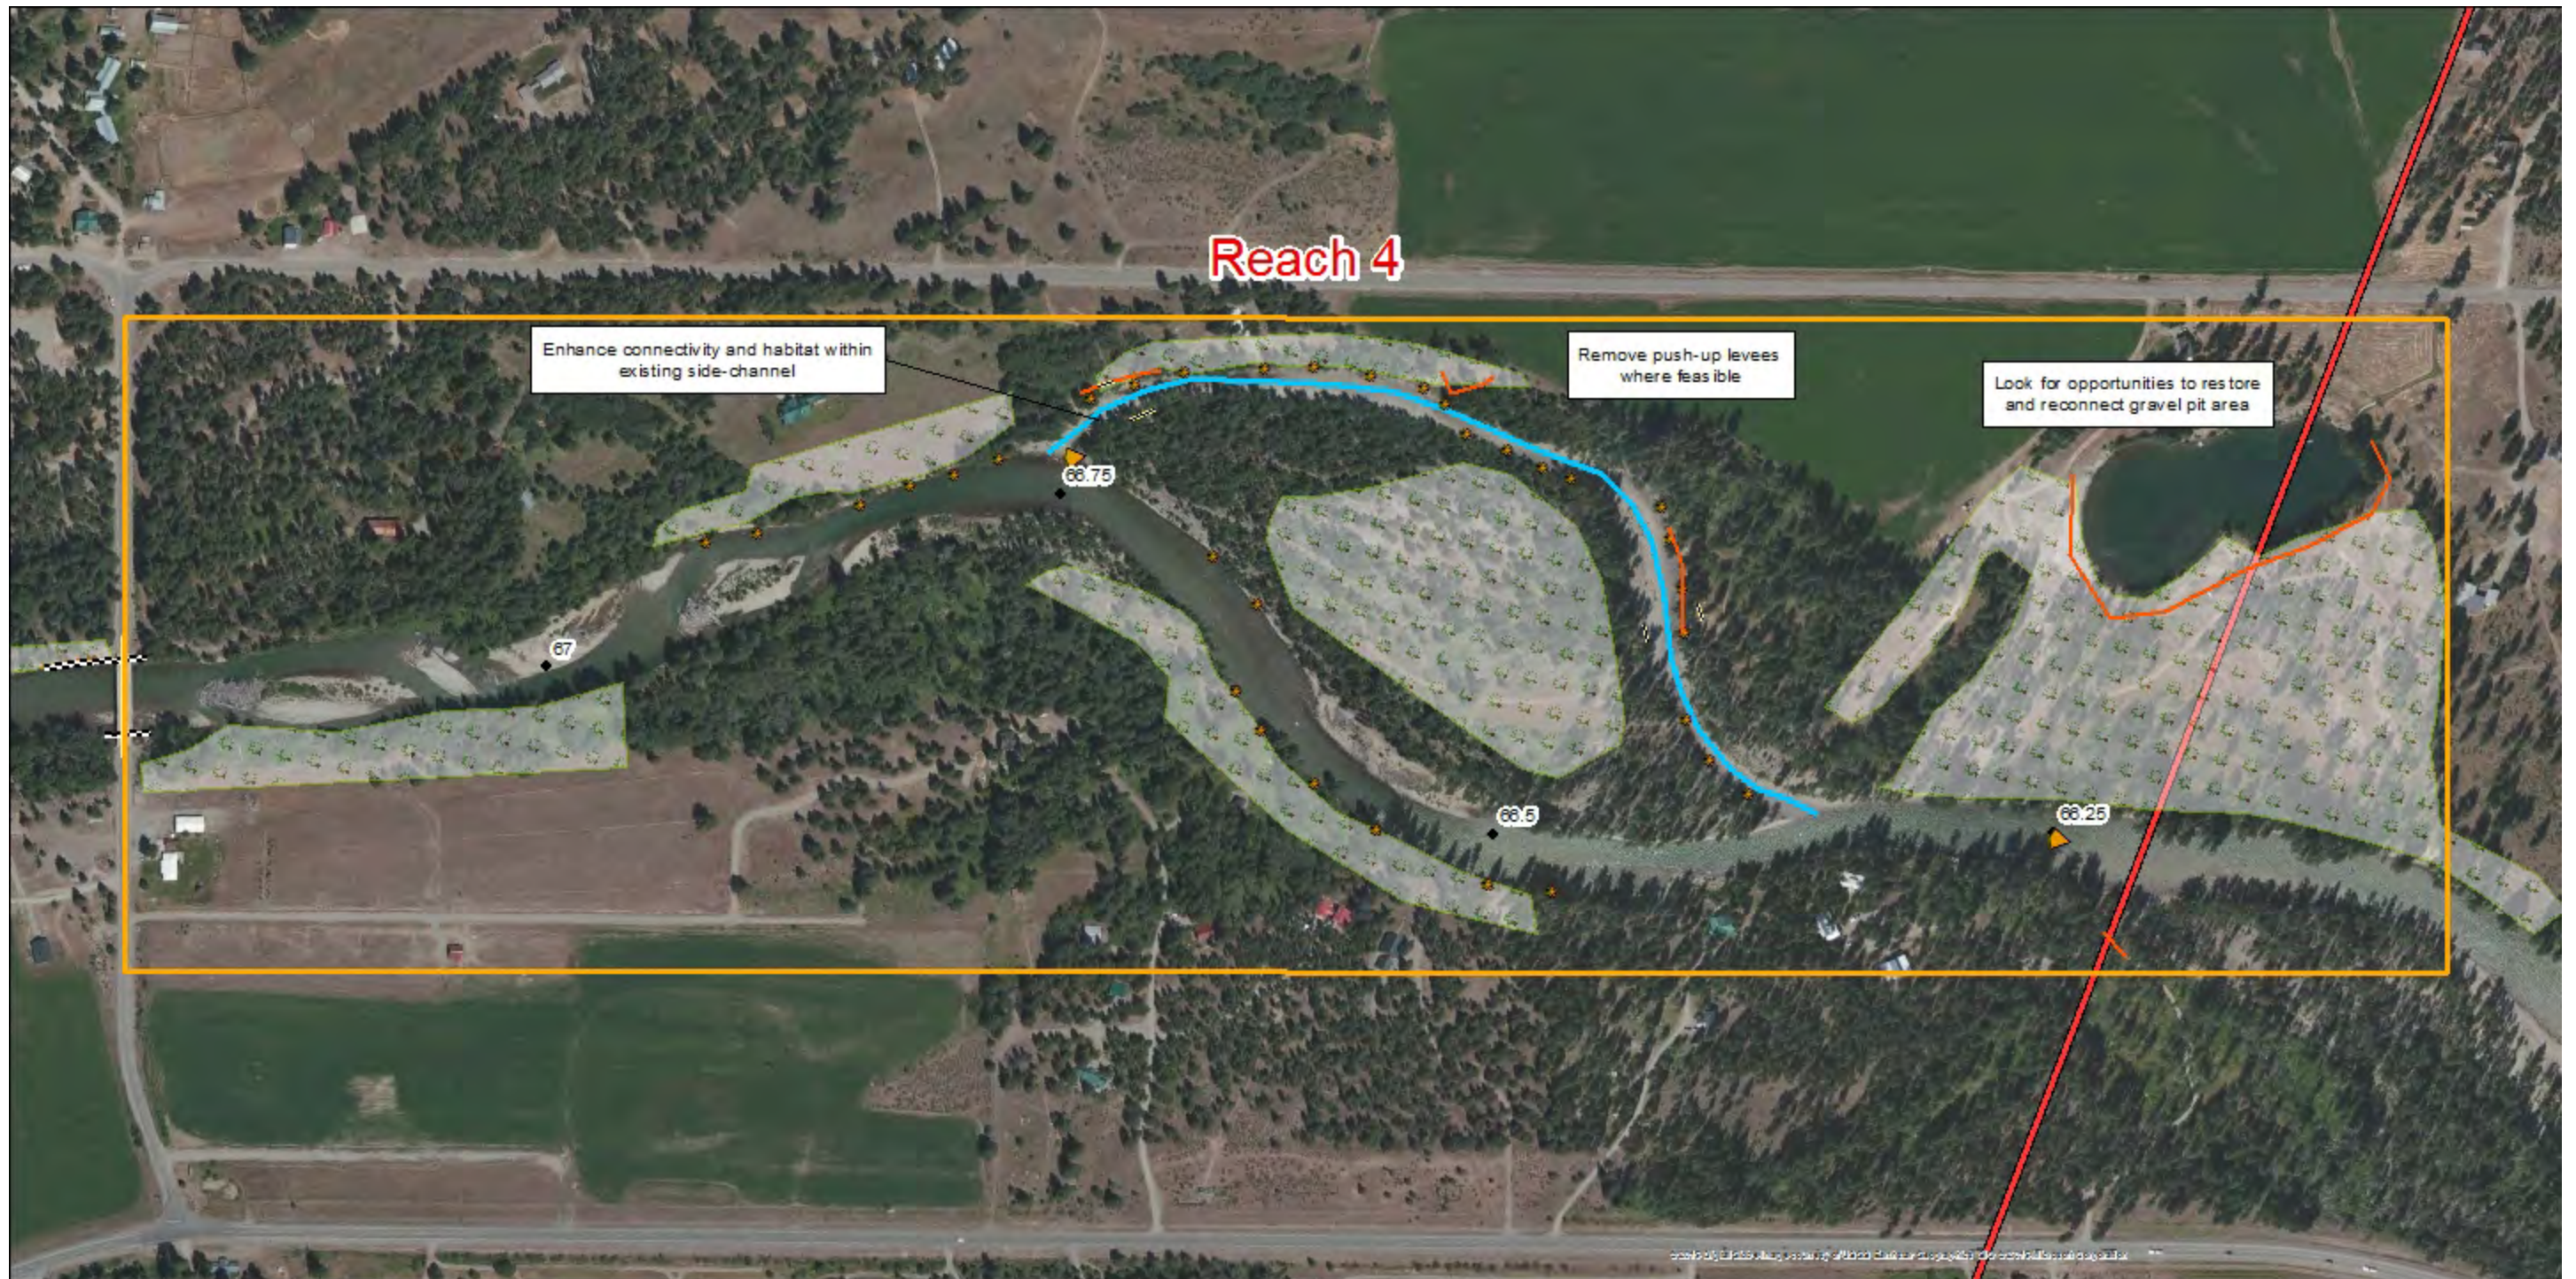
Upper Methow Reach Assessment  
 Project Opportunities  
**Lower Mazama Project**

These drawings should be viewed only as very preliminary concepts intended to describe the type of potential restoration work that could be performed. Additional site investigations and analysis will be necessary to determine specific treatment types and locations

Recent Bing Aerial Imagery

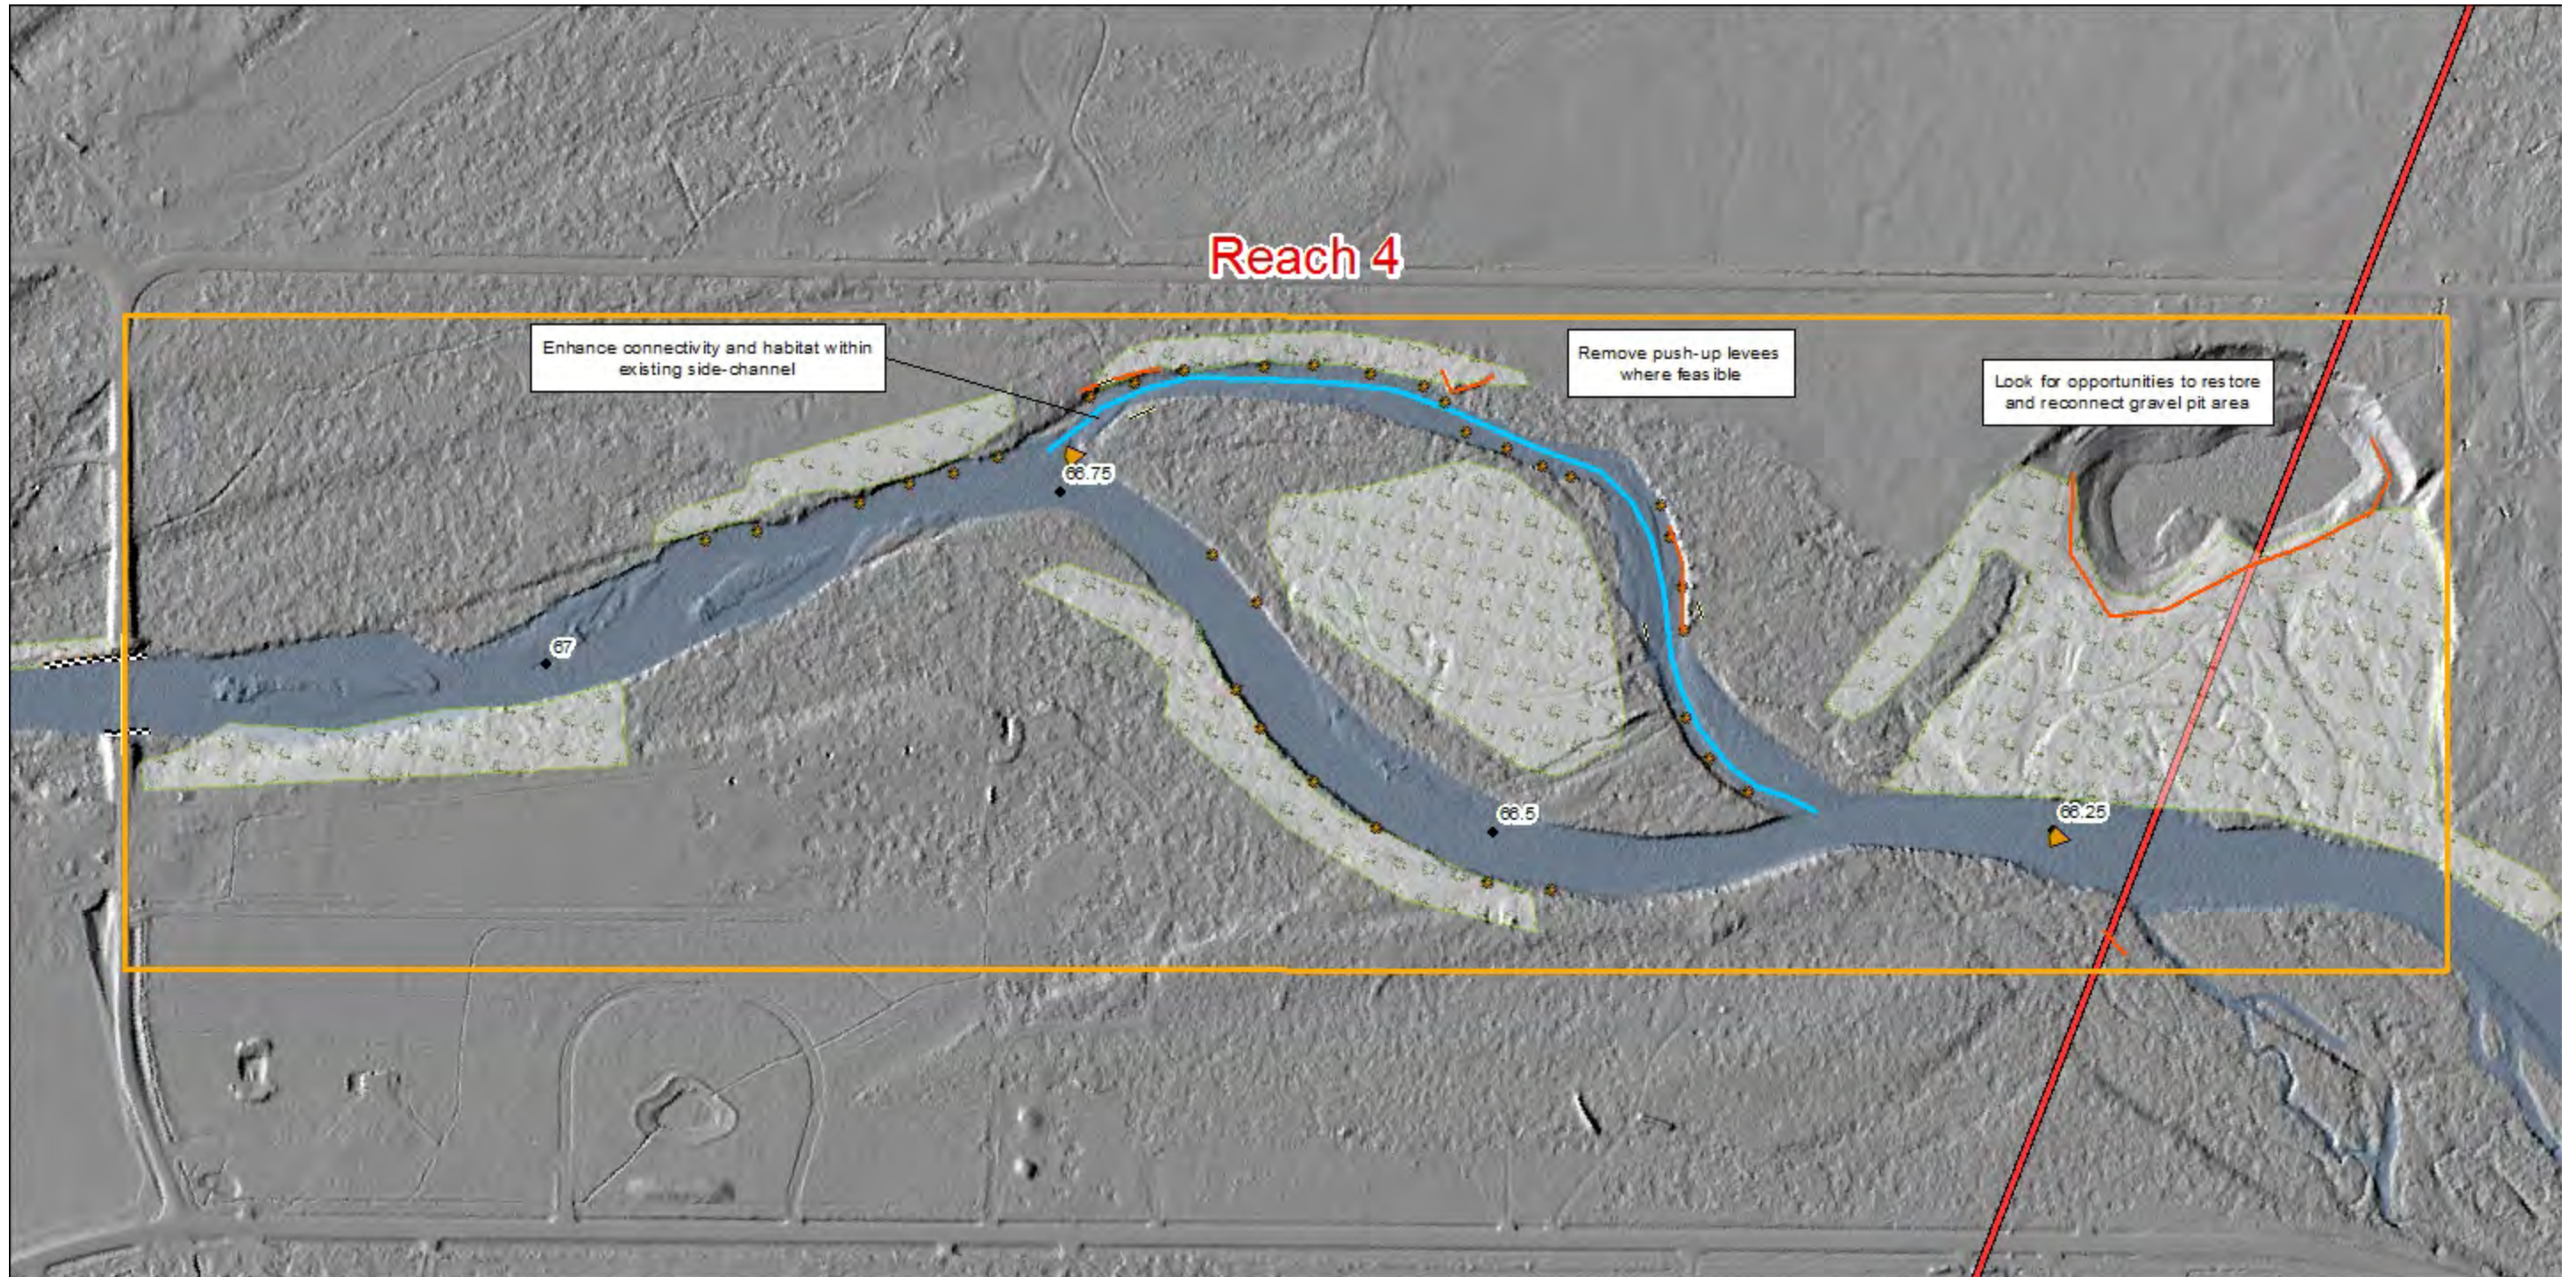
Upper Methow Reach Assessment  
 Project Opportunities  
**Lower Mazama Project**

2006 LiDAR

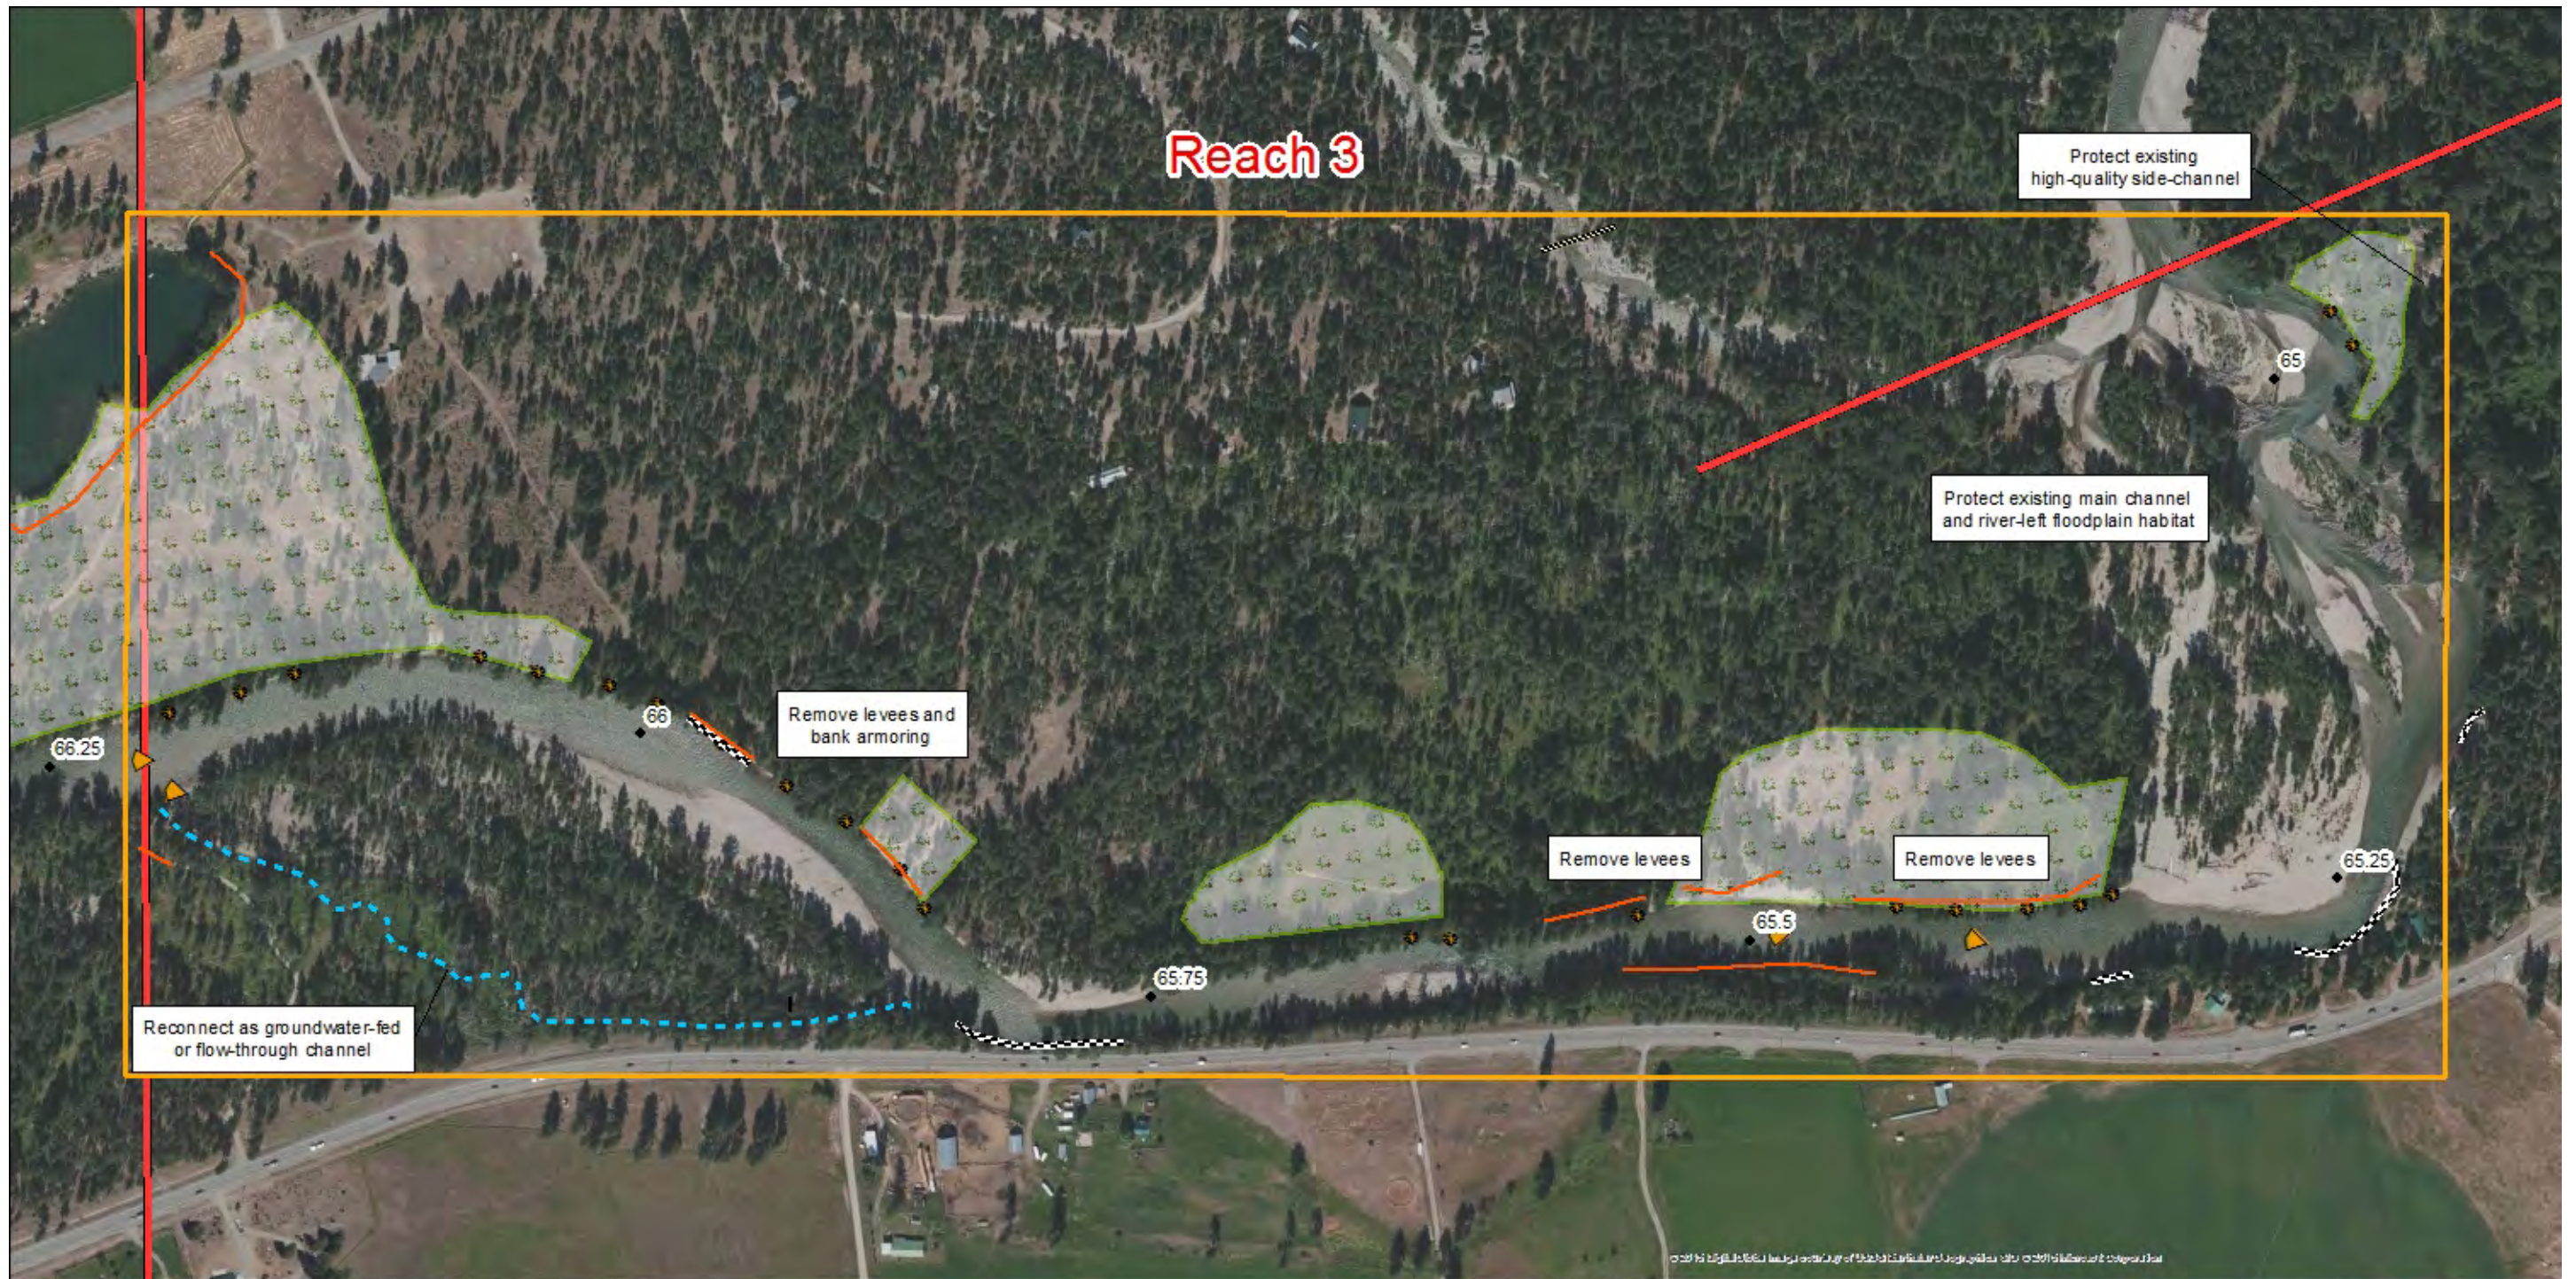
Upper Methow Reach Assessment  
 Project Opportunities  
**Goat Creek Project**

These drawings should be viewed only as very preliminary concepts intended to describe the type of potential restoration work that could be performed. Additional site investigations and analysis will be necessary to determine specific treatment types and locations

Recent Bing Aerial Imagery

Reach	Project RM	Project Name	Project Description	Considerations
3		Goat Creek Project	<p><b>Narrative</b>                      The Goat Creek Project spans an area of stark contrasts with respect to channel complexity and structure. The upper portion is highly uniform and impacted by human infrastructure, whereas the lower portion, where the channel is working through bedload material contributed by the Goat Creek and Little Boulder Creek fans, is highly complex, full of wood, and very dynamic. No significant work in this lower section is recommended, as it is mainly an area that should be targeted for protection, including a highly-functioning side-channel in the river-right floodplain (RM 64.4 – 65). The river-left floodplain could also be targeted for protection through acquisitions or easements in order to prevent any future development or clearing. At the upstream portion of the project area, there is the opportunity to remove push-up levees, install mid-channel apex jams, install bank complexity jams, and conduct riparian restoration in cleared areas. The proximity of the road in this location will need to be considered.</p> <p><b>Project Elements</b></p> <ul style="list-style-type: none"> <li>• RM 65.85 – 66.2 river-right: Reconnect right-bank side-channel either as flow-through (with apex jam at top end) or as wall-based groundwater-fed channel at downstream end. Use select excavation and wood placements in channel.</li> <li>• RM 65.85 – 66.1 river-left: Great opportunity to remove two locations of levees and bank armoring. Replace with channel margin jams.</li> <li>• RM 65.35 – 65.6: Remove left-bank push-up levees (although there are mature trees on usptream levee that may not be worth disturbing), add margin complexity jams along bank where levees removed, add apex jams for mid-channel complexity and to develop split-flow, and riparian restoration.</li> <li>• Entire project area: Use of bar apex jams are described above as part of those elements. There are also many locations for potential channel margin complexity jams to create local pool scour and to increase cover and complexity in existing pools. Complexity jams should be designed to enhance local cover and complexity, not to limit bank erosion.</li> <li>• Riparian restoration is identified throughout the reach where there has been clearing of riparian or floodplain areas.</li> <li>• Protection is identified for the lower 1/3 of the reach where there are active lateral channel dynamics and abundant large wood. The river-left floodplain should be protected from development and clearing. The downstream river-right floodplain has high quality side-channel habitat that should be protected.</li> </ul>	<p>Hwy 20 is close to the river in a few locations and needs to be taken into consideration with respect to potential impacts from restoration treatments.</p> <p>Houses and other infrastructure along banks and in floodplain/CMZ</p> <p>Wood placements need to account for potential river recreational uses.</p>

Goat Creek	3	65.00	66.25	1.25	3	6	3	Low to moderate existing. High potential assuming levees addressed	2.5	High spawning use. Assumed rearing but seasonally dry conditions may affect usability	2.5	Combination of Recovery (levee removal/modification, riparian work) and Enhancement (log jams)	8	1.5	Mostly push-up levees that can be spoiled on site. Mostly margin log jams	5.3	Moderate	Private lands. Some houses and infrastructure.
	Trail Bridge	2	63.85	64.90	1.05	3	6	3	Low to moderate existing. High potential due to low risk to infrastructure	3	High spawning use. Assumed rearing. Typically remains wetted.	2	Mostly enhancement	8	2	Moderately dense mainstem log jams	4.0	Moderate - High	Mostly in-channel work with relatively little risk to infrastructure, accessible
	Weeman	1-2	60.75	62.75	2.00	2	5	3	Low existing function. Moderate potential given existing infrastructure	3	High spawning use. Assumed rearing. Typically remains wetted.	2	Mostly enhancement due to existing infrastructure in place	8	2.5	Sparse mainstem log jams. Infrastructure mods at DS end potentially expensive.	3.2	Low	Full recovery challenging due to infrastructure limitations (Weeman Bridge and Hwy 20)

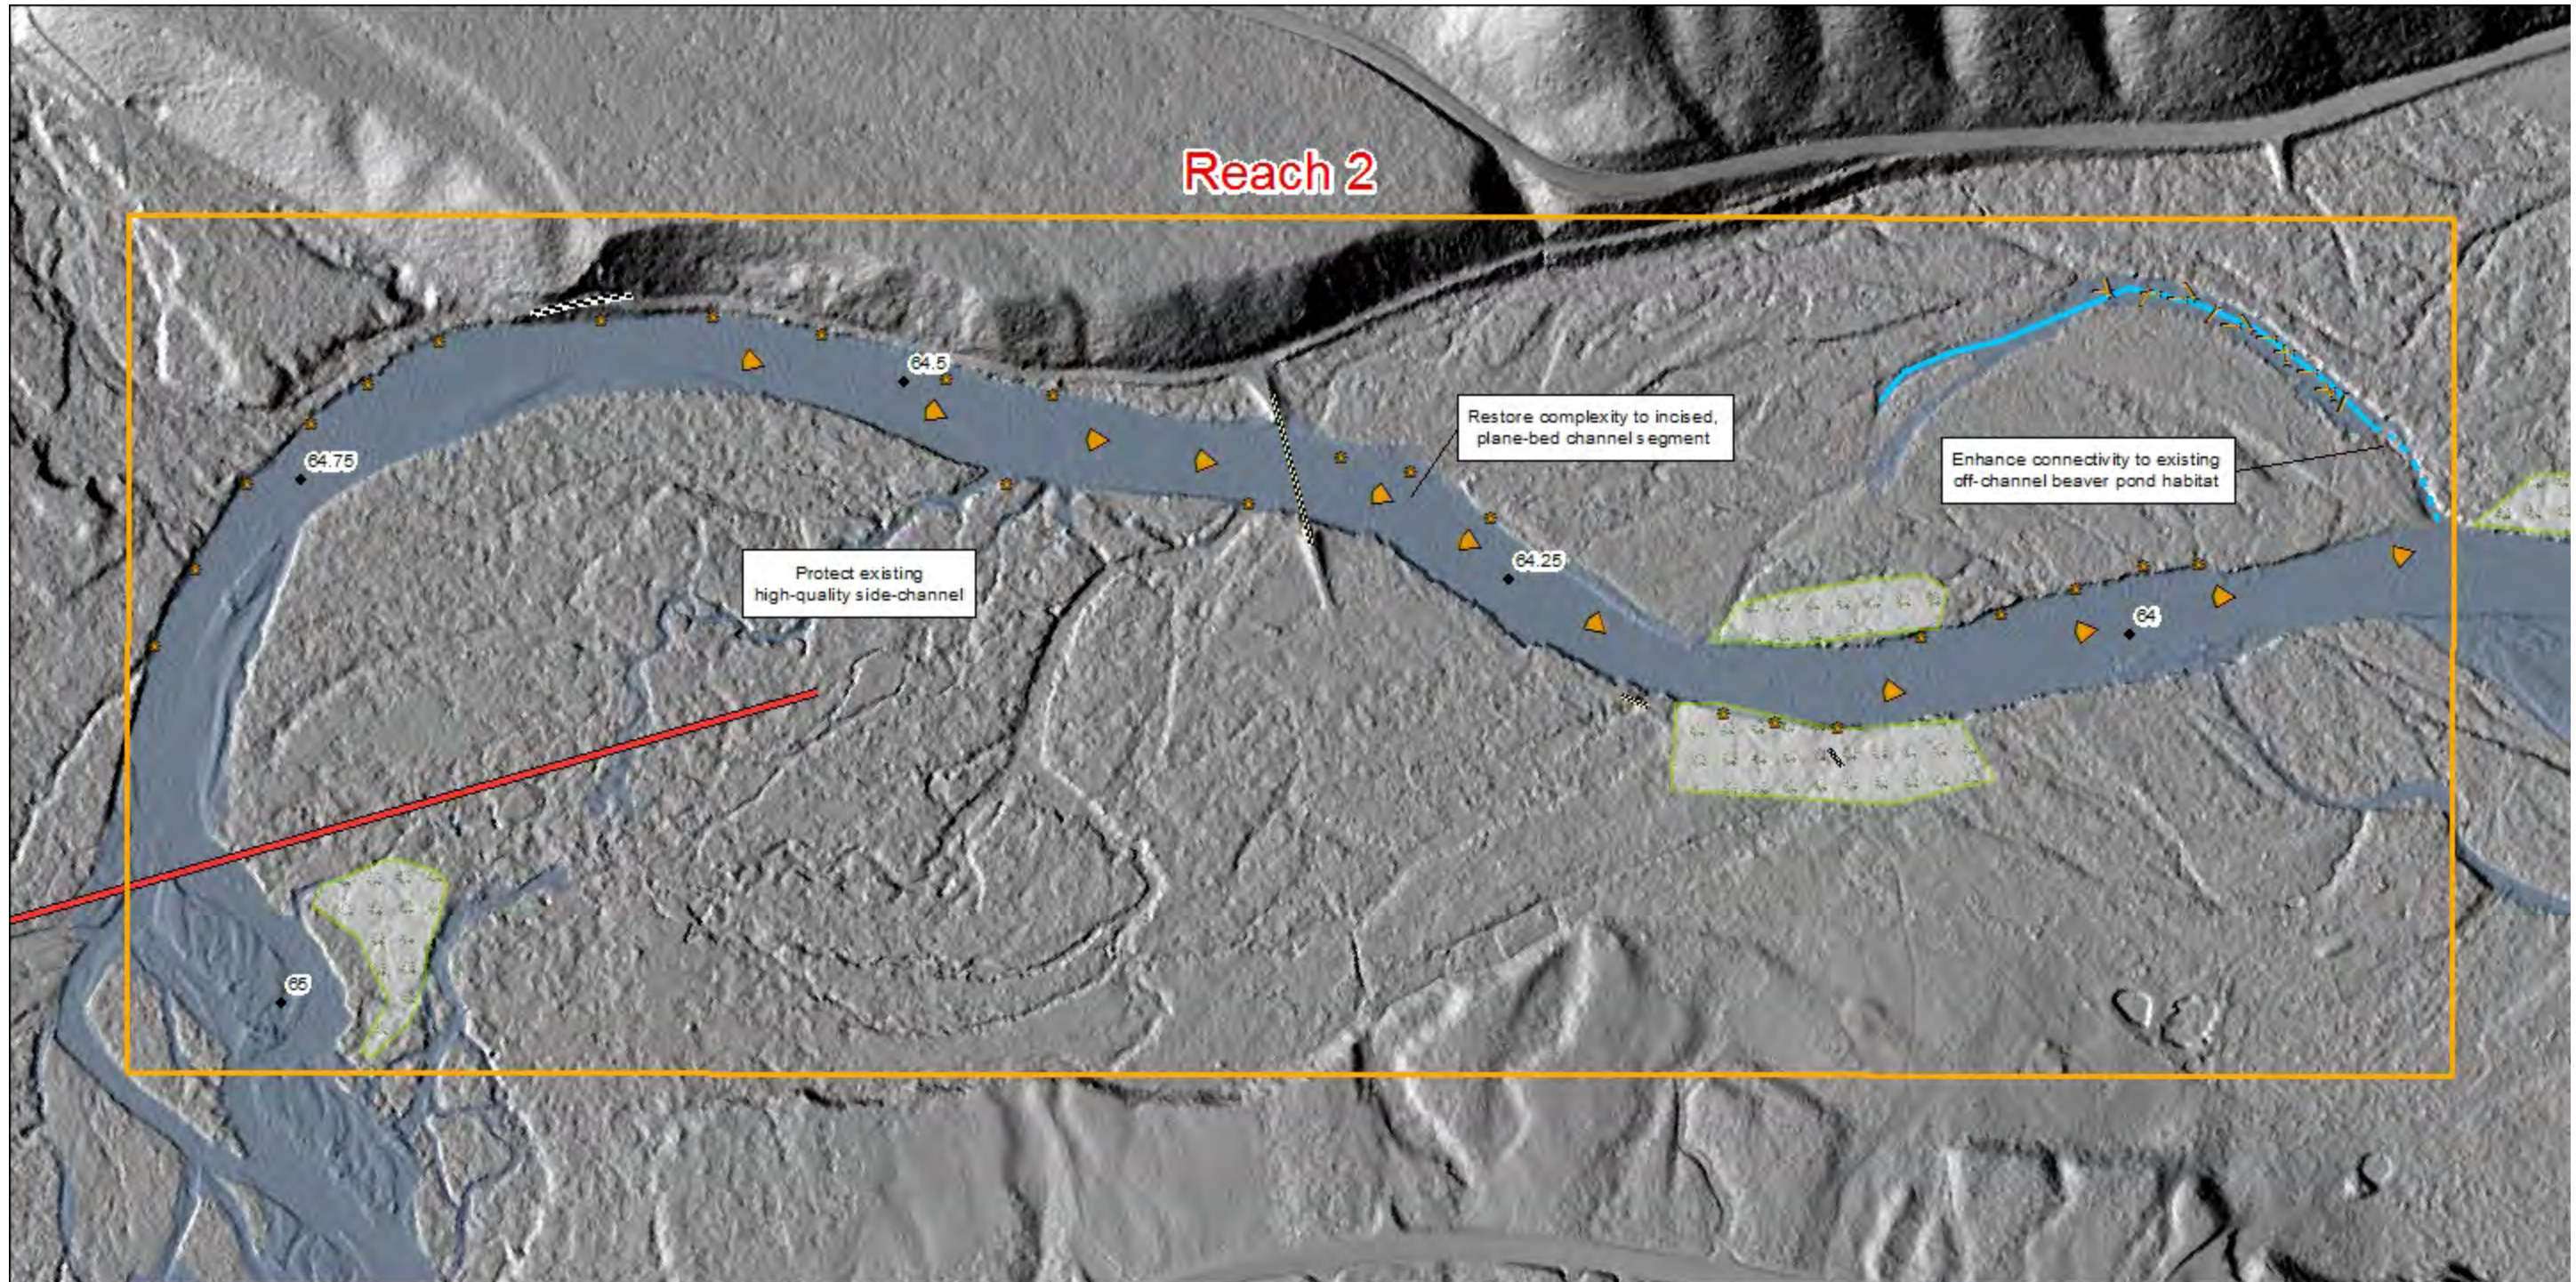
**Upper Methow Reach Assessment**  
*Project Opportunities*  
**Trail Bridge Project**

2006 LiDAR

2		Trail Bridge Project	<p><b>Narrative</b>                      The Trail Bridge Project encompasses the area above and below the community trail bridge. This is a long segment of uniform planebed channel (slightly incised) that would benefit from apex jams and bank complexity jams to capture wood, create mid-channel vegetated islands, and promote lateral channel dynamics. For the most part, there is great opportunity to increase channel conditions and floodplain connectivity using log jams without much infrastructure or property at risk. There is also some off-channel reconnection and enhancement potential on river-left at the downstream end of the project area.</p> <p><b>Project Elements</b></p> <ul style="list-style-type: none"> <li>• RM 63.85 – 64.6: Apex jams to build off of existing processes of mid-channel bar formation to protect vegetation growth on bars and promote the development of vegetated islands and split flow. Also to trap fluvial-transported wood from upstream. This is an otherwise highly uniform, moderately incised segment with very scarce large wood. Also add bank margin jams to increase margin habitat and roughness.</li> <li>• RM 63.85 river-left: Enhance connectivity to existing oxbow wetland and beaver pond habitat. Sediment deposits are currently filling in channel and likely obstruct passage at low flows. Excavate to improve access to beaver pond habitat. Add wood for cover and complexity in oxbow wetlands.</li> <li>• Entire project area: Use of bar apex jams are described above as part of those elements. There are also many locations for potential channel margin complexity jams to create local pool scour and to increase cover and complexity in existing pools. Complexity jams are designed to enhance local cover and complexity, not to limit bank erosion.</li> </ul>	<p>The ski trail and trail bridge need to be taken into consideration with respect to potential impacts from restoration treatments.</p> <p>Wood placements need to account for potential river recreational uses.</p>

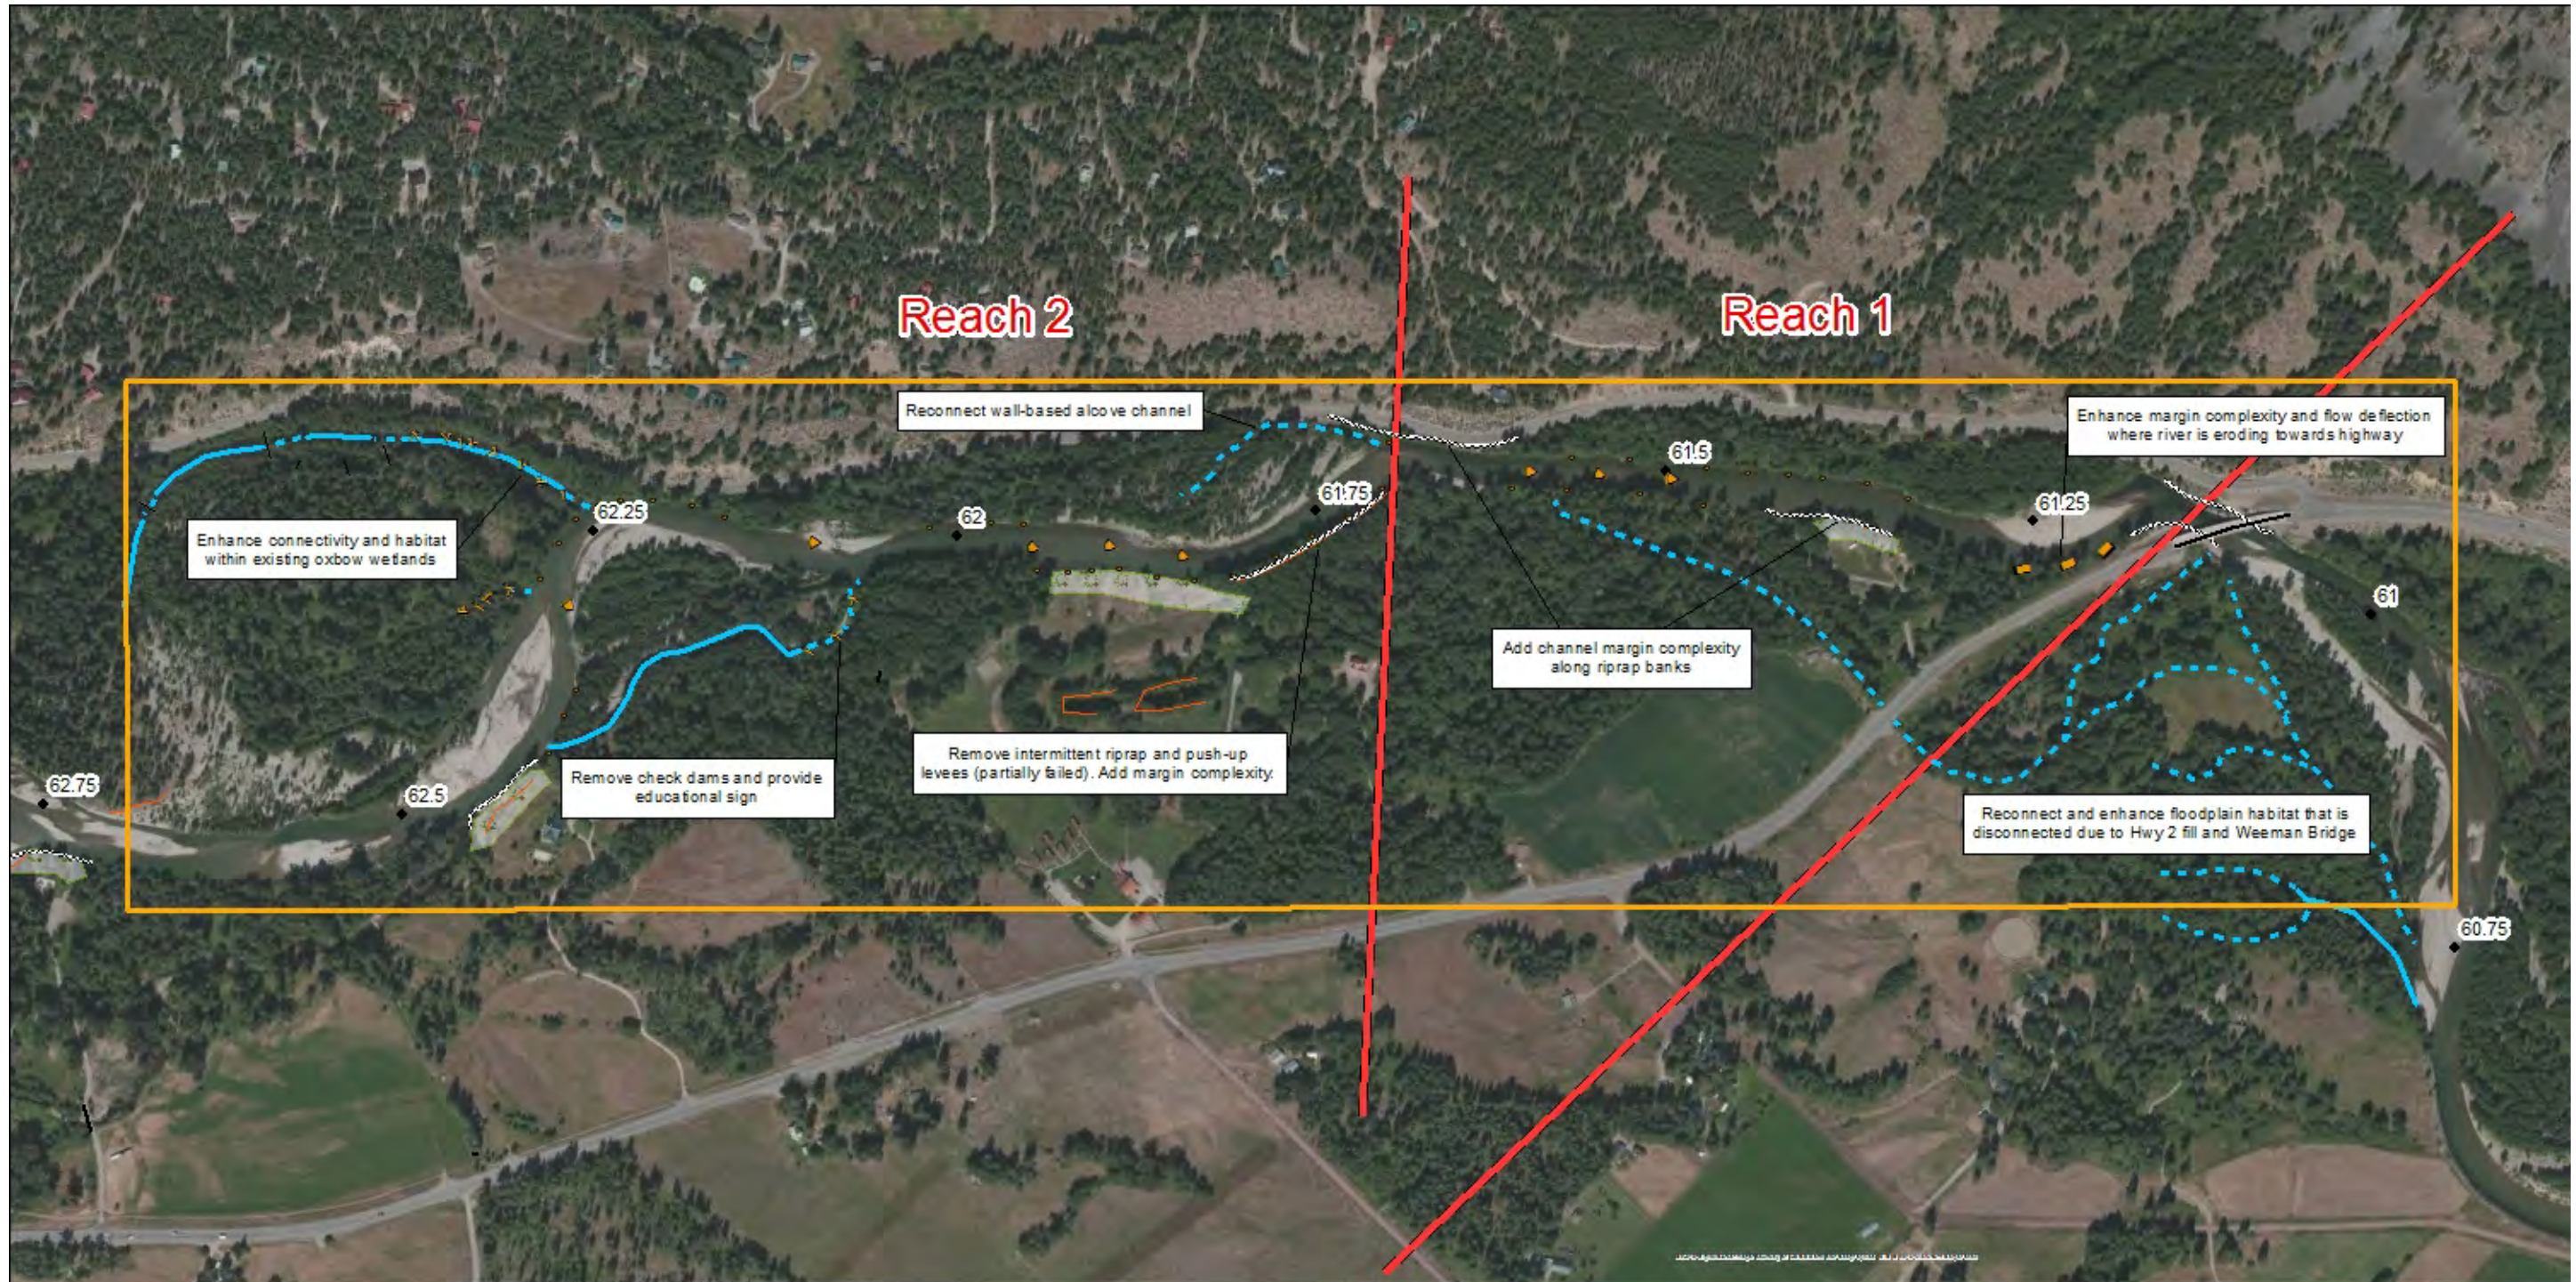
**Upper Methow Reach Assessment**  
*Project Opportunities*  
**Weeman Project**

These drawings should be viewed only as very preliminary concepts intended to describe the type of potential restoration work that could be performed. Additional site investigations and analysis will be necessary to determine specific treatment types and locations

Reach	Project RM	Project Name	Project Description	Considerations
<b>1-2</b>		Weeman Project	<p><b>Narrative</b>                      The Weeman Project spans Reach 1 and a portion of Reach 2. The portion in Reach 2 includes some good opportunities to enhance habitat within, and connectivity to, existing side-channel and oxbow wetland habitat. A couple of instances of cleared and rapidly eroding banks could be revegetated and enhanced with wood placed along the channel margin. At the downstream end of the reach, there is the opportunity to remove some failing riprap and push-up levees that appear to no longer be serving any protective purpose. In-channel log jam work is identified throughout to enhance lateral channel dynamics and the establishment of vegetated mid-channel island features.</p> <p><b>Project Elements</b></p> <ul style="list-style-type: none"> <li>• RM 62.25 river-left: Enhance connectivity to and habitat within existing oxbow wetland. Remove check dams, use select excavation, and add wood.</li> <li>• RM 62.1 river-right: Reconnect side-channel and education. This is a well-functioning side-channel that contains groundwater inputs and hyporheic flow but has small human-built check-dams that disconnect the channel during low flow (chin spawning). Remove check-dams and install educational sign for the campground (Rolling huts campground).</li> <li>• RM 61.75 river-right: Remove intermittent riprap and push-up levee that has partially failed. Add bank margin jams for complexity.</li> <li>• RM 61.7 river-left: Reconnect groundwater-fed wall-based alcove channel by modifying riprap at outlet, select excavation, and adding wood for habitat and to maintain scour at the outlet.</li> <li>• RM 61.25 river-right: Place channel margin jams on right bank upstream of bridge and river access to halt erosion toward highway and enhance channel margin habitat prior to this bank becoming armored by Dept of Transportation.</li> <li>• Entire project area: Main channel jams including bar apex jams to form stable, vegetated, mid-channel islands and to capture LW; and margin complexity jams to increase cover and complexity in existing pools. Place jams strategically to encourage erosion into banks with mature forests and to discourage erosion into banks with young forest. Complexity jams should be designed to enhance local cover and complexity, not to limit bank erosion.</li> <li>• Riparian restoration is identified throughout the reach where there has been clearing of riparian or floodplain areas.</li> </ul>	<p>Goat Creek Road, which is close to the river in two locations, and Weeman Bridge/Hwy 20 (downstream end) need to be taken into consideration with respect to potential impacts from restoration treatments.</p> <p>Houses and other infrastructure along banks and in floodplain/CMZ</p> <p>Wood placements need to account for potential river recreational uses.</p>
