APPENDIX B: SUB-UNIT MAPPING AND GEOMORPHOLOGY

UPPER WENATCHEE RIVER ASSESSMENT – APPENDIX B

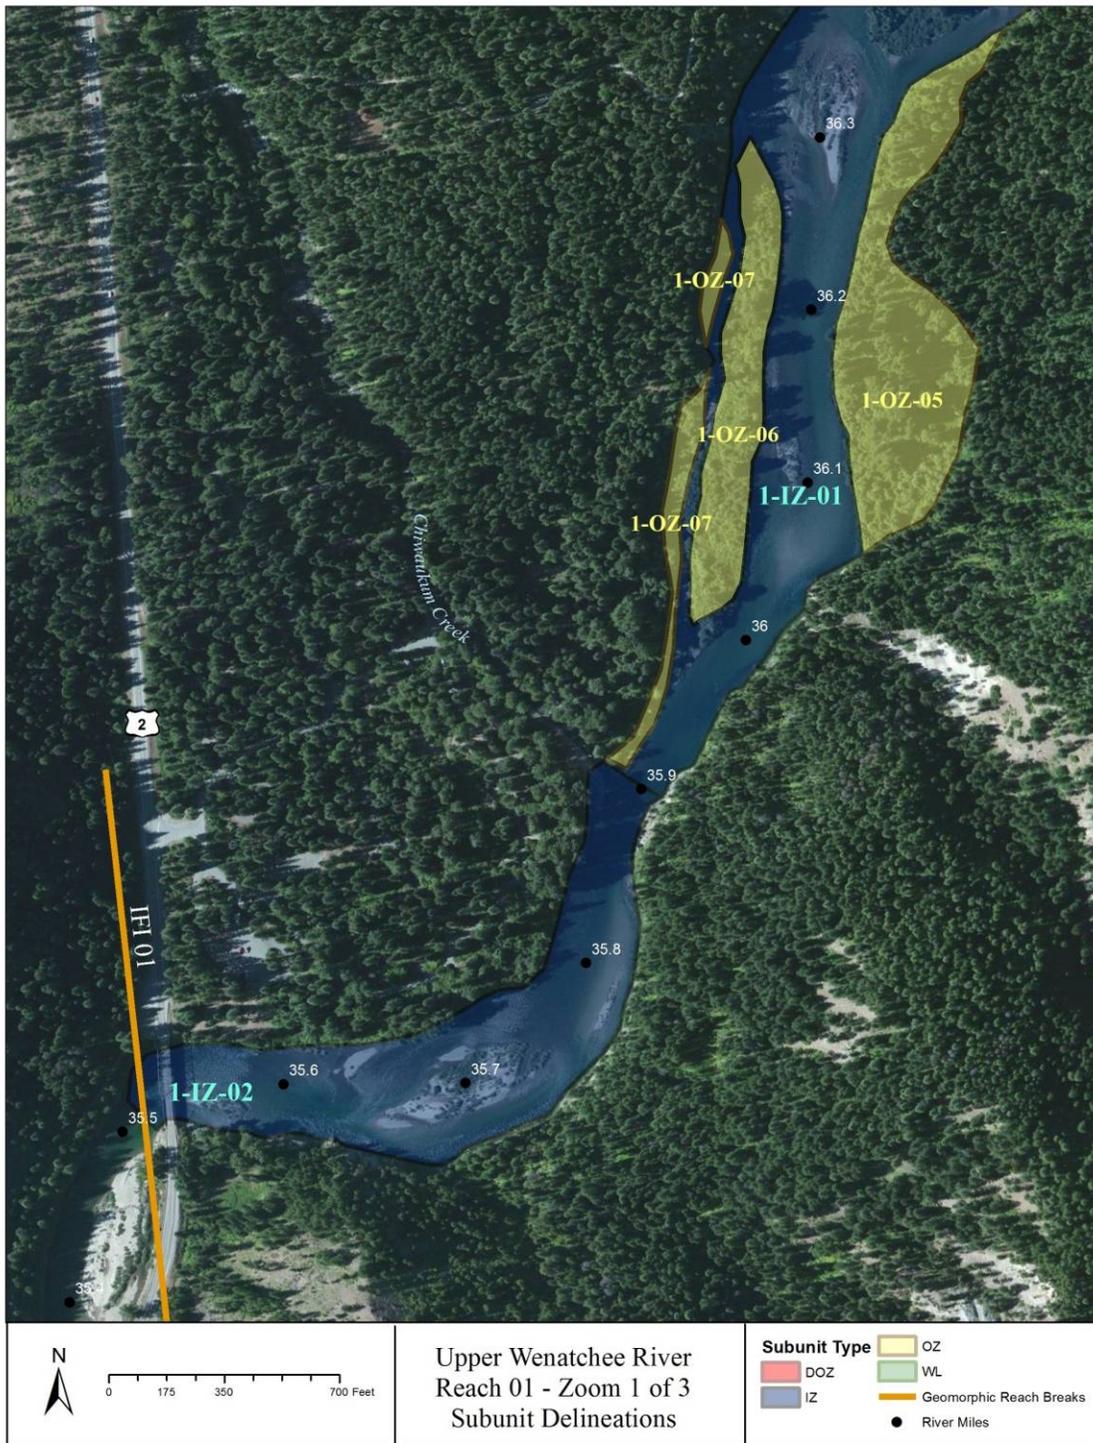
Figure 1. Subunit delineations for the downstream most portion of Reach 1. Flow is from north to south.

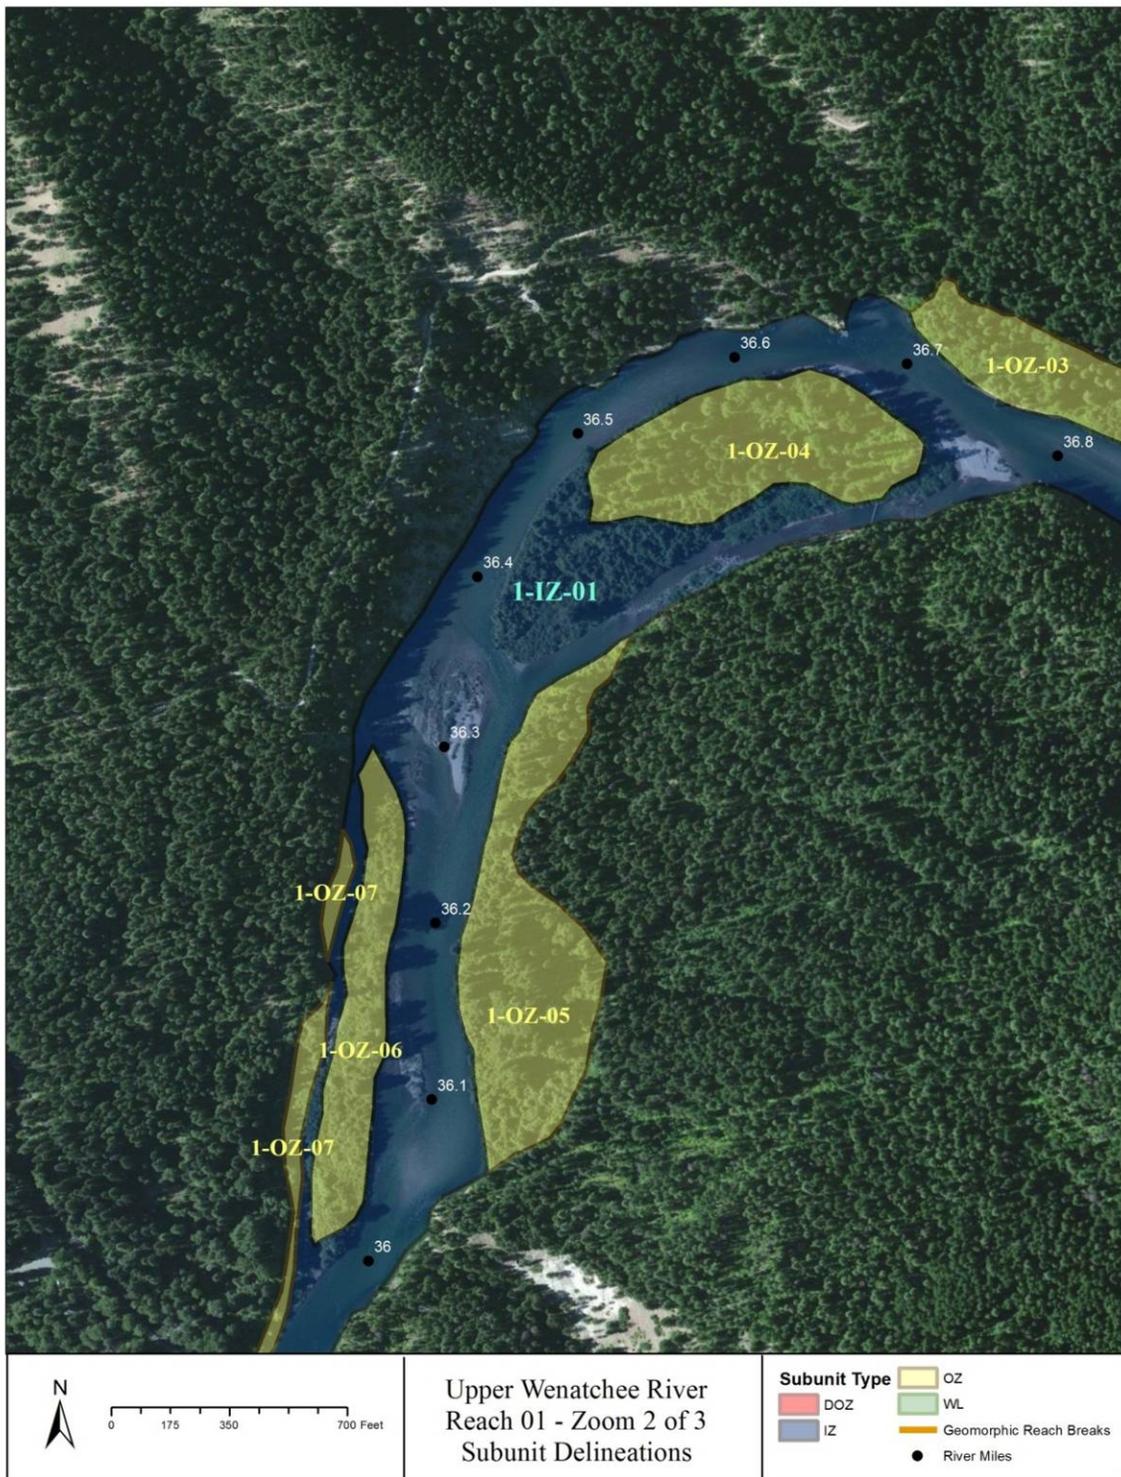
Figure 2. Subunit delineations for Reach 1. Flow is from north to south.

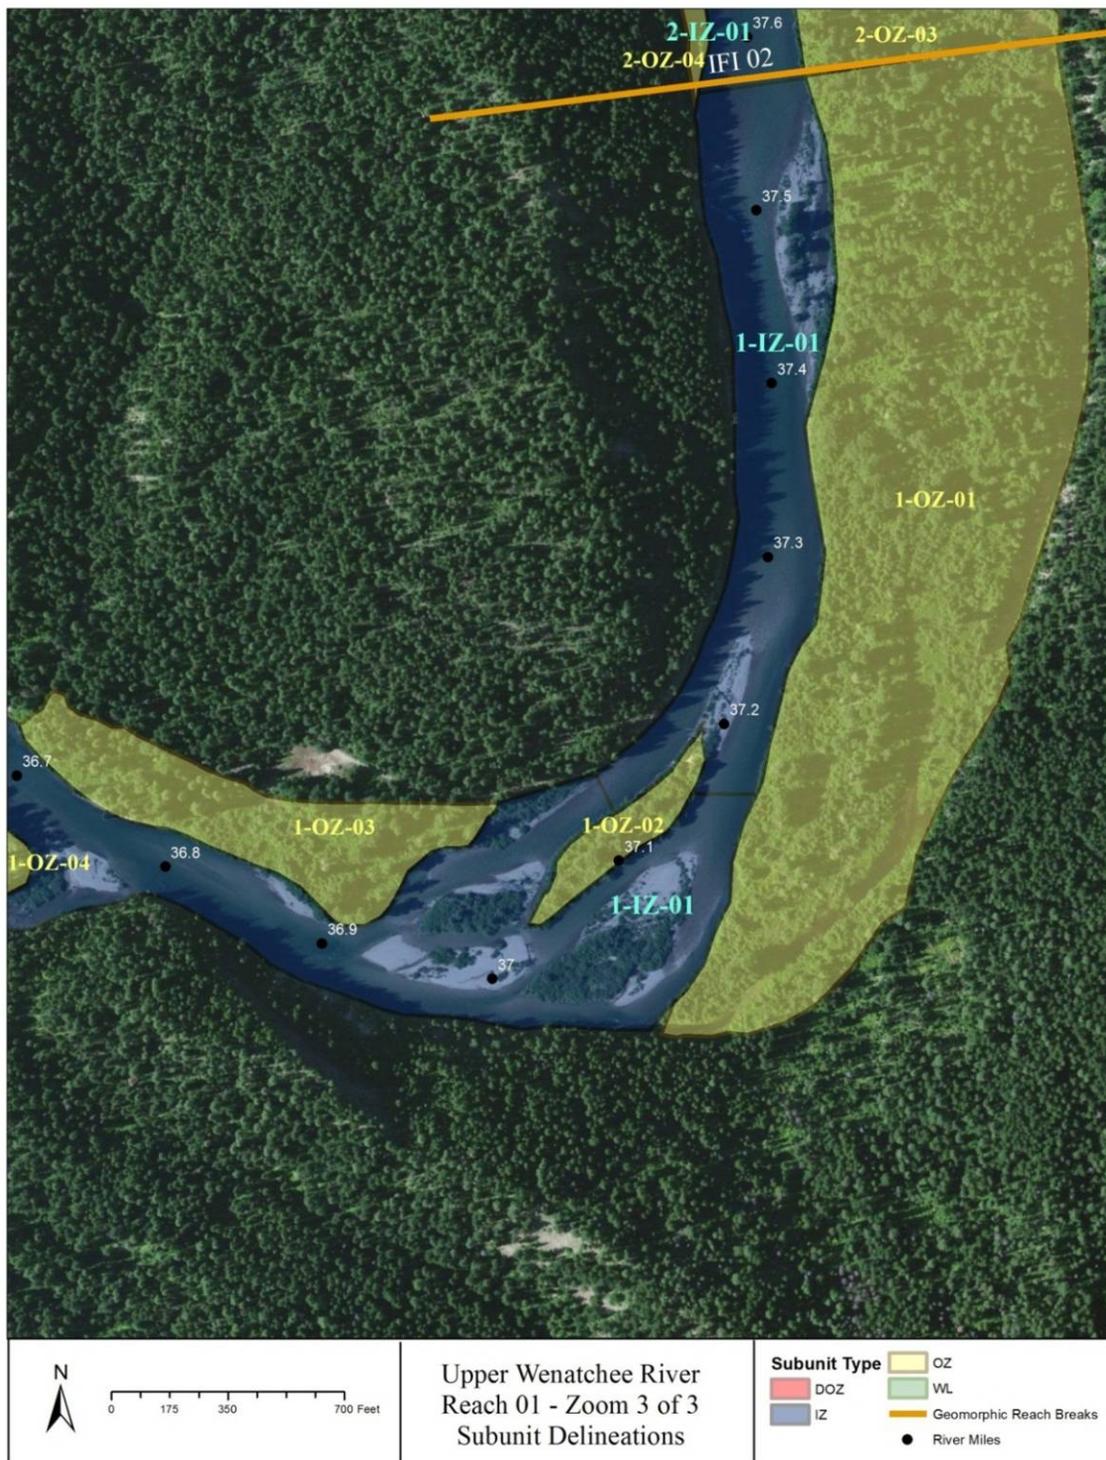
Figure 3. Subunit delineations for the upstream most portion of Reach 1. Flow is from north to south.

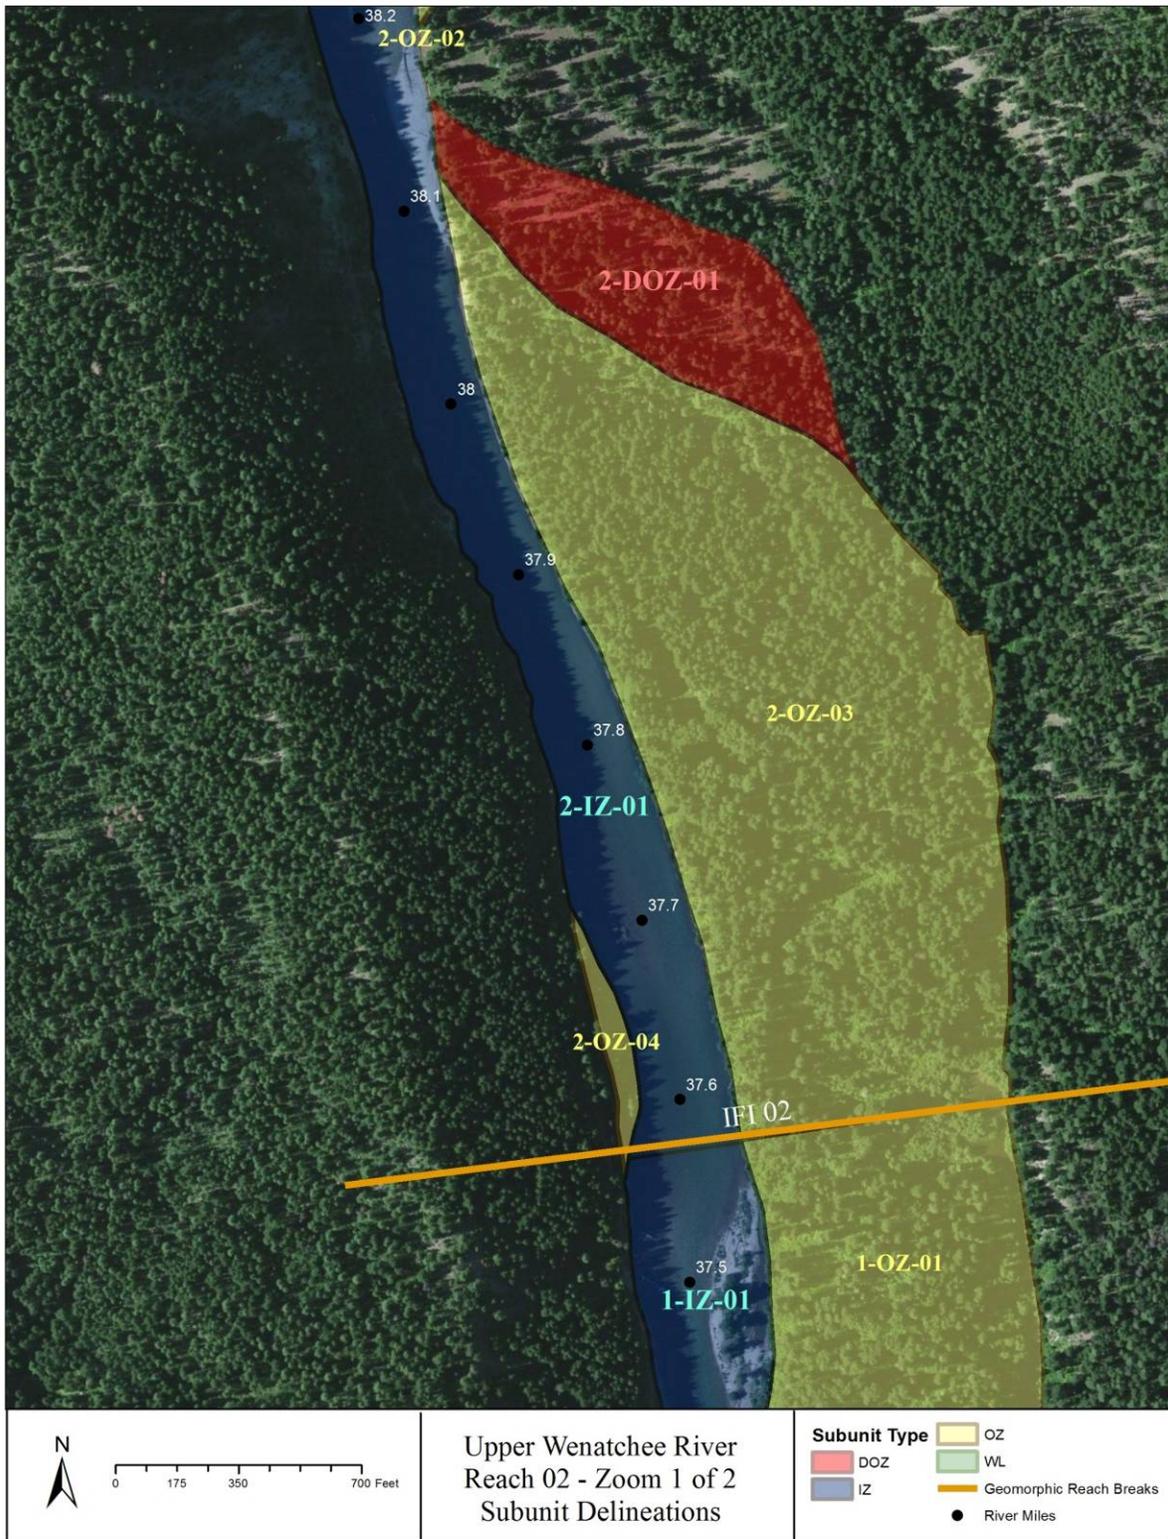
Figure 4. Subunit delineations for the downstream portion of Reach 2. Flow is from north to south.

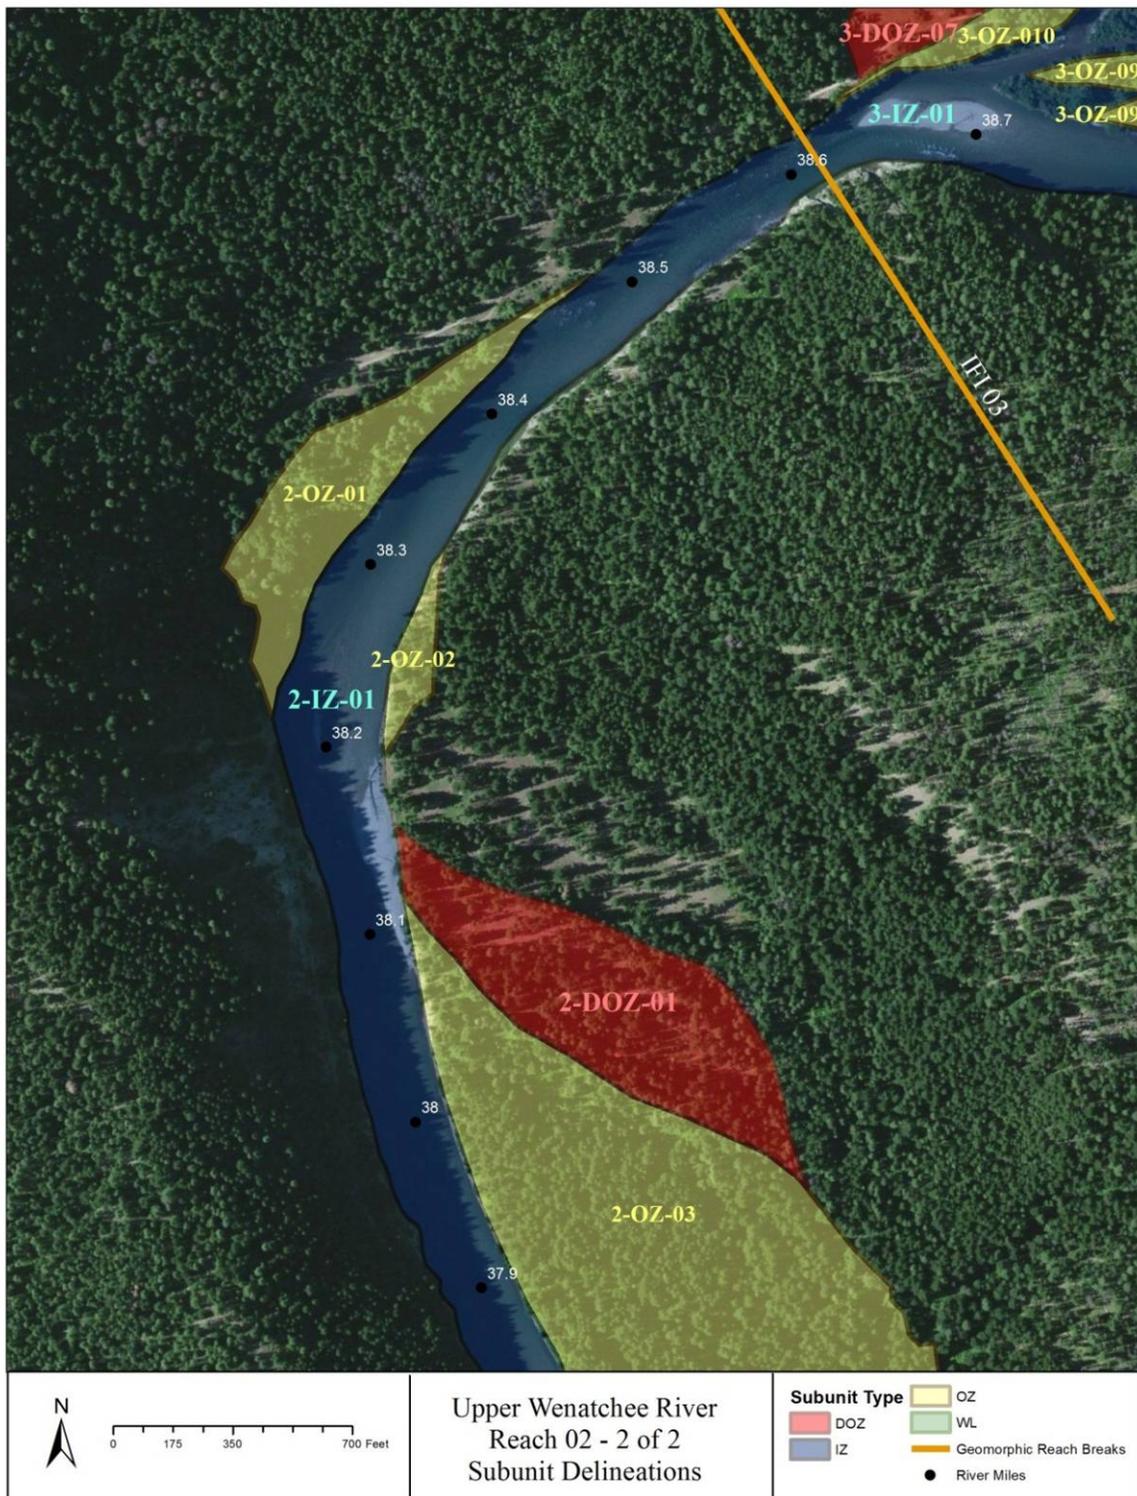
Figure 5. Subunit delineations for the upstream portion of Reach 2. Flow is from north to south

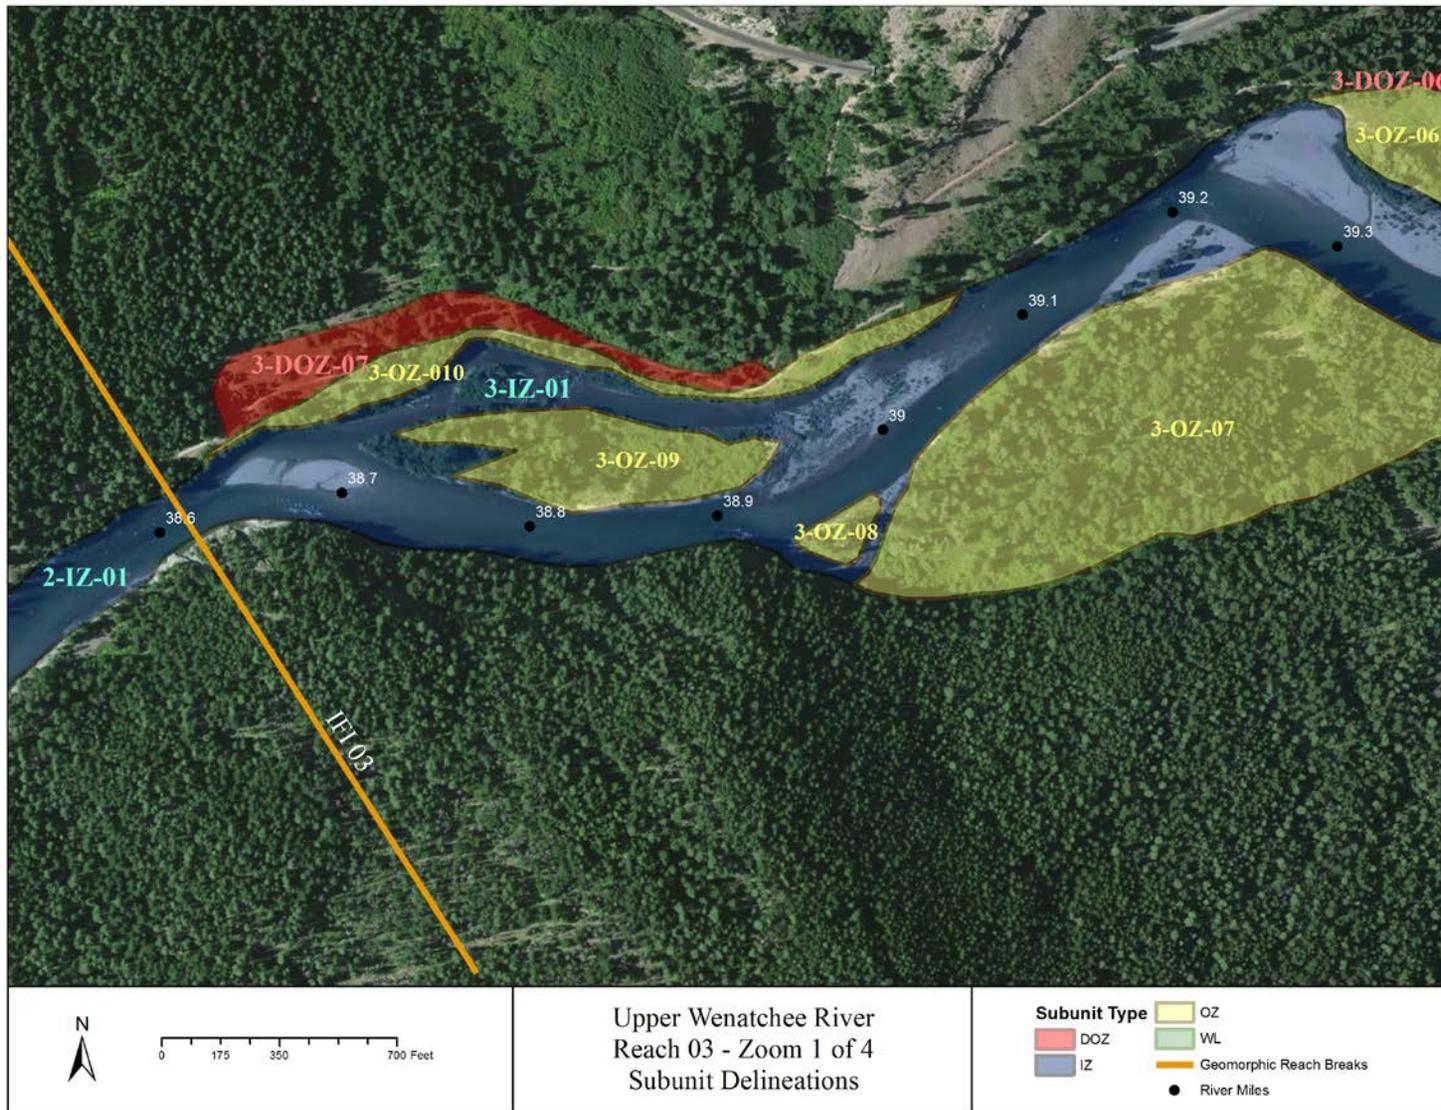
Figure 6. Subunit delineations in downstream portion of Reach 3. Flow is from west to east.

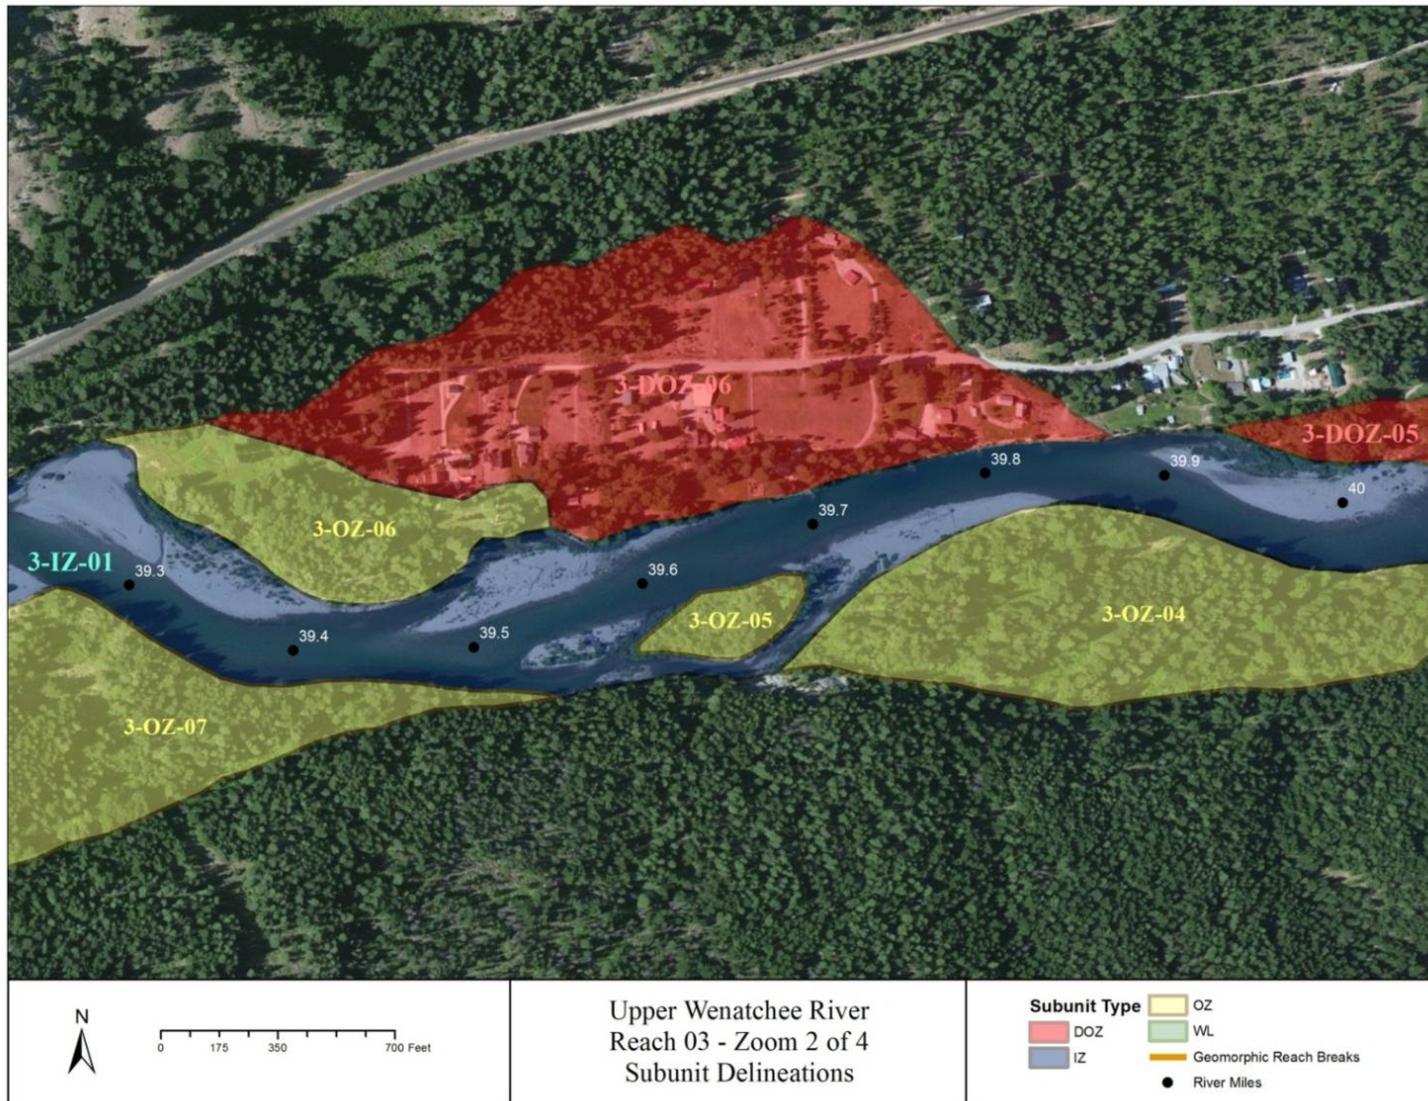
Figure 7. Subunit delineations in Reach 3. Flow is from west to east.

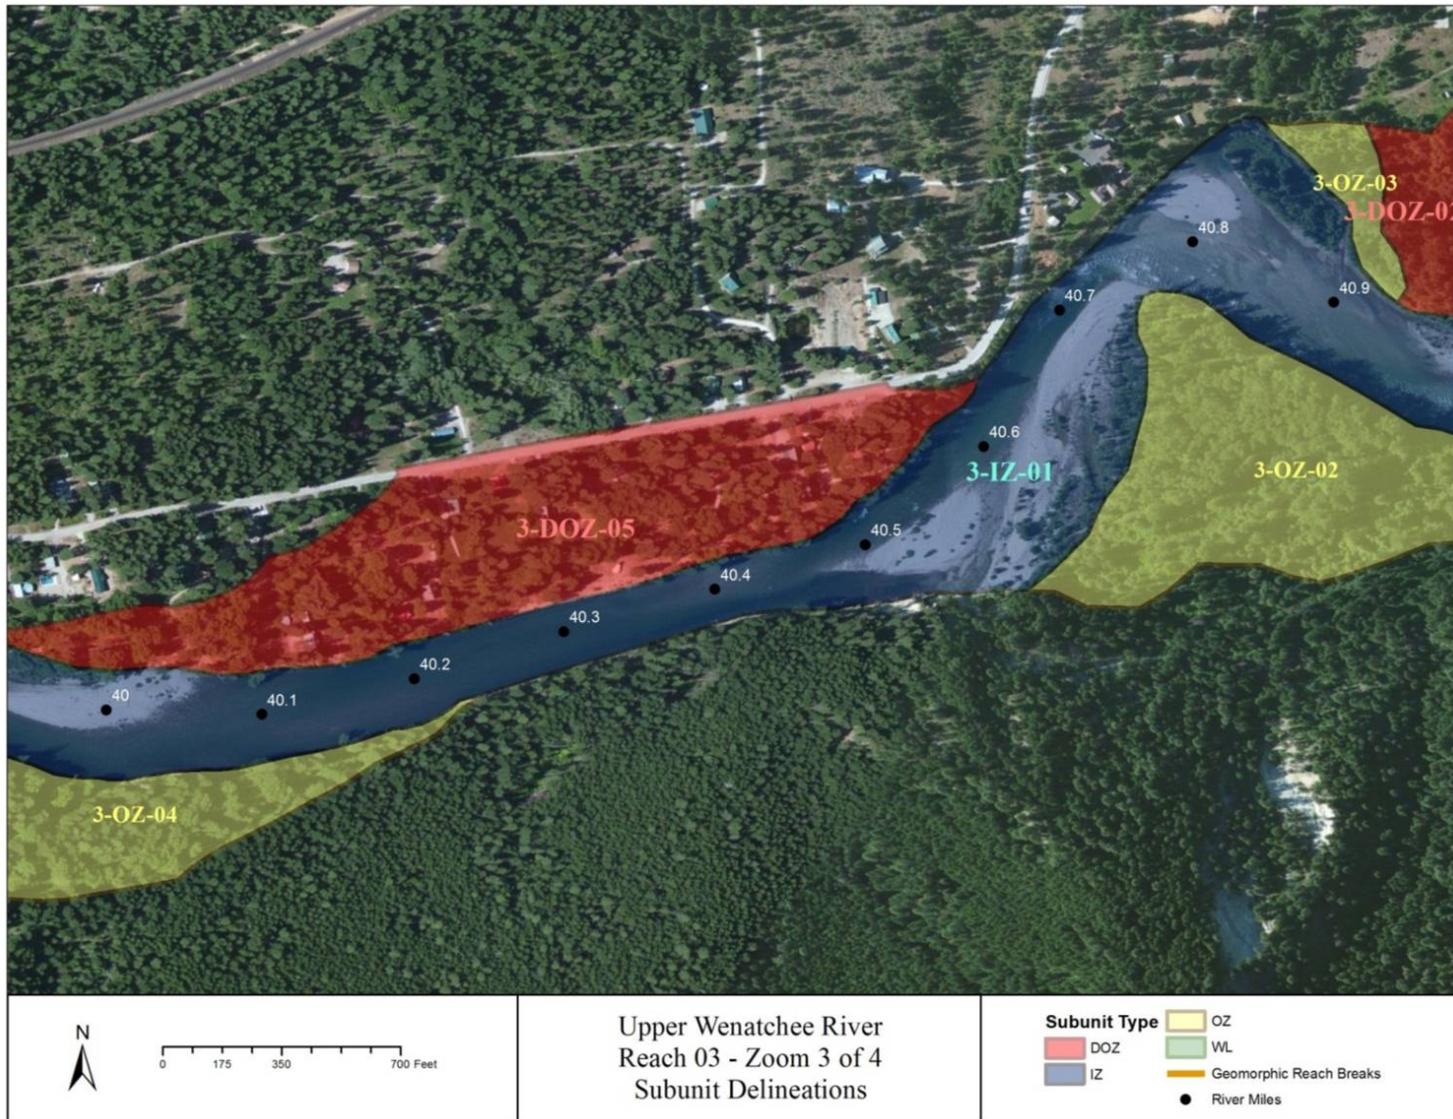
Figure 8. Subunit delineations in Reach 3. Flow is from west to east.

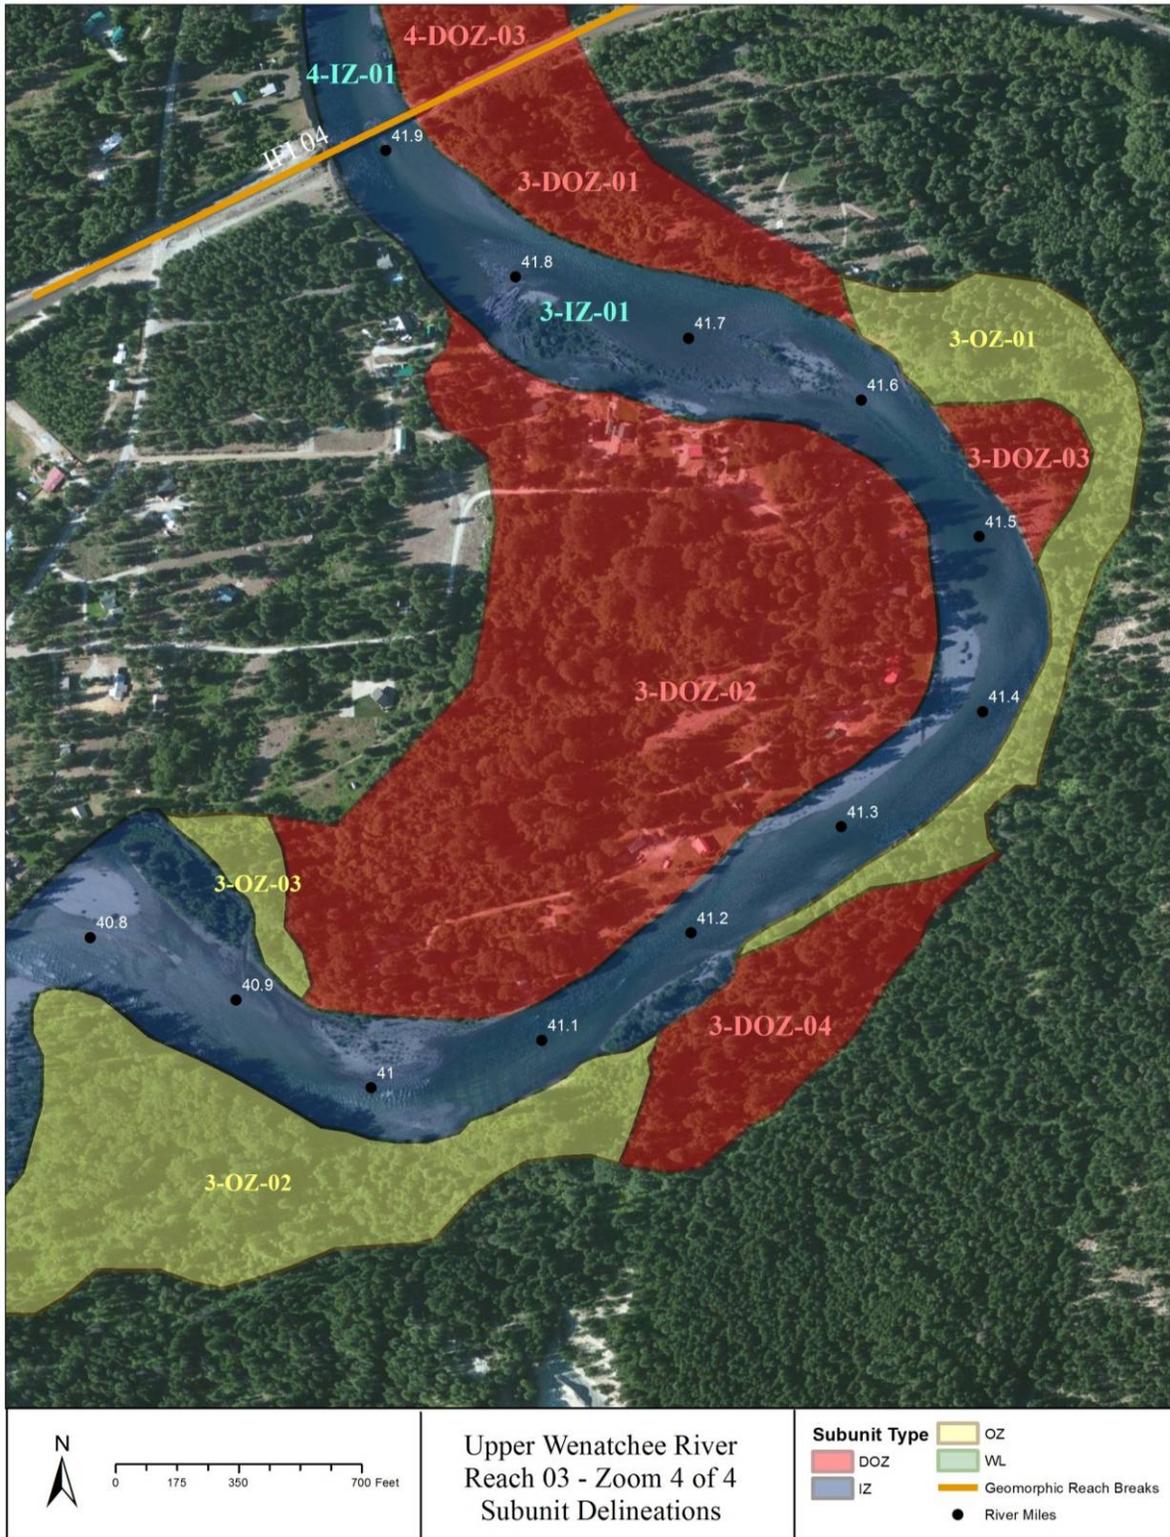
Figure 9. Subunit delineations in upstream most portion of Reach 3. Flow is from north to south.

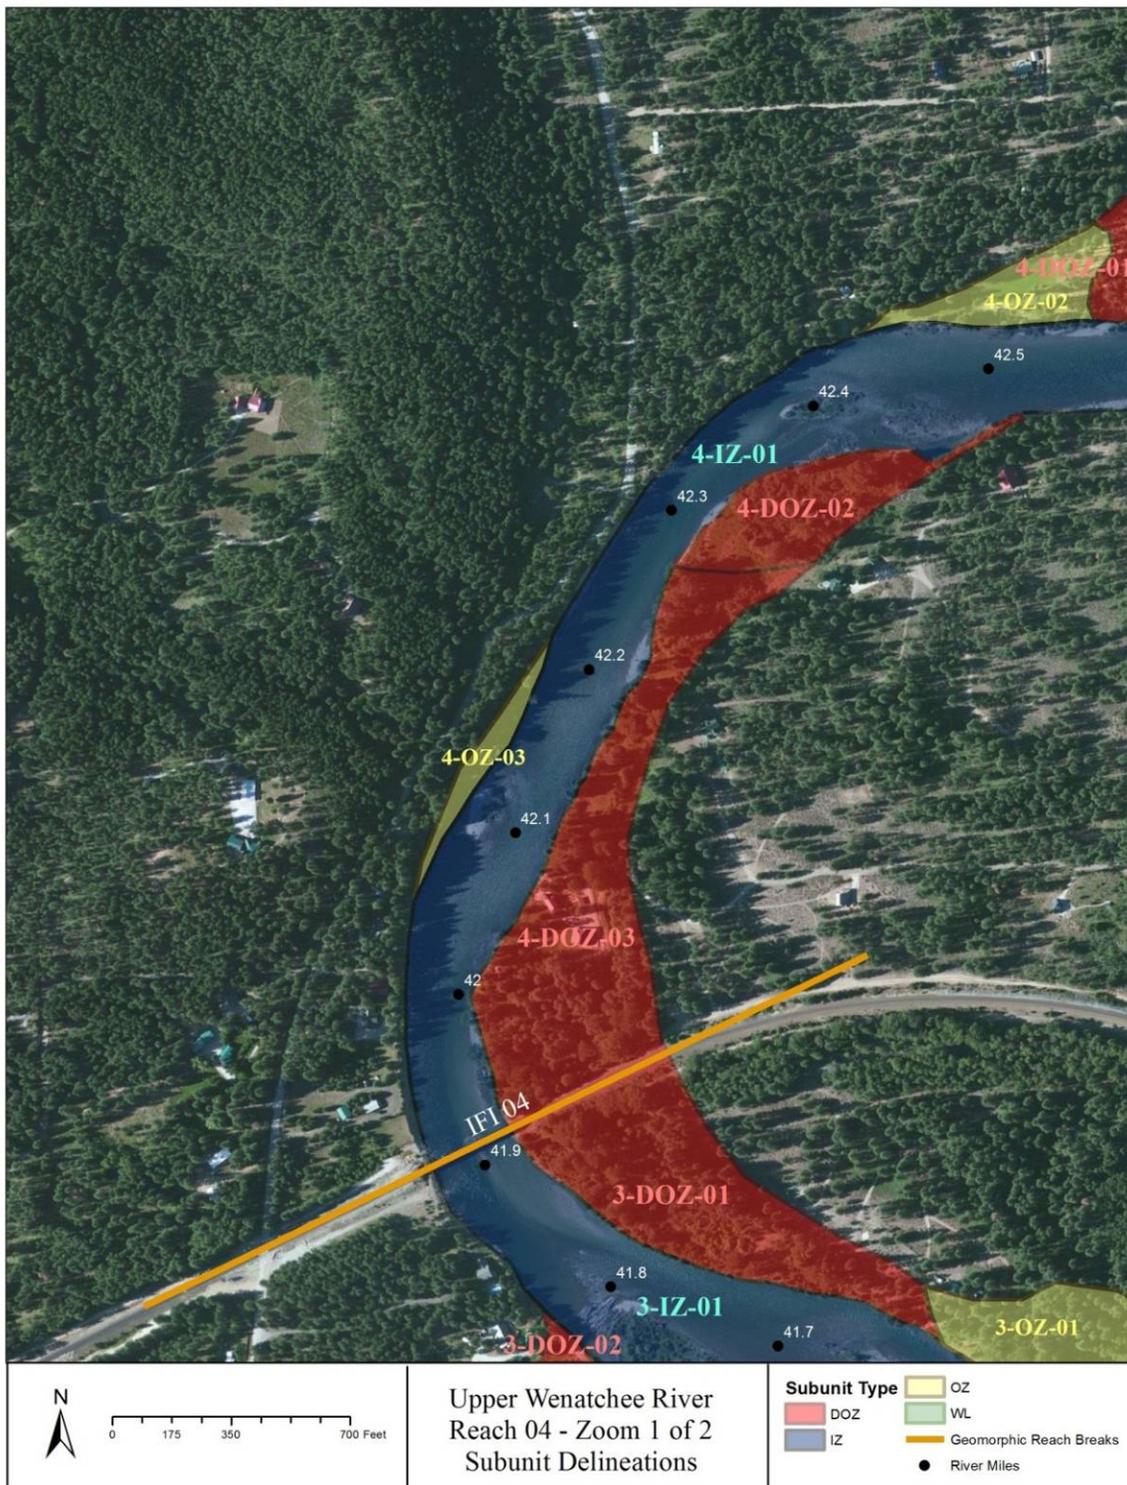
Figure 10. Subunit delineation map for downstream end of Reach 4. Flow is from north to south.

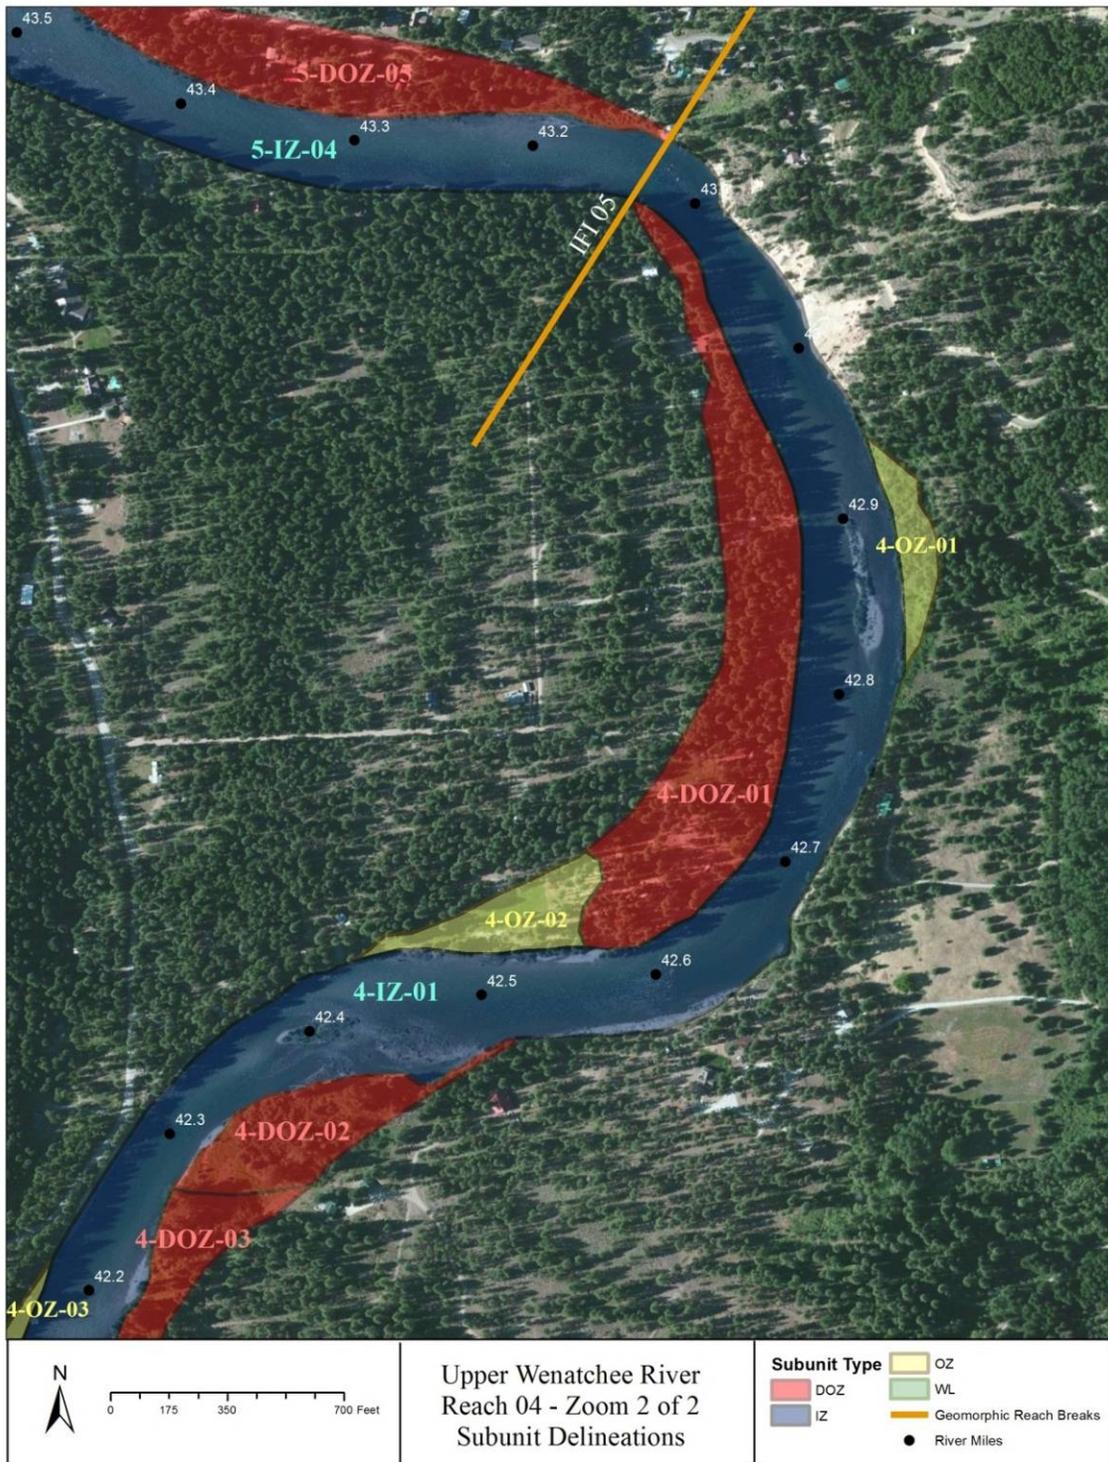
Figure 11. Subunit delineation map for upstream end of Reach 4. Flow is from north to south.

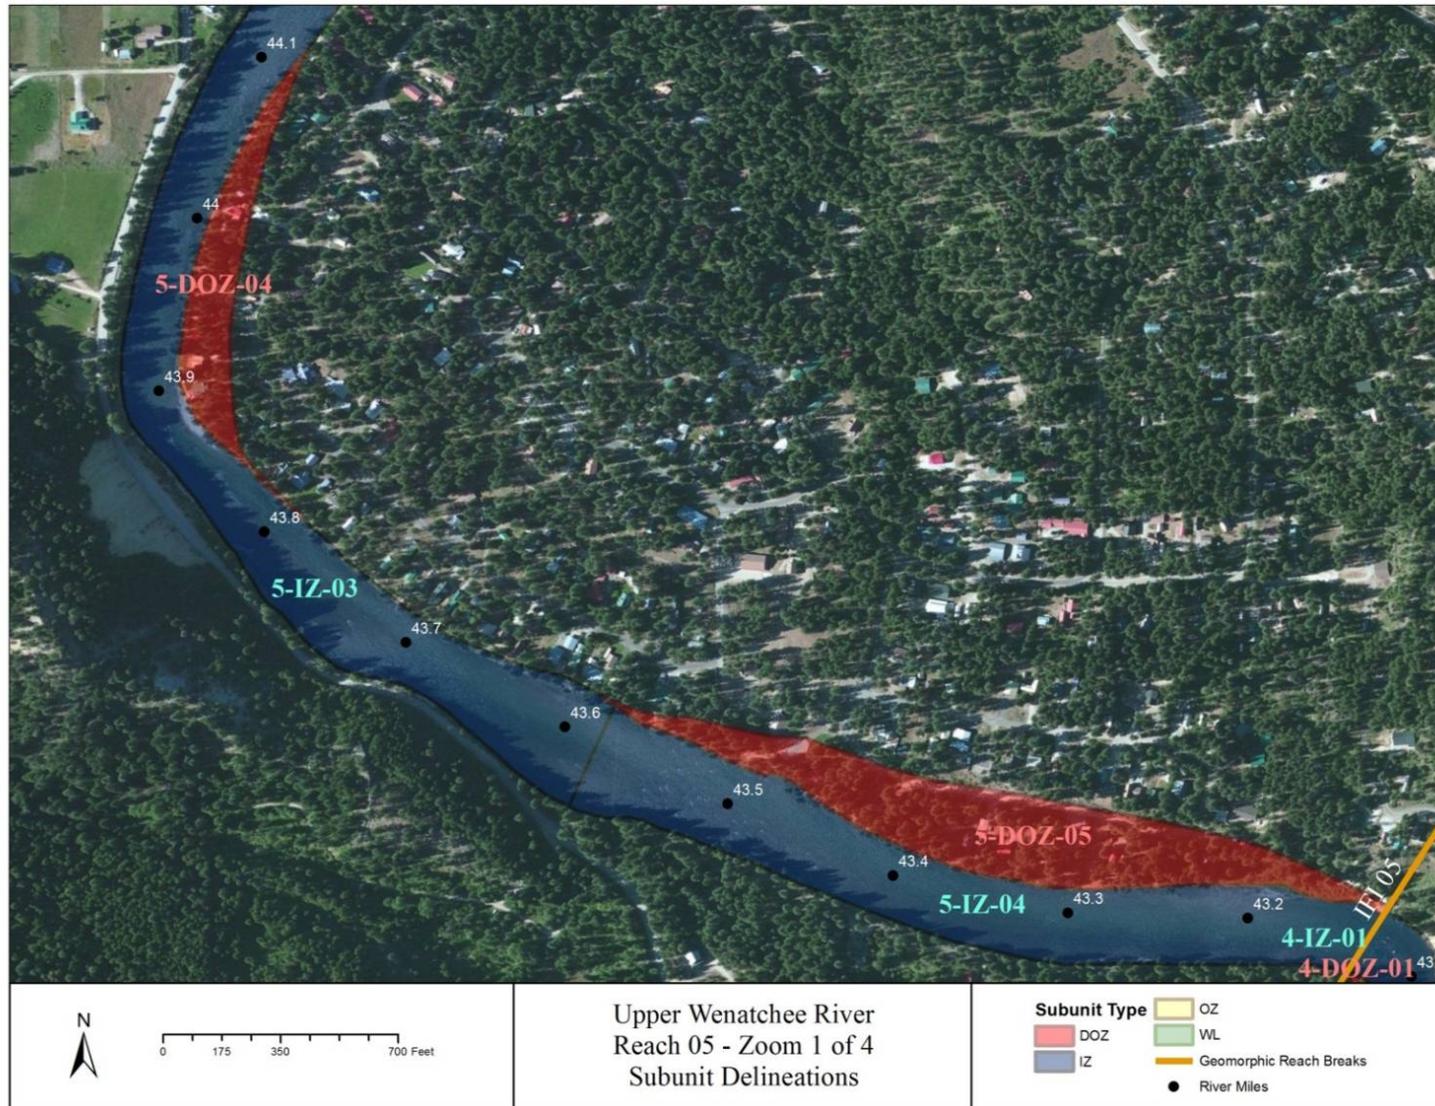
Figure 12. Subunit delineation map for downstream end of Reach 5. Flow is from northwest to to southeast.

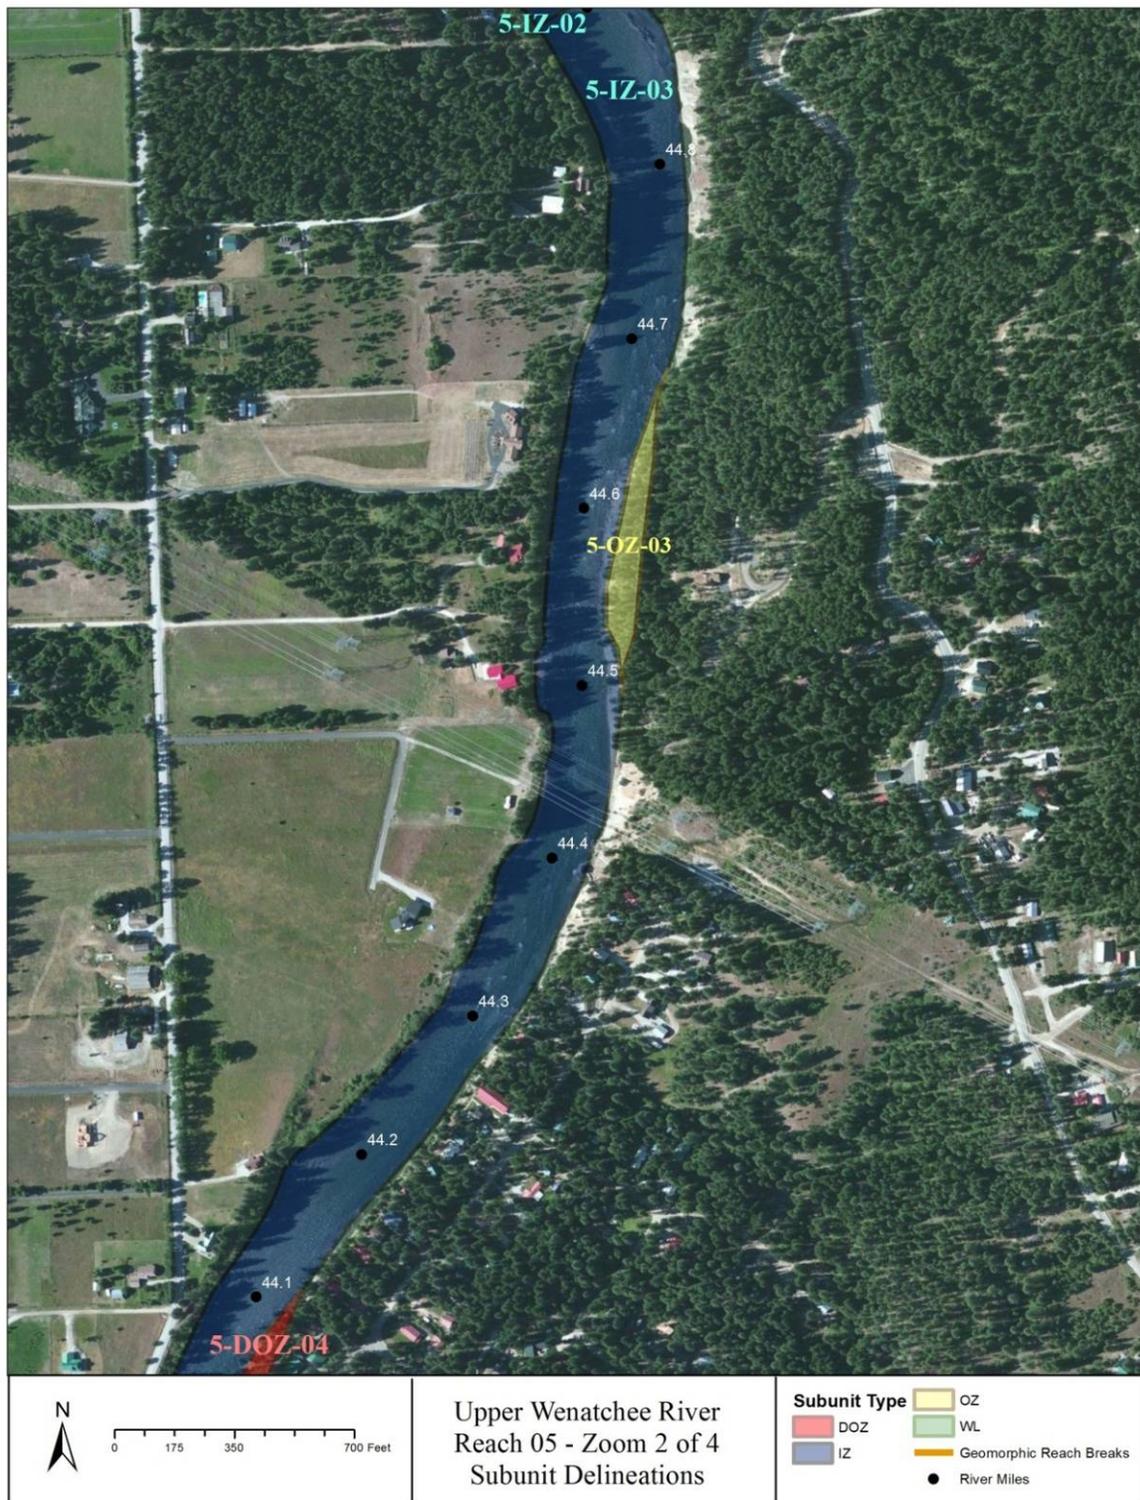
Figure 13. Subunit delineation map for upstream end of Reach 5. Flow is from North to South.
