APPENDIX B: SUB-UNIT MAPPING AND GEOMORPHOLOGY

UPPER WENATCHEE RIVER ASSESSMENT – APPENDIX B

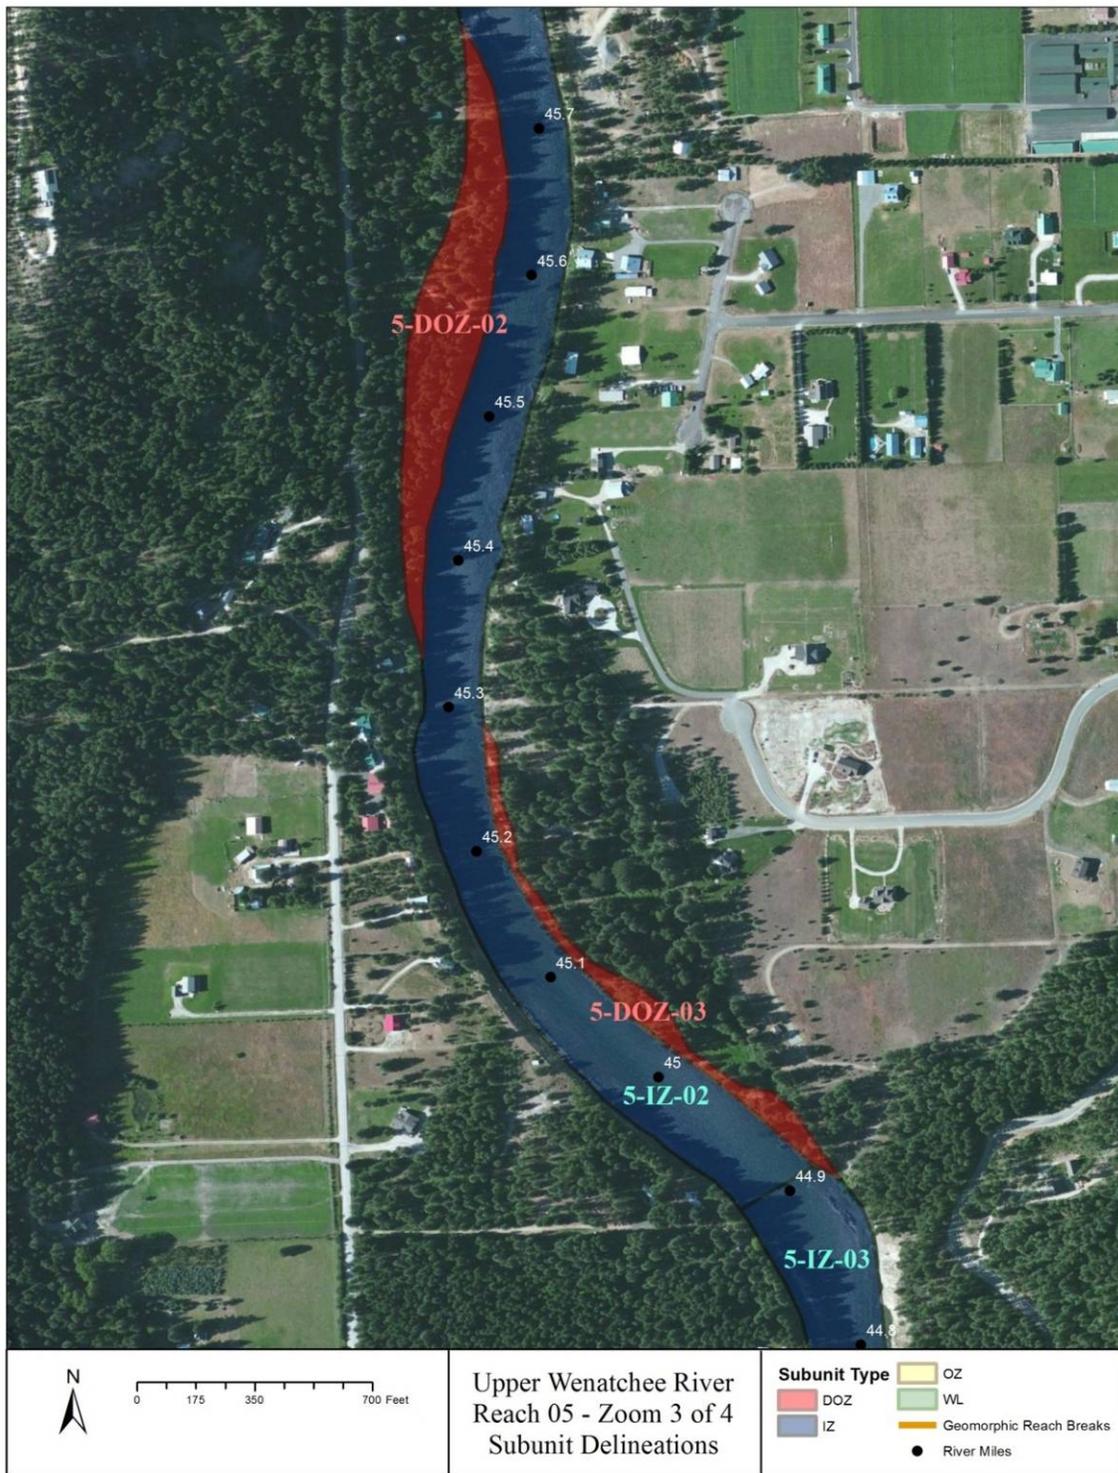
Figure 14. Subunit delineation map for upstream end of Reach 5. Flow is from north to south.

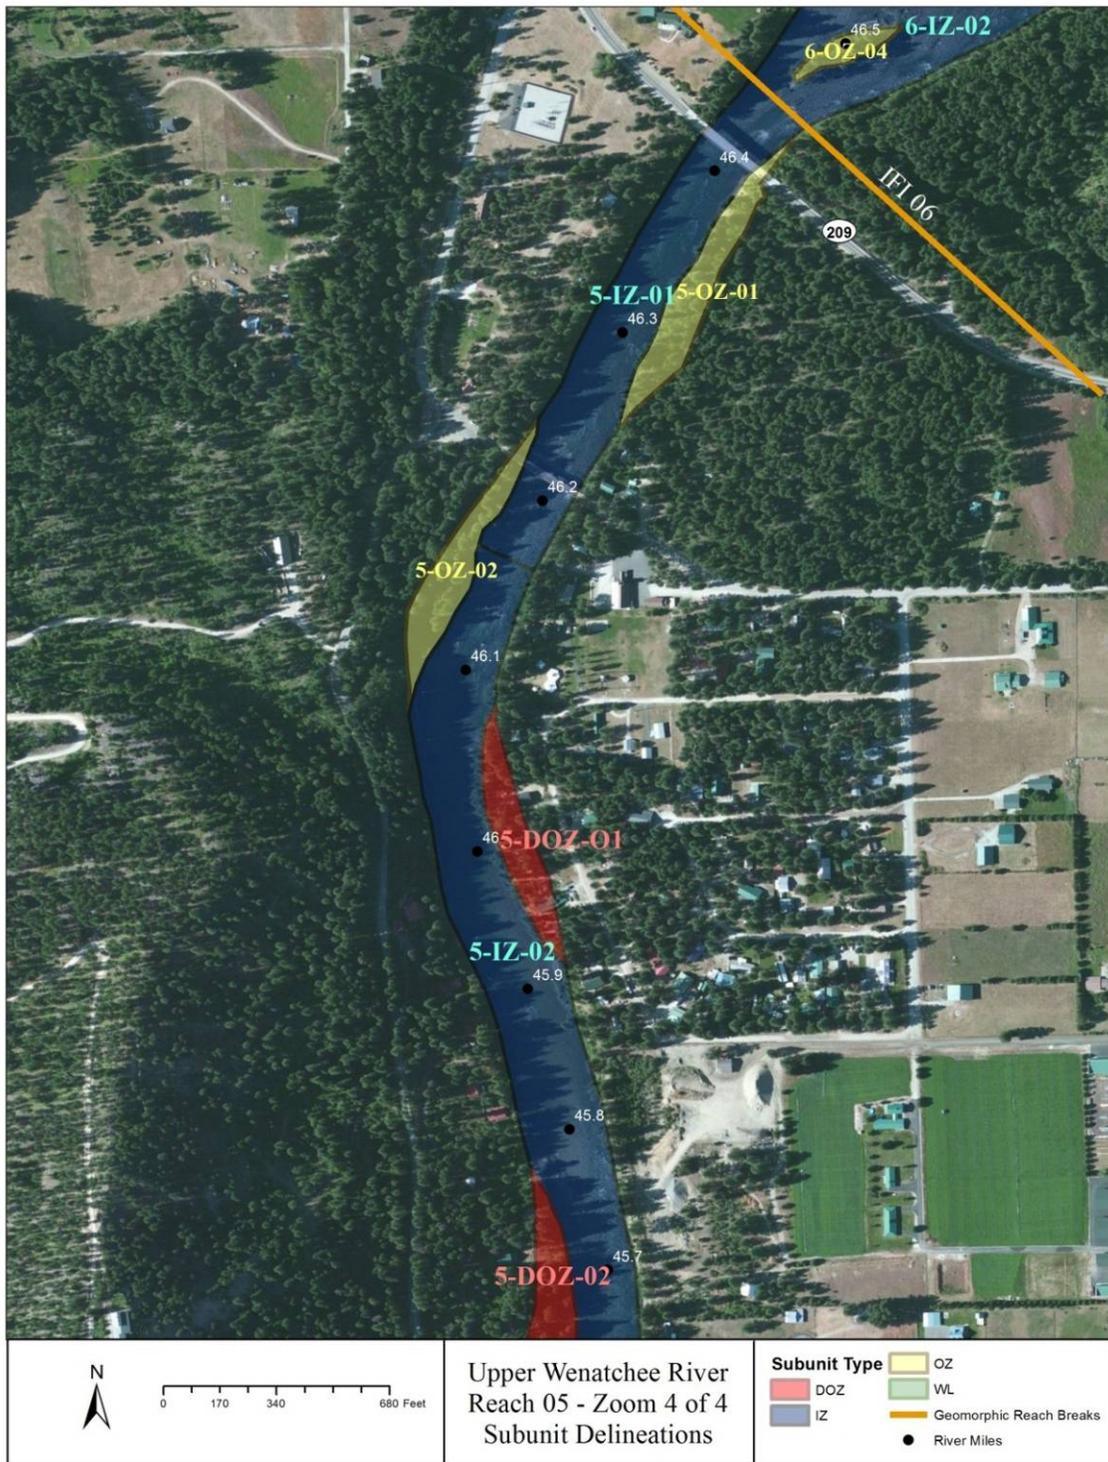
Figure 15. Subunit delineation map for upstream end of Reach 5. Flow is from north to south.

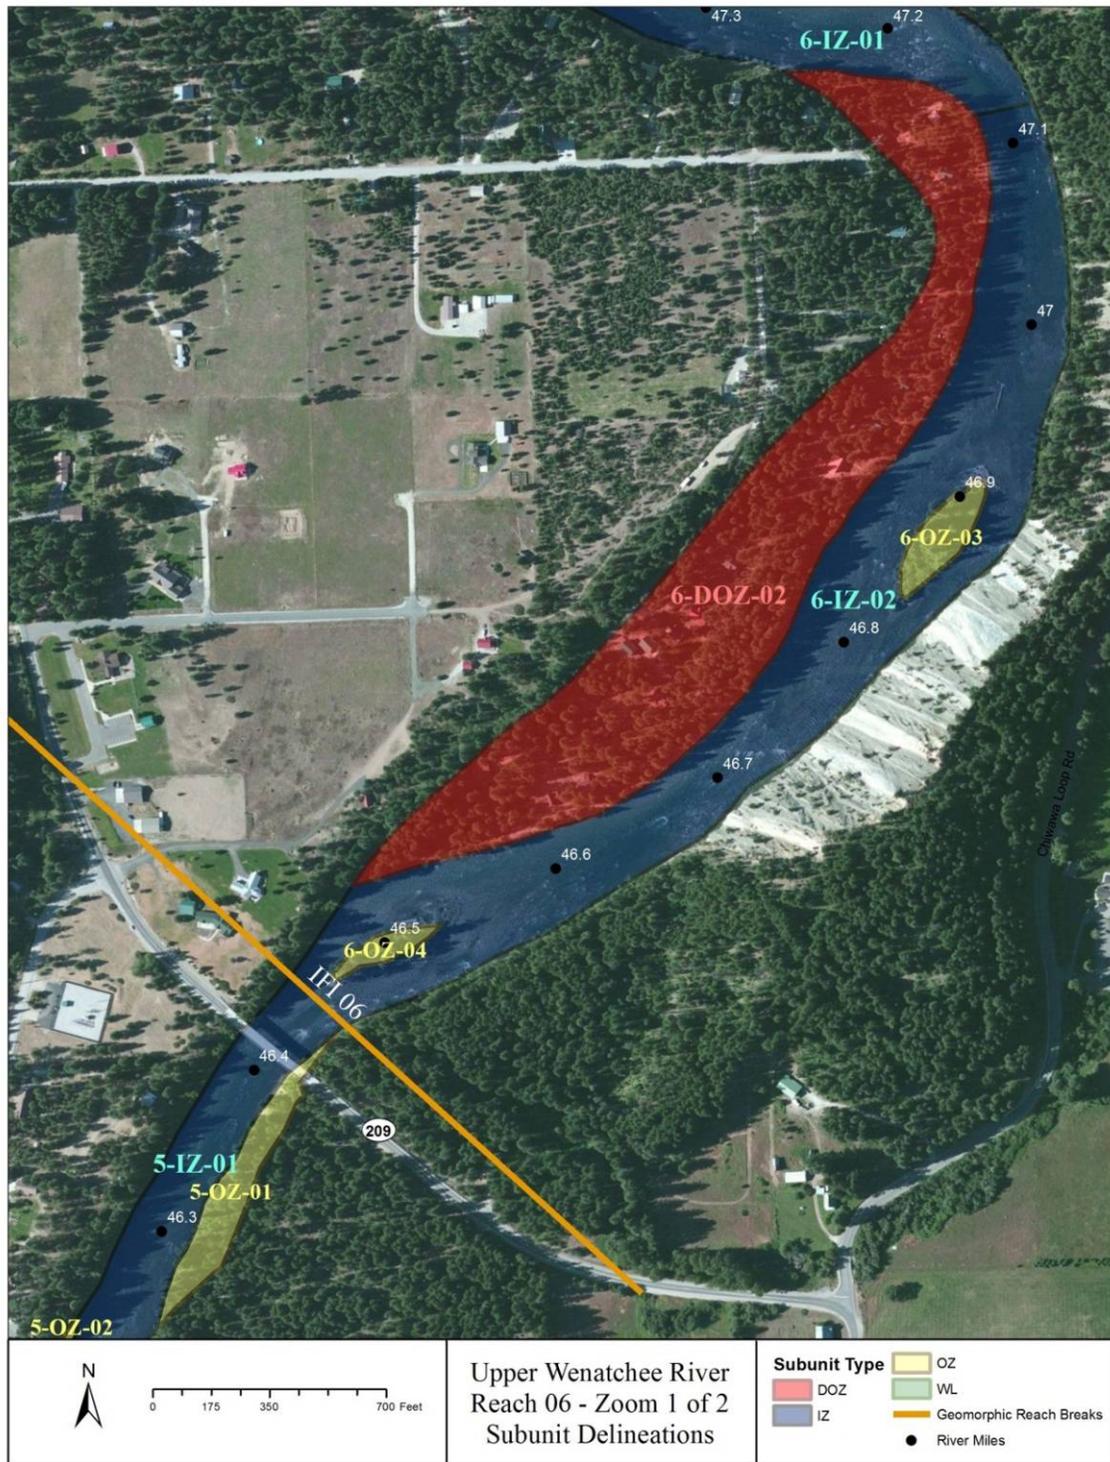
Figure 16. Overview map of Reach 6. Flow is from northwest to southwest.

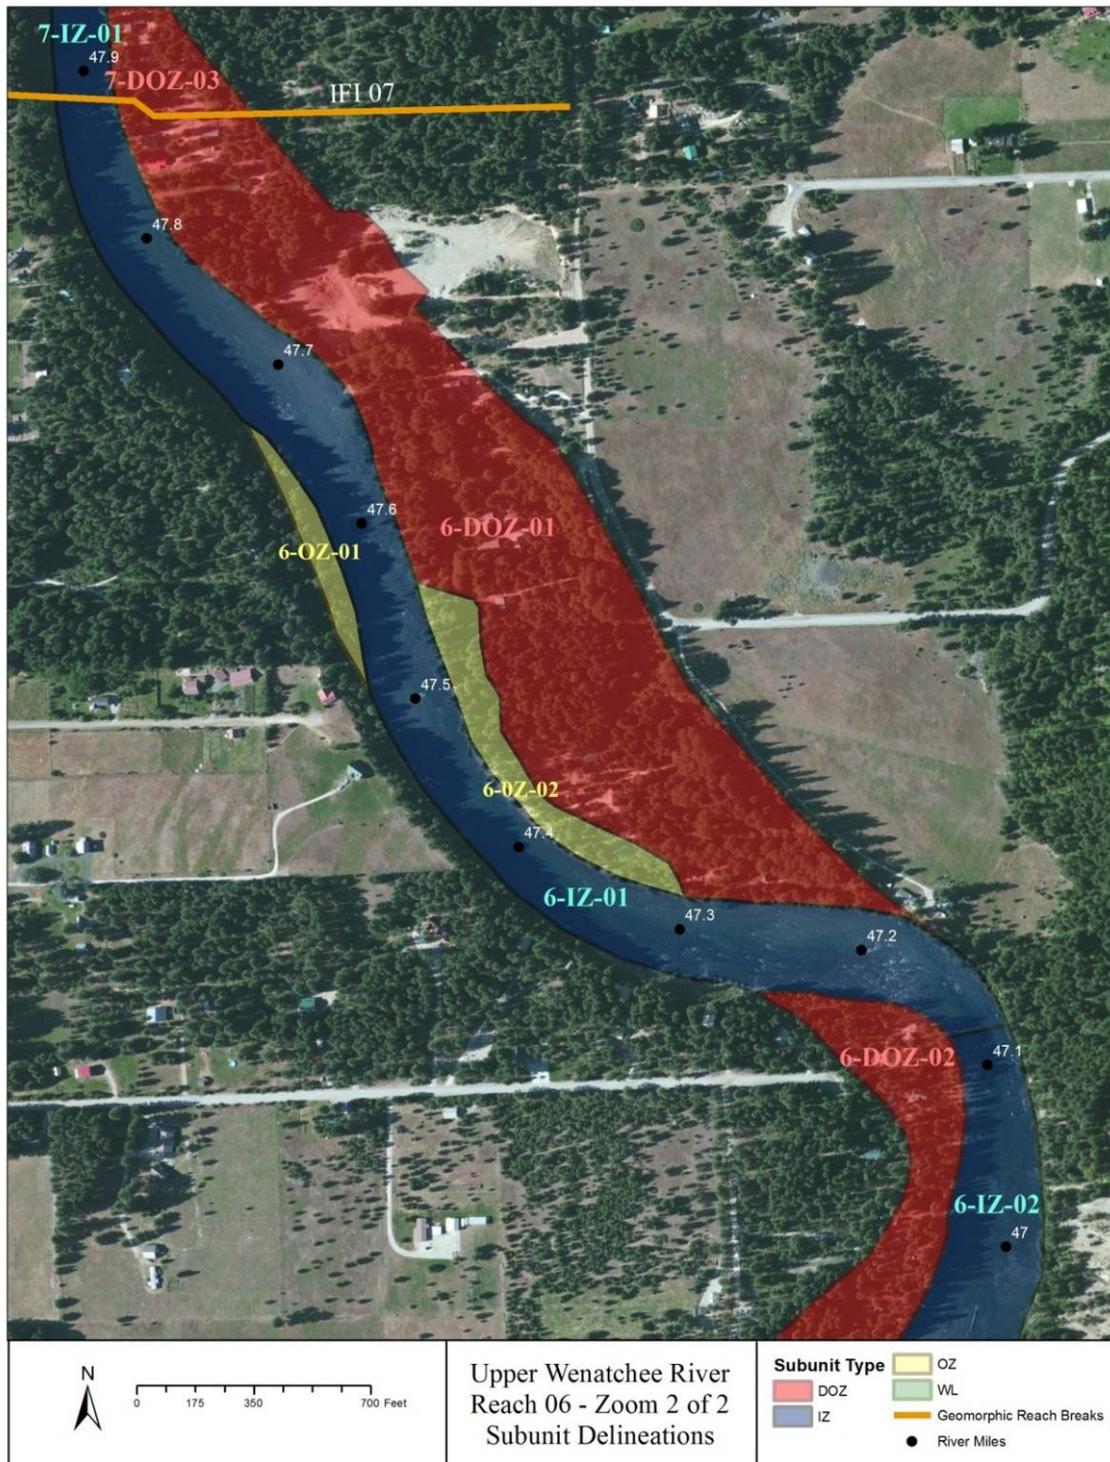
Figure 17. Overview map of Reach 6. Flow is from north to south.

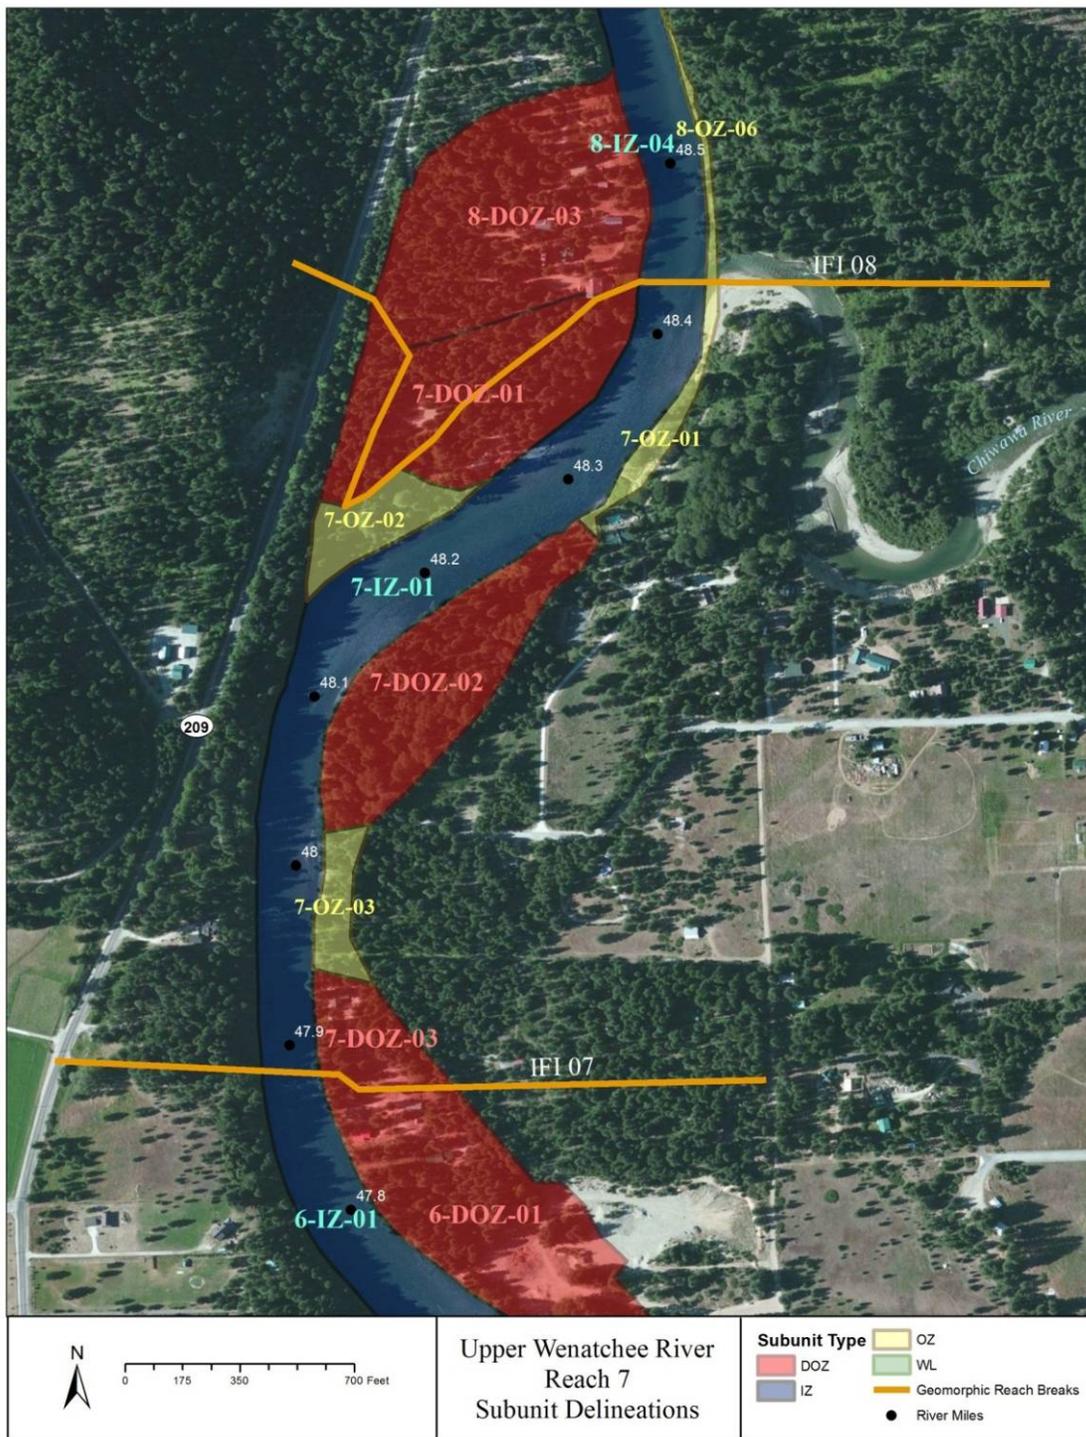
Figure 18. Subunit delineation map for Reach 7. Flow is from north to south.

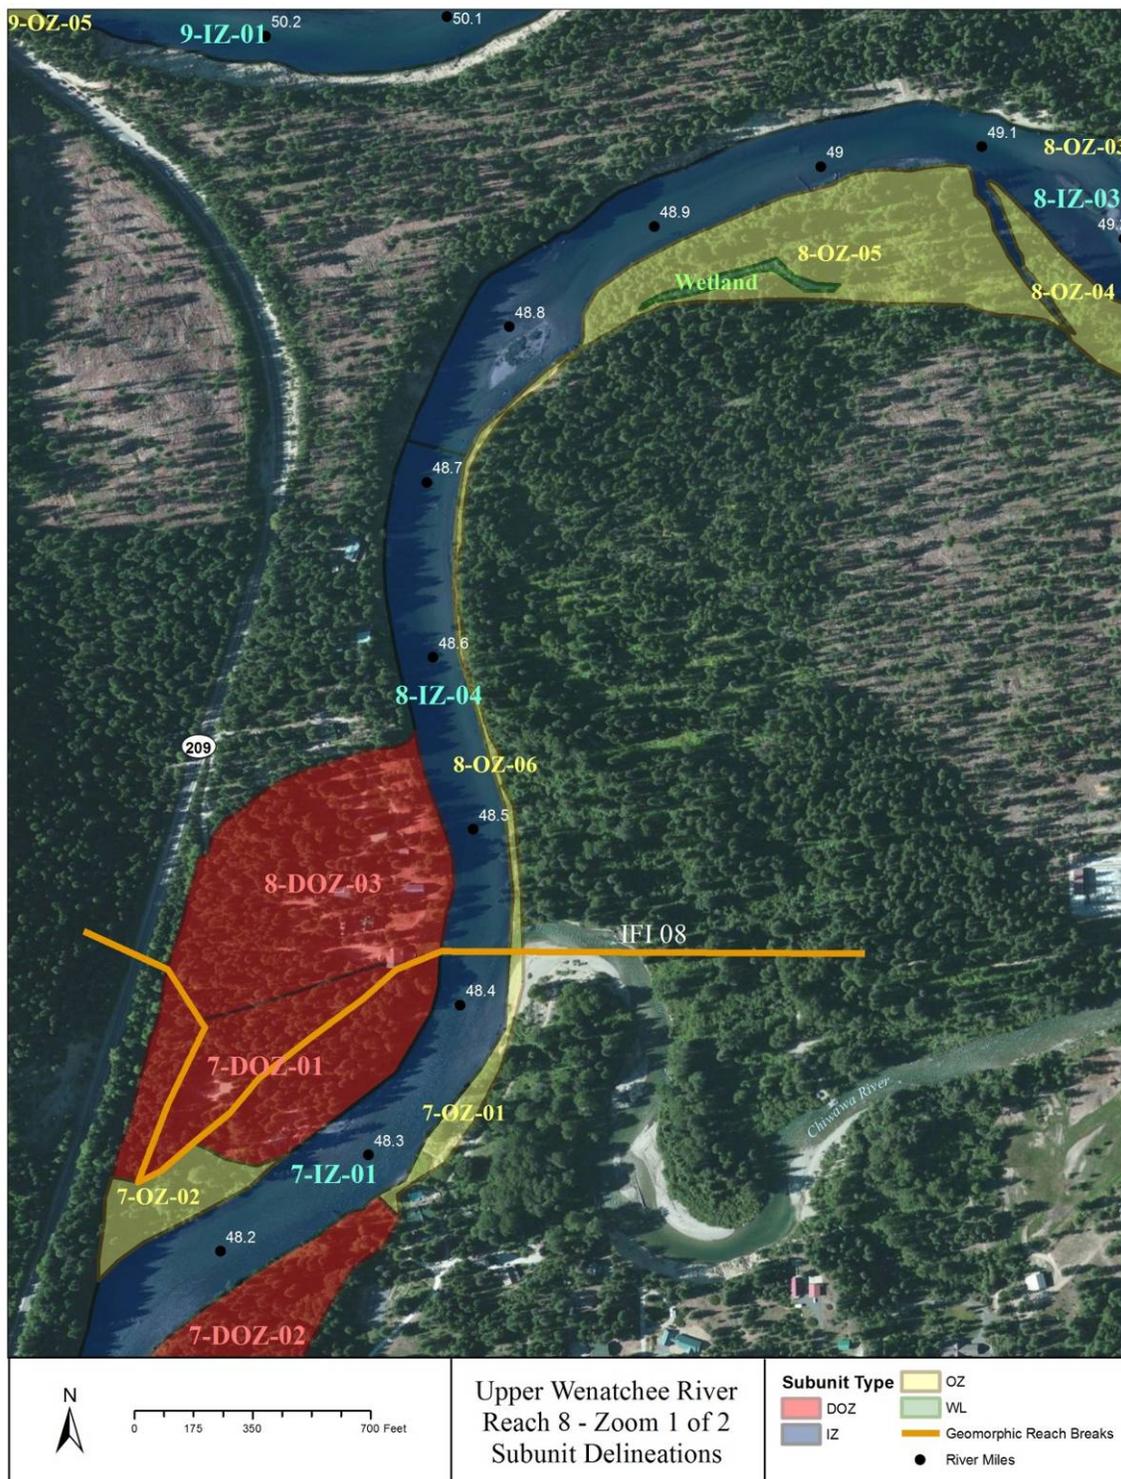
Figure 19. Subunit delineation map for downstream end of Reach 8. Flow is from north to south.

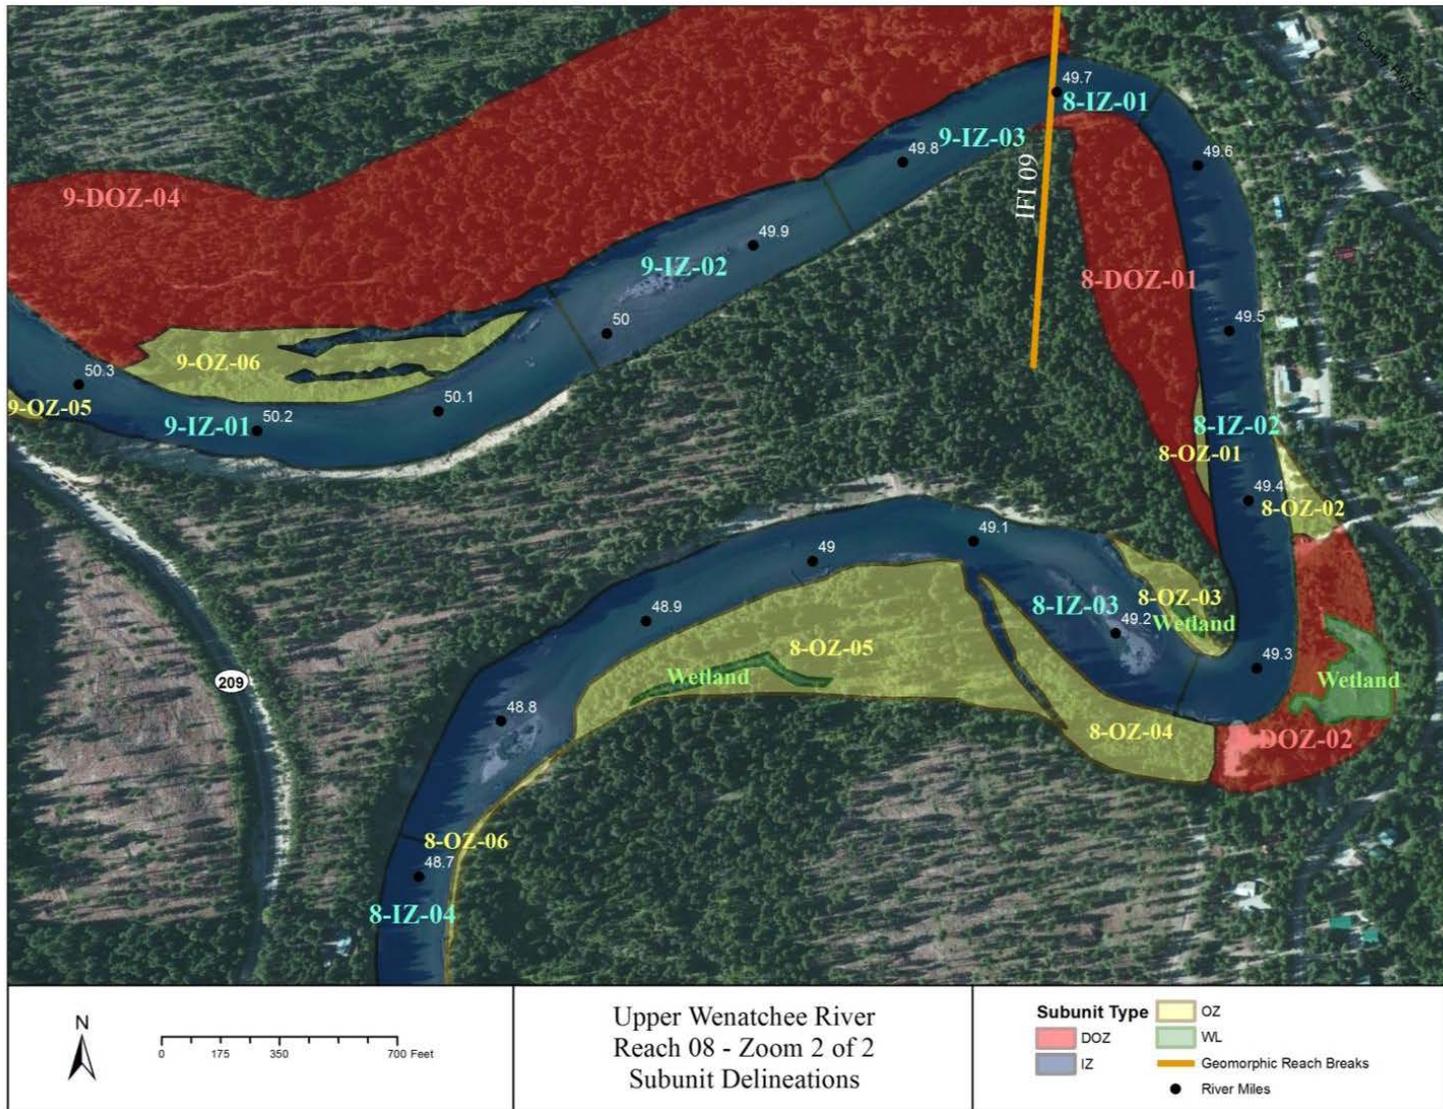
Figure 20. Subunit delineation map for upstream end of Reach 8.

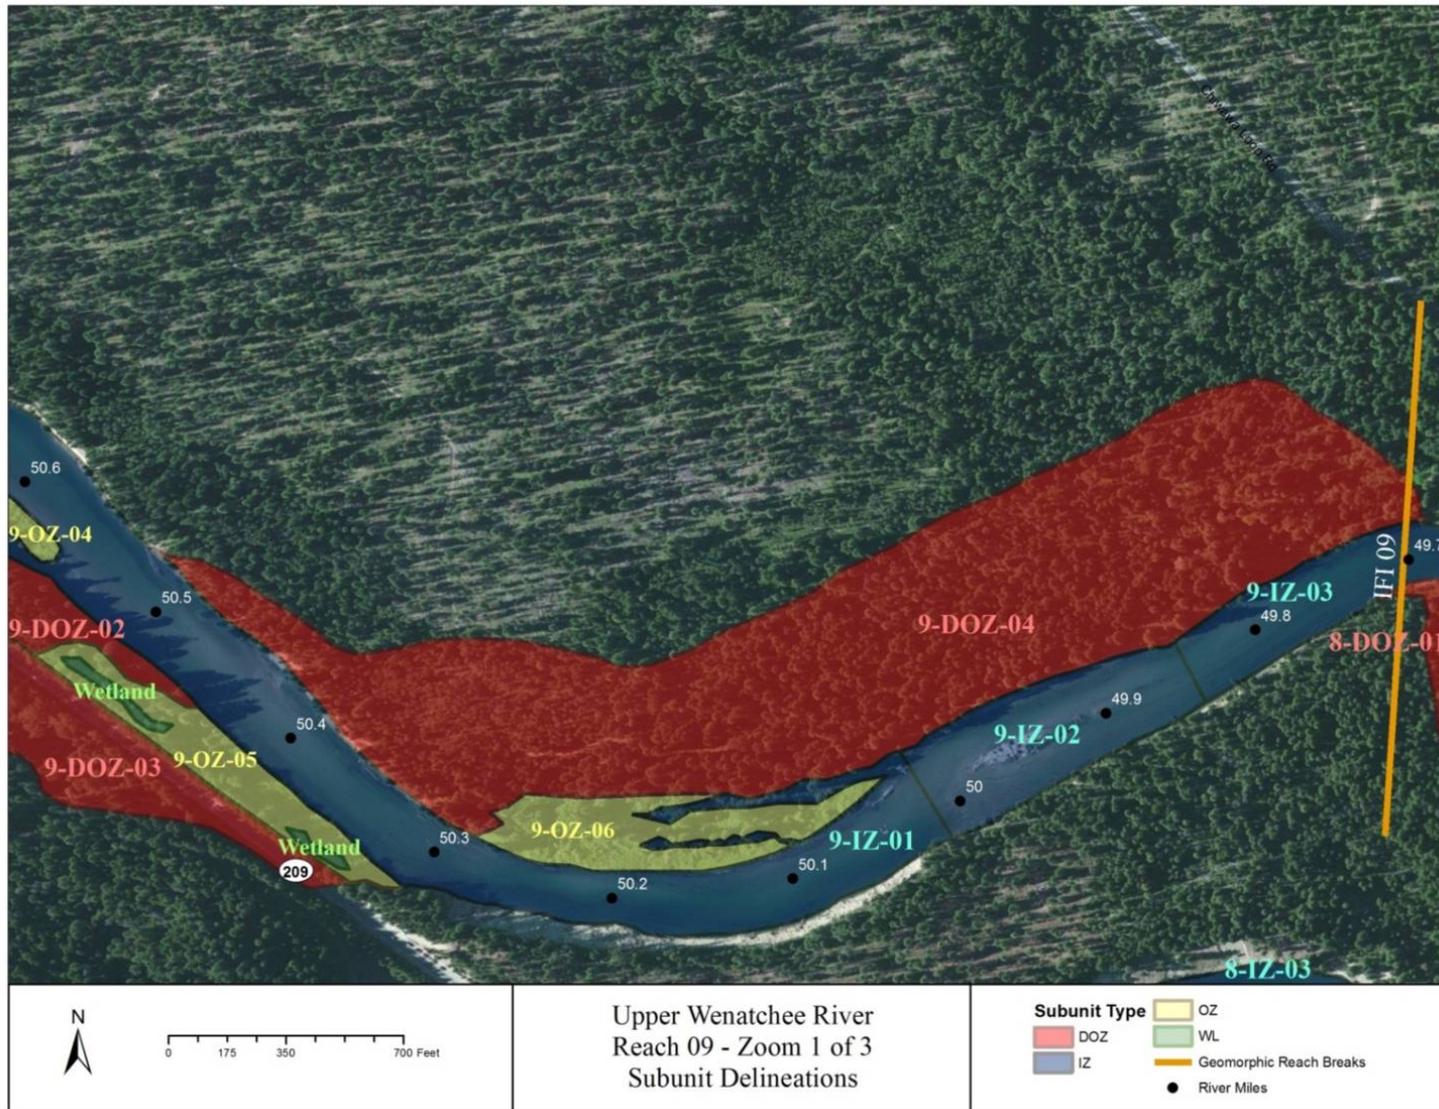
Figure 21. Subunit delineation map for downstream end of Reach 9. Flow is from west to east.

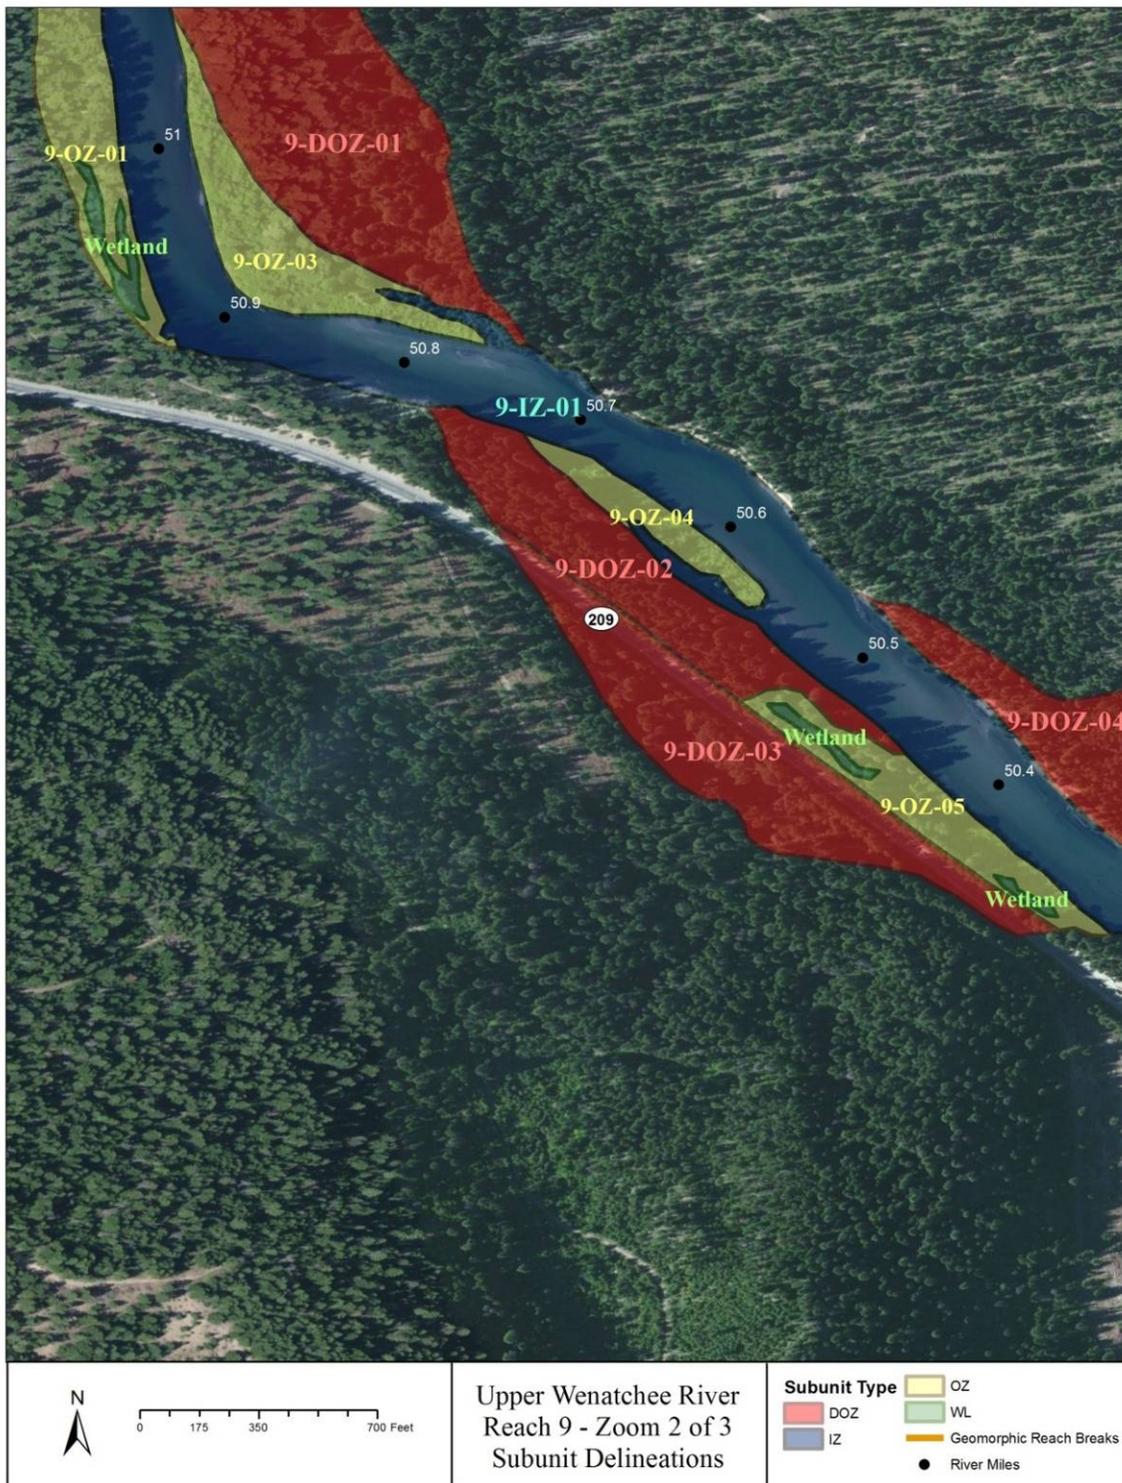
Figure 22. Subunit delineation map for upstream end of Reach 9. Flow is from northwest to southeast.

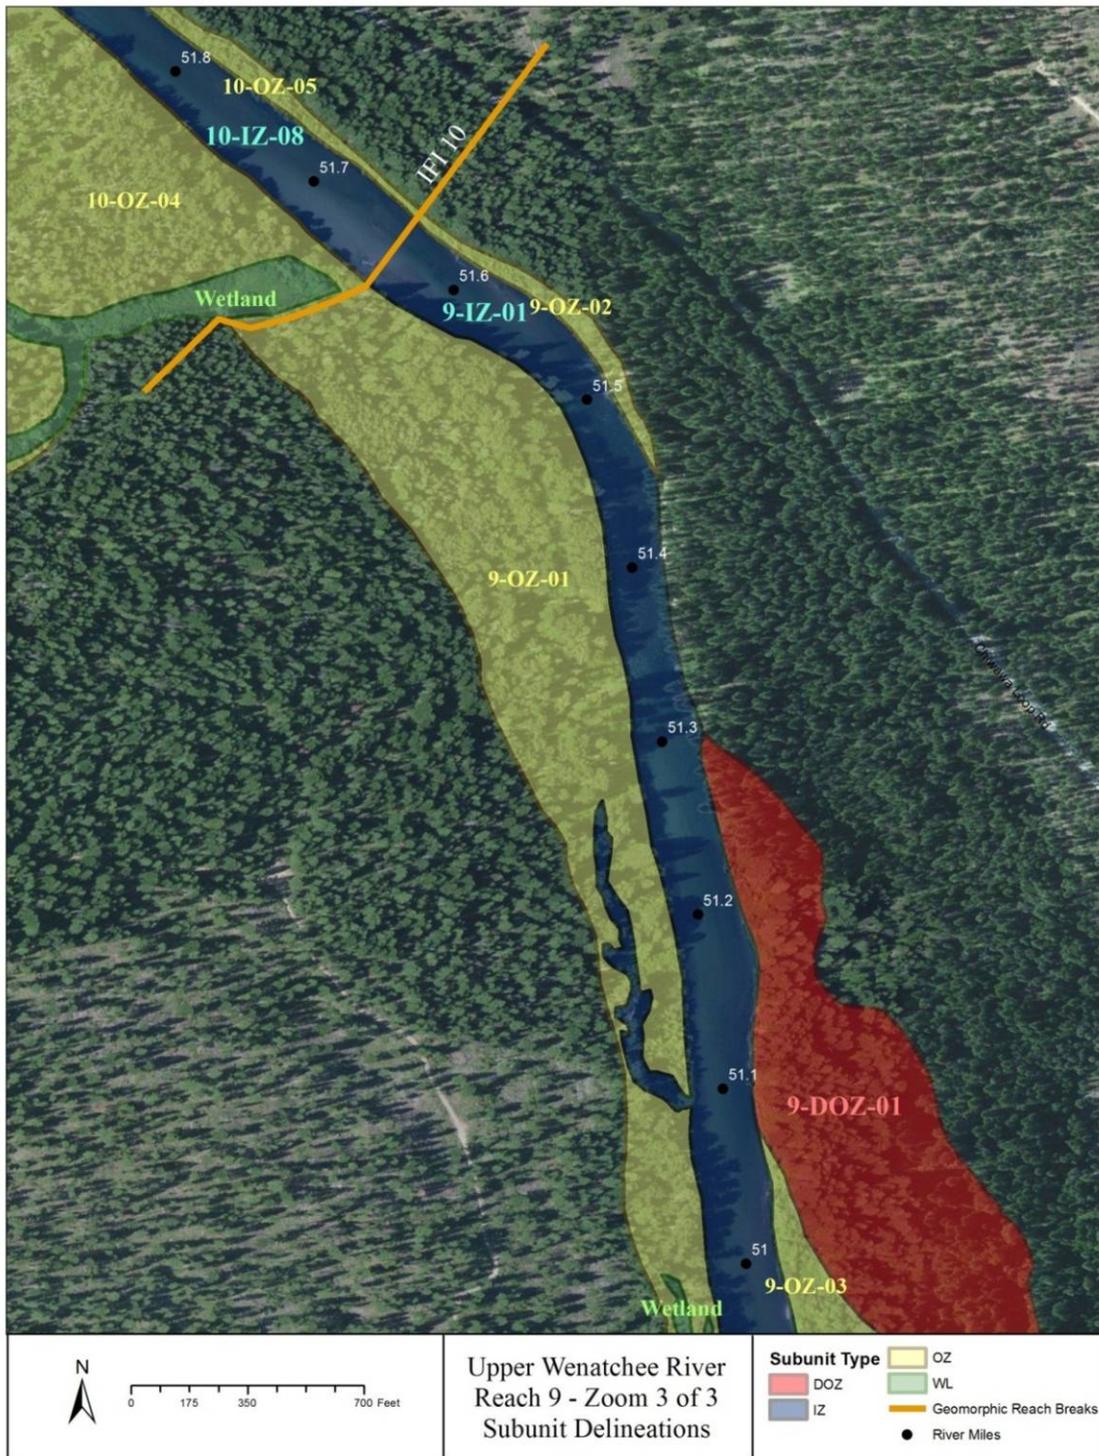
Figure 23. Subunit delineation map for upstream end of Reach 9. Flow is from north to south.

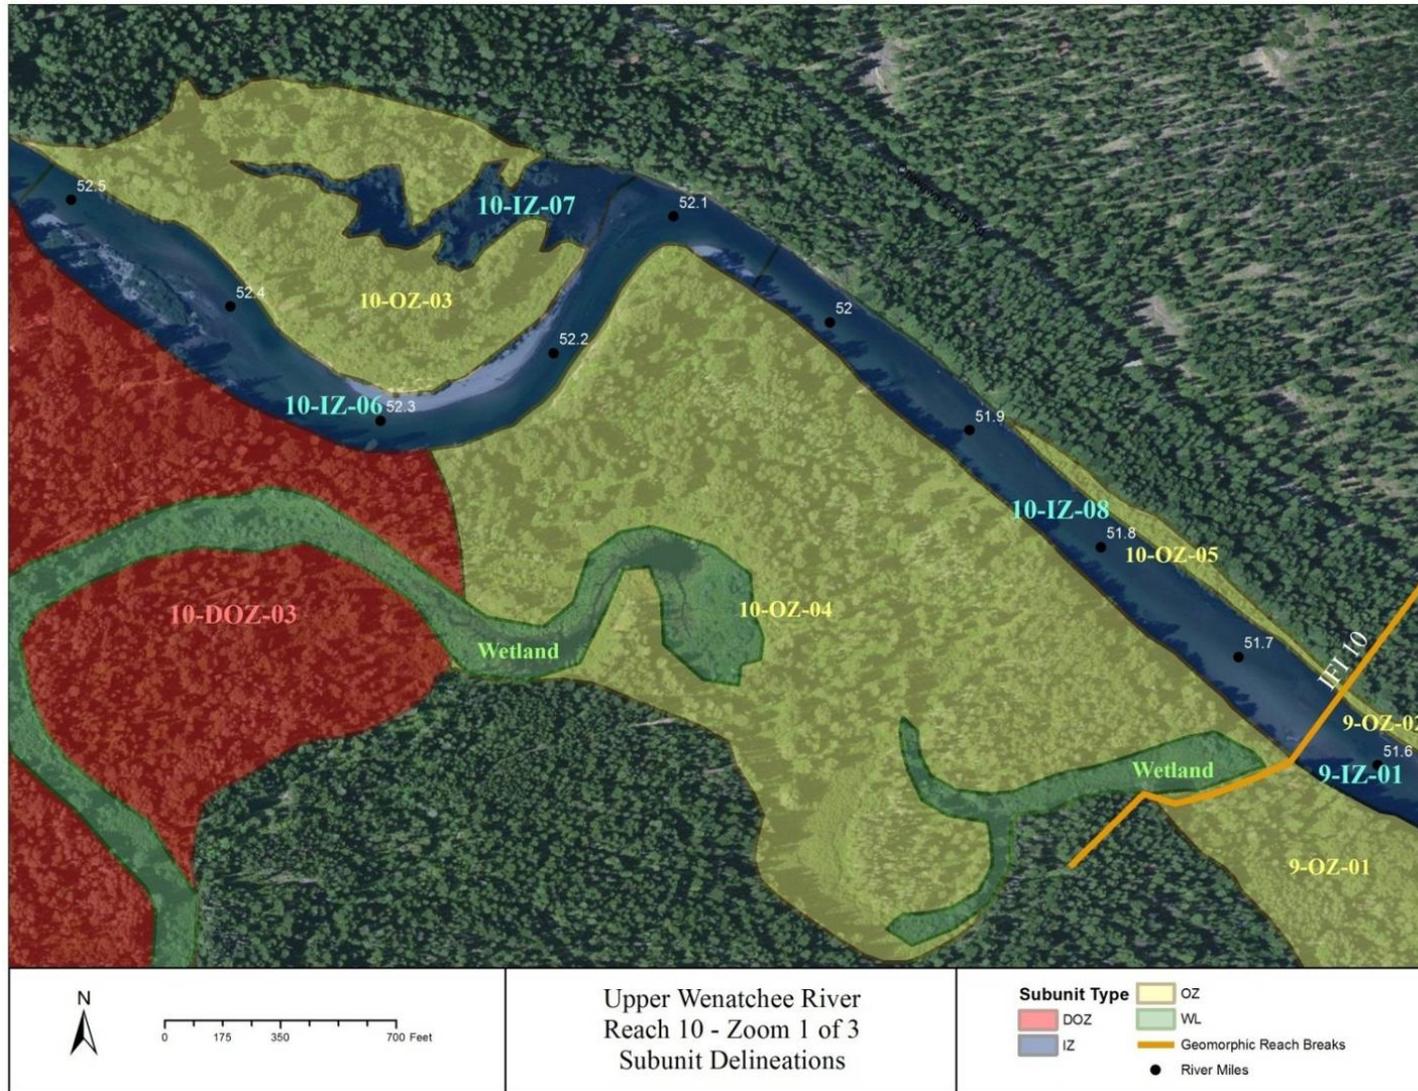
Figure 24. Subunit delineation map for downstream end of Reach 10. Flow is from northwest to southeast.

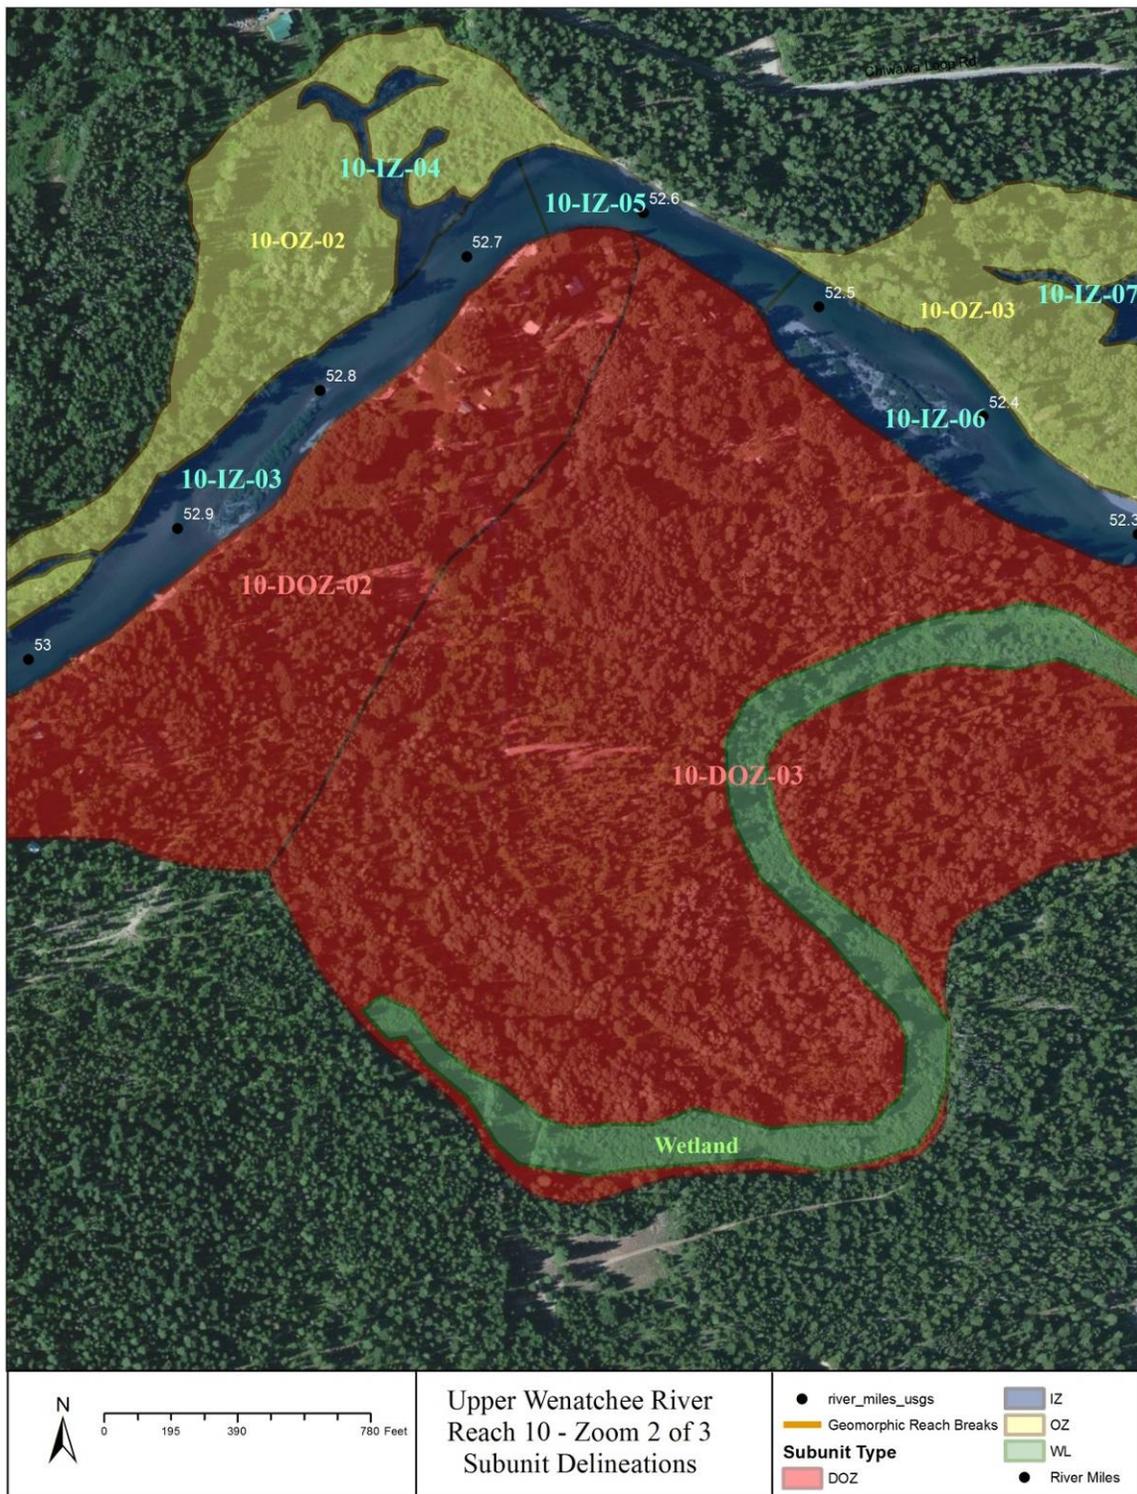
Figure 25. Subunit delineation map for Reach 10. Flow is from west to east.

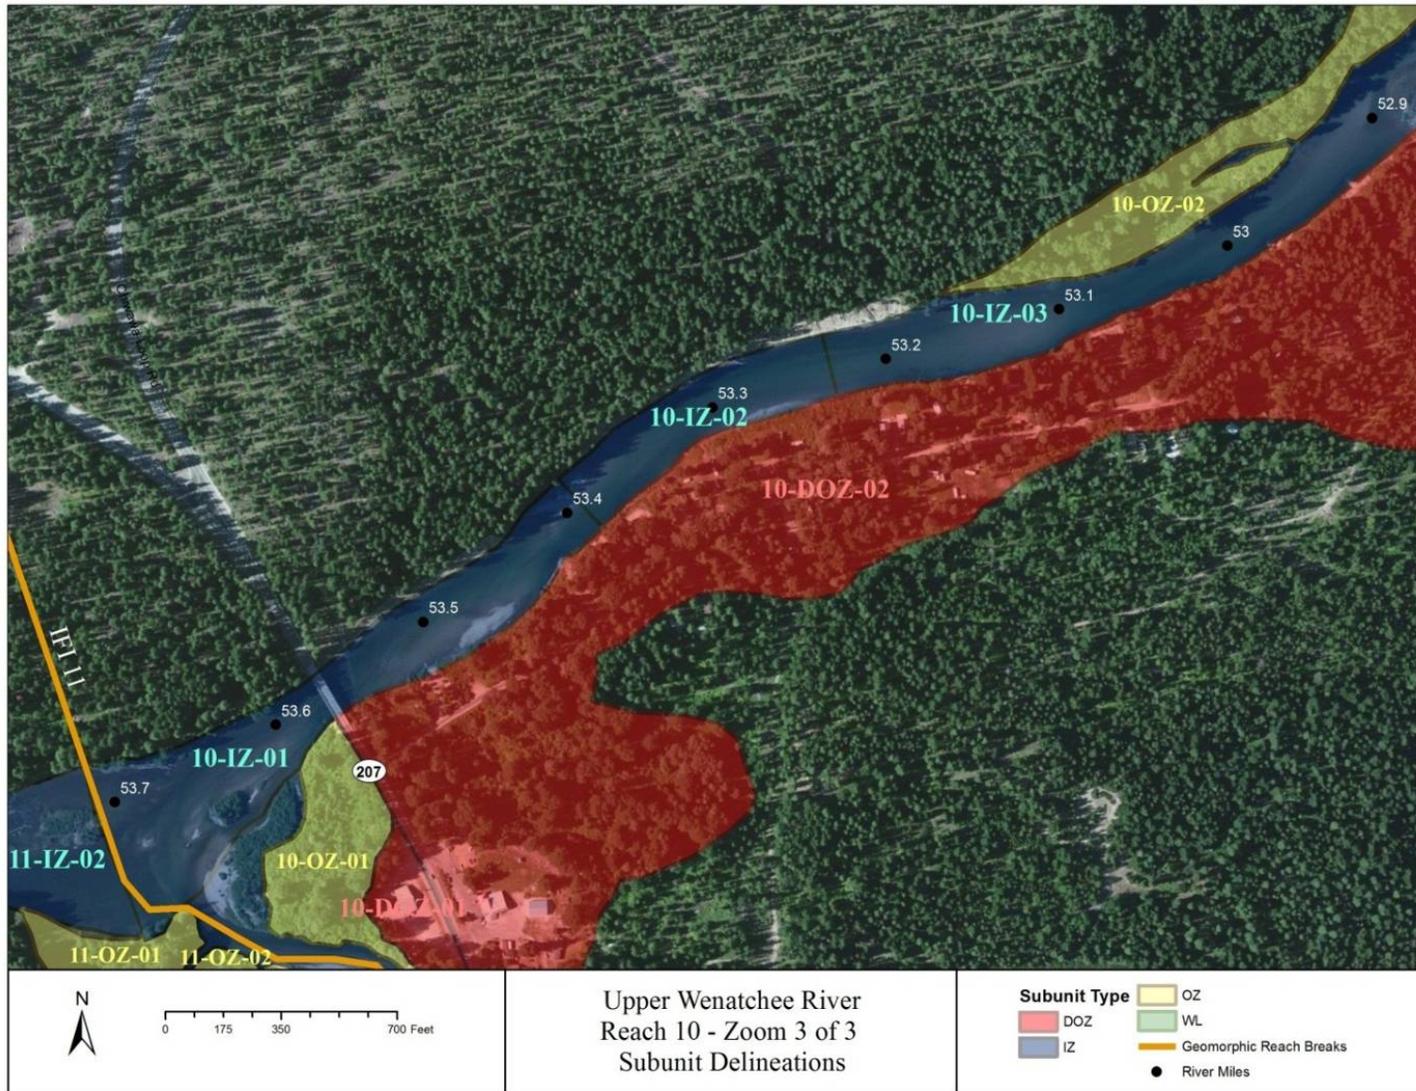
Figure 26. Subunit delineation map for the upstream end of Reach 10. Flow is from west to northeast.

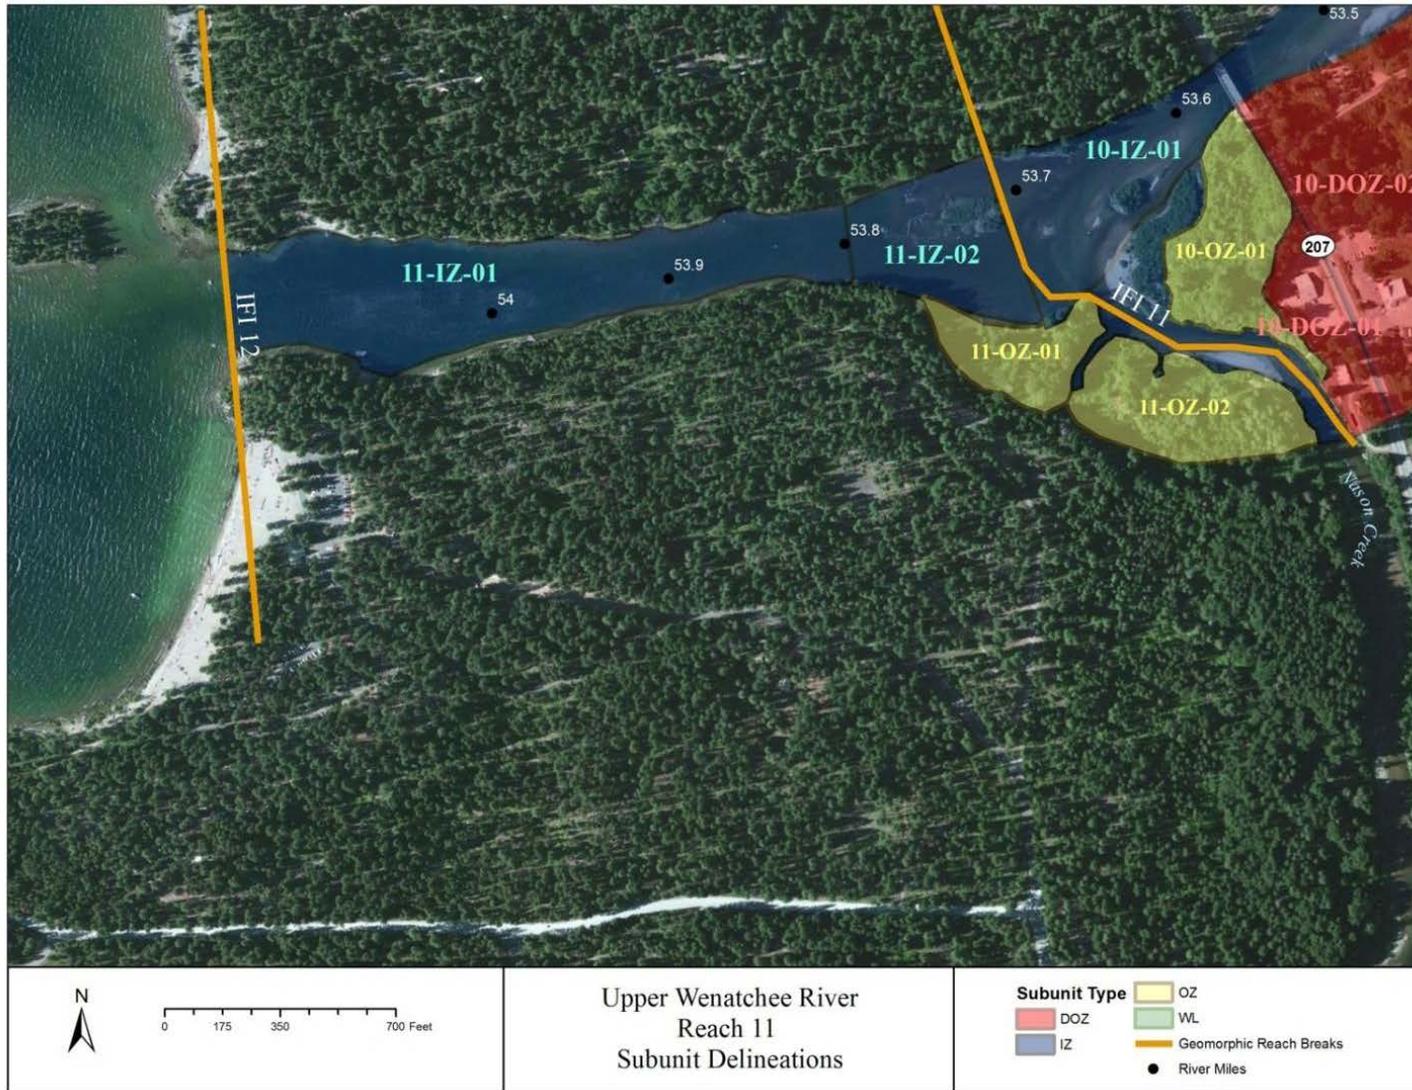
Figure 27. Subunit delineation map for Reach 11. Flow is from west to east.
