# Icicle Creek Reach Assessment

## Appendix C | Restoration Strategy

*February 2026*

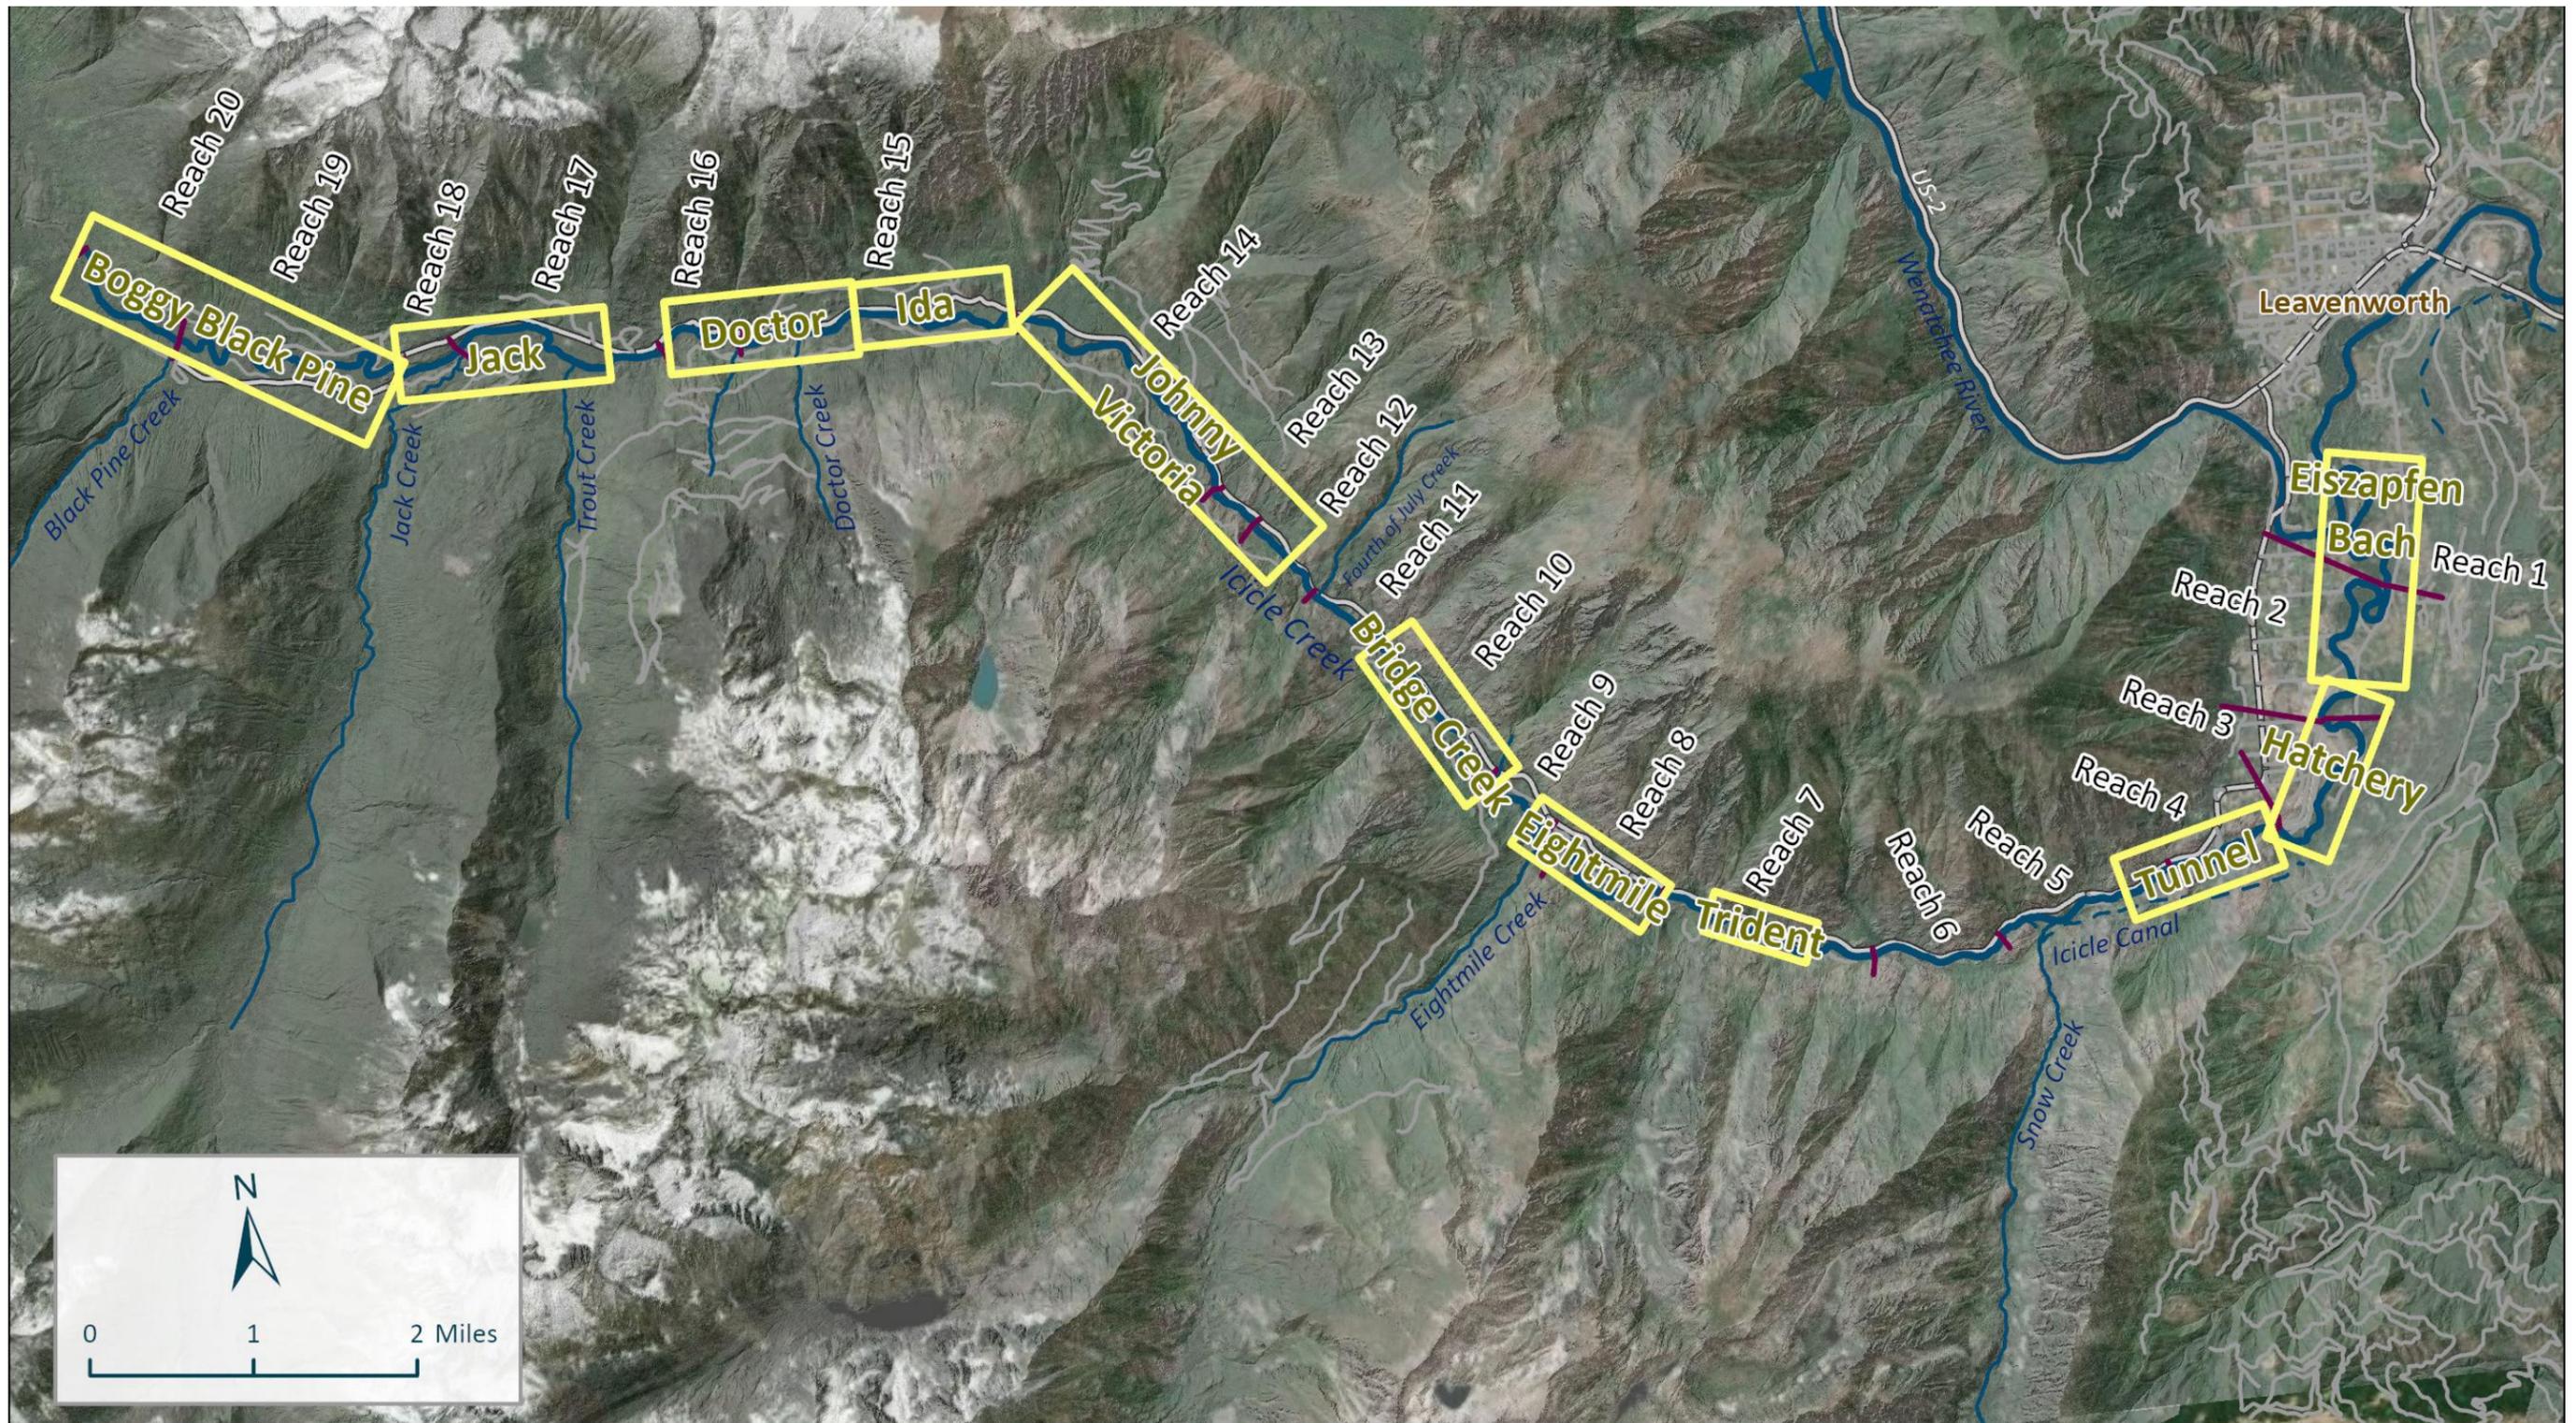
Figure 1. Overview map of project area locations and names

Projects were identified through field surveys and analysis performed in the Reach Assessment. A map of the project areas is provided in Figure 1. Project elements were identified that are believed to best achieve target conditions and address fish habitat limiting factors. The projects represent an initial first step; it is expected that projects will be modified once project-specific surveys, analysis, and stakeholder coordination are performed. Project descriptions and maps are provided below. Project prioritization was performed to rank the projects into three priority tiers. Prioritization occurred by subjecting the projects to a set of scoring criteria. These criteria are based on several factors, including how well projects address the “gap” between existing and target conditions, species use/potential use of the area, and whether or not projects address root causes of impairments. Projects are also given a relative cost score estimate and feasibility designation in order to provide a relative cost perspective in project selection and planning. A description of the scoring methods and guidance is provided at the end of this document (Section 3.2).

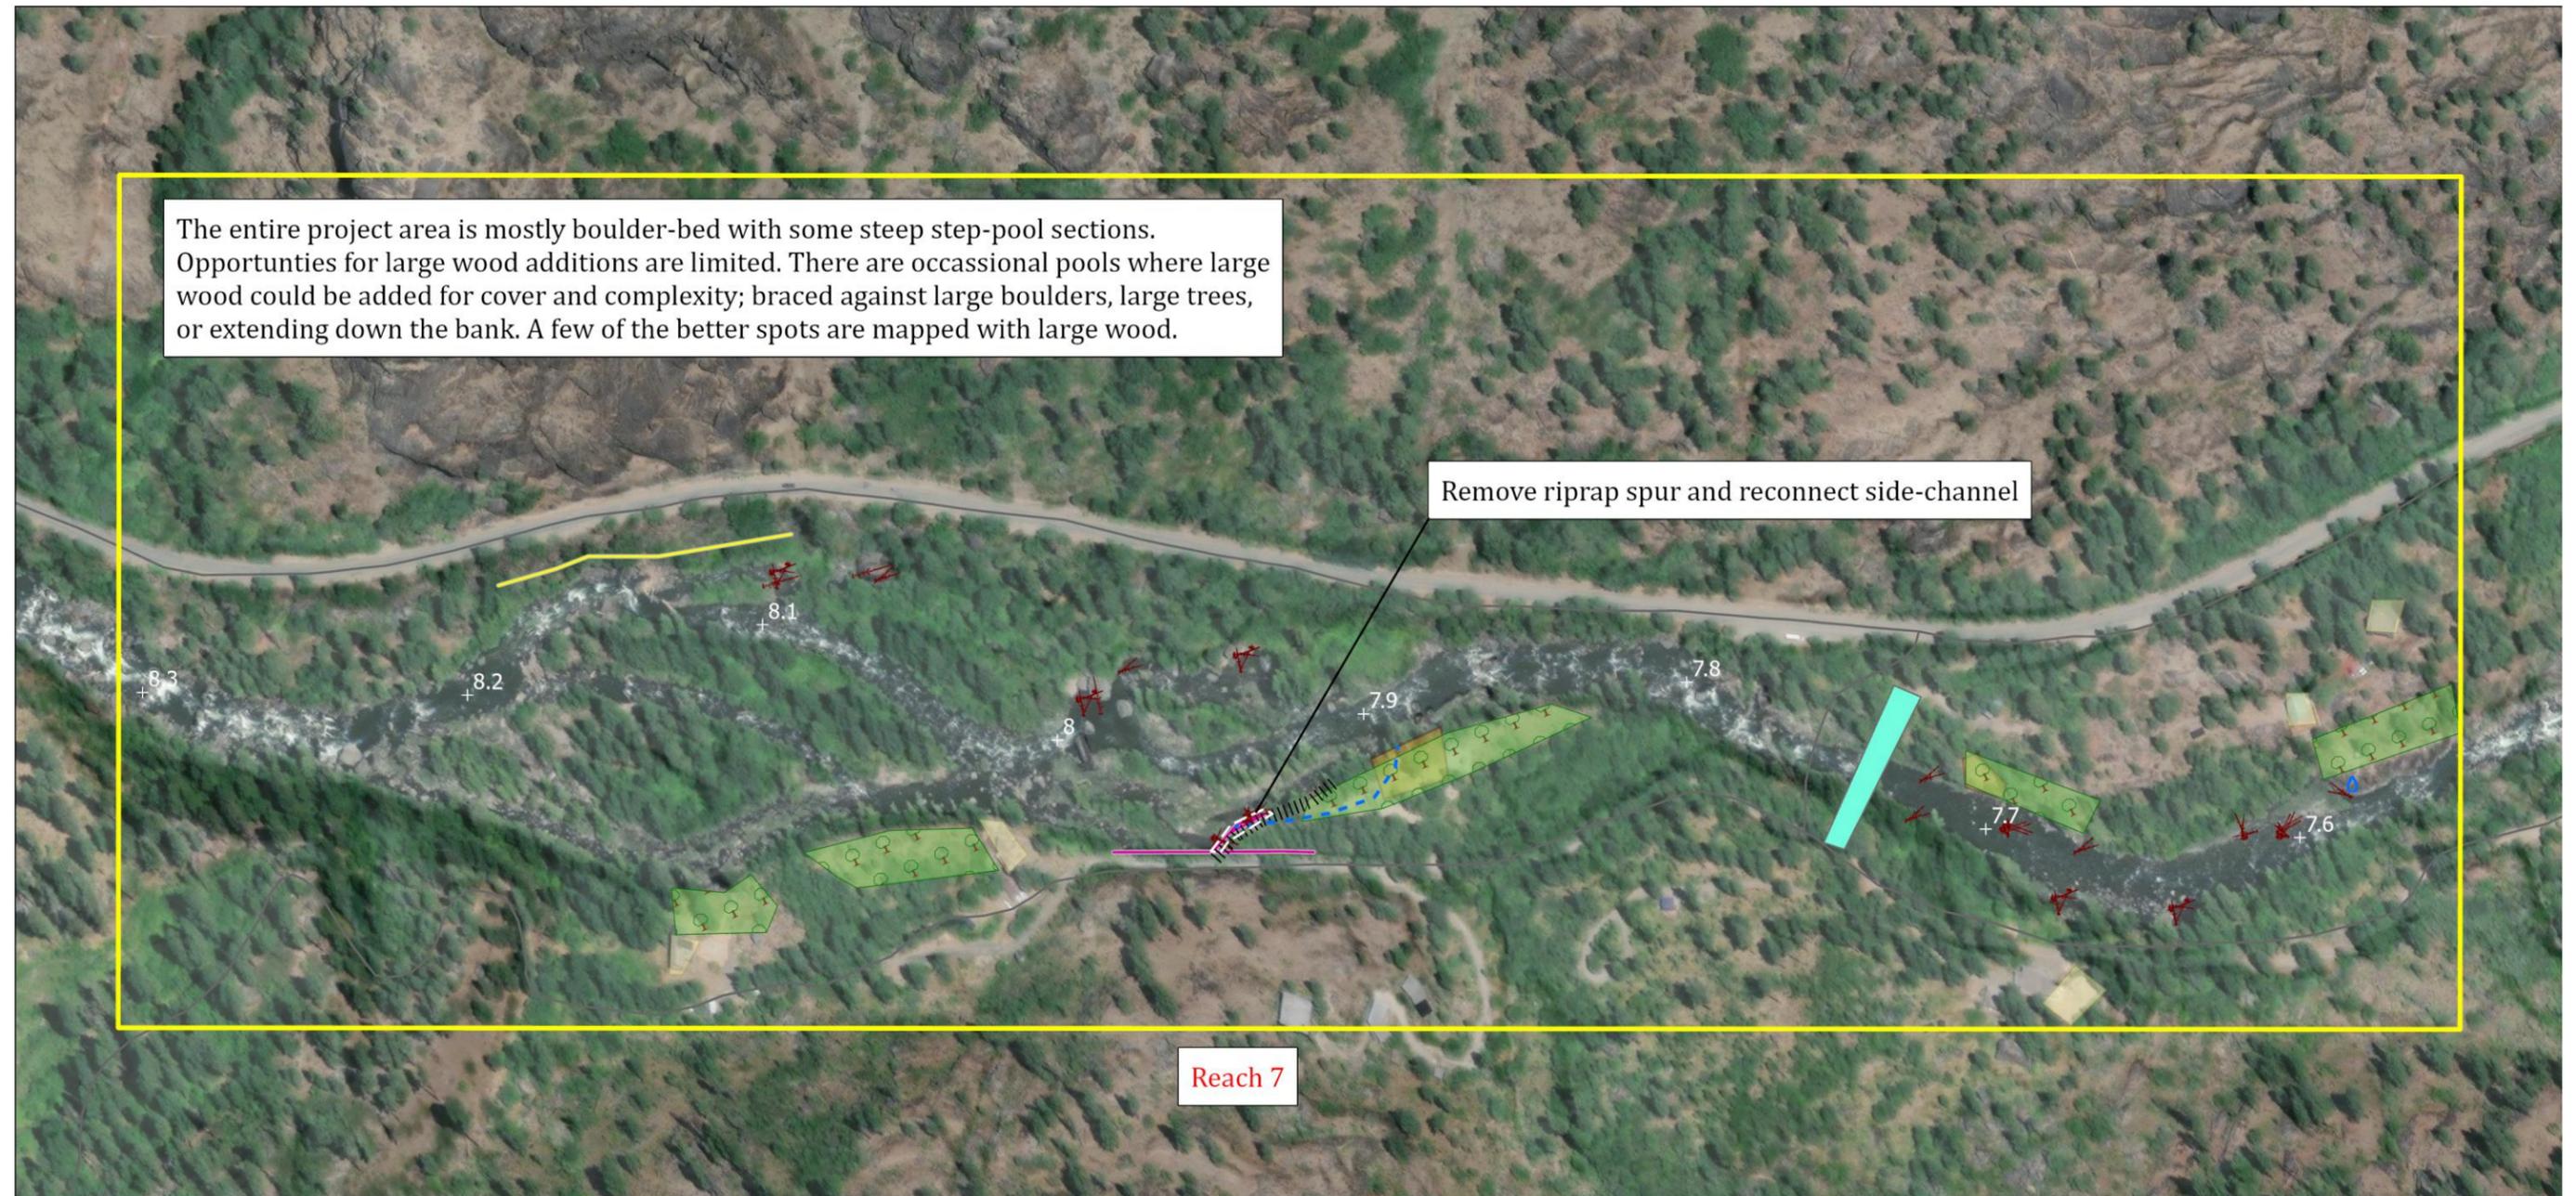
The entire project area is mostly boulder-bed with some steep step-pool sections. Opportunities for large wood additions are limited. There are occasional pools where large wood could be added for cover and complexity; braced against large boulders, large trees, or extending down the bank. A few of the better spots are mapped with large wood.

Remove riprap spur and reconnect side-channel

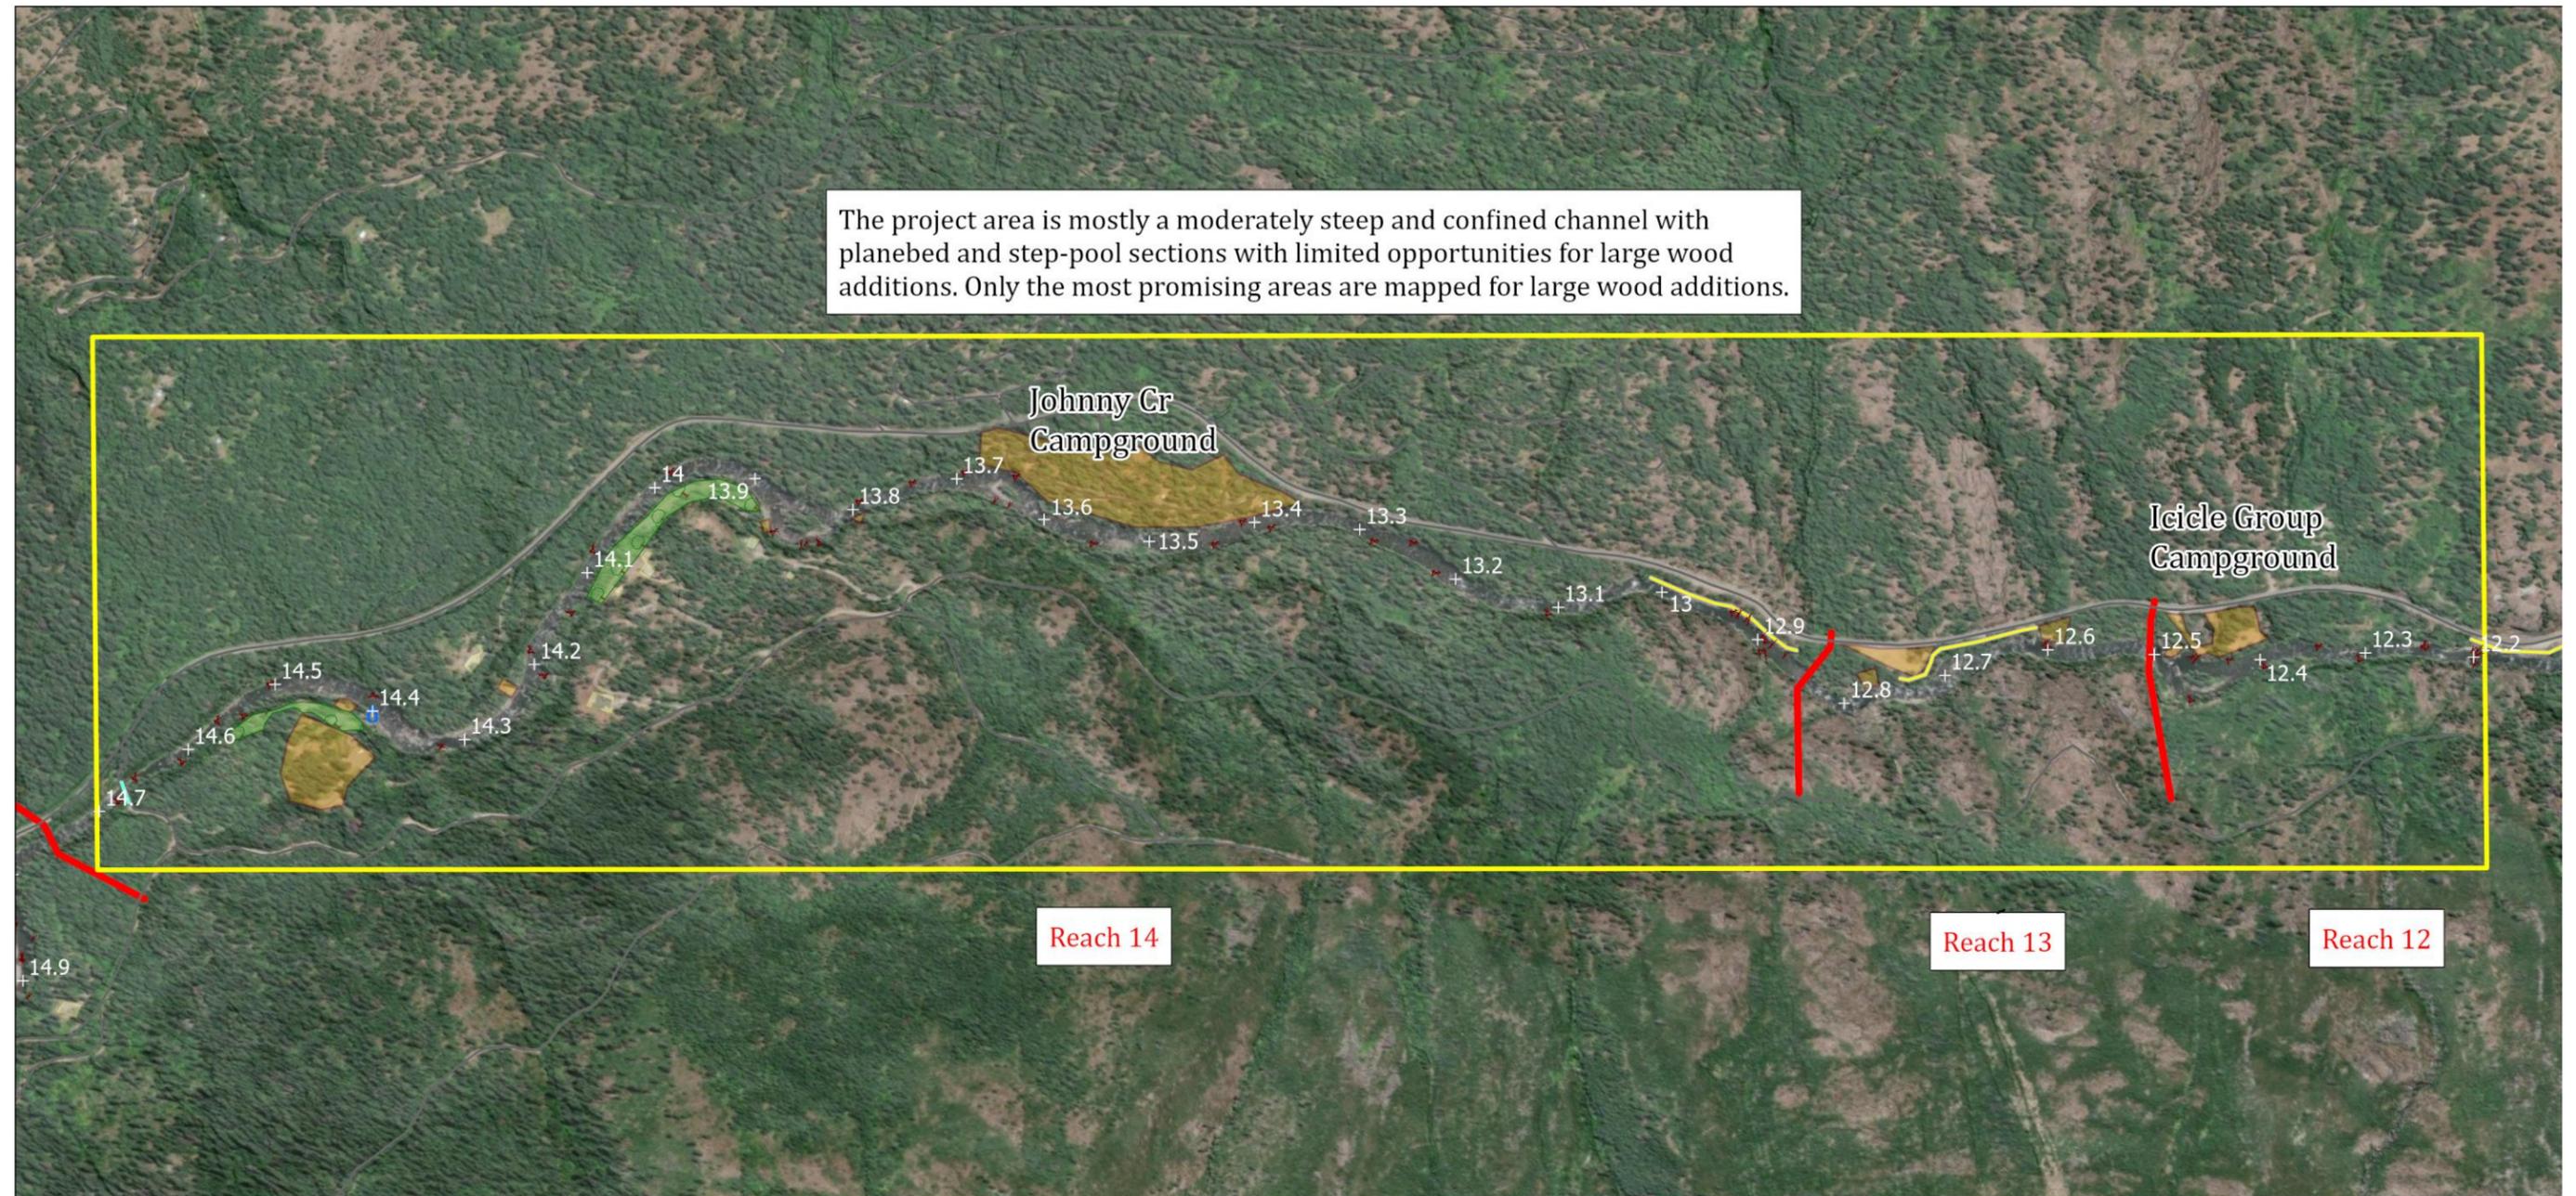
Icicle Creek Reach Assessment  
 Project Opportunities  
**Johnny Victoria**

The project area is mostly a moderately steep and confined channel with planebed and step-pool sections with limited opportunities for large wood additions. Only the most promising areas are mapped for large wood additions.
