## DEVELOPMENT CHECKLIST

**Sponsor Name: Yakama Nation**

**IAC Project Number: 06-2292R**

**Project Name: Hancock Springs**

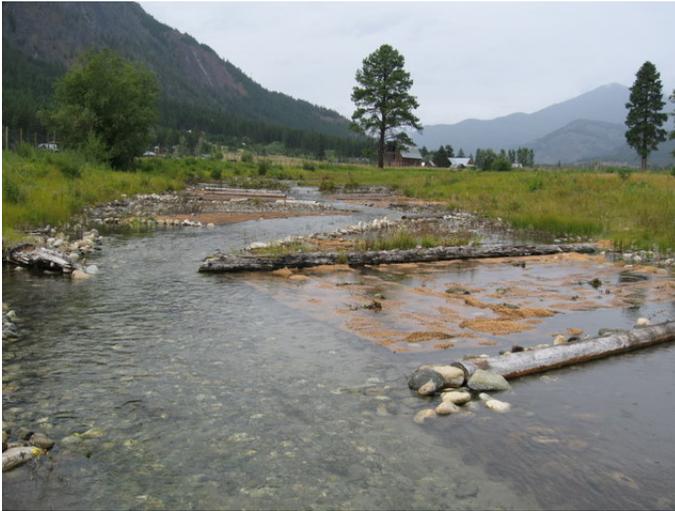
*Coir mats between log structures. (take note of the meander in the channel created by the log structures)*

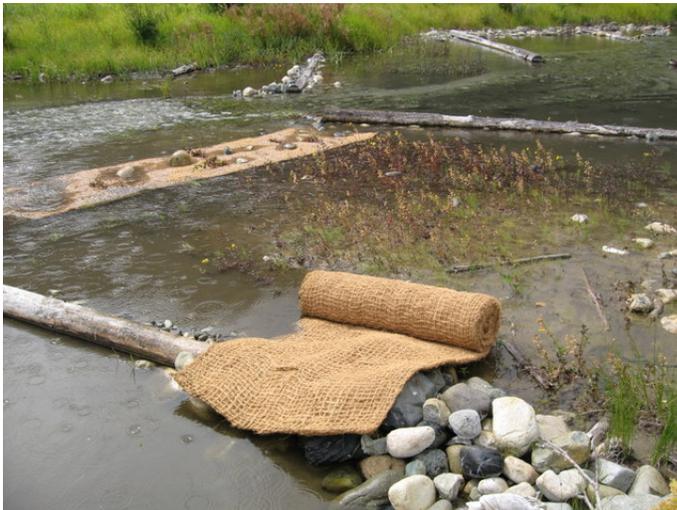
*Coir mats are installed around existing vegetation.*

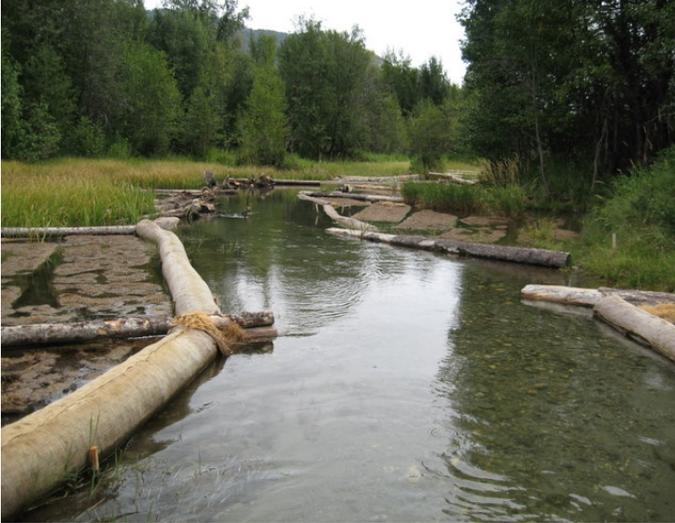
*Coir mats are placed within coir logs on bank margins in shallow/drier sections created by channel constriction. (construction is ongoing)*

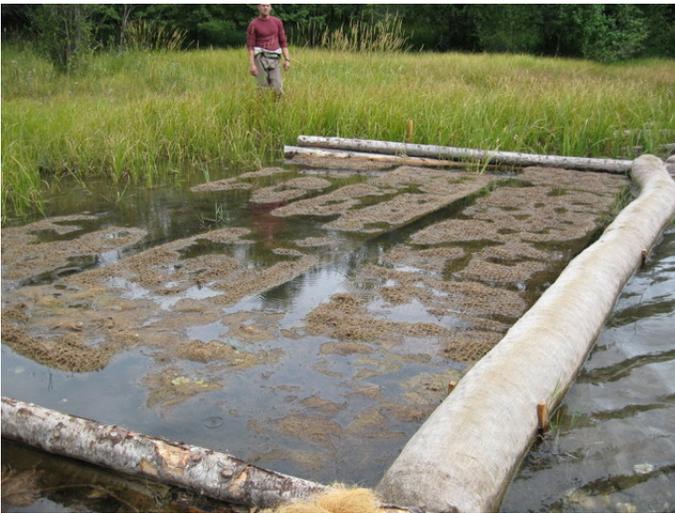
*Section of coir log structures with mats in between.*

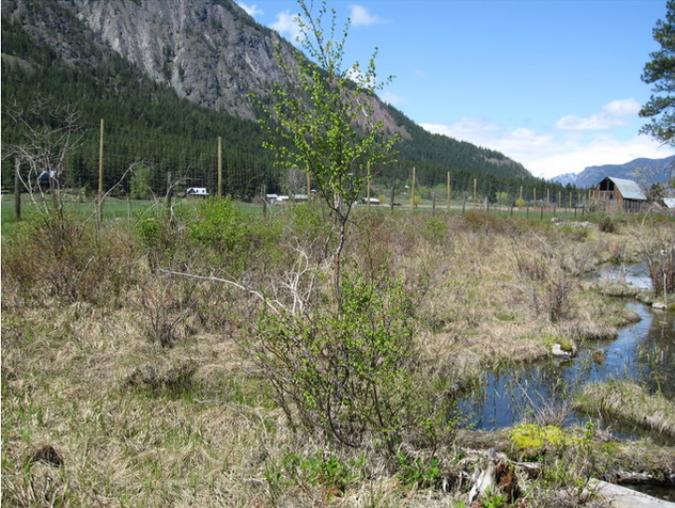
*Riparian plant survival has greatly increased due to the installation of a deer fence and supplemental plantings are beginning to show growth.*

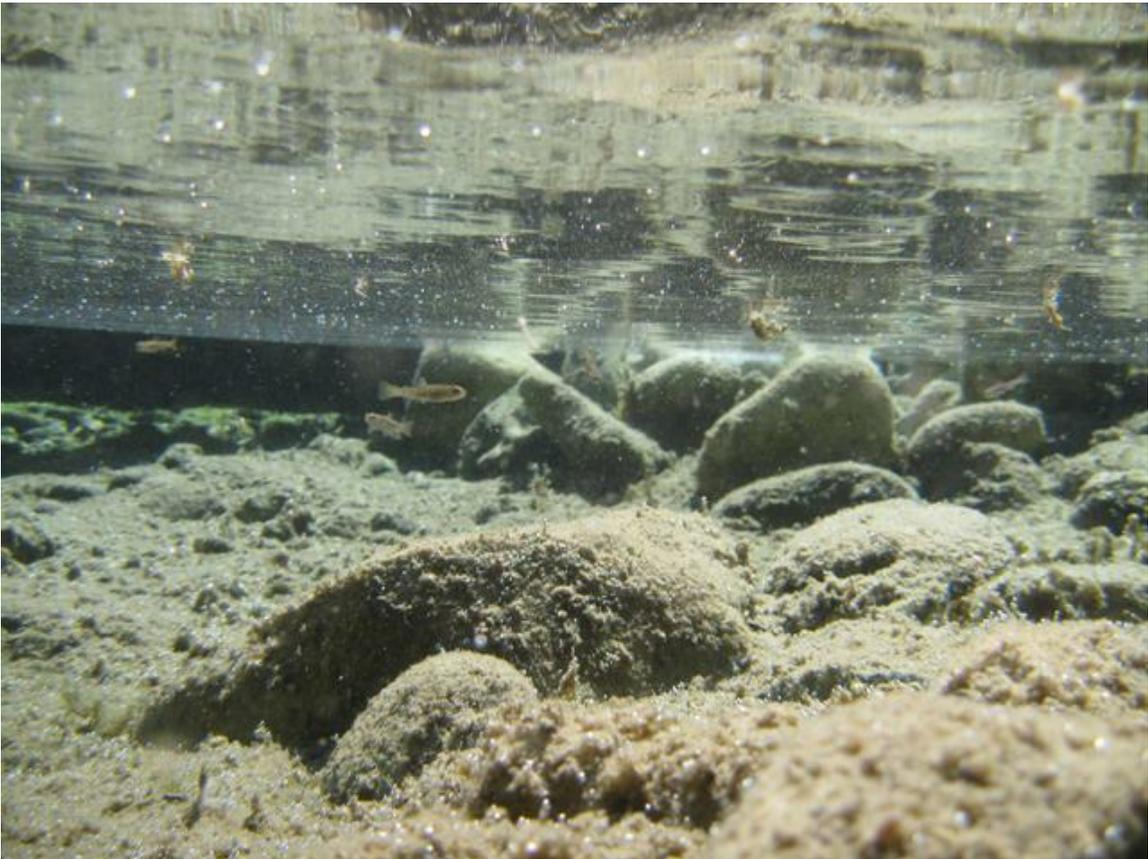
*Juvenile steelhead near a coir log structure*
