Lower Icicle Creek

Geomorphic and Hydraulic Assessment for the Identification of Protection and Restoration Actions

February 2017

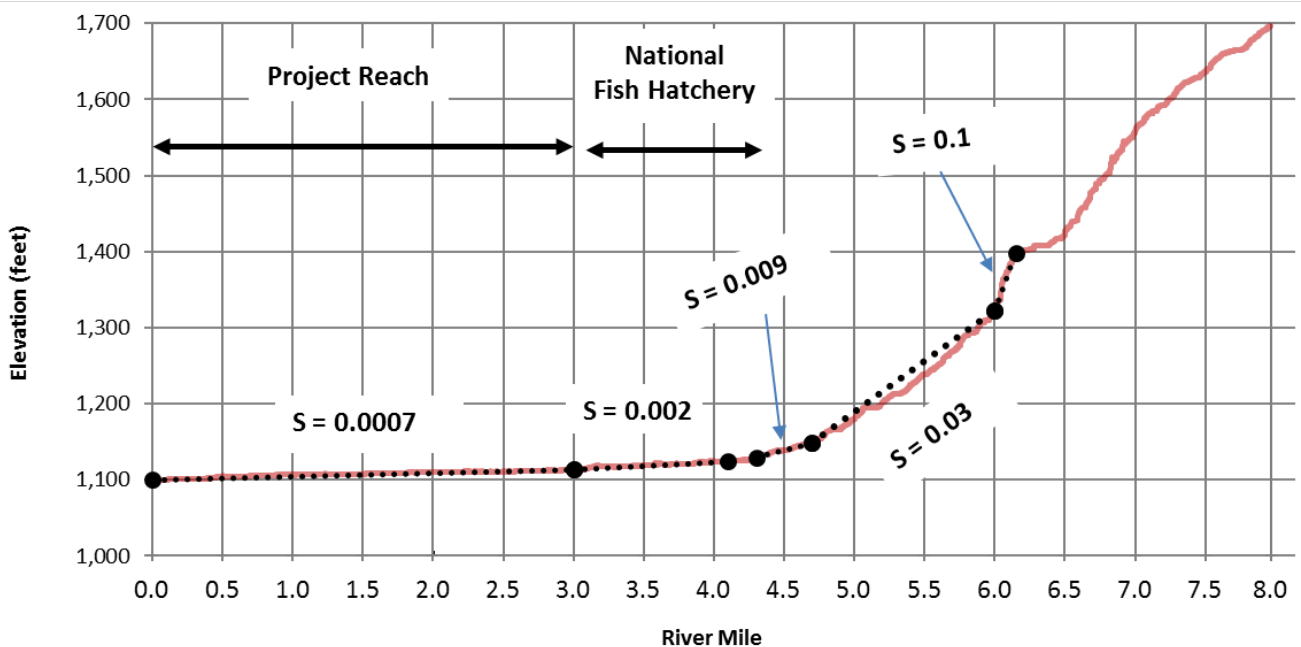
Figure 2. Longitudinal profile showing the transition in channel gradient over the lower reaches of Icicle Creek. Elevations extracted from 2015 LiDAR DEM.

Icicle Creek exits a relatively steep, bedrock confined valley segment and emerges into the broad, unconfined Lower Icicle Creek Valley near the vicinity of the Leavenworth National Fish Hatchery. Upstream of the hatchery, Icicle Creek runs through a series of boulder cascades that range in gradient between 3 and 10 percent (0.03 to 0.10 ft./ft.). The channel gradient transitions to a slope of nearly 1 percent near River Mile (RM) 4.5, then abruptly flattens to a slope of 0.2 percent (0.002 ft./ft.) in the channel segment passing through the hatchery. Downstream of the hatchery, the channel profile continues at a relatively uniform slope of 0.07 percent (0.0007 ft./ft.) over the lower 3 miles to the junction with the Wenatchee River (Figure 2).

The historical channel segment is located at the transitional area between the more confined, steeper segment upstream of the LNFH and the unconfined, low gradient alluvial valley of Lower Icicle Creek (Figure 2). Such rapid changes in gradient and valley confinement are common locations for development of alluvial fans. Mapping of pre-modified floodplain conditions showed a dynamic, anabranching channel pattern in this transitional area (see 1910 USGS map in Appendix A). In this geomorphic setting, channel migration tends to occur more episodically with sudden changes in channel planform in response to flood flows. Alluvial fans are very dynamic and would typically provide multiple relict side channel or off-channel habitats along with a complex main channel environment. Much of this dynamism and complexity would have depended on the presence of large woody material to drive hydraulic variability, sorting of sediment, creation of pools, and drive channel avulsion.

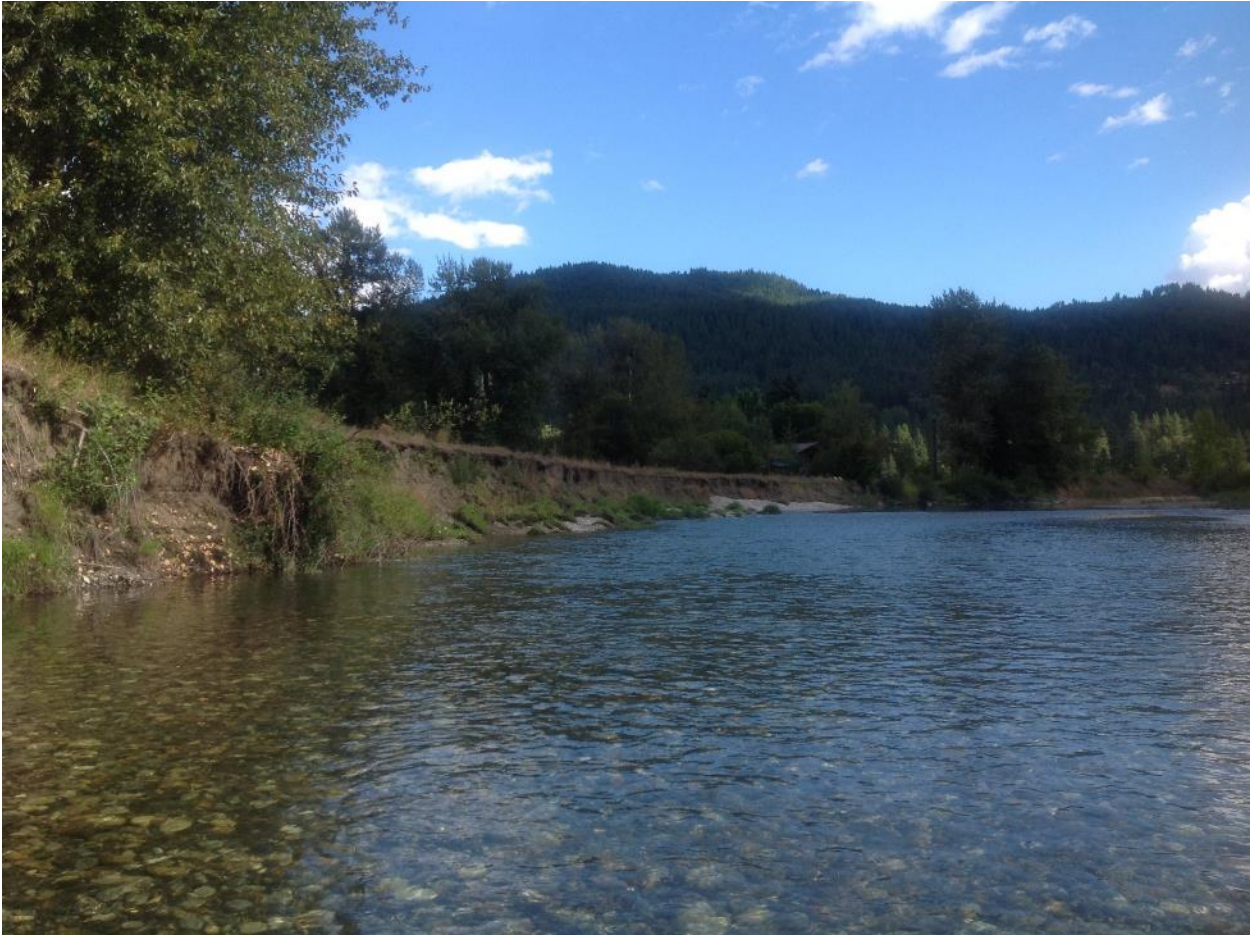
Figure 8. Photo looking upstream along the left bank upstream of the Wenatchee River confluence. The upper bank is composed of fine sediment accumulated in the early 1900s when the Wenatchee River was dammed near Leavenworth. The bank is approximately 12-14 feet high and is just barely overtopped at a 10-year recurrence interval flood.

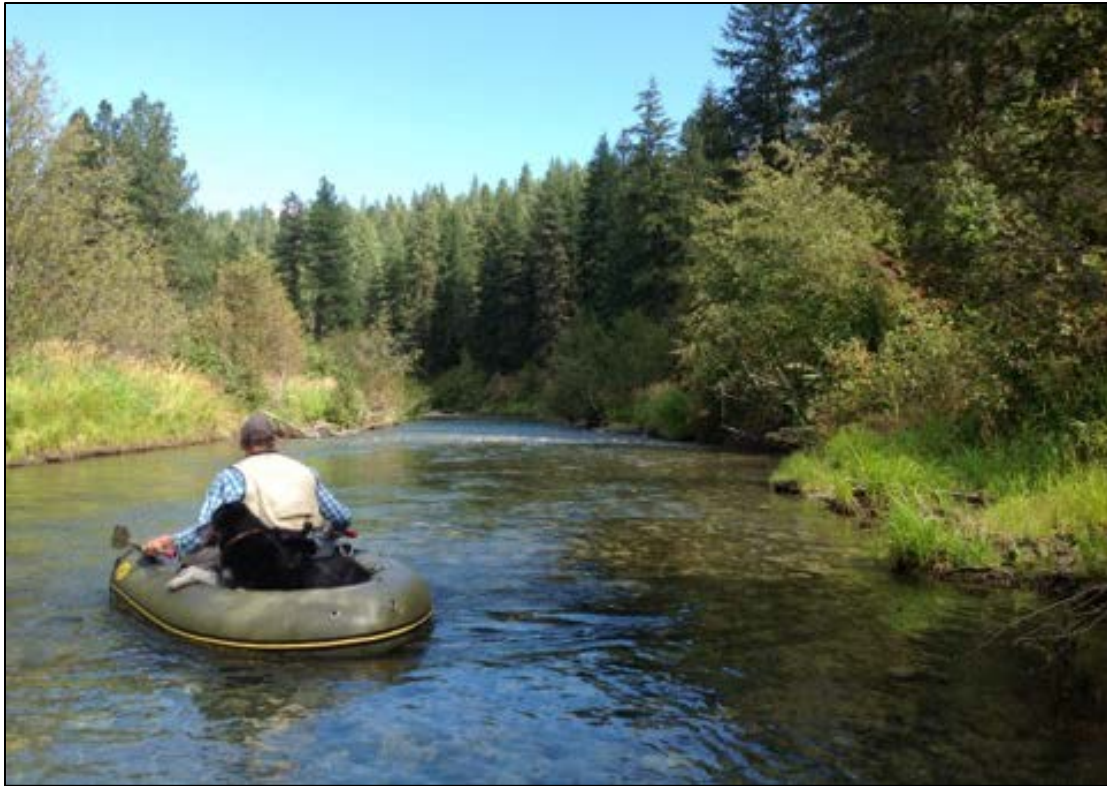
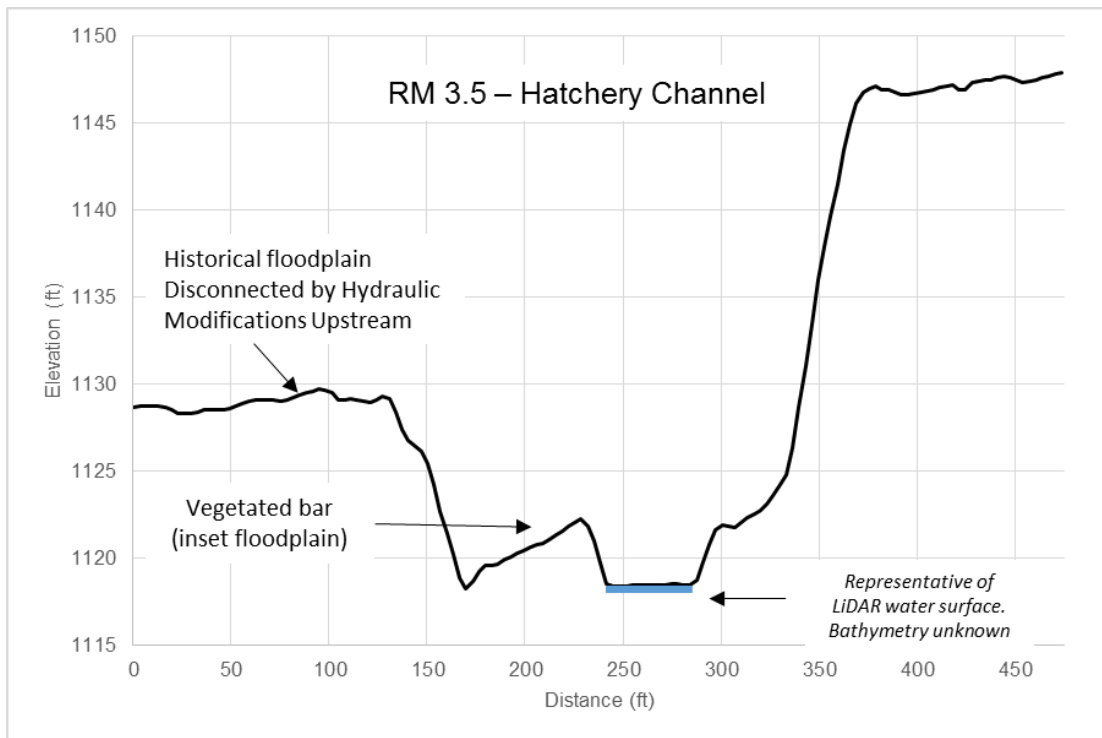
Figure 10. Photograph and cross-sectional profile of at RM 3.5. The left bank in photograph is the vegetated bar composed of historical deposition

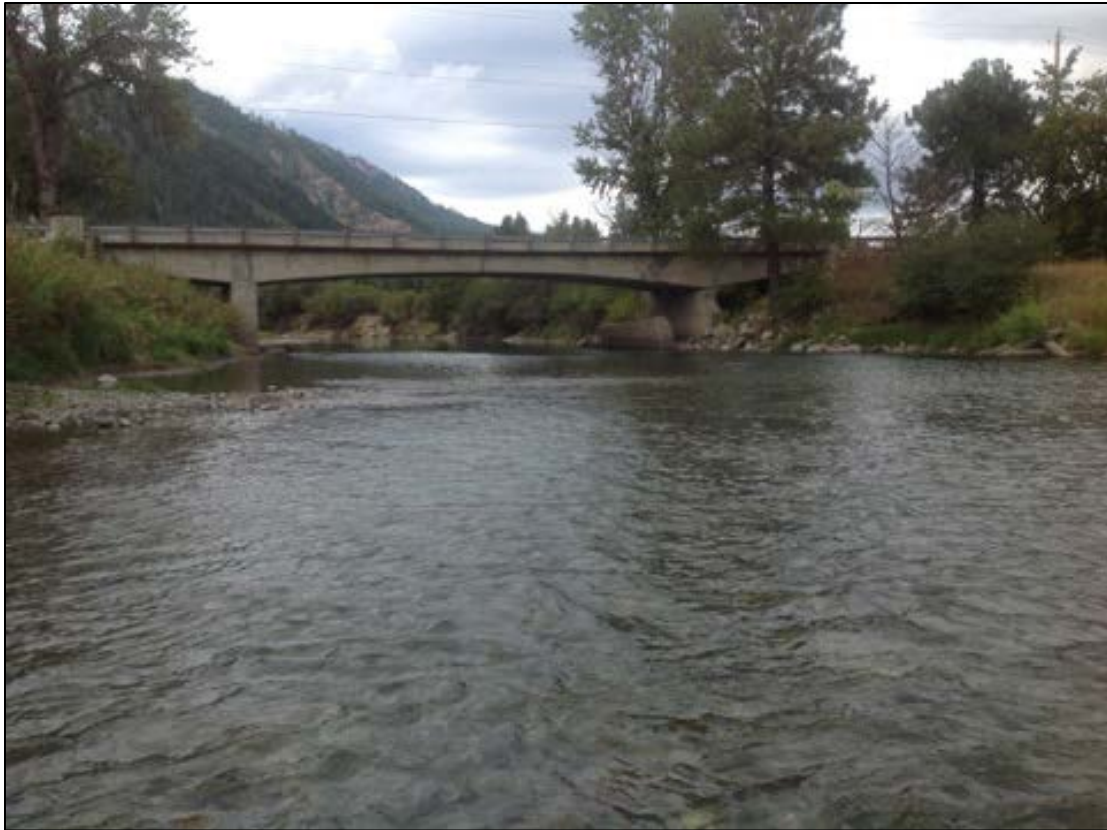
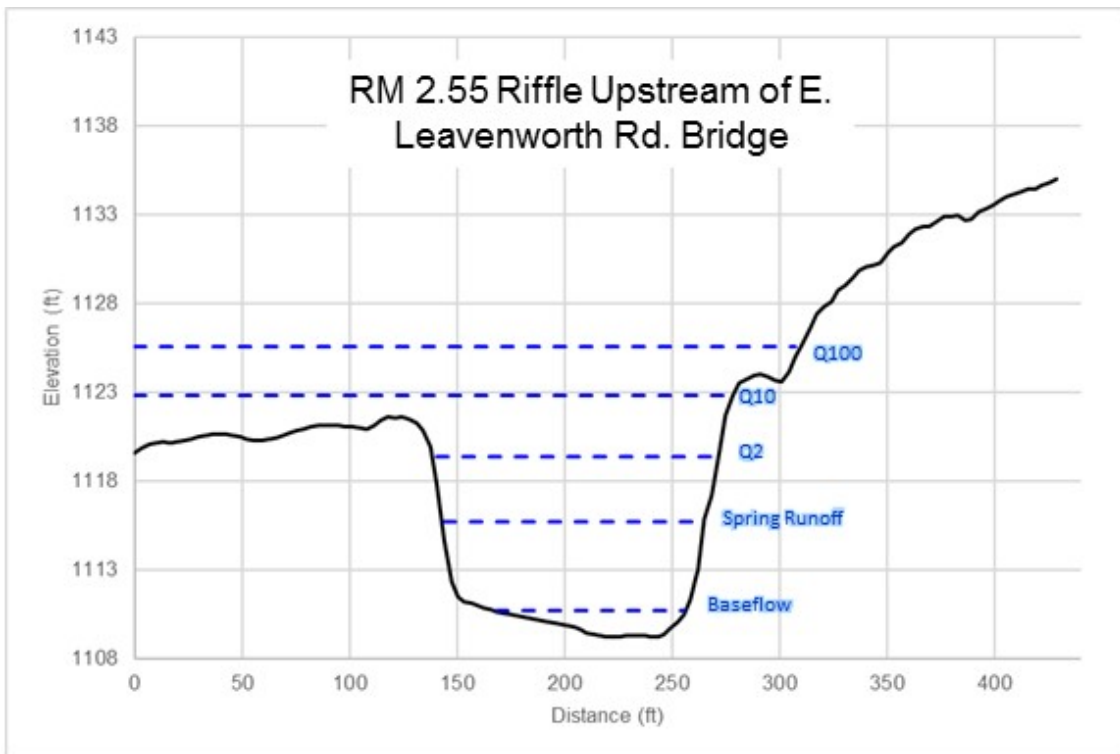
Figure 11. Photograph and cross-sectional profile of a riffle of Icicle Creek located at RM 2.55 directly upstream of the E. Leavenworth Rd. Bridge. The Q₂ water surface elevation was calculated using the 2-D hydraulic model described below in section 5.

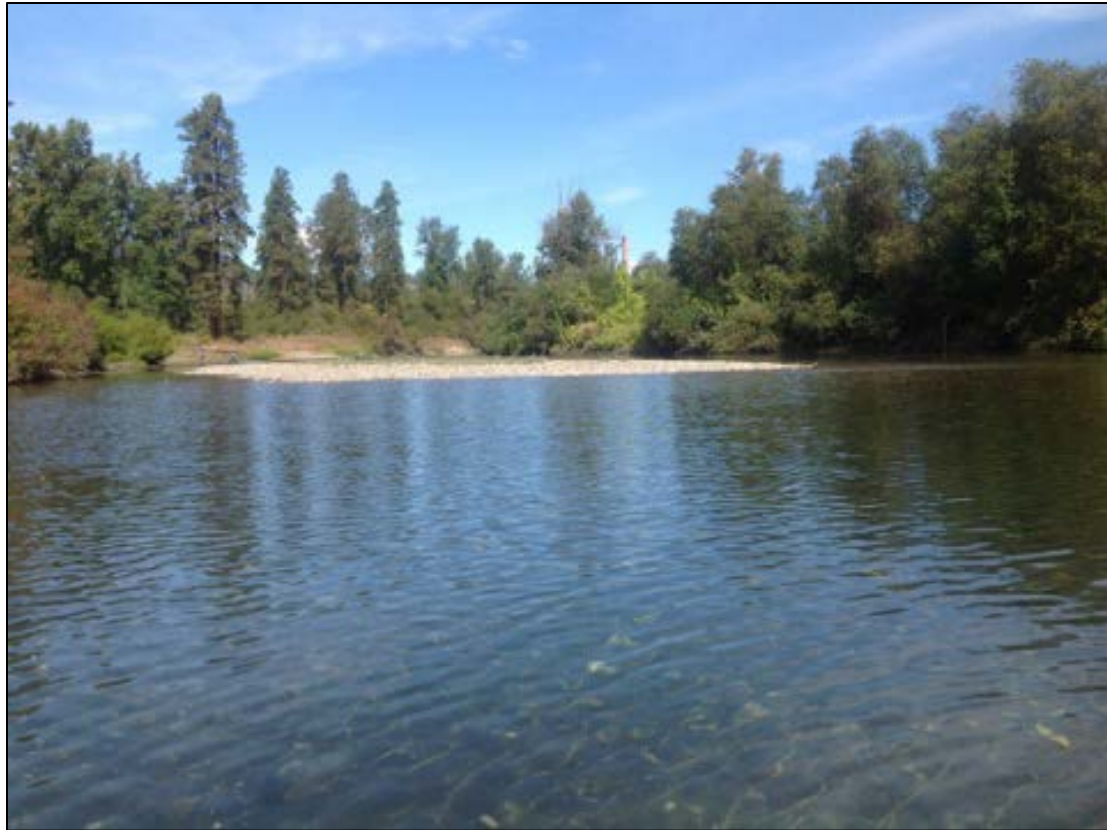
Figure 12. Photograph and cross-sectional profile of a riffle-run sequence of Icicle Creek located at RM 1.2. The Q2 water surface elevation was calculated using the 2-D hydraulic model described below in section 5.

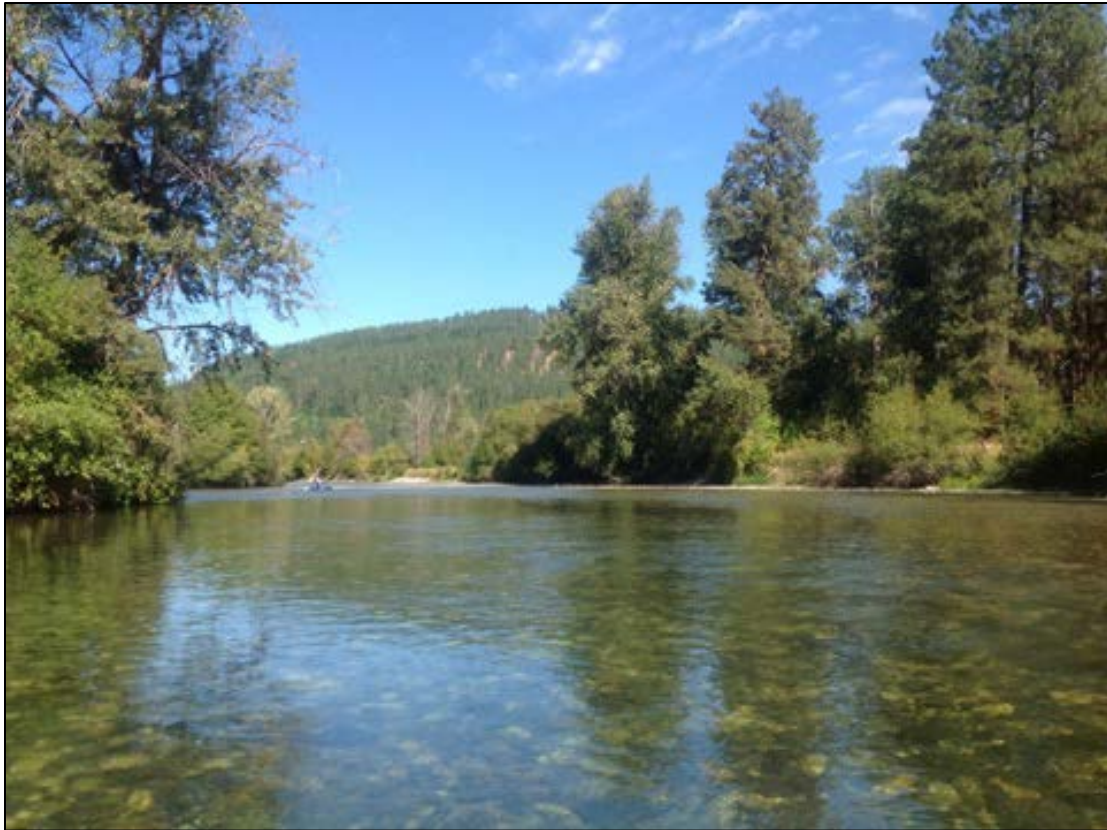
Figure 13. Photograph and cross-sectional profile of a riffle of Icicle Creek located at RM 0.5. The Q2 water surface elevation was calculated using the 2-D hydraulic model described below in section 5.

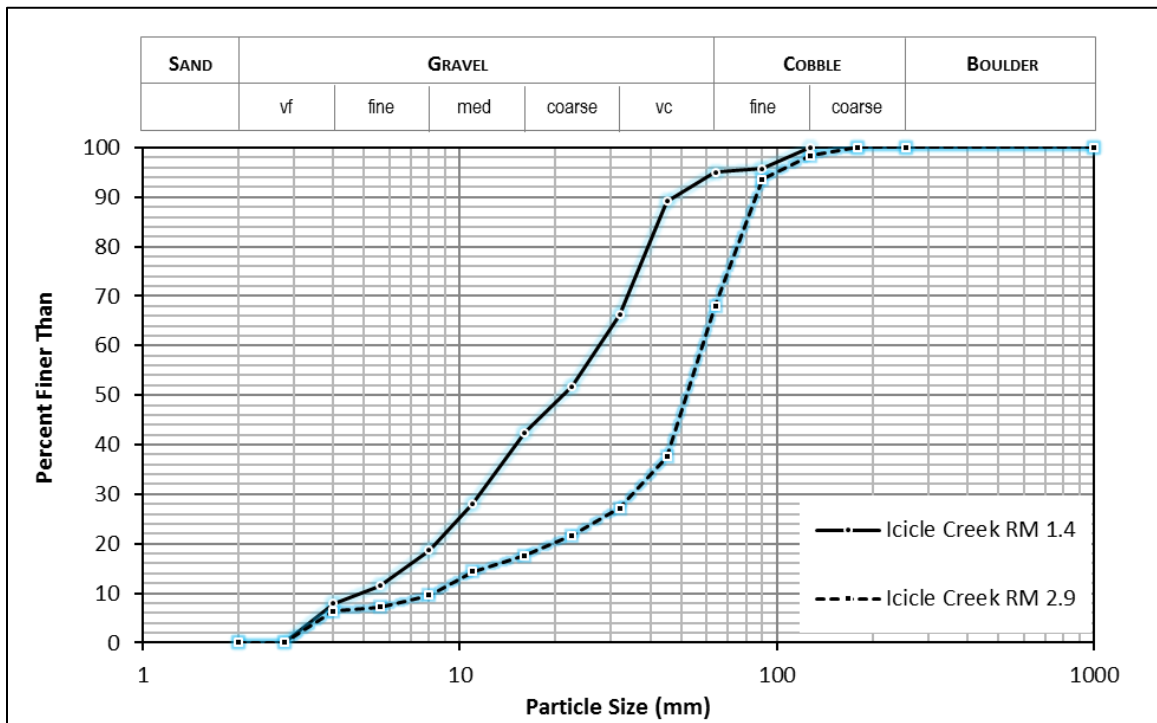
Figure 14. Grain size distribution plots of sediment samples collected from Icicle Creek on 9/7/16 and 9/8/16.

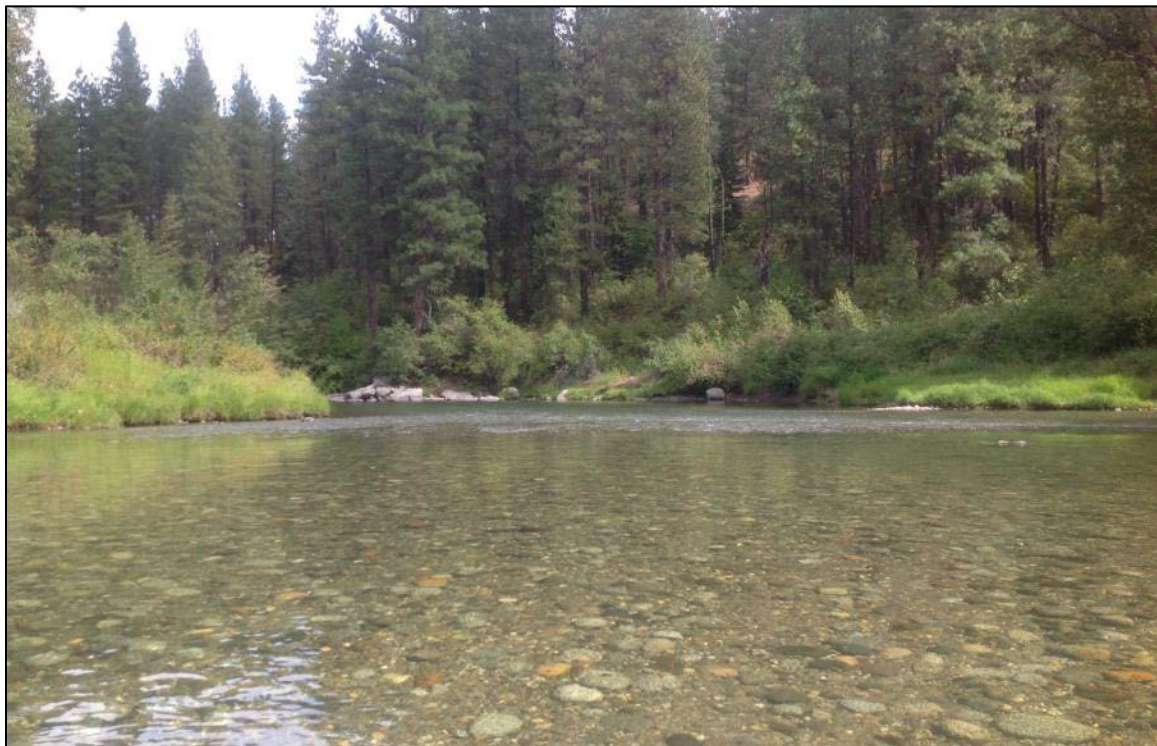
Figure 15. Photo illustrating bed material near RM 2.8.

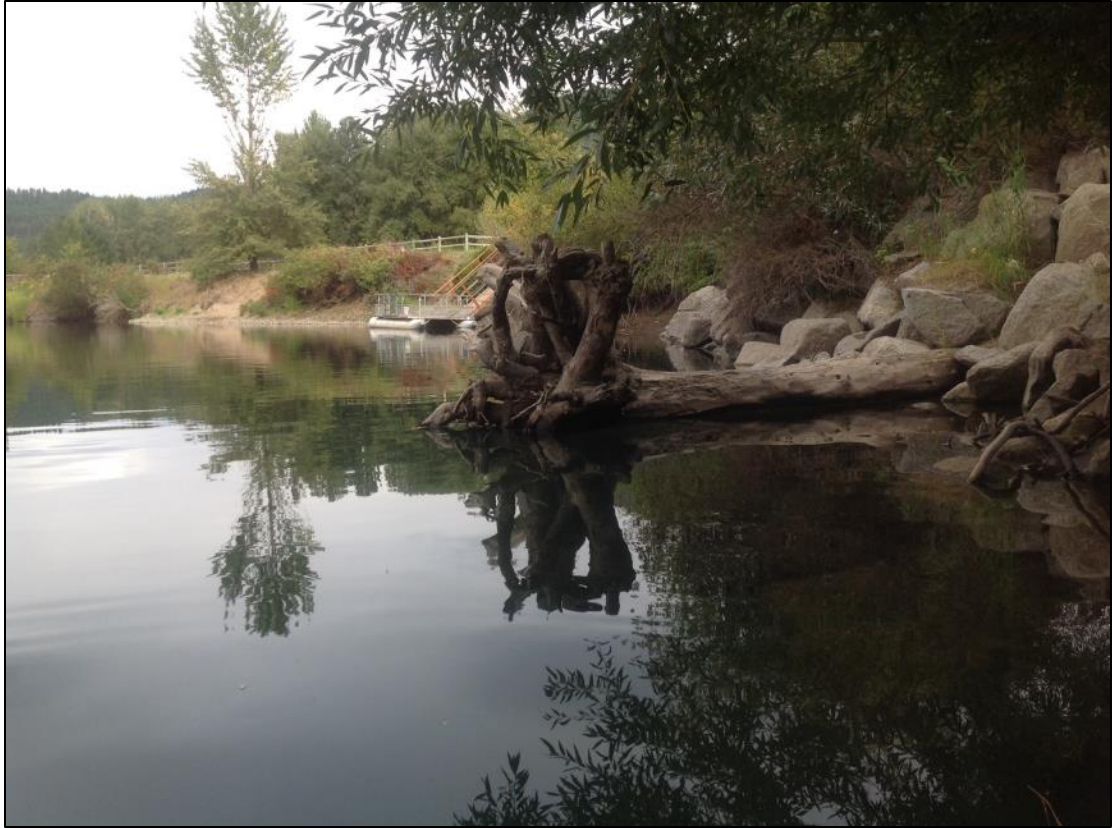
Figure 17. View downstream of single piece of wood with a diameter of 15" and a length of 24' cabled to rip rap along right bank at RM 2.27.

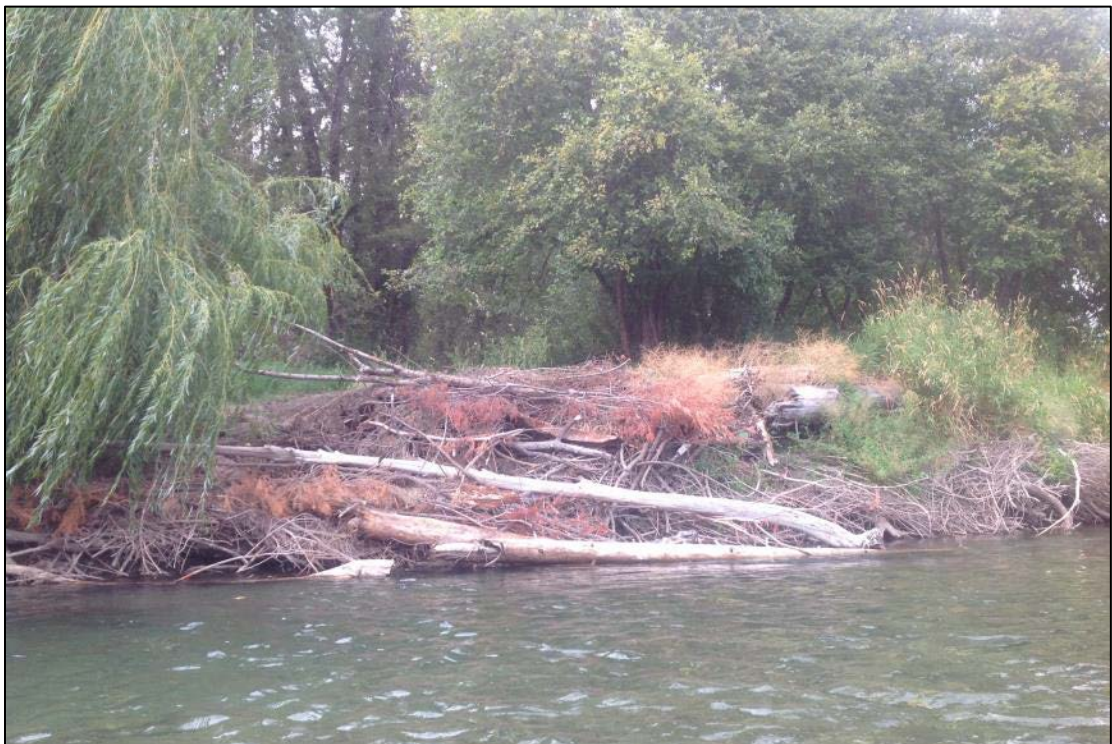
Figure 18. Photo looking cross stream at existing wood accumulation located on the left bank at RM 2.16.

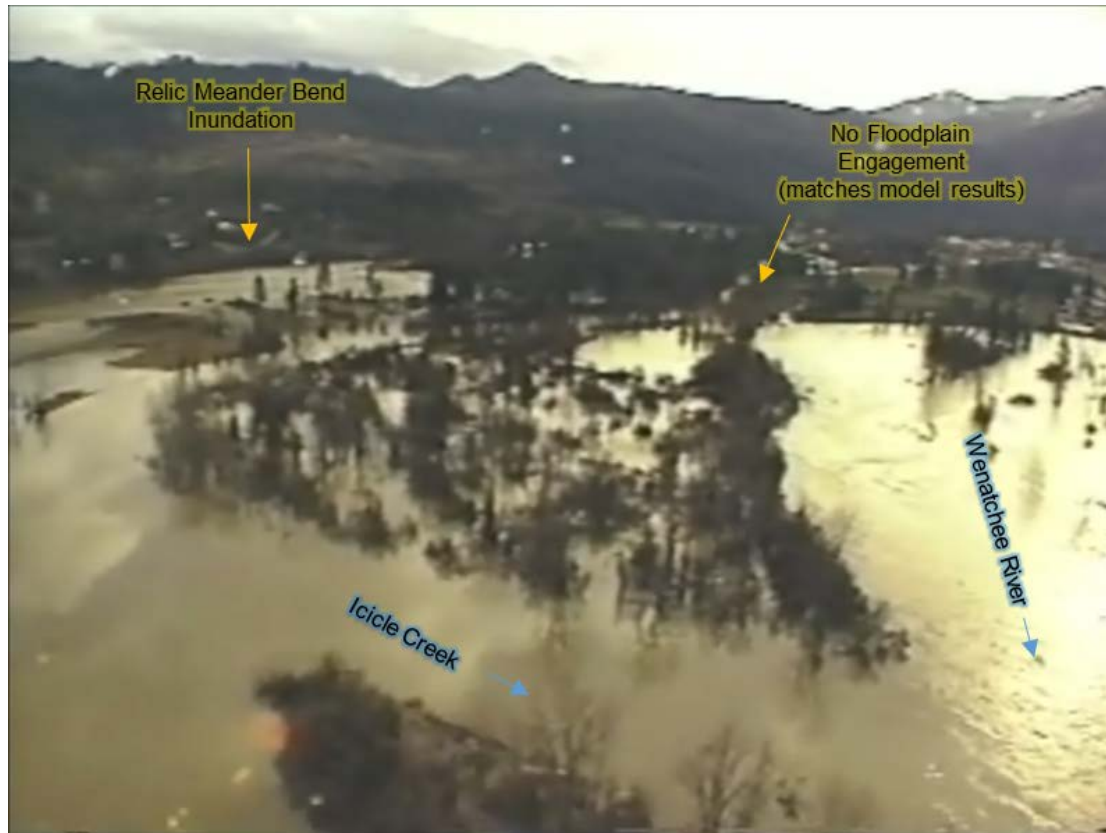
Figure 31. Confluence of Icicle Creek and the Wenatchee River on 11/30/1995. Daily mean discharge was measured as 8,540 cfs in the USGS gage along Icicle Creek and 38,900 cfs in the USGS gage along the Wenatchee River at Peshastin which corresponds closely to the Q100 modeling scenario.

The floodplain inundation results of the Q_{100} modeling scenario closely correspond to images recorded during the 11/30/1995 flood (Figure 31). Video taken from a helicopter during the flood indicate a strong hydraulic connection between Icicle Creek and the Wenatchee River as well as full inundation of the large relic meander bend towards the east side of the valley. The images also demonstrate a high terrace and lack of connection between Icicle Creek and the Wenatchee along Wilson Street near RM 0.6 – results that closely agree with our Q_{100} model. These agreements provide greater confidence in the high flow modeling results.

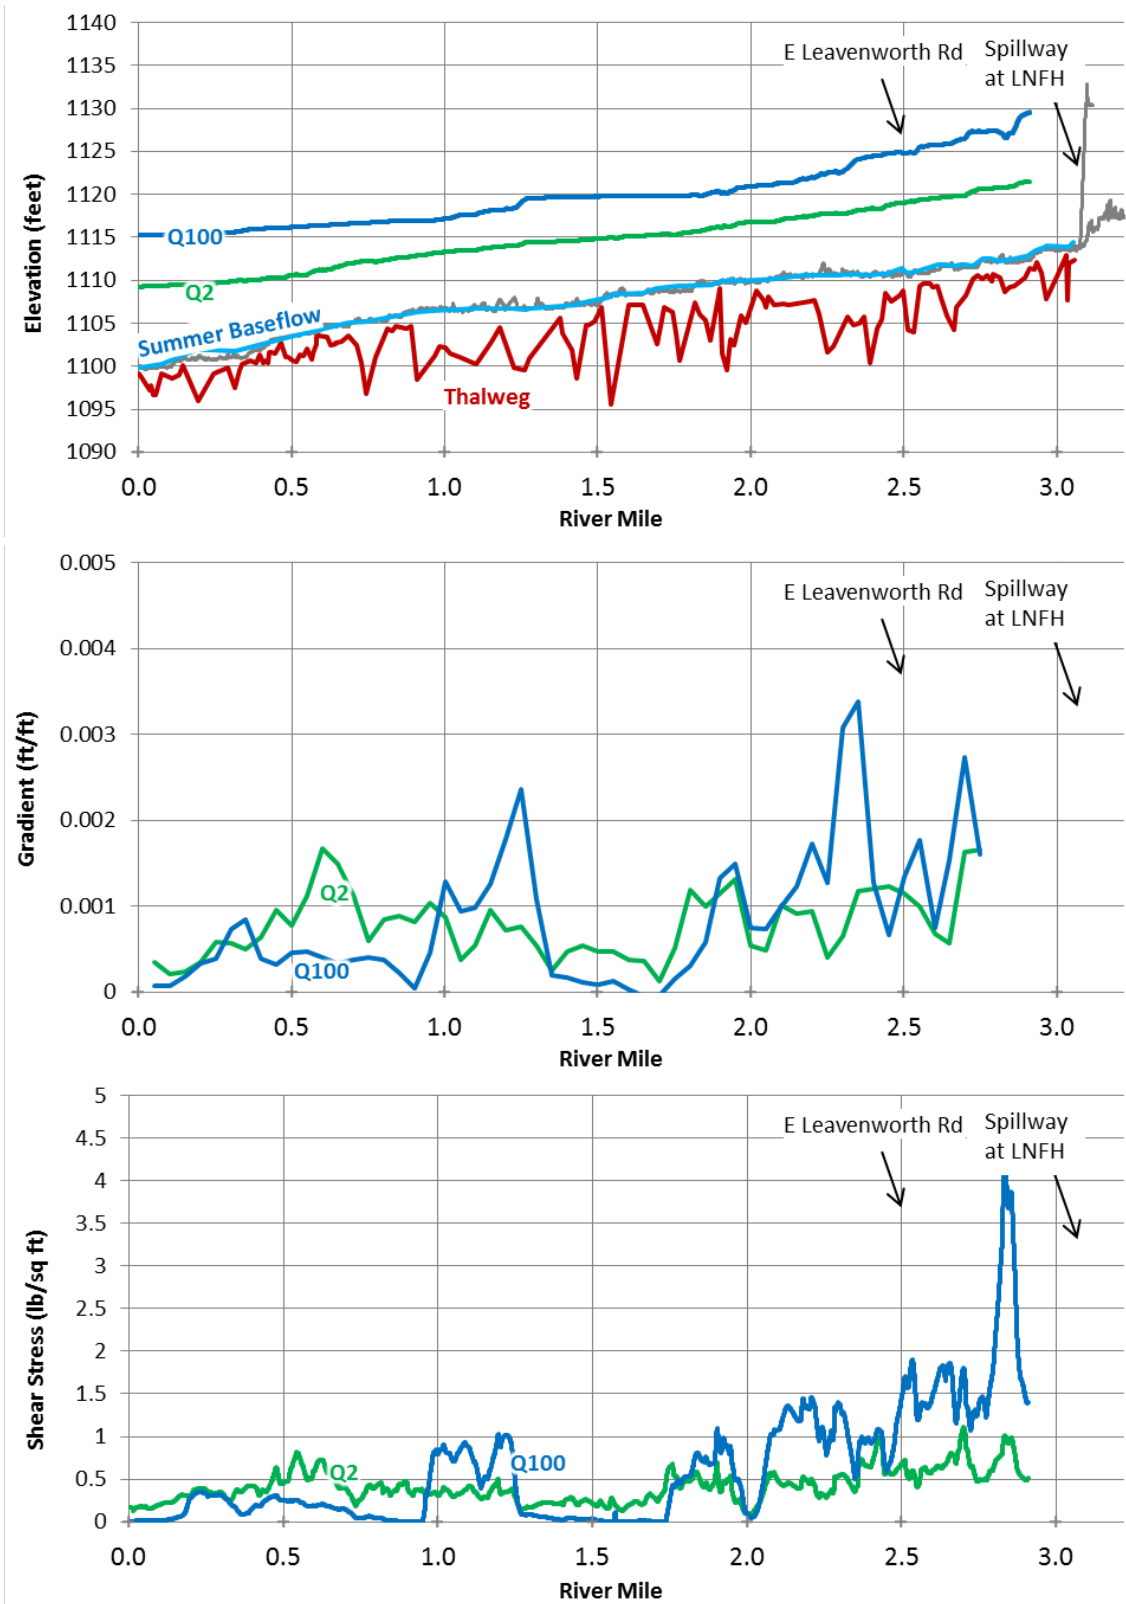
Figure 33. Longitudinal profiles of simulated water surface elevation (top), water surface gradient (middle), and shear stress (bottom) for the 2- and 100-year recurrence interval floods.

After bed material becomes mobilized, sediment transport capacity generally increases with additional flow and increased flow depth. Two additional factors in Lower Icicle Creek influence the change in sediment transport with increasing flood magnitude. First, as flood stage in the mainstem Wenatchee River increases, a backwater effect from the confluence to RM 0.8 decreases the energy gradient of Lower Icicle Creek resulting in lower shear stress values during extreme floods such as the 100-year event in comparison to shear stress resulting from more typical 1- to 2-year recurrence interval floods. Second, the channel pattern with high sinuosity between RM 1.3 and 1.8 affects the relation between sediment transport capacity and flood discharge. During typical flood events, flows are confined to the main channel and the energy gradient follows a relatively uniform slope in the downstream direction. As flood discharge increases to about the 10-year recurrence interval flood, flow spills overbank and bypasses the meander bend between RM 1.3 and 1.8. As a result, the meander bend above RM 1.3 becomes ponded and shear stress drops in this segment during extreme floods (Figure 33).

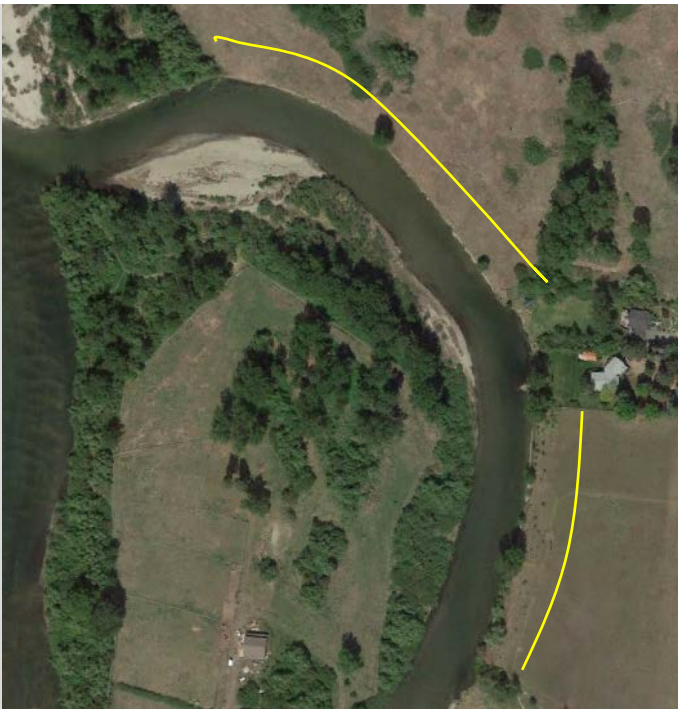
PROJECT LOCATION (RIVER MILE/BANK)	ACTION/STRATEGY / ECOLOGICAL CONCERN	DESCRIPTION	CONCEPT
RM 0.1 – 0.2; 0.3 Right Bank	Riparian Restoration <i>Riparian Condition</i>	<p>As discussed in the Geomorphic Assessment, much of the floodplain has been disturbed by land clearing activities and generally lacks mature forest. Large areas of the floodplain in lower Icicle Creek is dominated by pasture grasses which provides no stream shading, wood input, or bank stability. The priority areas for riparian restoration are those cleared areas within the 2-year floodplain and/or immediately adjacent to the stream bank.</p> <p>These areas are characterized by the high floodplain banks that are well above seasonal inundation and are located at the top of vertical cut-banks. Revegetation efforts should consider the installation of woody material at the bank toe to slow bank erosion rates, along with irrigation watering to ensure plant establishment.</p>

<p>The image is an aerial photograph showing a meandering river. Two yellow arrows point to specific areas on the right bank of the river, indicating the locations for riparian restoration. The surrounding landscape includes a mix of green trees, brownish grassy areas, and some buildings.</p>

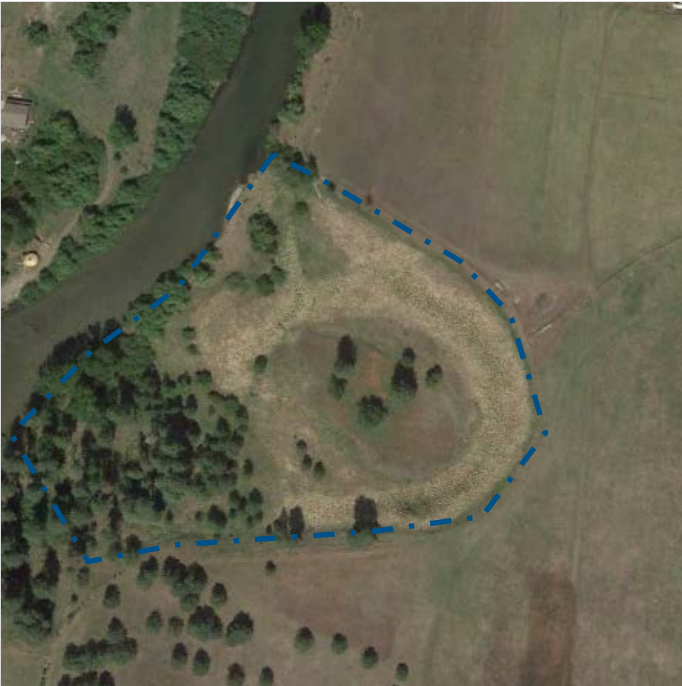
PROJECT LOCATION (RIVER MILE/BANK)	ACTION/STRATEGY /ECOLOGICAL CONCERN	DESCRIPTION	CONCEPT
RM 0.4	Reconnect Floodplain and Off-Channel Habitat <i>Peripheral and Transitional Habitat</i>	<p>A historical channel scar at RM 0.4 is currently an 8.5-acre pasture wetland swale. This area is flooded during a 2-year event, but is disconnected during the normal range of flows and unavailable for fish use. The feature is located on private property and is contiguous with adjacent floodplain (blue polygon)</p> <p>The goal at this location is to increase surface flow interaction with the low floodplain swale to allow greater periods of use by juvenile salmonids. This could be achieved through the construction of instream wood elements to increase surface water elevations, and could be combined with minor excavation within the wetland itself to lower relative elevations. Either action should be combined with the protection of the site from grazing and/or haying operations. Riparian planting along with protection should allow this site to return to a native riparian forest community.</p> <p>Efforts to increase connectivity and duration of flow into this floodplain area requires either substantial increase in channel roughness to back up water and raise bed elevations or an extensive excavation of floodplain deposits to create an open flowpath. Feasibility of this action is constrained by adjacent land use, recreation al activities, and potential issues with permitting.</p>

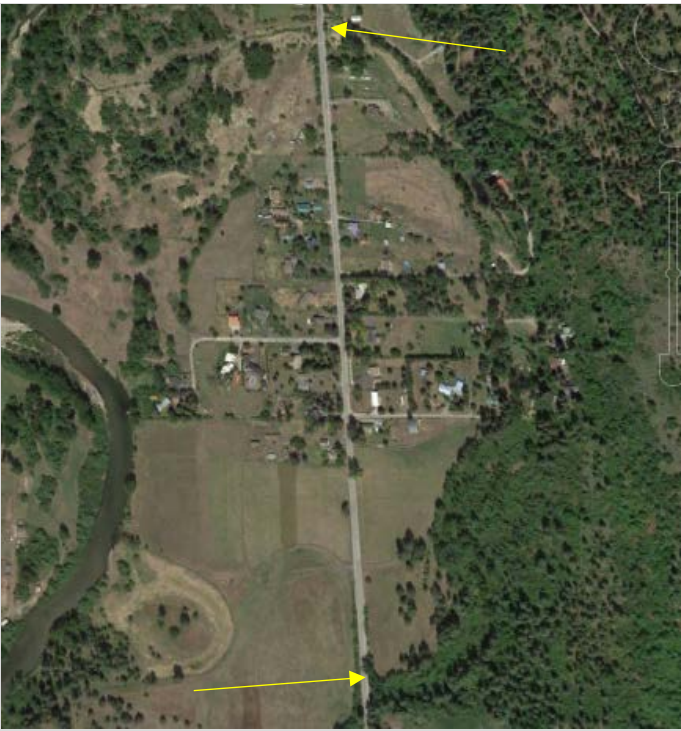
PROJECT LOCATION (RIVER MILE/BANK)	ACTION/STRATEGY / ECOLOGICAL CONCERN	DESCRIPTION	CONCEPT
RM 1.0 – 0.0	<p>Reconnect Floodplain and Off-Channel Habitat</p> <p>Install Culverts Within East Leavenworth Road</p> <p><i>Peripheral and Transitional Habitat</i></p>	<p>East Leavenworth Road bisects the eastern Icicle Creek floodplain. Hydraulic modeling shows that the road effectively restricts large flood flows (i.e. 10-year flow) from inundating floodplain areas to the east of the road. This blocks flood flows from entering existing wetland swale habitats located along the east floodplain valley wall. This swale does carry groundwater-fed surface flows during spring months which feed a surface water channel connected via a 2-foot concrete pipe under East Leavenworth Road back to the historical Icicle Creek channel described above</p> <p>The construction of culverts within E. Leavenworth Road would improve flow connectivity between not only flood flows and the wetland swale, but also from the wetland swale to the paleo-channel on the east side of the road. This action must be paired with additional actions that substantially increase roughness in the channel (e.g. placement of large wood) in order to achieve more frequent overbank flow and floodplain connectivity. The effects of increased flood waters to the east of the road would need to be quantified in relation to existing homes and private property.</p>

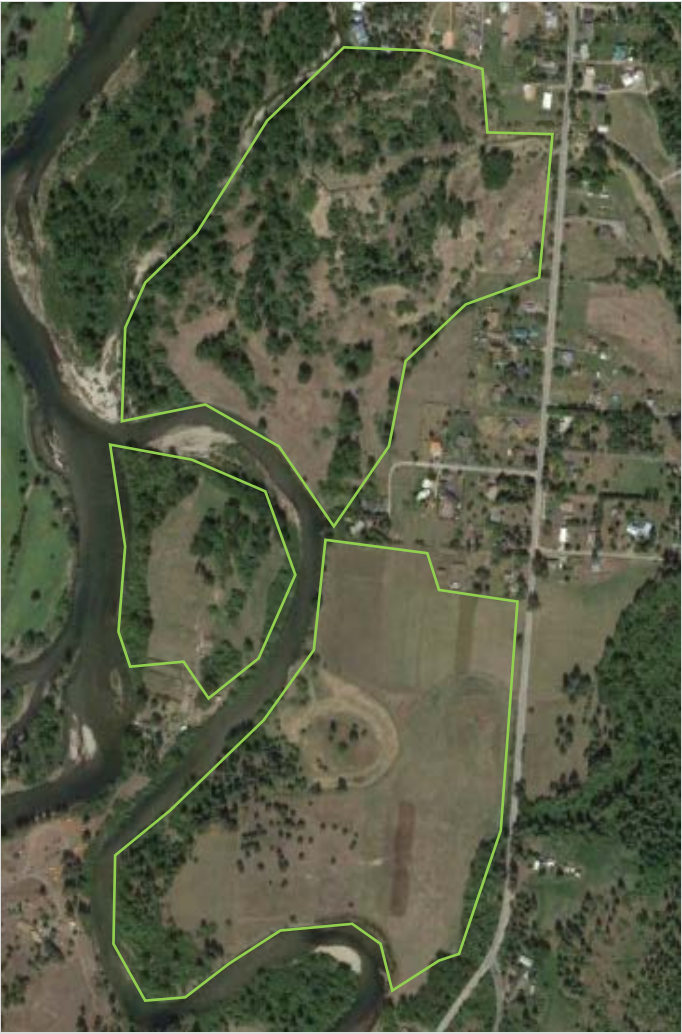
PROJECT LOCATION (RIVER MILE/BANK)	ACTION/STRATEGY <i>ECOLOGICAL CONCERN</i>	DESCRIPTION	CONCEPT
RM 1.0 – 0.0	Floodplain Protection Establish a Stream Corridor Acquisition <i>Peripheral and Transitional Habitat</i>	<p>The primary constraint to the restoration of channel migration and floodplain inundation processes on Icicle Creek is the close proximity of the channel to human structures. The lower Icicle Creek floodplain provides an opportunity to protect existing functional floodplain from future human development which will allow greater ability to restore impaired riverine processes.</p> <p>The lower Icicle river right floodplain includes over 150 acres of active floodplain that does not currently have human dwellings or structures. Approximately half of this area has been cleared of woody vegetation and now consists of pasture. The other half supports native riparian shrub and forest communities. An additional 15 acres of native floodplain lies on river left at the confluence of the Icicle Creek and the Wenatchee River. These areas are comprised of multiple private landowners and a large area of public landownership.</p> <p>Priority areas are shown in the yellow polygons. Future efforts to prioritize the protection of these areas should include a tiered ranking process that ranks parcels on their susceptibility to future development (Land Use Zoning Designation, Private vs. Public Ownership), amount (acres) of active floodplain, and amount (acres) forested riparian habitat.</p>

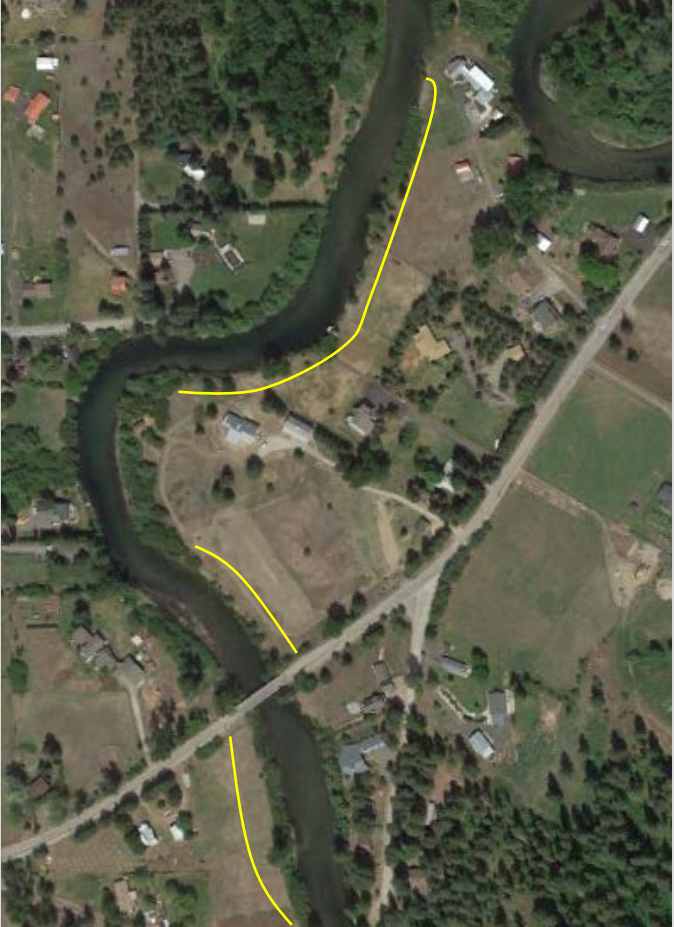
PROJECT LOCATION (RIVER MILE/BANK)	ACTION/STRATEGY /ECOLOGICAL CONCERN	DESCRIPTION	CONCEPT
RM 2.1 – 2.6	Riparian Restoration <i>Riparian Condition</i>	<p>Residential development between RM 2.1 and 2.6 has resulted in cleared vegetation up to the edge of the stream banks. The re-establishment of mature forested vegetation would improve stream shading and natural bank stability through this reach.</p> <p>Revegetation efforts should consider the installation of woody material at the bank toe to ensure bank stability. Wood structures may replace riprap protection in several locations. Install irrigation watering to ensure plant establishment.</p>

<p>The image is an aerial photograph showing a winding stream through a residential and agricultural area. Yellow lines are drawn along the stream banks to indicate the project reach. The banks are mostly cleared, with some remaining trees and vegetation. Houses and fields are visible on either side of the stream.</p>

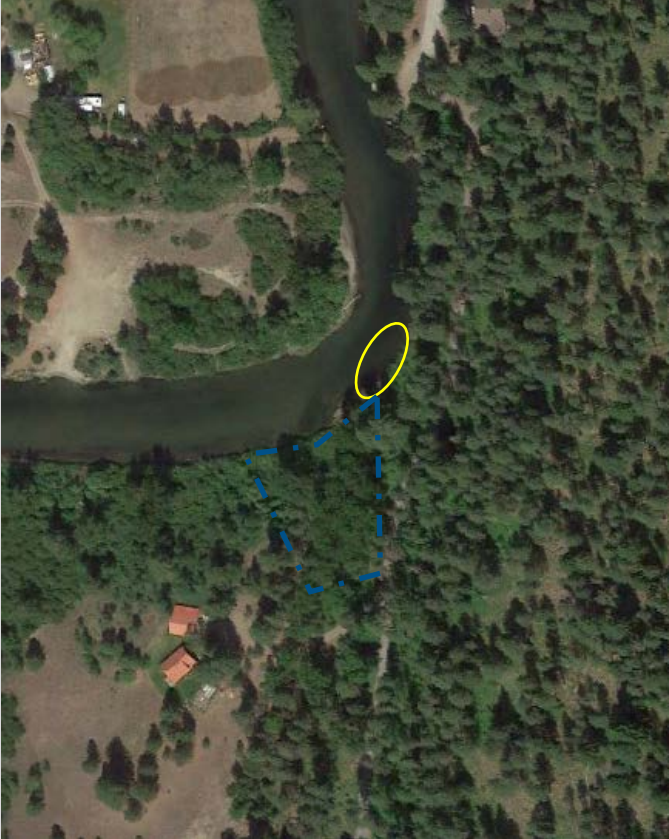
PROJECT LOCATION (RIVER MILE/BANK)	ACTION/STRATEGY /ECOLOGICAL CONCERN	DESCRIPTION	CONCEPT
RM 3 - 4.3 LNFH	<p>Large Woody Material Placement</p> <p><i>Peripheral and Transitional Habitat</i></p> <p><i>Channel Structure and Form</i></p>	<p>The historical Icicle Creek channel runs 6,400 linear feet to the east of the Leavenworth National Fish Hatchery bypass channel (3,950 linear feet).</p> <p>This action will increase wood loading within the historical channel. Wood installation will provide immediate improvements for cover, complexity, and pool formation. This action is appropriate with either the existing managed flow regime or in combination with potential actions to increase flow and/or for full channel realignment.</p> <p>Wood placement locations and design are dependent on management decisions regarding the existing hydraulic structures.</p>

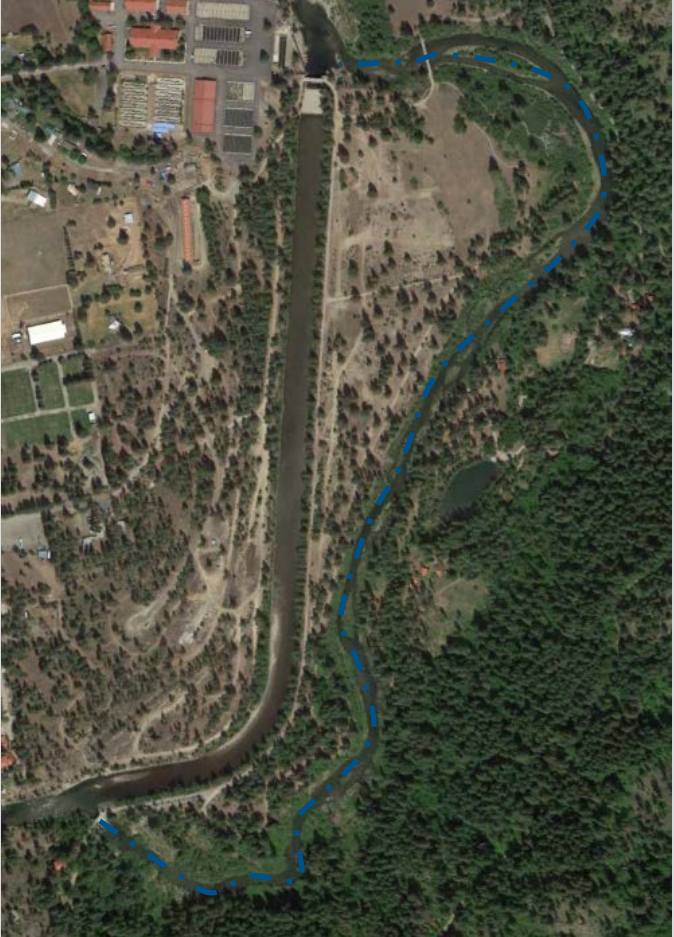
PROJECT LOCATION (RIVER MILE/BANK)	ACTION/STRATEGY /ECOLOGICAL CONCERN	DESCRIPTION	CONCEPT
RM 3 - 4.3 LNFH	<p>Reconnect Floodplain and Off-Channel Habitat</p> <p>Large Woody Material Placement</p> <p>Full Channel Reconnection</p> <p><i>Peripheral and Transitional Habitat</i></p> <p><i>Channel Structure and Form</i></p>	<p>Flows into the Historic Channel are controlled by Structure 2 at the inlet which limits flows larger than 2,600 cfs from entering the channel. This has resulted in deposition of sands, a narrowing of the channel, and it now functions similar to a side channel rather than a dynamic main channel. Multiple recommendations for flow and channel restoration are appropriate at this site. The ultimate action will depend on input from the LNFH, Tribal interests, adjacent landowners, and the local community.</p> <p>Increasing flood flows into the channel will promote dynamic channel process that would be expected within this alluvial fan feature. This would require a modification of Structure 2 to allow flows between a 2-10-yr event to enter the channel system. This would increase pool formation (with the addition of large wood), improve the creation and connection to side channel habitats, and scour/mobilize sands to increase channel-bed coarse grained materials.</p> <p>Full channel realignment option: The existing historical channel retains a planform that over time will accommodate full channel flows. This would require modification of the channel inlet and an equilibrium period during which accumulated sediments in the historical channel mobilize. This would restore dynamic channel process to the main channel. An assessment of the future use/flows within the bypass channel would be required, along with flood effects to adjacent landowners, and retention of Tribal fishing areas.</p>
