Twisp River  
Scaffold Camp  
Restoration Design and Engineering Services

**Request for Proposals**  
January 28, 2016

# Twisp River Scaffold Camp Concept Design Report

SUBMITTED TO  
Yakama Nation Fisheries

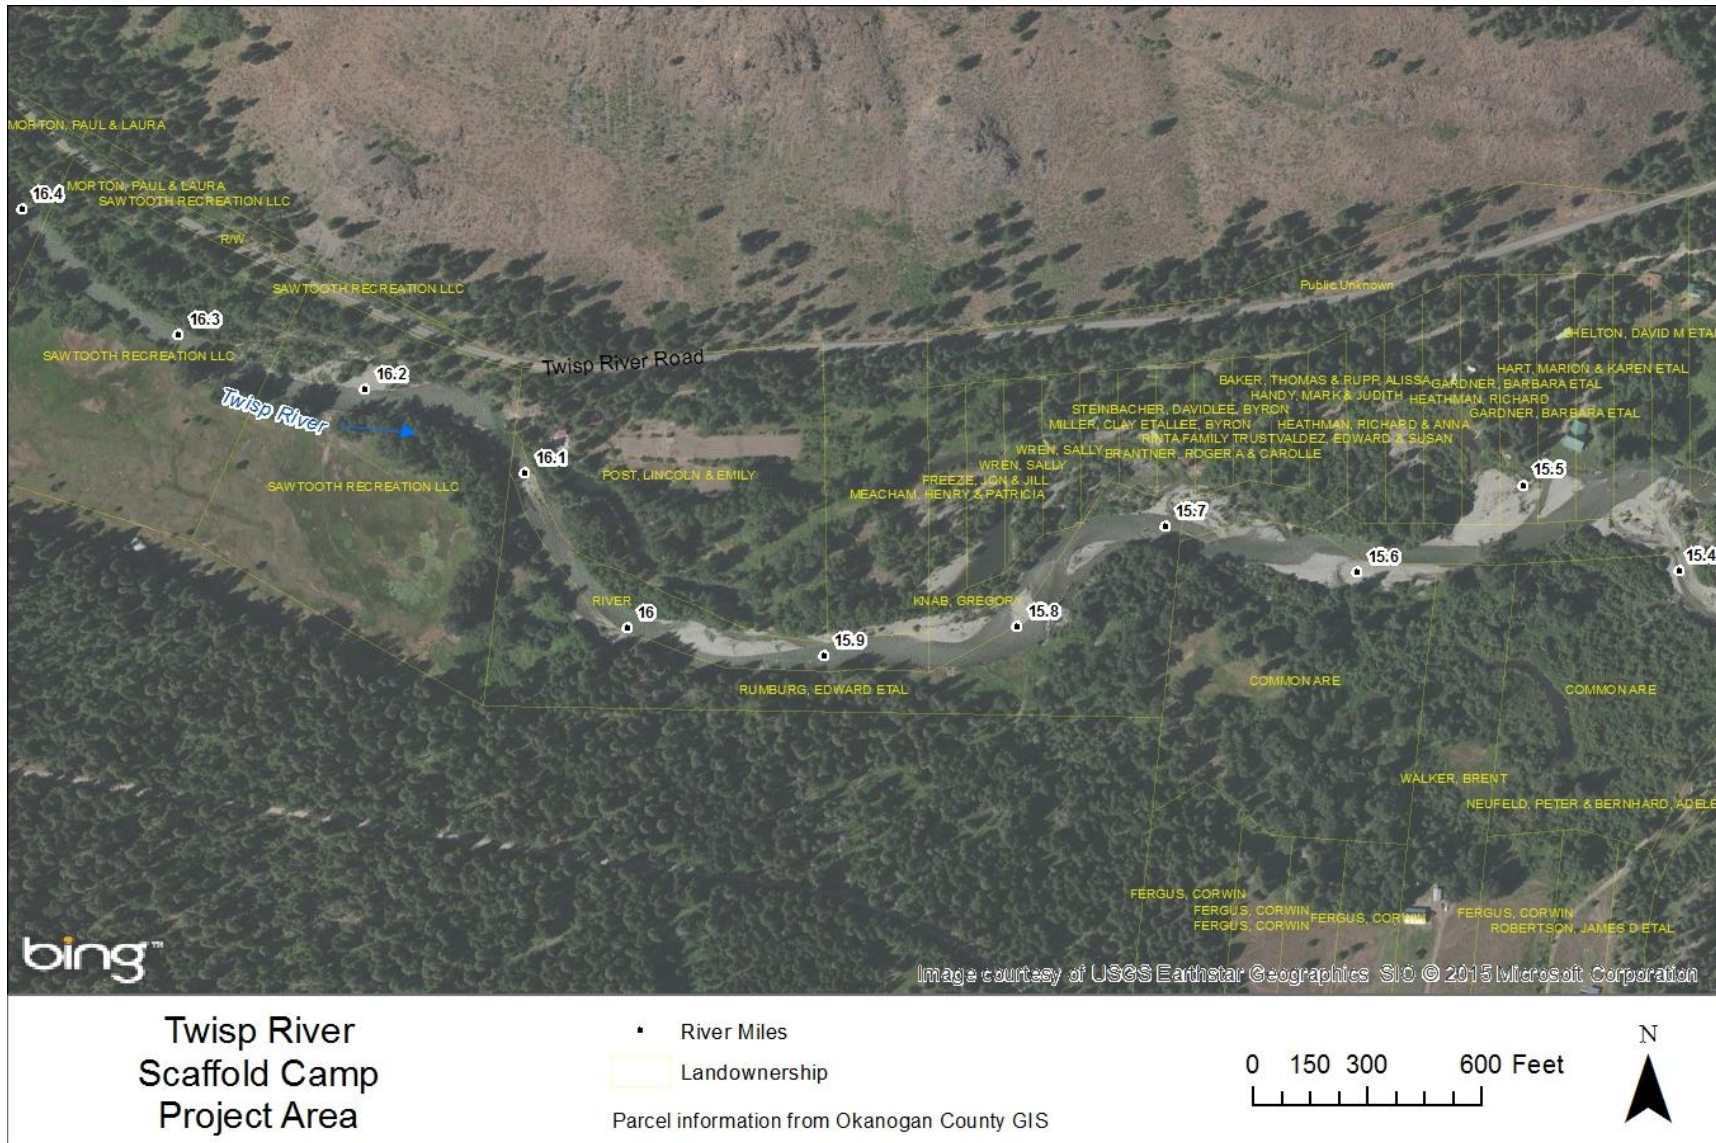
Figure 1 - Overview map of Scaffold Camp project area with aerial photo

The Scaffold Camp project area is located between River Mile (RM) 15.1 and 16.4 of the Twisp River. Land ownership along the project reach is mainly private, with two parcels on the right bank from RM 15.4 to RM 15.7 designated as “Common Areas”. Overview maps are included in Figure 1 and Figure 2.

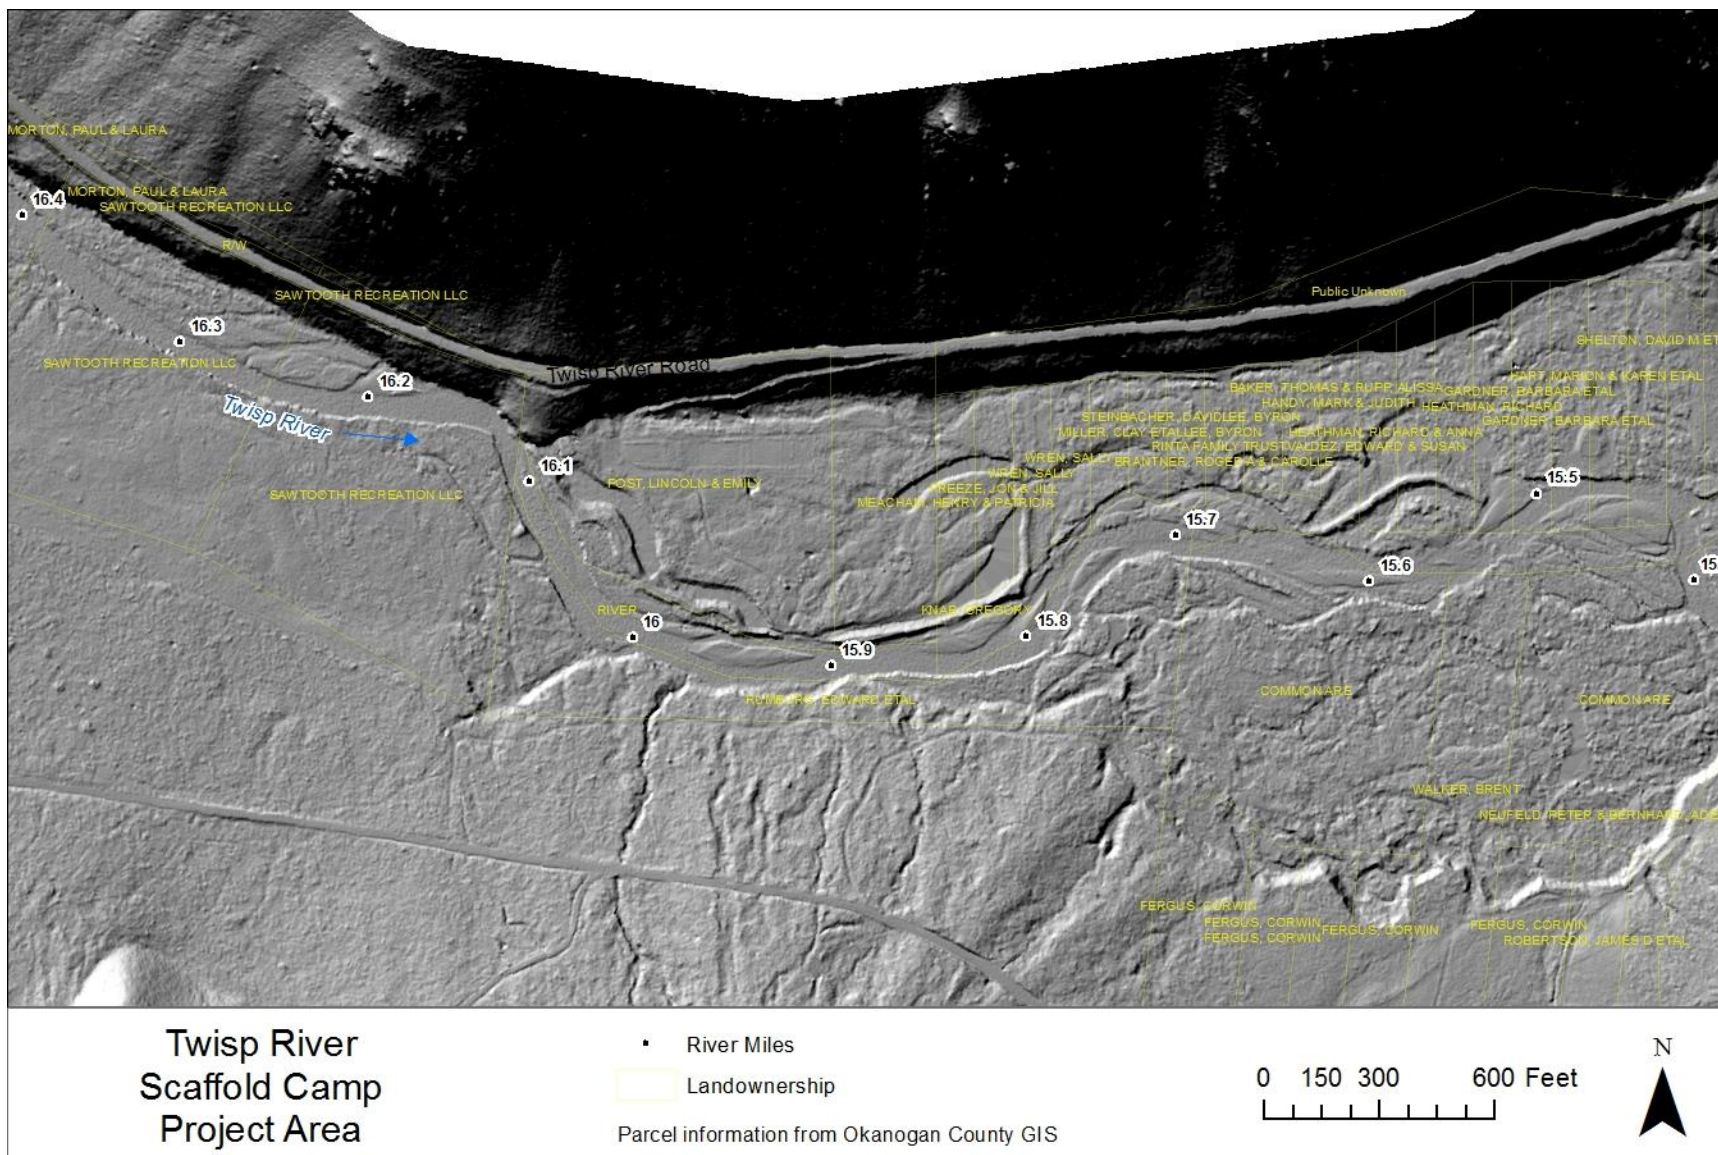
Figure 2- Overview map of Scaffold Camp project area with 2006 LiDAR hillshade

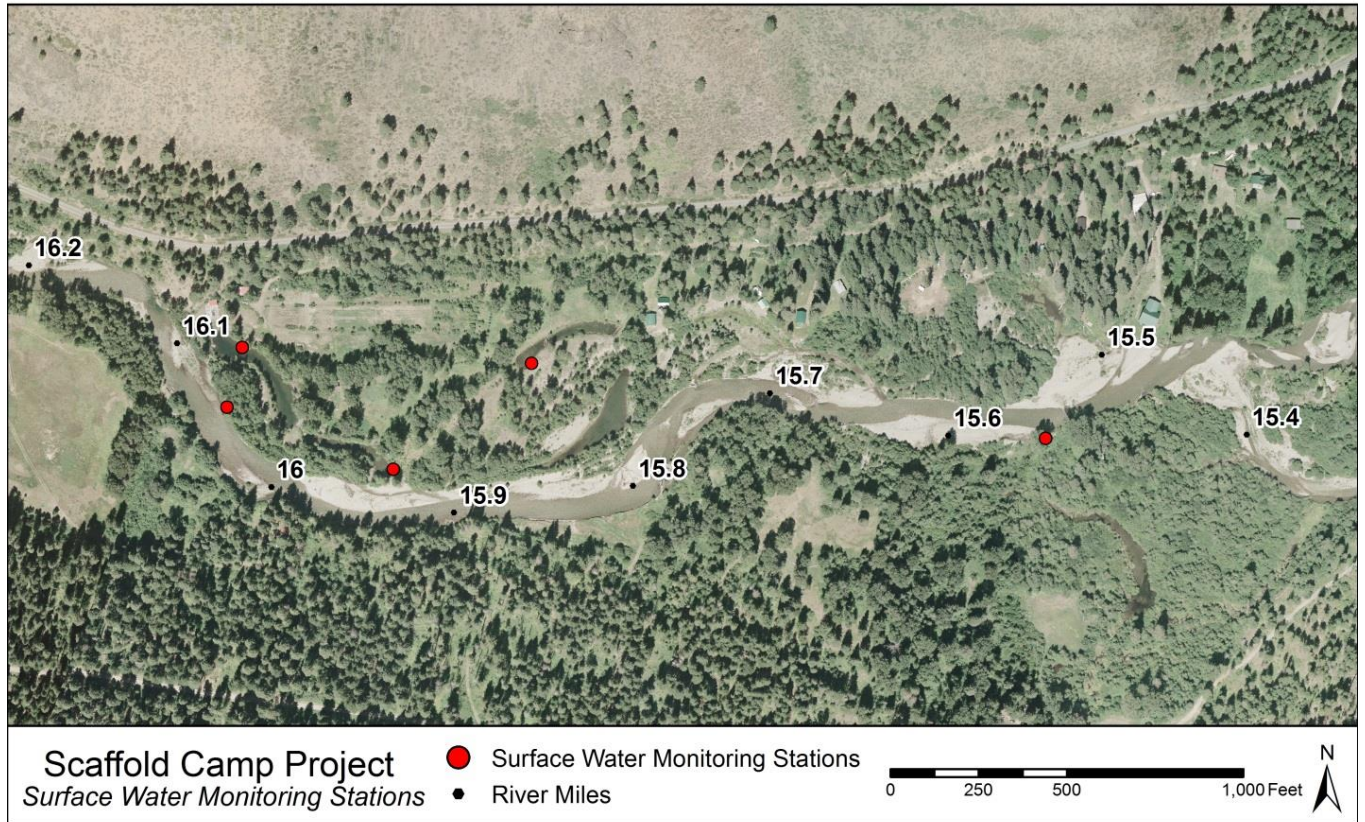
**Figure 3 - Location of surface water monitoring stations installed in October 2014.**

Water surface elevation monitoring stations were installed throughout the project site in October 2014. Monitoring stations utilize HOBO U20 water level data loggers. These loggers are used to monitor water levels via a pressure transducer. Water level loggers were installed at five locations throughout the project reach; two in the main channel and three in the pond complex (Figure 3). An additional logger was deployed to collect atmospheric pressure readings, which are used during data processing to correct water level readings given barometric fluctuations. These stations are intended to provide accurate water surface data for the reach, which will be used for model calibration and design of channel features. The U20 loggers also record water temperature, which will be useful for assessing temperature conditions as it relates to aquatic habitat quality.

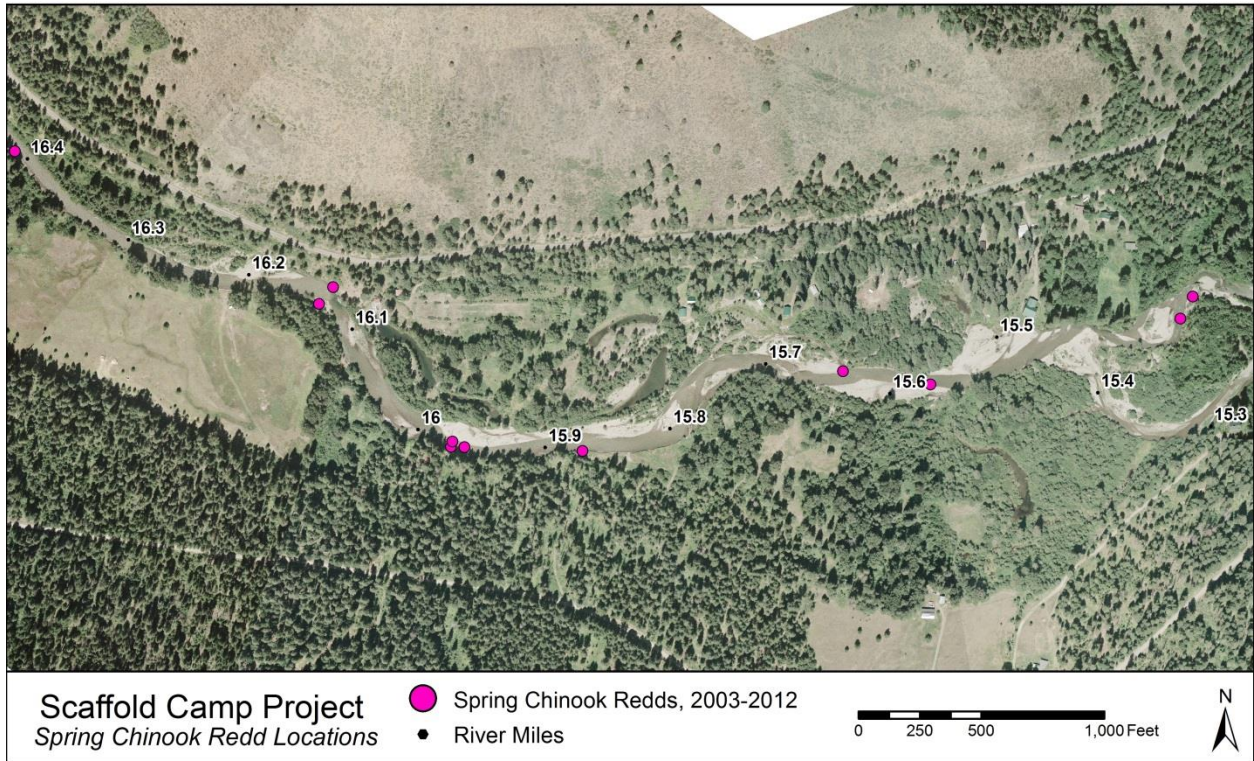
Figure 4 - Spring Chinook redds. Data acquired from UCSRB online GIS and Data Library, retrieved 12 January 2015.

Spawning ground surveys are performed annually throughout the Methow basin. The project area falls within a 4.6 mile long reach that consistently contains the highest number of spring Chinook redds in the Twisp River as well as a significant number of steelhead redds. During the 2012 survey, 74 spring Chinook redds and 43 steelhead redds were identified within this reach. (Snow et al. 2014). Surveyed locations of steelhead and Chinook redds from 2003 to 2012 are shown in Figure 4 and Figure 5.

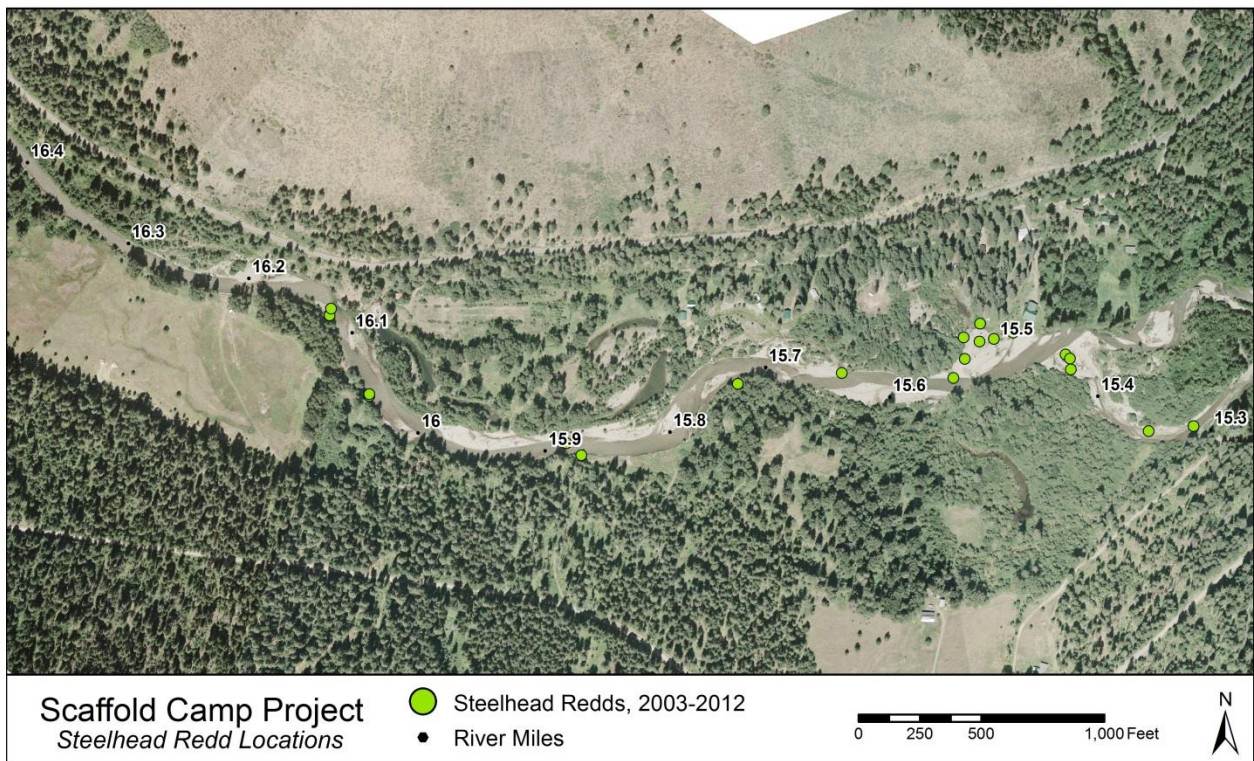
Figure 5. Steelhead trout redds. Data acquired from UCSRB online GIS and Data Library, retrieved 12 January 2015.

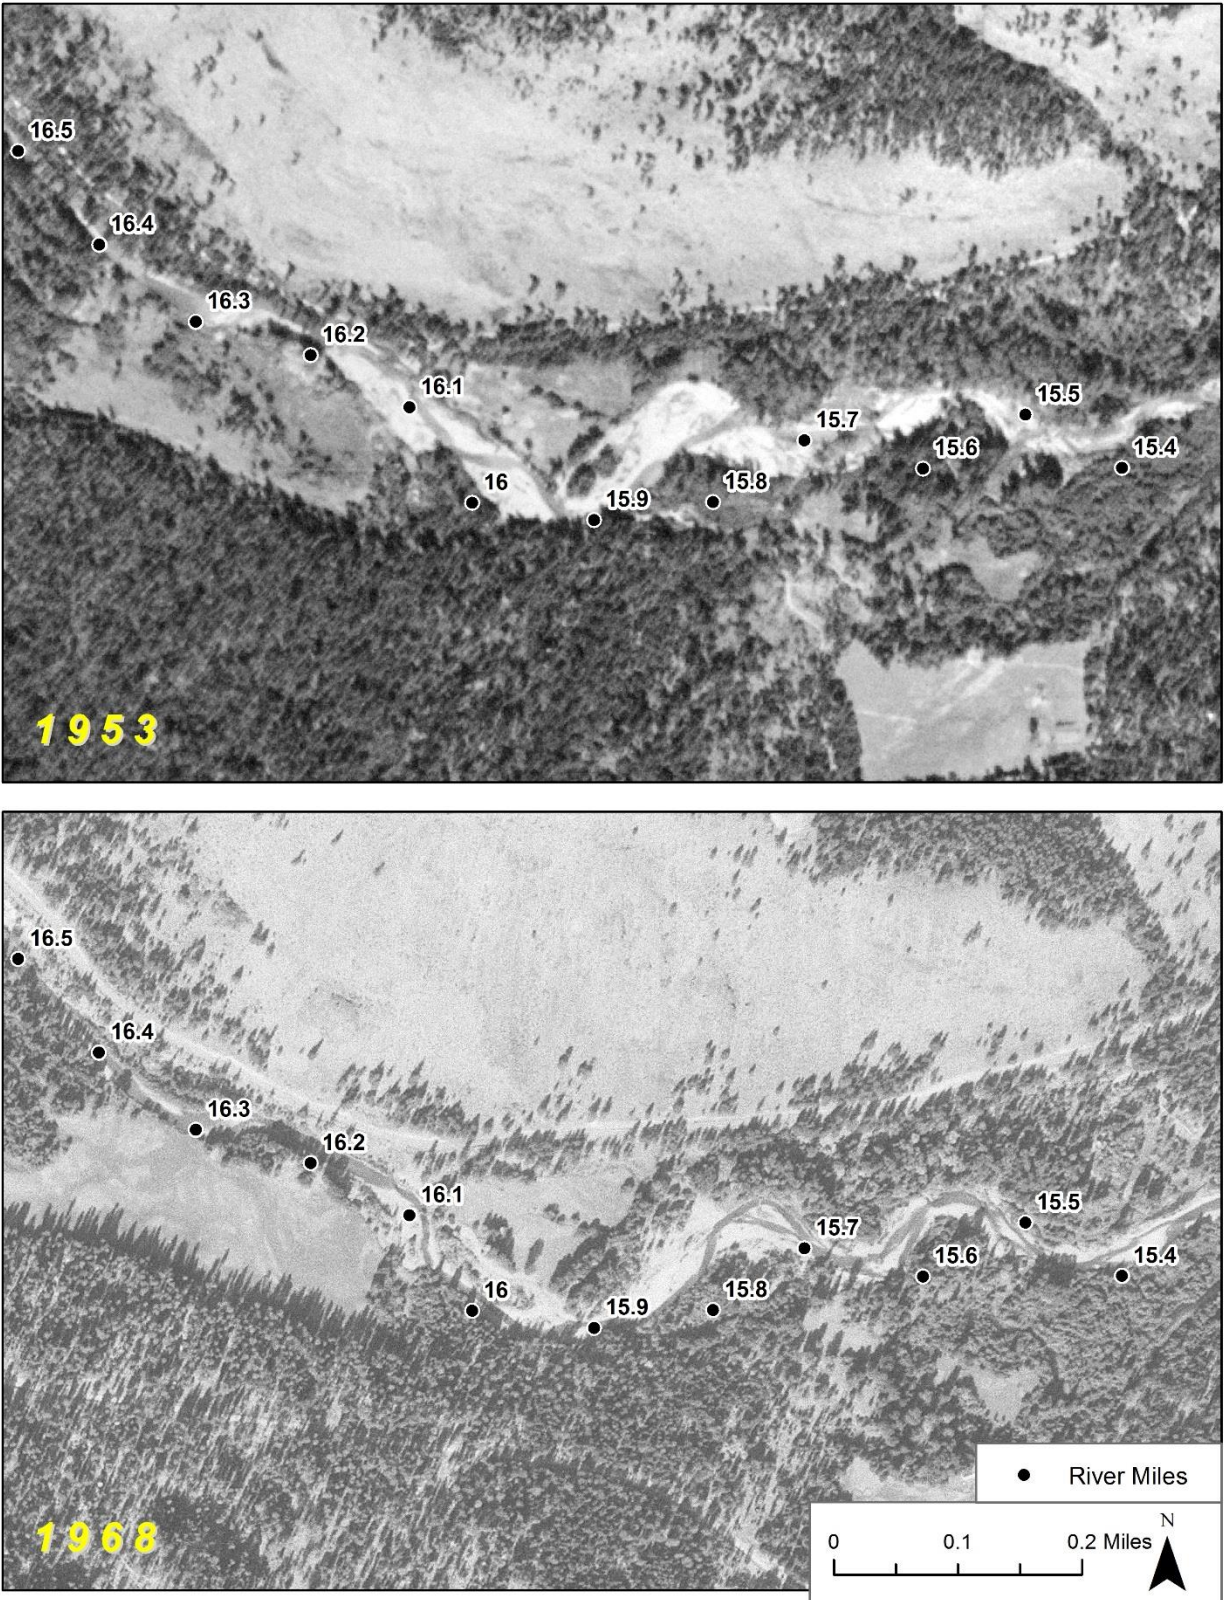
Figure 6 - 1953 and 1968 aerial photographs.

A series of historical aerial photos is presented in Figure 6 to Figure 8 below. The earliest photos (1953) are not early enough to capture pre-disturbance conditions; significant agricultural and residential uses appear to be established by then. There is nevertheless a significant increase in land-use disturbance and channel change that occurs between 1953 and contemporary times. The channel segment between RM

16.5 and 16.2 changes very little over the nearly 60 year photo history. Between RM 16.2 and 16.05, an area to the south of the existing channel has transitioned from being an un-vegetated floodplain surface to one with mature riparian vegetation. The most dramatic change within the project area has occurred between RM 16.1 and RM 15.53 on river left. A series of pushup berms has been constructed along the channel margin, with ponds excavated behind them. It is assumed, but not verified, that the material excavated from the ponds was used to create the pushup berms. The aerial photos show that the pushup berm construction occurred between 1975 and 1998. USBR mapping of the channel centerline suggests that portions of the pushup berm (between RM 15.53 and 15.63 and RM 15.75 and 15.9) were not constructed until after 1985. The meander bend between RM 15.75 and 15.9, delineated by the un-vegetated floodplain area observed in the 1953 photograph, scrolls to the east over the course of the photo record. A similar trend is observed in the meander bend located between RM 15.65 and 15.5 in the 1953 image. The channel planform through the project reach is fairly static between the 1998 and 2011 images, likely in part due to the influence of the pushup berms. At the downstream end of the site, a split flow channel is observed to form to the south of the existing channel near RM 15.4 at some point between 1975 and 1998. By 2006, this channel is the main low flow channel, but by 2011 (and confirmed during the 2014 ground survey), the main low flow channel is again in the alignment to the north near RM 15.4.

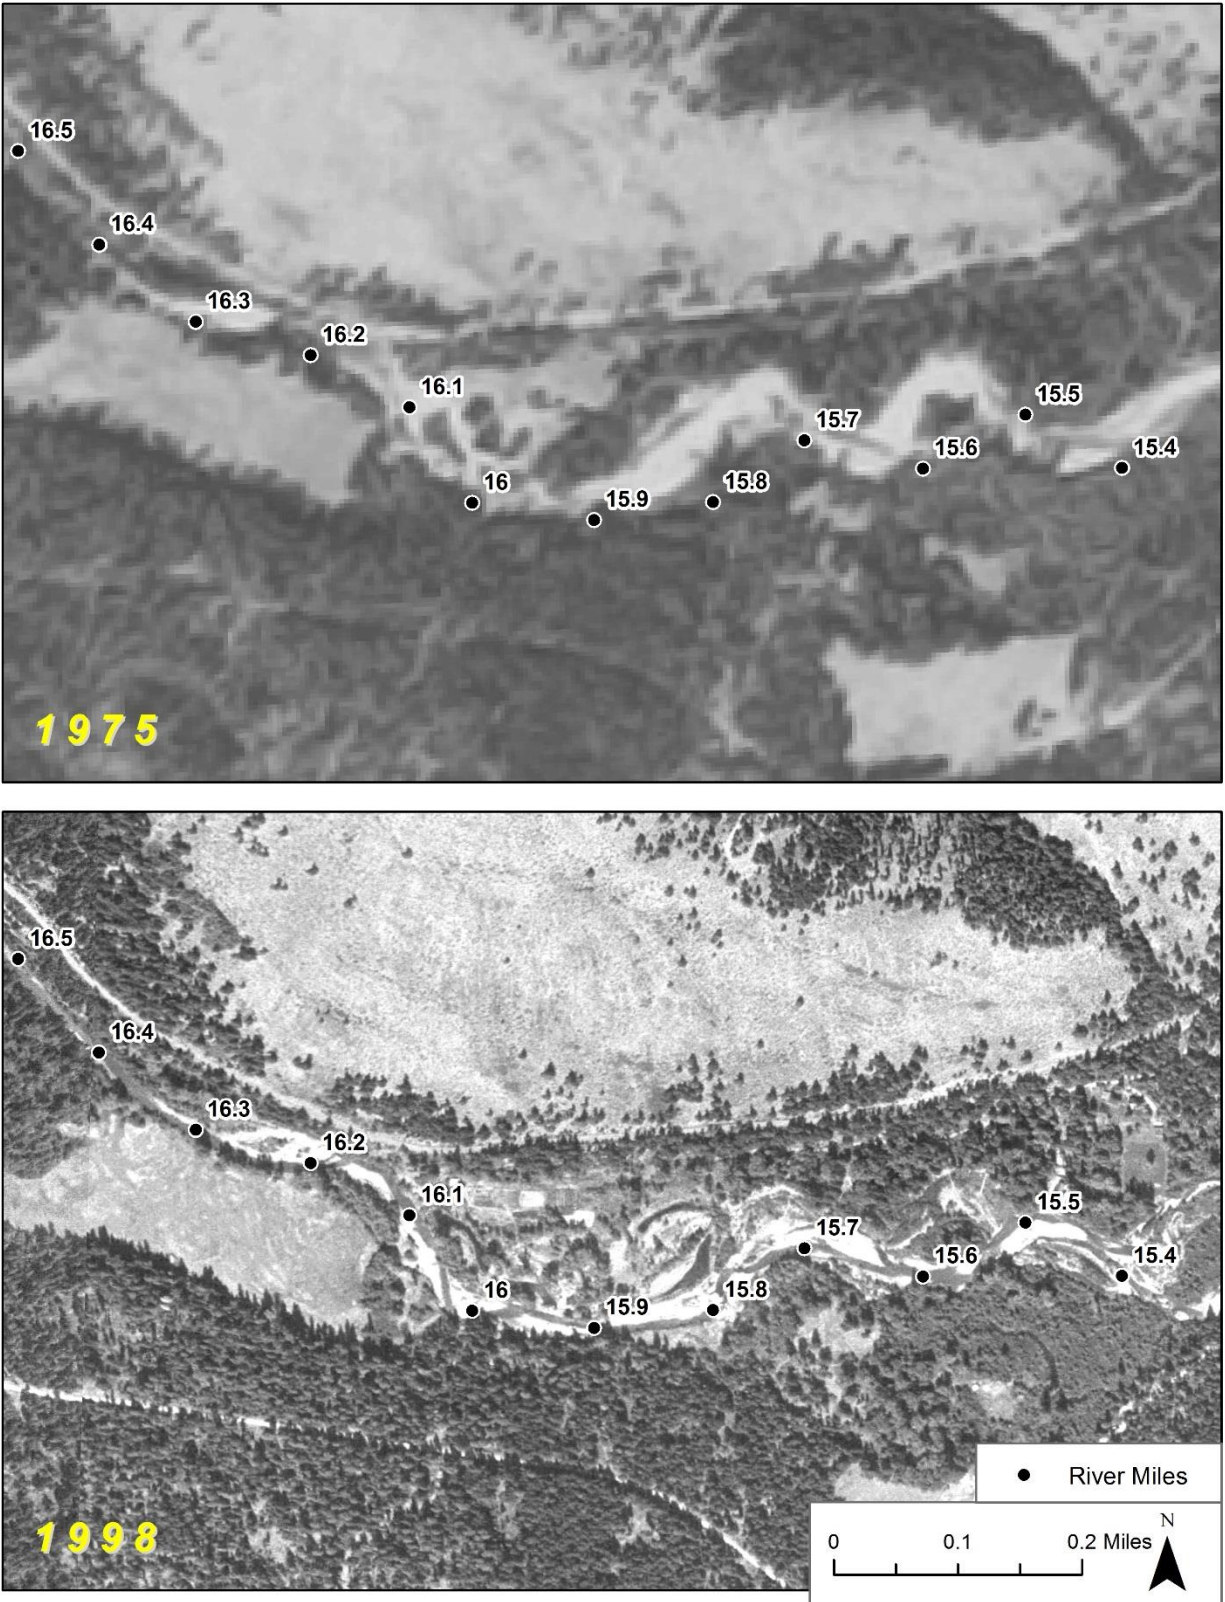
Figure 7 - 1975 and 1998 aerial photographs.

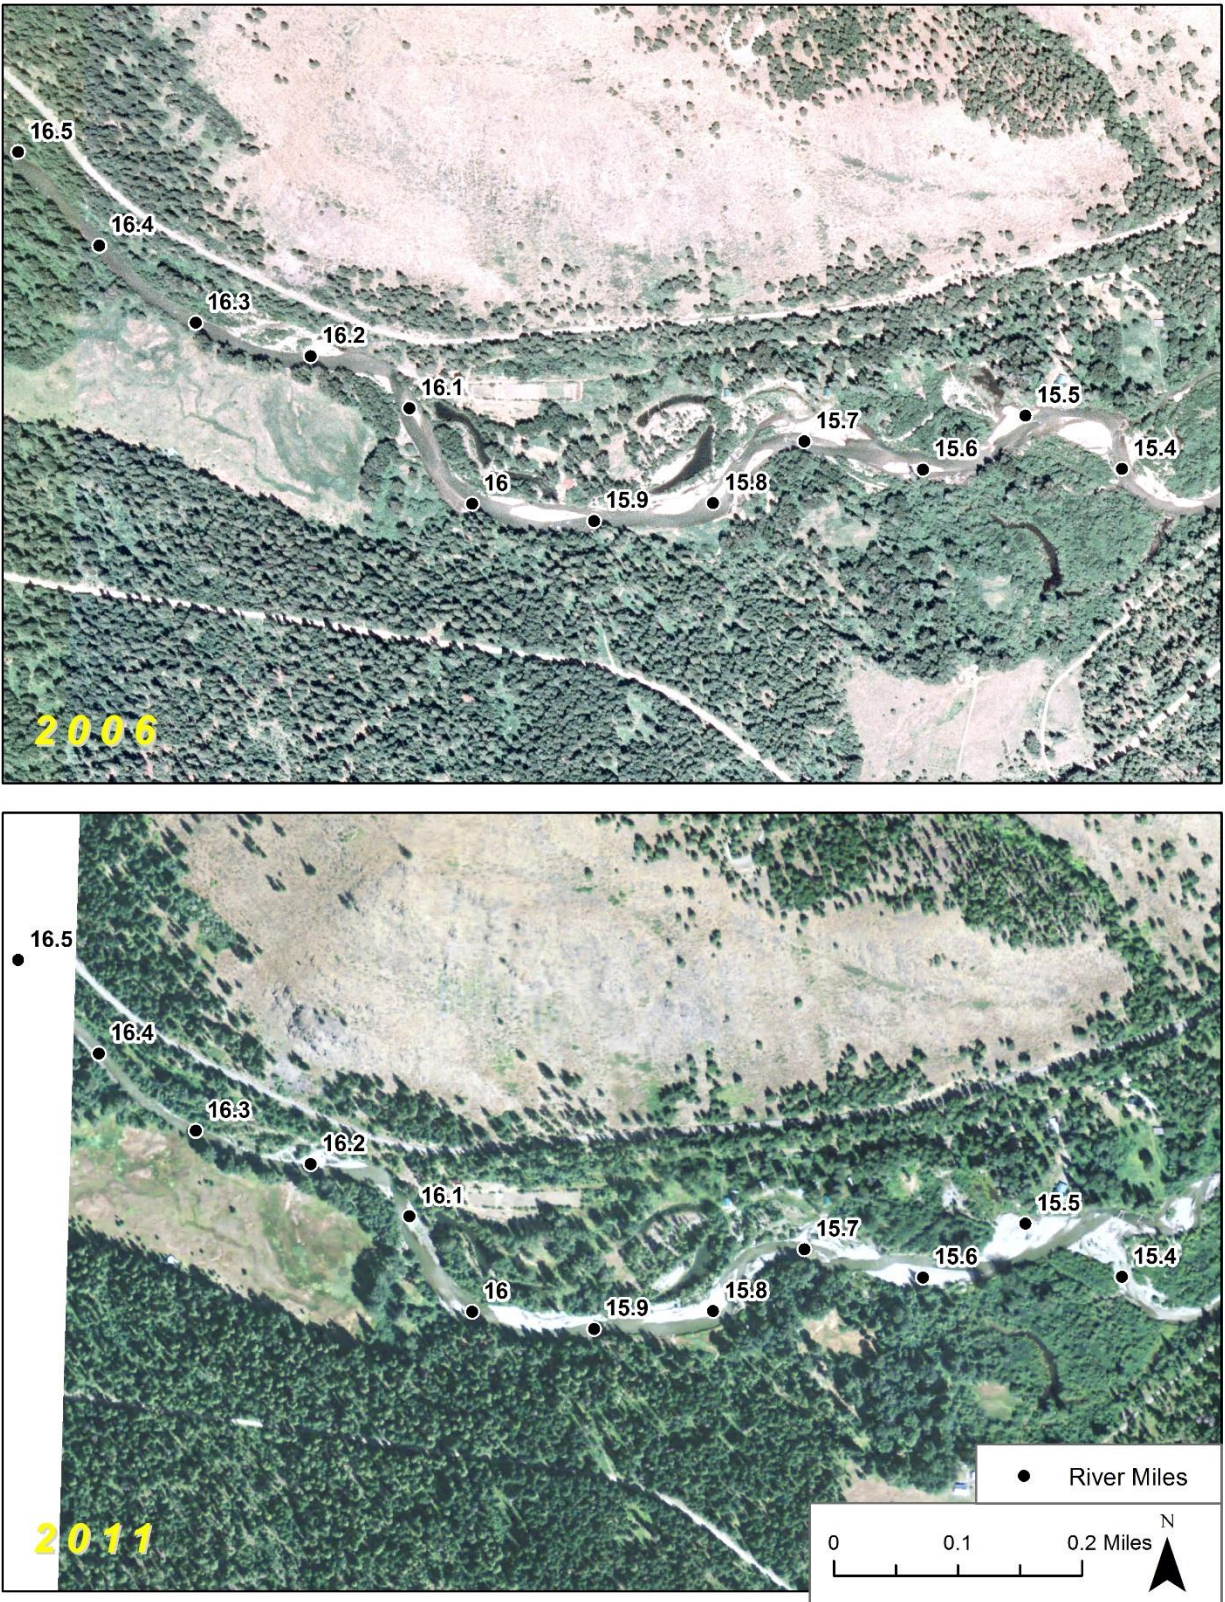
Figure 8 - Aerial photographs from 2006 and 2011.

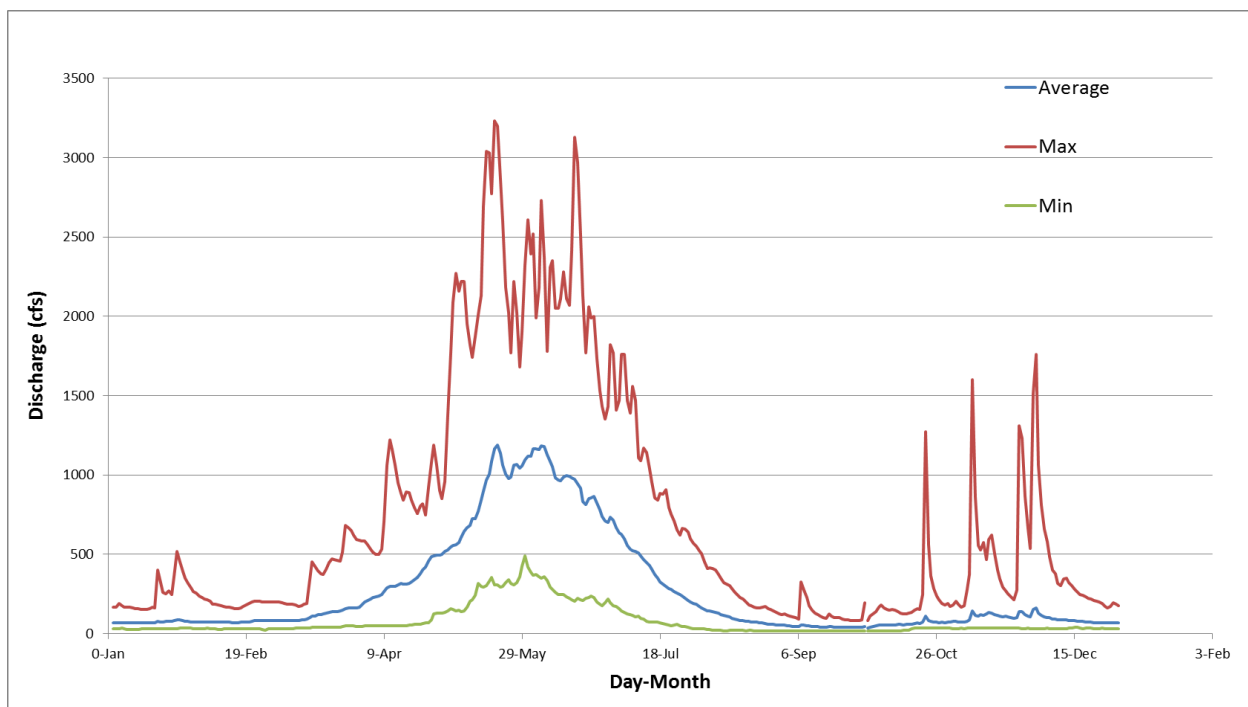
**Figure 9 - Average, maximum, and minimum values of average daily flows for the period between 10/1/1989 to 9/30/2013 (as measured at USGS gage number 12448998).**

Dominant hydrologic patterns are driven by precipitation in the form of snow and the subsequent spring snowmelt. Precipitation amounts vary with elevation and distance from source areas. In the higher elevation areas of the basin, where maximum elevations are near 8,780 feet, average annual precipitation is 65-70 inches, falling mainly as snow. Mean annual precipitation in the Twisp River watershed is about 43 inches (USGS 2013). Peak runoff usually occurs from April to August, with the highest discharges typically in June (Figure 9). Baseflow discharge conditions typically return in the Twisp River by September.

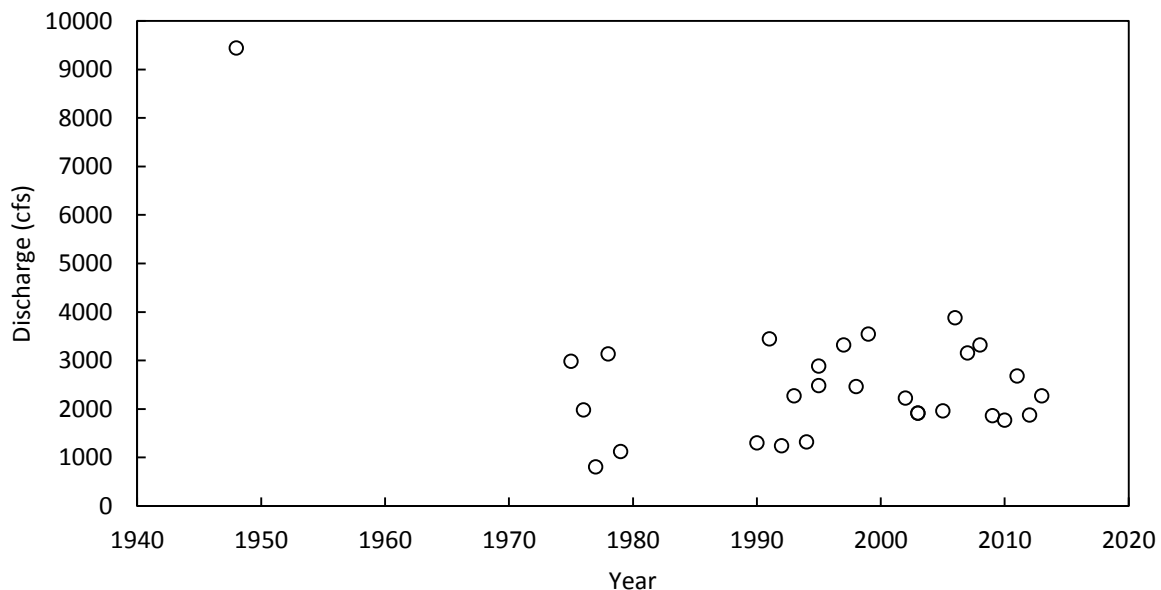
**Figure 10. Annual peak floods at the Twisp River gage (USGS 12448998). The 1948 magnitude of 9,440 cfs was estimated using high water marks by the USGS.**

were collected for the years 1975-1979 and 1990-1999. One flood peak from 1948 has been documented by the USGS (Figure 10).

The largest flood event on record in the Twisp River was 9,440 cfs in 1948. Although the gaging station was not in operation, the U.S. Geological Survey estimated the magnitude based on a contracted opening method with high water marks. The magnitude of the flood was nearly 2.5 times the magnitude of the next largest flood, which occurred in May 2006. Other notable flood events occurred in the Methow Valley in 1894 and 1972, although there is no gage data available for the Twisp River for any of these years. Of the 28 annual peak discharges in the gage record, only two took place outside the months of May or June.

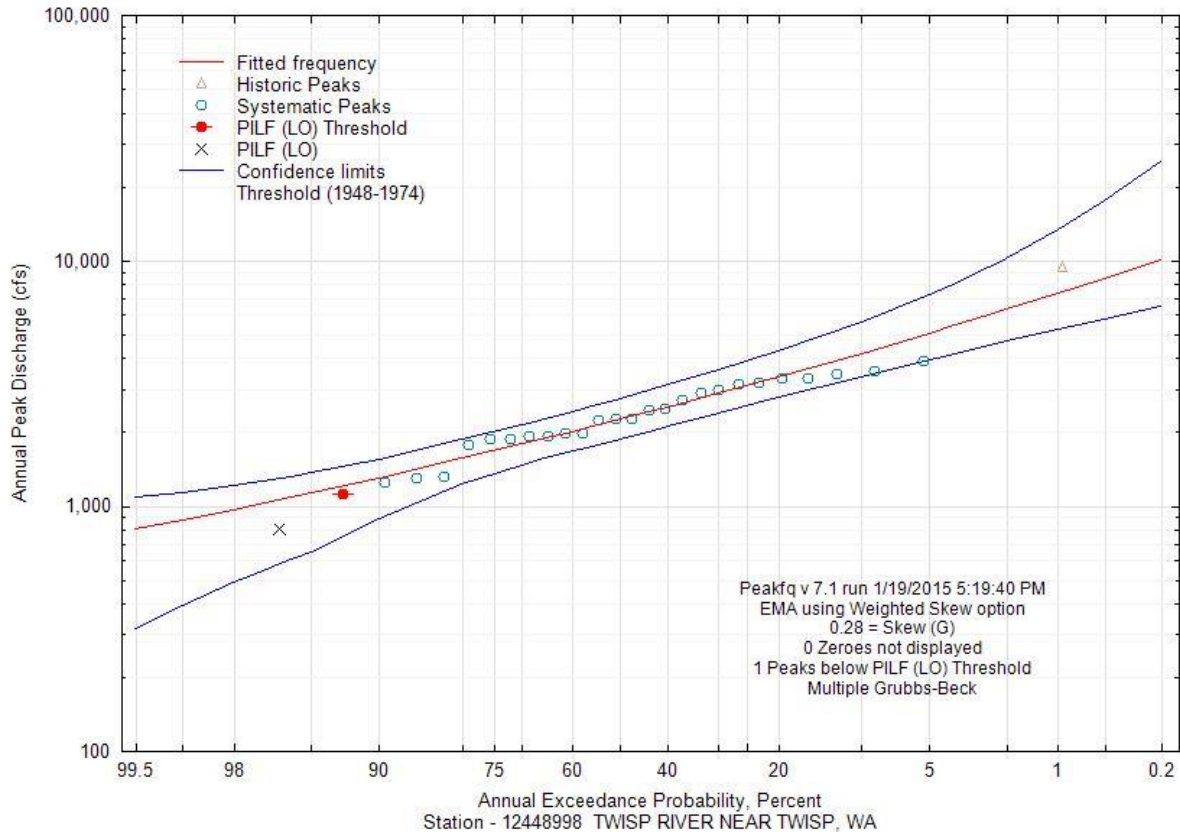
**Figure 11. Flood quantiles for the Twisp River gage along with the corresponding confidence limits, low outlier, and historic peak data.**

Flood magnitudes for specific recurrence intervals were estimated using the USGS gage on the Twisp River at Twisp, WA (#12448998). The data included annual instantaneous peak flood discharges for the years 1948, 1975-1979, 1990-1999, and 2002-2013. Quantiles were estimated by fitting these data to a log-Pearson Type III (LP3) probability distribution as recommended by the Interagency Advisory Committee on Water Data and described in Bulletin 17B (1981). Since the development of Bulletin 17B, however, there have been further improvements in flood quantile estimation. These improvements include the expected moments algorithm (EMA) for utilizing historic peak flood data (Cohn et al. 1997), a new procedure for estimating confidence intervals (Cohn et al., 2001), and the Multiple Grubbs-Beck (MGB) Test for low outliers (Cohn et al. 2013).

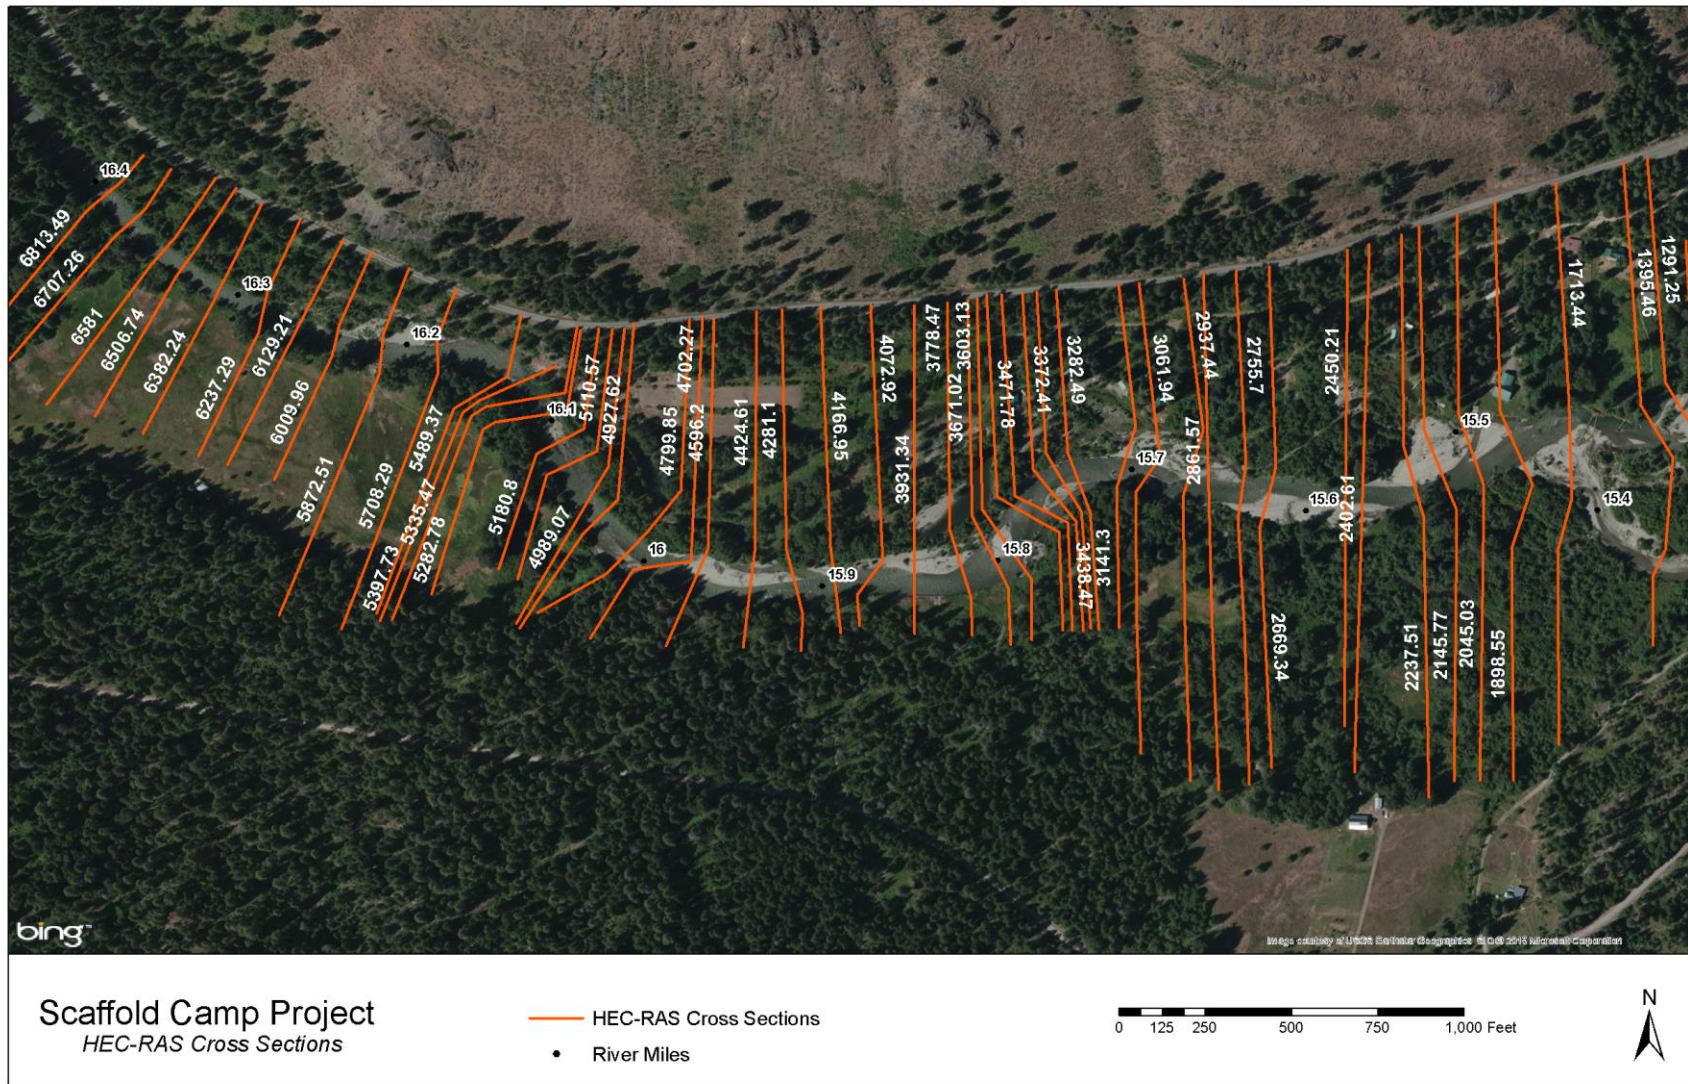
Figure 12. HEC-RAS Cross sections at Scaffold Camp project site.

The model geometry was developed using topographic data obtained through surveys completed by Inter-Fluve on October 21 to 23, 2014. Survey data were supplemented with available LiDAR data in select locations. The existing conditions model geometry includes 52 cross sections (Figure 12) spaced over the 0.96-mile project reach on the Twisp River. Reach slope was estimated at 0.7% using the survey data from riffle crest to riffle crest and verified as an accurate estimate for the larger reach by sampling several pairs of water surface points from LiDAR at a greater distance apart (0.5 to 1.0 miles). Cross sections extend through the floodplain and to surfaces on both banks which are inundated infrequently, but contain sections of manmade levees and various artificial ponds, some of which have bed elevations

Initial simulations of the estimated flow rates with comparisons between the modeled and surveyed water surface elevations revealed that  $Q = 56$  cfs produced a realistic bed roughness value that aligns with professional judgment, analogous systems, and similarity to reference photographs in USGS (1967). Therefore, this flow rate was adopted as  $Q$  for initial model calibrations, which produced a value of  $n = 0.055$  for the channel, and 0.1 for the floodplain. One possible reason for the discrepancy in estimated flows could be that the Similar Gages method was near the limits of its application (i.e.  $A_g$  compared to  $A_u$ ), which also corresponds to a large distance between the reach site and the gage (approximately 12.5 miles).

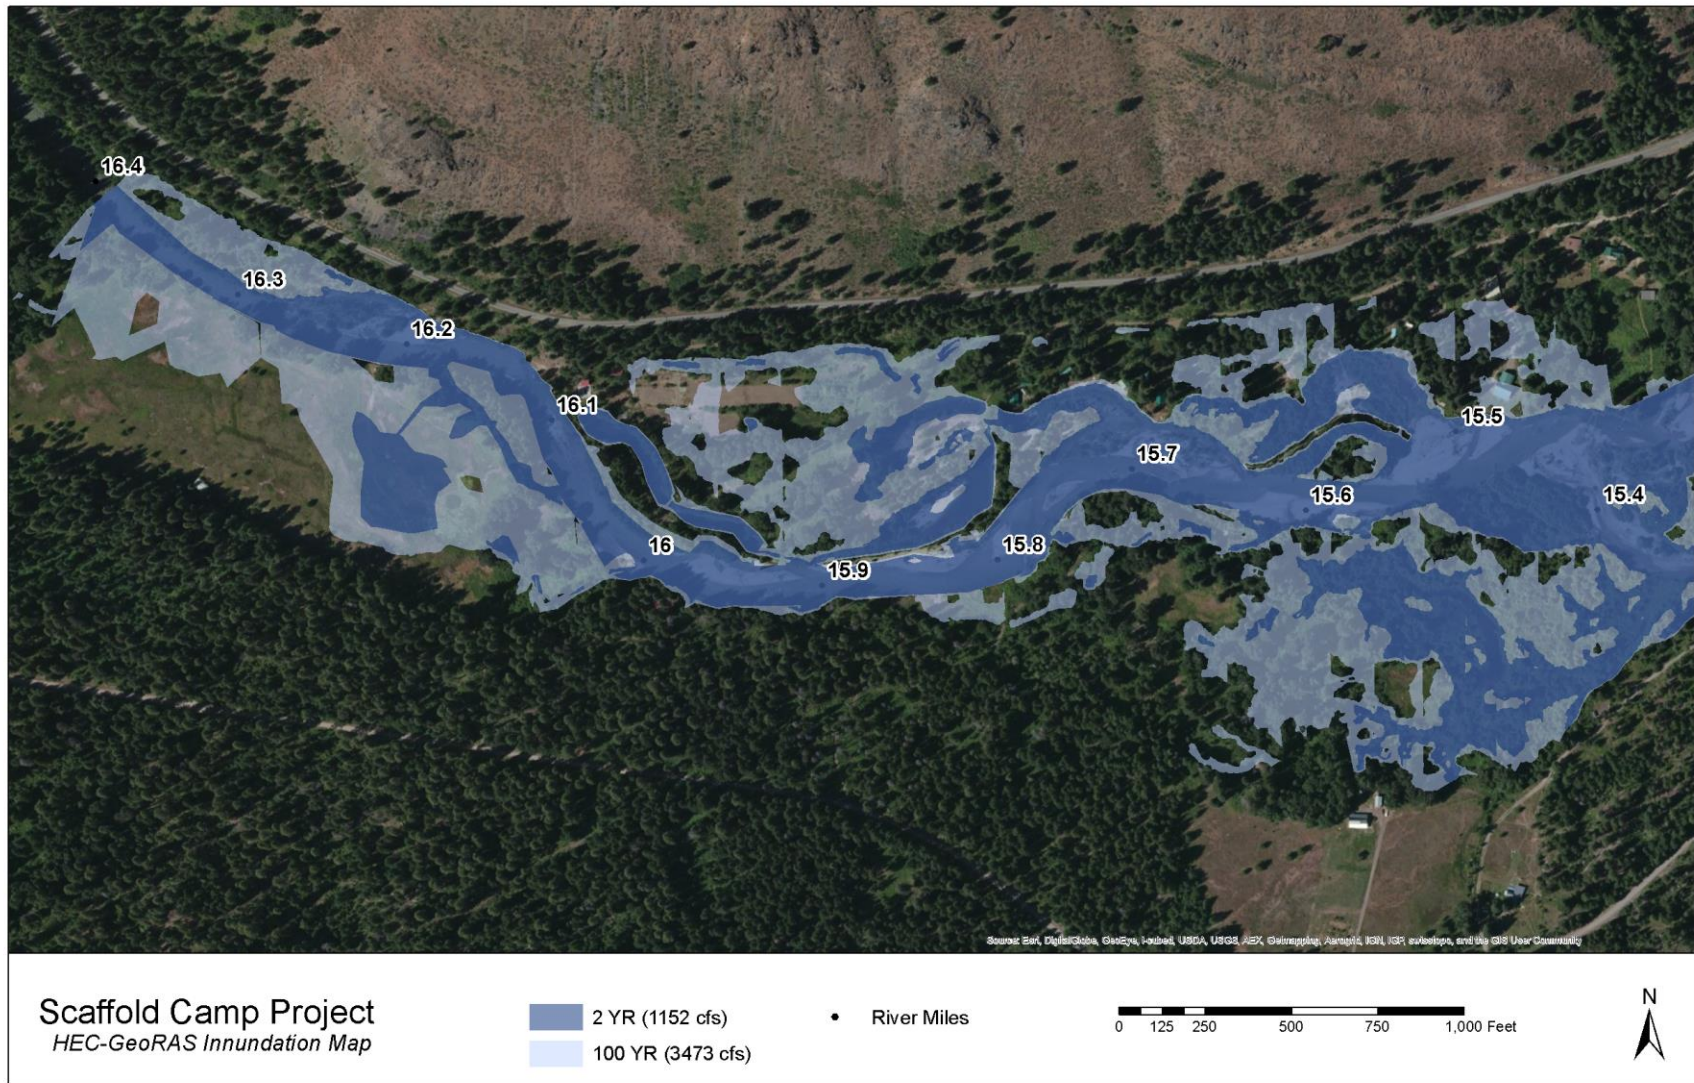
Figure 13. Inundation map showing model results for the Scaffold Camp project site, aerial photo background.

Following the initial calibration, hydraulic simulations were conducted using the 2, 5, 10, 25, 50, and 100-year recurrence interval floods. These flow values were calculated from the flood frequency analysis based on hydrologic analyses described above. Inundation maps for the 2 year and 100 year flood were created from the model results (Figure 13 and Figure 14. Detailed model results are presented in Attachment C. Finally, it should be noted that the initial calibration was performed using survey data collected at low flow, and additional model calibration will be performed with the collection of water surface elevation information using on-site data loggers, which will capture the high flow data from the winter and spring.
