Twisp River  
Scaffold Camp  
Restoration Design and Engineering Services

**Request for Proposals**  
January 28, 2016

# Twisp River Scaffold Camp Concept Design Report

SUBMITTED TO  
Yakama Nation Fisheries

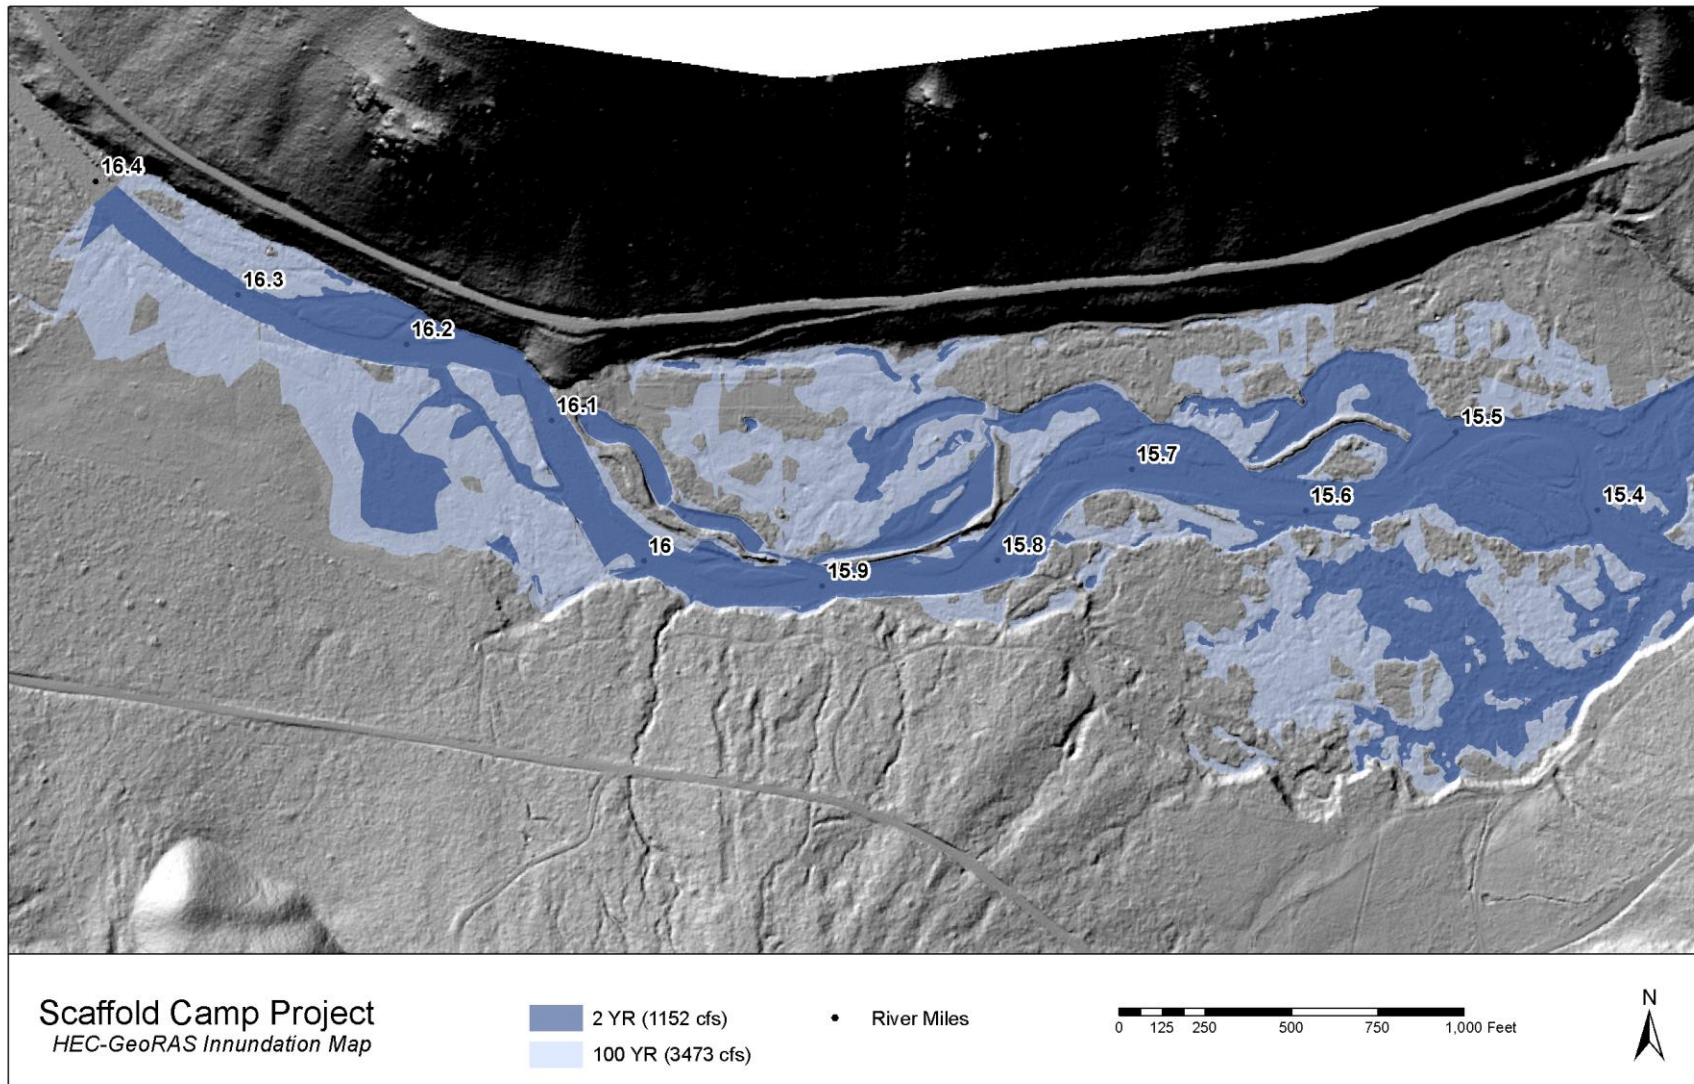
Figure 14. Inundation map showing model results for the Scaffold Camp project site, LiDAR hillshade background.

Following the initial calibration, hydraulic simulations were conducted using the 2, 5, 10, 25, 50, and 100-year recurrence interval floods. These flow values were calculated from the flood frequency analysis based on hydrologic analyses described above. Inundation maps for the 2 year and 100 year flood were created from the model results (Figure 13 and Figure 14. Detailed model results are presented in Attachment C. Finally, it should be noted that the initial calibration was performed using survey data collected at low flow, and additional model calibration will be performed with the collection of water surface elevation information using on-site data loggers, which will capture the high flow data from the winter and spring.

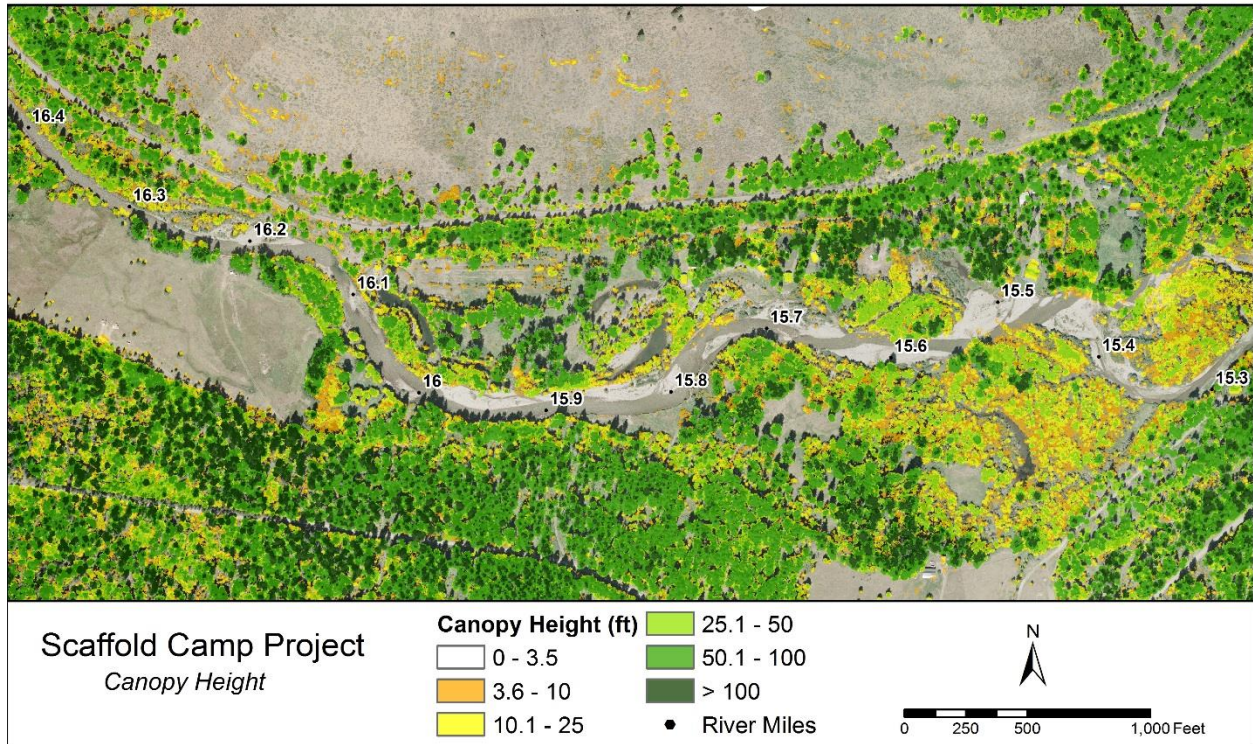
**Figure 15. Canopy heights at the Scaffold Camp project site estimated from LiDAR data.**

The Scaffold Camp area project area has a mix of coniferous forests and some aspen stands in the uplands, coupled with an understory of grassland and deciduous shrubs. Mature cottonwoods are present along the river margins throughout the site. Canopy height information, depicted in Figure 15, shows mature vegetation established on the north floodplain area between the pushup berms near RM 15.9. The berms themselves have less mature vegetation, another piece of evidence that they have been created somewhat recently. The side channel / wetland complex zone has a canopy dominated by willows and dogwoods.

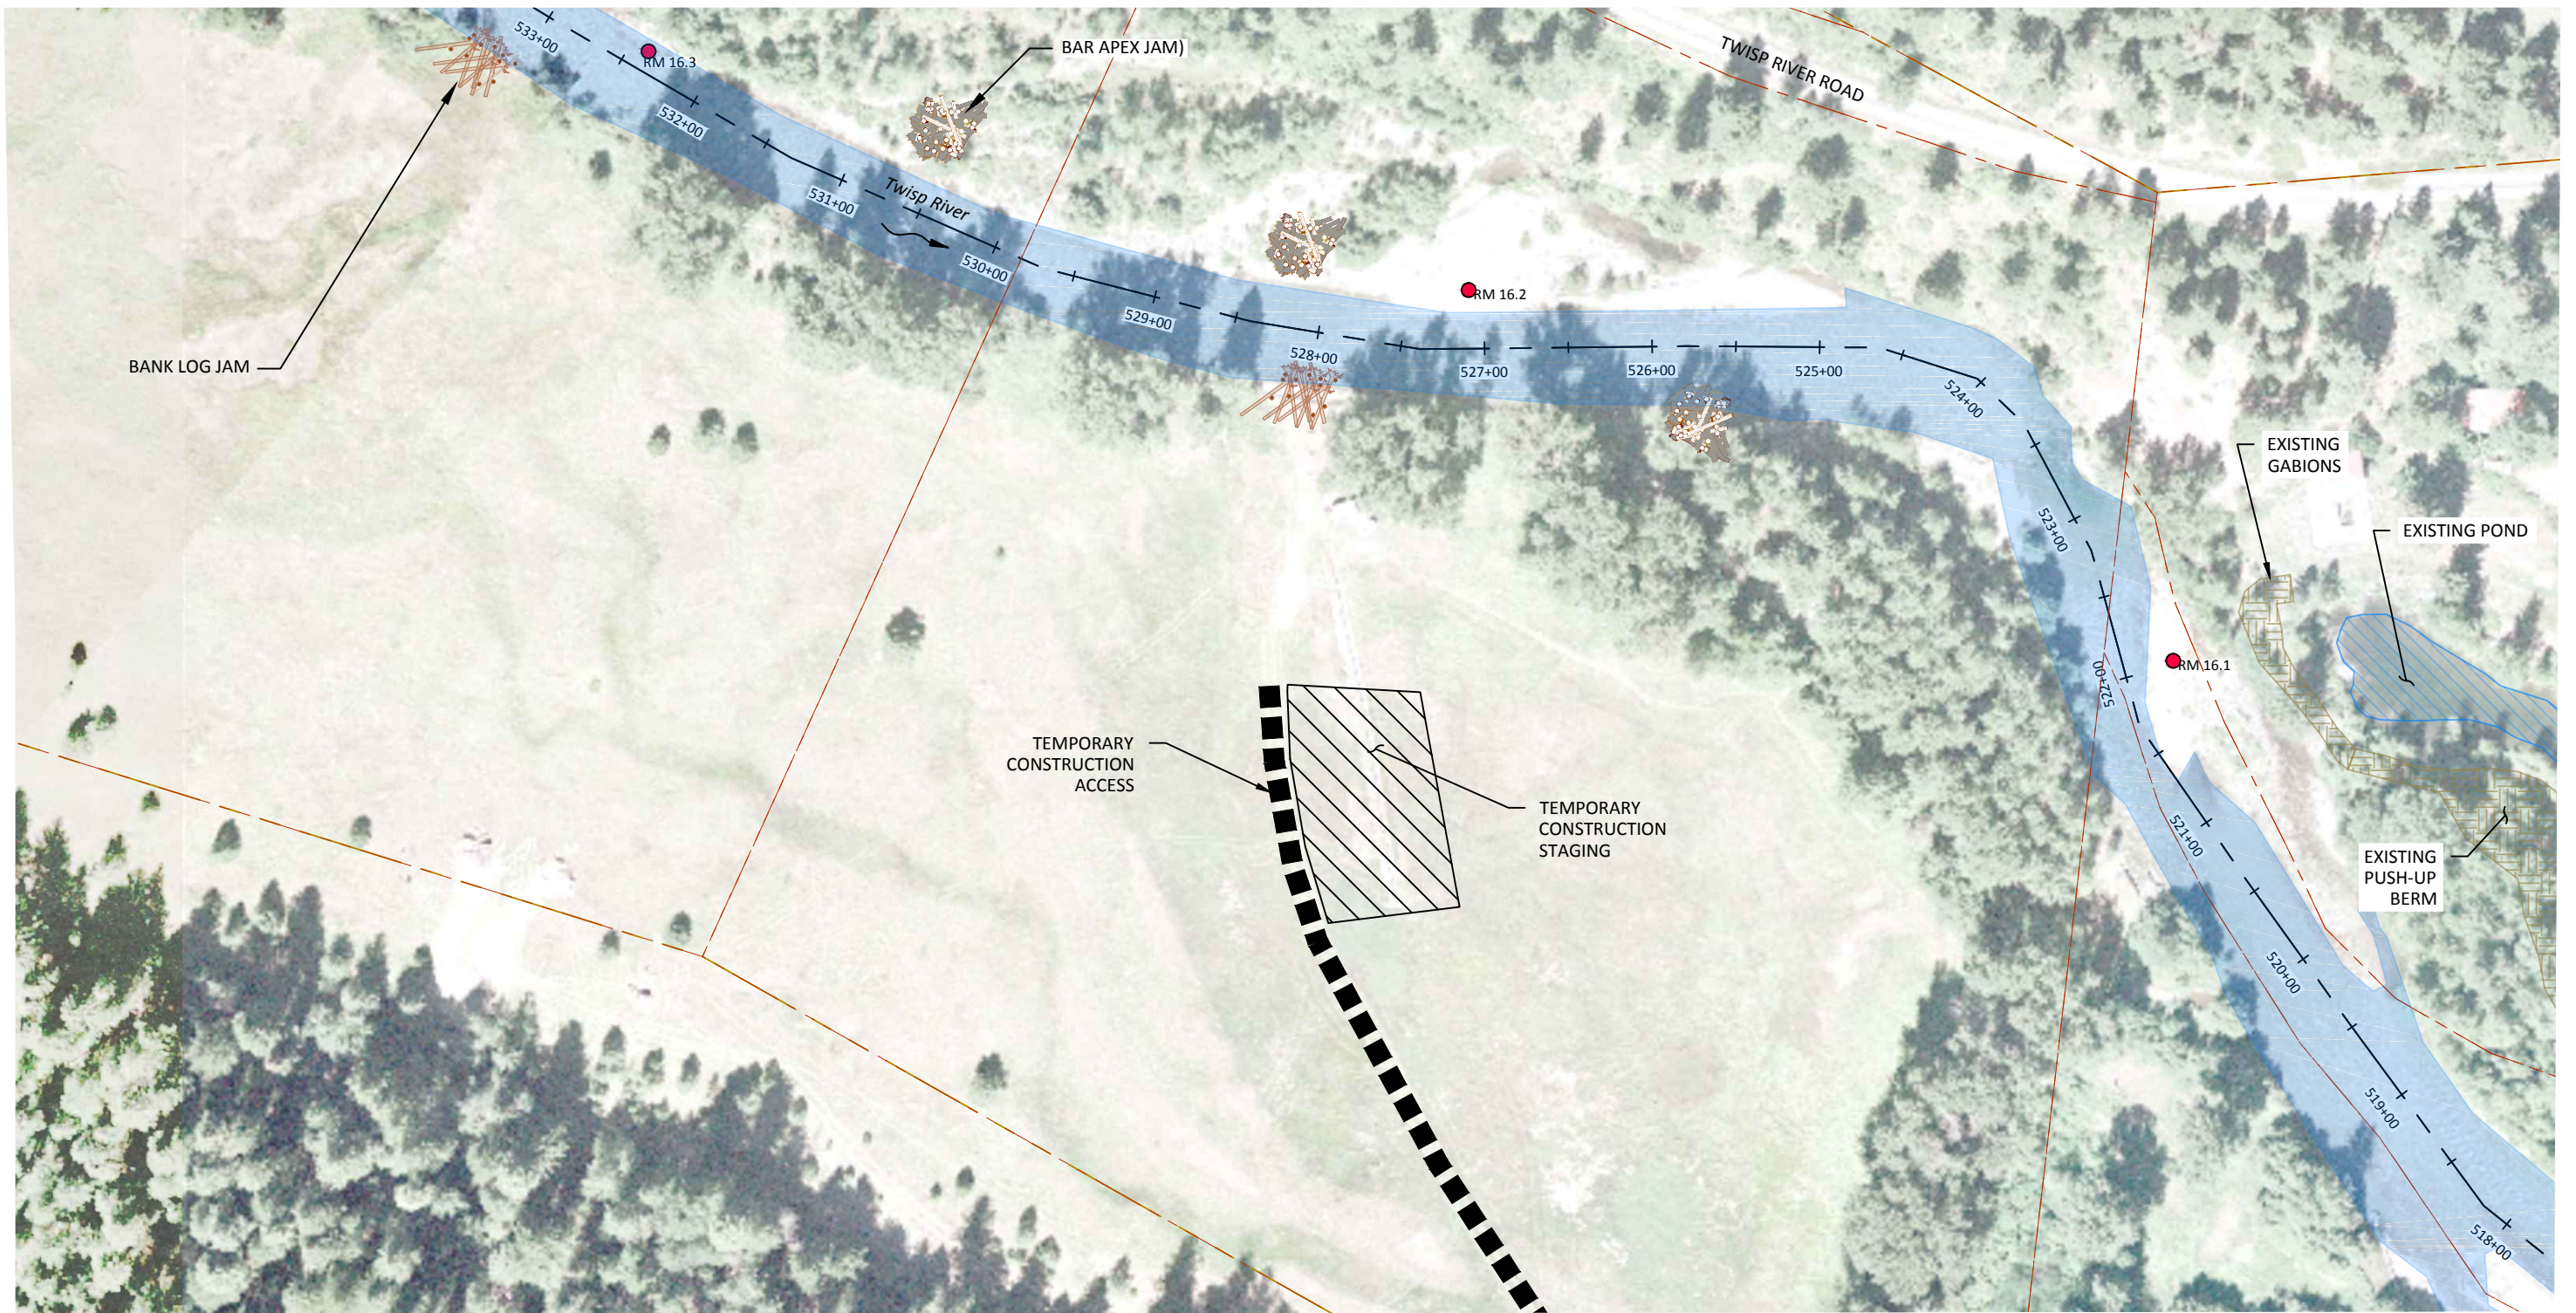
# UPPER SCAFFOLD LARGE WOOD PLACEMENT

- RIVER MILE MARKER
- TWISP RIVER STATIONS
- EXISTING TWISP RIVER CHANNEL
- PARCEL BOUNDARIES
- PROPOSED BANK LOG JAM (TYP), SEE DETAIL SHEET 12
- PROPOSED BAR APEX JAM (TYP), SEE DETAIL SHEET 12

- EXISTING PUSH-UP BERM
- EXISTING POND
- TEMPORARY CONSTRUCTION ACCESS
- TEMPORARY CONSTRUCTION STAGING

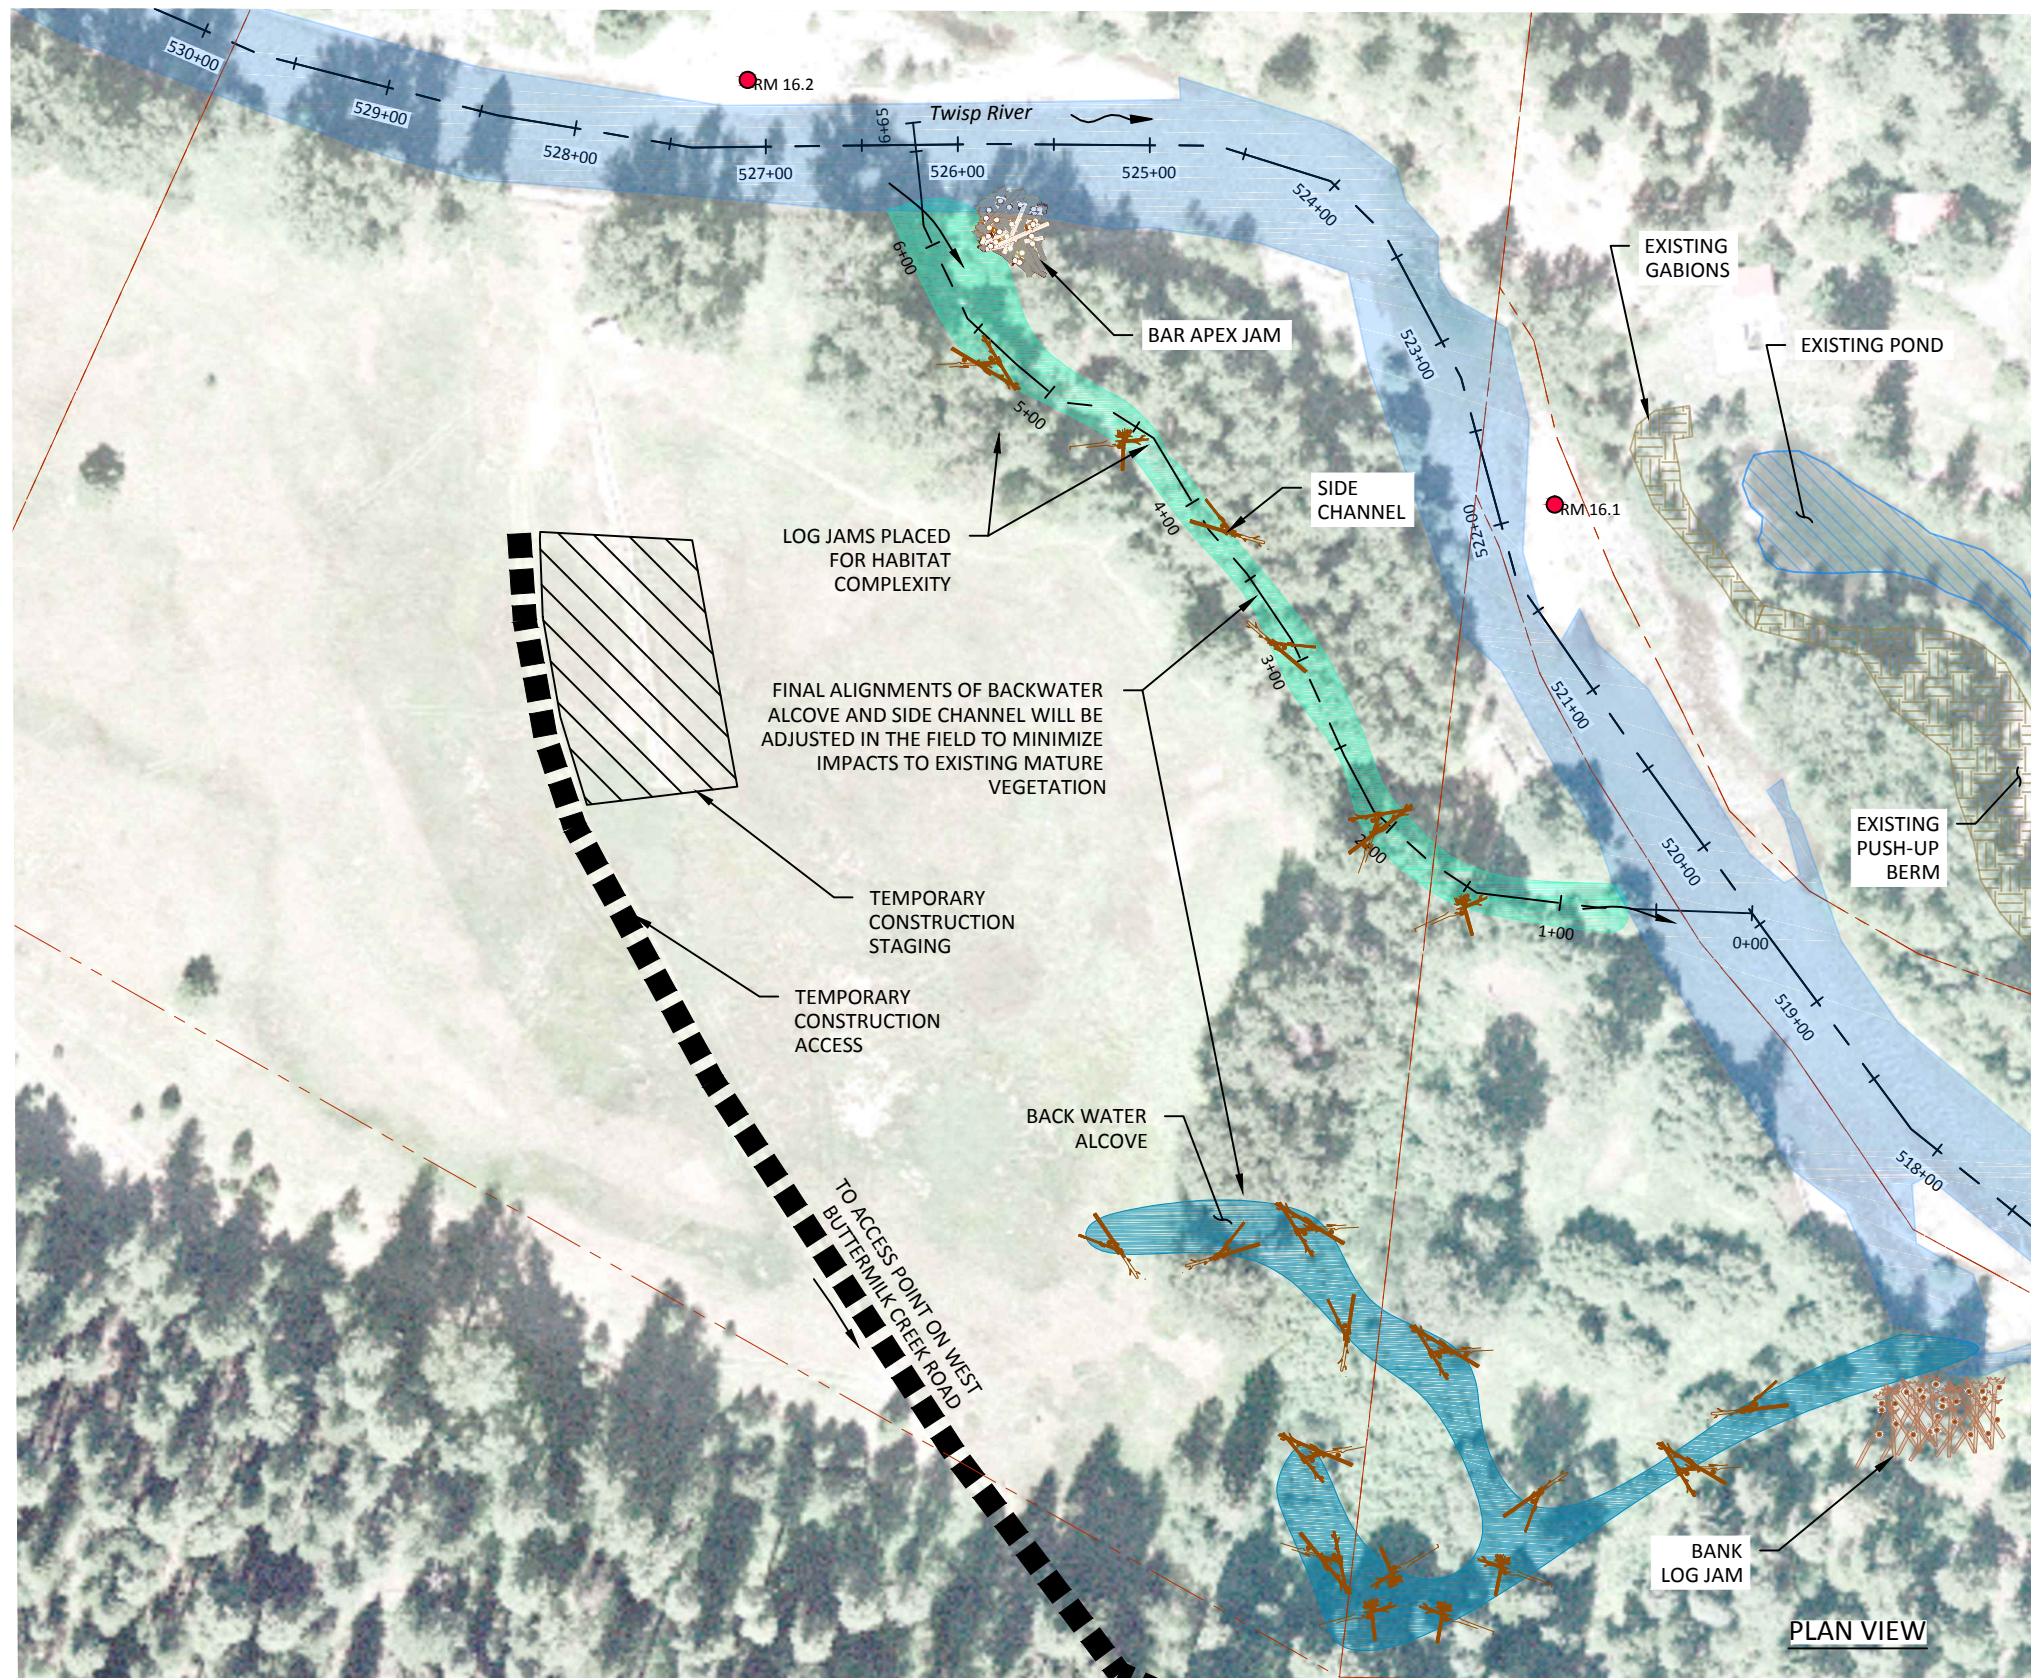
## UPPER SCAFFOLD SIDE CHANNEL AND ALCOVE ENHANCEMENT

- RIVER MILE MARKER
- TWISP RIVER STATIONS
- EXISTING TWISP RIVER CHANNEL
- EXISTING POND
- EXISTING PUSH-UP BERM
- PARCEL BOUNDARIES
- TEMPORARY CONSTRUCTION STAGING
- TEMPORARY CONSTRUCTION ACCESS
- PROPOSED SIDE CHANNEL
- PROPOSED BACKWATER ALCOVE
- PROPOSED BANK LOG JAM (TYP), SEE DETAIL SHEET 12
- PROPOSED BAR APEX JAM (TYP), SEE DETAIL SHEET 12
- PROPOSED ALCOVE HABITAT WOOD PLACEMENT (TYP), SEE DETAIL SHEET 13

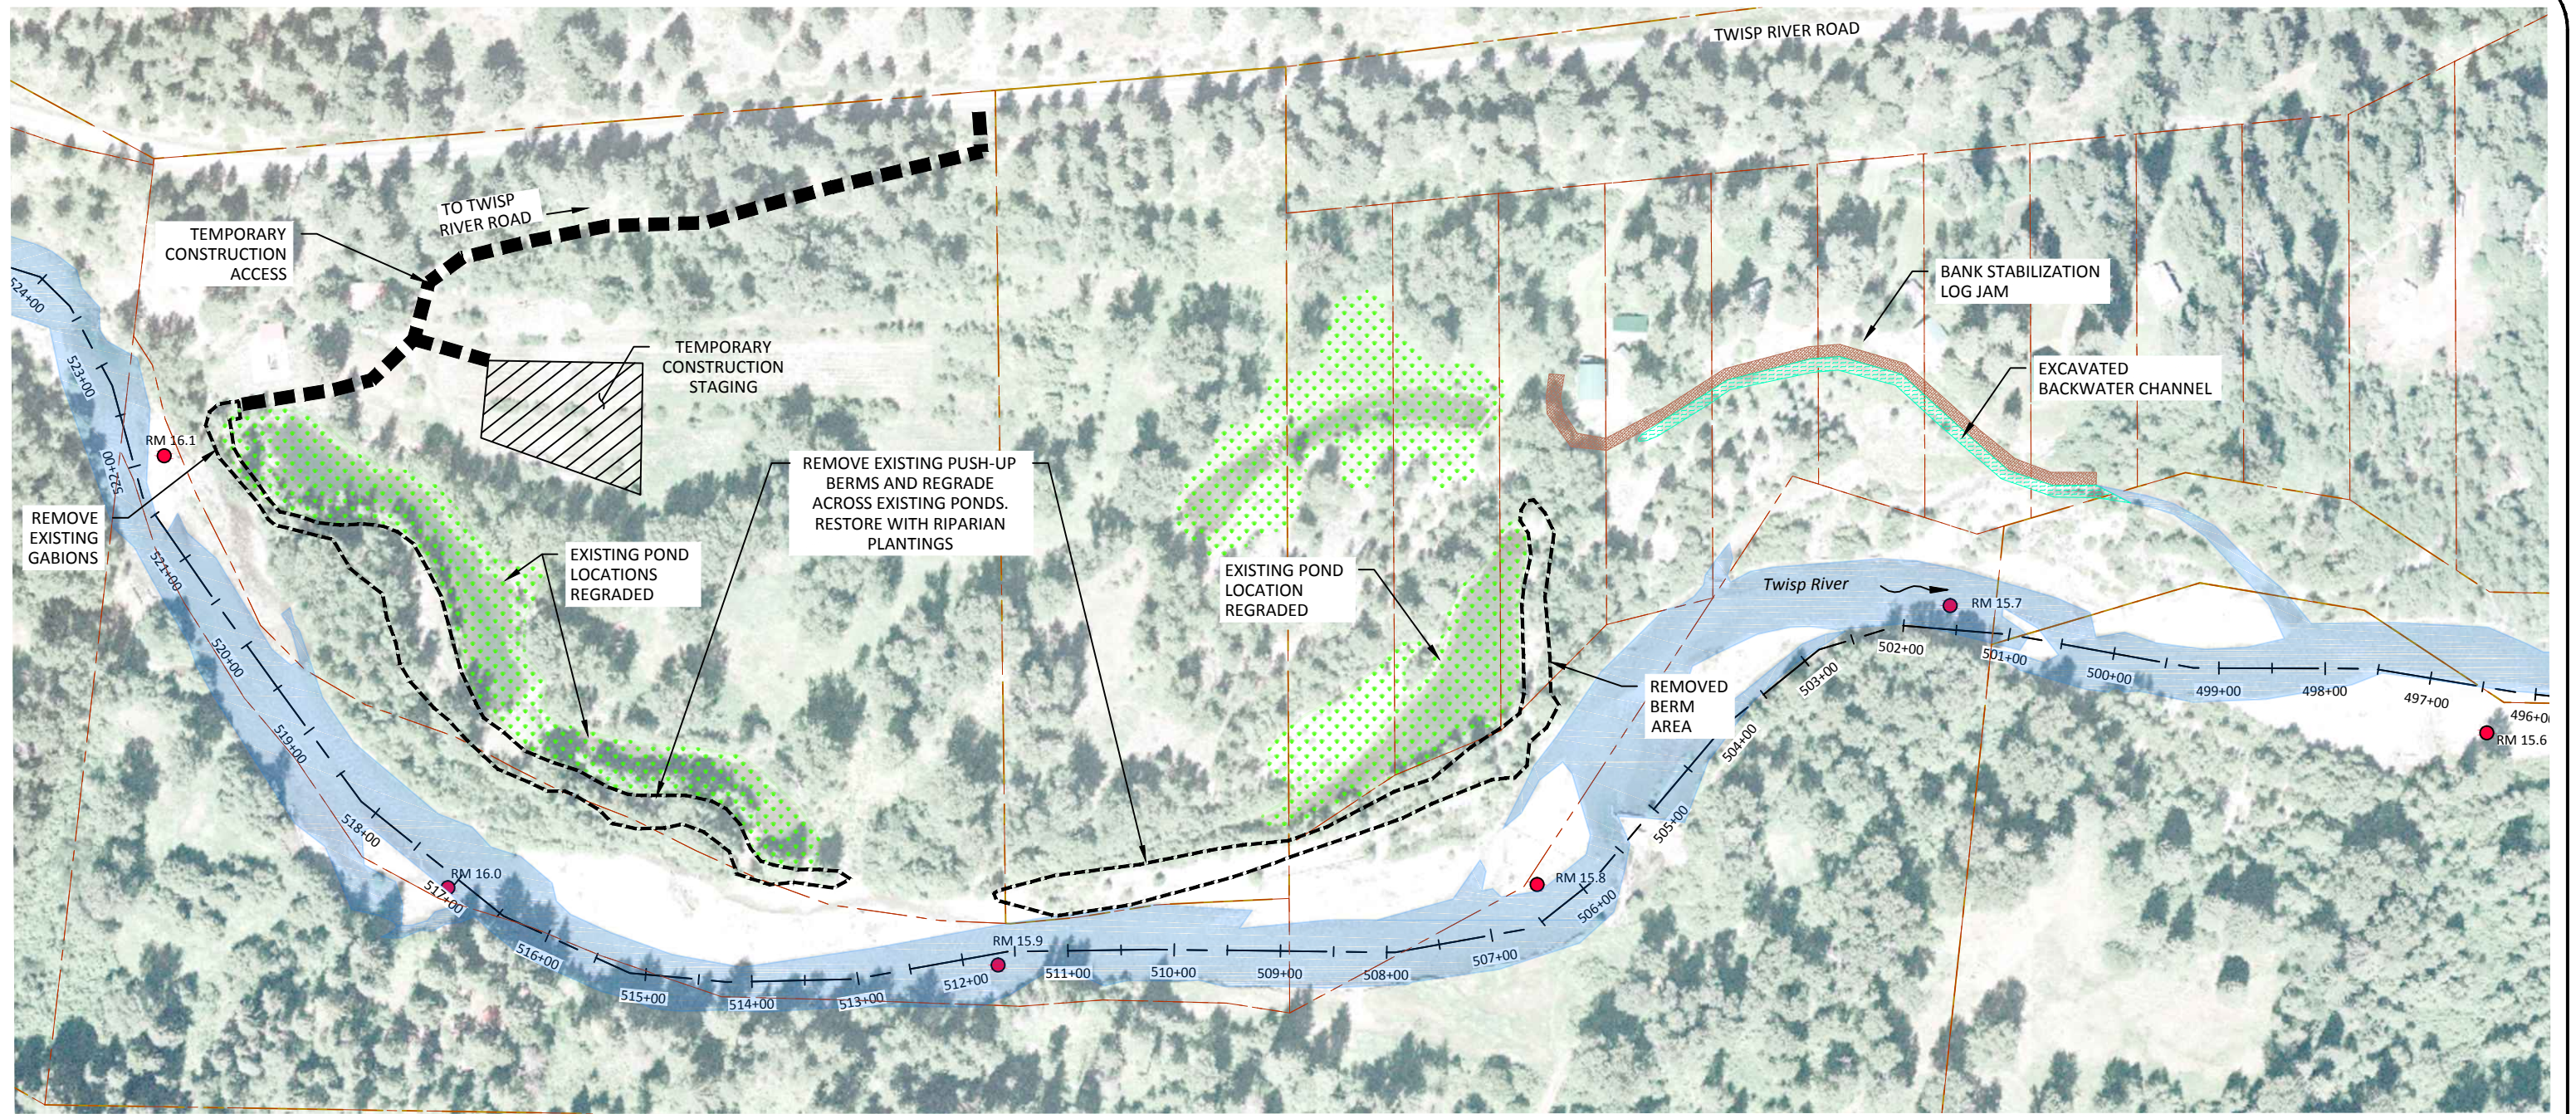
## MIDDLE SCAFFOLD BERM REMOVAL WITH REGRADED BANKS

- RIVER MILE MARKER
- TWISP RIVER STATIONS
- EXISTING TWISP RIVER CHANNEL
- RIPARIAN PLANTING
- AREA OF BERM REMOVAL
- PROPOSED BANK STABILIZATION LOG JAM, SEE DETAIL SHEET 13
- PARCEL BOUNDARIES
- TEMPORARY CONSTRUCTION ACCESS
- TEMPORARY CONSTRUCTION STAGING
- PROPOSED BACKWATER CHANNEL

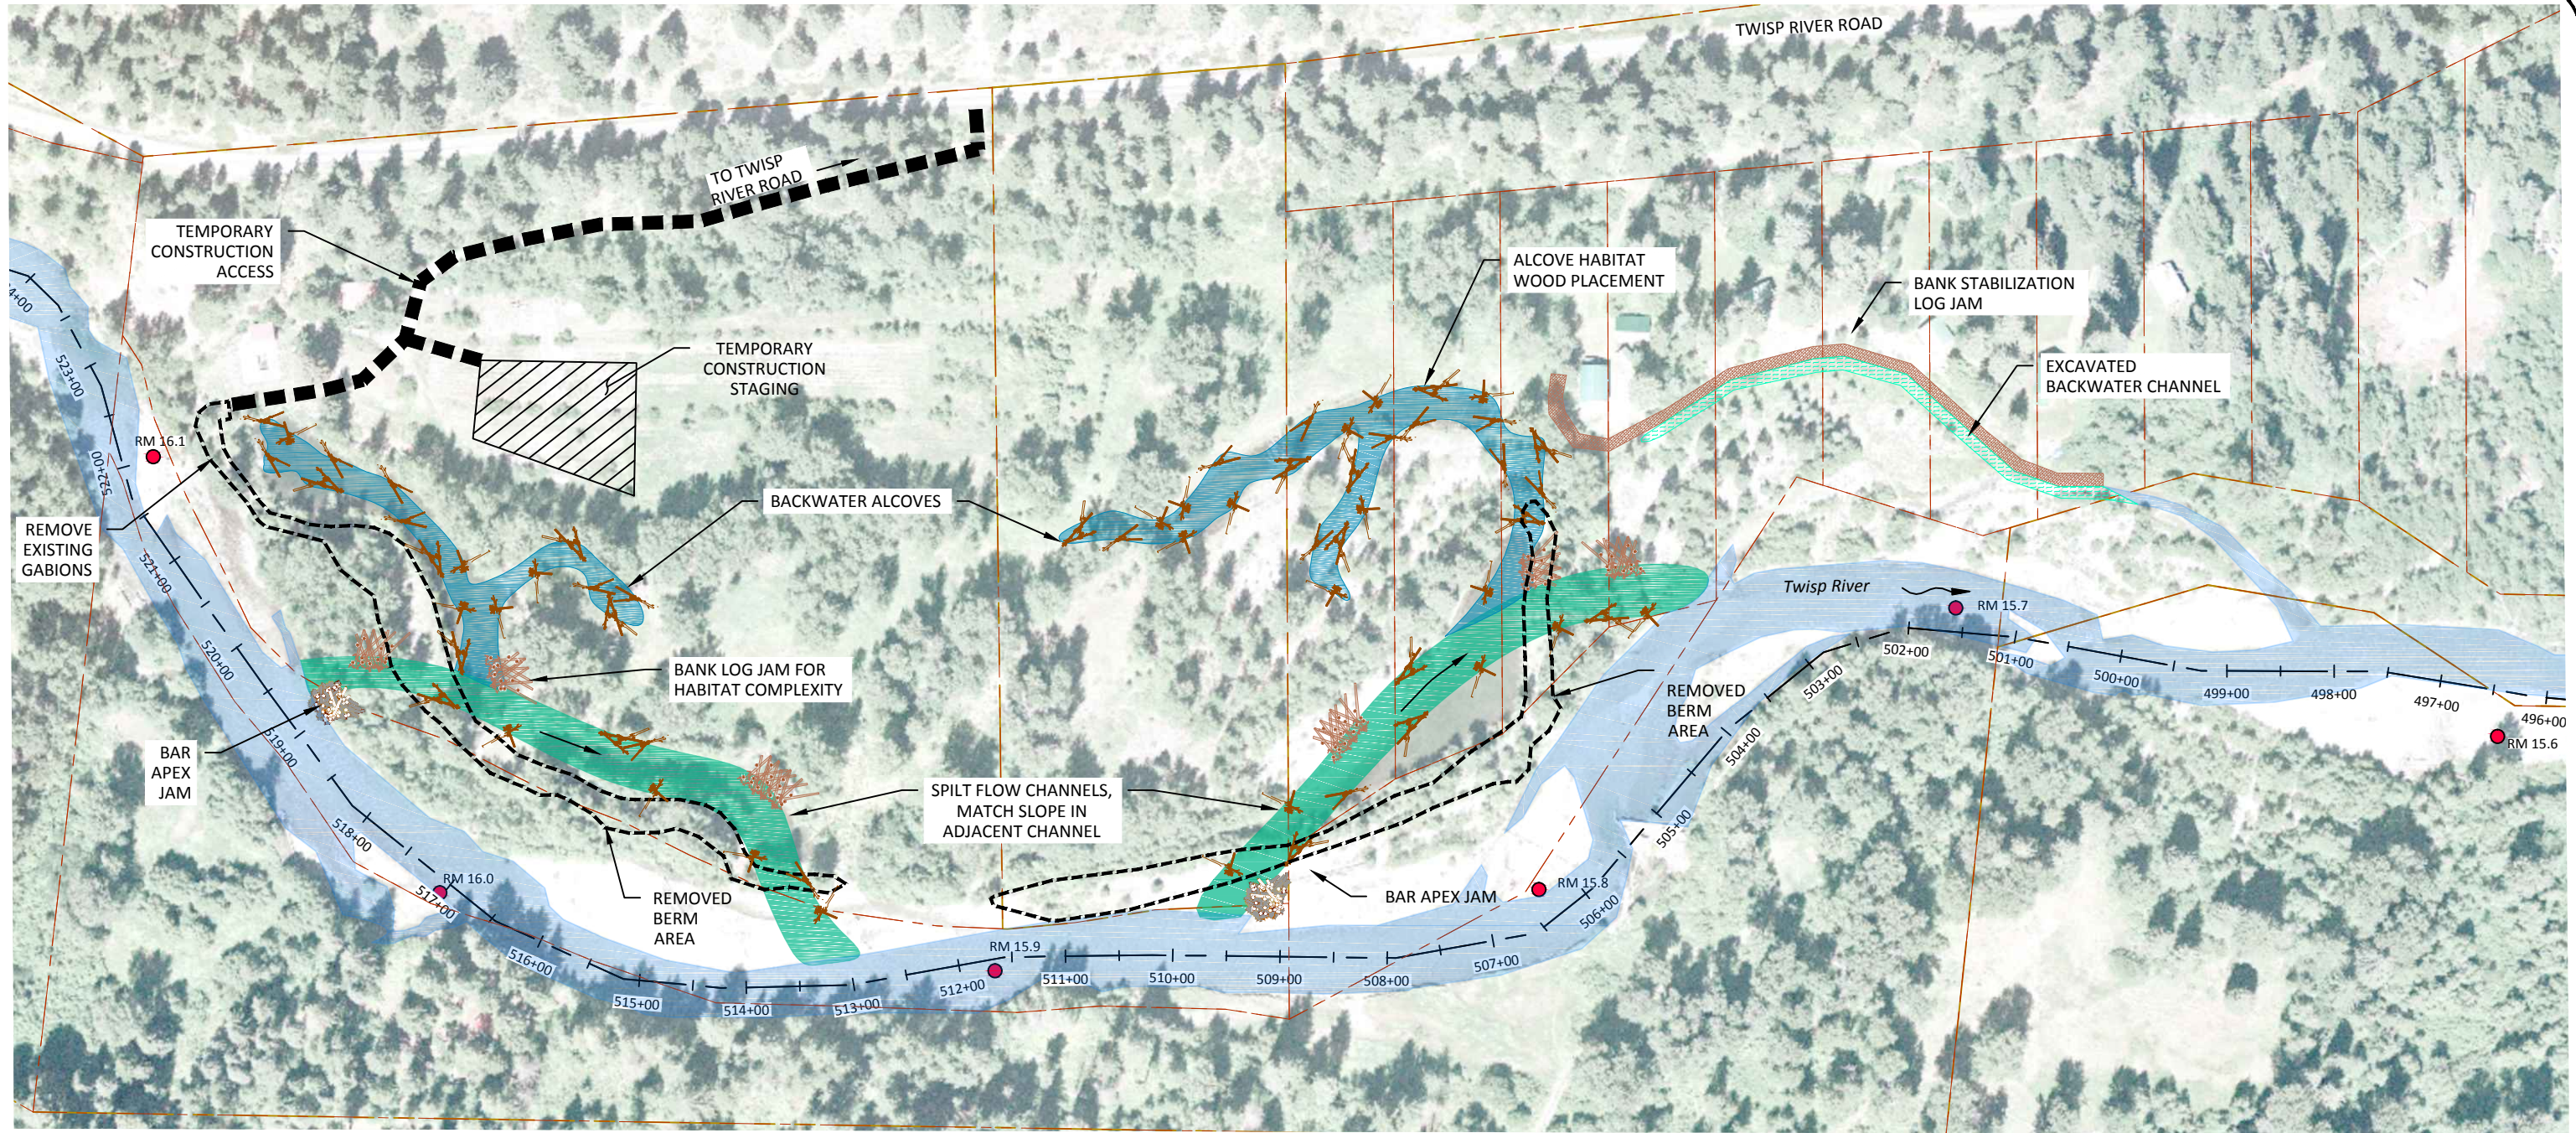
## MIDDLE SCAFFOLD BERM REMOVAL WITH SPLIT FLOW CHANNELS

- RIVER MILE MARKER
- TWISP RIVER STATIONS
- EXISTING TWISP RIVER CHANNEL
- AREA OF BERM REMOVAL
- PROPOSED SPLIT FLOW CHANNEL
- PROPOSED BACKWATER CHANNEL
- PROPOSED BANK LOG JAM (TYP), SEE DETAIL SHEET 12
- PROPOSED BAR APEX JAM (TYP), SEE DETAIL SHEET 12
- PROPOSED BANK STABILIZATION LOG JAM, SEE DETAIL SHEET 13
- PARCEL BOUNDARIES
- TEMPORARY CONSTRUCTION ACCESS
- TEMPORARY CONSTRUCTION STAGING
- PROPOSED BACKWATER ALCOVE
- PROPOSED ALCOVE HABITAT WOOD PLACEMENT, SEE DETAIL SHEET 13

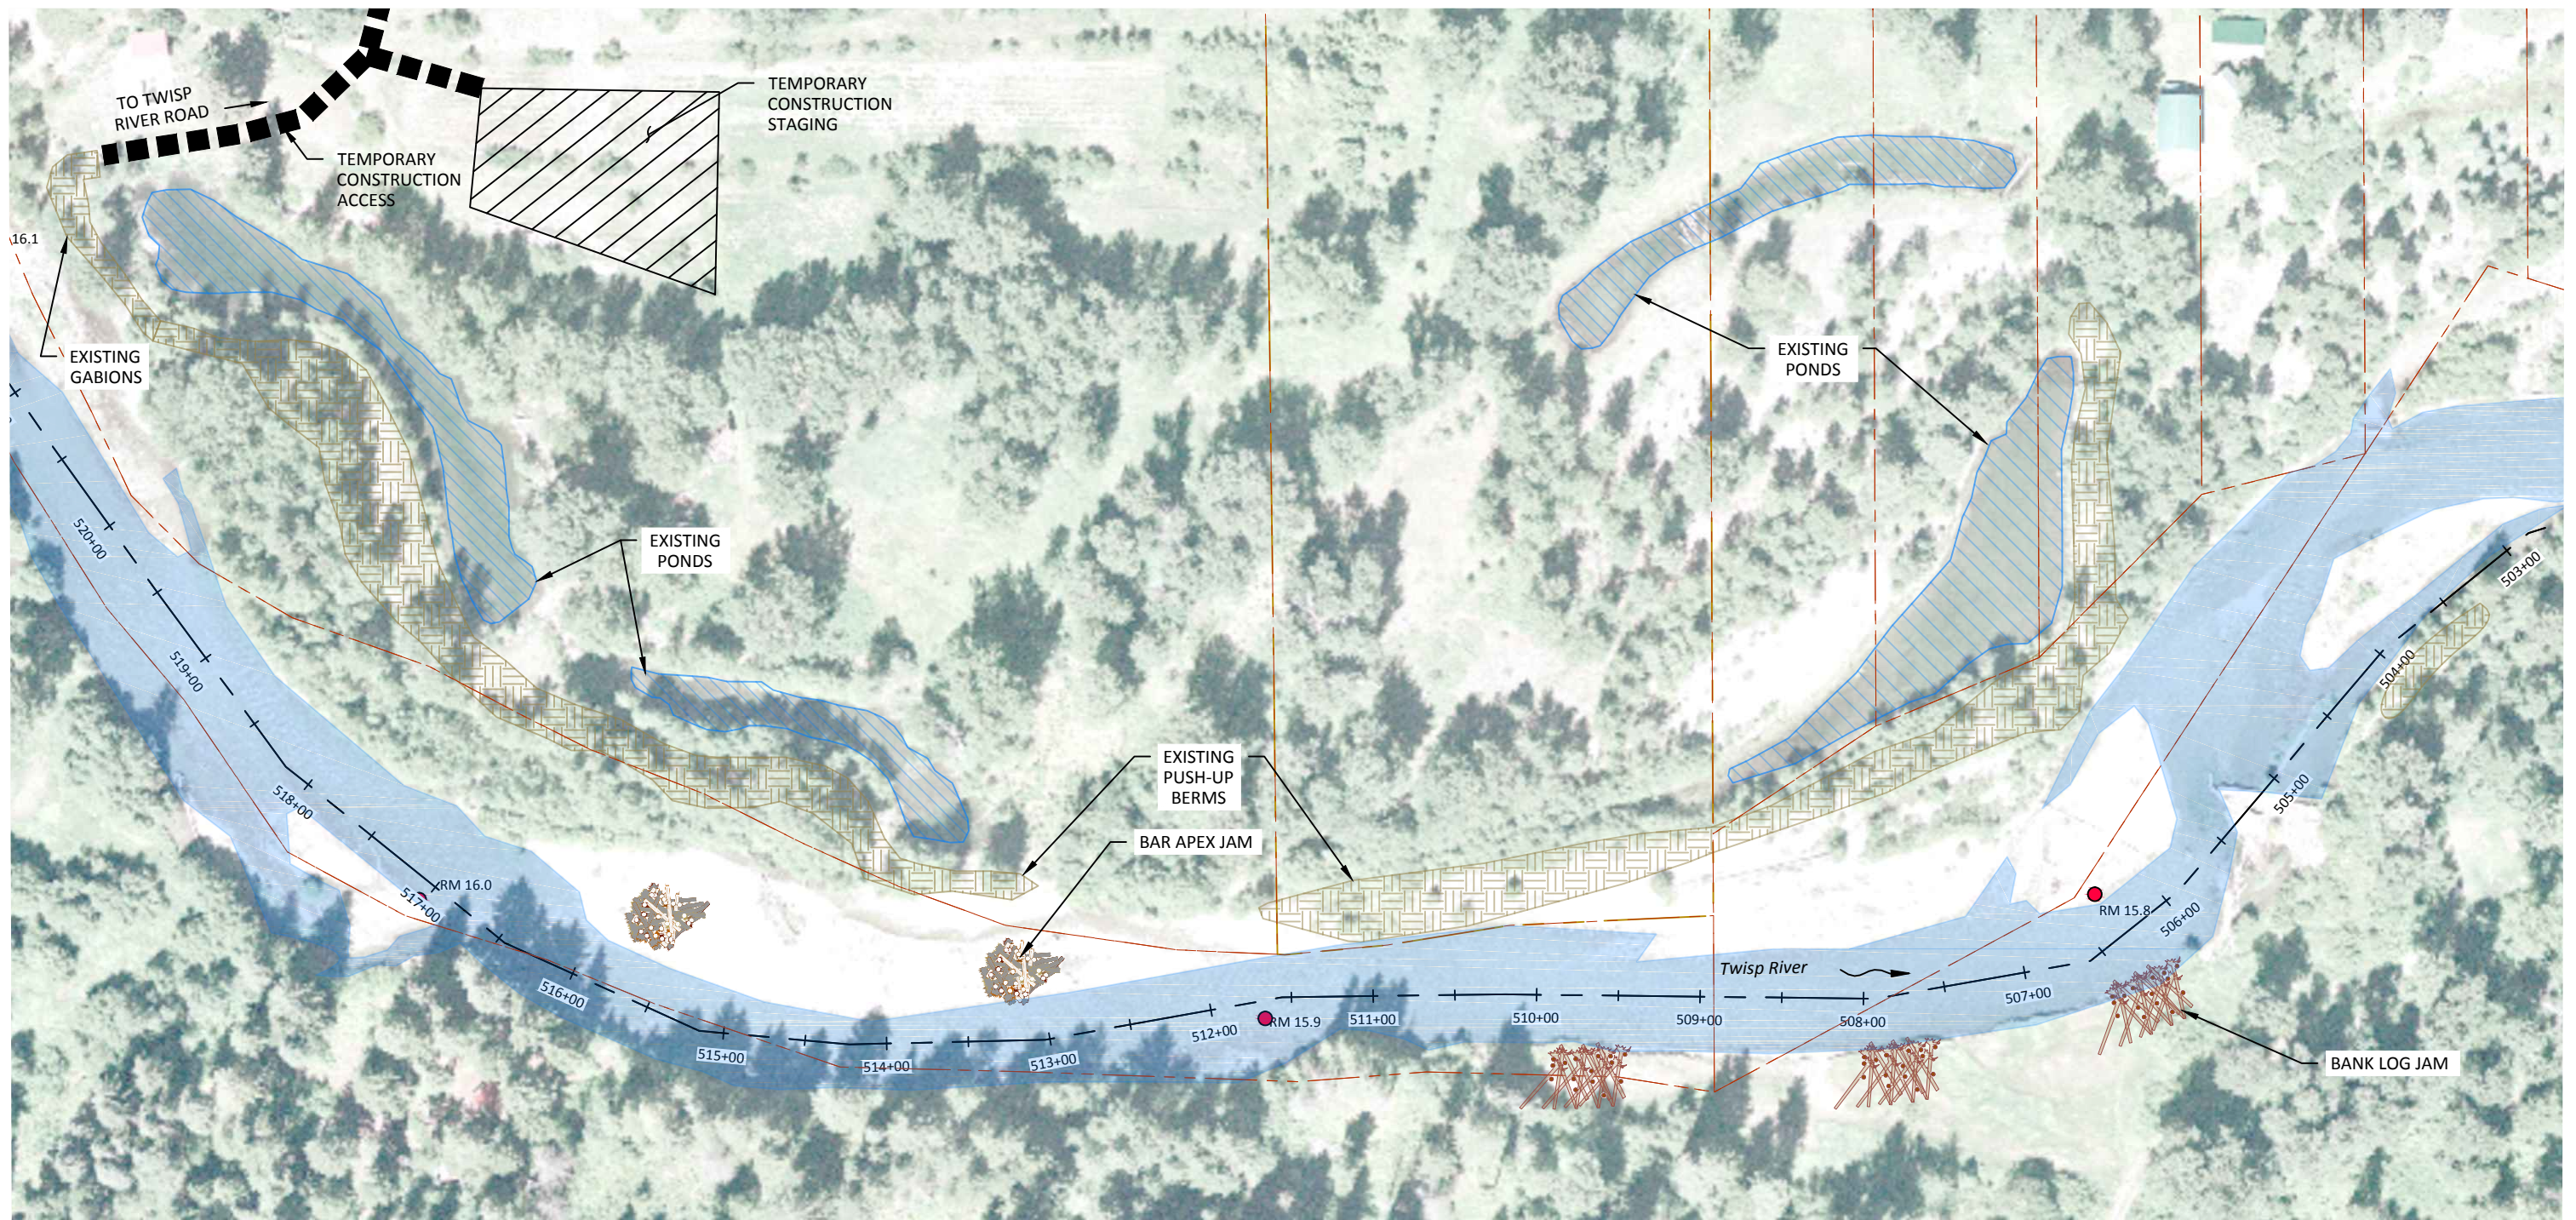
**MIDDLE SCAFFOLD WOOD PLACEMENT**

- RIVER MILE MARKER
- TWISP RIVER STATIONS
- EXISTING TWISP RIVER CHANNEL
- PROPOSED BANK LOG JAM (TYP), SEE DETAIL SHEET 12
- PROPOSED BAR APEX JAM (TYP), SEE DETAIL SHEET 12

- PARCEL BOUNDARIES
- TEMPORARY CONSTRUCTION ACCESS
- TEMPORARY CONSTRUCTION STAGING
- EXISTING PUSH-UP BERM
- EXISTING PONDS

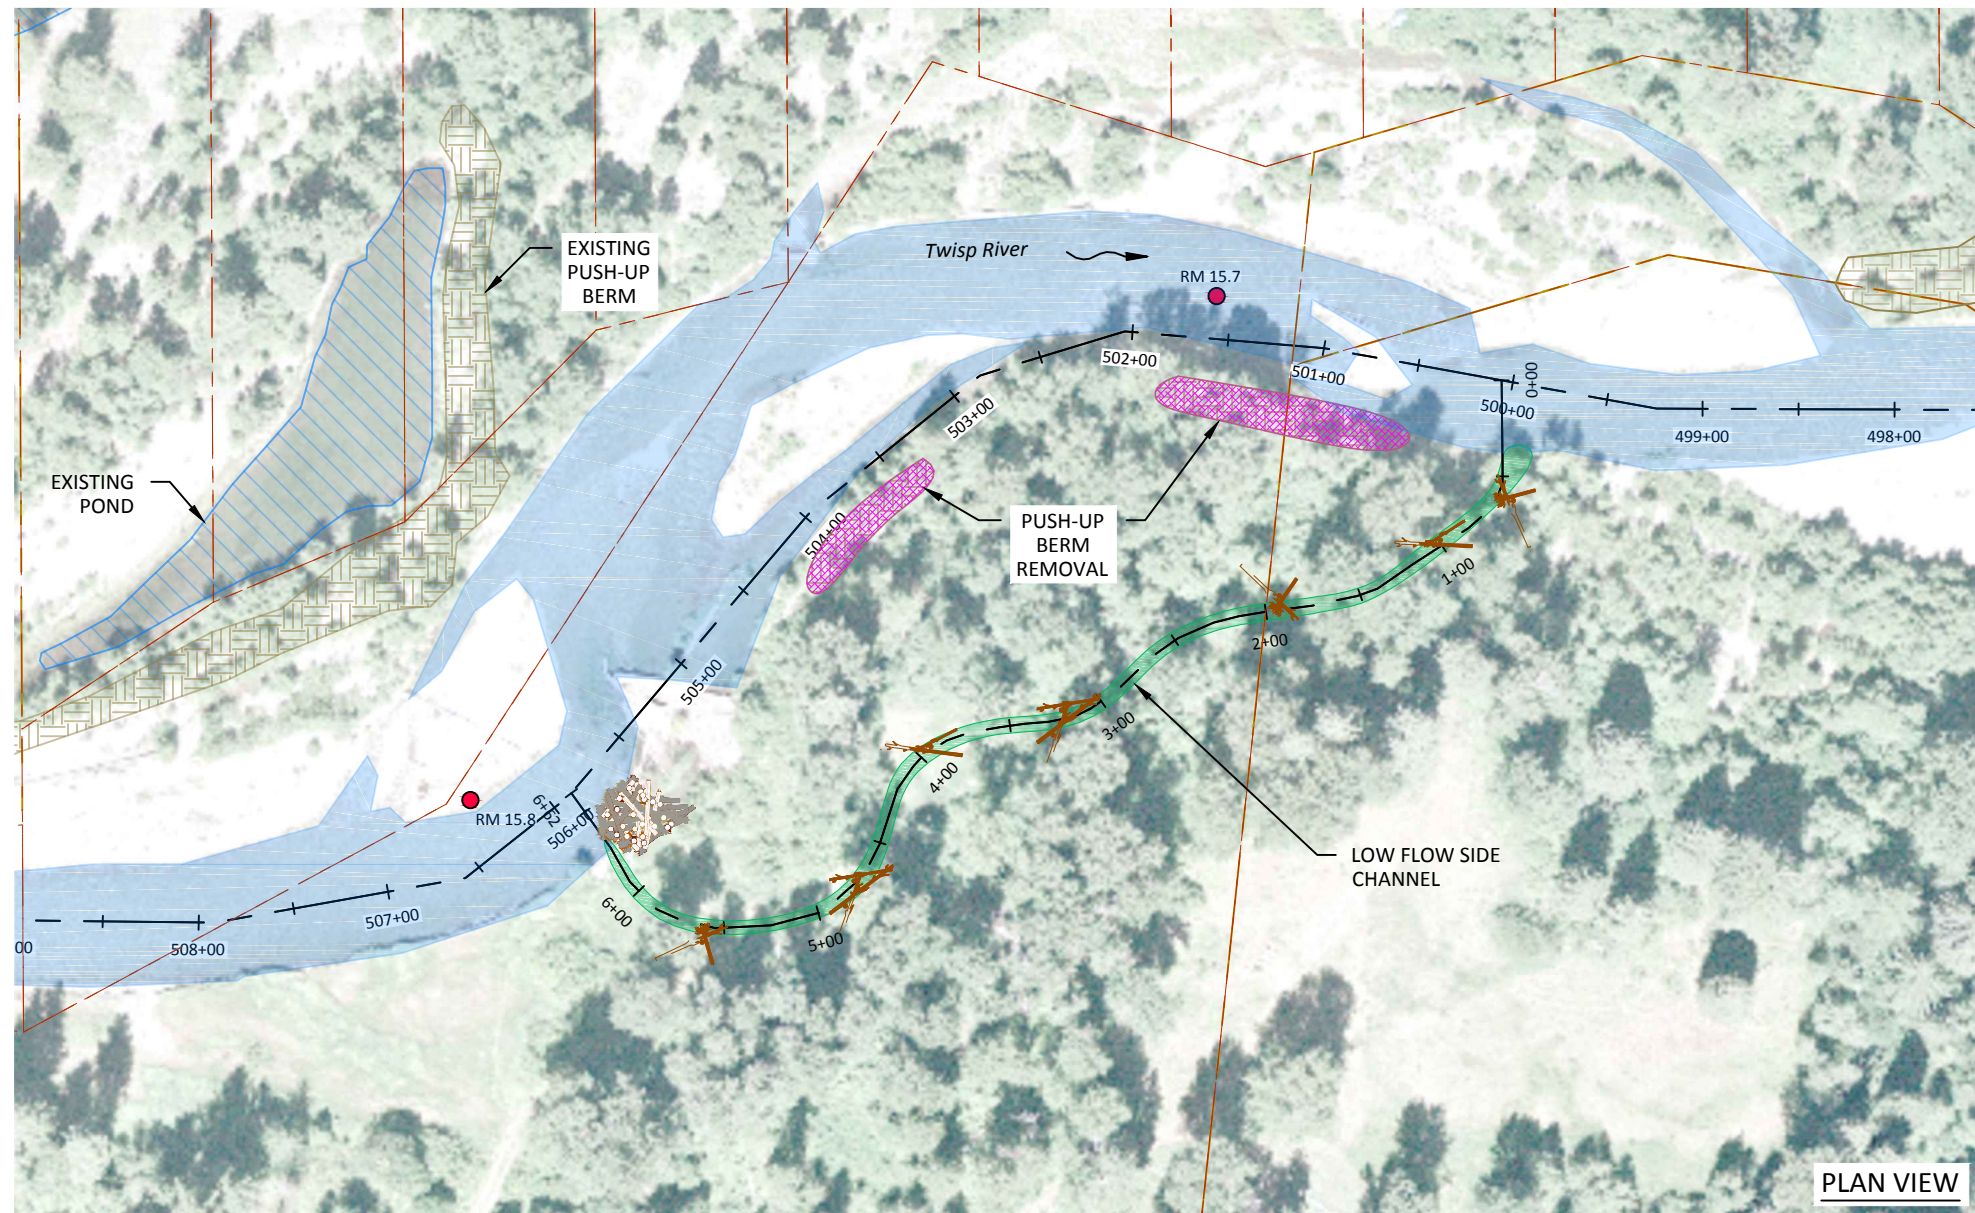
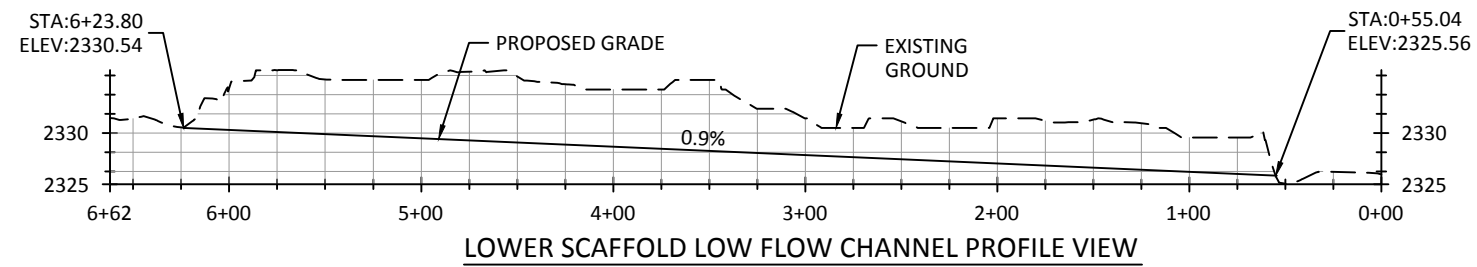
**LOWER SCAFFOLD BERM REMOVAL AND  
SIDE CHANNEL ACTIVATION**

PUSH-UP BERM REMOVAL

PLAN VIEW

LOWER SCAFFOLD LOW FLOW CHANNEL PROFILE VIEW
