Twisp River  
Scaffold Camp  
Restoration Design and Engineering Services

**Request for Proposals**  
January 28, 2016

# Twisp River Scaffold Camp Concept Design Report

SUBMITTED TO  
Yakama Nation Fisheries

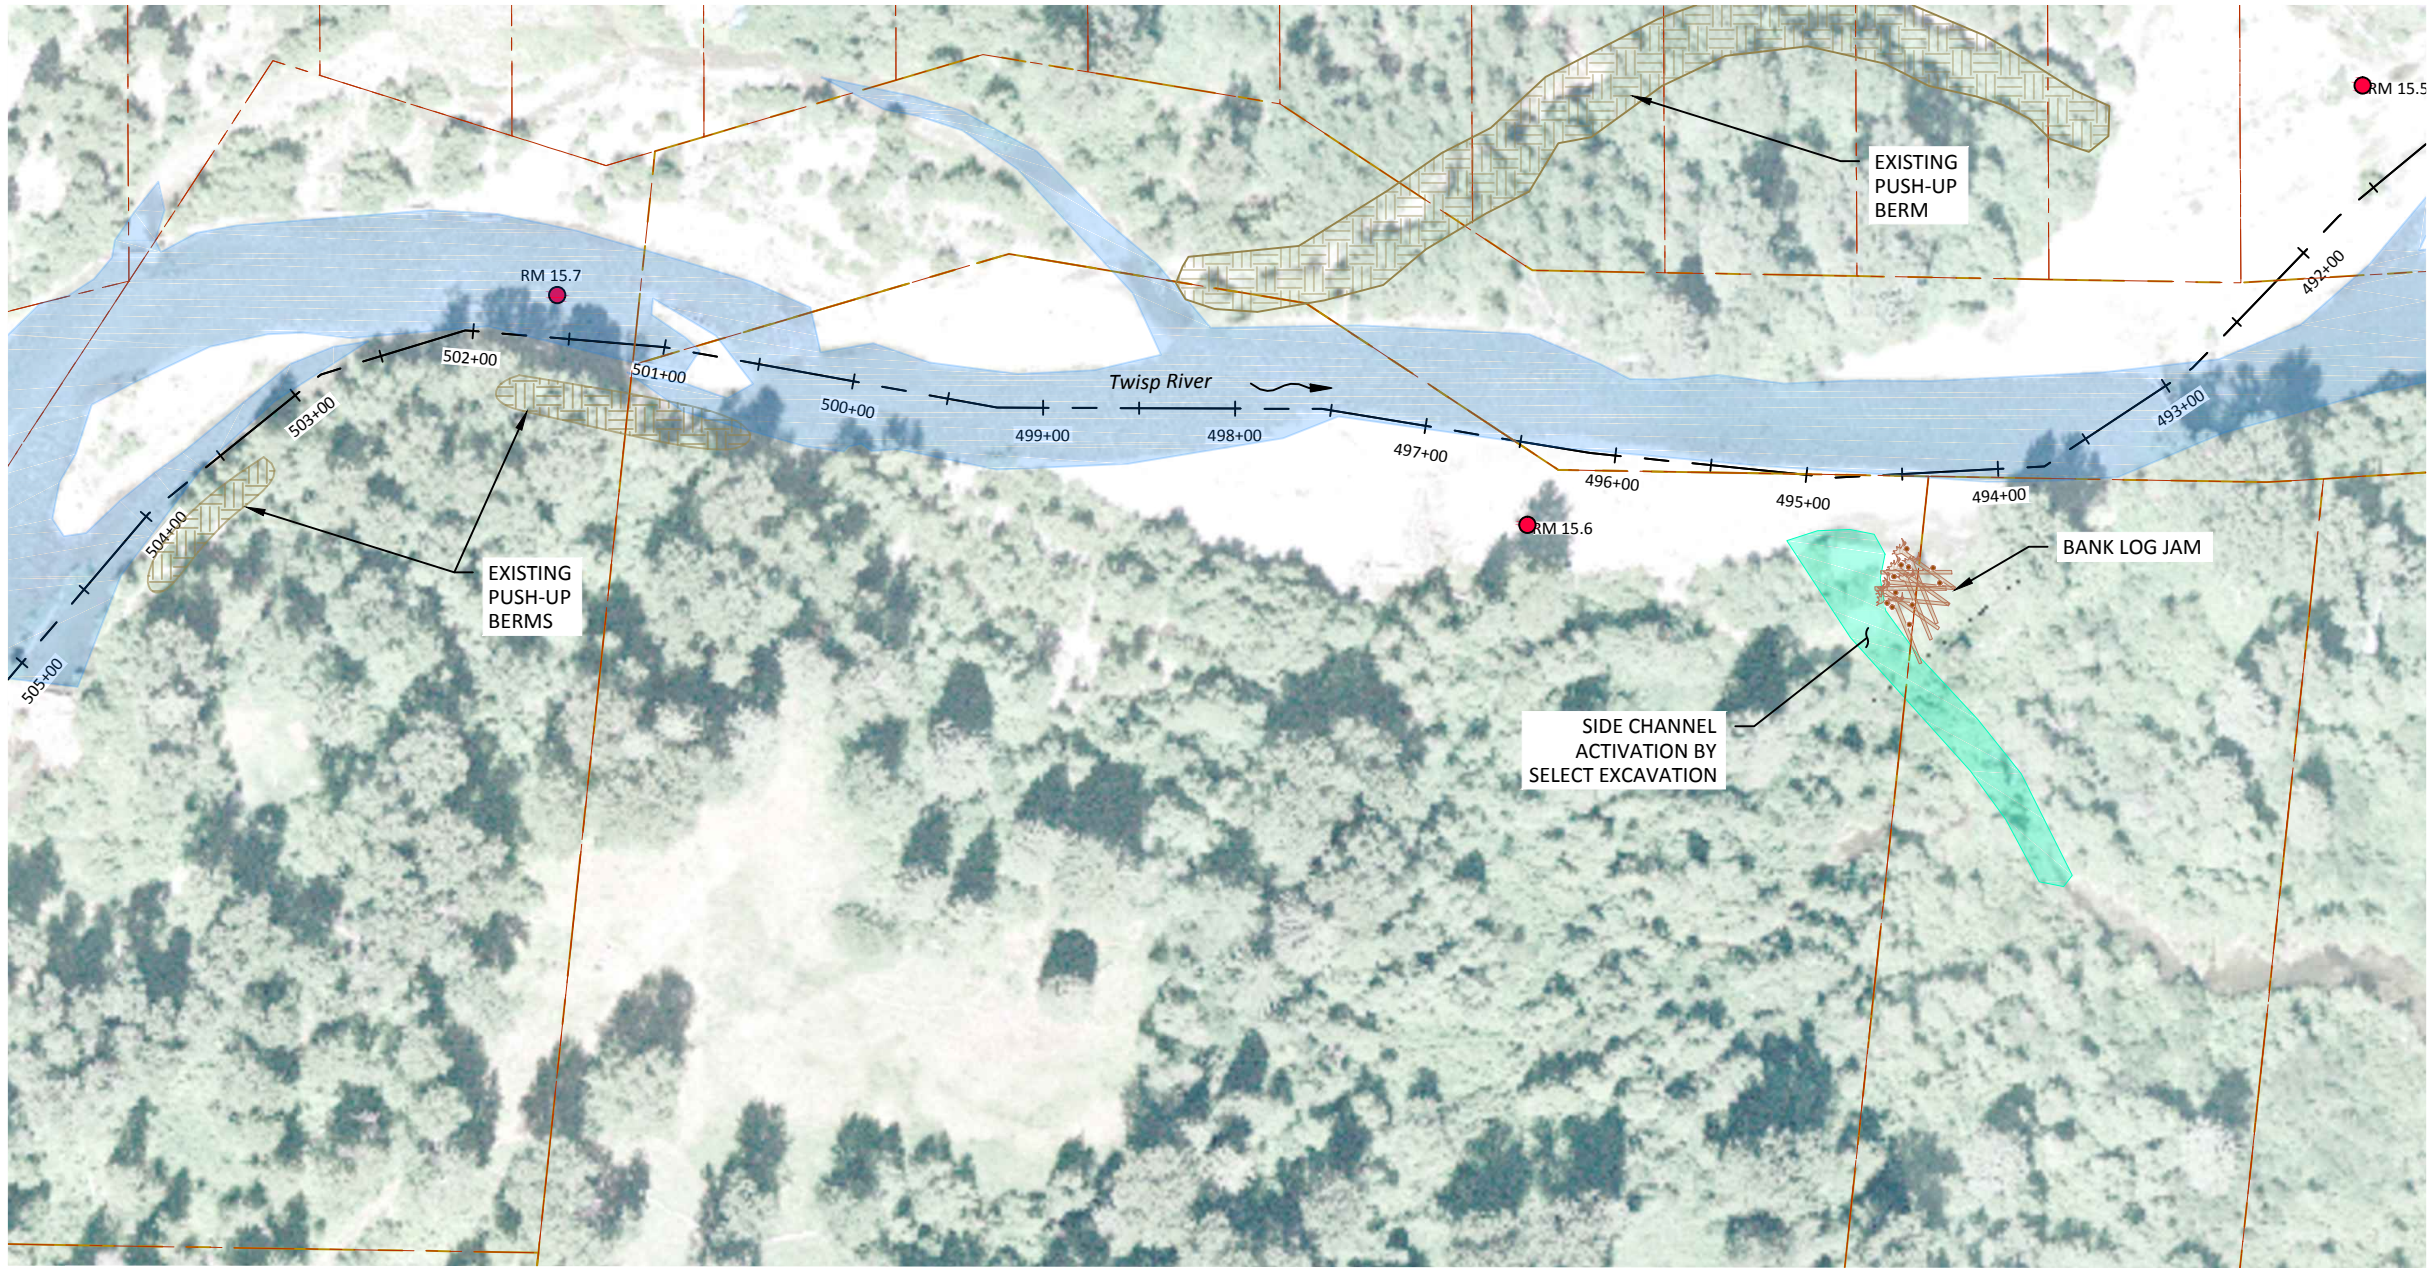
## LOWER SCAFFOLD SIDE CHANNEL INLET EXCAVATION

- RIVER MILE MARKER
- TWISP RIVER STATIONS
- EXISTING TWISP RIVER CHANNEL & SIDE CHANNEL
- PARCEL BOUNDARIES
- EXISTING PUSH-UP BERMS
- PROPOSED SIDE CHANNEL ACTIVATION
- TEMPORARY CONSTRUCTION ACCESS
- TEMPORARY CONSTRUCTION STAGING
- PROPOSED BANK LOG JAM (TYP)  
SEE DETAIL, SHEET 12

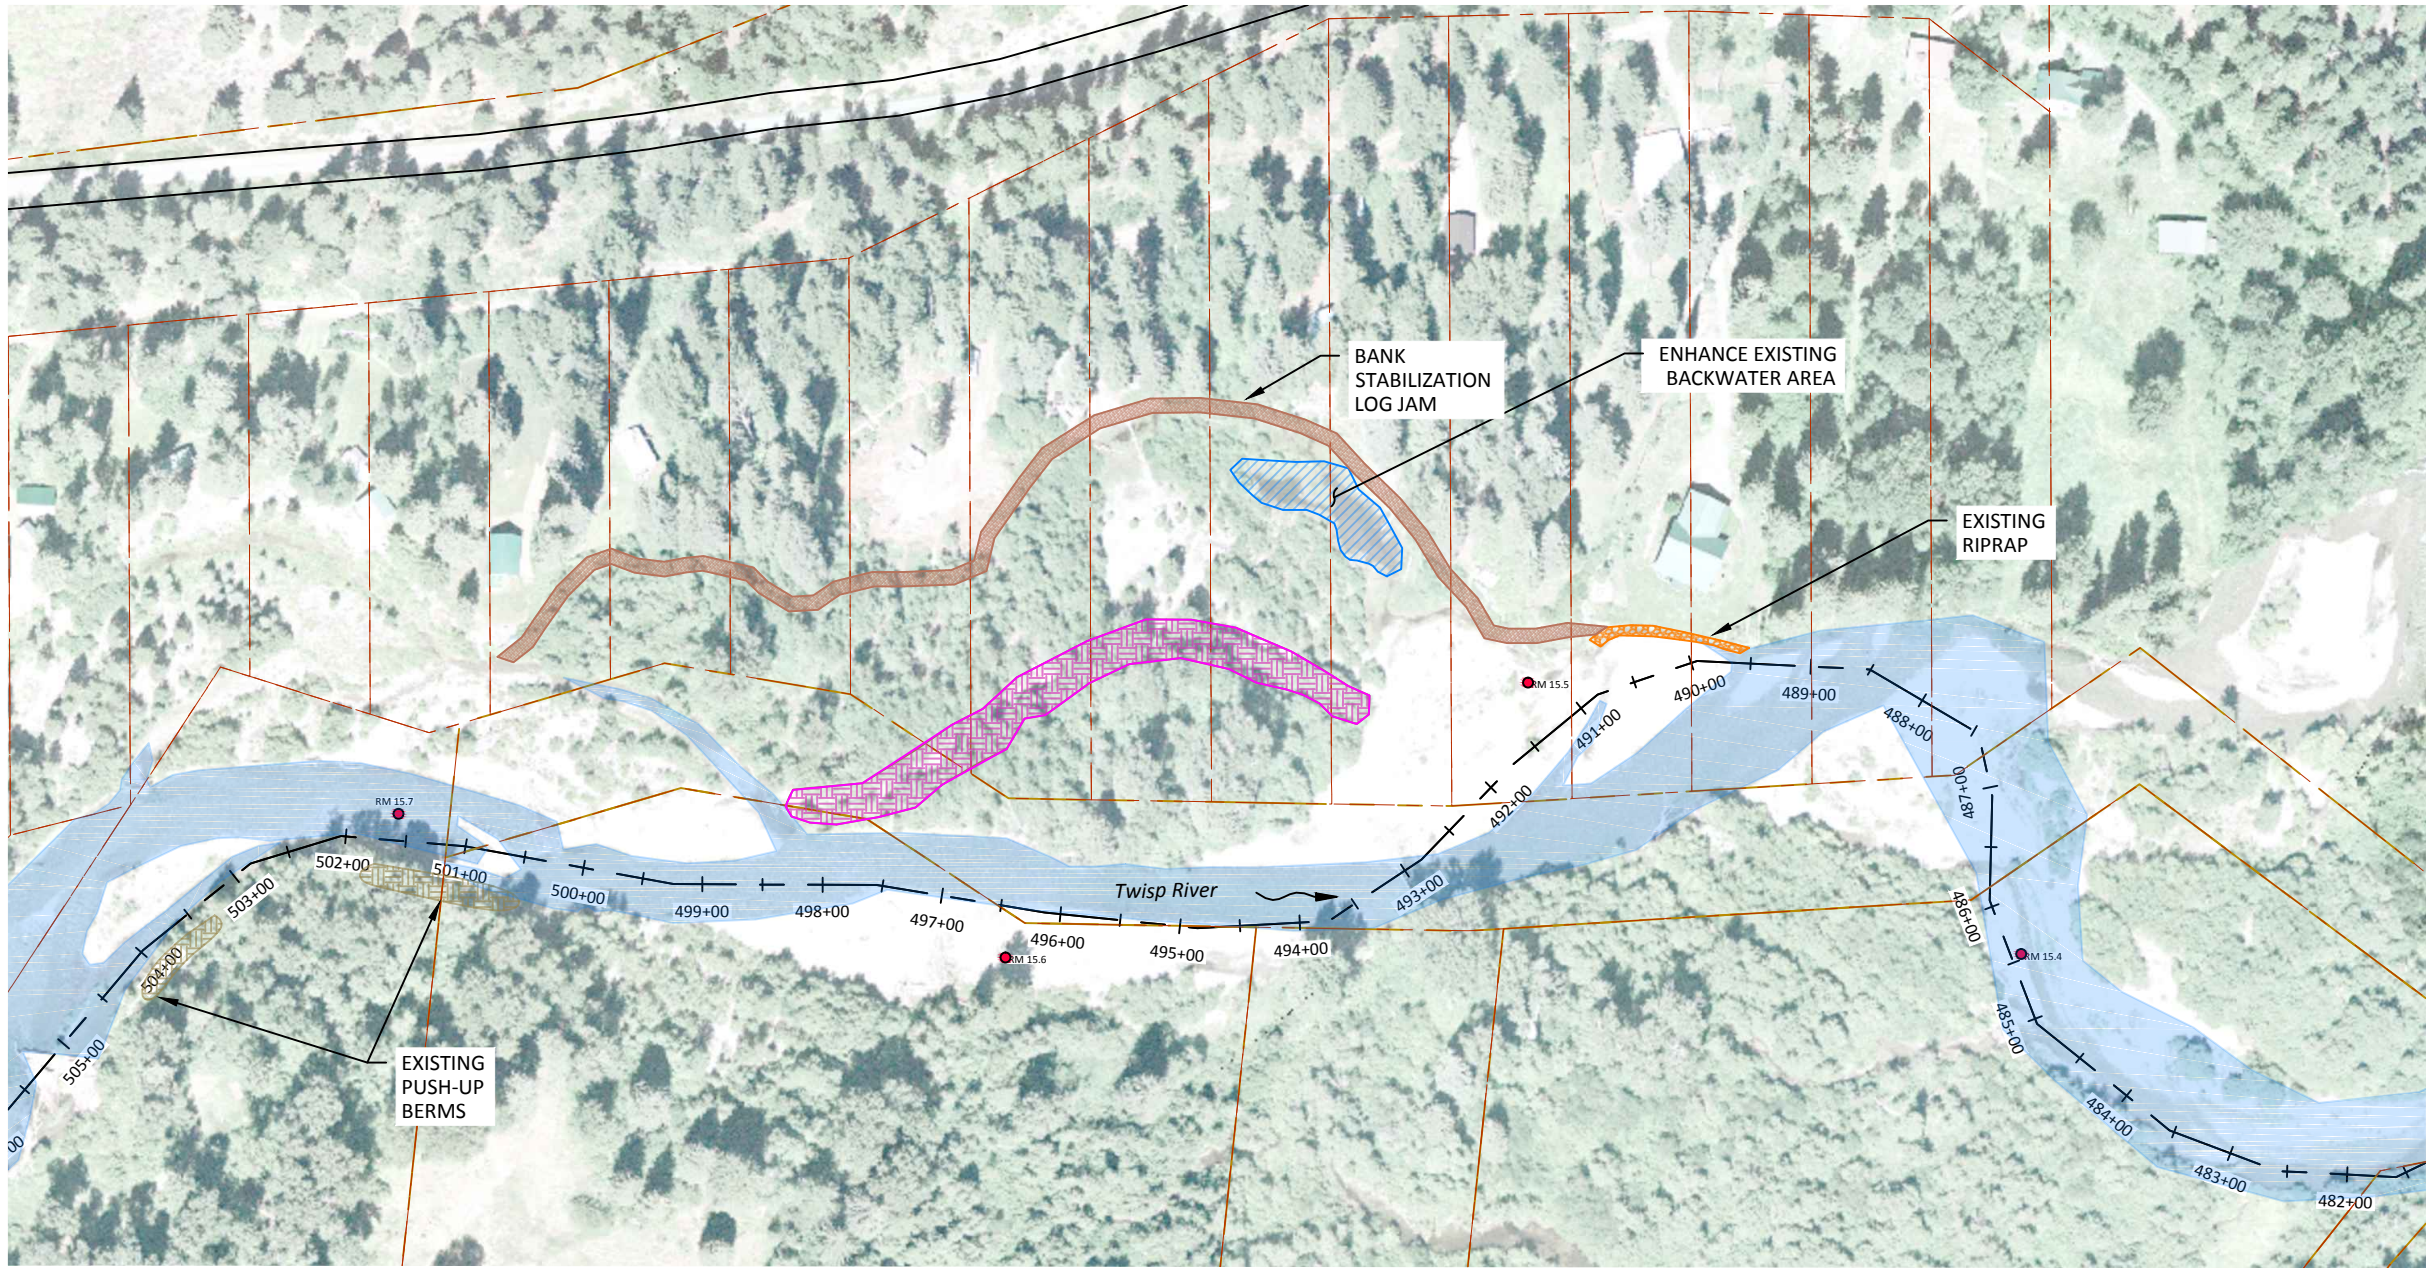
**LOWER SCAFFOLD MAIN CHANNEL  
BERM REMOVAL**

- RIVER MILE MARKER
- TWISP RIVER STATIONS
- EXISTING TWISP RIVER CHANNEL & SIDE CHANNEL
- PARCEL BOUNDARIES
- EXISTING PUSH-UP BERMS
- LEVEE REMOVAL AREA

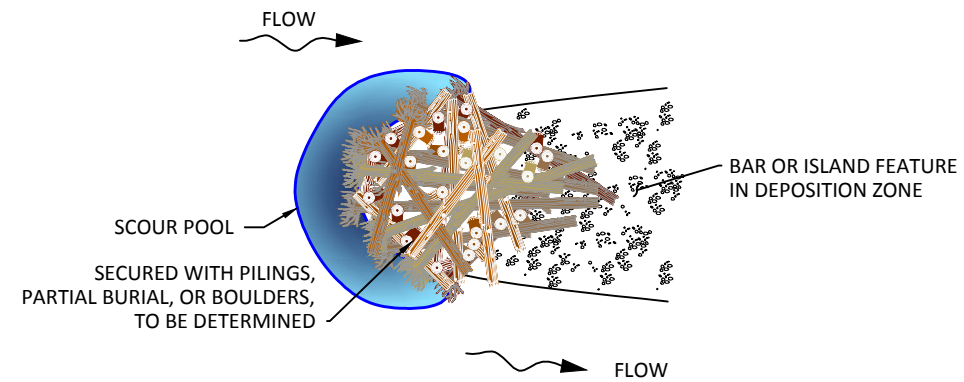
TYPICAL PLAN VIEW  
BAR APEX JAM  
NTS

Bar apex jams would be located in mid-channel areas at the upstream end of areas prone to deposition, creating (and maintaining) a horseshoe-shaped scour pool at the face of the jam and increasing deposition behind the jam structure. These jams, designed to rack additional wood, would help to stabilize aggraded material into stable bars/islands that may become vegetated over time. These jams, and the split-flow conditions that result, provide dynamic complexity and increase channel margin habitat. The jams, often in combination with margin jams, can also be used to activate side-channels and reconnect floodplains. The apex jams that are associated with the side-channel alternatives are intended to serve this purpose.

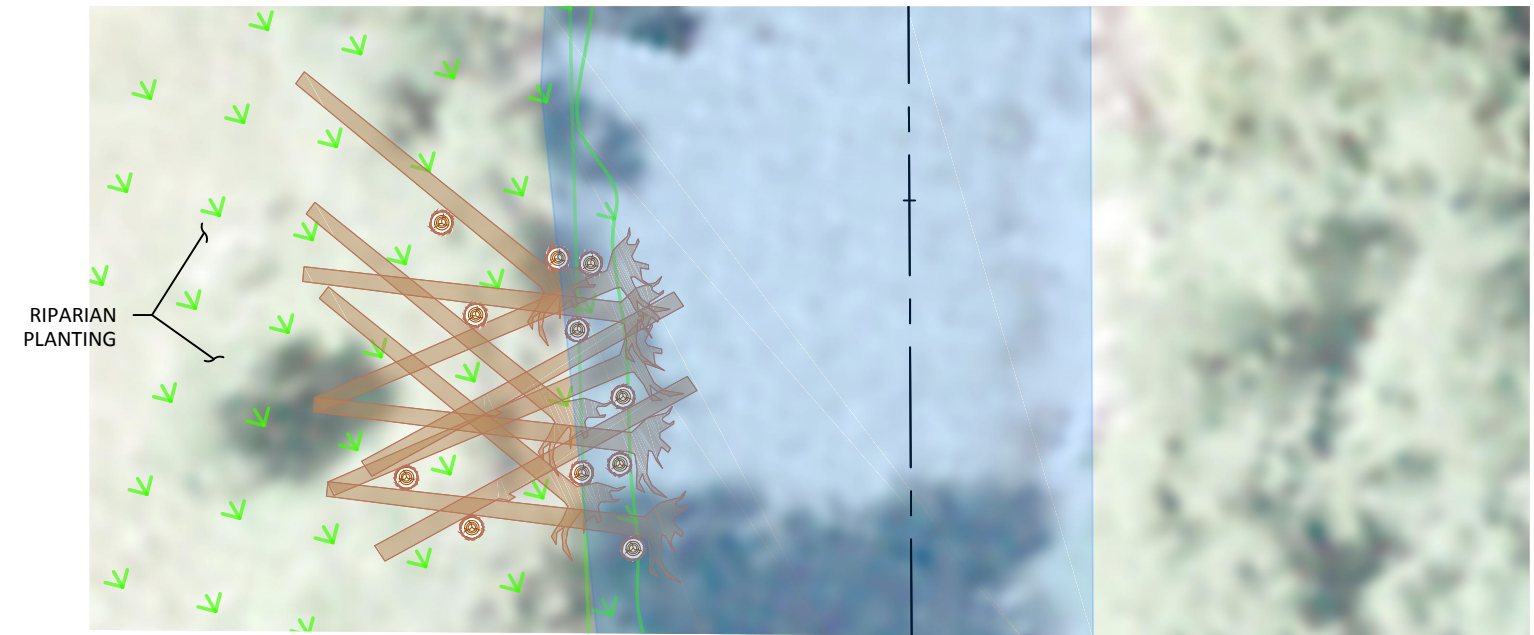
TYPICAL PLAN VIEW  
BANK LOG JAM  
SCALE: 1" = 40'

A large bank log jam would be constructed along the bank downstream of the inlet. This log jam would create scour conditions at the mouth of the inlet as well as provide cover. The inlet to the alcove would be deepened and widened in order to facilitate more connectivity with the main channel. The existing alcove would be selectively excavated so that perennial connectivity would be maintained. Additionally, select excavation could extend the alcove along the terrace wall to the south and along an existing swale parallel to the main channel. Large wood would be added along the length of the alcove to provide cover and habitat complexity.

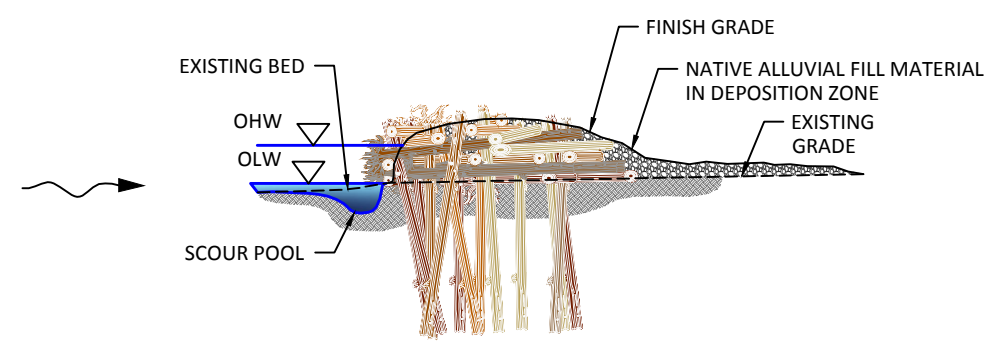
TYPICAL SECTION VIEW  
BAR APEX JAM  
NTS
